[11] Patent Number: 4,866,828

[54] METHOD OF REPAIRING TURBINE
BLADES

[73] Assignee: Refurbished Turbine Components
Limited, Hereford and Worcester,
England

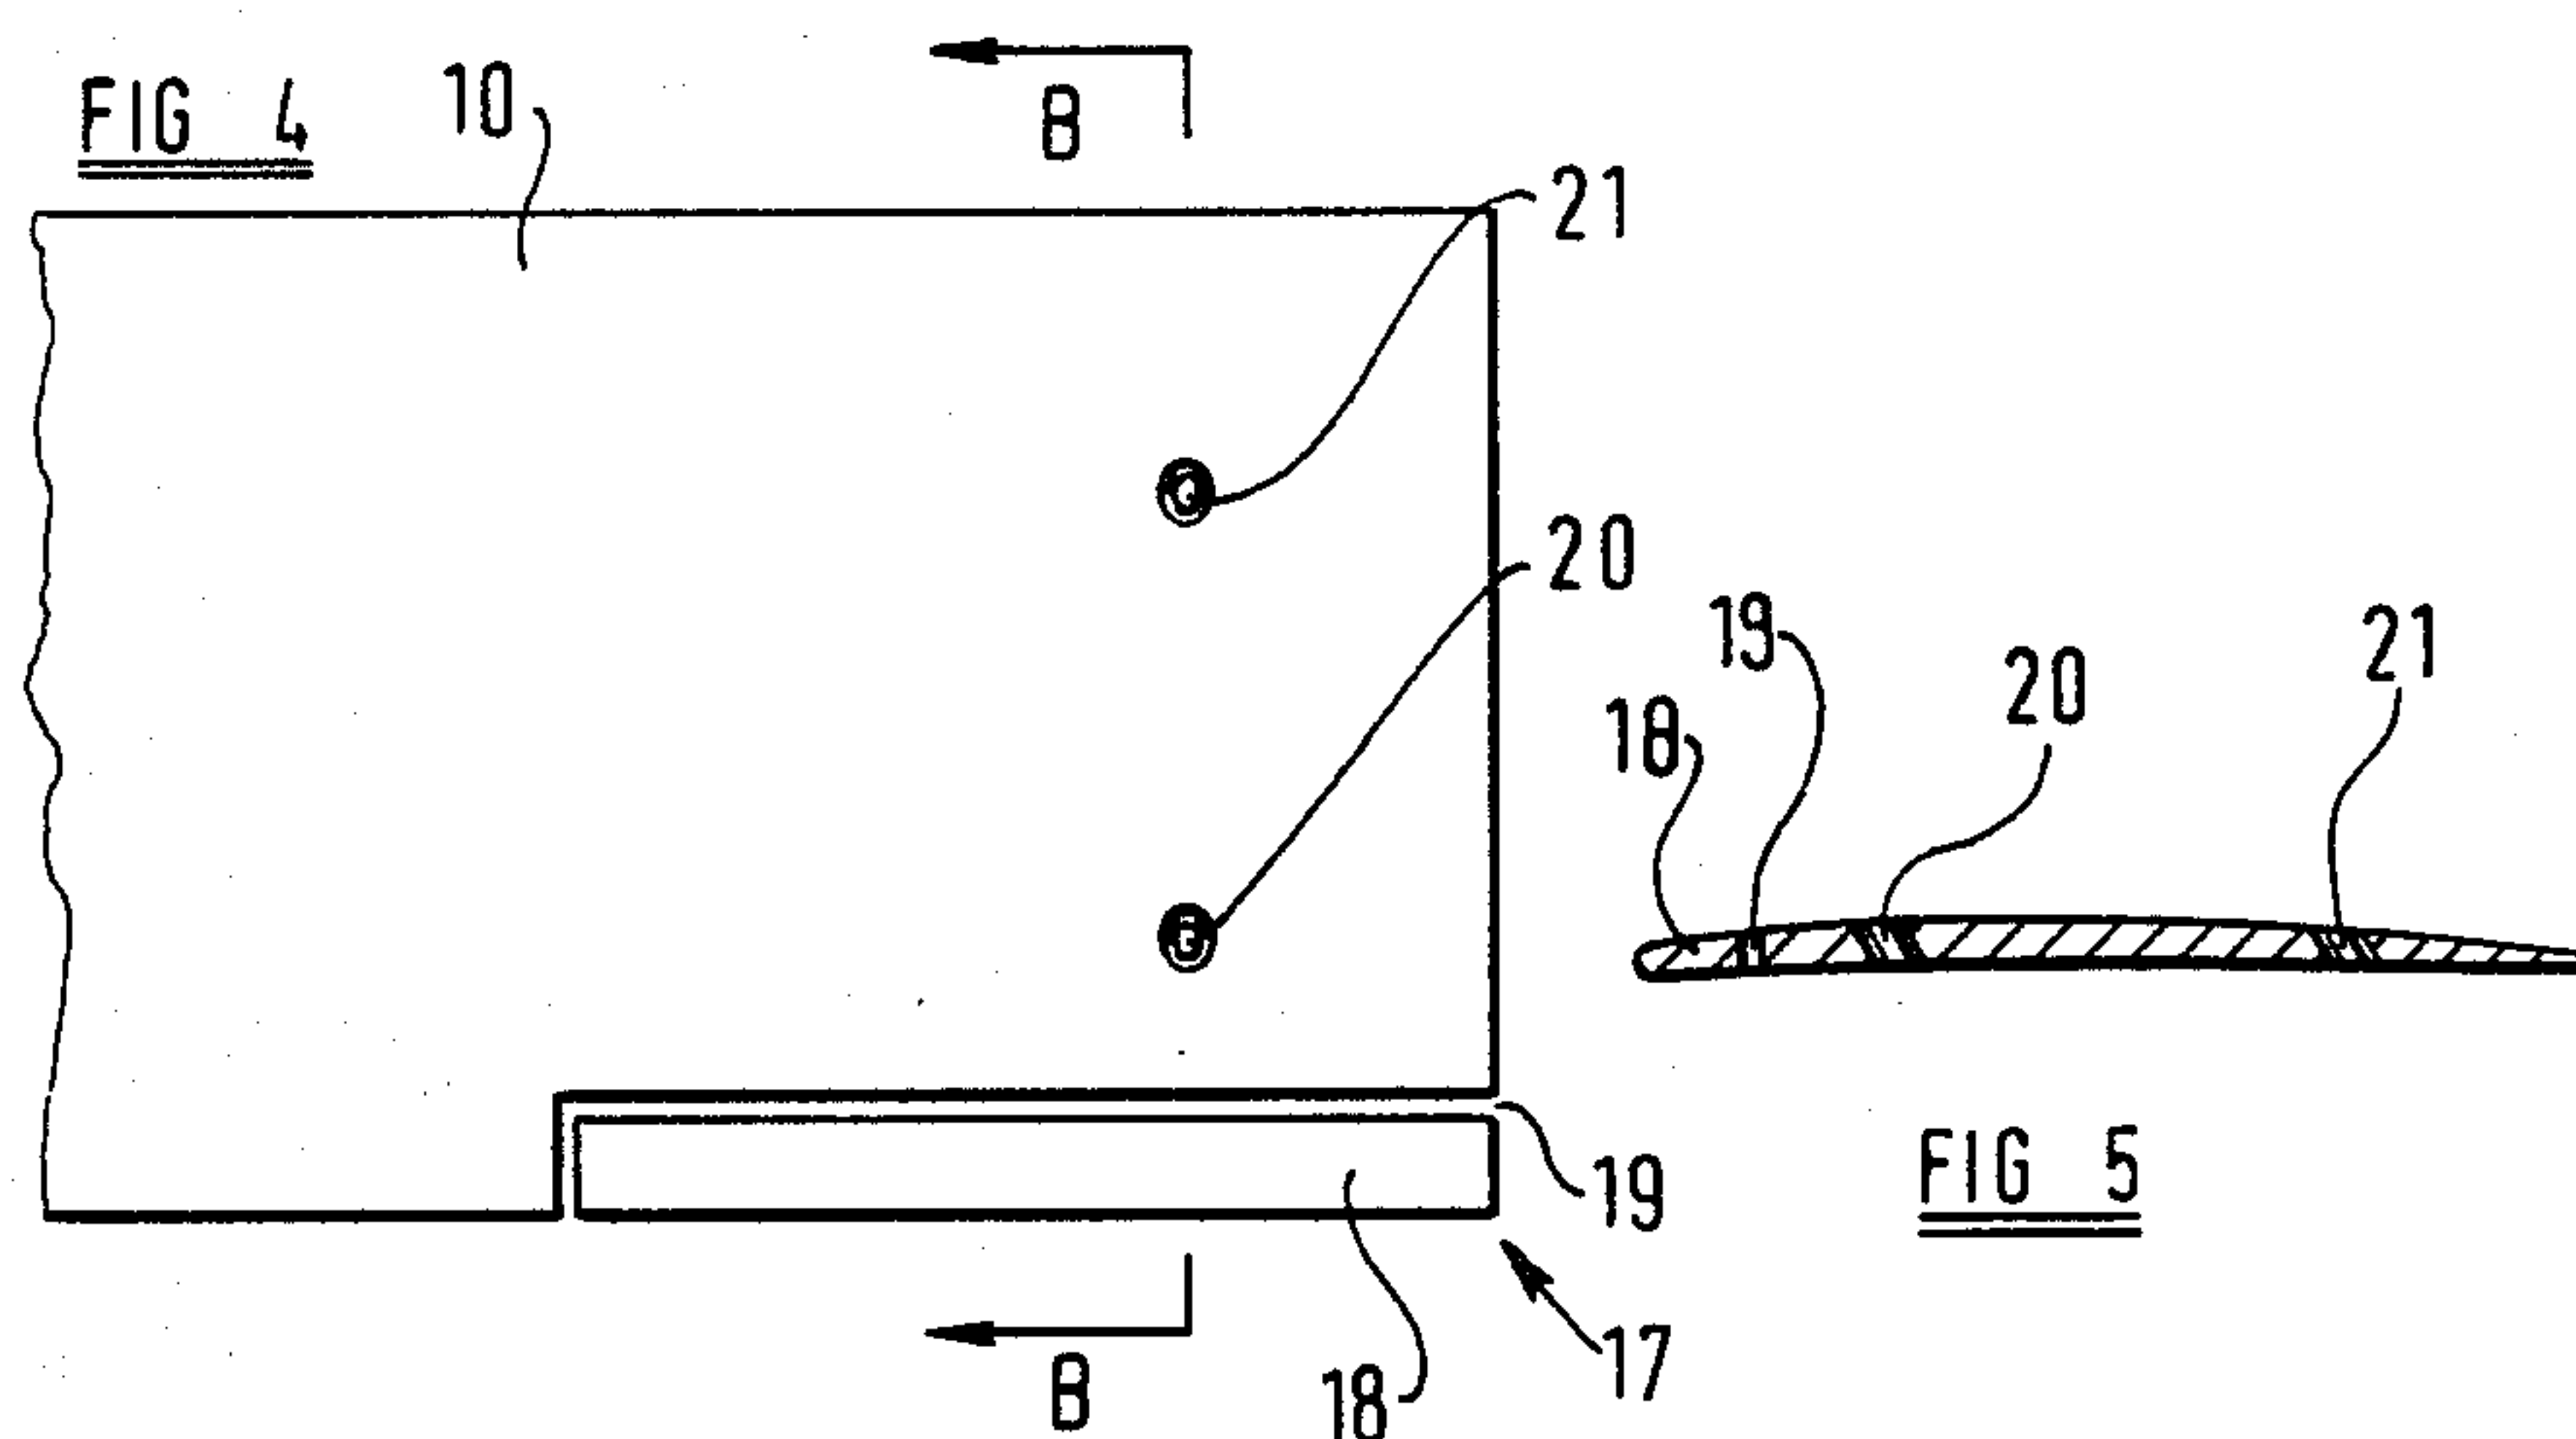
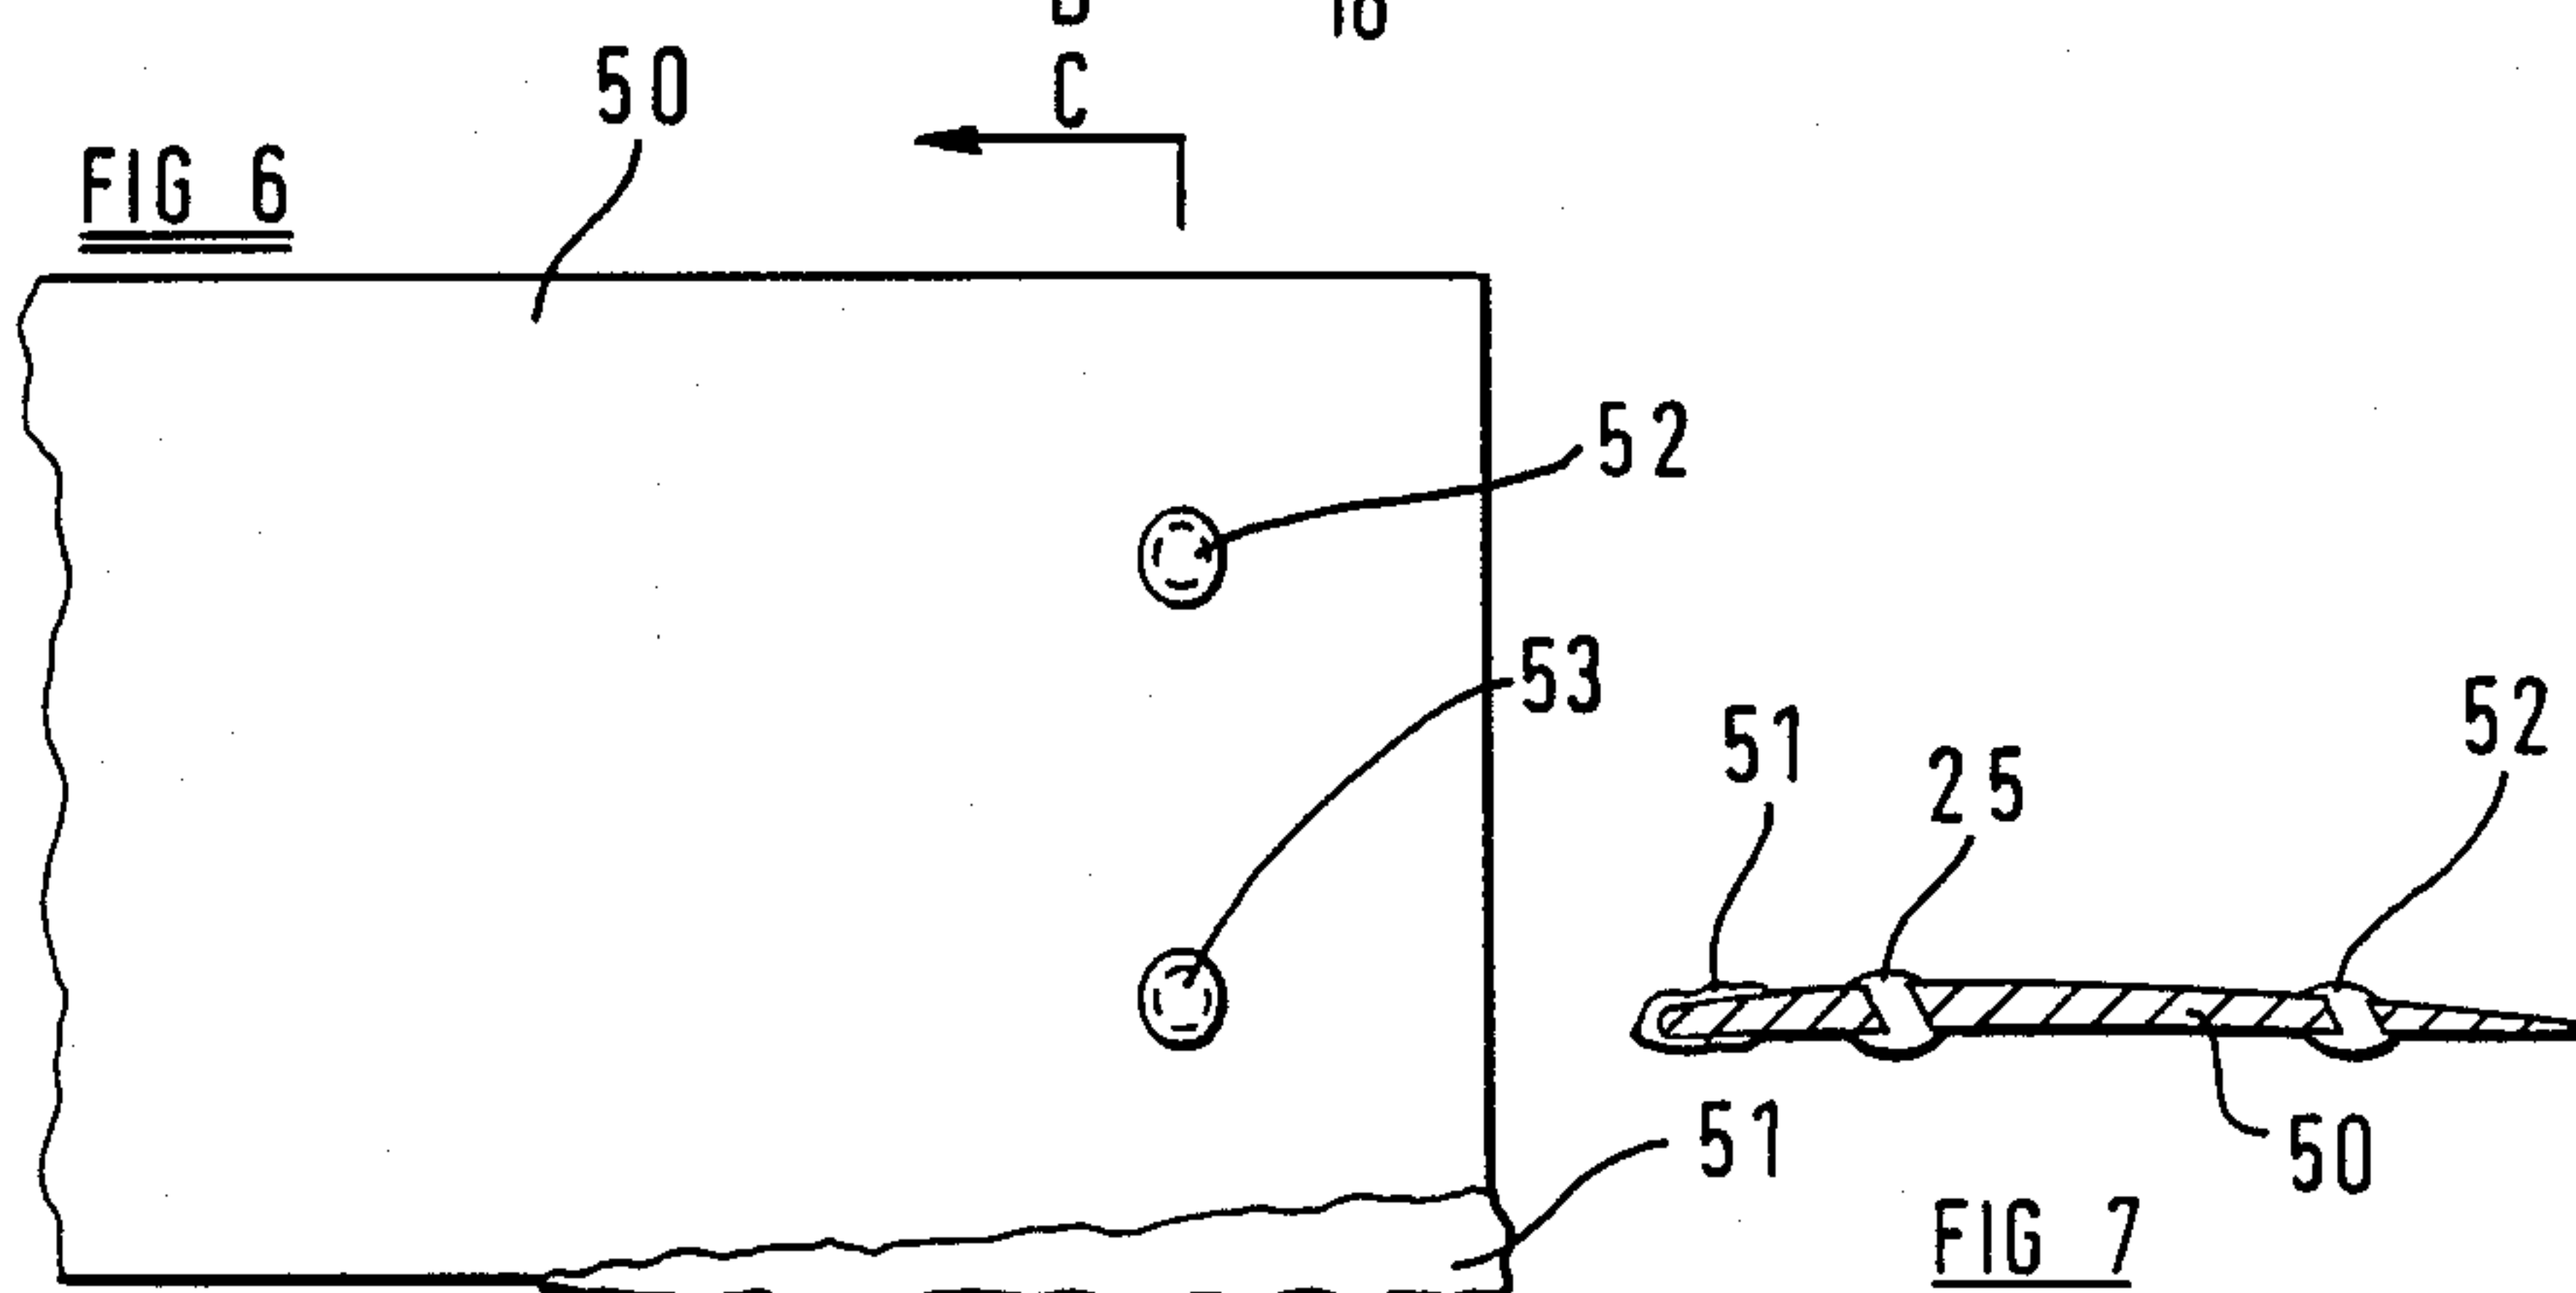
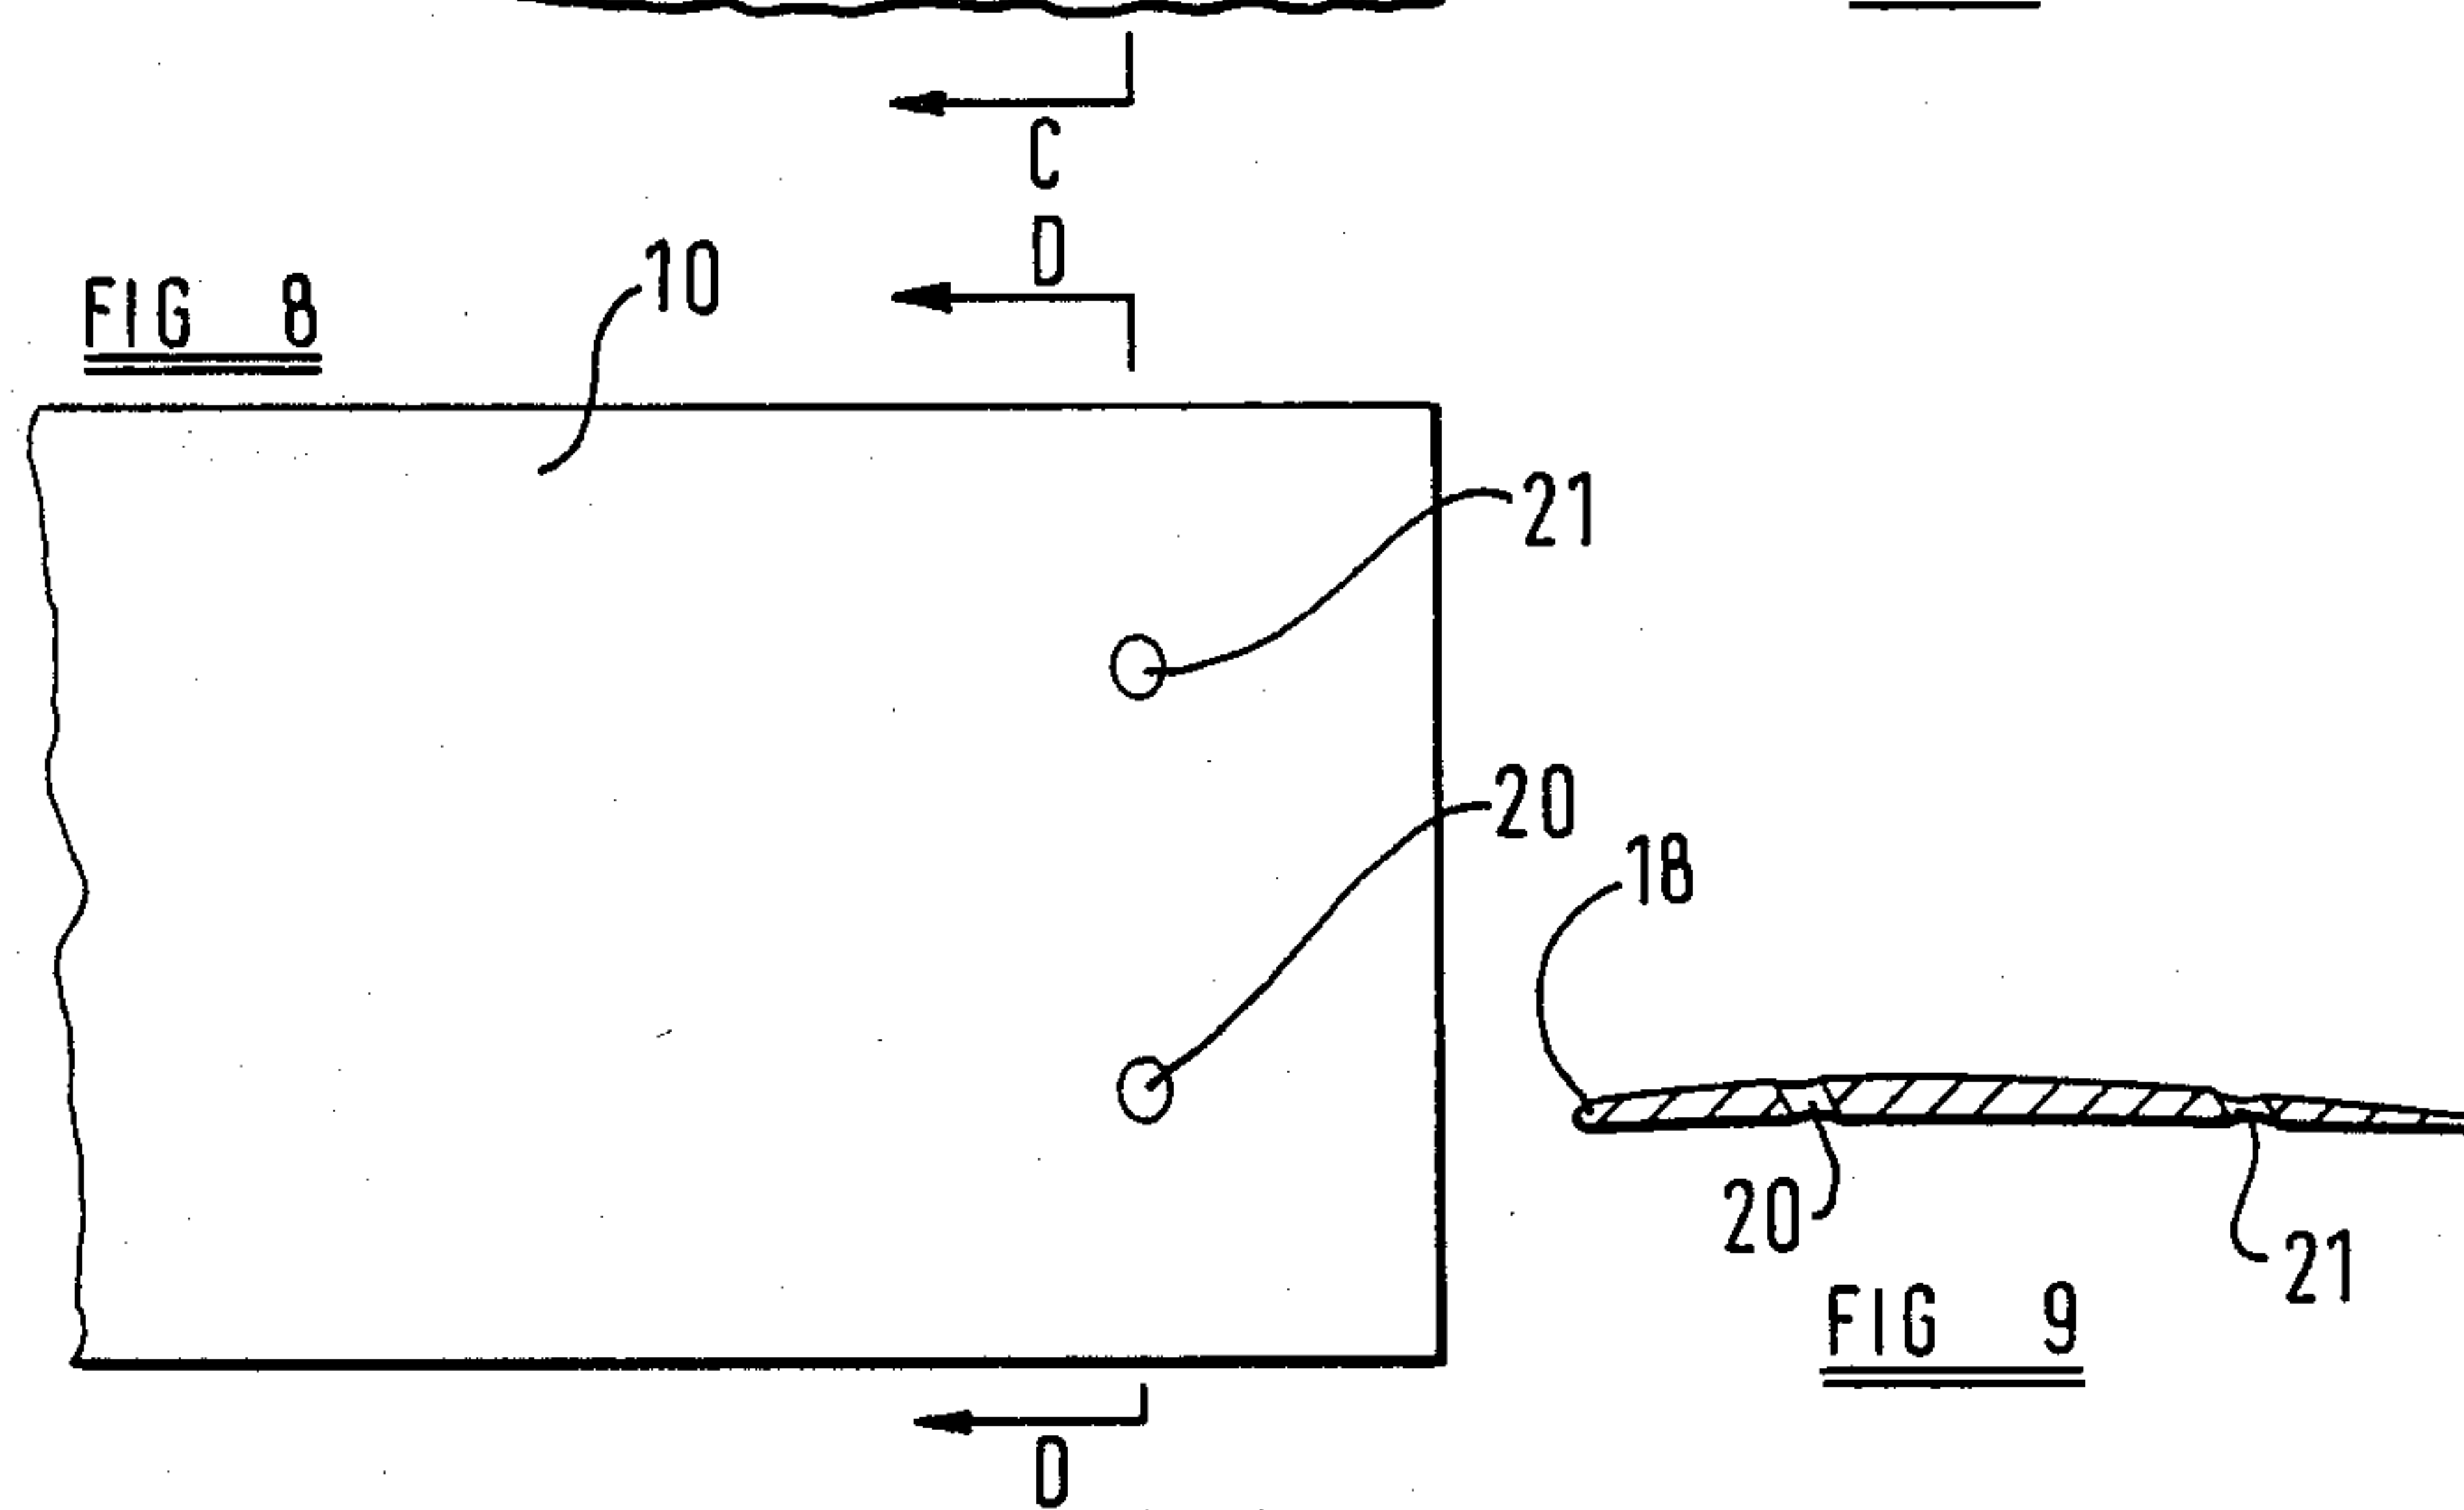
FIG. 8 illustrates a repaired turbine blade;

FIG. 9 is a cross-section along the line D—D shown in FIG. 8;

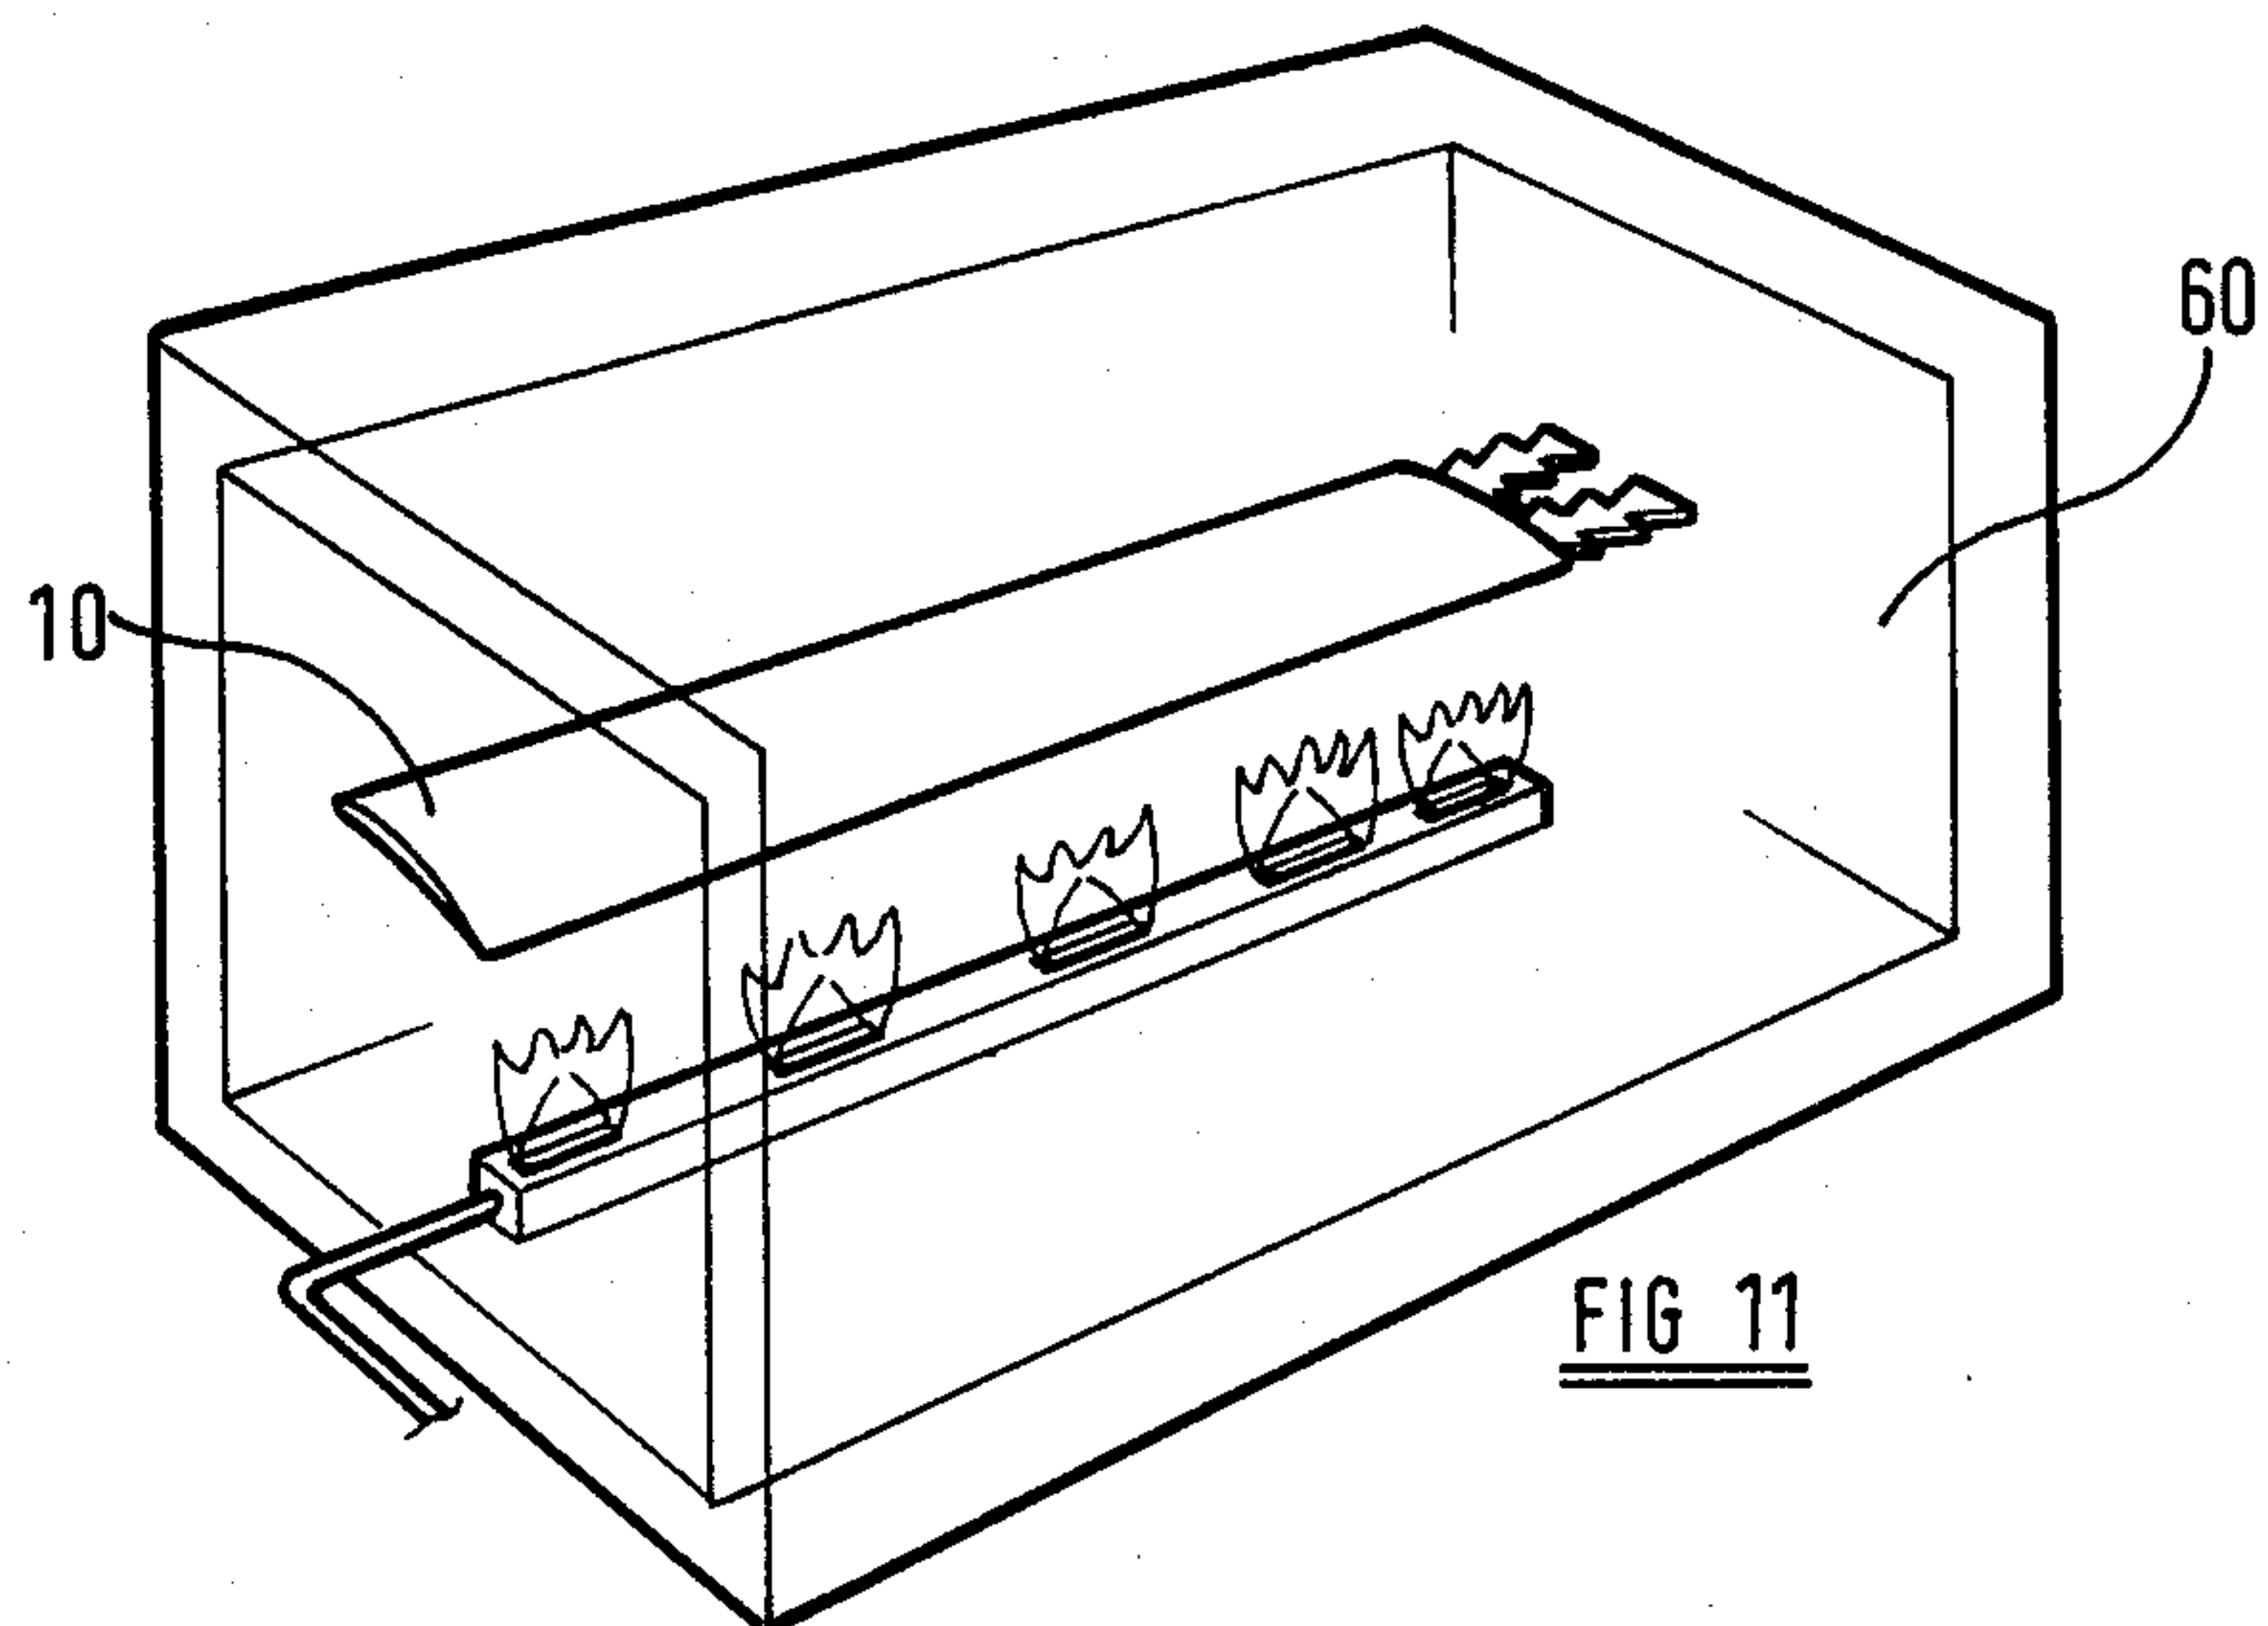
FIG. 10 is a view of a turbine blade in an apparatus to subject the blade to mechanical forces in order to return it to its required form;

The form of the blade involves causing a twisting of the blade between its ends and a simple apparatus for carrying out such twisting is illustrated in FIG. 10.

The root end 24 is held in a vice 25 and the other end 26 is held in a second vice 27 which is pivotally mounted about an axis 28. The vice 27 carries a lever arm 29 having a helically threaded through bore 30 into which extends a helically threaded member 31, which also extends through a helically threaded nut part 32 secured to base member 33. The helically threaded member 31 is provided with a handle 34 by means of which the helically threaded member 31 may be rotated causing pivotal movement of the second vice 26. Since the root end 24 of the turbine blade 10 is held in the vice 25, the turbine blade 10 will be twisted about its longitudinal axis and sufficient mechanical force is used to twist the turbine blade 10 until it has the correct form after having been released from the vices 25 and 27.

It may sometimes be necessary to cause twisting of the turbine blade 10 at localised positions intermediate its ends 24 and 36. A modified apparatus may be provided in which the vices 25 and 27 are movable towards and away from each other along an axis parallel with the turbine blade longitudinally, thereby enabling the blade 10 to be gripped at any two positions along its length.

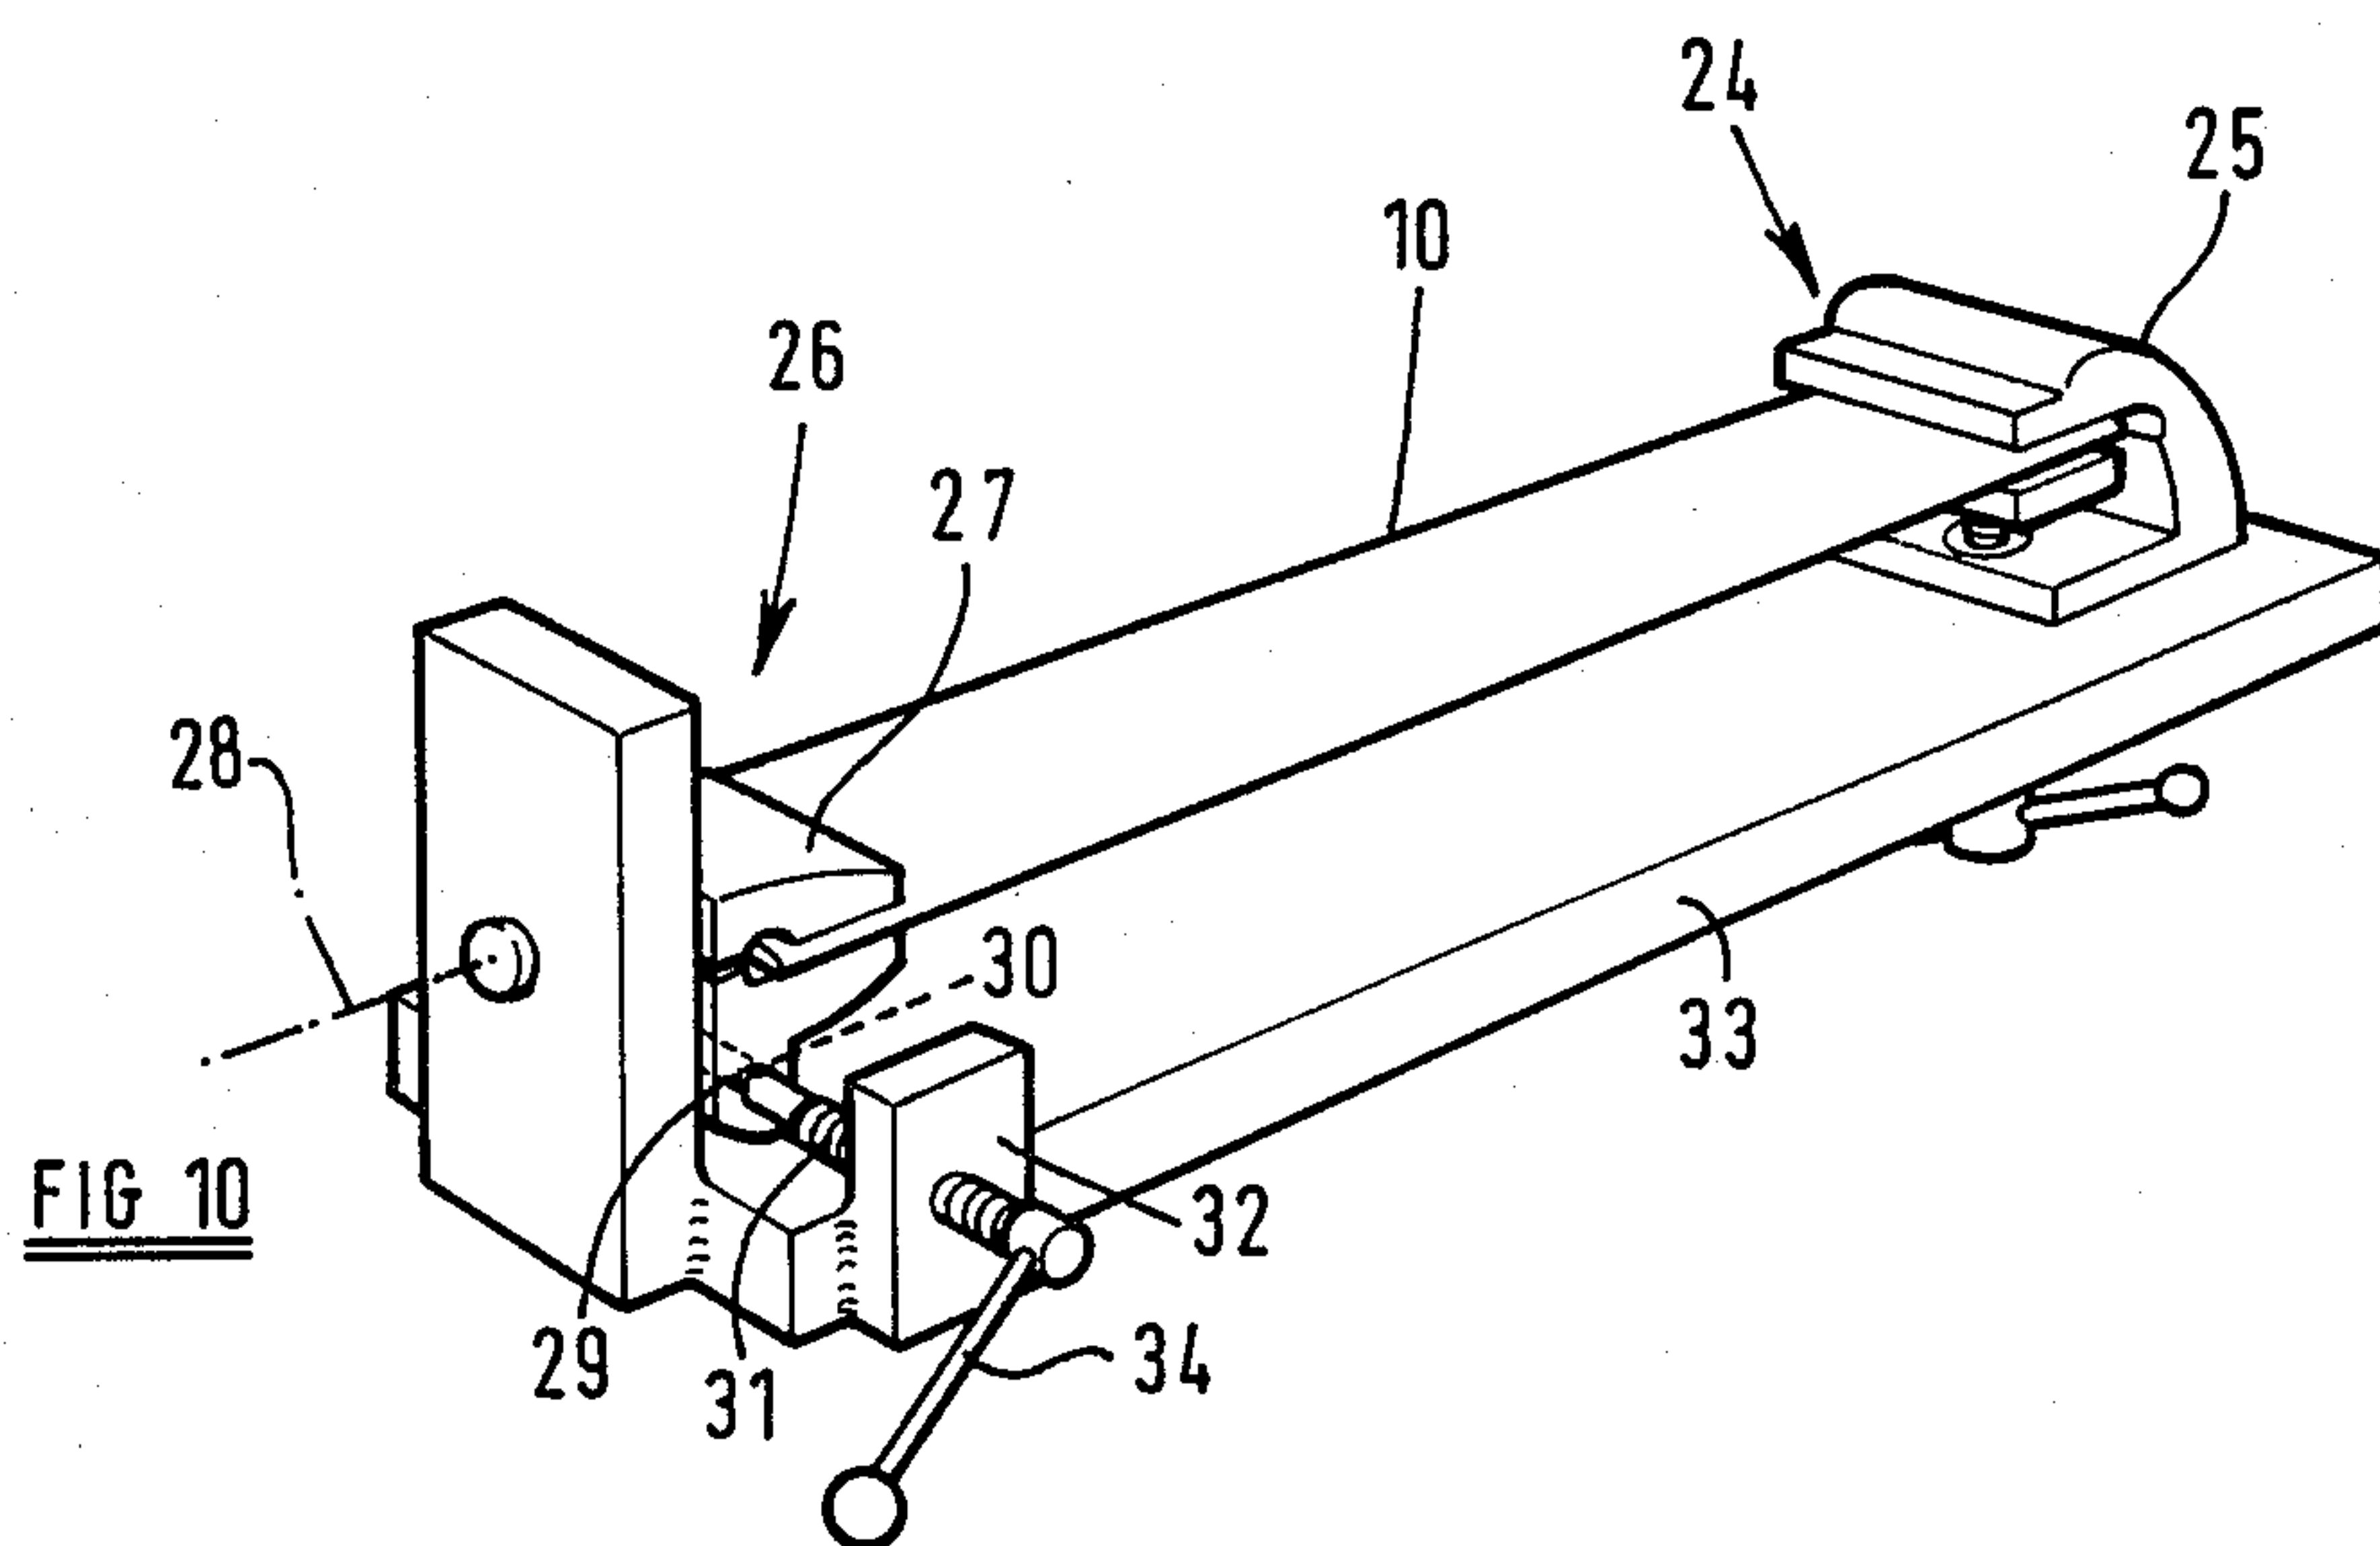
FIG. 11 is a schematic view illustrating the turbine blade in a furnace or heat treatment;

Referring to FIG. 11, the heat treatment may be carried out in any suitable oven 60, the temperature to which the blade is heated and the time to which it is subjected to such heat, depending on the size of the turbine blade and the material from which it is made. A typical heat treatment for a blade made from a 12% chrome steel being 1 hour at 660° C.

After the application of such mechanical forces, the blade is subjected to heat treatment, for example as in the oven 60 shown in FIG. 11, and then the form and shape of the blade may be checked by a gauge such as that shown in FIGS. 12 and 13.

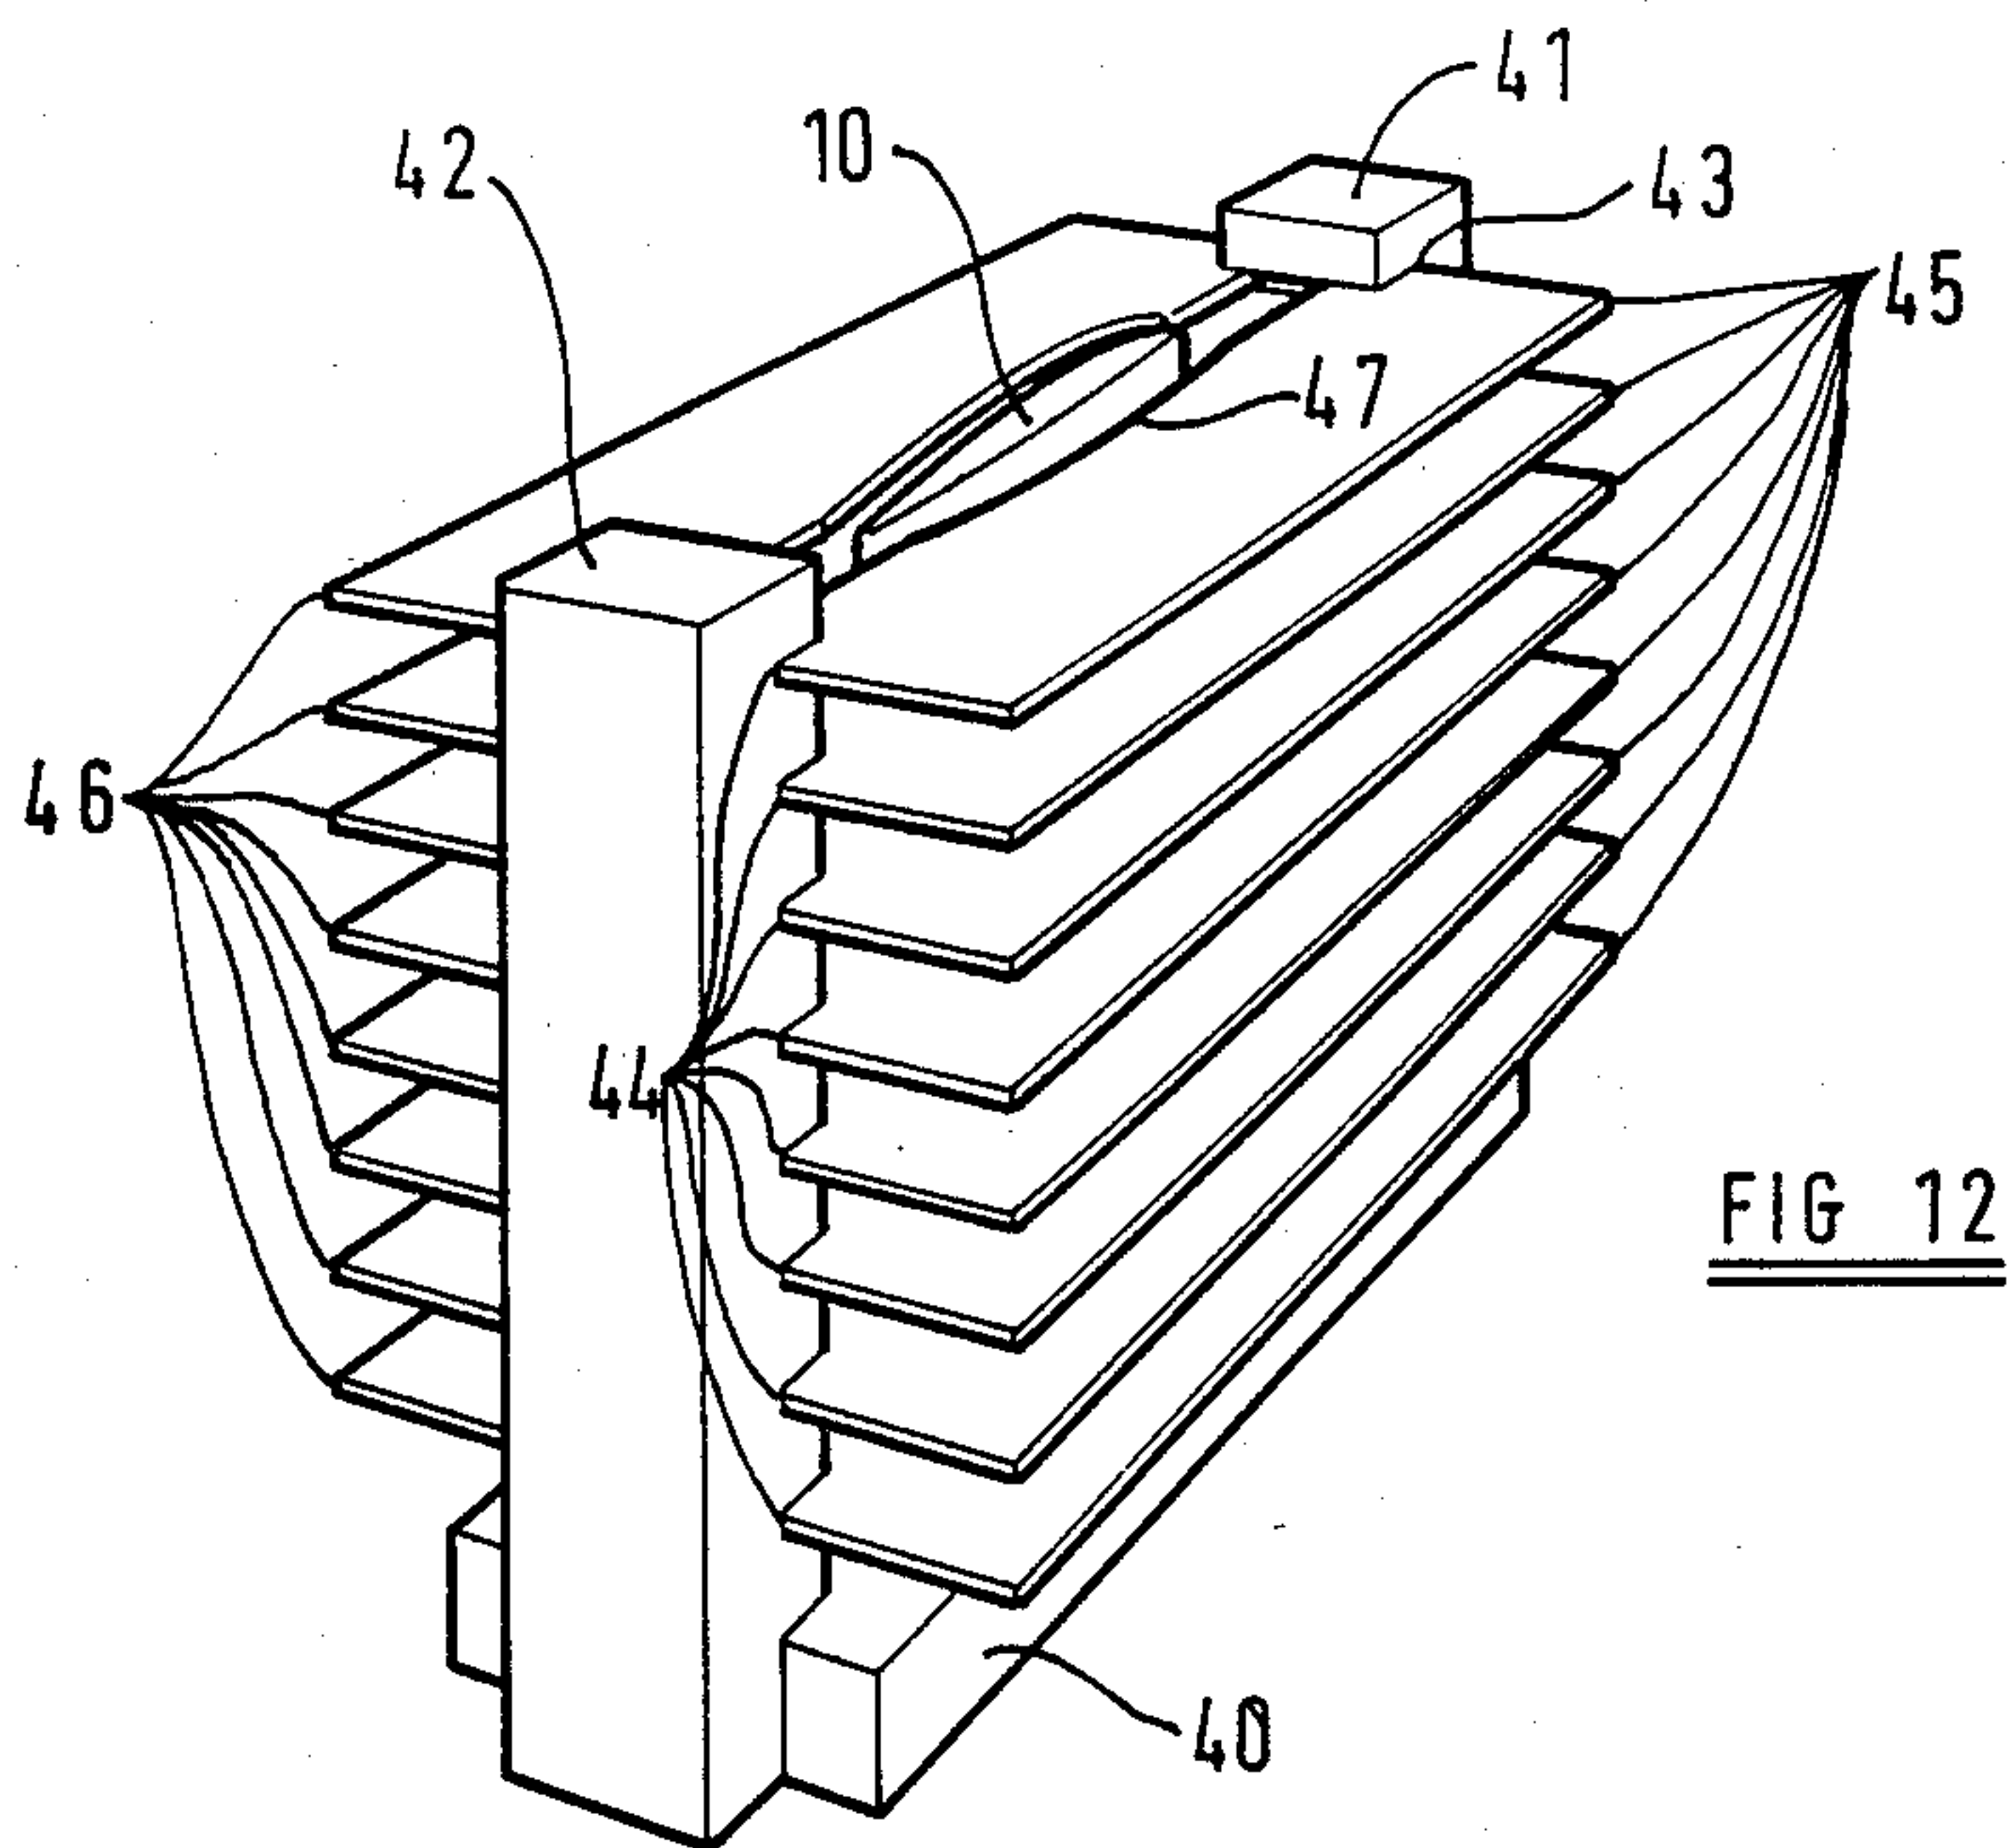
FIG 12

FIG. 12 is a perspective view of a gauge apparatus;

The gauge shown in FIGS. 12 and 13 comprises a base member 40 having a pair of upwardly extending support members 41 and 42, each of the members 41 and 42 being provided with horizontally aligned slots 43 and 44 respectively.

Extending between and located in each pair of horizontally opposed slots 43 and 44 are a pair of gauge members 45 and 46. Each of the gauge members 45 and 46 which comprise metal plates have a cut-out 47 and 48 respectively which corresponds to half the desired cross-sectional profile of the turbine blade 10 at a distance from the base member 40 determined by the distance from the base of the respective horizontally opposed channels 42 and 43.

In order to check if the turbine blade 10 is of the correct form and shape, it is carefully positioned on the base member 40 and the gauge plates 45 and 46 inserted into their respective channels 42 and 43 and moved into contact with the turbine blade 10. If the gauge plates 45 and 46 do not fit around the turbine blade perfectly, i.e. there is a gap at any position between a gauge plate and the turbine blade, either the form or shape of the blade requires some correction, the form being corrected by imparting a twisting force to the blade as afore-described, and the shape being corrected by the addition or removal of material by welding or grinding respectively for example.
