[11] Patent Number: 4,866,828

[54] METHOD OF REPAIRING TURBINE
BLADES

[73] Assignee: Refurbished Turbine Components
Limited, Hereford and Worcester,
England

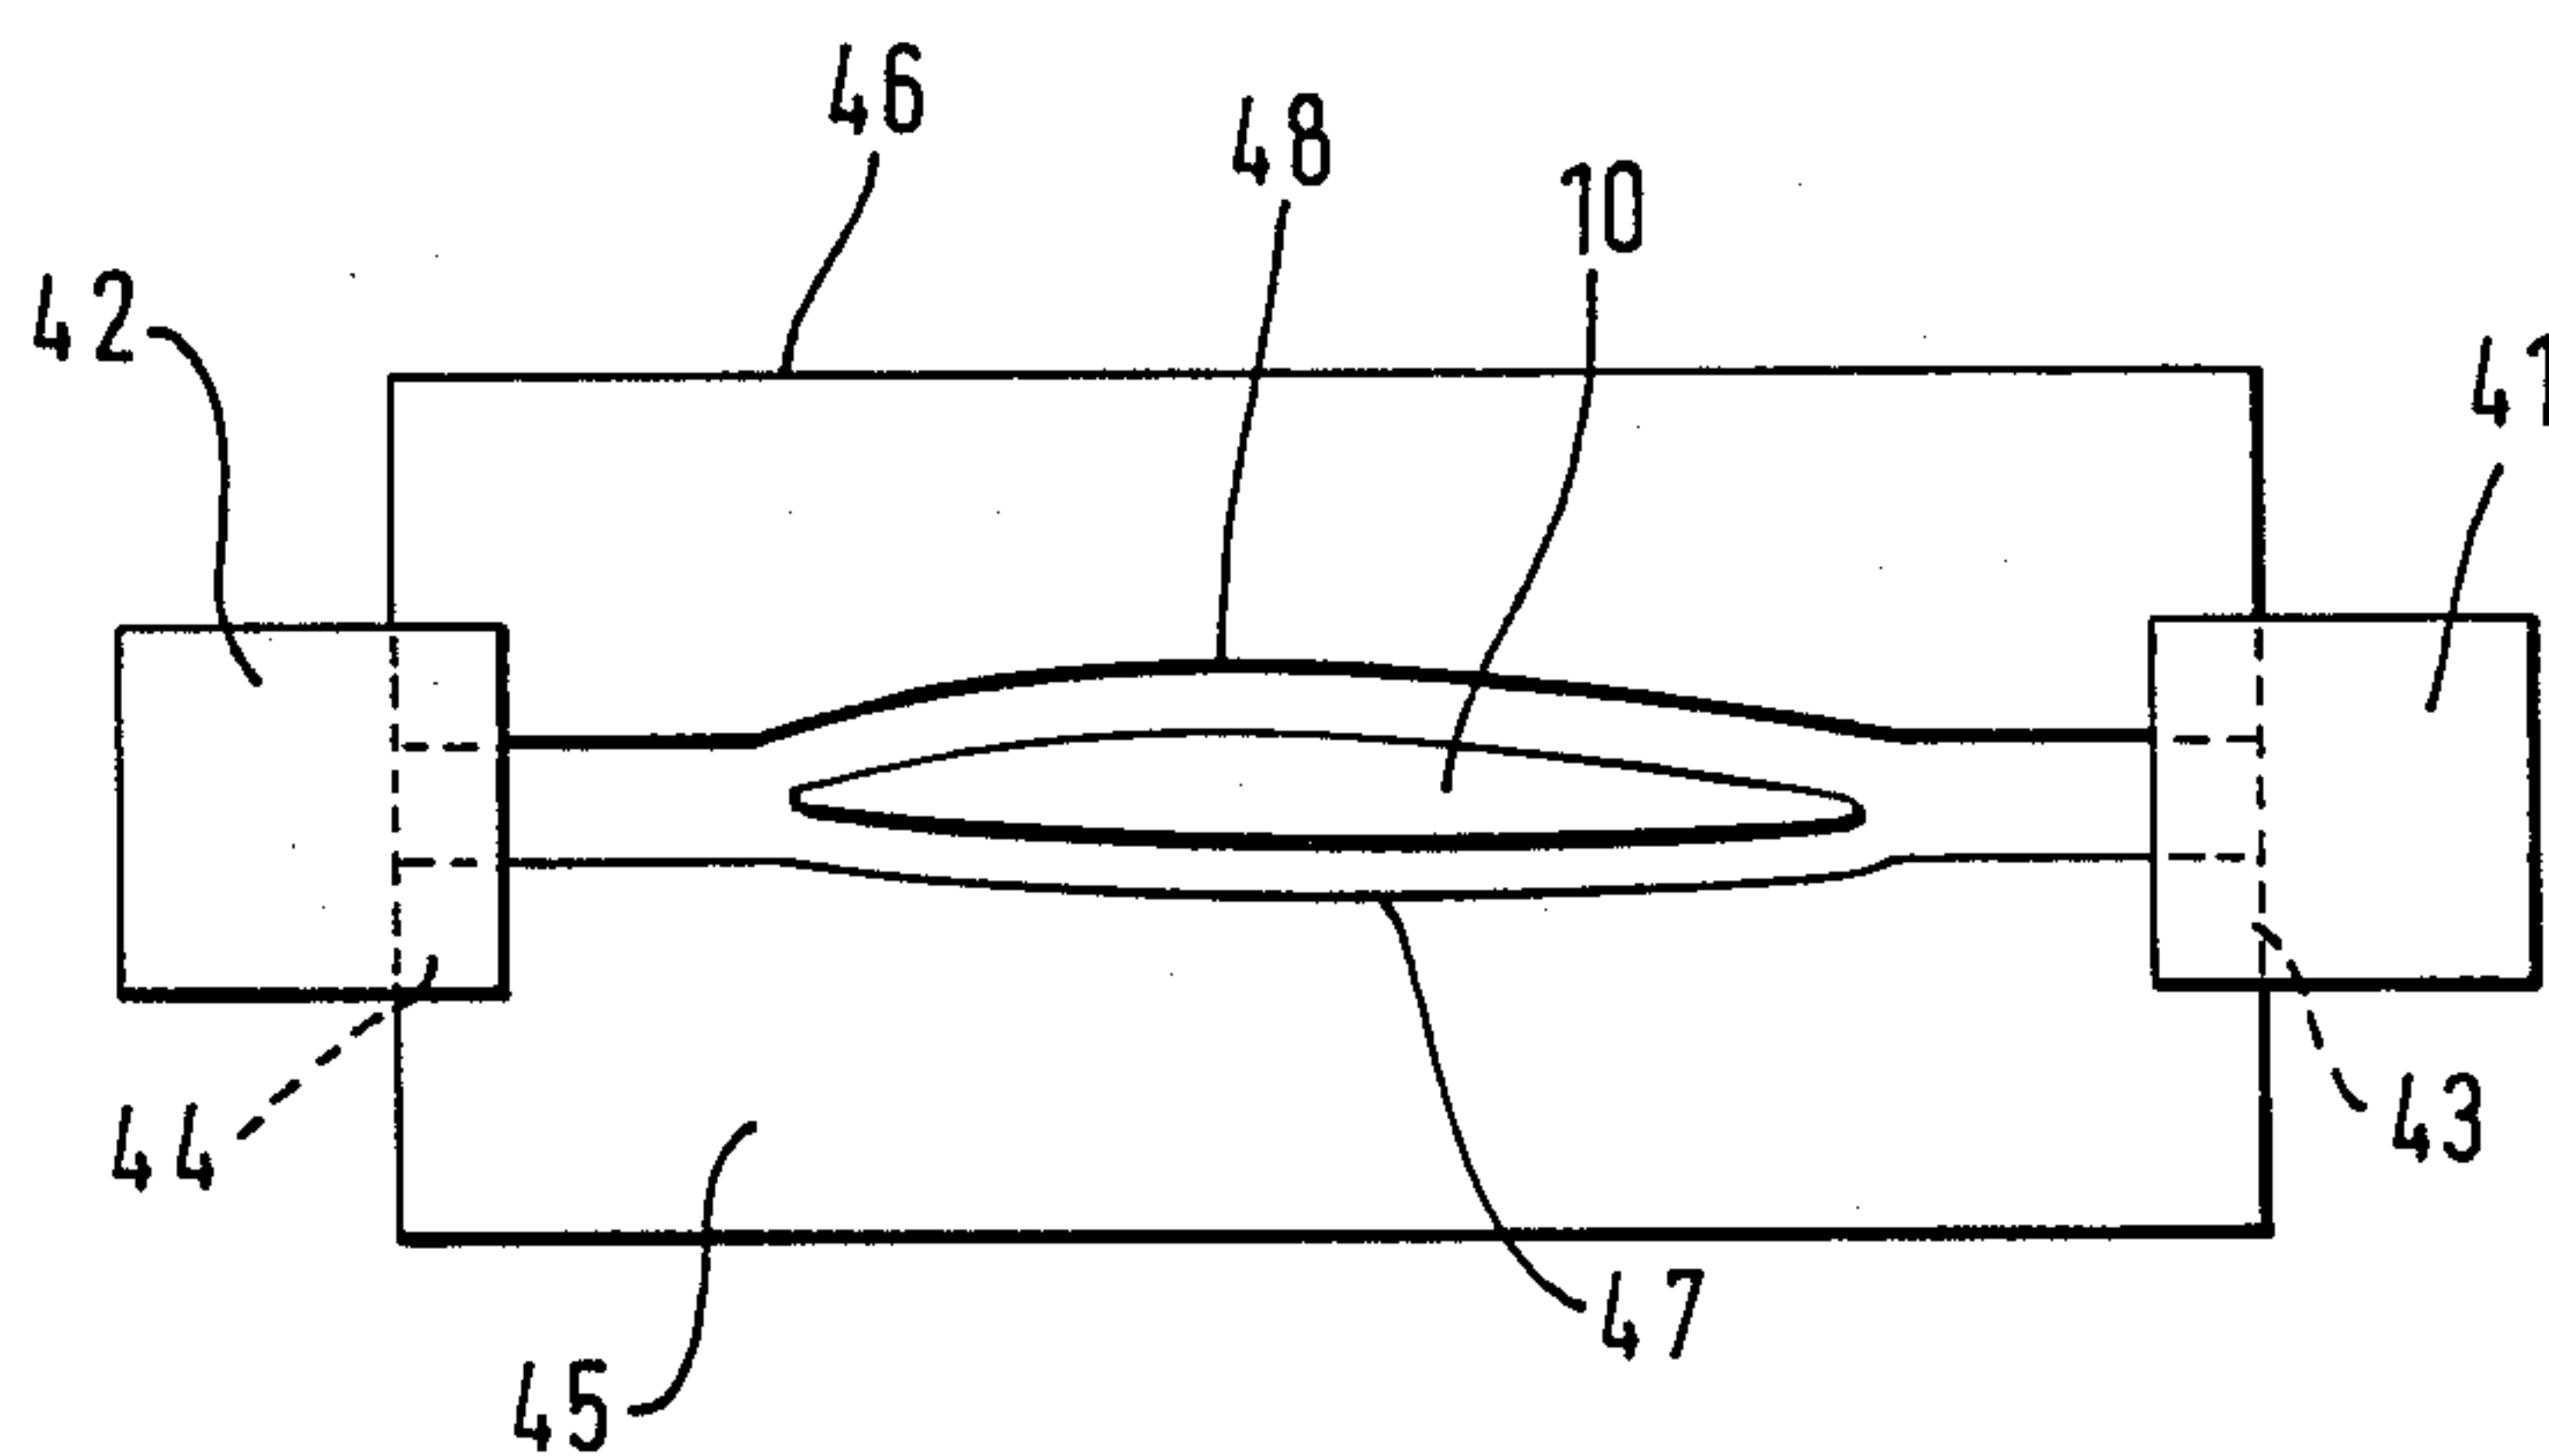
FIG 13

FIG. 13 is a plan view of the gauge apparatus shown in FIG. 12.

The gauge shown in FIGS. 12 and 13 comprises a base member 40 having a pair of upwardly extending support members 41 and 42, each of the members 41 and 42 being provided with horizontally aligned slots 43 and 44 respectively.

Extending between and located in each pair of horizontally opposed slots 43 and 44 are a pair of gauge members 45 and 46. Each of the gauge members 45 and 46 which comprise metal plates have a cut-out 47 and 48 respectively which corresponds to half the desired cross-sectional profile of the turbine blade 10 at a distance from the base member 40 determined by the distance from the base of the respective horizontally opposed channels 42 and 43.

In order to check if the turbine blade 10 is of the correct form and shape, it is carefully positioned on the base member 40 and the gauge plates 45 and 46 inserted into their respective channels 42 and 43 and moved into contact with the turbine blade 10. If the gauge plates 45 and 46 do not fit around the turbine blade perfectly, i.e. there is a gap at any position between a gauge plate and the turbine blade, either the form or shape of the blade requires some correction, the form being corrected by imparting a twisting force to the blade as afore-described, and the shape being corrected by the addition or removal of material by welding or grinding respectively for example.
