[54] **HEAT TREATED CHEMICALLY VAPOR DEPOSITED PRODUCTS**

[57] **ABSTRACT**

"A coated substrate product is described wherein the outer coating on the substrate is comprised of a chemically vapor deposited and heat treated mixture of tungsten and tungsten carbide. The tungsten carbide phase consists of W₂C or W₃C or a mixture of W₂C and W₃C. During the heat treating, the coated substrate is heated to the deposition temperature or not substantially above the deposition temperature in a non-reactive atmosphere. The heat treating temperature is sufficient to confer a desired improvement in erosive and abrasive wear resistance in the outer coating but does not result in substantial degradation of the mechanical properties of the substrate or in formation of undesirable inter-metallic layers".

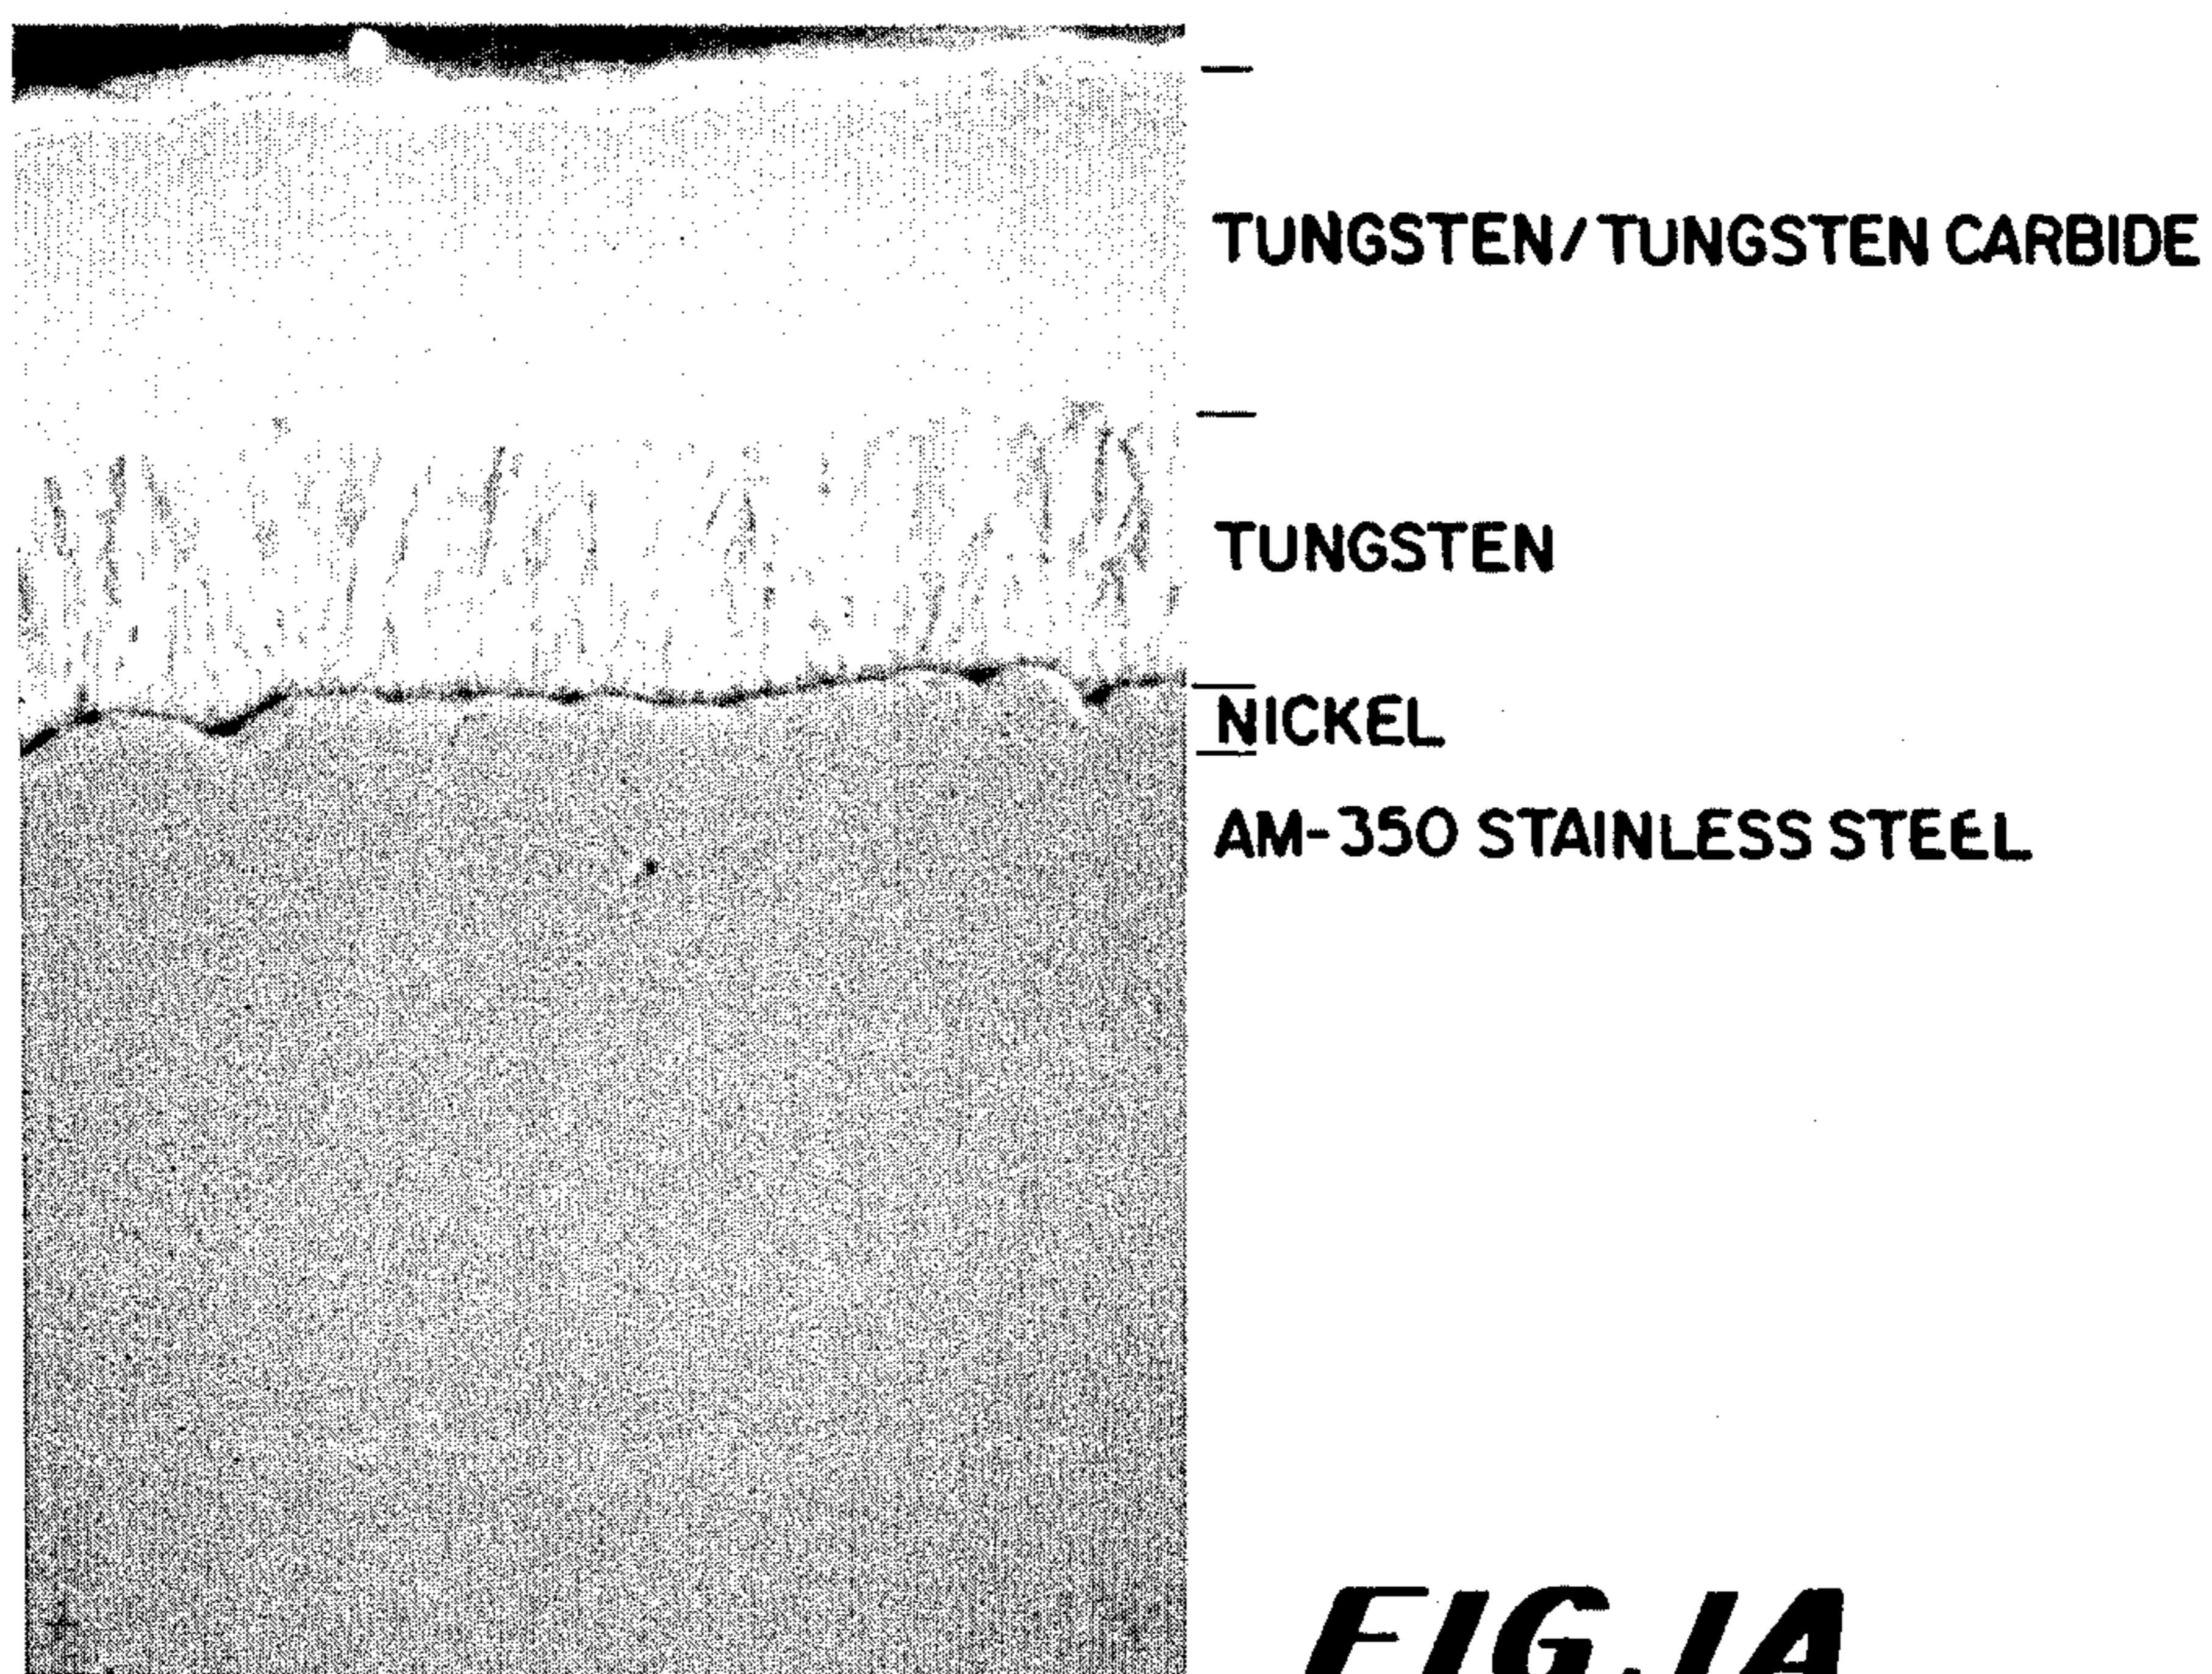
FIG. 1A is a photomicrograph, magnified 2000 times, of an etched cross section of a coating system according to the invention on AM-350 stainless steel substrate in the as-deposited and unheat-treated condition showing non-uniform microstructure in the top one-fourth thickness of the tungsten/tungsten carbide layer.

The resultant product includes an outer layer of a tungsten/tungsten carbide which has a substantially layered and uniform microstructure substantially free of cracks. By viewing FIG. 1A, the substantially layered microstructure of the deposit before heat treatment may be observed. It will also be noted that, although the deposit is substantially free of cracks, a somewhat non-uniform microstructure exists in the outer 25% of the tungsten/tungsten carbide layer. As may be seen in FIG. 2A, the heat treatment removes this non-uniformity. Moreover, the data set out below demonstrate that the outer layer furthermore has a substantially higher erosion and abrasion wear resistance than in the unheat-treated condition.

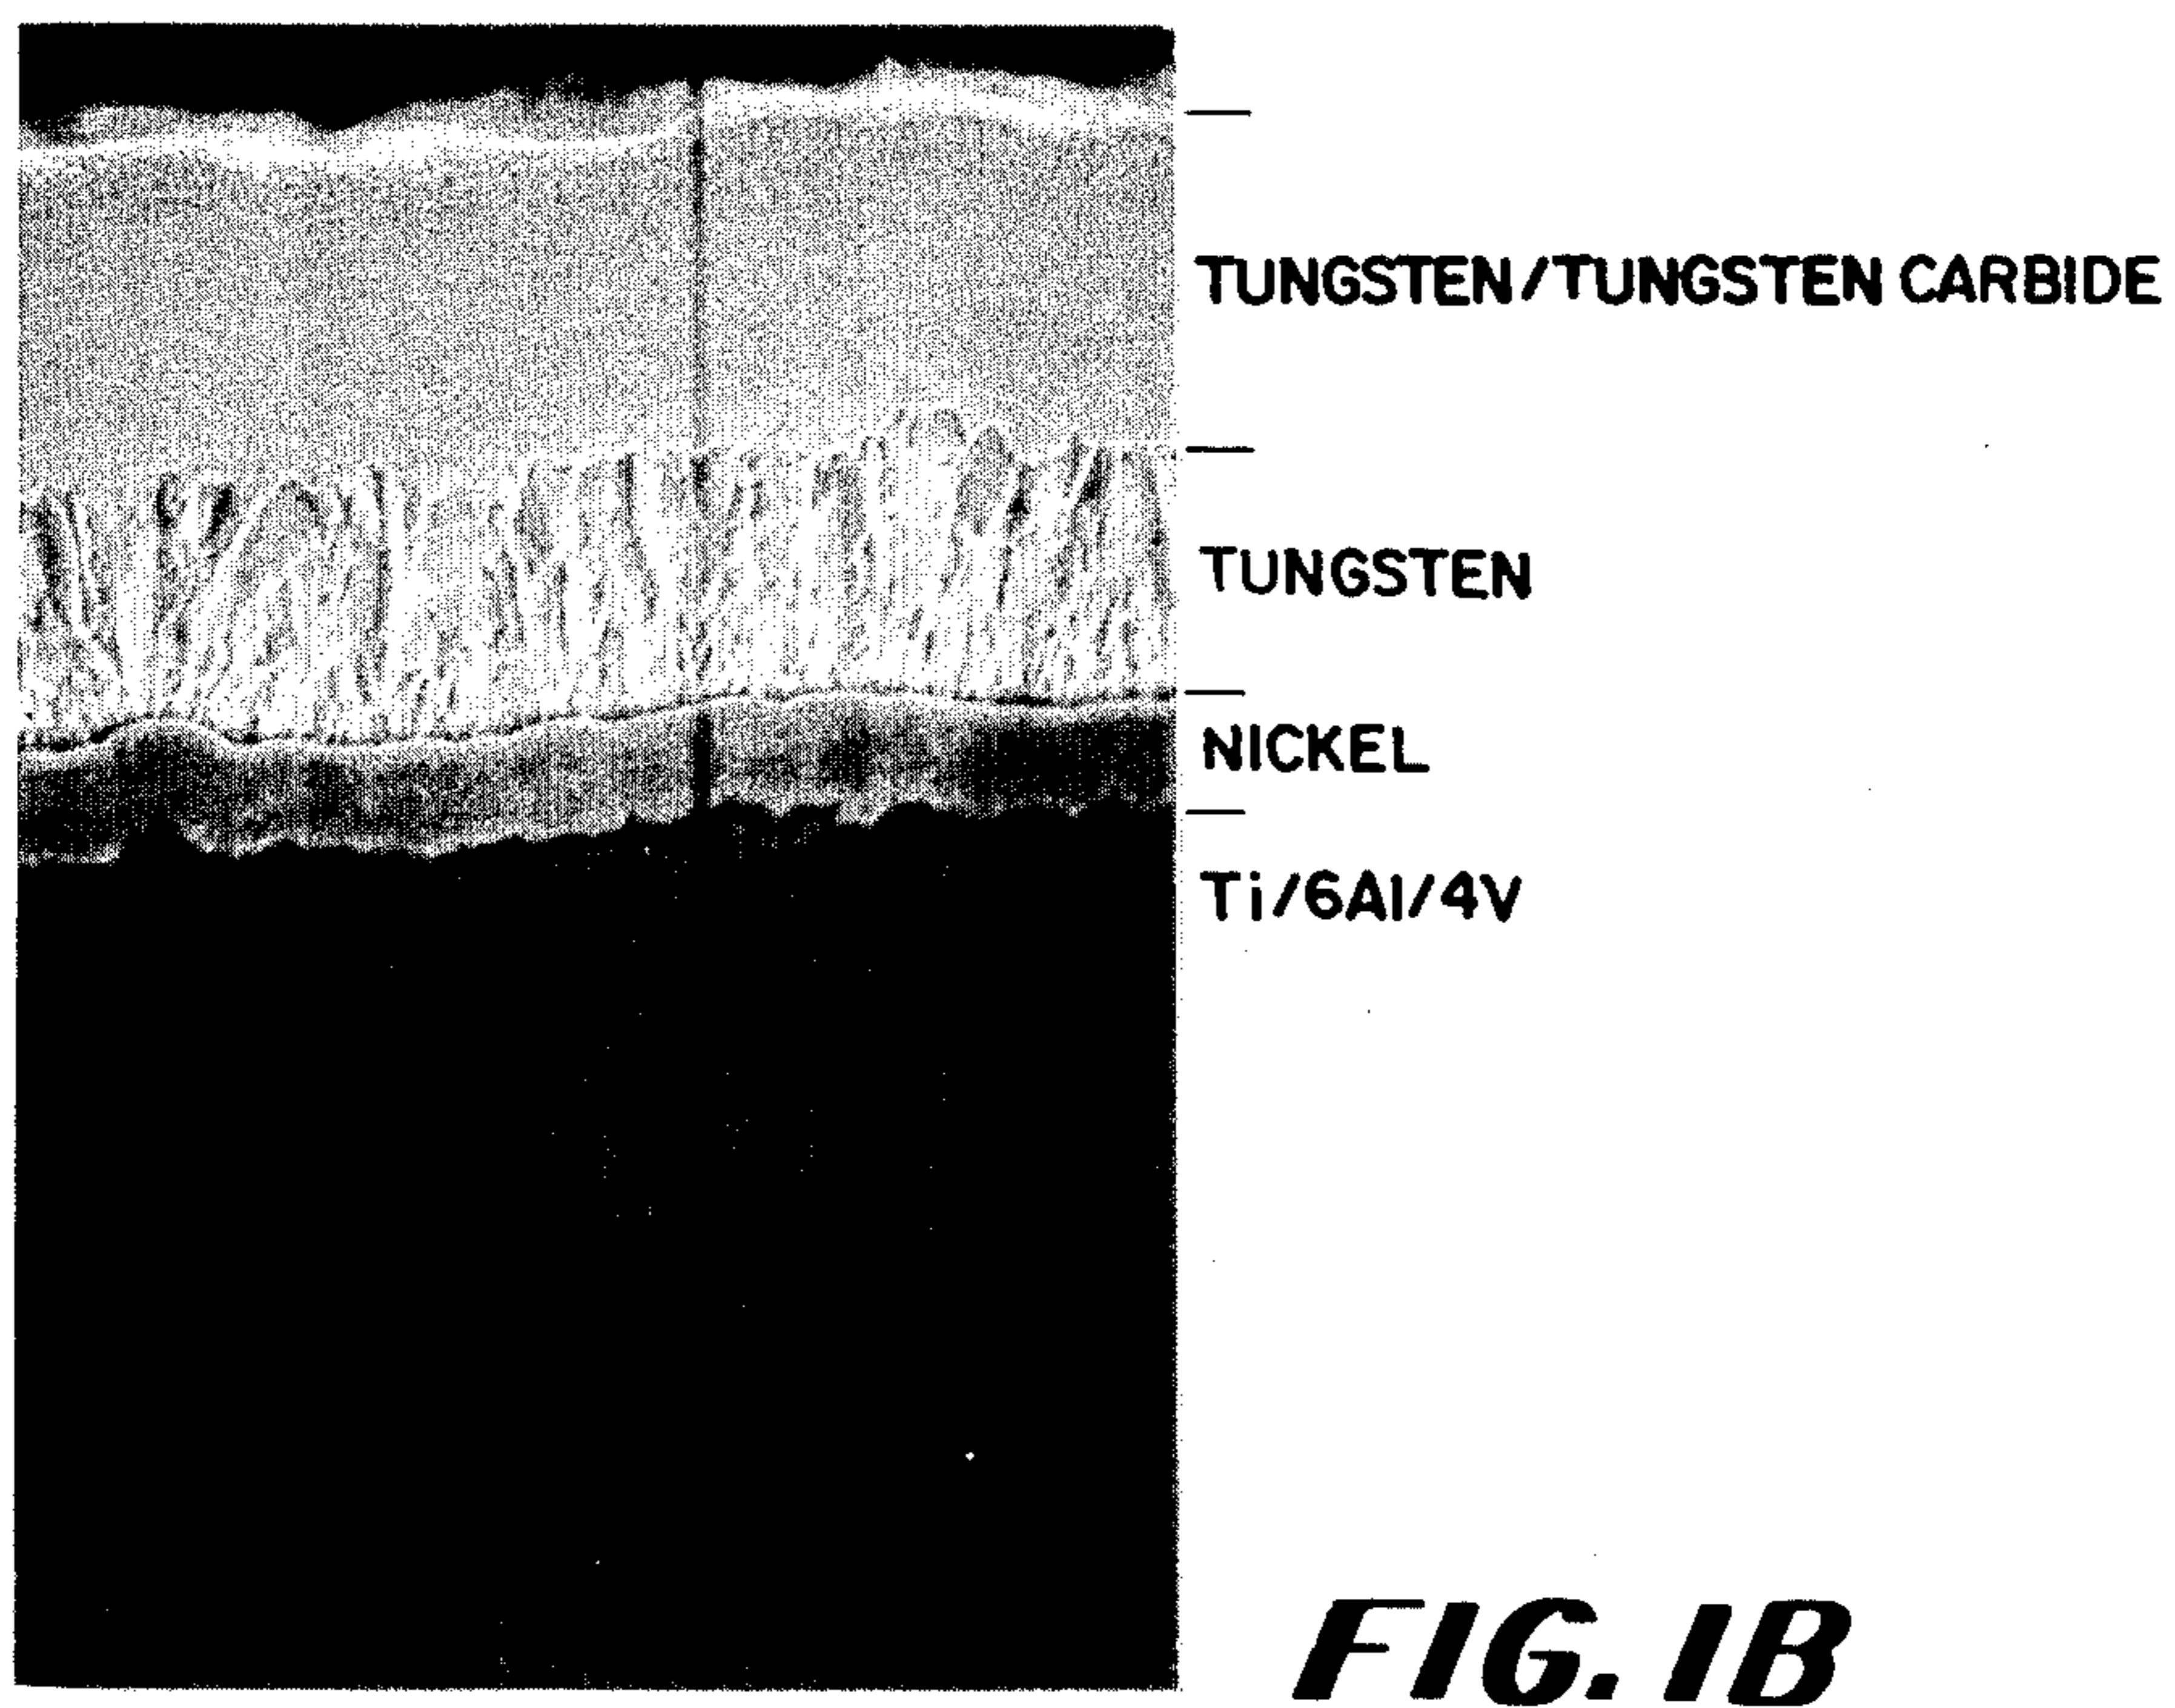
FIG. 1B is a photomicrograph, magnified 2000 times, of an etched cross section of a coating system according to the invention on Ti/6Al/4V substrate in the as-deposited and unheat-treated condition showing non-uniform microstructure in the top one-fourth thickness of the tungsten/tungsten carbide layer.

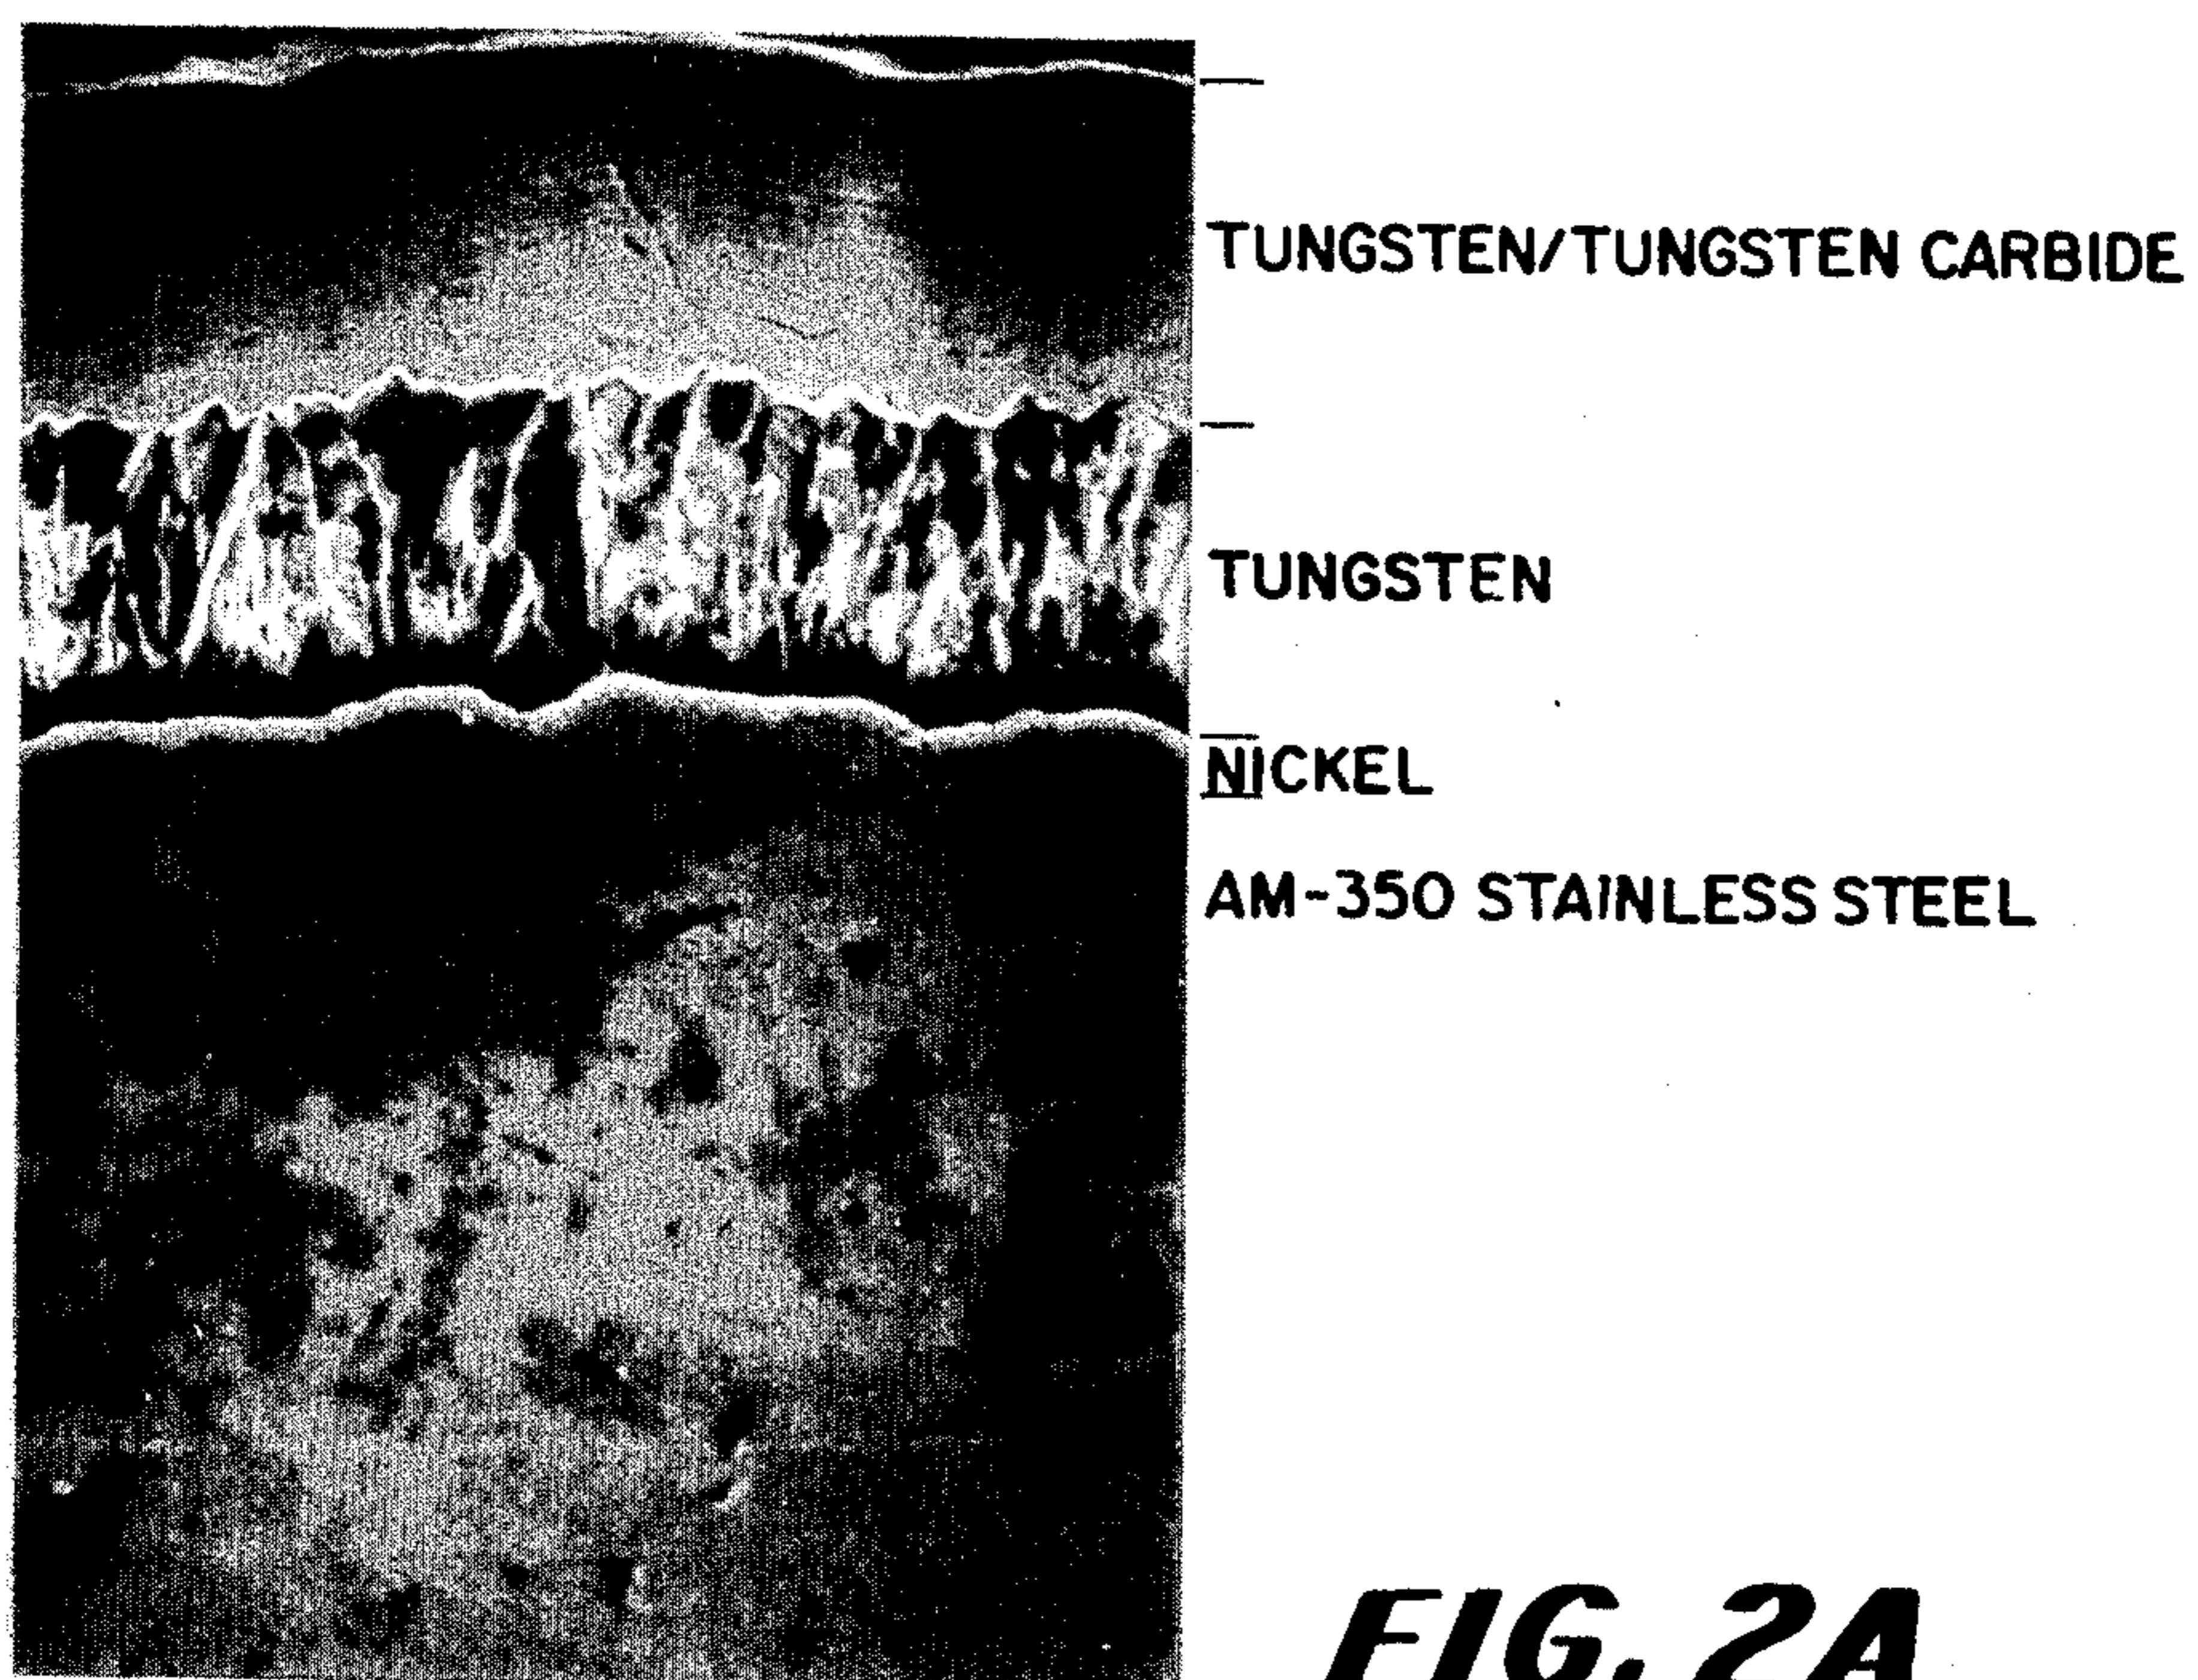
FIG. 2A is a photomicrograph, magnified 2000 times, of an etched cross section of a coating system according to the invention on AM-350 stainless steel substrate heat treated in-situ for 60 minutes showing the absence of non-uniformity in the microstructure.

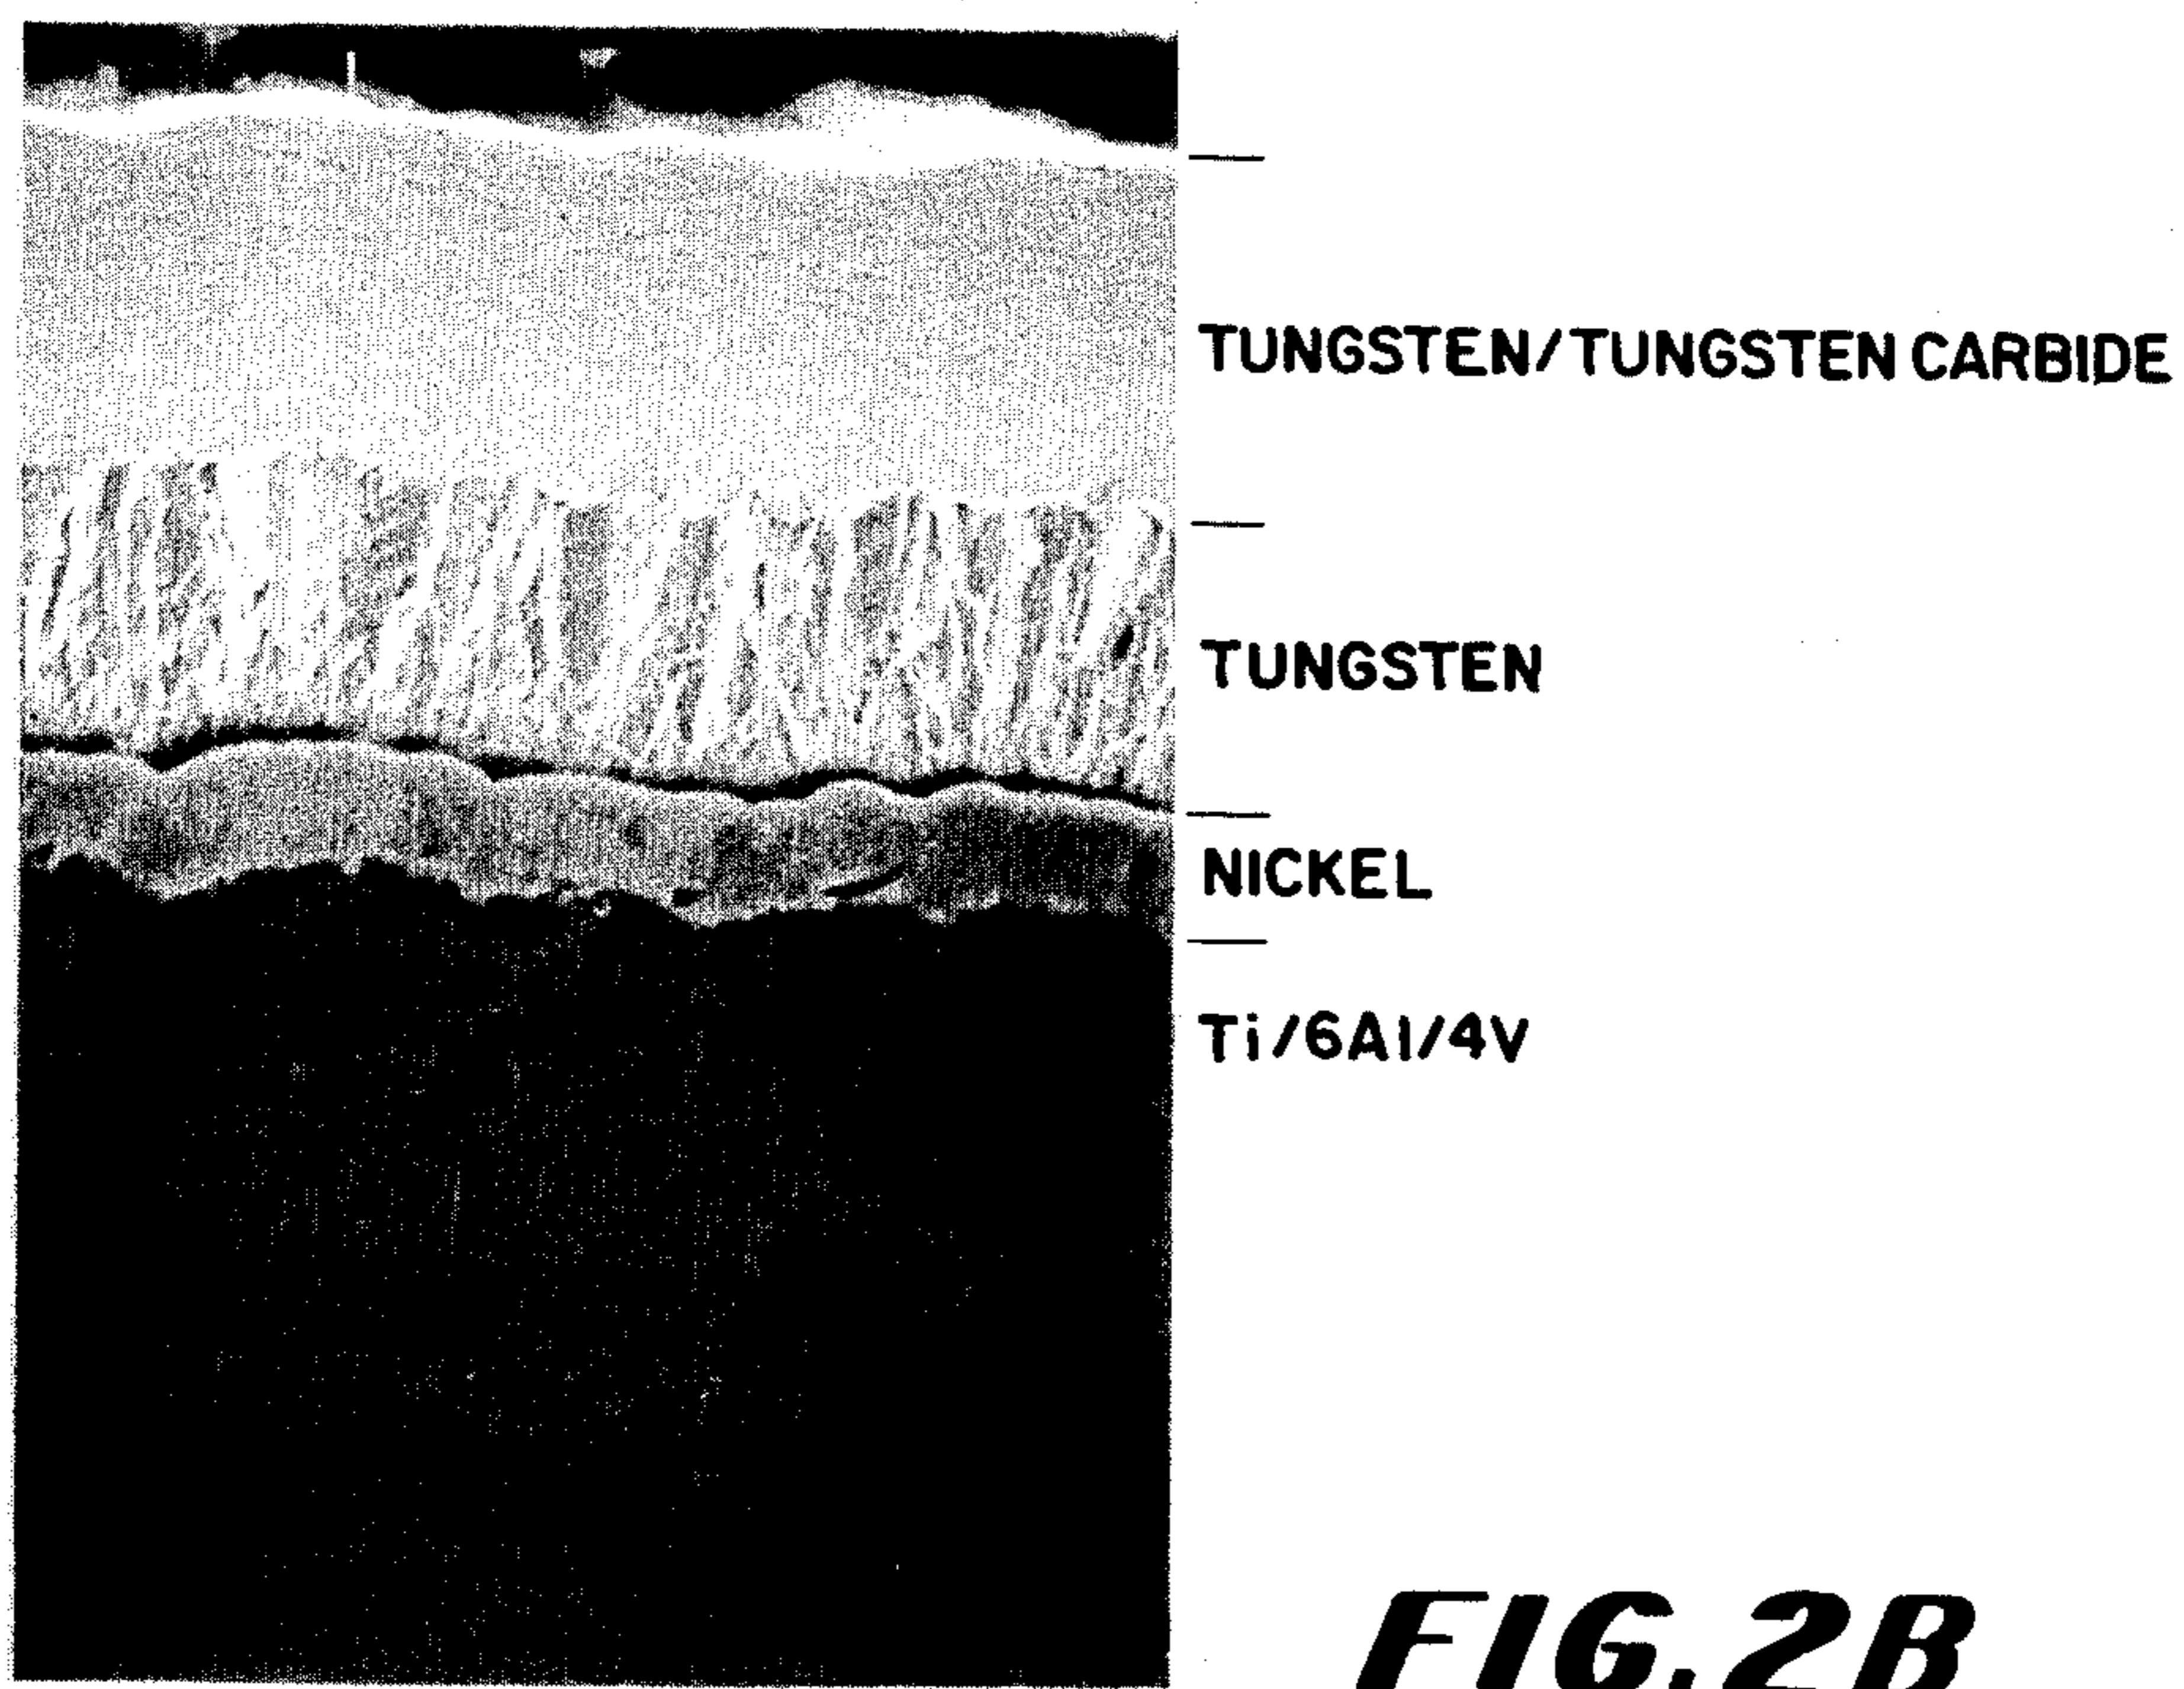
FIG. 2B is a photomicrograph, magnified 2000 times, of an etched cross section of a coating system according to the invention on Ti/6Al/4V substrate heat treated in-situ for 60 minutes showing the absence of non-uniformity in the microstructure.

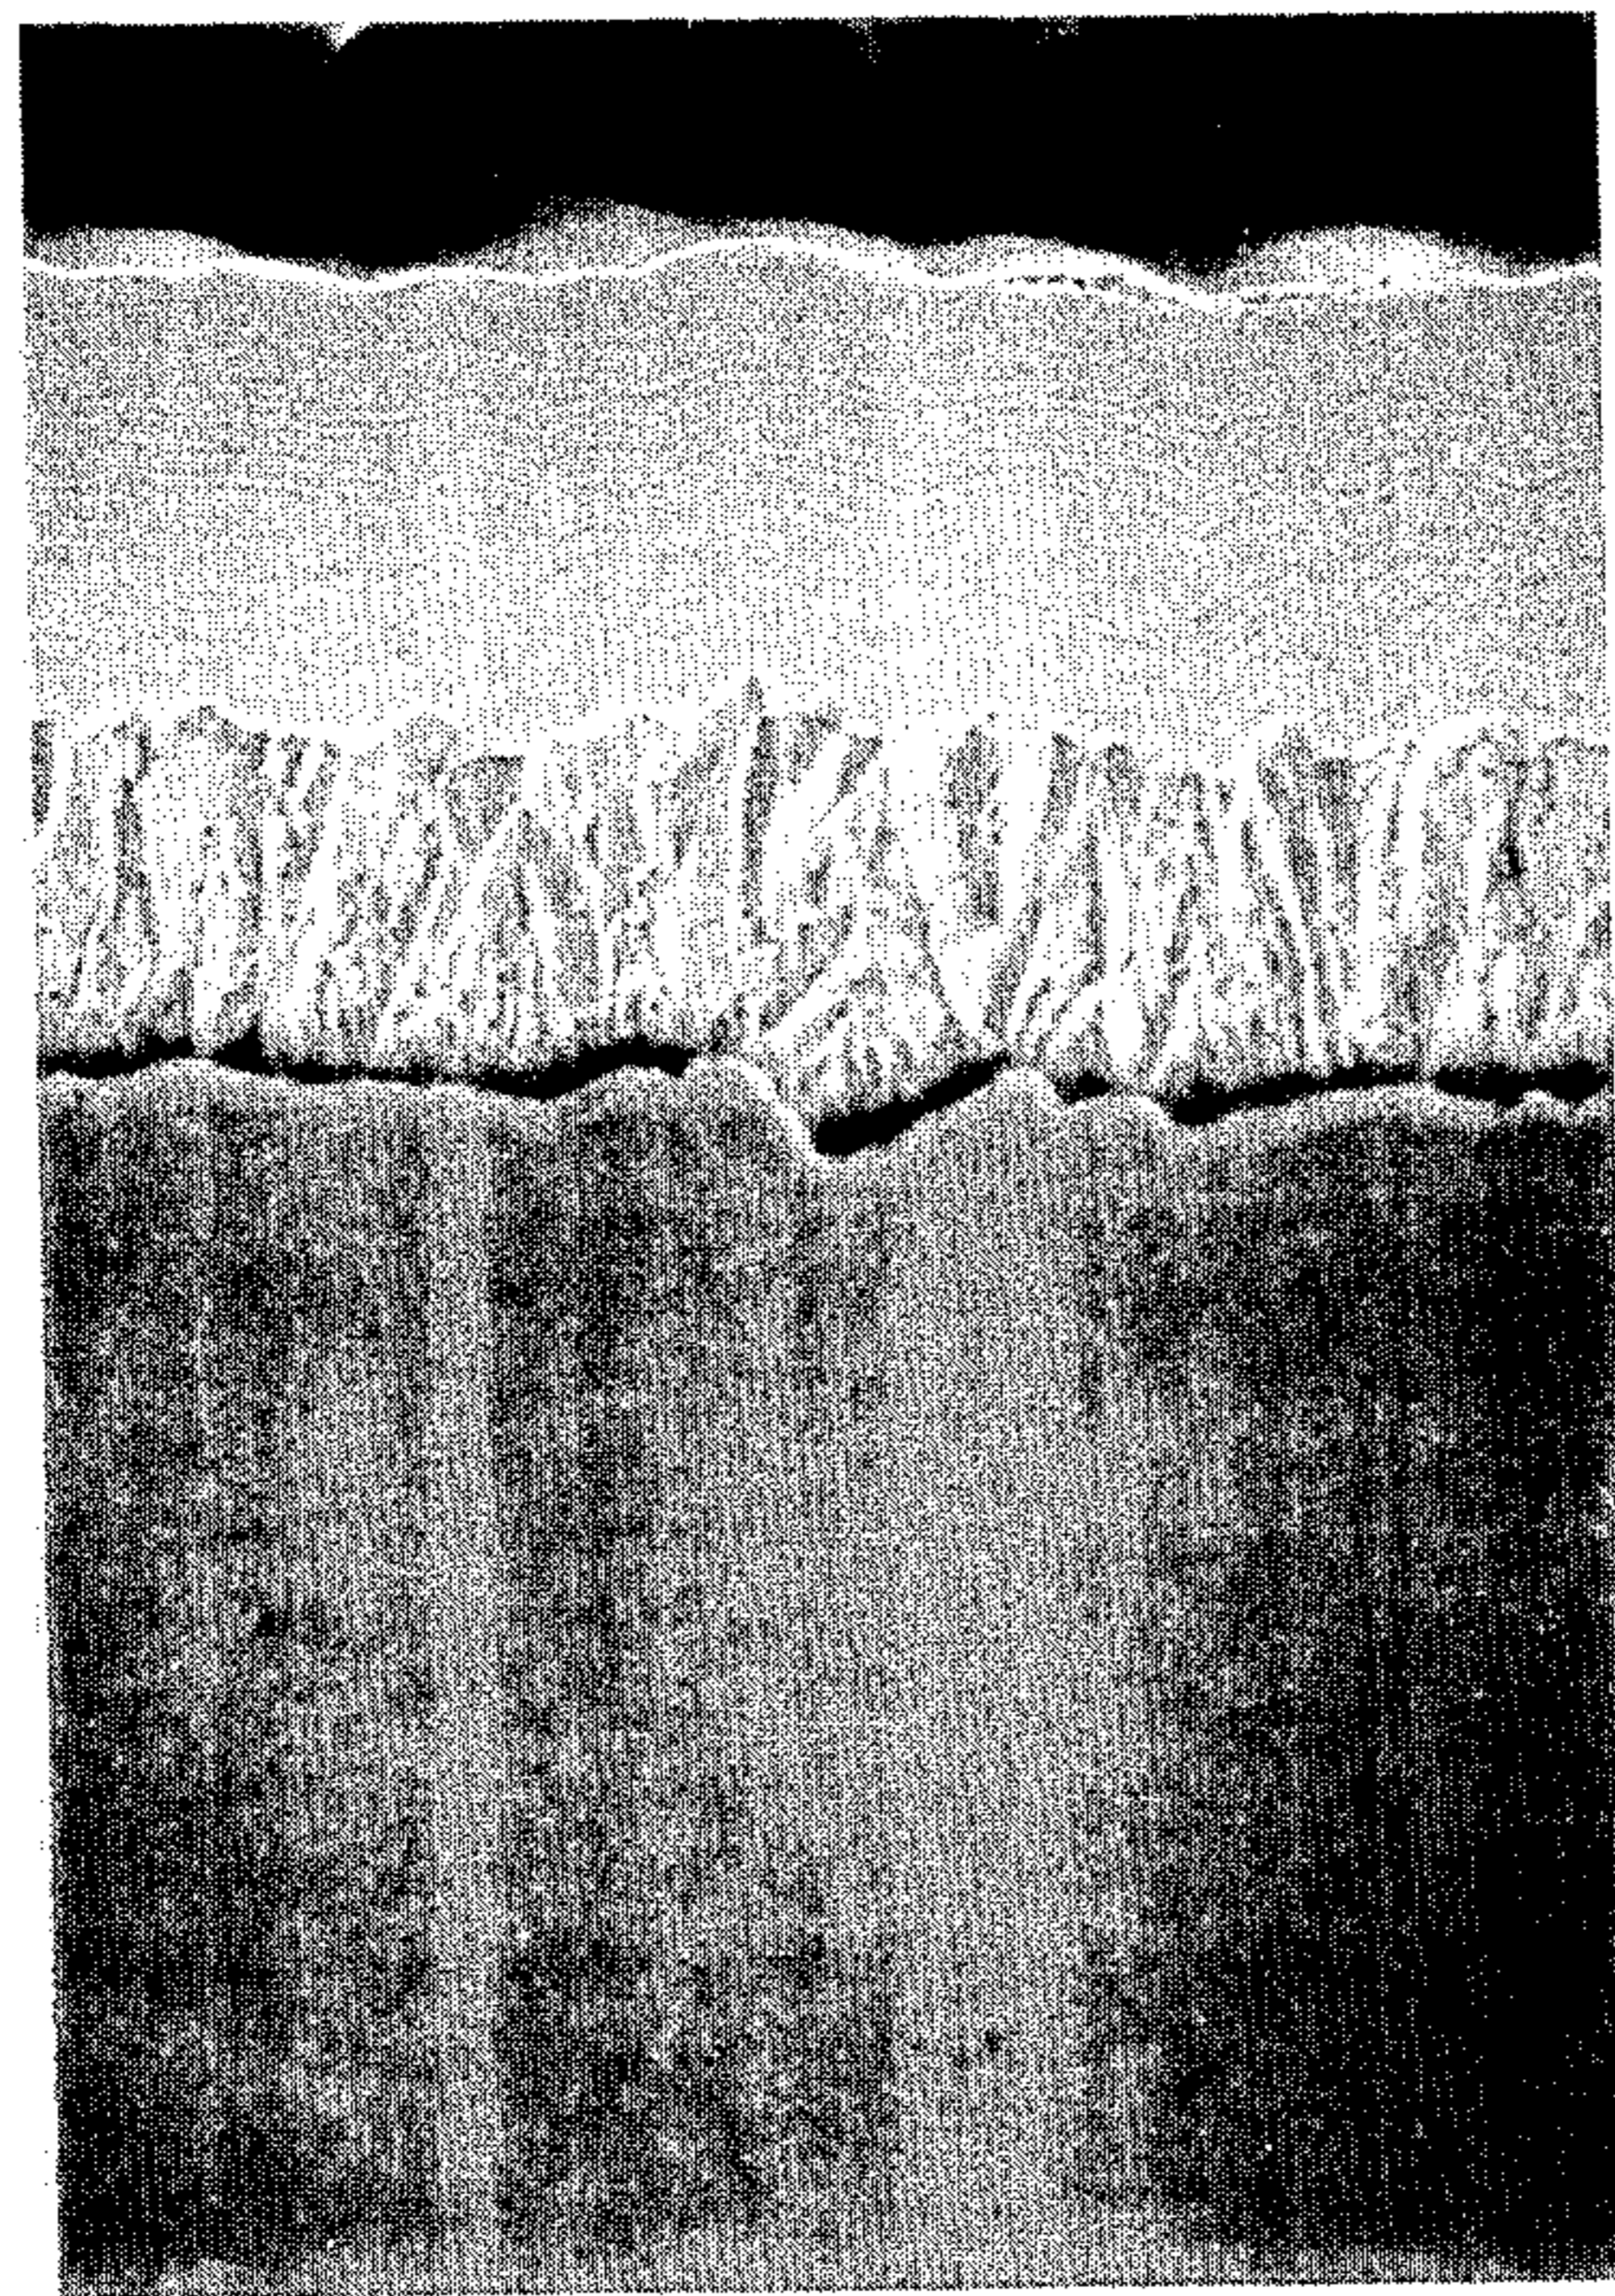
FIG. 3A is a photomicrograph, magnified 2000 times, of an etched cross section of a coating system according to the invention on AM-350 stainless steel substrate heat treated in-situ for 120 minutes showing the absence of non-uniformity in the microstructure.

top coat had a fine-layered structure, as shown in FIGS. 3A and 3B. As noted in Example 3, the 120 minute post heat treatment eliminated the microstructural nonuniformity that was present without heat treatment (compares FIGS. 3A and 3B with FIGS. 1A and 1B). The tungsten/tungsten carbide coating, once again, had a surface finish of $\sim 20\mu$ inch.
