[54] **HEAT TREATED CHEMICALLY VAPOR DEPOSITED PRODUCTS**

[57] **ABSTRACT**

"A coated substrate product is described wherein the outer coating on the substrate is comprised of a chemically vapor deposited and heat treated mixture of tungsten and tungsten carbide. The tungsten carbide phase consists of W₂C or W₃C or a mixture of W₂C and W₃C. During the heat treating, the coated substrate is heated to the deposition temperature or not substantially above the deposition temperature in a non-reactive atmosphere. The heat treating temperature is sufficient to confer a desired improvement in erosive and abrasive wear resistance in the outer coating but does not result in substantial degradation of the mechanical properties of the substrate or in formation of undesirable inter-metallic layers".

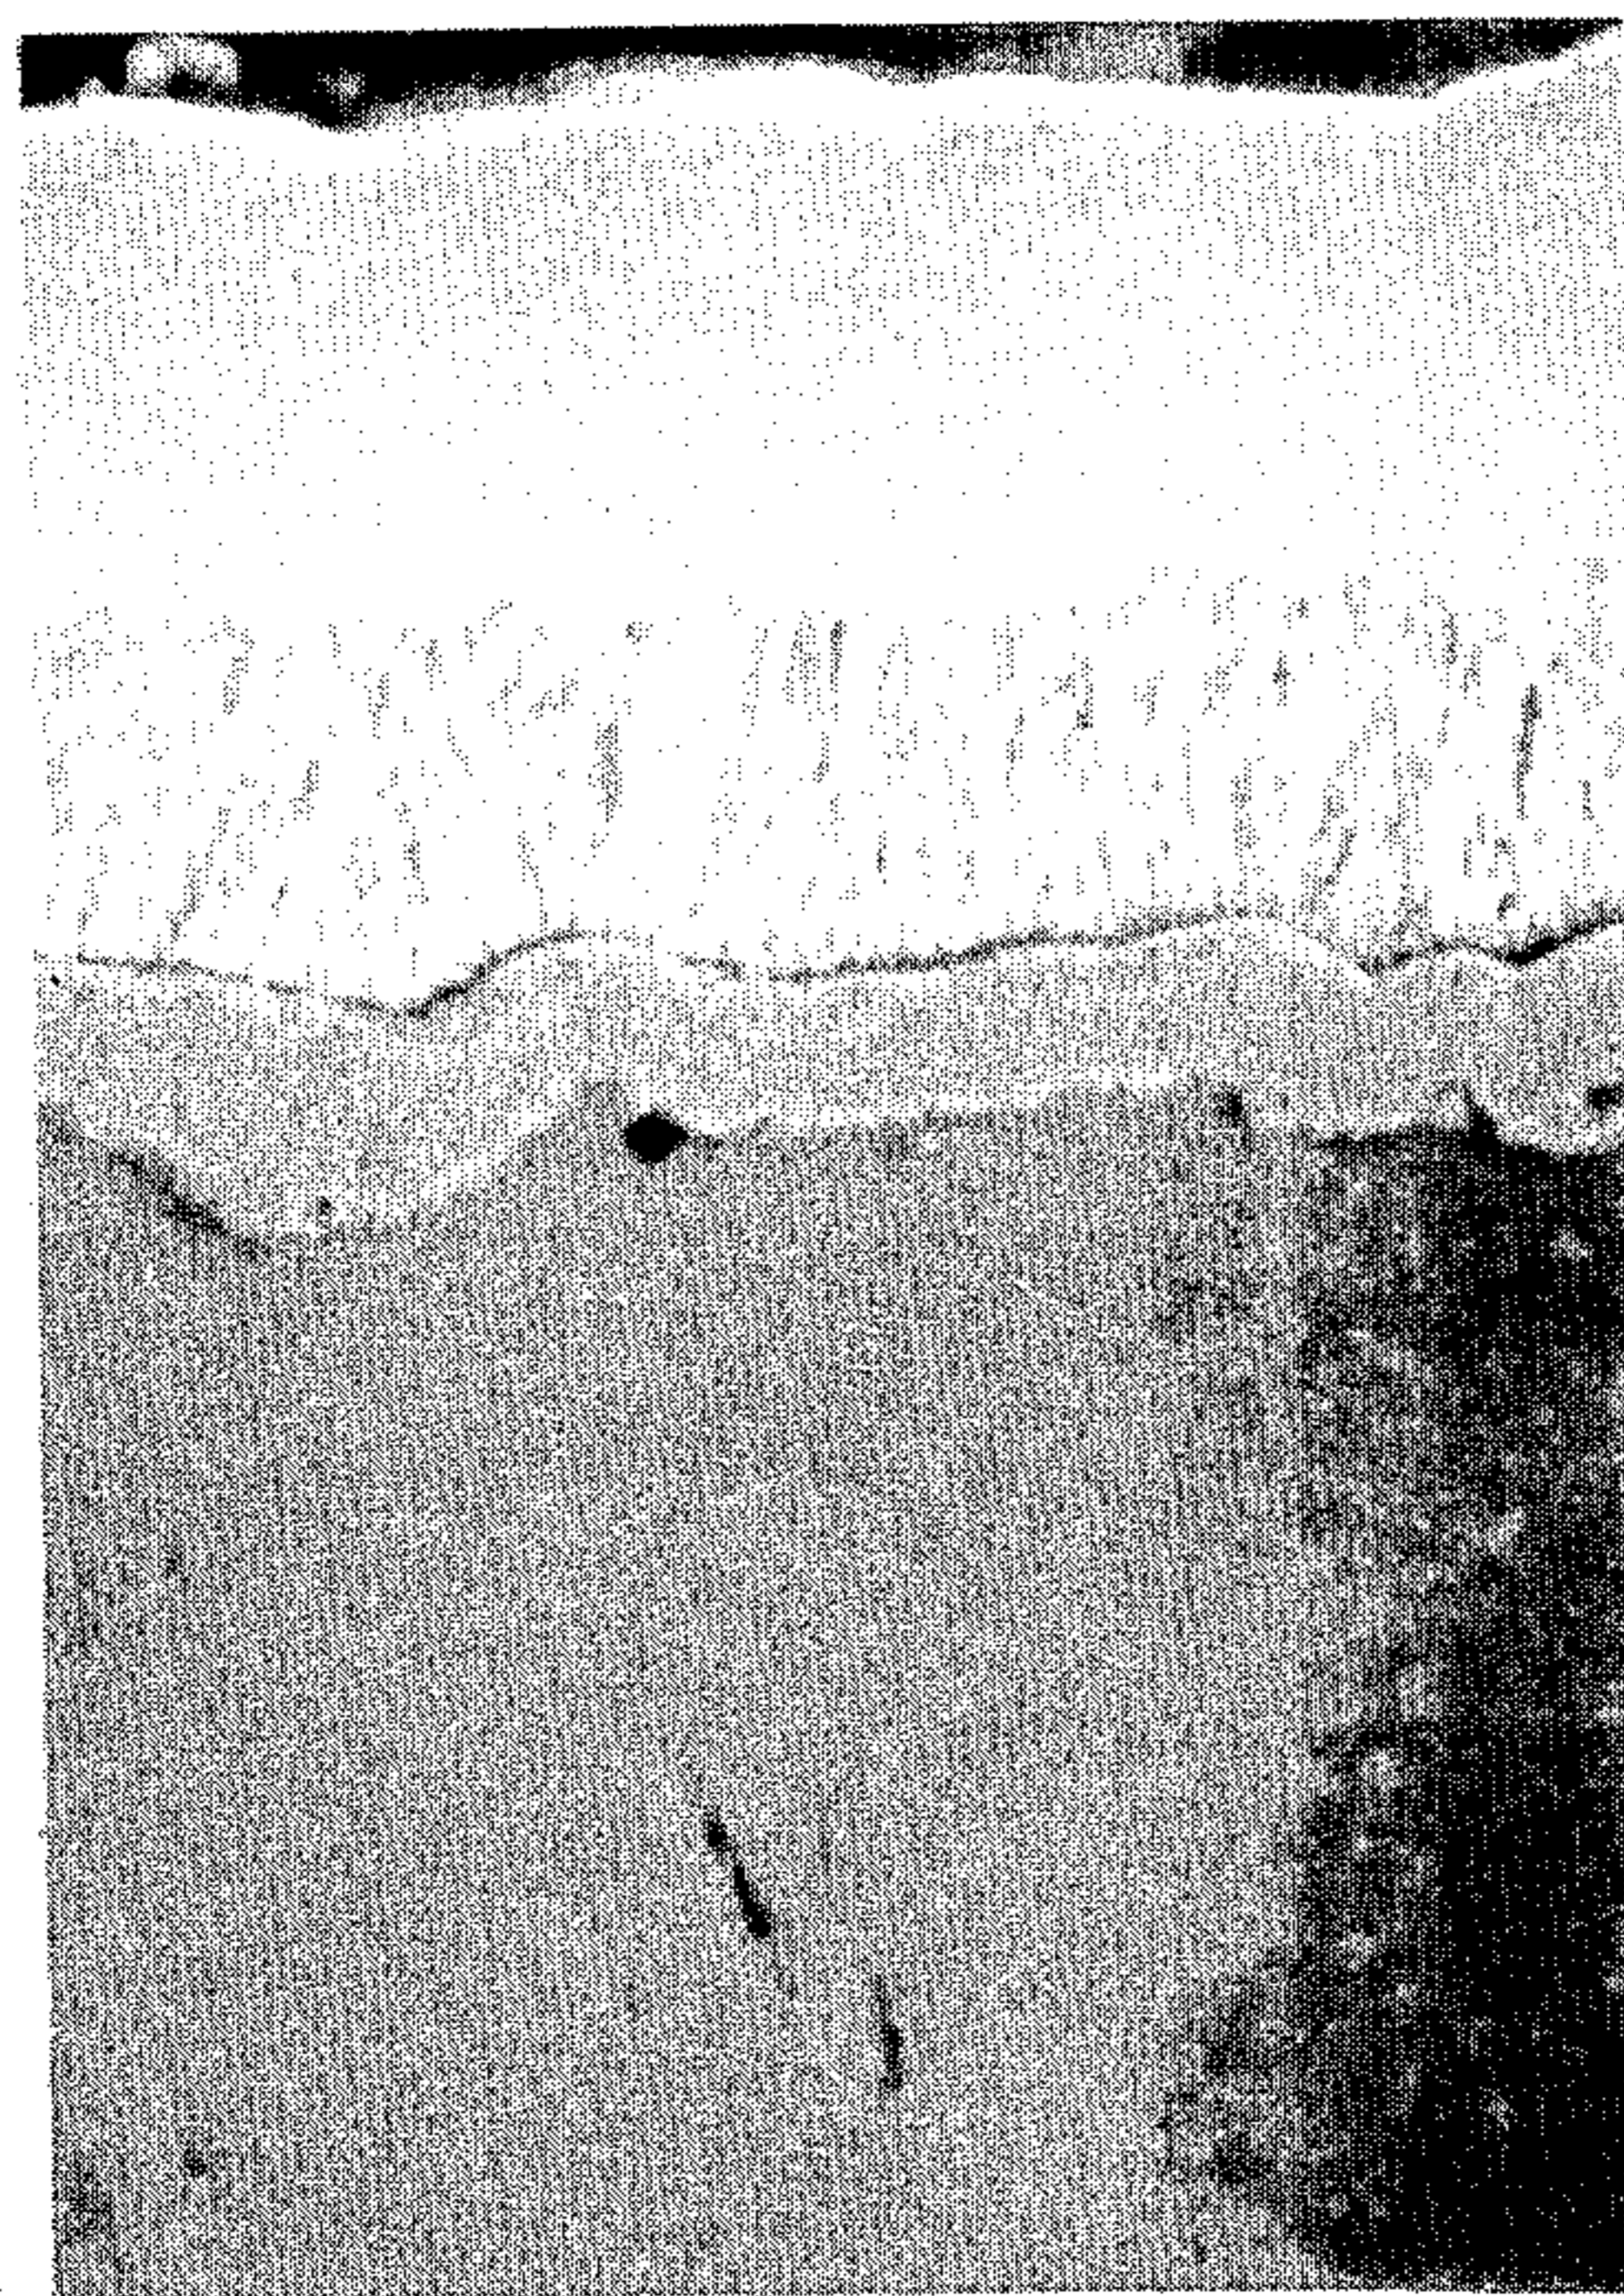
FIG. 3B is a photomicrograph, magnified 2000 times, of an etched cross section of a coating system according to the invention on Ti/6Al/4V substrate heat treated in-situ for 120 minutes showing the absence of non-uniformity in the microstructure.

top coat had a fine-layered structure, as shown in FIGS. 3A and 3B. As noted in Example 3, the 120 minute post heat treatment eliminated the microstructural nonuniformity that was present without heat treatment (compares FIGS. 3A and 3B with FIGS. 1A and 1B). The tungsten/tungsten carbide coating, once again, had a surface finish of $\sim 20\mu$ inch.

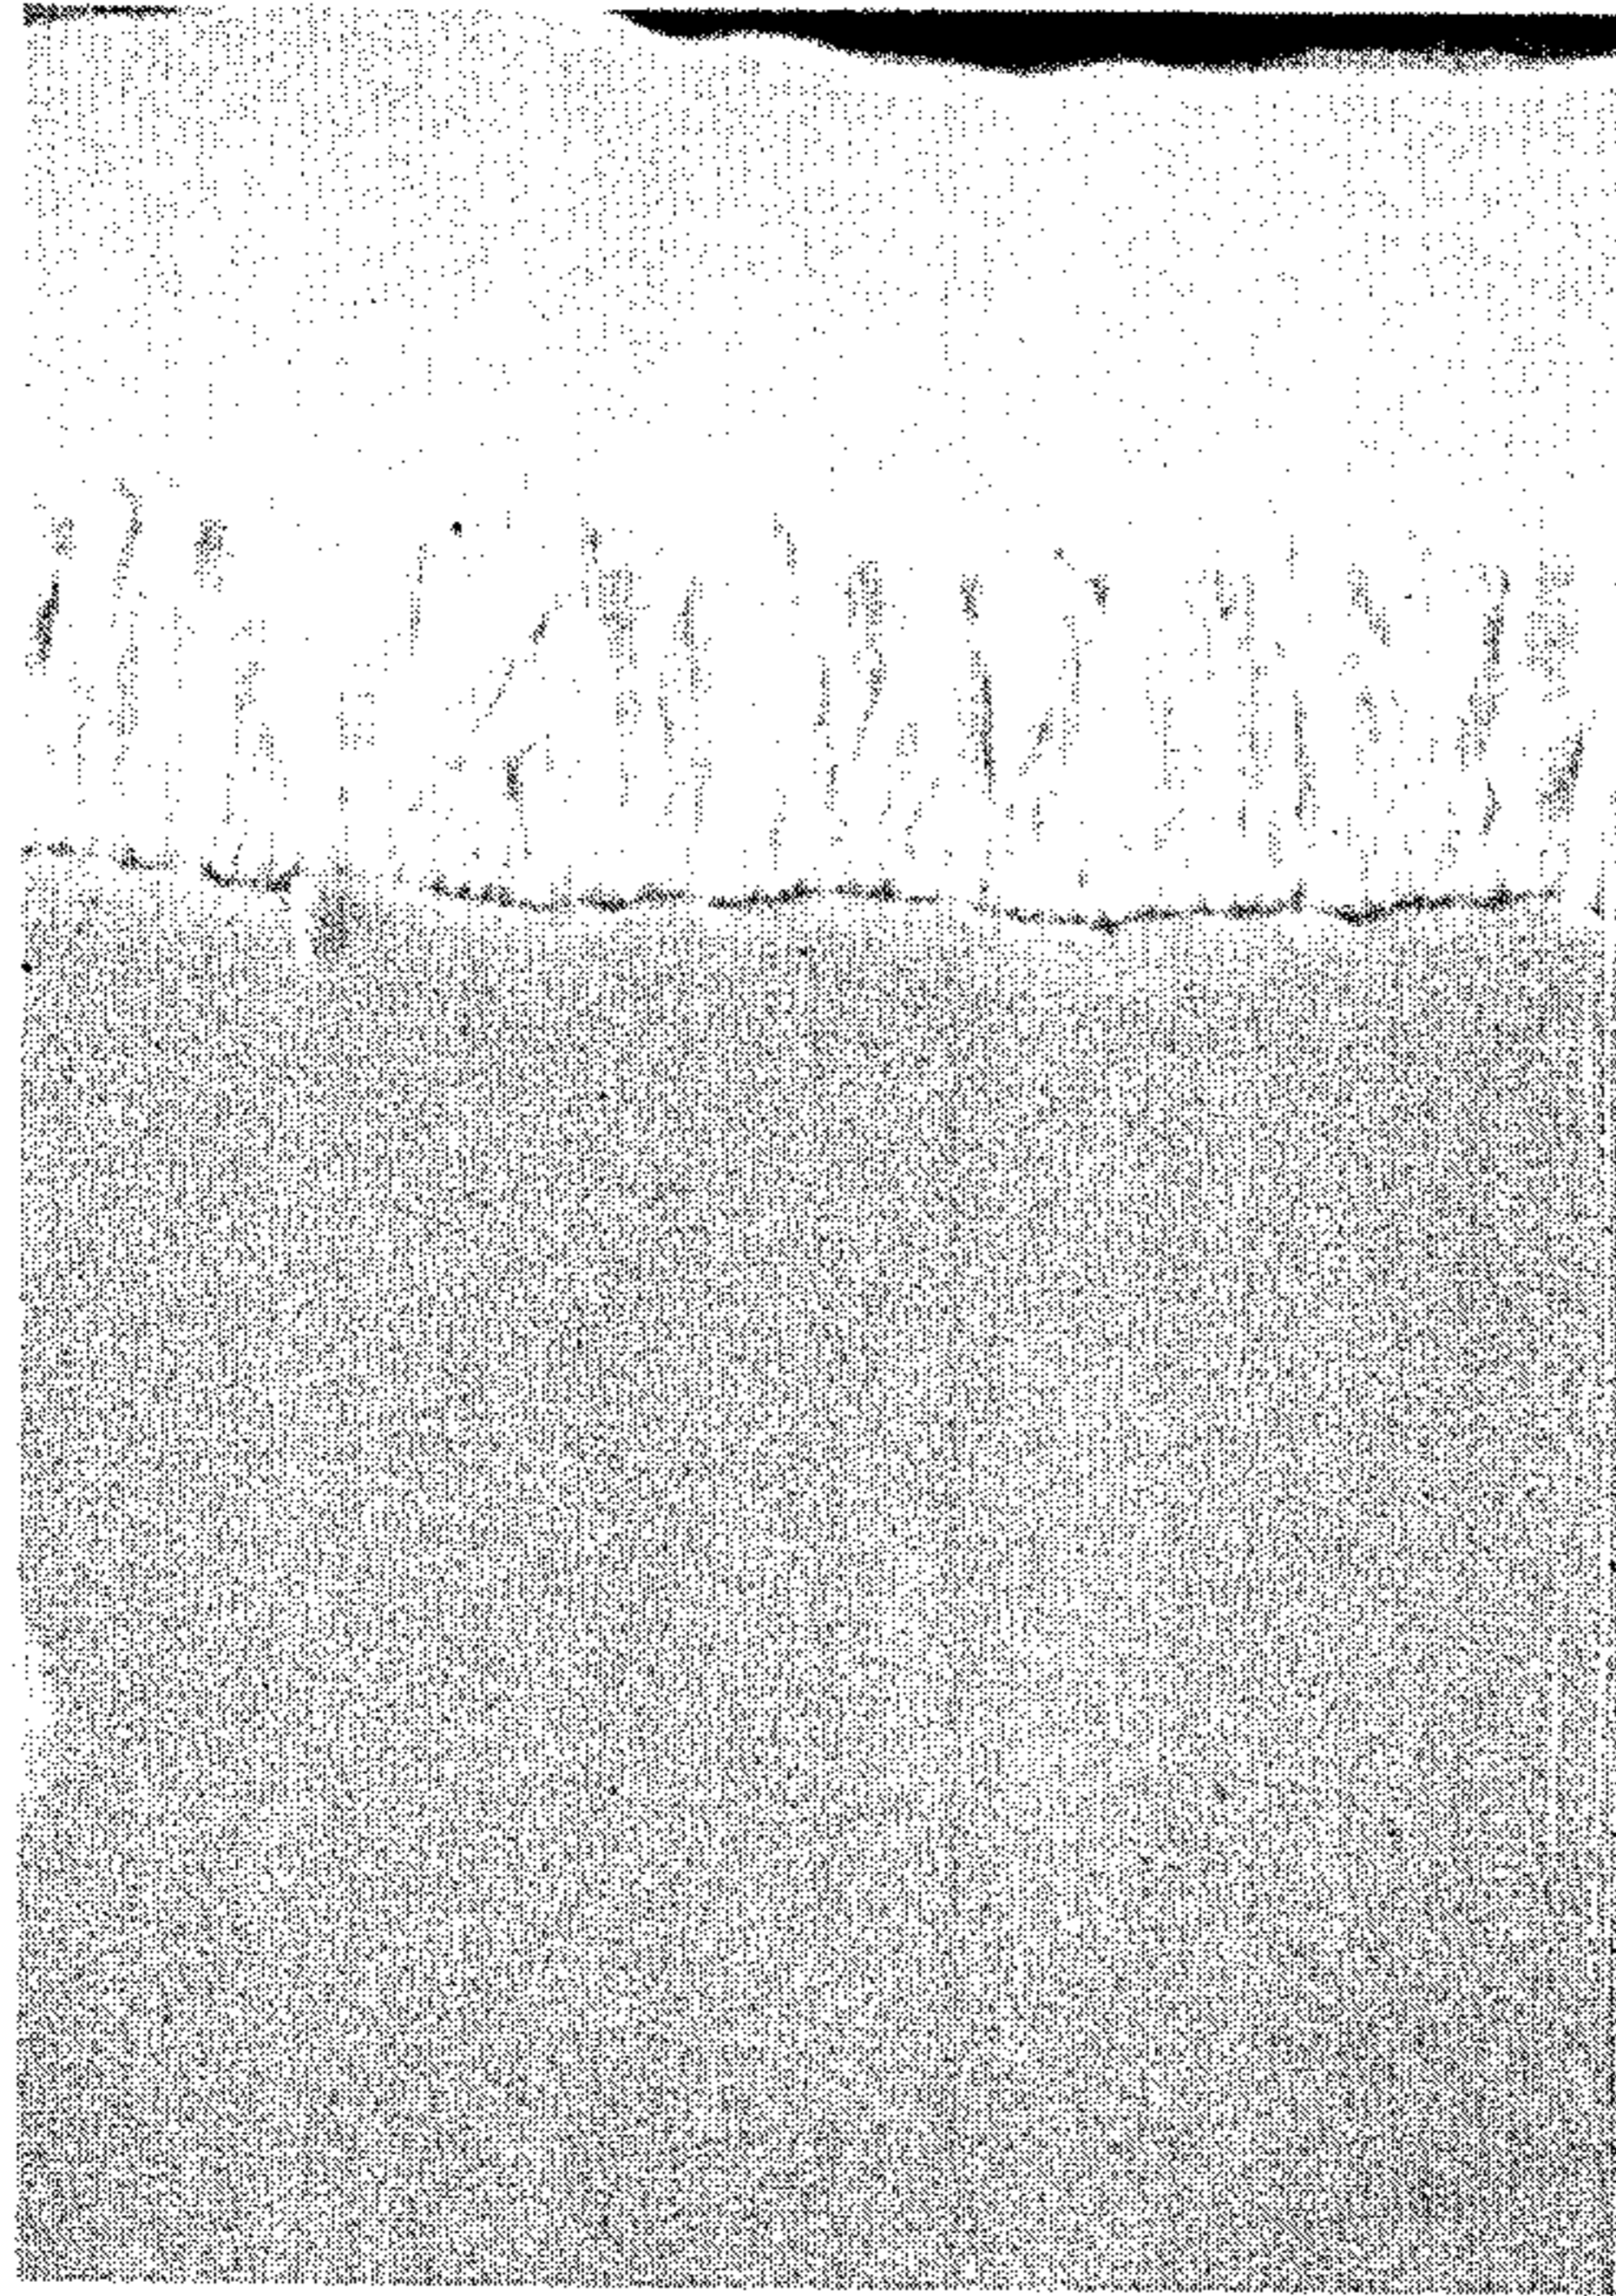
FIG. 4A is a photomicrograph, magnified 2000 times, of an etched cross section of a coating system according to the invention on AM-350 stainless steel substrate heat treated externally for 60 minutes showing significantly reduced non-uniformity in the microstructure.

Compared to coatings with no heat treatment, coatings post heat treated for only 60 minutes in the controlled atmosphere furnace showed a dramatic reduction in the non-uniform microstructure of the tungsten/tungsten carbide layer which is revealed by etching, as shown in FIGS. 4A and 4B. The coating was absolutely crack-free, indicating that the post heat treatment at $475^\circ C.$, which was $15^\circ C.$ higher than the deposition temperature, did not generate cracks in the coating. The surface finish of the coating was $\sim 20\mu$ inch. X-ray diffraction analysis of the heat treated coating showed no changes in the coating composition. Additionally, the hardness of the tungsten/tungsten carbide top coat did not change with the post heat treatment. The erosion resistance of the coatings on AM-350 and Ti/6Al/4V, however, improved by more than 6% (see Table 5). The erosion resistance of the coatings after 60 minutes of external heat treatment was surprisingly lower than that noted after 60 minutes of in-situ heat treatment (compare Examples 3 and 6). The differences in the improvement in the erosion resistance by in-situ and external heat treatments could be due to the use of vacuum during in-situ heat treatment as opposed to using atmospheric pressure in the external heat treatment.

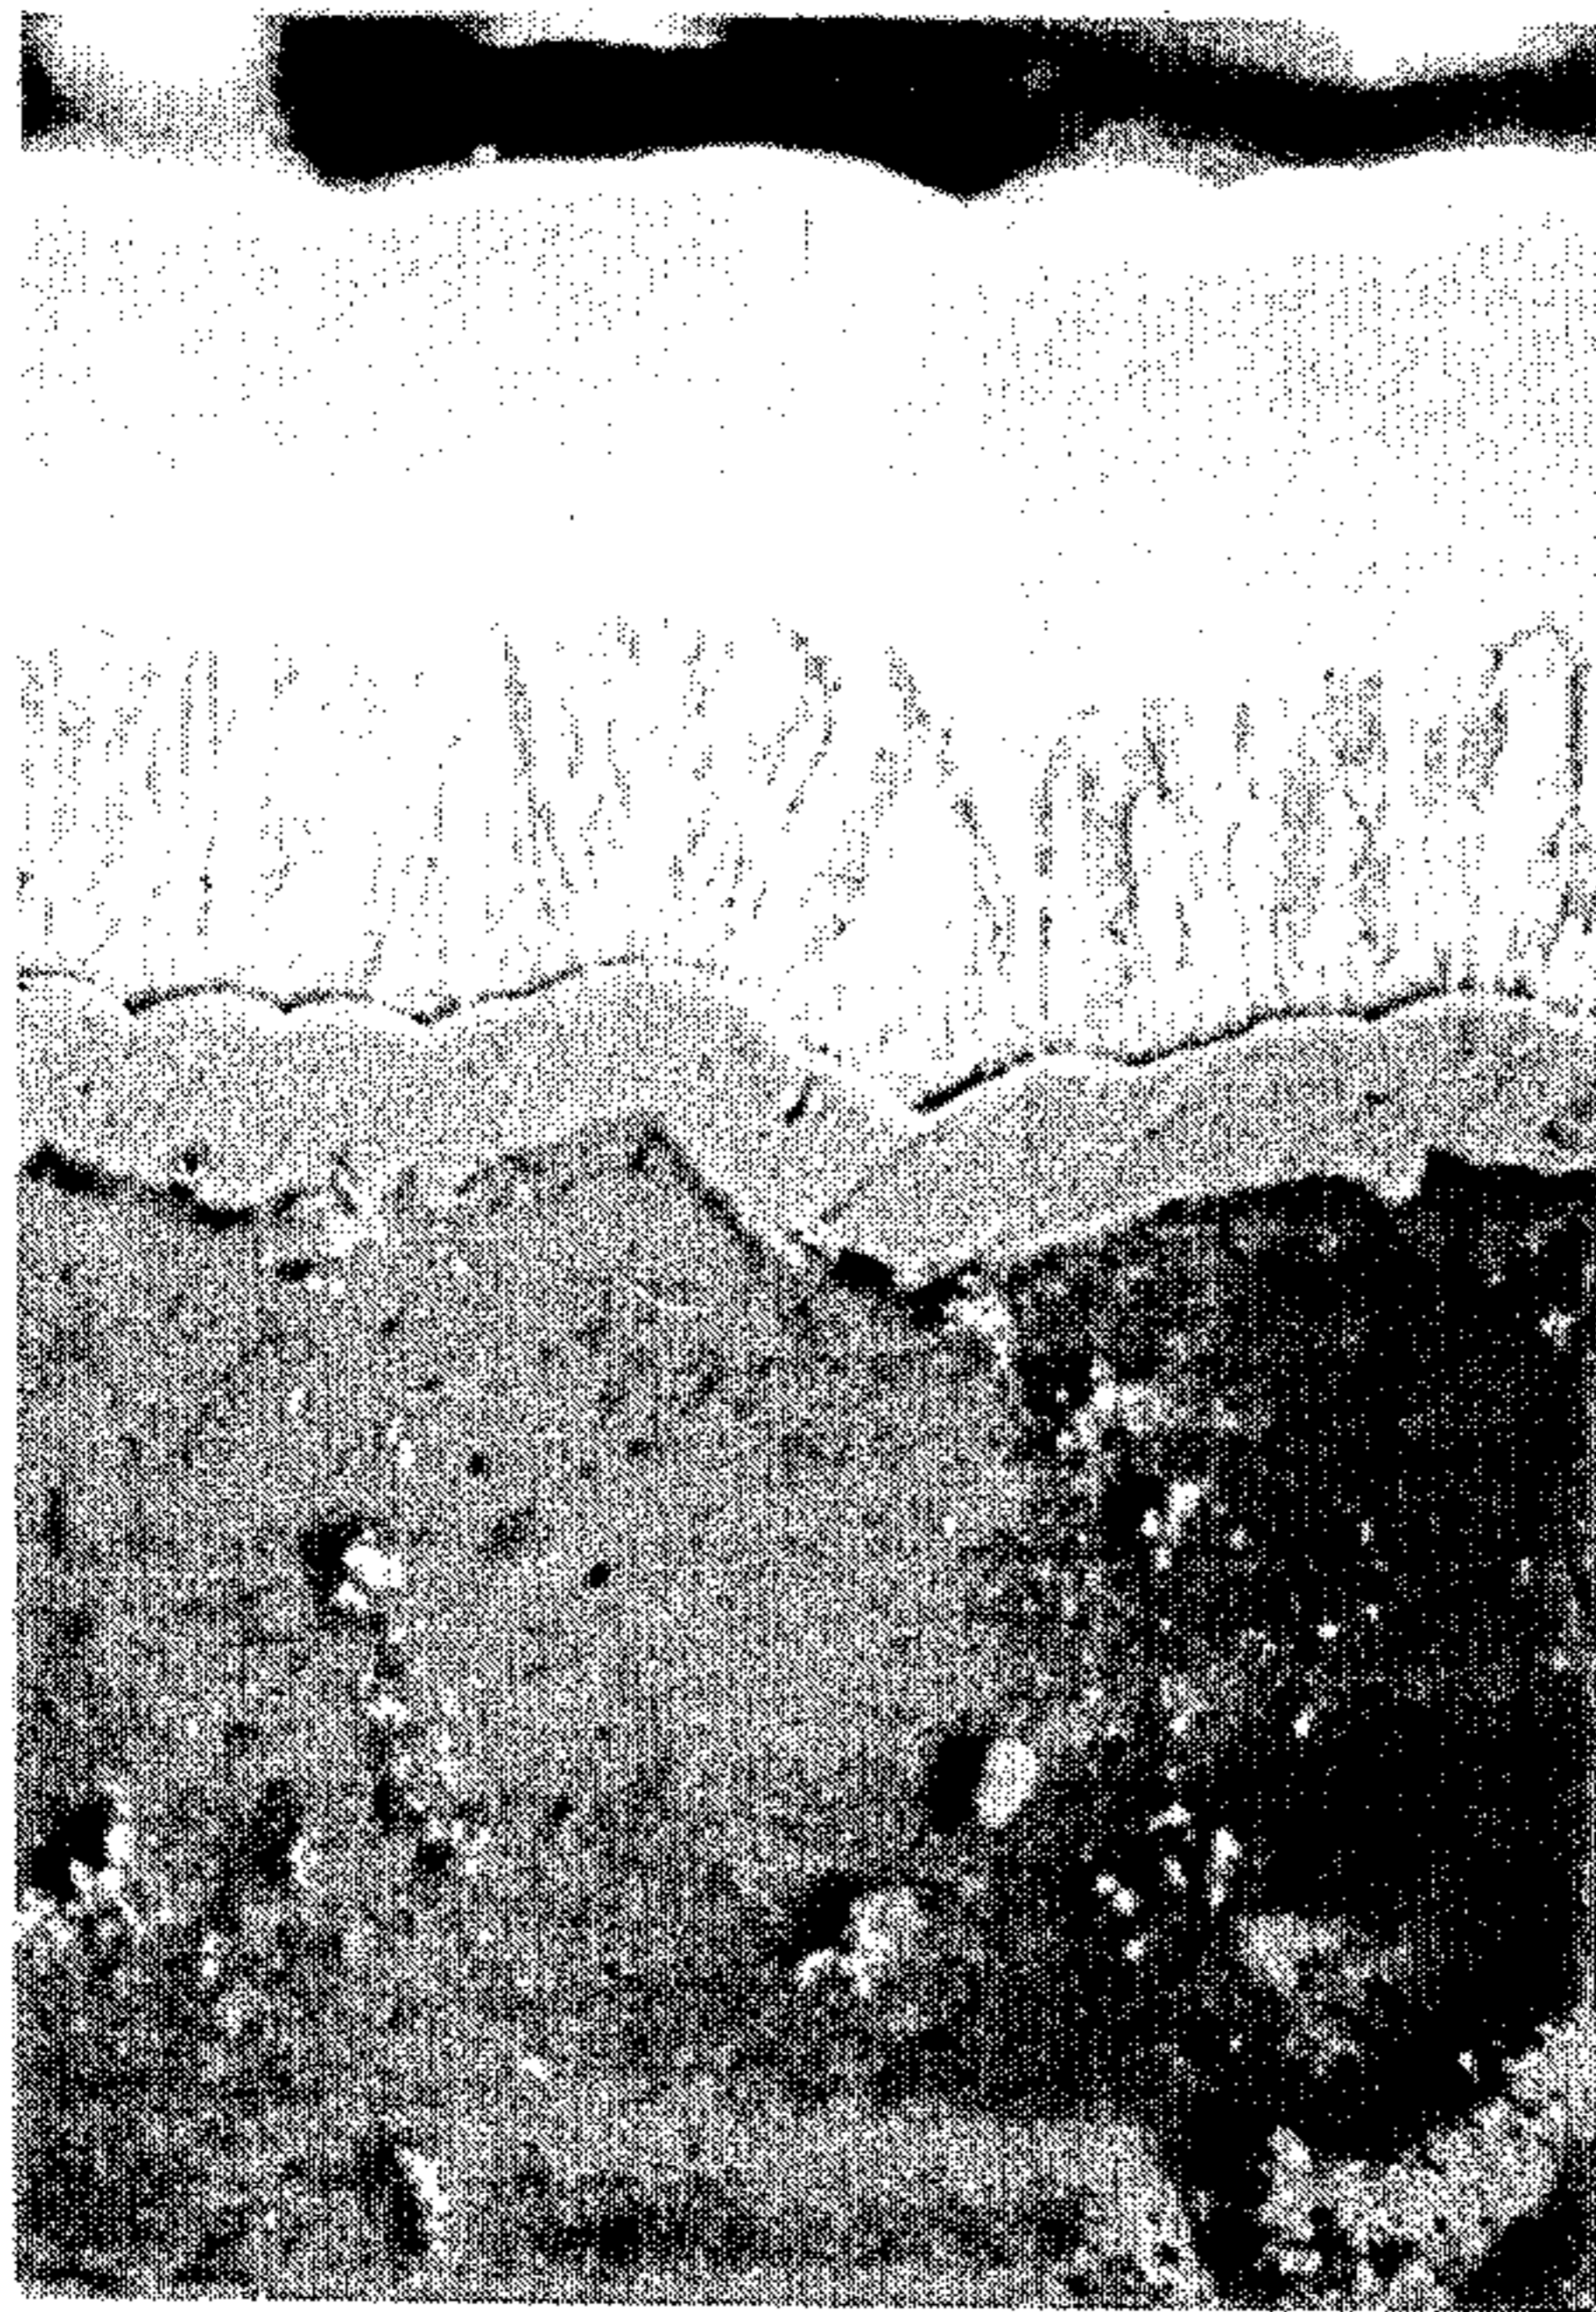
FIG. 4B is a photomicrograph, magnified 2000 times, of an etched cross section of a coating system according to the invention on Ti/6Al/4V substrate heat treated externally for 60 minutes showing significantly reduced non-uniformity in the microstructure.

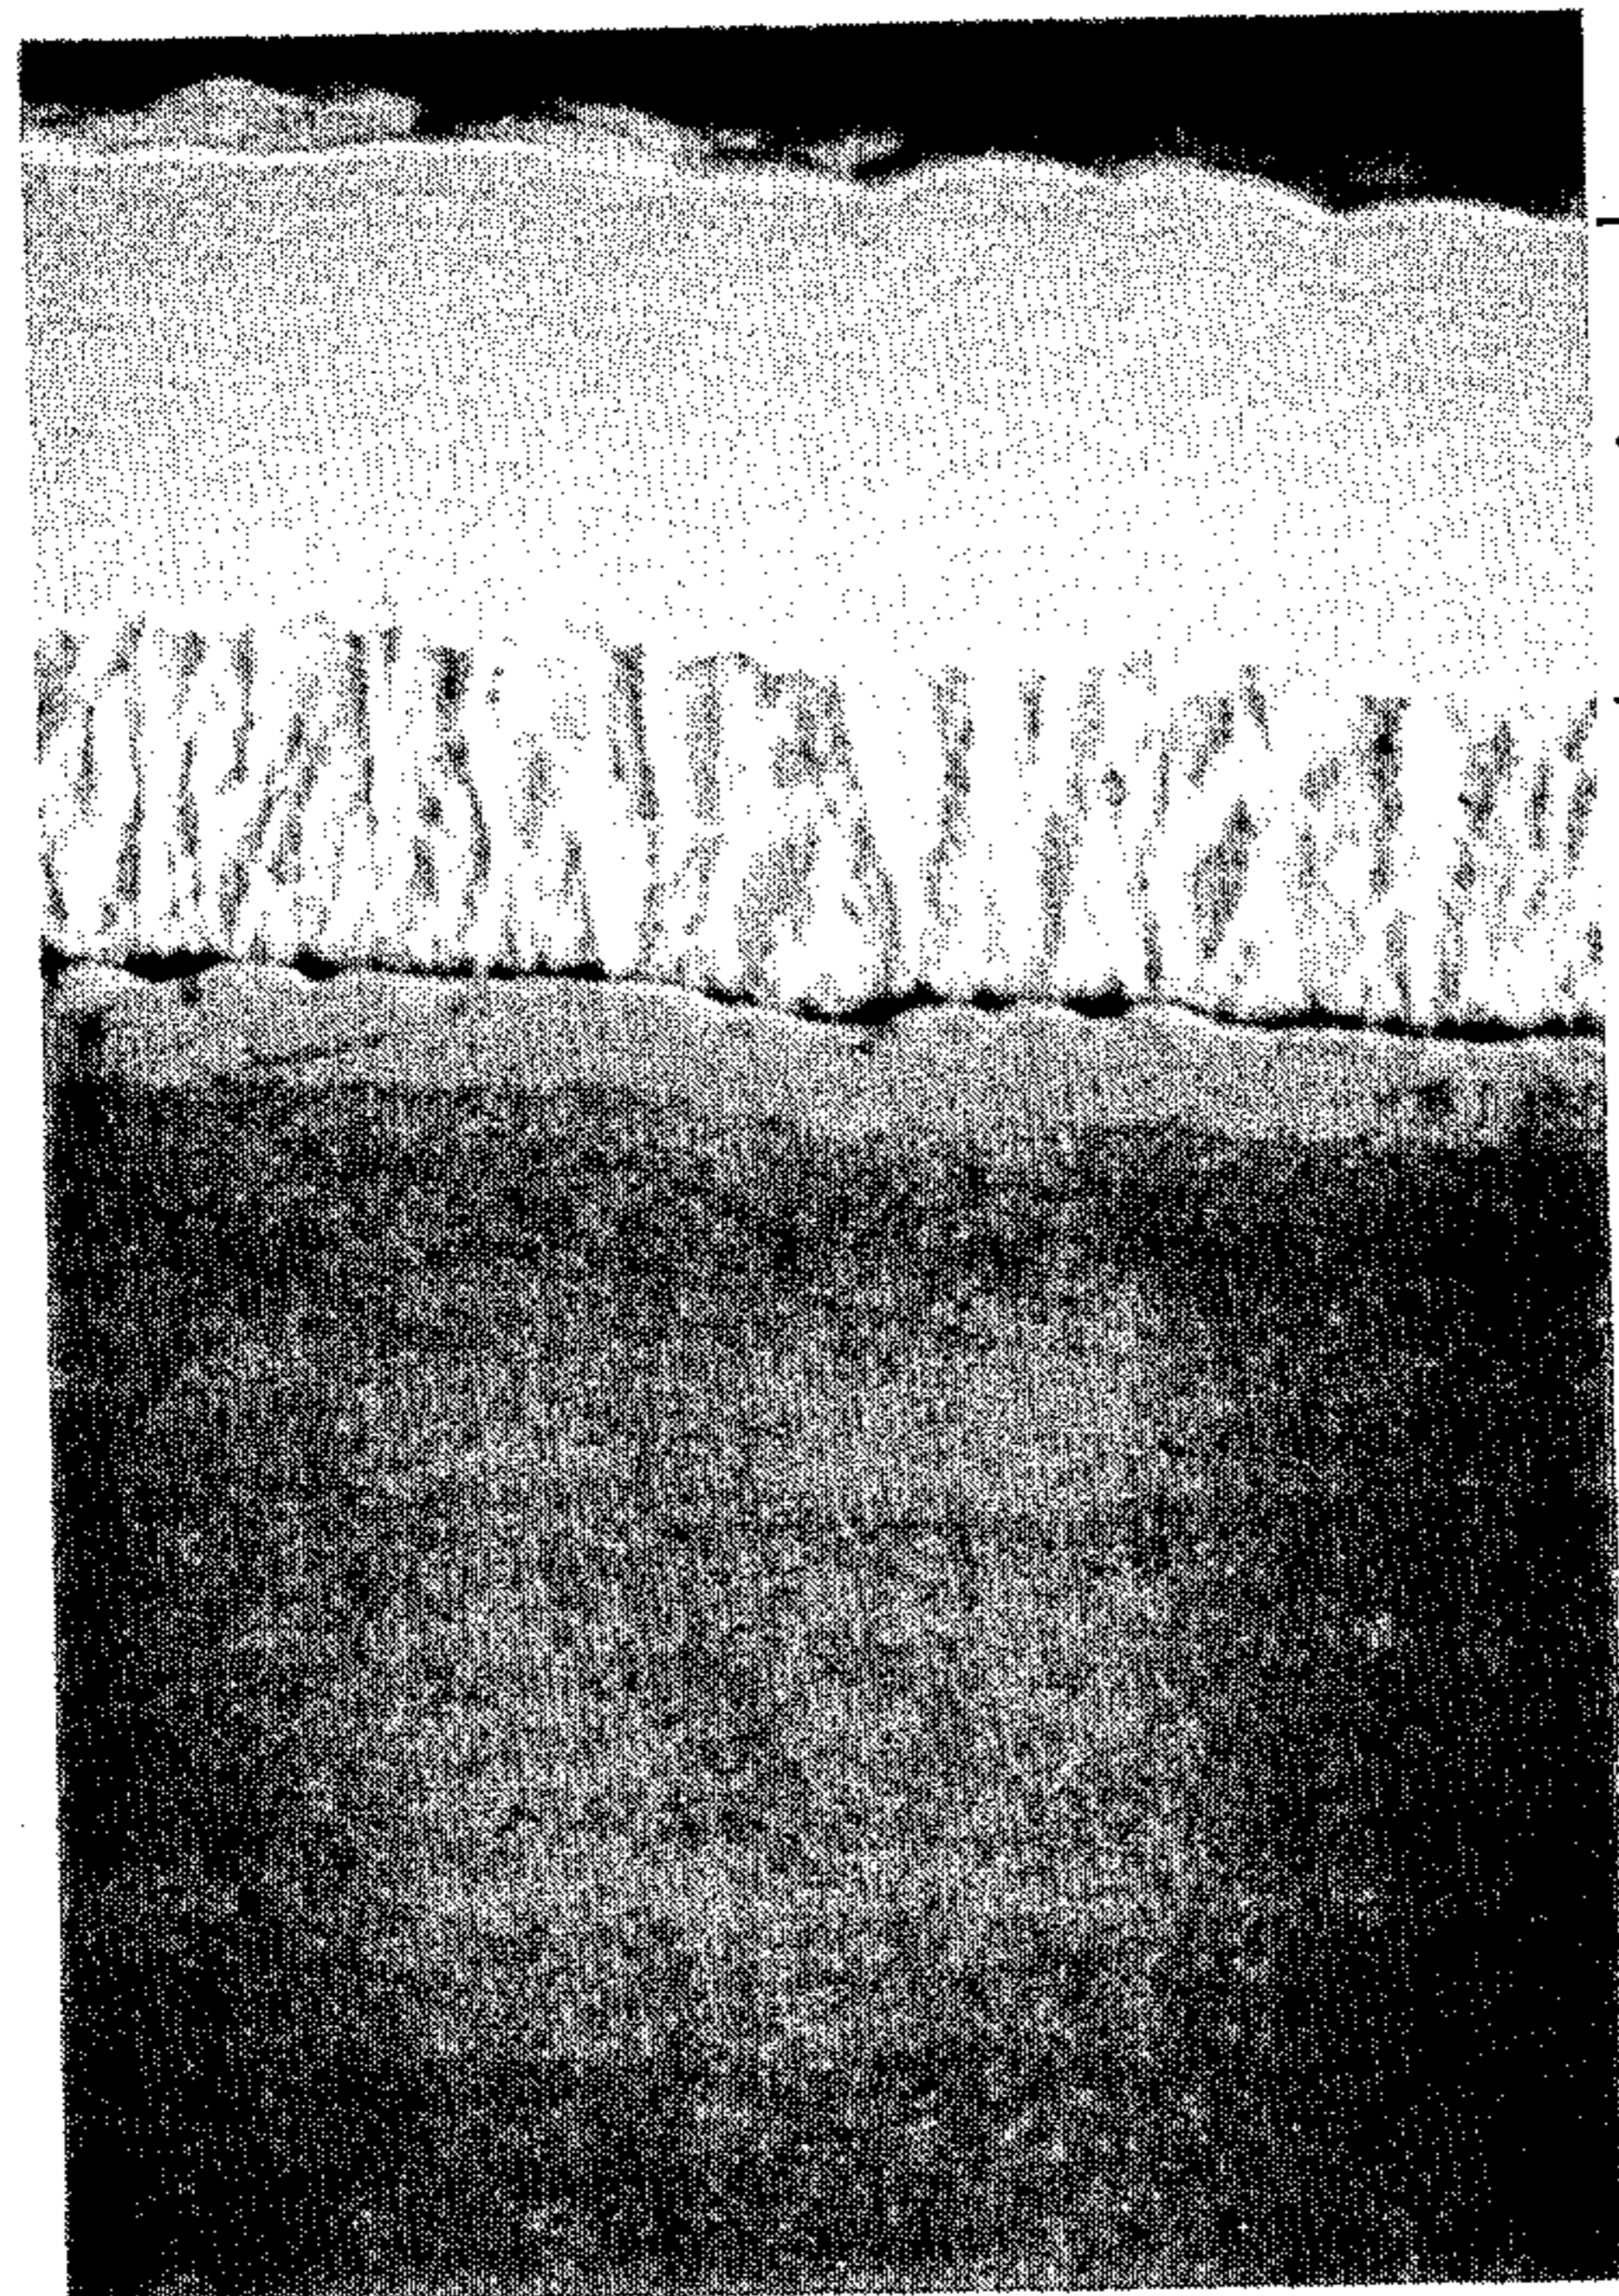
FIG. 5A is a photomicrograph, magnified 2000 times, of an etched cross section of a coating system according to the invention on AM-350 stainless steel substrate heat treated externally for 1440 minutes showing the absence of non-uniformity in the microstructure.

Etched cross sections showed that the coating was microstructurally uniform after 1,440 minutes of heat treatment (see FIGS. 5A and 5B). No changes in coating composition and hardness, however, were noted with the post heat treatment. The erosion resistance of the coatings, on the other hand, improved by more than 13% (see Table 5). The erosion resistance of the coating on AM-350 stainless steel after 1,440 minutes of external heat treatment was very close to the value noted after 60 minutes of in-situ heat treatment. This data indicated that longer external heat treatment times were needed to match the improvements in erosion resistance noted with in-situ heat treatment.

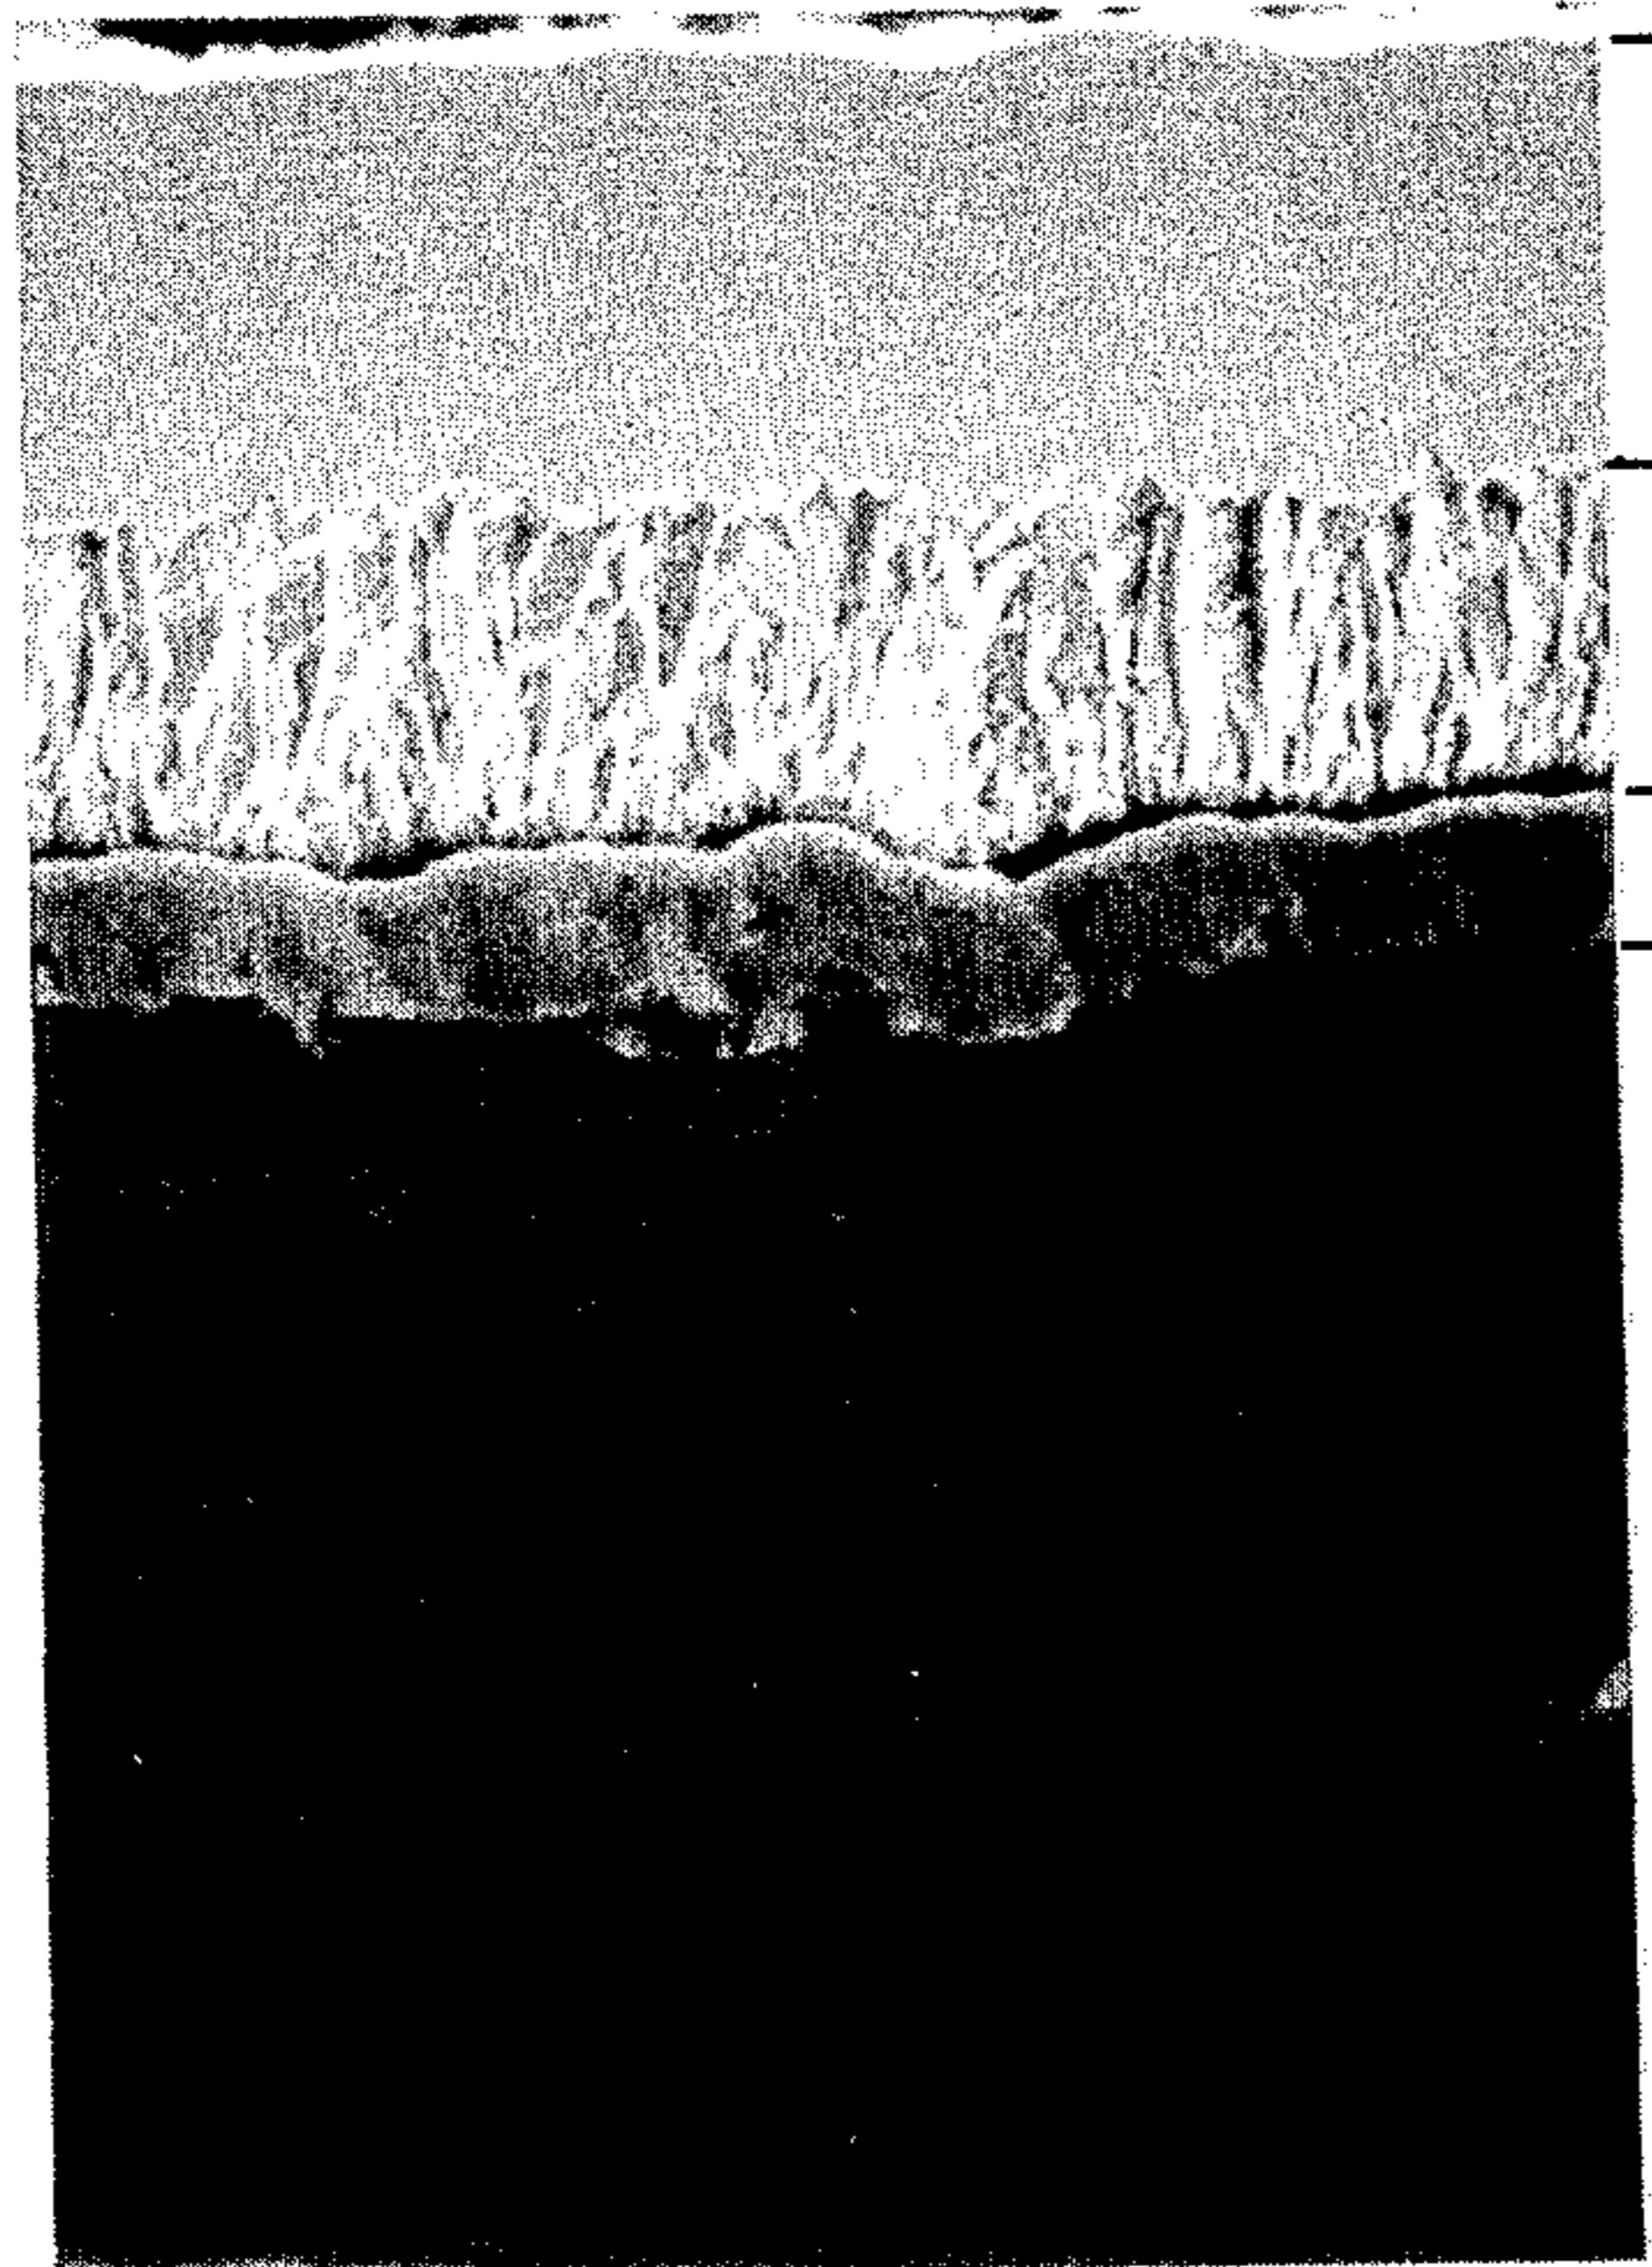
FIG. 5B is a photomicrograph, magnified 2000 times of an etched cross section of a coating system according to the invention on Ti/6Al/4V substrate heat treated externally for 1440 minutes showing the absence of non-uniformity in the microstructure.
