[54] **HEAT TREATED CHEMICALLY VAPOR DEPOSITED PRODUCTS**

[57] **ABSTRACT**

"A coated substrate product is described wherein the outer coating on the substrate is comprised of a chemically vapor deposited and heat treated mixture of tungsten and tungsten carbide. The tungsten carbide phase consists of W₂C or W₃C or a mixture of W₂C and W₃C. During the heat treating, the coated substrate is heated to the deposition temperature or not substantially above the deposition temperature in a non-reactive atmosphere. The heat treating temperature is sufficient to confer a desired improvement in erosive and abrasive wear resistance in the outer coating but does not result in substantial degradation of the mechanical properties of the substrate or in formation of undesirable inter-metallic layers".

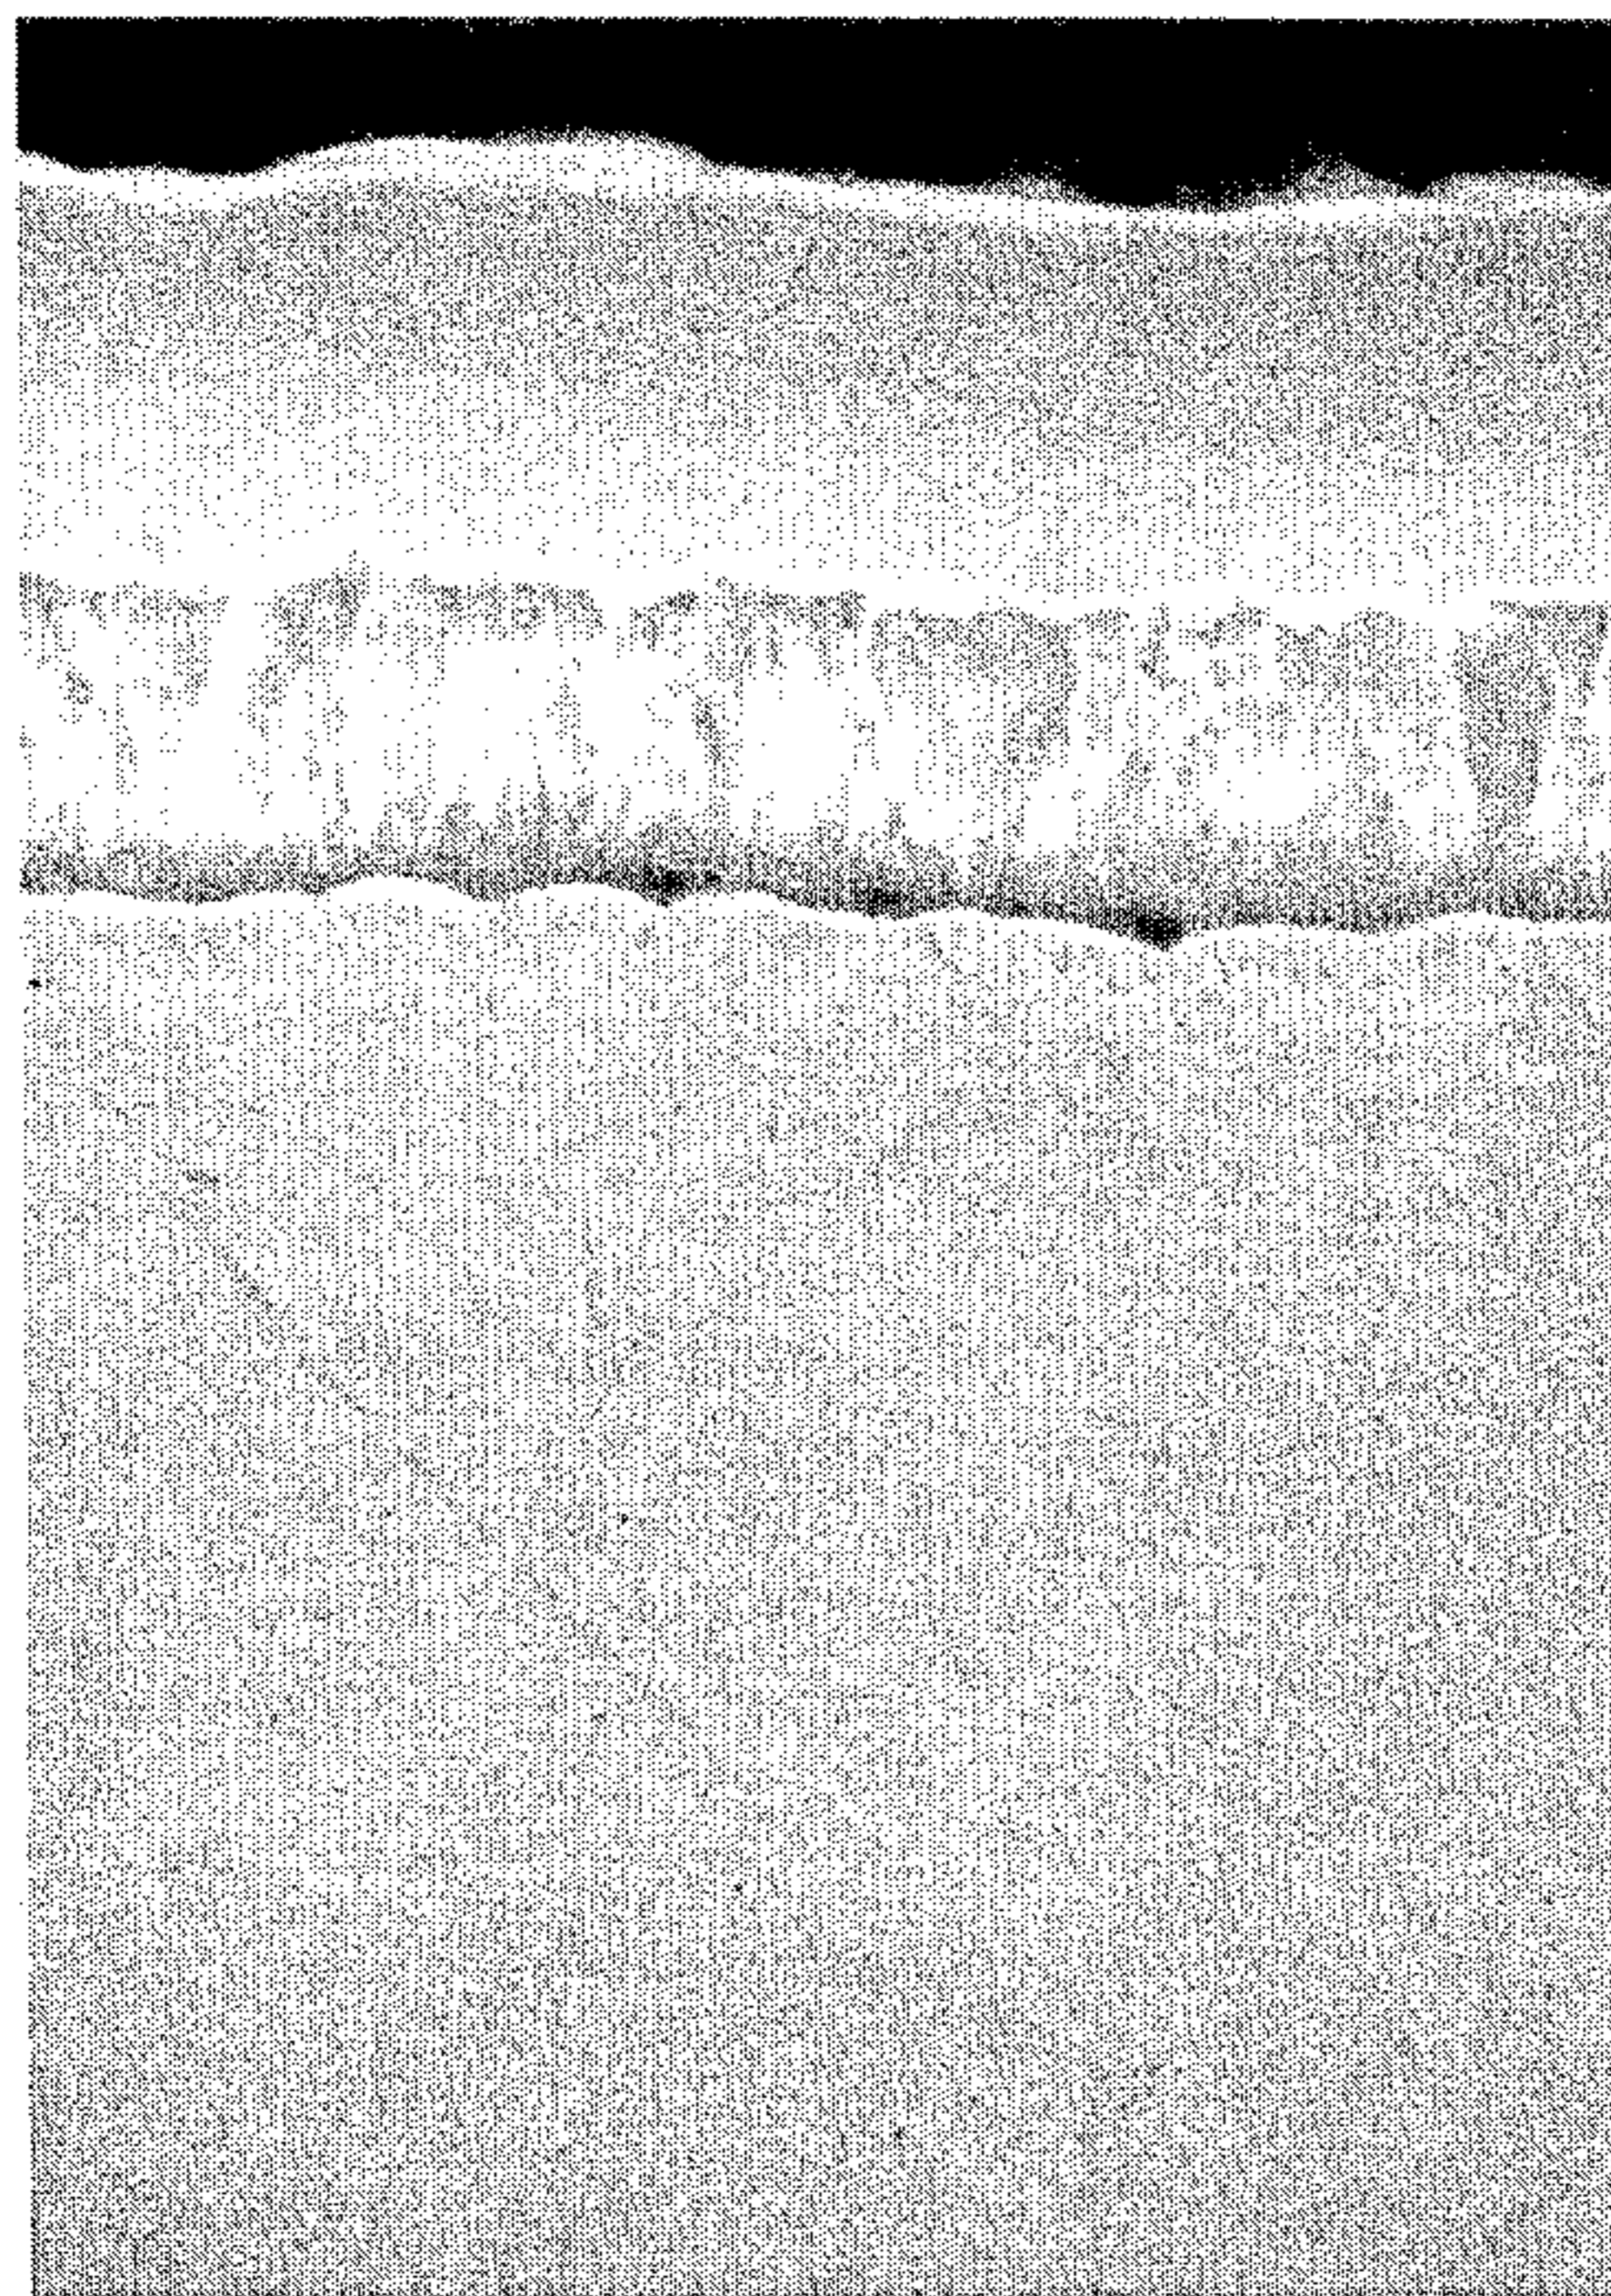
FIG. 6A is a photomicrograph, magnified 2000 times, of an etched cross section of a coating system according to the invention on AM-350 stainless steel substrate heat treated in-situ for 60 minutes followed by external heat treatment for 720 minutes at 500° C. showing the absence of non-uniformity in the microstructure.

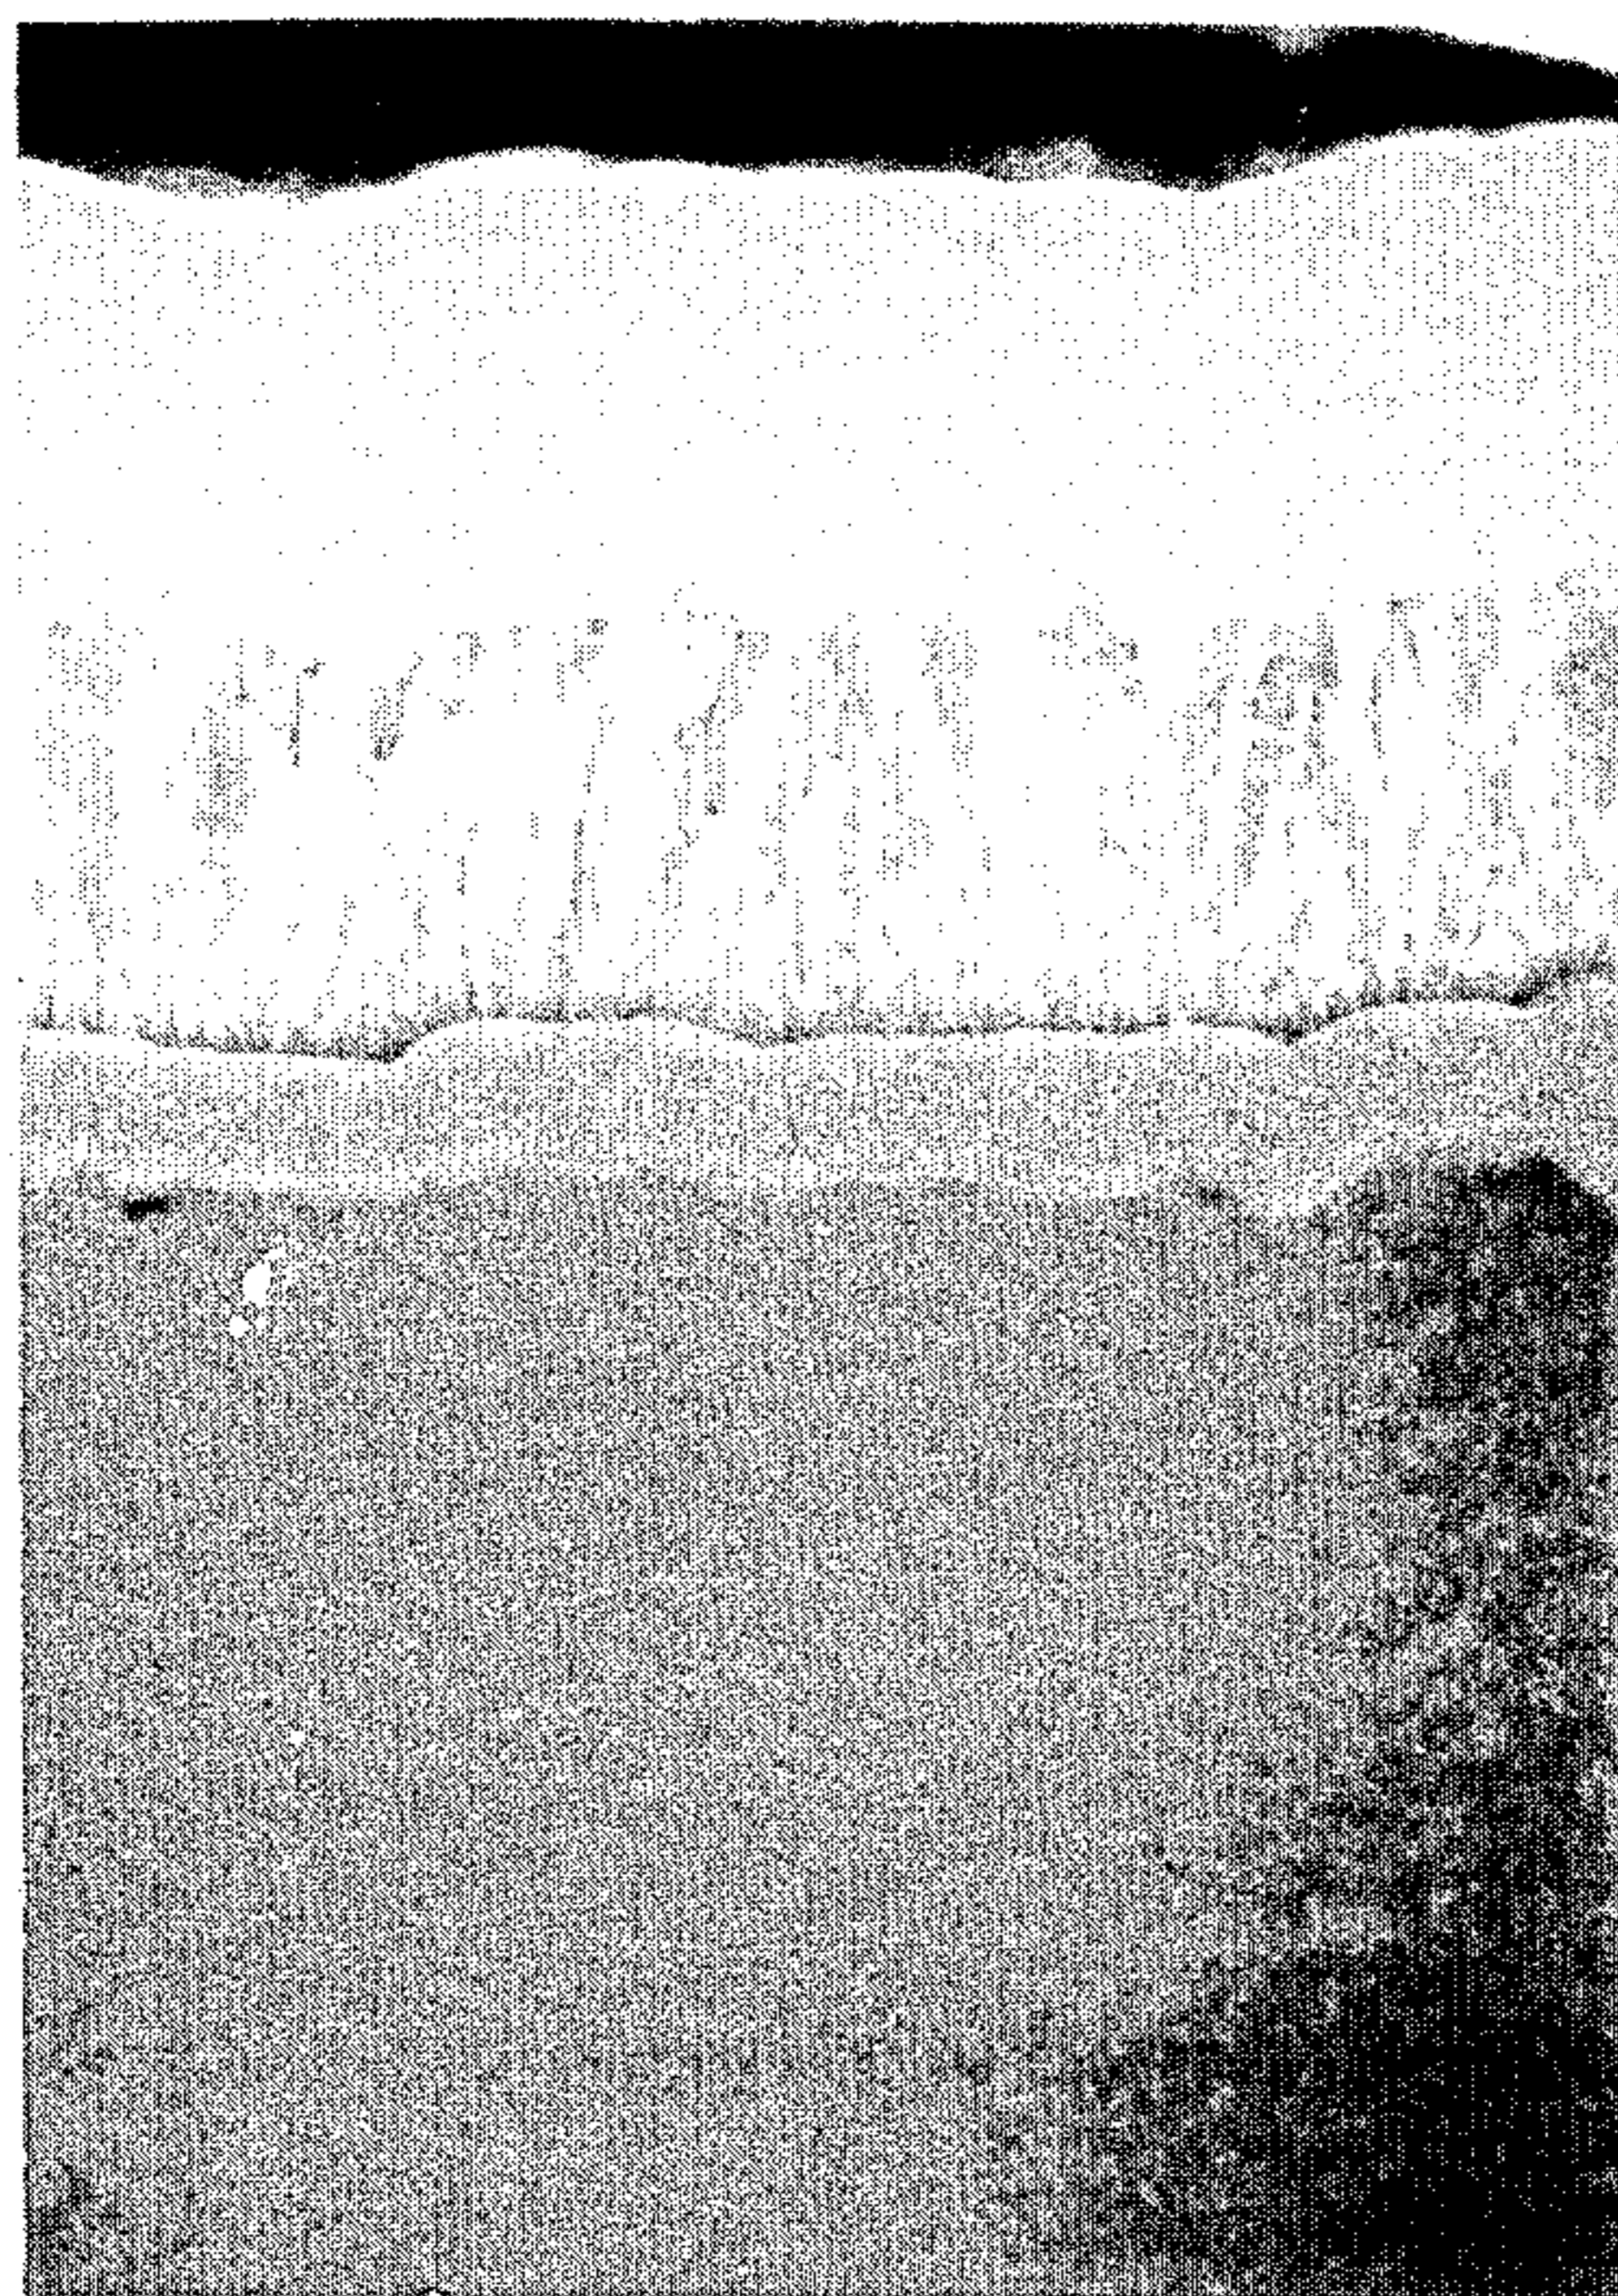
FIG. 6B is a photomicrograph, magnified 2000 times, of an etched cross section of a coating system according to the invention on Ti/6 Al/4 V substrate heat treated in-situ for 60 minutes followed by external heat treatment for 720 minutes at 500° C. showing the absence of non-uniformity in the microstructure.

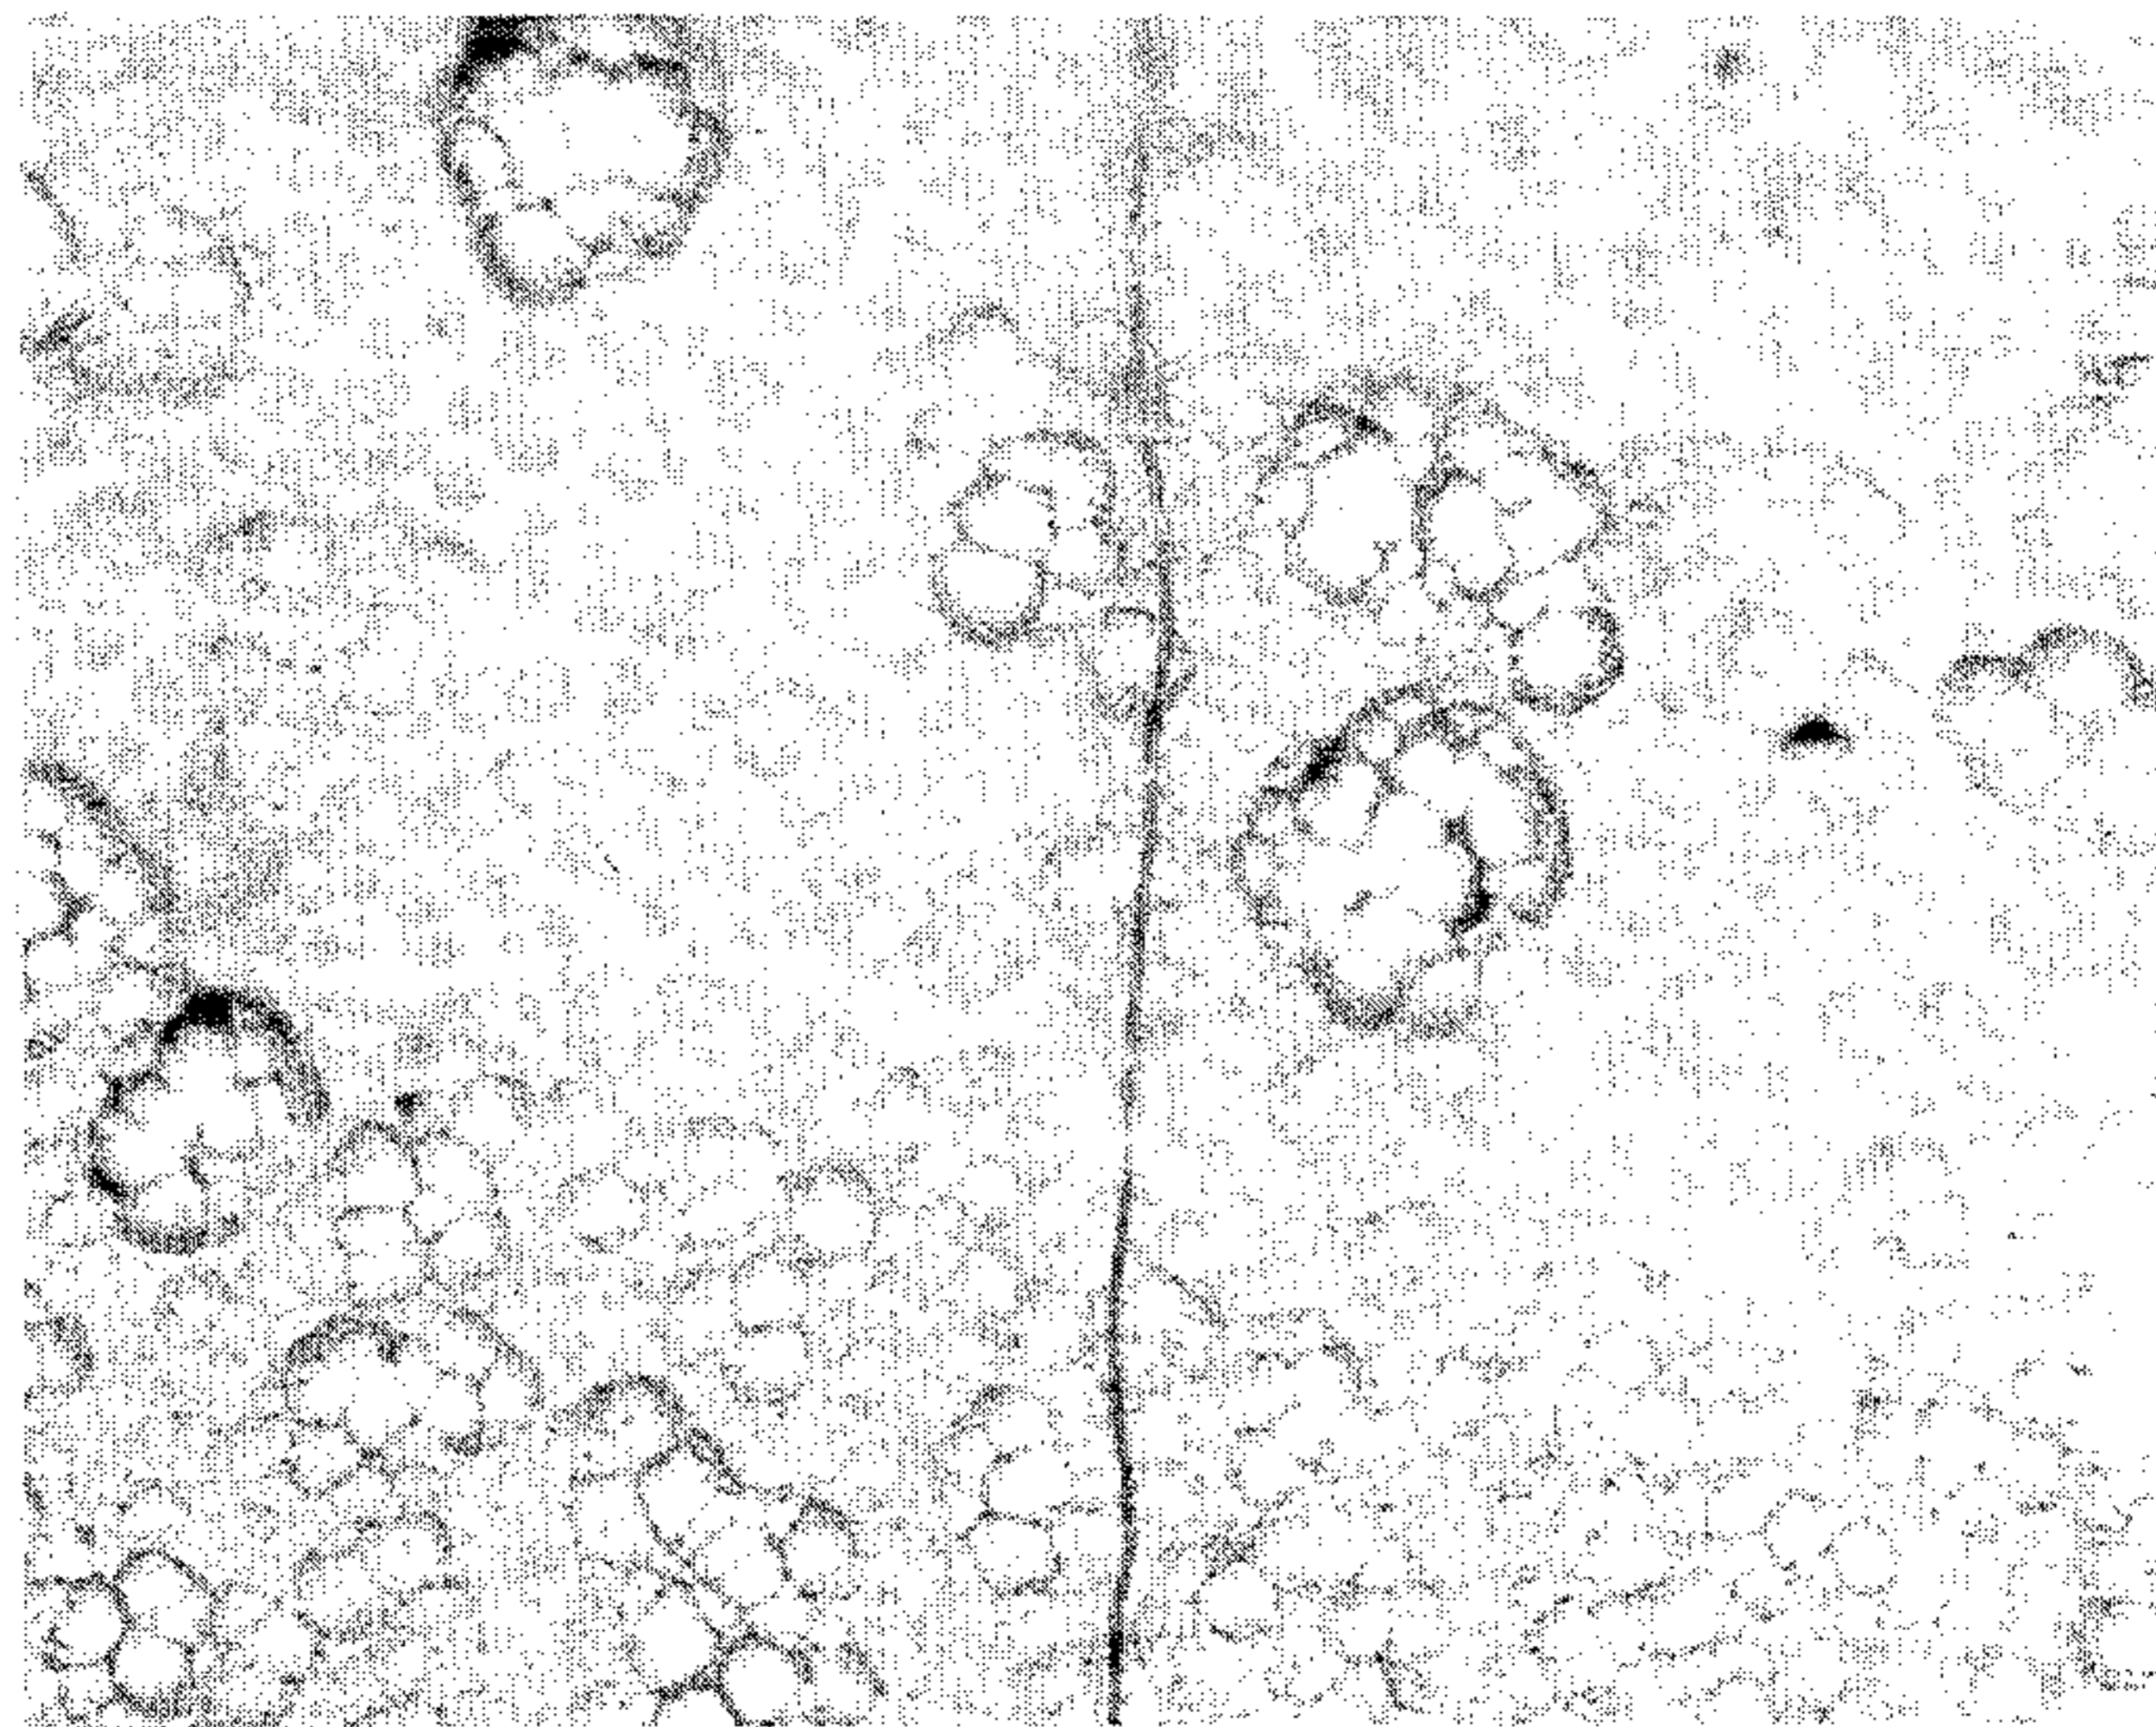
FIG. 6D is a photomicrograph, magnified 1000 times, of a coating on Ti/6 Al/4 V substrate heat treated in-situ for 60 minutes followed by external heat treatment for 720 minutes at 500° C. showing cracks in the coating.

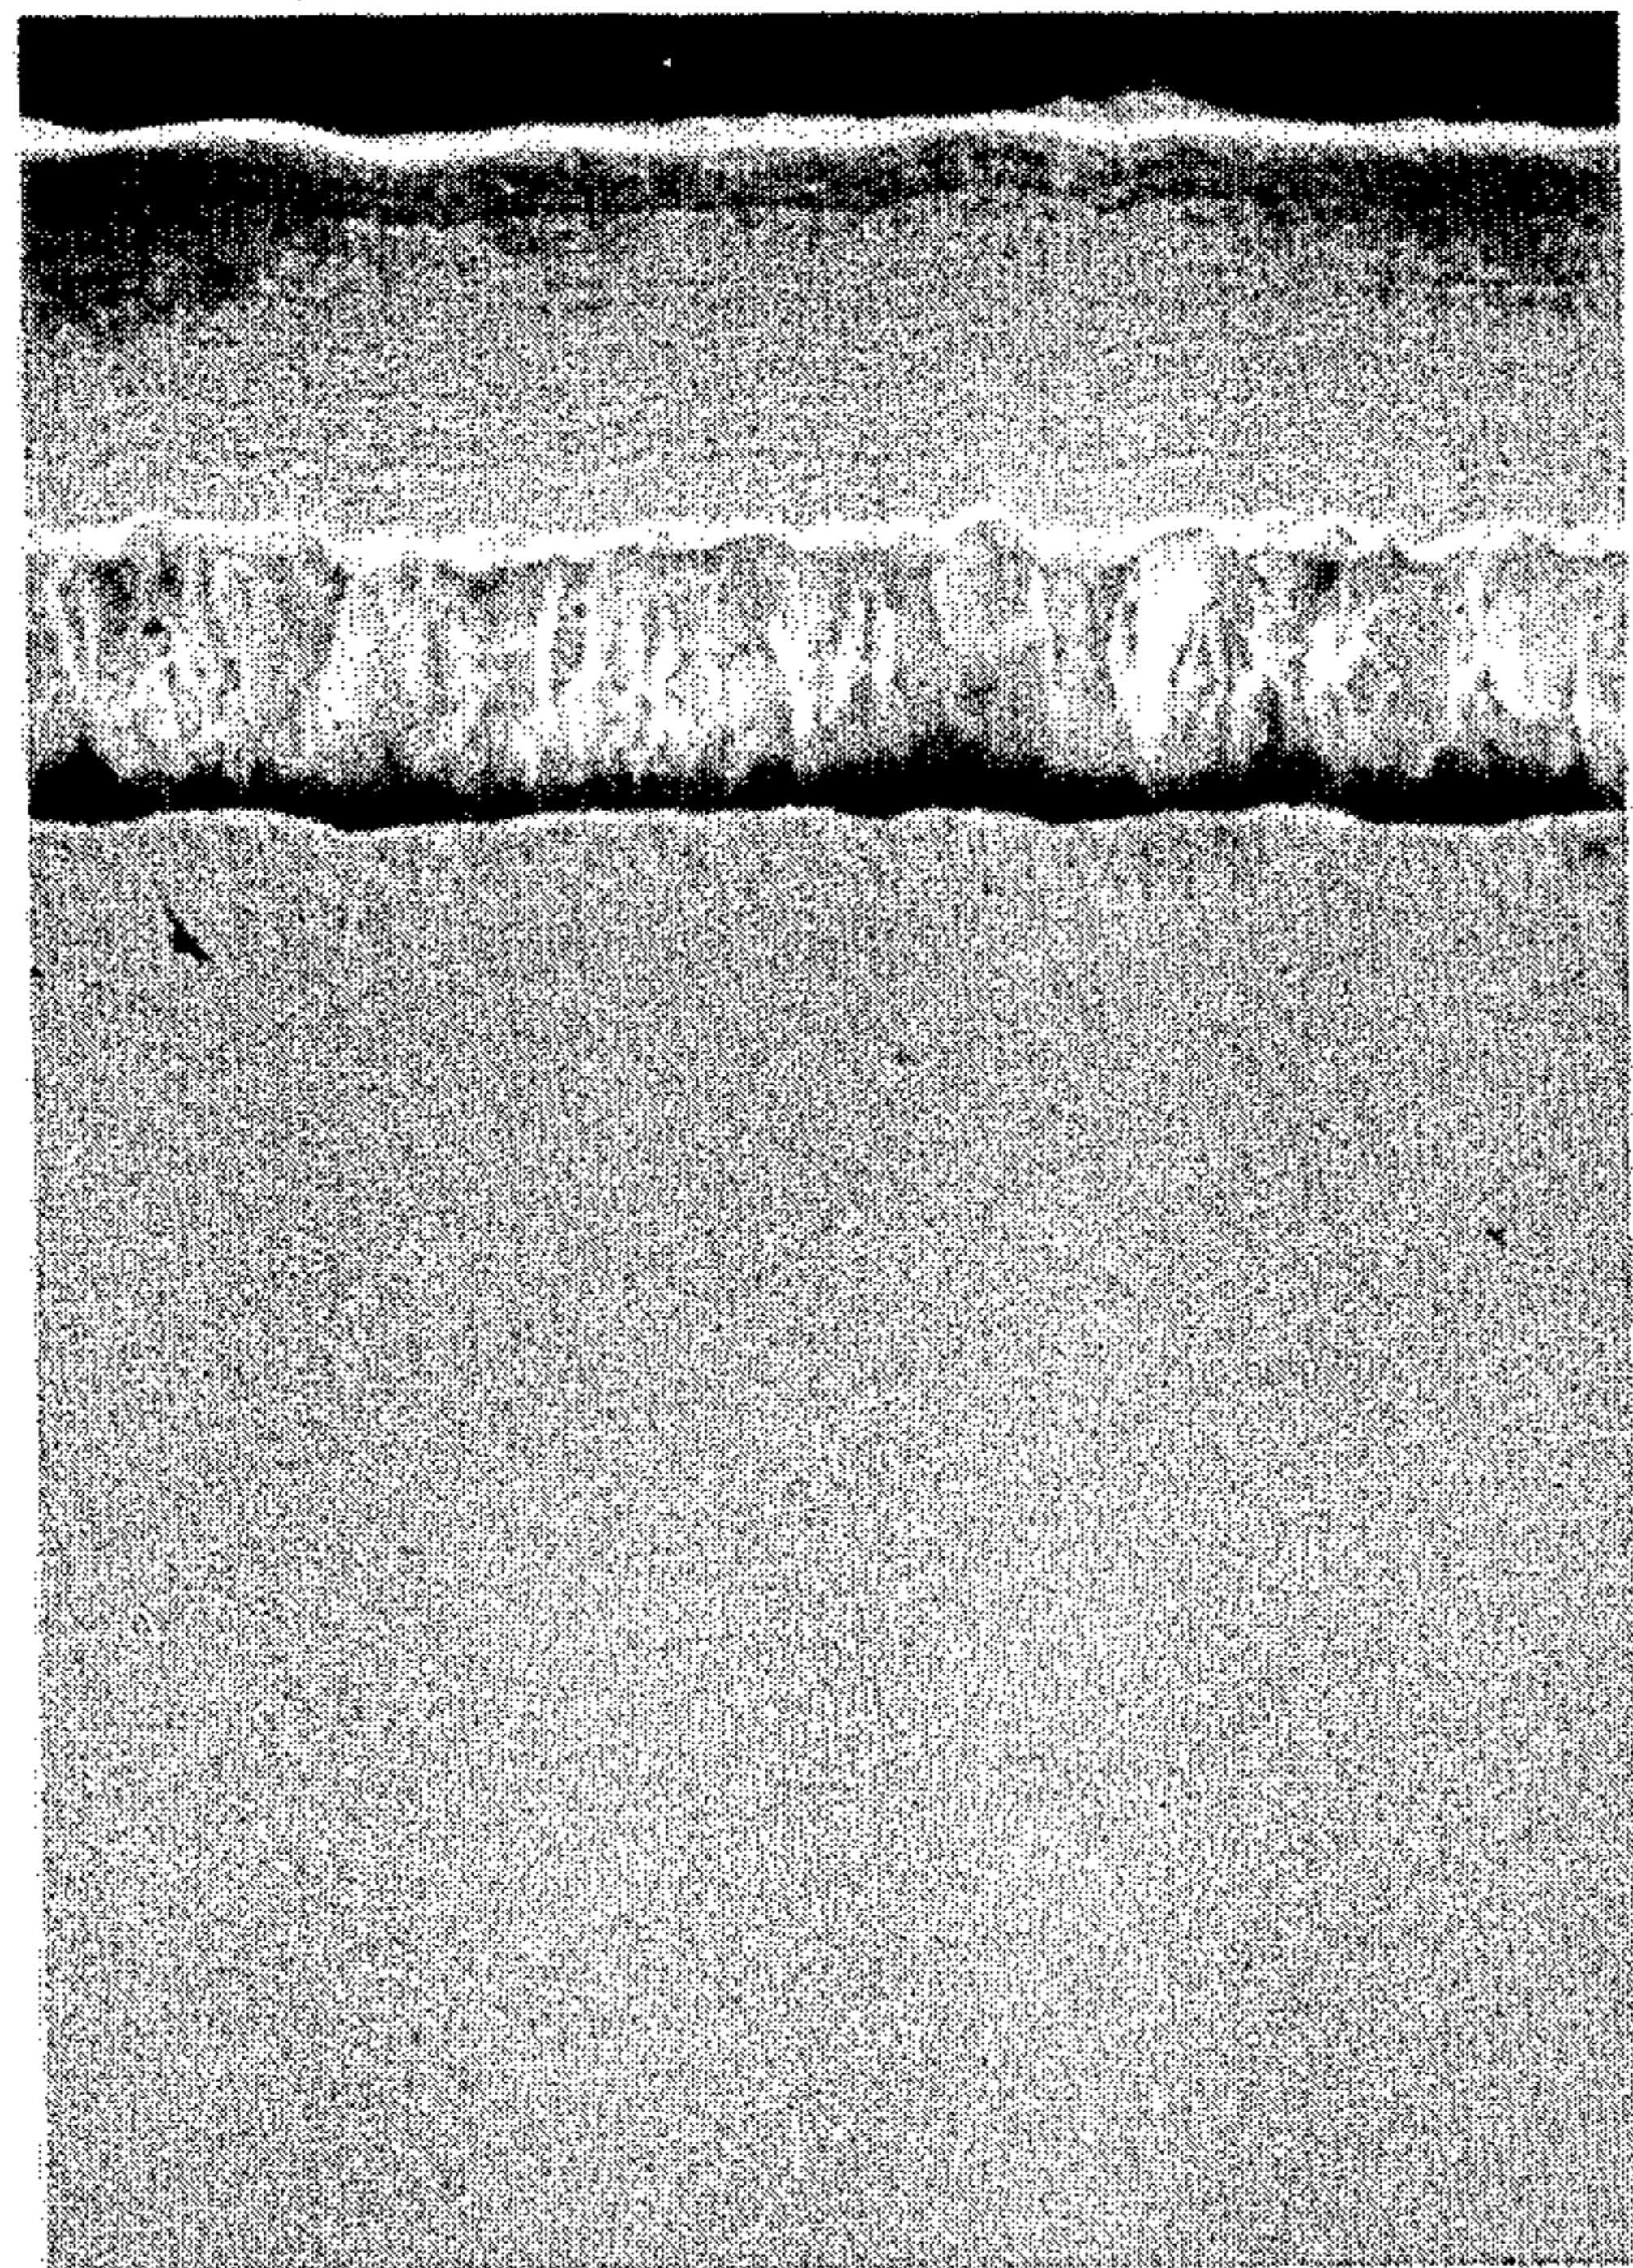
FIG. 7A is a photomicrograph, magnified 2000 times, of an etched cross section of a coating system according to the invention on AM-350 stainless steel substrate heat treated in-situ for 60 minutes followed by external heat treatment for 720 minutes at 550° C. showing the absence of non-uniformity in the microstructure.

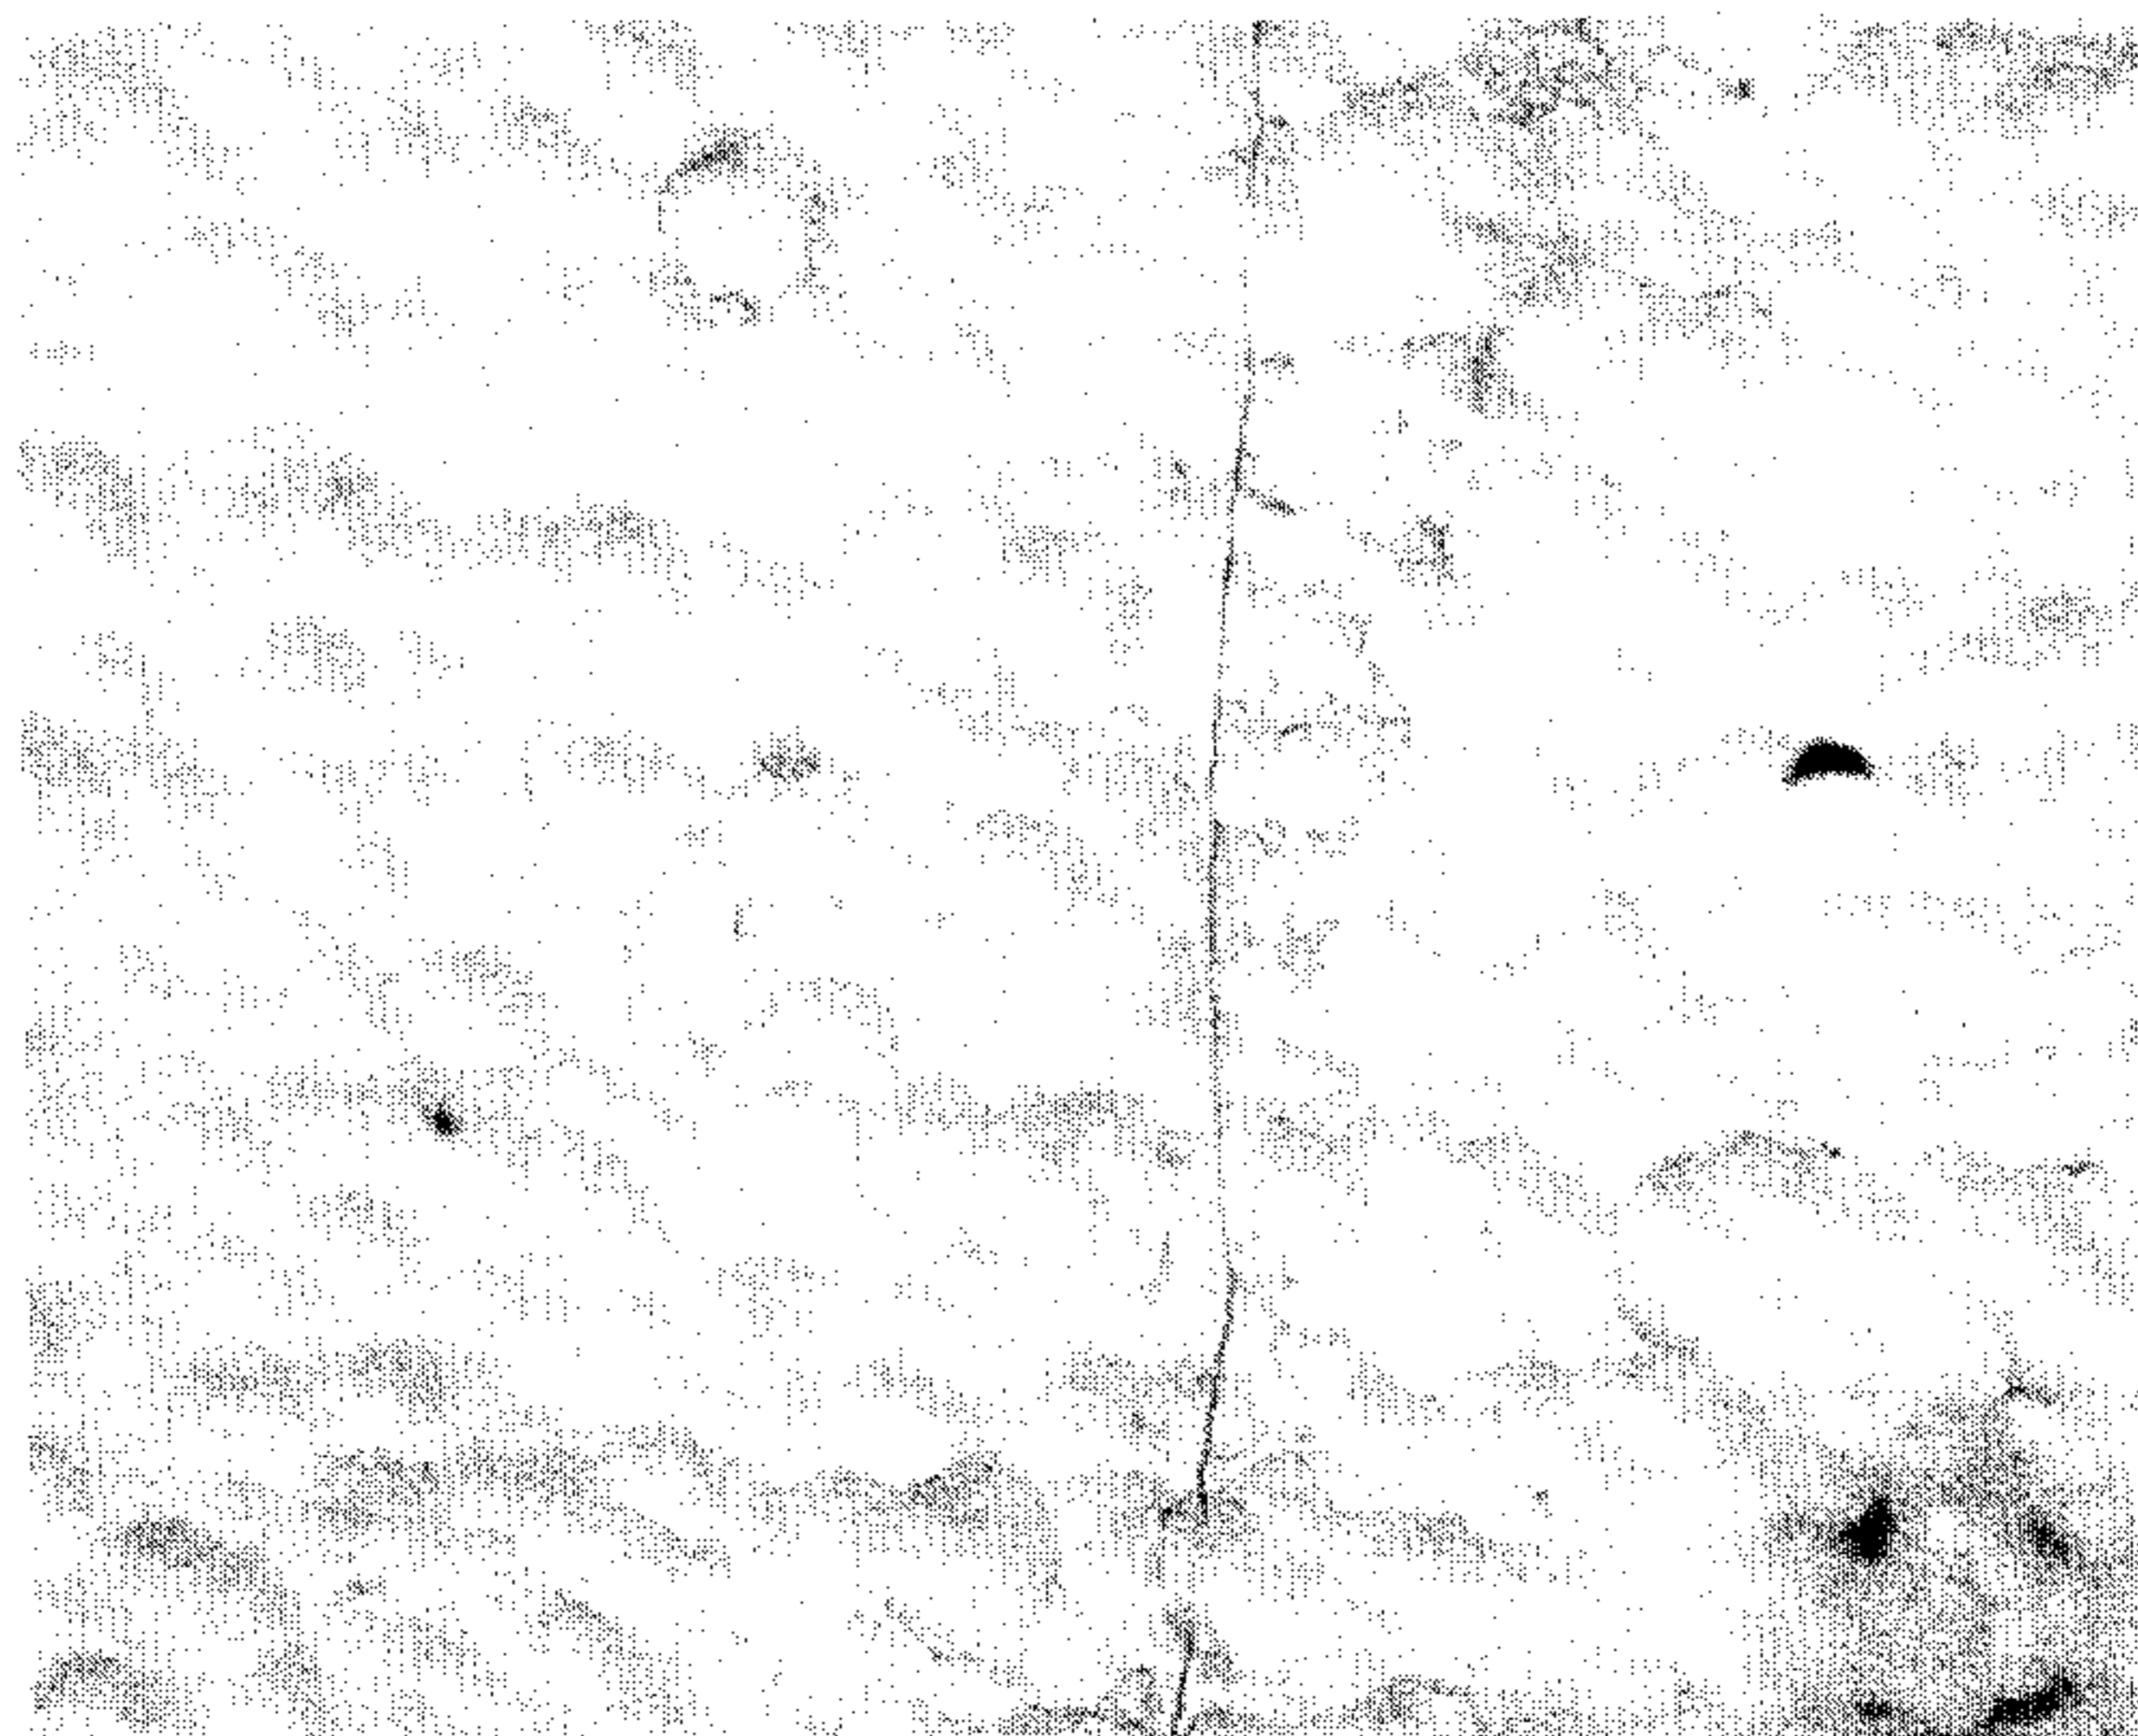
FIG. 8A is a photomicrograph, magnified 1000 times, of a coating on AM-350 stainless steel substrate heat treated in-situ for 60 minutes followed by external heat treatment for 720 minutes at 600° C. showing cracks in the coating.

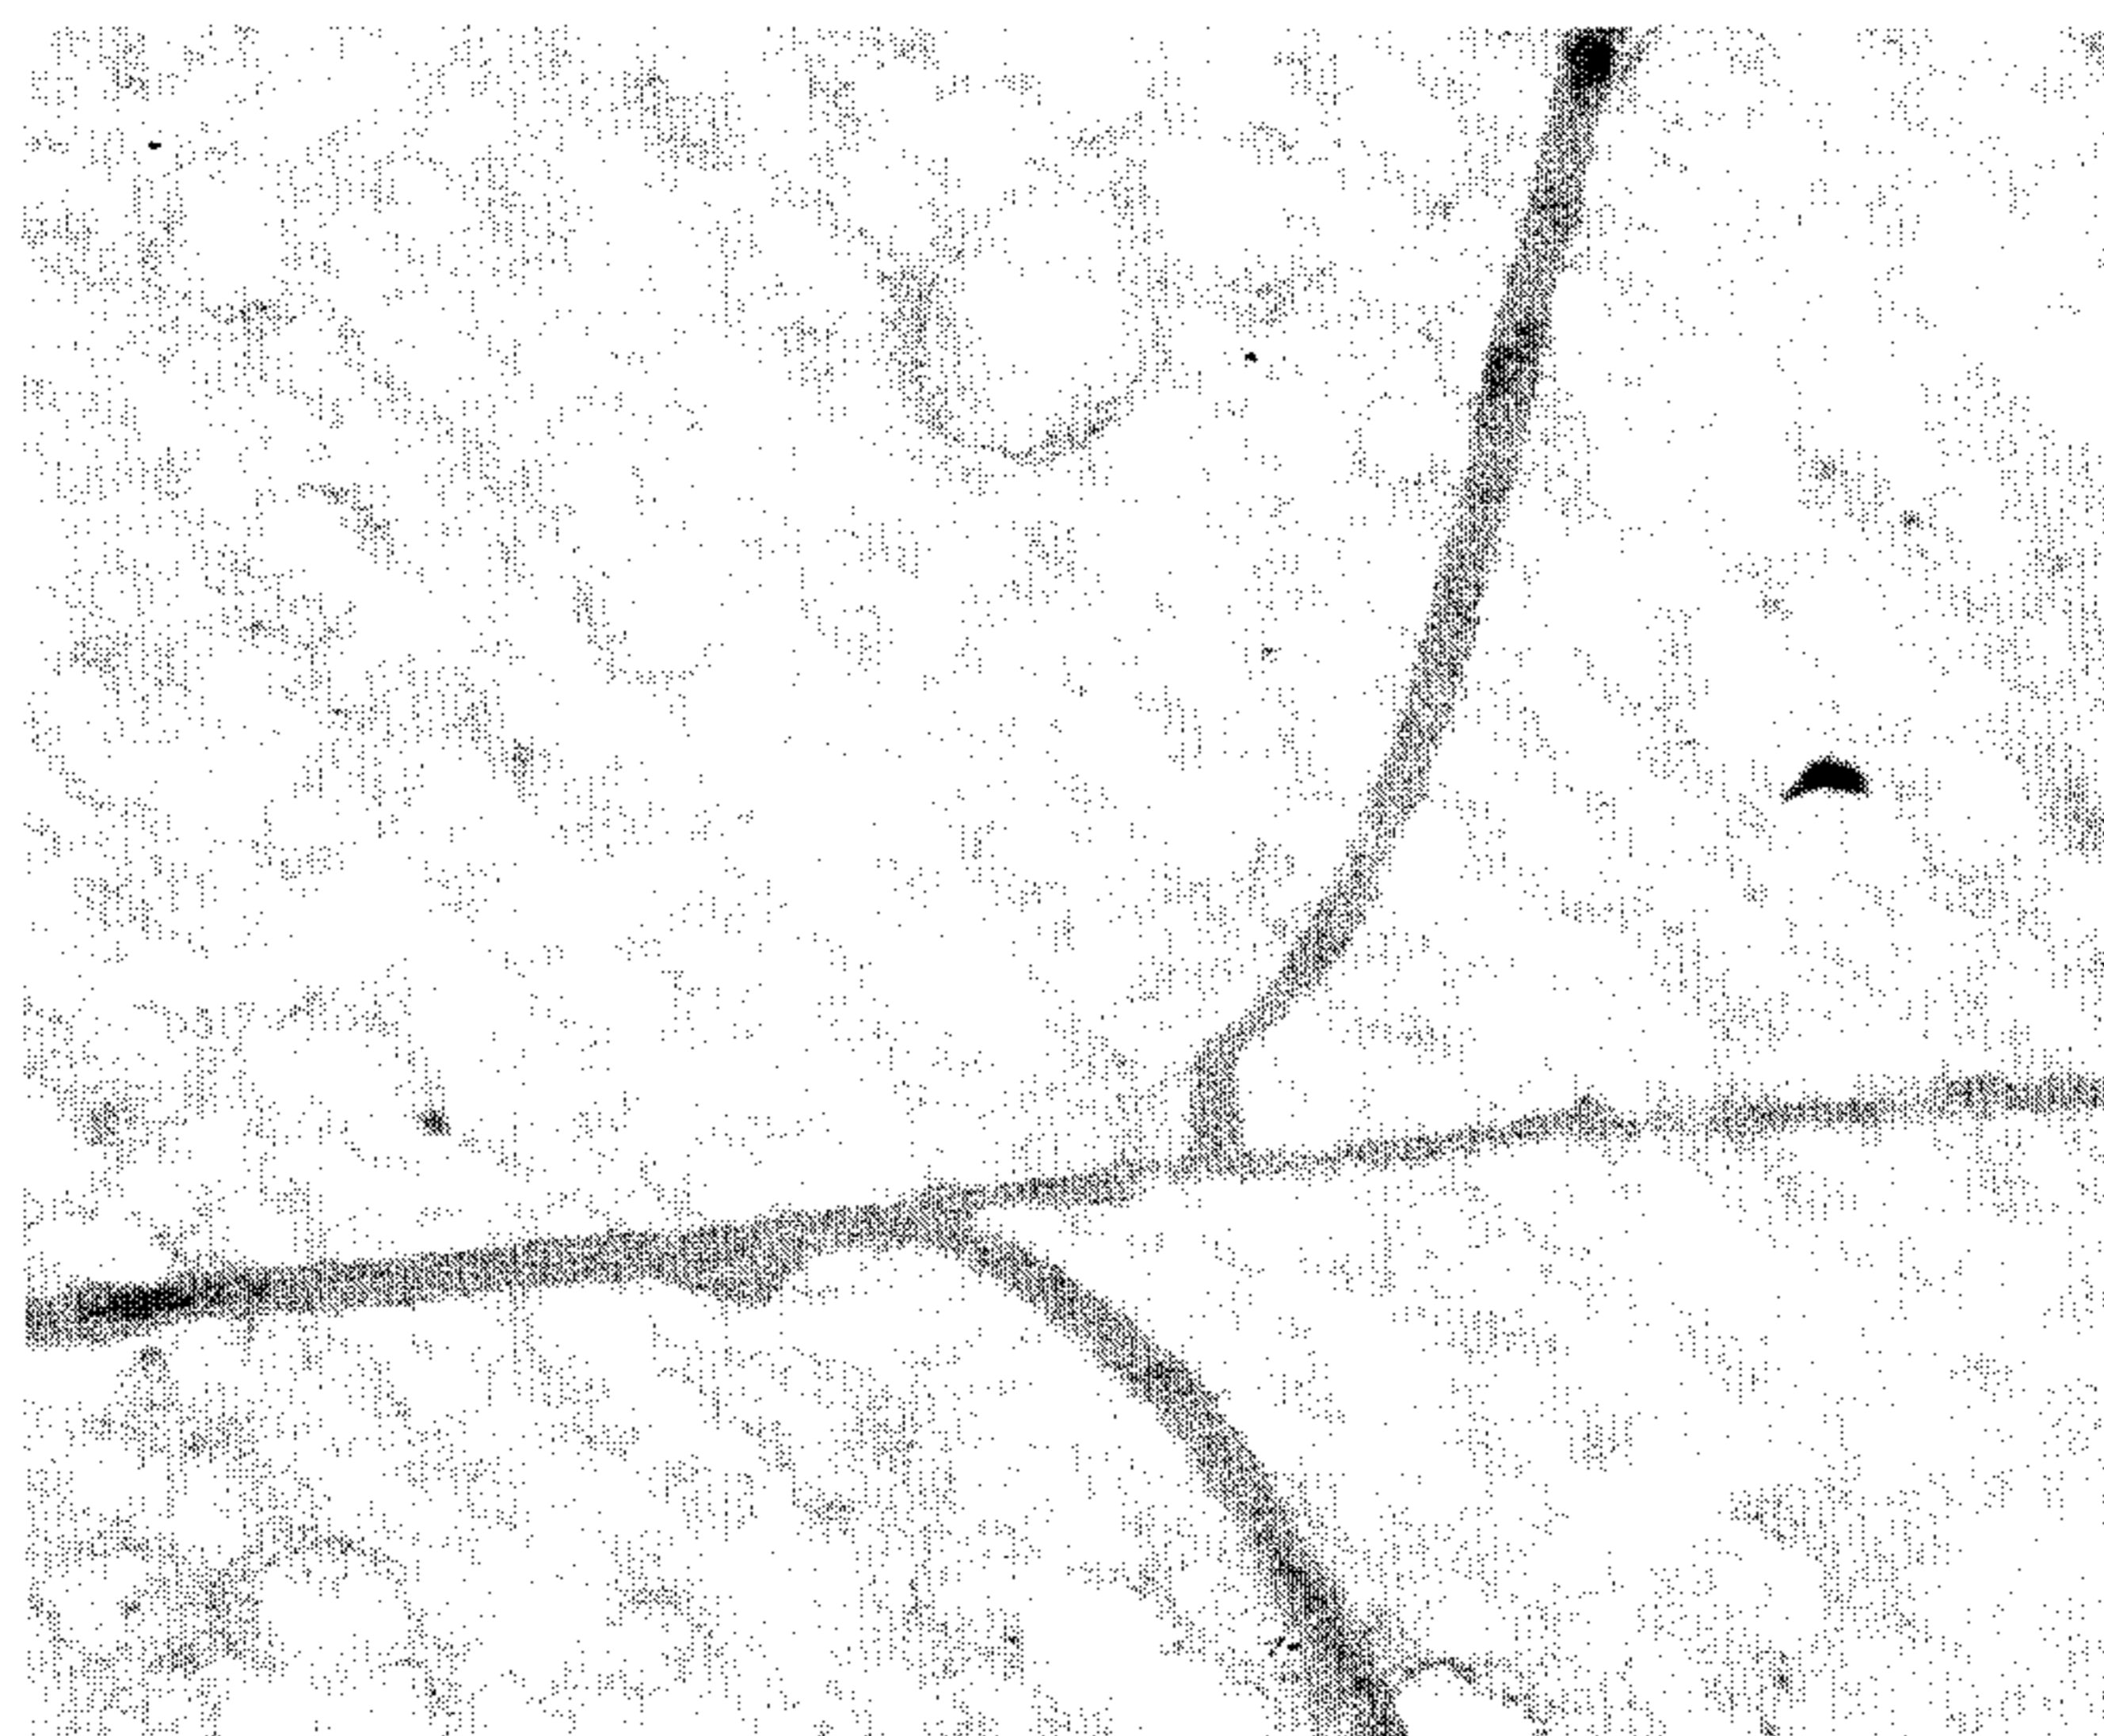
FIG. 8B is a photomicrograph, magnified 1000 times, of a coating on Ti/6Al/4V substrate heat treated in-situ for 60 minutes followed by external heat treatment for 720 minutes at 600° C. showing cracks in the coating.
