[54] **HEAT TREATED CHEMICALLY VAPOR DEPOSITED PRODUCTS**

[57] **ABSTRACT**

"A coated substrate product is described wherein the outer coating on the substrate is comprised of a chemically vapor deposited and heat treated mixture of tungsten and tungsten carbide. The tungsten carbide phase consists of W₂C or W₃C or a mixture of W₂C and W₃C. During the heat treating, the coated substrate is heated to the deposition temperature or not substantially above the deposition temperature in a non-reactive atmosphere. The heat treating temperature is sufficient to confer a desired improvement in erosive and abrasive wear resistance in the outer coating but does not result in substantial degradation of the mechanical properties of the substrate or in formation of undesirable inter-metallic layers".

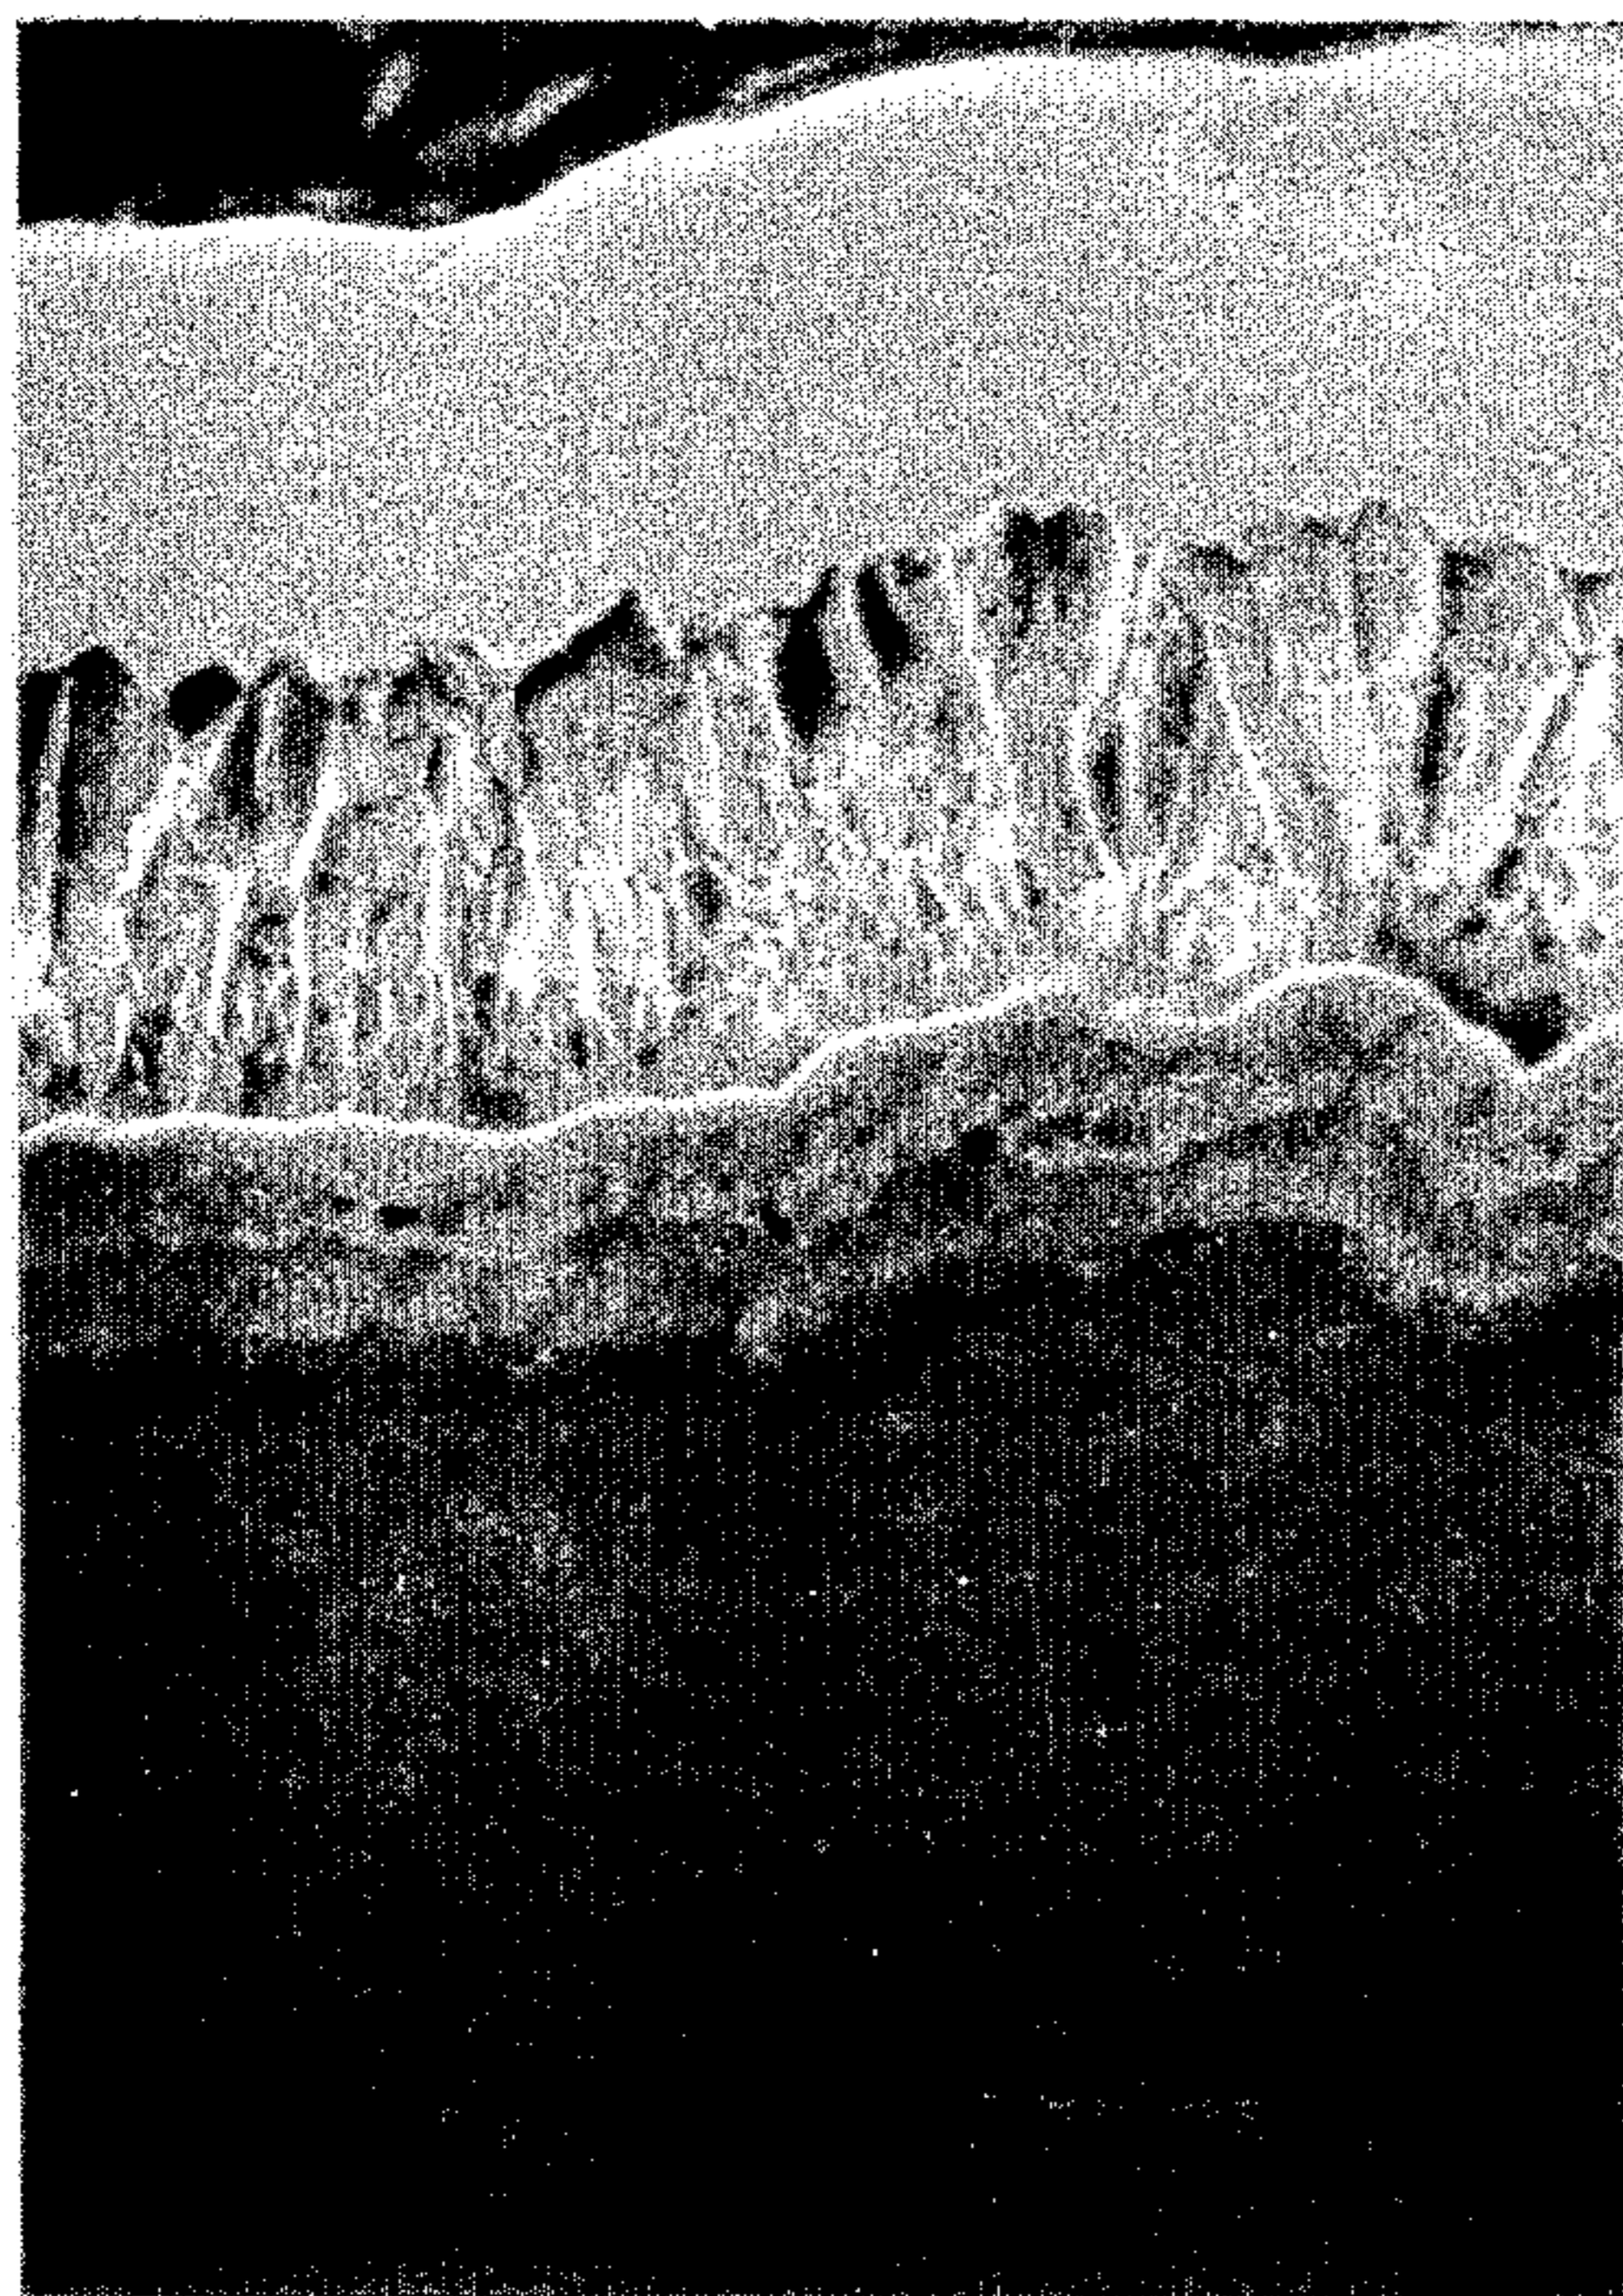
FIG. 8D is a photomicrograph, magnified 2000 times, of an etched cross section of a coating system according to the invention on Ti/6Al/4V substrate heat treated in-situ for 60 minutes followed by external heat treatment for 720 minutes at 600° C. showing the absence of non-uniformity in the microstructure and the formation of an intermetallic titanium-nickel compound.

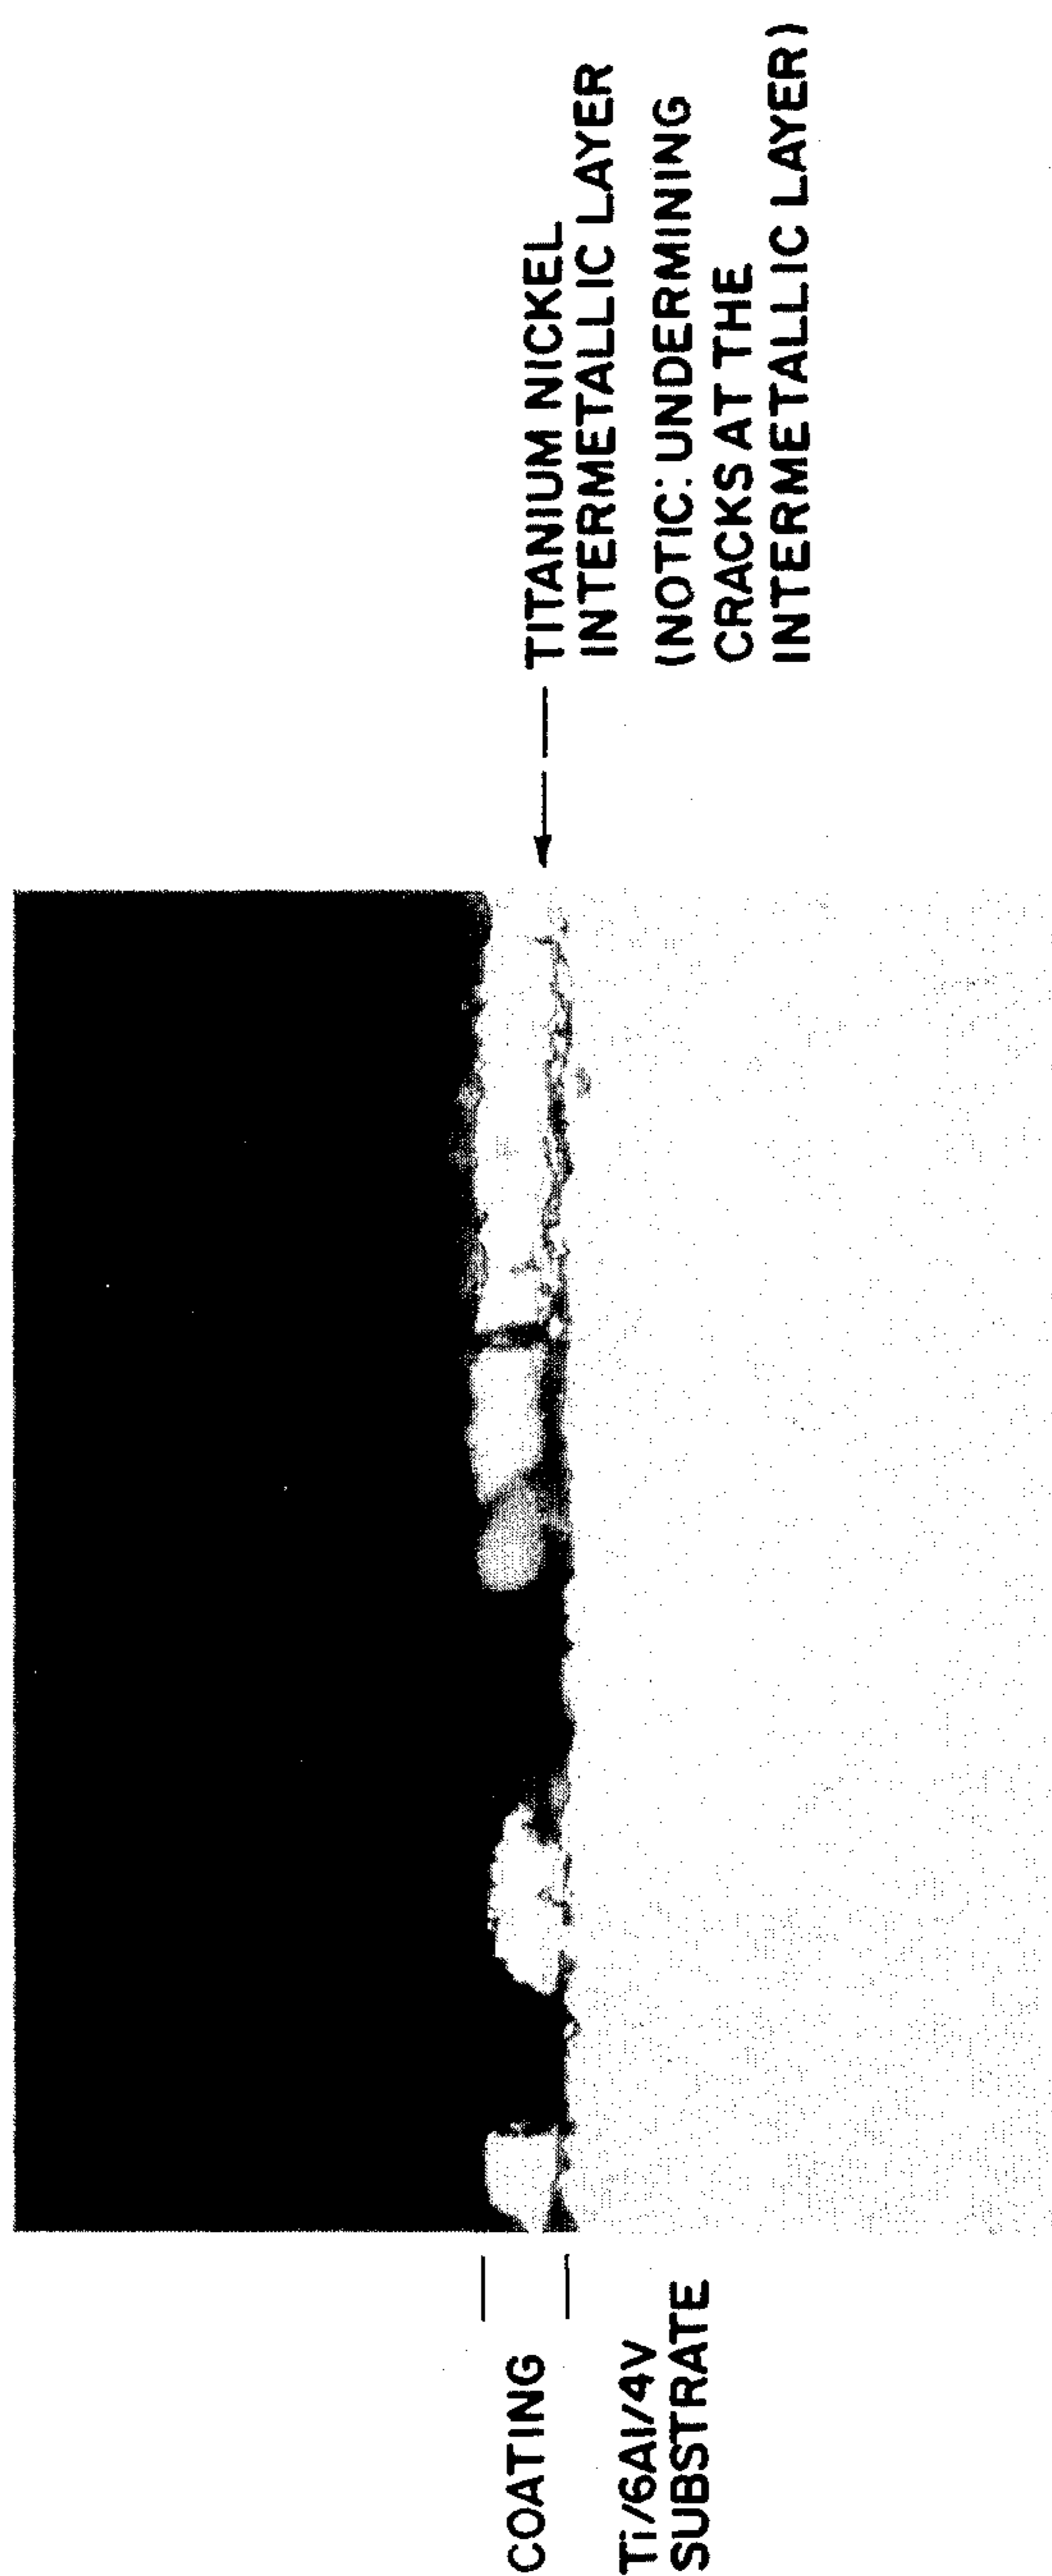
FIG. 9 is a photomicrograph, magnified 500 times, of a cross section of a coating system on Ti/6Al/4V substrate heat treated in-situ for 60 minutes followed by external heat treatment for 720 minutes at 600° C. showing the failure of the coating during the erosion test.
