- [54] **INSPECTING GLASS CONTAINERS FOR LINE-OVER FINISH DEFECTS WITH BIFURCATED FIBER OPTIC BUNDLE**
- [75] **Inventor:** Mark P. Claypool, Horseheads, N.Y.
- [73] **Assignee:** Emhart Industries, Inc., Hartford, Conn.
- [21] **Appl. No.:** 161,623
- [22] **Filed:** Feb. 29, 1988
- [51] **Int. Cl.⁵** G01N 9/04; B07C 5/00
- [52] **U.S. Cl.** 280/223 B; 250/227.29; 209/524
- [58] **Field of Search** 250/223 B, 227; 356/240; 209/526, 524; 350/96.25, 96.26, 96.27

INSPECTING GLASS CONTAINERS FOR LINE-OVER FINISH DEFECTS WITH BIFURCATED FIBER OPTIC BUNDLE

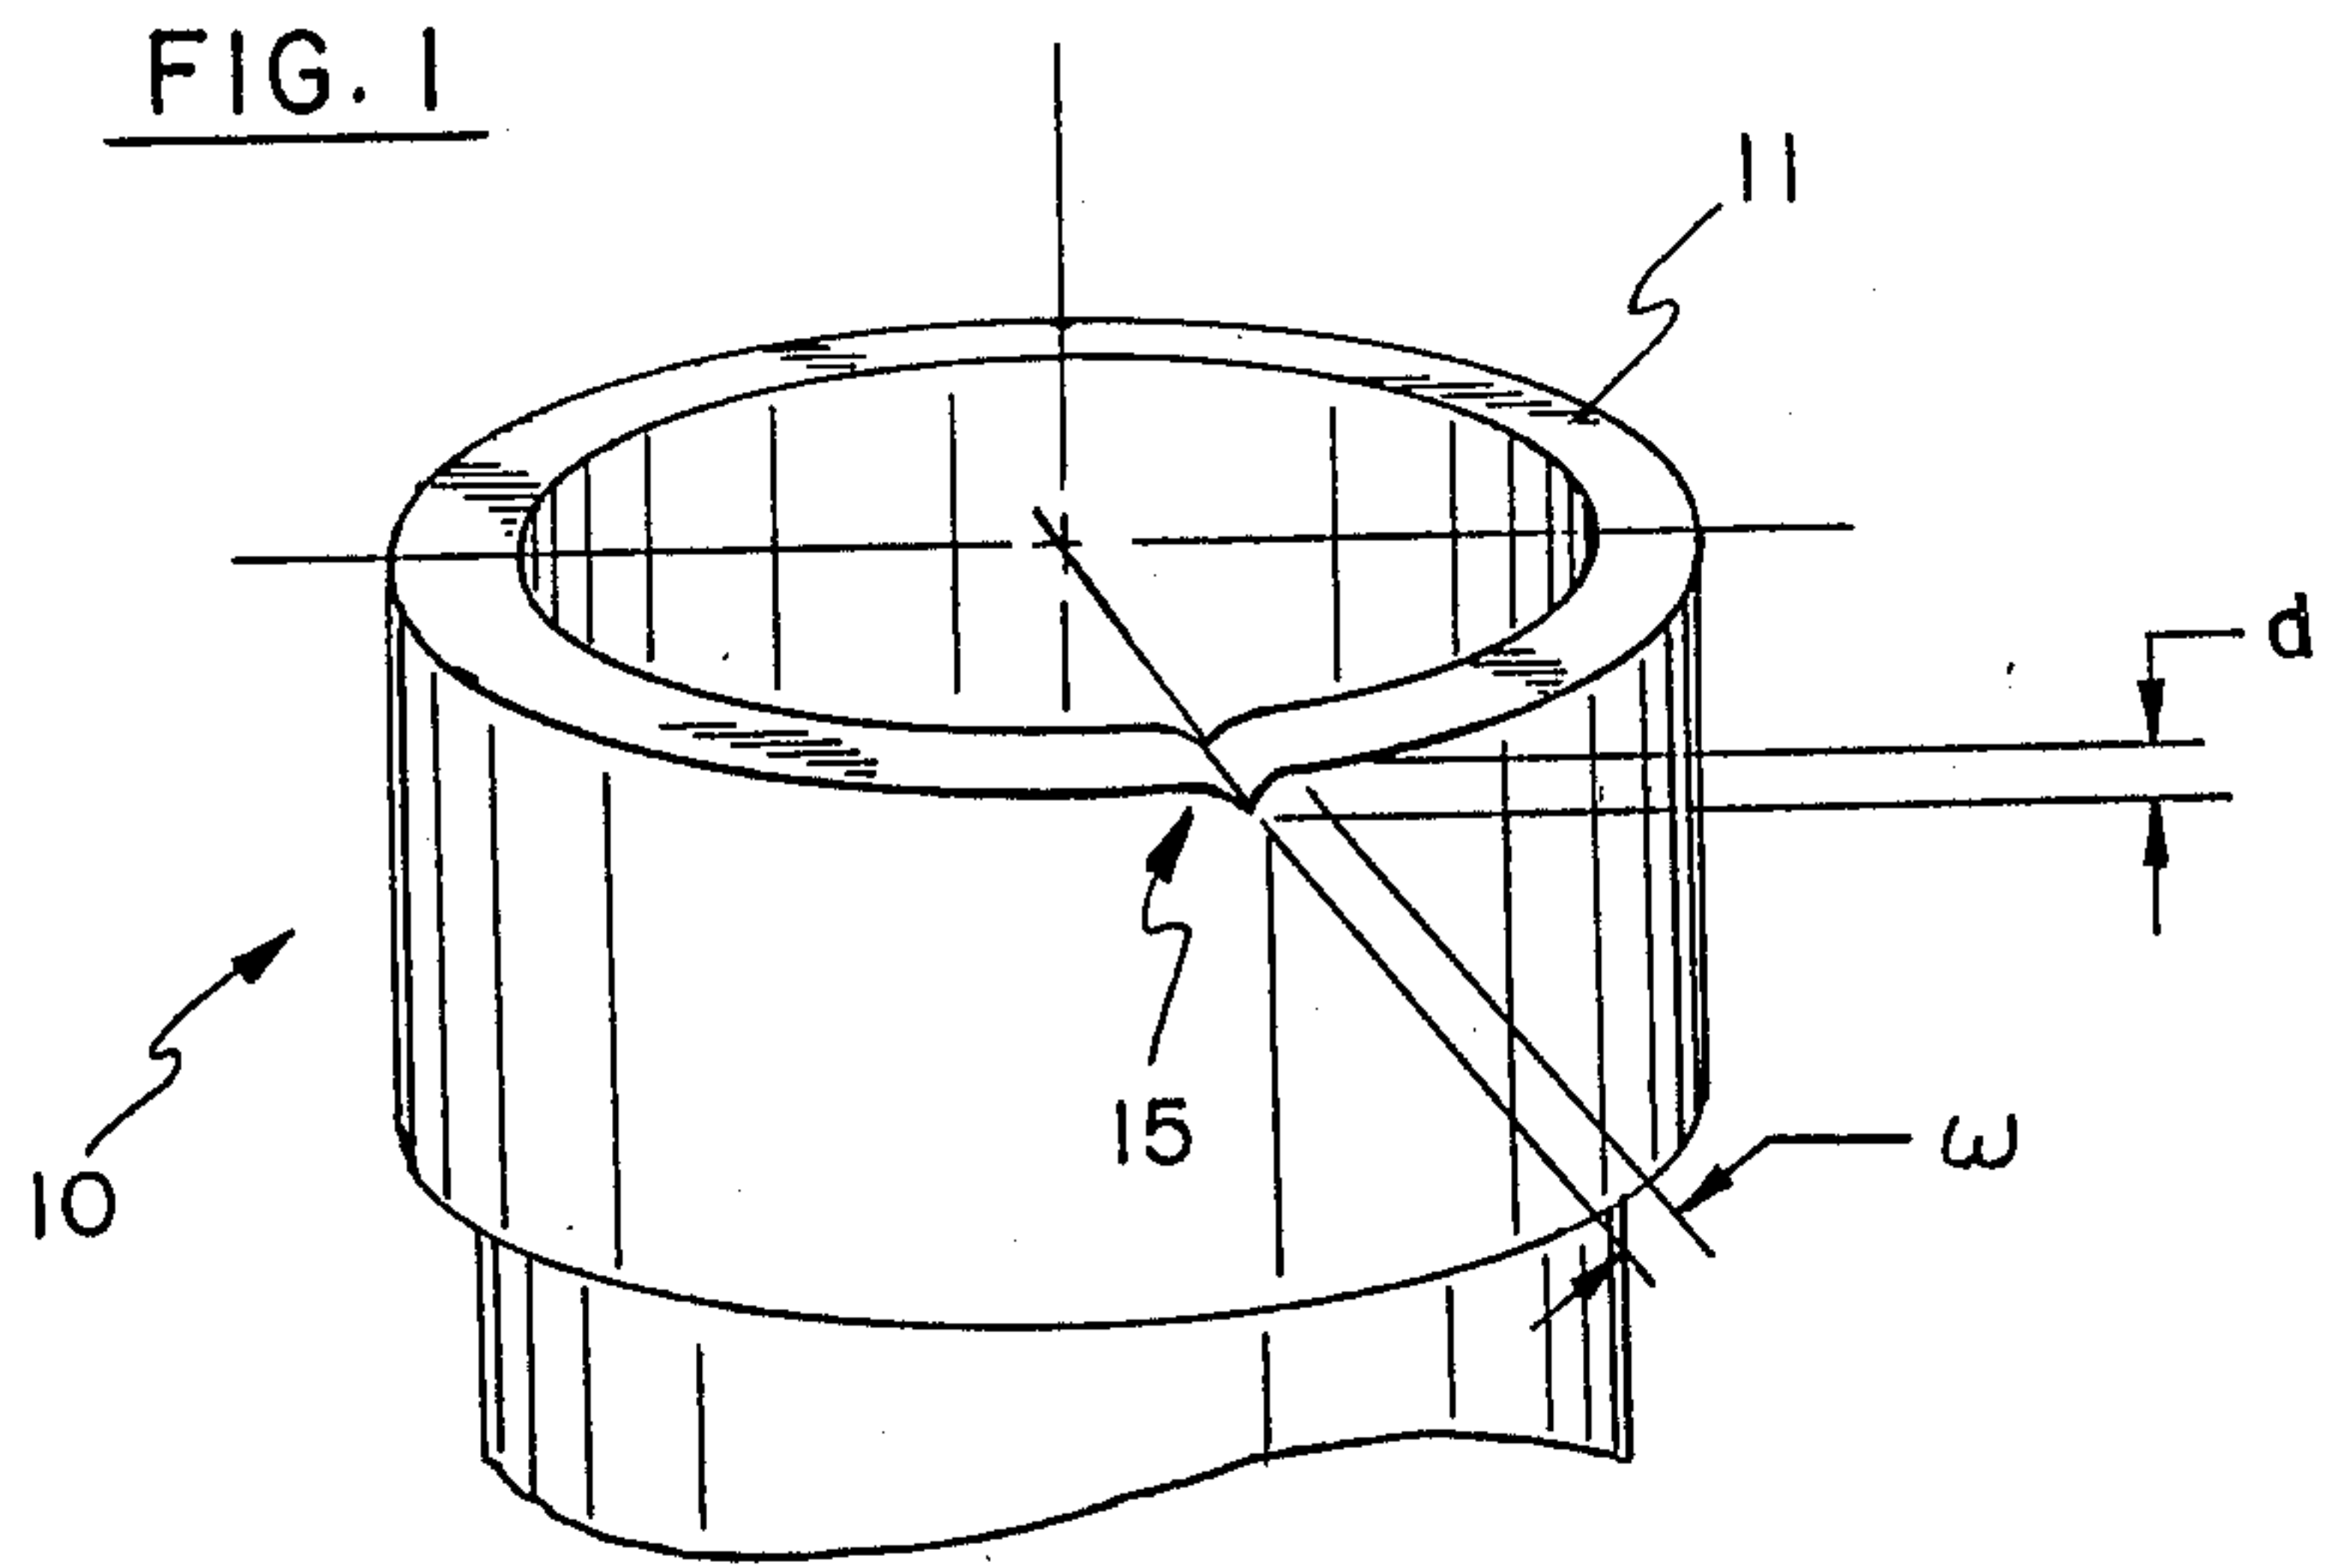
FIG. 1 is a perspective view of a glass bottle finish, with a line-over groove;

The so-called "line-over" defect is a common problem in the manufacture of glass containers; other common names for line-overs are "shear marks" and "nit marks". This defect is a very small groove which extends radially across the sealing surface of the finish of the glass container; see FIG. 1. It has been considered one of the worst and hardest to detect defects throughout the industry. In carbonated beverages, for example, the cap seal is not capable of sealing these fine grooves, and over a period of time, the carbonation gases seep out and the beverage goes flat. Food jars are another critical area. If the seal is bad due to this defect, the food can become contaminated. The baby food industry is particularly concerned with line-overs.

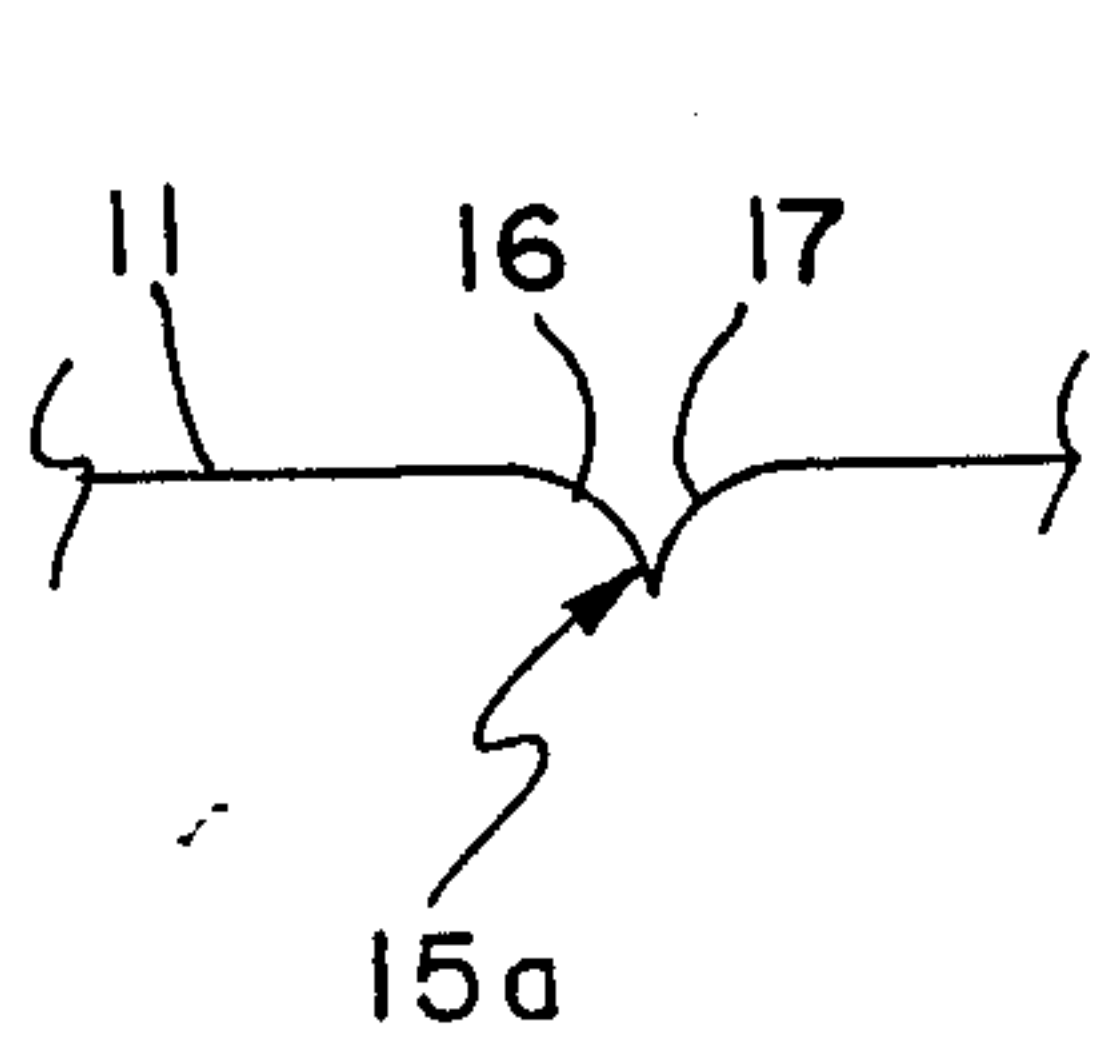
FIG. 2A shows a groove with a steep right wall, shallow left wall;

FIGS. 2A, 2B, and 2C are partial elevation views of a glass container finish, viewed from the interior, with three different line-over groove orientations:

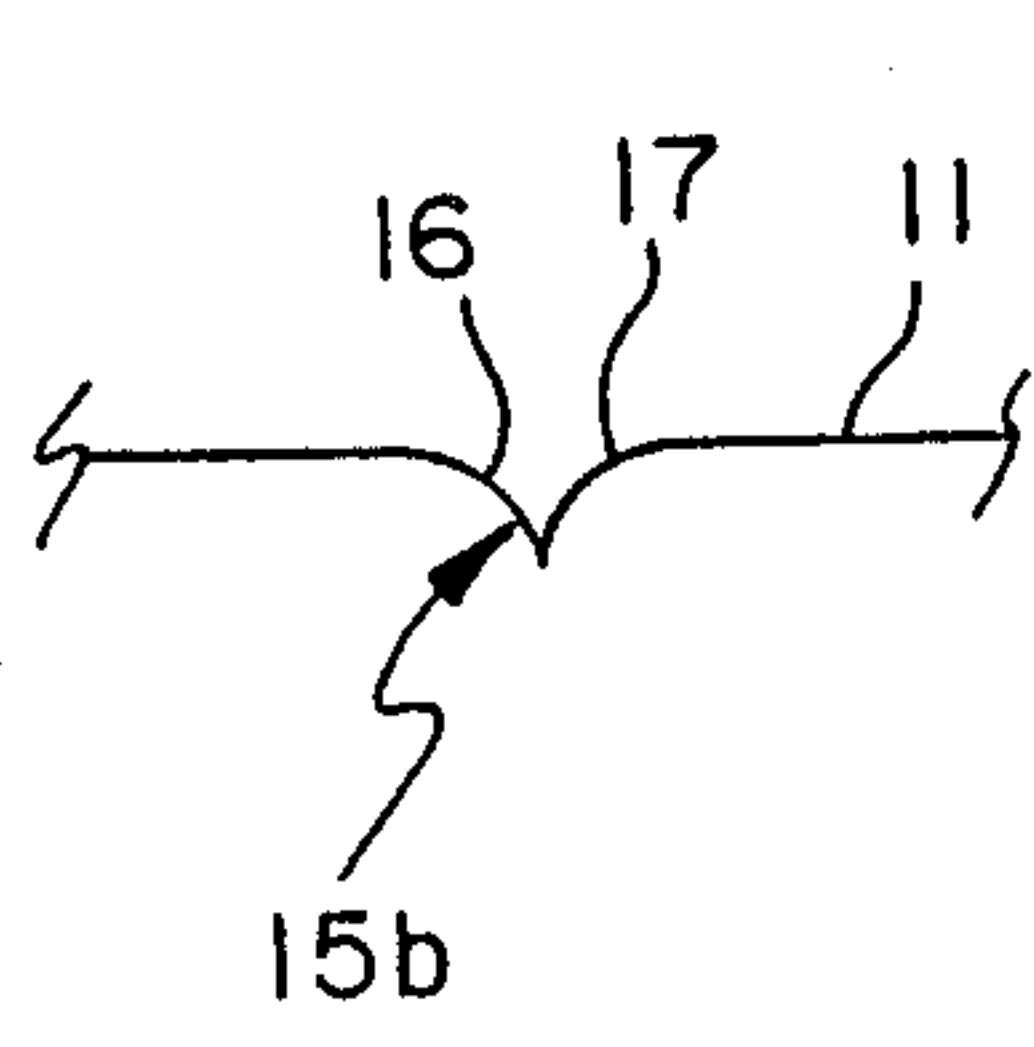
FIG. 2B shows a groove with a symmetrical profile;

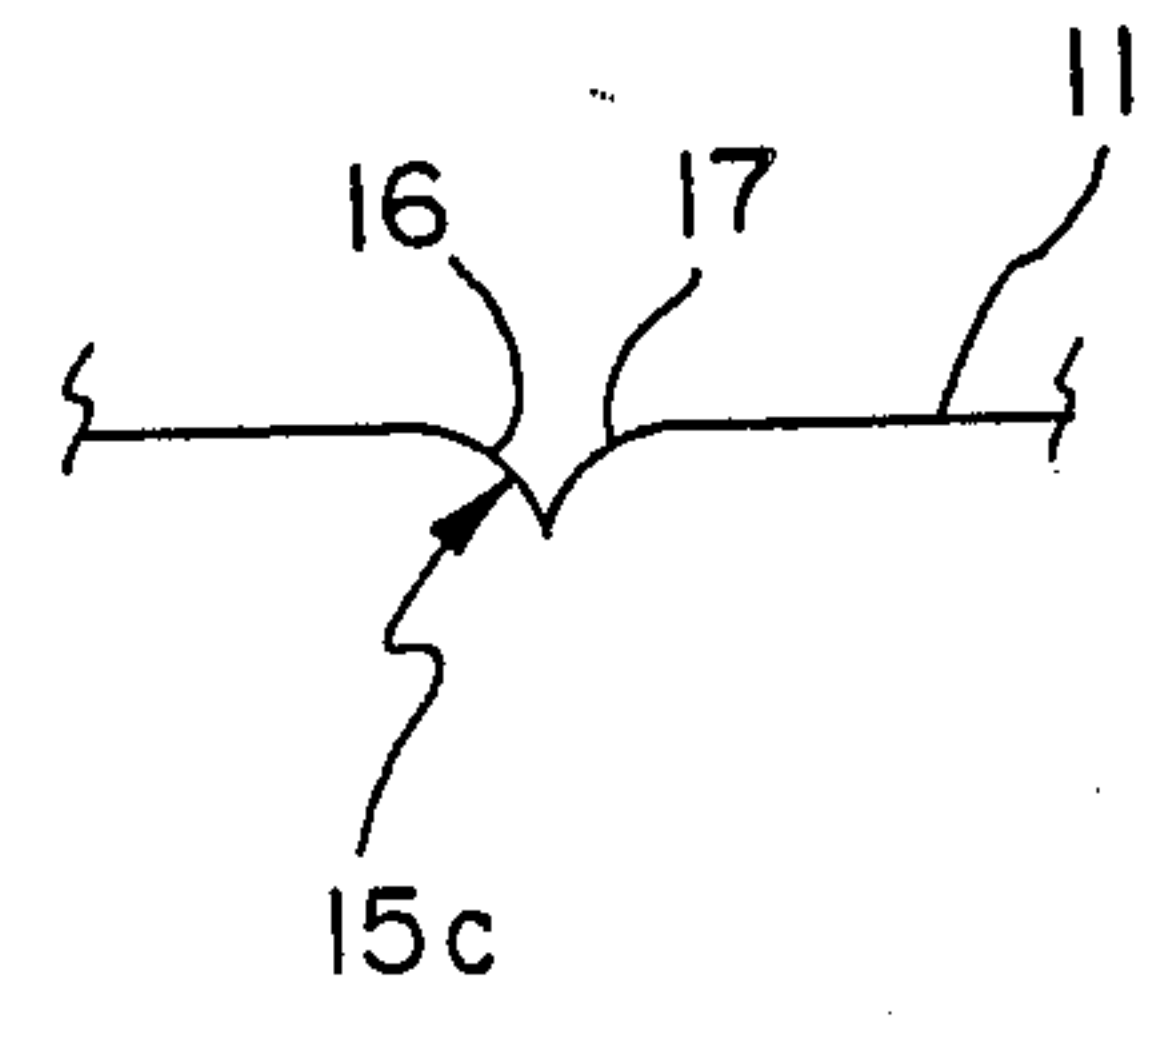
FIG. 2C shows a groove with a shallow right wall, steep left wall;

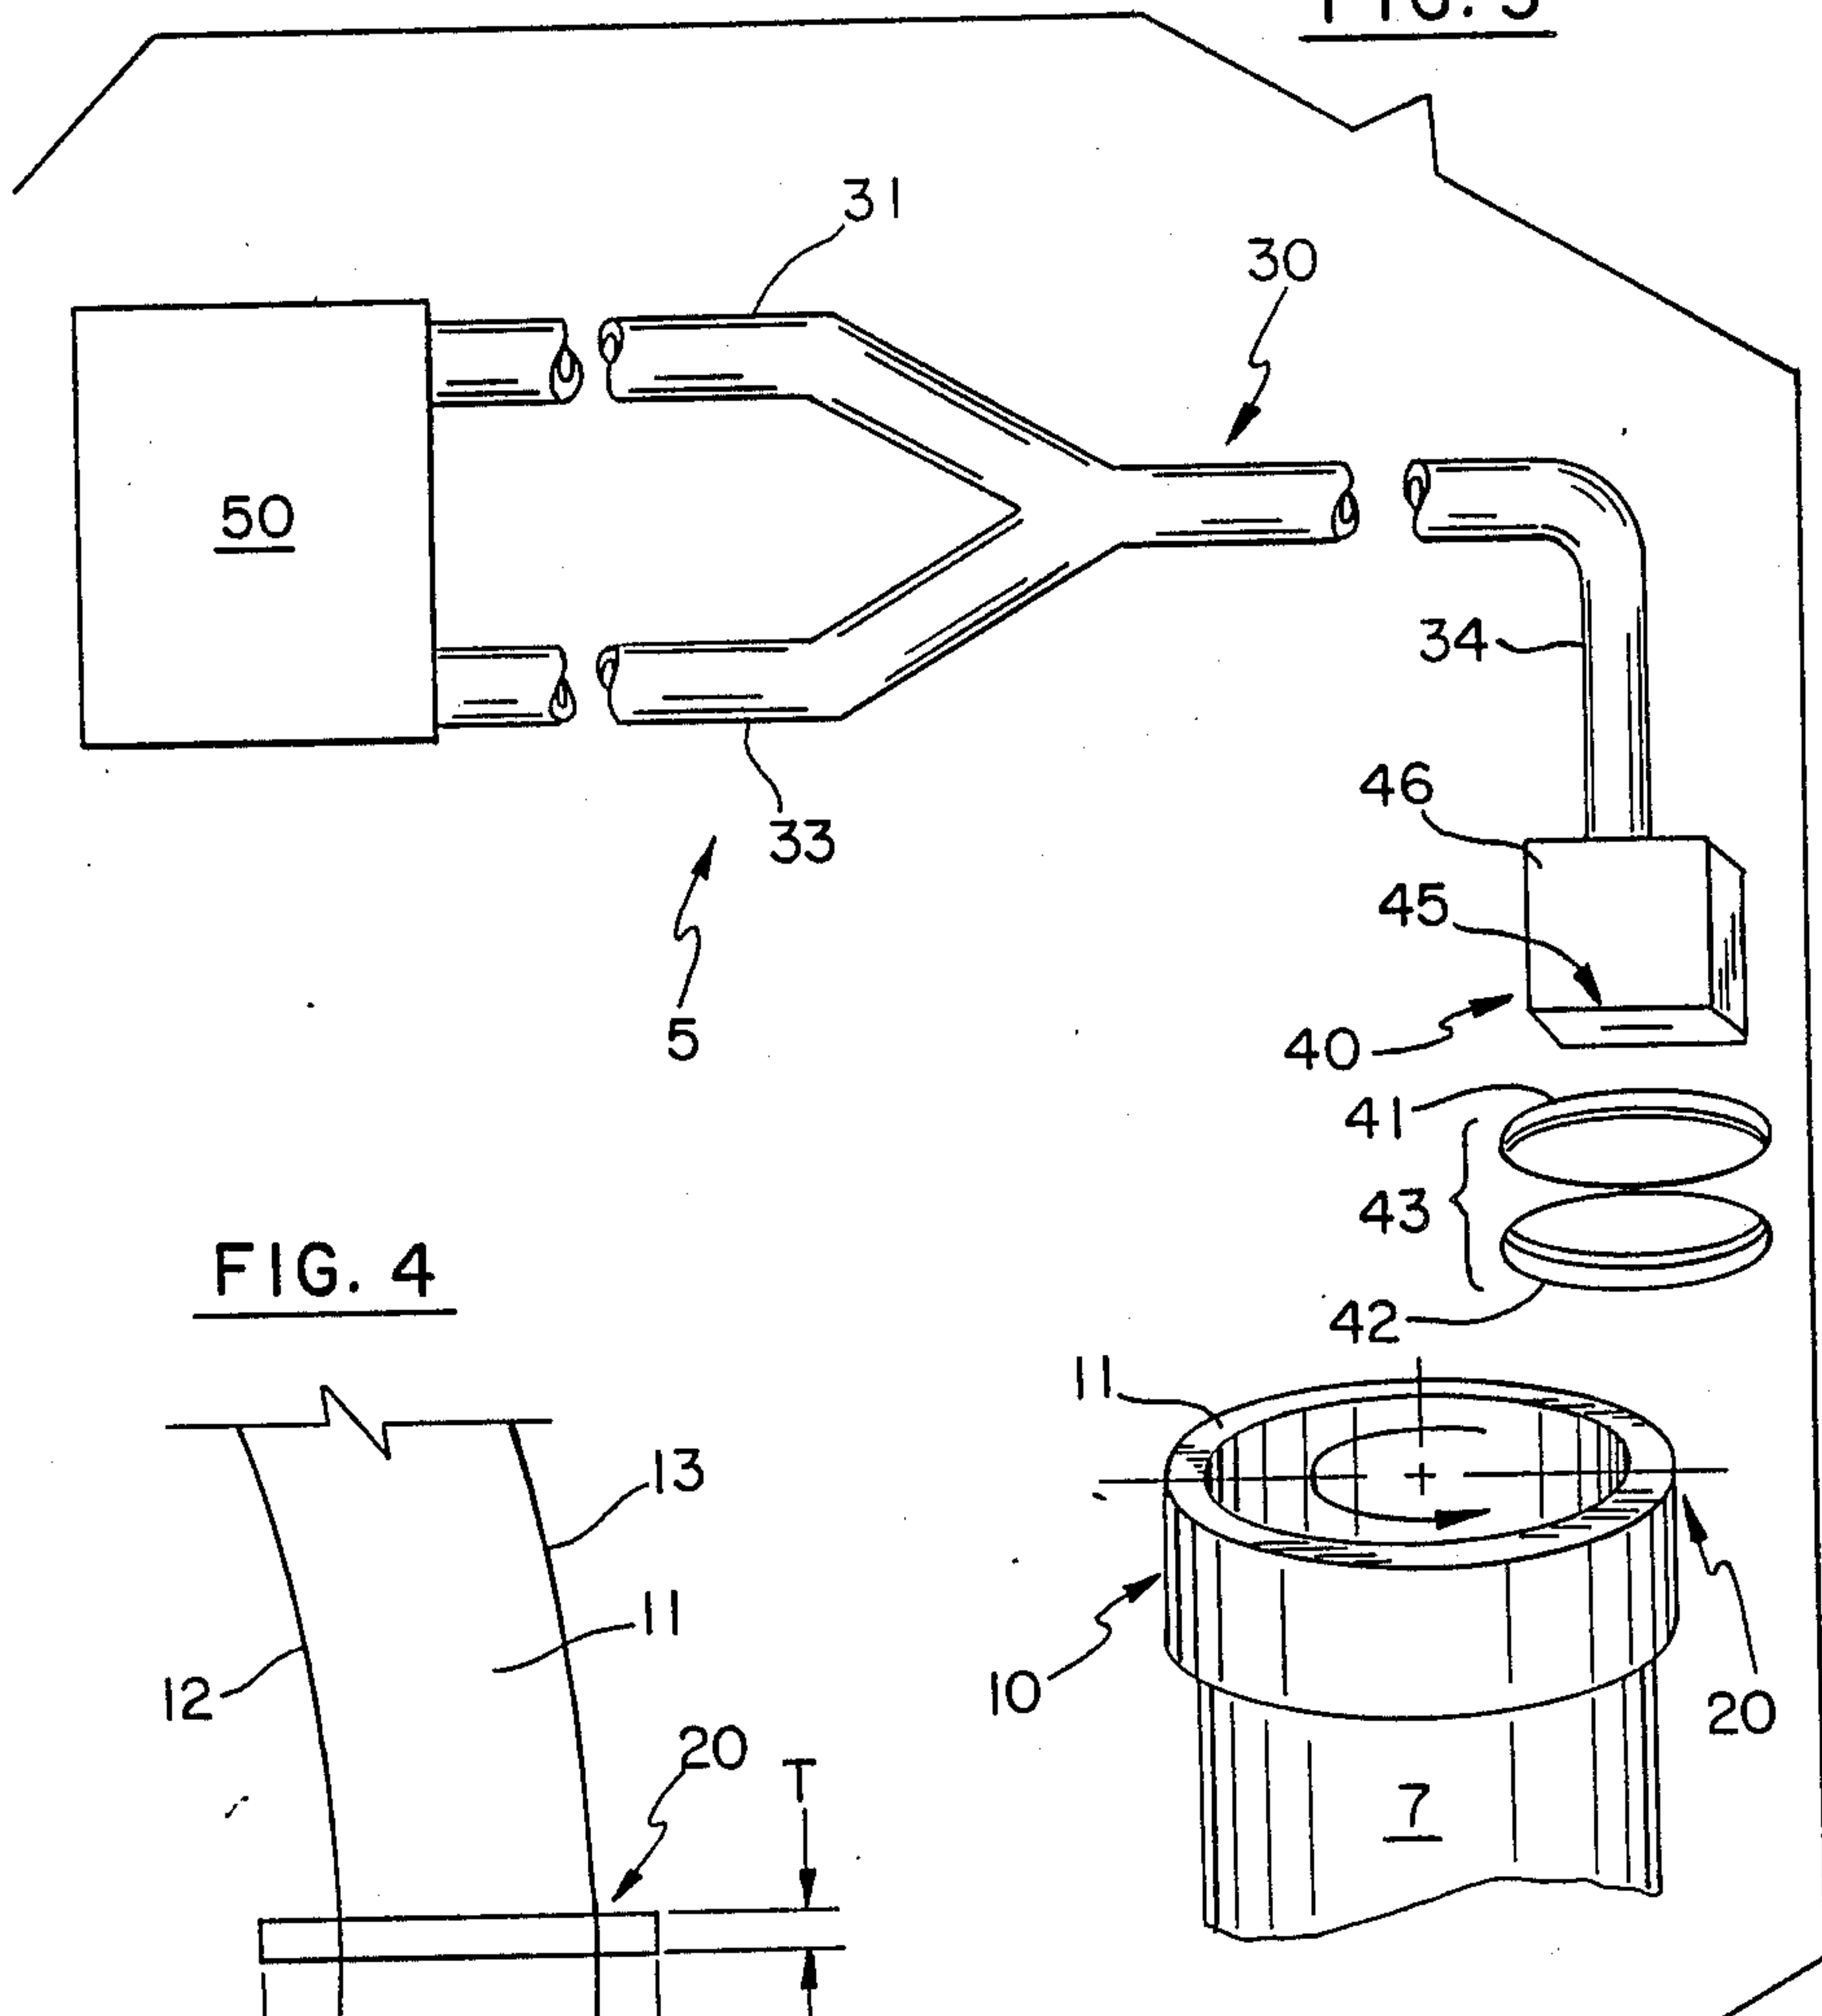
FIG. 3 is a somewhat schematic view of an overall inspection system in accordance with a preferred embodiment of the invention, scanning a bottle finish in counterclockwise rotation;

FIG. 3 illustrates the construction of an inspection device 5 in accordance with the preferred embodiment of the invention. Inspection assembly 5 includes a fiber optic probe 30 trained on the finish 10 of a glass container 7. In the illustrated embodiment, container 7 is caused to rotate relative to probe 30 so that probe 30 performs a complete circumferential scan of the sealing surface 11. Fiber optic probe 30 includes, bifurcations 31, 33 and a joined portion 34. Bifurcation 31 includes sender fibers; bifurcation 33 carries receiver fibers; and joined portion 34 has the sender and receiver fibers intermingled terminating at a probe end 40 at which the fibers are thoroughly intermixed in a random distribution. The probe end 40 is carried in a probe mount 46 and terminates at an elongated rectangular slit 45. Probe mount 46 is set up to align and orient the fiber optic bundle end 45 over the sealing surface 11 to form an elongate image 20 directly below. 1:1 lens assembly 43, comprising lenses 41 and 42, advantageously creates a slightly out-of-focus image 20 of the probe end 45 across sealing surface 11. It is desirable to provide a slightly out of focus image so that the reflections from the sealing surface return to both the sender and re-

ceiver fibers at probe end 40, rather than just to the sender fibers.

The inspection system 5 works as follows. Modulated LED light travels down the sending fibers and is imaged slightly out-of-focus by lens assembly 43 onto the sealing surface 11 of finish 10. This light is reflected back up through the lens assembly 43 onto the sending and receiving random fiber pattern 45. The receiving fibers carry the light back to photosensor 37, where as described above the photosensor signal is demodulated to create an analog signal based upon the amount of light reflected back from the finish. As container 7 rotates axially below probe 30, the entire sealing surface 11 is scanned by this device. The result is a signal representative of the reflection pattern of the entire sealing surface 11. As a line-over passes through the image 20, light is reflected in many different directions and very little will return through the lensing system 43. This will cause a significant drop in signal level. Dust, dirt, and rough finish areas can also reduce the light reflected back, but as illustrated below with reference to FIGS. 6A-6C, the use of a radially oriented long, narrow light pattern 20 markedly improves the response of the inspection system 5 to line-over defects while discriminating such defects from other causes of signal reduction.

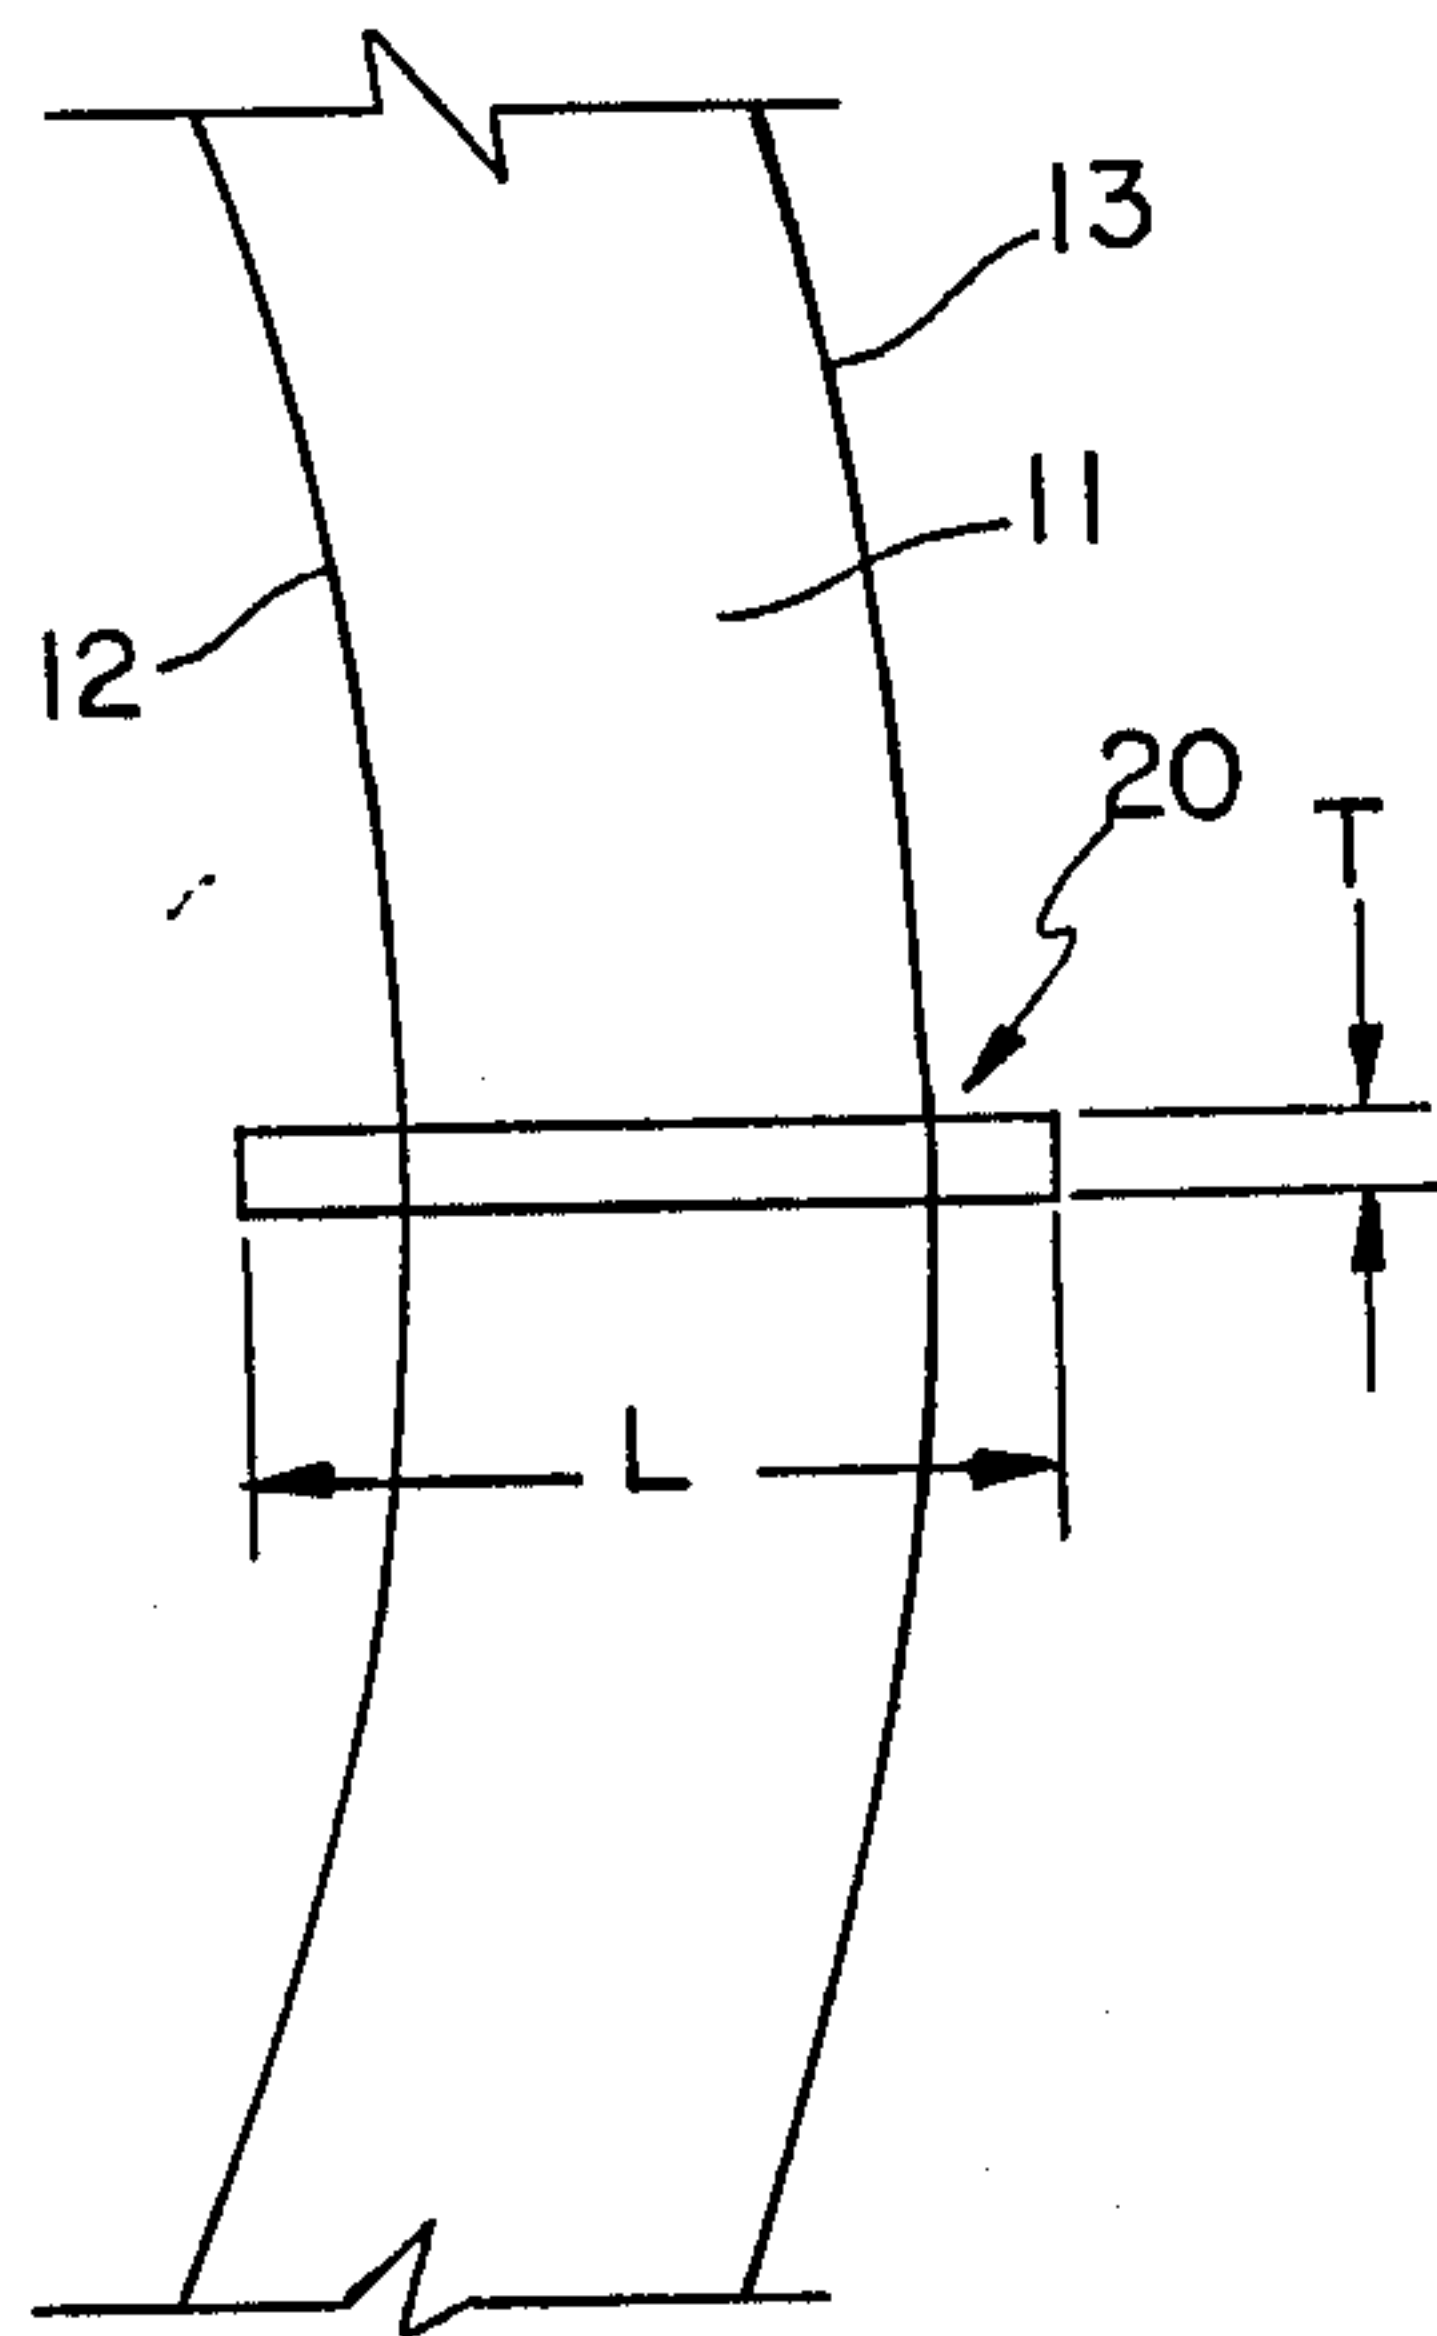
FIG. 4 is a partial plan view of a container sealing surface seen from above, showing the rectangular light image of the inspection system of FIG. 3;

Now having reference to the partial plan view of the sealing surface 11 shown in FIG. 4, the probe end image 20 comprises an elongate rectangle having a length L and width T. The dimension L is somewhat greater than the thickness between the inner wall 12 and outer wall 13 of container finish 10. In an operative embodiment of the invention, L equalled 0.154 inches and T equalled 0.012 inches. This value of L was chosen to accommodate most common thicknesses of glass bottle finishes, and of T to yield a good signal-to-noise ratio. Rectangular image 20 is oriented with its long axis along a radius of the sealing surface 11.

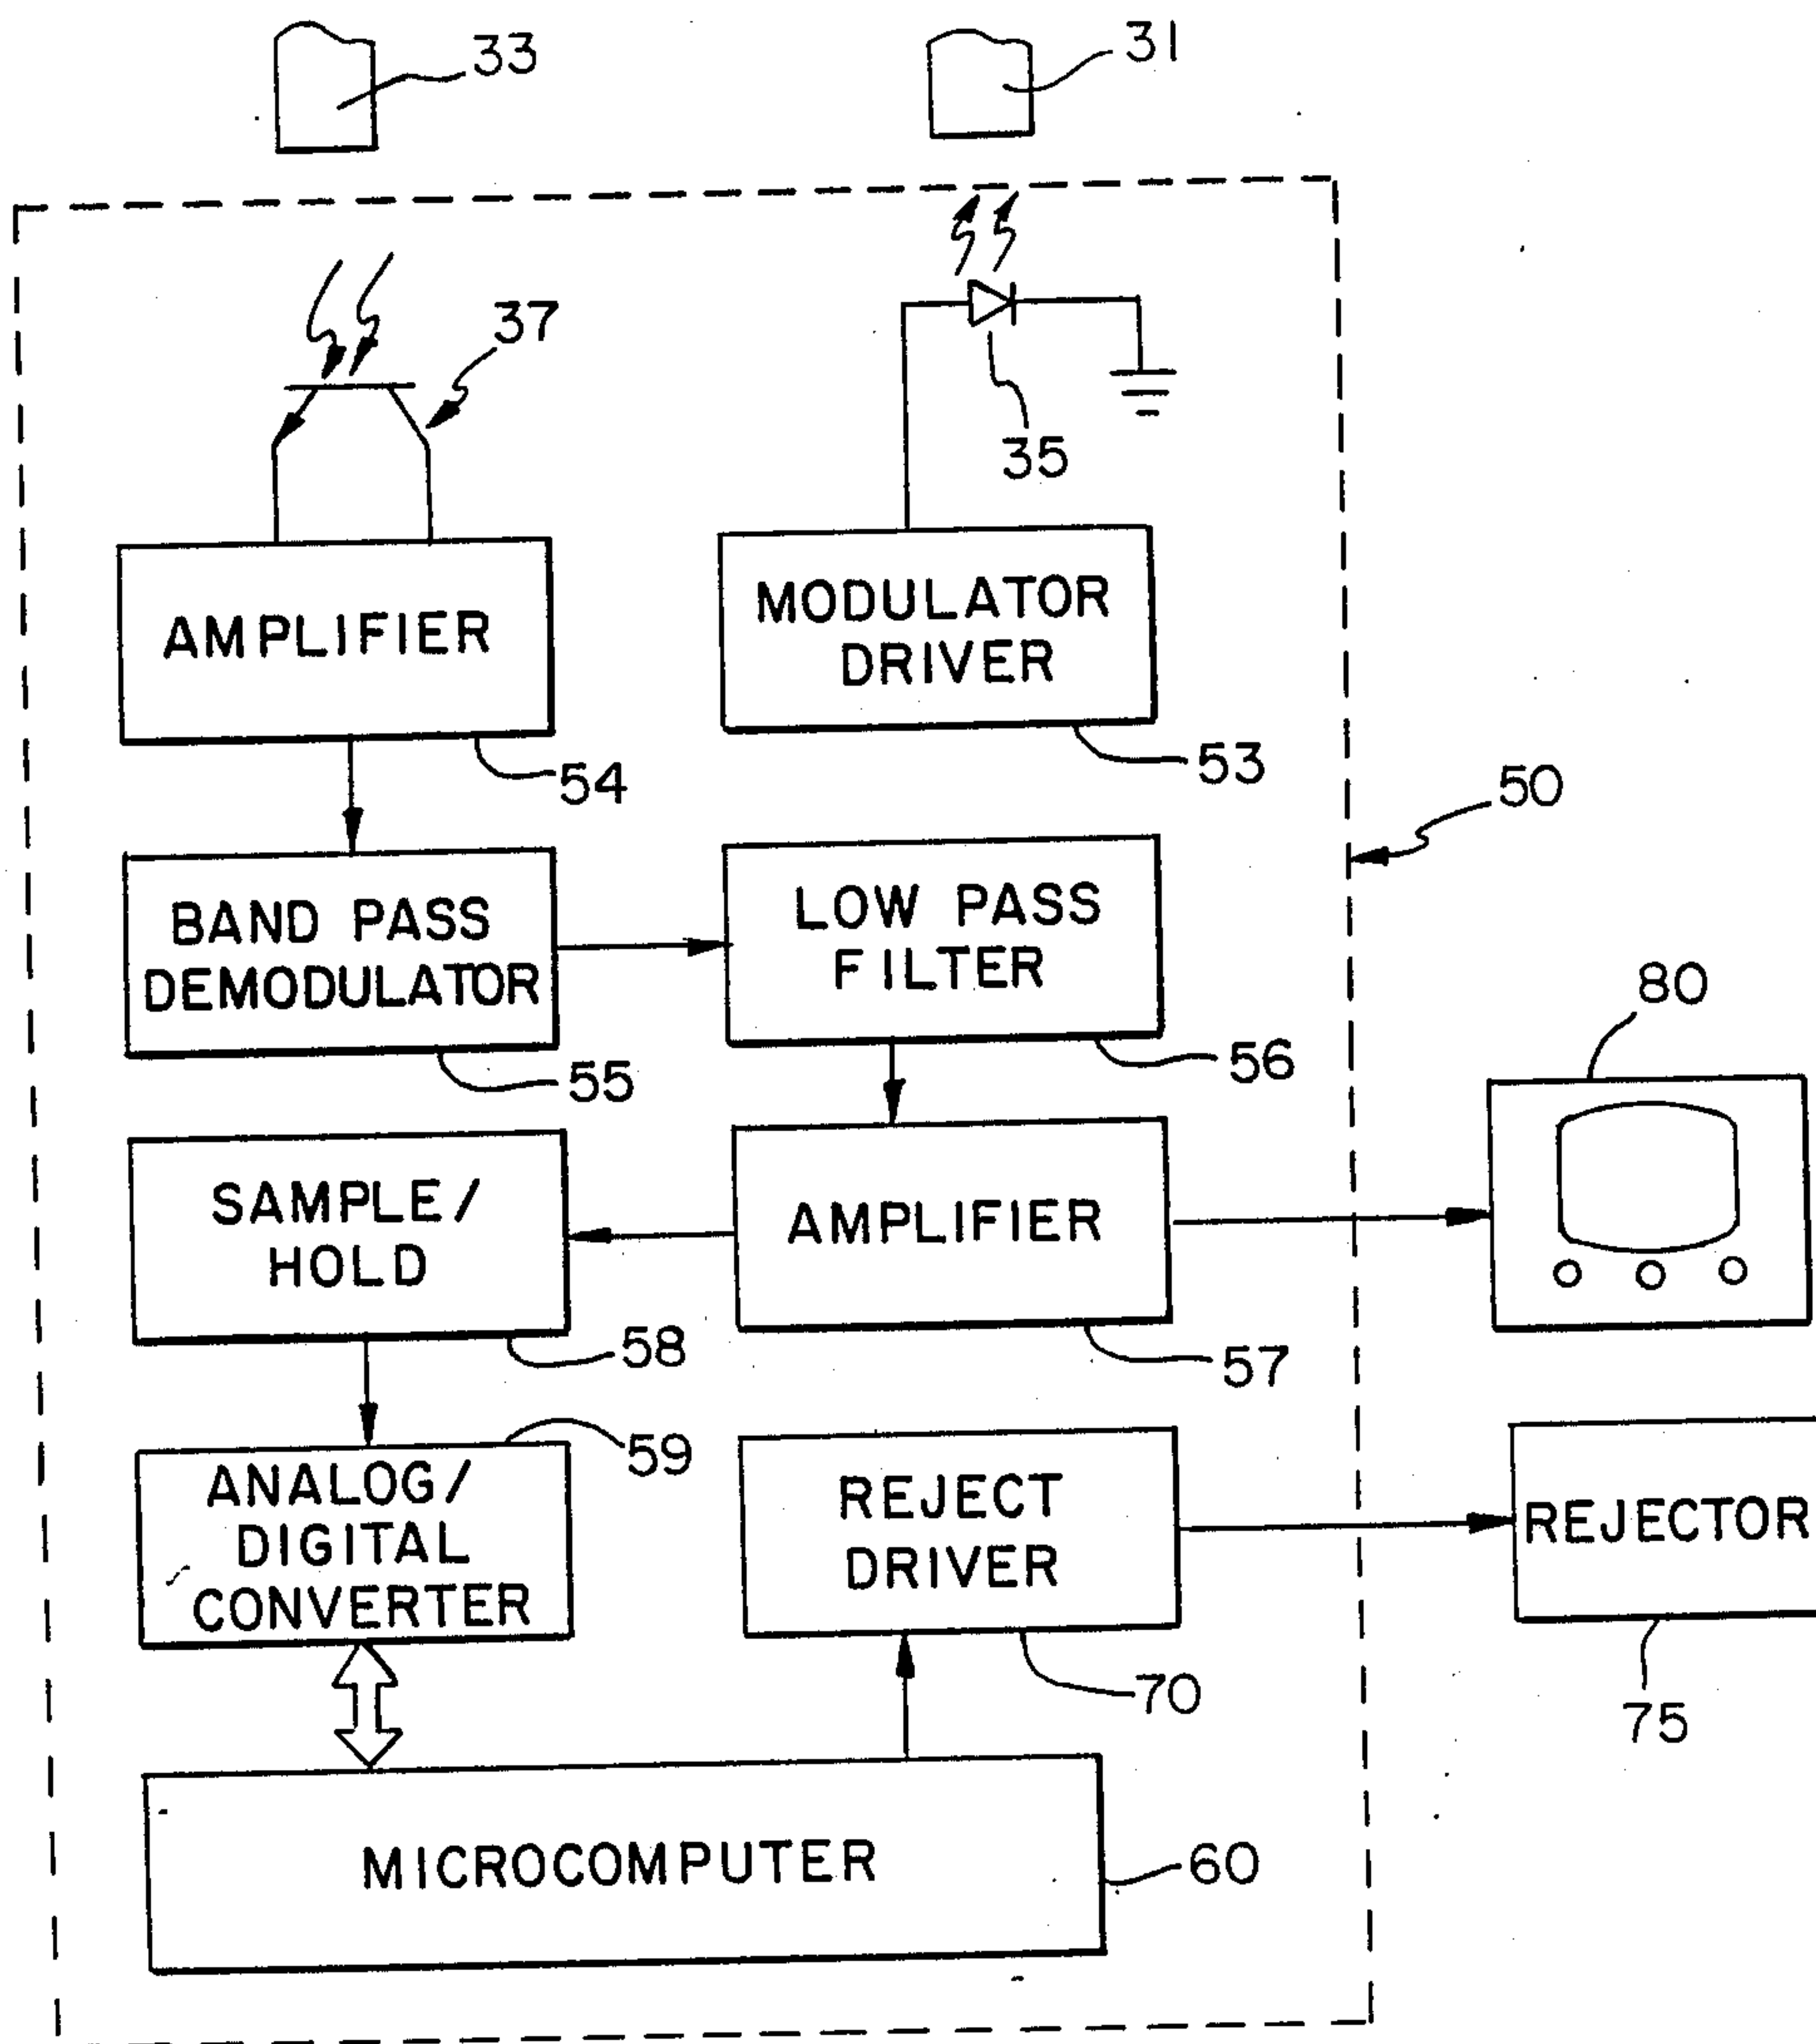
FIG. 5 is a schematic diagram of the light source, photodetector, and associated electronics, from the system of FIG. 3; and

FIG. 5 schematically illustrates a set of components for the signal processing electronics 50 of FIG. 3. The light source for transmitting fiber 31 is a high intensity visible LED 35, in the red part of the visible spectrum. LED light source devices may be modulated at different frequencies, and provide a continuous, high-intensity output with minimum drift, over a prolonged service life. It should be understood that other light sources may be employed, taking into account the optical characteristics of the container finish 10. The photo receiver 37 is a phototransistor device which was matched in spectral response to LED 35. The phototransistor output, amplified at 54, is demodulated by band pass filter 55 calibrated to pass the modulation frequency of the red visible light LED 35. Low pass filter 56 extracts the slope signal from the modulated carrier signal, which slope signal is amplified at 57. The amplified slope signal is fed to sample/hold circuit 58 and thence to analog-to-digital converter 59 which integrates and digitalizes this signal for each sample point. A microcomputer 60 analyzes the integrated slope signal from circuit 50 as such signal is compiled for rotating container 7. Microcomputer 60 may in appropriate cases actuate reject device 75 via reject driver 70 to reject the container 7 when the processed information for that container indicates the presence of an unacceptable line-over defect.

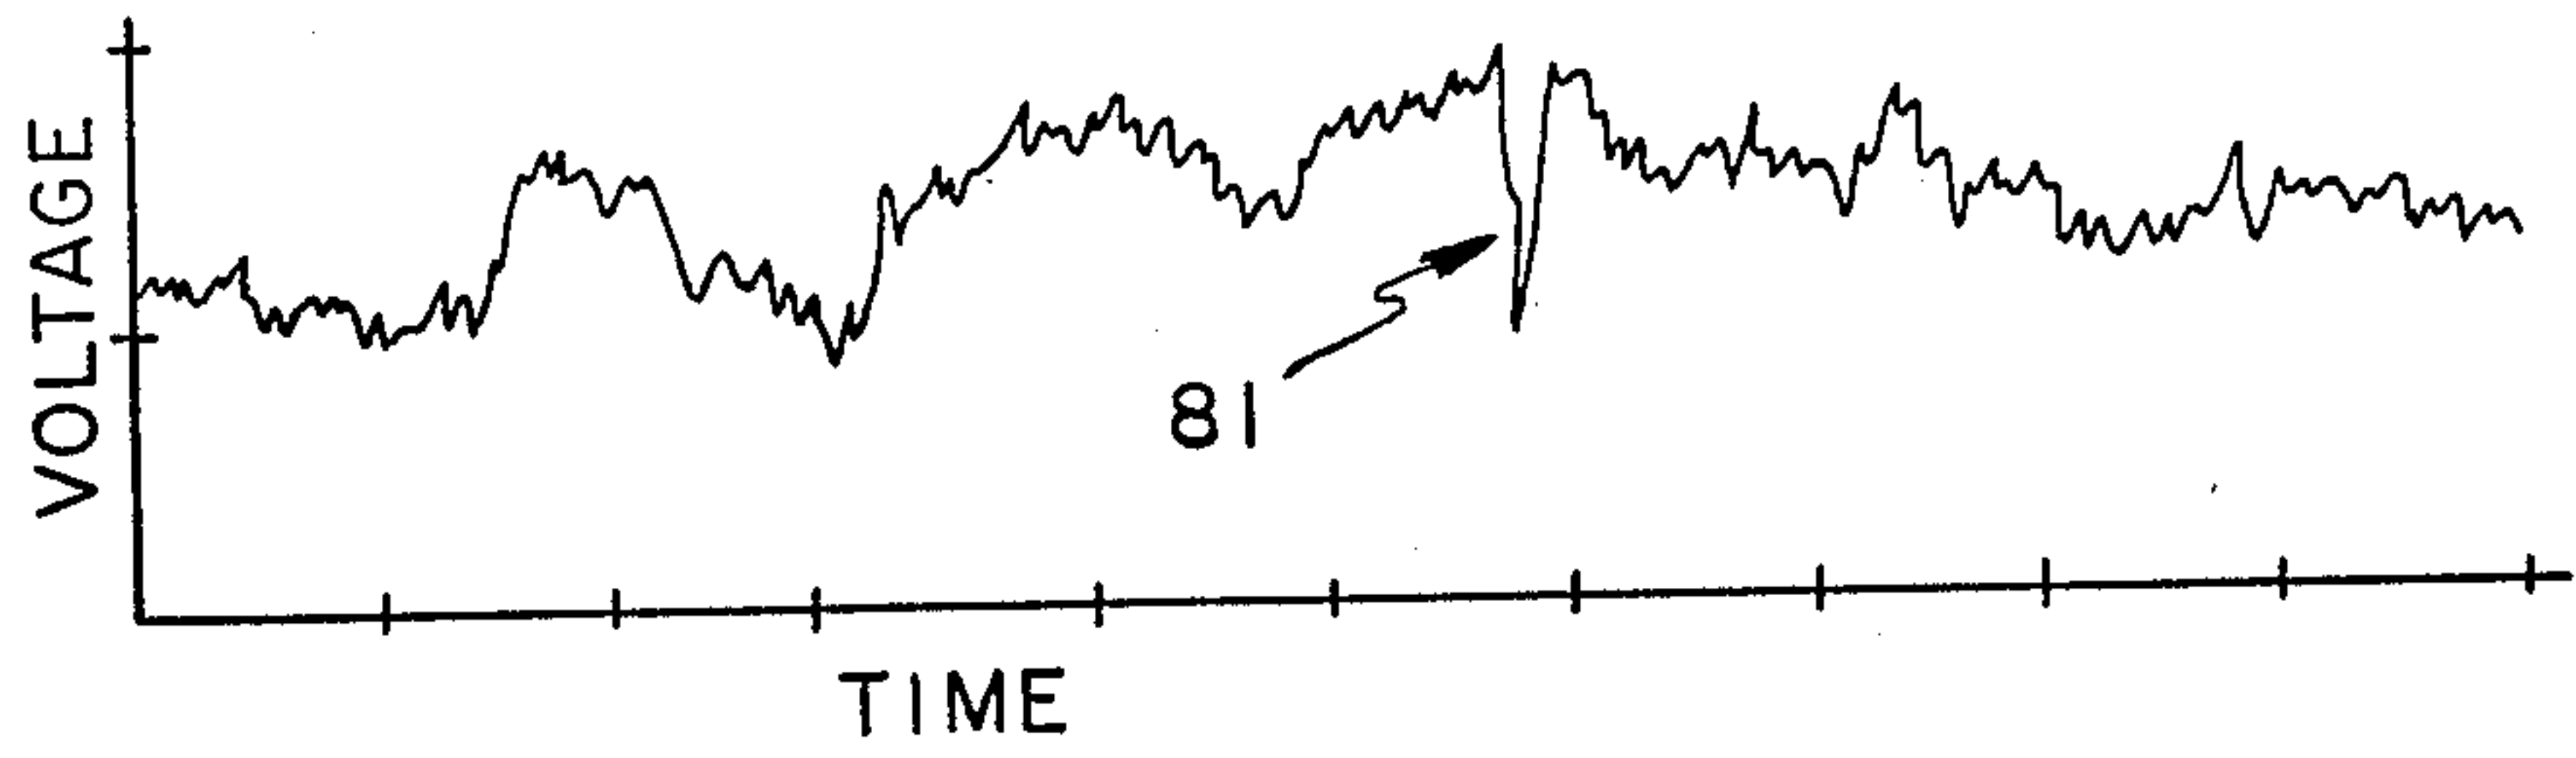
FIG. 6A shows a typical signal-to-noise wave form;

FIGS. 6A-6C are various plots or displays of an analog signal produced by the processing electronics 50 representing the amount of LED light reflected back through the fiber optic bundle 30 over various points of

a scanning interval. The waveforms of FIGS. 6A-6C were displayed at an oscilloscope 80 which received the output of amplifier 57 from the circuit 50 of FIG. 5. The plot of FIG. 6A illustrates a typical signal-to-noise waveform including a dip at 81 caused by the passage of a line-over defect under the fiber optic probe 30. The plot of FIG. 6B shows a signal reduction 83 created by a line-over defect after expanding the scale of the plot to 500 microseconds per division as compared with 10 milliseconds per division for the plot of FIG. 6A. FIG. 6C shows a plot taken at 2.5 milliseconds per division in which dips 85 and 87 were caused by dust particles, while signal drop 89 was caused by a line-over defect. It will be seen that the line-over defect caused a much sharper drop in signal level. The plot of FIGS. 6A-6B illustrate the capability of line-over inspection system 5 to selectively and repeatedly detect true line-over defects while minimizing good ware lost due to other finish marks that are not considered problems.
