- [54] **INSPECTING GLASS CONTAINERS FOR LINE-OVER FINISH DEFECTS WITH BIFURCATED FIBER OPTIC BUNDLE**
- [75] **Inventor:** Mark P. Claypool, Horseheads, N.Y.
- [73] **Assignee:** Emhart Industries, Inc., Hartford, Conn.
- [21] **Appl. No.:** 161,623
- [22] **Filed:** Feb. 29, 1988
- [51] **Int. Cl.⁵** G01N 9/04; B07C 5/00
- [52] **U.S. Cl.** 280/223 B; 250/227.29; 209/524
- [58] **Field of Search** 250/223 B, 227; 356/240; 209/526, 524; 350/96.25, 96.26, 96.27

INSPECTING GLASS CONTAINERS FOR LINE-OVER FINISH DEFECTS WITH BIFURCATED FIBER OPTIC BUNDLE

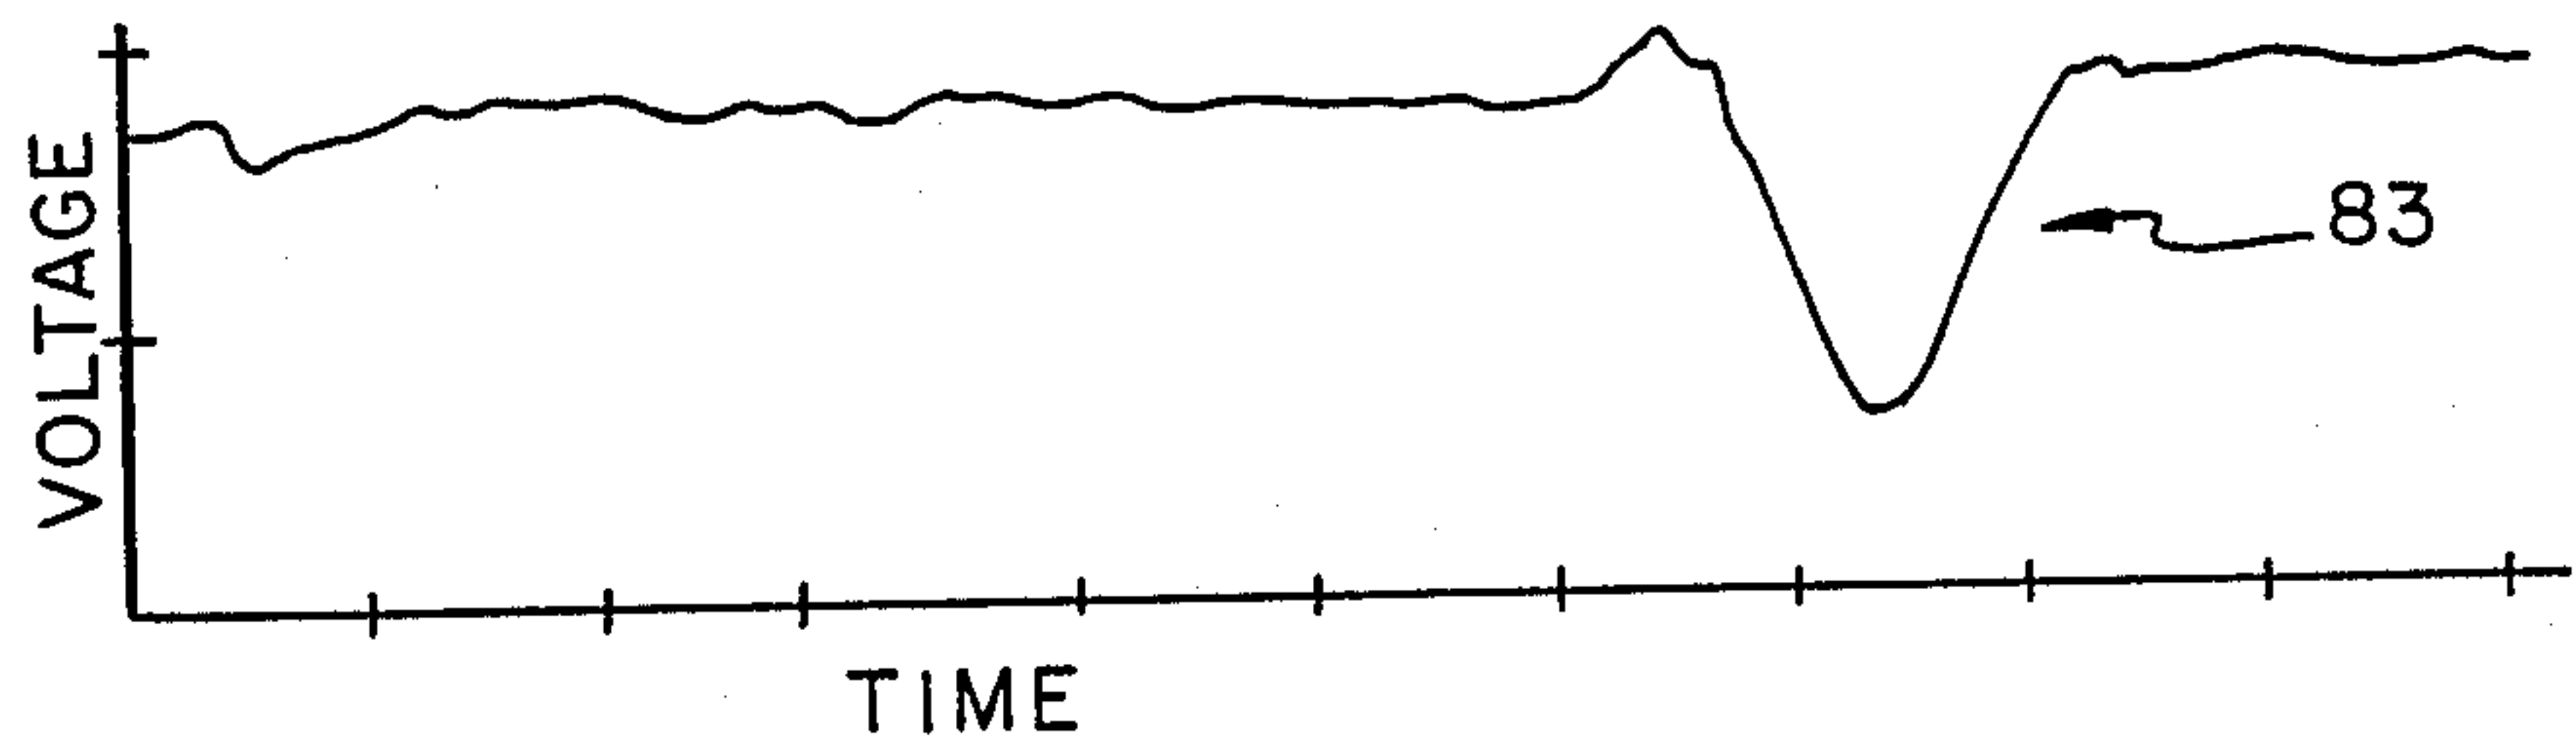
FIG. 6B shows an expanded view of scan including a line-over defect signal; and

FIGS. 6A-6C are various plots or displays of an analog signal produced by the processing electronics 50 representing the amount of LED light reflected back through the fiber optic bundle 30 over various points of

a scanning interval. The waveforms of FIGS. 6A-6C were displayed at an oscilloscope 80 which received the output of amplifier 57 from the circuit 50 of FIG. 5. The plot of FIG. 6A illustrates a typical signal-to-noise waveform including a dip at 81 caused by the passage of a line-over defect under the fiber optic probe 30. The plot of FIG. 6B shows a signal reduction 83 created by a line-over defect after expanding the scale of the plot to 500 microseconds per division as compared with 10 milliseconds per division for the plot of FIG. 6A. FIG. 6C shows a plot taken at 2.5 milliseconds per division in which dips 85 and 87 were caused by dust particles, while signal drop 89 was caused by a line-over defect. It will be seen that the line-over defect caused a much sharper drop in signal level. The plot of FIGS. 6A-6B illustrate the capability of line-over inspection system 5 to selectively and repeatedly detect true line-over defects while minimizing good ware lost due to other finish marks that are not considered problems.

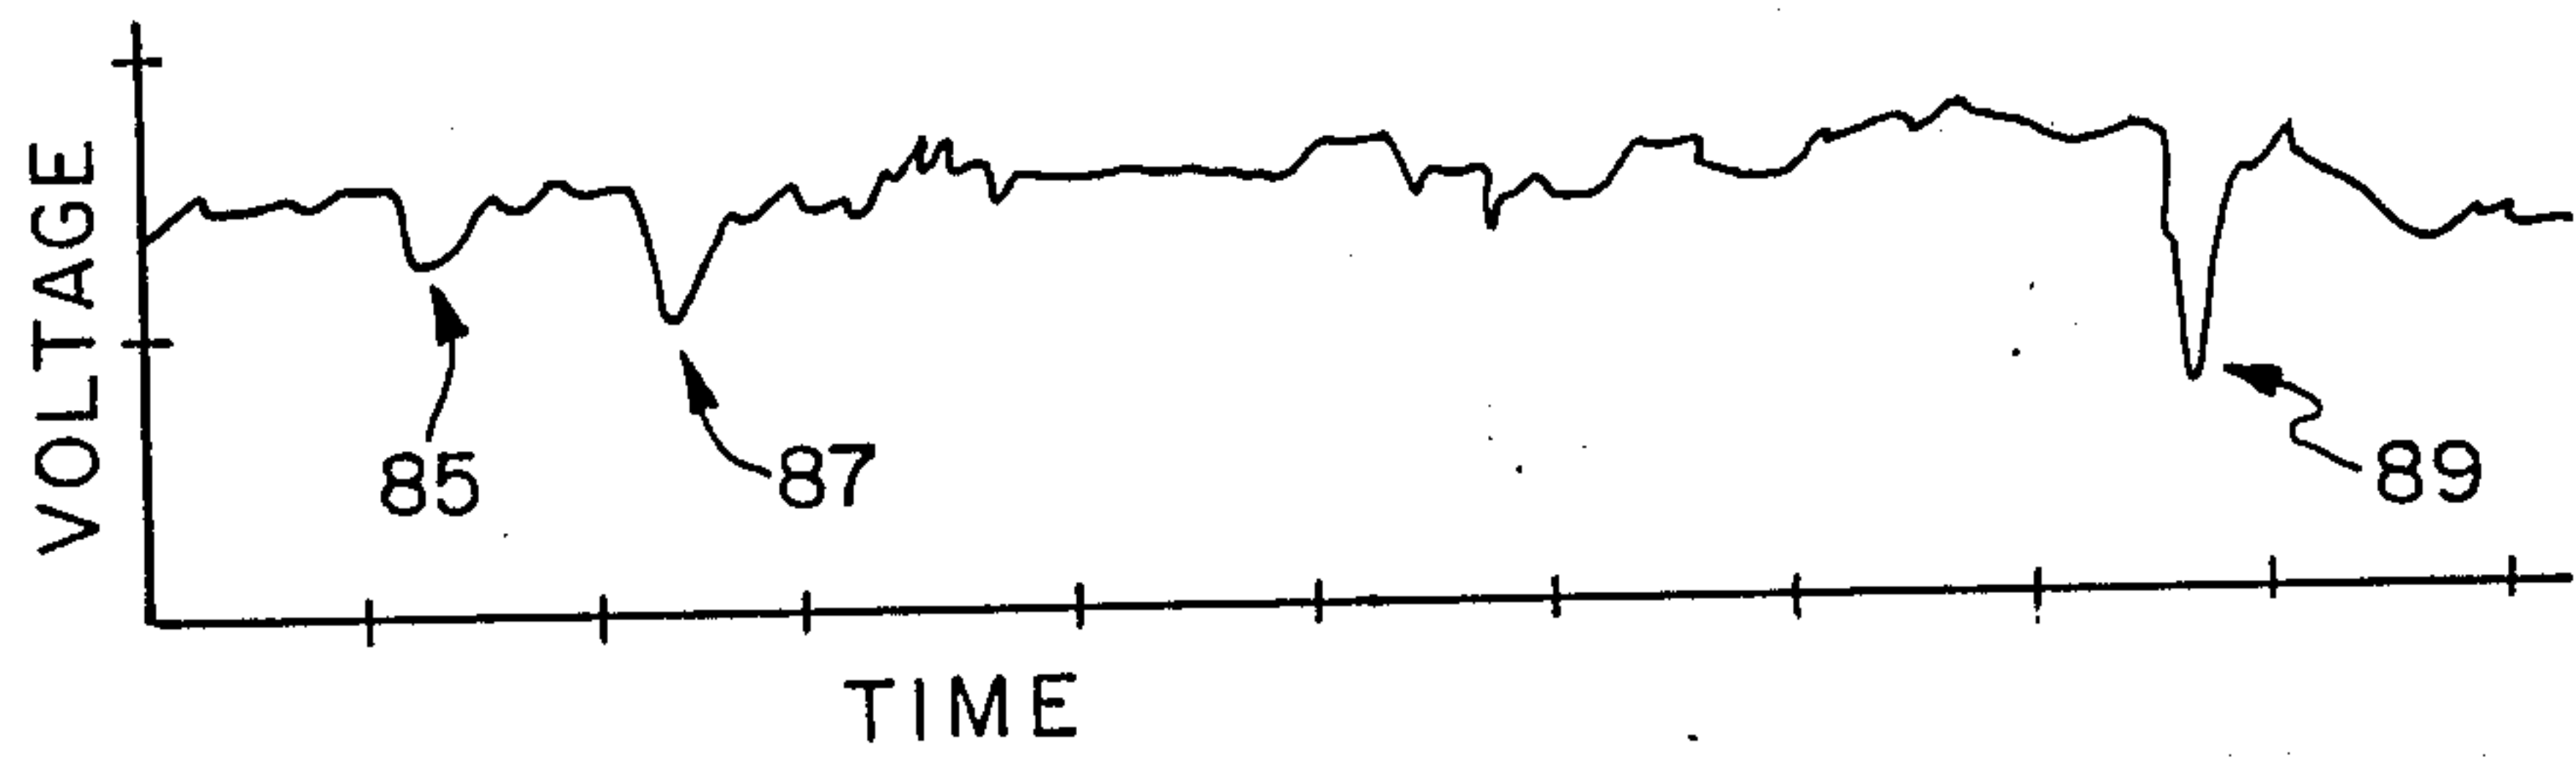
FIG. 6C shows a wave form featuring both a line-over signal and dust signals.
