[54] **METHOD OF MAKING AND REPAIRING TURBINE BLADES**

[73] **Assignee:** Solar Turbines Incorporated, San Diego, Calif.

METHOD OF MAKING AND REPAIRING TURBINE BLADES

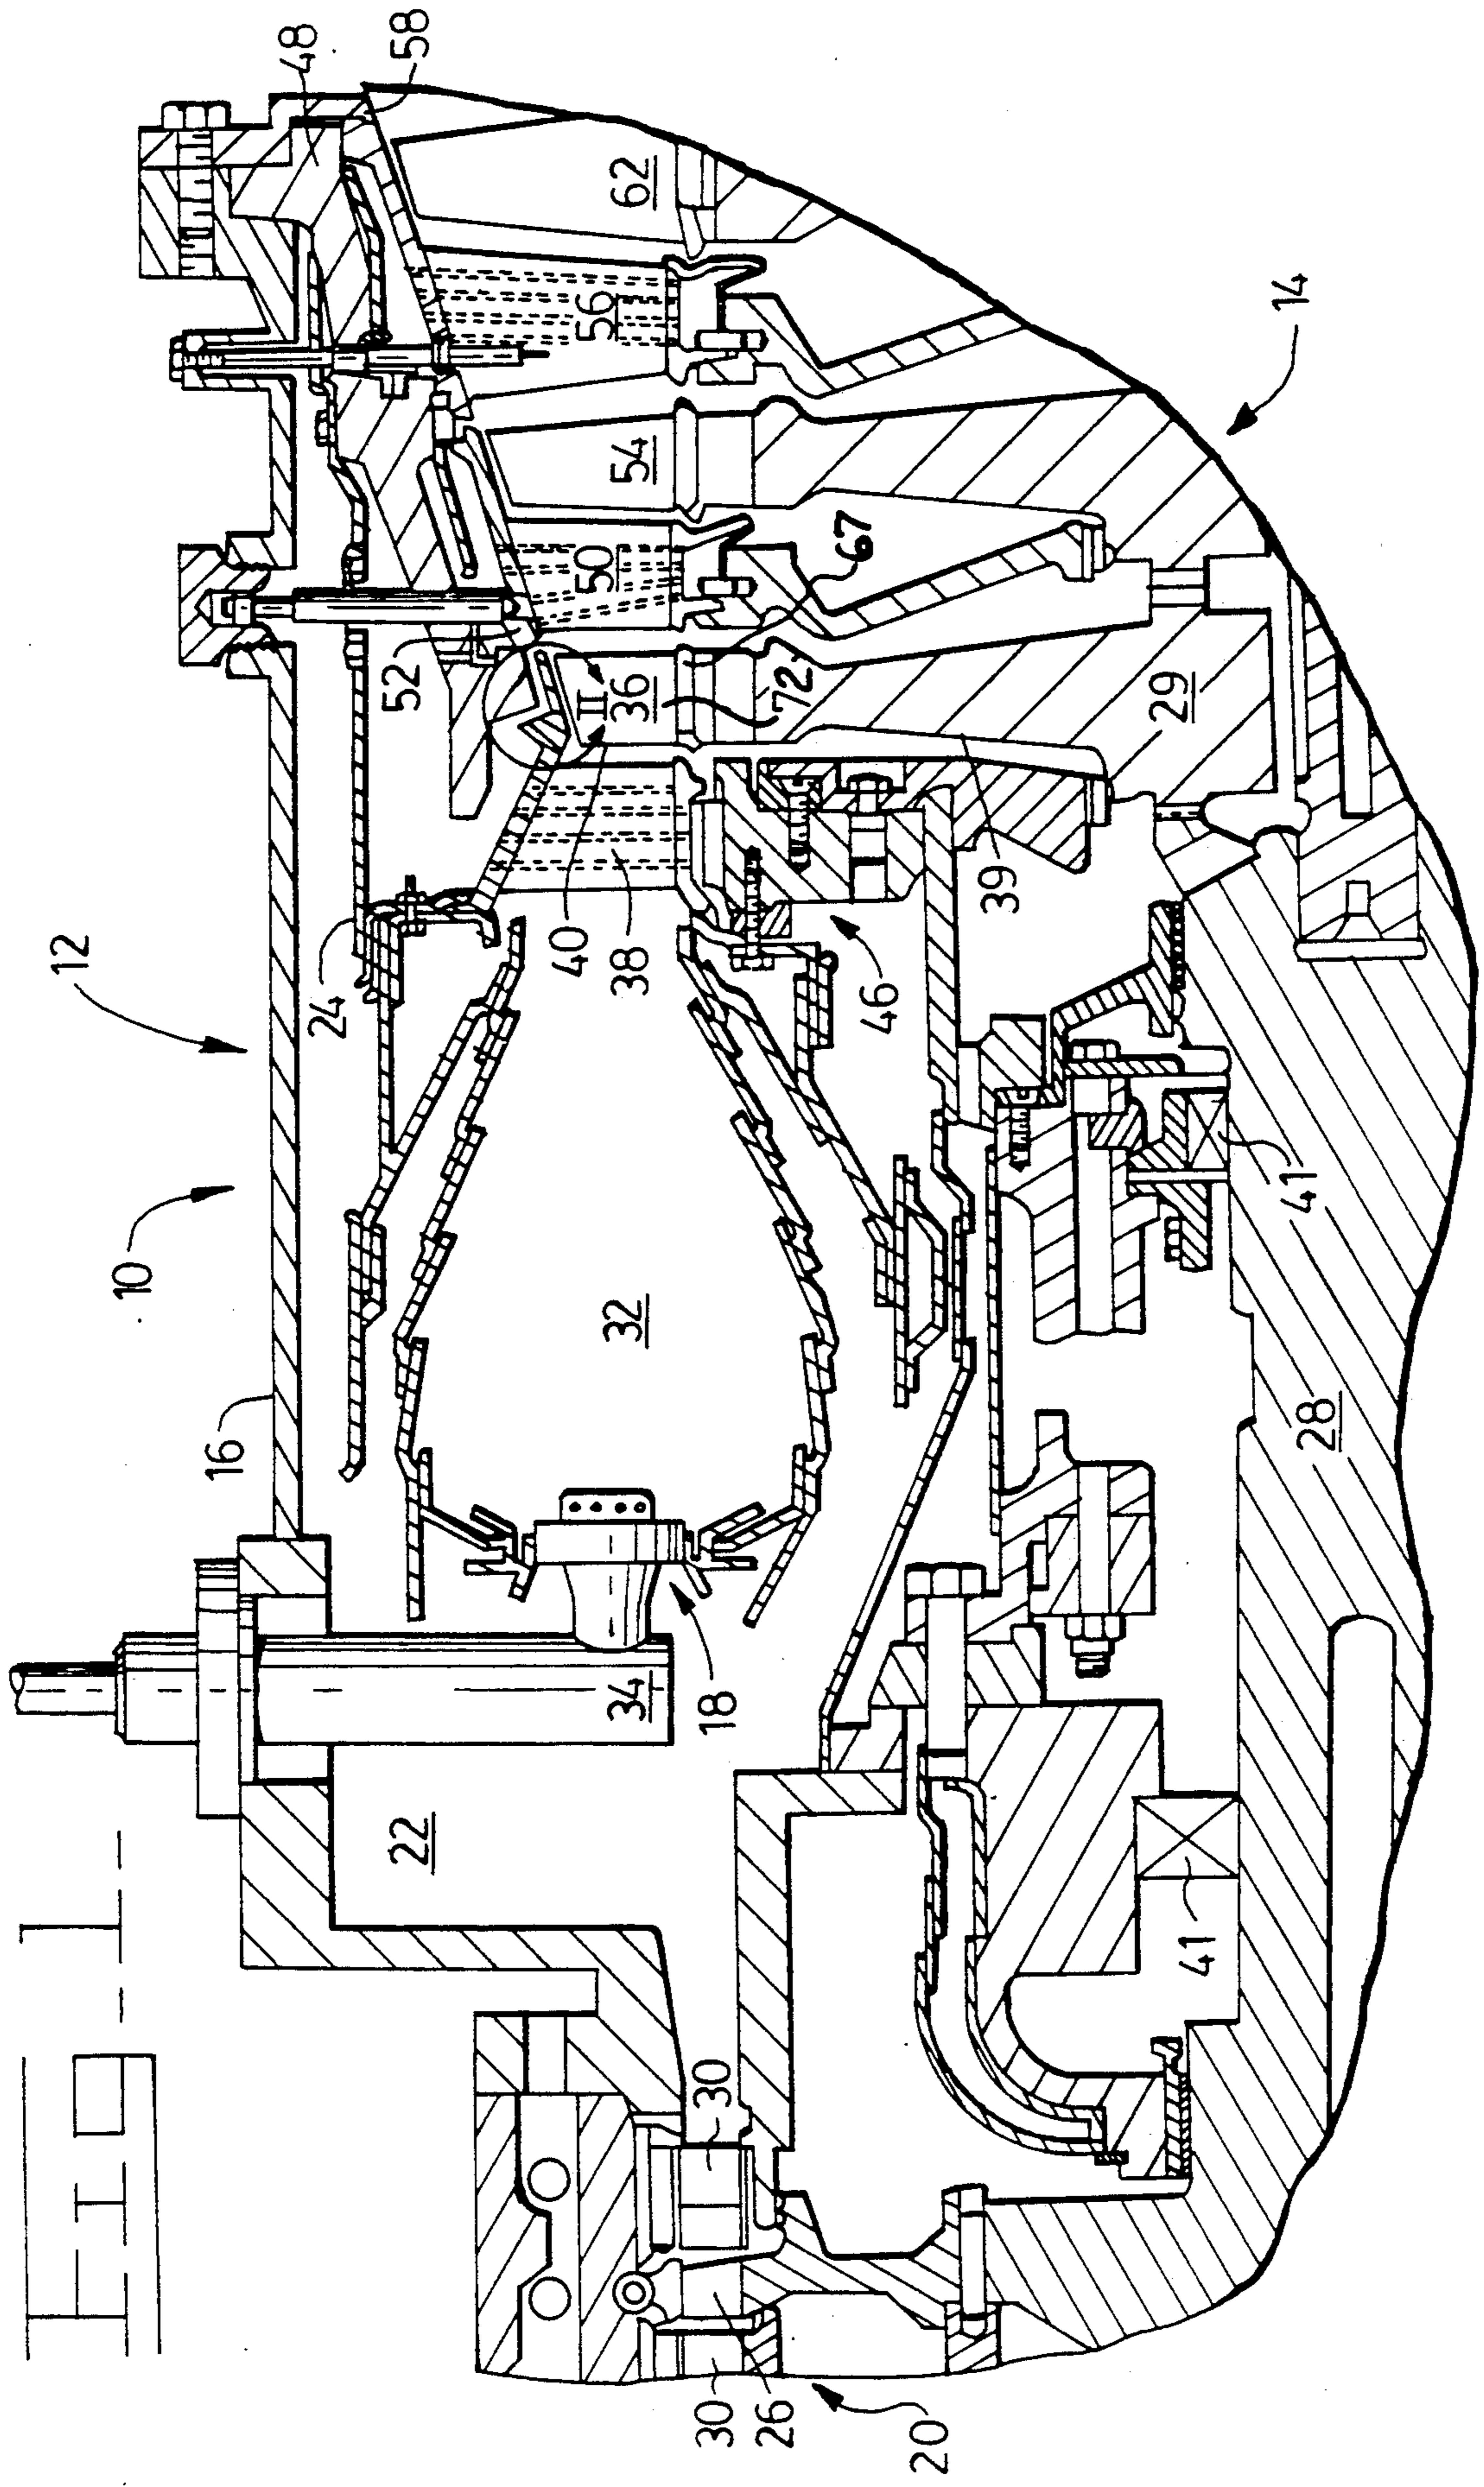
FIG. 1 is a partial sectional side view of a gas turbine engine disclosing the turbine blade tip control system of this invention.

Referring to FIG. 1, a gas turbine engine 10, not shown in its entirety, has been sectioned to show a turbine tip control system 12 for controlling internal leakage of a turbine section 14 of the engine. The engine 10 includes an outer case 16, a combustor section 18, a compressor section 20 and a compressor discharge plenum 22 fluidly connected to the compressor section 20. The plenum 22 is partially defined by the outer case 16 and a multipiece inner wall 24 partially surrounding the turbine section 14 and the combustor section 18. The compressor section 20 includes a plurality of rotatable blades 26 attached to a longitudinally extending center shaft 28 driven by a gasifier turbine section 29. A plurality of compressor stator blades 30 extend from the outer case 16 and are positioned between the rotatable blades. For illustration convenience, only a single stage of a multistage axial compressor 20 is shown. The combustor section 18 includes a combustion chamber 32 positioned in the plenum 22 and a plurality of fuel nozzles 34 (one shown) positioned in the chamber 32 at the end near the compressor section 20. The turbine section includes a first stage turbine 36 disposed partially within an integral first stage nozzle and shroud assembly 38. The first stage turbine 36 includes a rotatable turbine wheel 39 and an annular array of turbine blades 40 (one shown) attached thereto. The assembly 38 is attached to the inner wall 24 and supported from the center shaft 28 by a bearing arrangement 41 and a series of thermally varied masses 46 which are assembled to prevent rapid thermal variation during heating and cooling of such masses 46. A nozzle support case 48 is disposed within the outer case 16 and is attached to the case 16 by a plurality of bolts and dowels not shown. An integral second stage nozzle and shroud assembly 50 is attached to the nozzle support case 48 by a plurality of nozzle hooks 52 and a second stage turbine 54 is disposed partially within the assembly 50. An integral third stage nozzle and shroud assembly 56 is attached to the nozzle support case 48 by a plurality of nozzle hooks 58 and a third stage turbine 62 is disposed partially within the assembly 56. All the turbines 36, 54, 62 are connected to the longitudinally extending center shaft 28.

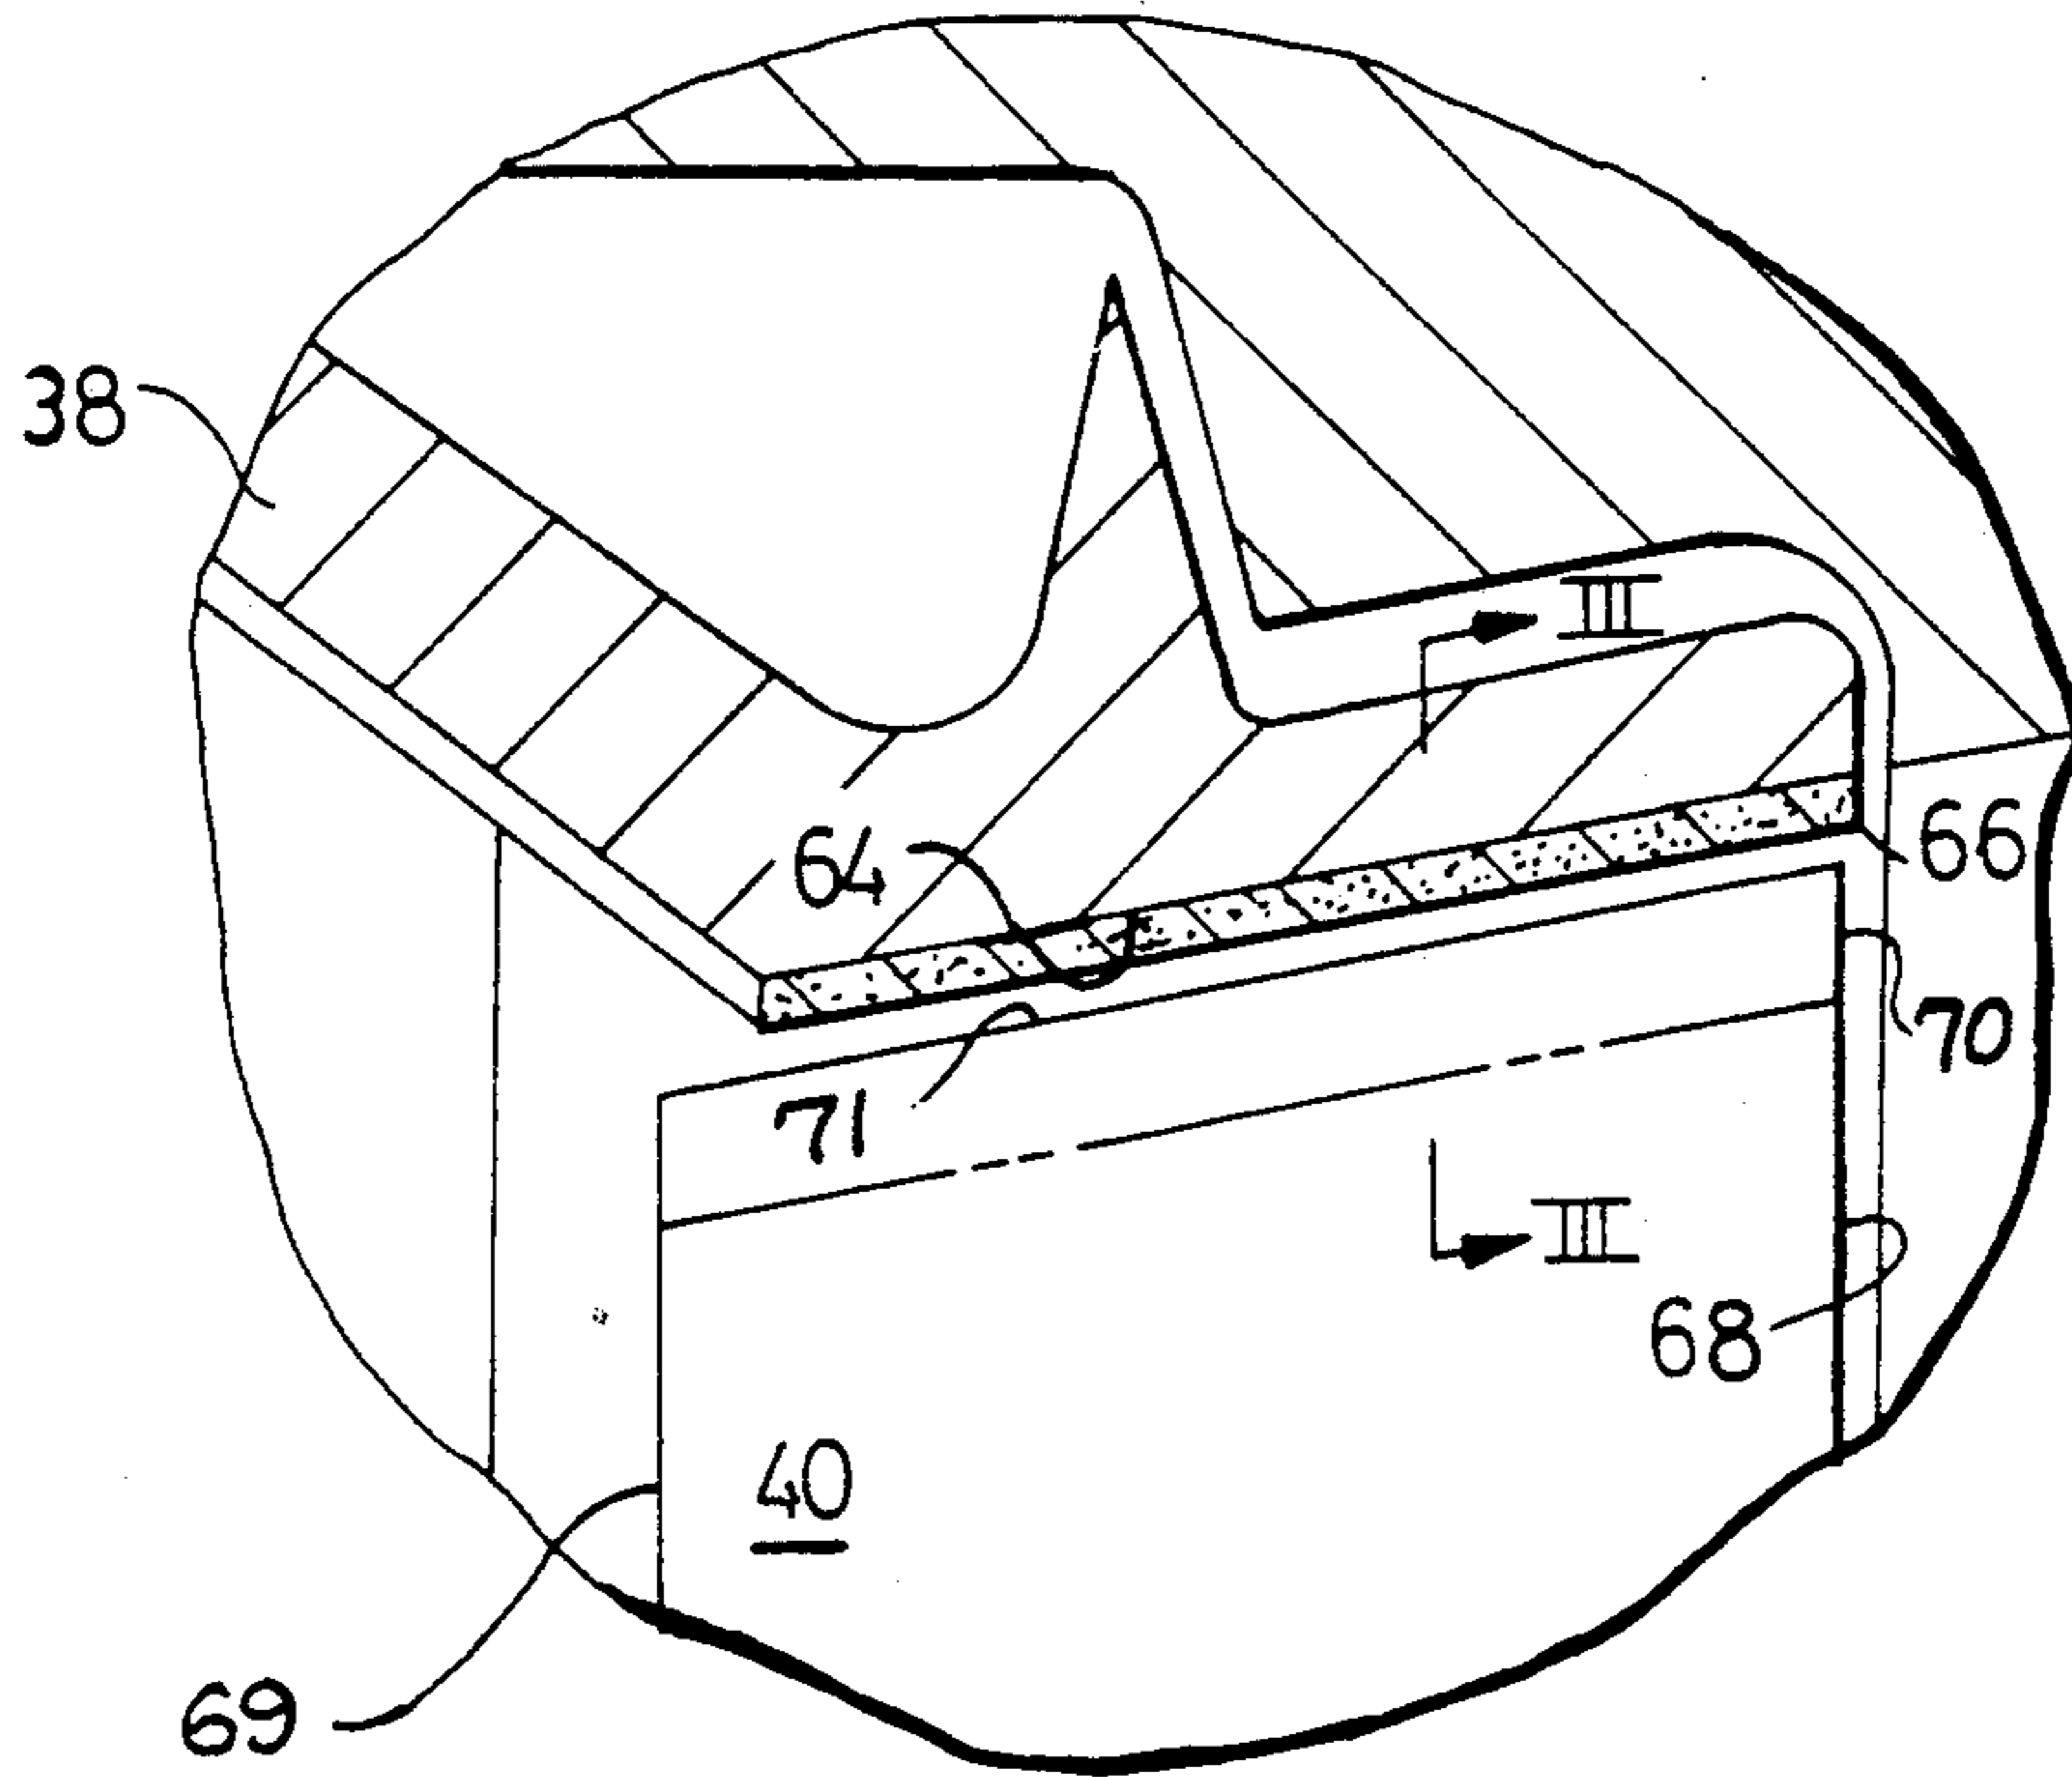
FIG. 2 is an enlarged sectional view of the turbine tip clearance area encircled by line II of FIG. 1.

As more clearly shown in FIG. 2, the shroud assembly 38 has a radially inwardly facing surface 64 positioned adjacent and radially outwardly of the turbine blade 40. A coating 66 is affixed to the surface 64 and is resistant to high temperature, oxidation, corrosion and sulfidation and is rub-tolerant. Rub-tolerant means that the coating will separate from itself in fine particle form or smear when rubbed by the blades rather than to break in larger pieces. The rub-tolerant coating is applied by a plasma spray process and has a thickness of approximately 0.7 mm. The coating is comprised of cobalt, nickel, chromium and aluminum. The coating has the physical characteristics and is applied in a process to result in a uniform, continuous surface free from spalling, cracking, chipping or flaking.

Each of the turbine blades 40 has an attaching base 67 connected to the turbine wheel 39 and a blade portion 68 attached to the base 67. The blade portion includes a metallic body 69 attached to the base 67 and an outer tip 70 formed outwardly on the body. The outer tip 70 has an outer face 71 thereon opposite the end formed on the body 69. The metallic body 69 has a root area 72 near the base 67, an outer extremity 73 outwardly of the root area 72 and a perimeter 74 around the body. The body 69 is of a material which has a predetermined strength sufficient to resist structural deformation at normal operating parameters of the engine 10. The outer extremity 73 is positioned adjacent the coating 66 to provide a normal operating clearance therebetween. The outer tip 70 can be formed to include a flat tip portion, not shown, or a squealer tip portion 76. The squealer tip portion 76 provides a better seal between the blade 40 and the coating 66 than does a flat tip portion. The squealer tip portion 76 is formed to have a ridge 78 positioned at and around the perimeter 74 of the metallic body 69 and a concave portion 80 is formed in the center of the ridge 78. The ridge 78 of the squealer tip portion 76 has a tip extremity 82 and a bottom portion 84. As best shown in FIG. 3 the thickness of the ridge 78 is of a thinner cross-sectional area near the tip extremity 82 than is the thickness of a cross-sectional area of the ridge 78 near the bottom portion 84 resulting in the squealer tip portion 76 including a tapered build-up being thinner near the tip extremity 82 than near the bottom portion 84 of the squealer tip portion 76. The above structure is a result of the welding process since the layered build-up results in a narrower pass per respective build-up pass or series of repetitive passes. Thus, the squealer tip portion 76 is approximately 50% shorter than a conventional squealer tip configuration shown by phantom line 86. The outer tip 70 is comprised of a material which has a predetermined strength less than that of the body 69 yet has sufficient strength to prevent breaking and/or separating from the metallic body 69 during hard rubbing contacts between the blade 40 and the coating 66 and/or the shroud 38. Thus, the outer tip 70 must have sufficient length to accept the wearing away of a portion of the material and yet not be totally removed from protecting the metallic body 69 from oxidation, sulfidation and corrosion. For example, the metallic body 69 has a tensile strength of approximately 1080 kPa at room temperature and approximately 750 kPa at 870° C. and a yield strength of approximately 930 kPa at room temperature and approximately 650 kPa at 870° C. The outer tip 70 has a tensile strength of approximately 870 kPa at room temperature and approximately 380 kPa at 870° C. and a yield strength of approximately 380 kPa at room temperature

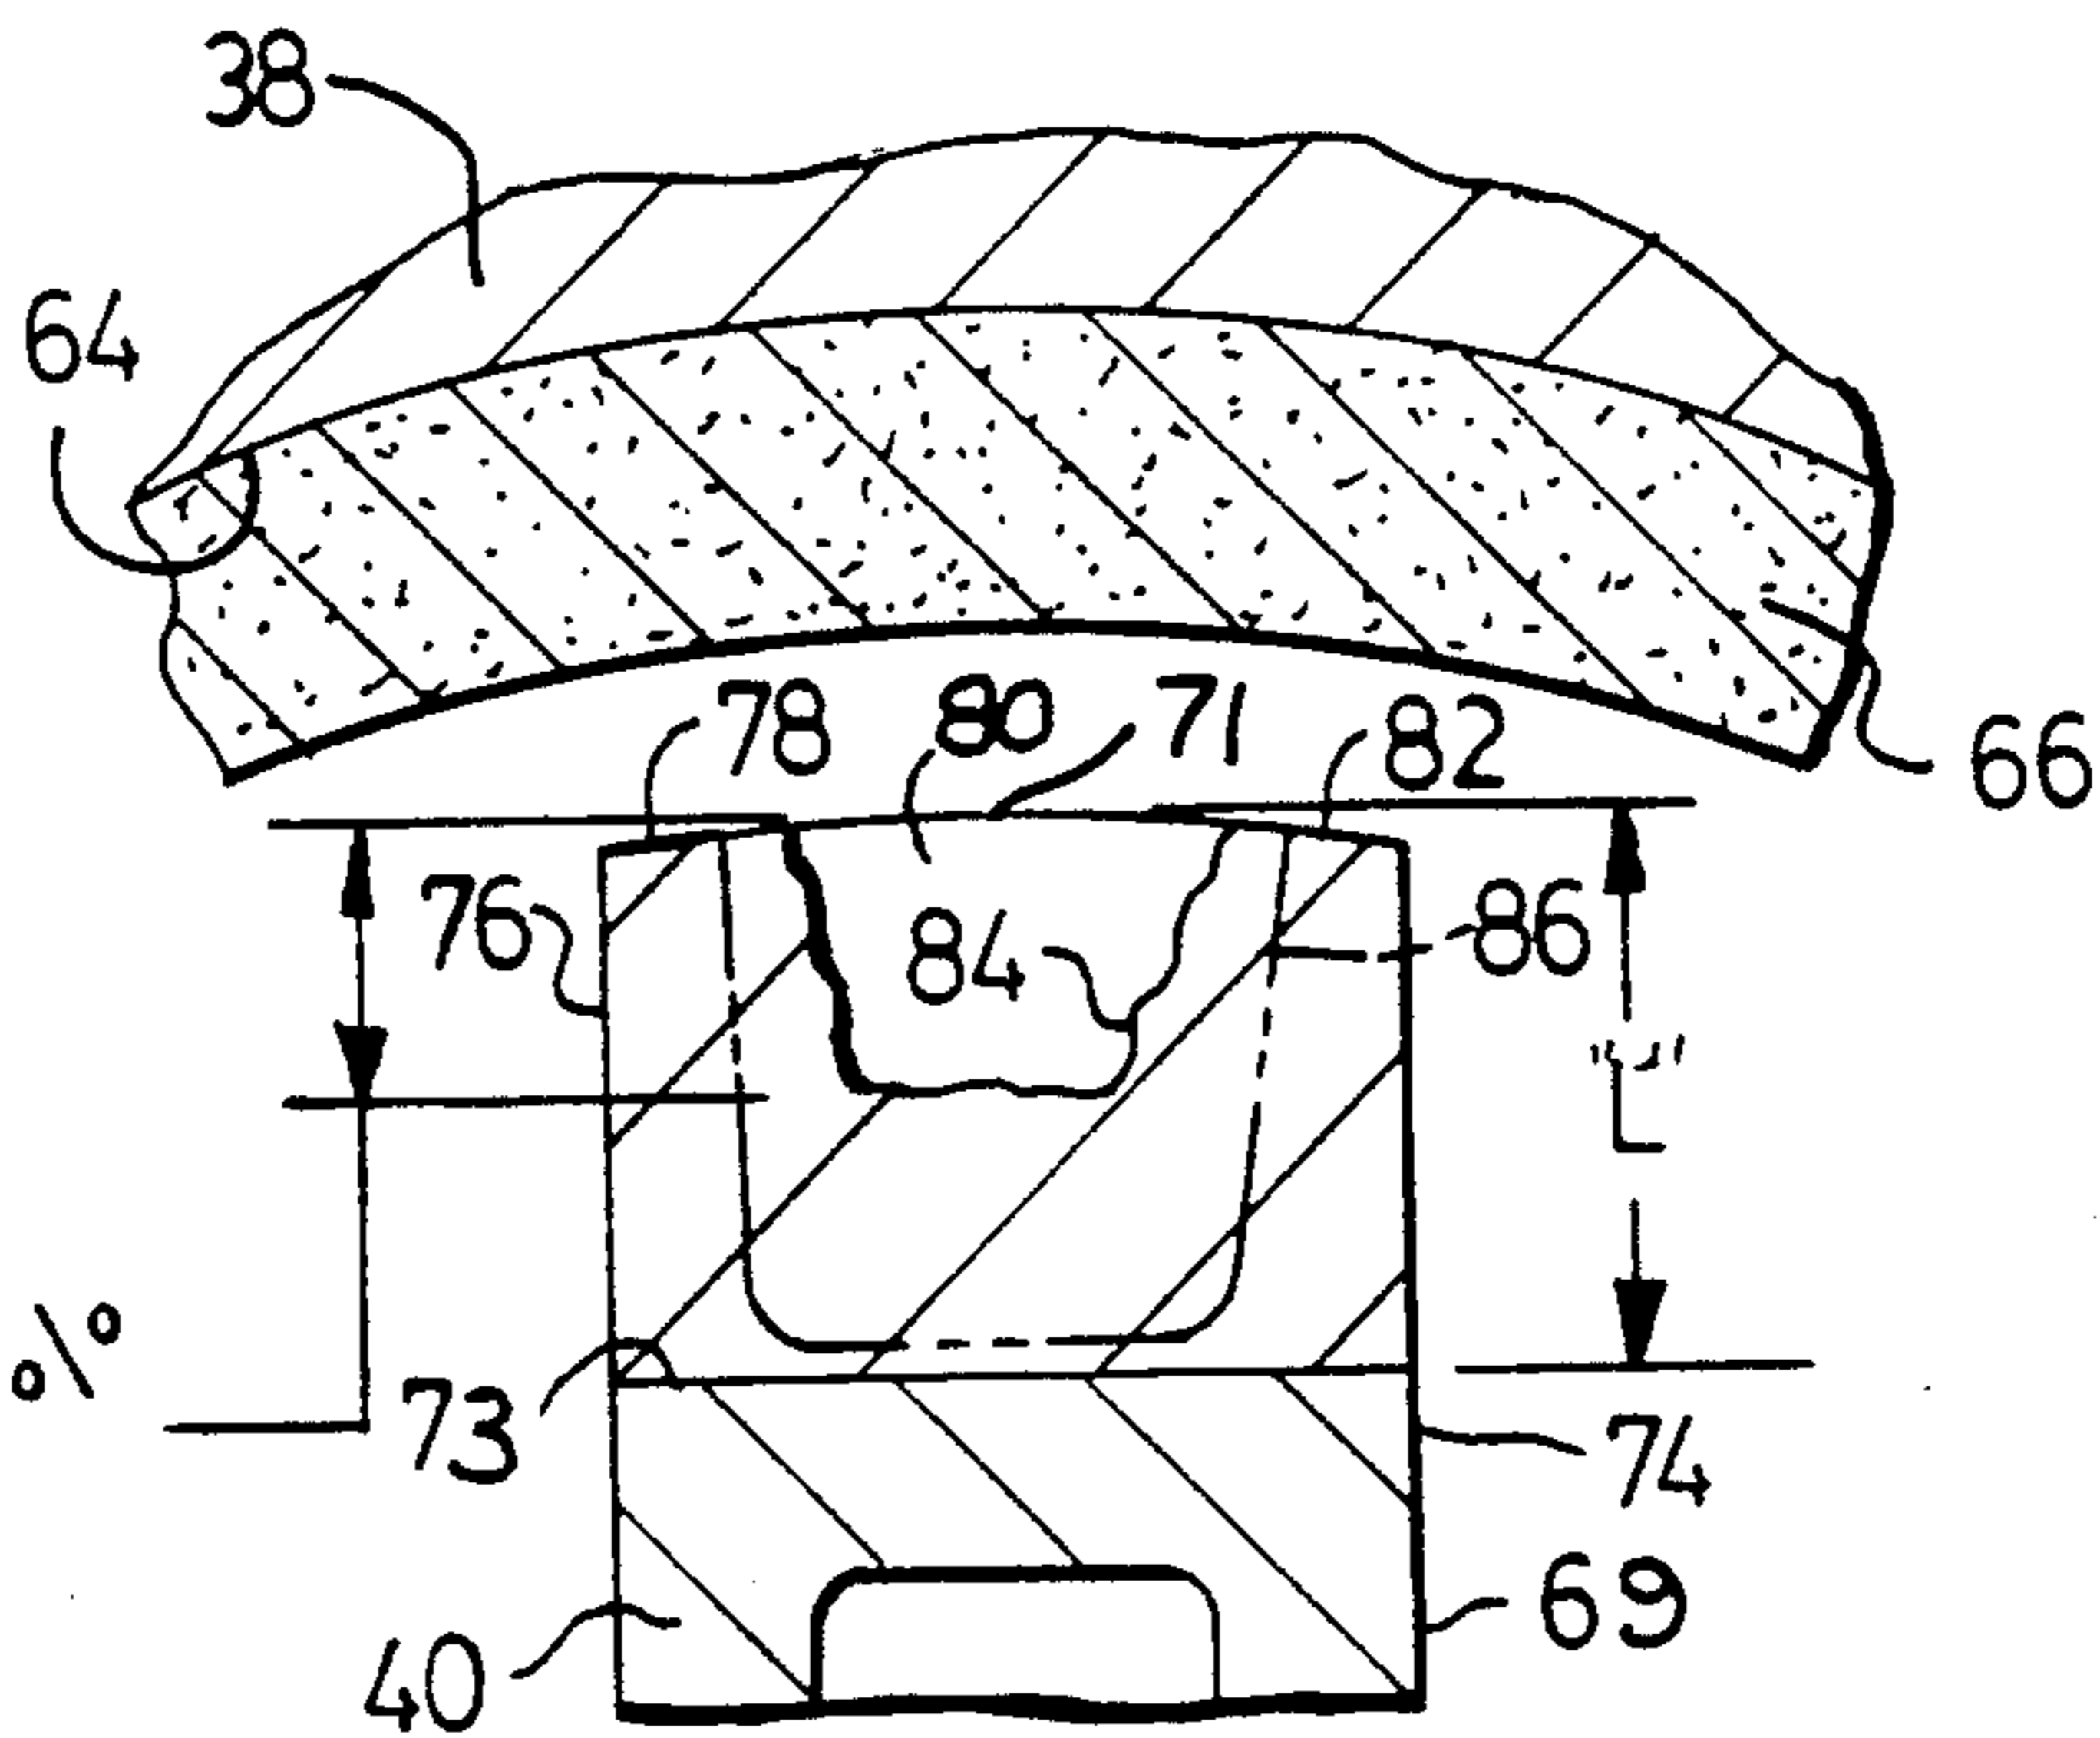
FIG. 3 is an enlarged sectional view taken along line III—III of FIG. 2.

As best shown in FIG. 3, the outer tip 70 has a radial length "L" sufficient to insure protection of the metallic body 69 from the corrosive gases at the highest operating temperature even after a plurality of rubs occur between the blade 40 and the coating 66 and/or the shroud 38. Thus, the length of the outer tip 70 is at least 1 mm to insure that if a portion of the tip 70 is worn away during the rubbing of the blade 40 and the coating 66 and/or shroud 38 a portion of the material remains on the metallic body 69.
