[54] **METHOD OF MAKING AND REPAIRING TURBINE BLADES**

[73] Assignee: Solar Turbines Incorporated, San Diego, Calif.

[57] **ABSTRACT**

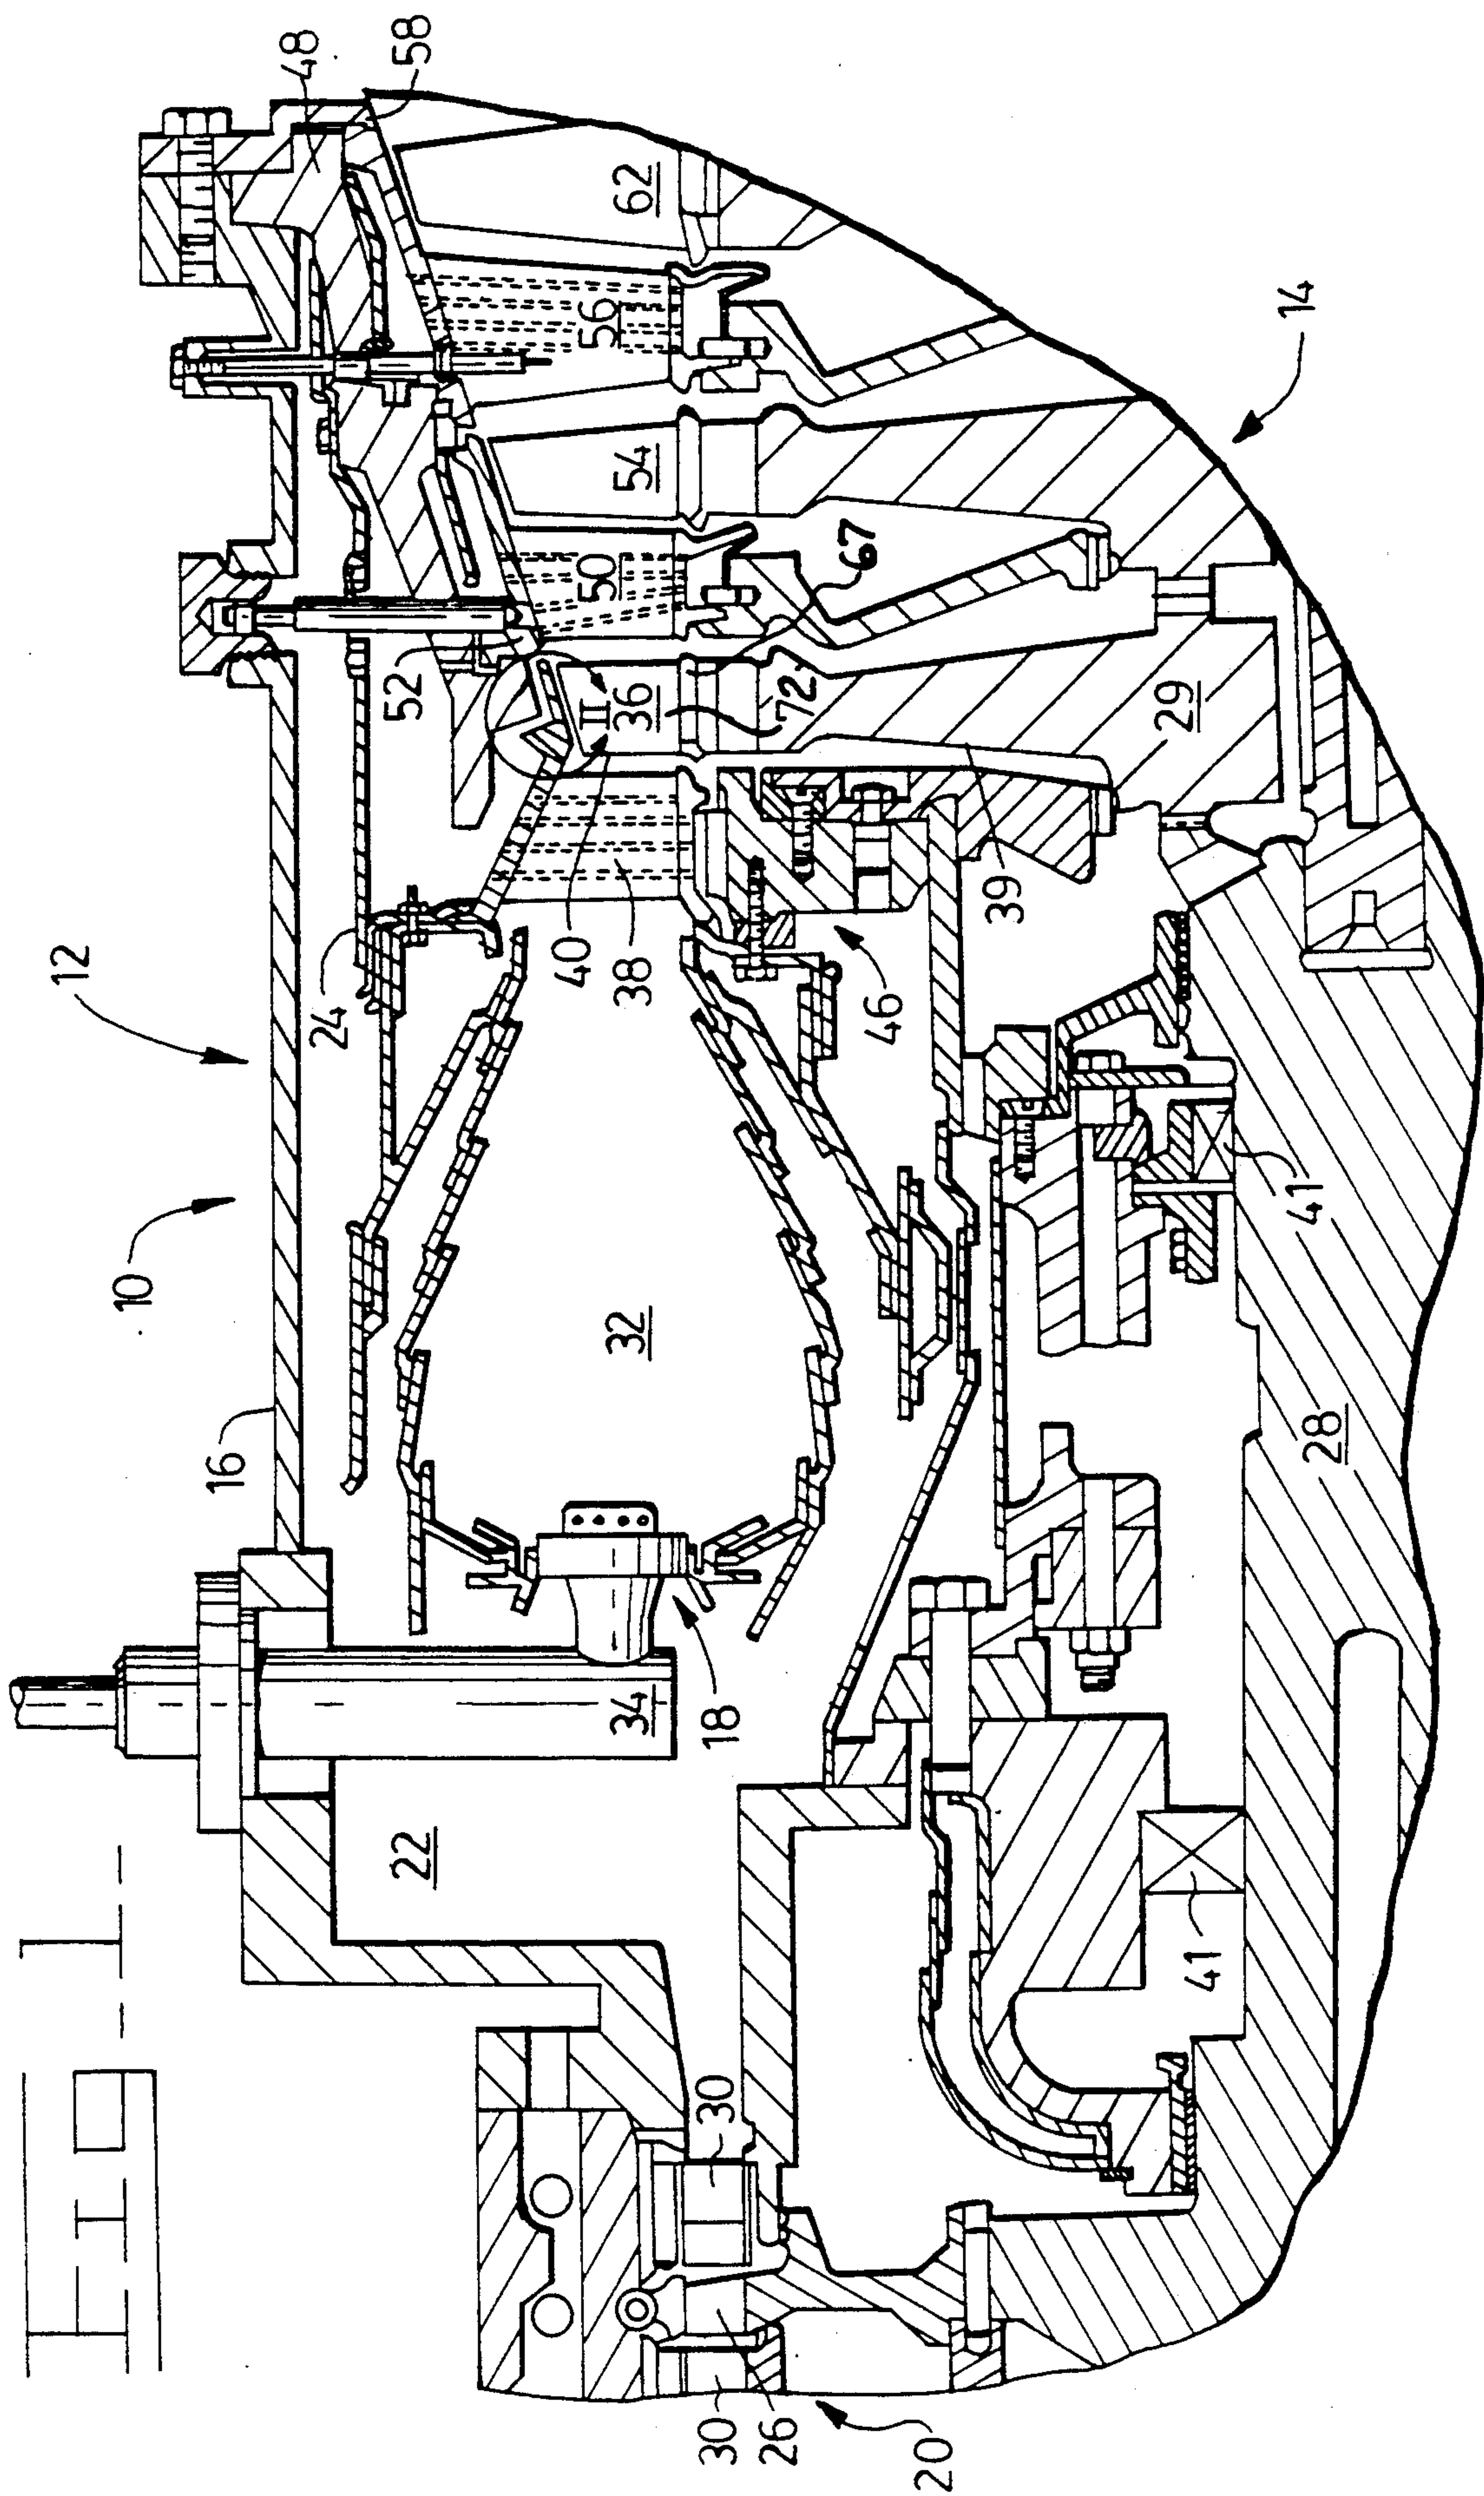
FIG. 1 is a partial sectional side view of a gas turbine engine disclosing the turbine blade tip control system of this invention.

Referring to FIG. 1, a gas turbine engine 10, not shown in its entirety, has been sectioned to show a turbine tip control system 12 for controlling internal leakage of a turbine section 14 of the engine. The engine 10 includes an outer case 16, a combustor section 18, a compressor section 20 and a compressor discharge plenum 22 fluidly connected to the compressor section 20. The plenum 22 is partially defined by the outer case 16 and a multipiece inner wall 24 partially surrounding the turbine section 14 and the combustor section 18. The compressor section 20 includes a plurality of rotatable blades 26 attached to a longitudinally extending center shaft 28 driven by a gasifier turbine section 29. A plurality of compressor stator blades 30 extend from the outer case 16 and are positioned between the rotatable blades. For illustration convenience, only a single stage of a multistage axial compressor 20 is shown. The combustor section 18 includes a combustion chamber 32 positioned in the plenum 22 and a plurality of fuel nozzles 34 (one shown) positioned in the chamber 32 at the end near the compressor section 20. The turbine section includes a first stage turbine 36 disposed partially within an integral first stage nozzle and shroud assembly 38. The first stage turbine 36 includes a rotatable turbine wheel 39 and an annular array of turbine blades 40 (one shown) attached thereto. The assembly 38 is attached to the inner wall 24 and supported from the center shaft 28 by a bearing arrangement 41 and a series of thermally varied masses 46 which are assembled to prevent rapid thermal variation during heating and cooling of such masses 46. A nozzle support case 48 is disposed within the outer case 16 and is attached to the case 16 by a plurality of bolts and dowels not shown. An integral second stage nozzle and shroud assembly 50 is attached to the nozzle support case 48 by a plurality of nozzle hooks 52 and a second stage turbine 54 is disposed partially within the assembly 50. An integral third stage nozzle and shroud assembly 56 is attached to the nozzle support case 48 by a plurality of nozzle hooks 58 and a third stage turbine 62 is disposed partially within the assembly 56. All the turbines 36, 54, 62 are connected to the longitudinally extending center shaft 28.

The turbine tip control system 12 of the present invention is part of a gas turbine engine 10. The compressor section 20 provides combustion air for the engine 10. The air is mixed with fuel from the fuel nozzles 34 in the combustion chamber 32. The mixture of fuel and air is combusted and the resulting gas expands and is used to drive the turbines 36, 54, 62. The gas is directed into the first stage turbine 36 through the first stage nozzle-and shroud assembly 38. The nozzle guides the gas so that it strikes the blades 40 at a preestablished angle to exert a maximum force for rotating the turbine 36. Any leakage between the turbine blades 40 and the shroud assembly 38 results in reduced power and a loss of efficiency. Thus, the tightness or clearance between the outer extremity 73 of the turbine blade 40 and the shroud assembly 38 controls efficiency. For example, the clearance between the turbine 36, 54, 62 and the shroud assembly 38, 50, 56 in a typical application is approximately 0.5 mm.

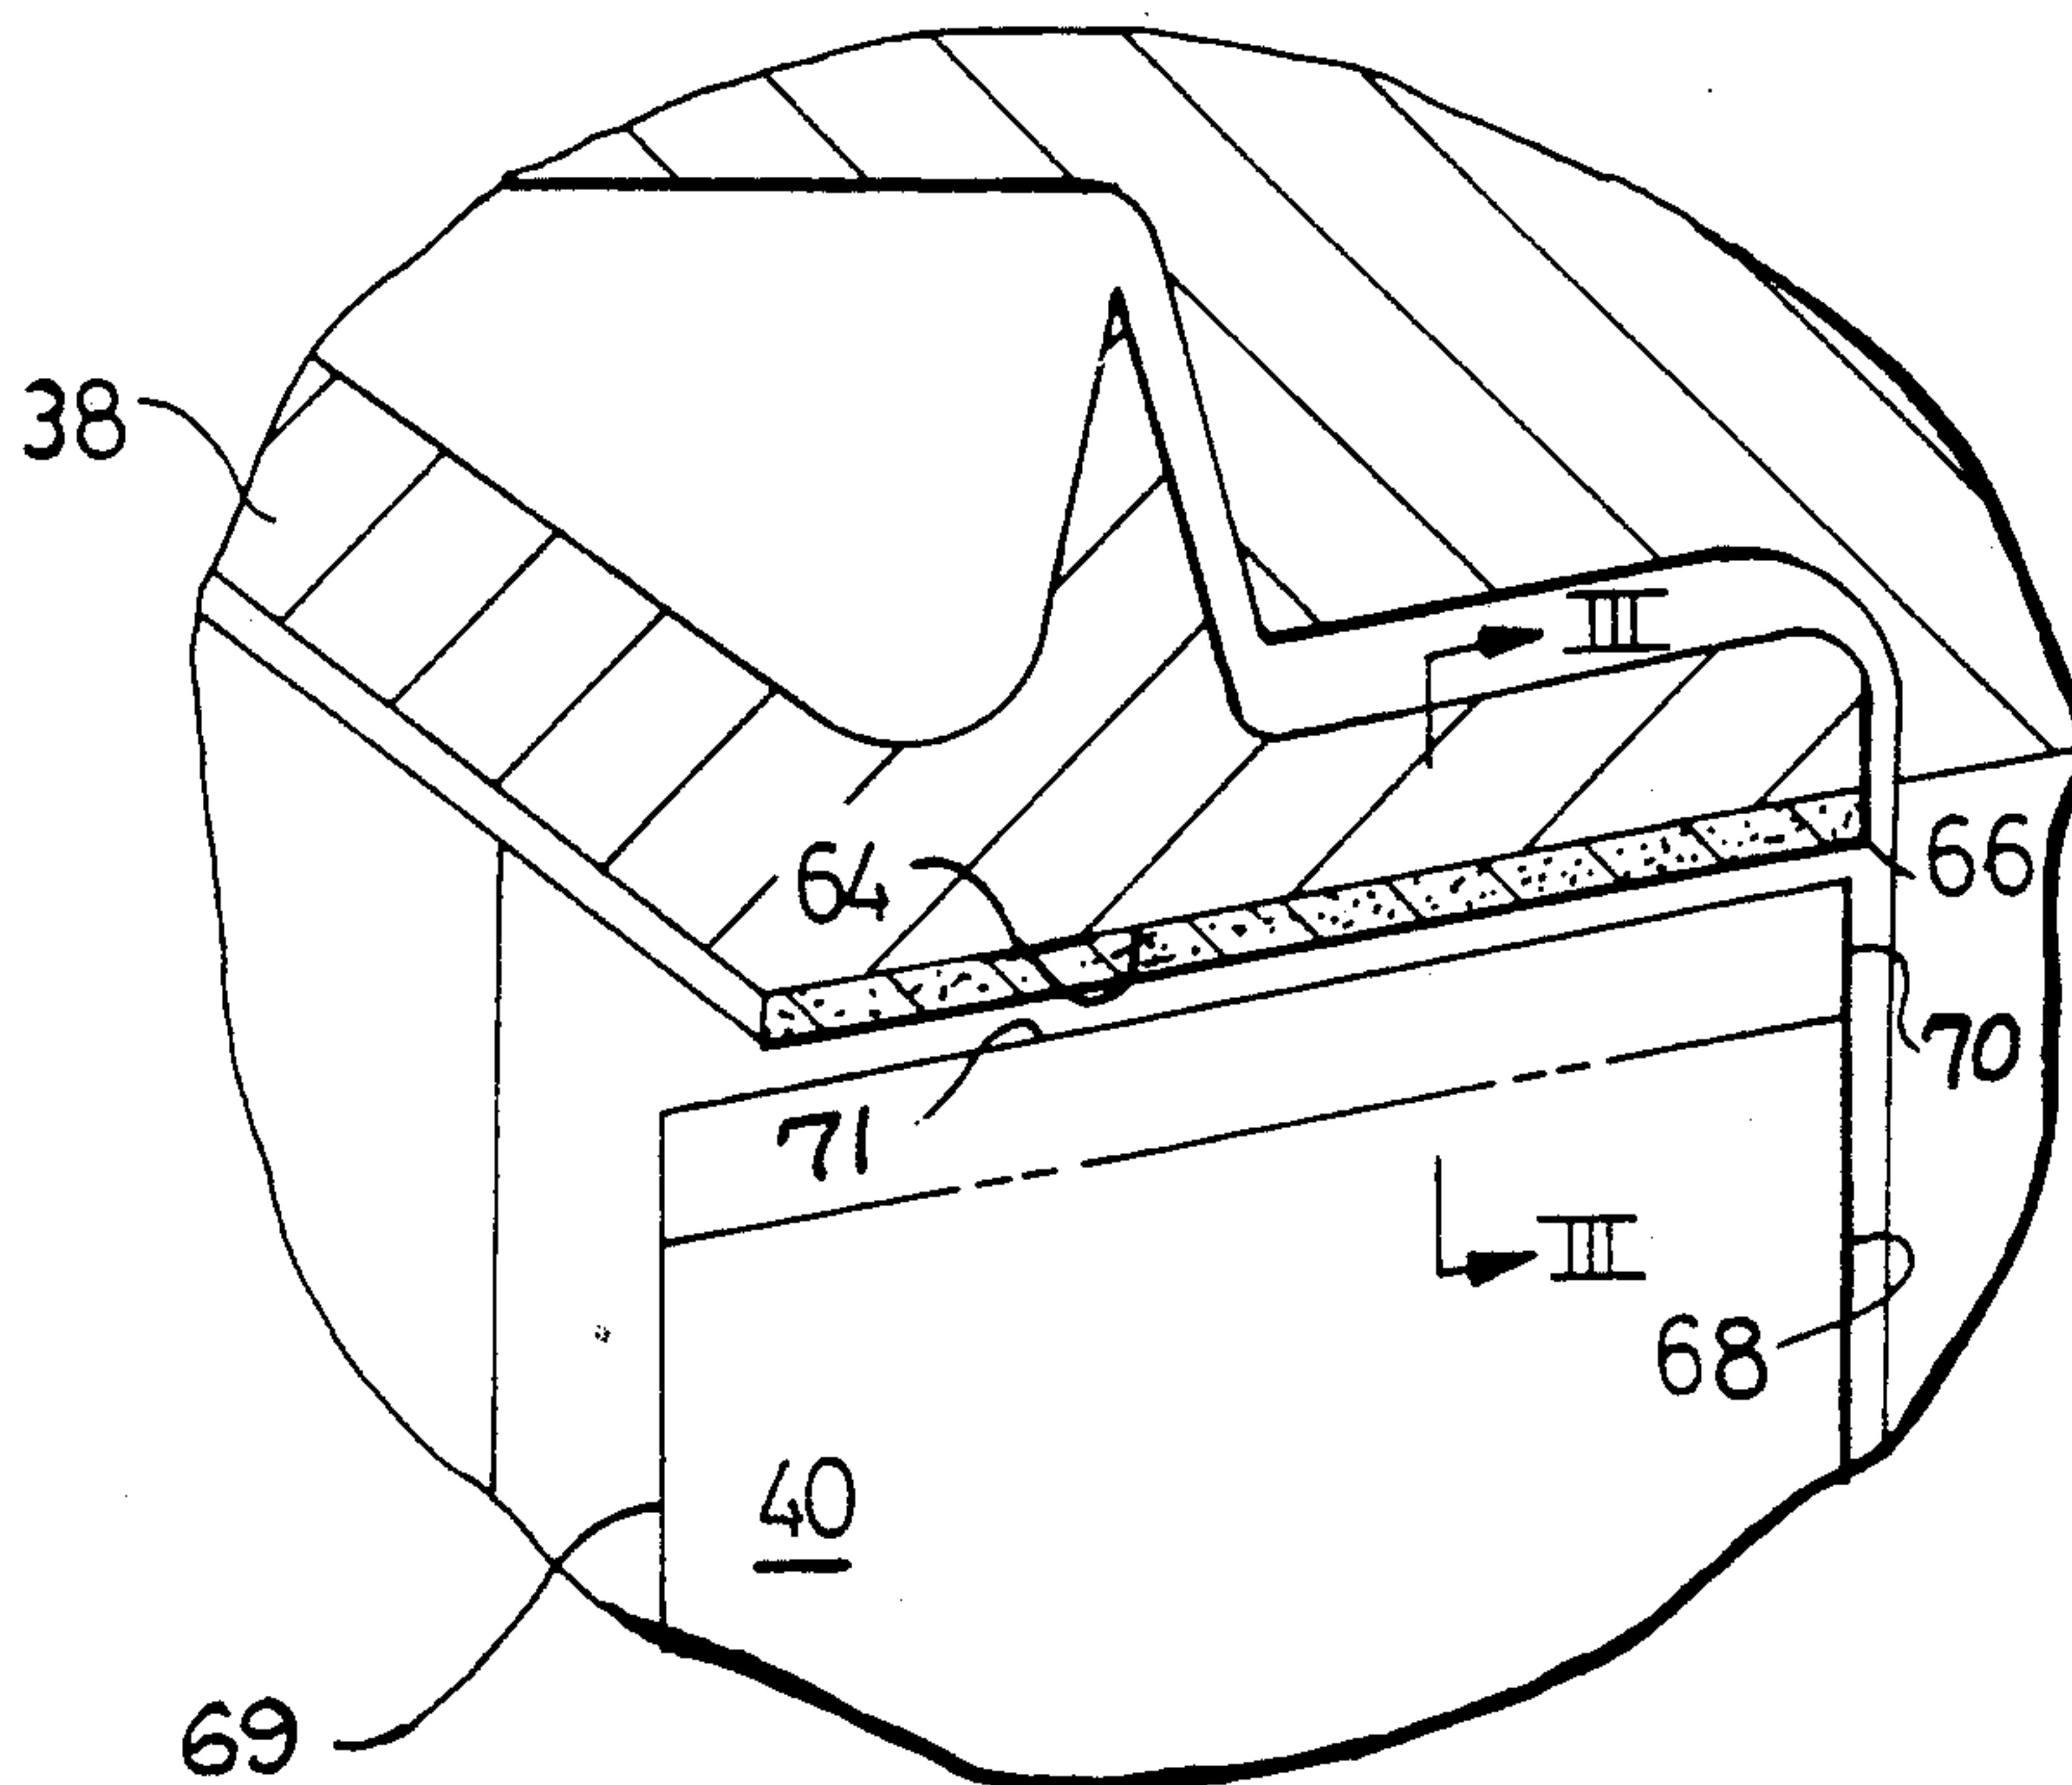
FIG. 2 is an enlarged sectional view of the turbine tip clearance area encircled by line II of FIG. 1.

As more clearly shown in FIG. 2, the shroud assembly 38 has a radially inwardly facing surface 64 positioned adjacent and radially outwardly of the turbine blade 40. A coating 66 is affixed to the surface 64 and is resistant to high temperature, oxidation, corrosion and sulfidation and is rub-tolerant. Rub-tolerant means that the coating will separate from itself in fine particle form or smear when rubbed by the blades rather than to break in larger pieces. The rub-tolerant coating is applied by a plasma spray process and has a thickness of approximately 0.7 mm. The coating is comprised of cobalt, nickel, chromium and aluminum. The coating has the physical characteristics and is applied in a process to result in a uniform, continuous surface free from spalling, cracking, chipping or flaking.

Each of the turbine blades 40 has an attaching base 67 connected to the turbine wheel 39 and a blade portion 68 attached to the base 67. The blade portion includes a metallic body 69 attached to the base 67 and an outer tip 70 formed outwardly on the body. The outer tip 70 has an outer face 71 thereon opposite the end formed on the body 69. The metallic body 69 has a root area 72 near the base 67, an outer extremity 73 outwardly of the root area 72 and a perimeter 74 around the body. The body 69 is of a material which has a predetermined strength sufficient to resist structural deformation at normal operating parameters of the engine 10. The outer extremity 73 is positioned adjacent the coating 66 to provide a normal operating clearance therebetween. The outer tip 70 can be formed to include a flat tip portion, not shown, or a squealer tip portion 76. The squealer tip portion 76 provides a better seal between the blade 40 and the coating 66 than does a flat tip portion. The squealer tip portion 76 is formed to have a ridge 78 positioned at and around the perimeter 74 of the metallic body 69 and a concave portion 80 is formed in the center of the ridge 78. The ridge 78 of the squealer tip portion 76 has a tip extremity 82 and a bottom portion 84. As best shown in FIG. 3 the thickness of the ridge 78 is of a thinner cross-sectional area near the tip extremity 82 than is the thickness of a cross-sectional area of the ridge 78 near the bottom portion 84 resulting in the squealer tip portion 76 including a tapered build-up being thinner near the tip extremity 82 than near the bottom portion 84 of the squealer tip portion 76. The above structure is a result of the welding process since the layered build-up results in a narrower pass per respective build-up pass or series of repetitive passes. Thus, the squealer tip portion 76 is approximately 50% shorter than a conventional squealer tip configuration shown by phantom line 86. The outer tip 70 is comprised of a material which has a predetermined strength less than that of the body 69 yet has sufficient strength to prevent breaking and/or separating from the metallic body 69 during hard rubbing contacts between the blade 40 and the coating 66 and/or the shroud 38. Thus, the outer tip 70 must have sufficient length to accept the wearing away of a portion of the material and yet not be totally removed from protecting the metallic body 69 from oxidation, sulfidation and corrosion. For example, the metallic body 69 has a tensile strength of approximately 1080 kPa at room temperature and approximately 750 kPa at 870° C. and a yield strength of approximately 930 kPa at room temperature and approximately 650 kPa at 870° C. The outer tip 70 has a tensile strength of approximately 870 kPa at room temperature and approximately 380 kPa at 870° C. and a yield strength of approximately 380 kPa at room temperature

and approximately 230 kPa at 870° C. Furthermore, the outer tip 70 is made of a nickel base material and is selected to include approximately 20%-24% chromium, 13%-15% tungsten, 1%-3% molybdenum and a trace of boron, lanthanum, silicon and manganese. A weld layered puddling build-up process is used to form the outer tip 70 on the metallic body 69. The process uses a filler rod having the nickel base material as described above as an ingredient thereof.

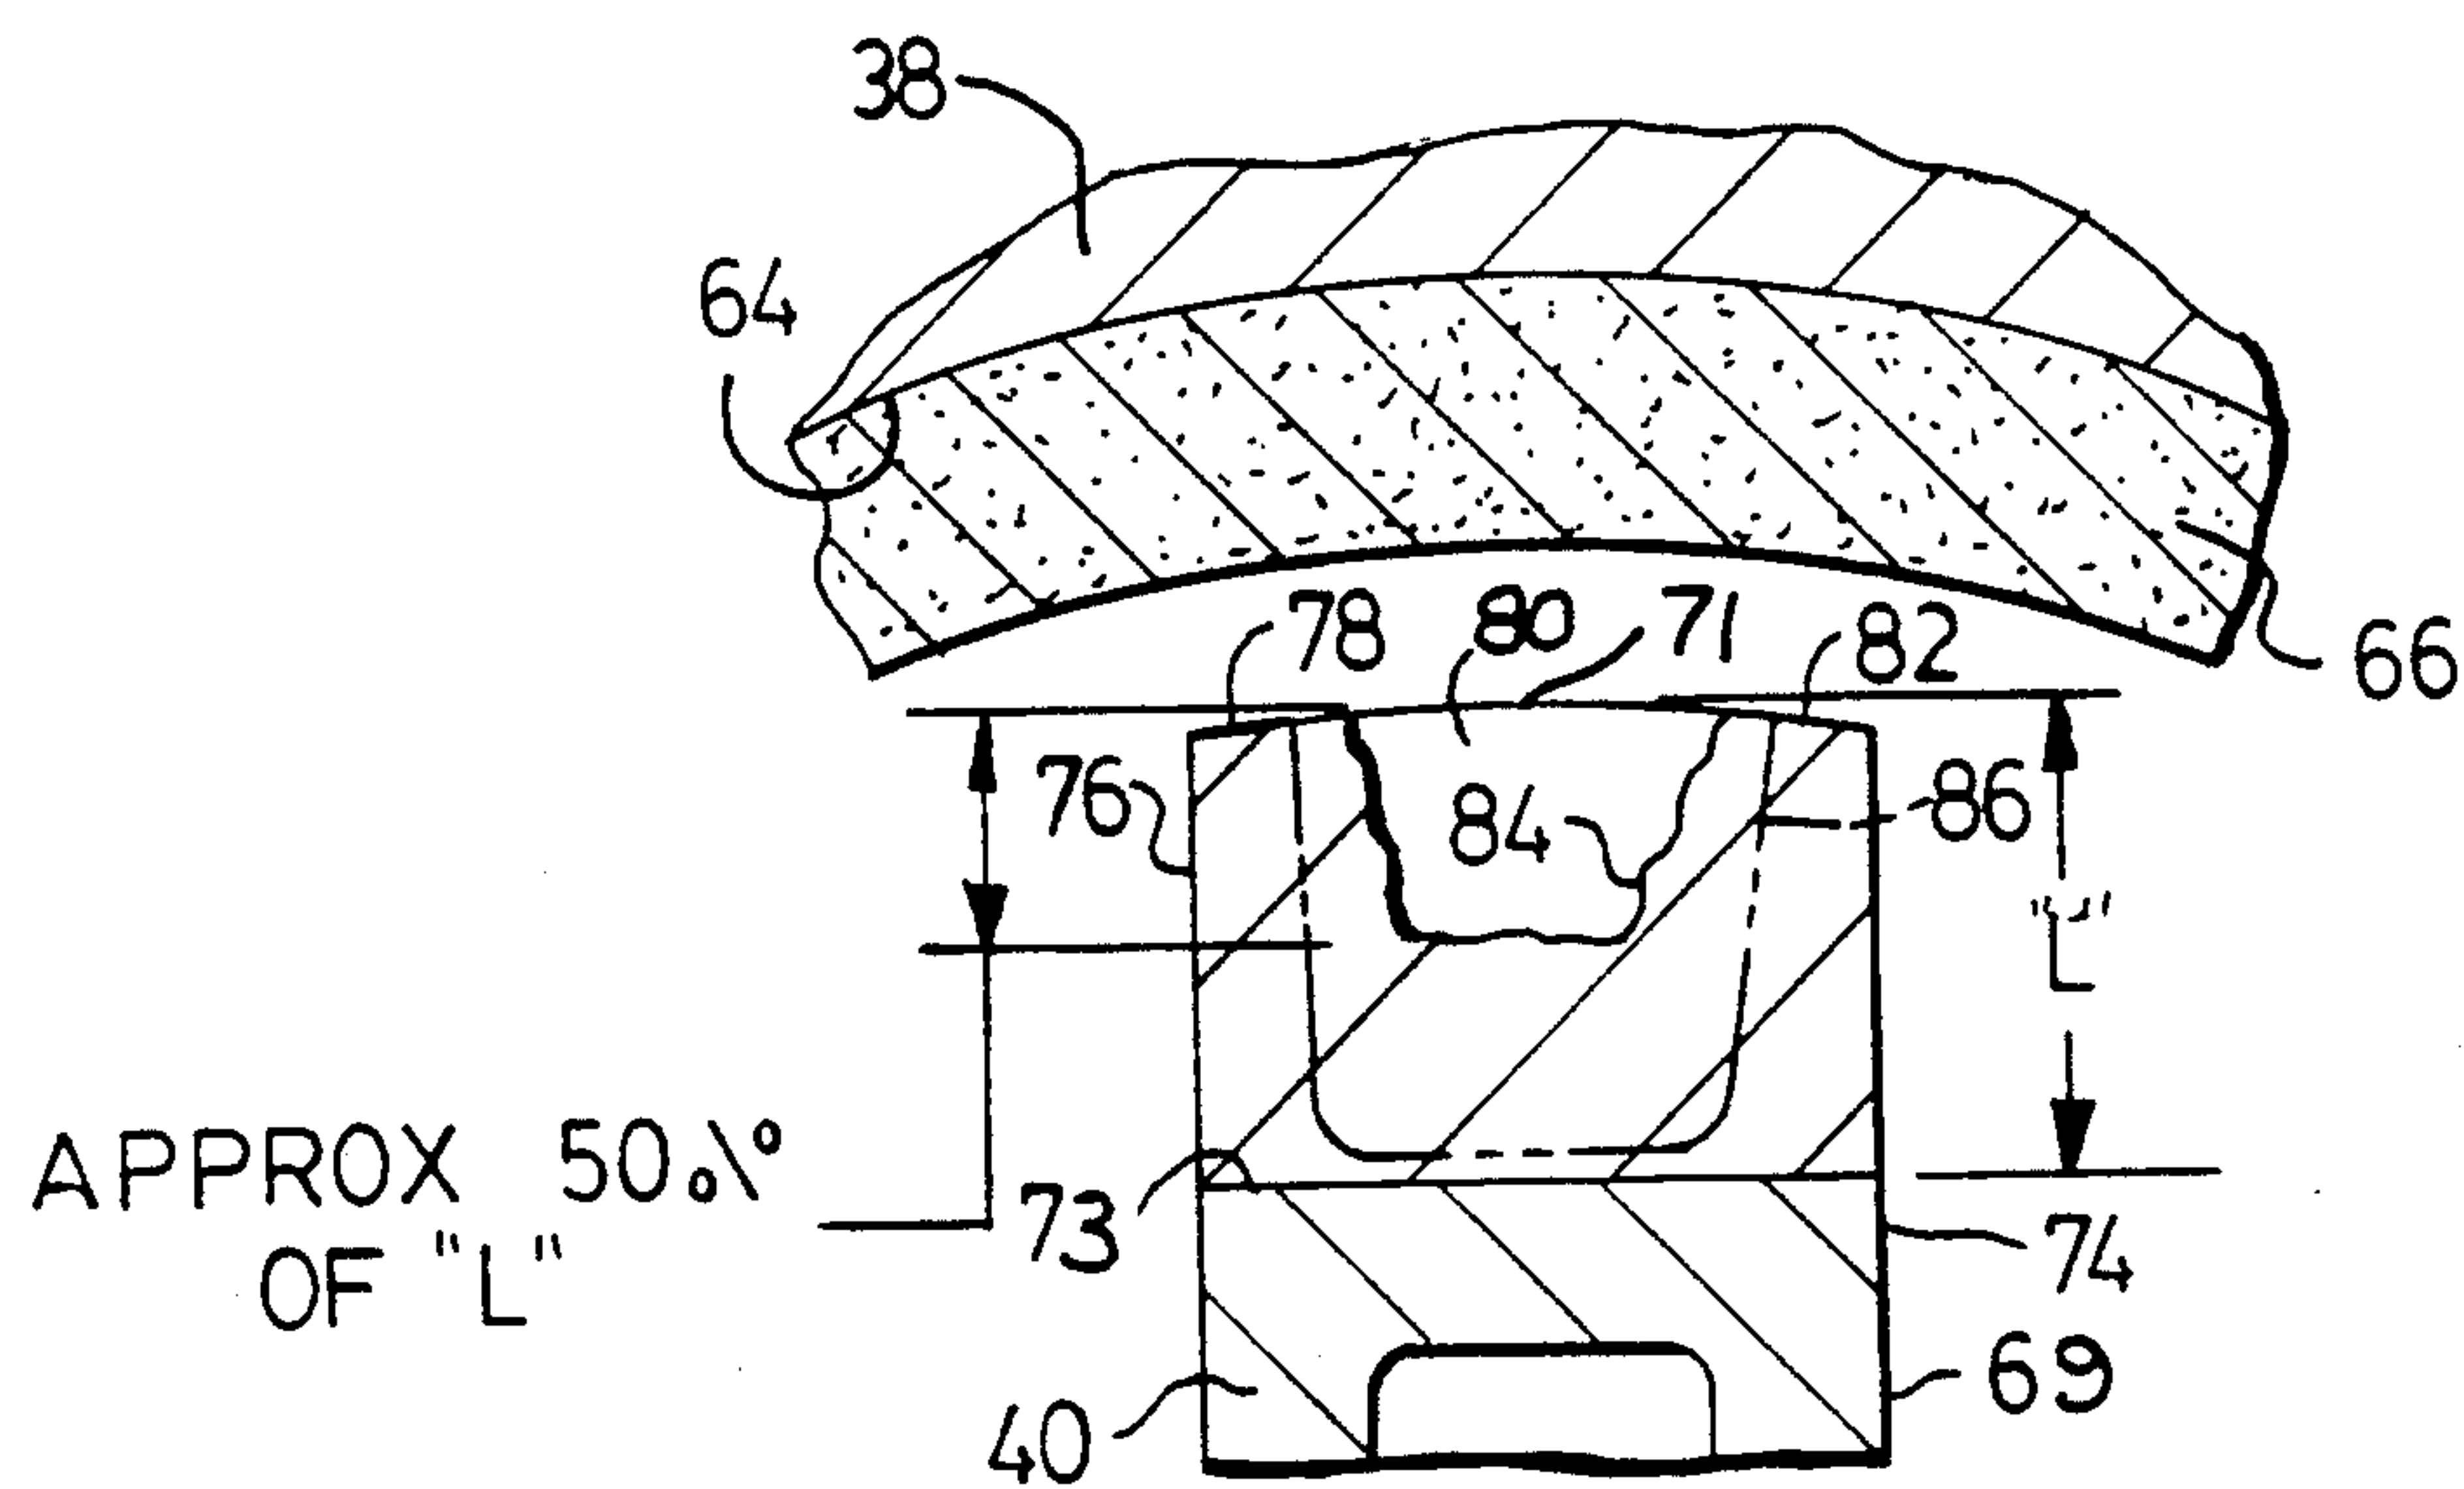
FIG. 3 is an enlarged sectional view taken along line III—III of FIG. 2.

As best shown in FIG. 3, the outer tip 70 has a radial length "L" sufficient to insure protection of the metallic body 69 from the corrosive gases at the highest operating temperature even after a plurality of rubs occur between the blade 40 and the coating 66 and/or the shroud 38. Thus, the length of the outer tip 70 is at least 1 mm to insure that if a portion of the tip 70 is worn away during the rubbing of the blade 40 and the coating 66 and/or shroud 38 a portion of the material remains on the metallic body 69.
