[54] **METHOD OF MAKING AND REPAIRING TURBINE BLADES**

[73] **Assignee:** Solar Turbines Incorporated, San Diego, Calif.

METHOD OF MAKING AND REPAIRING TURBINE BLADES

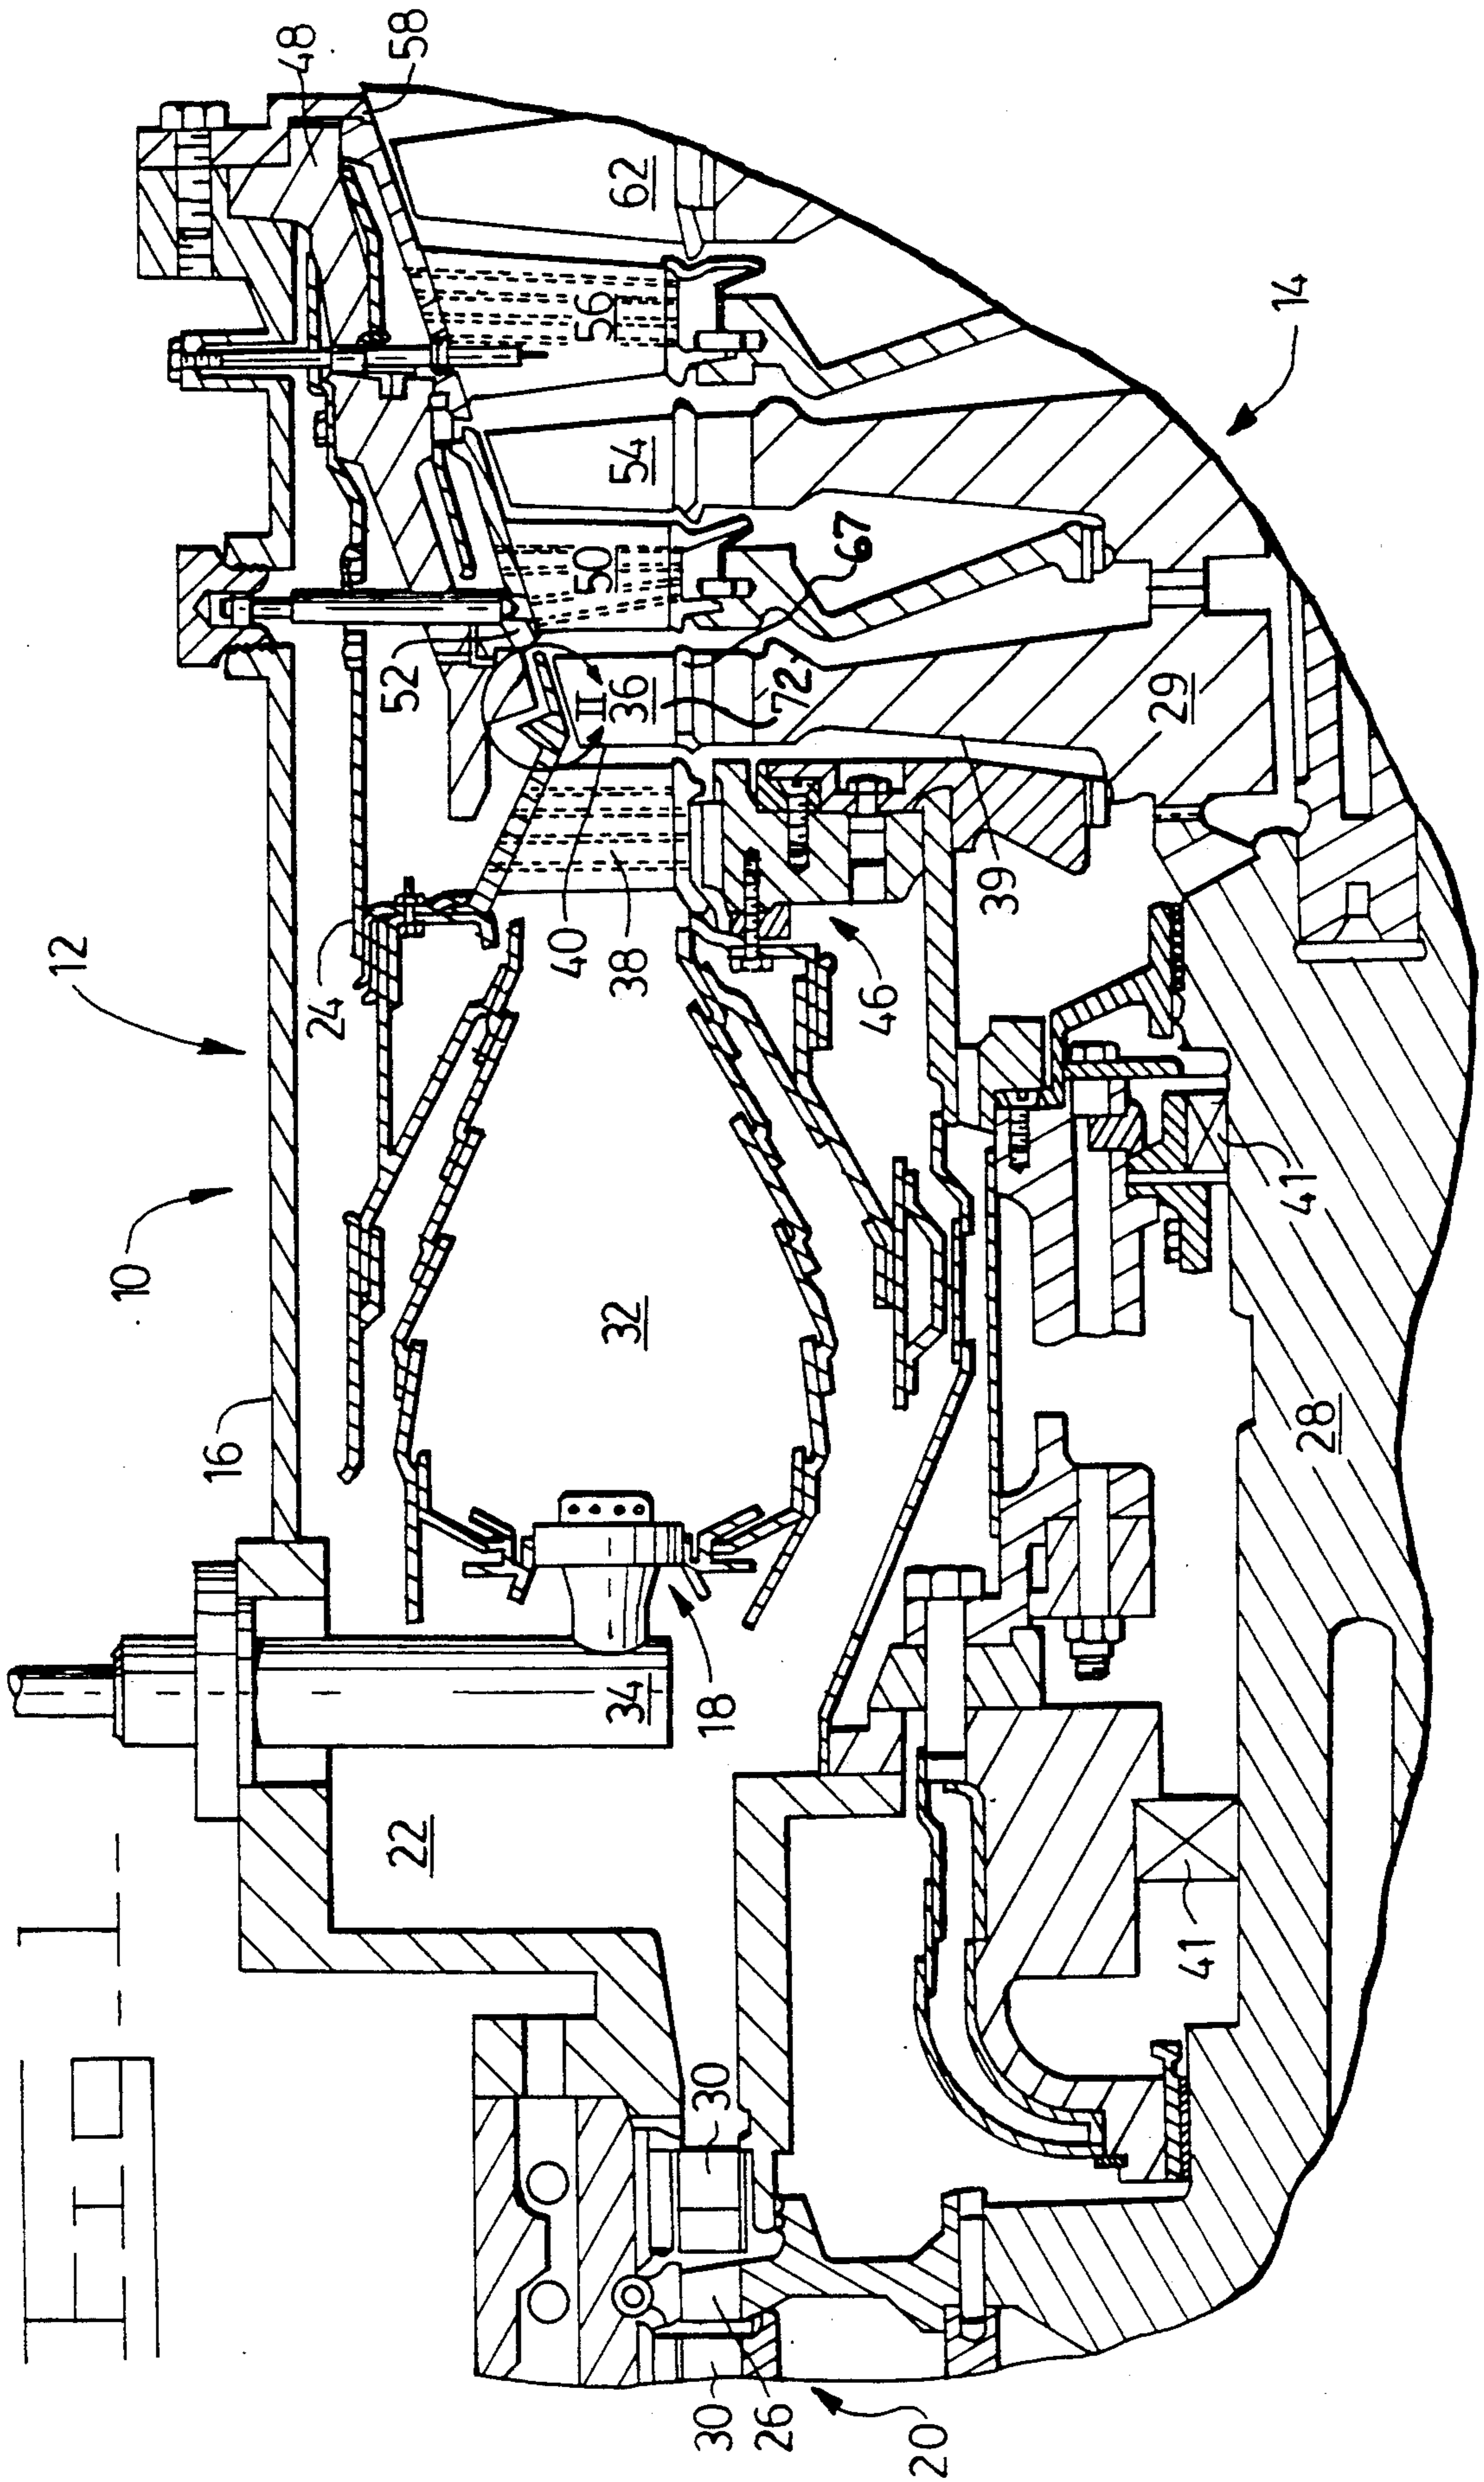
FIG. 1 is a partial sectional side view of a gas turbine engine disclosing the turbine blade tip control system of this invention.

Referring to FIG. 1, a gas turbine engine 10, not shown in its entirety, has been sectioned to show a turbine tip control system 12 for controlling internal leakage of a turbine section 14 of the engine. The engine 10 includes an outer case 16, a combustor section 18, a compressor section 20 and a compressor discharge plenum 22 fluidly connected to the compressor section 20. The plenum 22 is partially defined by the outer case 16 and a multipiece inner wall 24 partially surrounding the turbine section 14 and the combustor section 18. The compressor section 20 includes a plurality of rotatable blades 26 attached to a longitudinally extending center shaft 28 driven by a gasifier turbine section 29. A plurality of compressor stator blades 30 extend from the outer case 16 and are positioned between the rotatable blades. For illustration convenience, only a single stage of a multistage axial compressor 20 is shown. The combustor section 18 includes a combustion chamber 32 positioned in the plenum 22 and a plurality of fuel nozzles 34 (one shown) positioned in the chamber 32 at the end near the compressor section 20. The turbine section includes a first stage turbine 36 disposed partially within an integral first stage nozzle and shroud assembly 38. The first stage turbine 36 includes a rotatable turbine wheel 39 and an annular array of turbine blades 40 (one shown) attached thereto. The assembly 38 is attached to the inner wall 24 and supported from the center shaft 28 by a bearing arrangement 41 and a series of thermally varied masses 46 which are assembled to prevent rapid thermal variation during heating and cooling of such masses 46. A nozzle support case 48 is disposed within the outer case 16 and is attached to the case 16 by a plurality of bolts and dowels not shown. An integral second stage nozzle and shroud assembly 50 is attached to the nozzle support case 48 by a plurality of nozzle hooks 52 and a second stage turbine 54 is disposed partially within the assembly 50. An integral third stage nozzle and shroud assembly 56 is attached to the nozzle support case 48 by a plurality of nozzle hooks 58 and a third stage turbine 62 is disposed partially within the assembly 56. All the turbines 36, 54, 62 are connected to the longitudinally extending center shaft 28.

The turbine tip control system 12 of the present invention is part of a gas turbine engine 10. The compressor section 20 provides combustion air for the engine 10. The air is mixed with fuel from the fuel nozzles 34 in the combustion chamber 32. The mixture of fuel and air is combusted and the resulting gas expands and is used to drive the turbines 36, 54, 62. The gas is directed into the first stage turbine 36 through the first stage nozzle-and shroud assembly 38. The nozzle guides the gas so that it strikes the blades 40 at a preestablished angle to exert a maximum force for rotating the turbine 36. Any leakage between the turbine blades 40 and the shroud assembly 38 results in reduced power and a loss of efficiency. Thus, the tightness or clearance between the outer extremity 73 of the turbine blade 40 and the shroud assembly 38 controls efficiency. For example, the clearance between the turbine 36, 54, 62 and the shroud assembly 38, 50, 56 in a typical application is approximately 0.5 mm.
