United States Patent [19] Cuk

- [54] **TRANSFORMER INTERNAL FAULT WARNING INDICATOR**
- [75] Inventor: **Nikola Cuk**, North Vancouver, Canada
- [73] Assignee: **Powertech Labs Inc.**, Canada
- [21] Appl. No.: **631,547**
- [22] Filed: **Dec. 21, 1990**
- [51] Int. Cl.⁵ **G01L 19/12; G08B 5/18; H01H 9/50**
- [52] U.S. Cl. **116/272; 116/266; 361/37**
- [58] Field of Search **116/218, 220, 266, 268, 116/270, 272, 283; 73/744; 361/37; 340/646**

TRANSFORMER INTERNAL FAULT WARNING INDICATOR

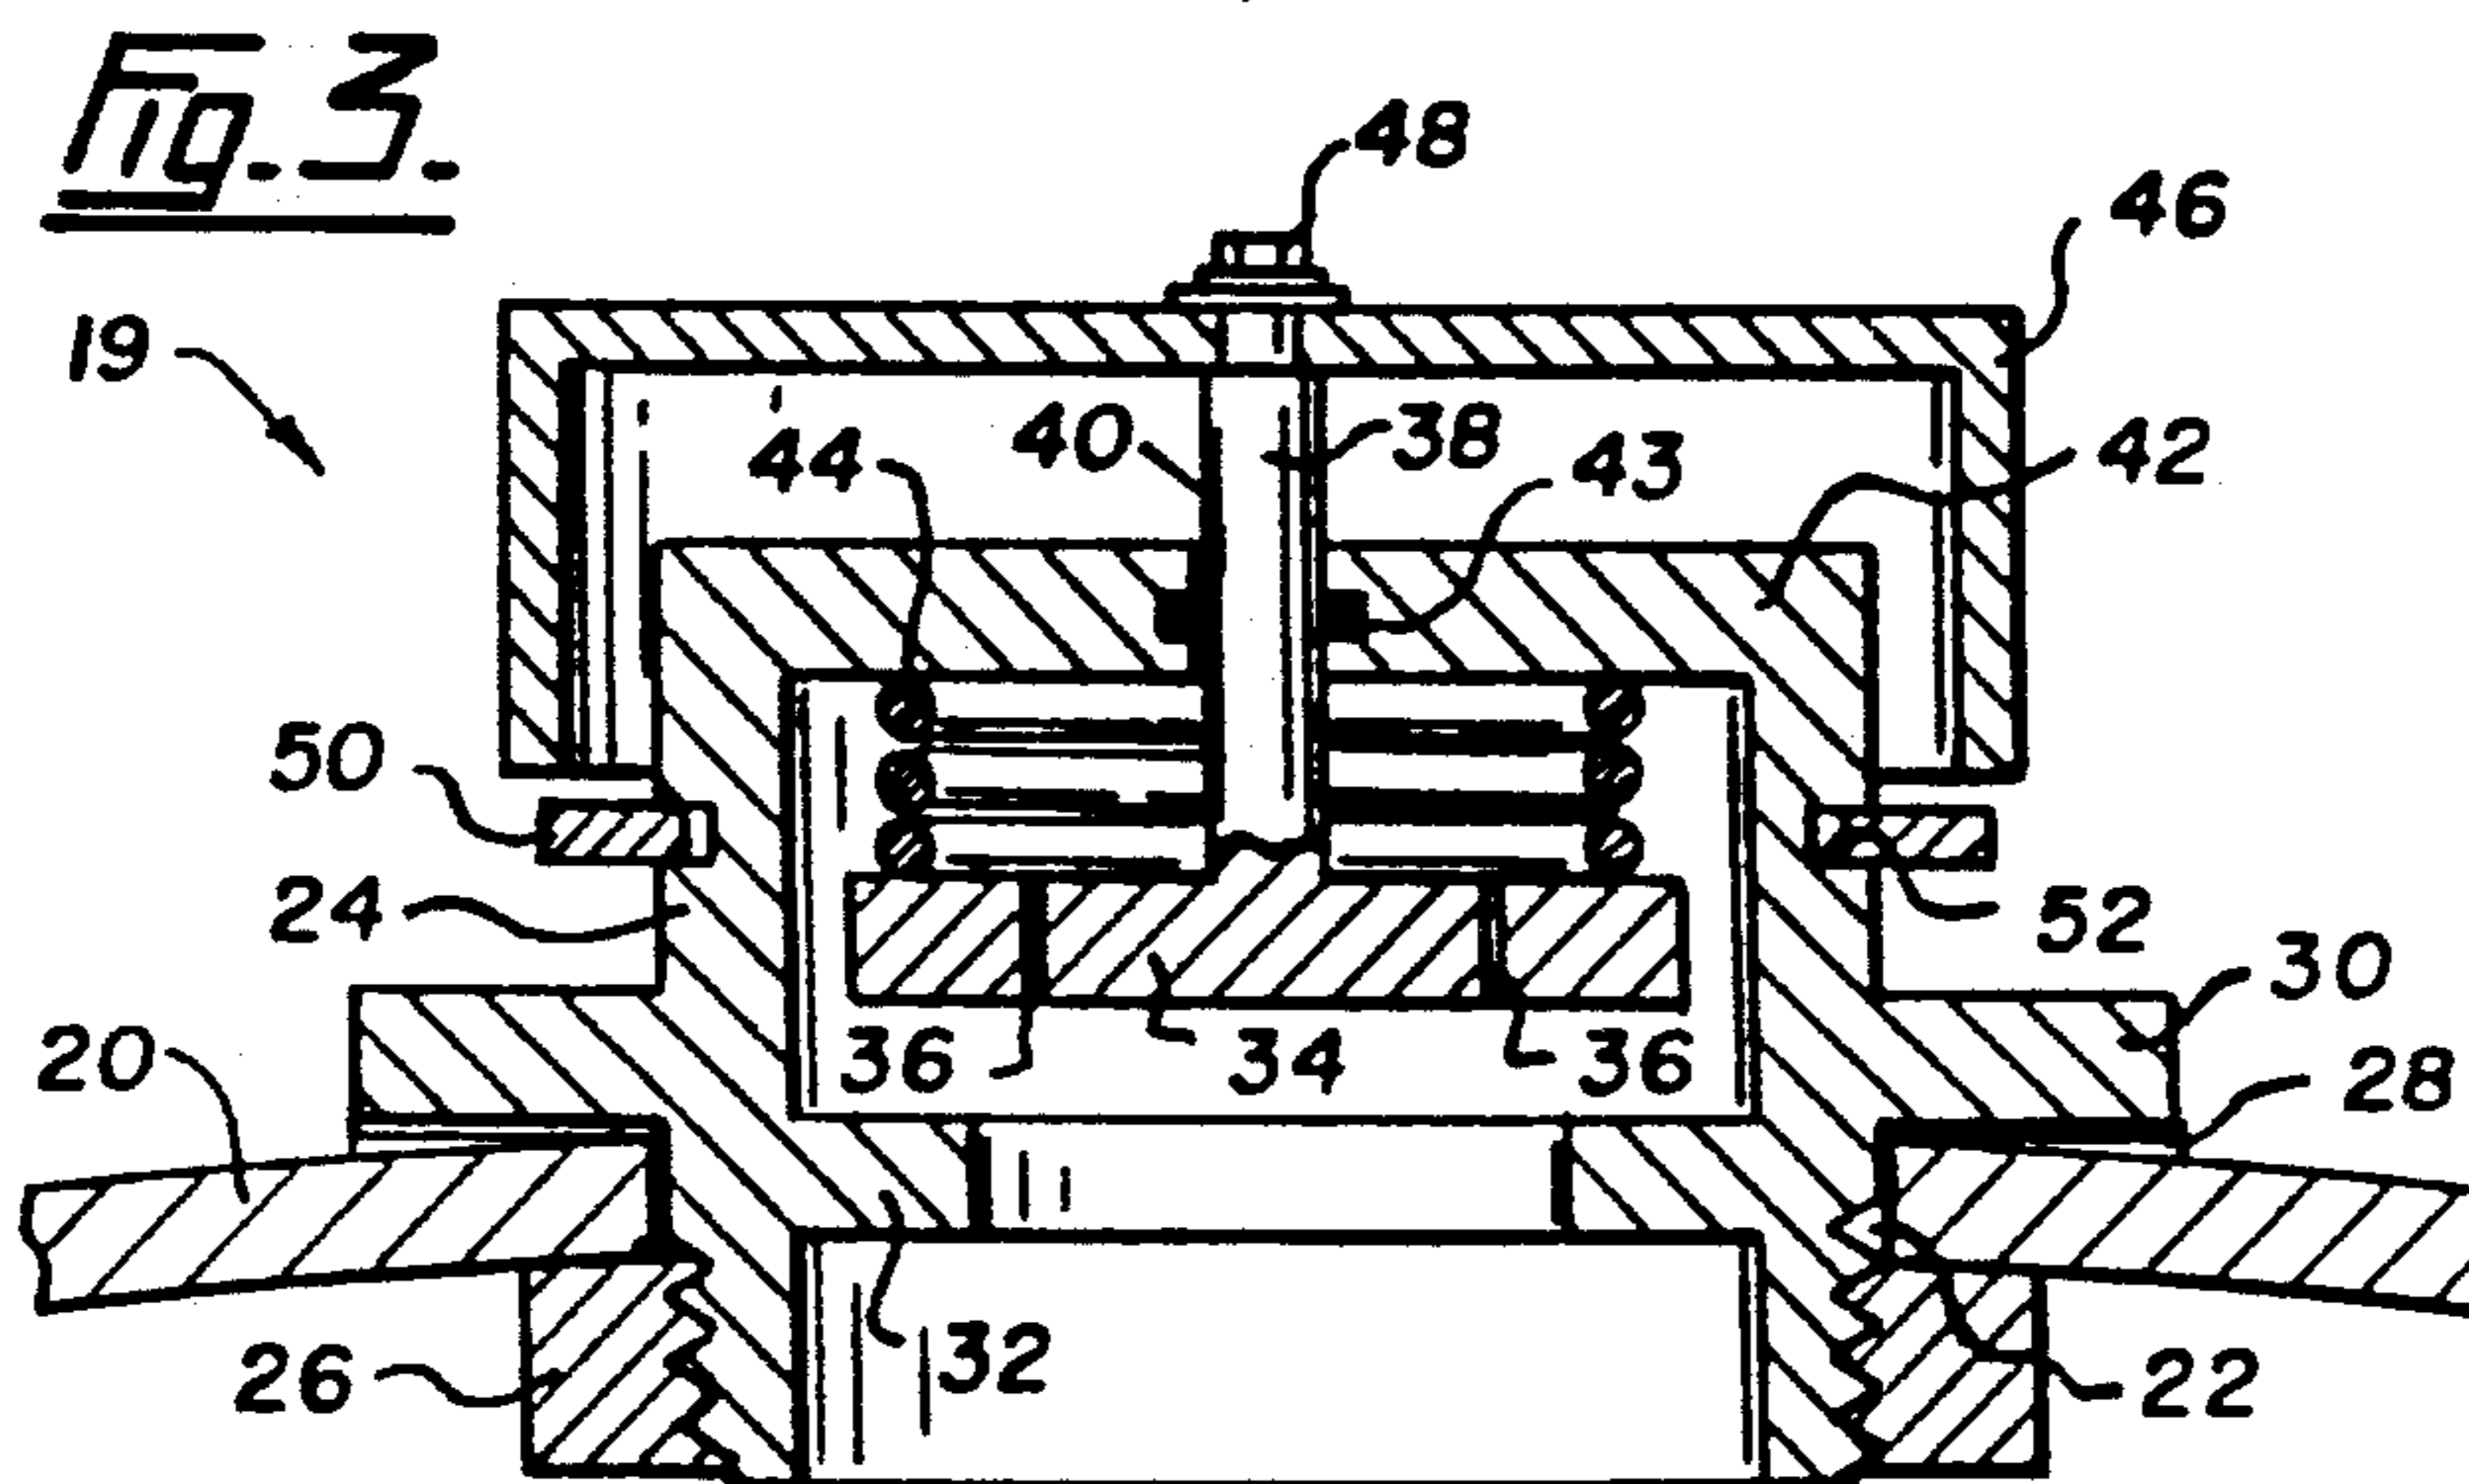
FIG. 3 is a detailed sectional view of the indicator shown in FIG. 2 which has tripped to show an arcing fault has occurred.

When the cup member 46 rises up above the ring clip 50, then the clip 50 opens out, as can be seen in FIG. 3, and prevents the cup member 46 from dropping back

In operation, when there is an internal arcing fault within the transformer 16 a rapid increase in pressure results and the small apertures 36 in the piston 34 are not large enough to admit the sudden release of gas to balance the pressure on both sides of the piston 34. Thus, the piston 34 is driven upwards forcing the stem 38 up through the hole 38. The cup member 46 rises to release the spring clip 50, and the bright color on the spring clip 50 is visible from the ground. It may well be that the fused cutout 18 has also operated or the casing of the transformer has bulged which can clearly be seen by a lineman. However as soon as he sees the colored ring clip 50, he knows there had been a pressure surge in the transformer 16. If he sees the colored ring clip 50, then he knows that the fault is in the transformer, and he would not reset the fused cutout 18 until the transformer has been replaced.
