United States Patent [19] Cuk

[11] Patent Number: **5,078,078**
[45] Date of Patent: **Jan. 7, 1992**

- [54] **TRANSFORMER INTERNAL FAULT WARNING INDICATOR**
- [75] Inventor: **Nikola Cuk**, North Vancouver, Canada
- [73] Assignee: **Powertech Labs Inc.**, Canada
- [21] Appl. No.: **631,547**
- [22] Filed: **Dec. 21, 1990**
- [51] Int. Cl.⁵ **G01L 19/12; G08B 5/18; H01H 9/50**
- [52] U.S. Cl. **116/272; 116/266; 361/37**
- [58] Field of Search **116/218, 220, 266, 268, 116/270, 272, 283; 73/744; 361/37; 340/646**

TRANSFORMER INTERNAL FAULT WARNING INDICATOR

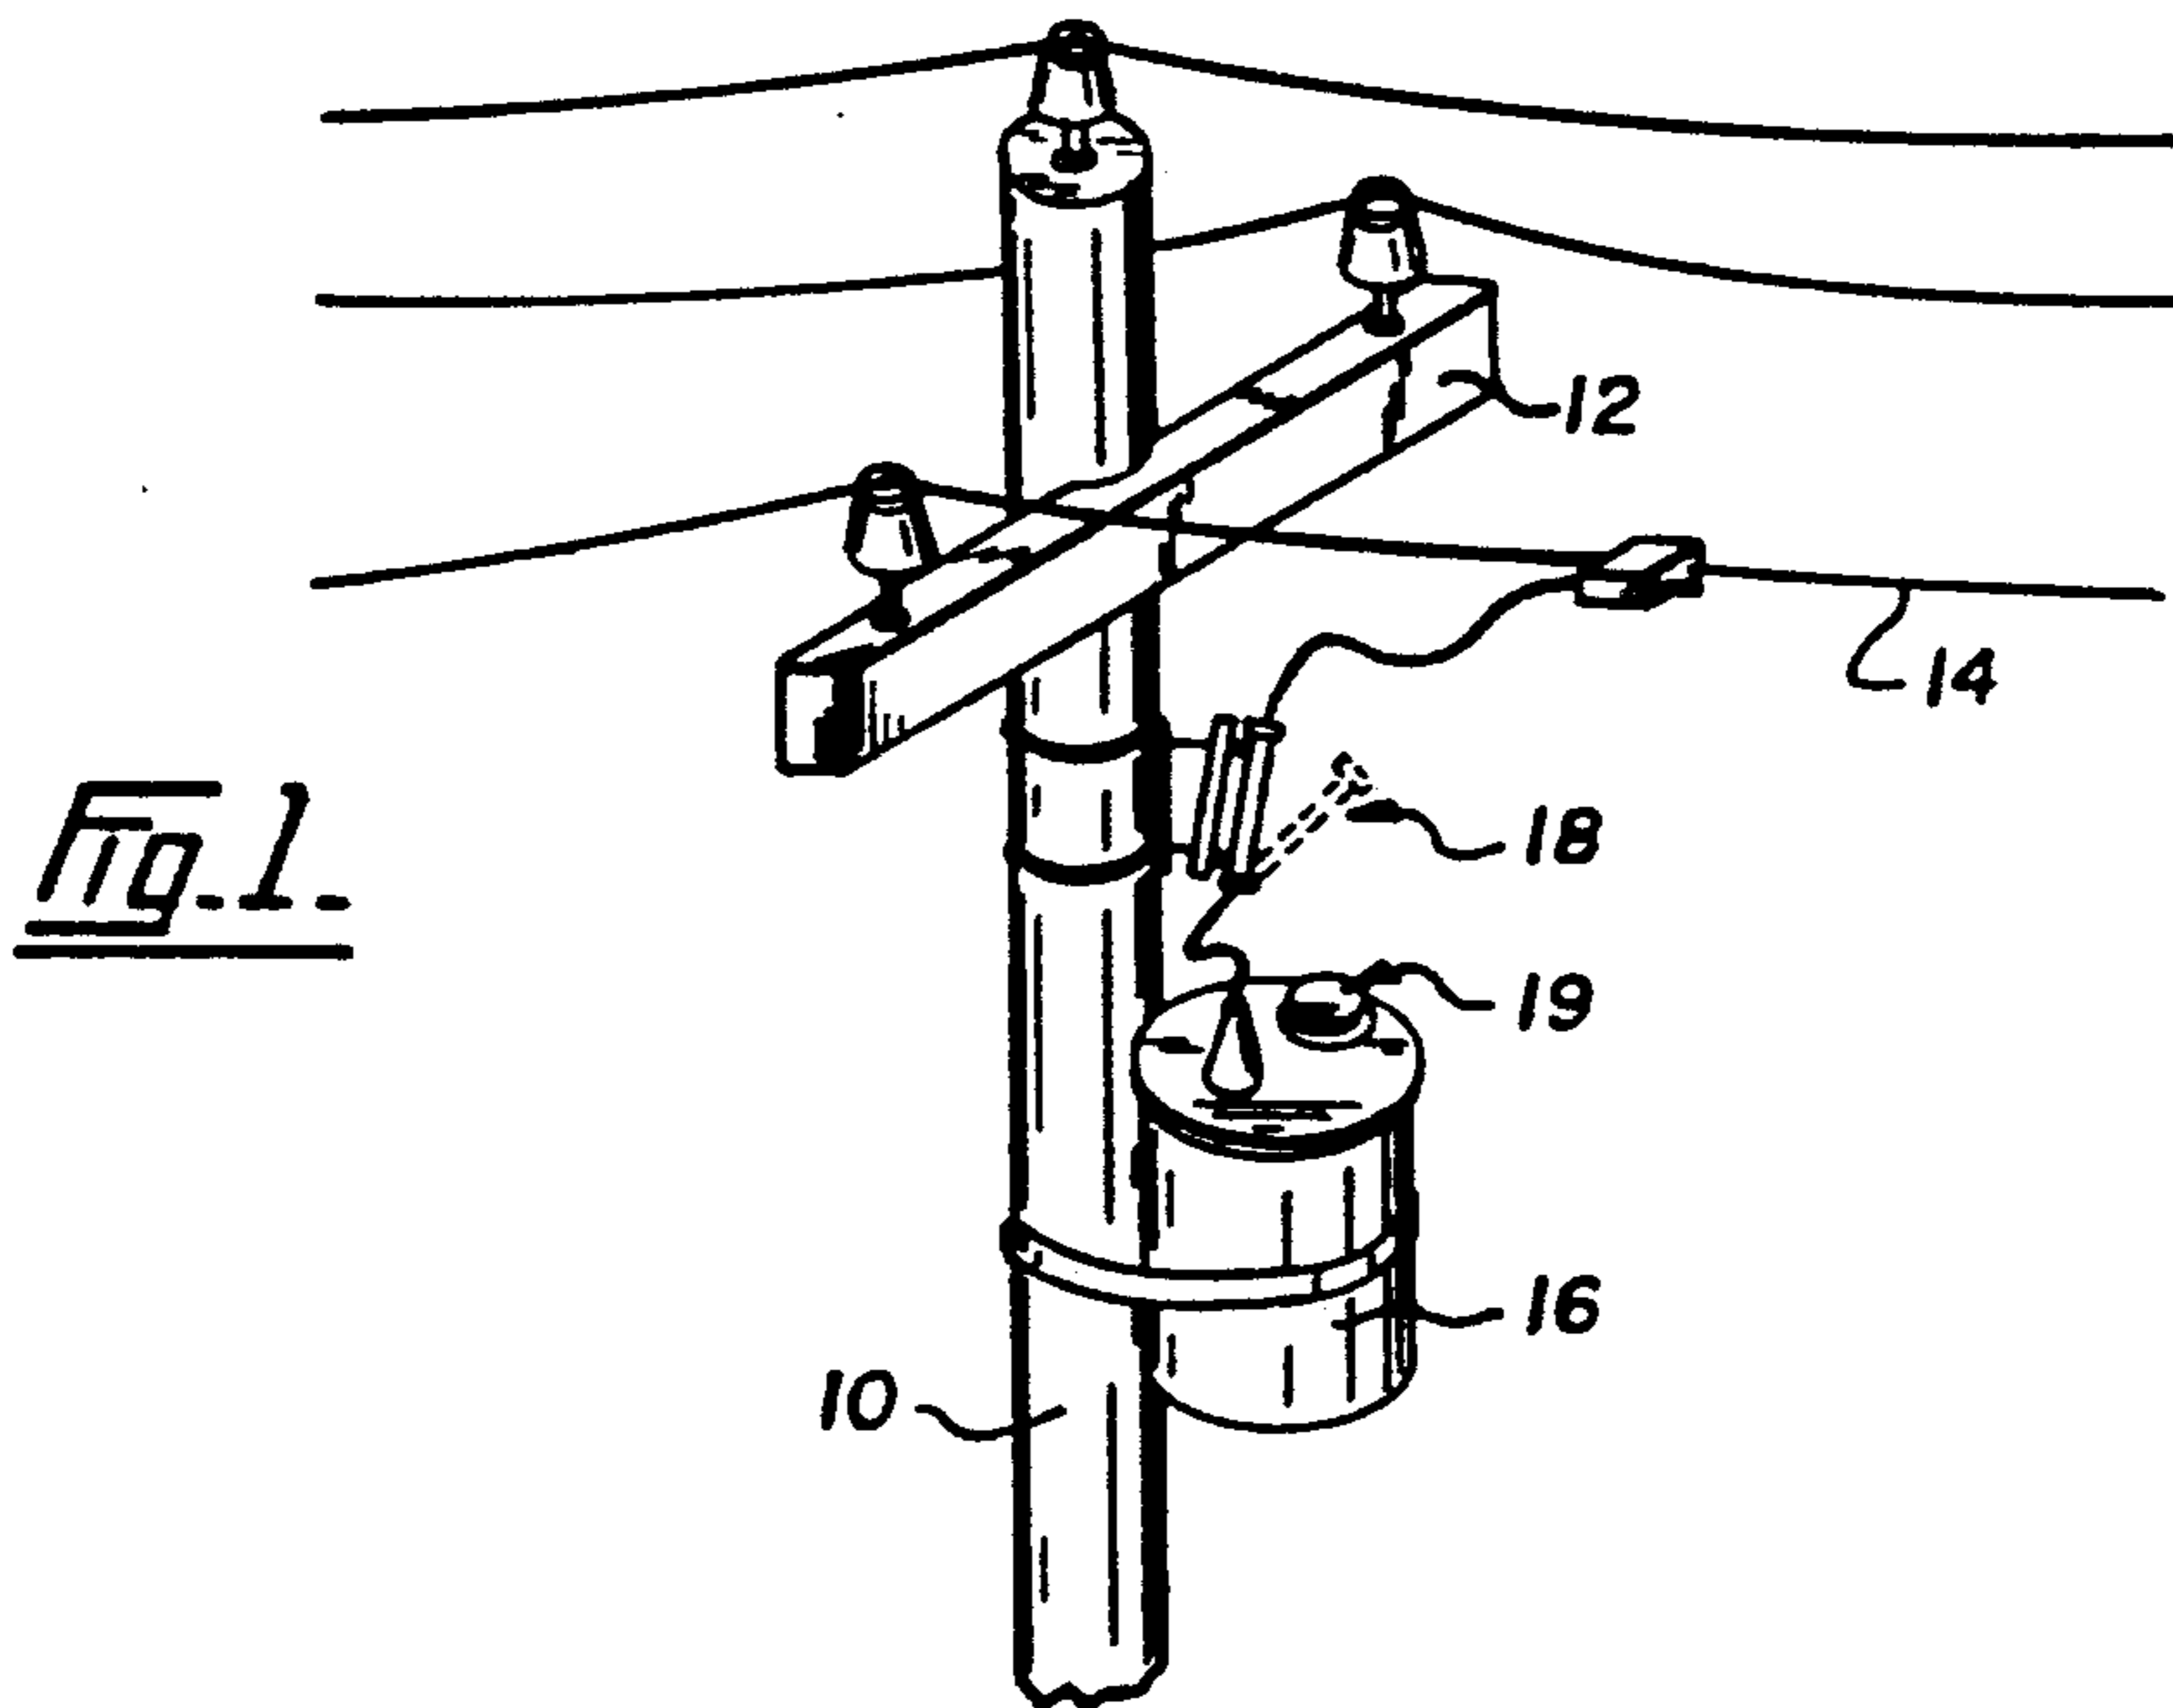
FIG. 1 is an elevational view showing a pole with a transformer mounted thereon.

Referring now to the drawings, FIG. 1 illustrates a distribution pole 10 with a cross piece 12 supporting power lines 14. A transformer 16 is mounted on the pole 10 and is connected via a fused cutout 18 to one of the lines 14. In the event of the fuse tripping, it hinges down as illustrated in FIG. 1 breaking the circuit between the transformer 16 and the line 14.

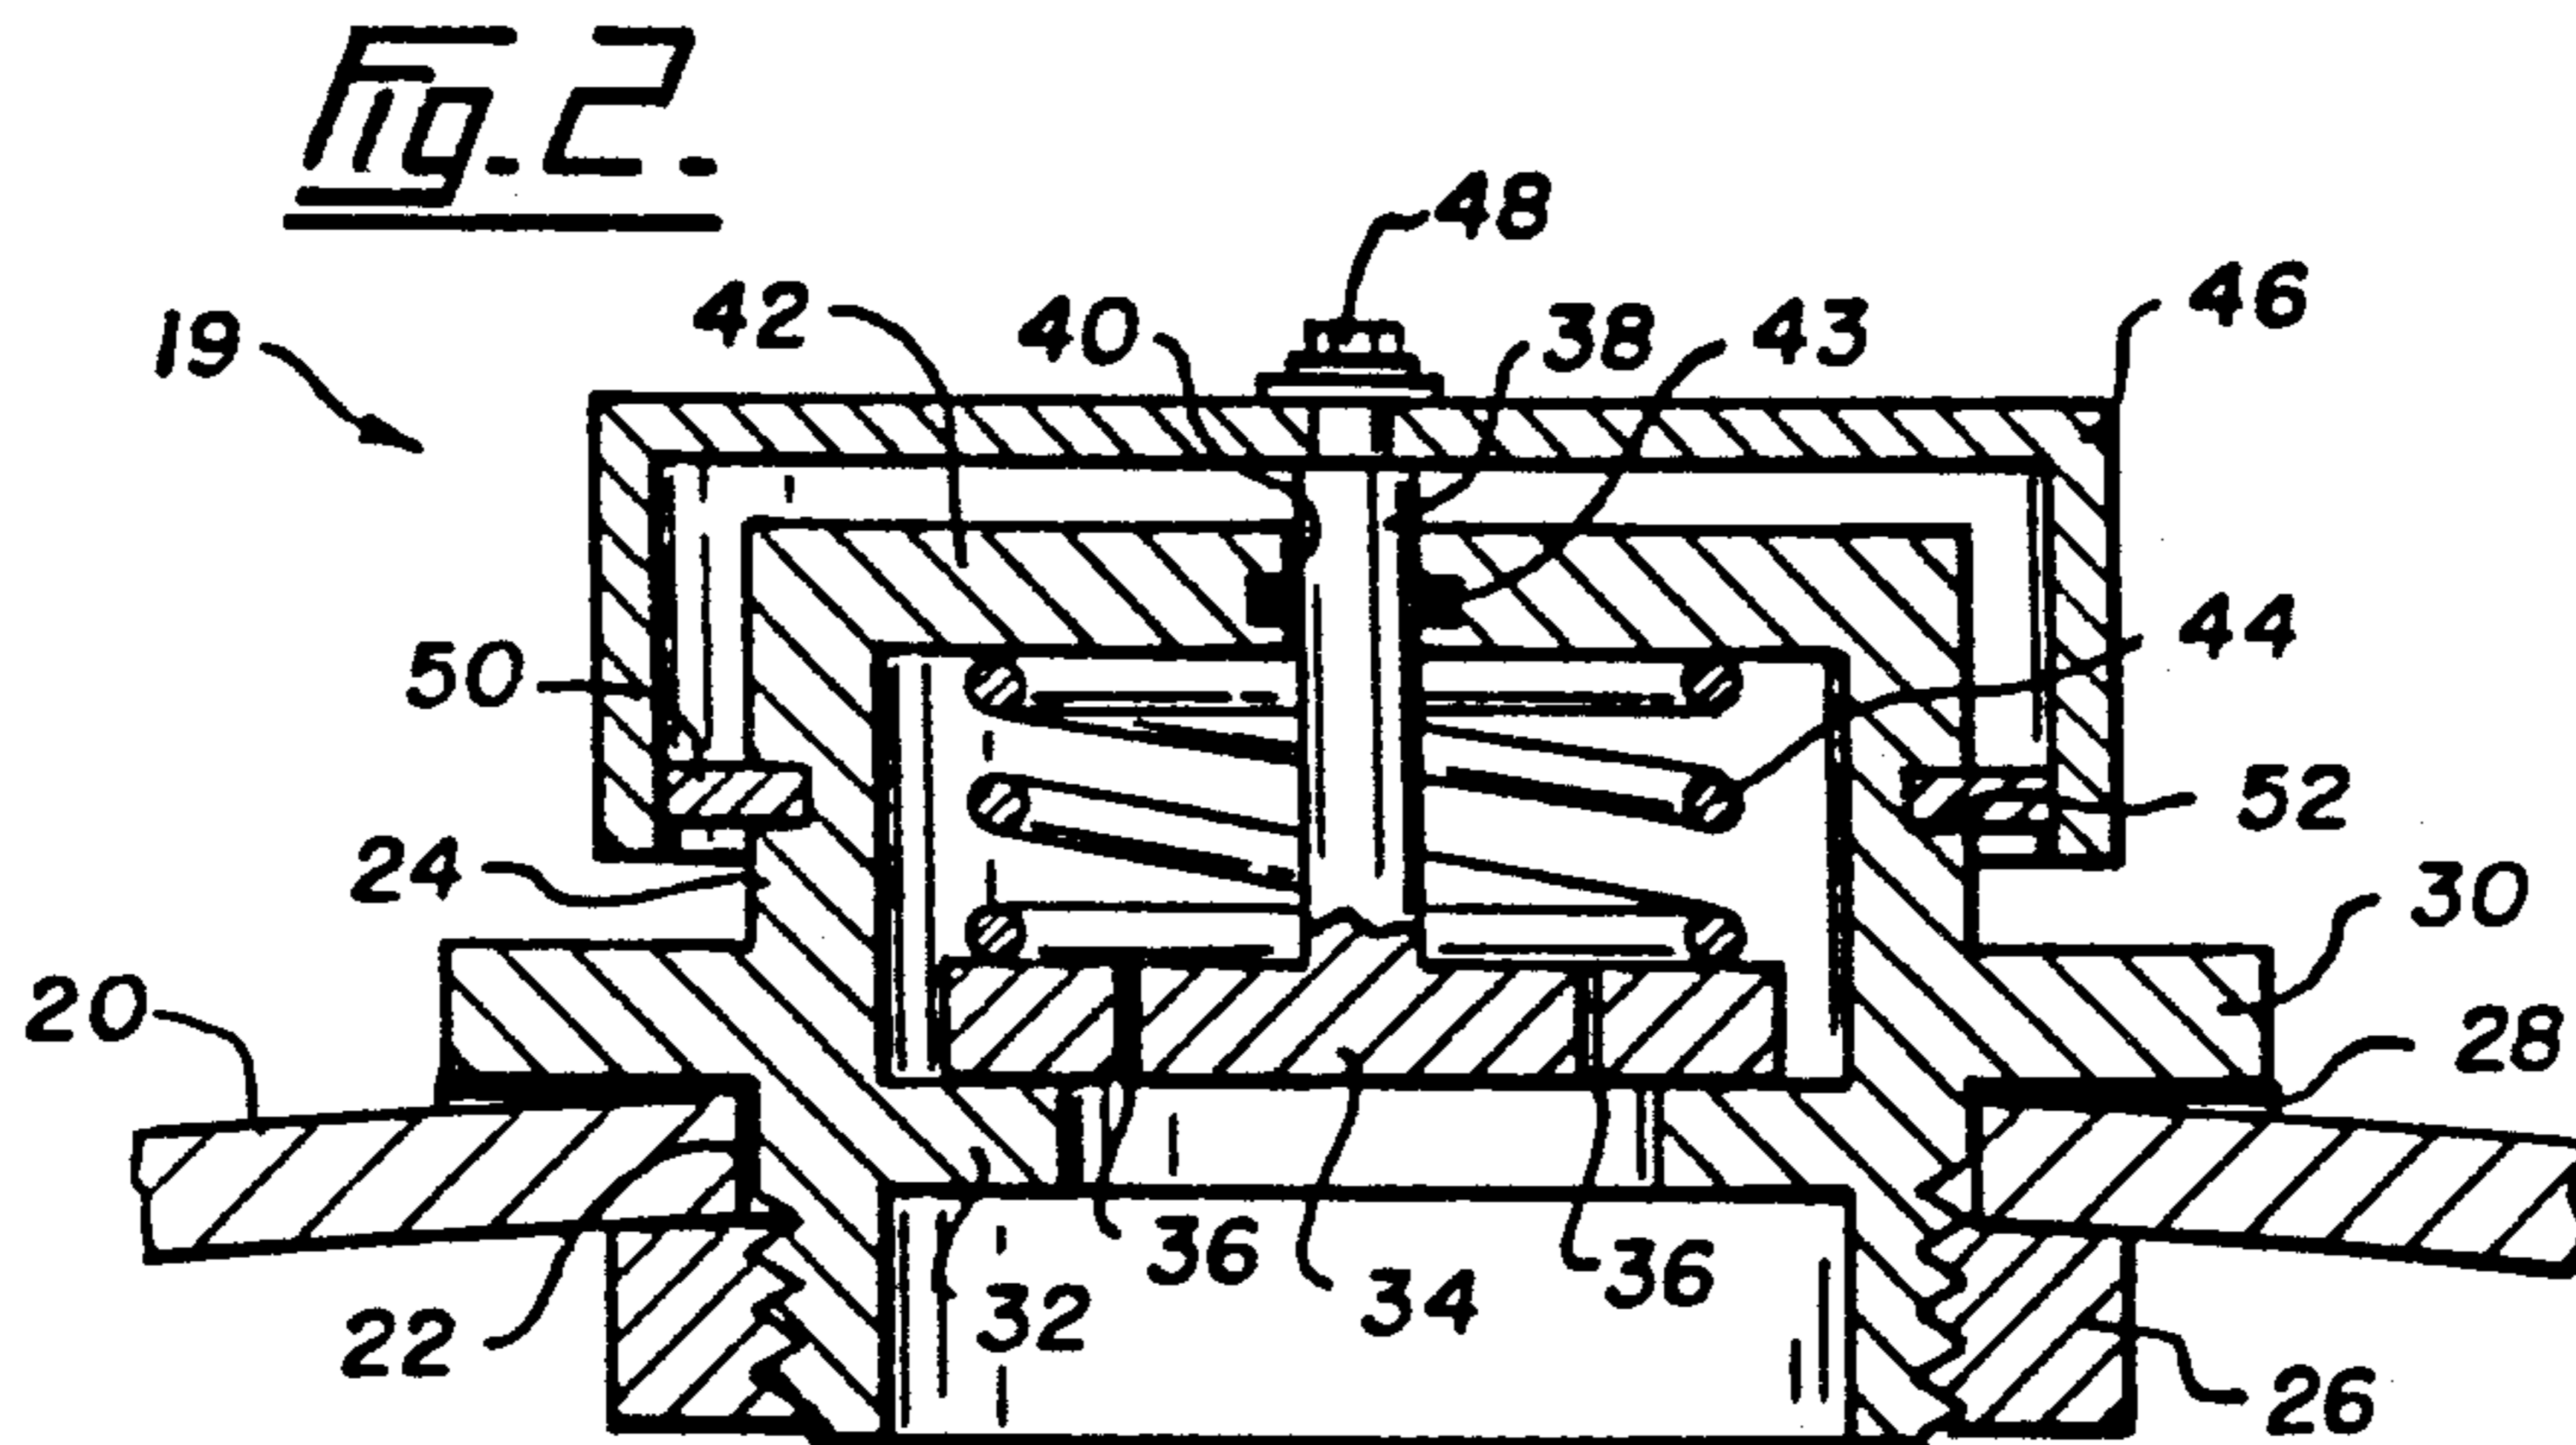
FIG. 2 is a detailed sectional view of an indicator for a transformer according to one embodiment of the present invention showing no arcing fault has occurred in the transformer.

As shown in FIG. 2, the transformer 16 has a casing 20 which encloses the transformer, and has an indicator 19 which fits into an opening 22 at the top of the casing 20. The indicator 19 has a flanged body member 24 with a lock nut 26 to hold the body member 24 in place. A weatherproof seal 28 is provided between an external flange 30 of the body member 24 and the casing 20. An internal flange 32 within the body member supports a piston 34 with a series of small apertures 36 therein to permit a small flow of gas to pass therethrough sufficient to equalize pressure on both sides of the piston 34. Thus small or slow changes in internal pressure within the casing 20 do not move the piston 34.

The piston 34 has a central stem 38 which extends up through a hole 40 in the cover 42 of the body member 24. A gasket 43 is provided in the hole 40 to prevent outside air entering the cover 42 and consequently entering the transformer. Outside air may have moisture therein which should not enter the transformer casing 20. A coiled spring 44 is positioned about the stem 38 between the piston 34 and the cover 42. The spring retains the piston 34 in position on the internal flange 32 of the body member 24.

On top of the stem 38 above the body member 24, a cup member 46 is provided attached to the stem by a bolt 48. The side or skirt of the cup member 46 extends down over the body member 24 and retains an indicator ring clip 50 in a groove 52 in the body member 24.

Whereas a spring 44 is shown herein, it will be apparent that a spring is not always essential. The weight of the piston 34, stem 38 and cup member 46 may be sufficient to hold the piston 34 in position. The piston 34 is guided so that a pressure surge in the transformer 16 raises the piston 34 so that the skirt of the cup member 46 is above the ring clip 50. The ring clip 50 springs out and indicates a pressure surge has occurred.

Because of the small apertures 36 in the piston 34, any increase or decrease in pressure in the casing 20 that may occur for a variety of reasons such as heating or cooling of the transformer in different weather conditions does not cause the piston 34 to move far enough for the skirt of the cup member 46 to expose the ring clip 50.

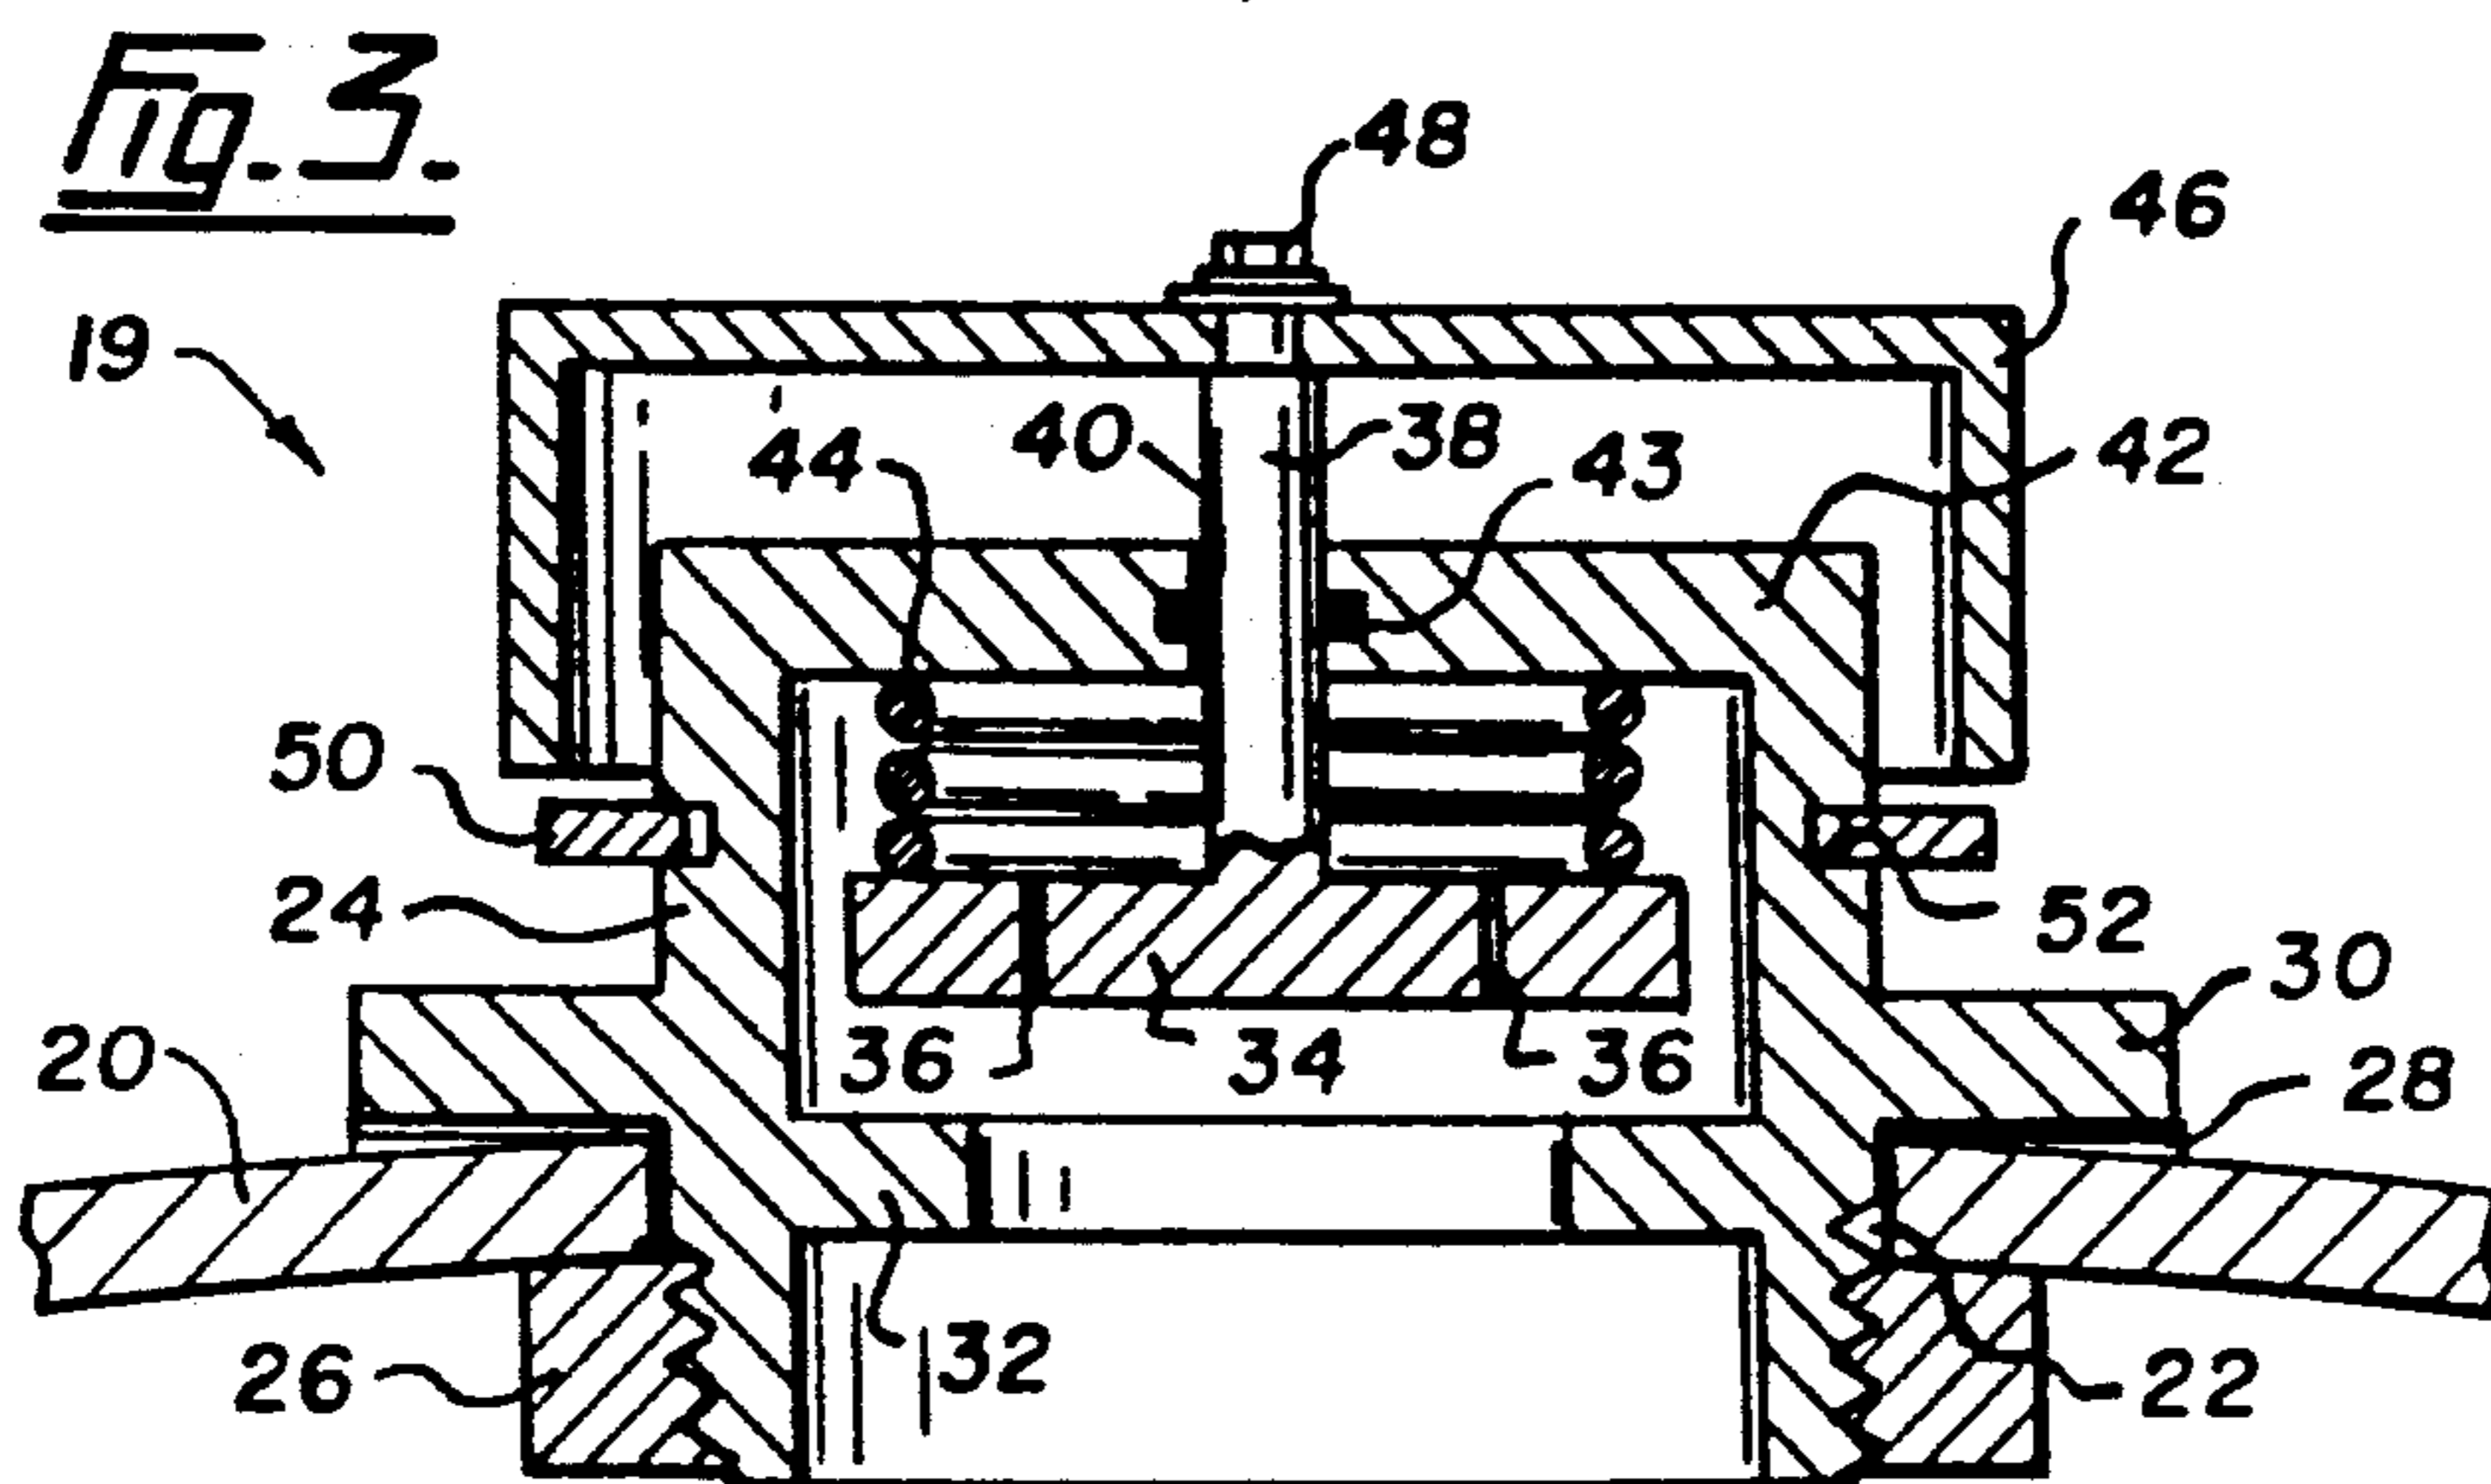
FIG. 3 is a detailed sectional view of the indicator shown in FIG. 2 which has tripped to show an arcing fault has occurred.

When the cup member 46 rises up above the ring clip 50, then the clip 50 opens out, as can be seen in FIG. 3, and prevents the cup member 46 from dropping back

over the ring clip 50. The ring clip is brightly colored, such as a red color, so that it is clearly visible when the indicator has tripped. A lineman sees this ring clip when an external inspection occurs and immediately is aware that there has been a pressure surge in the transformer.

In operation, when there is an internal arcing fault within the transformer 16 a rapid increase in pressure results and the small apertures 36 in the piston 34 are not large enough to admit the sudden release of gas to balance the pressure on both sides of the piston 34. Thus, the piston 34 is driven upwards forcing the stem 38 up through the hole 38. The cup member 46 rises to release the spring clip 50, and the bright color on the spring clip 50 is visible from the ground. It may well be that the fused cutout 18 has also operated or the casing of the transformer has bulged which can clearly be seen by a lineman. However as soon as he sees the colored ring clip 50, he knows there had been a pressure surge in the transformer 16. If he sees the colored ring clip 50, then he knows that the fault is in the transformer, and he would not reset the fused cutout 18 until the transformer has been replaced.
