# United States Patent [19] Cuk

[11] Patent Number: **5,078,078**  
[45] Date of Patent: **Jan. 7, 1992**

## TRANSFORMER INTERNAL FAULT WARNING INDICATOR

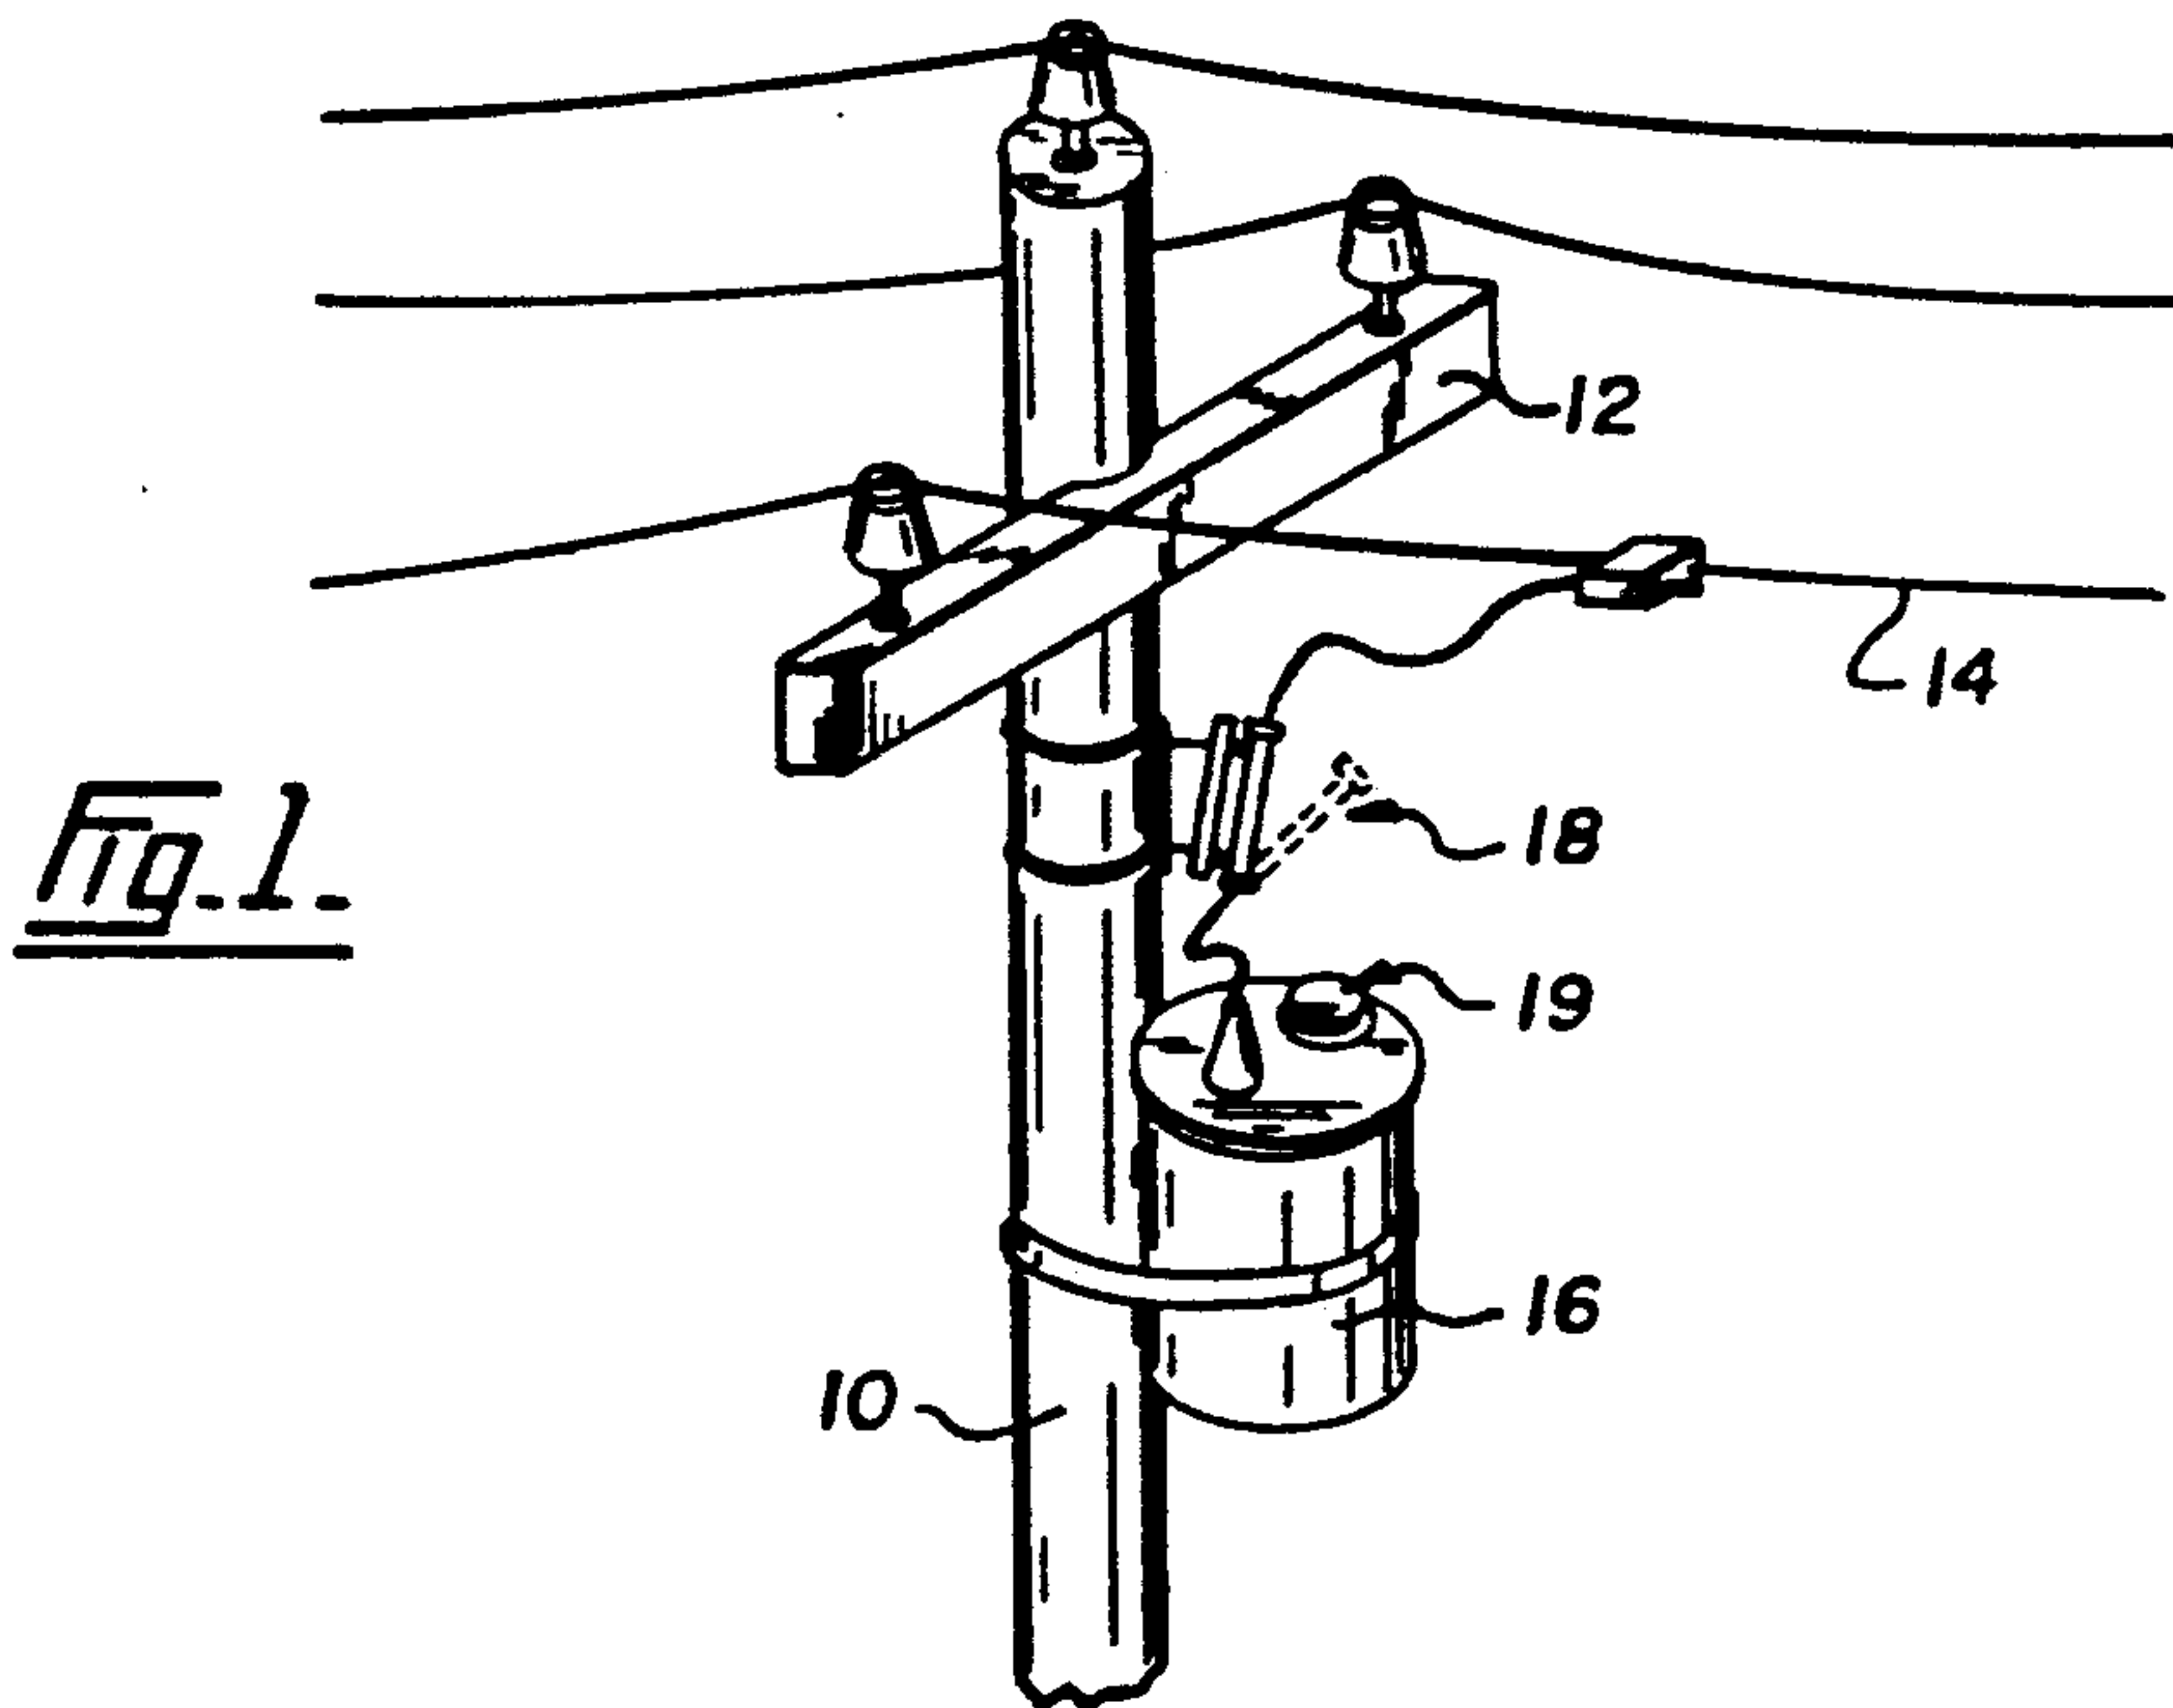
FIG. 1 is an elevational view showing a pole with a transformer mounted thereon.

Referring now to the drawings, FIG. 1 illustrates a distribution pole 10 with a cross piece 12 supporting power lines 14. A transformer 16 is mounted on the pole 10 and is connected via a fused cutout 18 to one of the lines 14. In the event of the fuse tripping, it hinges down as illustrated in FIG. 1 breaking the circuit between the transformer 16 and the line 14.

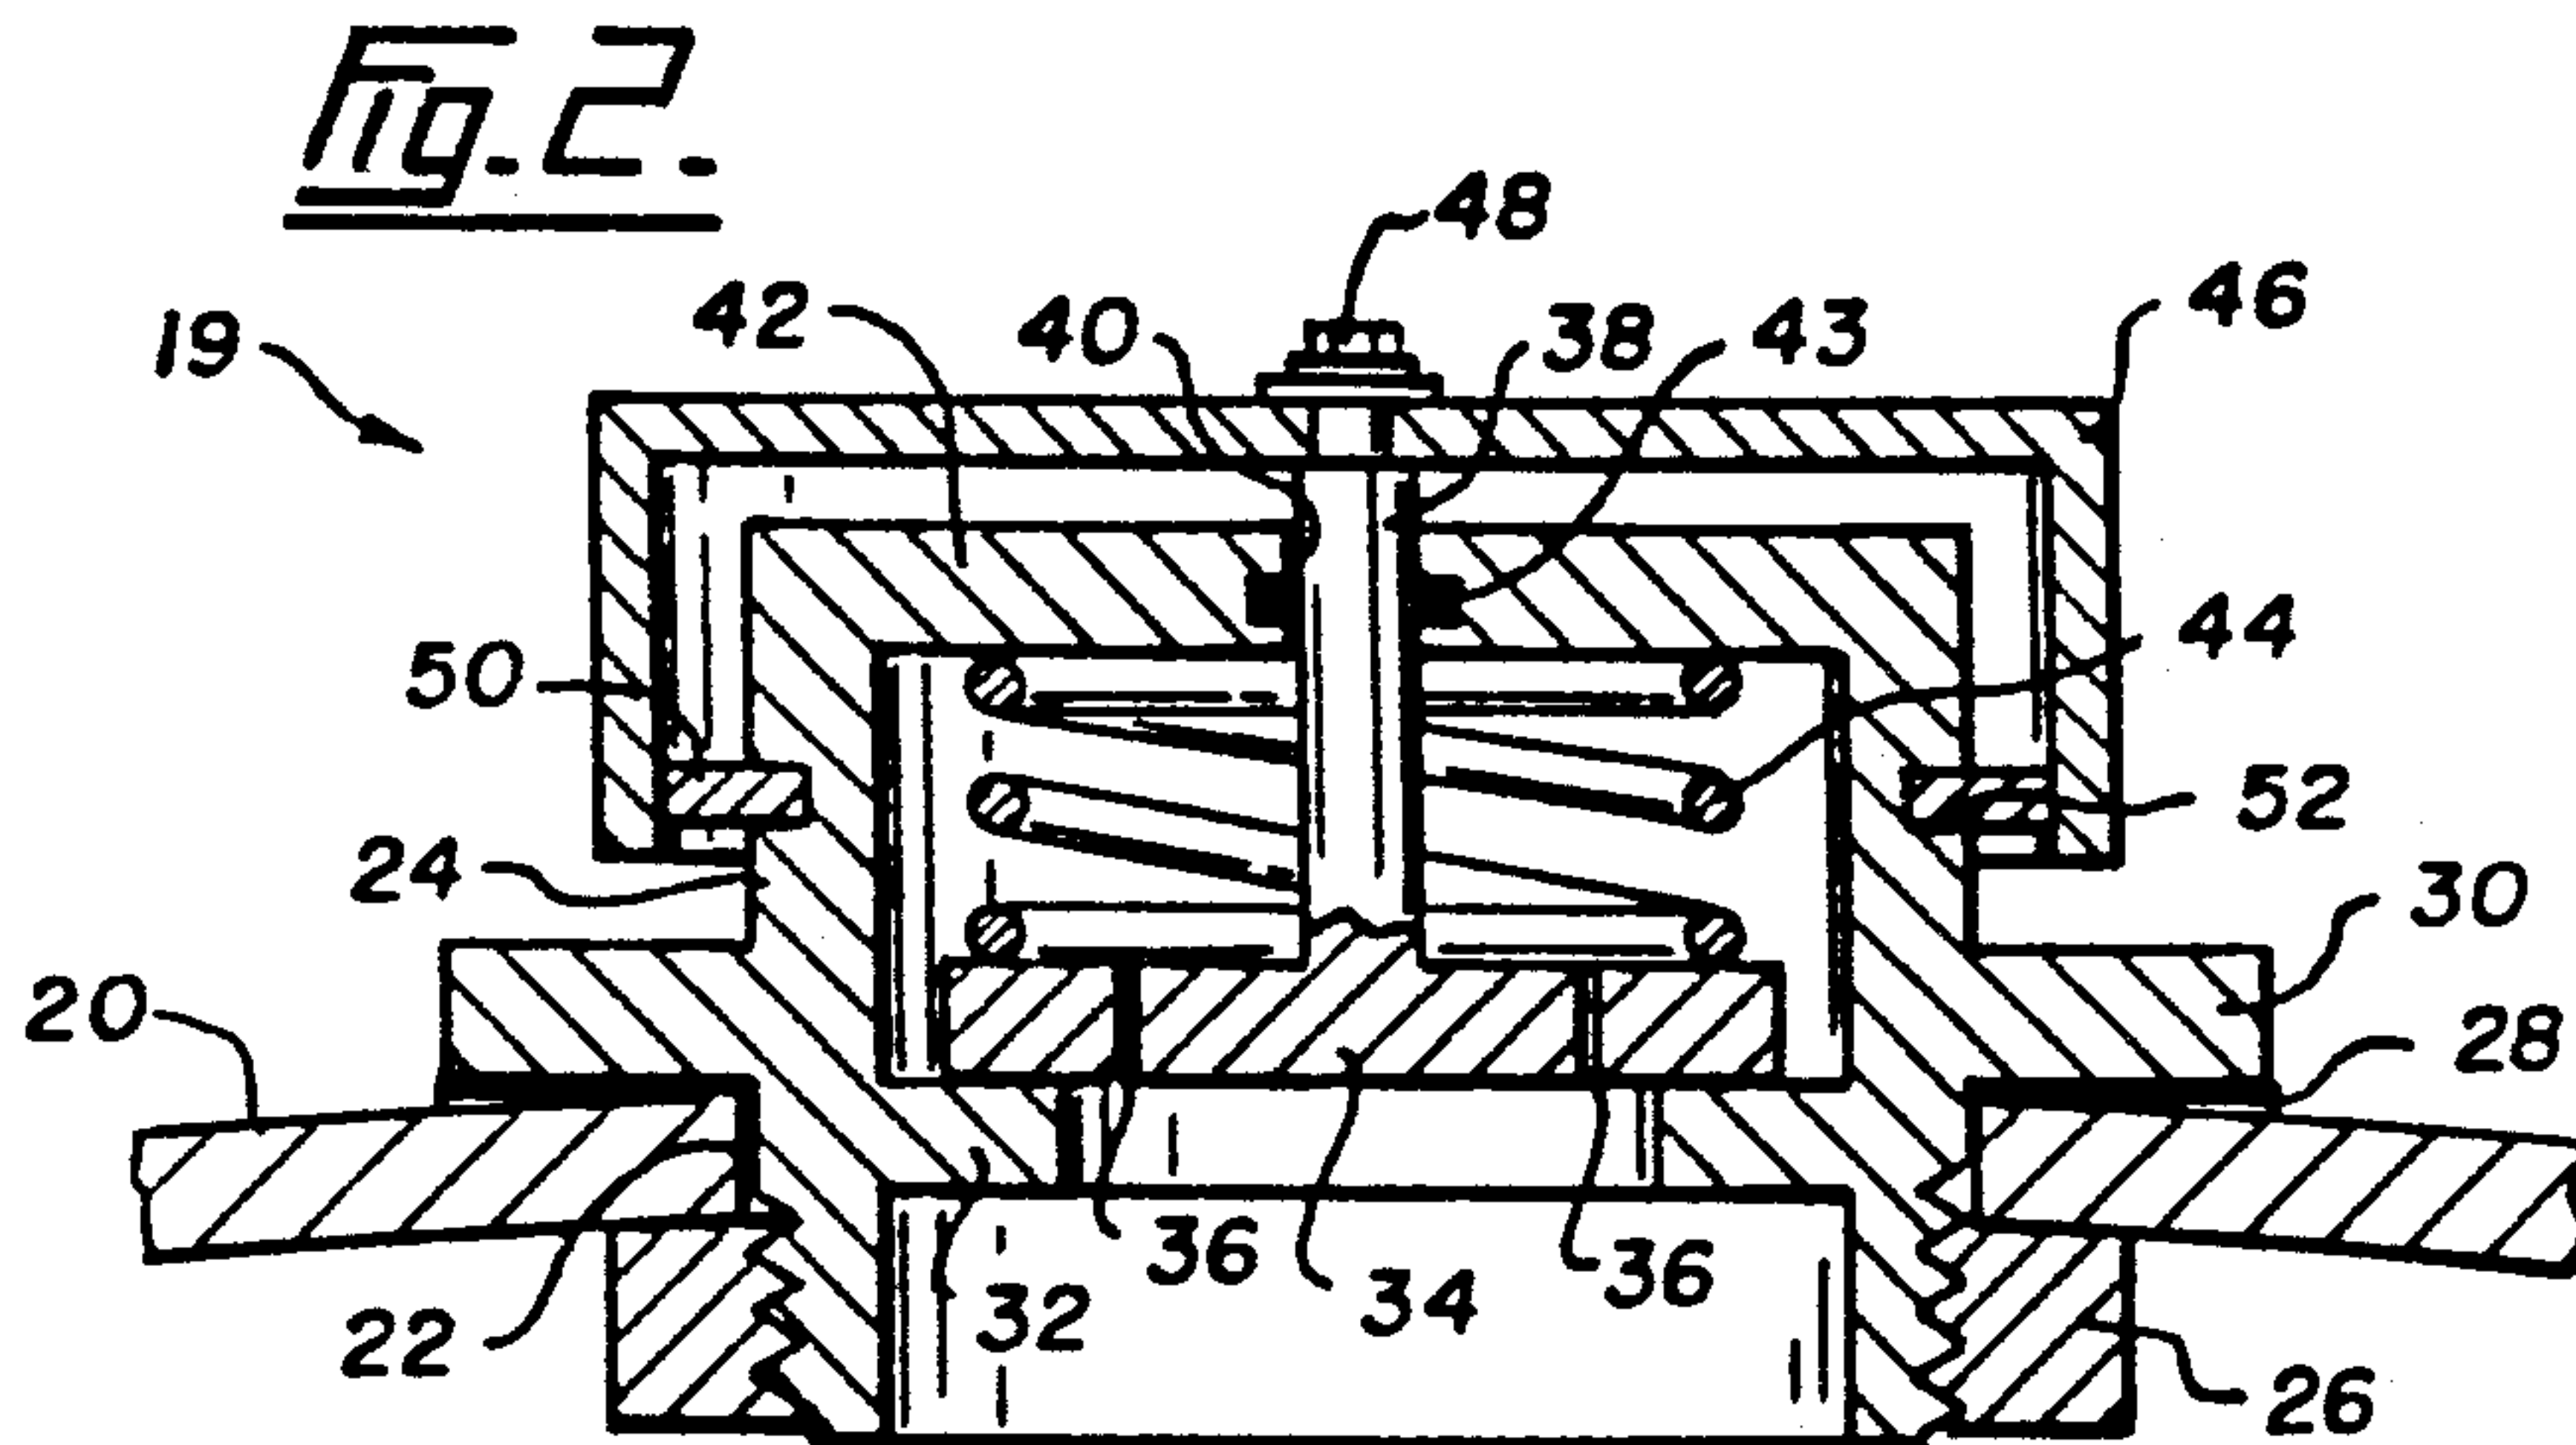
FIG. 2 is a detailed sectional view of an indicator for a transformer according to one embodiment of the present invention showing no arcing fault has occurred in the transformer.

As shown in FIG. 2, the transformer 16 has a casing 20 which encloses the transformer, and has an indicator 19 which fits into an opening 22 at the top of the casing 20. The indicator 19 has a flanged body member 24 with a lock nut 26 to hold the body member 24 in place. A weatherproof seal 28 is provided between an external flange 30 of the body member 24 and the casing 20. An internal flange 32 within the body member supports a piston 34 with a series of small apertures 36 therein to permit a small flow of gas to pass therethrough sufficient to equalize pressure on both sides of the piston 34. Thus small or slow changes in internal pressure within the casing 20 do not move the piston 34.

The piston 34 has a central stem 38 which extends up through a hole 40 in the cover 42 of the body member 24. A gasket 43 is provided in the hole 40 to prevent outside air entering the cover 42 and consequently entering the transformer. Outside air may have moisture therein which should not enter the transformer casing 20. A coiled spring 44 is positioned about the stem 38 between the piston 34 and the cover 42. The spring retains the piston 34 in position on the internal flange 32 of the body member 24.

On top of the stem 38 above the body member 24, a cup member 46 is provided attached to the stem by a bolt 48. The side or skirt of the cup member 46 extends down over the body member 24 and retains an indicator ring clip 50 in a groove 52 in the body member 24.

Whereas a spring 44 is shown herein, it will be apparent that a spring is not always essential. The weight of the piston 34, stem 38 and cup member 46 may be sufficient to hold the piston 34 in position. The piston 34 is guided so that a pressure surge in the transformer 16 raises the piston 34 so that the skirt of the cup member 46 is above the ring clip 50. The ring clip 50 springs out and indicates a pressure surge has occurred.

Because of the small apertures 36 in the piston 34, any increase or decrease in pressure in the casing 20 that may occur for a variety of reasons such as heating or cooling of the transformer in different weather conditions does not cause the piston 34 to move far enough for the skirt of the cup member 46 to expose the ring clip 50.

In operation, when there is an internal arcing fault within the transformer 16 a rapid increase in pressure results and the small apertures 36 in the piston 34 are not large enough to admit the sudden release of gas to balance the pressure on both sides of the piston 34. Thus, the piston 34 is driven upwards forcing the stem 38 up through the hole 38. The cup member 46 rises to release the spring clip 50, and the bright color on the spring clip 50 is visible from the ground. It may well be that the fused cutout 18 has also operated or the casing of the transformer has bulged which can clearly be seen by a lineman. However as soon as he sees the colored ring clip 50, he knows there had been a pressure surge in the transformer 16. If he sees the colored ring clip 50, then he knows that the fault is in the transformer, and he would not reset the fused cutout 18 until the transformer has been replaced.

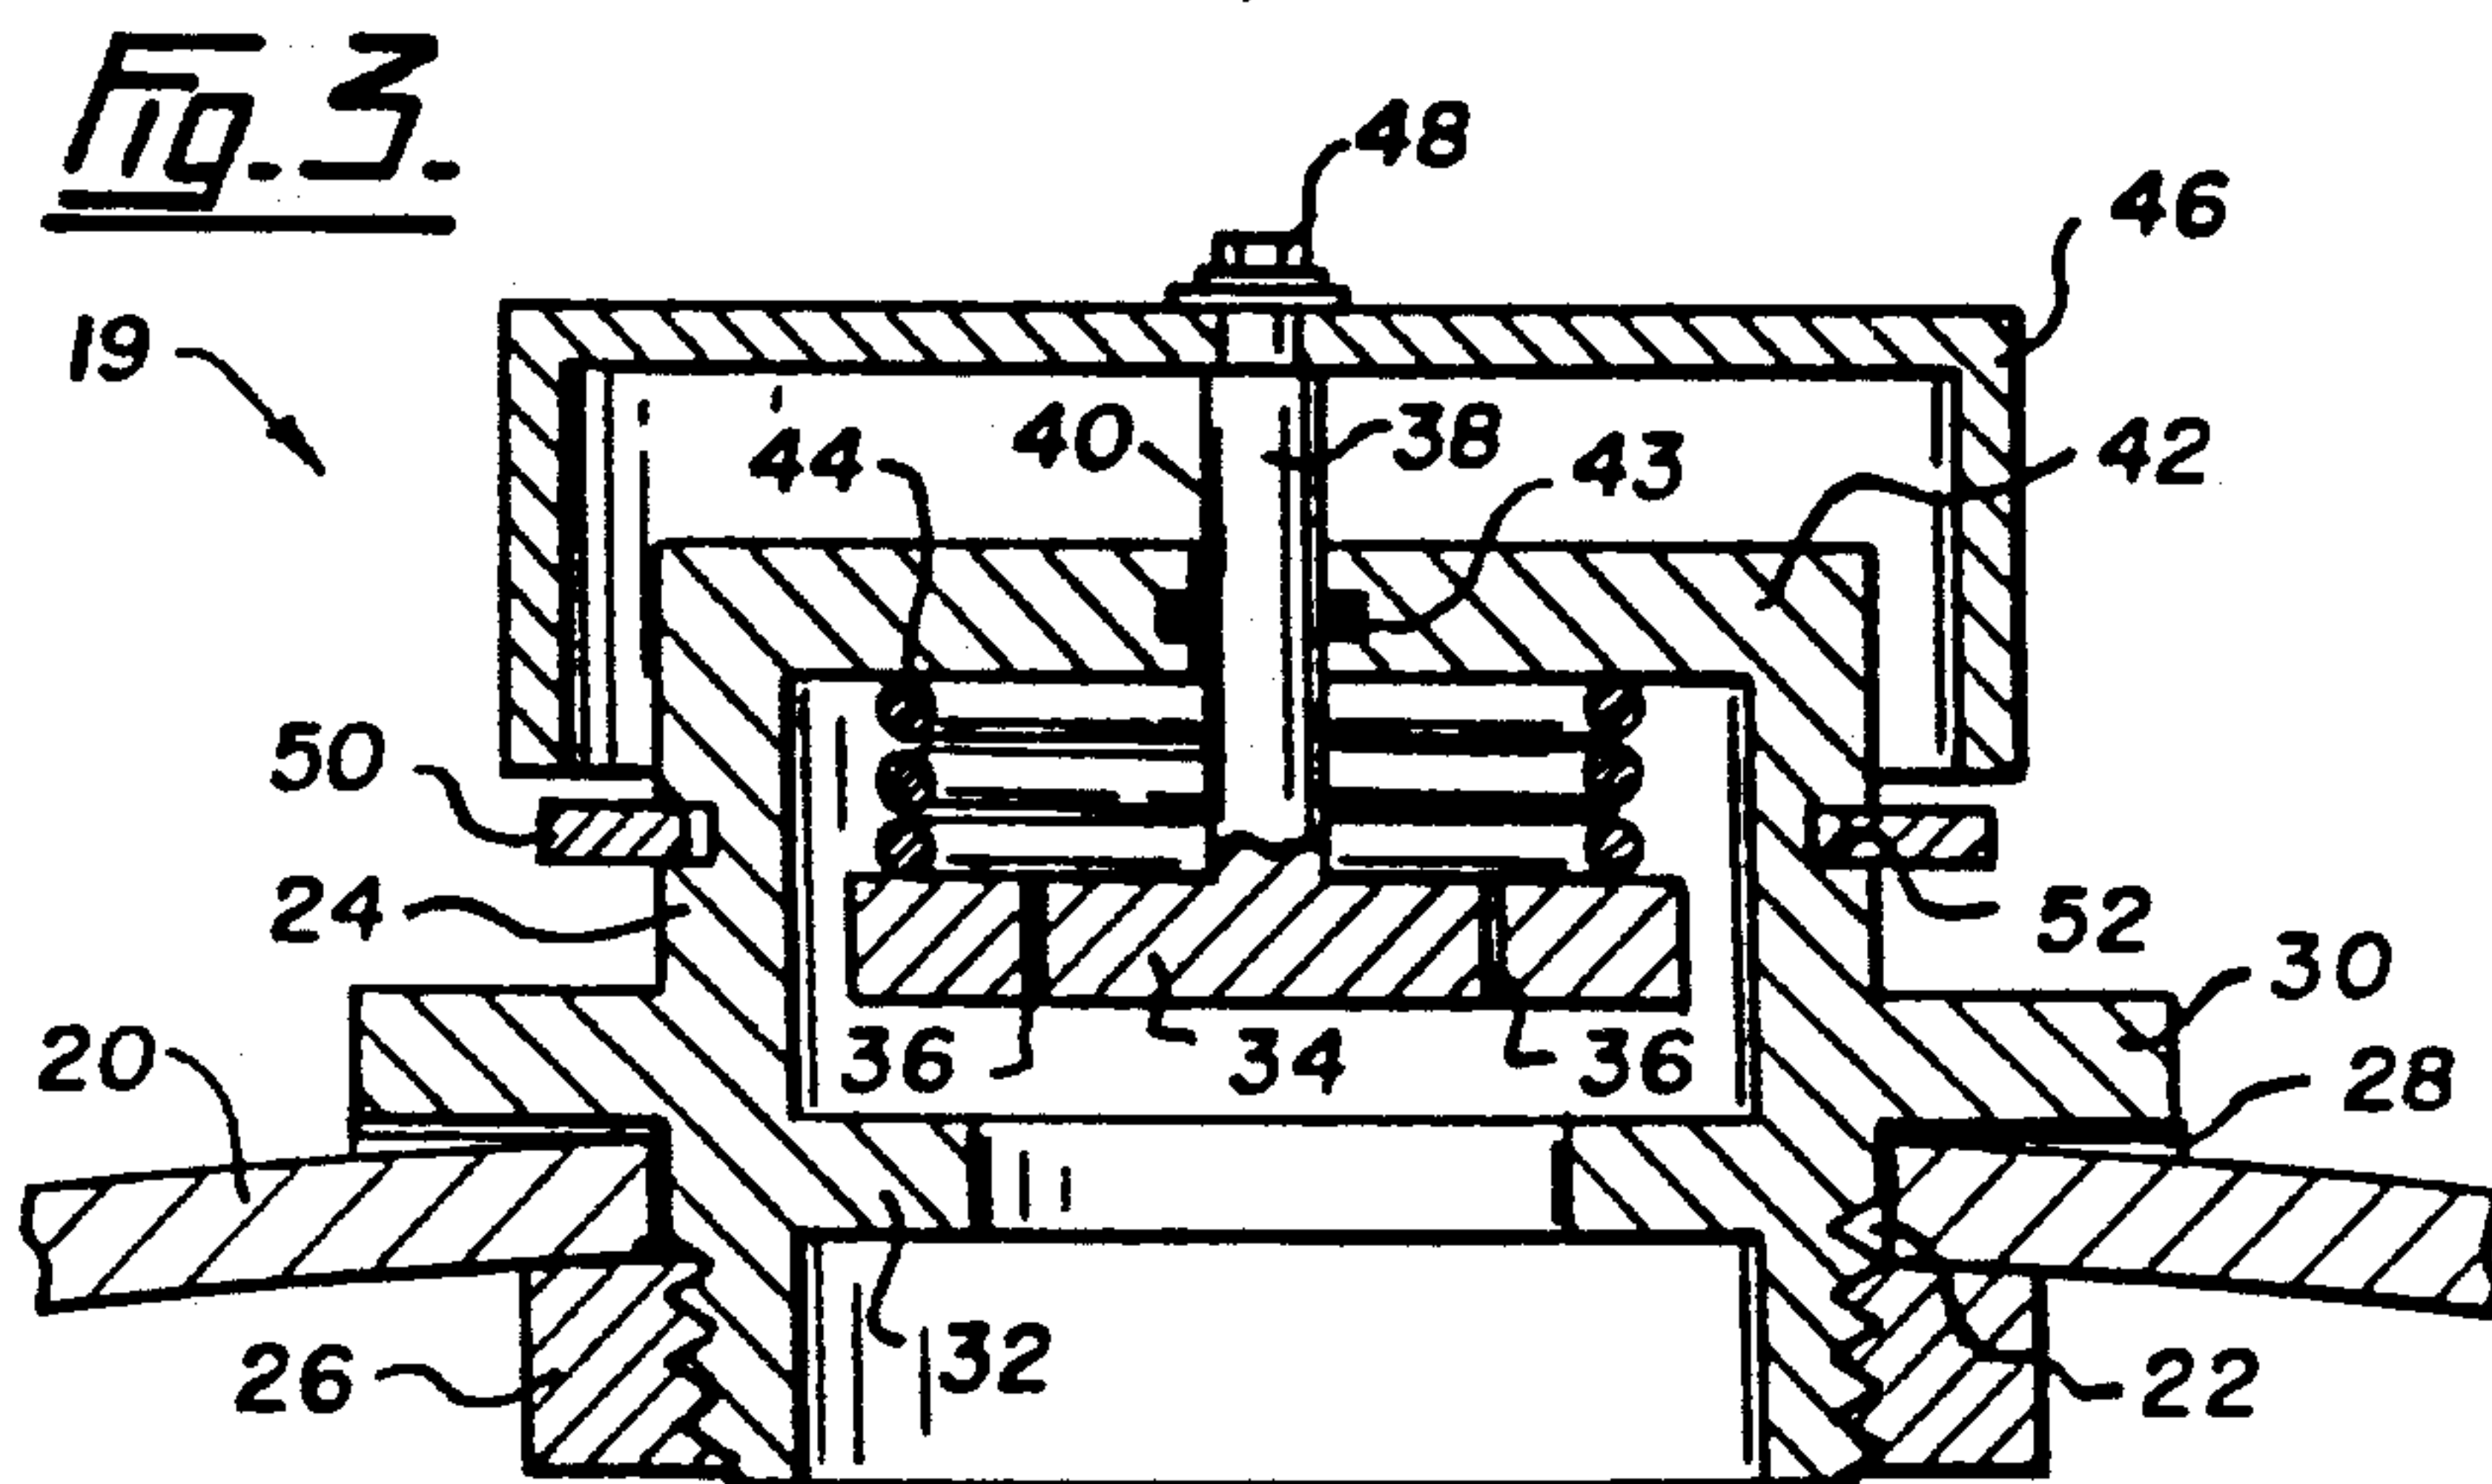
FIG. 3 is a detailed sectional view of the indicator shown in FIG. 2 which has tripped to show an arcing fault has occurred.

When the cup member 46 rises up above the ring clip 50, then the clip 50 opens out, as can be seen in FIG. 3, and prevents the cup member 46 from dropping back

over the ring clip 50. The ring clip is brightly colored, such as a red color, so that it is clearly visible when the indicator has tripped. A lineman sees this ring clip when an external inspection occurs and immediately is aware that there has been a pressure surge in the transformer.
