[11] Patent Number: **5,078,078**
[45] Date of Patent: **Jan. 7, 1992**

- [54] **TRANSFORMER INTERNAL FAULT WARNING INDICATOR**
- [75] Inventor: **Nikola Cuk**, North Vancouver, Canada
- [73] Assignee: **Powertech Labs Inc.**, Canada
- [21] Appl. No.: **631,547**
- [22] Filed: **Dec. 21, 1990**
- [51] Int. Cl.⁵ **G01L 19/12; G08B 5/18; H01H 9/50**
- [52] U.S. Cl. **116/272; 116/266; 361/37**
- [58] Field of Search **116/218, 220, 266, 268, 116/270, 272, 283; 73/744; 361/37; 340/646**

TRANSFORMER INTERNAL FAULT WARNING INDICATOR

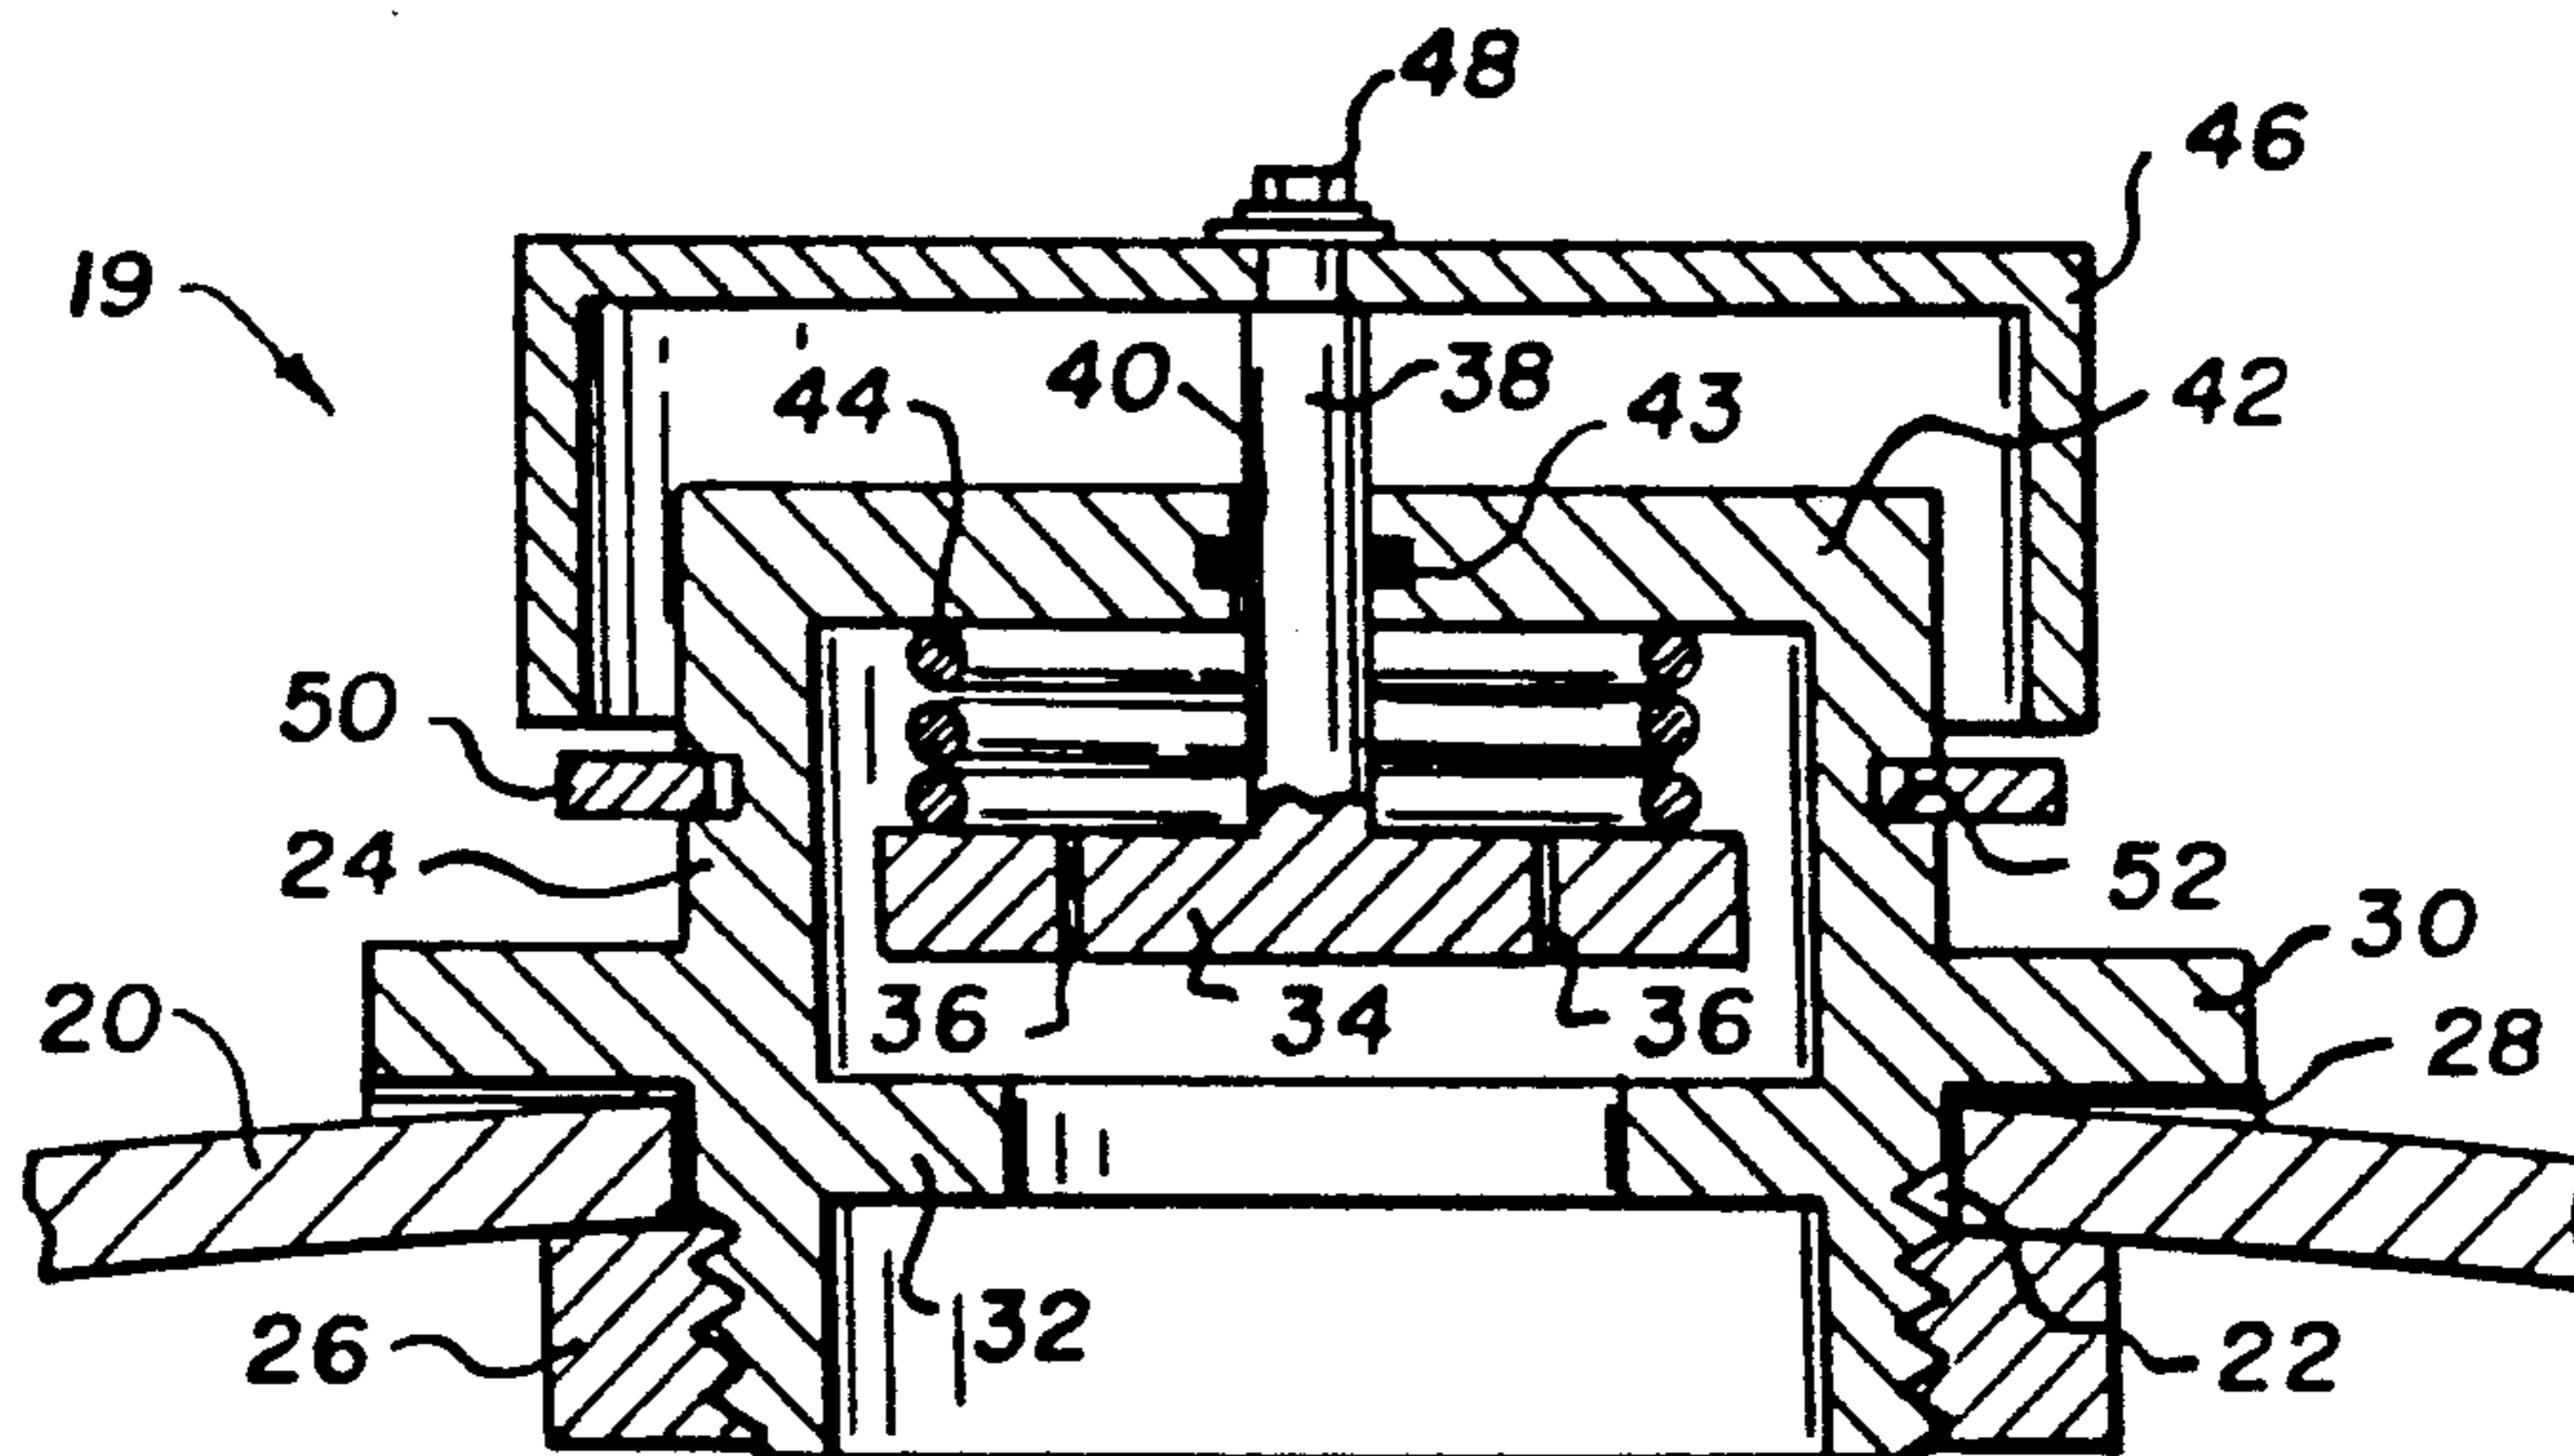
A warning indicator provides an indication that a transient over-pressure condition has occurred in a transformer. The indicator takes into account small or slow pressure changes and only indicates pressure surges. The internal arcing warning indicator comprises an opening in a casing of a transformer, a movable piston over the opening with a retainer to retain the piston over the opening, the piston having at least one small aperture therein to allow slow increases and decreases of pressure within the transformer without the piston moving, and an indicator attached to the piston, the indicator providing an indication that the piston has moved a predetermined distance and retaining the indication until reset.
