US005188445A

[11] Patent Number: **5,188,445**[45] Date of Patent: **Feb. 23, 1993****[54] VEHICLE HAVING WARNING UNITS
MOUNTED WITHIN HOOD CUTOUTS**

[73] Assignee: **Wheeled Coach Corporation**, Winter Park, Fla.

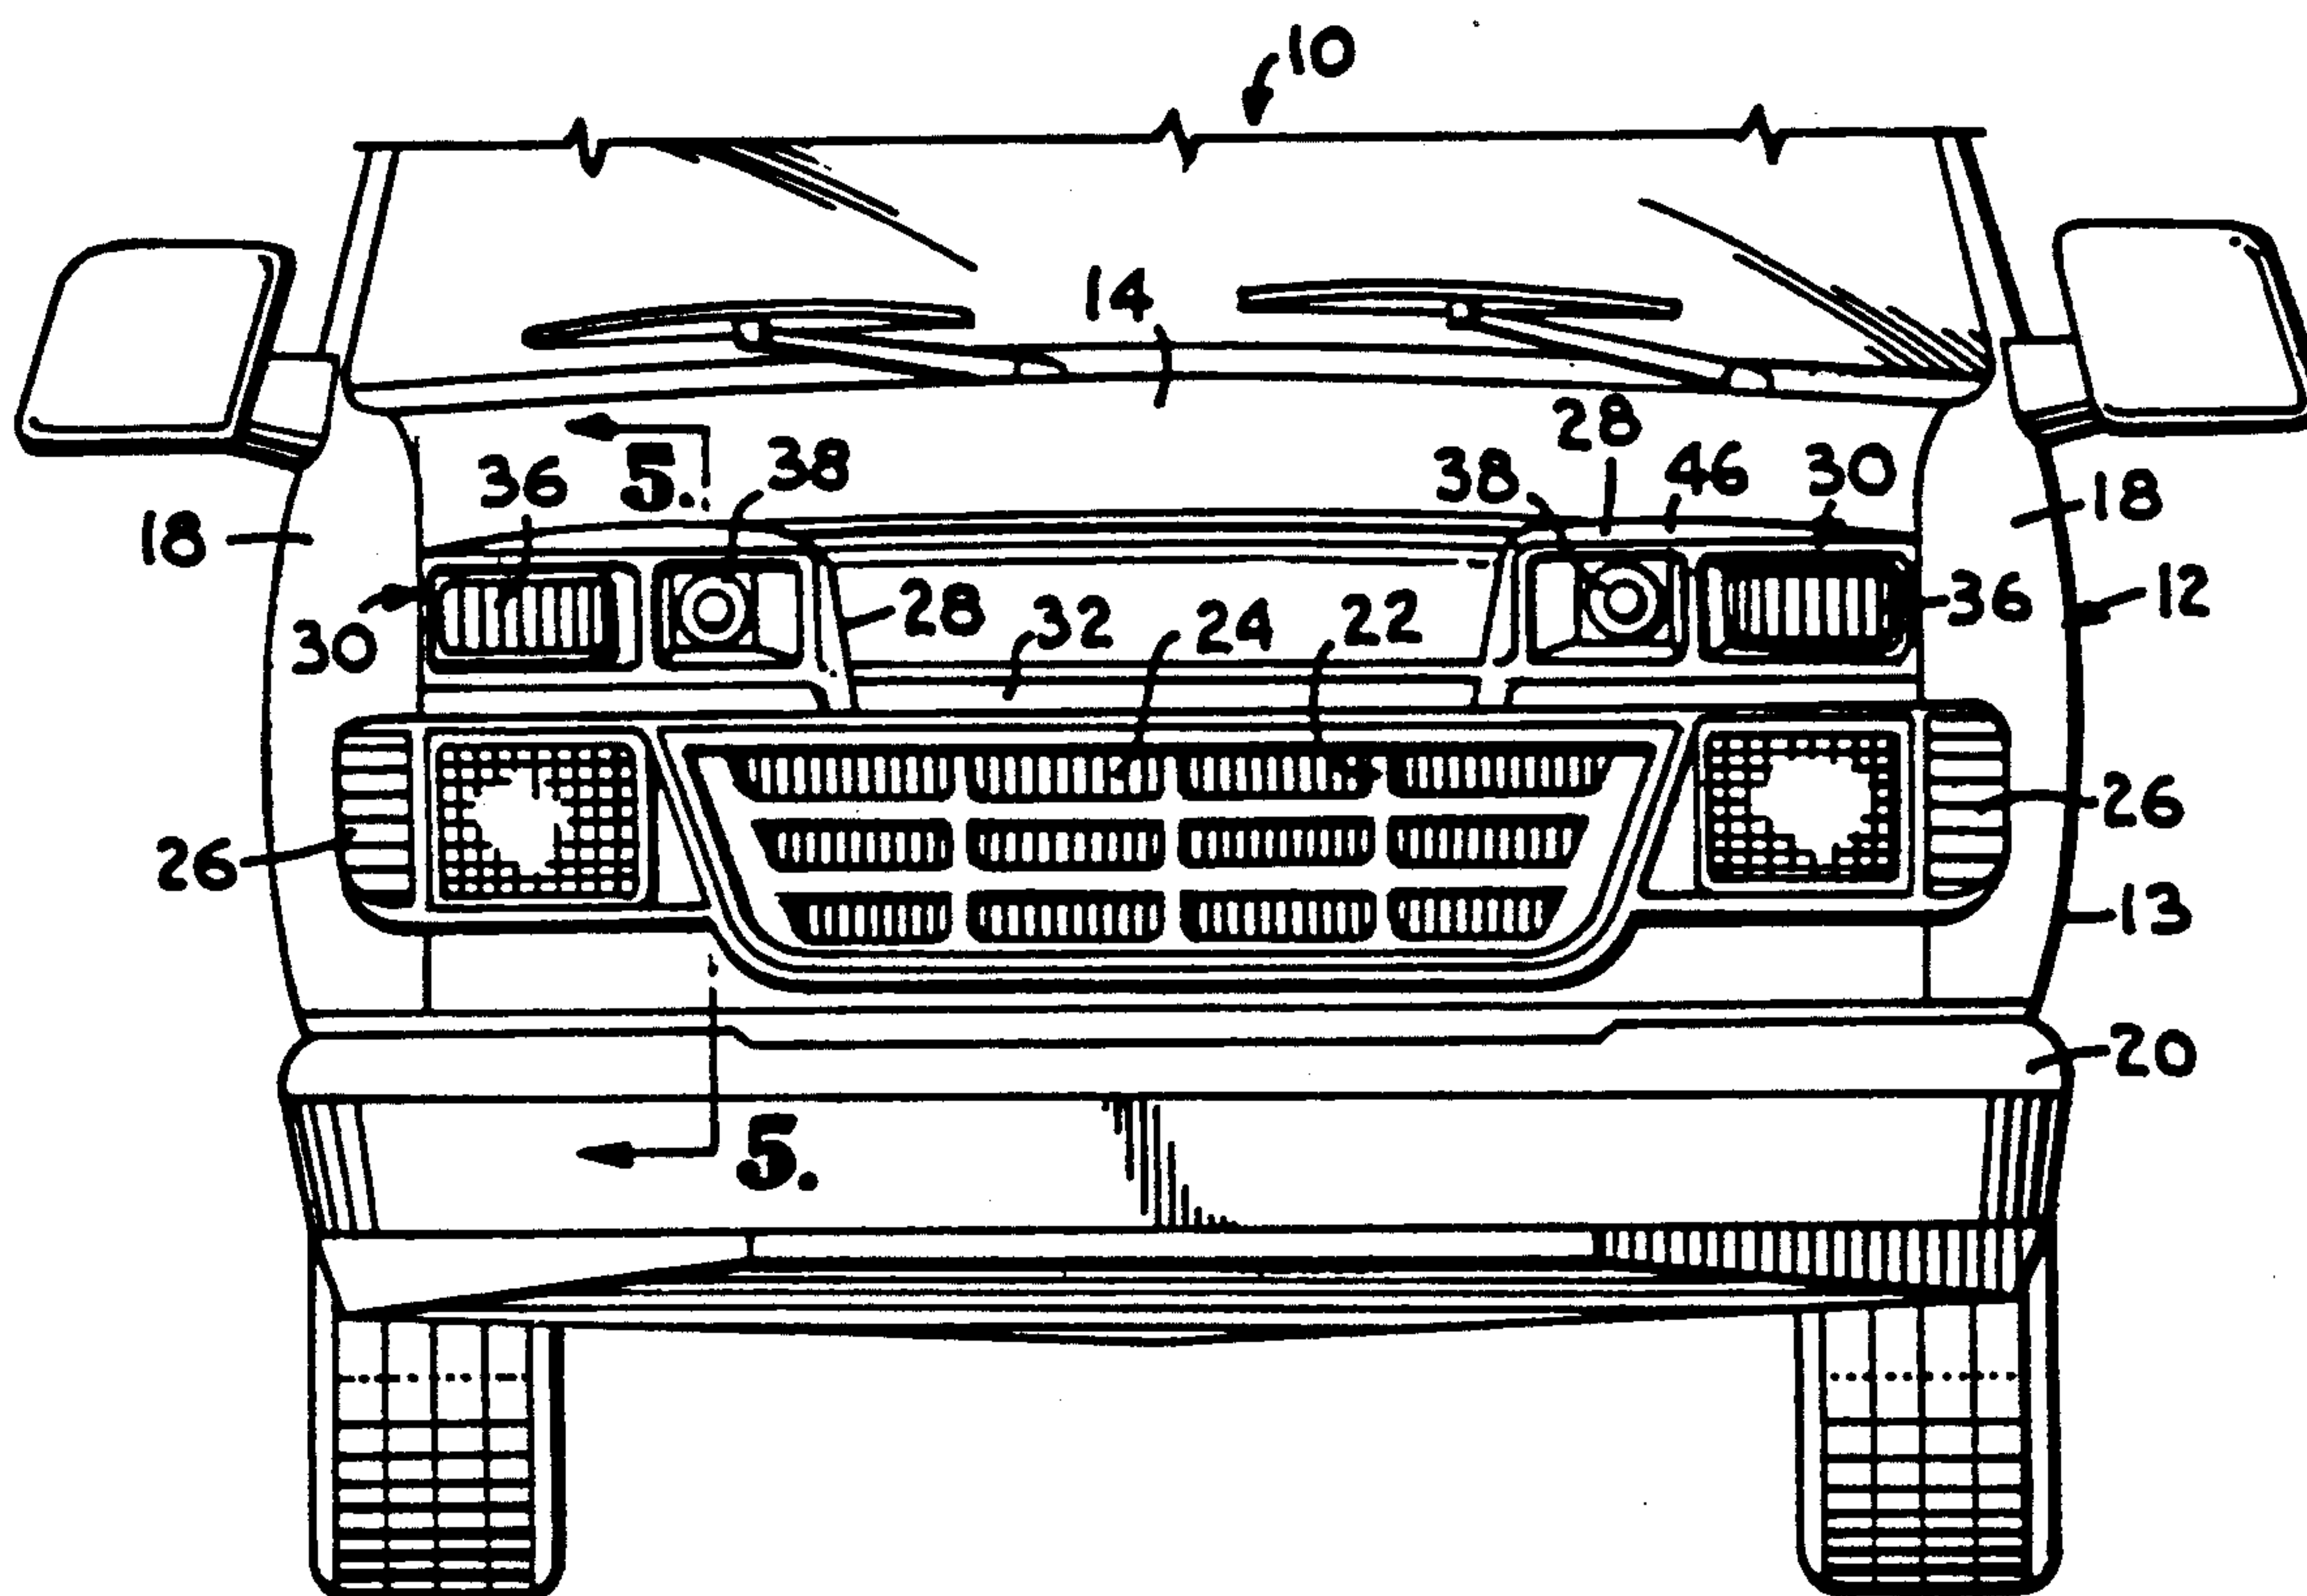
Fig. 1.

FIG. 1 is a fragmentary front elevational view of an emergency vehicle in accordance with the present invention having warning units comprising flashing lights and sirens mounted within cutouts provided in the hood of the vehicle;

In accordance with the present invention, a pair of cutouts 28 are provided in the hood 14 at locations to receive warning units 30. The cutouts 28 are positioned adjacent the fenders 18 and extend upwardly from a lowermost forward edge 32 of the hood 14. A sealing strip 34 (FIG. 5) is provided along the edge of each cutout 28 to cover the sharp edge of the cutout and to provide a seal against the associated warning unit 30. The lateral positioning of the cutouts 28 may of course be varied from that illustrated.

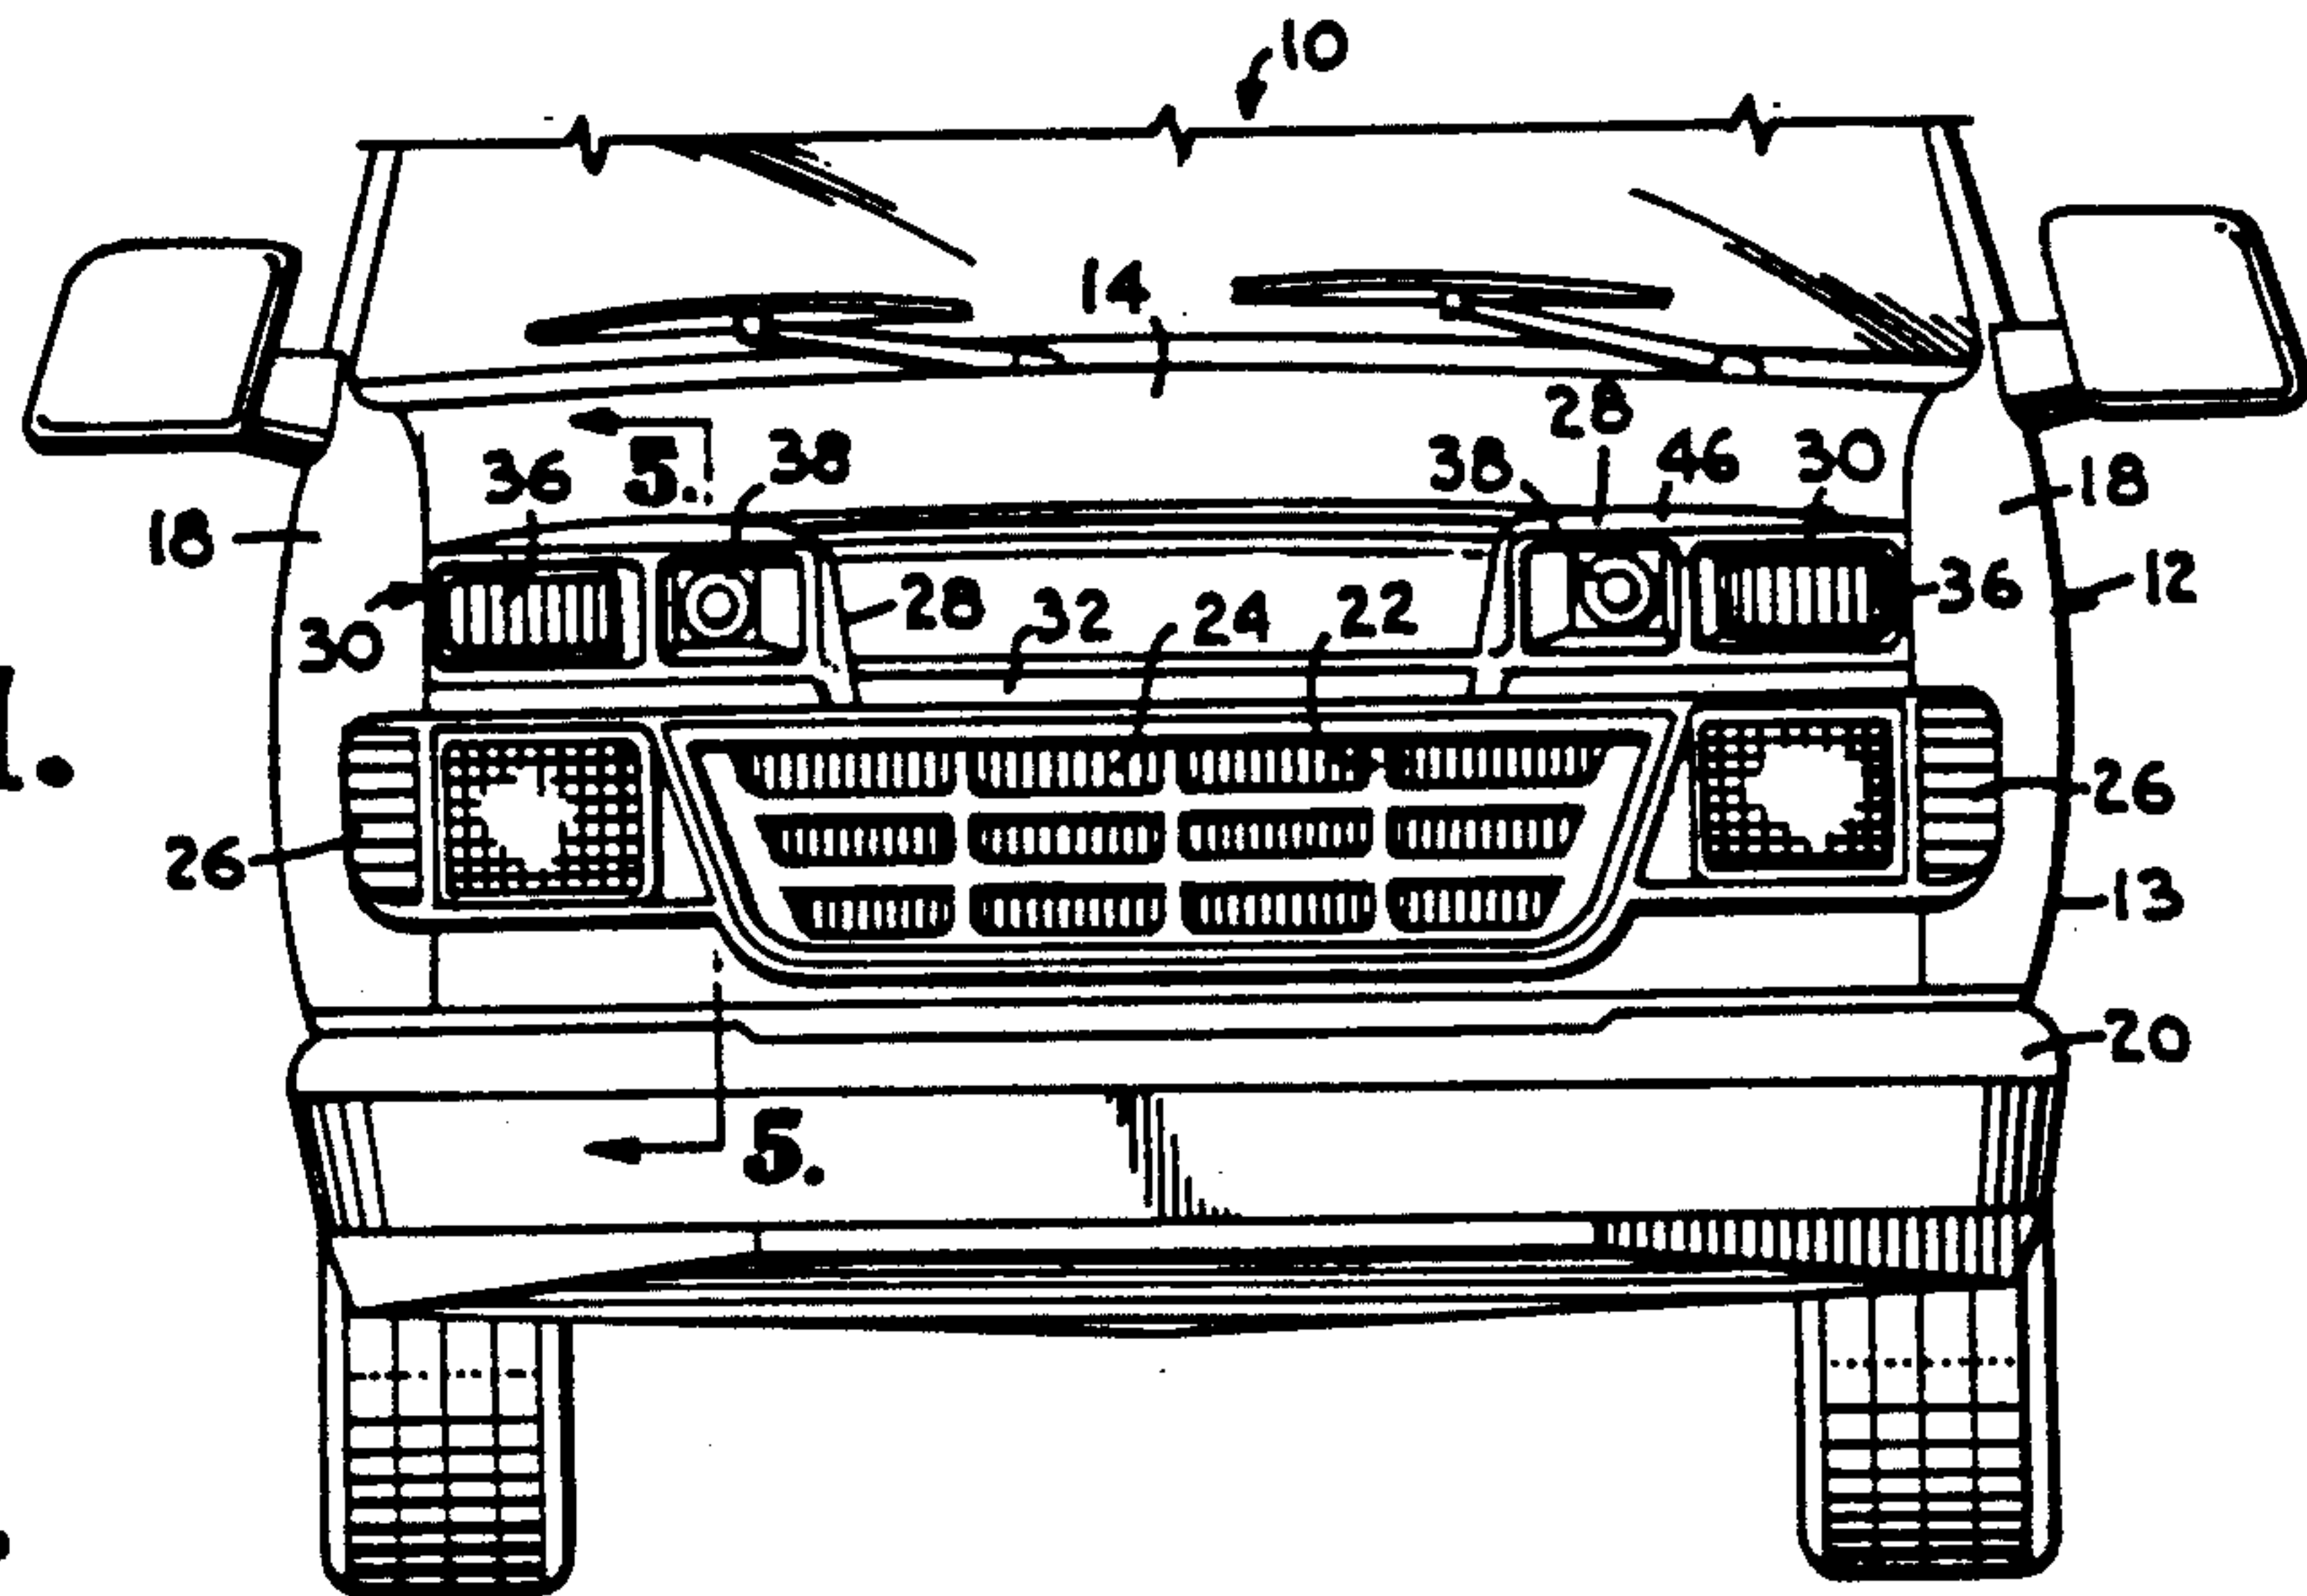
Fig. 2.

FIG. 2 is a fragmentary top plan view of the forward portion of the vehicle shown in FIG. 1 but on a reduced scale and with portions of the vehicle hood being broken away to shown the engine compartment and with broken lines being used to illustrate various internal features including a control panel for the warning units;

The warning units 30 are operatively coupled by suitable wiring 40 with a control panel 42 which is positioned within the vehicle 10 at a location readily accessible to the vehicle driver. Each warning unit 30 includes a base 44 and an outer housing 46 which is made from cast aluminum and is generally configured to conform to the aerodynamic shape of the hood 14 when positioned within cutout 28. The housing 46 is segmented to provide separate compartments 48 and 50 for receiving the siren 38 and light 36.

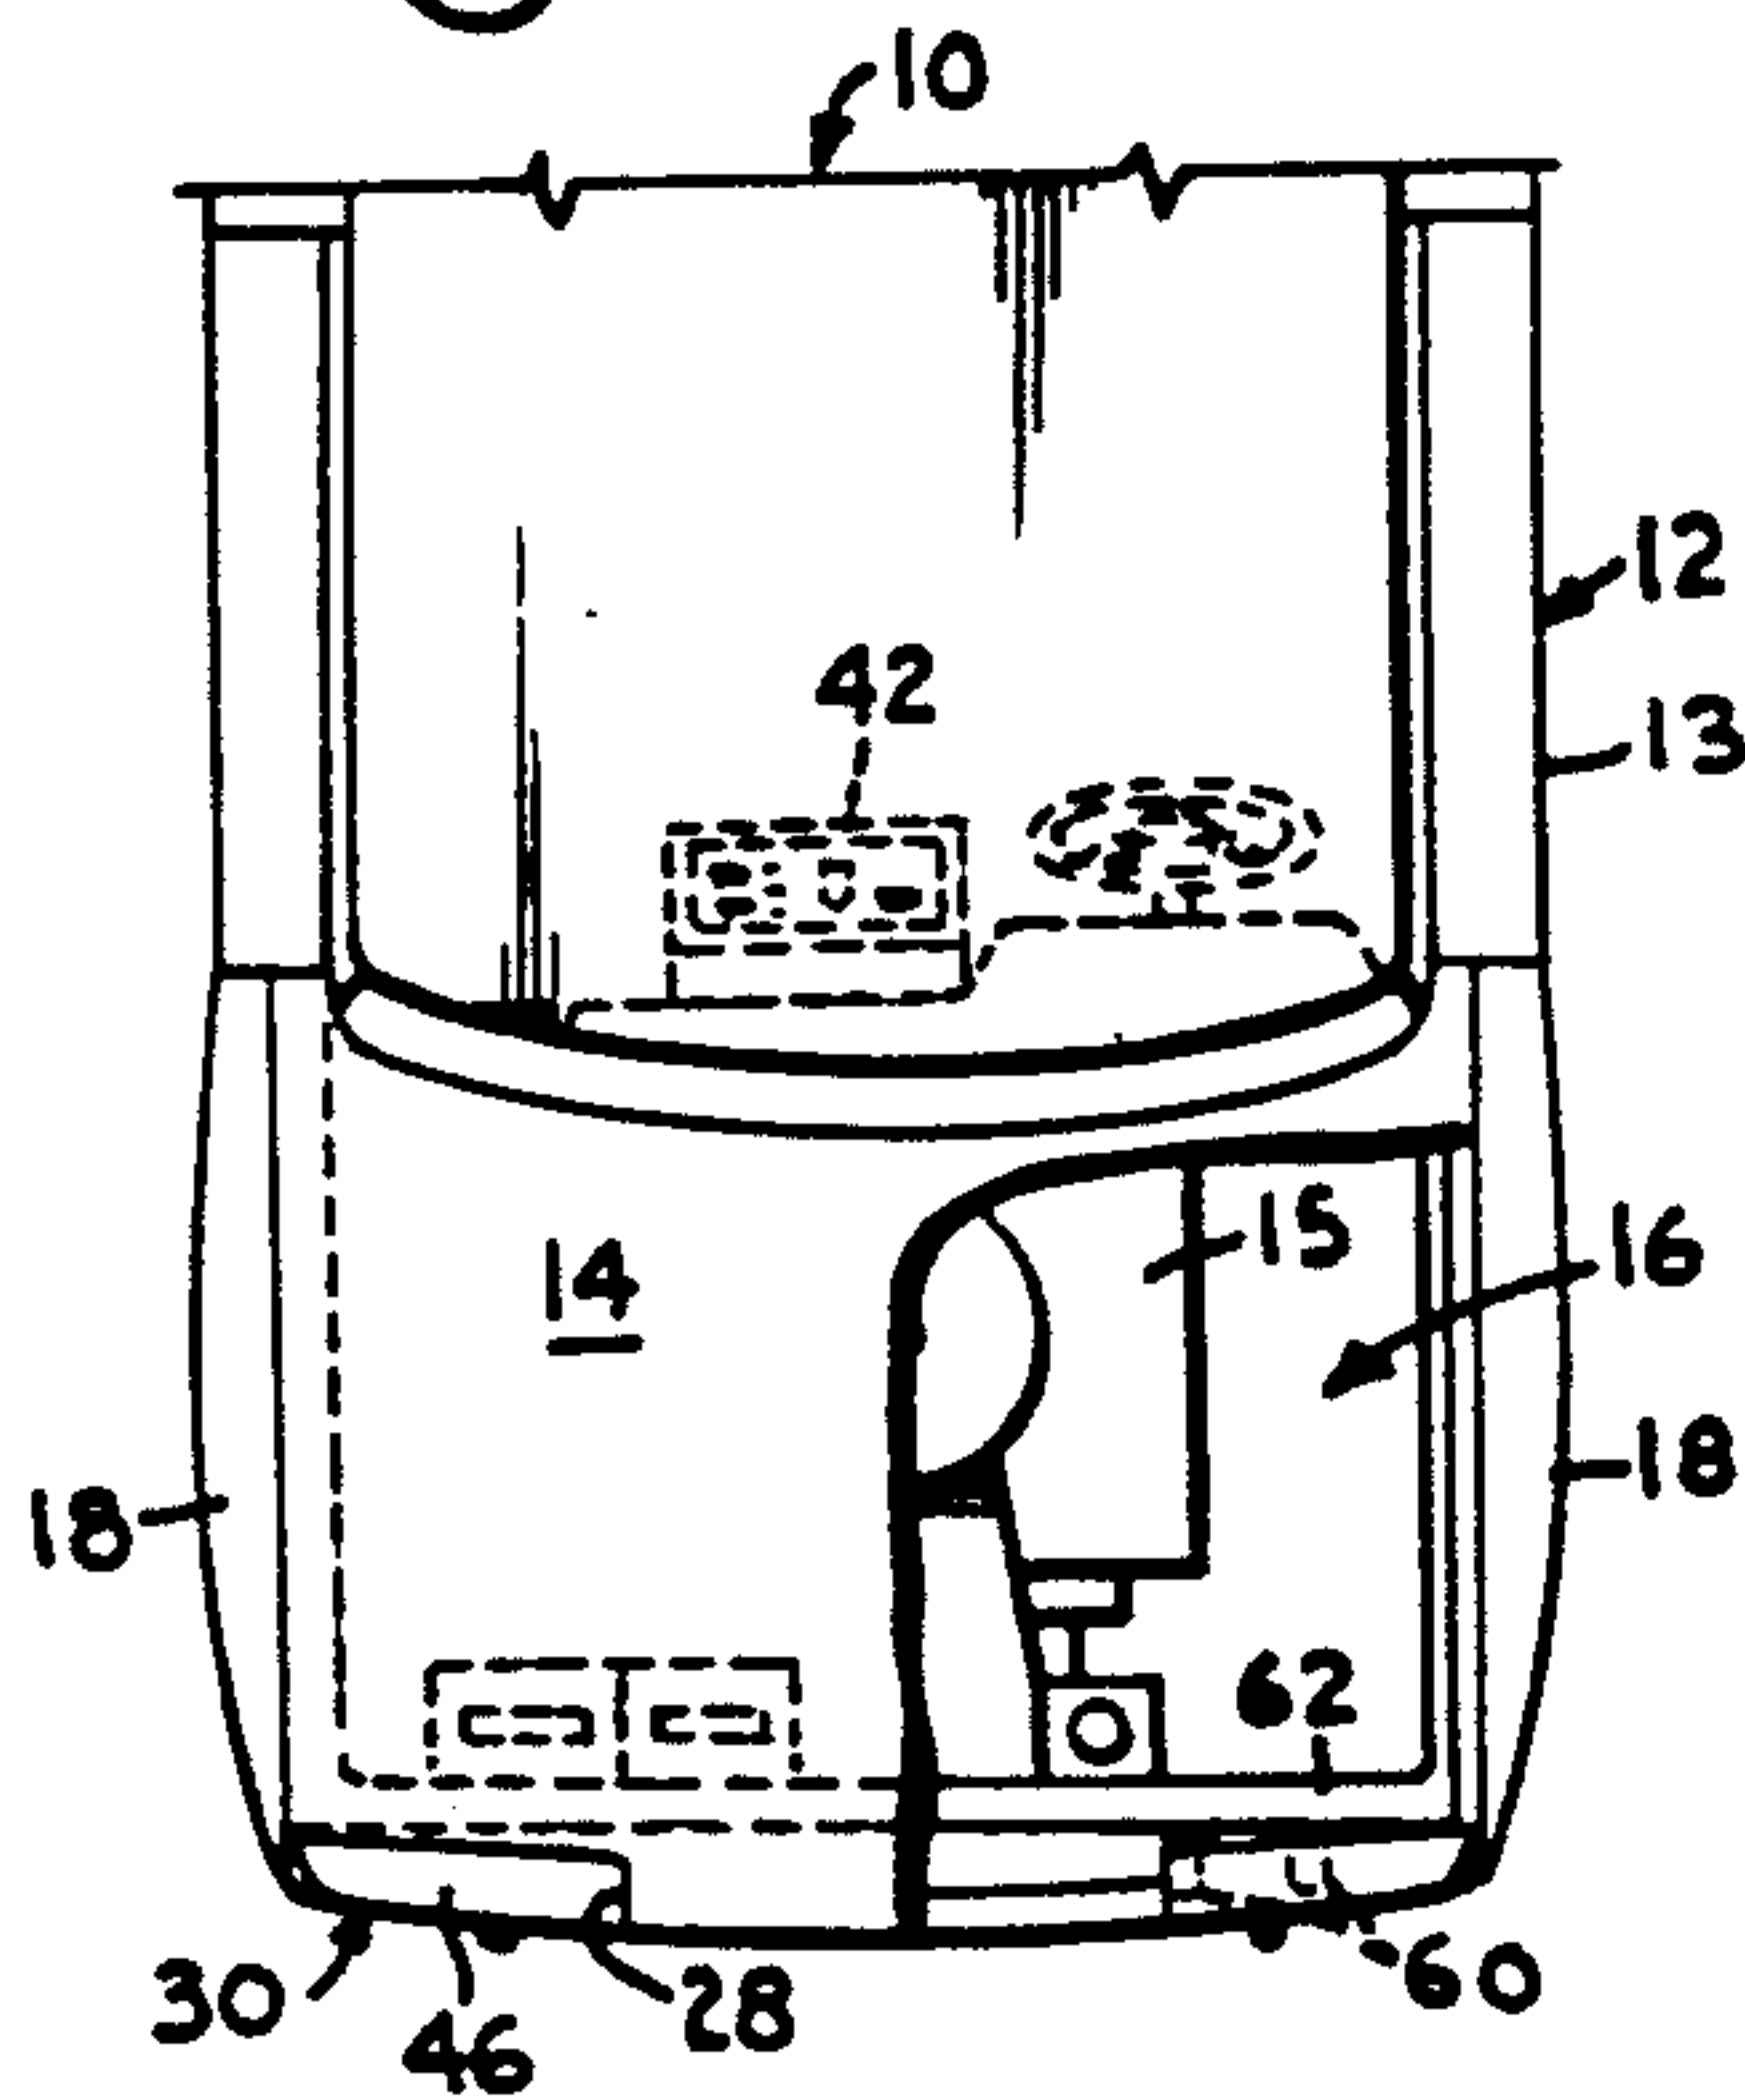
Fig. 3.

FIG. 3 is an enlarged fragmentary perspective view of a front part of the vehicle with the hood and one of the warning units removed to show the mounting brackets used to secure the warning unit to a radiator support wall within the engine compartment;

The warning units 30 are mounted within cutouts 28 in hood 14 by a pair of L-shaped brackets 60 that are bolted to the front of a radiator support wall 62 within the engine compartment 16. The brackets 60 are mounted to the base 44 of the warning units 30 and slots 64 are provided in each bracket to allow for fore-and-aft and vertical adjustment of the positioning of the warning units. If needed, the warning units can be readily removed for servicing or replacement by simply discon-
