US005188445A

[11] Patent Number: 5,188,445

[54] VEHICLE HAVING WARNING UNITS MOUNTED WITHIN HOOD CUTOUTS

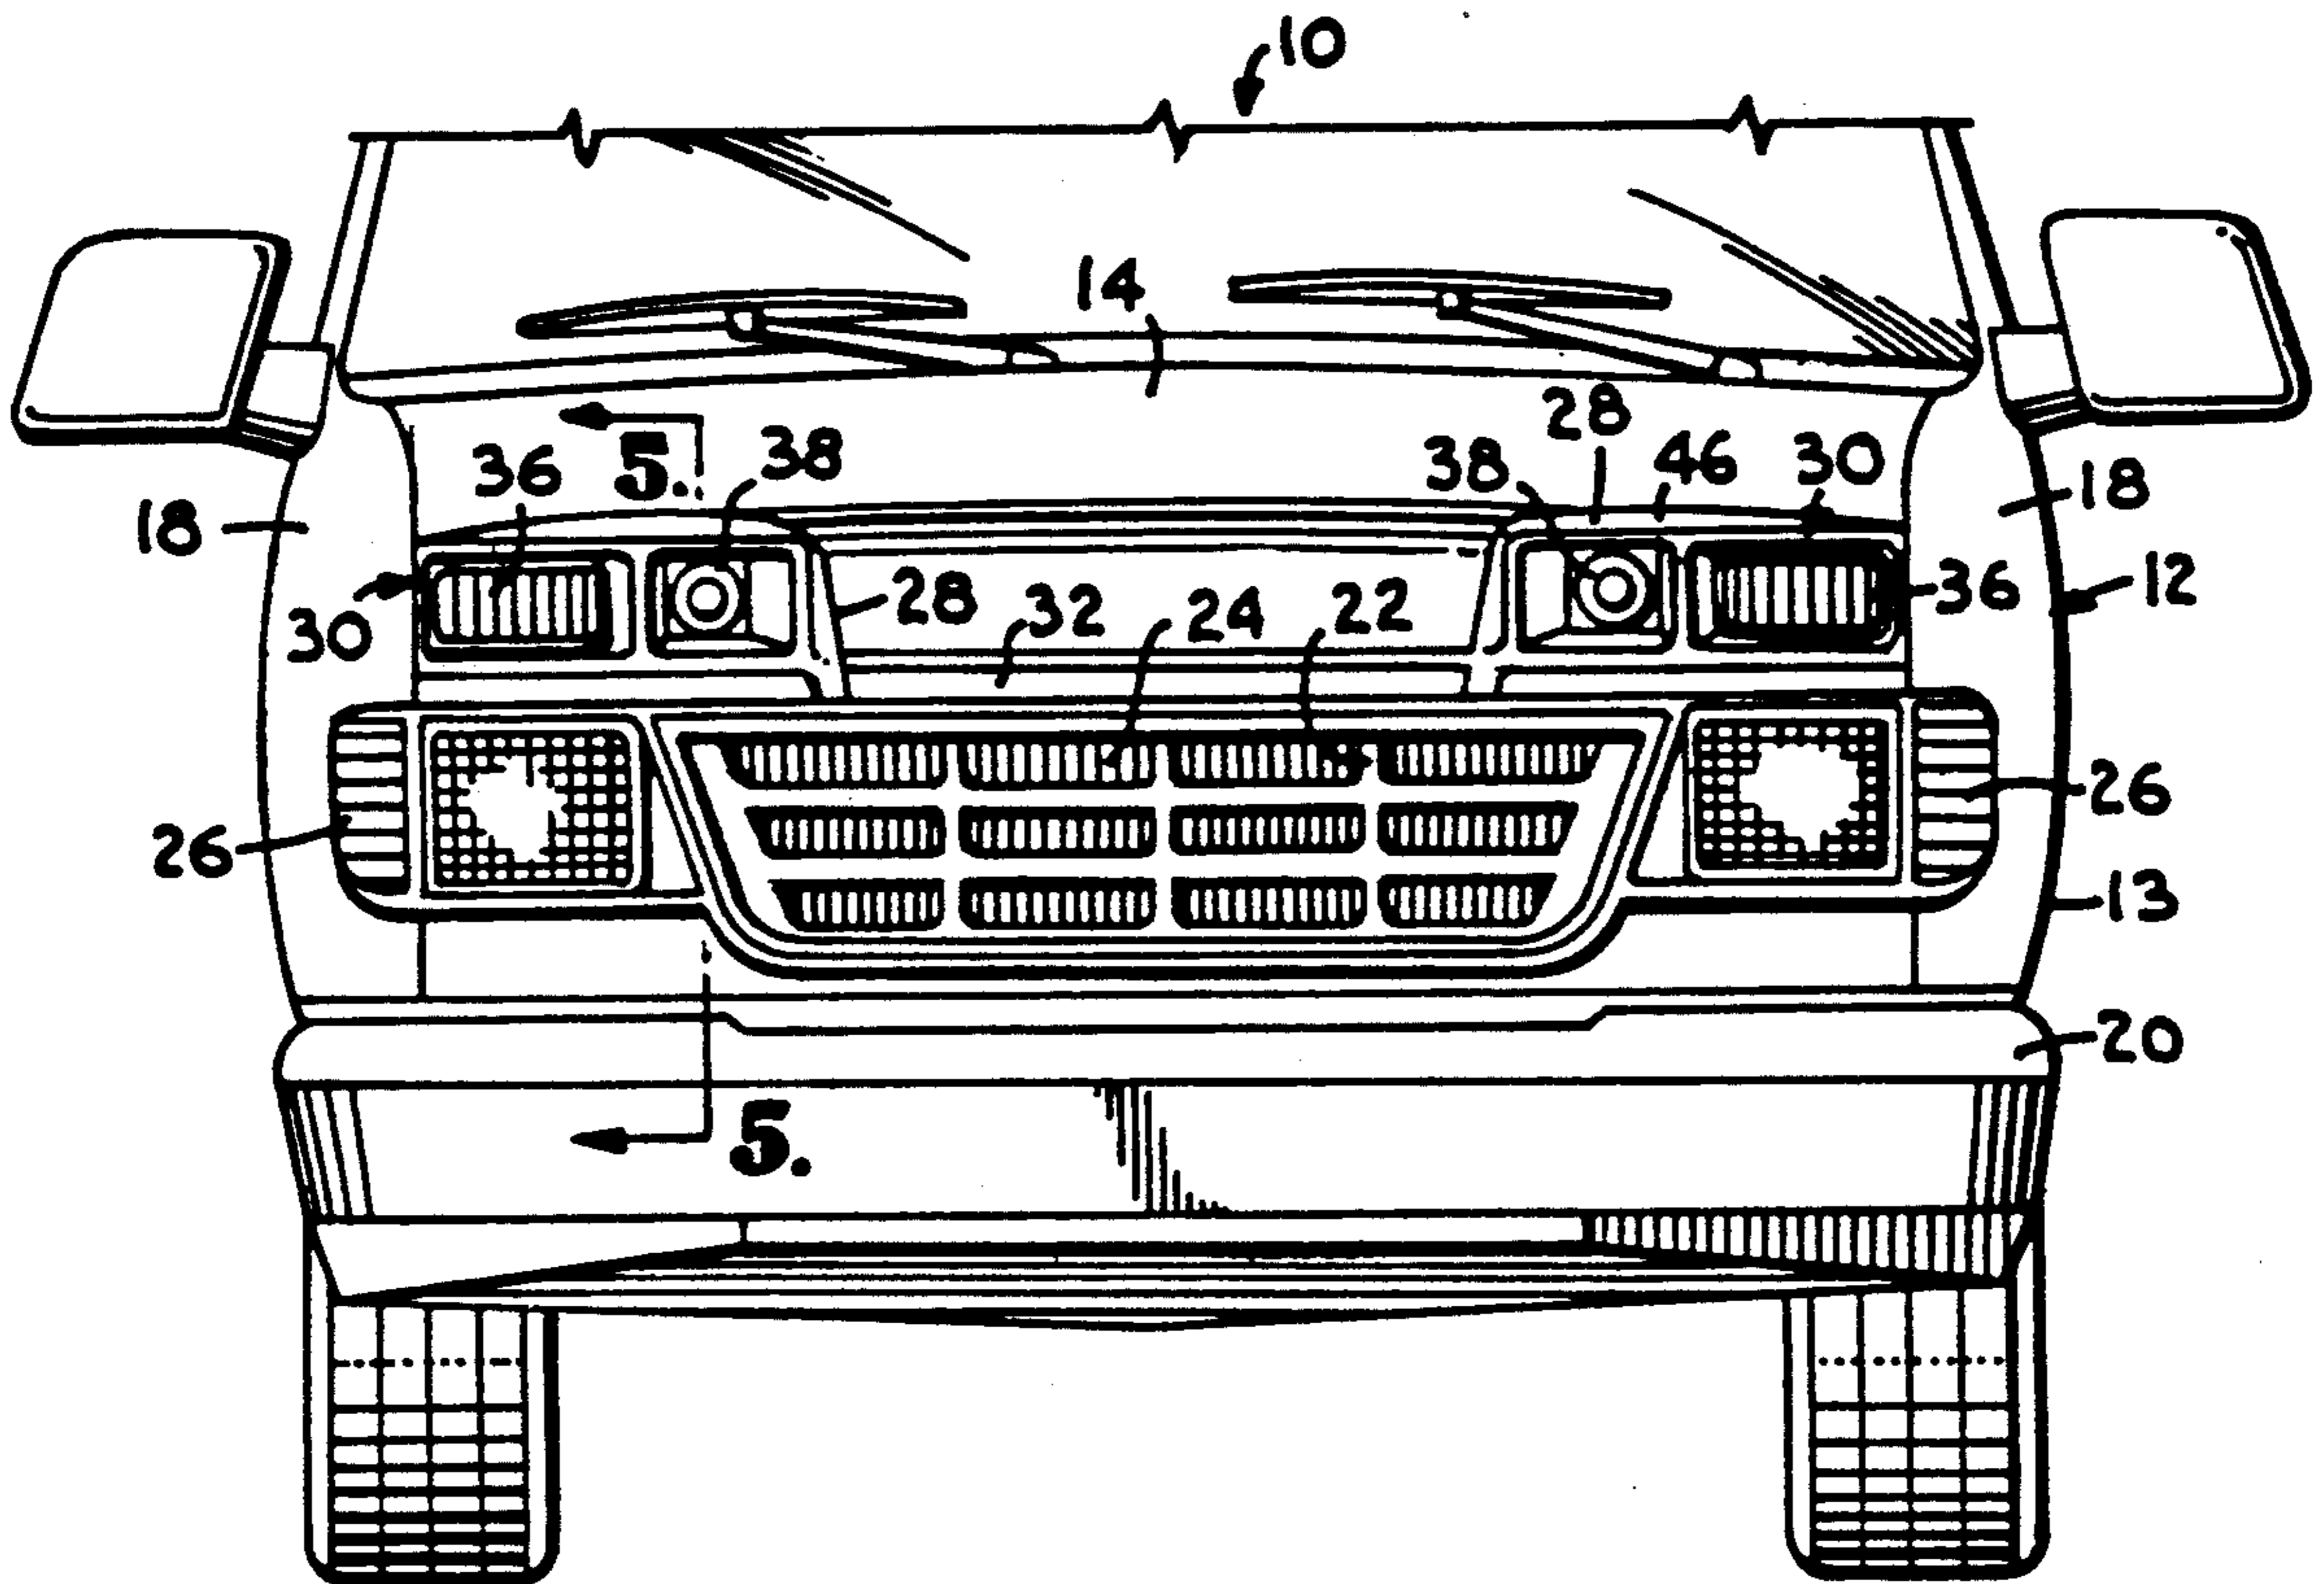
Fig. 1.

FIG. 1 is a fragmentary front elevational view of an emergency vehicle in accordance with the present invention having warning units comprising flashing lights and sirens mounted within cutouts provided in the hood of the vehicle;

In accordance with the present invention, a pair of cutouts 28 are provided in the hood 14 at locations to receive warning units 30. The cutouts 28 are positioned adjacent the fenders 18 and extend upwardly from a lowermost forward edge 32 of the hood 14. A sealing strip 34 (FIG. 5) is provided along the edge of each cutout 28 to cover the sharp edge of the cutout and to provide a seal against the associated warning unit 30. The lateral positioning of the cutouts 28 may of course be varied from that illustrated.

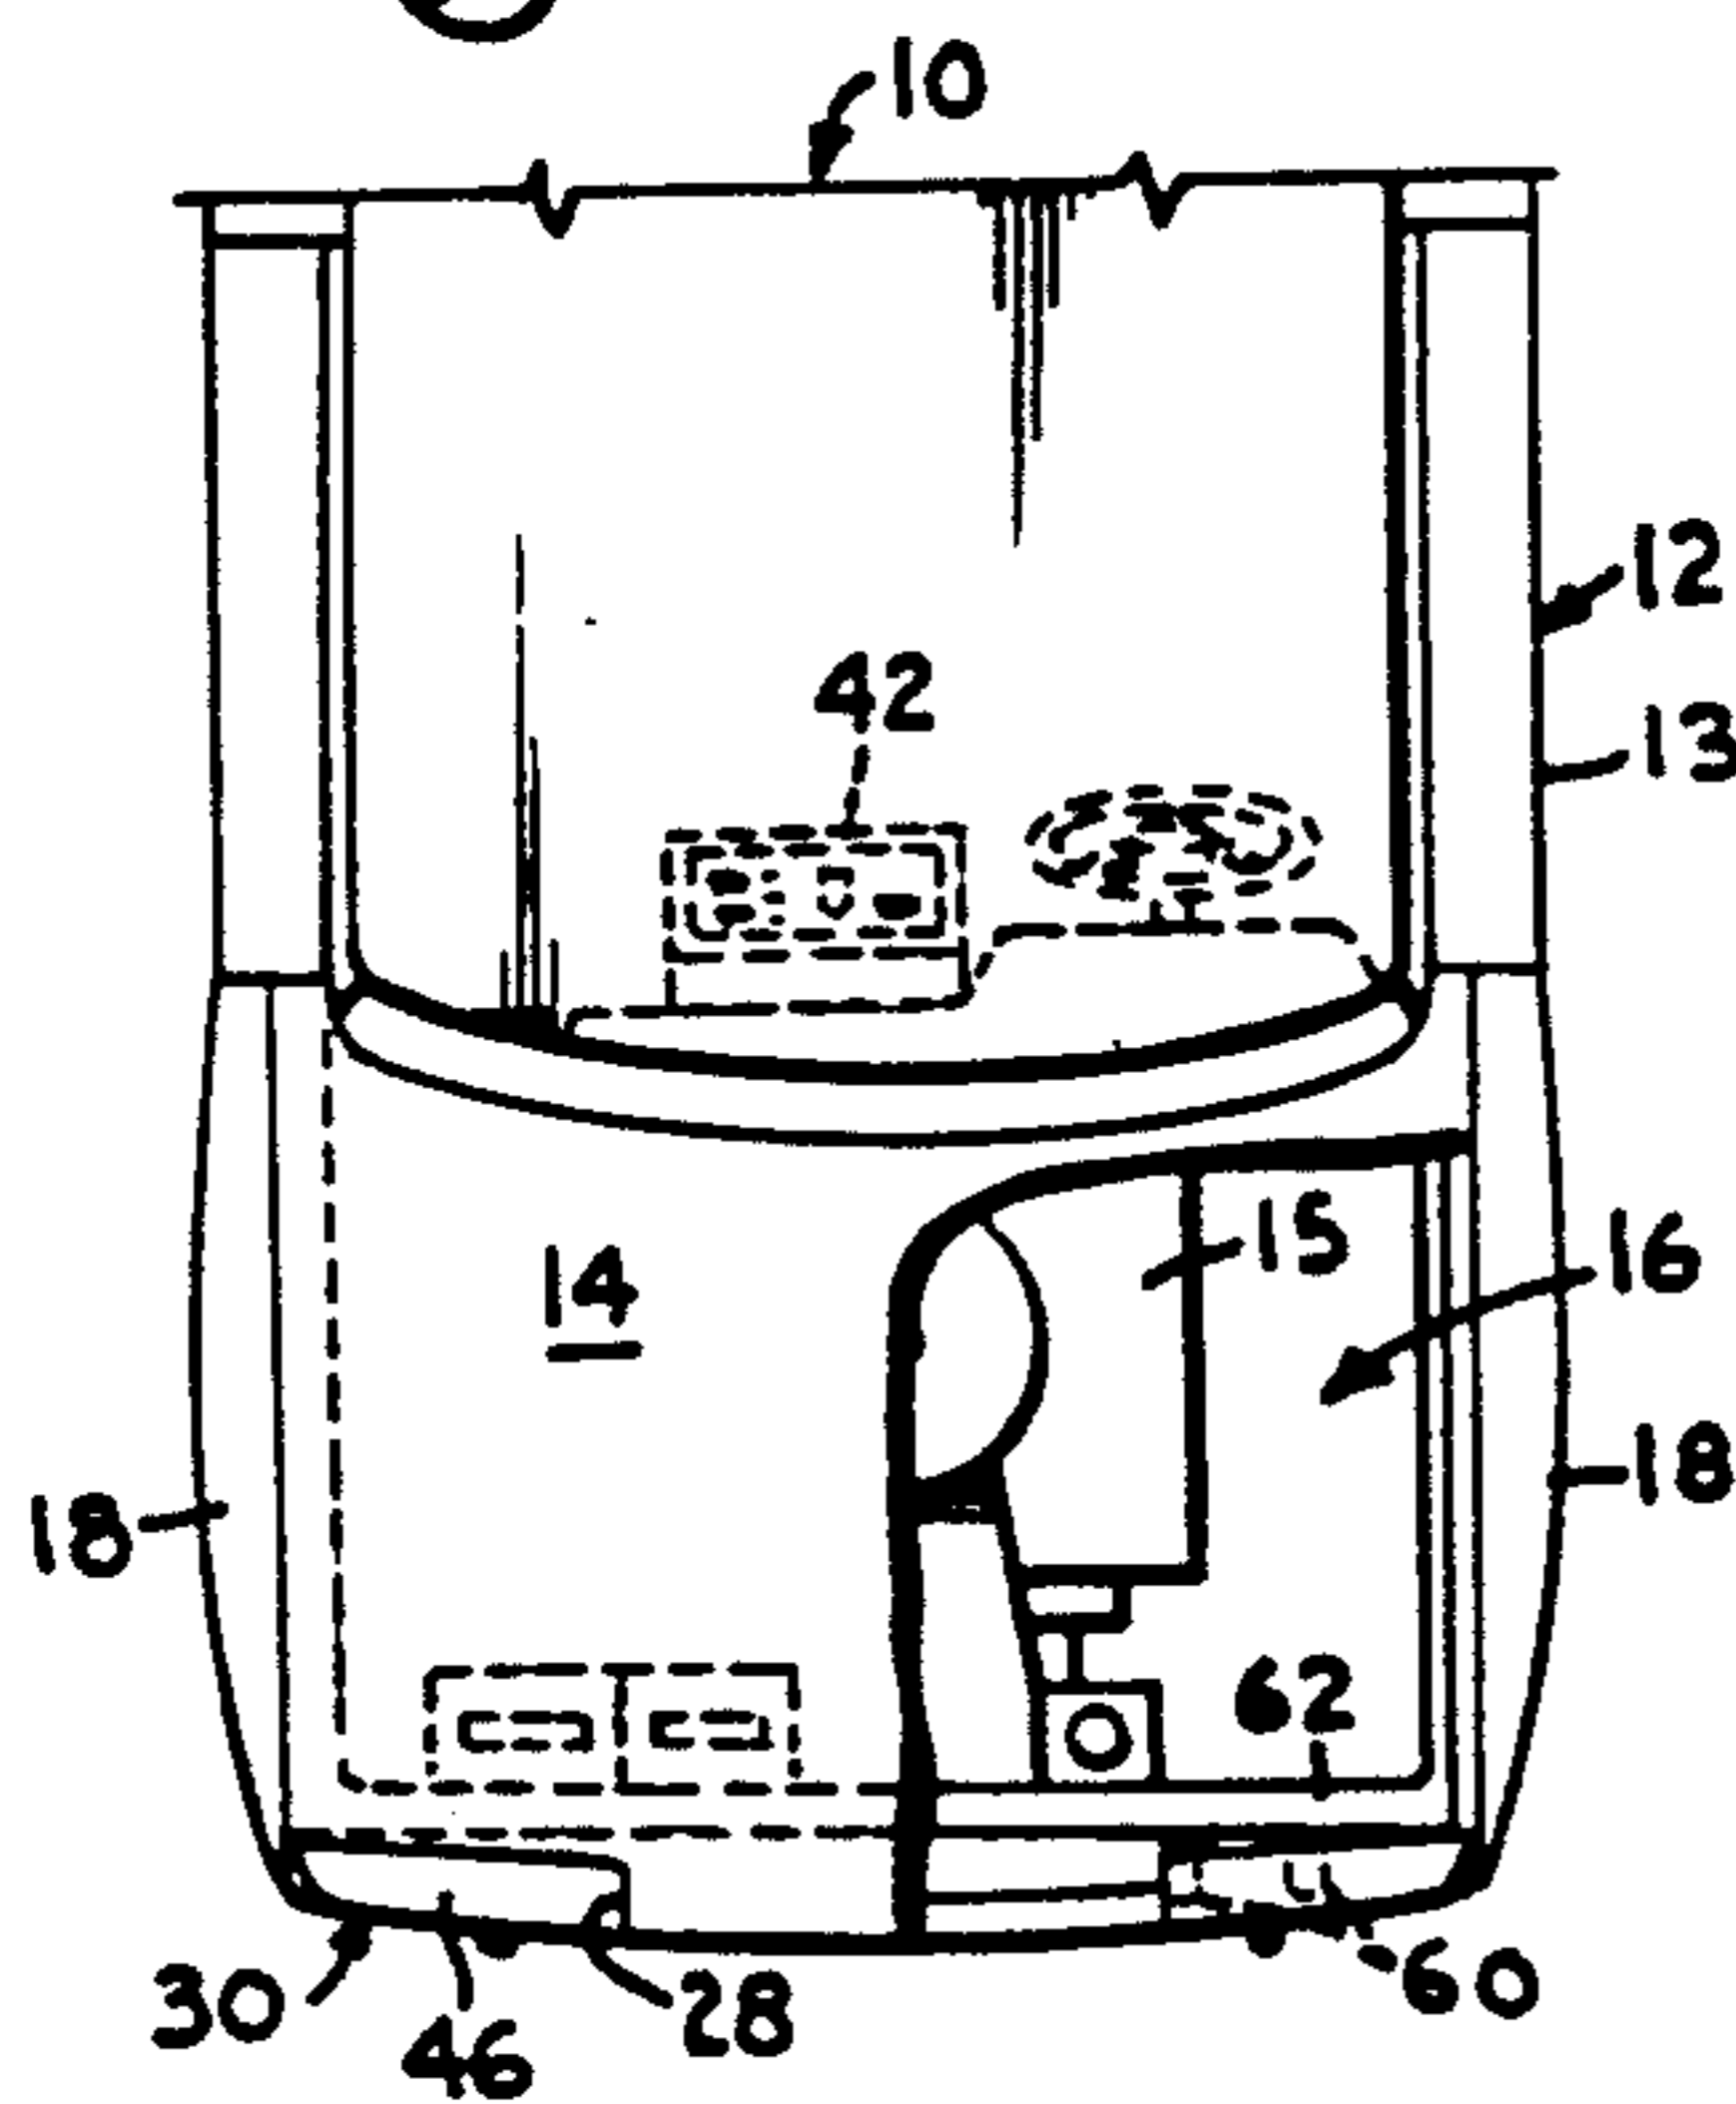
Fig. 3.

FIG. 3 is an enlarged fragmentary perspective view of a front part of the vehicle with the hood and one of the warning units removed to show the mounting brackets used to secure the warning unit to a radiator support wall within the engine compartment;

The warning units 30 are mounted within cutouts 28 in hood 14 by a pair of L-shaped brackets 60 that are bolted to the front of a radiator support wall 62 within the engine compartment 16. The brackets 60 are mounted to the base 44 of the warning units 30 and slots 64 are provided in each bracket to allow for fore-and-aft and vertical adjustment of the positioning of the warning units. If needed, the warning units can be readily removed for servicing or replacement by simply discon-
