[11] Patent Number: **5,211,685**

[54] FIRE HYDRANT BASE ENCLOSURE

An improved procedure and apparatus for mounting and replacing fire hydrants including a hollow, box-like structure comprising a plastic cylinder which can enclose the hydrant-mounting flange to protect the flange, yet which can quickly and easily be removed and replaced, even by unskilled workmen, to provide access to the hydrant-mounting flange and the break-away bolts without requiring expensive and time-consuming cement work.

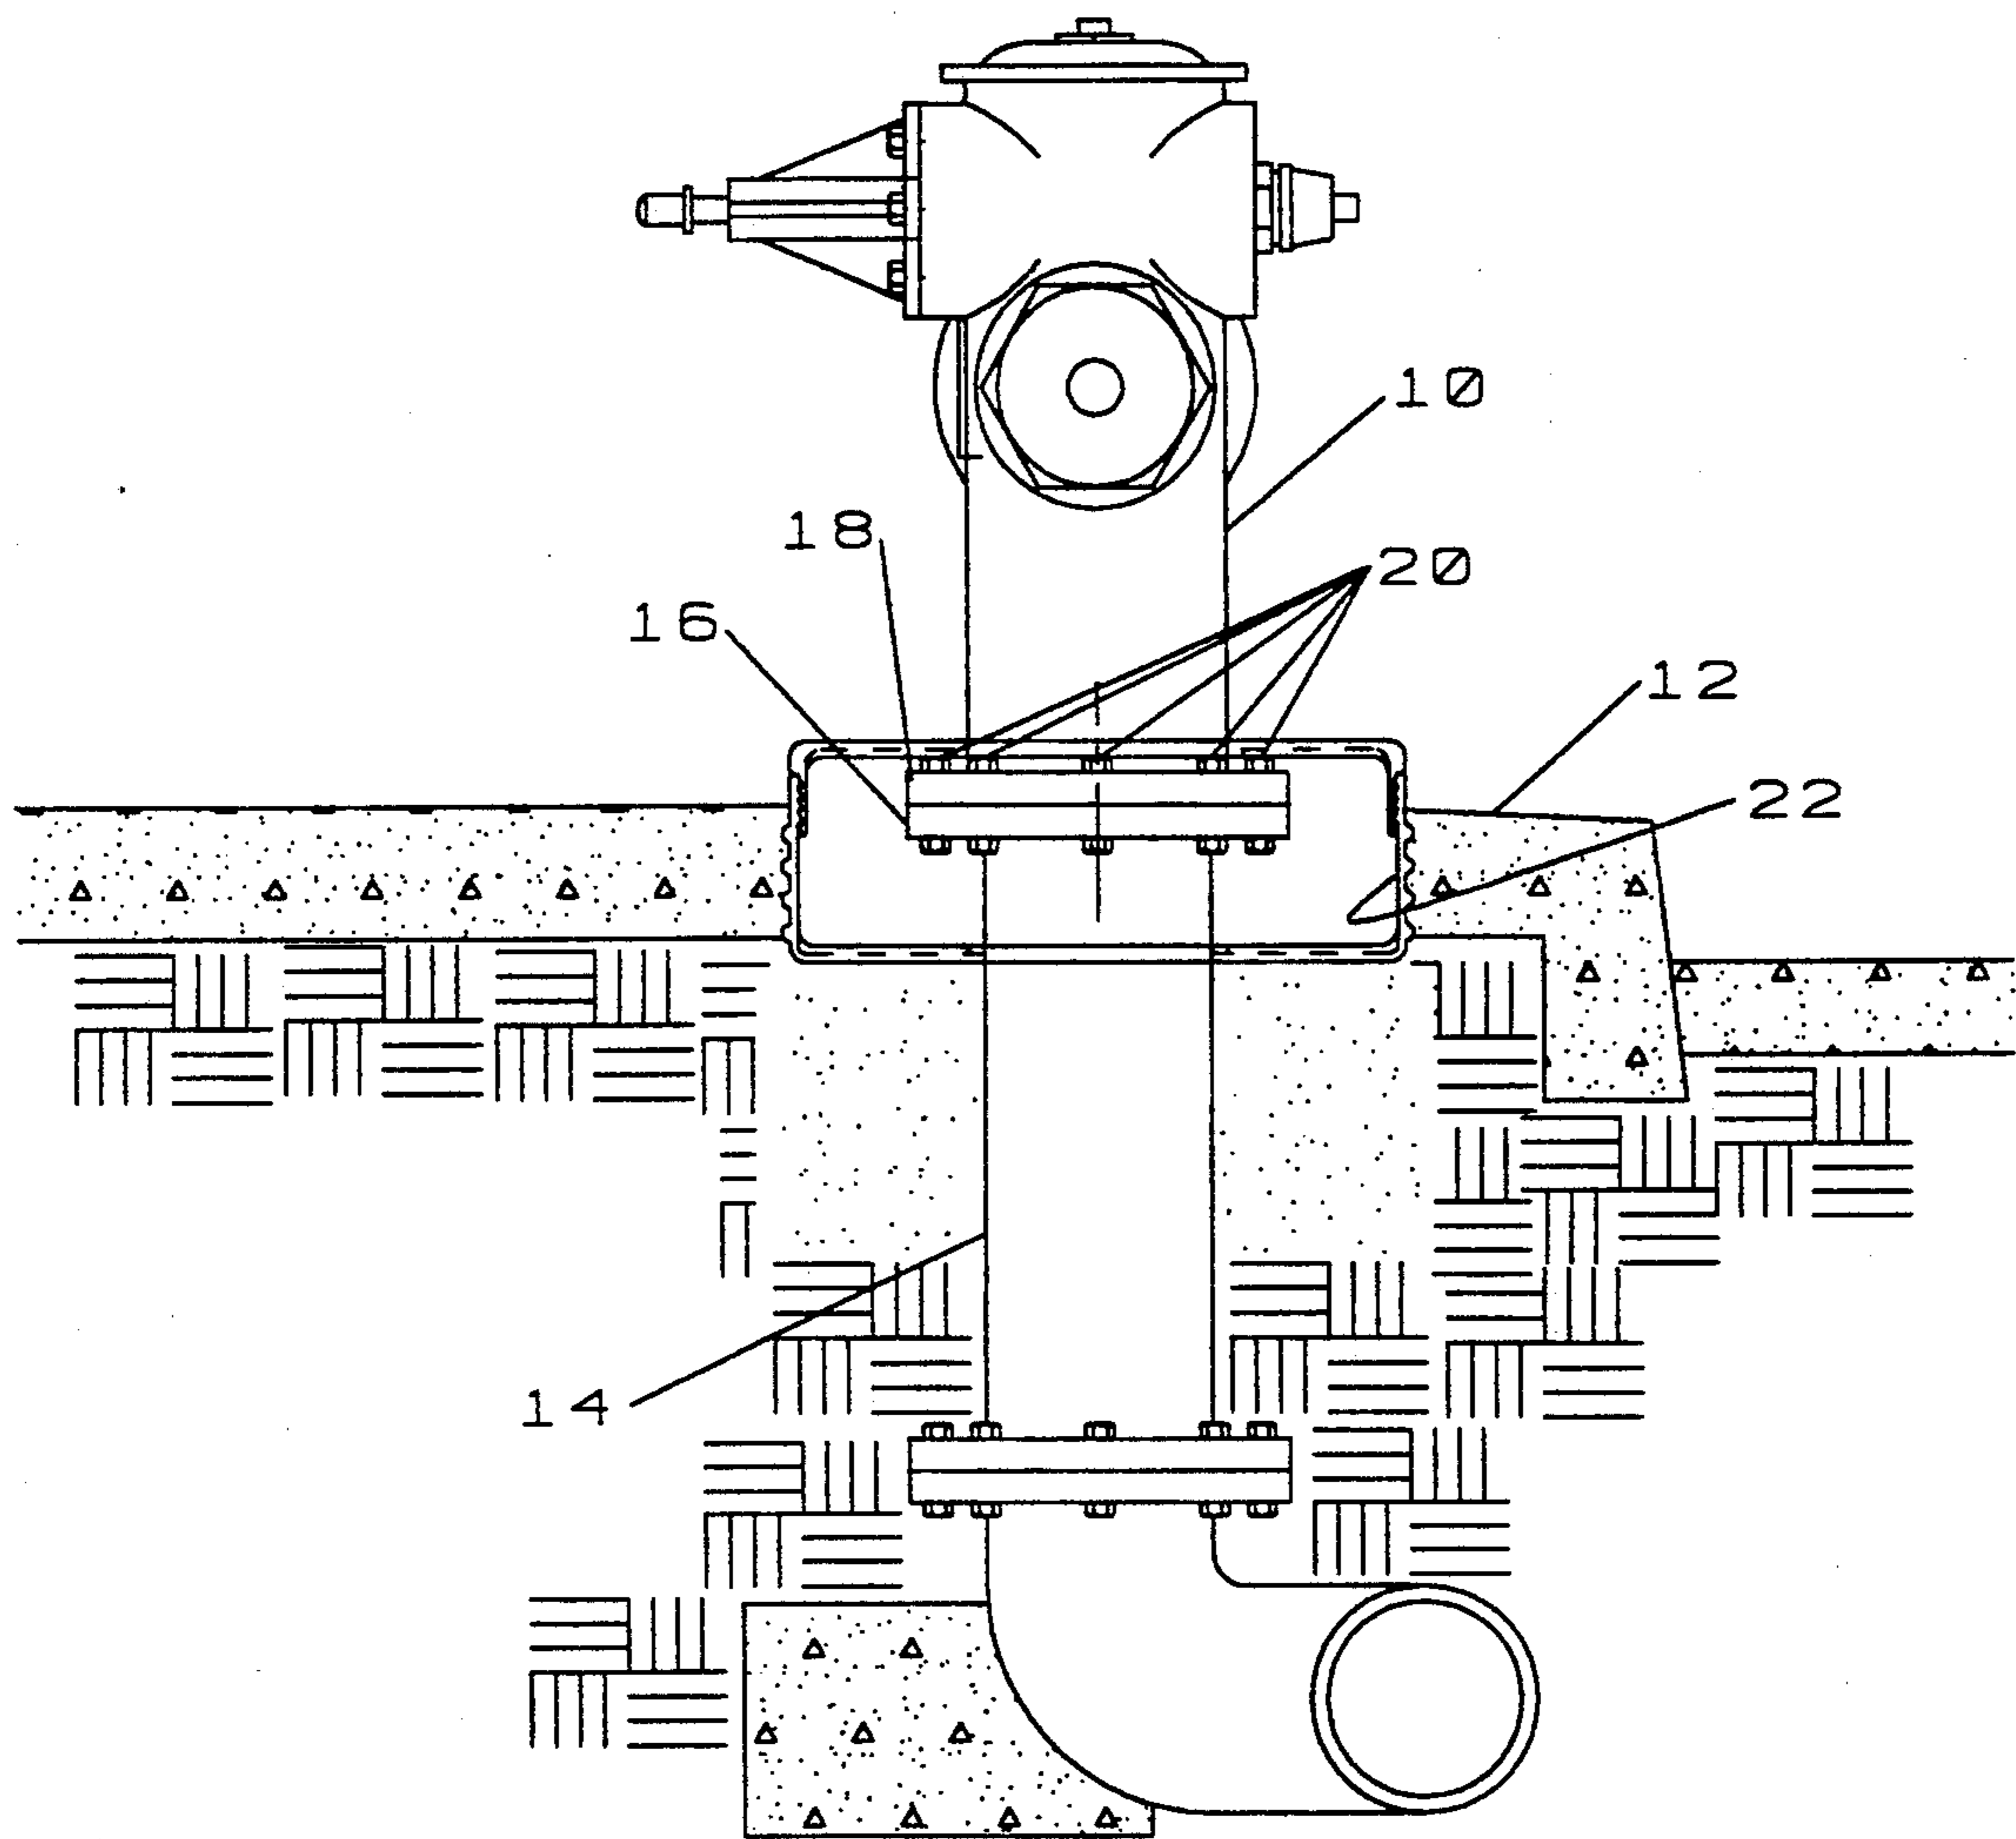
FIG 1.

FIG. 1 is a diagrammatic representation showing a fire hydrant having its base enclosed in cement according to the prior art procedure;

FIG. 1 shows a fire hydrant, indicated generally at 10, mounted in a sand and cement base enclosure 12 in accordance with the procedures of the prior art. As shown, a standpipe 14 supplies water to the hydrant 10 from a municipal water main or the like, not shown, and terminates in a flangeplate 16. The fire hydrant 10 has a lower flange 18 which sits on the flangeplate 16 and is secured thereto by suitable means, such as break-away bolts 20. Conventionally, a hole 22 approximately one foot deep and having a diameter approximately one foot larger than that of the standpipe 14 is dug out about the flangeplate 16 and, after the hydrant 10 has been secured to the flangeplate 16 by means of the break-away

bolts 20, the base enclosure 12 is formed by filling the hole 22 with sand or dirt, which is covered with a layer of cement so as to be level with the surrounding sidewalk.

If the hydrant 10 is struck by a vehicle, the break-away bolts 20 are designed to shear off to allow the hydrant 10 to be displaced, so as to minimize damage to the hydrant 10. Unfortunately, the displacement of the hydrant 10 causes the upper portion of the cement base enclosure 12 to be shattered. Thus, in order to replace, the hydrant 10, it is necessary to call a water department crew to shut off the water flowing through the standpipe 14 and a work crew with jackhammers or picks and shovels to dig out the remainder of the cement base enclosure 12, so as to provide access to the flangeplate 16 to enable reattachment of the hydrant 10 with new break-away bolts 20. Thereafter, a cement crew must be called to pour a new cement base enclosure, such as the base enclosure 12, to again enclose the flangeplate 16, flange 18 and the break-away bolts 20. As noted above, the working time required for each such hydrant replacement is about 1-10 hours and the cost, including the cost of workmen, supervisors, vehicles, etc. can easily amount to approximately \$150-\$1500 for each such replacement.

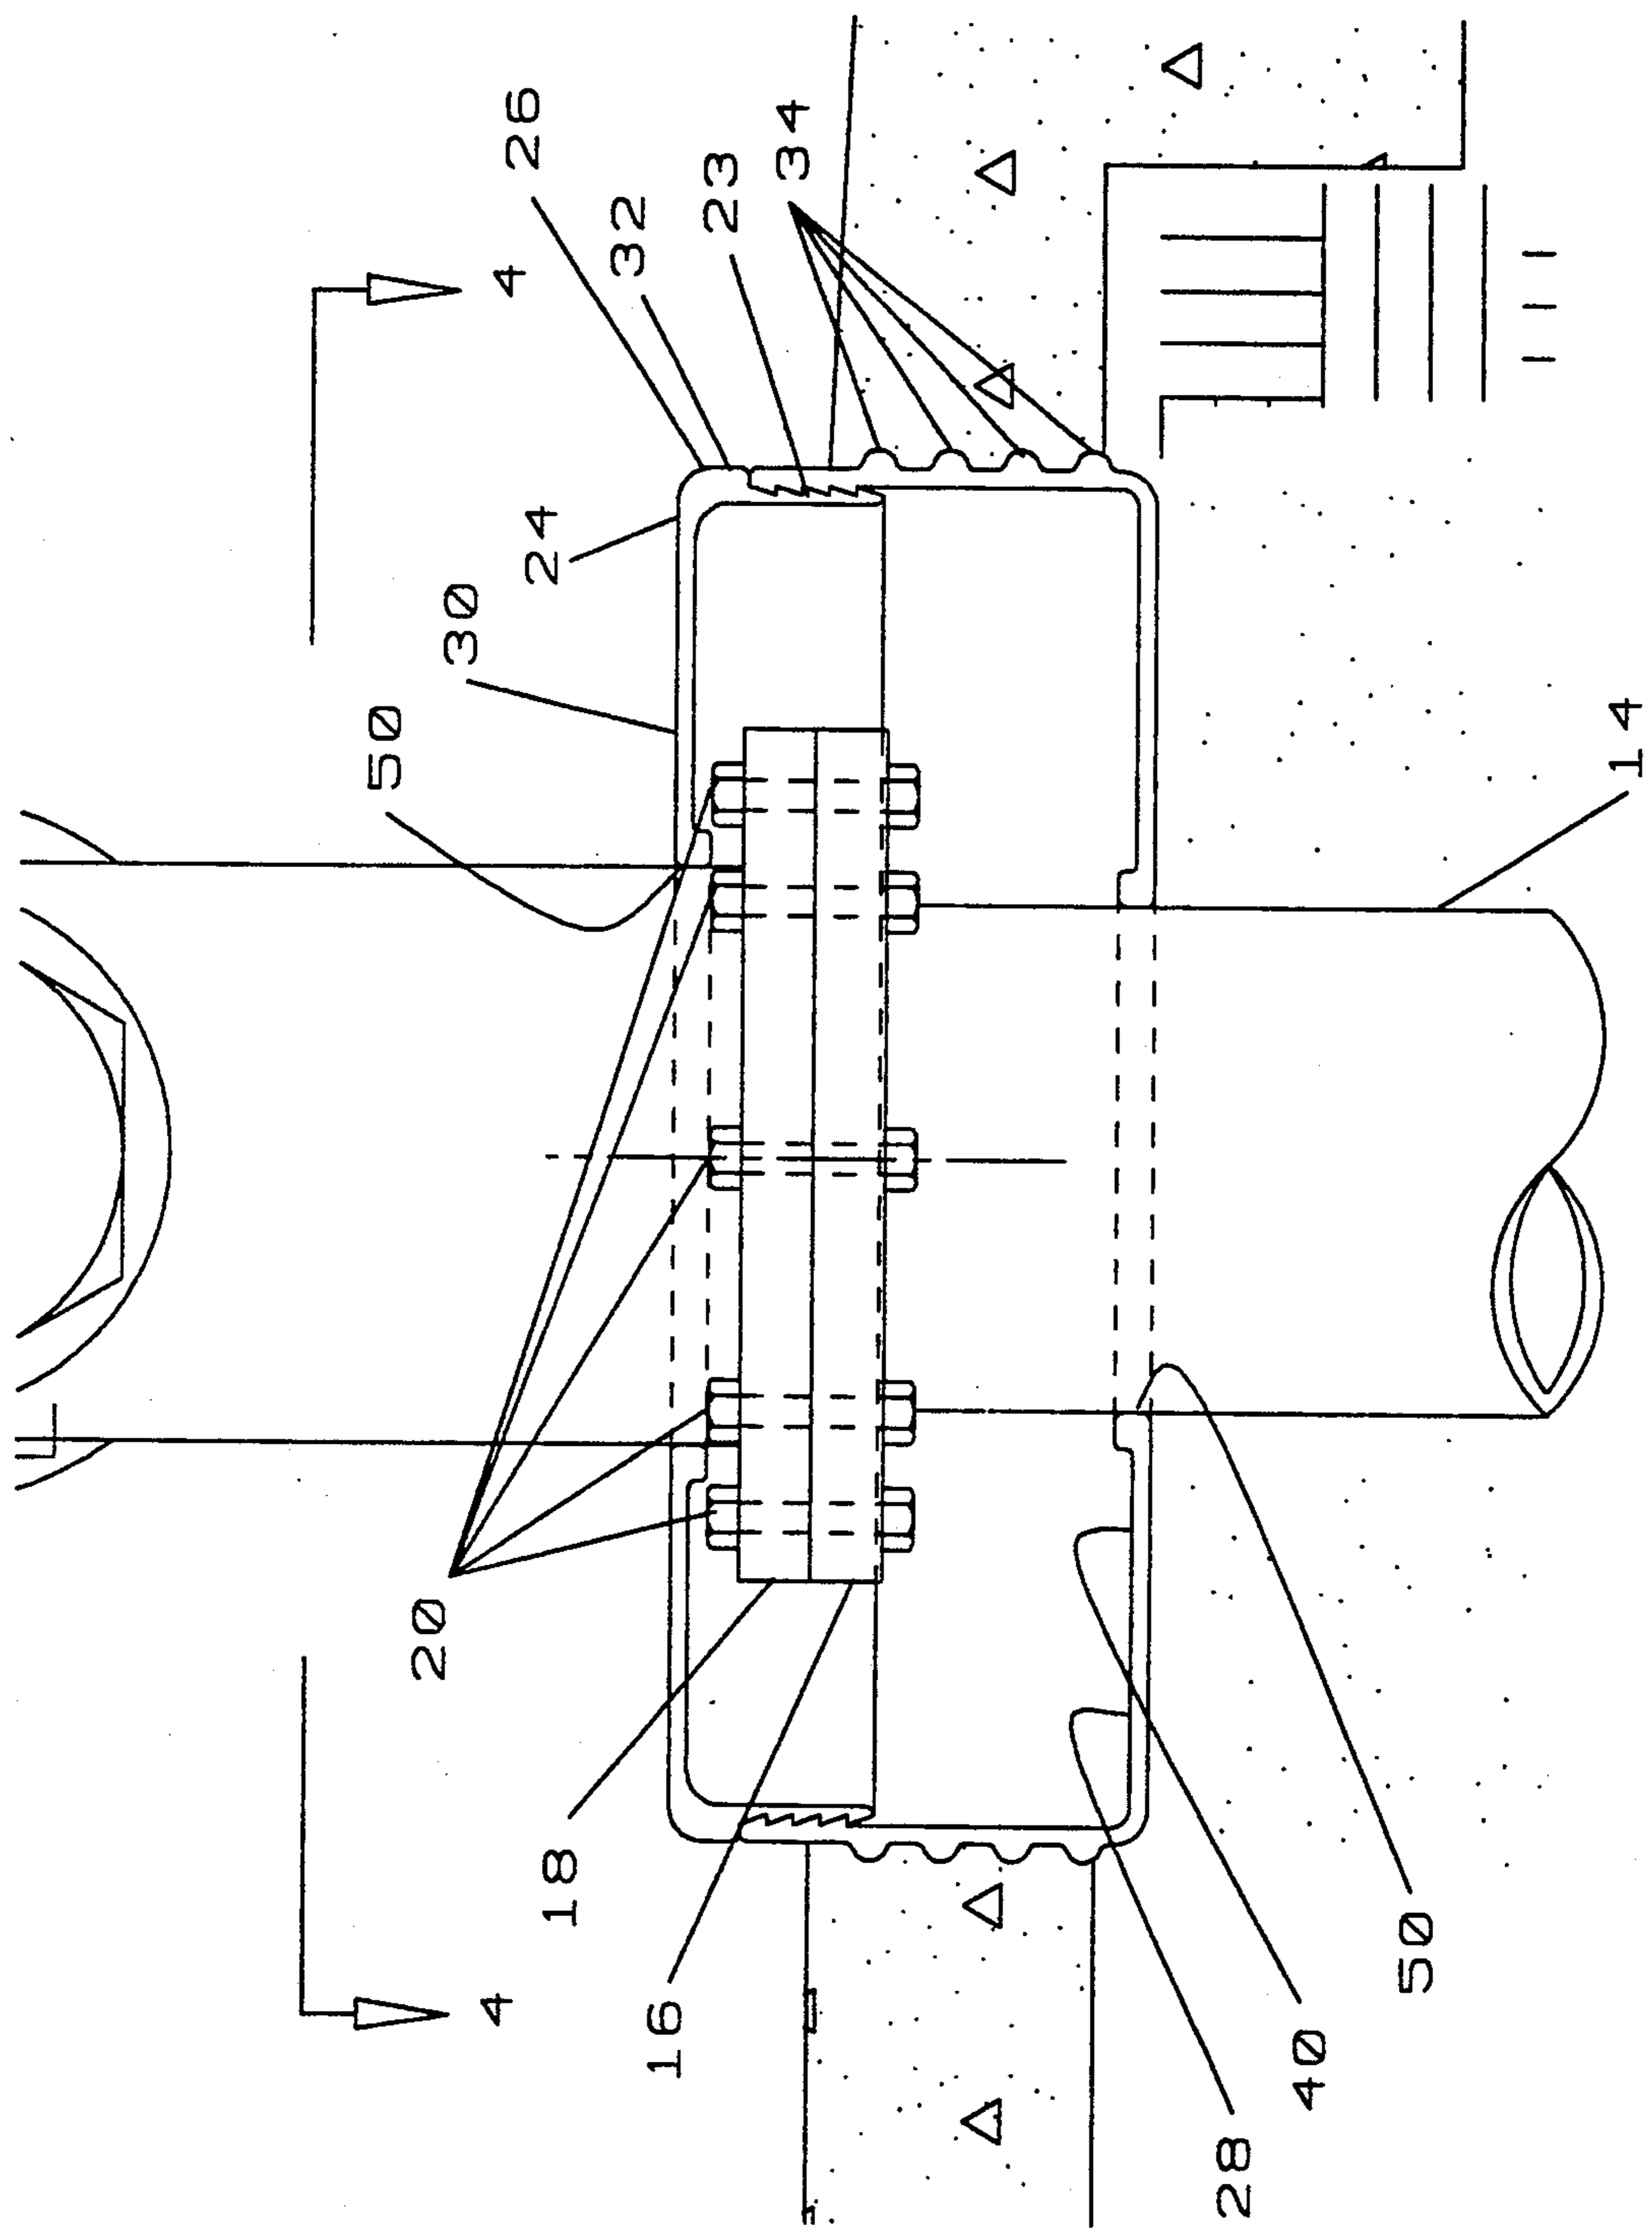
FIG. 2 is a view, similar to that of FIG. 1, showing a fire hydrant having its base enclosed with a base enclosure device embodying the present invention;

FIG. 2 shows the fire hydrant 10 mounted in a base enclosure 24, embodying the present invention. The base enclosure 24 is basically a hollow, box-like structure which encloses the flange plate 16, flange 18 and break-away bolts 20, replacing the cement block base enclosure 12 of FIG. 1, and comprises four semi-cylindrical members. There are two identical upper members 26 and two identical lower members 28 and the upper members 26 mate with the lower members 28, as best seen in FIGS. 2 and 3. The members 26 and 28 are formed of material, such as plastic or metal, which is sufficiently rigid to readily support a person standing on the base enclosure 24. As best seen in FIG. 3, each of the upper members 26 comprises a half cylinder having a flat, generally disc-like upper surface 30 with a side wall 32 extending perpendicularly downward from the periphery of the upper surface 30 and formed with a plurality of ridges 22 projecting outwardly from the side wall 32, each having a slanted lower surface 36 and a substantially horizontal upper surface 38. Each of the lower members 28 comprises a half cylinder having a flat, generally disc-like lower surface 40 with a side wall 42 extending perpendicularly upward from the periphery of the lower surface 40 and formed with a plurality of ridges 22, projecting inwardly from the side wall 42 to mate with the ridges 22 which project outwardly from the sidewall 32 of the upper member 26, each having a slanted upper surface 46 and a substantially horizontal lower surface 48. Each of the members 26 and 28 is formed with a central recess 50 which, when the members 26 and 28 are assembled form openings to fit closely about the standpipe 14 or hydrant 10. If necessary or desirable, suitable gasket material, not shown, may be interposed between the recesses 50 and the adjacent hydrant 10 of standpipe 14 to provide a watertight seal therebetween. If desired, the lower members 28 may also be formed with a plurality of outwardly projecting ridges, as best seen at 34 in FIGS. 2 and 3, for engagement with the surrounding layer of cement and, hence, to prevent dislocation of the lower member 28 in the event the upper member 26 is forcibly removed, as by a collision of a vehicle with the fire hydrant 10.

In use, two of the lower members 28 are placed in the bottom of the hole 22 with their adjacent edges abutting each other and with the recesses 50 abutting the standpipe 14, as seen in FIG. 2, and with their side walls 42 extending upward along the edges of the hole 22. Next, the flange 18 of the fire hydrant 10 is secured to the flangeplate 16 by suitable means, such as break-away bolts 20. Finally, two of the upper members 26 are placed about the hydrant 10, overlying the flange plate 16 and flange 18, with their adjacent edges abutting each other and with the recesses 50 abutting the hydrant 10 and with the side walls 32 engaging the side walls 42 of the lower members 28. The two upper members 26 are then pressed downward, causing the ridges 23 of the upper members 28 to ratchet over the ridges 44 of the lower members 28 for form the integral base enclosure 24, as seen in FIGS. 2, 3 and 4. Obviously, the assembly of the base enclosure 24 can be accomplished in a matter of minutes, even by unskilled workmen. Moreover, once assembled in this manner, the base enclosure 24 cannot easily be disassembled, due to the interlocking action of the ridges 34 and 44, and, hence, serves to protect the flangeplate 16, flange 18 and bolts 20 against weather, tampering, etc. In the event of a collision, the break-away bolts 20 will allow the hydrant 10 to shear off, as usual, and it will be necessary to call a water department crew to turn off the flow of water through the standpipe 14. The shearing off of the hydrant 10 will probably also result in damage to and dislocation of the upper members 26 of the base enclosure 24. However, once the water has been turned off, it is an easy matter to remove the upper members 26 and, hence, to obtain access to the flangeplate 16 to reseal and resecure the flange 18 of the hydrant 10 with the break-away bolts 20. Then, if necessary or desirable, the lower members 28 may be replaced, by simply removing the old lower members 28 and inserting the new lower members 28. New upper members 26 may then be applied, in the manner described above, in only minutes and without requiring any skilled workmen or any cement work, either for removal or replacement. Thus, the base enclosure 24 is renewed and the hydrant 10 is restored to operation, quickly and easily and at minimum cost of time and money.

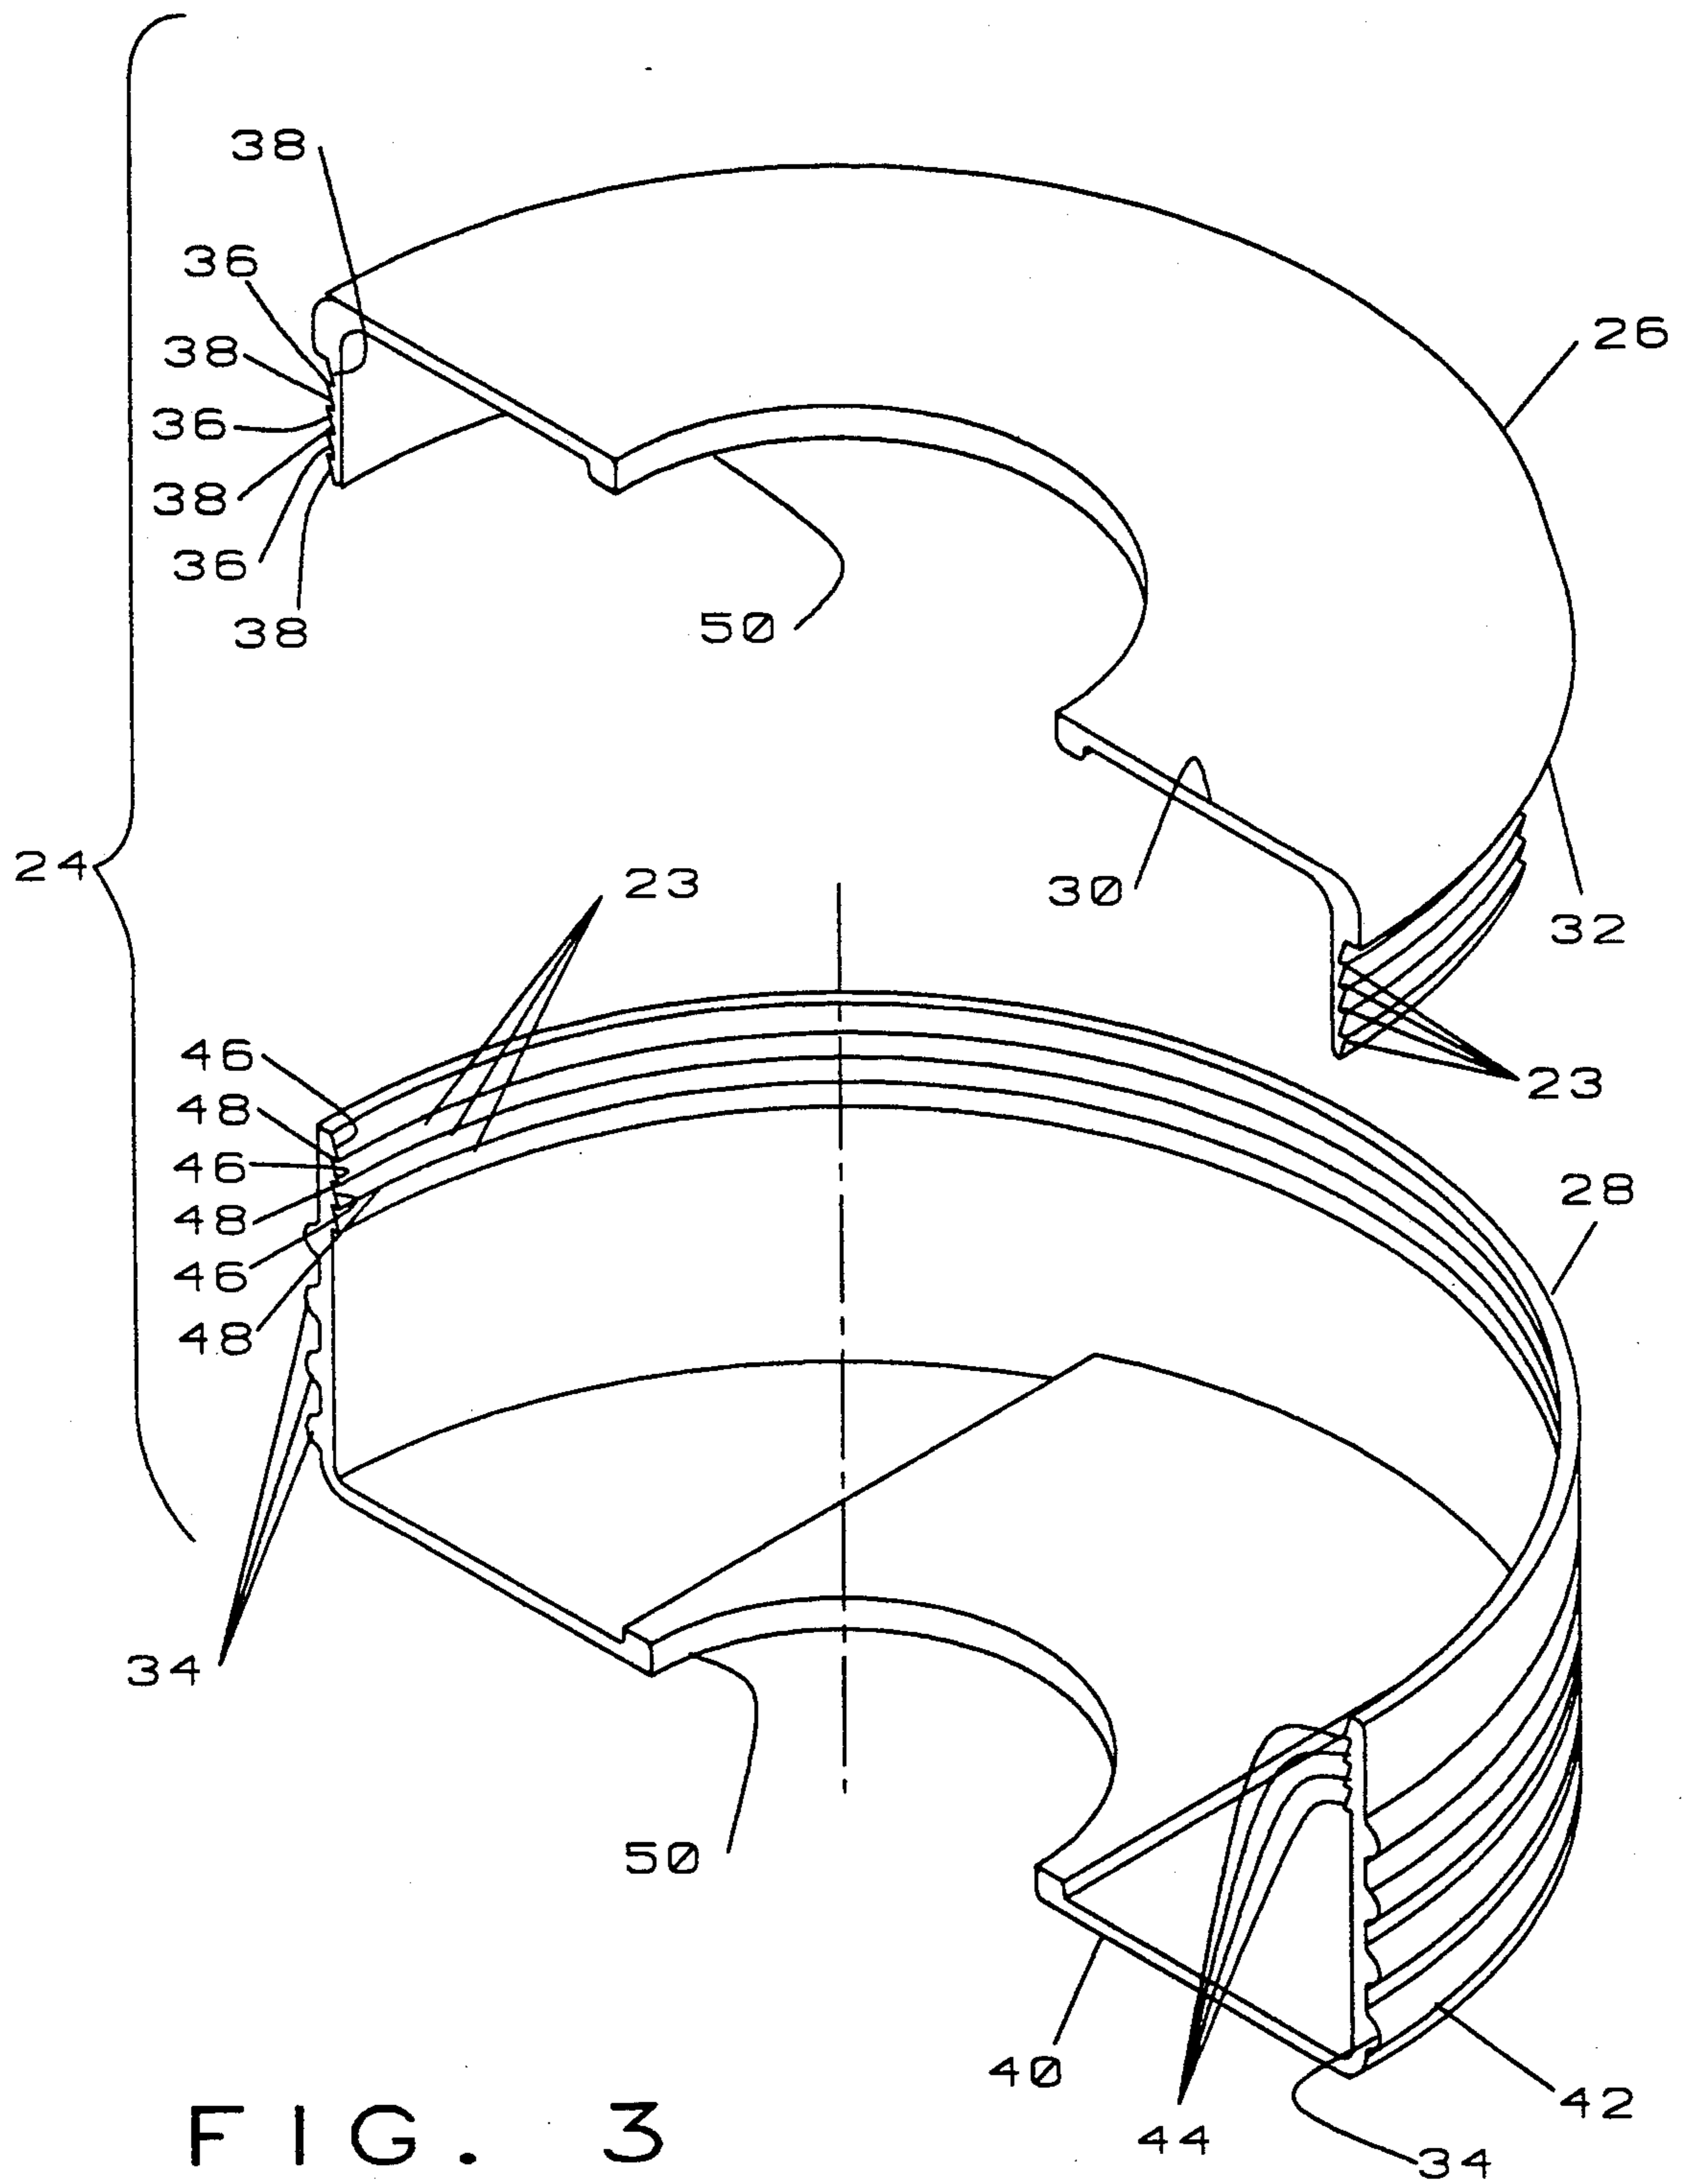
FIG. 3 is an exploded isometric view showing one upper half and one lower half of the fire hydrant base enclosure device of FIG. 2; and

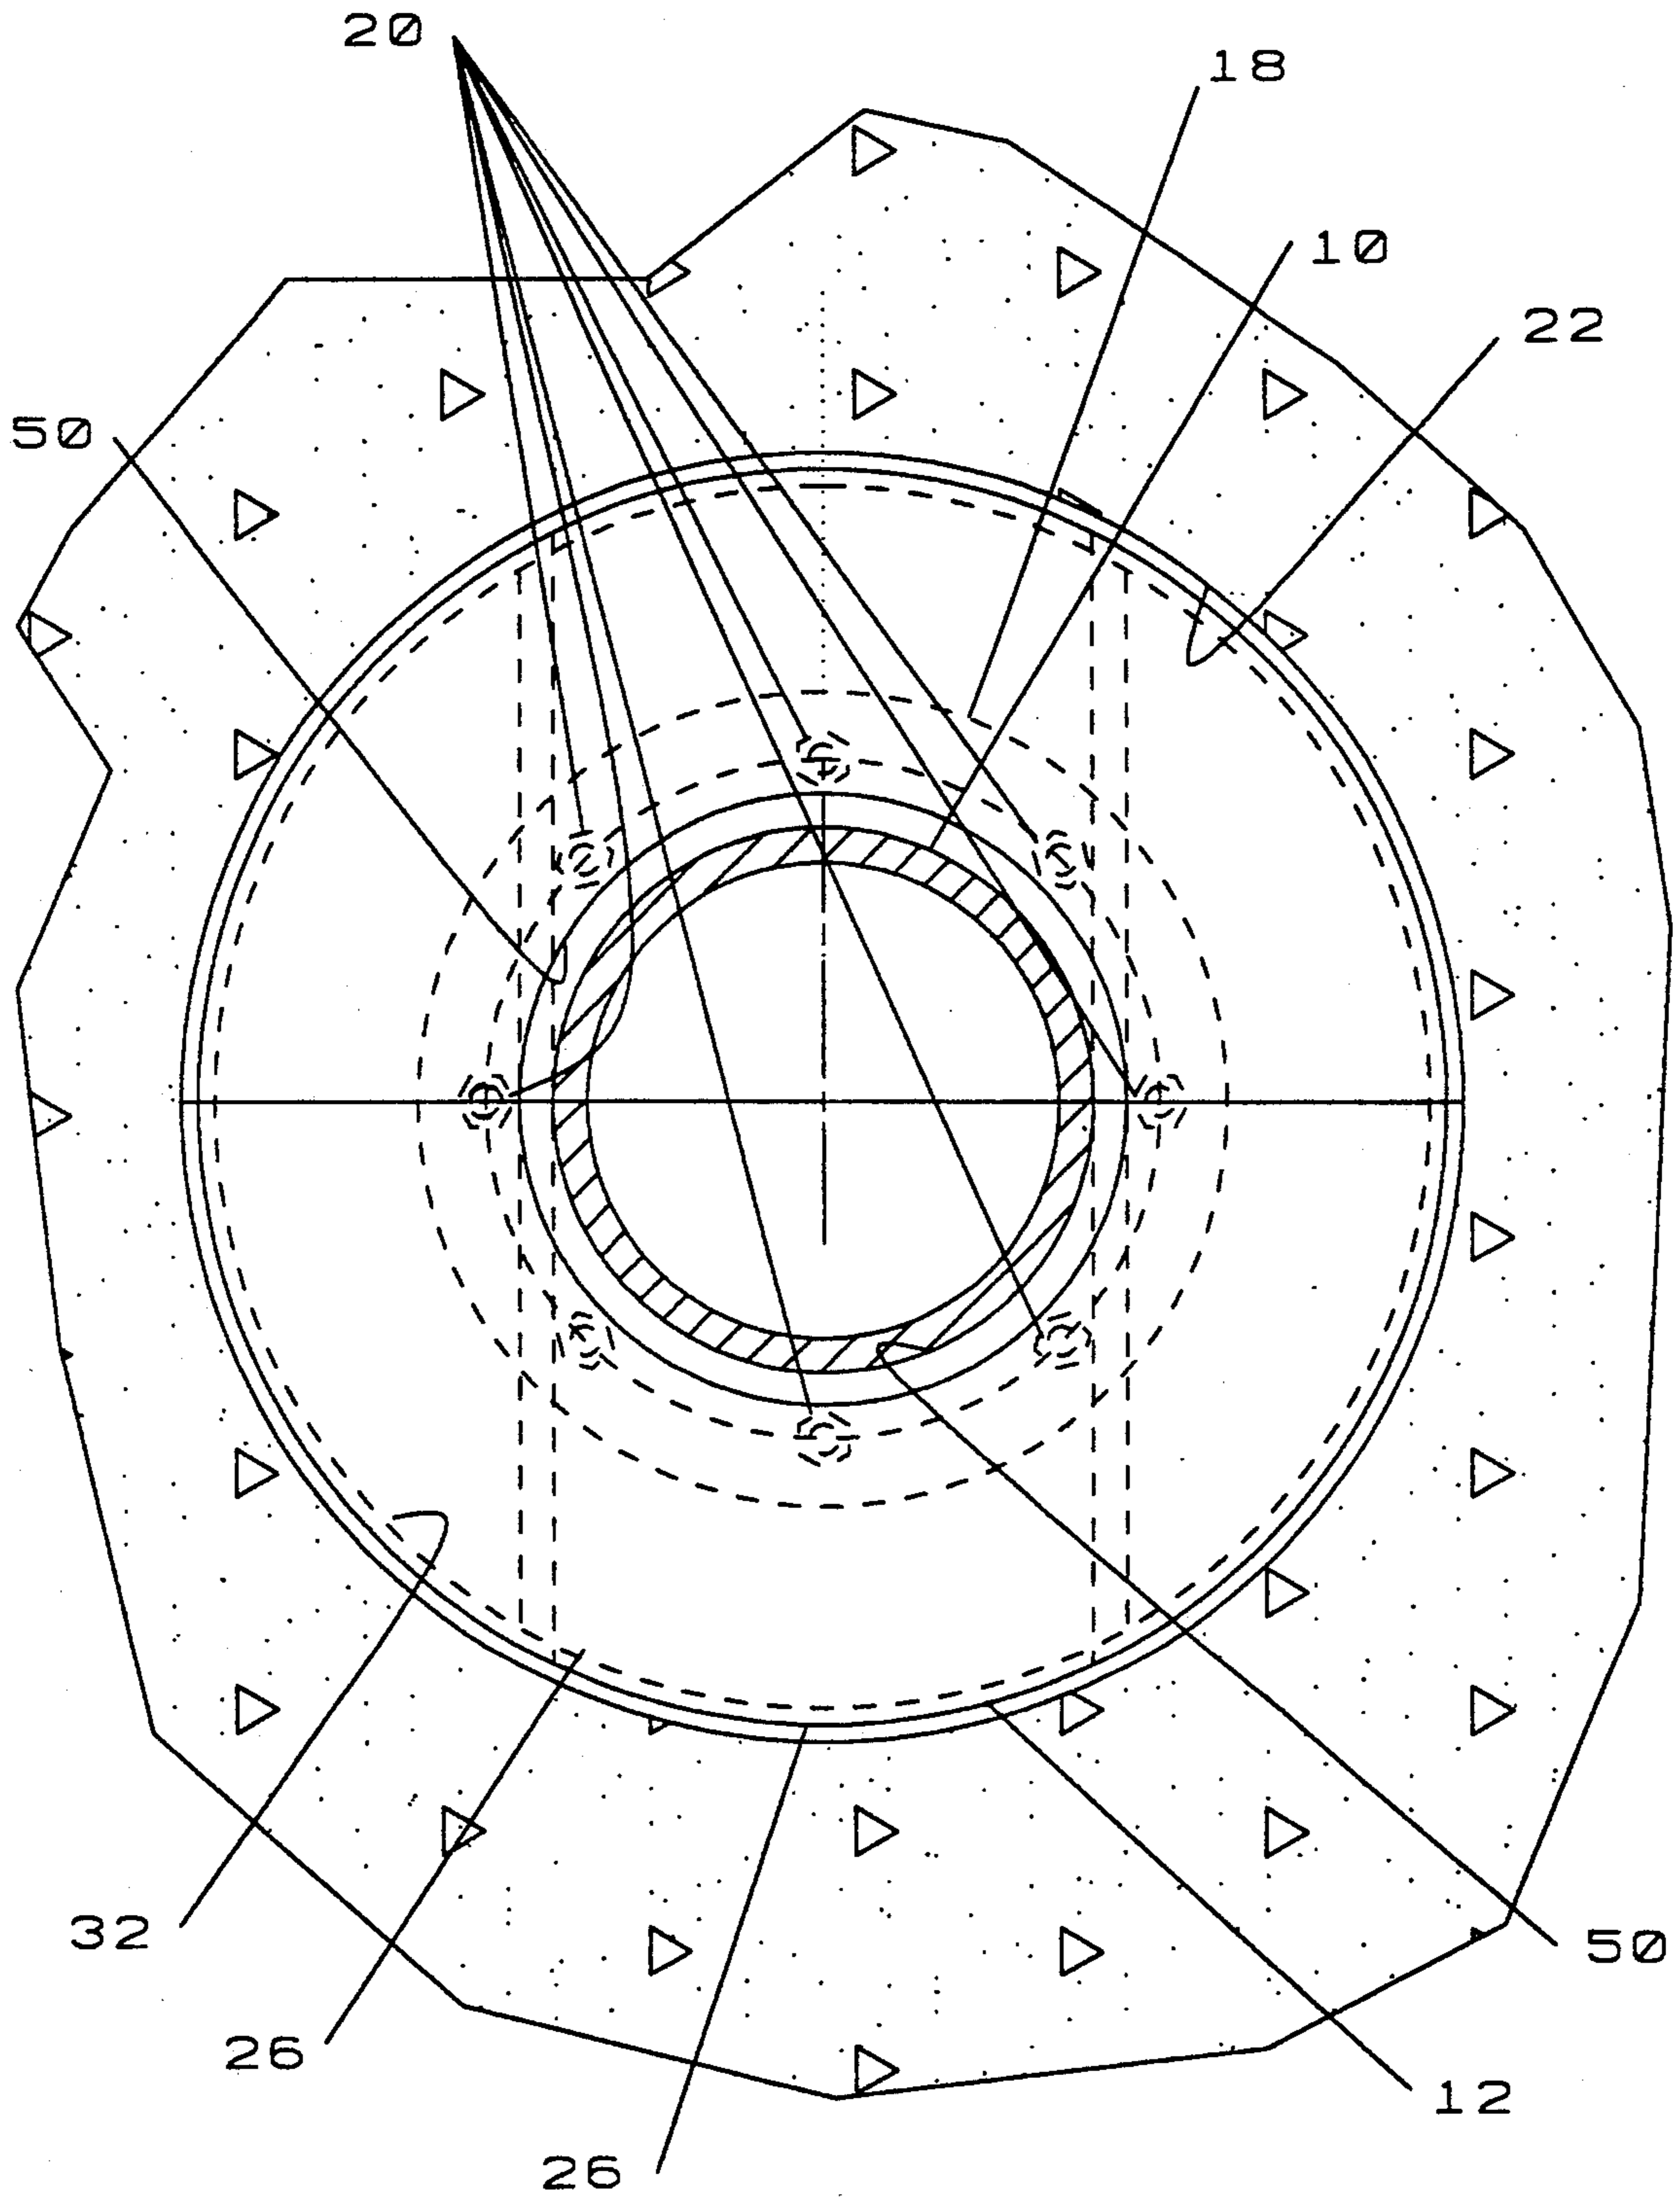
FIG. 4 is a transverse view, partly in section, taken on the line 4-4 of FIG. 2, of the fire hydrant and base enclosure of the present invention.
