US005262202A

[11] Patent Number: **5,262,202**

[54] **HEAT TREATED CHEMICALLY VAPOR DEPOSITED PRODUCTS AND TREATMENT METHOD**

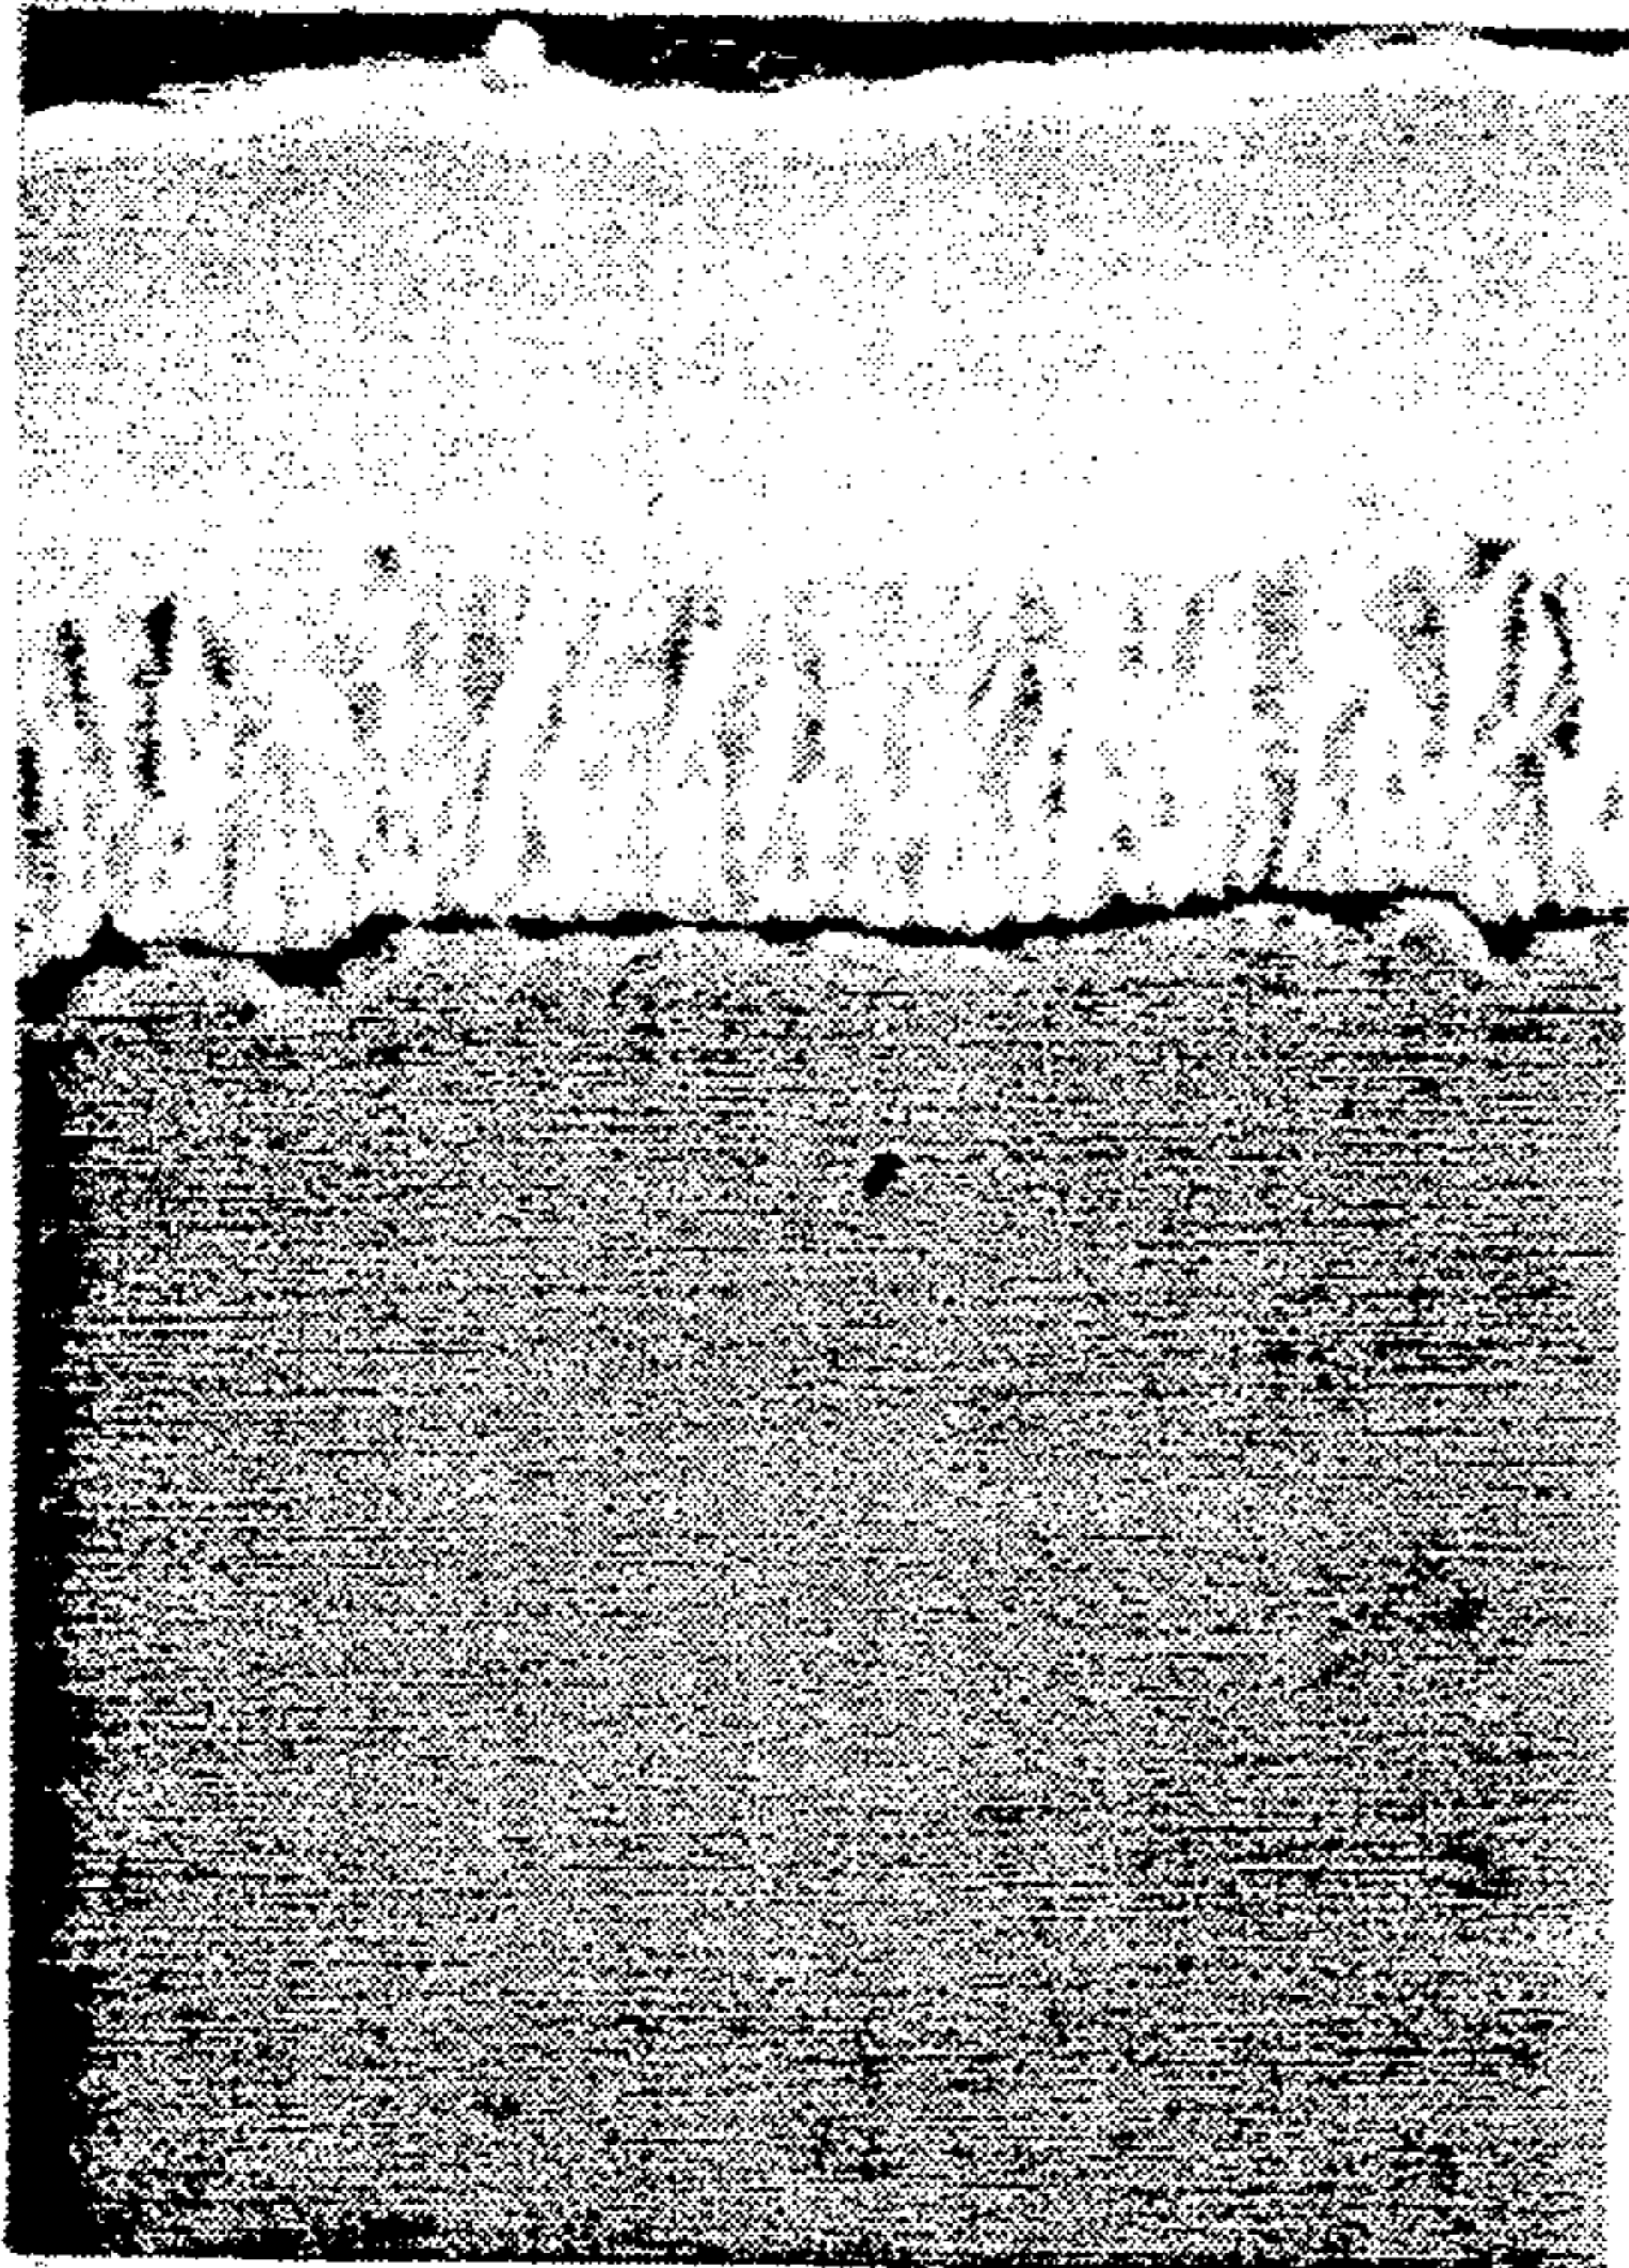
FIG. 1A is a photomicrograph, magnified 2000 times, of an etched cross section of a coating system according to the invention on AM-350 stainless steel substrate in the as-deposited and unheat-treated condition showing non-uniform microstructure in the top one-fourth thickness of the tungsten/tungsten carbide layer.

The resultant product includes an outer layer of a tungsten/tungsten carbide which has a substantially layered and uniform microstructure substantially free of cracks. By viewing FIG. 1A, the substantially layered microstructure of the deposit before heat treatment may be observed. It will also be noted that, although the deposit is substantially free of cracks, a somewhat non-uniform microstructure exists in the outer 25% of the tungsten/tungsten carbide layer. As may be seen in FIG. 2A, the heat treatment removes this non-uniformity. Moreover, the data set out below demonstrate that the outer layer furthermore has a substantially higher erosion and abrasion wear resistance than in the unheat-treated condition.
