US005276401A

[11] Patent Number: **5,276,401**

[54] **METHOD FOR DIAGNOSING AN INSULATION DETERIORATION OF AN ELECTRIC APPARATUS**

[73] Assignee: **Hitachi Cable, Ltd.**, Tokyo, Japan

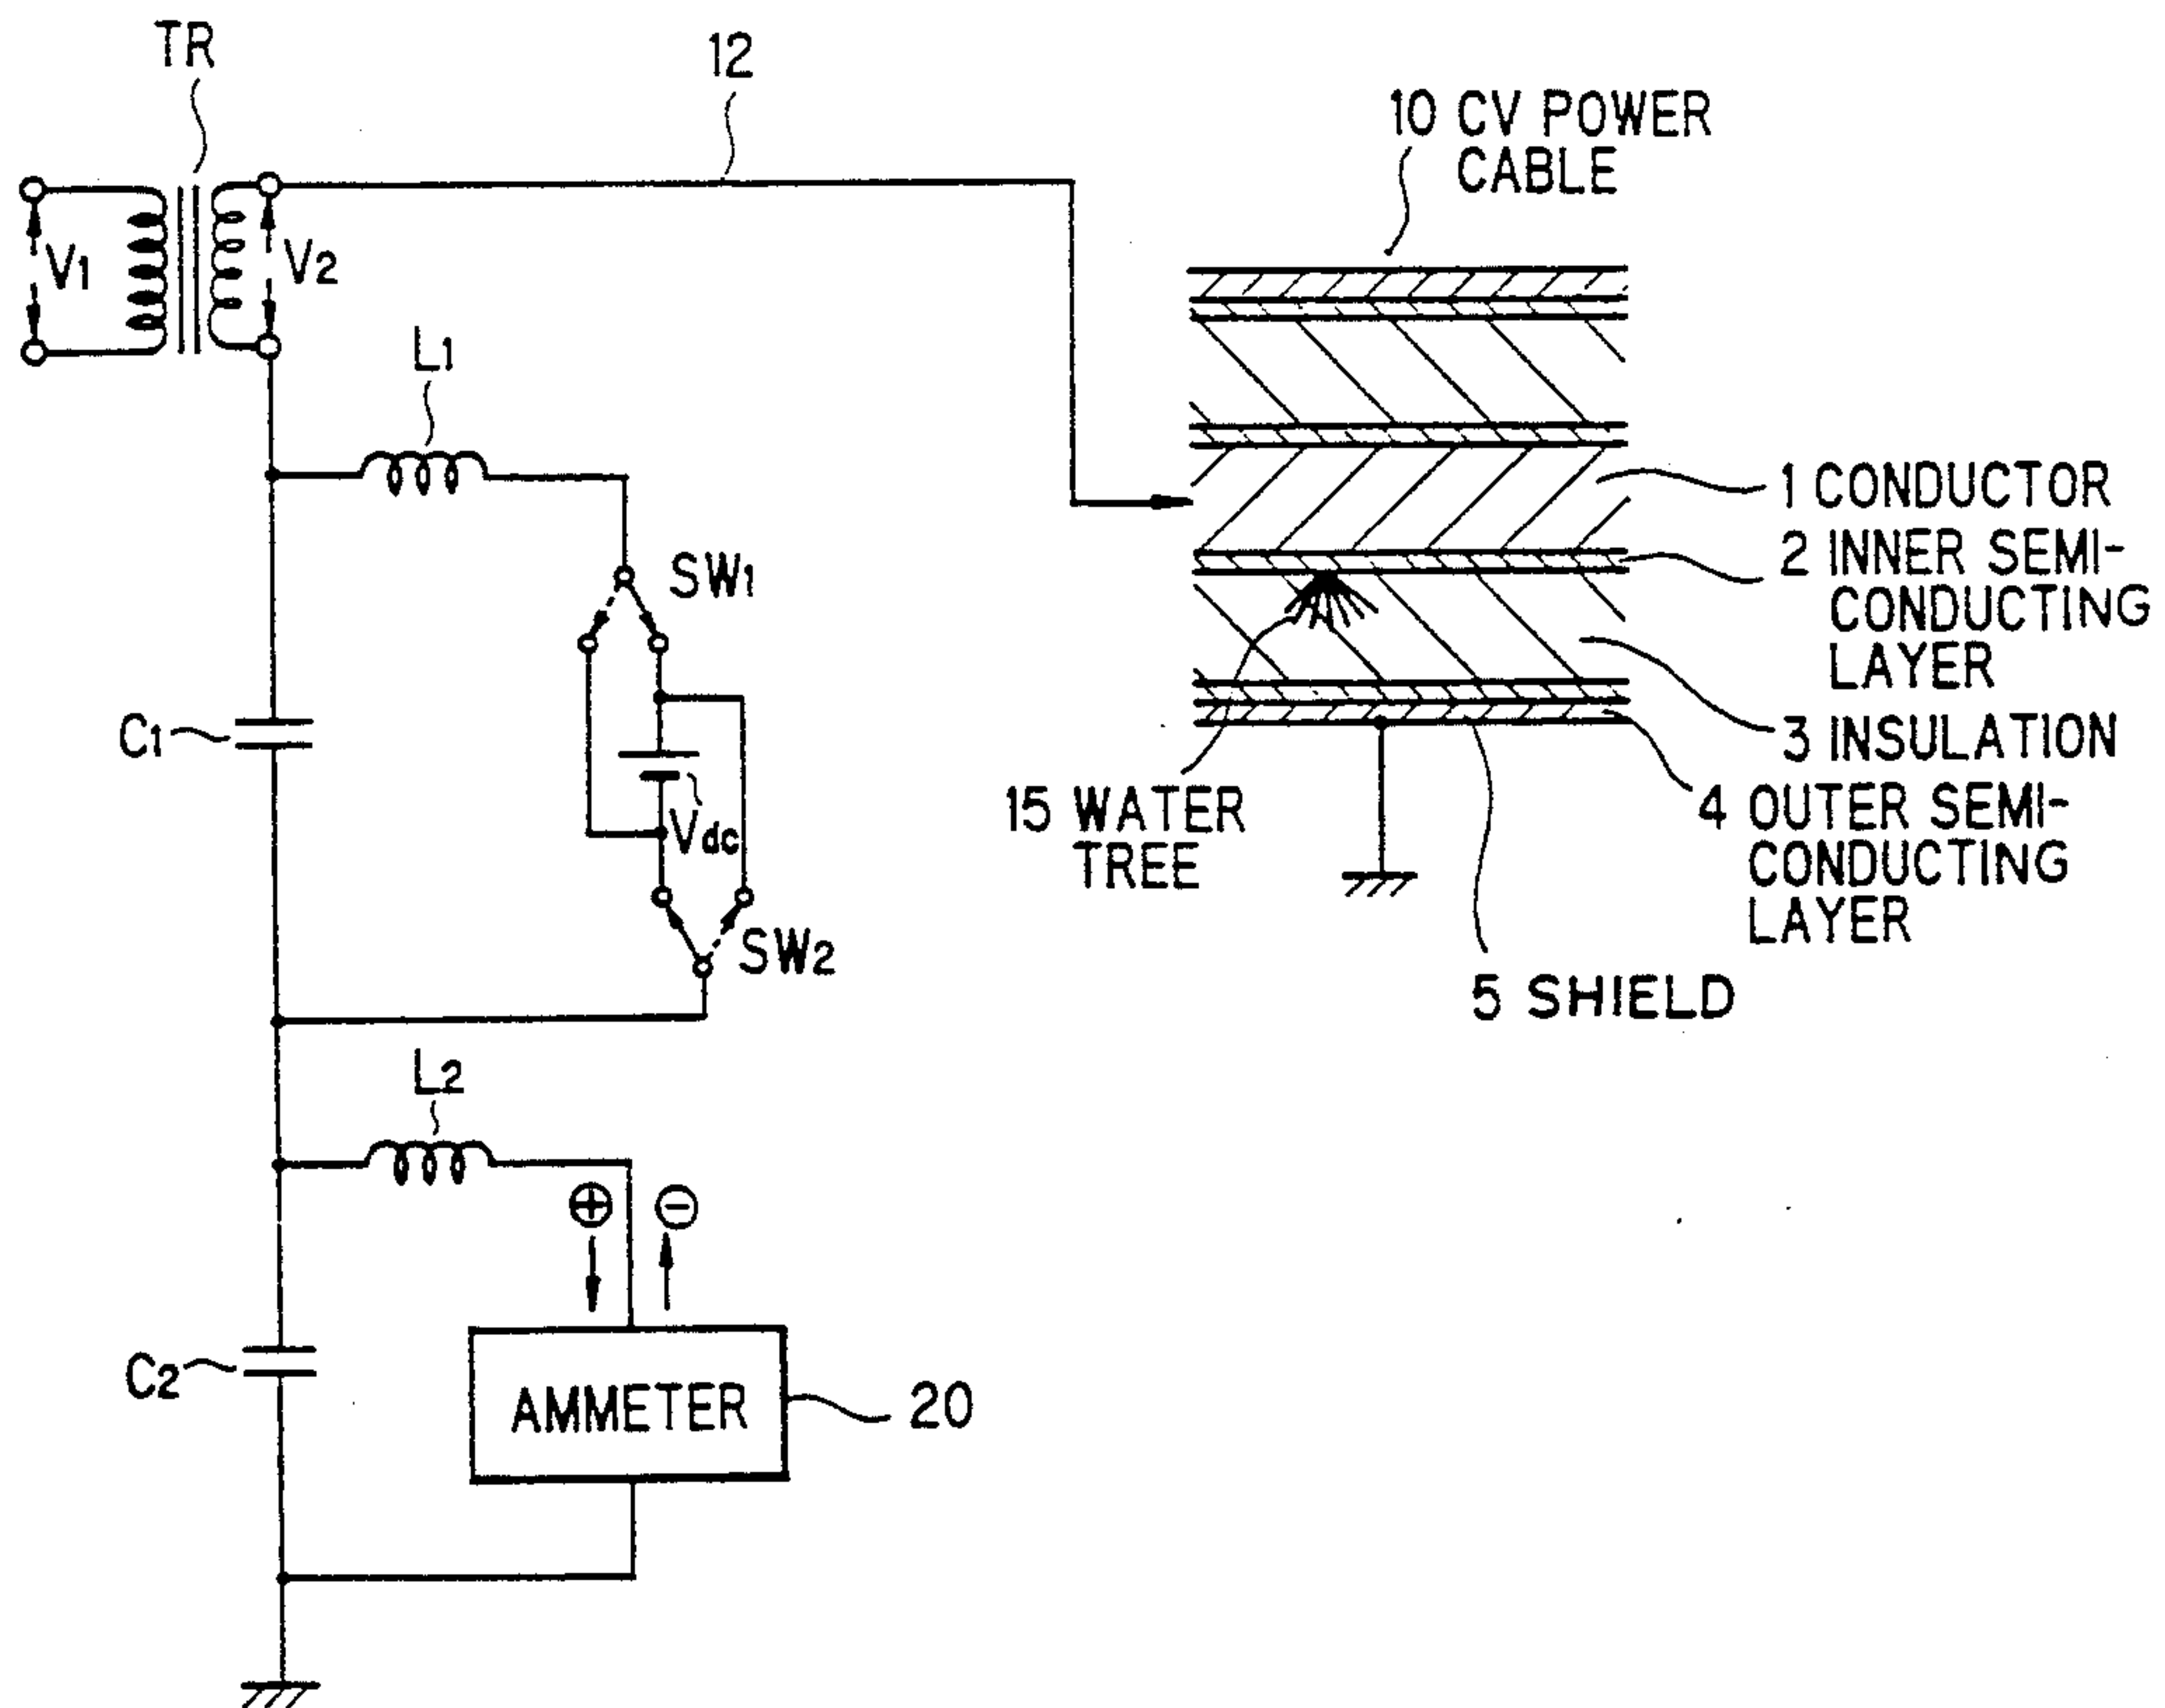
FIG. 1 is a circuitry diagram showing a method for diagnosing an insulation deterioration of a CV power cable in a preferred embodiment according to the invention;

FIG. 1 shows a method for diagnosing an insulation deterioration of a CV cable 10 having a water tree 15 in a cross-linked polyethylene insulation 3 in the preferred embodiment according to the invention. A circuit for detecting a direct current component flowing through the insulation 3 comprises a transformer TR for apply-

ing an AC voltage V_2 which is obtained from an AC voltage V_1 through a lead 12 to a conductor 1 of the CV cable 10, capacitances C_1 and C_2 provided between a secondary winding of the transformer TR and ground, a DC voltage biasing circuit including a blocking coil L_1 , a DC power supply V_{dc} , and switches SW_1 and SW_2 for changing a polarity of a bias DC voltage, and a direct current component detecting circuit including a blocking coil L_2 and an ammeter 20. The CV cable 10 comprises a conductor 1, an inner semiconductive layer 2 provided on the conductor 1, the cross-linked polyethylene insulation 3, an outer semiconducting layer 4 provided on the insulation 3, and a metal shield 5 connected to ground. A polyvinylchloride anti-corrosion layer provided on the metal shield 5 is not shown in FIG. 1. Here, it is assumed that a polarity of a direct current component is positive, when the direct current component flows from the metal shield 5 to the conductor 1. The polarity is shown in FIG. 1 by the symbols \oplus and \ominus .

The detection of a direct current component and an amplified direct current component is carried out on the CV cable 10 which has been installed at an installation site in the same manner as the operation in FIG. 1. Then, the CV cable is removed from the installation site, and is subject to an AC voltage breakdown test. The length of water trees found in an insulation of the removed CV cable is measured. The results are shown in TABLE 1.

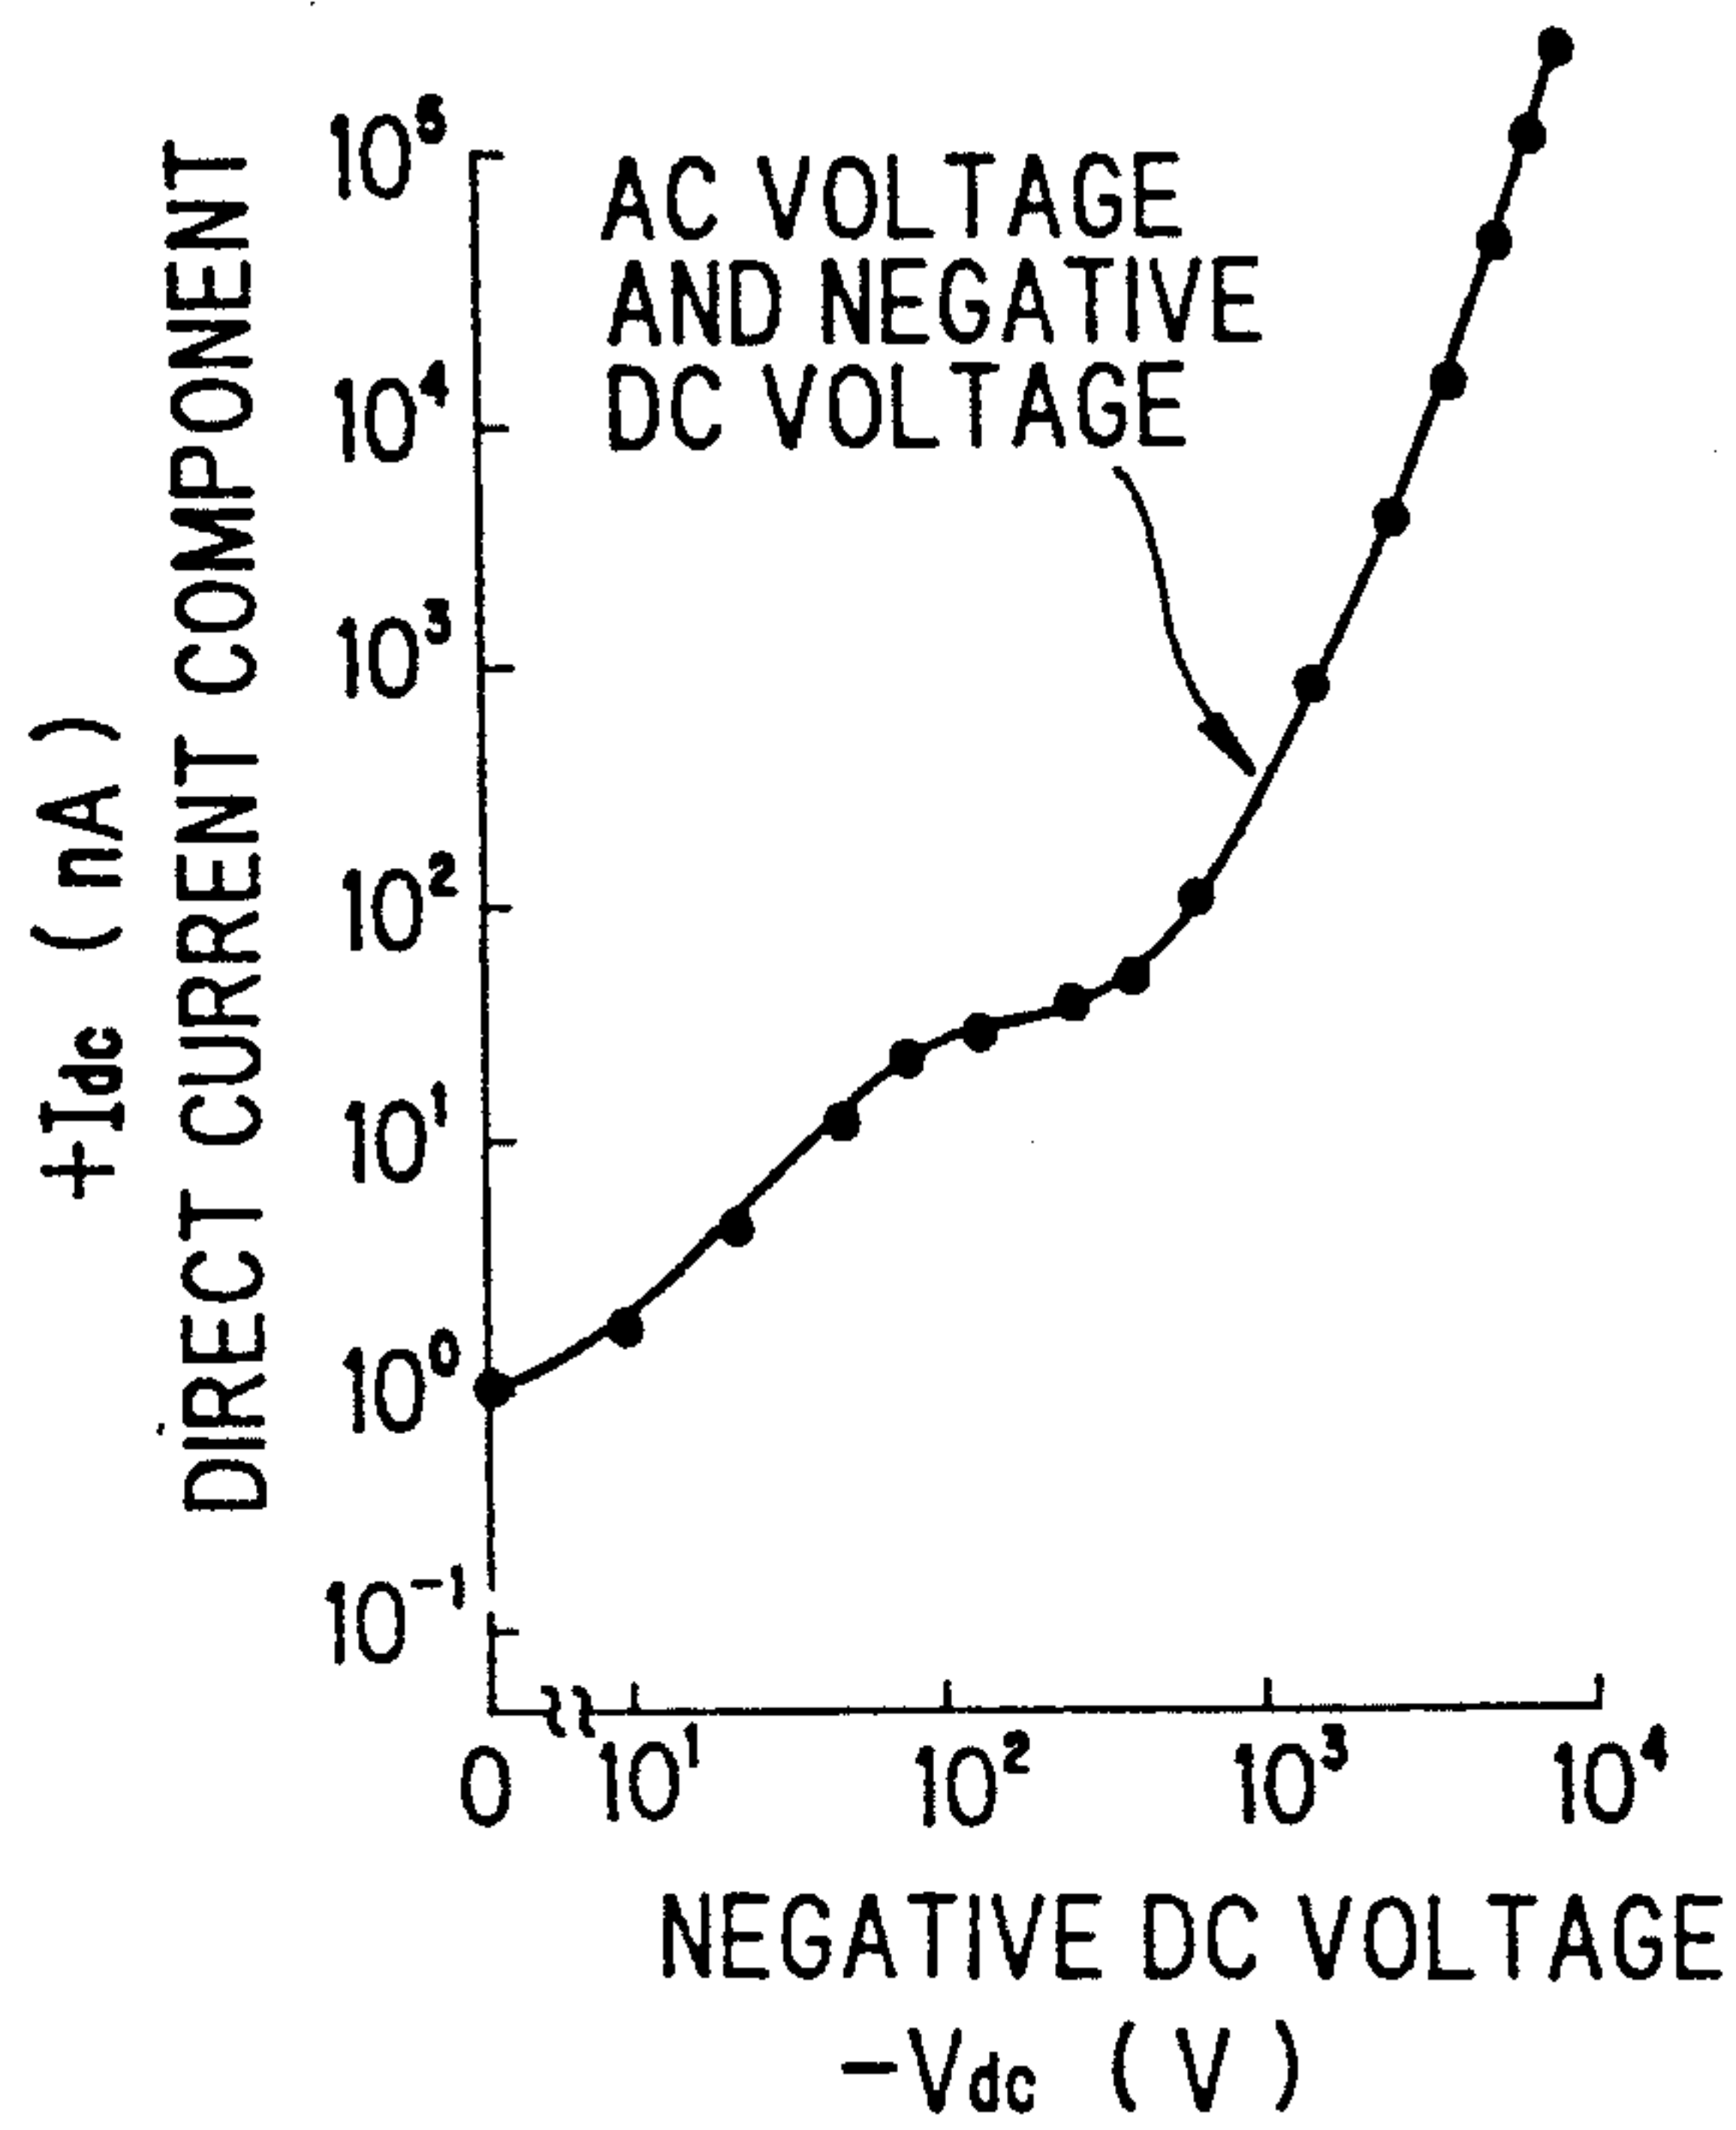
FIGS. 2A and 2B are graphs explaining a relation between an amplified direct current component and a bias DC voltage, and

FIG. 2A shows an amplified direct current component I_{dc} , when a negative bias voltage $-V_{dc}$ is applied to the conductor 1, that is, the switches SW_1 and SW_2 are turned on by the dotted lines. The direct current component I_{dc} increases with a relatively

complicated motion, as the negative bias voltage $-V_{dc}$ increases in its absolute value. When the negative bias voltage $-V_{dc}$ is -1000 V, the direct current component I_{dc} is amplified by two to three figures, as compared to a direct current component flowing through the insulation 3 only by the application of an AC voltage.

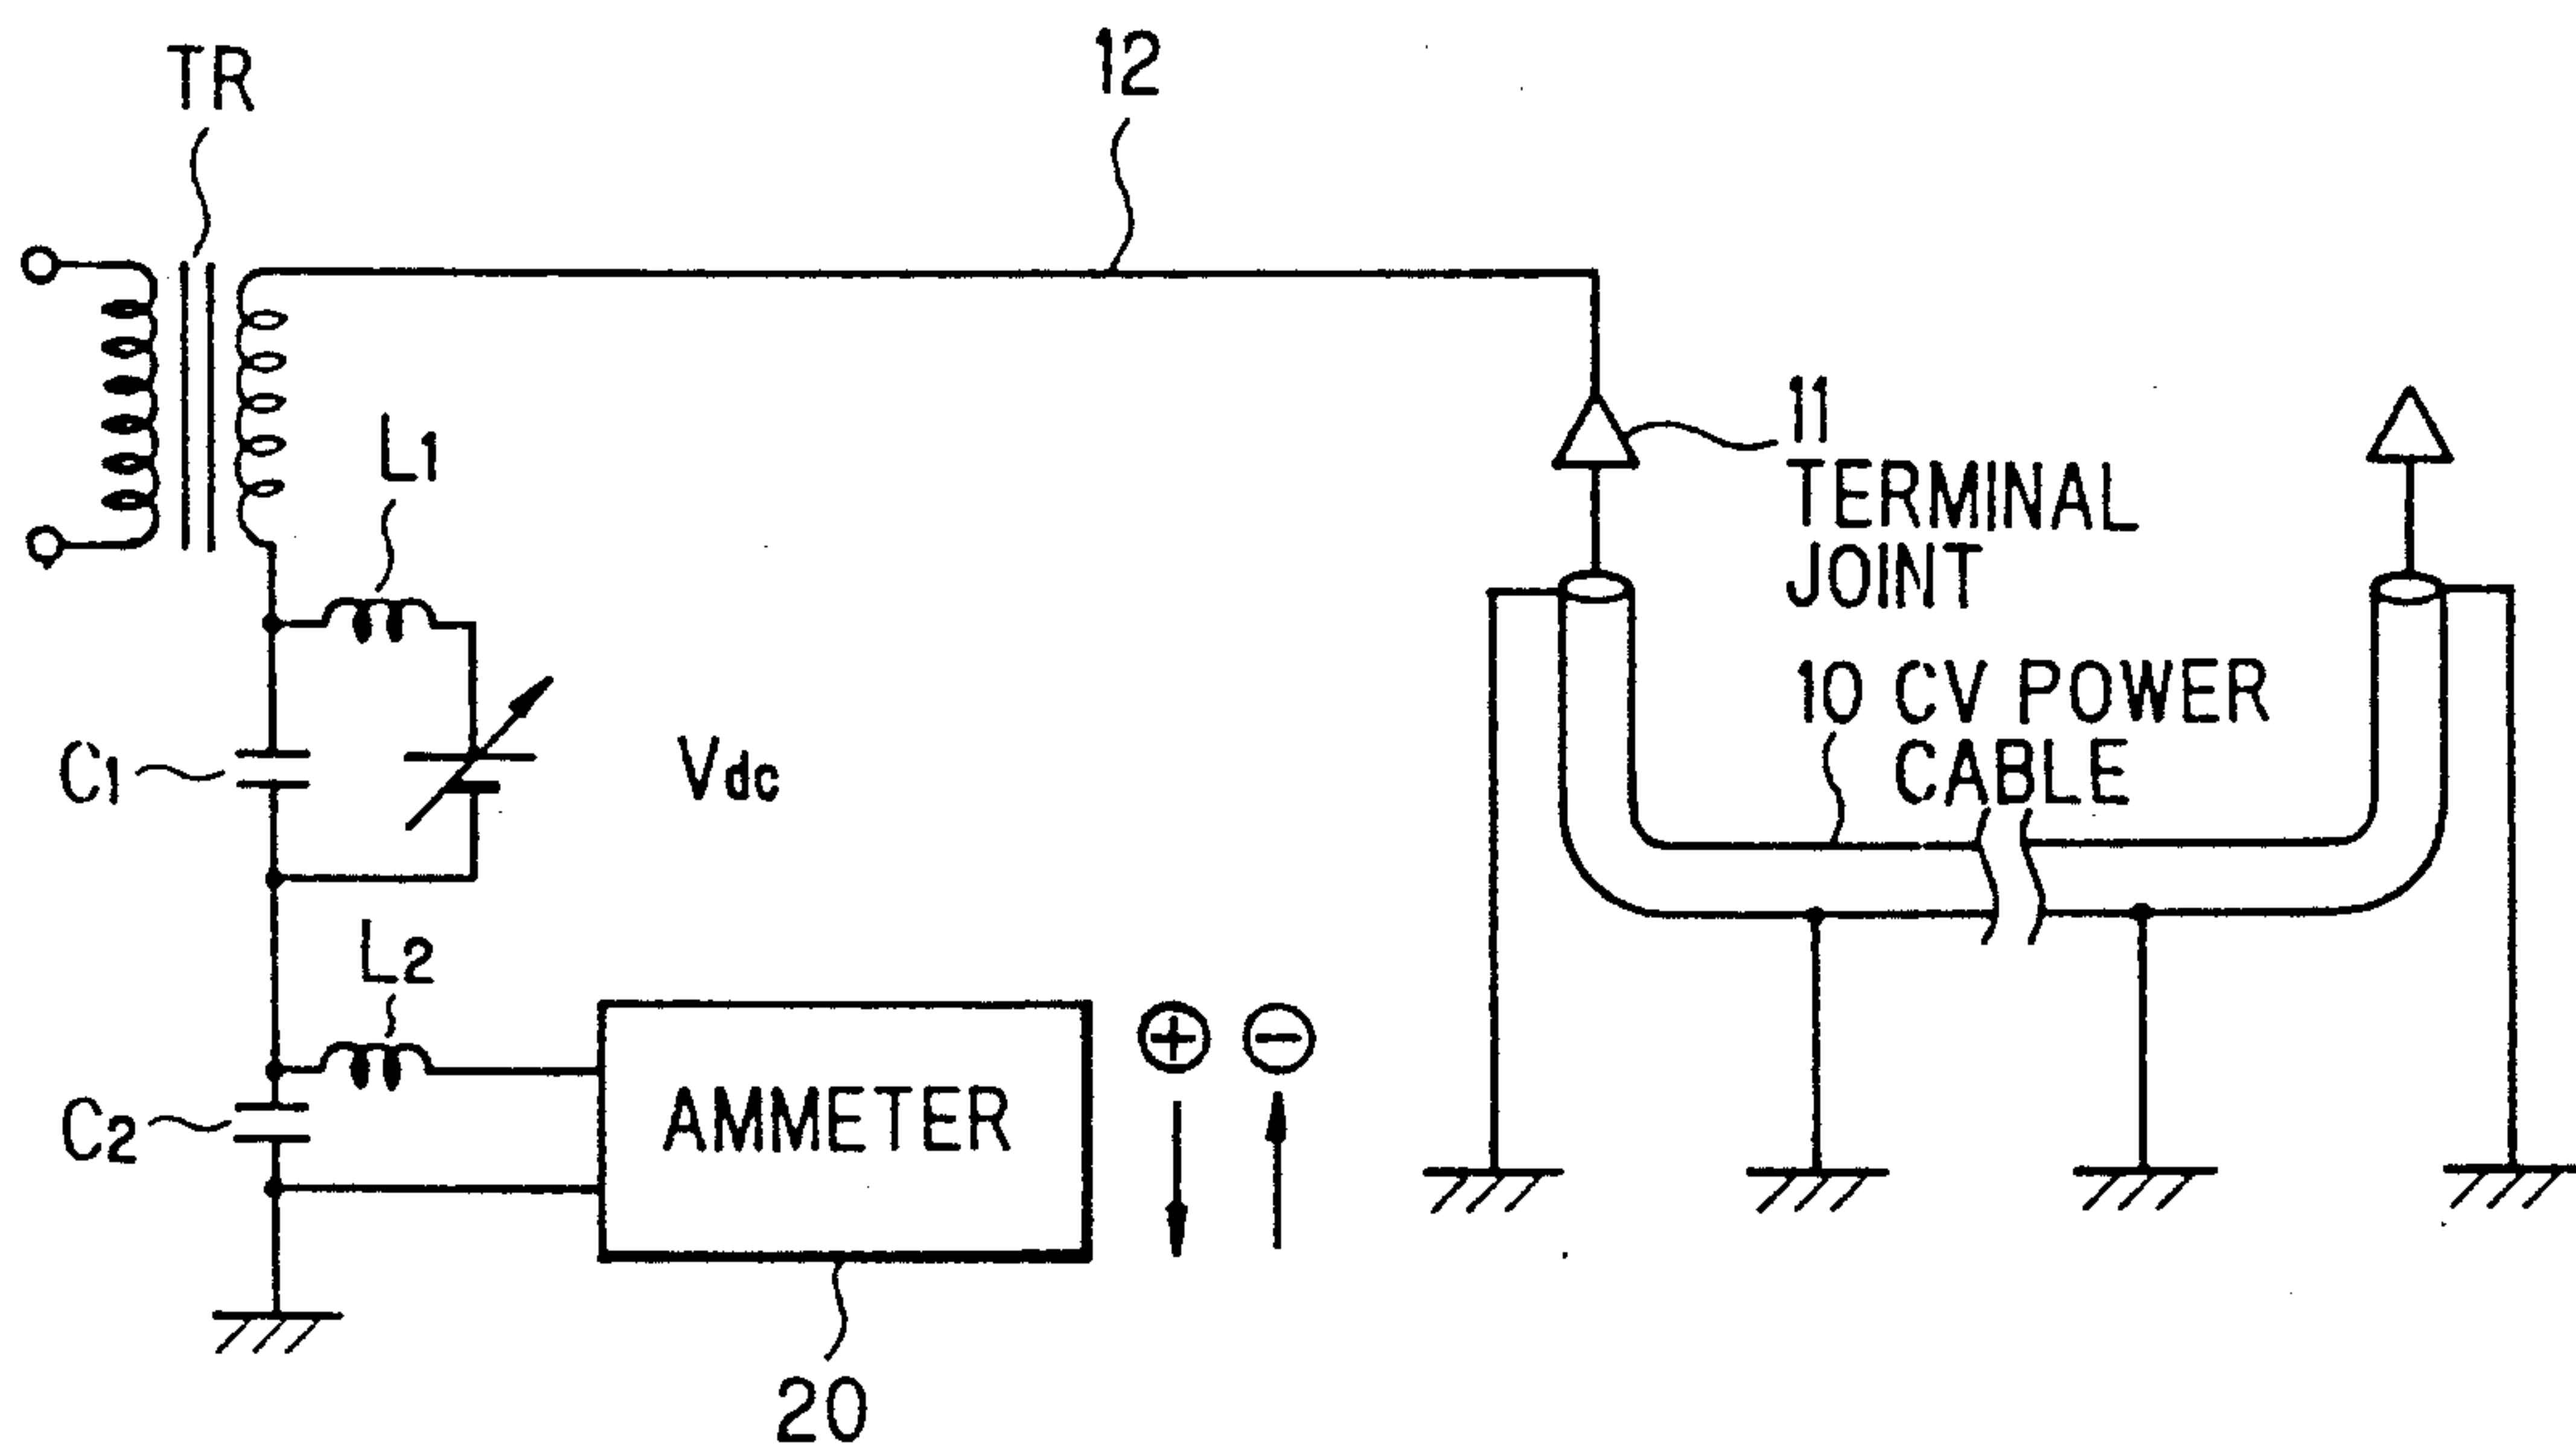
FIG. 3 is an explanatory diagram illustrating the method of the preferred embodiment applied to a CV cable system.

FIG. 3 shows a method for diagnosing an insulation deterioration of a CV cable 10 which is connected at multi-points to ground. In this method, a conductor of the CV cable 10 is connected through a lead 12 to a transformer TR by a terminal joint 11. The transformer TR is connected through serial capacitances C_1 and C_2 to ground, and a DC bias voltage applying circuit including a blocking coil L_1 and a DC power supply V_{dc} and a direct current component detecting circuit including a choke coil L_2 and an ammeter 20 are connected in parallel to the capacitances C_1 and C_2 , respectively.
