[11] Patent Number: **5,327,633**

[54] METHOD OF REPAIRING VEHICLE SUN VISORS

A method for restoring worn or damaged sun visors for a vehicle to a like-new appearance typical of original sun visors. Any deteriorated upholstery and padding material that covers the core/frame of an original sun visor may be removed and discarded. A new cover is fabricated with an appropriate size to slip over the old visor. The cover is made by sewing together front and rear panels along about 50 percent of their juxtaposed edges. Each panel is shaped like the original core, and has a structural base made of a thin sheet of chipboard or the like; each panel is sufficiently stiff as to be self-supporting. Each panel is cosmetically completed by providing it with an outer covering of finished upholstery material or the like. The slip cover may be placed about a visor core, or about an entire visor, to provide a new outer surface. Once the new slip cover has been slipped over the visor core, the confronting edges along that part of the cover that is still open are then secured to one another, preferably with a fastener like Velcro. This permits the new slip cover to be removed at a later time, if desi

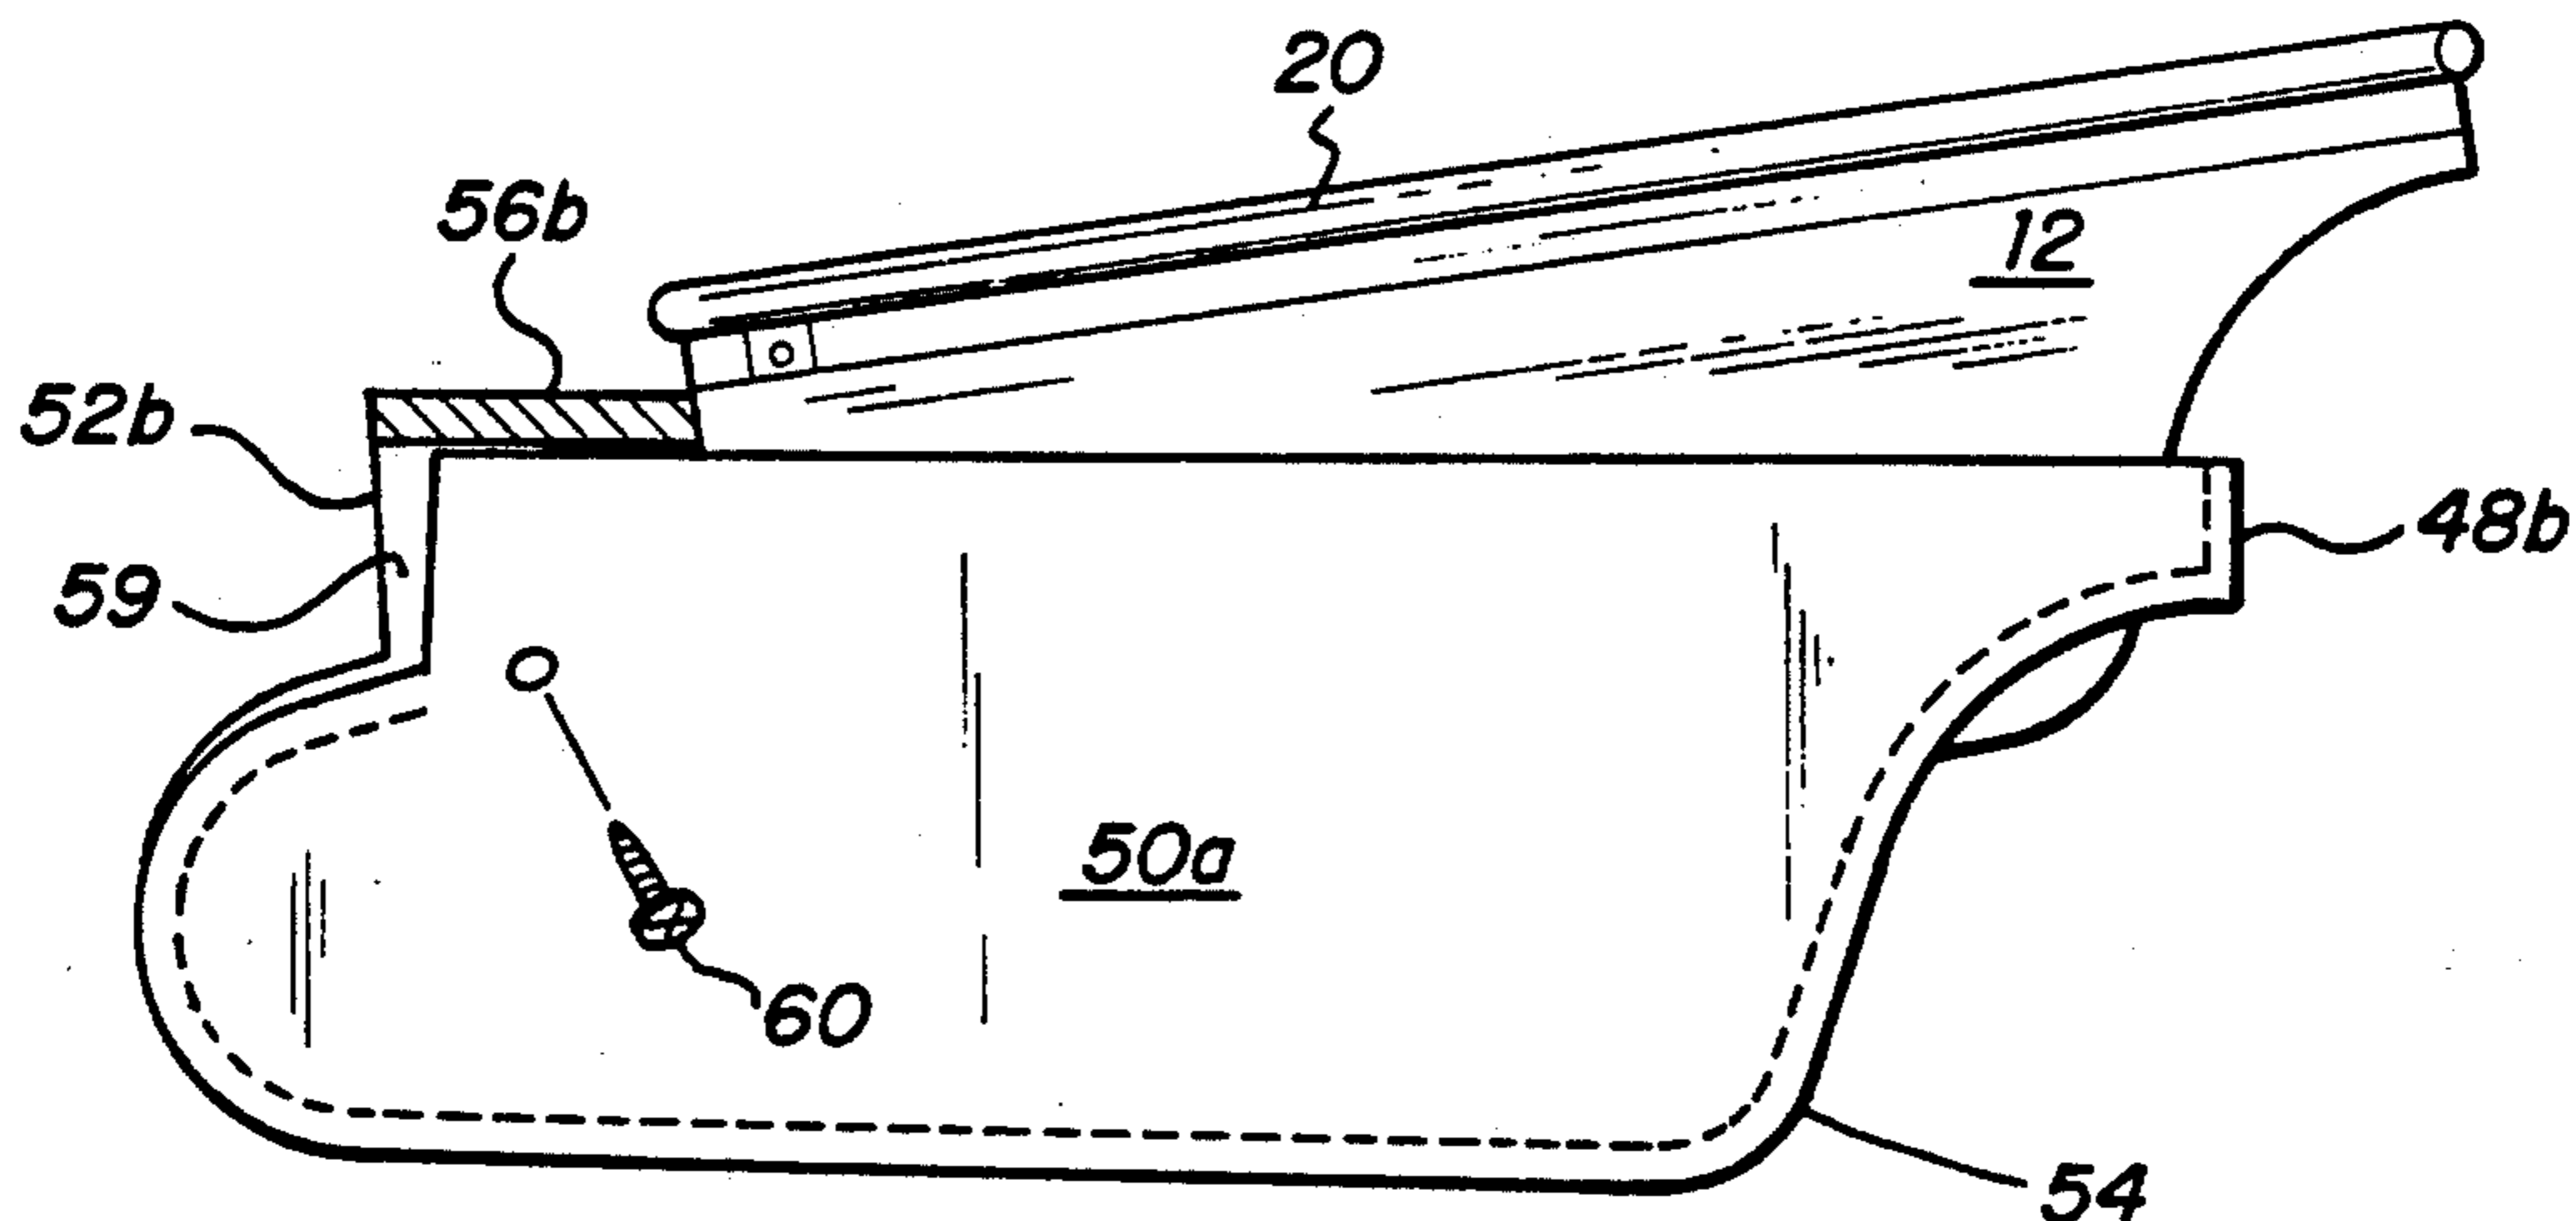
FIG. 1 provides a partially broken-away perspective view of an exemplary original equipment sun visor;

FIG. 2 is a second partially broken-away perspective view further illustrating composition of the original equipment sun visor;

FIGS. 1 and 2 illustrate in perspective view a automotive vehicle sun visor 10 of a variety that was common on several new U.S. vehicles during the 1970's. This particular design incorporates design and manufacturing features which have made it difficult for skilled craftsmen to restore a worn visor to the appearance of an original product. The visor 10 includes a core 12 formed with hard board material which is covered with padding 14; the padding is, in turn, covered with an attractive finish material 16 (usually cloth) whose color has been selected to coordinate with the decor of the vehicle's interior.

A support rod 18 is secured along the upper edge of the core 12 through a stamped metal hinge 20. At its proximal end, the rod 18 is pivotally connected to the body header through a mounting bracket (not illustrated). With this arrangement a vehicle occupant can rotate the visor about the hinge 20 from a raised, storage position against the body header to a low, sun-blocking position. Also, pivotal movement about the mounting bracket allows for swinging the visor from a position adjacent the upper windshield edge to the side window of the vehicle.

A step in the original fabrication process for a visor 10 is the folding of the padding 14 and finish material 16 about the core 12 and hinge 20. Open ends of the folded materials meet below the lower edge of the core 12. As illustrated, these ends are stitched together, beginning at a point below one end of the hinge 20 and extending to a point below the other end of the hinge 20. The resulting seam is spaced from the hinge ends to leave openings 22 in order for the support rod to pass through the visor 10. To provide a neat appearance to the finished product, a flap of excess material (not shown) is often tucked into each opening and the stitch is sewn through a bead 24.

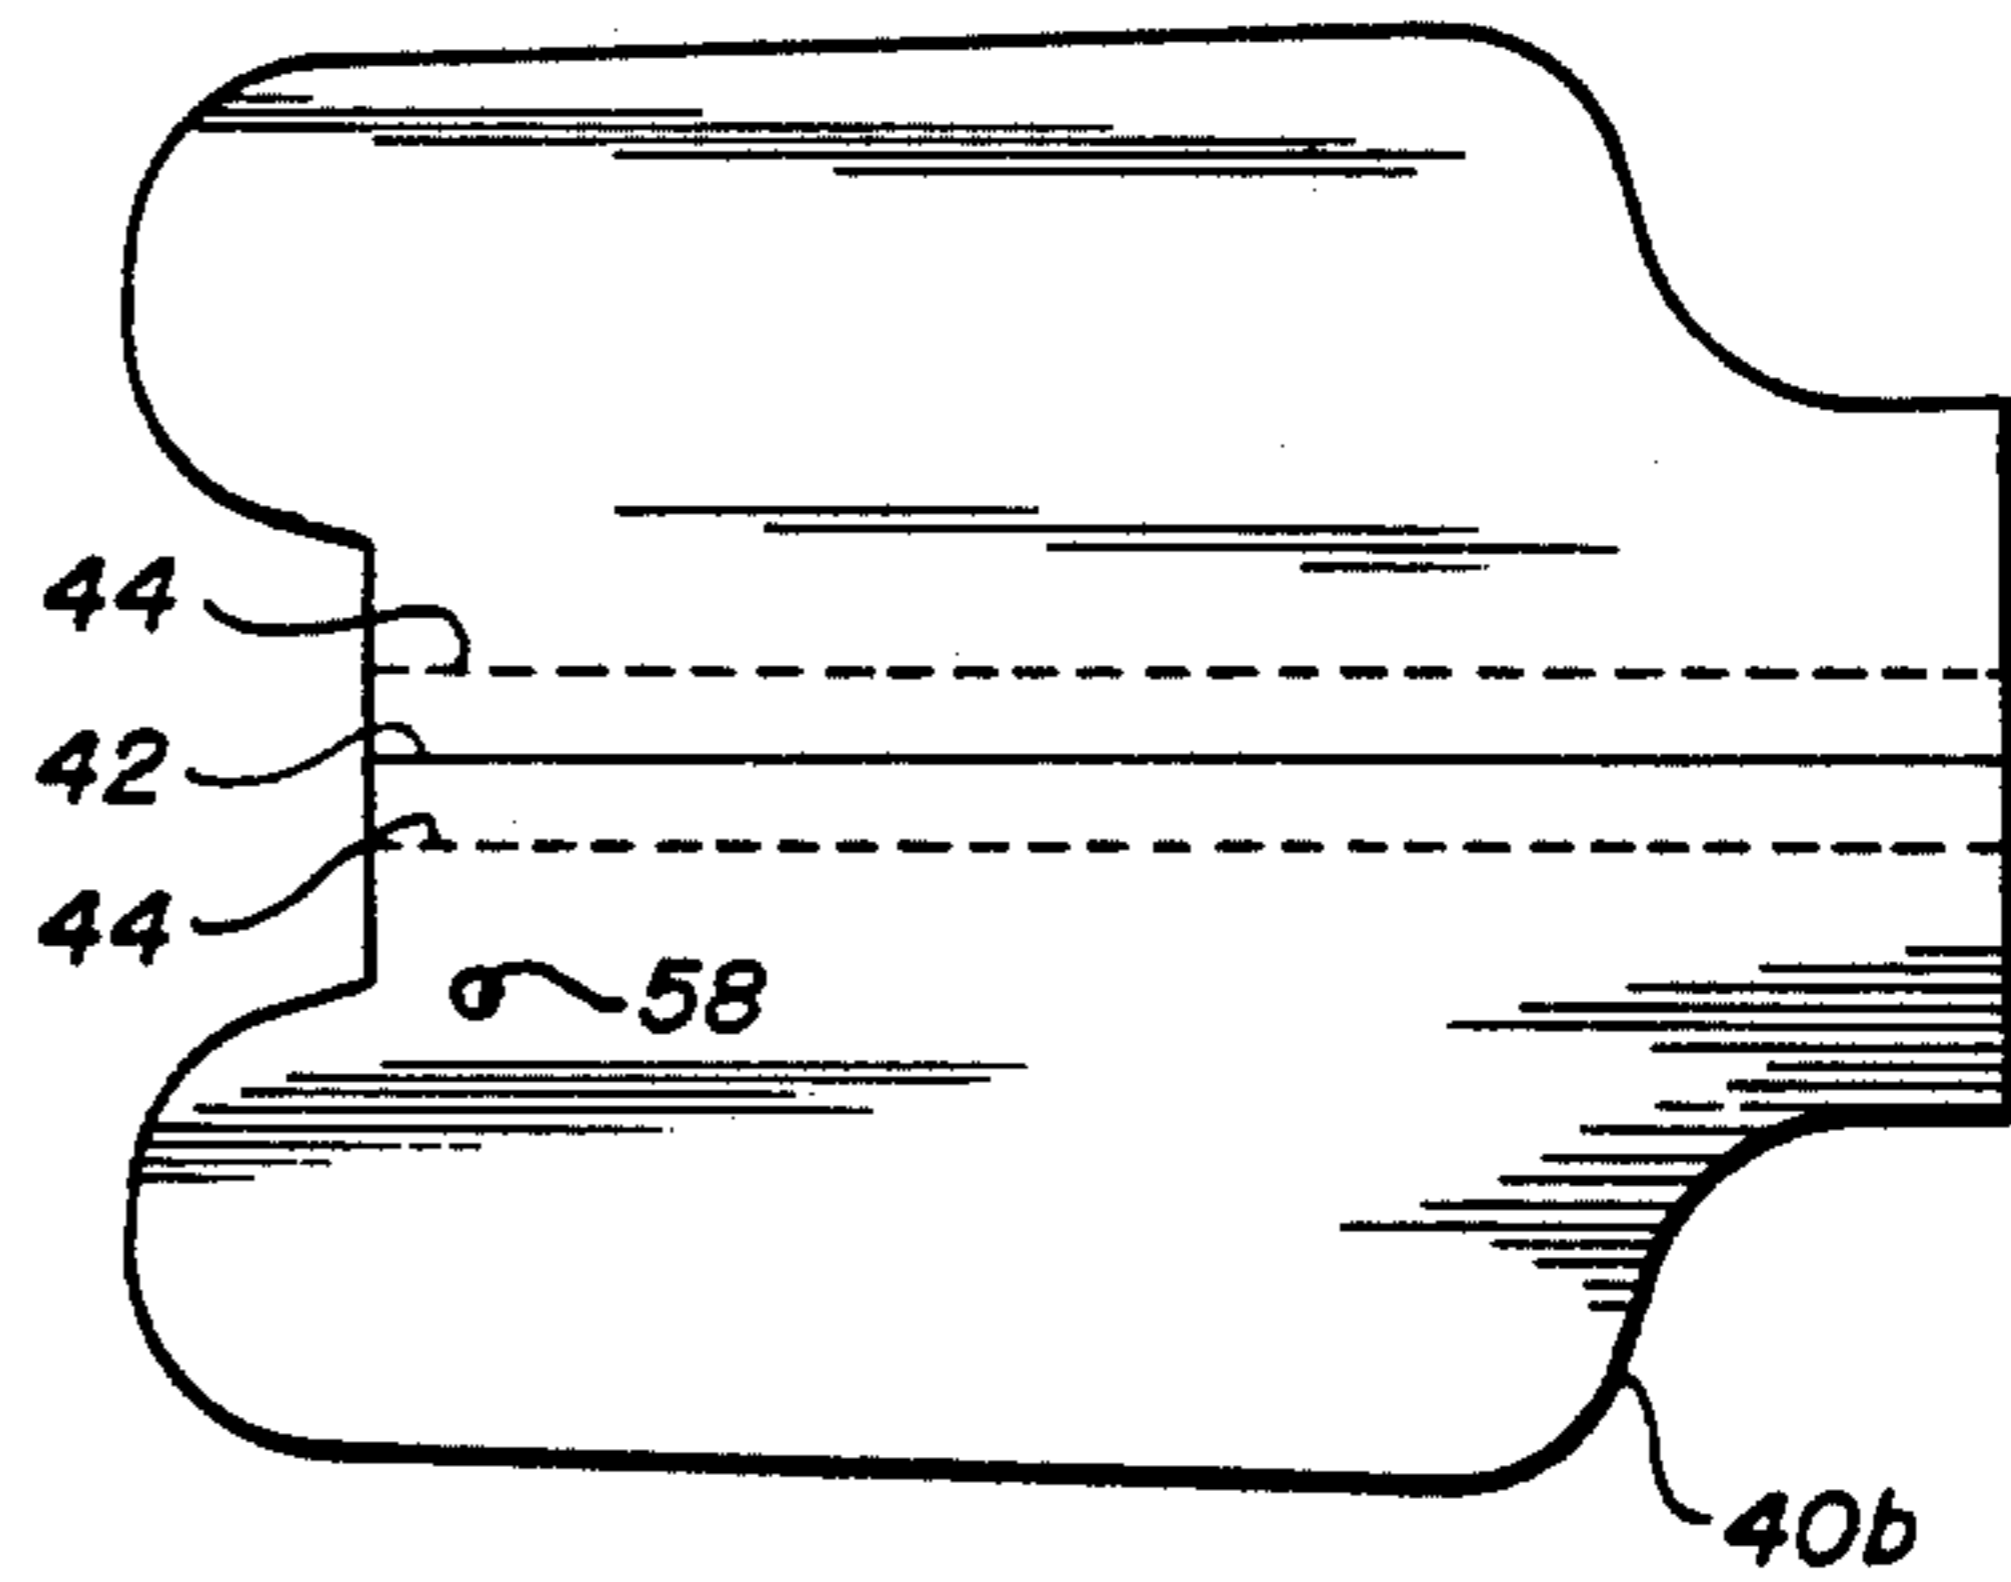
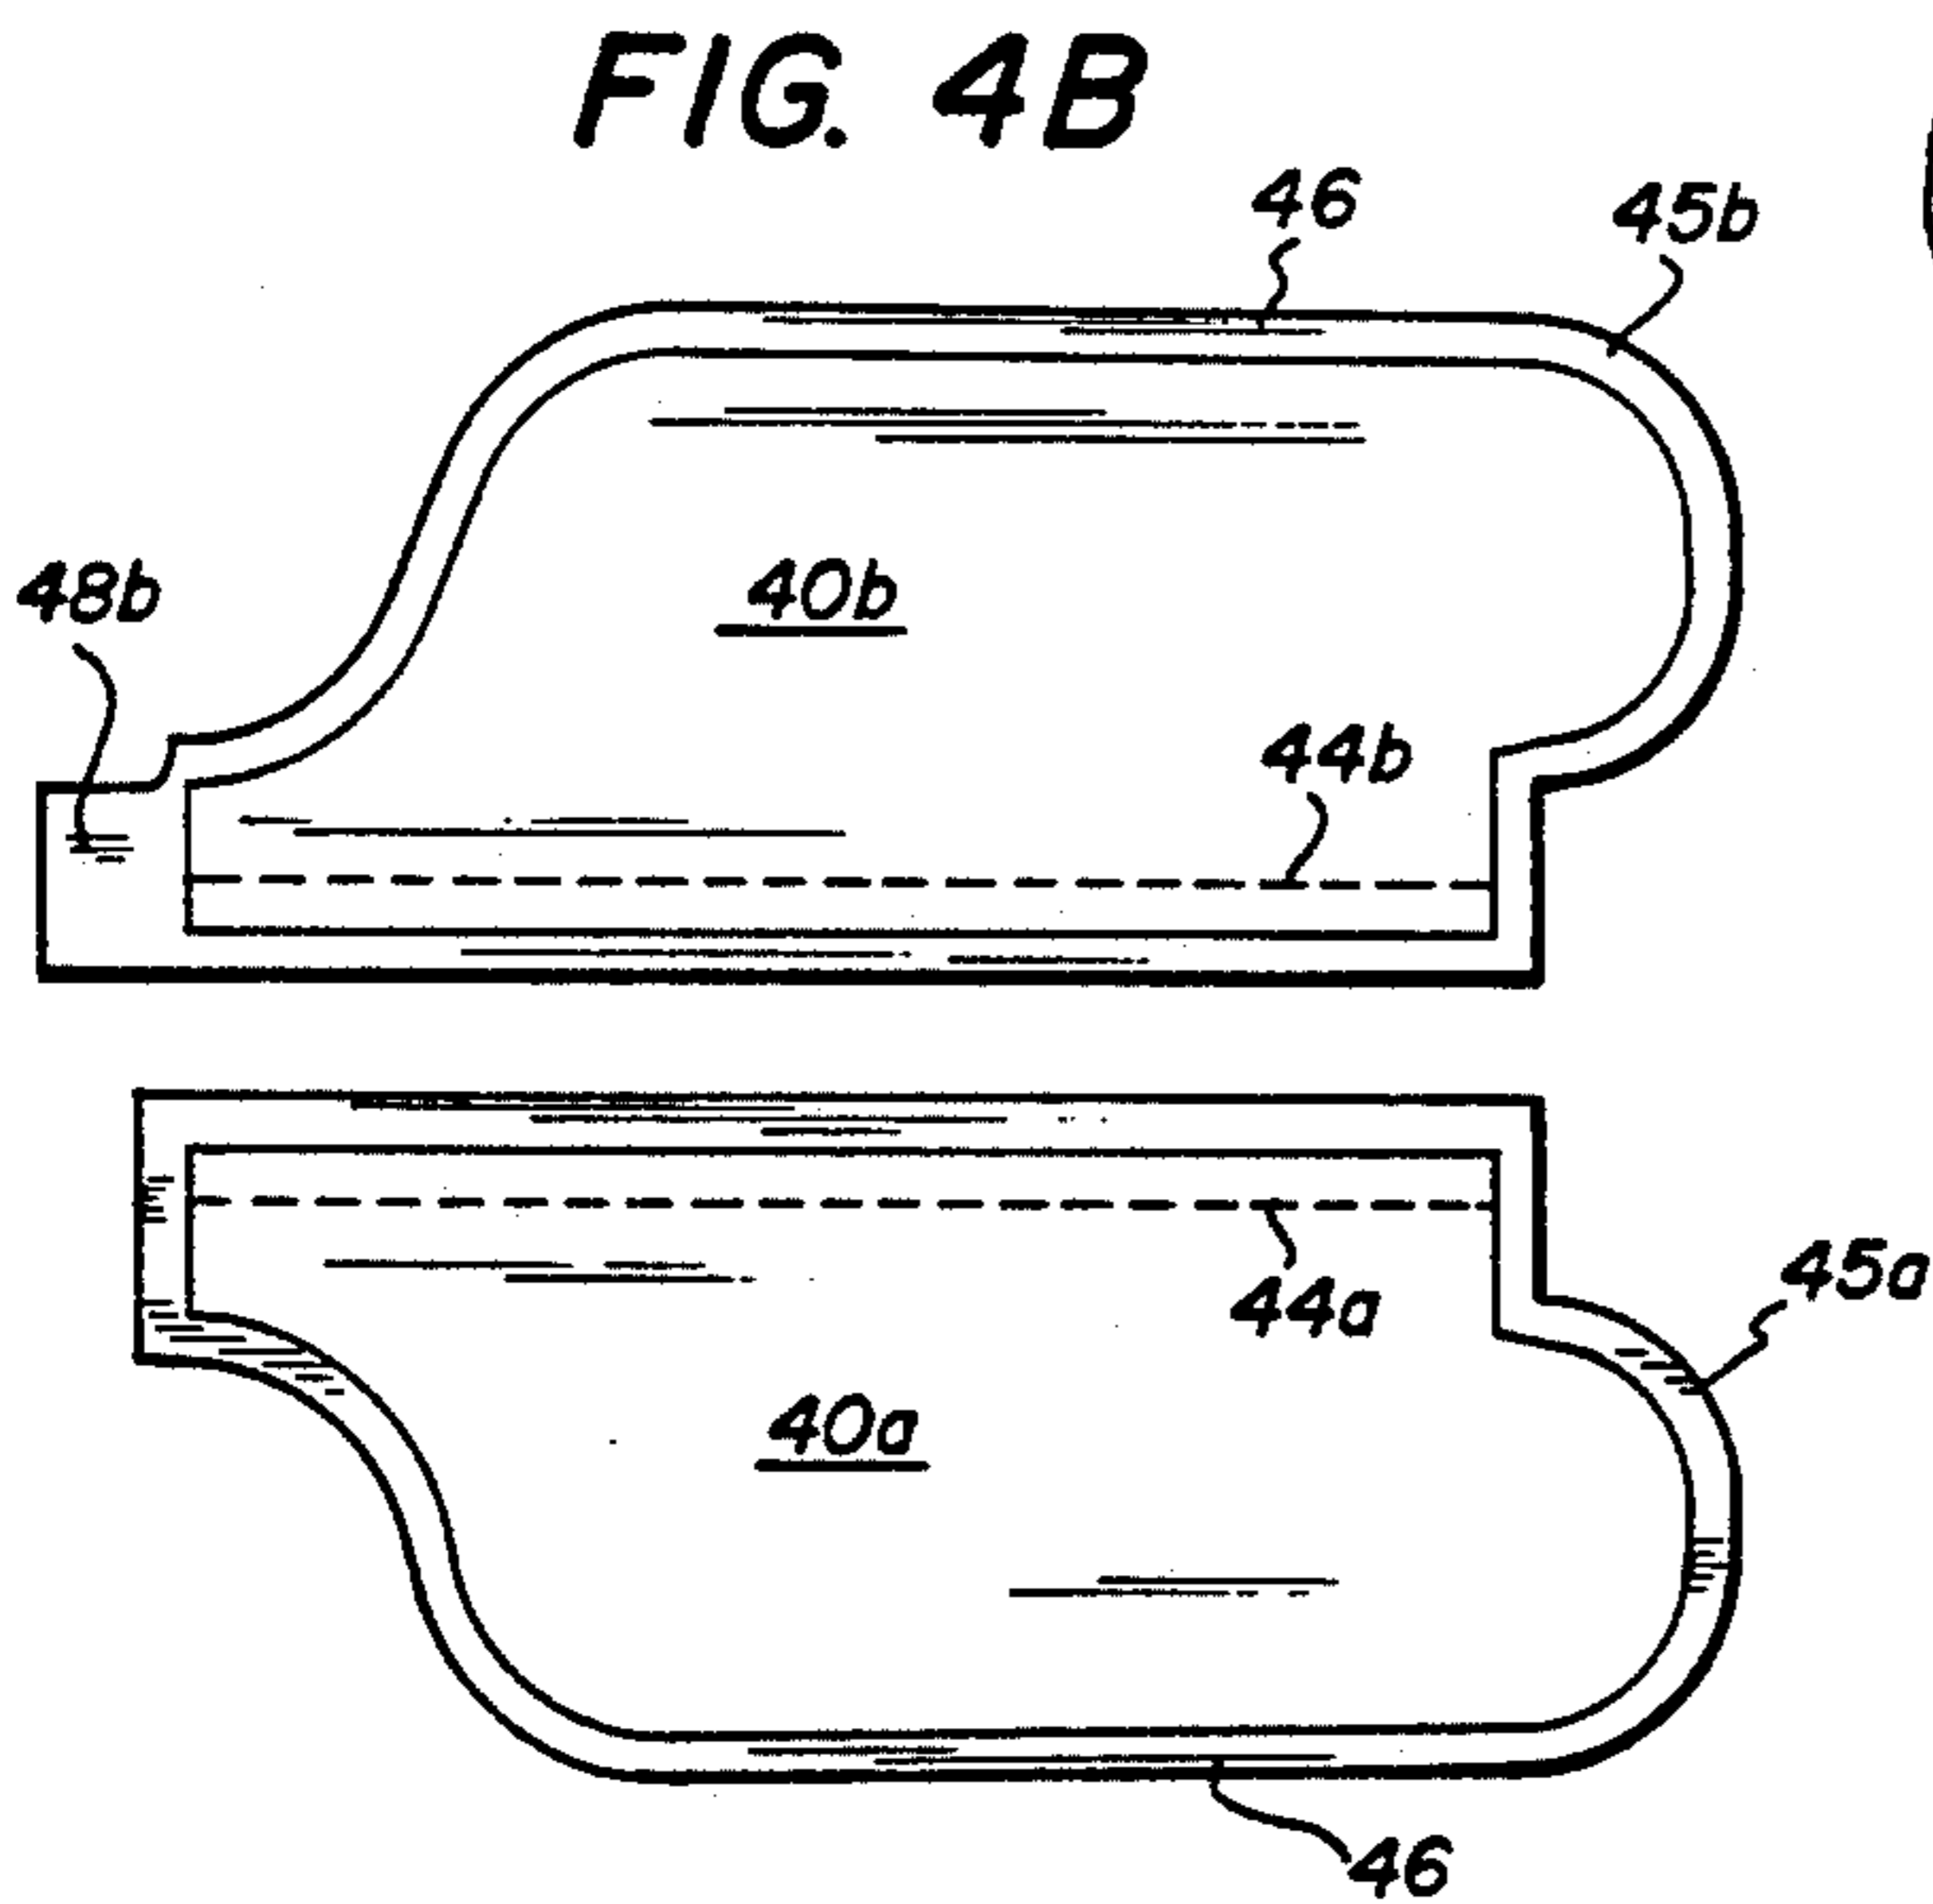
FIG. 4A

FIGS. 4a and 4b illustrate application of finish material to the forward and rear backing members of FIG. 3;

FIGS. 4a and 4b, respectively, provide views of what will become the inner or back sides of the visor cover, i.e., the sides that are opposite the forward face of member 40a and the rear face of the member 40b. These inner sides will not be seen when the visor is completed,

but they illustrate placement of the members 40a, 40b over the foam backing of the sheets 45a, 45b. Edge portions 46 of the sheets 45a, 45b extend approximately one half to one inch beyond the edges of the members 40a, 40b. In addition, sheet 45b includes an extended tab section 48b.

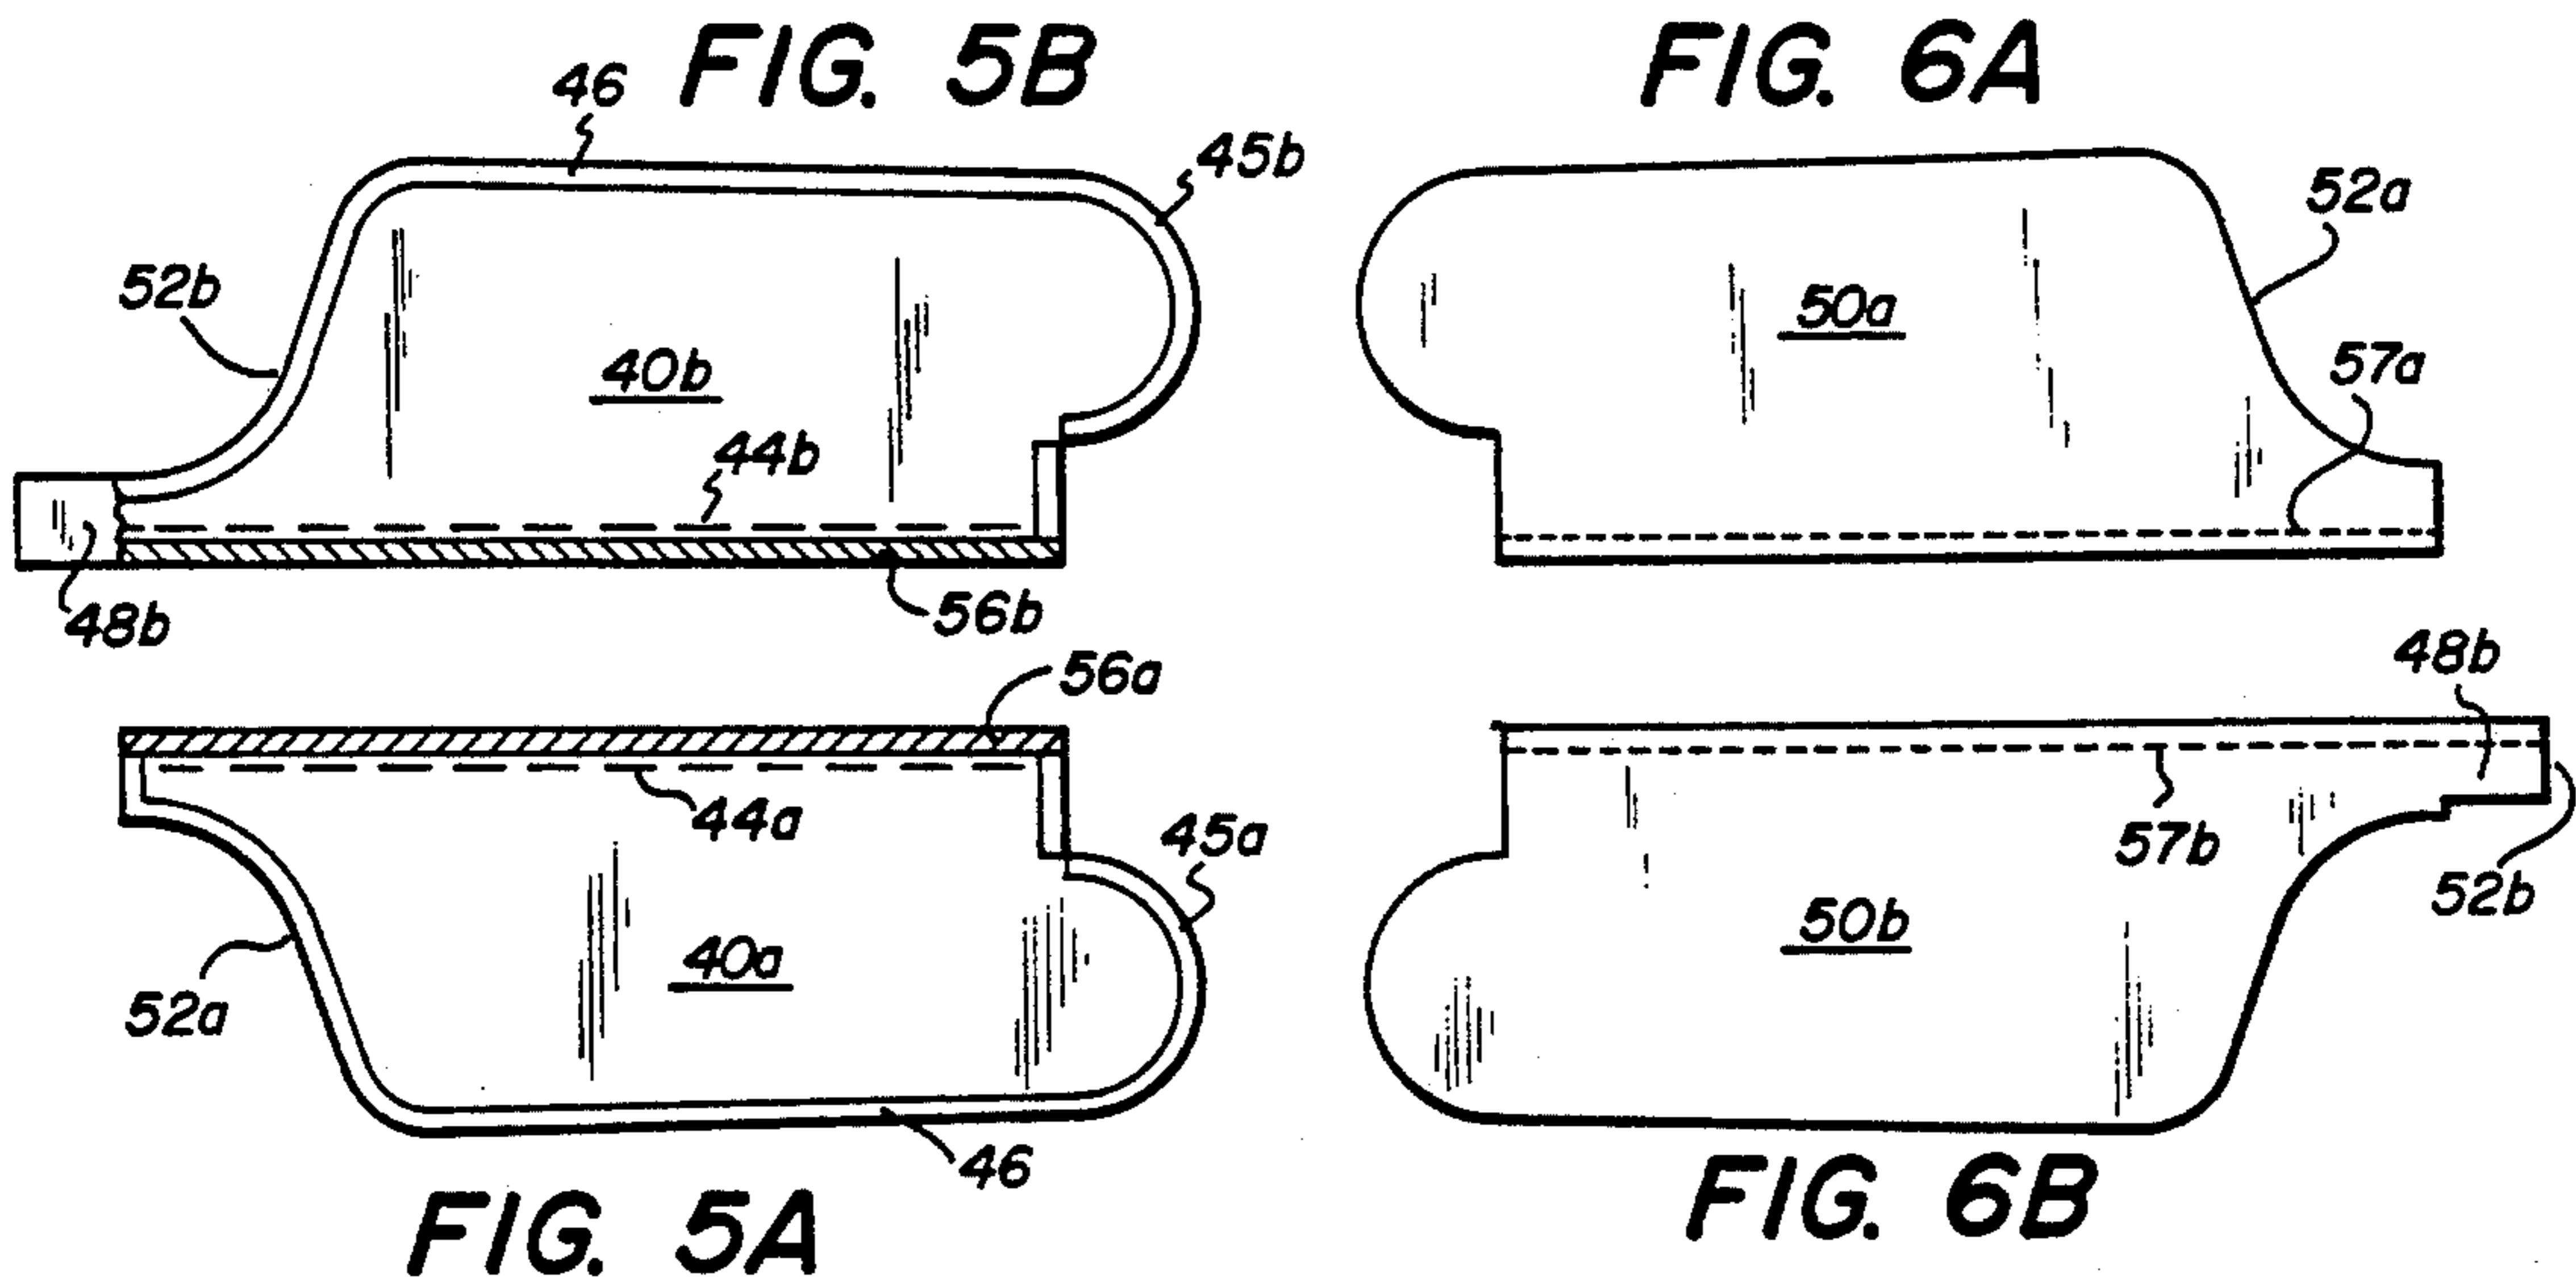
FIGS. 5a and 5b illustrate edges of the finish material wrapped over the edges of the backing material and bonded thereto;

FIGS. 6a and 6b illustrate a pair of panels formed from the backing members and finish material;

The foam backing of each sheet 45a, 45b is bonded in approximate symmetric alignment with either the forward face of member 40a or the rear face of member 40b. When completing the joinder of the sheets 45a, 45b to the members 40a, 40b, all of the edge portions 46 (except for the tab section 48b) are folded over the edges of the members 40a, 40b and are bonded to the reverse sides of the chipboard members. This folded-over condition is shown in FIGS. 5a and 5b.

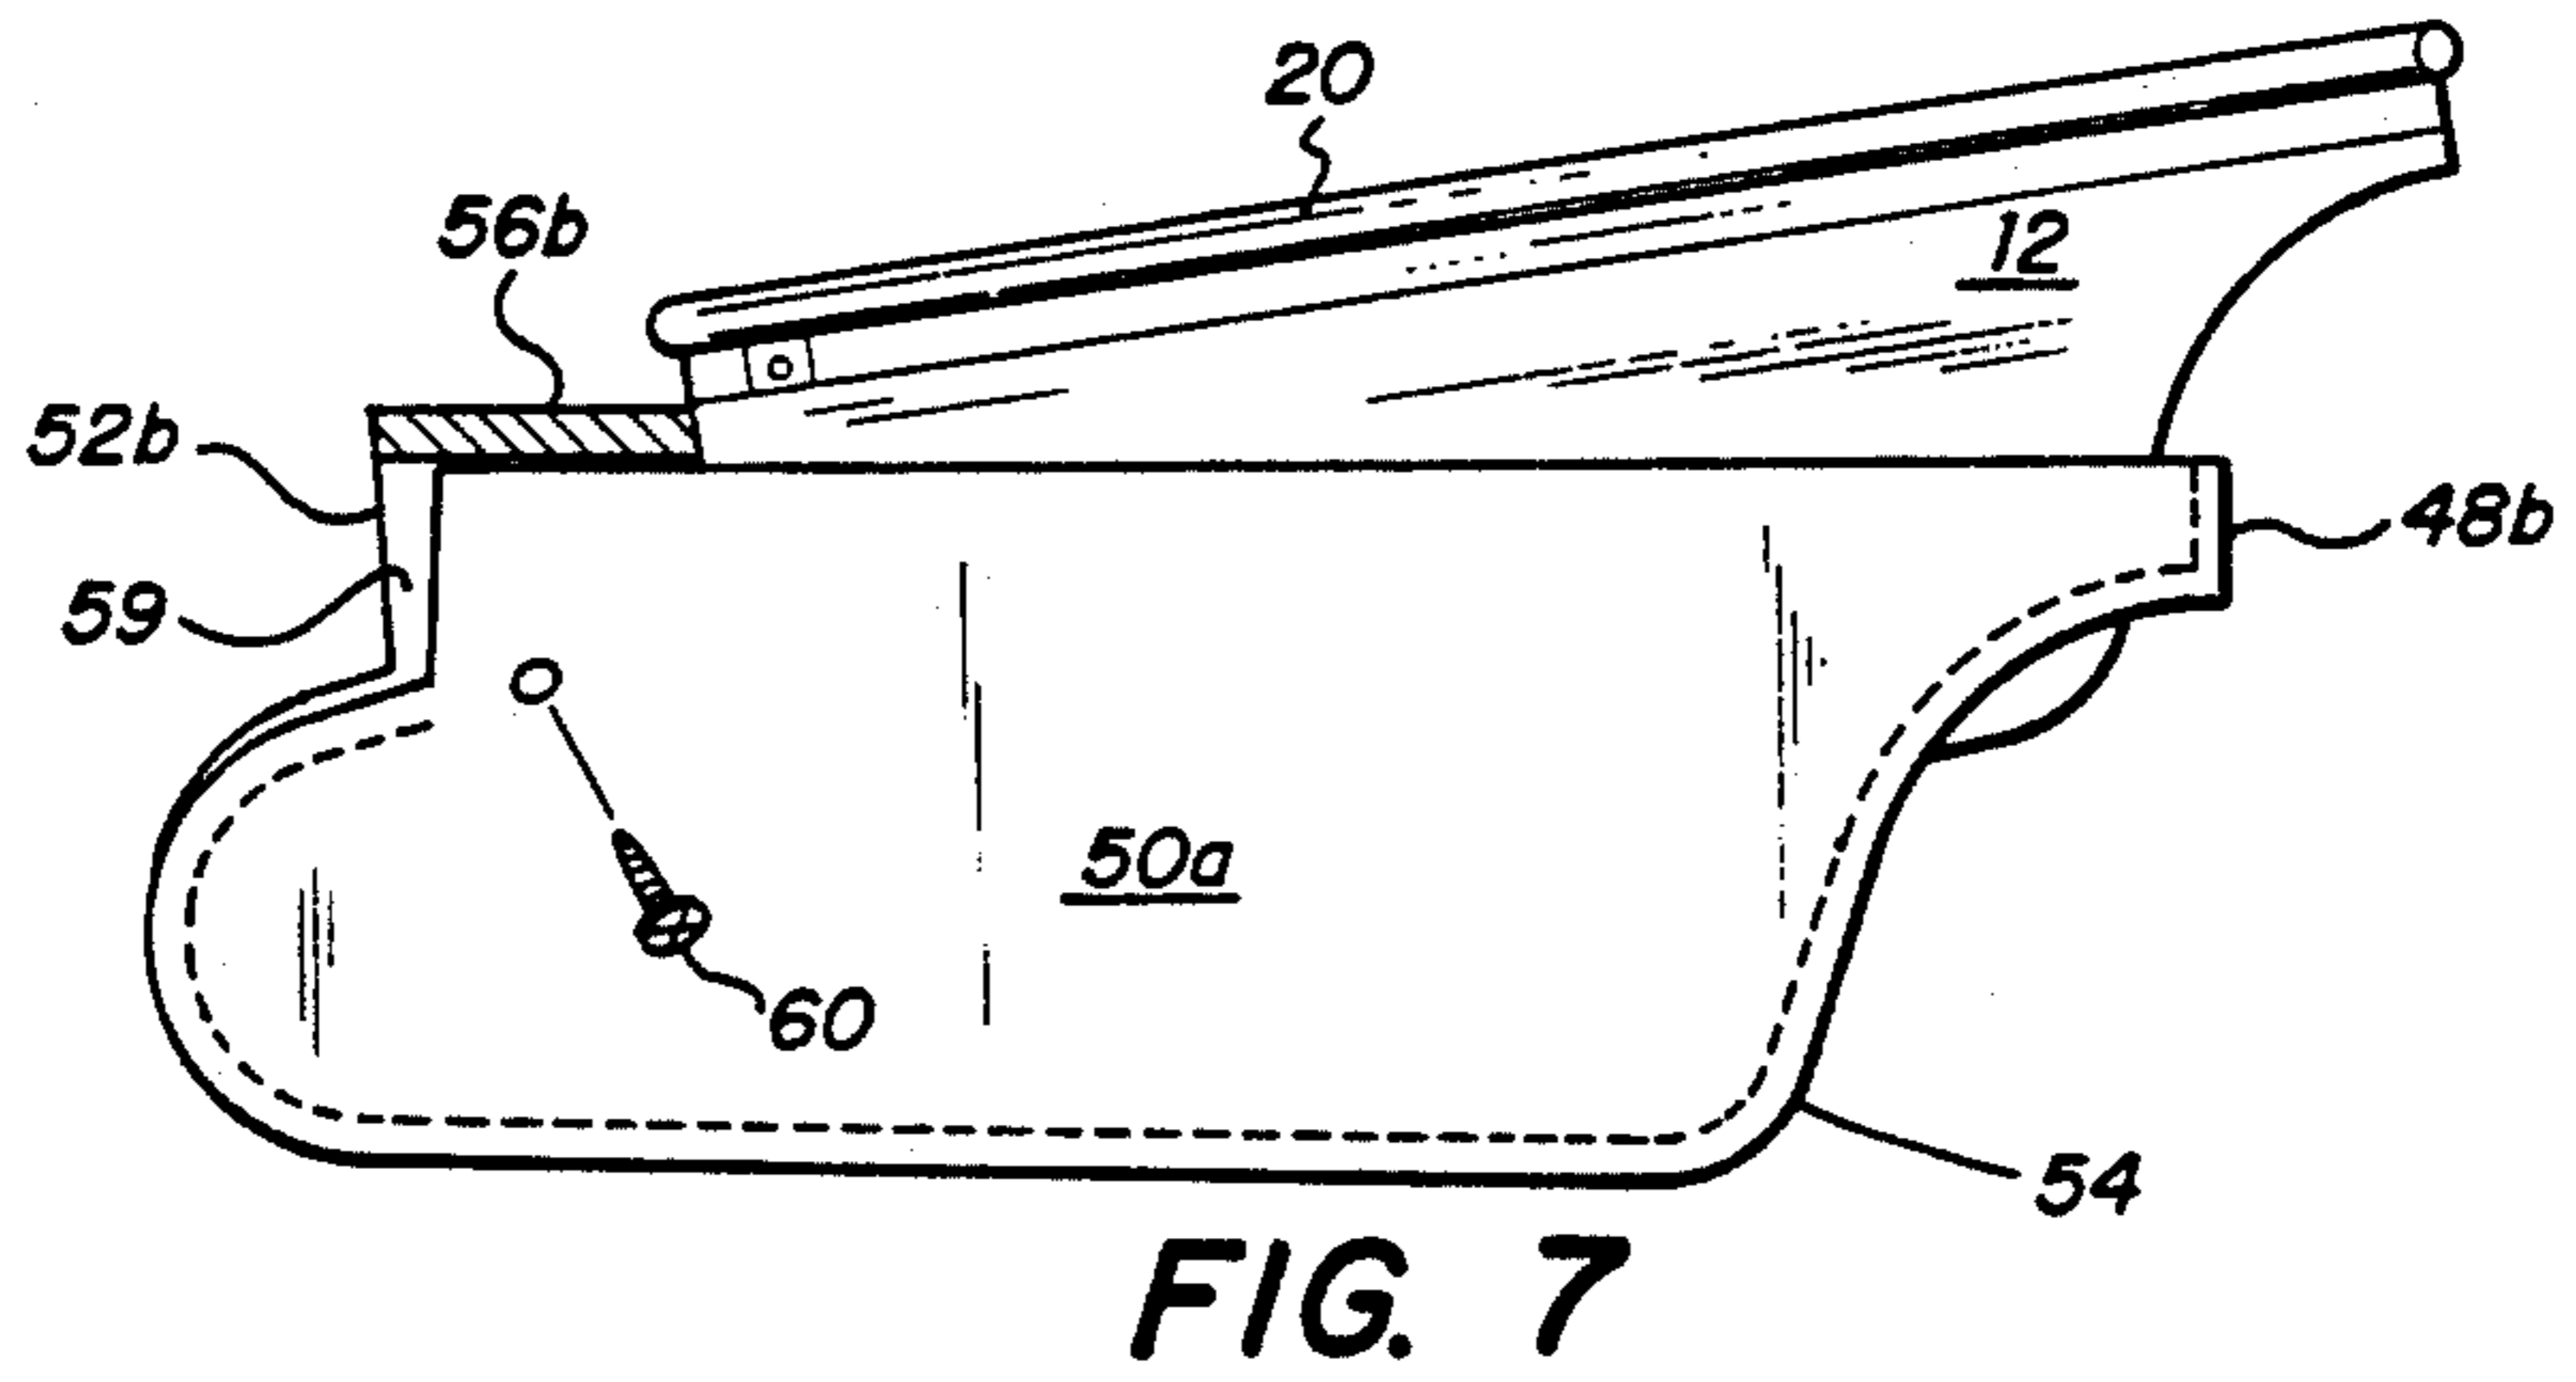
FIG. 7 illustrates the panels of FIG. 6 joined in an envelope configuration to receive a visor core; and

As illustrated in FIG. 7, most of the matching edge portions along the panels 52a and 52b (i.e., more than 50 percent) are stitched together to provide the envelope shape. Although a decorative bead 24 (such as the bead illustrated in FIG. 1) may be incorporated with the stitch, this is likely to be done only for the purpose to replicate the original visor style. With the process disclosed herein, a bead is not necessary for the purpose of concealing unattractive edges. A neat, uniform appearance will result without the bead because the edge portions 46 of the finish material 16 are bonded to the backing members. After the slip cover 54 has been pushed over the original core of the visor, the remaining unstitched tab section 48b may then be tucked into the slip cover 54 to close the last remaining opening into the now-covered visor.

Perhaps it should be mentioned at this point that the fastening assembly formed from mating elements 56a, 56b may be engaged and disengaged without the use of any tools. And when the hook/loop assembly 56a, 56b is "open," the slip cover 54 has an opening (along the chipboard fold lines 44) that is more than ample for receiving the visor core. Hence, there is no necessity to remove the original visor from a vehicle in order to repair it. This alone should save considerable time in the repair of visors. But it may be more convenient for a worker to remove a visor and take it to a workbench for repair. Either way, a worker need only insert the visor core 12 into the new slip cover 54 (as shown in FIG. 7) to have a neat, tight-fitting cover with no sags from loose material.

If the original visor has a clamping screw 60 which is secured as an integral part of the mounting process, as shown in FIG. 7, this can be readily accommodated. A small opening 58 can be cut in the rear backing member as shown in FIG. 3, or a hole can be punched through the panel 52b, after assembly of the slip cover 54.

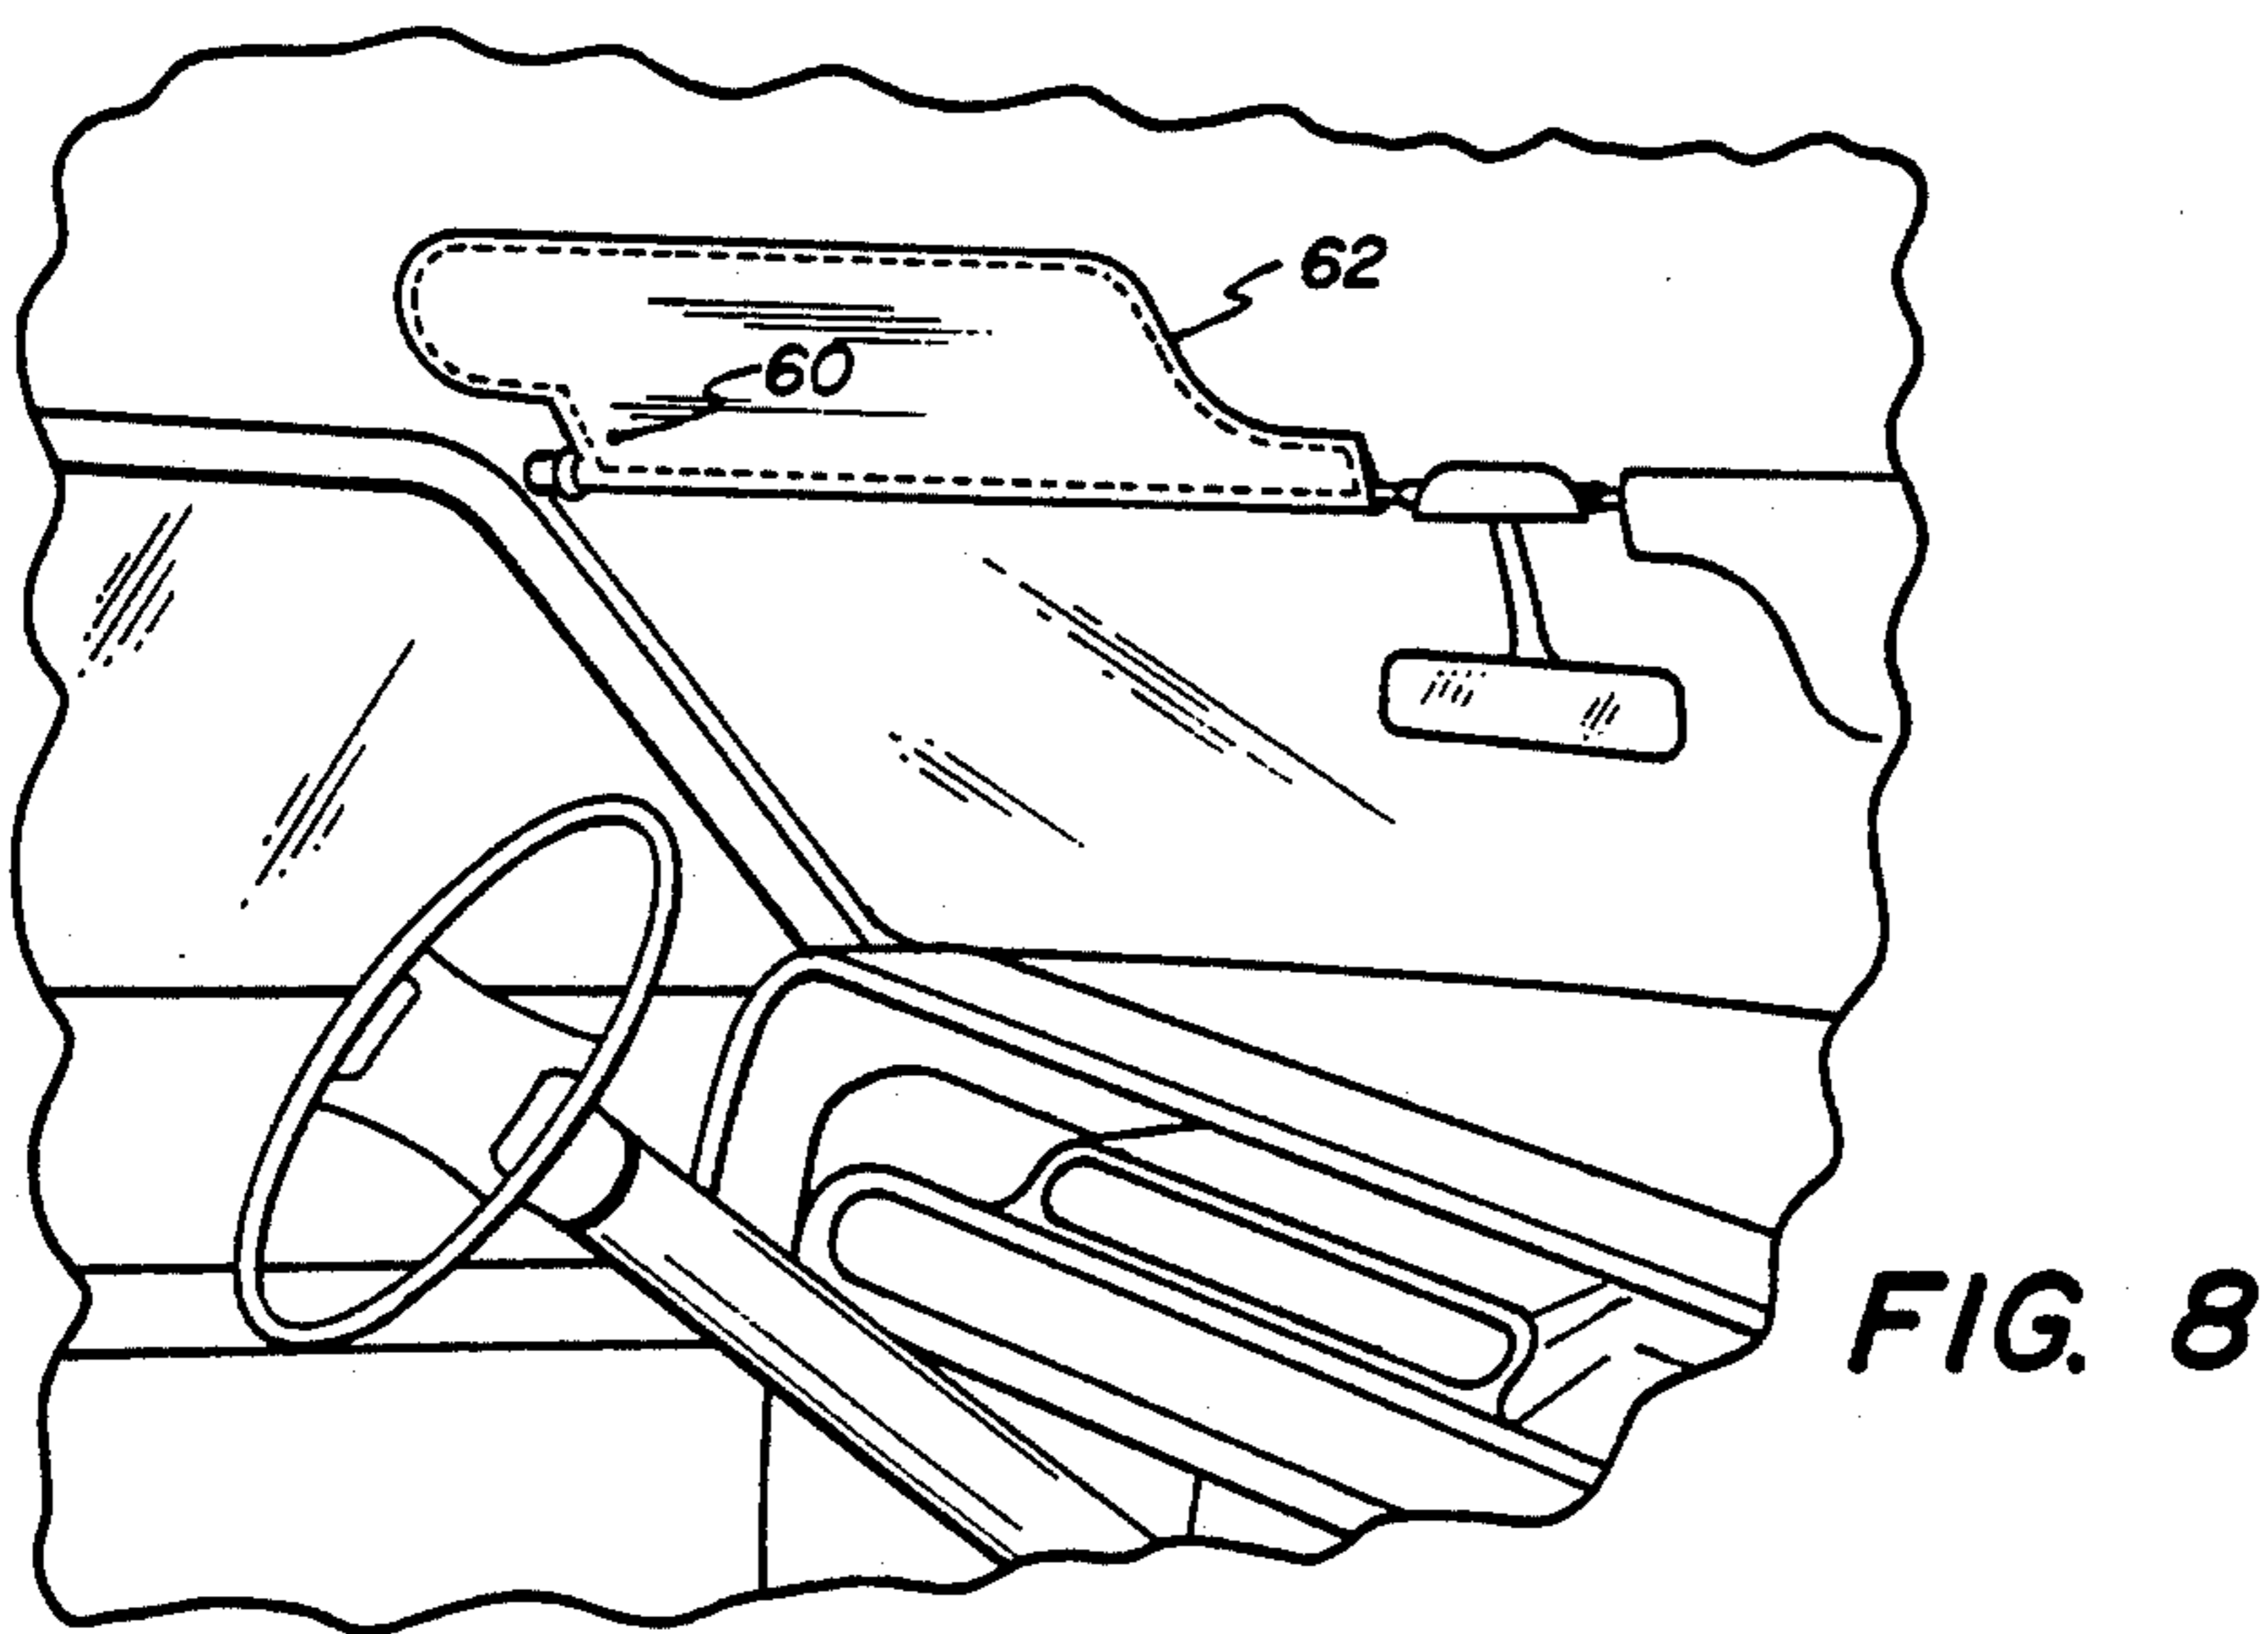
FIG. 8 illustrates a completely remanufactured sun visor according to the invention, installed in a vehicle.

FIG. 8 illustrates remanufactured visor 62, incorporating the slip cover 54, installed against the header structure of a vehicle. From a passenger's vantage point, the visor 62 looks essentially no different than an original equipment product. The stitching around the

panel edge portions 46 appears neat and uniform. The "VELCRO" fastening assembly 56a, 56b along the upper edge of the core 12 eliminates the need for any stitching after the core (or entire worn visor) is inserted. By locating the slip cover opening 59 along the visor hinge, the final step in mounting a visor cover (connecting the elements 56a, 56b) results in effectively concealing the fastening assembly 56a, 56b adjacent the header structure. If the last opening to be closed were formed along the lower edge 22 of the core, then whatever fastening means was used would be plainly visible to vehicle occupants.
