[11] Patent Number: **5,402,207**

Michlin

## [54] LONG-LIFE AND IMPROVED PHOTORECEPTOR DRUM GEAR

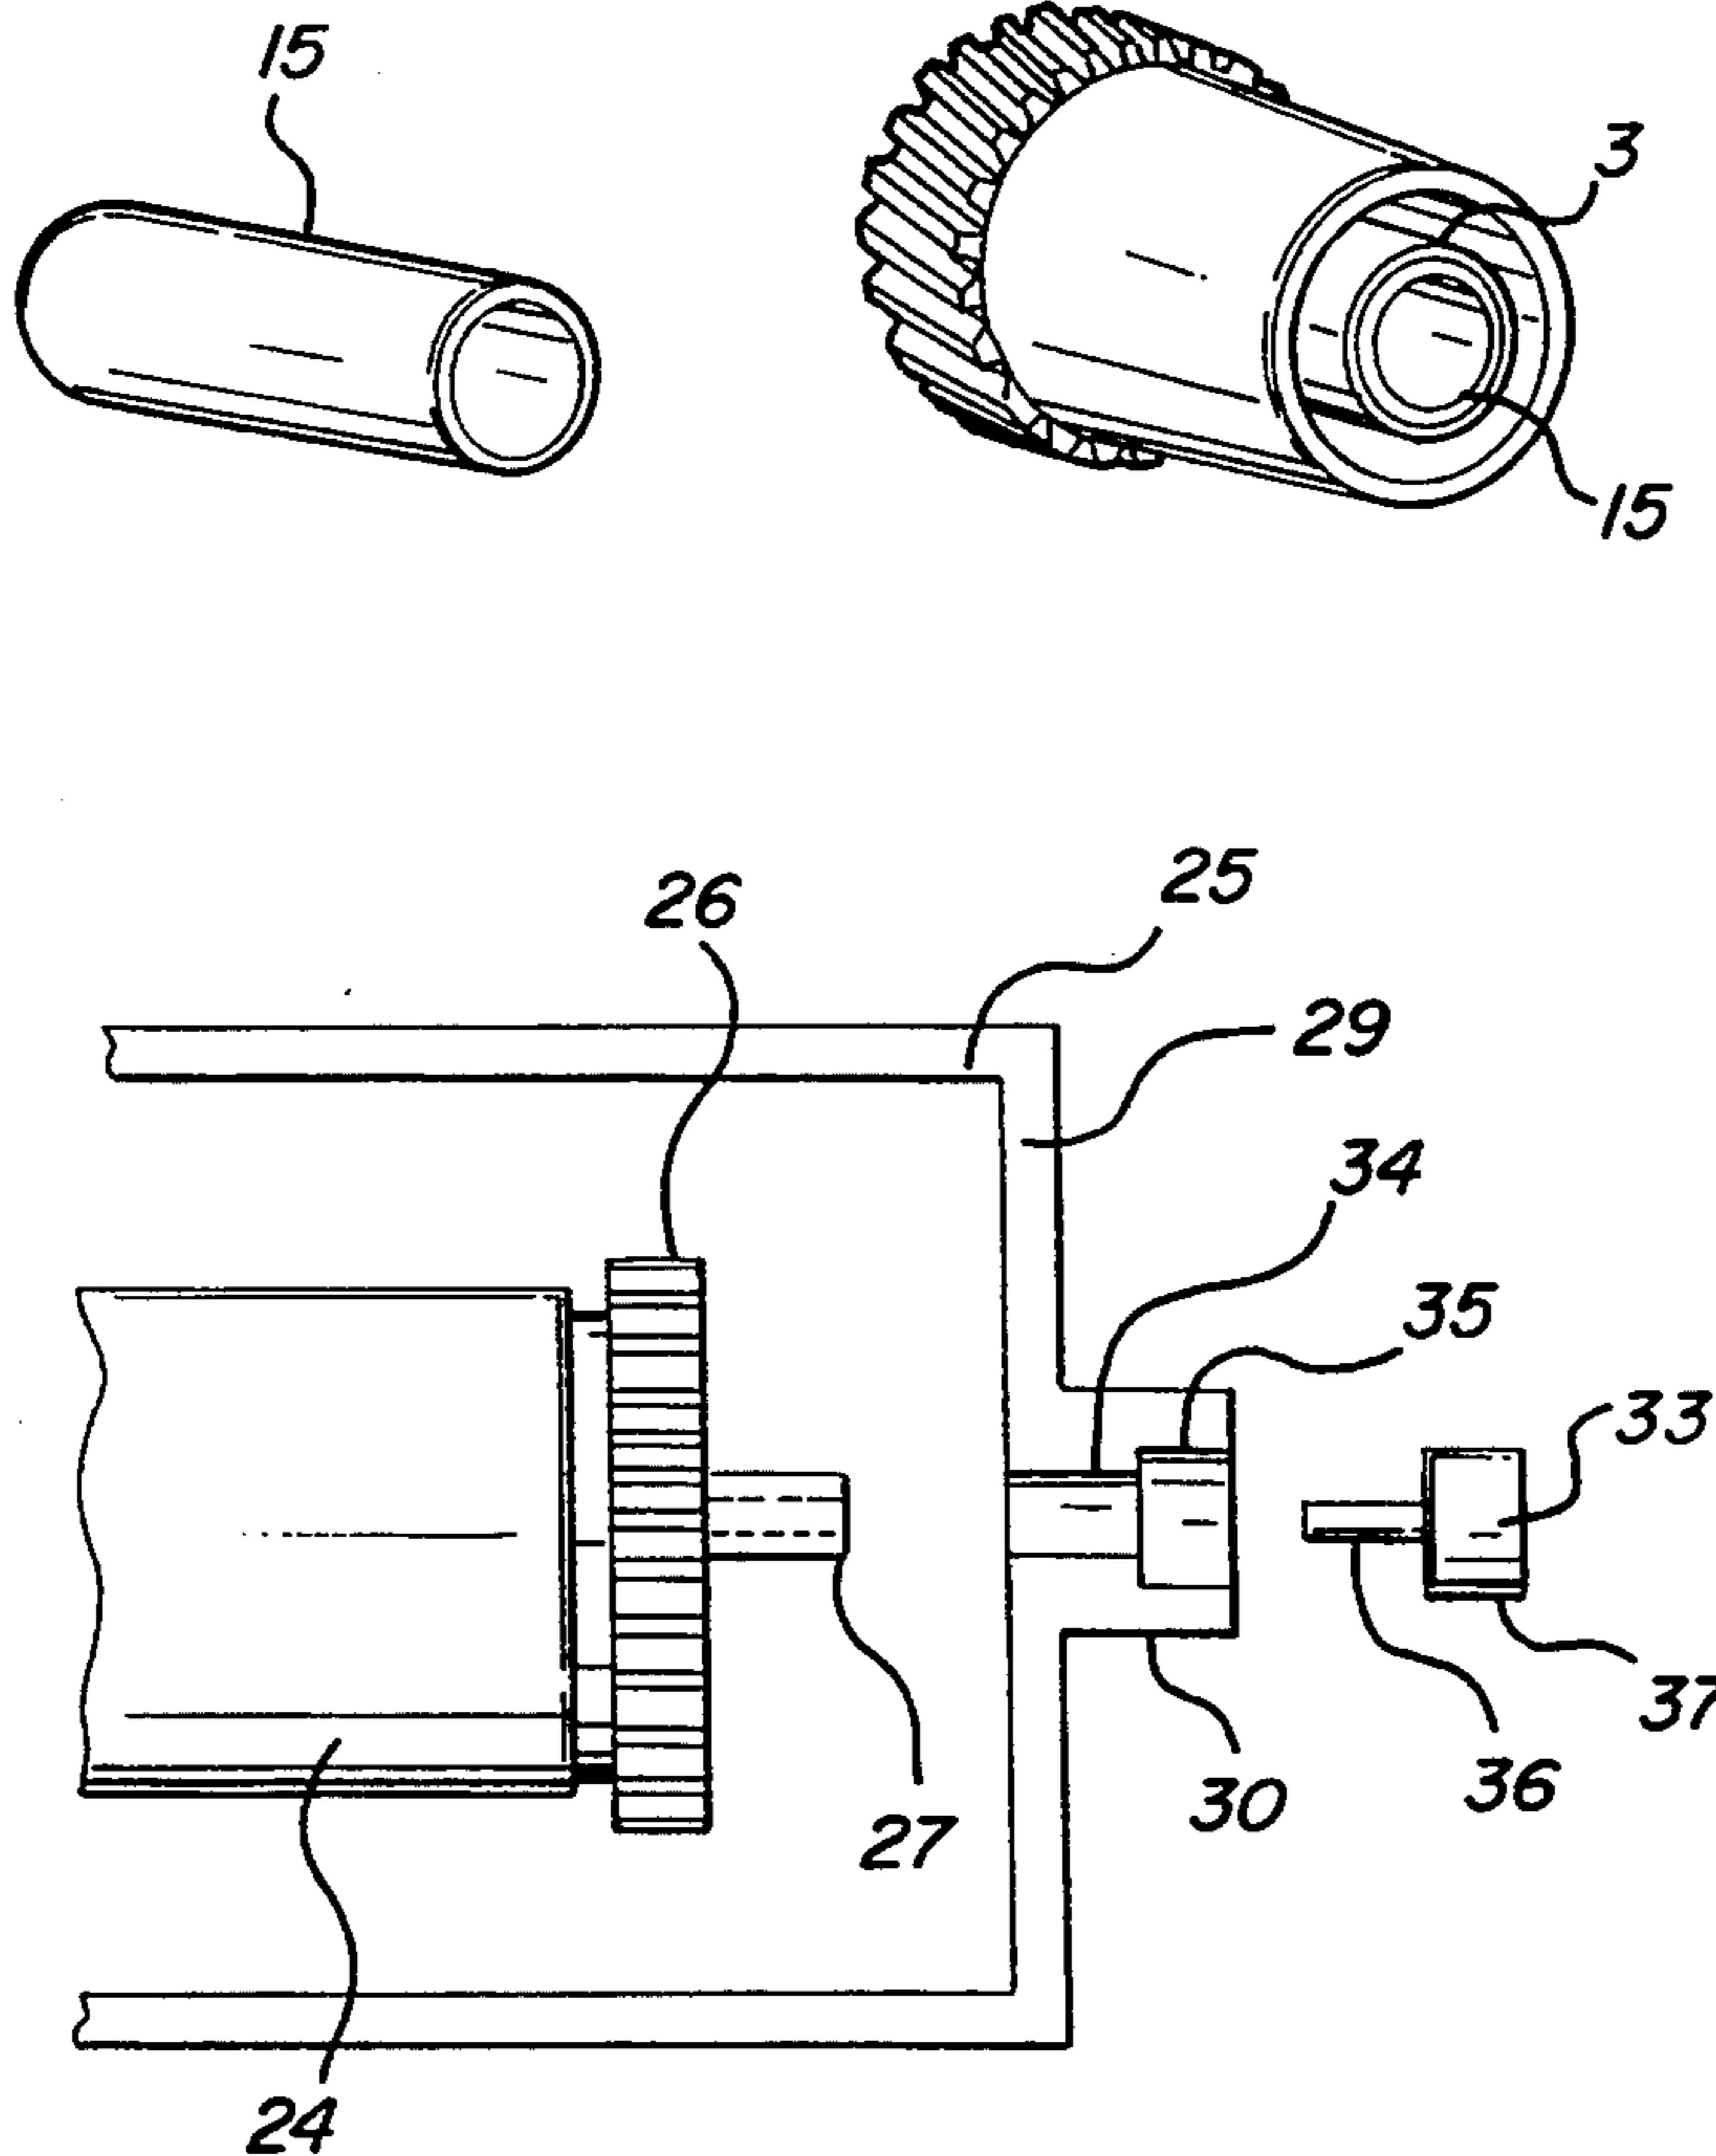
FIG. 1 shows a conventional photoreceptor drum with a gear attached at each end.

FIG. 1 shows a conventional photoreceptor drum 1. A plastic gear 2 is received in the end of the drum 1. The gear 2 has an inner cylindrical bushing 3 with a bore 4 sized to fit around the photoreceptor drum shaft (not shown). A gear 5 on the other end of the drum 1 has wider teeth and a cylindrical protrusion 6 for being received by the wall of the toner cartridge assembly. A gear in the printer, copier or facsimile machine meshes with the gear 5 to turn the drum 1. The gear 2 rotates with the drum 1 and is used to turn other components in the cartridge assembly (such as the toner agitator in the hopper) through the use of other gears. The drum 1 and gears 2 and 5 are part of the toner cartridge assembly.

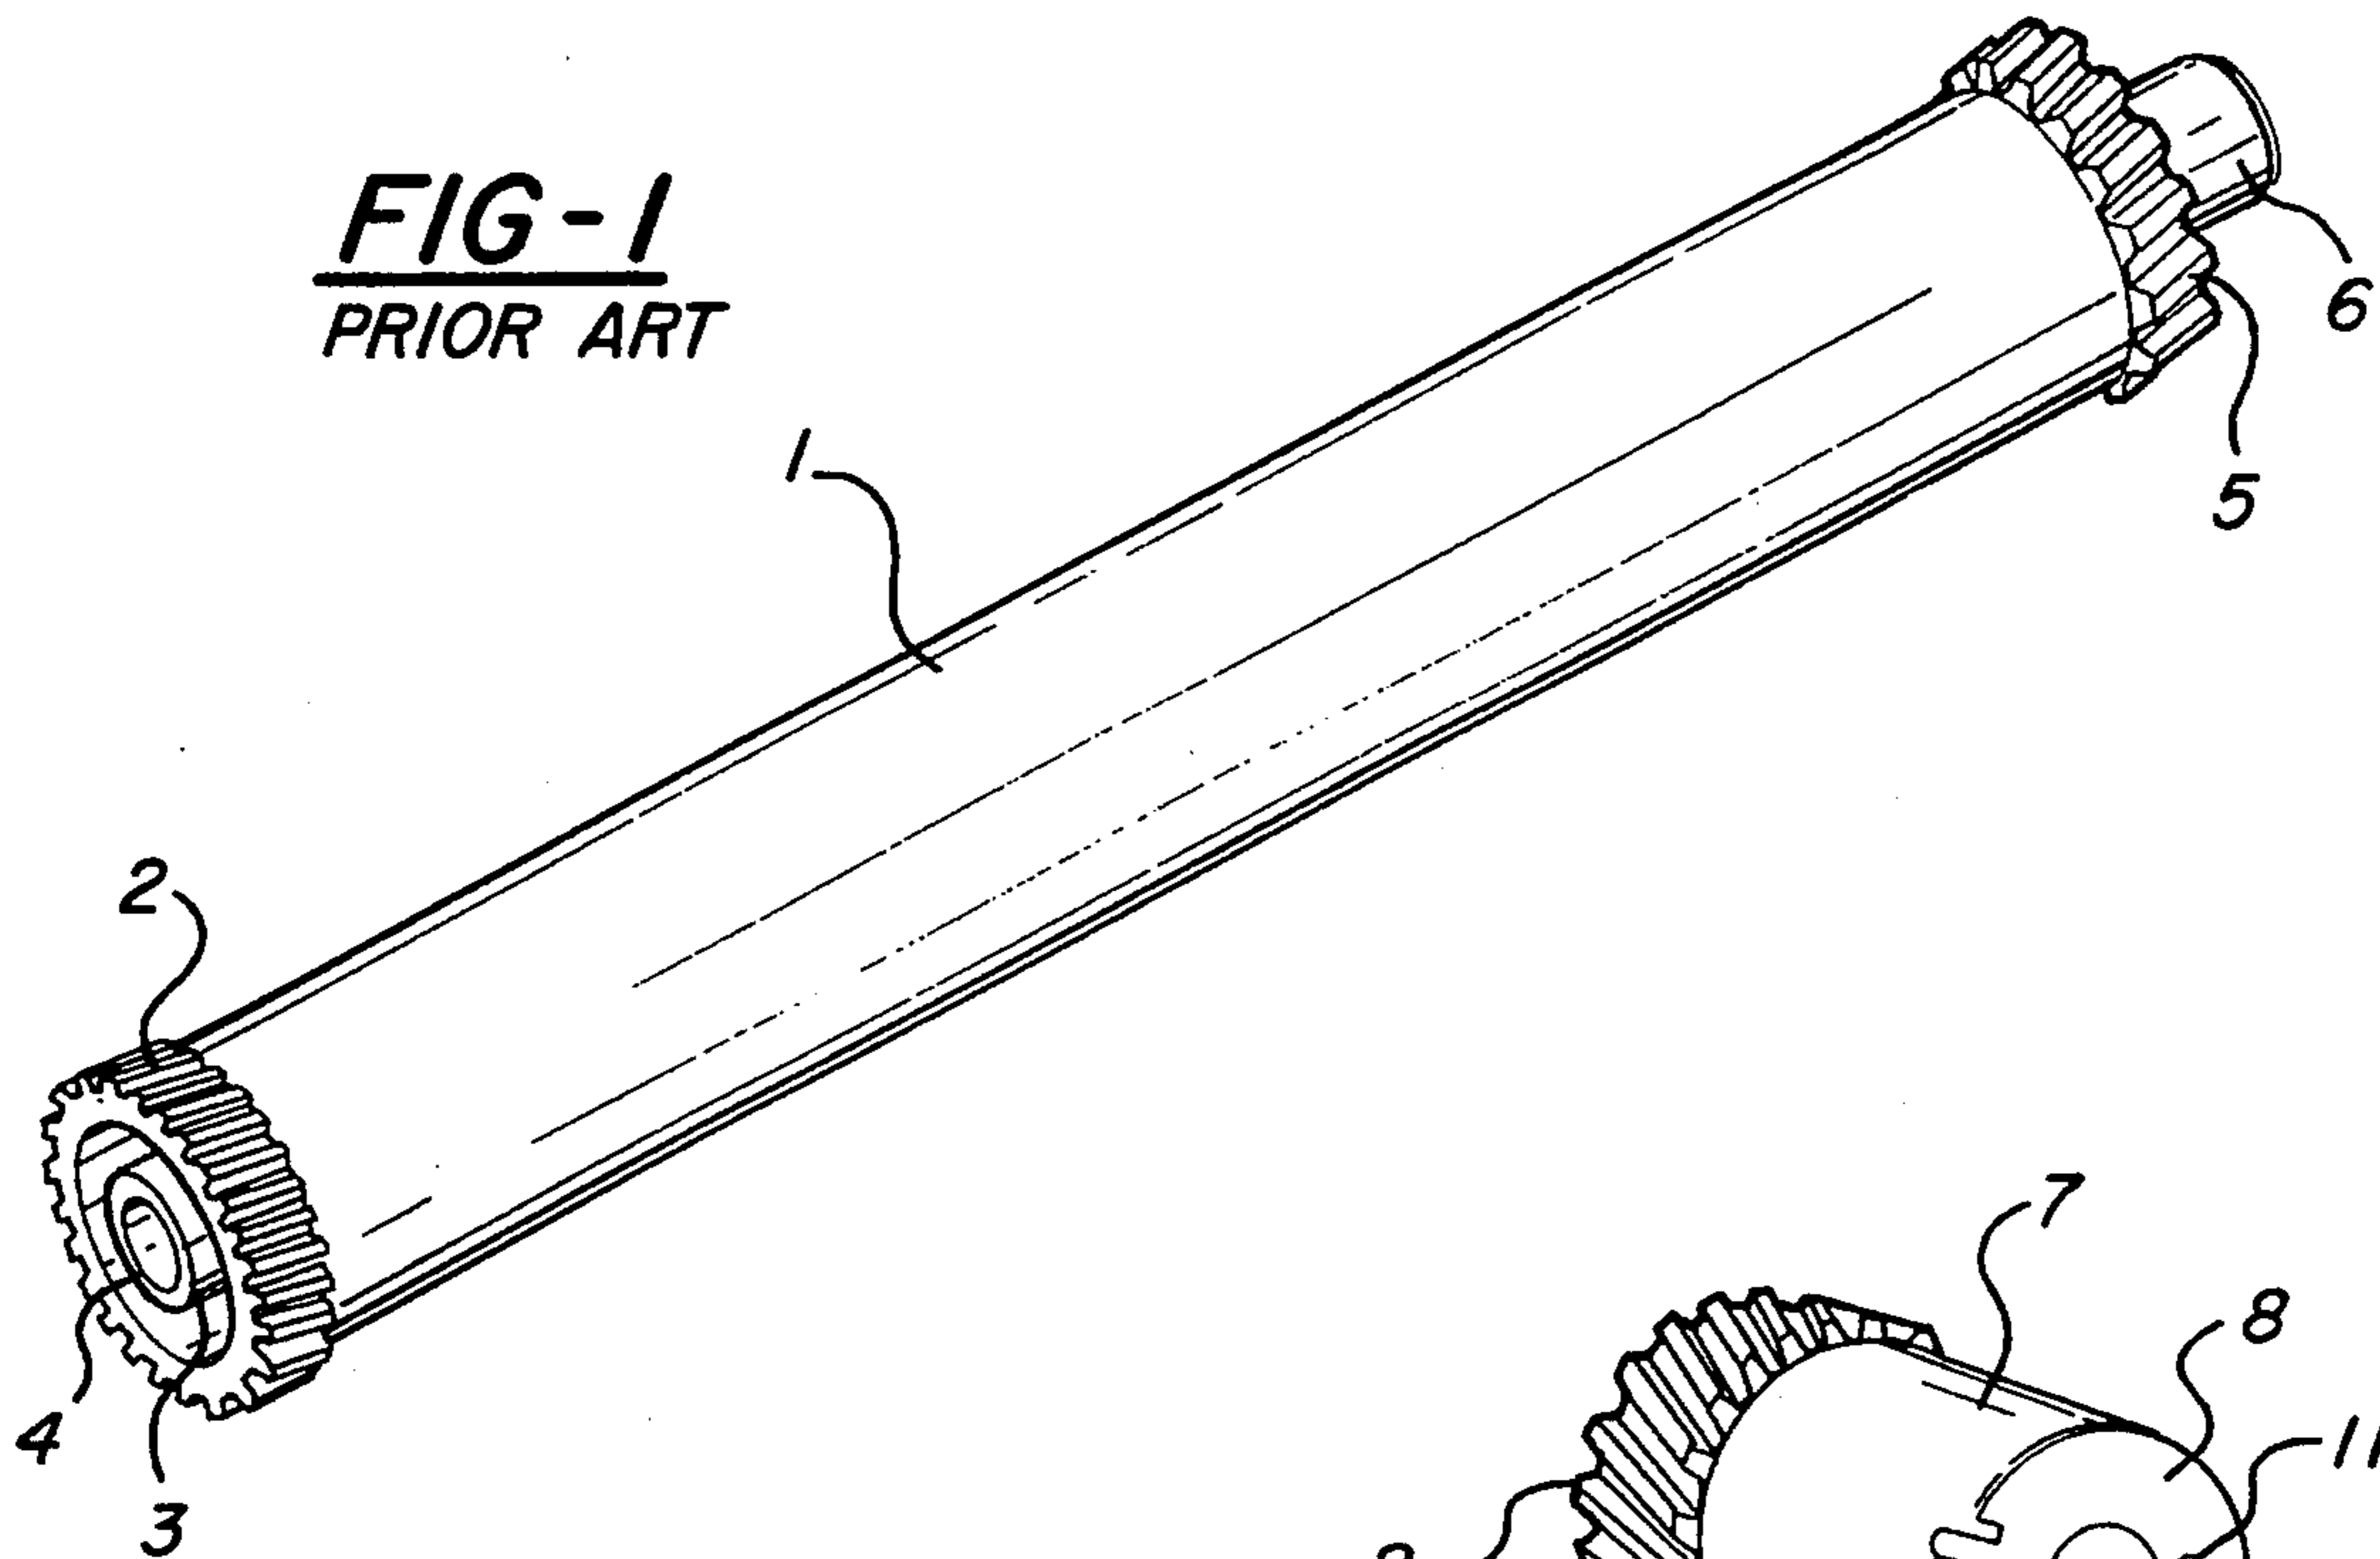
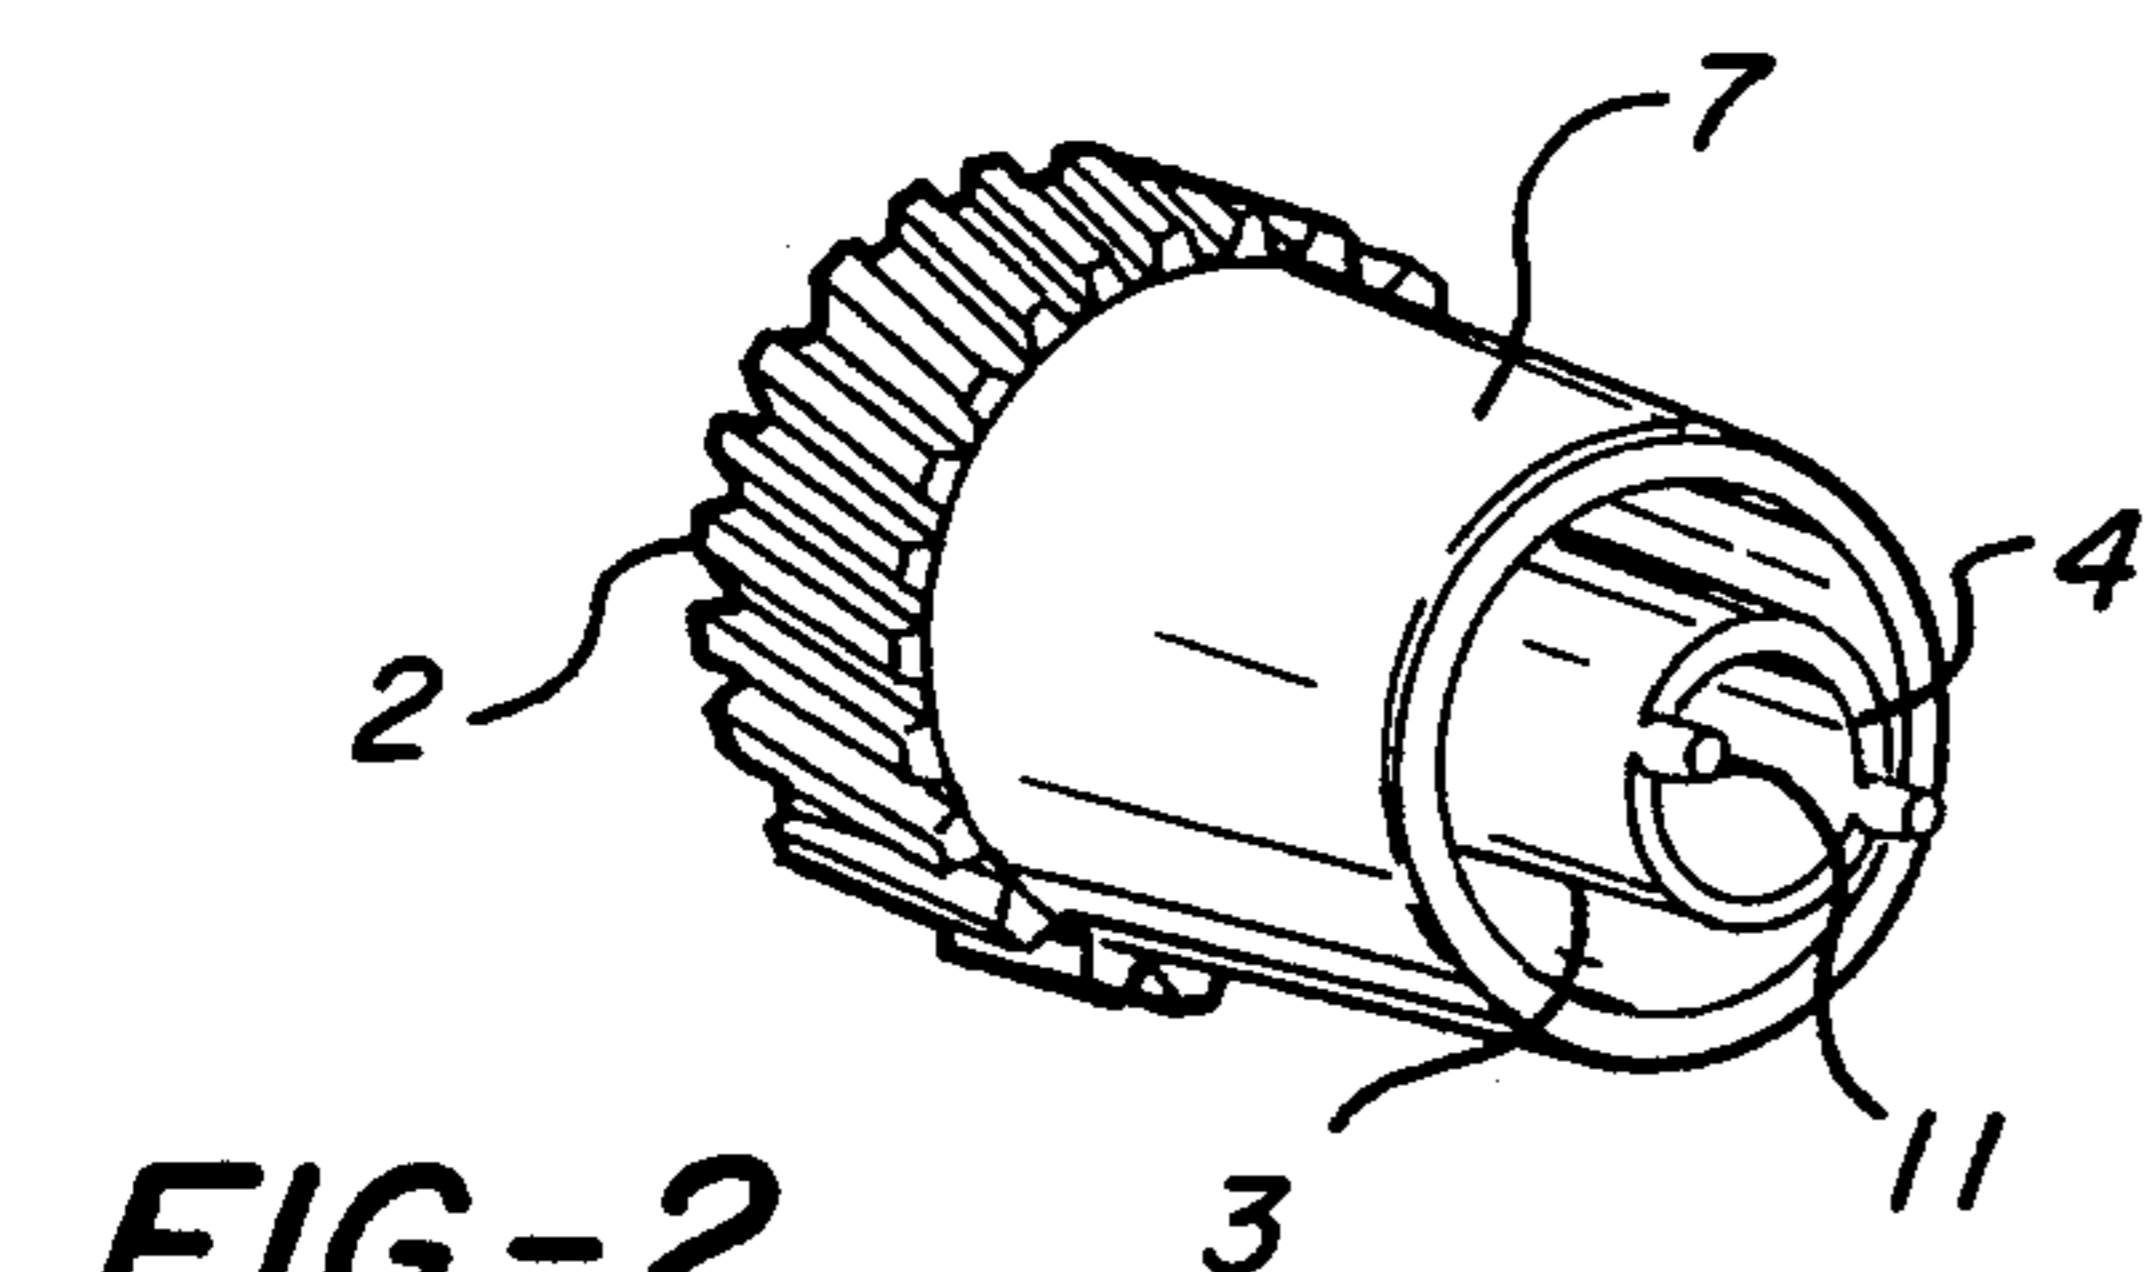
FIG. 2 more fully illustrates the conventional plastic gear.

The conventional plastic gear 2 is more completely shown in FIG. 2. The photoreceptor drum 1 is basically hollow and at one end and receives the sleeve 7 of the gear 2. The surface of the sleeve 7 is attached to the inner wall of the drum 1 by glue or other known adhesives such that when the gear 5 is driven, the gear 2 rotates with the drum 1. The bushing 3 extends for the

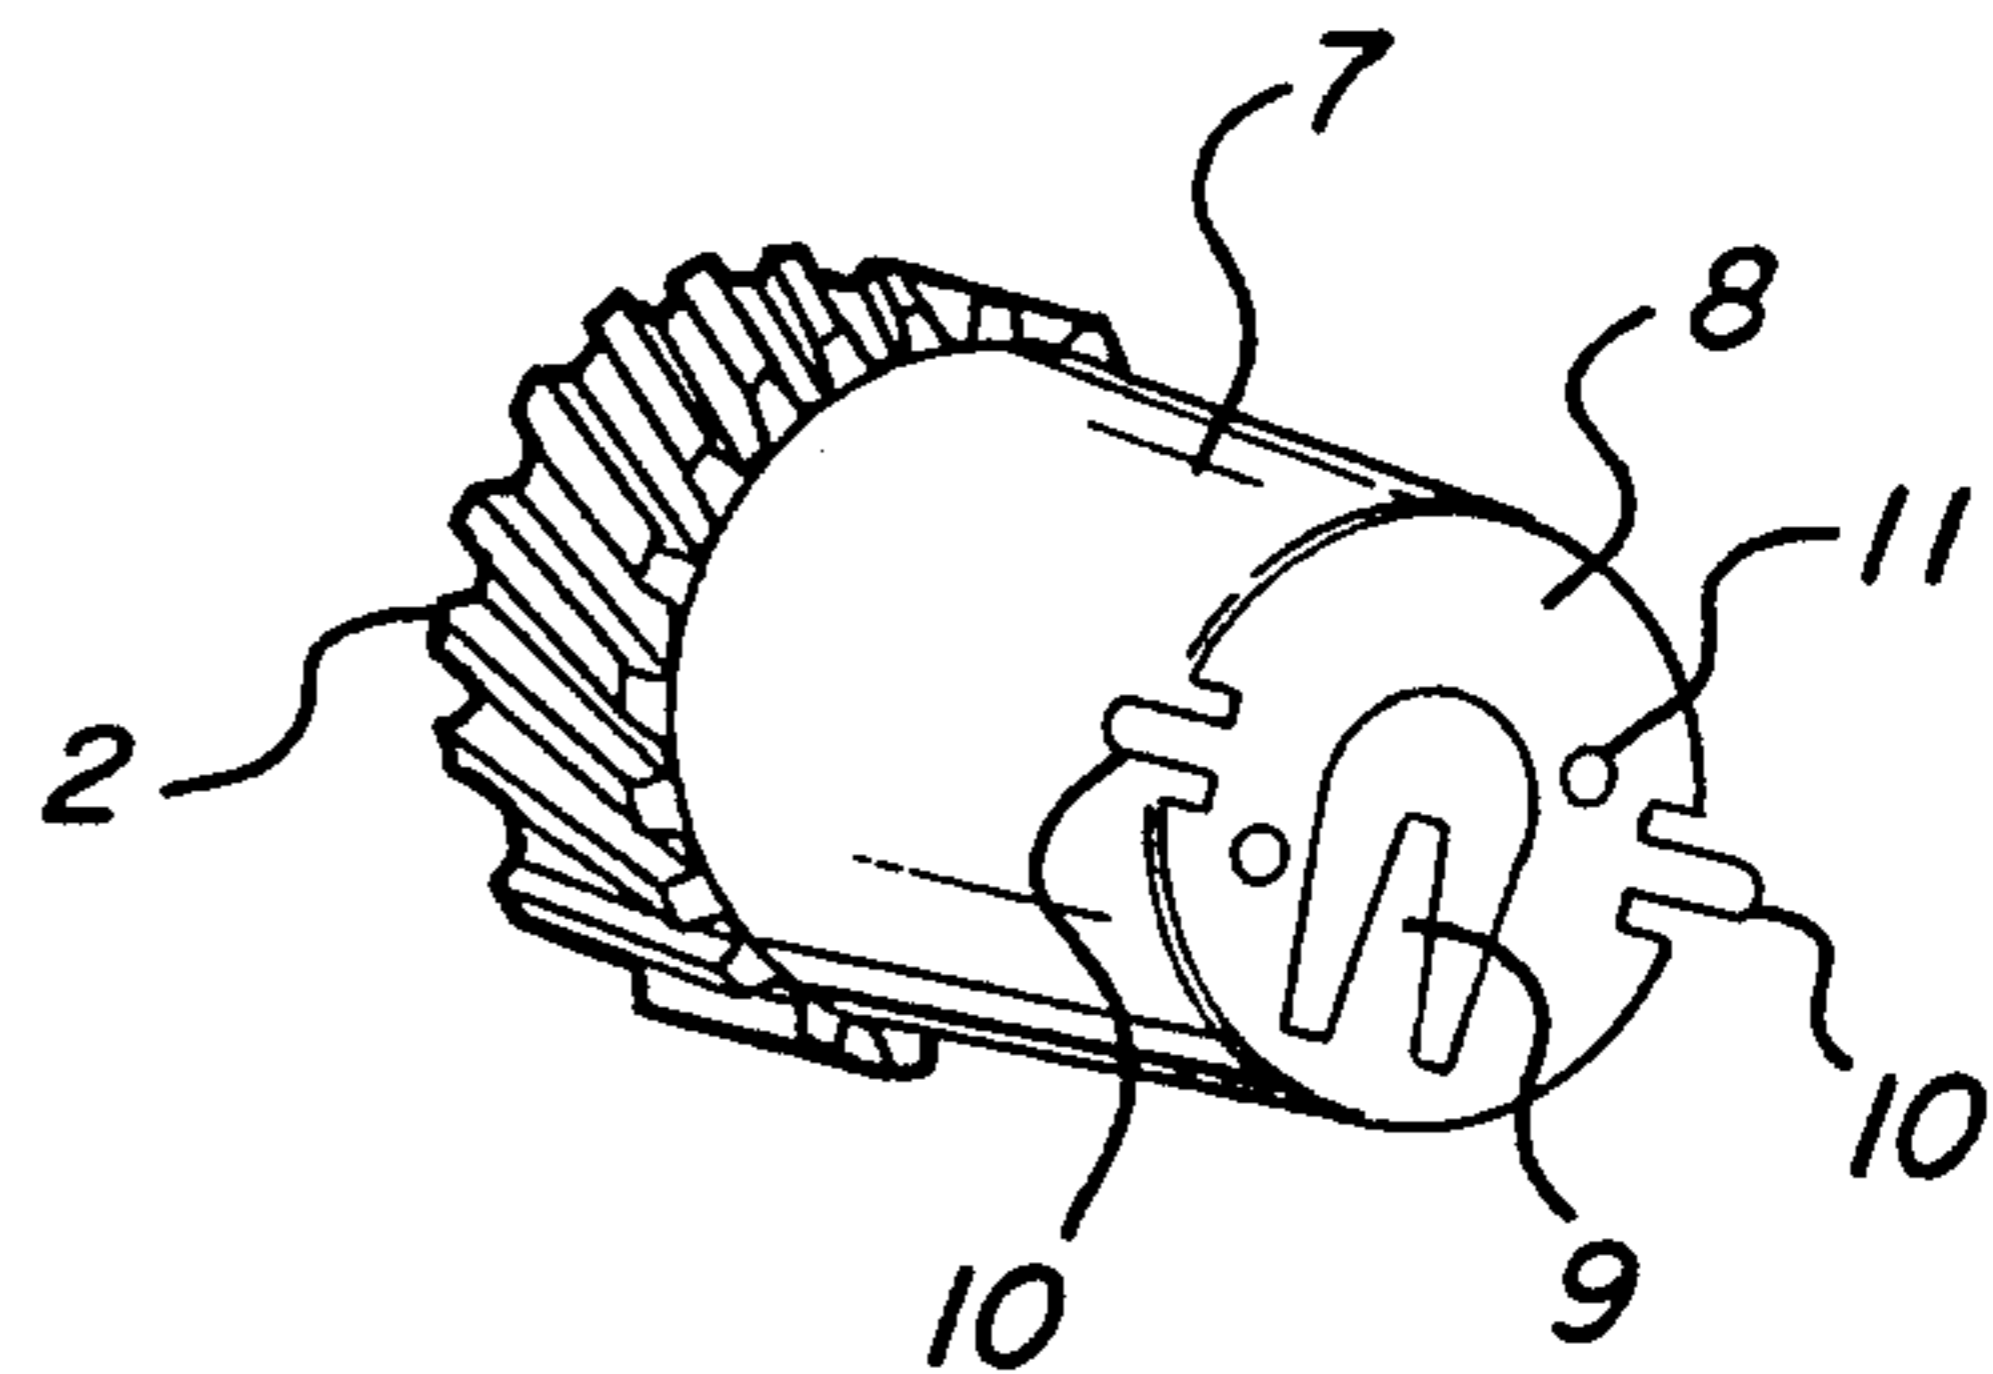
**FIG-4**  
PRIOR ART

FIG. 3 shows a prior art spring-clip contact attached to the photoreceptor drum gear.

length of the gear 2 and its sleeve 7. FIG. 3 shows the same gear 2 with a conventional spring-clip contact 8 attached. The spring-clip contact 8 is metal and has a prong 9 for contacting the stationary drum shaft and prongs 10 for contacting and scratching into the inner wall of the drum 1. The spring-clip contact 8 is attached to the bushing 3 through the use of nubs 11 extending from the bushing 3. The spring-clip contact 8 rotates with the gear 2 and drum 1. Its function is to electrically ground the photoreceptor drum 1 by connecting the drum 1 with the grounded stationary drum shaft extending through the bushing 3. This allows electrical charge to be conducted away from the photoreceptor drum 1 areas saturated by light during the imaging process, ensuring the quality of the image on the output paper.

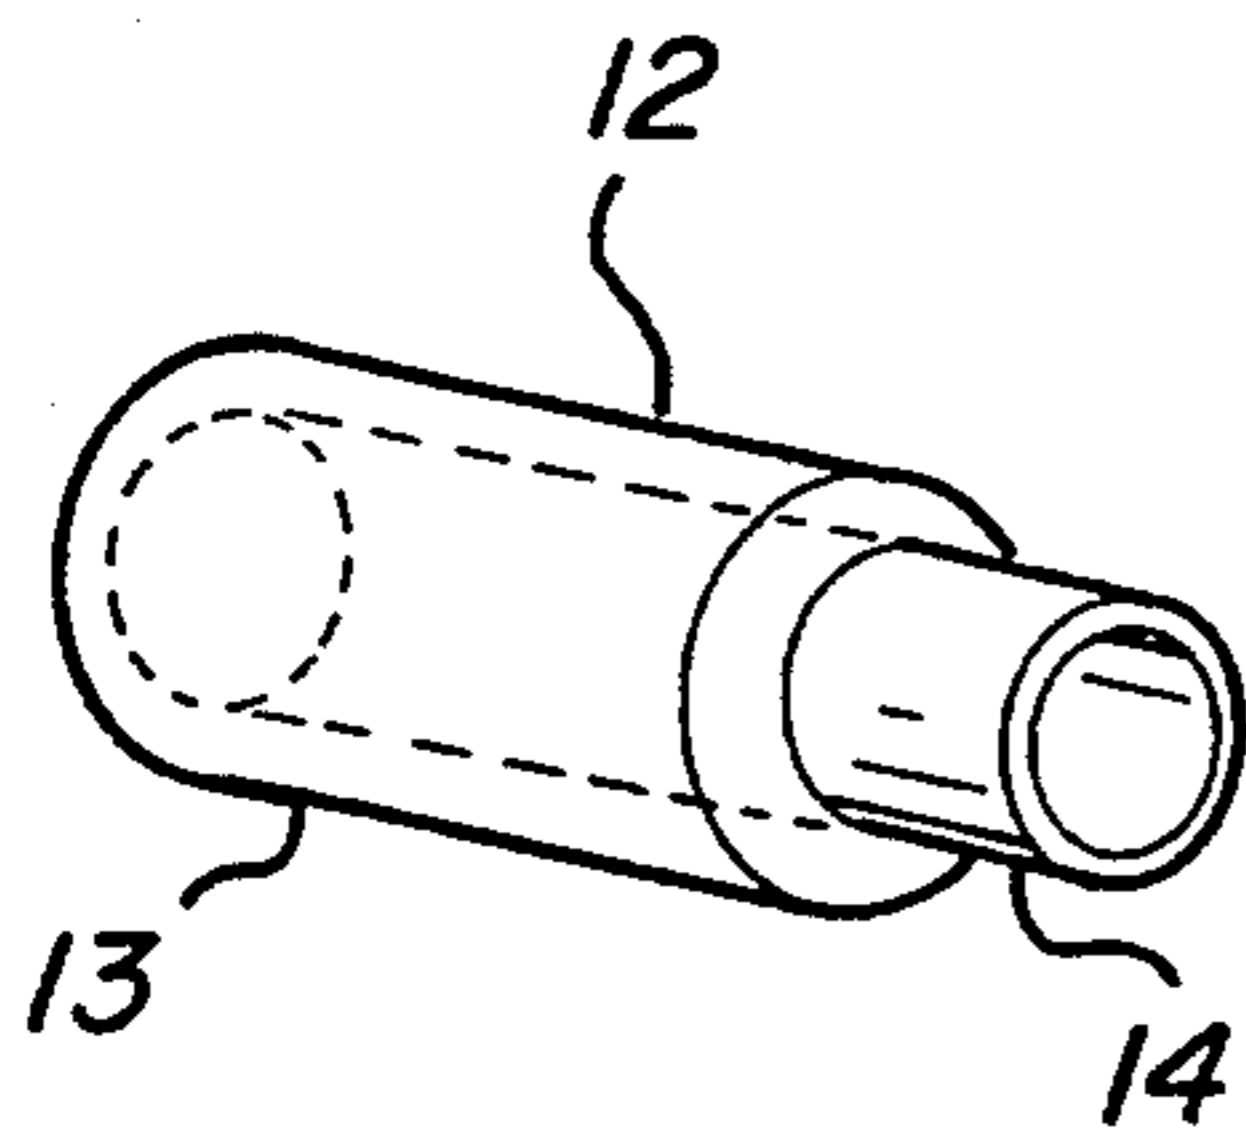
**FIG-4**

FIG. 4 illustrates the first embodiment of this invention in which a metal bushing having different outside diameters is provided for the gear.

In FIG. 4, the metal bushing 12 is shown as having a larger outer diameter portion 13 for most of its length and a smaller outer diameter portion 14 for the remainder of its length. The reasons for this are the nubs 11. When enlarging the bore 4 in the gear bushing 3, care must be taken so the nubs 11 are not drilled away. If this happens, the spring-clip contact 8 will fall off the bush-

ing 3. So the bore 4 at the end of the bushing 3 with the nubs 11 is not enlarged as much. But the wider portion 13 of the metal bushing 12 allows extra strength and wear life.

FIG. 4 illustrates a first embodiment of this invention. The invention is described in terms of the gear 2, but it should be noted that the improvements of each embodiment of the invention may also be applied to the gear 5 at the other end of the photoreceptor drum 1. It should also be noted that the gear 5 may be the gear which includes the spring-clip contact 8. In the first embodiment the existing prior art gear 2 is upgraded by enlarging the bore 4 in the bushing 3 and inserting a semi-permanent or replaceable cylindrical metal bushing 12 into the wider bore. The bushing 12 is sized to fit around the photoreceptor drum shaft and rotates with the bushing 3. The metal bushing 12 separates the plastic bushing 3 from the stationary shaft. The metal bushing 12 gives the conventional gear 2 a longer life. The metal bushing 12 is attached to the inner wall of the plastic bushing 3 by glue or other adhesive, but not permanently attached. When the metal bushing 12 wears, it may be removed and replaced with a new bushing. The gear 2 may now last longer than the photoreceptor drum, almost indefinitely since the metal bushing 12 may be replaced anytime it becomes worn. The life of the gear 2 is only limited by the life or wear of the gear teeth, no longer by the life of the plastic bushing 3. The bushing 12, may be also made of conductive plastic (and insulative plastic on the non-grounding gear), designed to be replaceable or modular.

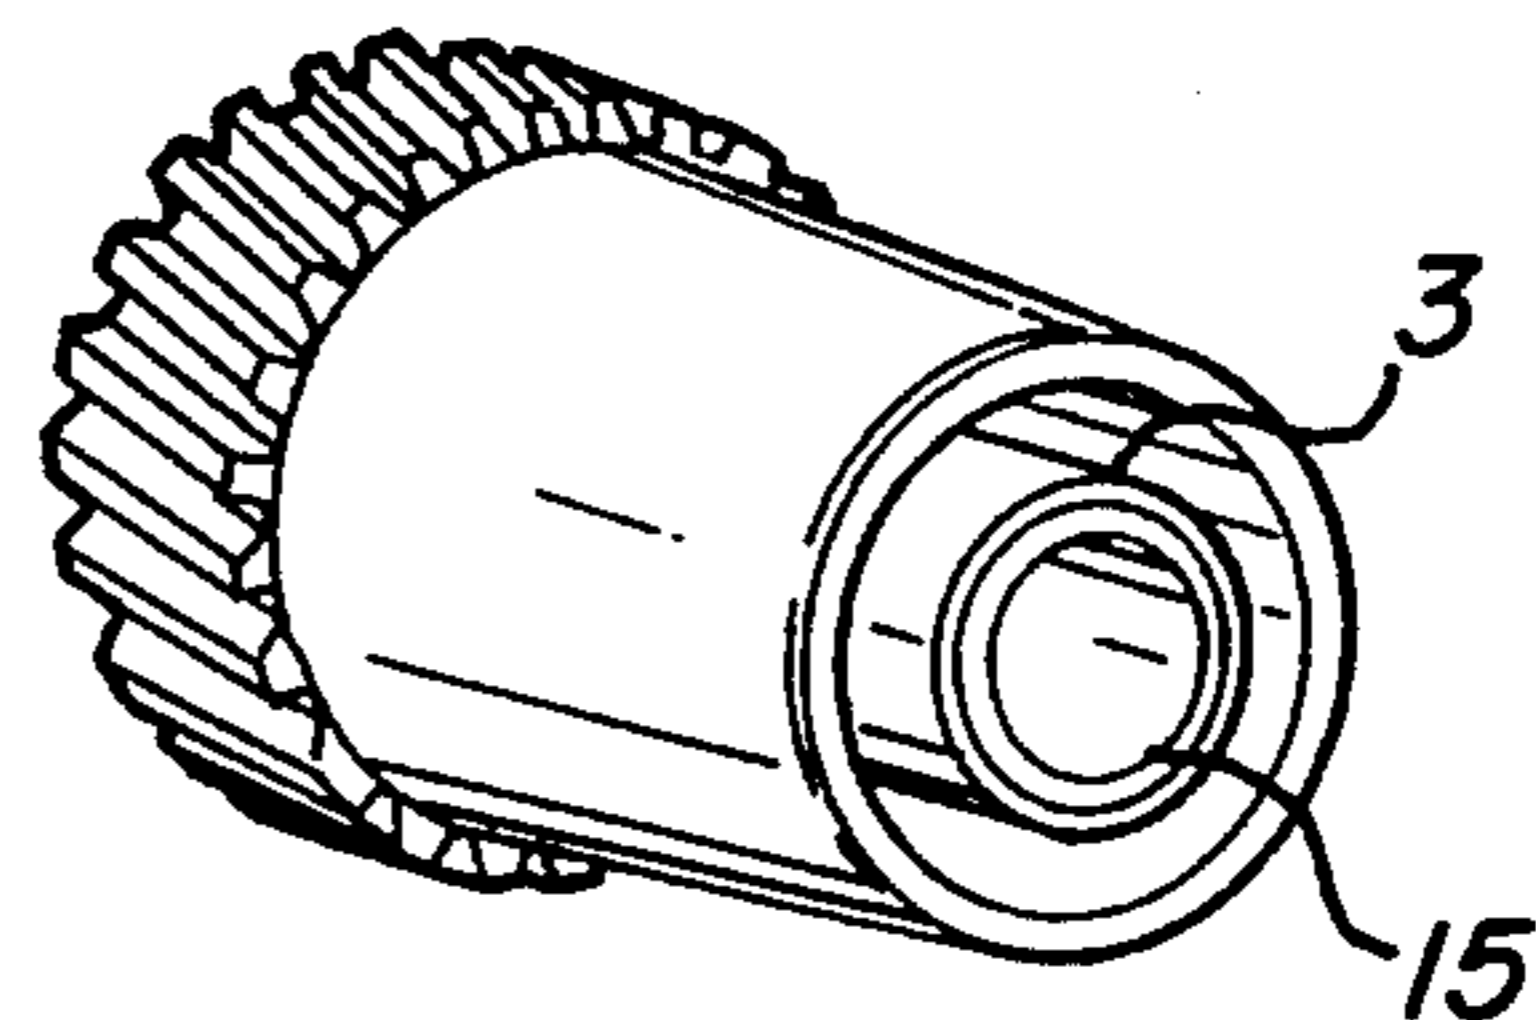
**FIG-6**

FIG. 6 illustrates the metal bushing inserted in the gear.

FIG. 5 shows a metal bushing 15 uniform in diameter. This is for gear bushings 3 where the spring-clip contact 8 is held on in ways other than the nubs 11, or where the nubs 11 are in a position not affected by enlarging the bore 4. The metal bushing 15 could also be for use in the gear 5. FIG. 6 is an illustration of the metal bushing 15 inserted in the bushing 3 of a gear.

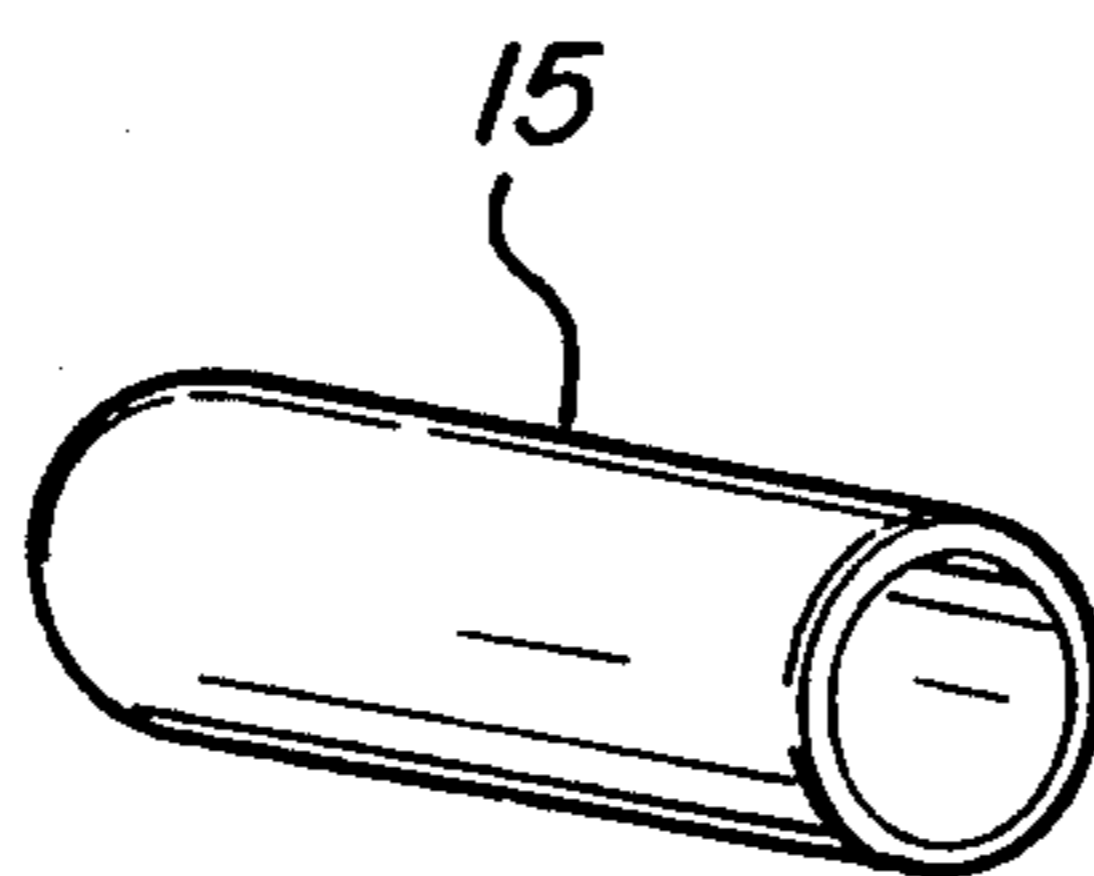
**FIG-5**

FIG. 5 shows a metal bushing with a uniform outside diameter for use with various types of gears.

Aluminum, stainless steel, or other steel alloys would be good selections for the material from which the metal bushing 12 and 15 are made. It is important that the metal bushings 12 and 15 have good electrical conductivity, since the metal bushings are designed to press against the spring-clip contact 8 when the contact 8 is attached on the end of the sleeve 7 of the gear 2. In this way, when the prong 9 of the spring-clip contact 8 loses good electrical contact with the drum shaft, the drum 1 is still well grounded through the connection between the drum shaft, metal bushing 12 or 15, spring-clip contact 8, prongs 10 and the inner wall of the photoreceptor drum 1.

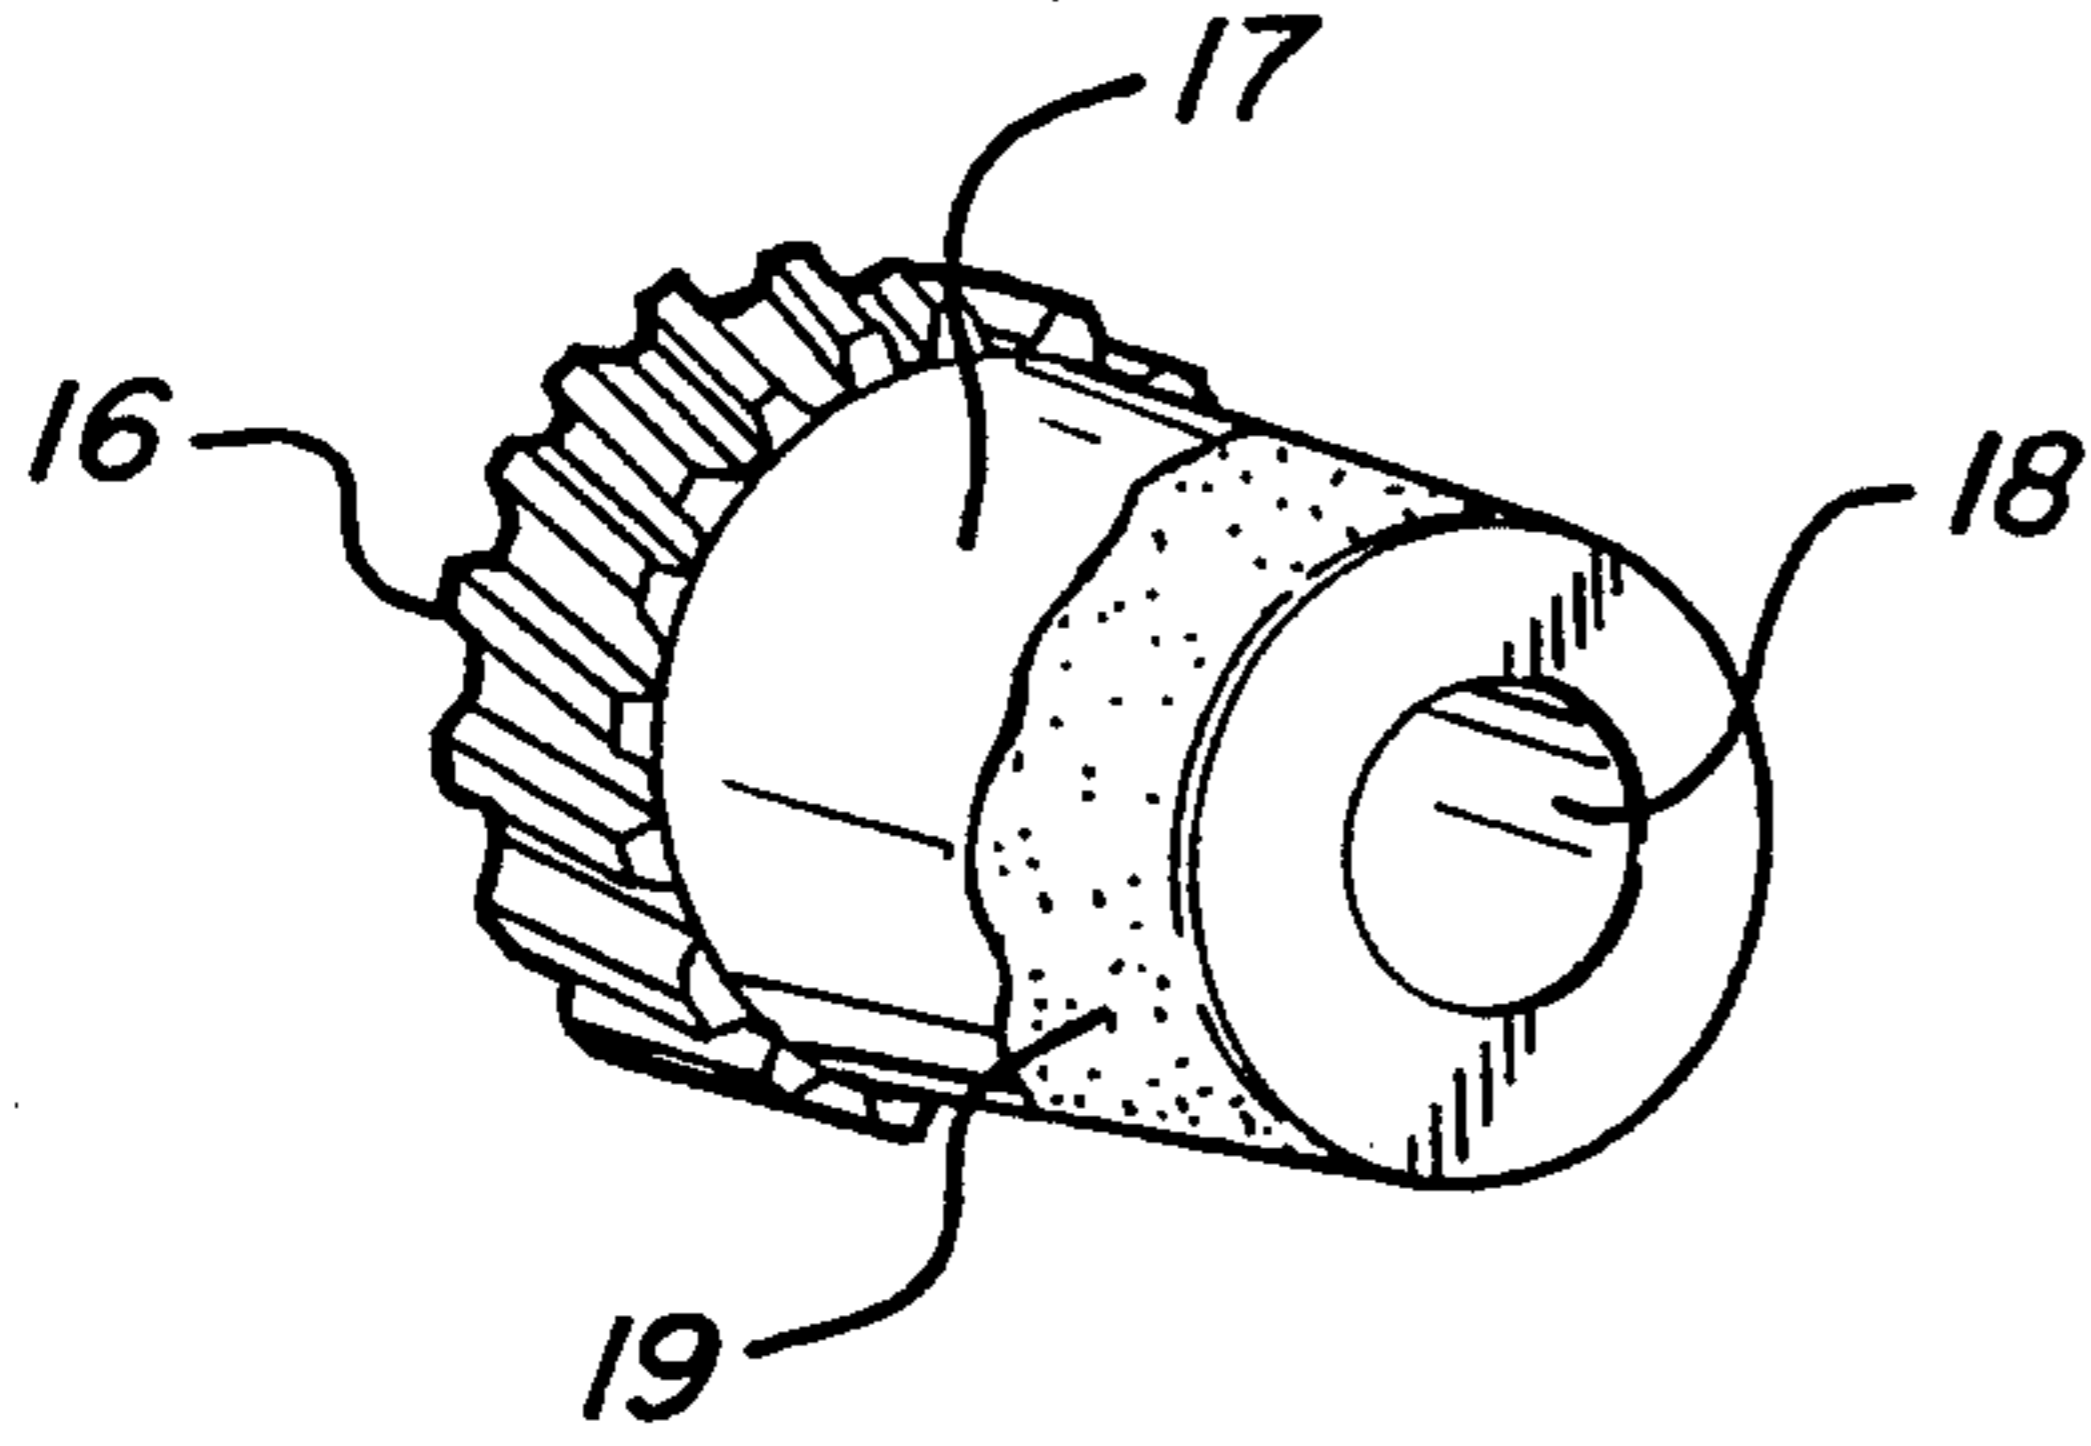
FIG-7

FIG. 7 shows a second embodiment of this invention comprising an all-metal gear.

FIG. 7 shows a second embodiment of this invention. The all-metal gear 16 is manufactured with the metal bushing 17 cast in. The outer surface of the bushing 17 acts as a sleeve for fitting within the inner wall of the photoreceptor drum 1. A bore 18 through the bushing 17 is sized such that the gear 16 rotates smoothly around the photoreceptor drum shaft. Having the metal gear and its bushing manufactured from aluminum would give the gear better conductivity, but it would wear quicker than steel. Having the metal gear 16 and bushing 17 made from stainless steel would give them good corrosion resistance, and other steel alloys with higher electrical conductivity would also be good engineering selections. Because, in this embodiment, there is no need for the spring-clip contact 8. The bushing 17 grounds the photoreceptor drum 1 to the axle or shaft since it is completely metal. A conductive joining material 19, such as a liquid glue with fine aluminum or copper particles suspended in the glue, would be used to secure the bushing 17 to the inner wall of the drum 1.

Applicant is not aware of an all-metal gear ever having been used on a photoreceptor drum. The logic in the prior art has been that one wants the photoreceptor drum gear in the all-in-one toner cartridge to wear quicker than the printer or copy machine gear that drives the photoreceptor drum gear. The concept of the toner cartridge is that few printer or copier components need routine replacement since the moving parts that wear are in the cartridge. However, if the printer and copier manufacturers made the printer gear into an easily replaceable metal modular gear, then the photoreceptor drum gears could be made of metals without fear of damaging or quickly wearing the printer or copier gear. An aluminum printer gear (for example) would work fine. Such gears could be inexpensively manufactured by casting. A customer-installable-and-removable metal gear for the printer could be provided with this invention to allow more efficient use of the metal photoreceptor drum gear 16.
