[11] Patent Number: **5,402,207**

Michlin

## [54] LONG-LIFE AND IMPROVED PHOTORECEPTOR DRUM GEAR

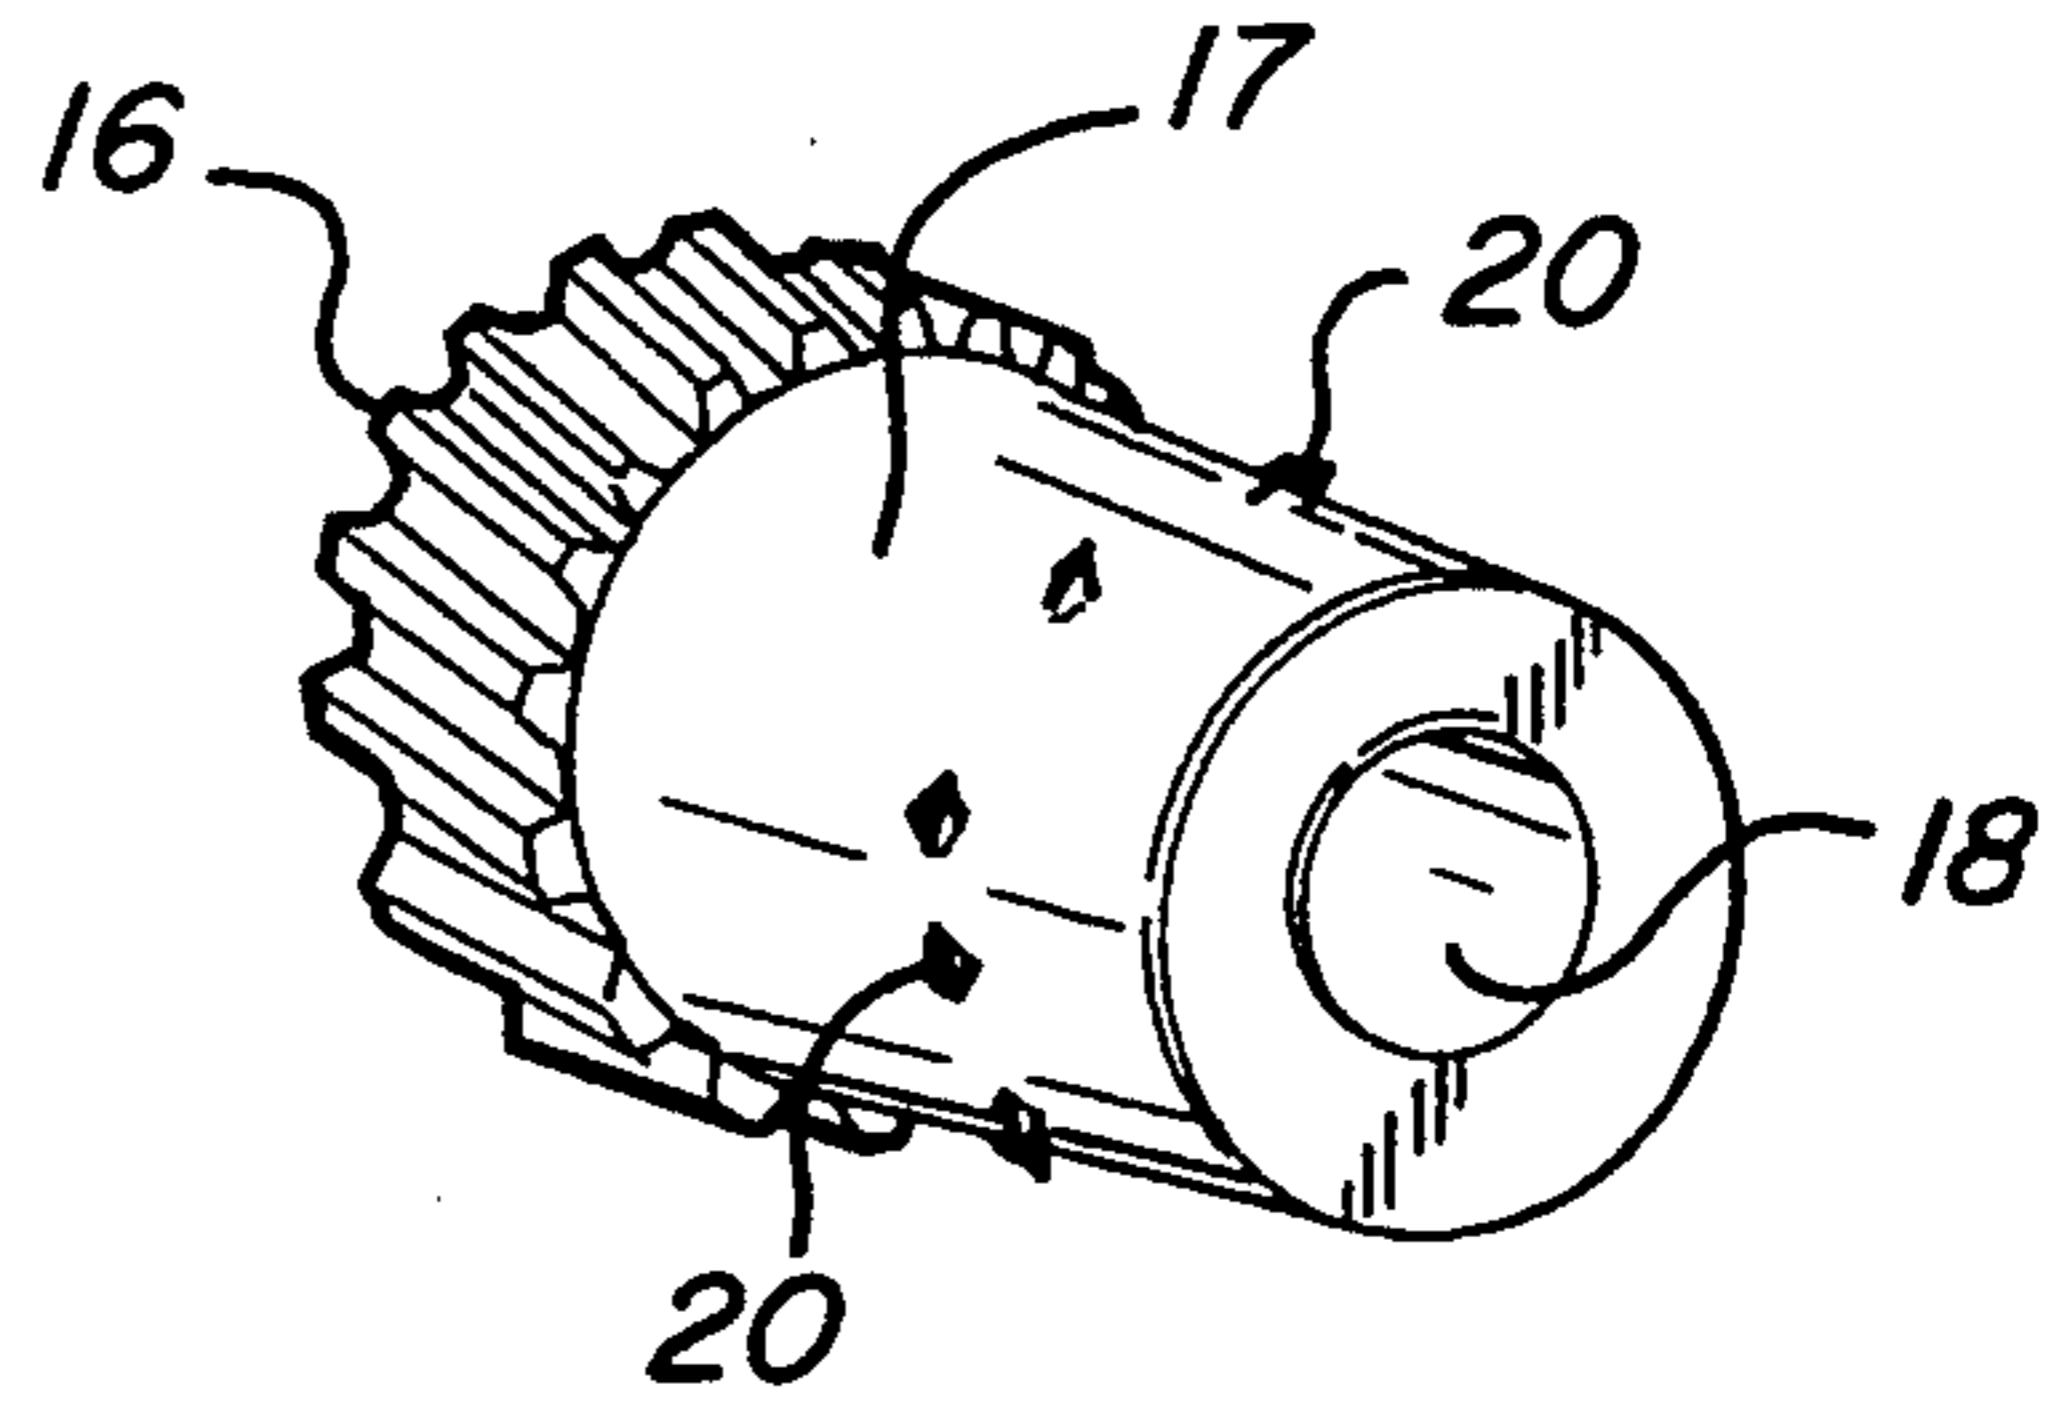
FIG-8

FIG. 8 illustrates a modification of the all-metal gear so it includes prongs to help electrically ground the drum.

FIG. 8 illustrates an alternative to the conductive joining material 19. Little prongs 20 could be added to the outer surface of the bushing 17 in the casting process to scratch into the inner wall of the drum 1, ensuring electrical contact for the grounding function. The

prongs 20 could be in the shape of little pyramids for good strength and so the tip and corners of each pyramid cut into the inner wall of the drum 1.

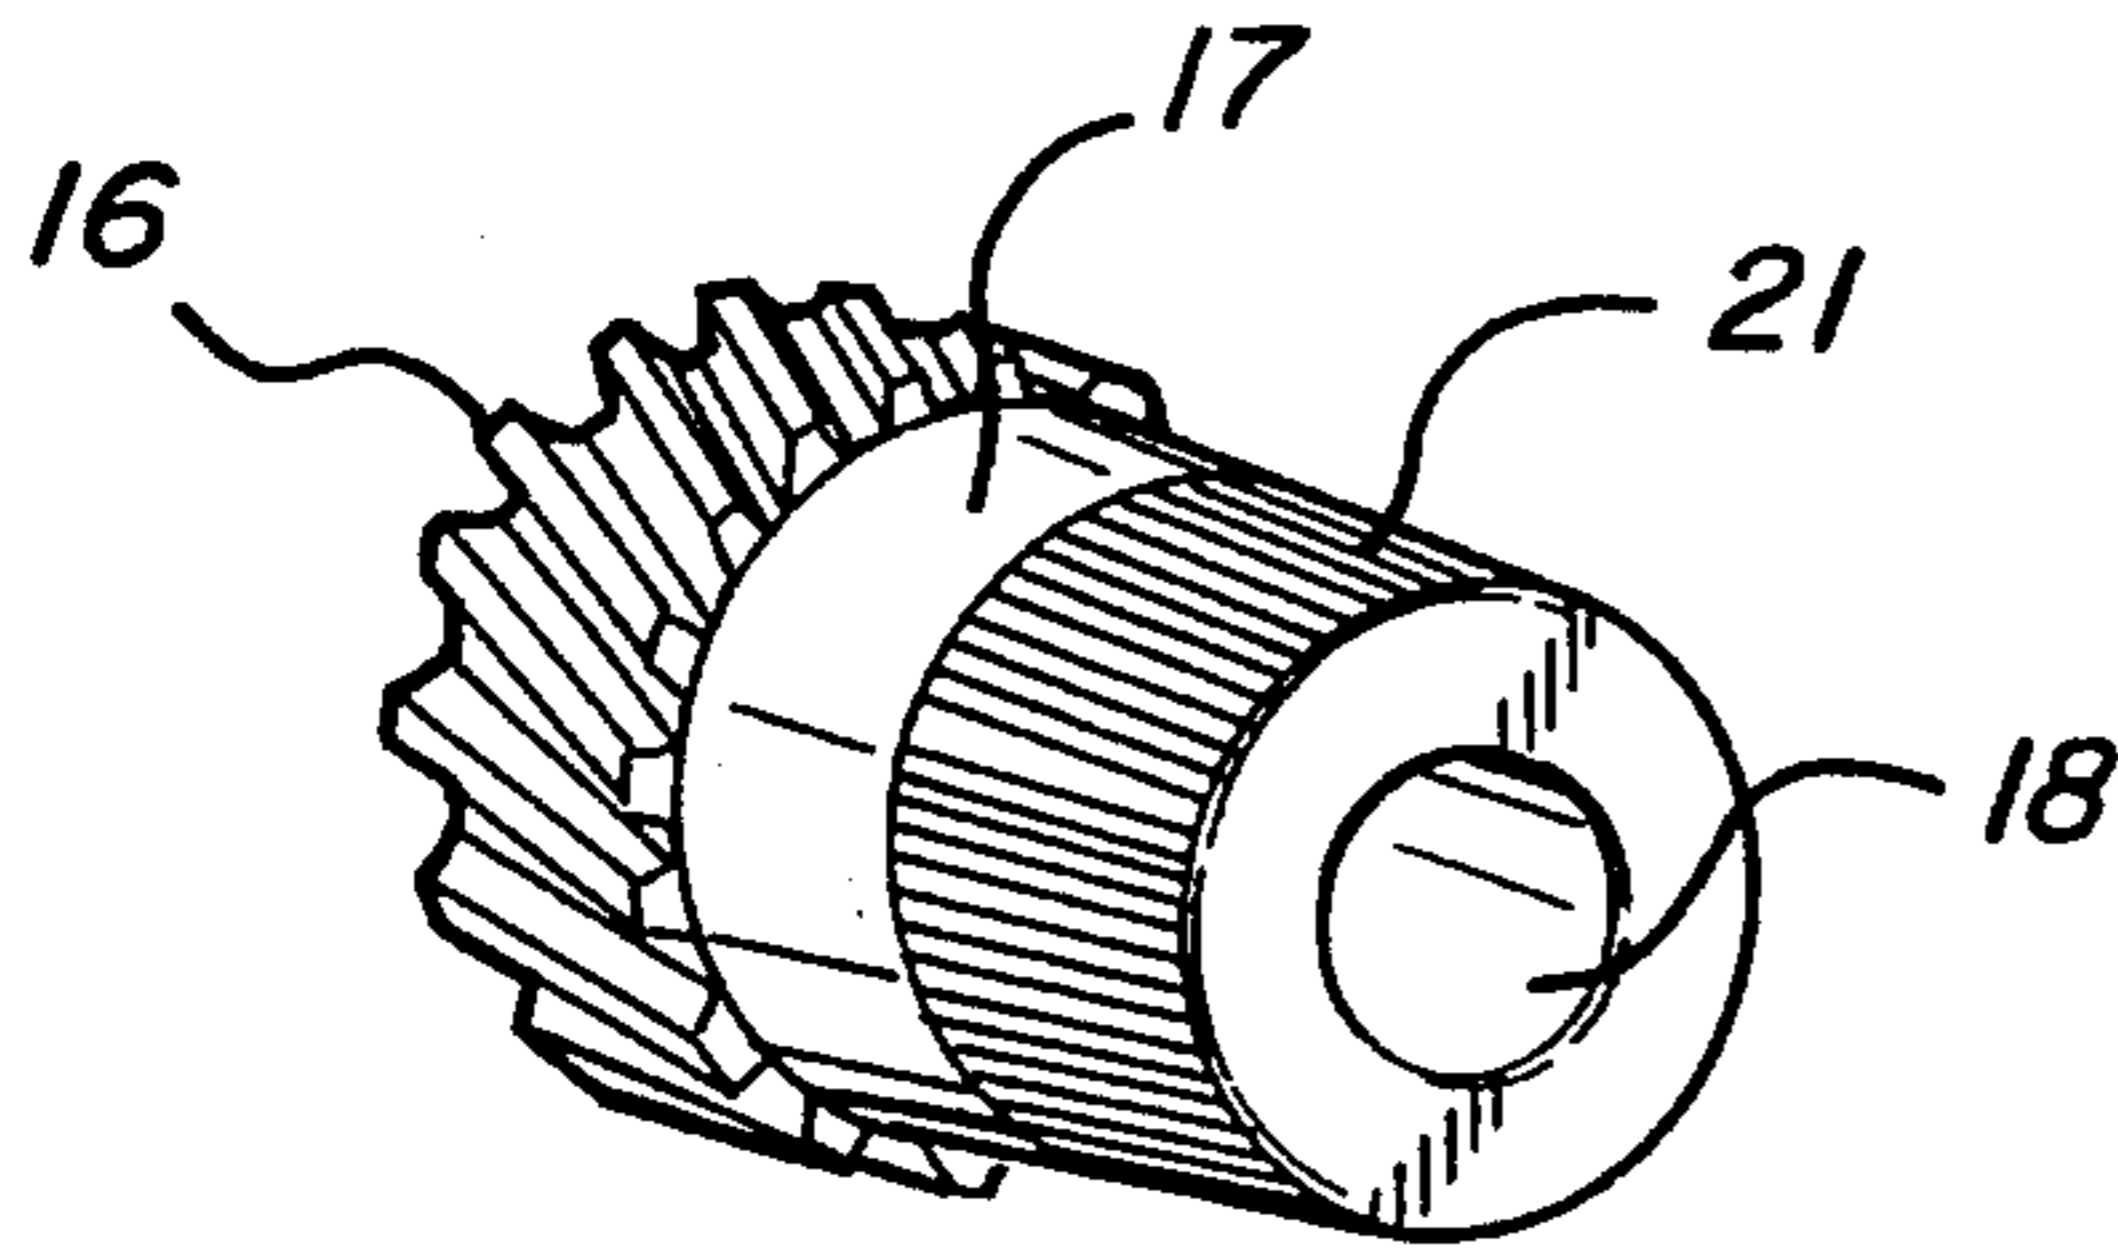
FIG-9

FIG. 9 shows a modification which uses knurls parallel to the axis of the gear as an alternative to prongs.

FIGS. 9-11 illustrate more alternatives to the conductive joining material 19 and prongs 20. A portion of the outer surface of the bushing 17 is knurled. The roughness or ridges of the knurls would cut into the inner wall of the drum 1, providing the electrical connection needed to ground the drum. Care must be taken so the glue or adhesive which secures the bushing 17 to the inner wall of the drum 1, if insulative glue or adhesive is used, does not cover the knurls and insulate the contact to prevent grounding. The knurls would not only help make electrical contact, but could help the gear 16 grip the inner wall of the drum 1. FIG. 9 and 10 show single knurls. The knurls 21 shown in FIG. 9 are parallel to the rotational axis of the gear 11. The knurls 22 shown in FIG. 10 each extend around the circumference of the bushing 17. The parallel knurls 21 grip the inner wall of the drum 1 best, reducing slippage. The double knurl 23 shown in FIG. 11, with the knurls perpendicular or at some other angle to each other, also works very well. Any type of knurl would help the gear 16 grip the inner wall of the drum 1 and ensure the soundness of the electrical connection for grounding the drum.

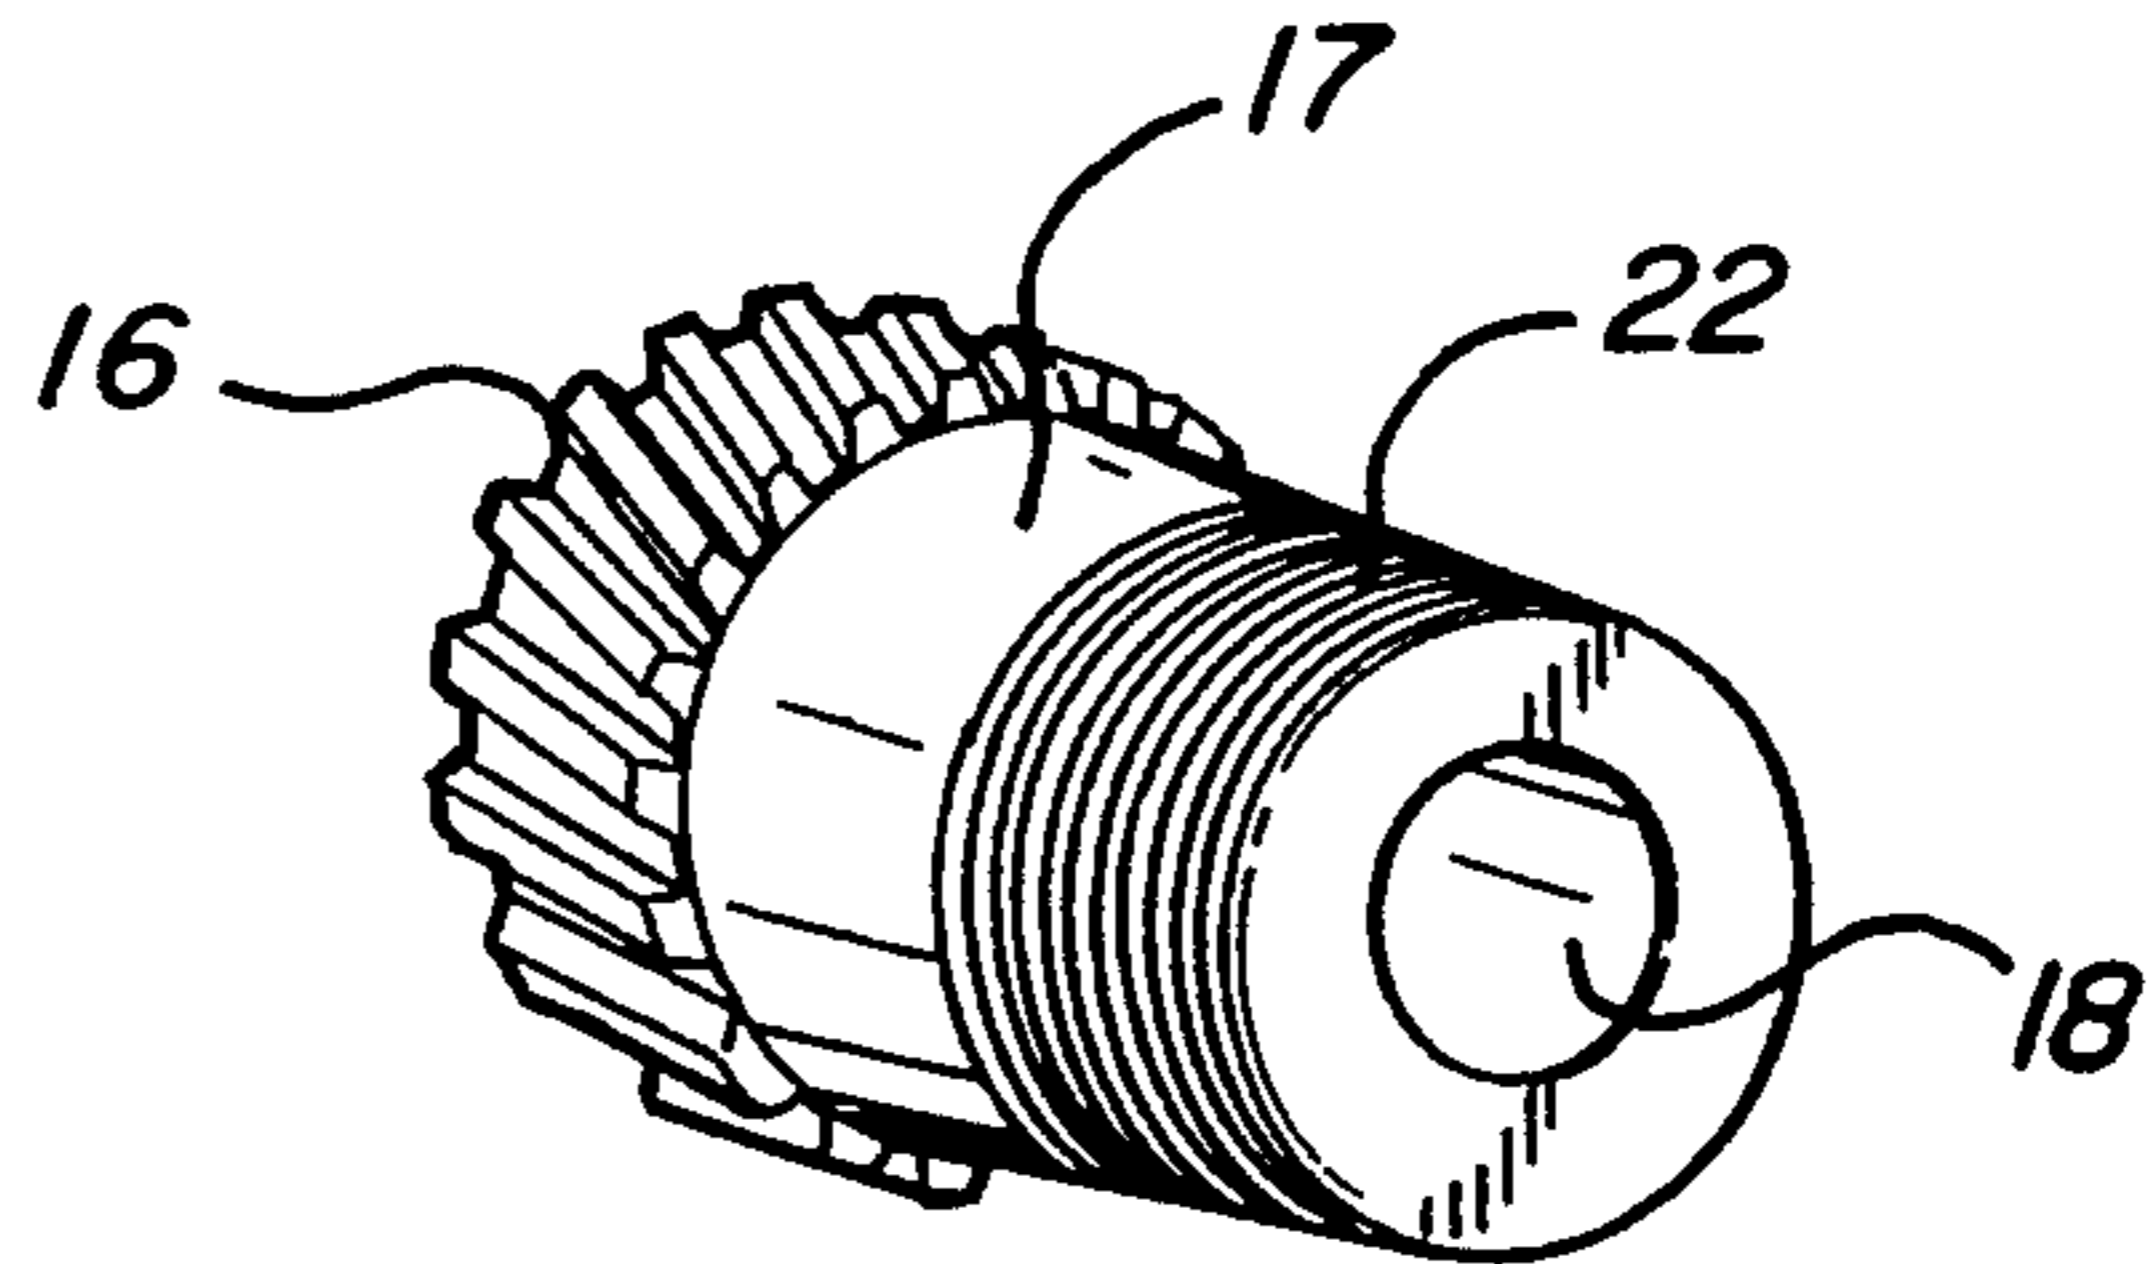
FIG-10

FIG. 10 illustrates a gear with knurls extending around the circumference of the bushing.

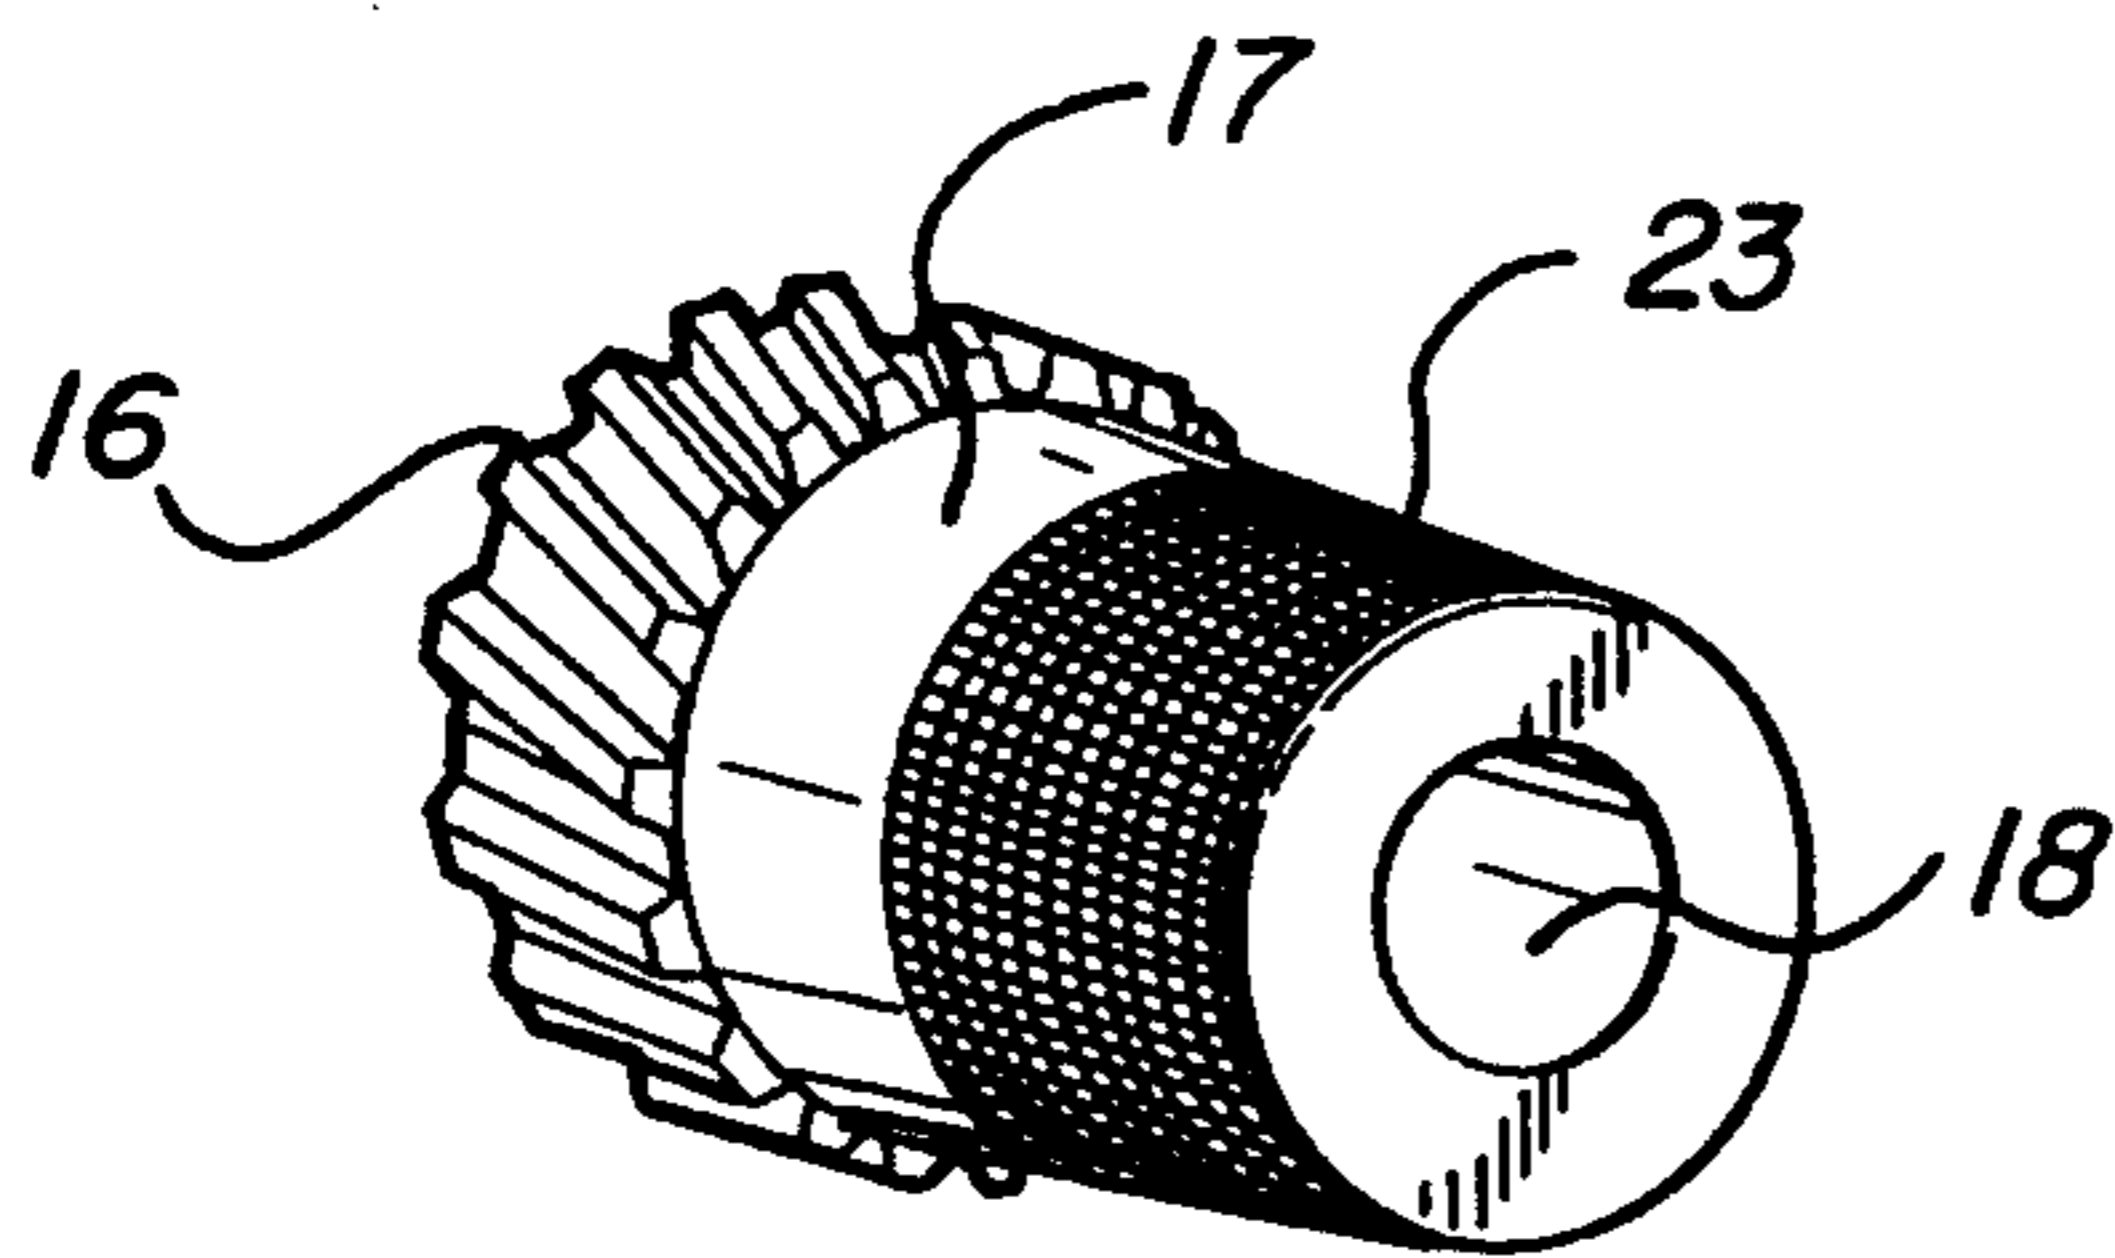
FIG-11

FIG. 11 shows a gear having double knurls on the bushing for improved grounding contact.

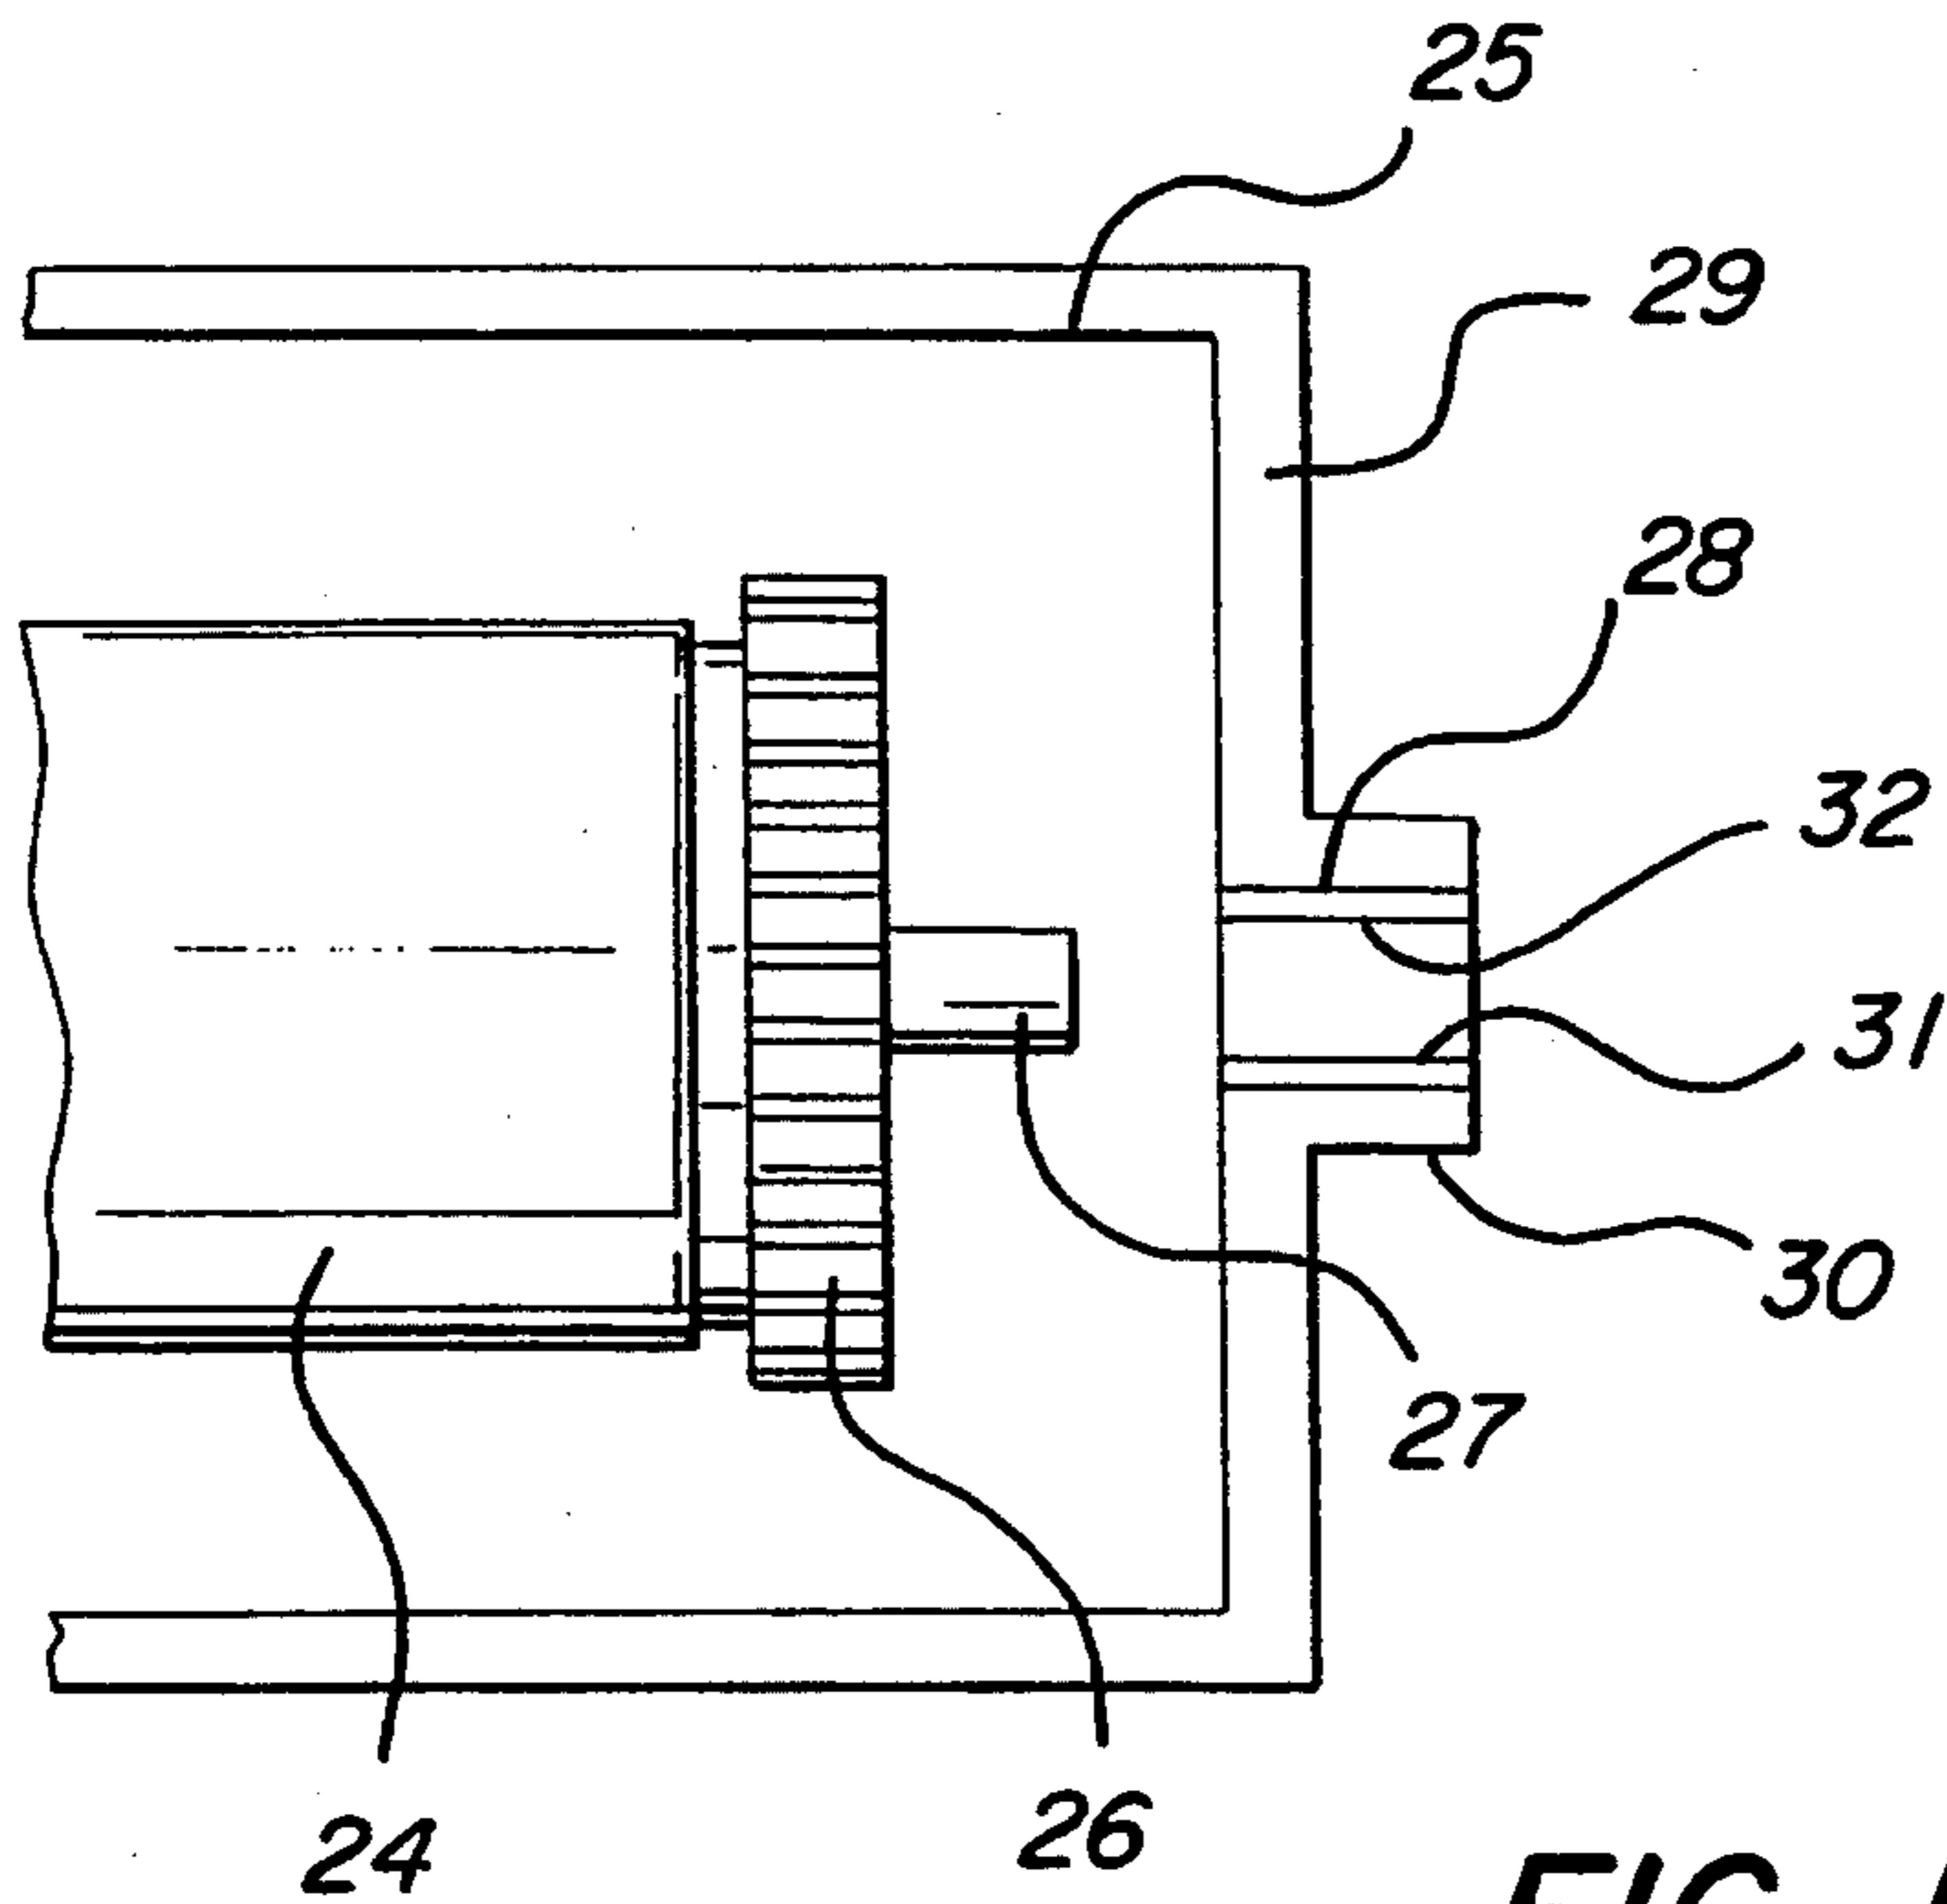
**FIG-12**

FIG. 12 shows the third embodiment of the invention, which comprises a bushing inserted in the cartridge wall for receiving the gear shaft.

FIG. 12 shows a third embodiment of this invention. The wear problems in the HEWLETT PACKARD SERIES 4 or EX toner cartridge involve the usually nonconductive gear side of the photoreceptor drum 24. Only a cross-sectional view of the waste hopper assembly 25 is shown. The plastic gear 26 is attached to the drum 24 and turned by a gear in the printer, copier, or facsimile machine. The gear 26 has a hollow plastic gear shaft 27 which fits into a hole 28 in the wall 29 of the waste hopper assembly 25. When the drum 24 rotates, the gear shaft 27 rotates in the hole 28. The hole 28 extends through a raised cylindrical rim 30 on the opposite side of the waste hopper assembly wall 29. The rim 30 helps support the gear shaft 26. With this invention, the hole 28 through the assembly wall 29 and rim 30 has been enlarged by drilling or other method and lined with a metal, plastic, nylon or TEFLON bushing 31 replaceably secured in the hole 28. The bushing 31 prevents the hole 28 from wearing and becoming oblong or oversized. So the drum 24 does not wobble or otherwise rotate unevenly and the quality of the image is maintained. When the inside diameter 32 of the bushing 31 begins to wear, the bushing 31, unlike the wall 29 of the waste hopper assembly 25, can be easily replaced. The bushing 31 may be used to repair a waste hopper assembly that already has an oblong hole as well as for preventing such wearing. Please note that the hole 28 in FIG. 12 has been drilled and reamed in this case to modify the EX waste toner 25 hopper to prepare it for the bushing 31. Originally, before drilling, the waste hopper is as seen in FIG. 13 where the hole has two different diameters at 34 and 35. However, the hole is drilled out. The main reason the invention is necessary is because the hole 34 gets worn out and disfigured, often oblong, by the rotating shaft 27, because the ABS plastic of the waste hopper 25 is not wear resistant like the plastic of the gear 26. In many cases, the majority of the hole 34 is worn, where it contacts the shaft, how-

ever, a small portion where hole 34 joins hole 35 and in the vicinity, the hole is not as deformed or not deformed at all.

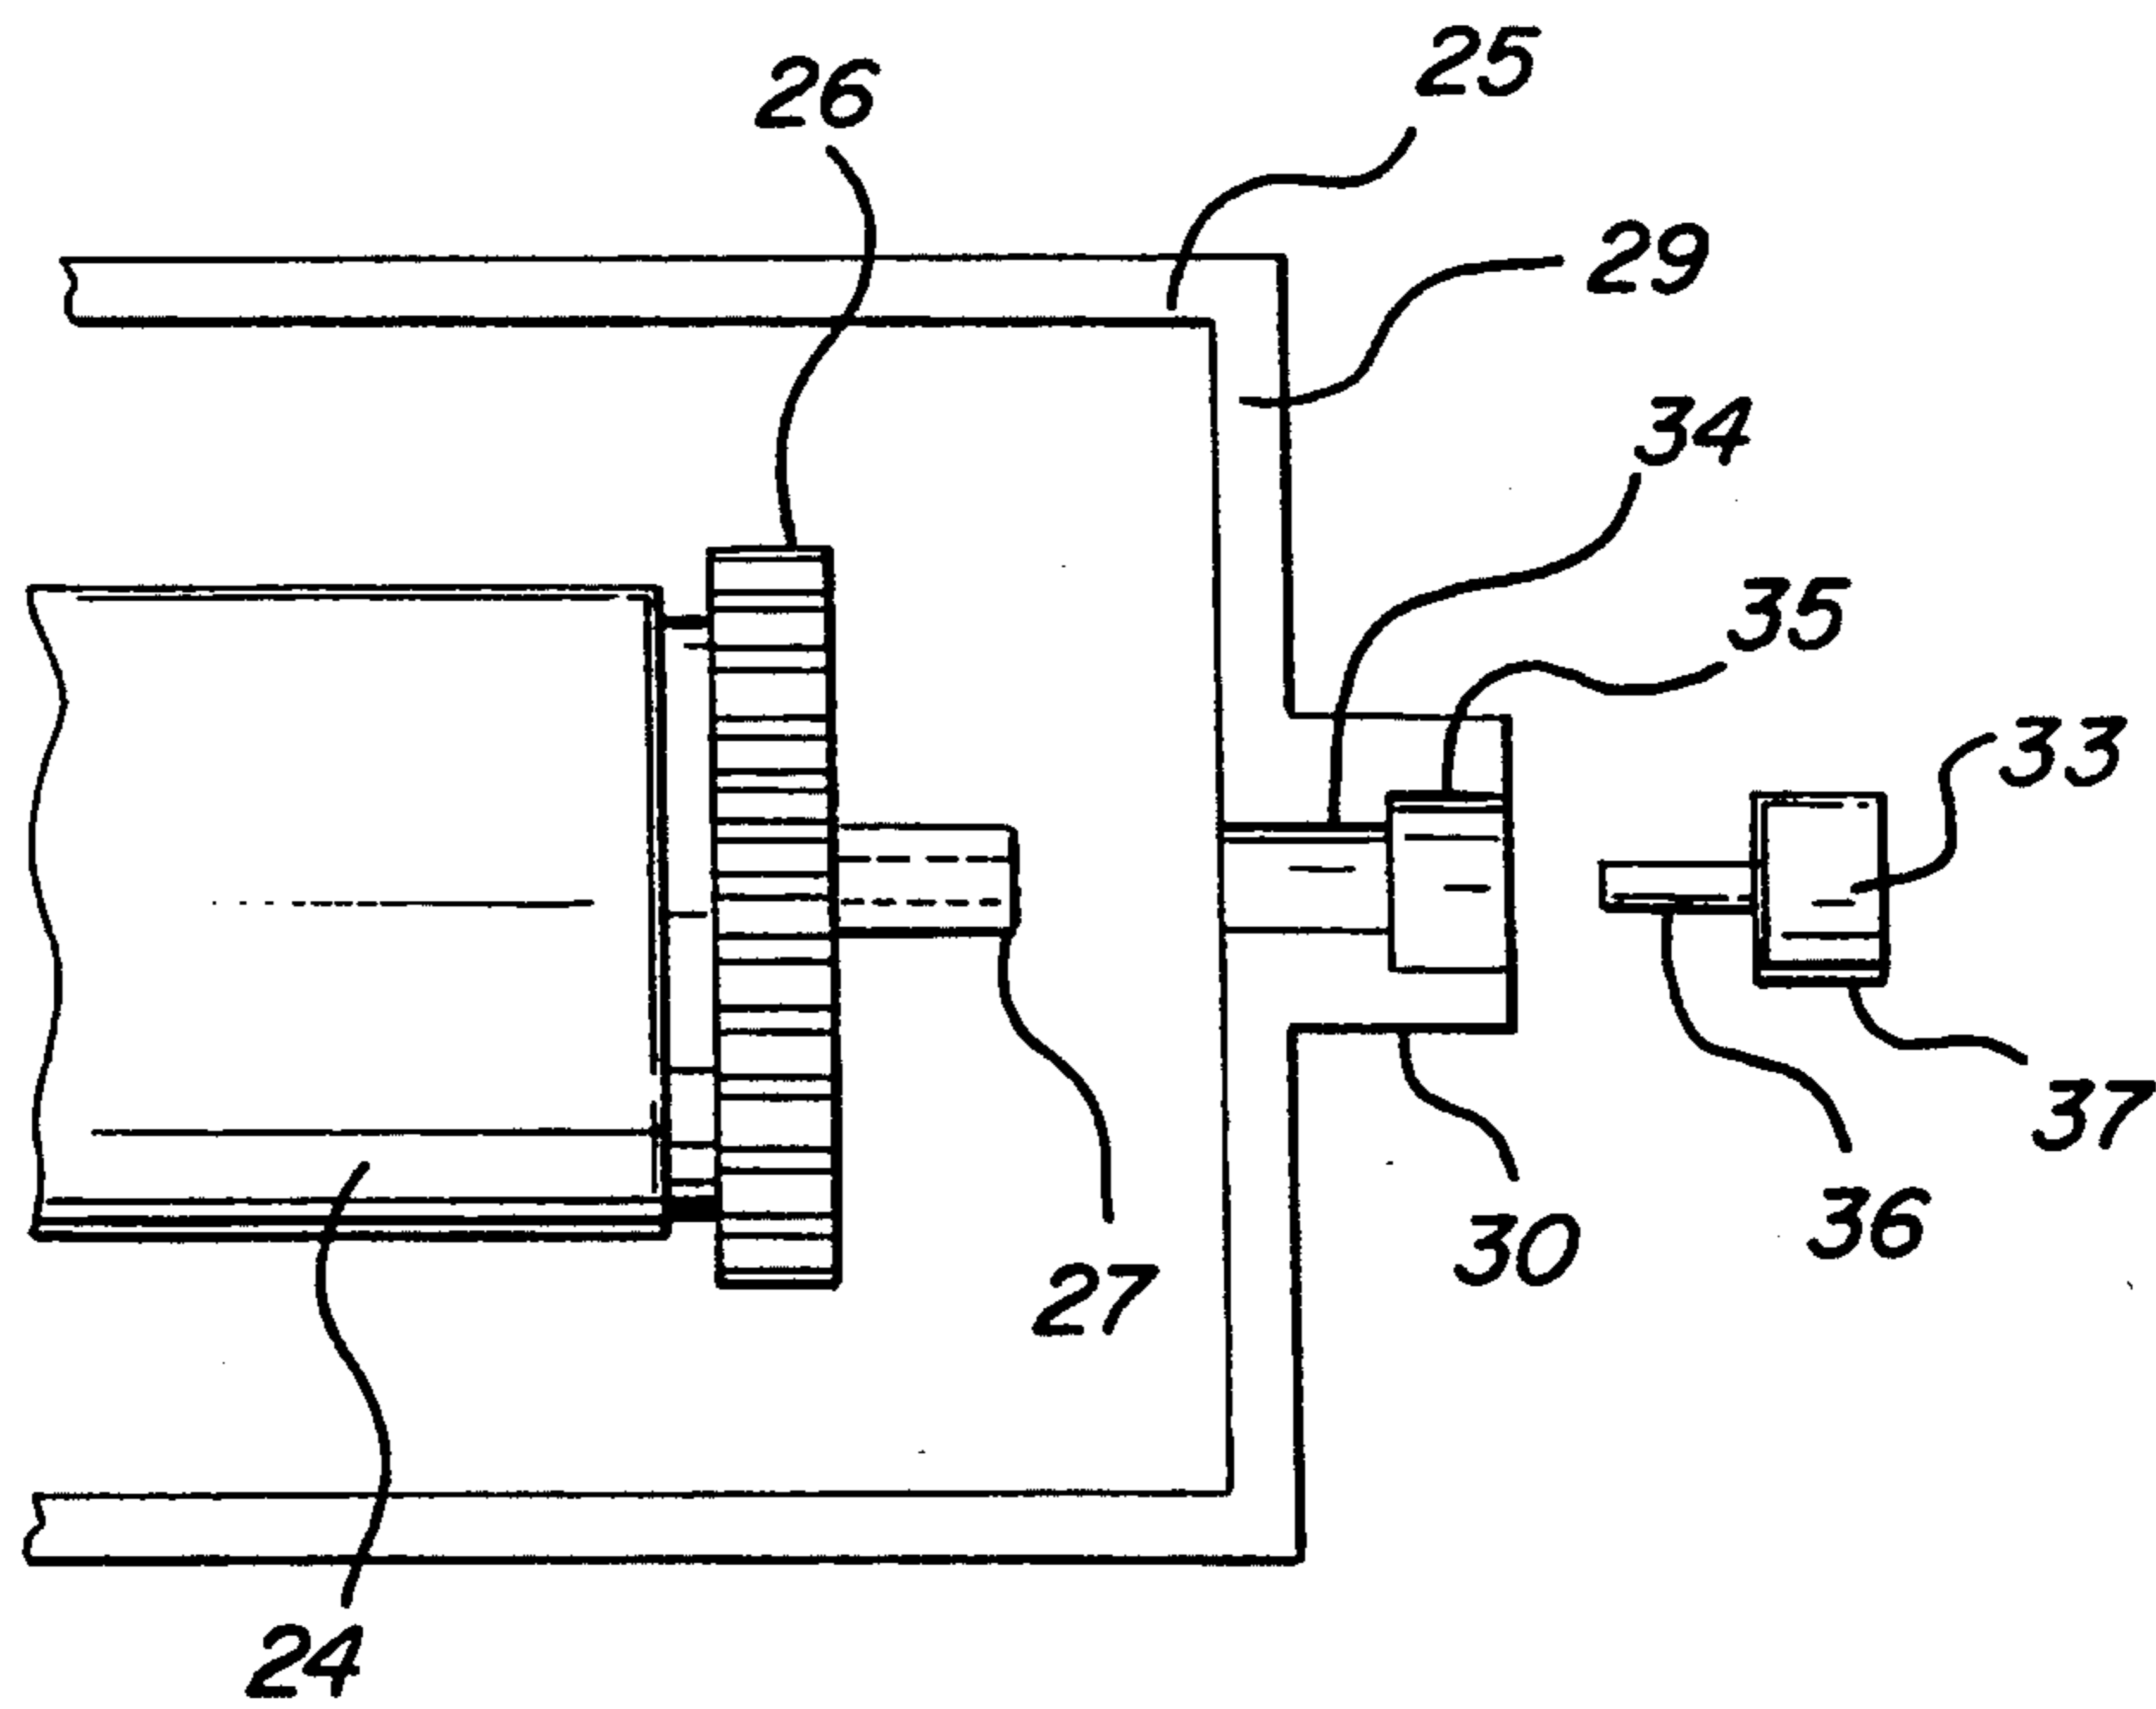
**FIG-13**

FIG. 13 illustrates a fourth embodiment consisting of a gear aligner device for keeping the rotation of the drum true.

The fourth embodiment of this invention uses the gear aligner device 33 shown in FIG. 13 to keep the rotation of the photoreceptor drum 24 straight and true. The gear shaft 27 is hollow and does not extend through the full, length of the raised cylindrical rim 30 when inserted in the hole 28. The hole 28 in some toner waste hopper assemblies, such as in the EX cartridge, has two different sizes. In the first part 34 of the hole 28, the hole is sized to receive the gear shaft 27. The second part 35 or remainder of the hole 28 is slightly larger in diameter. The gear aligner device 33 has two portions. The first portion 36 of the gear aligner device 33 is sized to fit inside the hollow gear shaft 27. The second portion 37 of the gear aligner device 33 is sized to snugly fit within the second, larger diameter part 35 of the hole 28, since the gear aligner device 33 is inserted through the hole 28 into the drum gear shaft 27 from the rim 30 side of the waste hopper assembly wall 29. This aligns the gear 26 properly, allowing true rotation of the drum 24, and moves the wear problem to the hollow gear shaft 27 of the easily replaceable wear-resistant gear 26. In cases where the hole 28 has two different diameters 34 and 35, the shaft 27 may not fill the entire hole 34 for the hole 34's full length or the drum 24 may have some play along its longitudinal axis. For this reason, the gear aligner device 33 may optionally have two different diameters 37, some that is correct diameter to fit the hole 35 and some of correct diameter to fill the hole 34, to achieve better alignment and also minimize play along the drum 24's longitudinal axis. Aligning the drum 24 and preventing the longitudinal sway thus helps prevent the drum 24 from wearing as quickly as otherwise. Optionally, the gear aligner device 33 may be glued in place to secure it in the hole 35. The gear aligner device 33, as well as the bushing 31, may be molded and works best when made of metal, such as aluminum for example, but may also be made from plastic with a high wear resistance, such as nylon, or TEFLON.
