## ADDRESS LINE REPAIR STRUCTURE AND METHOD FOR THIN FILM IMAGER DEVICES

This application is a Continuation of application Ser. No. 08/169,260, filed Dec. 20, 1993, now abandoned.

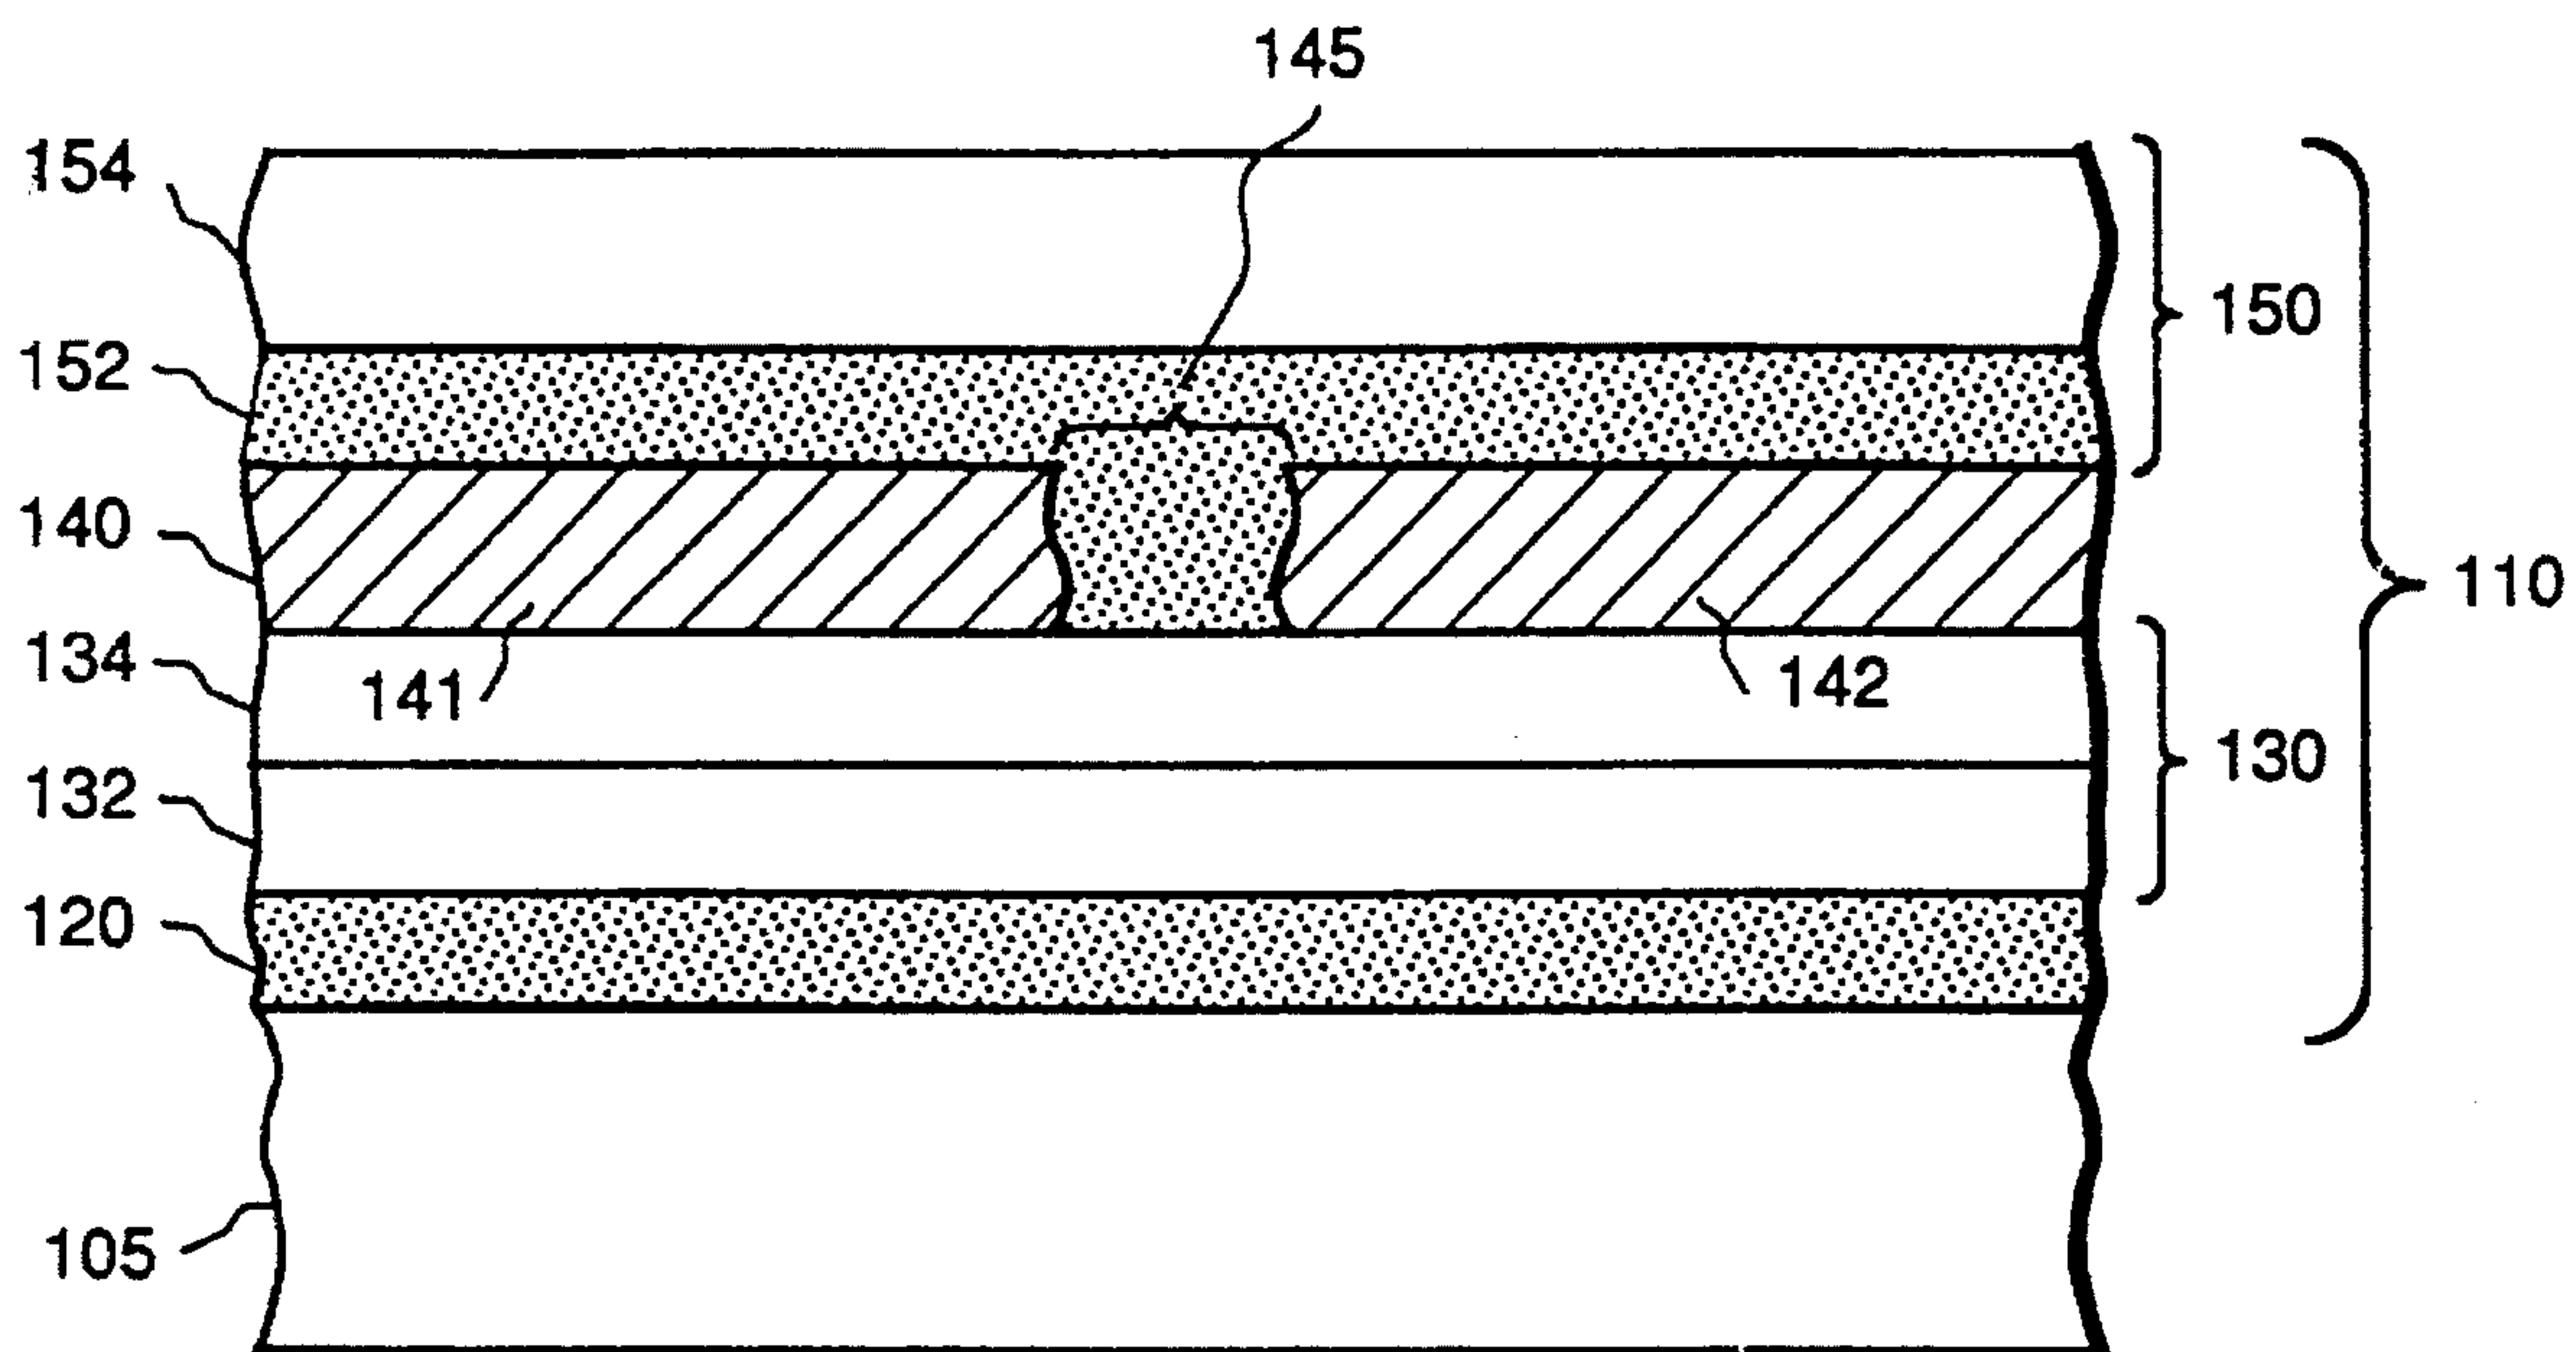
FIG. 1 is a cross-sectional view of an imager device having a damaged first conductive component and illustrated at a point in the fabrication process prior to deposition of an overlying second conductive component.

A thin film electronic imager device **100**, such as a solid state radiation imager, typically comprises a photosensor array **110** disposed on a substrate **105**, as illustrated in FIG. 1. Photosensor array **110** comprises a plurality of photosensor pixels (not shown), comprising photodiodes or the like, which are sensitive to incident photons. Each pixel is respectively addressed by a matrix of address lines coupled to the pixels; address lines comprise scan lines (not shown) that are coupled to switching devices to access respective pixels, and data lines that conduct charge collected on the photodiode to readout circuitry. The scan and data lines are typically electrically insulated from one another by a dielectric layer disposed between them.

In the fabrication of the photosensor array in a typical imager device, scan lines are formed on substrate **105**; a dielectric layer **120** comprising silicon nitride, silicon dioxide, or the like, is deposited over the scan line array; a semiconductive layer **132** comprising silicon or the like is deposited over dielectric layer **120**, and a doped semiconductive layer **134** comprising silicon doped to exhibit n type conductivity or the like is deposited over the semiconductive layer. Semiconductive layer **132** and doped semiconductive layer **134** are patterned to form the bodies of switching devices (not shown), such as a field effect transistor (FET) (also referred to as a thin film transistor (TFT)) associated with each pixel. The combined layers of semiconductive layer **132**, and doped semiconductive layer **134** are typically referred to collectively as a FET sandwich **130**. Conductive material, such as molybdenum, titanium, aluminum, chromium, or the like, is deposited and patterned to form source and drain electrodes (not shown) for each TFT and typically also is patterned to form data lines **140** (a representative one of which is shown in cross section in FIG. 1) in the array.

Additional fabrication steps include formation of the photodiodes, including the deposition and patterning of semiconductive material, typically silicon, to form the photodiode body (not shown in the cross-sectional portion of the imager illustrated in FIG. 1), deposition of a barrier layer **150**, which typically comprises a first protective layer comprising an inorganic dielectric material such as silicon dioxide, silicon nitride, or the like, and a second protective layer comprising an organic dielectric material such as polyimide or the like. Fabrication of photosensor array **110** is completed with the deposition and patterning of a common electrode (not illustrated in FIG. 1) disposed over the barrier layer and in electrical contact with a portion of each photosensor body through vias opened in the barrier layer.

FIG. 1 illustrates an imager device at the stage in the fabrication process just prior to the deposition of the common electrode. A defect **145** is disposed in data line **140** such that an open circuit condition exists between a first portion **141** and a second portion **142** of data line **140**. Defect **145** comprises a break in the conductive material of data line **140** in which non-conductive material is disposed between respective portions **141**, **142**, of the data line. The non-conductive material typically comprises dielectric material from barrier layer **150**; as used herein, "non-conductive" refers to both dielectric and semiconductive material that may be disposed in defect **145** so as to create the open circuit condition (the term also implies a non-gaseous material, such as a solid or fluid that reposes in the defect region). Defect **145** results from damaged or missing metal for data line **140** such as might occur when there is a defect in the mask used for the deposition or patterning of the conductive

material comprising data line **140**, or from damage to the conductive line in processing. Alternatively, the defect may be purposely made, such as with a laser to cut the line, in order to isolate a portion of data line **140** shorted to an underlying conductive component, e.g., a scan line, such as at a crossover point between the two types of address lines. The open circuit condition of the data line is typically determined and recorded during inspection of the imager device following formation of the data lines.

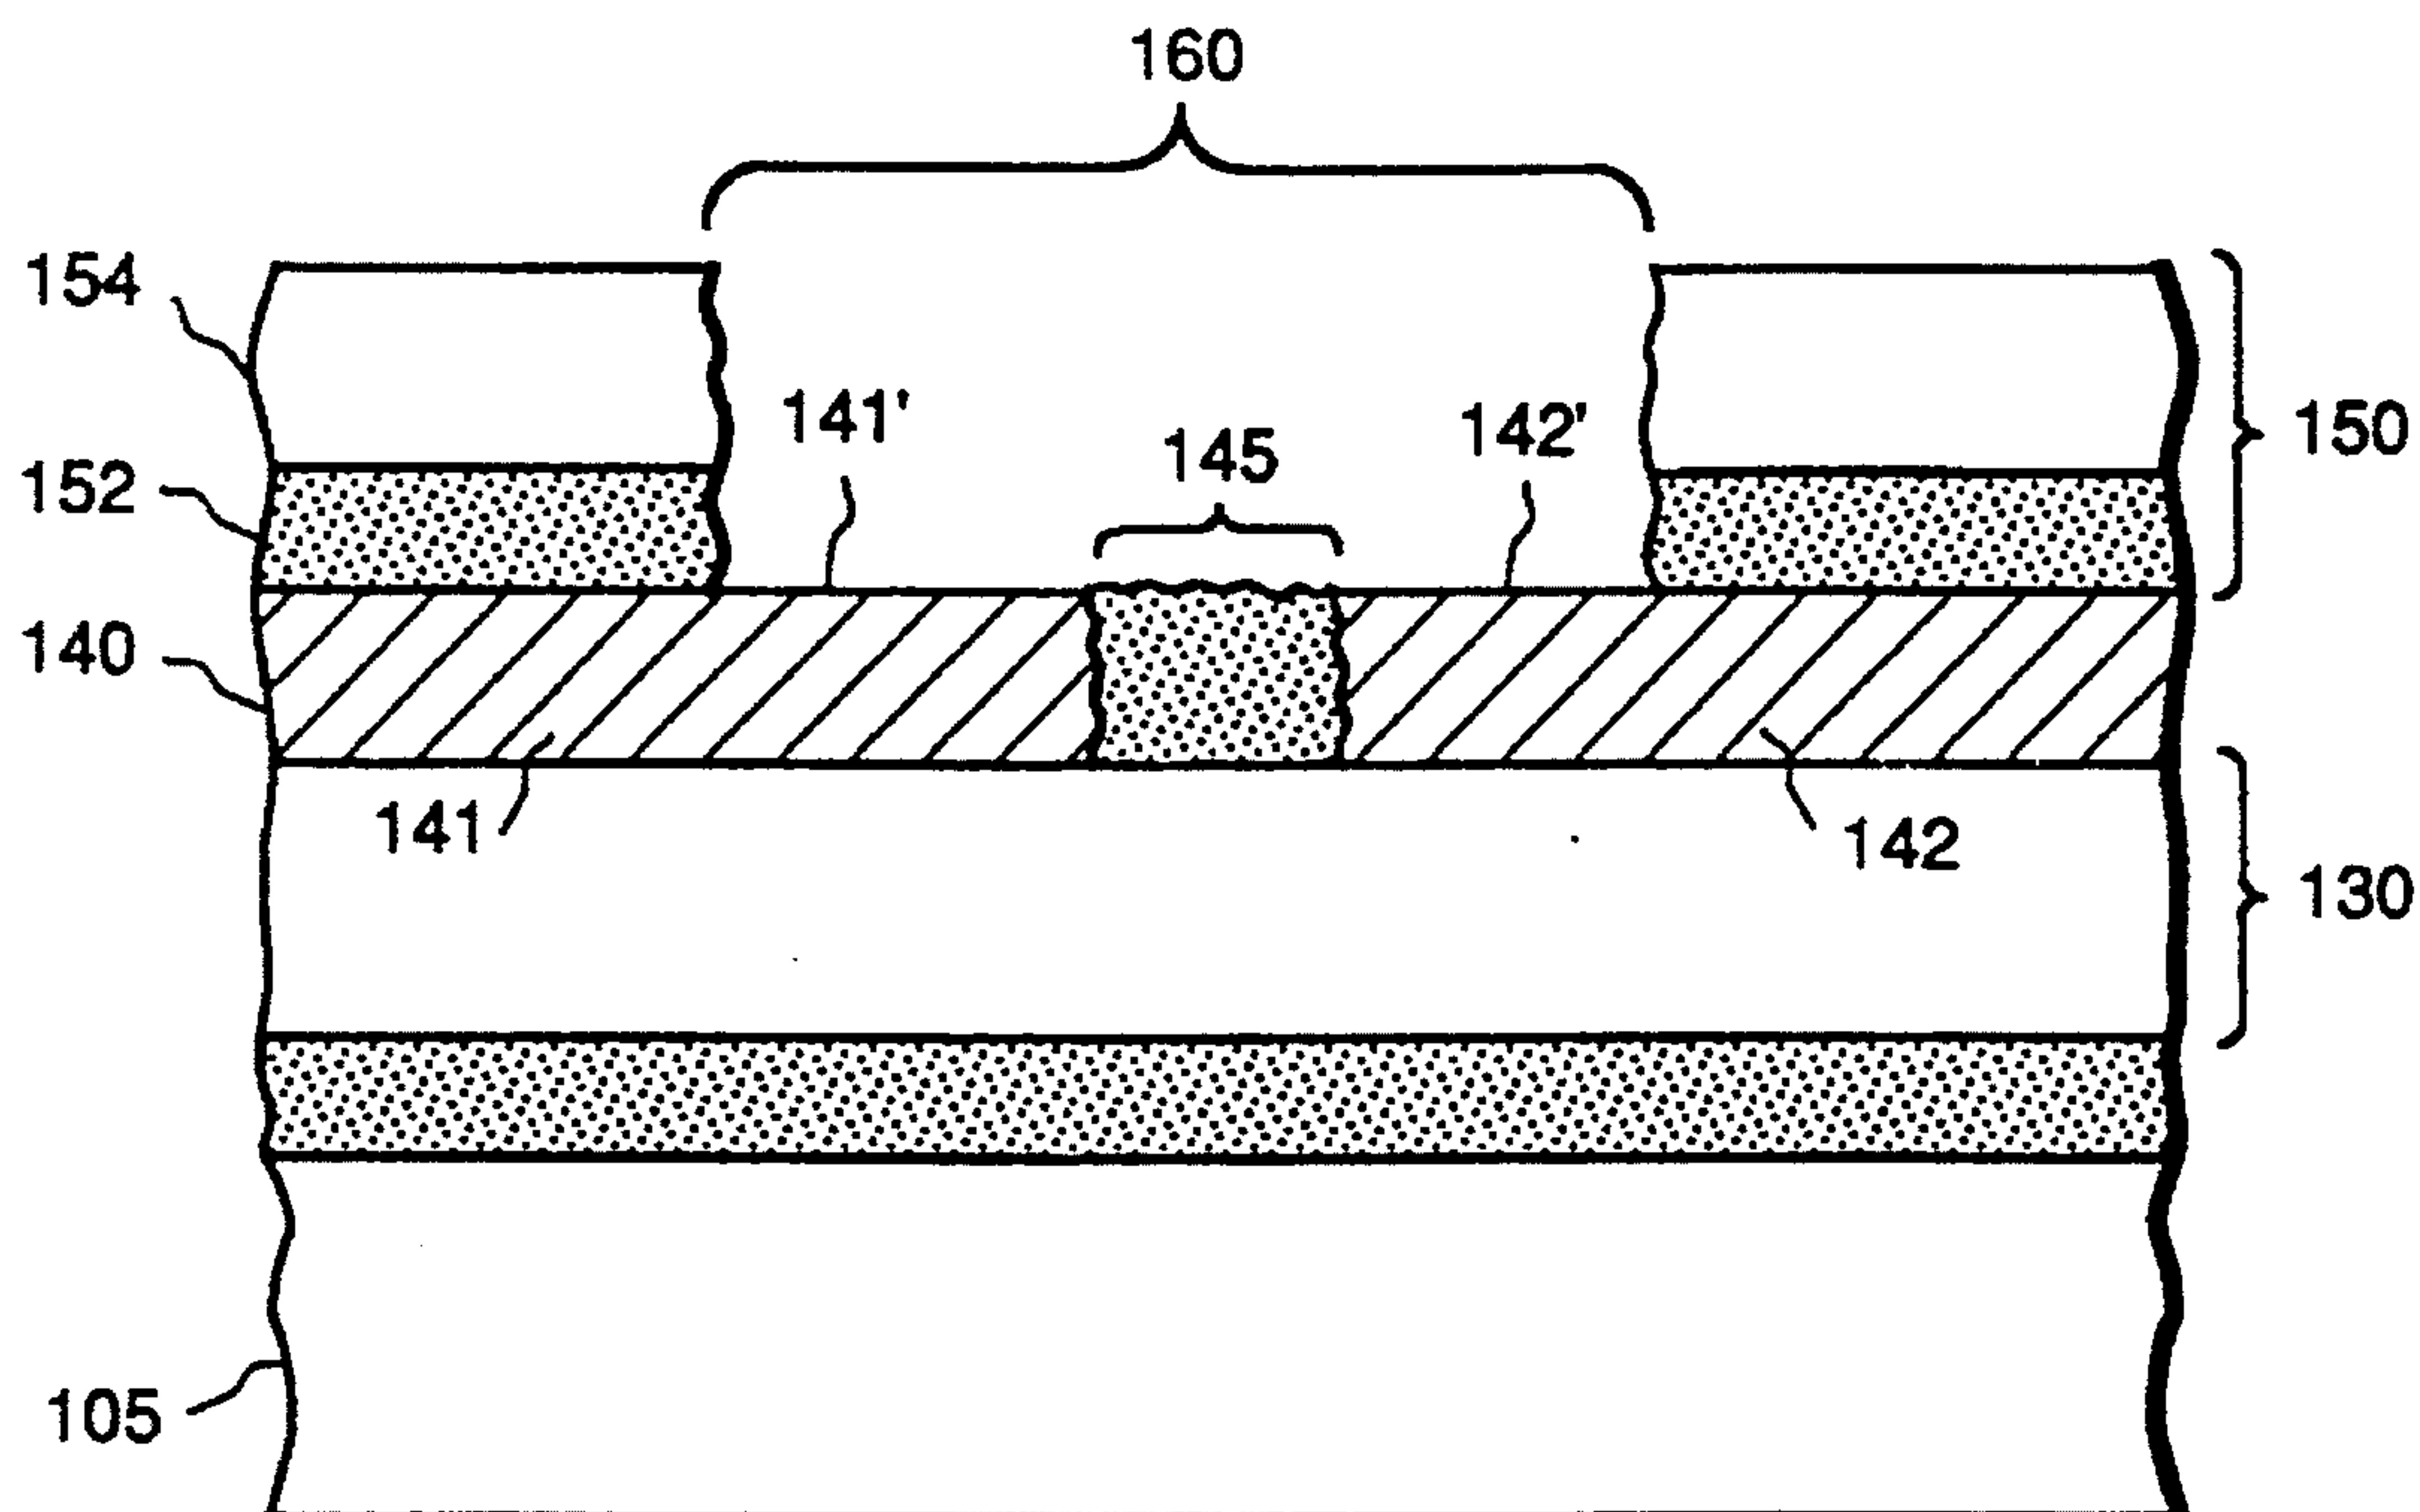
FIG. 2 is a cross-sectional view of an imager device in which the device has been prepared for the deposition of the repair shunt in accordance with the present invention.

Prior to deposition of conductive material to form the common electrode, a selected repair area **160** (FIG. 2) is formed by removing material to expose defect **145** and selected adjoining portions of data line **140**. The selected adjoining portions of data line **140** include a first segment **141'** of first portion **141** and a second segment **142'** of second portion **142** of data line **140**, the selected adjoining portions collectively comprising areas on each portion of the data line adjoining by open circuit defect **145**. Segments **141'** and **142'** are sufficiently large to allow the subsequently deposited conductive material to make satisfactory electrical contact to data line **140** and to form a stable structure. In a typical imager in which data line **140** has a width of about 7  $\mu\text{m}$ , segments **141'** and **142'** each have a length of about 10  $\mu\text{m}$ . As illustrated in FIG. 2, non-conductive material around defect **145** is removed so as to form a substantially planar surface in the selected repair area (that is, some portion of the nonconductive material remains disposed in defect **145** so as to provide a substantially smooth, planar surface between the respective exposed portions **141'**, **142'** of data line **140**). Additionally, the sidewalls of barrier layer **150** where the non-conductive material has been removed are typically also substantially planar (that is, relatively smooth surfaces that are typically disposed substantially vertically between the bottom surface of selected repair area **160** and the upper surface of barrier layer **150**). Alternatively, all or a portion of non-conductive material can be removed from defect **145**.

Typically laser ablation is used to remove non-conductive material from selected repair area **160**. In particular, an excimer laser provides a finely-focussed beam that is very effective in ablating the non-conductive material without simultaneously ablating other components, such as data line segments **141'** and **142'**. For example, in a typical imager device structure in which data line **140** comprises molybdenum having a thickness in the range between about 2,000 Å and 10,000 Å (and typically about 4000 Å), first protective layer **152** comprises silicon dioxide having a thickness in the range between about 1,000 Å and 10,000 Å (and typically about 5000 Å), and second protective layer **154** comprises polyimide having a thickness in the range between about 0.8  $\mu\text{m}$  and 2.5  $\mu\text{m}$  (and typically about 1.2  $\mu\text{m}$ ), a Florod brand Model LCM 308 excimer laser has been

used at about 15% power (total power being about 350 microjoules) to ablate non-conductive material to form selected repair area **160** having dimensions of about 10  $\mu\text{m}$  by 20  $\mu\text{m}$  (width, depth, etc) At the conclusion of the laser ablation step, the portion of damaged data line **140** appears as illustrated in FIG. 2.

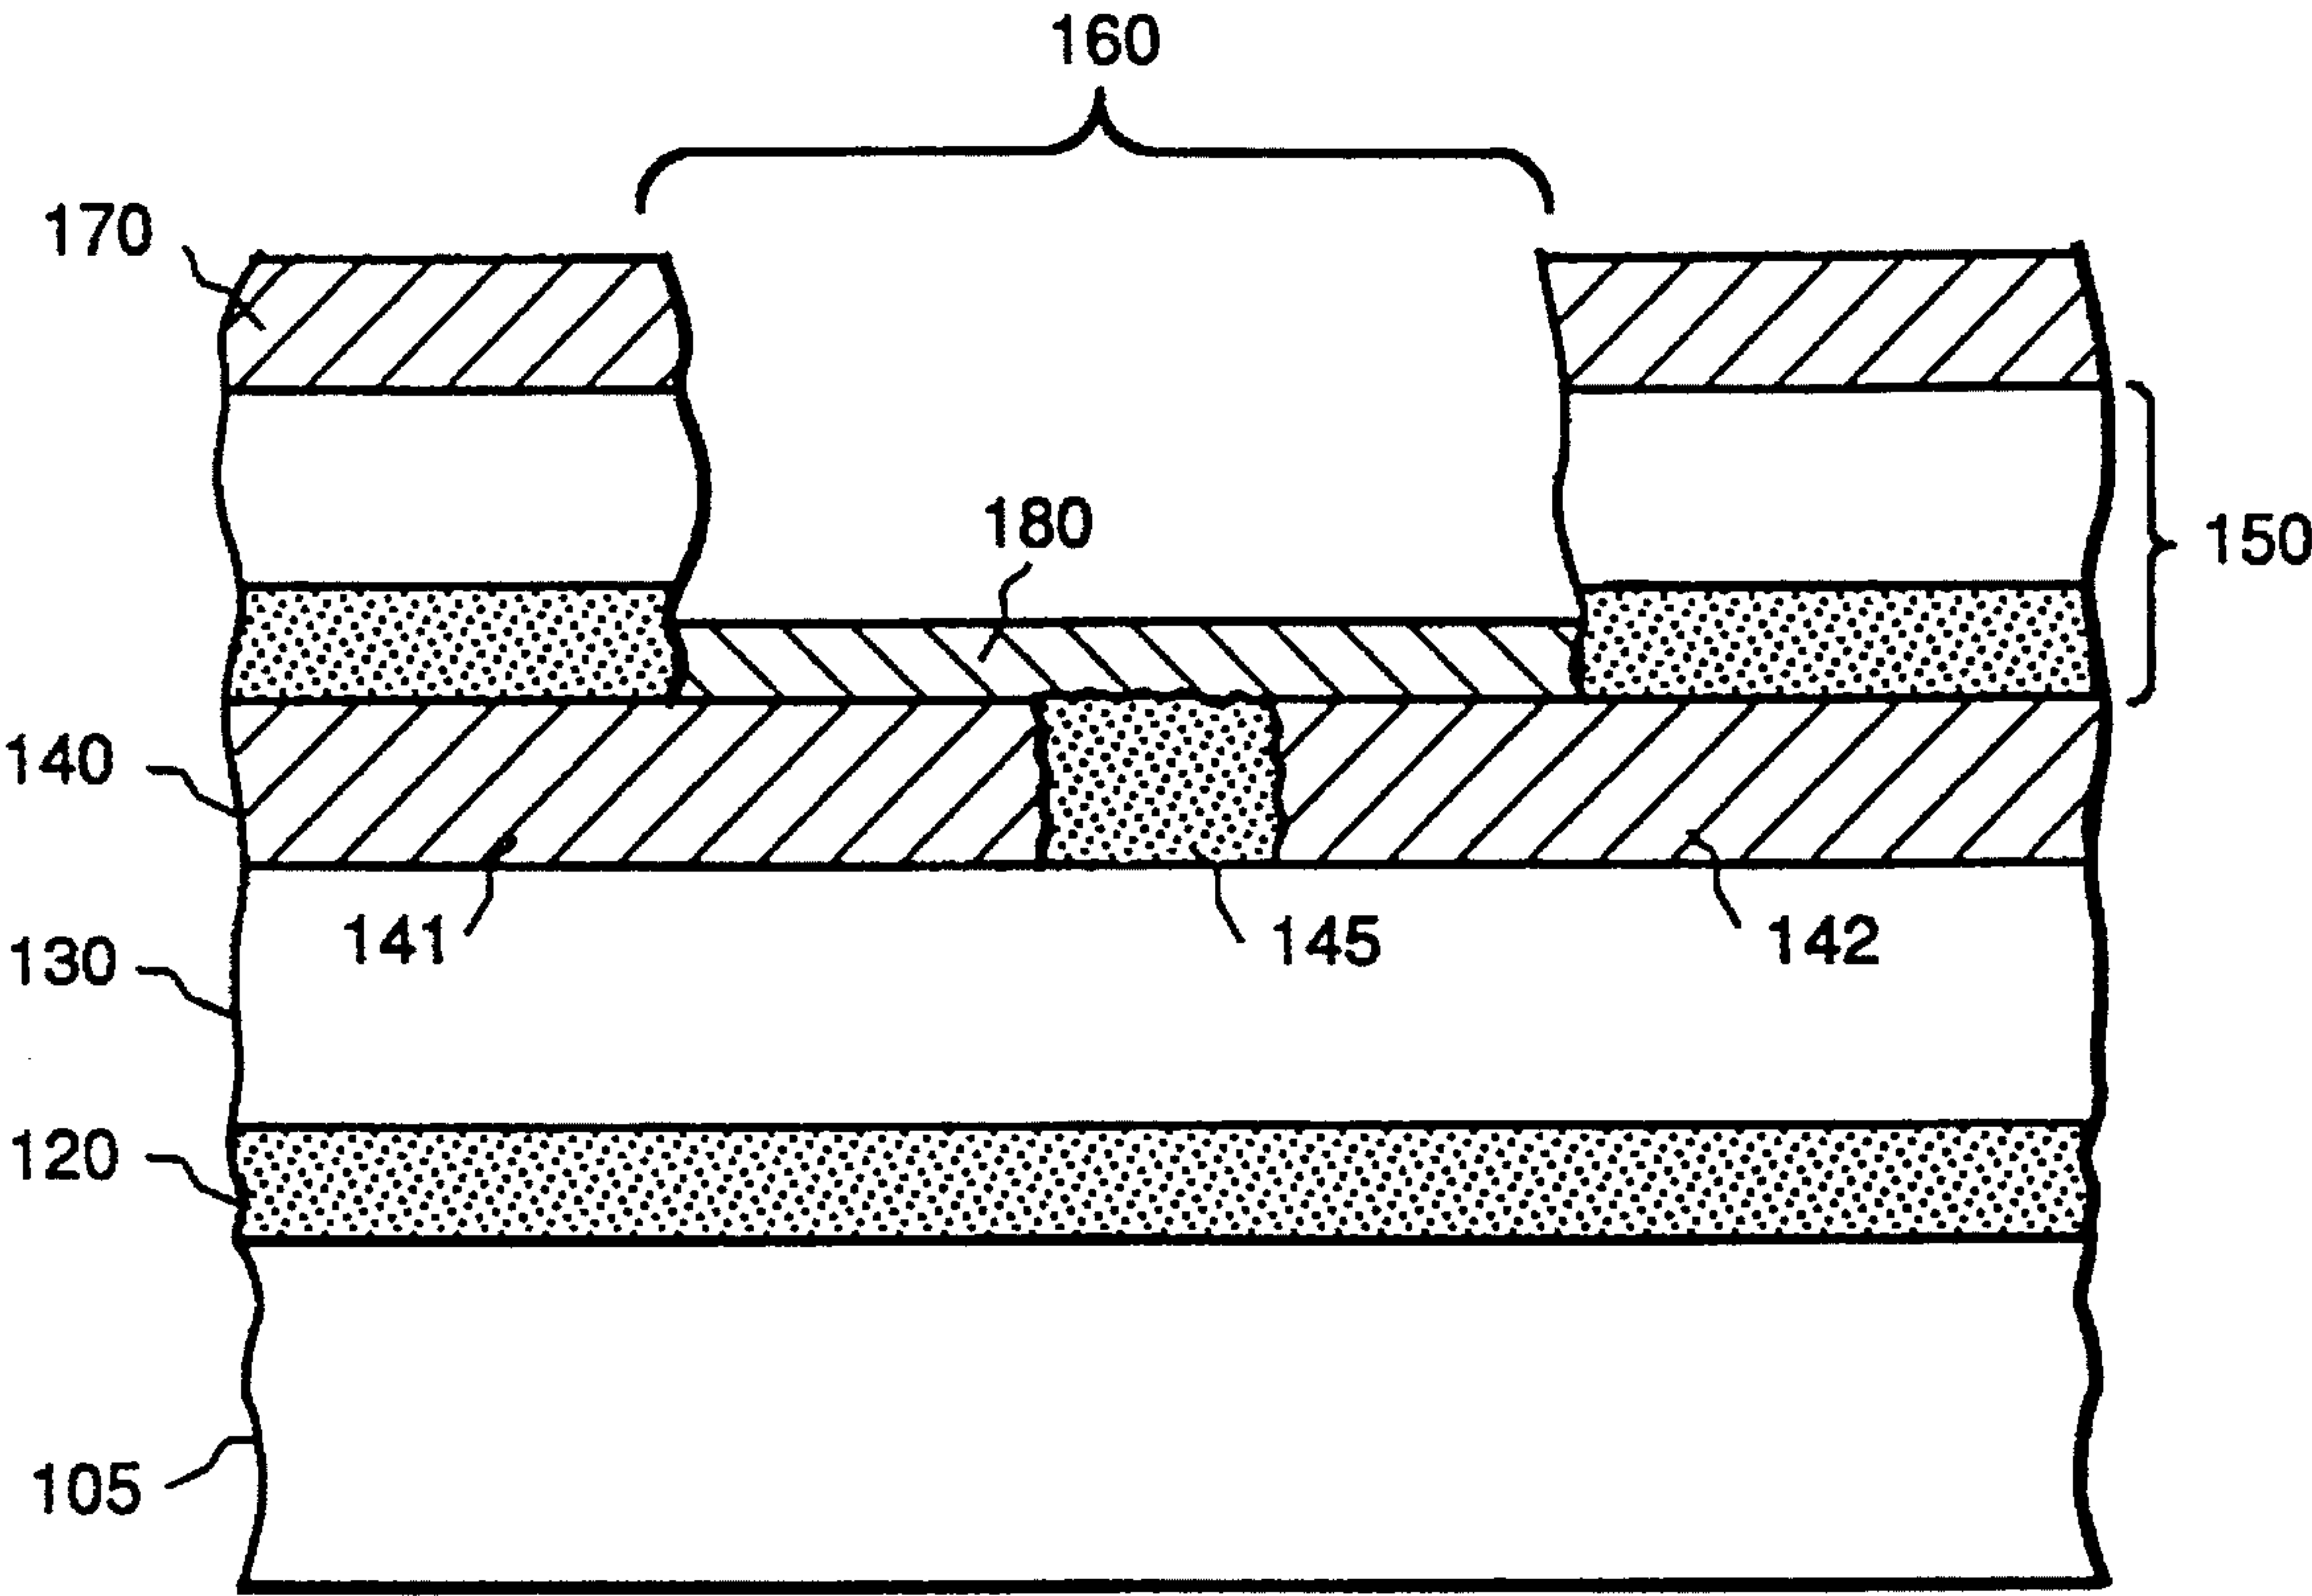
FIG. 3 is a cross-sectional view of an imager device after deposition of the repair shunt in accordance with the present invention.

Next, the conductive material to form a conductive component on a succeeding level of the device is deposited. For example, a common electrode **170** (FIG. 3) is formed in imager device **100** by depositing a conductive material (for imager devices, this material is deposited to form a substantially optically transparent layer) such as indium tin oxide, or the like using, for example, a sputter process. Alternatively, conductive materials such as aluminum, chromium, or the like is used to form the common electrode; if such non-optically transparent material is used, however, additional process steps are required to pattern the common electrode so that it does not prevent light from reaching large portions of the photodiode surface. Coincidentally with the deposition of common electrode **170**, a repair shunt **180** is formed in selected repair area **160** as the same conductive material that is used to form common electrode **170** is deposited over defect **145** and on segments **141'** and **142'** of data line **140**. As illustrated in FIG. 2, repair shunt **180** thus comprises the same conductive material as common electrode **170** and is disposed so as to electrically bridge defect **145** such that first portion **141** and second portion **142** of data line **140** are electrically coupled together. Similarly, the thickness of repair shunt **180** corresponds with the thickness of common electrode **170** as the two components are formed in the same deposition process. Alternatively, dependent on the component being repaired, the conductive material deposited to form the repair shunt may be the same as the conductive material of the underlying component in which the defect exists.

As illustrated in FIG. 3, repair shunt **180** is substantially planar, which is desirable from the standpoint of structural integrity when using a conductive material such as indium tin oxide or the like. Alternatively, repair shunt **180** can be disposed in-between first portion **141** and second portion **142** of data line **140** in addition to, or alternatively, in lieu of, being disposed on the upper surfaces of segments **141'** and **142'**, so long as adequate electrical contact is made to bridge the open circuit between first and second data line portions **141**, **142**.

Following formation of repair shunt **180**, any conductive material coupling repair shunt **180** to common electrode **170** is removed so as to electrically isolate repair shunt **180** from common electrode **170**. Removal of such conductive material (as may be adhering to sidewalls of barrier layer **150** in selected repair area **160**) is typically accomplished with laser ablation, particularly with the use of an excimer laser for the reasons set out above.
