**[11] Patent Number: 5,486,096**

- A coating for protection of airfoil surfaces from erosion caused by the impingement of particles in the incoming air stream of a gas turbine engine or on helicopter blades. The coating consists of an epoxy film toughened with hard particles to improve the erosion resistance and softer particles which impede the progression of cracks through the coating. A method for applying the coating is also described.

## EROSION RESISTANT SURFACE PROTECTION

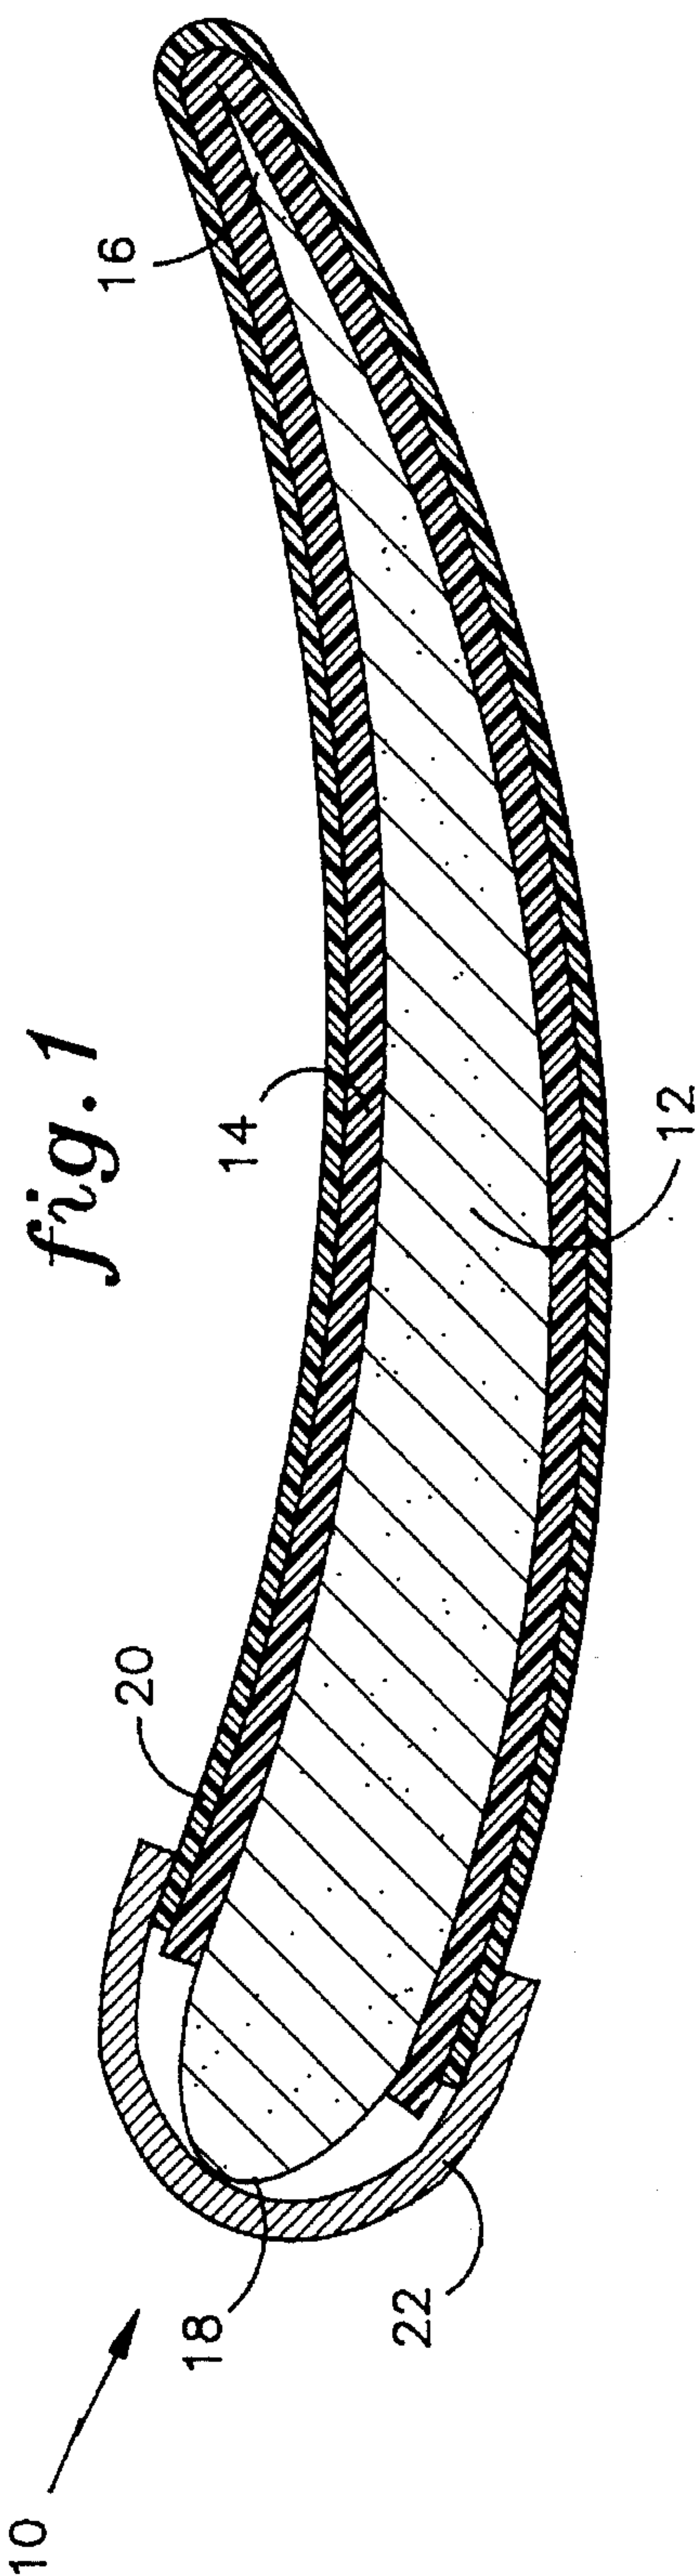
FIG. 1 is a cross section through the airfoil of the 55 assembled vane components.

By way of illustration of the method of the invention for 60 applying an erosion resistant coating, the fabrication of a fan exit guide vane for a gas turbine engine will be described. As shown in FIG. 1, the vane 10 was formed by laying up precut 65 epoxy impregnated plies 12 of carbon reinforcing fibers in a

manner which will give the desired mechanical properties in the finished vane. A layer of epoxy impregnated fiberglass cloth 14 was then placed over the surface of the airfoil portion of the vane, with the approximate center of the cloth 14 at the trailing edge 16 of the vane and the edges of the cloth 14 near the leading edge 18 of the vane. In a similar manner a layer of toughened epoxy film 20 reinforced with a mat of randomly oriented fibers was placed over the fiberglass both 14. FM® 300 Interleaf, a product of the 10 American Cyanamid Company, Wayne, N.J., was used as the toughened epoxy film for this experiment. A stainless steel mesh cap 22, shaped to conform to the shape of the leading edge 18, was then placed over the vane.

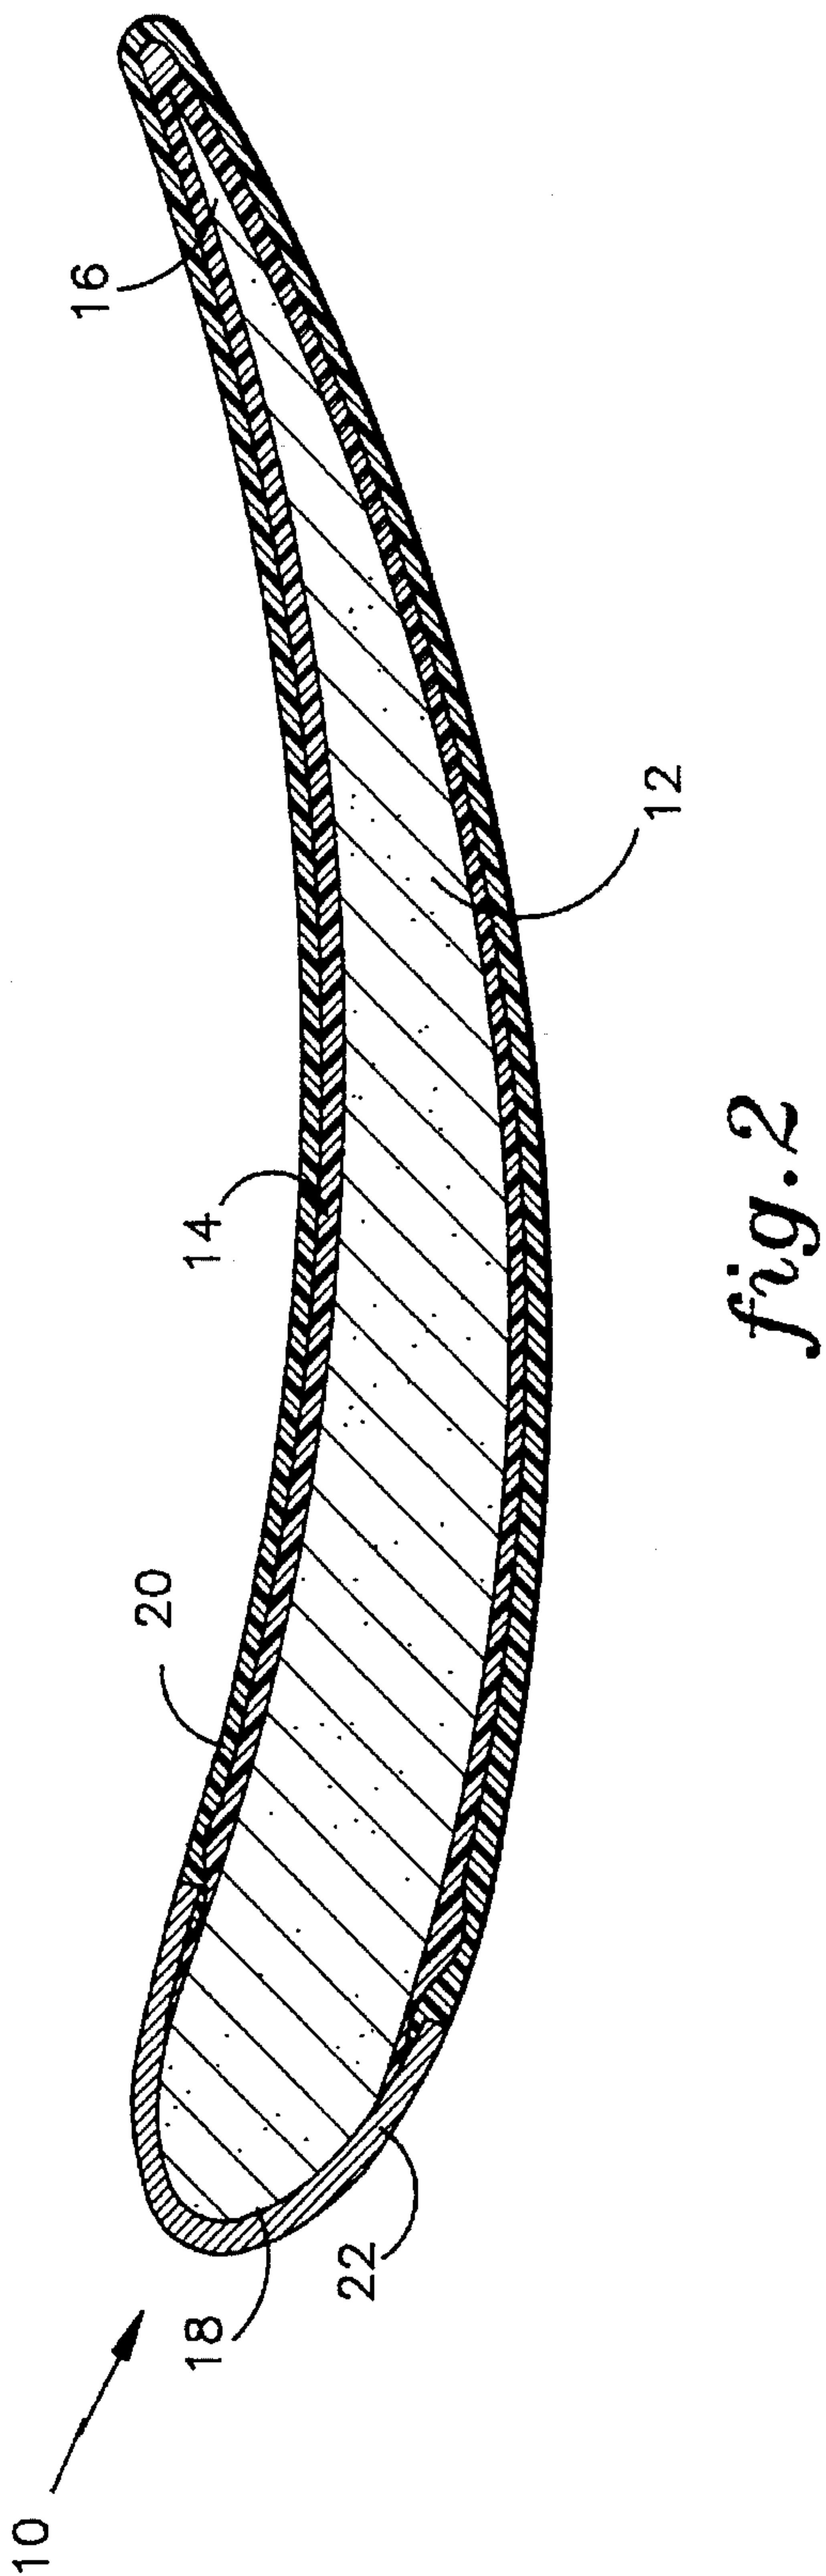
FIG. 2 is a cross section through the airfoil of the vane of FIG. 1 after completion.

The assembled components were then placed in a mold 15 shaped to the desired configuration of the finished article, the mold was gradually heated in a hydraulic press to 350° F. (177° C.) in 30 minutes, a pressure of about 1000 psi was applied when the temperature reached about 280° F. (138° C.), and the assembly was held for one hour at temperature. 20 A cross section through the airfoil portion of the completed vane is shown in FIG. 2.
