[11] Patent Number: **5,509,117**

[54] **FRANKING MACHINE**

[73] Assignee: **Frama AG**, Lauperswil, Switzerland

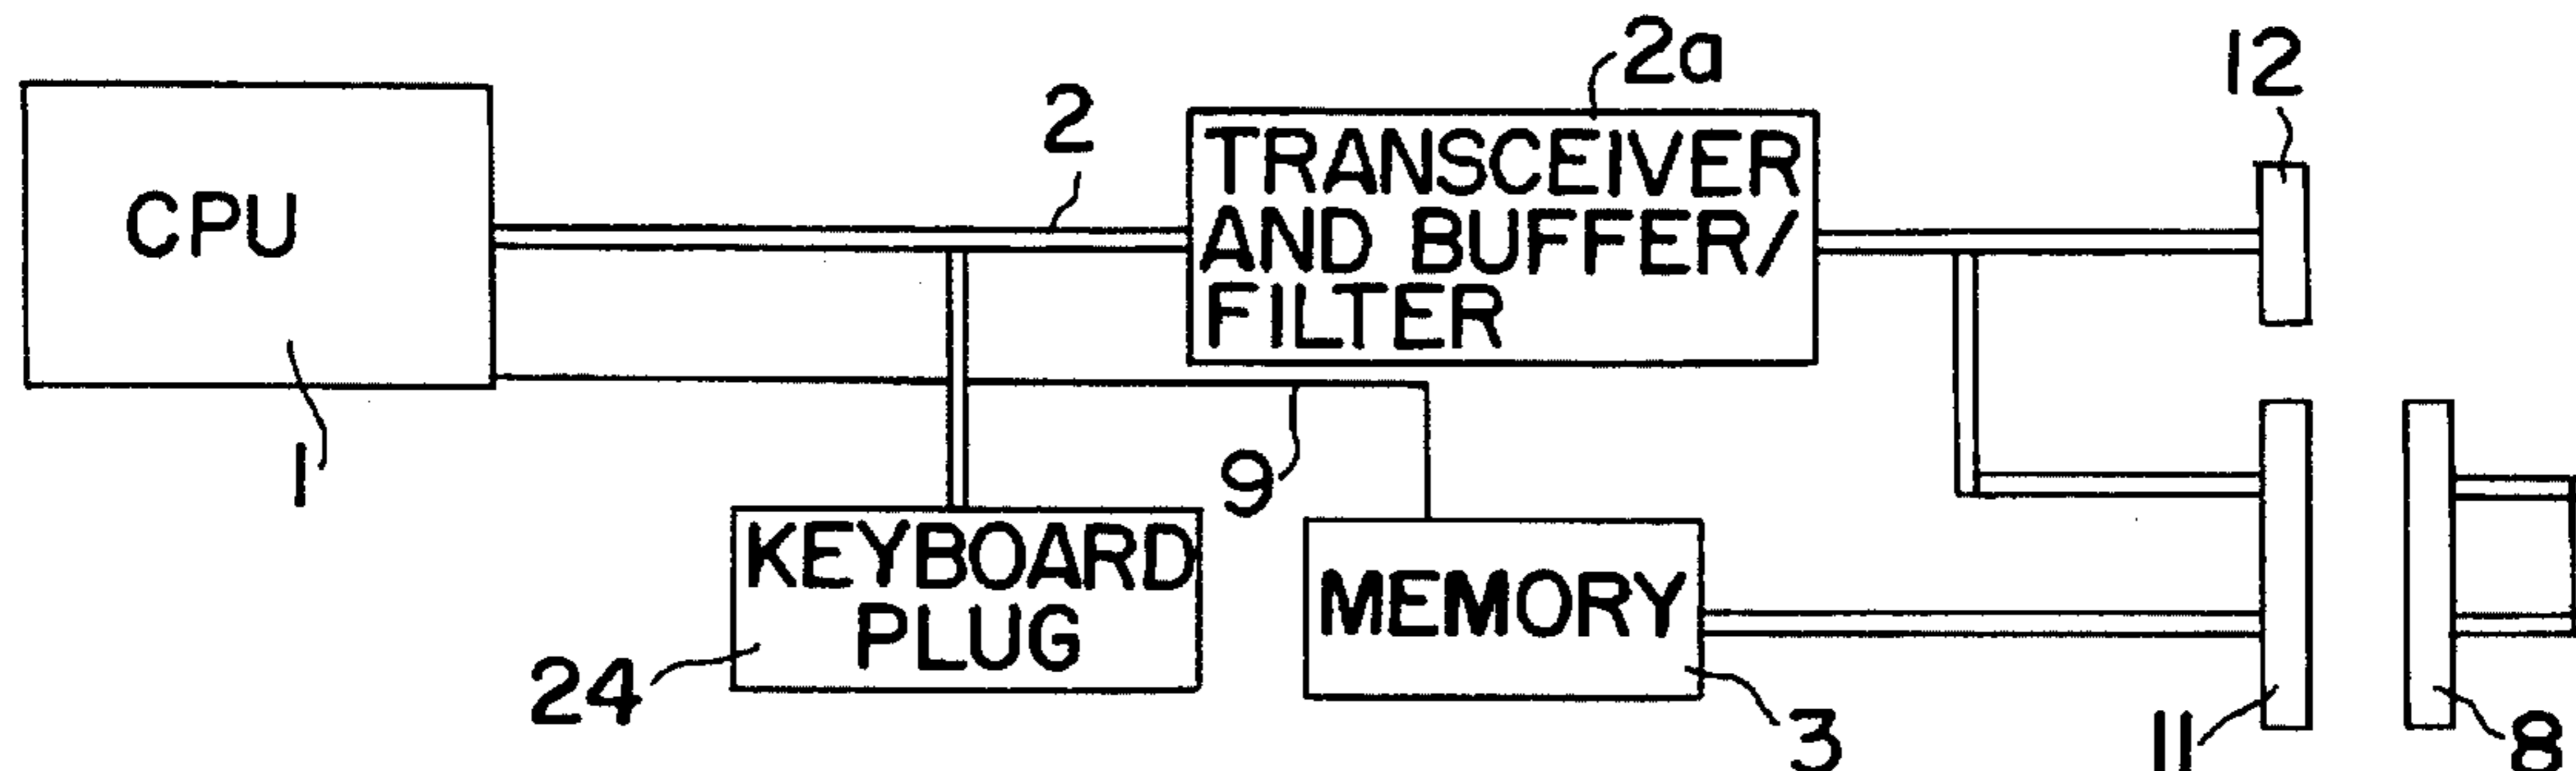
FIG. 1 A block diagram with the franking machine parts essential to the invention.

In order that the memory 3 cannot be replaced in an unauthorized manner, it, together with the CPU 1, is enclosed in a casing part 4, whose flat cover 5 is fixed by four lead-sealed screws 6 to the mounting board 7. In addition, the at least one memory 3 is not connected by a plug-socket arrangement to the electronic mounting board 7. Thus, an interchange is avoided, because, otherwise, on interchanging, by accident or by falsification, the data contained therein could be changed. The connection of the memory 3 to the CPU allowing data traffic, e.g. interrogation of the remaining value amount, etc., takes place by means of a connector unit 8 located in the transceiver bus 2 and in which the data transmission is looped. The transceiver bus 2a forms an amplifier, which can be switched on and off and enables the direction to be reversed. It also fulfills buffer functions for unblocking faults and acts as a data filter, in that it only allows the passage of data in a specific direction, which e.g. following the replacement of the assembly unit 10, are to be transmitted from the old assembly unit 10 or from its memory 3.

In addition to the transceiver bus 2a there is an independent writing line 9 by means of which data can be read into the memory 3, so that the data content changes. As this writing line is not looped across the transceiver bus 2, the memory cannot be modified from outside the lead-sealed casing part 4. In the dead or standby mode of the CPU, the writing line 9 is switched in such a way that data can only be read out of the memory 3.

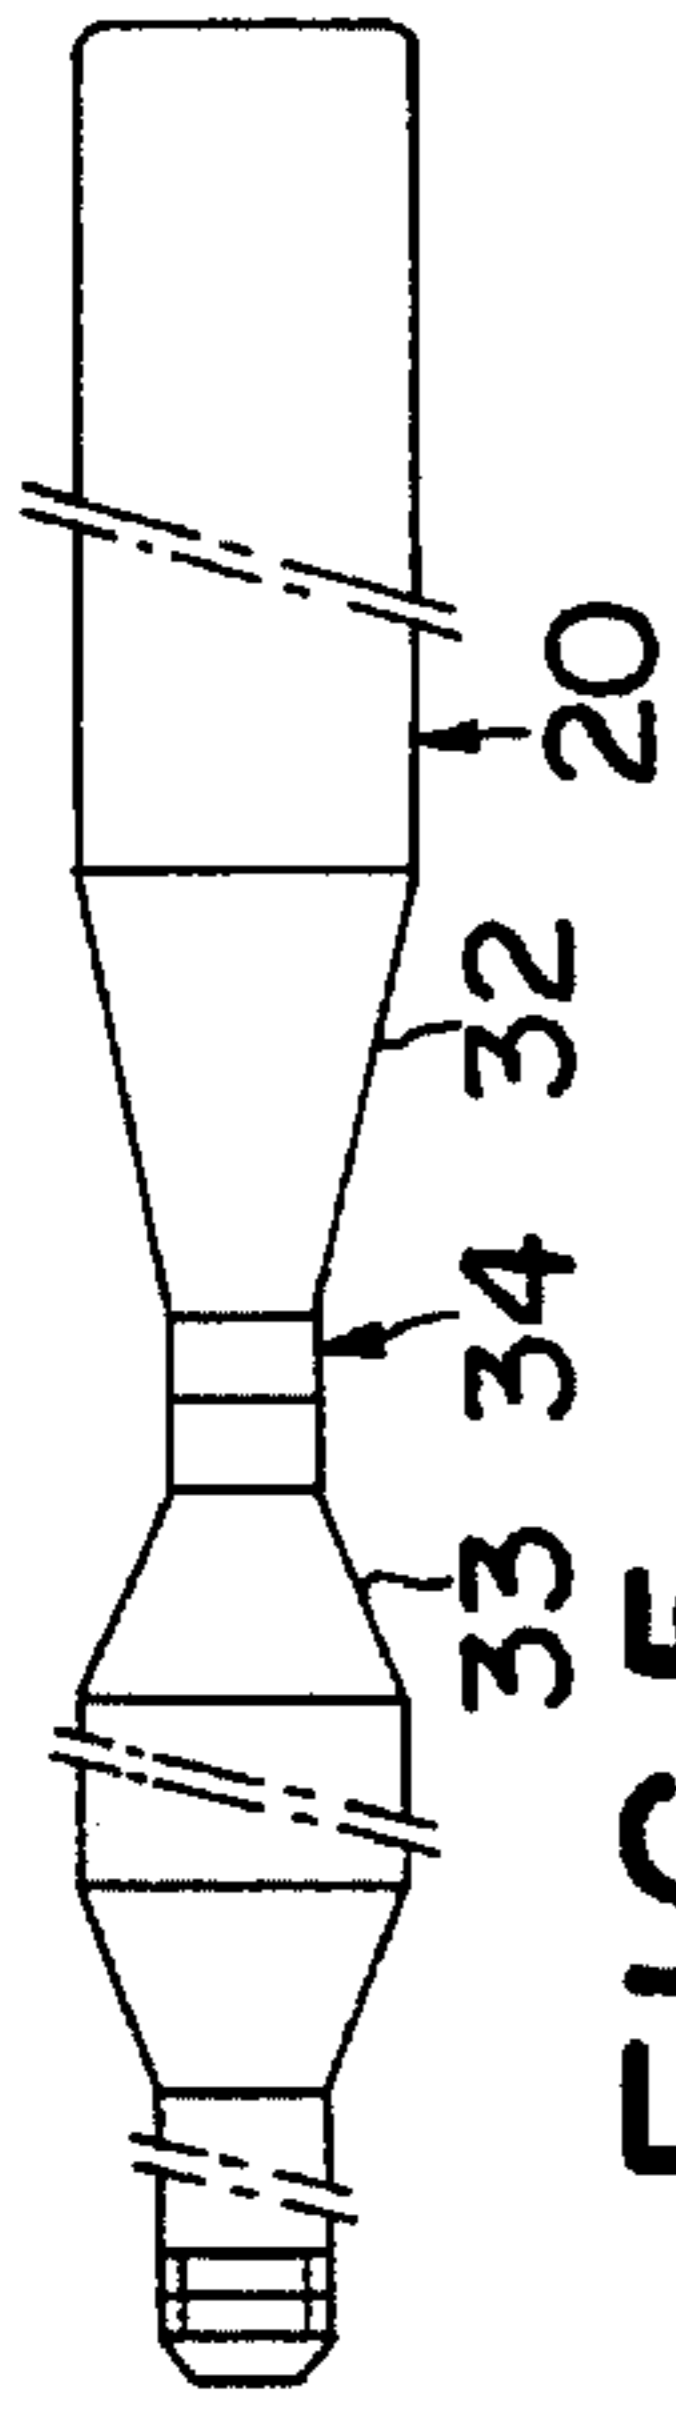
FIG. 5 A shortened representation of the locking bolt.

In order to be able to disassemble from the franking machine the defective assembly unit 10 or a defective electronic component, with the franking machine switched off, it is firstly necessary to remove a locking bolt 20. The latter extends transversely through the casing part 4 and through two wall parts 21,22 of an inner casing frame of the franking machine laterally enclosing the casing part 4. Corresponding passage openings 28 are provided in these parts.

The drawing out of the locking bolt 20 secured by a split pin 30 or a lock washer (not shown) not only brings about

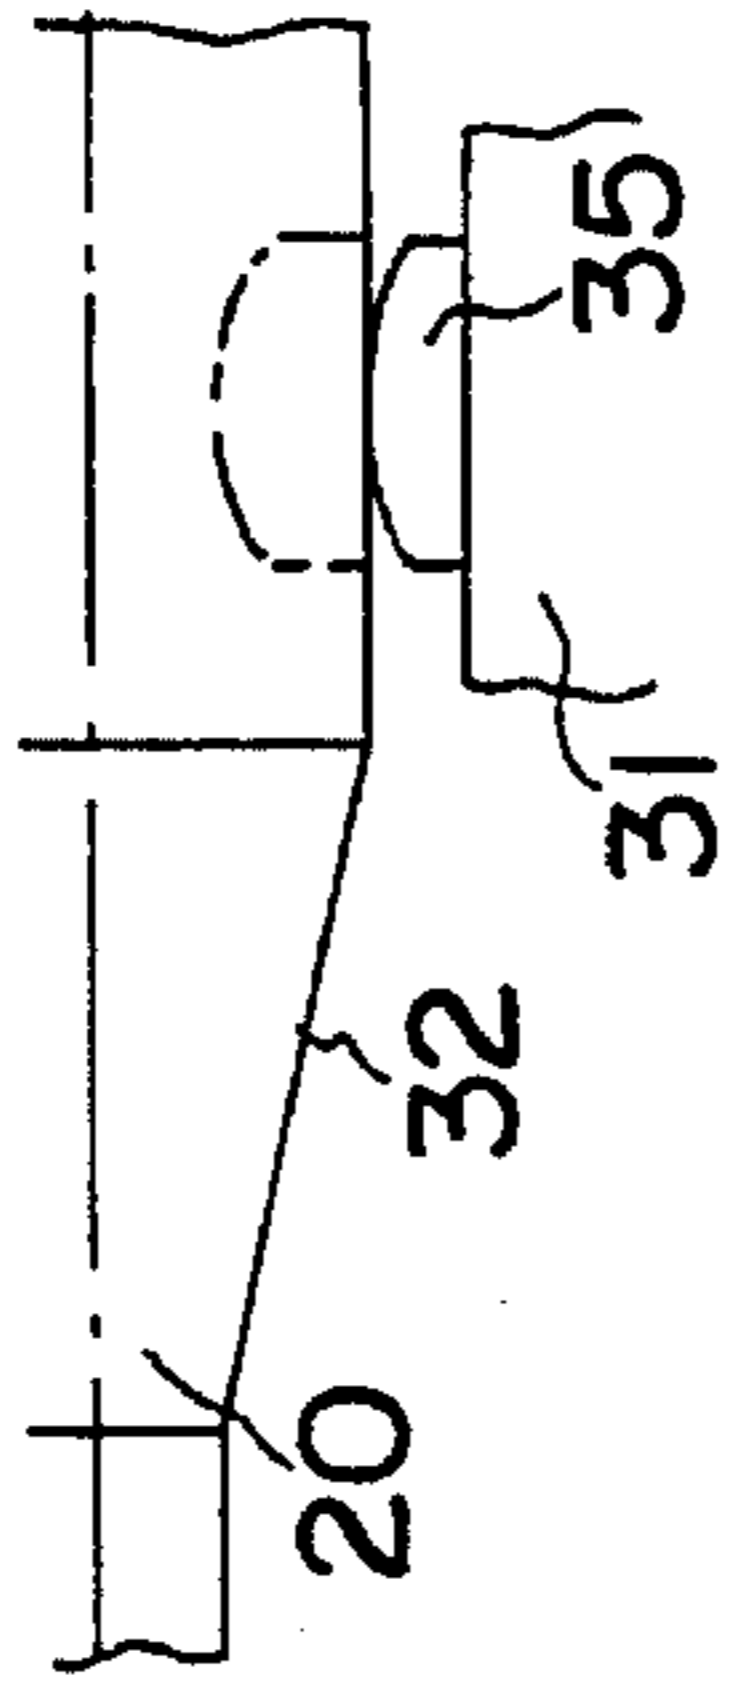
FIG. 6 A larger-scale representation of Part of a locking bolt, with attached signal switch.

the release of the assembly unit 10 for its dismantling, but also, by means of a signalling switch 31 enclosed in the casing part 4, brings about the setting of an electronic flag in two battery-assisted one bit memories (not shown) provided in the assembly unit 10. Thus, this flag indicates that the assembly unit 10 has been disassembled. For this switch operation, the locking bolt 20 has a constriction 34 formed by two conical areas 32, 33 and into which moves the switch button 35 on drawing out the locking bolt 20. Both one bit memories can be read by the CPU and reset. The second memory can also be set by the CPU.

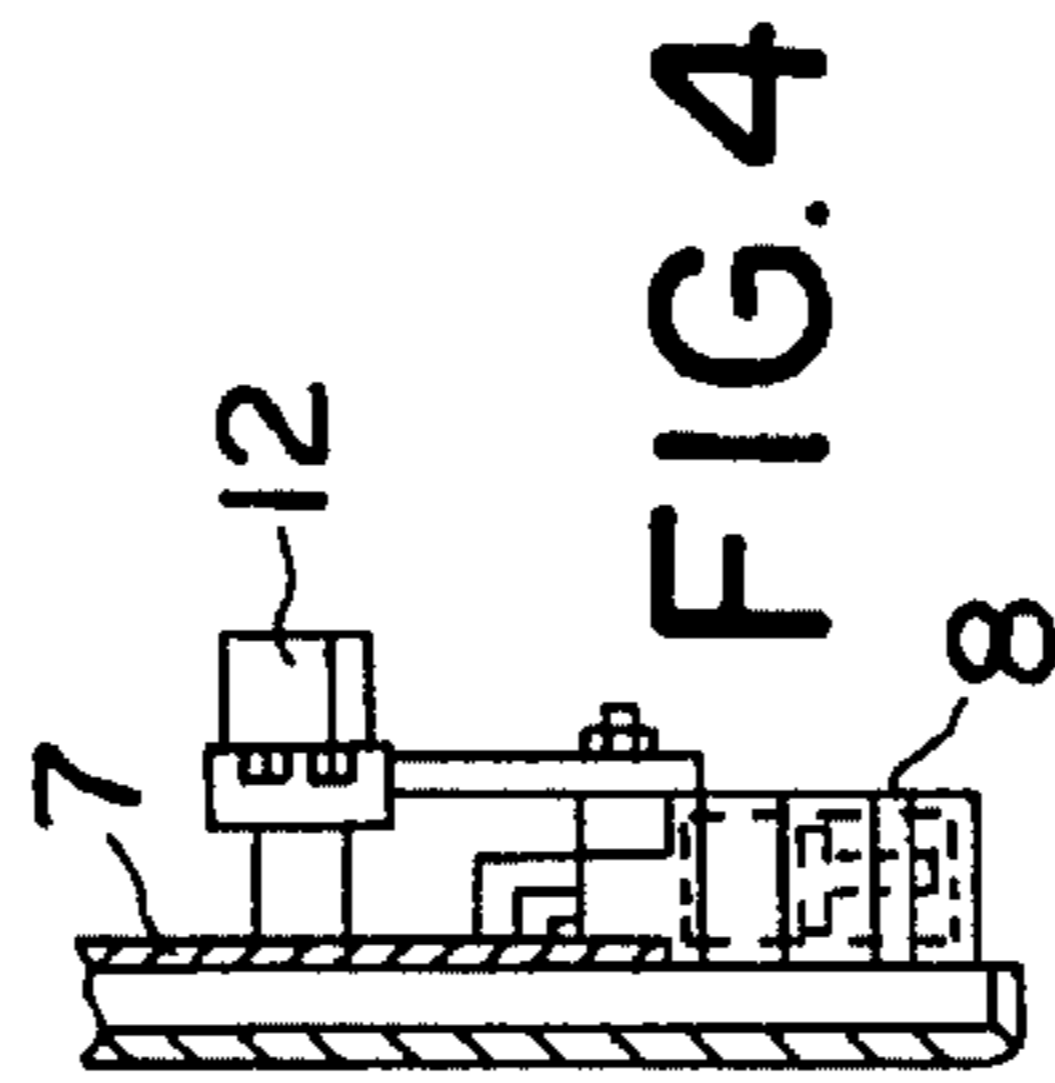
FIG. 4 Part of the assembly unit according to FIG. 2 in the vicinity of the looping plug and in part sectional side view.

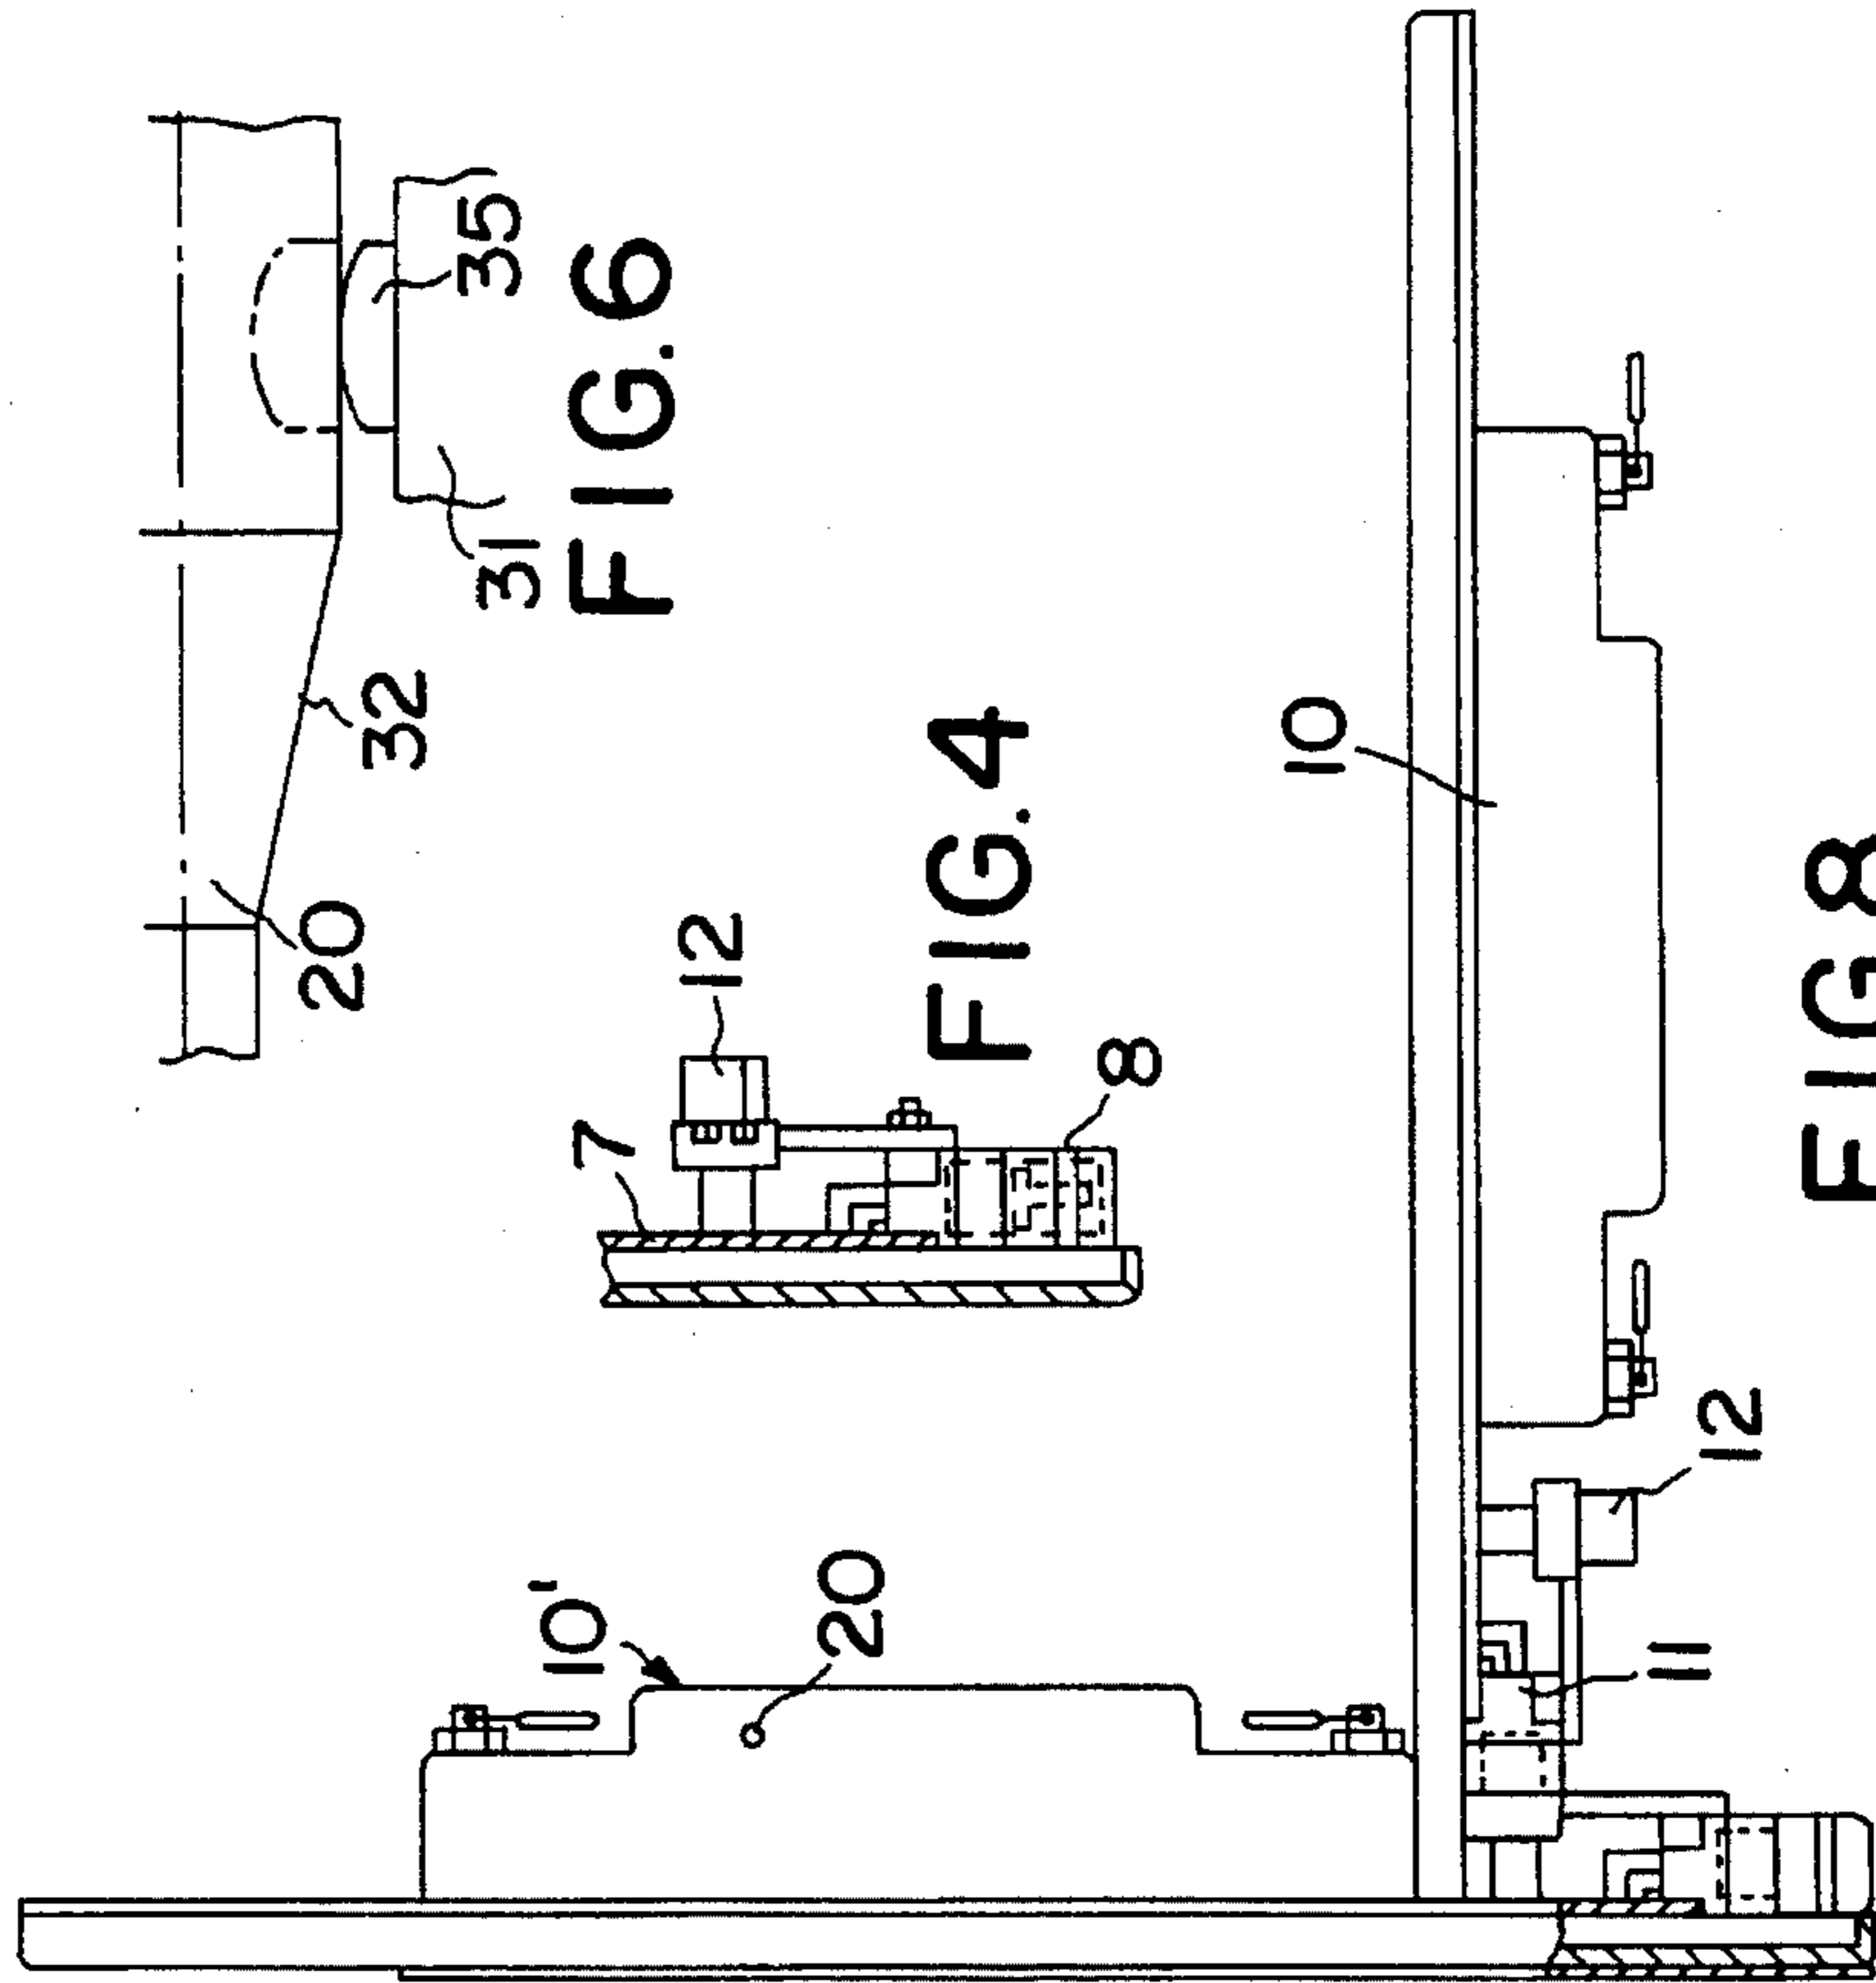
FIG. 8 A side view of the two, coupled together assembly units according to FIG. 7.

The new assembly unit 10' is installed in the machine in the reverse order, and in it is also set a flag. Following the removal of the connector unit 8, the old, defective assembly unit 10, with its released, lower plug unit 11, is inserted in the plug unit 12' of the new assembly unit 10', so that for this purpose it assumes the vertical position shown in FIG. 8. The franking machine is then connected to power, a special key is inserted in the key receptacle (not shown, but see U.S. Pat. No. 4,788,623 (EP-A-0 214 410)) and a key (DEST) of the keyboard (not shown) of the franking machine is depressed. These instructions start the transfer programme for the data transfer from the old, dismantled assembly unit to the new, fitted assembly unit 10' and this is preceded by a plausibility programme described hereinafter. The flag of the new assembly unit 10' is then erased by its CPU, and in the old defective assembly unit 10 is set a second, non-erasable flag, so that the old assembly unit 10 cannot be improperly used for a second data transfer. The sequence of the transfer programme is displayed on the display (not shown) by the term "transfer", and at the end of the transfer programme the word "end" appears. The franking machine is then switched off again and the postal rate memory 36 (model PROM) and a code memory 37 (U.S. Ser. No. 07/499,64 (EPA-0 390 731) are removed from the old assembly unit 10 and connected to the new assembly unit 10'. This is possible because they are positioned outside the lead-sealed casing part 4. The old assembly unit 10 is then released again from the new assembly unit 10' and is again provided with its connector unit 8. Power is then again switched on and the franking machine is tested with the machine casing open.

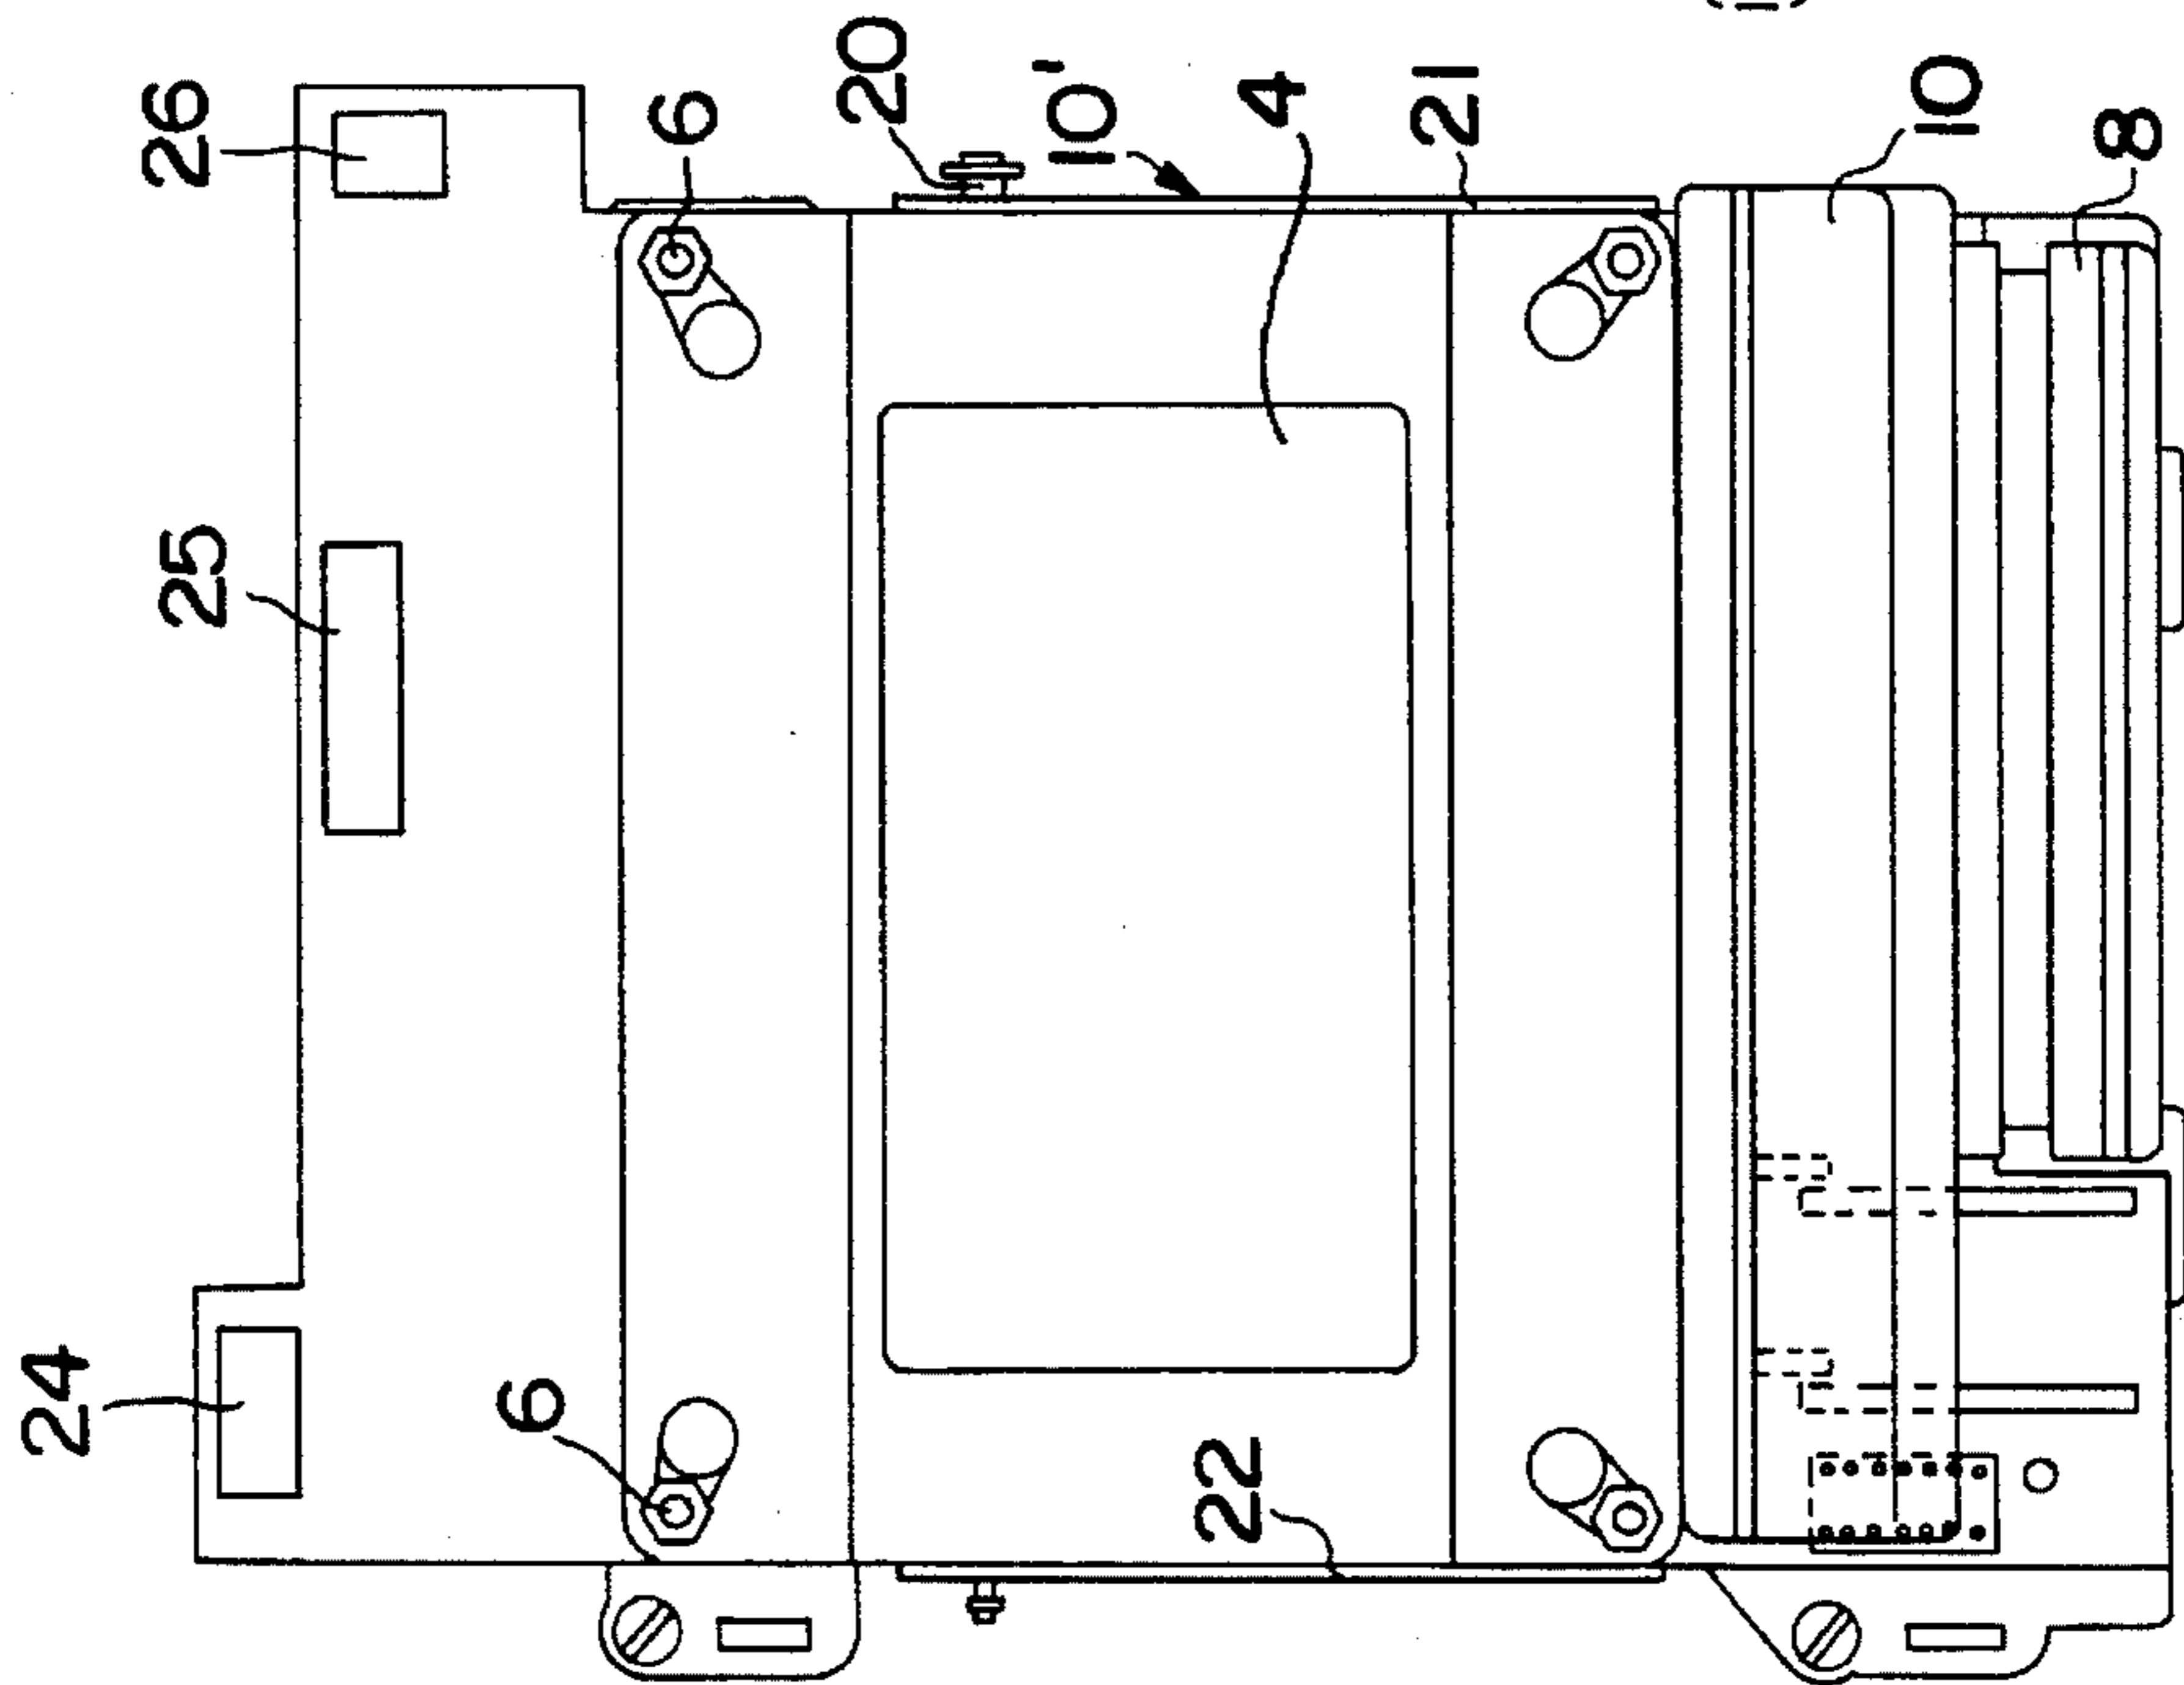
FIG. 7 A representation of a new assembly unit corresponding to FIG. 2 with a coupled, old assembly unit.

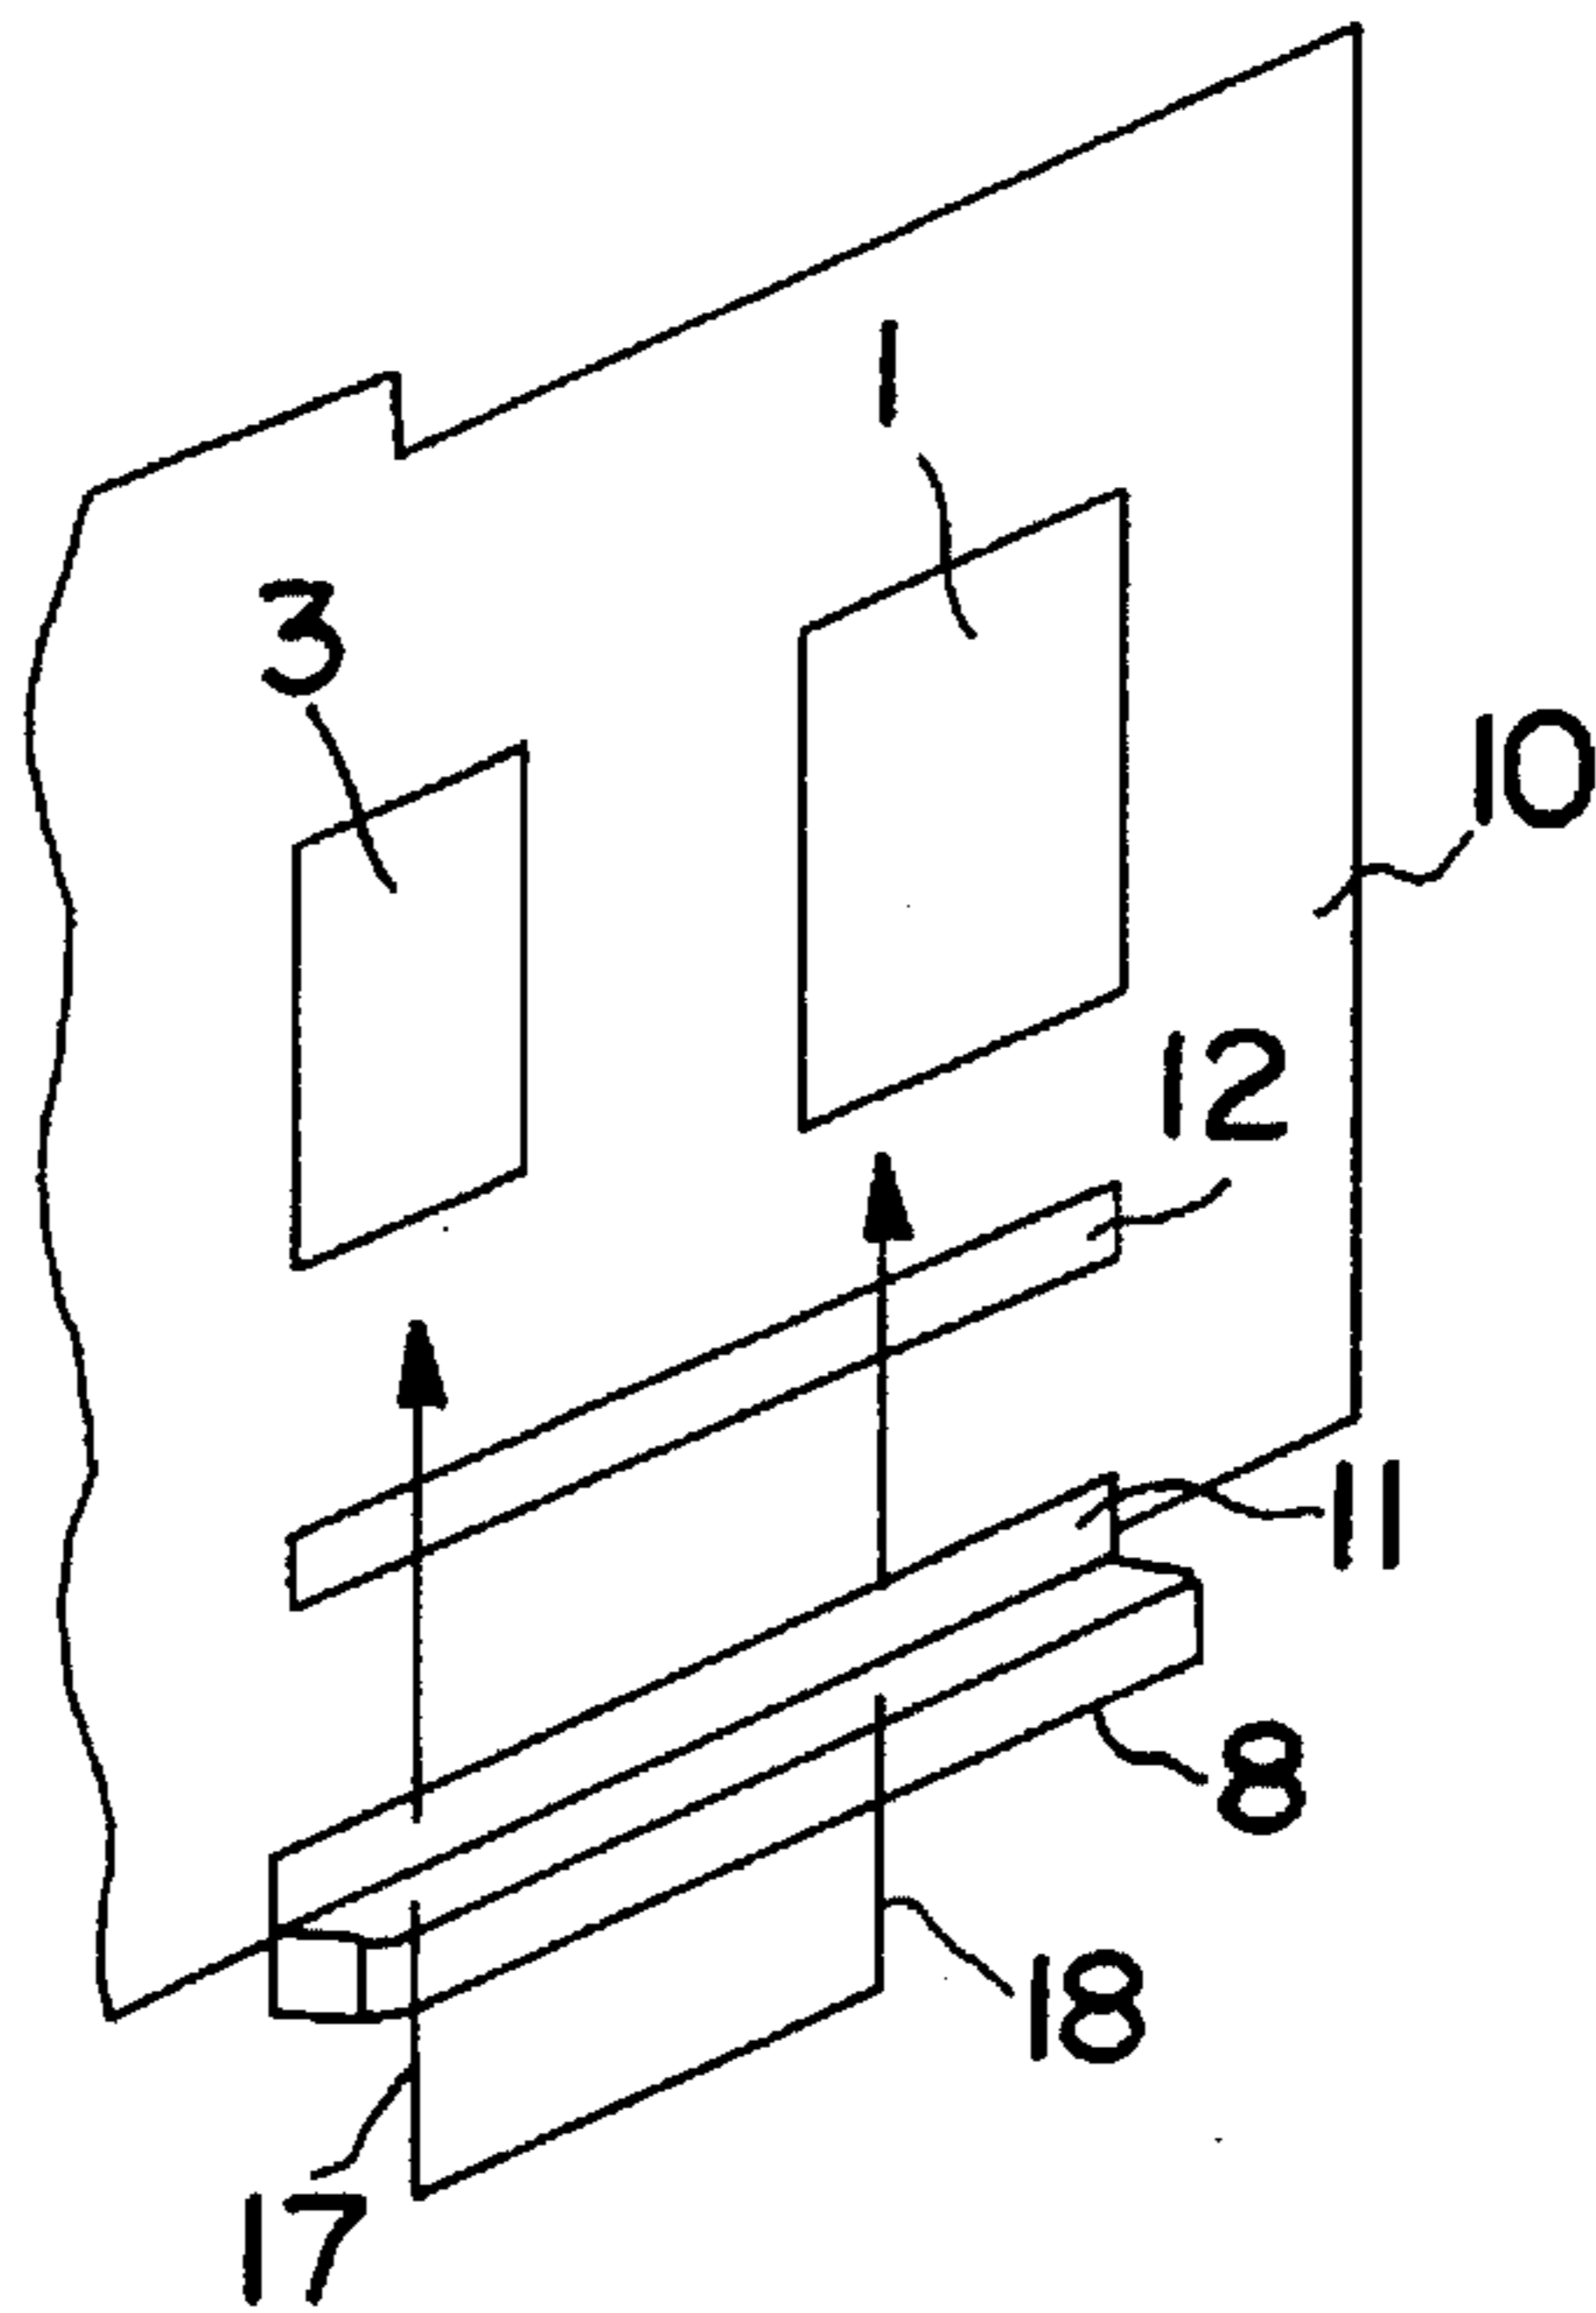
FIG. 9 A diagrammatic perspective view of an assembly unit with electronic components and its data flow.

If a fault or error occurs on an electronic element connected to the mounting board 7 in the lead-sealed casing part 4, e.g. due to the failure of a microprocessor or by a short-circuit in the supply, then instead of opening the lead-sealed casing part 4 and replacing or repairing the particular part, the assembly unit 10 constituted by the mounting board 7 and the casing part 4 is merely replaced by a new one. The connector unit 8 is then removed from the old mounting board 7, and the consequently freed counter-plug or mating connector 11 is inserted in a free plug unit 12 (FIGS. 1, 2, 7, and 8) of the new assembly unit 10' provided on the transceiver bus 2. As a result, the CPU 1' of the new assembly unit 10' can read in the data of the memory 3 of the old assembly unit 10. This data flow is indicated by the arrows 14 to 16 in FIG. 10. The data flow during normal operation is indicated in FIG. 9, in which the looping across the connector unit 8 is symbolized by the arrows 17,18.

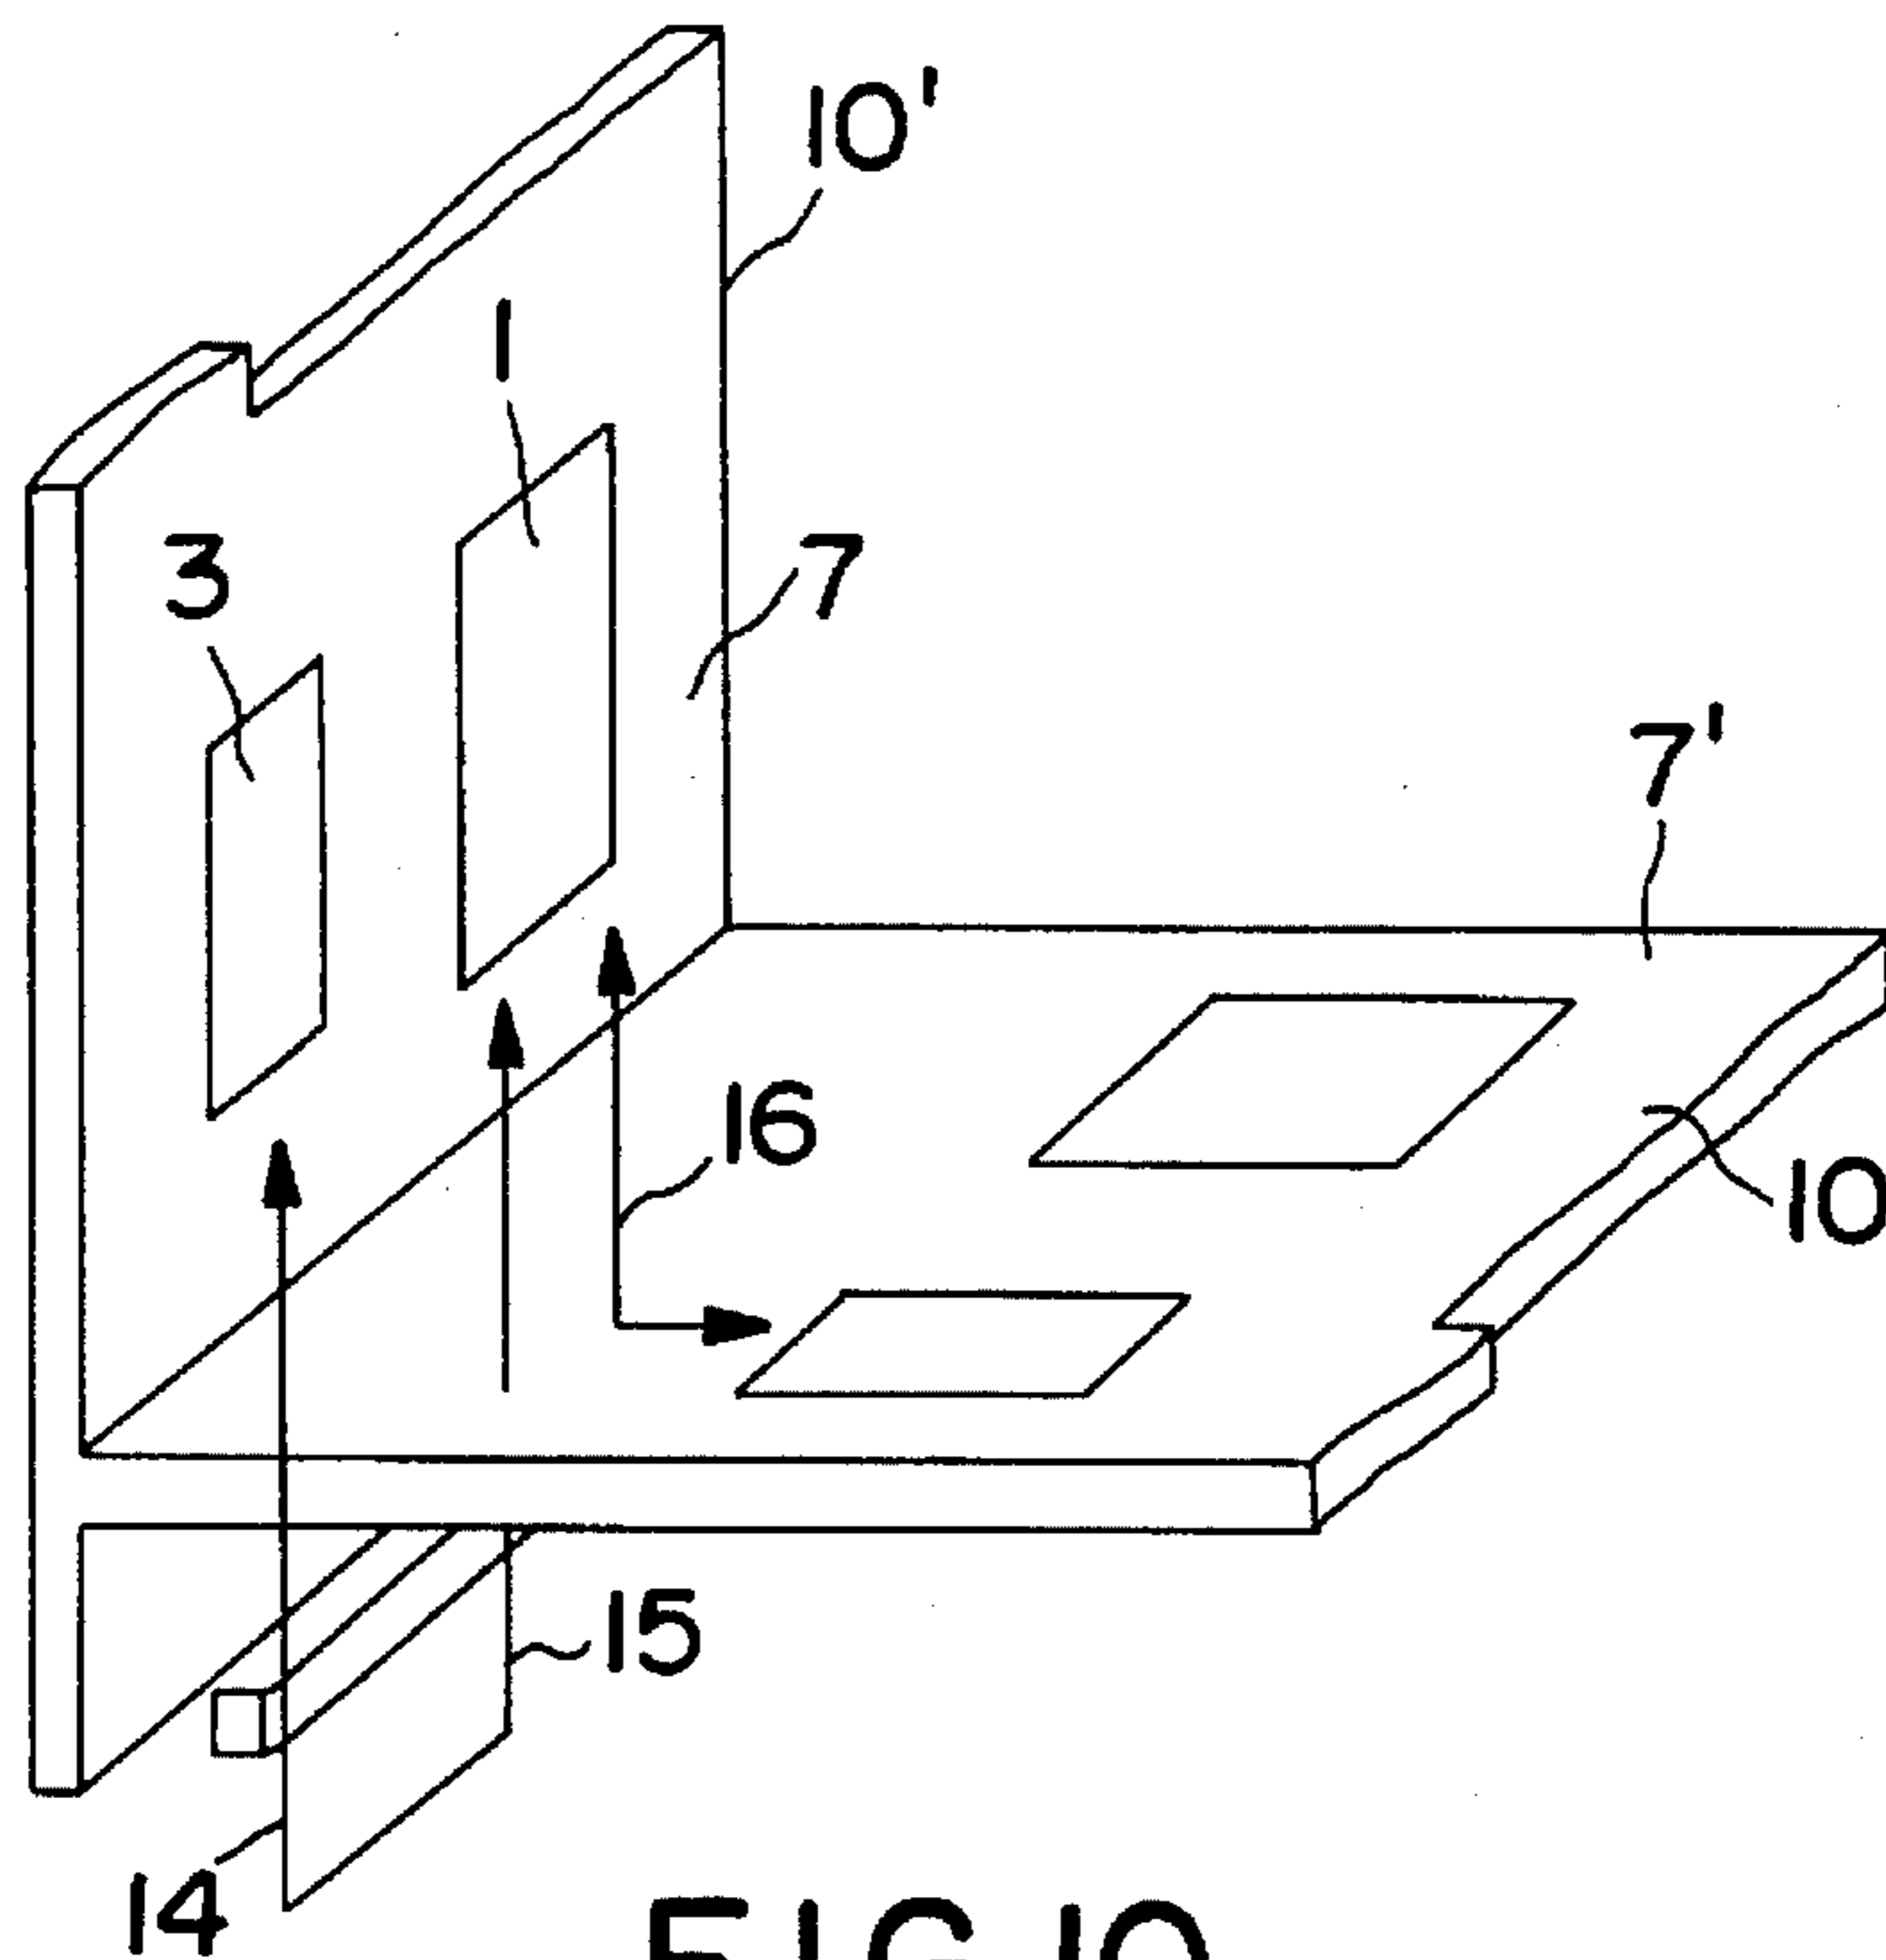
FIG. 10 A representation corresponding to FIG. 9 of a new assembly unit with coupled, old assembly unit indicating the data flow on data transfer.
