[11] Patent Number: **5,509,117**

[54] **FRANKING MACHINE**

[73] Assignee: **Frama AG**, Lauperswil, Switzerland

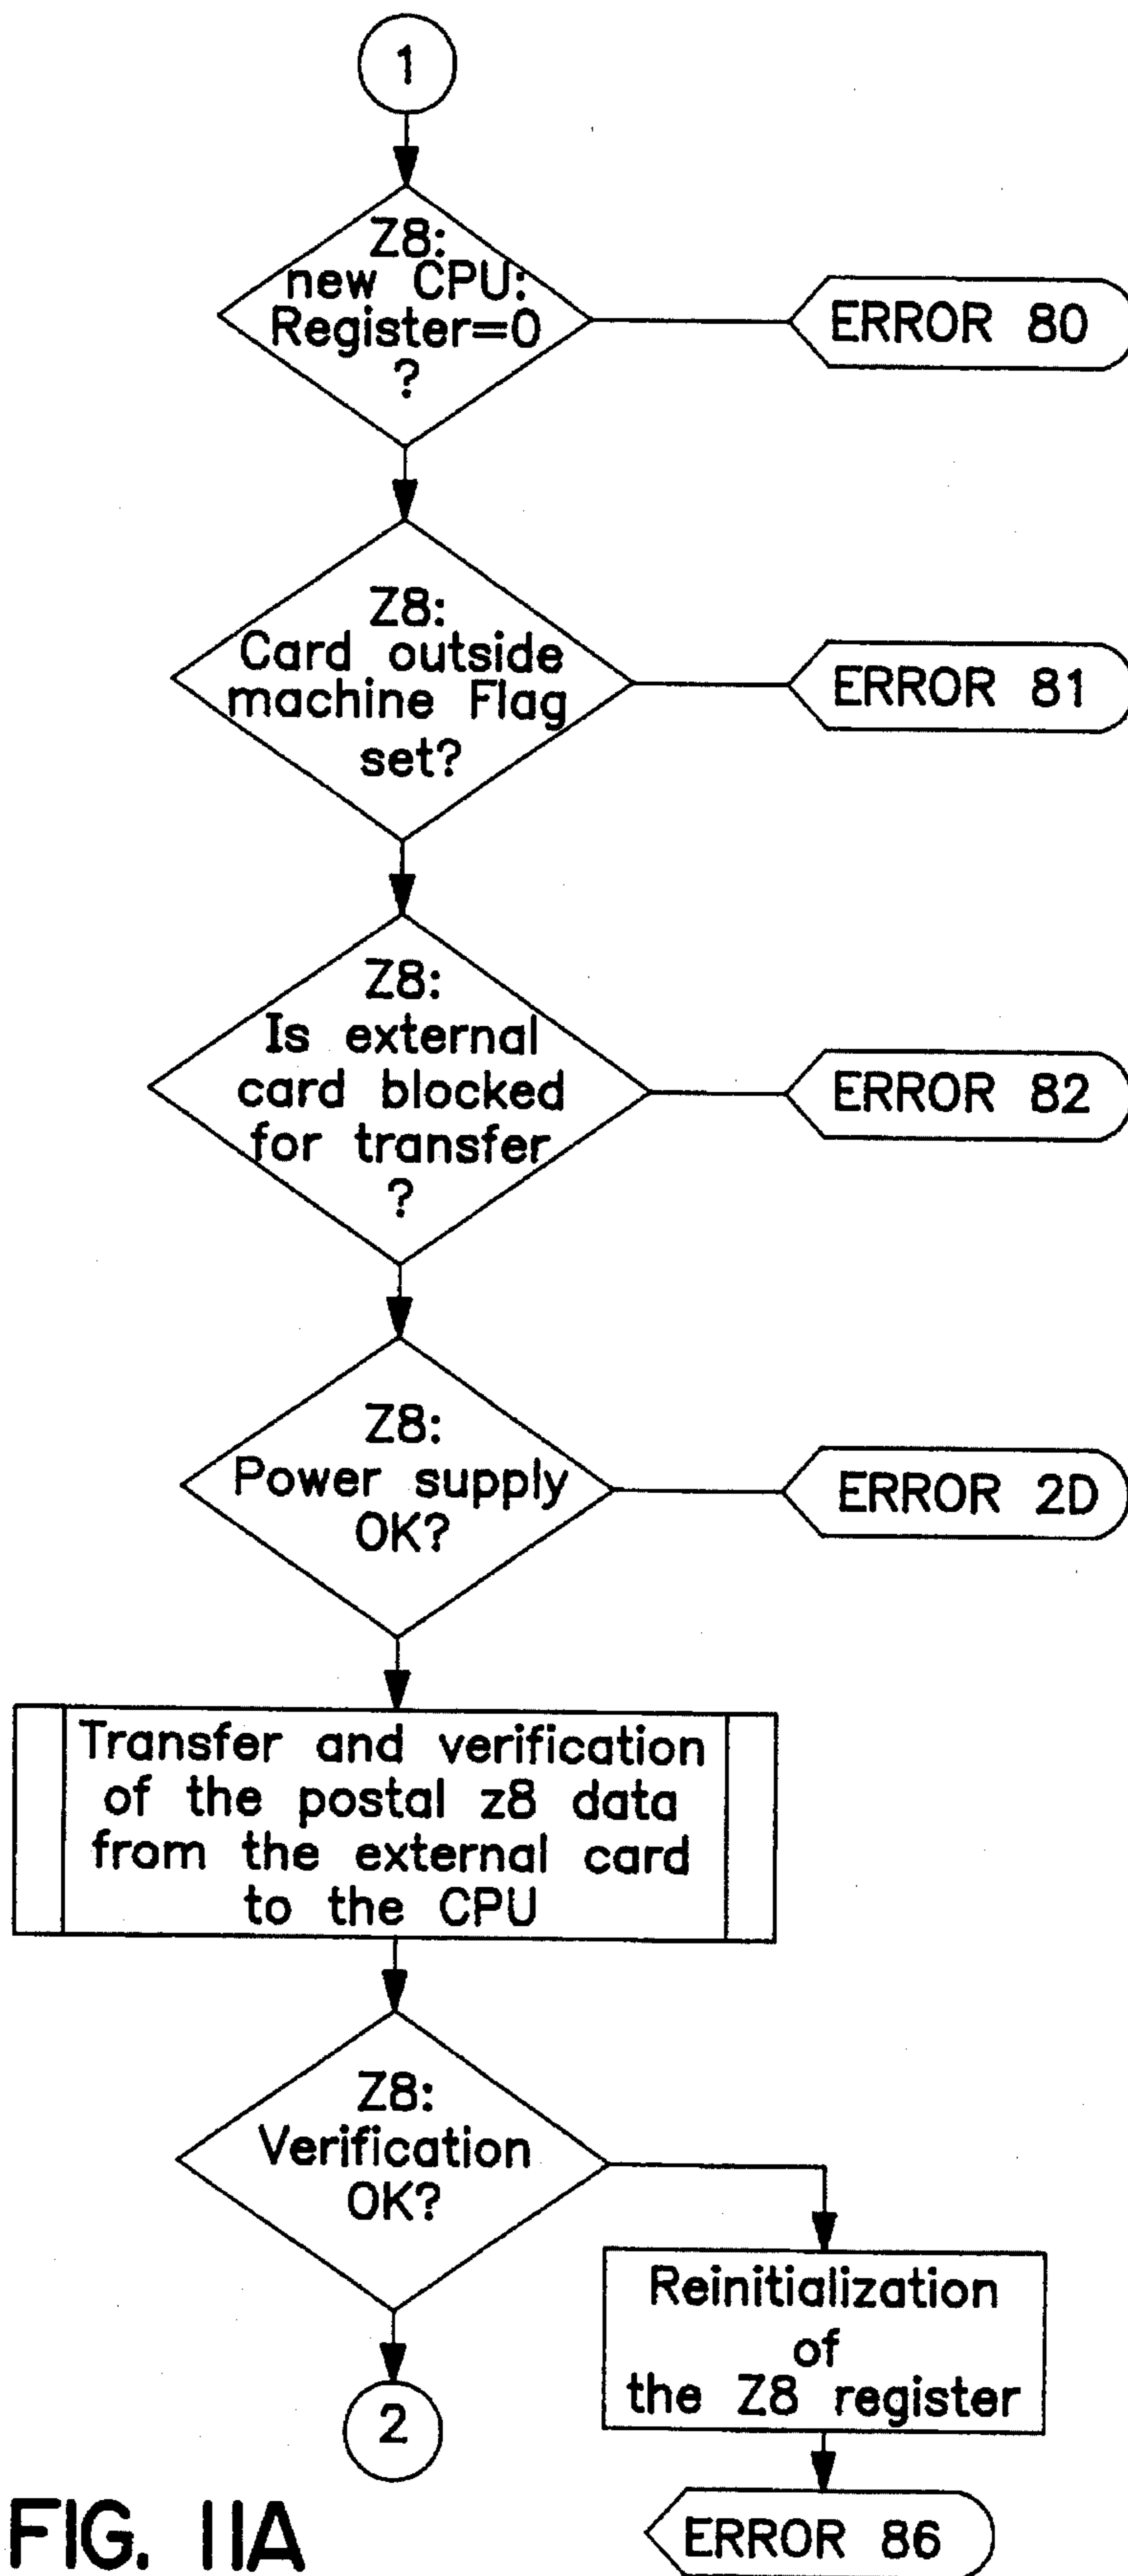
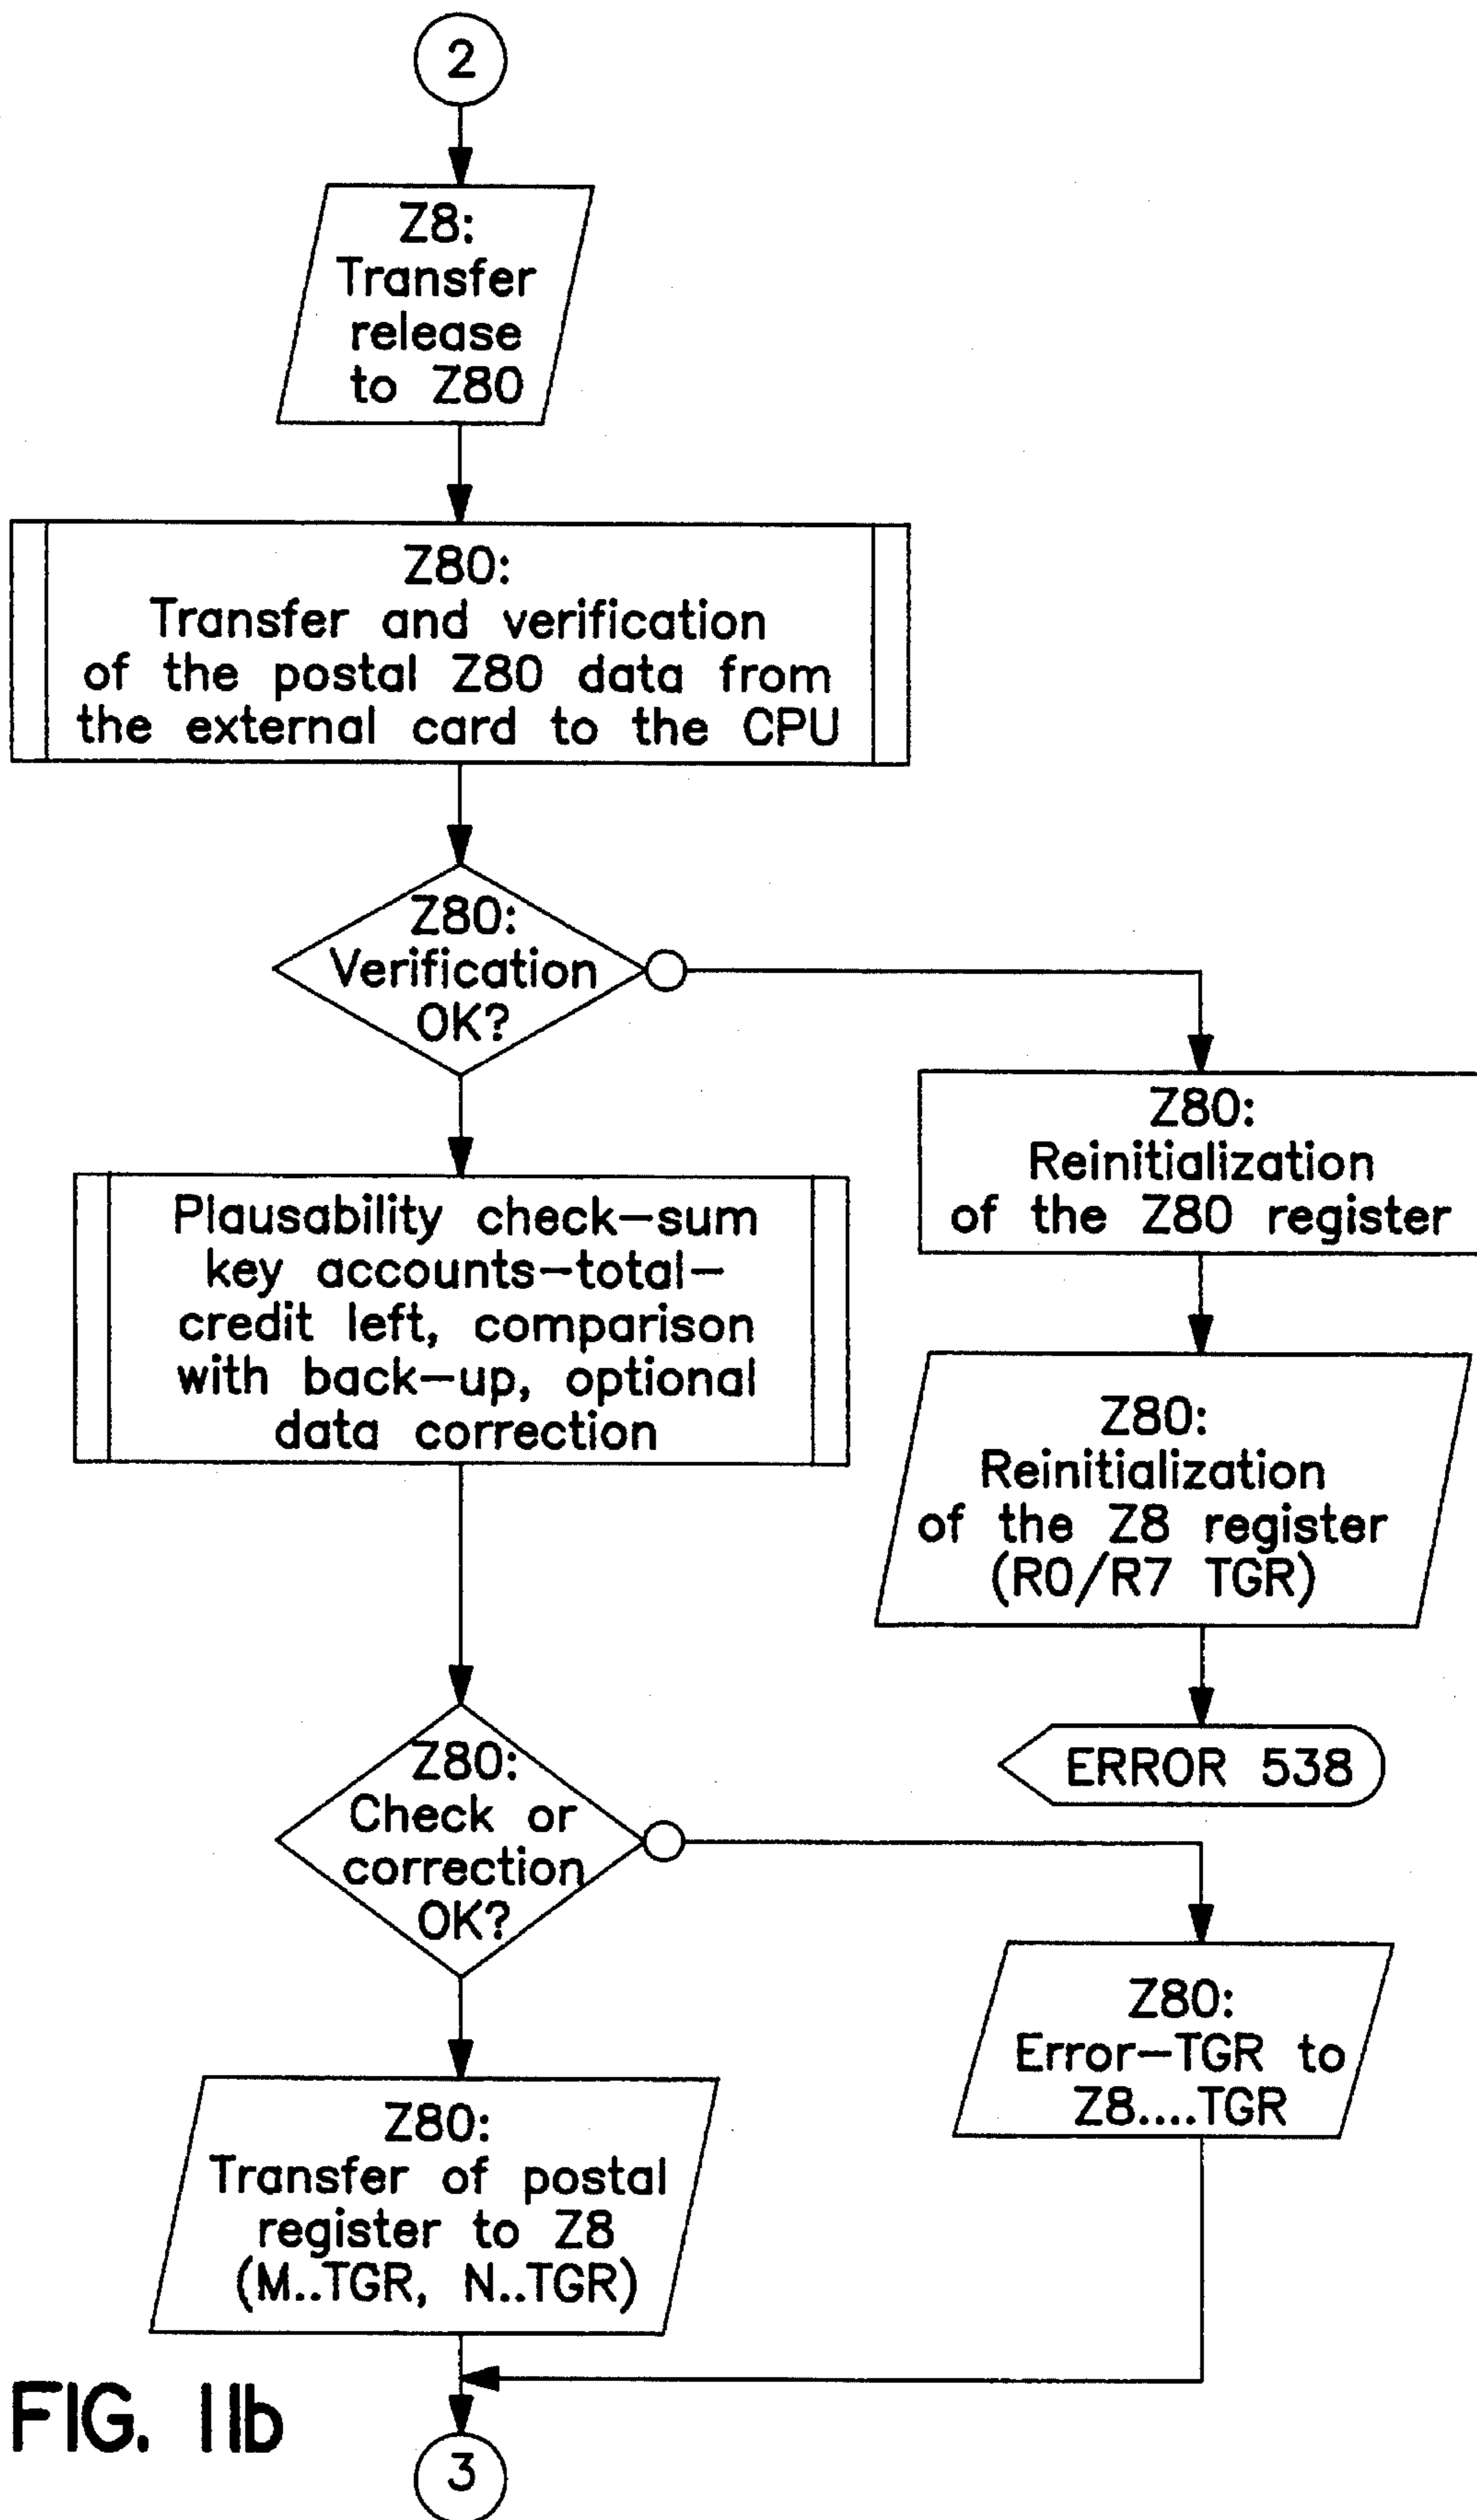
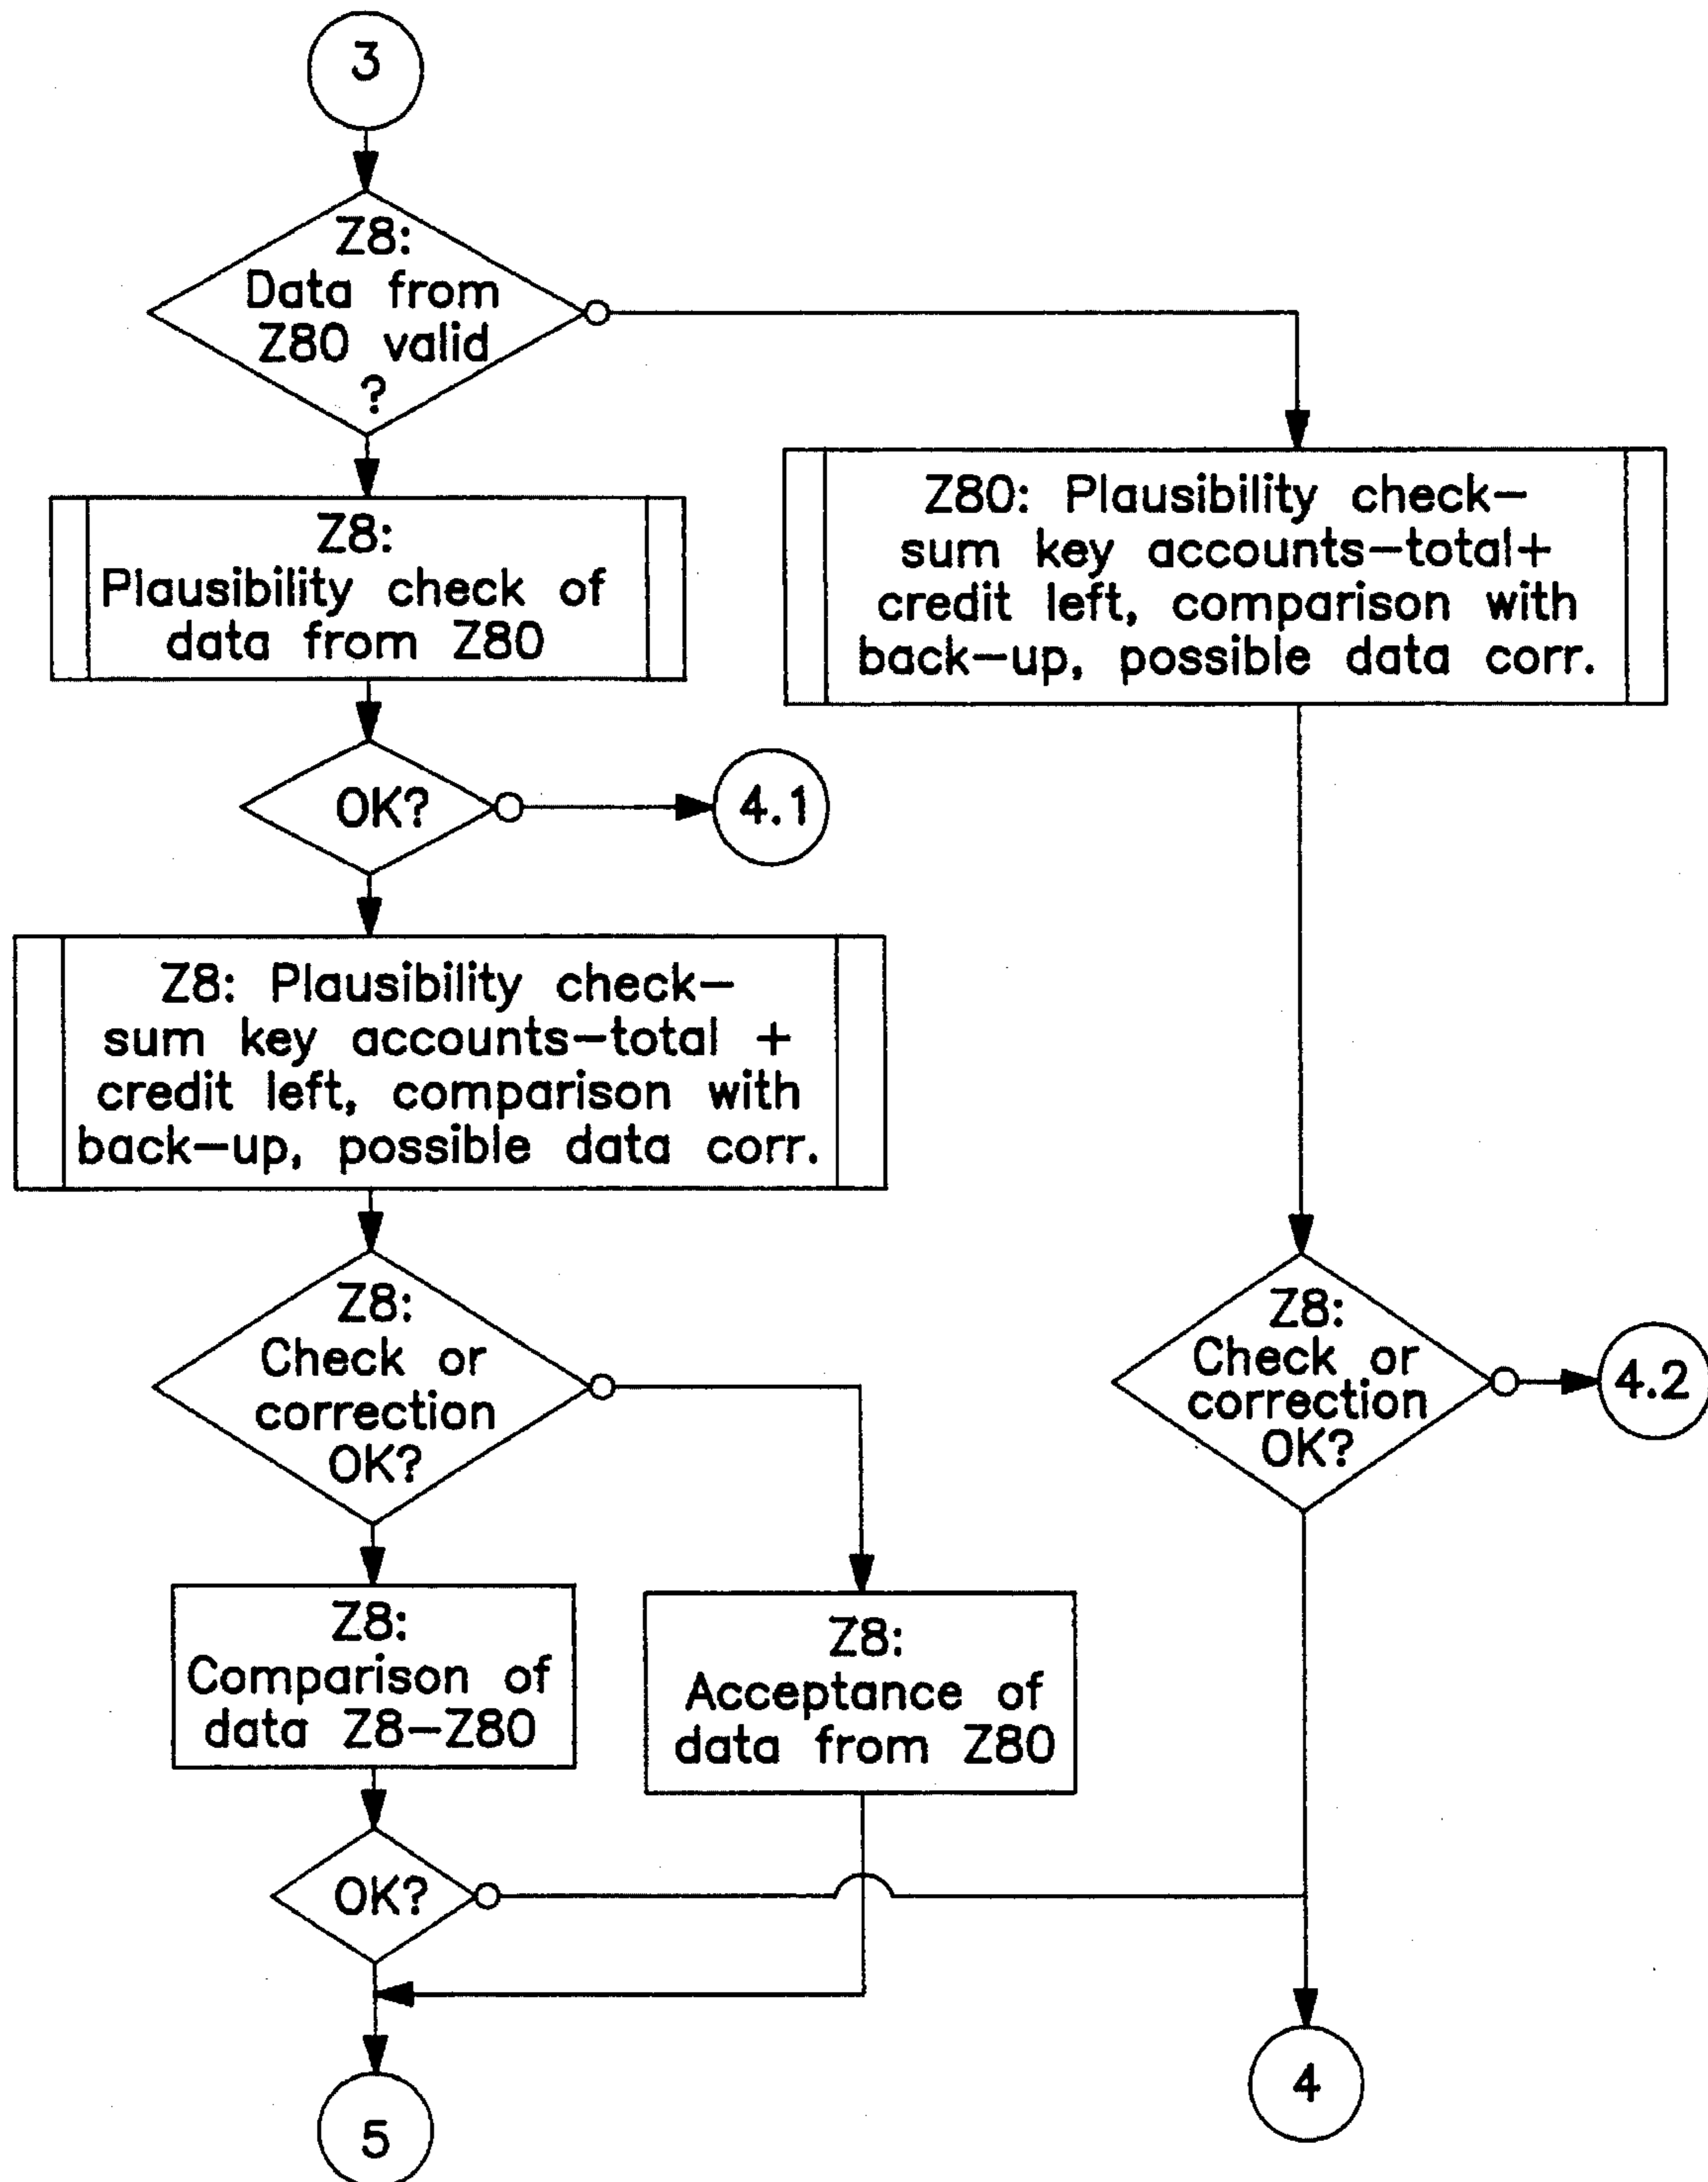
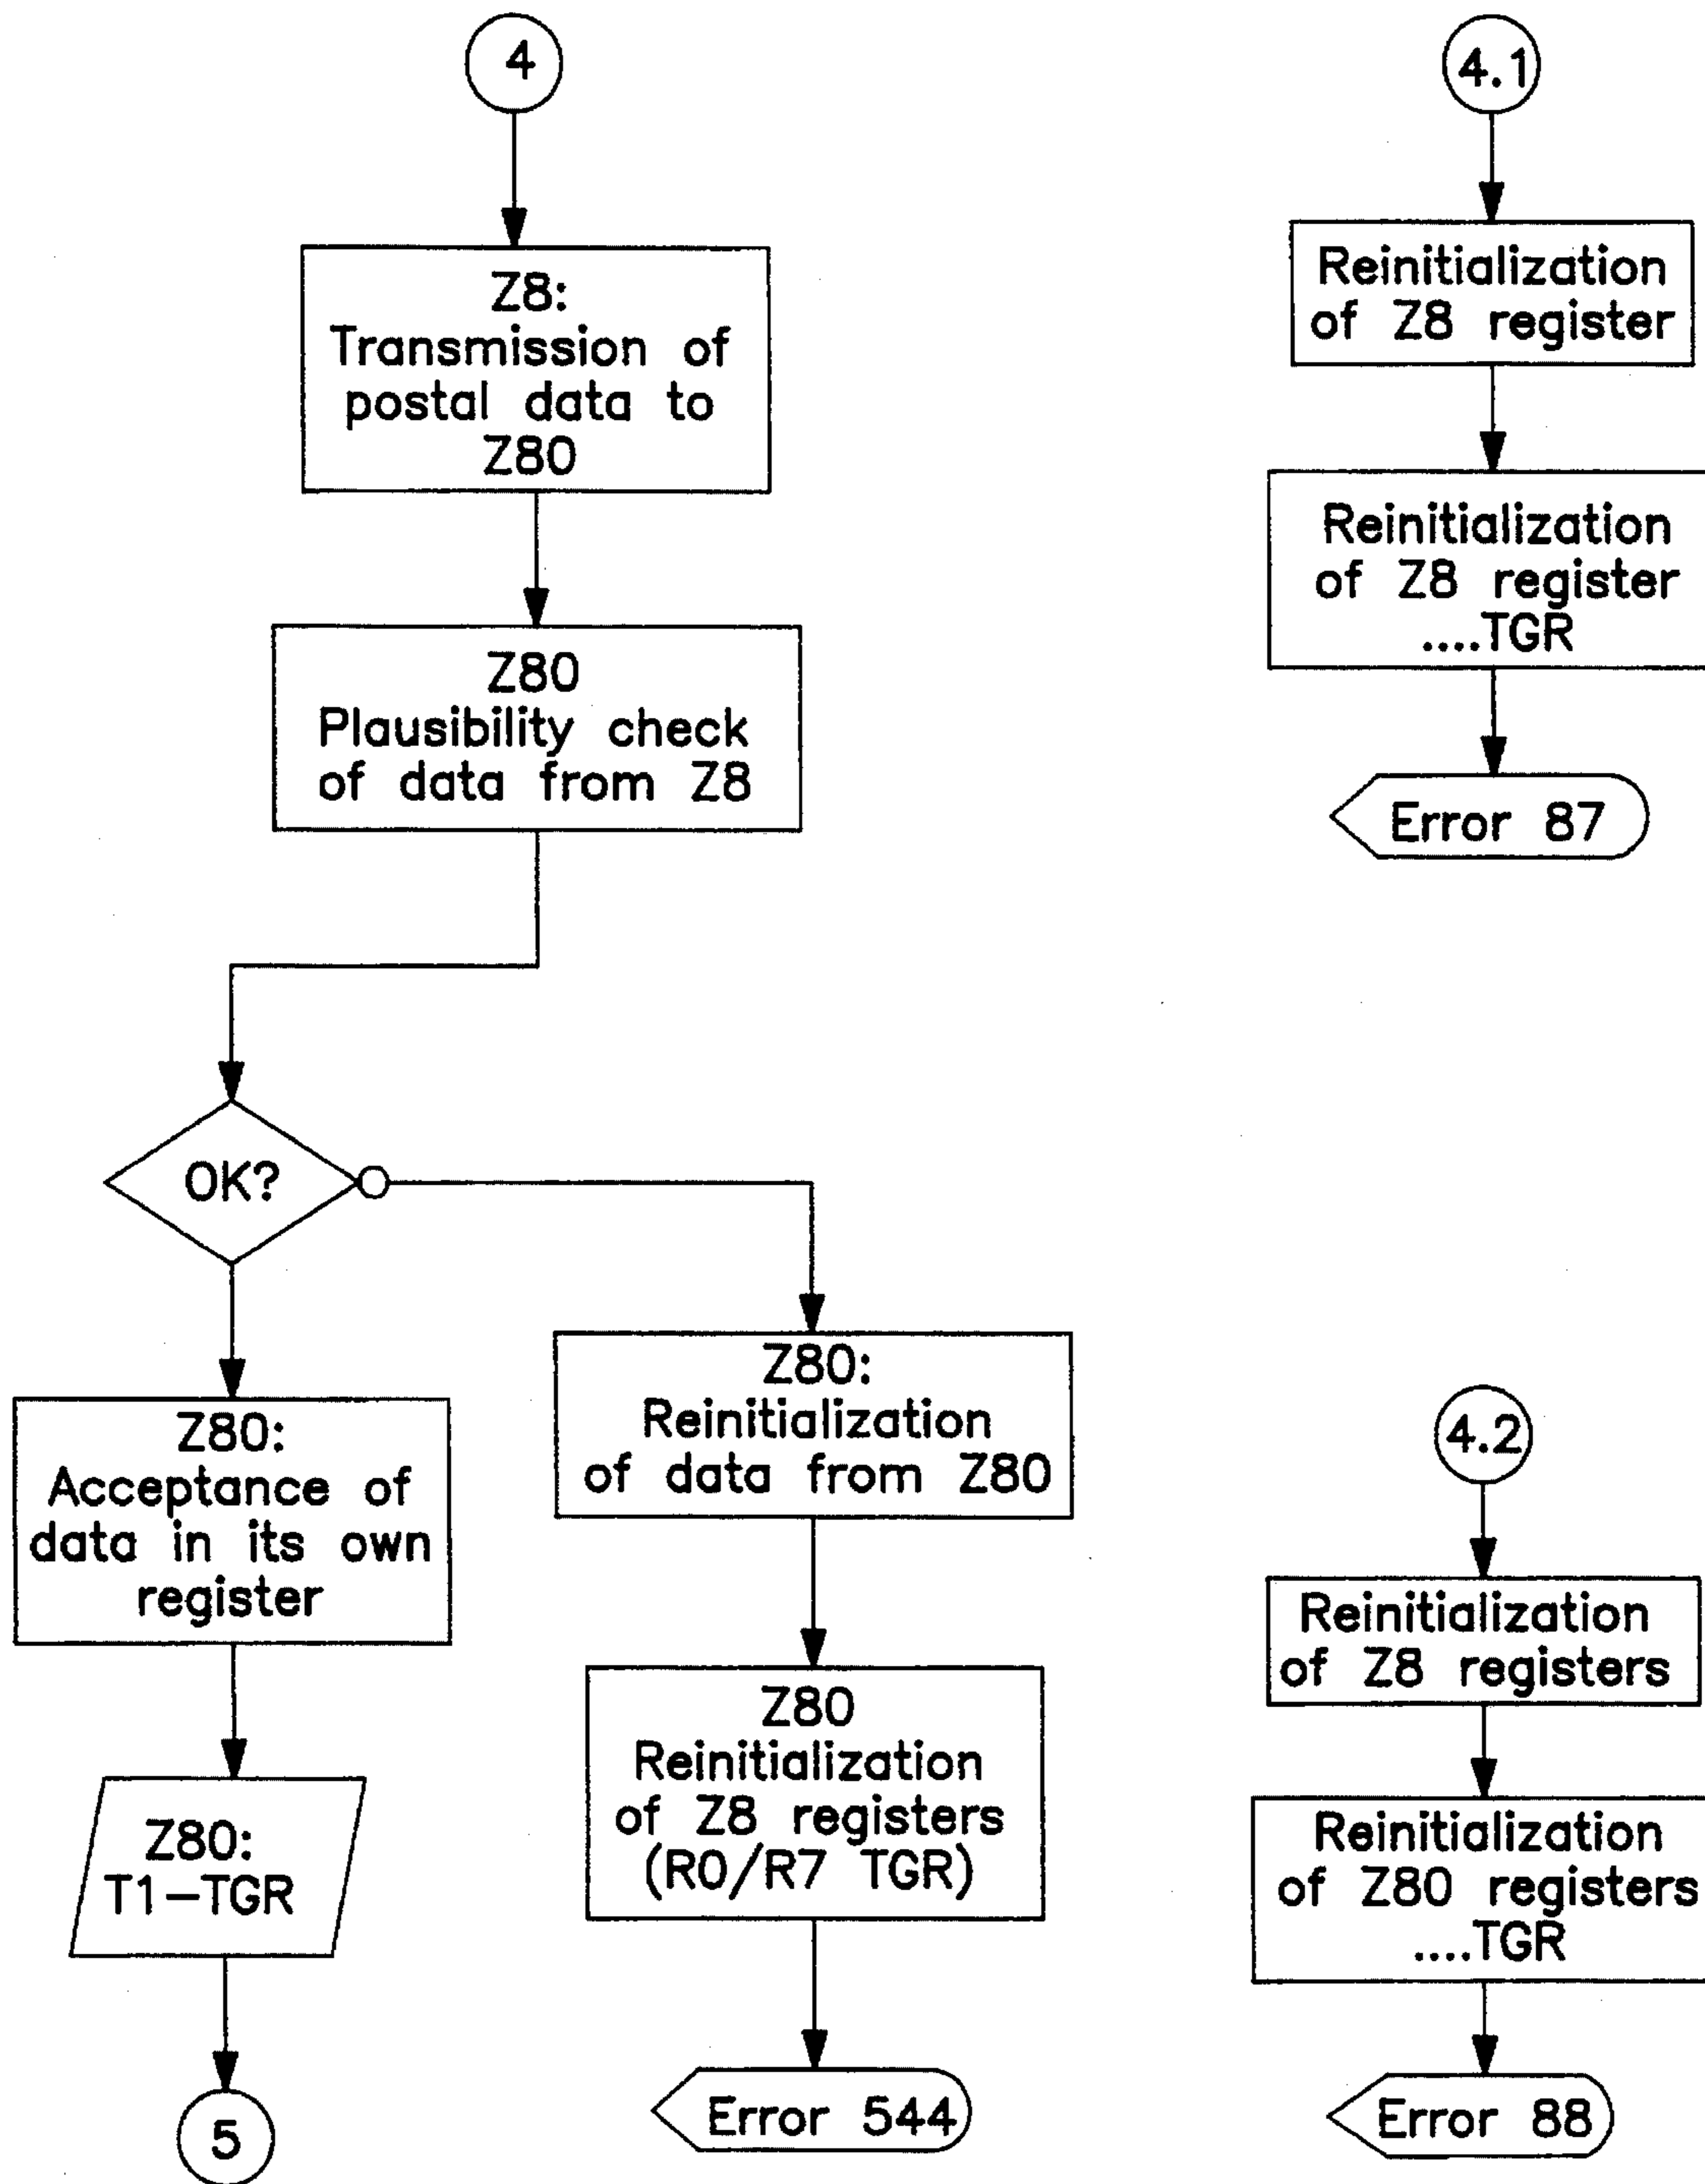
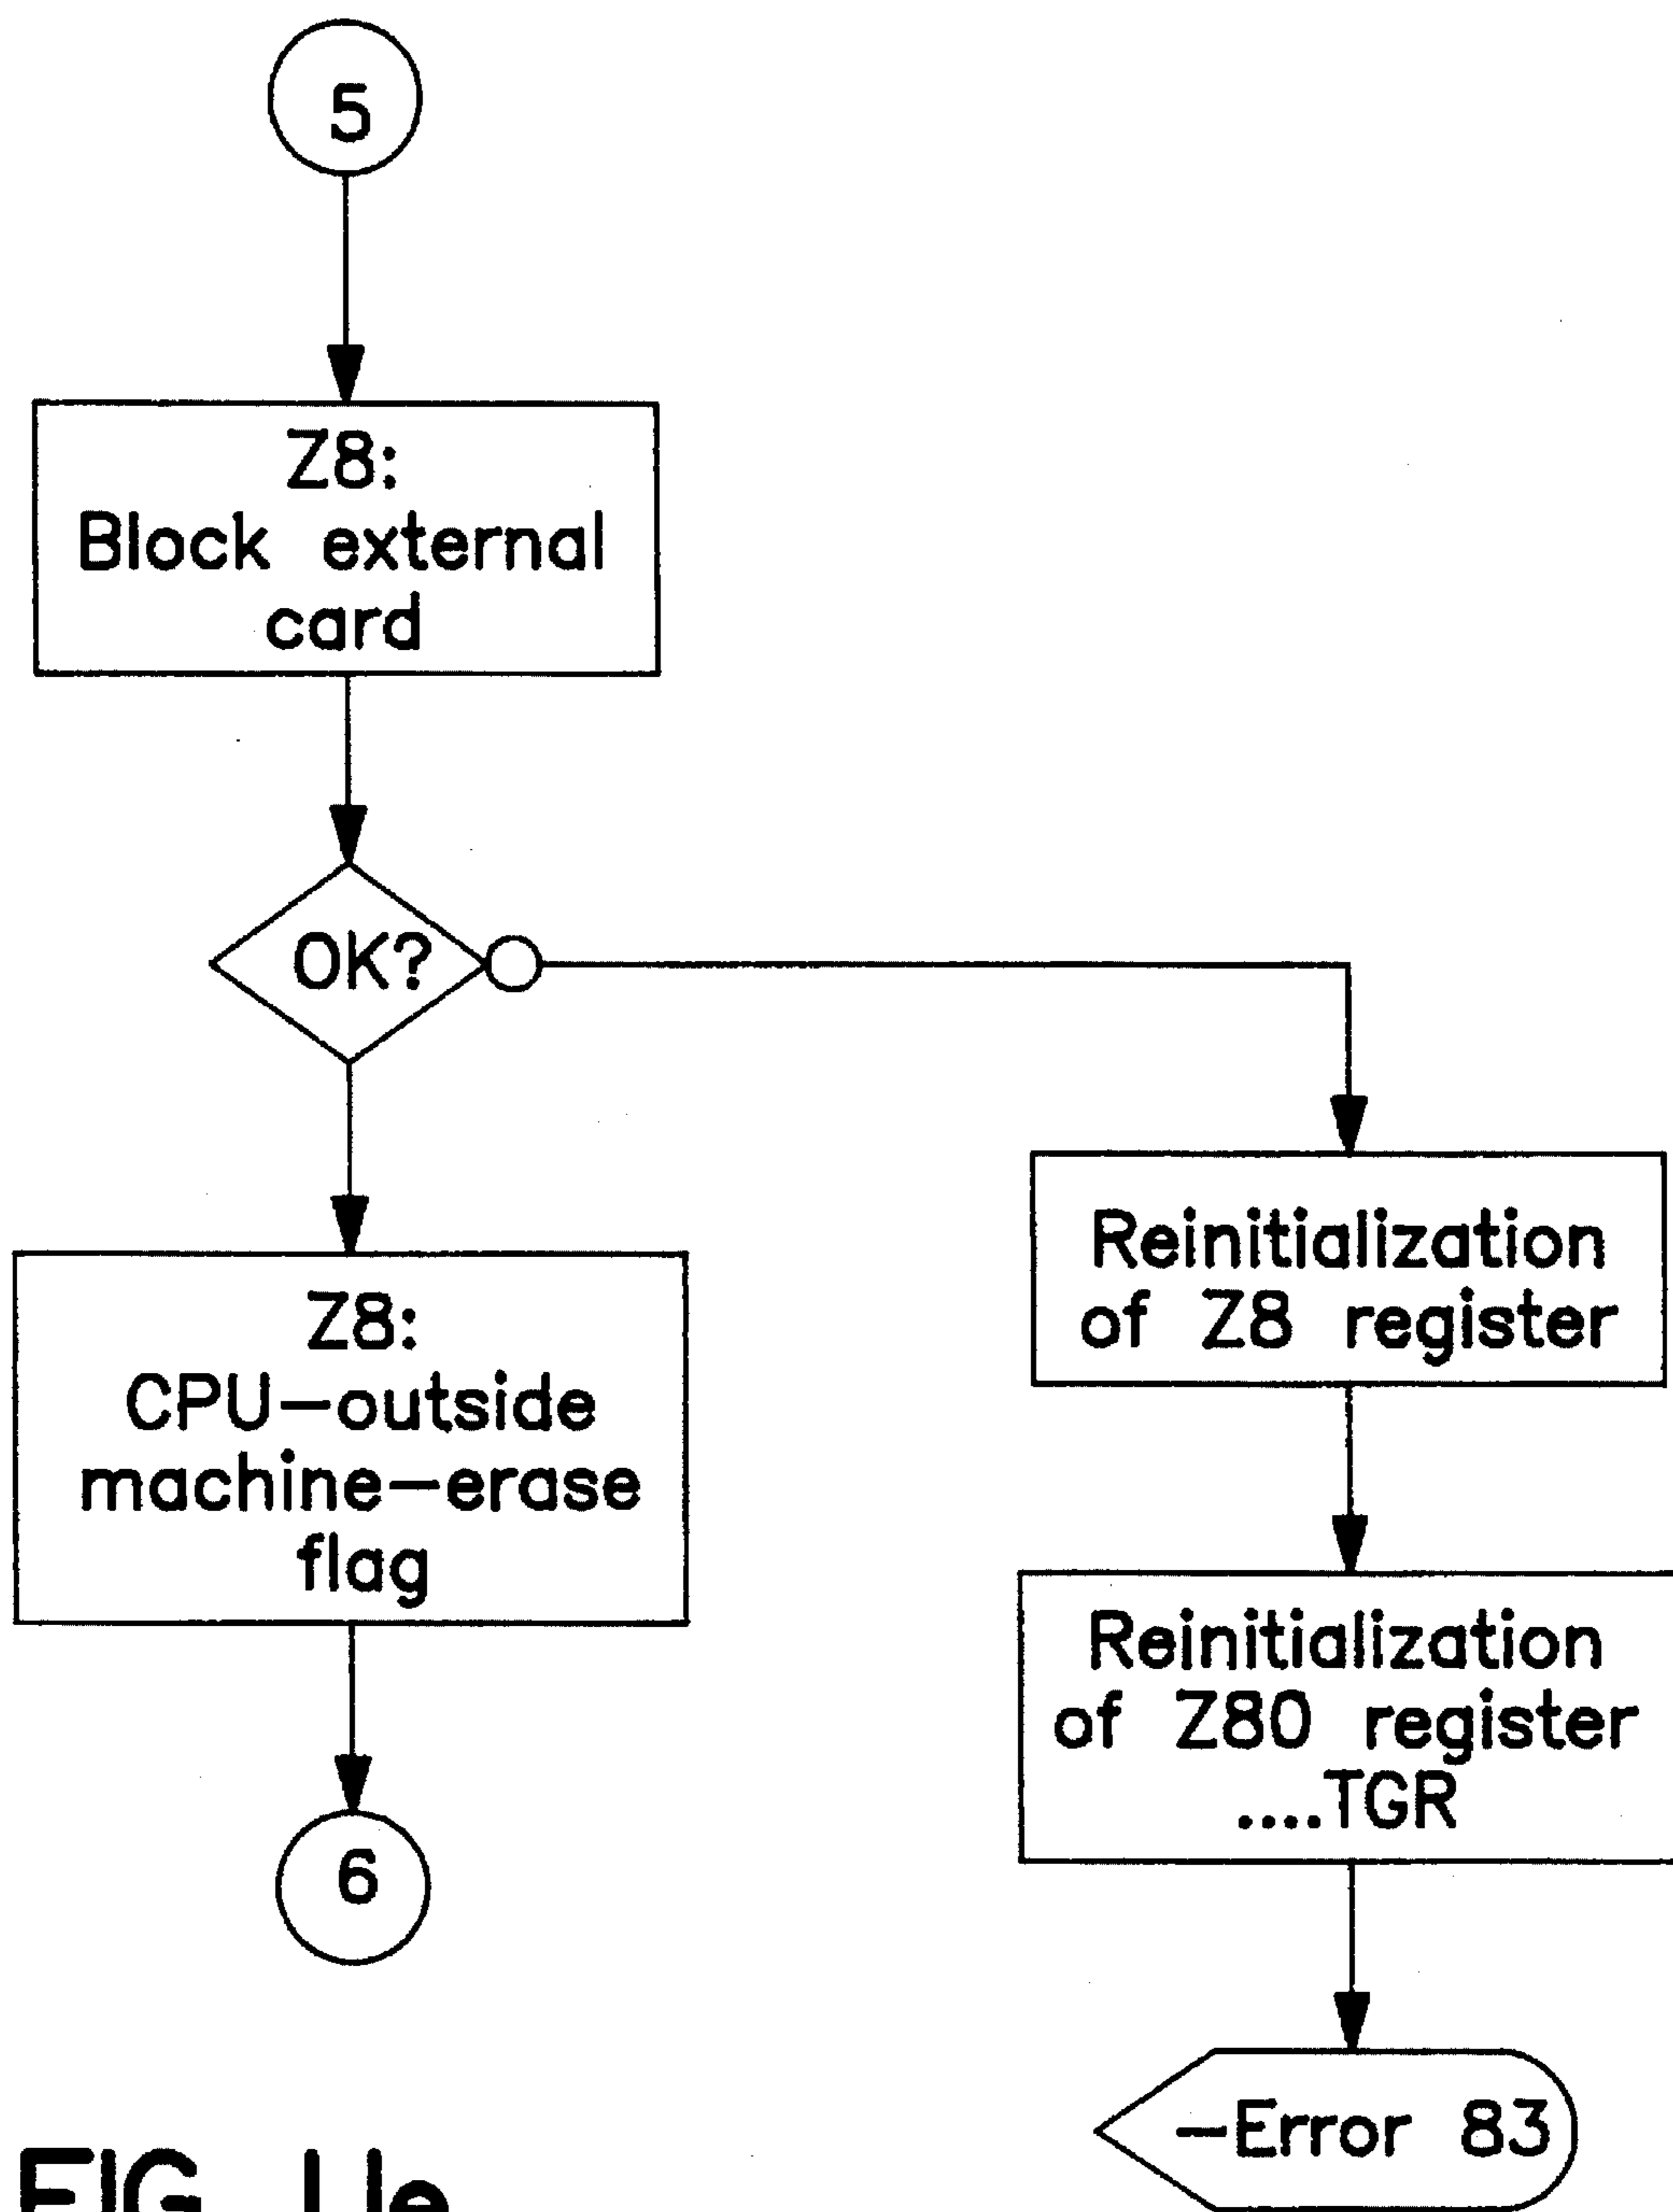
FIG. 11 A-F Programme sequence plans for the data transfer from the old to the new assembly unit.

FIGS. 11A to F additionally show the programme runs in a programme representation mode. The different function fields mean e.g. start, end, decision, function, complex function and output. Z8 relates to a control computer, whilst Z80 relates to the computer associated with the control and display panel or keyboard. Errors or faults which may occur are figured and appear with said figure and the reading "error" in the keyboard. The error numbers have the following meaning:

Error 80: The counter or register of the new assembly unit 10 does not have the value zero.

Error 81: The flag is not set in the new assembly unit connected for data transfer.

Error 82: The new assembly unit connected for data transfer is blocked for this purpose or does not respond.

Error 86: Error detection during checking, data transfer to be repeated.

Error 88: Both memory systems cancelled and the data cannot be retrieved.
