[11] Patent Number: **5,519,486**

[54] **METHOD OF CREATING HOLOGRAPHIC INTERFEROGRAMS FOR STRUCTURAL EXAMINATION OF COMPOSITES IN SHEET METAL SURFACES**

**METHOD OF CREATING HOLOGRAPHIC
INTERFEROGRAMS FOR STRUCTURAL
EXAMINATION OF COMPOSITES IN SHEET
METAL SURFACES**

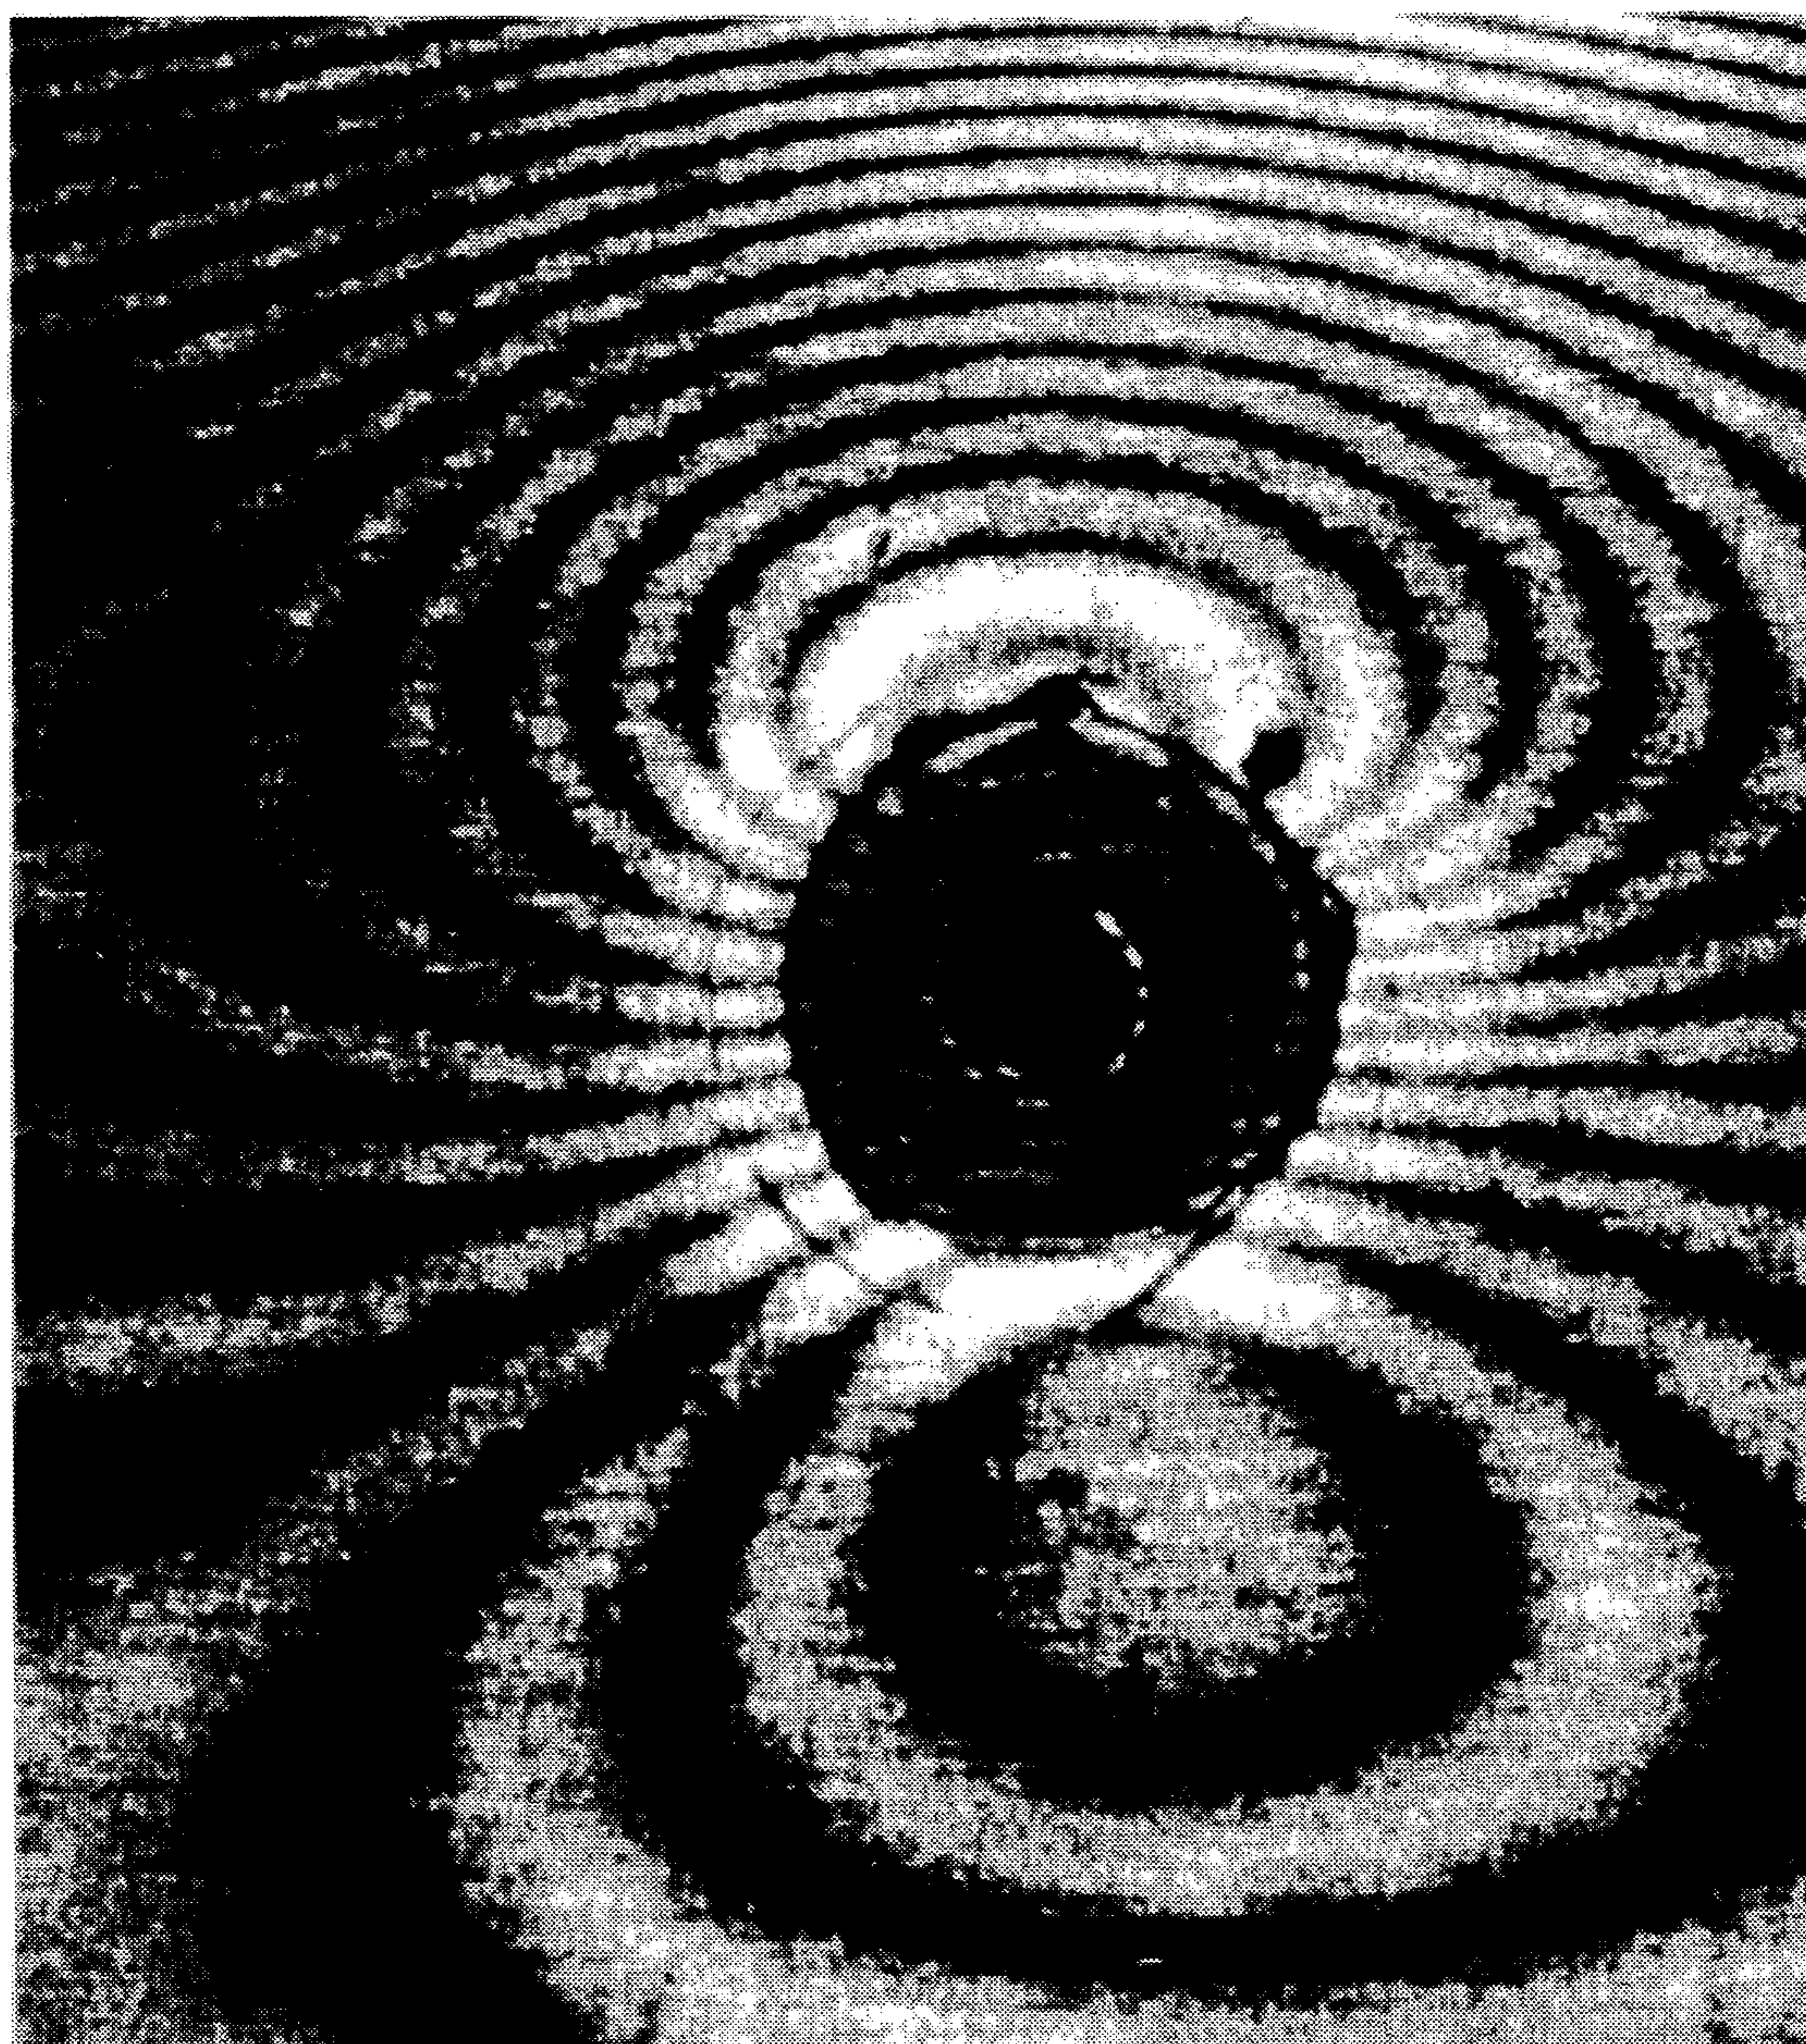
FIG. 3 is a holographic interferogram of a correctly riveted join.

A holographic interferogram, obtained using the present invention, of a good riveted joint is shown in FIG. 3.

The arrow A in FIG. 3 indicates the direction of the load applied to the rivet. It will be noted that circular fringes appear above and below the rivet in FIG. 3.
