[11] Patent Number: **5,540,096**

[54] **METHOD FOR THE NON-DESTRUCTIVE EVALUATION OF PRESTRESSED CONCRETE STRUCTURES**

[73] Assignee: **Washington Suburban Sanitary Commission**, Laurel, Md.

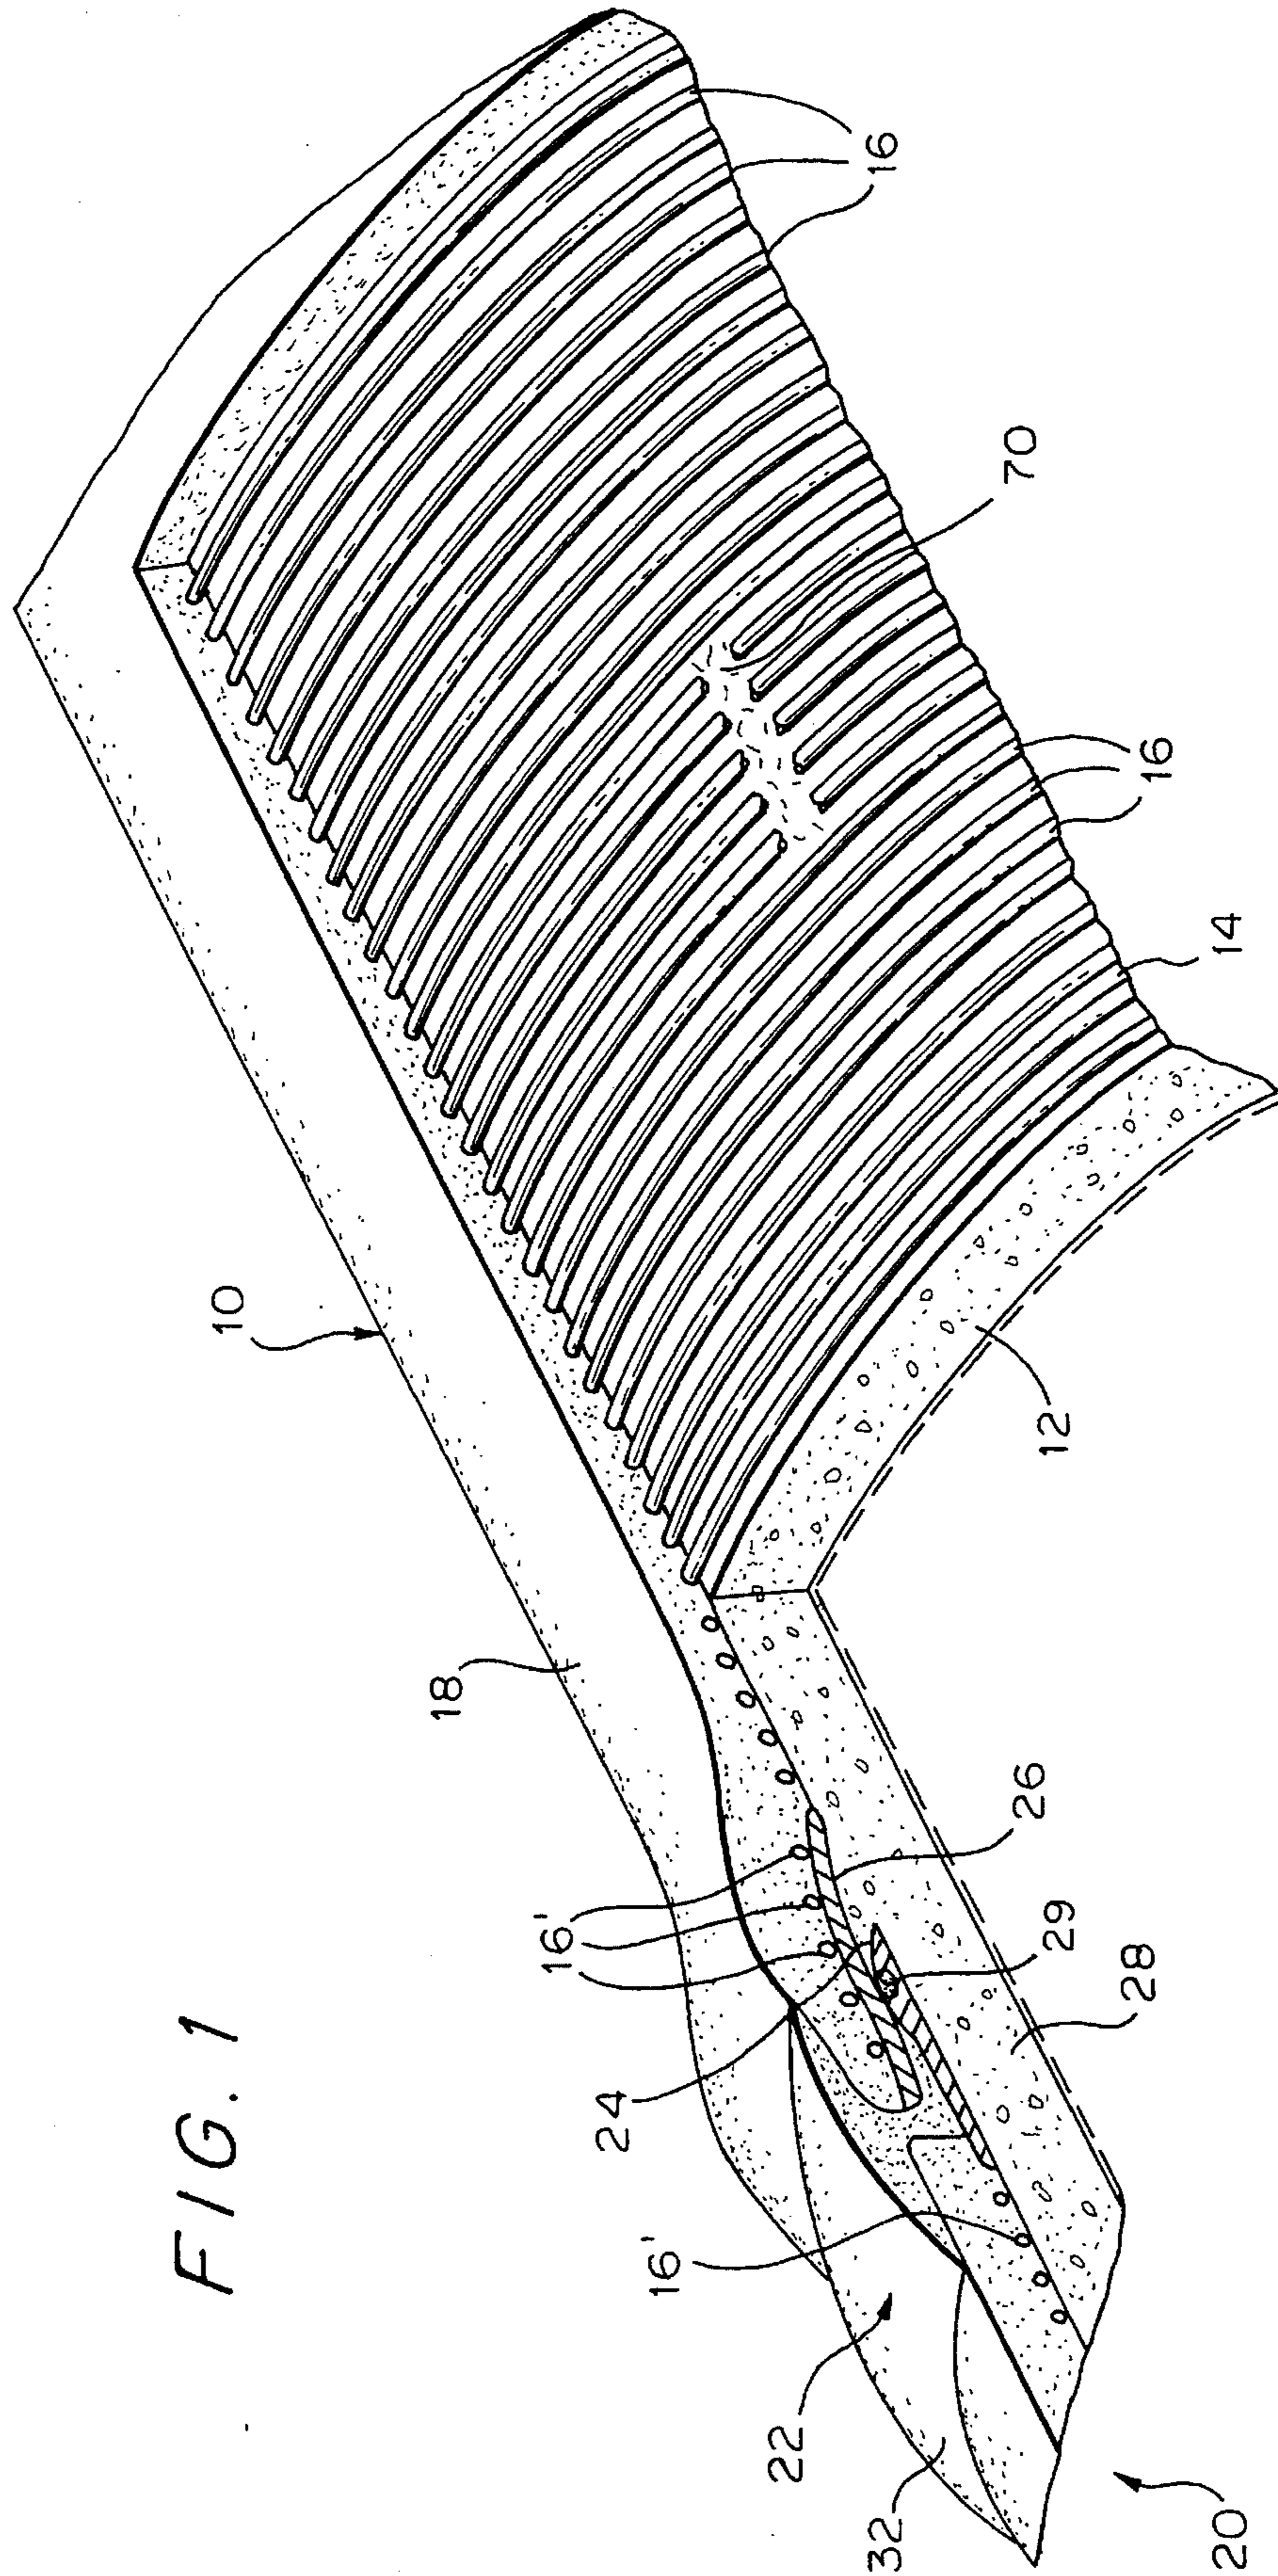
FIG. 1 is a perspective view with portions in cross-section illustrating a pipe of a first configuration;

Referring now to FIG. 1, a PCCP pipe 10 of a first embodiment known as a lined cylinder pipe is shown. The pipe 10 includes a inner layer of concrete 12; a layer of steel 14 which forms what is known as a steel membrane; a strand layer 16 comprised of coiled steel wire and finally a layer of mortar 18 which envelopes the steel reinforcing wires over areas thereof which do not abut the steel membrane.

The PCCP pipe 10 is coupled to a second similarly configured PCCP pipe 20 by a joint 22. At the joint 22, there is an annular lip 24 which extends from the pipe 10. The lip 24 has a gasket 26 on the underside thereof around which steel reinforcing wire 16' is wrapped over steel cylinder 14. The lip 24 also overlies a male end 28 of the PCCP pipe 20 with the gasket 26 on the lip abutting a gasket 29 on the male end of the pipe 20. The joint is then covered by a layer of sealing mortar 32.

In both the pipes 10 and 30, the reinforcing wires 16 and 42, respectively, place the inner concrete layers 12 and 32, respectively, in circumferential compression enabling the pipes to withstand water pressure within the pipe on the order of 200 pounds per square inch. Without the prestressed steel reinforcing wire 16 or 42, the pressure within the pipes 30 and 10 forces the steel cylinder apart and water begins to seep through the walls of the pipe, resulting in very rapid destruction of the pipe.

When the first wire turns 16 or 42 break, as is illustrated by areas 70 and 72, there is immediate localized difference in compression between the portions of the concrete cores 12 or 38 compressed by the wires and the portions of the concrete cores which have had their compression relieved by

rupture of the wires. Over time, the resulting tension between these adjacent portions of the concrete cores 12 and 38 reach a level that exceeds the physical strength of the concrete cores 12 and 38, initiating microcracking 73 of the cores. With time, these cracks grow.

As the pipes 10 and 30 deteriorate adjacent the ruptures 70 and 72, the mortar 18 and 43 delaminates from the wires 16 and 12, respectively. More of the wire turns 16 and 42 become exposed to ground water and eventually additional wire breaks occur which in turn increases the number and rate of cracks in the concrete cores 12 and 38.

As the delamination continues, groups of wire turns 16 and 42 fail and the extent of cracking of the concrete cores 12 and 38 increase in severity. Since the cylindrical steel membrane 36 is relatively thin, it will rupture when not sufficiently supported by the concrete core 38. Rupture is accelerated by voids 74 occurring in the concrete core 38 and concrete layer 34.

Normally, sudden bursting failure occurs when about one hundred of the mid-pipe wire turns 16 or 42 are broken. If the deterioration occurs near the pipe joints 22 and 52, total failure of the pipes occur sooner because rupture of fewer, approximately 40, wire turns 16' or 42', will result in failure.

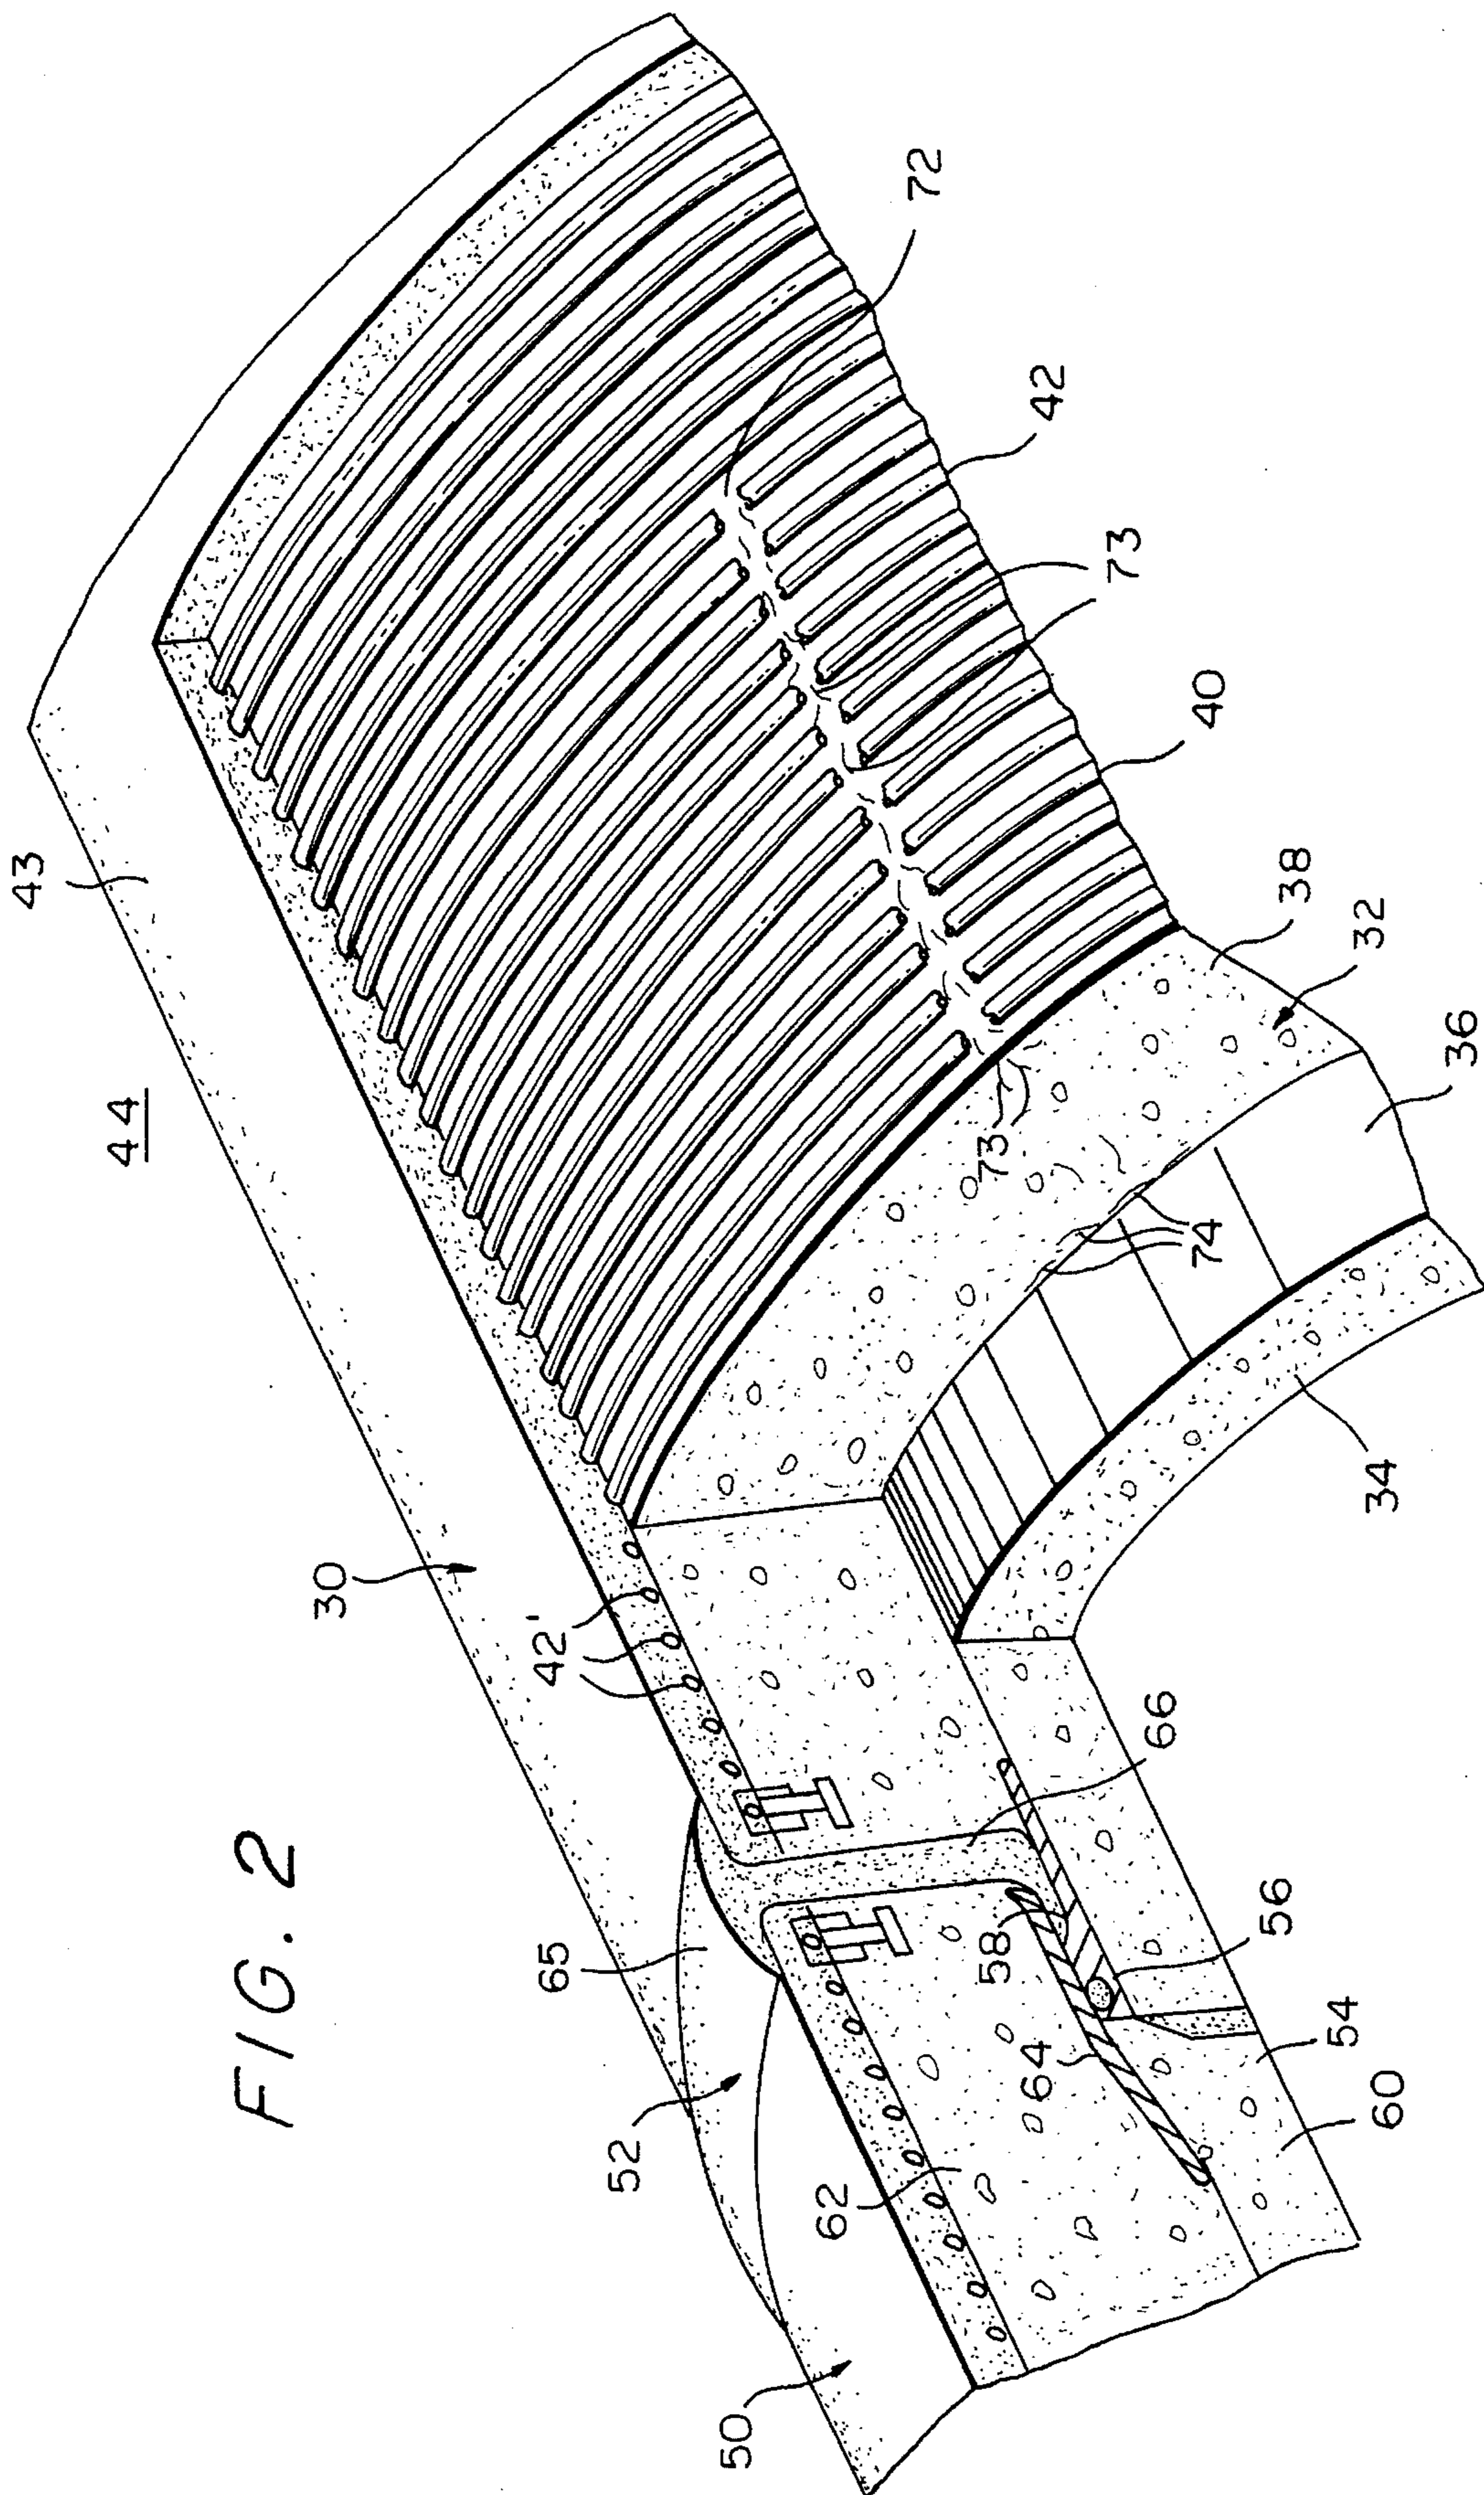
FIG. 2 is a perspective, similar to FIG. 1, of a pipe having a second configuration;

FIG. 2 discloses a second embodiment of PCCP pipe 30 which is configured differently from the pipe 10 of FIG. 1 in that a steel cylinder 36 is embedded in the concrete. The pipe 30 includes a core concrete layer 32 a concrete liner layer 34, a steel membrane 36 and a core layer 38. Disposed over the core layer 38 is the strand layer 40 comprised of steel reinforcing "wire" 42 wound around the core layer. The steel reinforcing wire 42 is in turn enveloped by a mortar layer 43 which interfaces with the soil 44 surrounding the pipe 30 and prevents the surrounding soil environment from coming into contact with and corroding the steel wire 42.

In the embodiment of FIG. 2, the pipe 30 couples with a second pipe 50 of a similar configuration with a joint 52. At the joint 52, the concrete core 38 is stepped back from the liner layer 34 to form an annular lip 54 which has an annular gasket 56 thereon. The pipe 50 has an opposed, complementing step 58 formed by indenting its concrete liner layer 60 with respect to its concrete core layer 62. A gasket 64 is positioned on the projecting portion of the concrete core 62 and engages the gasket layer 56 on the projecting annular lip 54 of the pipe 30. An annular bead 65 of mortar with a rib portion 66 extends between the concrete cores 62 and 38 of the respective pipes 30 and 50 and seals the gap at the pipe joint 52.
