[11] Patent Number: **5,549,767**

[54] **HEAT TREATMENT AND REPAIR OF COBALT BASE SUPERALLOY ARTICLES**

[73] Assignee: **United Technologies Corporation**, Hartford, Conn.

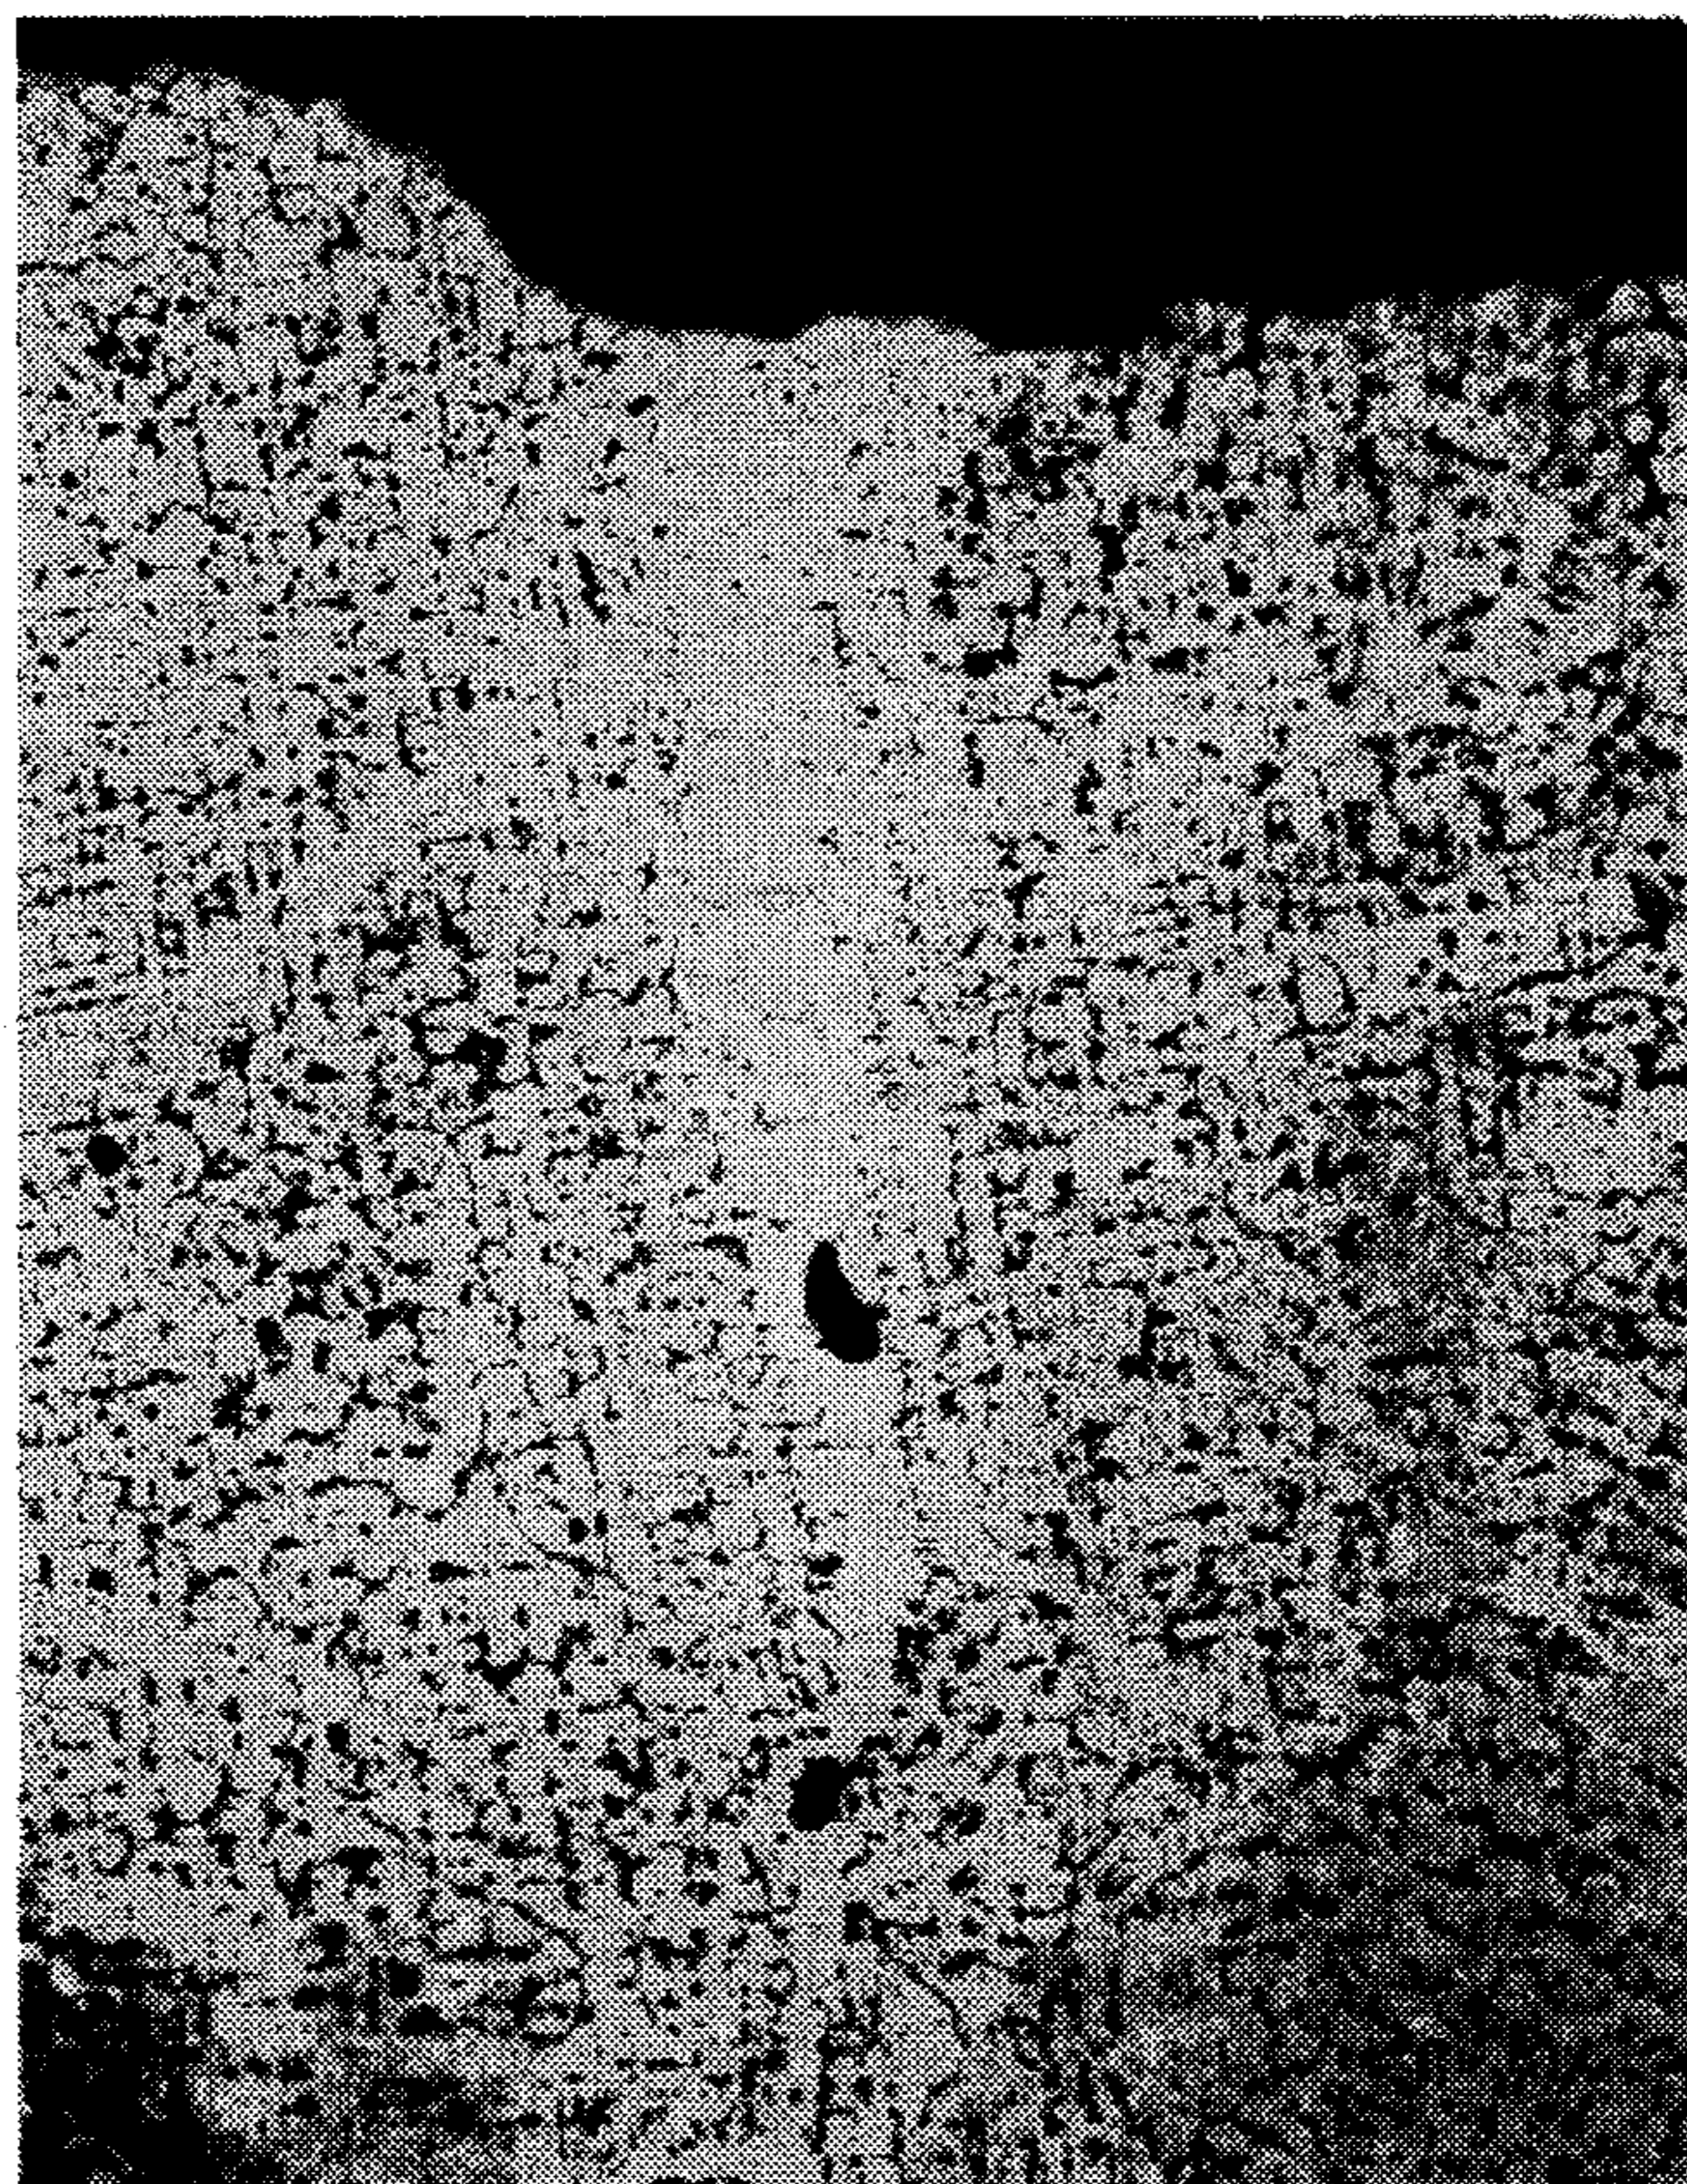
fig. 1

FIG. 1 is a graph showing the 1% creep life for MAR-M 509 for various processing conditions.

The 1% creep life was determined at 1800° F. and 11.5 ksi, and at 2000° F. and 7.5 ksi. The results as shown in FIG. 1 show that the 1% creep life peaked in the samples prepared at 2275° F. in both cases, with an improvement at the lower test temperature of about 700%, and at the higher test temperature of about 200%, compared to the baseline condition of four hours at 1975° F. on as-cast material.

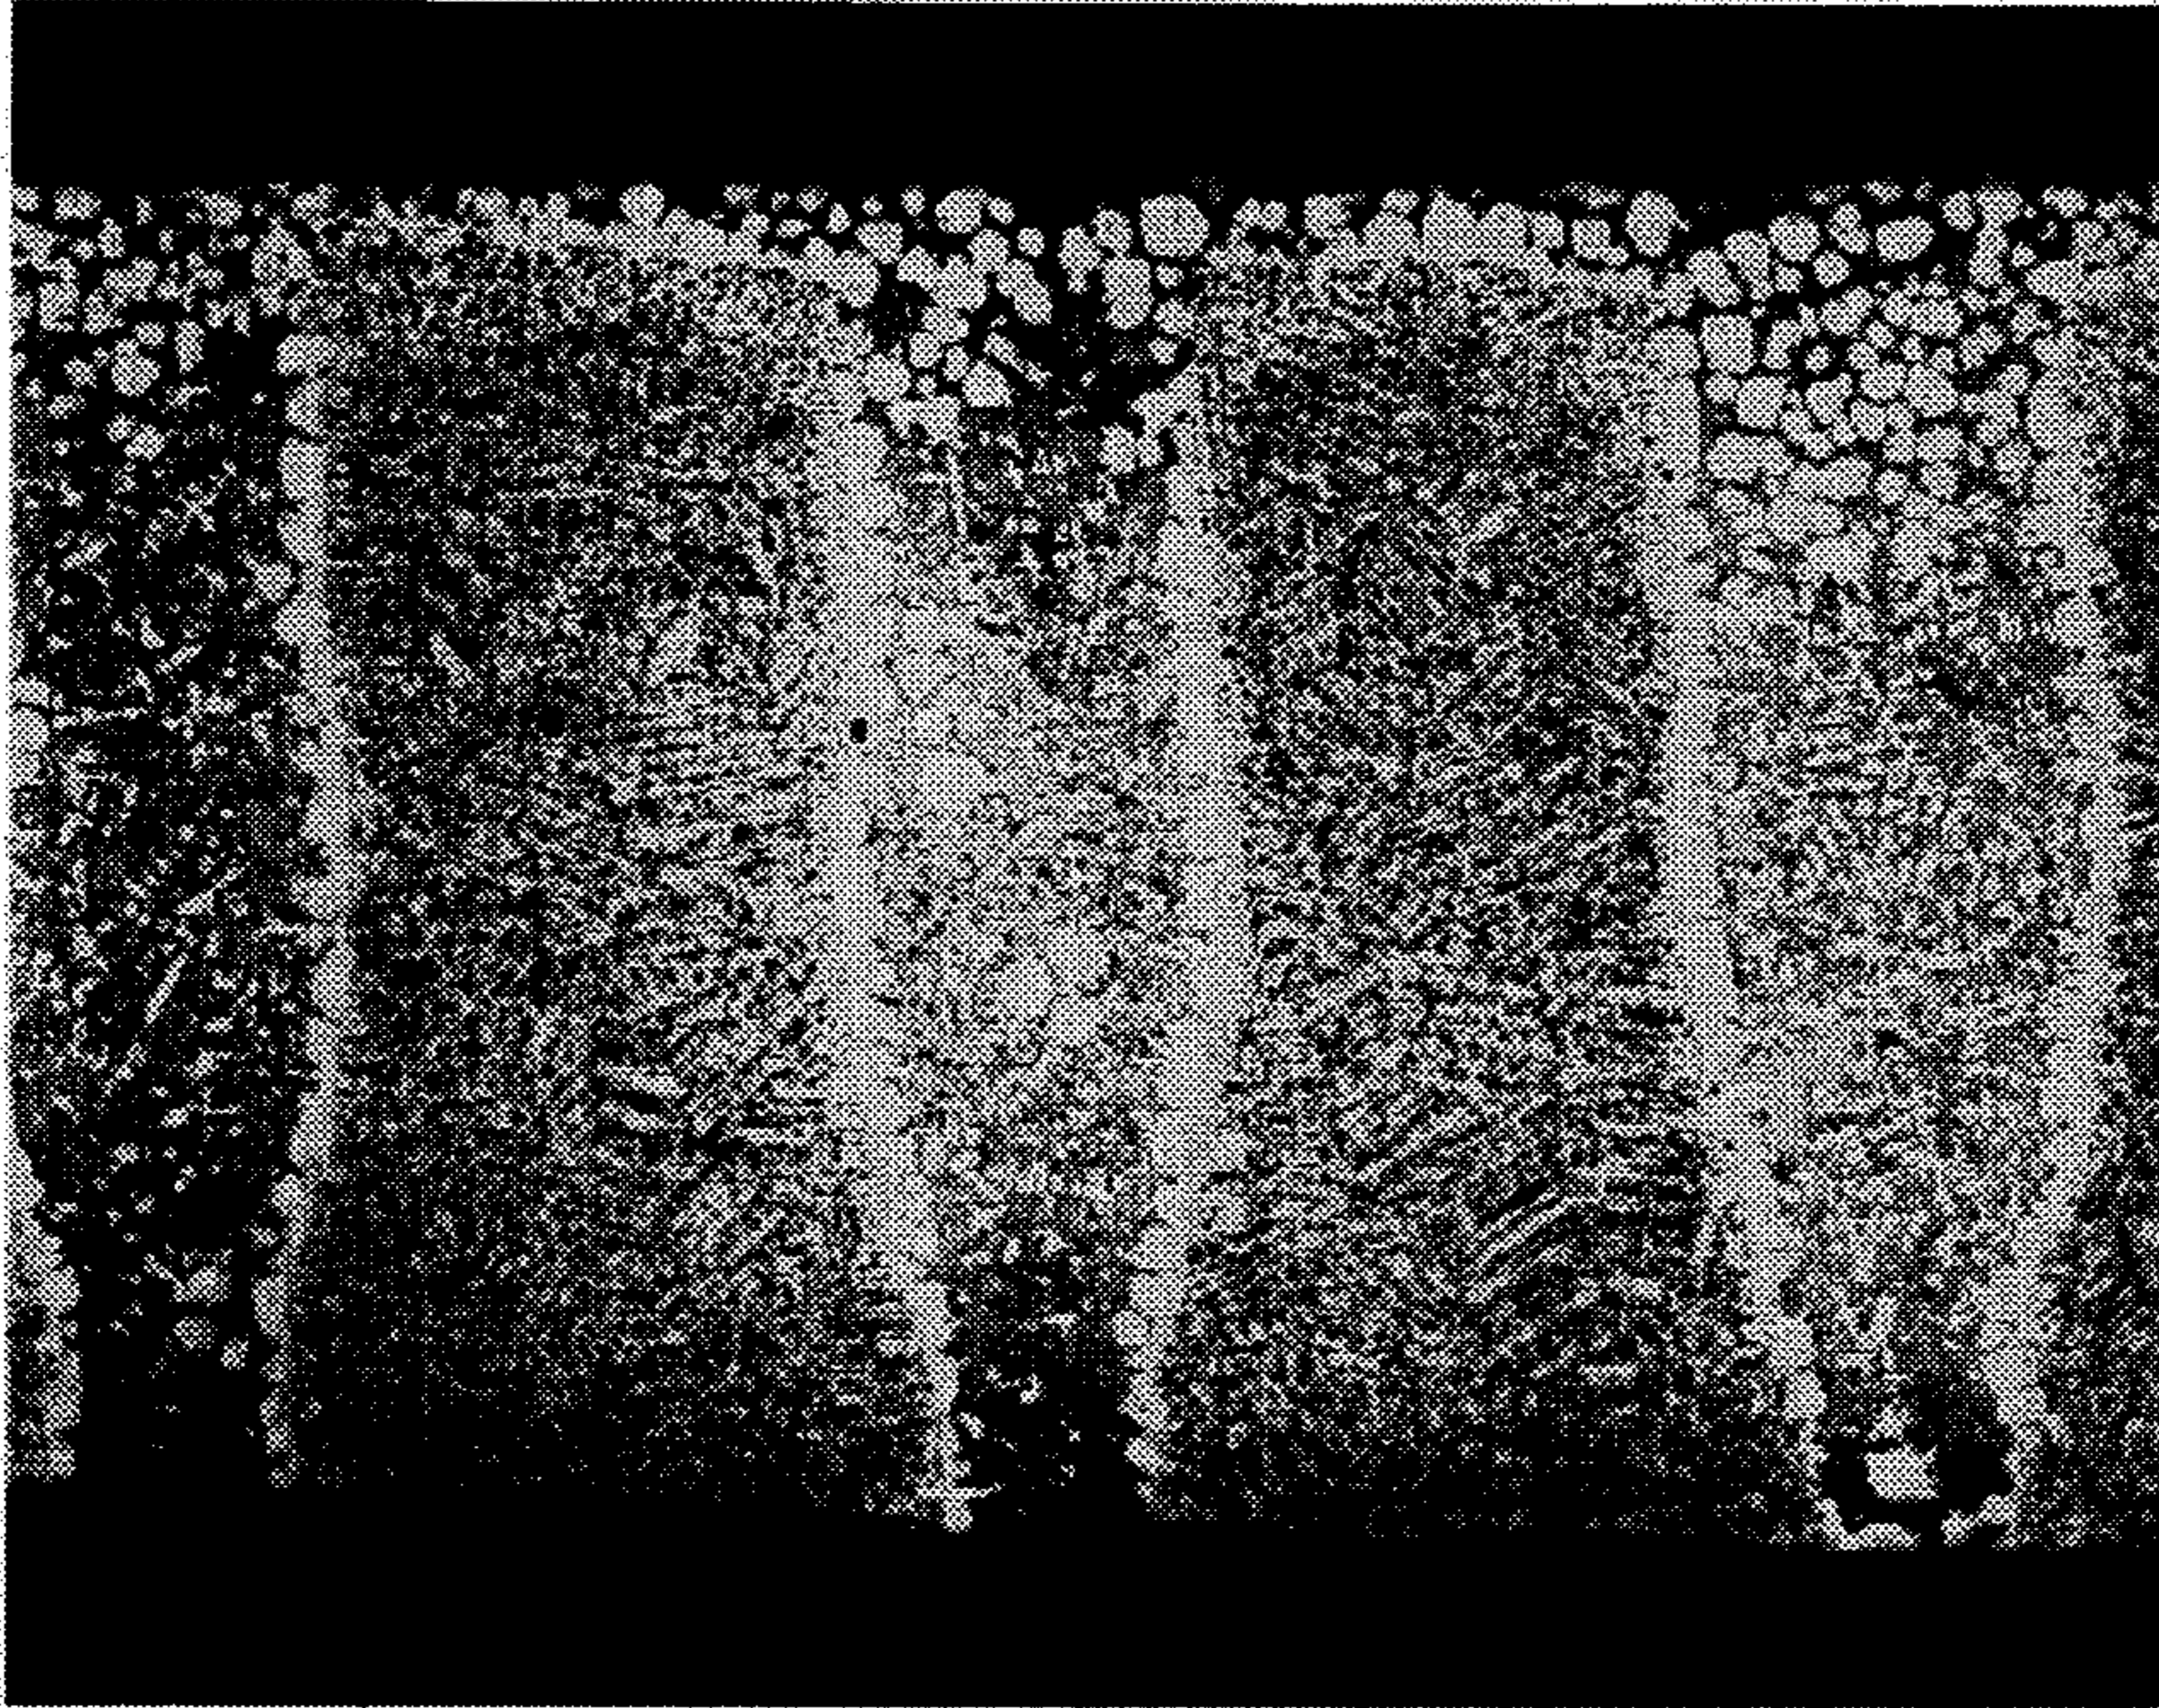
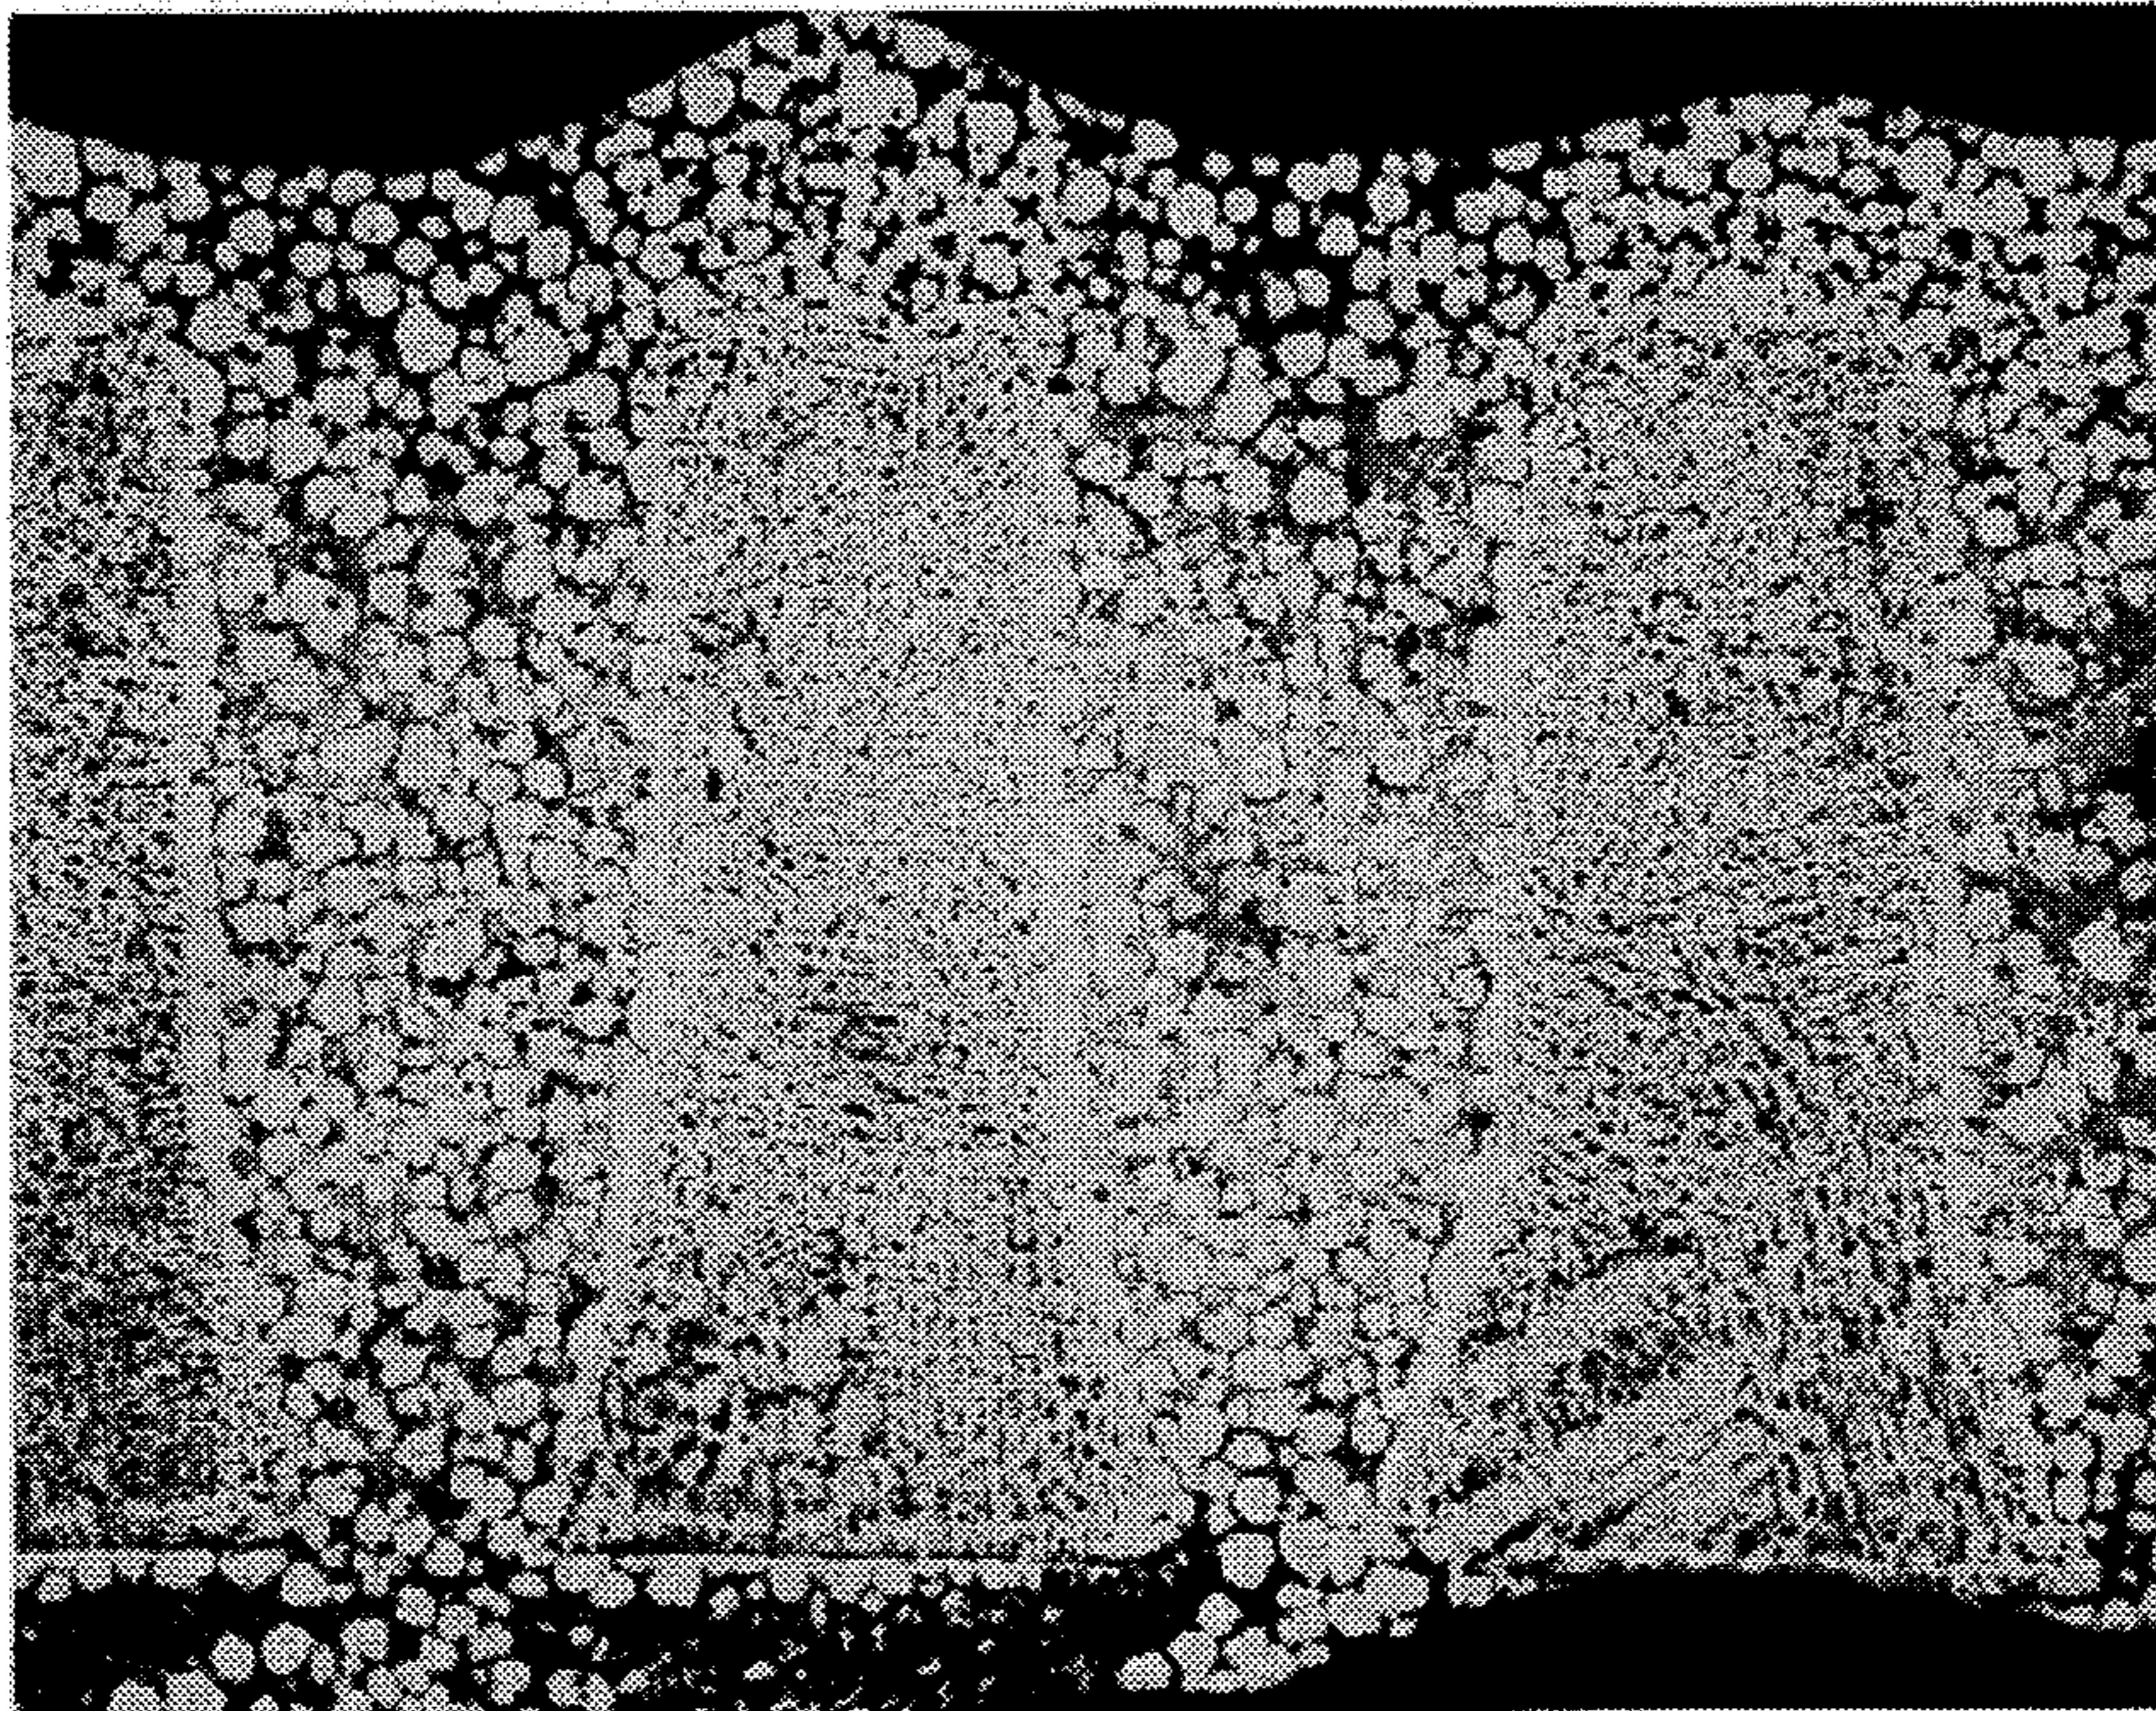
fig. 4

FIG. 4 is a 20× photomicrograph of the repaired cooling holes in a MAR-M 509 turbine vane with the repair powder packed into the holes prior to melting and isothermal diffusion.

In comparison, the microstructure of the filler material where the powder was packed into the cooling holes is shown in FIG. 4. Here the MAR-M 509 particles are uniformly distributed throughout the length of the holes, with the AMS 4783 matrix uniformly distributed between the particles.

This procedure successfully filled the gap, with the repair powder remaining in the gap, rather than running out when the low melting point powder melted. The microstructure is similar to that shown in FIG. 4.

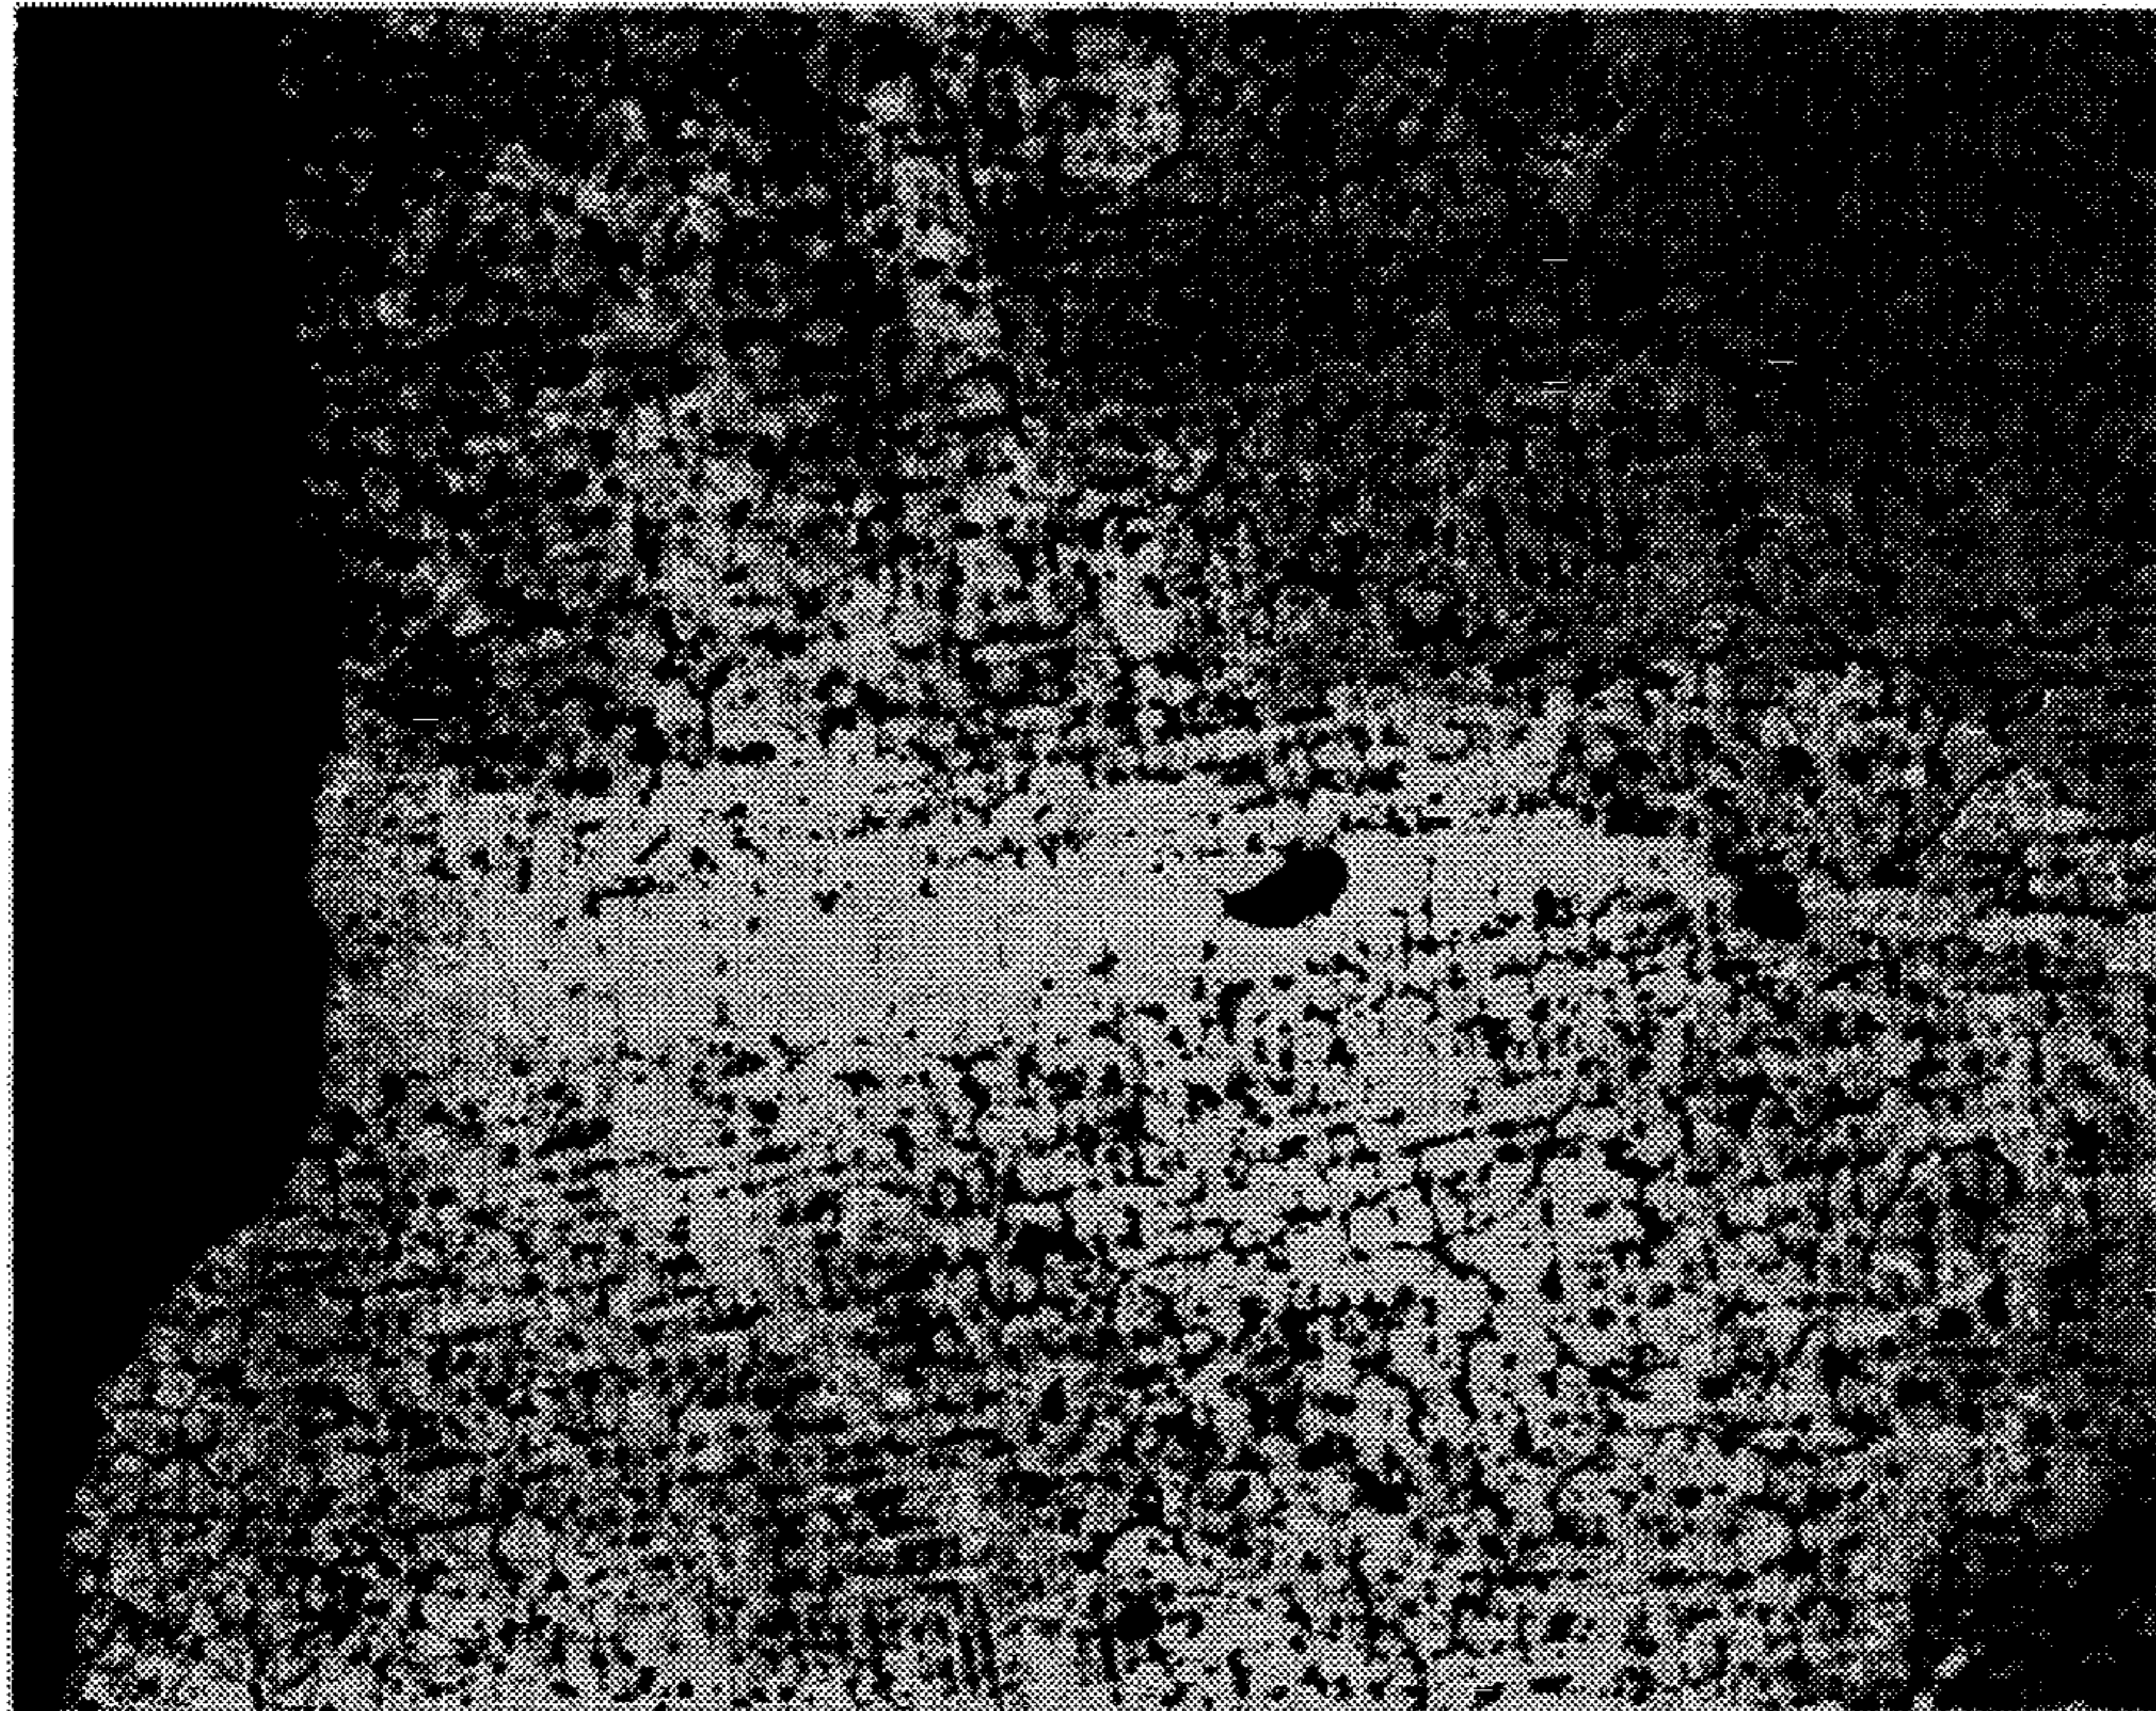
fig. 6

FIG. 6 is a 50× photomicrograph of a repaired blind crack in a MAR-M 509 turbine vane with the repair powder placed over the crack prior to melting and isothermal diffusion.

The crack was successfully filled to the crack tip with a uniform dispersion of the repair powder, as shown in FIG. 6.

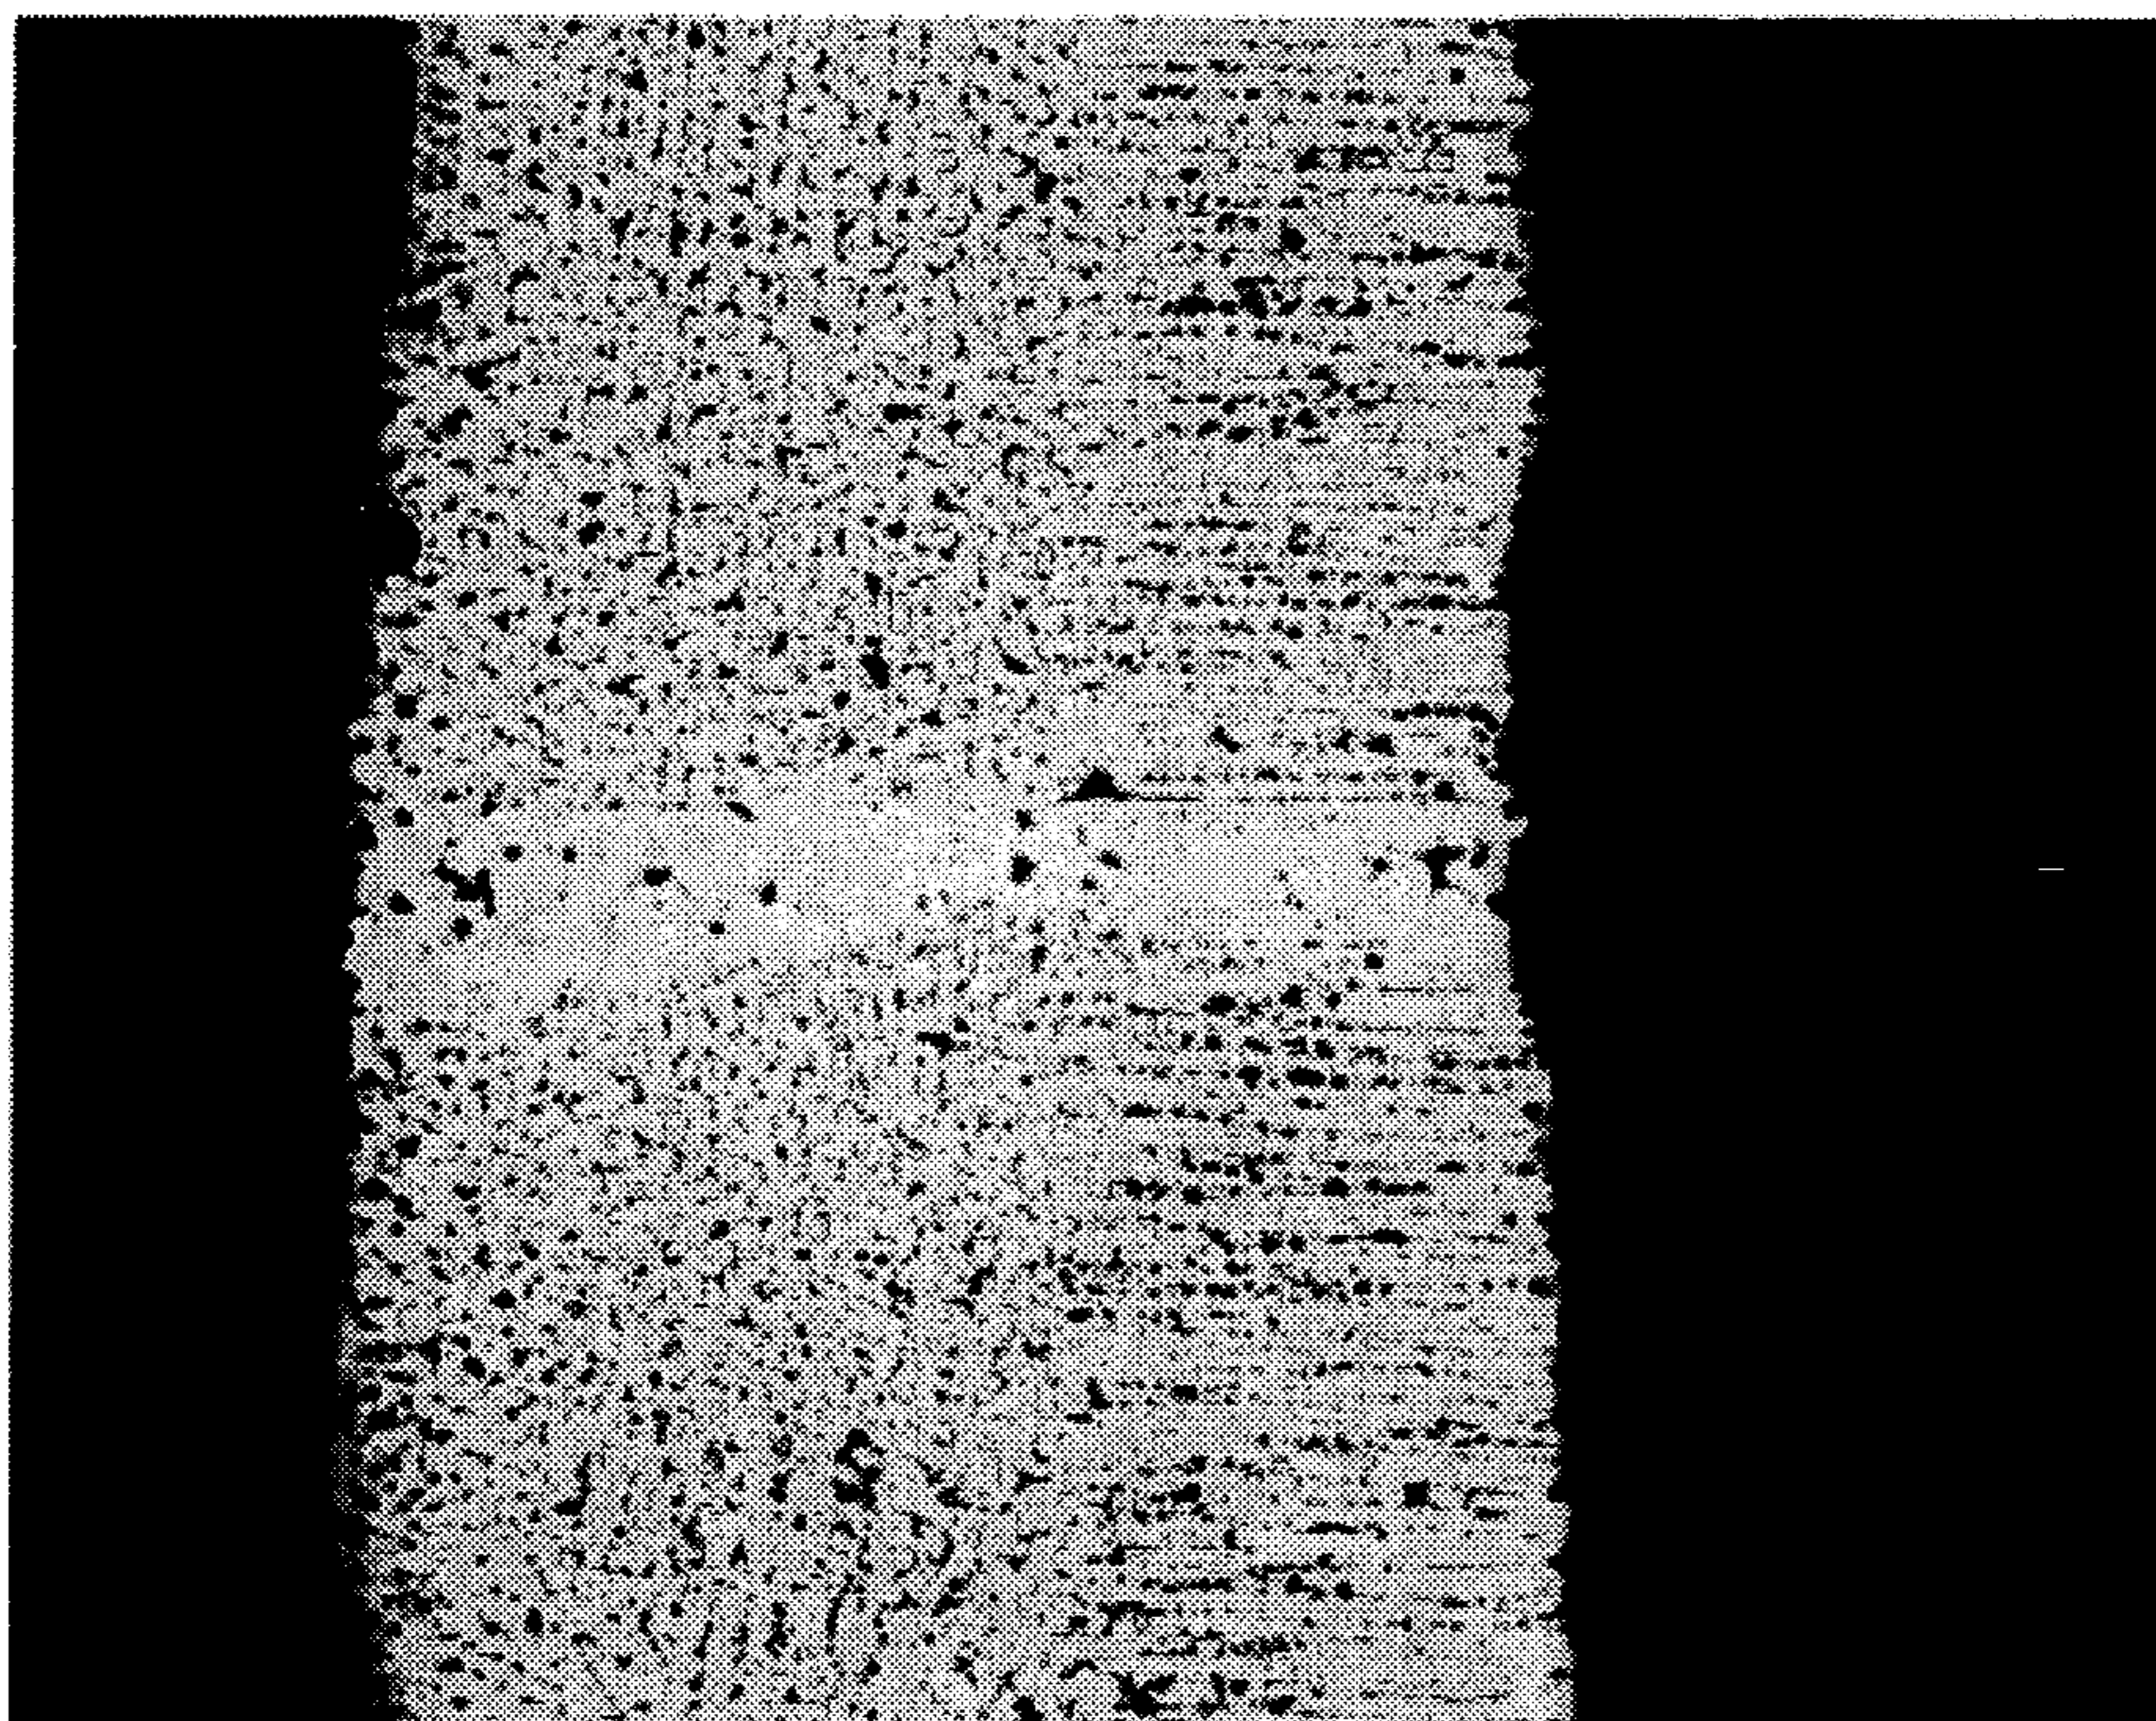
fig. 5

FIG. 5 is a 50× photomicrograph of a repaired crack in a MAR-M 509 turbine vane with the repair powder placed over the crack prior to melting and isothermal diffusion.

The cracks were successfully filled through the full thickness of the sample with a uniform dispersion of the repair powder, as shown in FIG. 5, for a crack having a width of about 0.008".
