5,552,607

[54] IMAGER DEVICE WITH INTEGRAL ADDRESS LINE REPAIR SEGMENTS

[73] Assignee: General Electric Company,

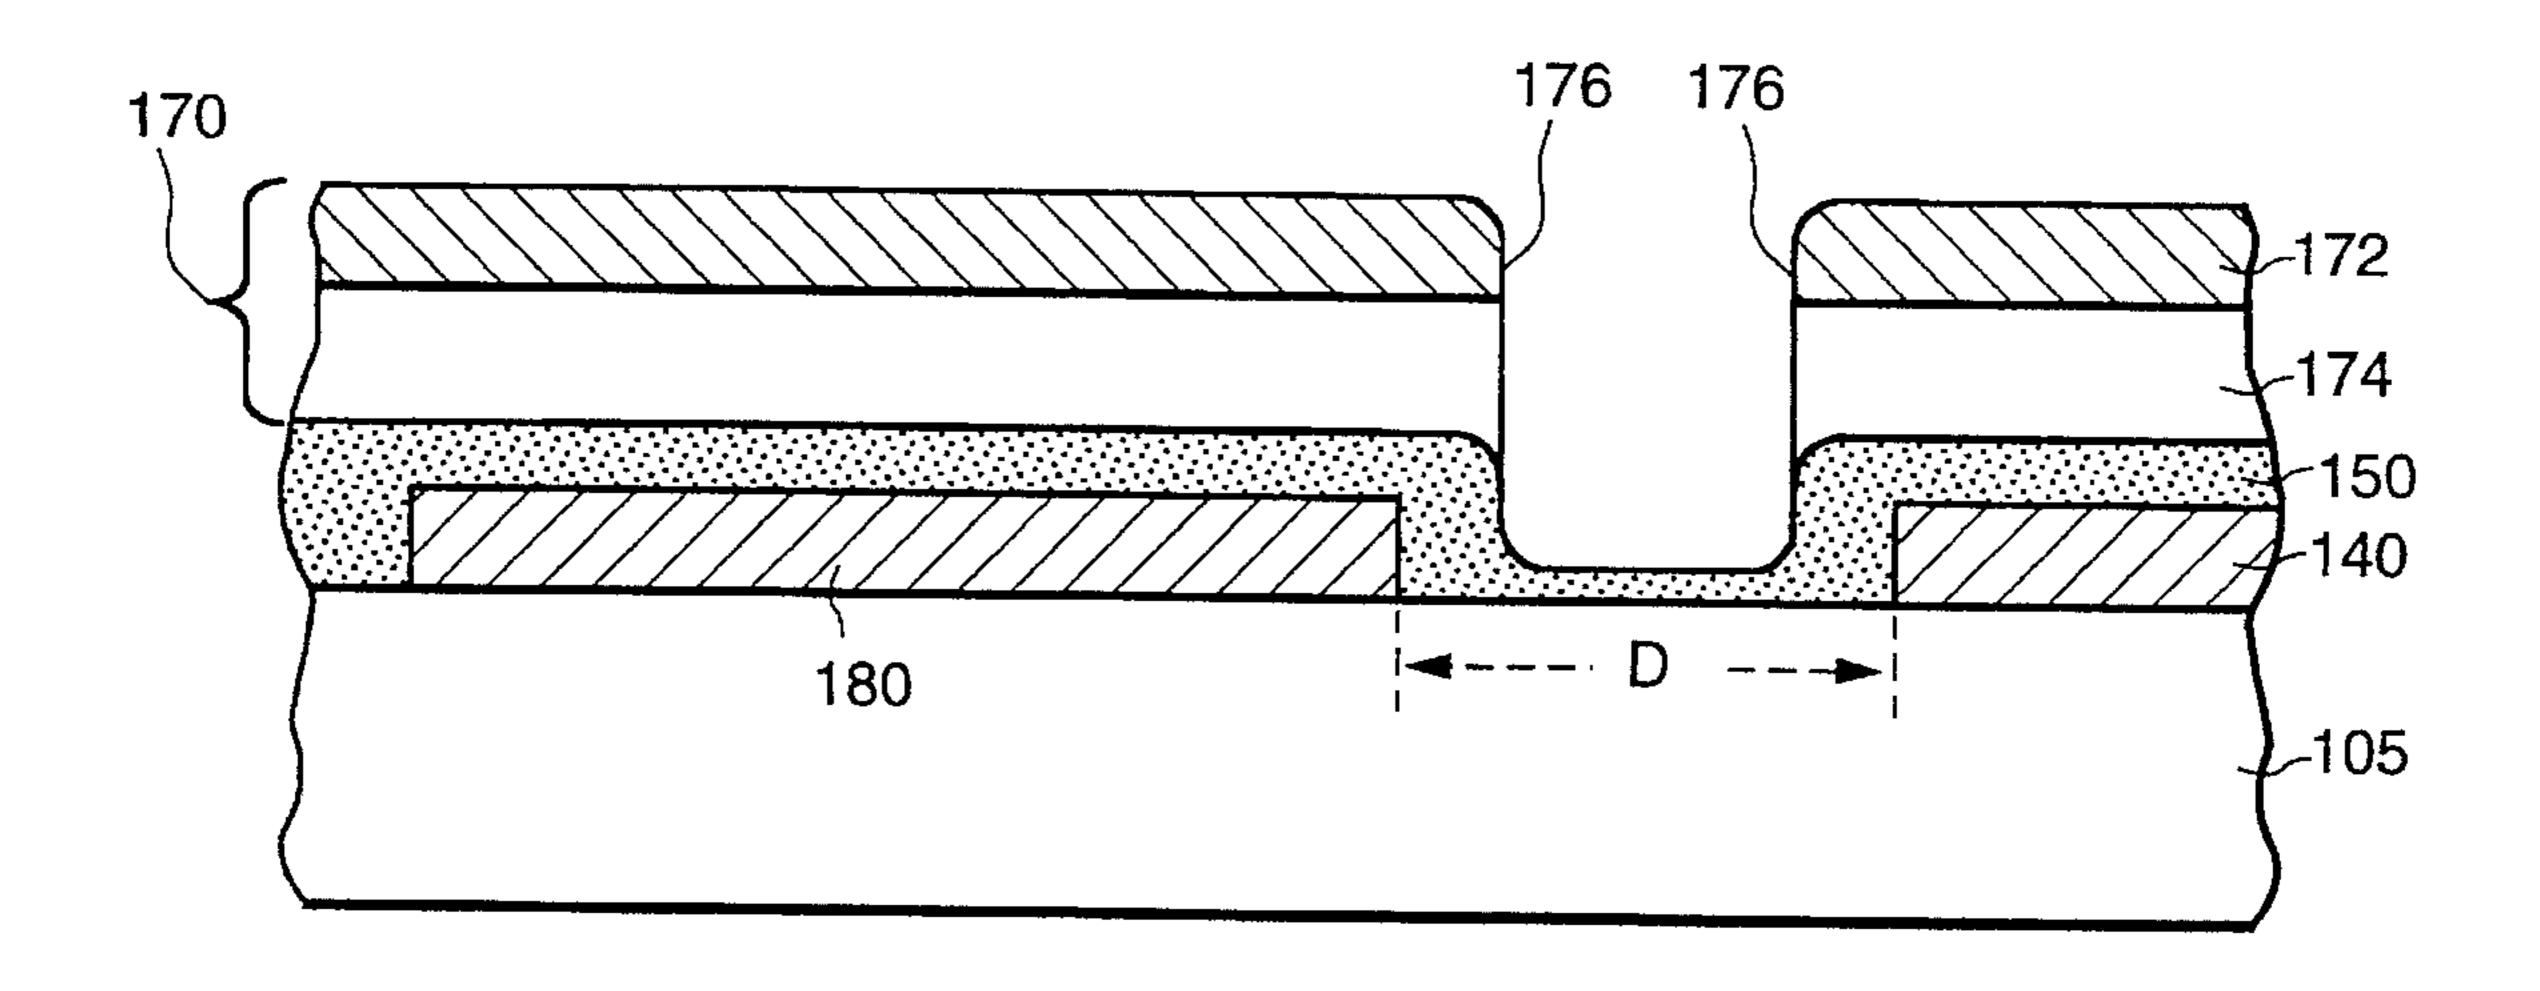
FIG. 1(B) is a cross sectional view of a portion of the imager of FIG. 1(A) taken along line I—I of that Figure.

Scan lines 140 are typically disposed on a substrate 105 that comprises an optically transmissive material such as glass or the like, as illustrated in FIG. 1(B). Integral address line repair segments 180 are similarly disposed on substrate 105 but are electrically isolated from scan lines 140. Typi- 5 cally scan lines 140 and integral address line repair segments are separated from one another by a setoff distance "D" of at least about 5 µm so as to reduce capacitive coupling therebetween and reduce the possibility of electrical shorts therebetween. In the fabrication process, scan lines 140 and integral address line repair segments are formed as a part of the same step by the deposition of conductive material (such as molybdenum, chromium, titanium, or the like) and patterning that material (e.g., by photolithographic means) to provide the desired arrangement of conductive material on 15 substrate 105. In accordance with this invention, integral address line repair segments are typically formed in the same process, without additional steps in the fabrication process (the only modification necessary is adjustment of the pattern of the photolithographic etching of the conductive 20 material forming scan lines 140); the structure of the present invention is thus readily implemented in current fabrication methodologies. Scan lines 140 typically have a thickness in the range between about 0.1 µm and 1 µm and have a width in the range between about 5 μ m and 15 μ m. Integral address ₂₅ line repair segments similarly have a thickness in the same range as scan lines 140.

An intermediate layer 150 is disposed over scan lines 140 and the respective integral address line repair segments 180. The words "over", "above", "upper" and the like are used 30 herein for convenience to refer to the relative position of layers or components with respect to substrate 105 and do not imply a particular orientation of imager array 100. Intermediate layer comprises at least one insulative material, for example an inorganic material such as silicon nitride or 35 silicon oxide, an organic material such as polyimide or the like, or combinations thereof. The dielectric material in intermediate layer 150 is disposed to provide the gate dielectric layer in TFTs 130 and further is disposed to electrically isolate integral address line repair segments from 40 scan lines 140 and semiconductive and conductive materials in array components disposed over repair segments 180. The thickness of intermediate layer 150 in the vicinity of repair segments 180 is in the range between about 0.1 μm and 1 μm. Additionally, TFT semiconductive material such as 45 silicon (not shown) can further be disposed across the array between scan lines 140 and data lines 170.

Data lines 170 comprise a layer of conductive material 172 such as molybdenum, chromium, aluminum, or the like, that has a thickness in the range of about 0.1 μ m and 1 μ m. 50 In one embodiment of the present invention, data lines 170 further have a layer of semiconductive material 174, such as amorphous silicon, disposed under conductive material 172. Such semiconductive material is commonly deposited on the array in the course of fabrication of TFTs 130 and, after 55 patterning to form the transistor, can be left in the regions for data lines so as to provide a foundation for conductive material layer 172 of data lines 170. Further, the semiconductive material serves to vertically separate data line conductive layer 172 from scan lines 140 to reduce capacitive 60 coupling therebetween by reducing likely reduction in thickness of dielectric layer 150 during fabrication processing. Data lines 170 desirably have a narrow width, that is, a width in the range between 5 μ m and 15 μ m so as to maximize the array space available for the active (photosensing) areas of 65 photosensors 120 and to reduce capacitance-induced noise in the imager system. Commonly both semiconductive layer

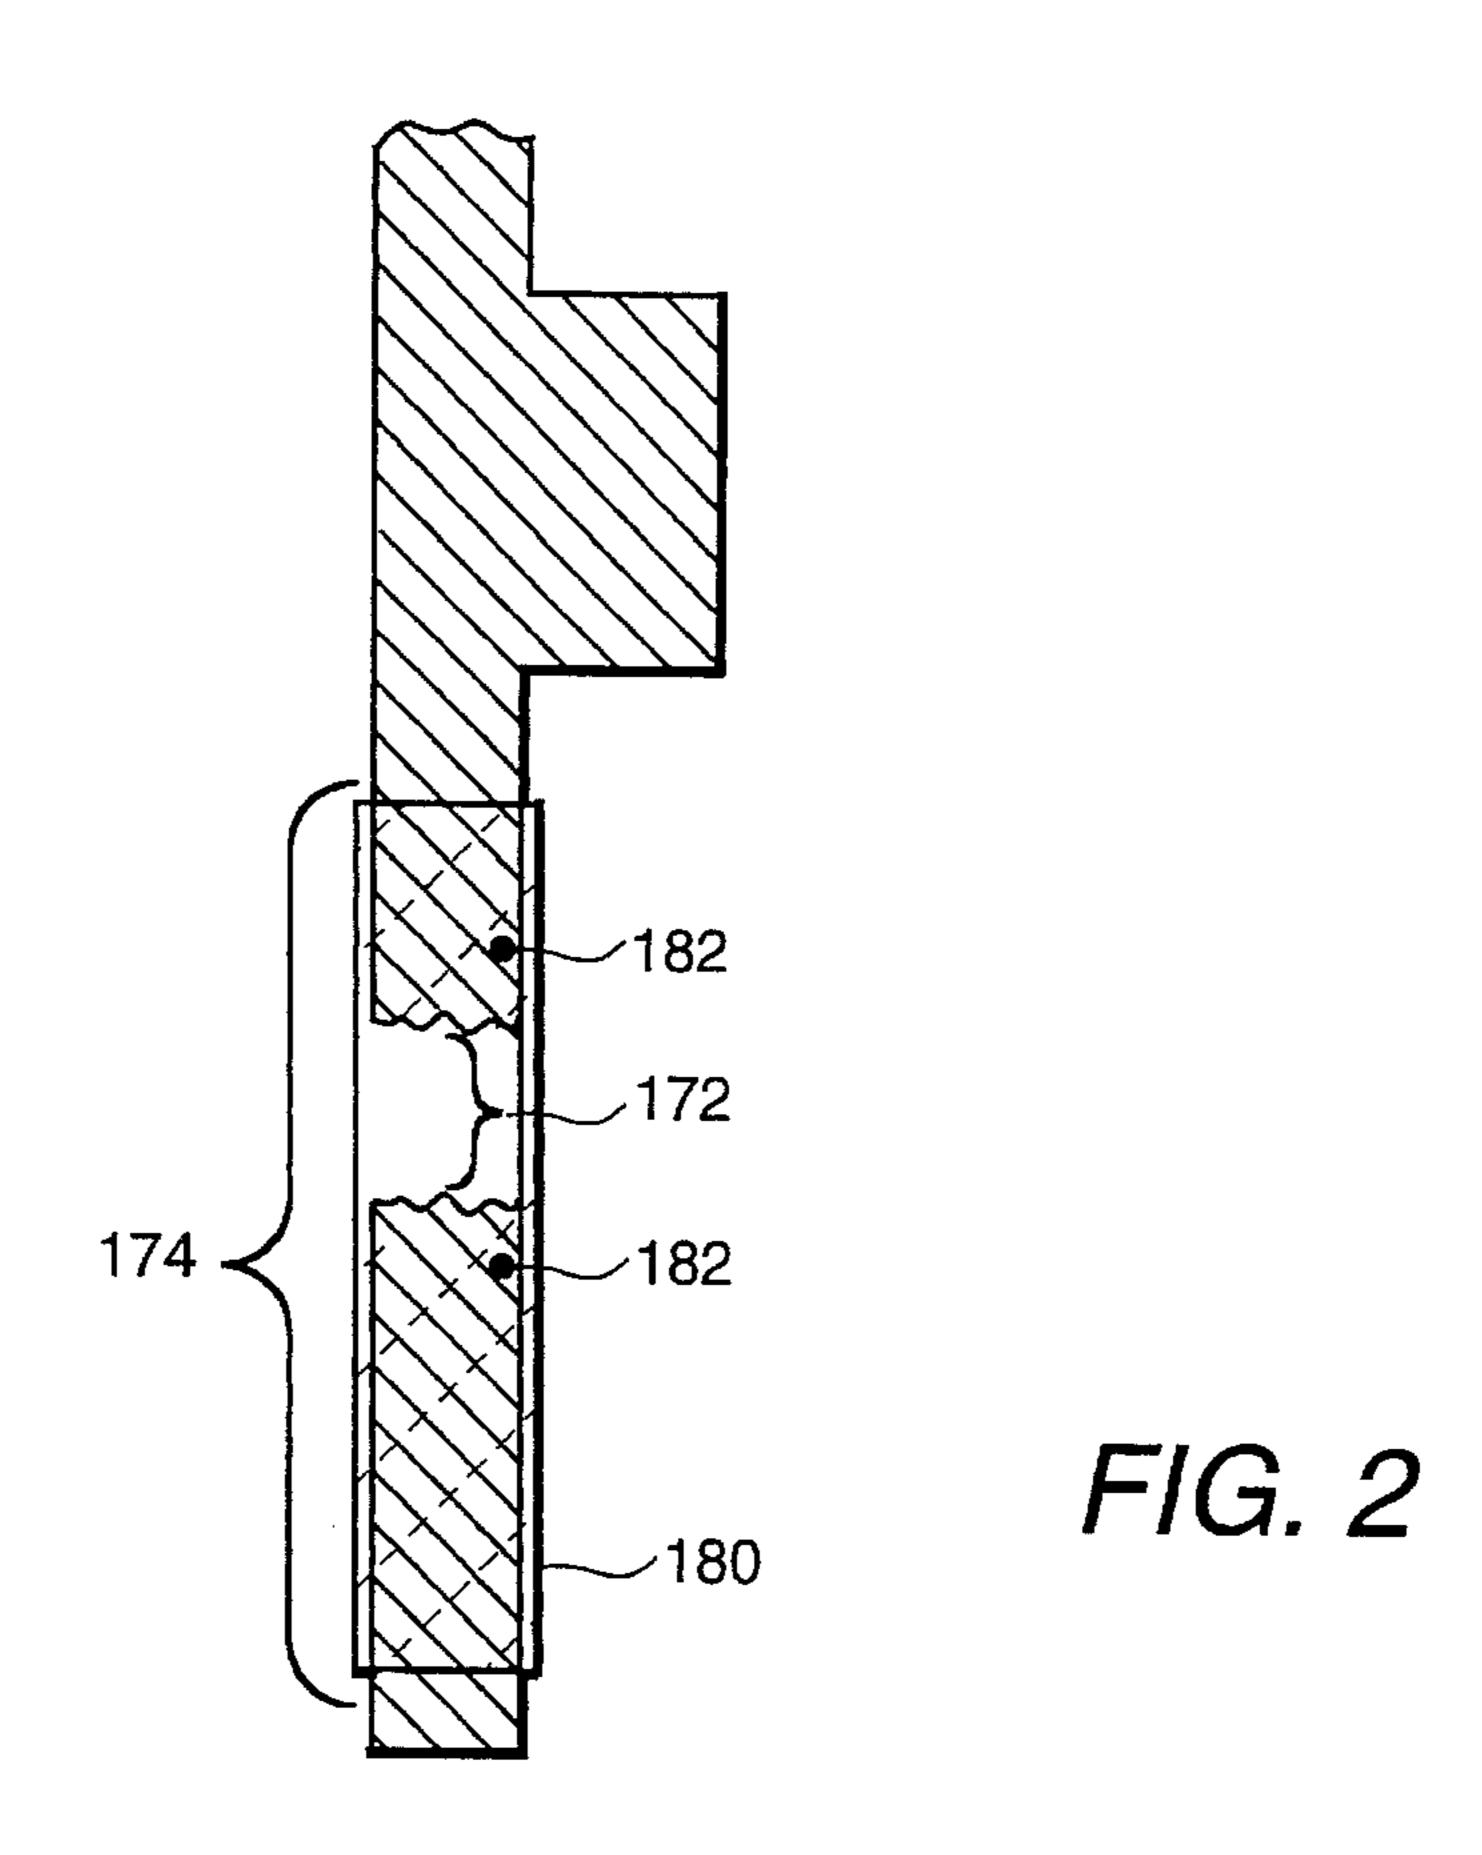
FIG. 2 is a detail view of a portion of the presentation of FIG. 1(A) illustrating an integral address line repair segment coupled to a repair portion of an overlying address line having a defect therein.

During fabrication and after completion of fabrication of imager 100, tests are run to determine the electrical integrity of scan lines 140 and data lines 170 and the couplings between these components and TFTs 130 and photosensors 120. An open circuit defect 177 (FIG. 3) in data line 170, particularly one having a termination point 176 near the midpoint of the array, is desirably repaired in order to be able to have access to the maximum number of pixels in the array. With the structure of the imager of the present invention, an open circuit defect in the repair portion of data line 170 is readily repaired. Repair portions 175 adjacent to termination points 176 are shown in FIG. 1 for purposes of illustration. Respective repair portions 175 disposed in pixels closer to the edge of the array provide the means for repairing defects in the conductive material of the data lines so as to maintain data line contact to all pixels between termination point 176 and the edge of the array.

The various repair portions 175 on a data line 170 typically would comprise about 50% of the total length of the data line, but alternatively may be as little as about 25% or as much as about 75% of the line length, depending on pixel pitch. A laser weld 182 (FIG. 3) is disposed between data line 170 and integral address line repair segment 180 (shown as the cross-hatched region in FIGS. 1(A) and FIG. 3) on each side of defect 177. The laser weld comprises a fusion of the conductive materials of repair segment 180 and the overlying data line portion such that the intermediate layer 150 insulative material is displaced so that a low-resistance (e.g., 50 Ω , which is a small fraction of line resistance, which is on the order of several $k\Omega$ or more) contact is made between the repair segment and the data line. The laser weld is typically made by applying laser light
