United States Patent [19]
Wei et al.

[11] **Patent Number:** **5,616,524**
[45] **Date of Patent:** **Apr. 1, 1997**

[54] **REPAIR METHOD FOR LOW NOISE METAL LINES IN THIN FILM IMAGER DEVICES**

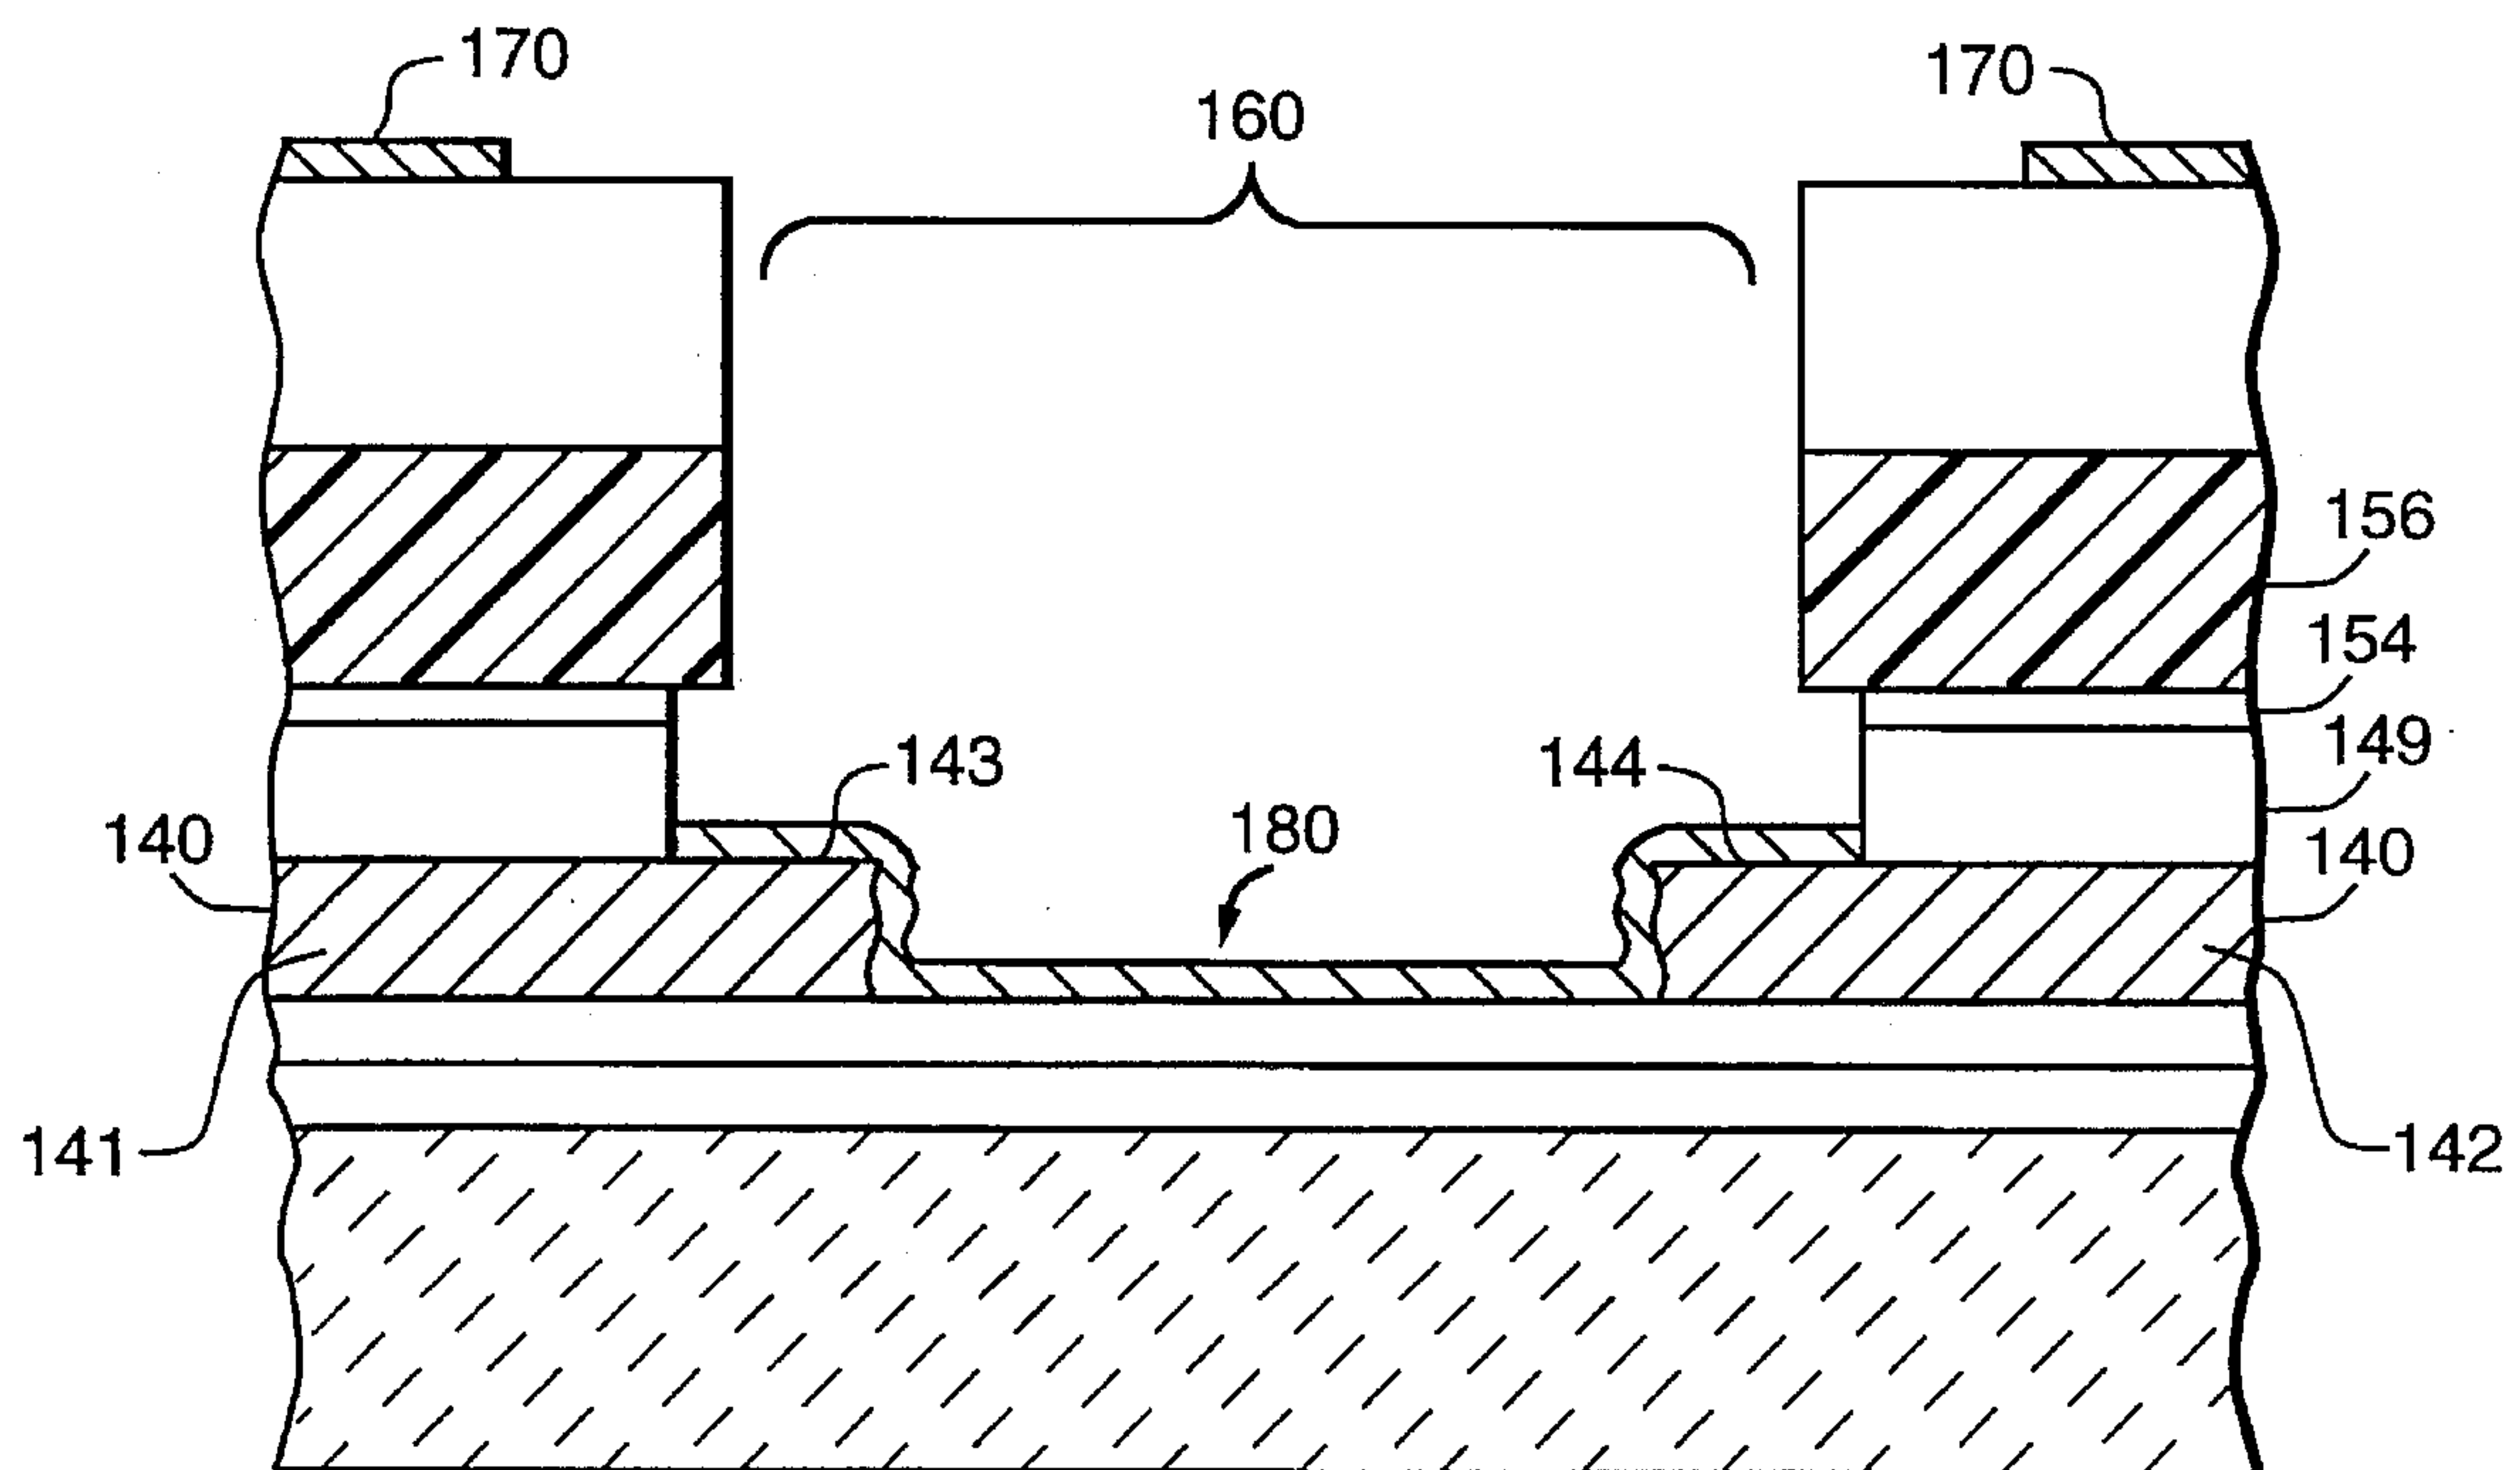
FIG. 1 is a cross-sectional view of an imager device having a defective first conductive component and illustrated at a point in the fabrication process prior to deposition of an overlying second conductive component.

Additional fabrication steps include the formation of the photodiodes, including the deposition and patterning of semiconductive material, typically silicon, to form the photodiode body (not shown in the cross-sectional portion of the imager illustrated in FIG. 1). A photosensor barrier layer **150** is then formed over the array; barrier layer **150** typically comprises a first protective layer **154** comprising an inorganic dielectric material such as silicon nitride (SiN_x) or the like. In the portion of the array illustrated in cross section in FIG. 1, first protective layer **154** is disposed over FET passivation layer **149**. First protective layer **154** of silicon nitride typically has a thickness in the range between about $0.04\ \mu\text{m}$ and $0.5\ \mu\text{m}$. A second protective layer **156** comprising an organic dielectric material such as polyimide or the like is disposed over first protective layer **156** and FET passivation layer **149**. Second protective layer **156** typically has a thickness in the range between about $0.5\ \mu\text{m}$ and $2.5\ \mu\text{m}$.

After formation of barrier layer **150**, fabrication of photosensor array **110** is continued with the deposition and patterning of a common electrode (not illustrated in FIG. 1) disposed over barrier layer **150** and in electrical contact with a portion of each photosensor body through vias (not shown) opened in the barrier layer. A scintillator material (not shown) is then deposited over the common electrode to complete the array.

FIG. 1 illustrates an imager device at a first stage in the repair process of the present invention; at this point in the

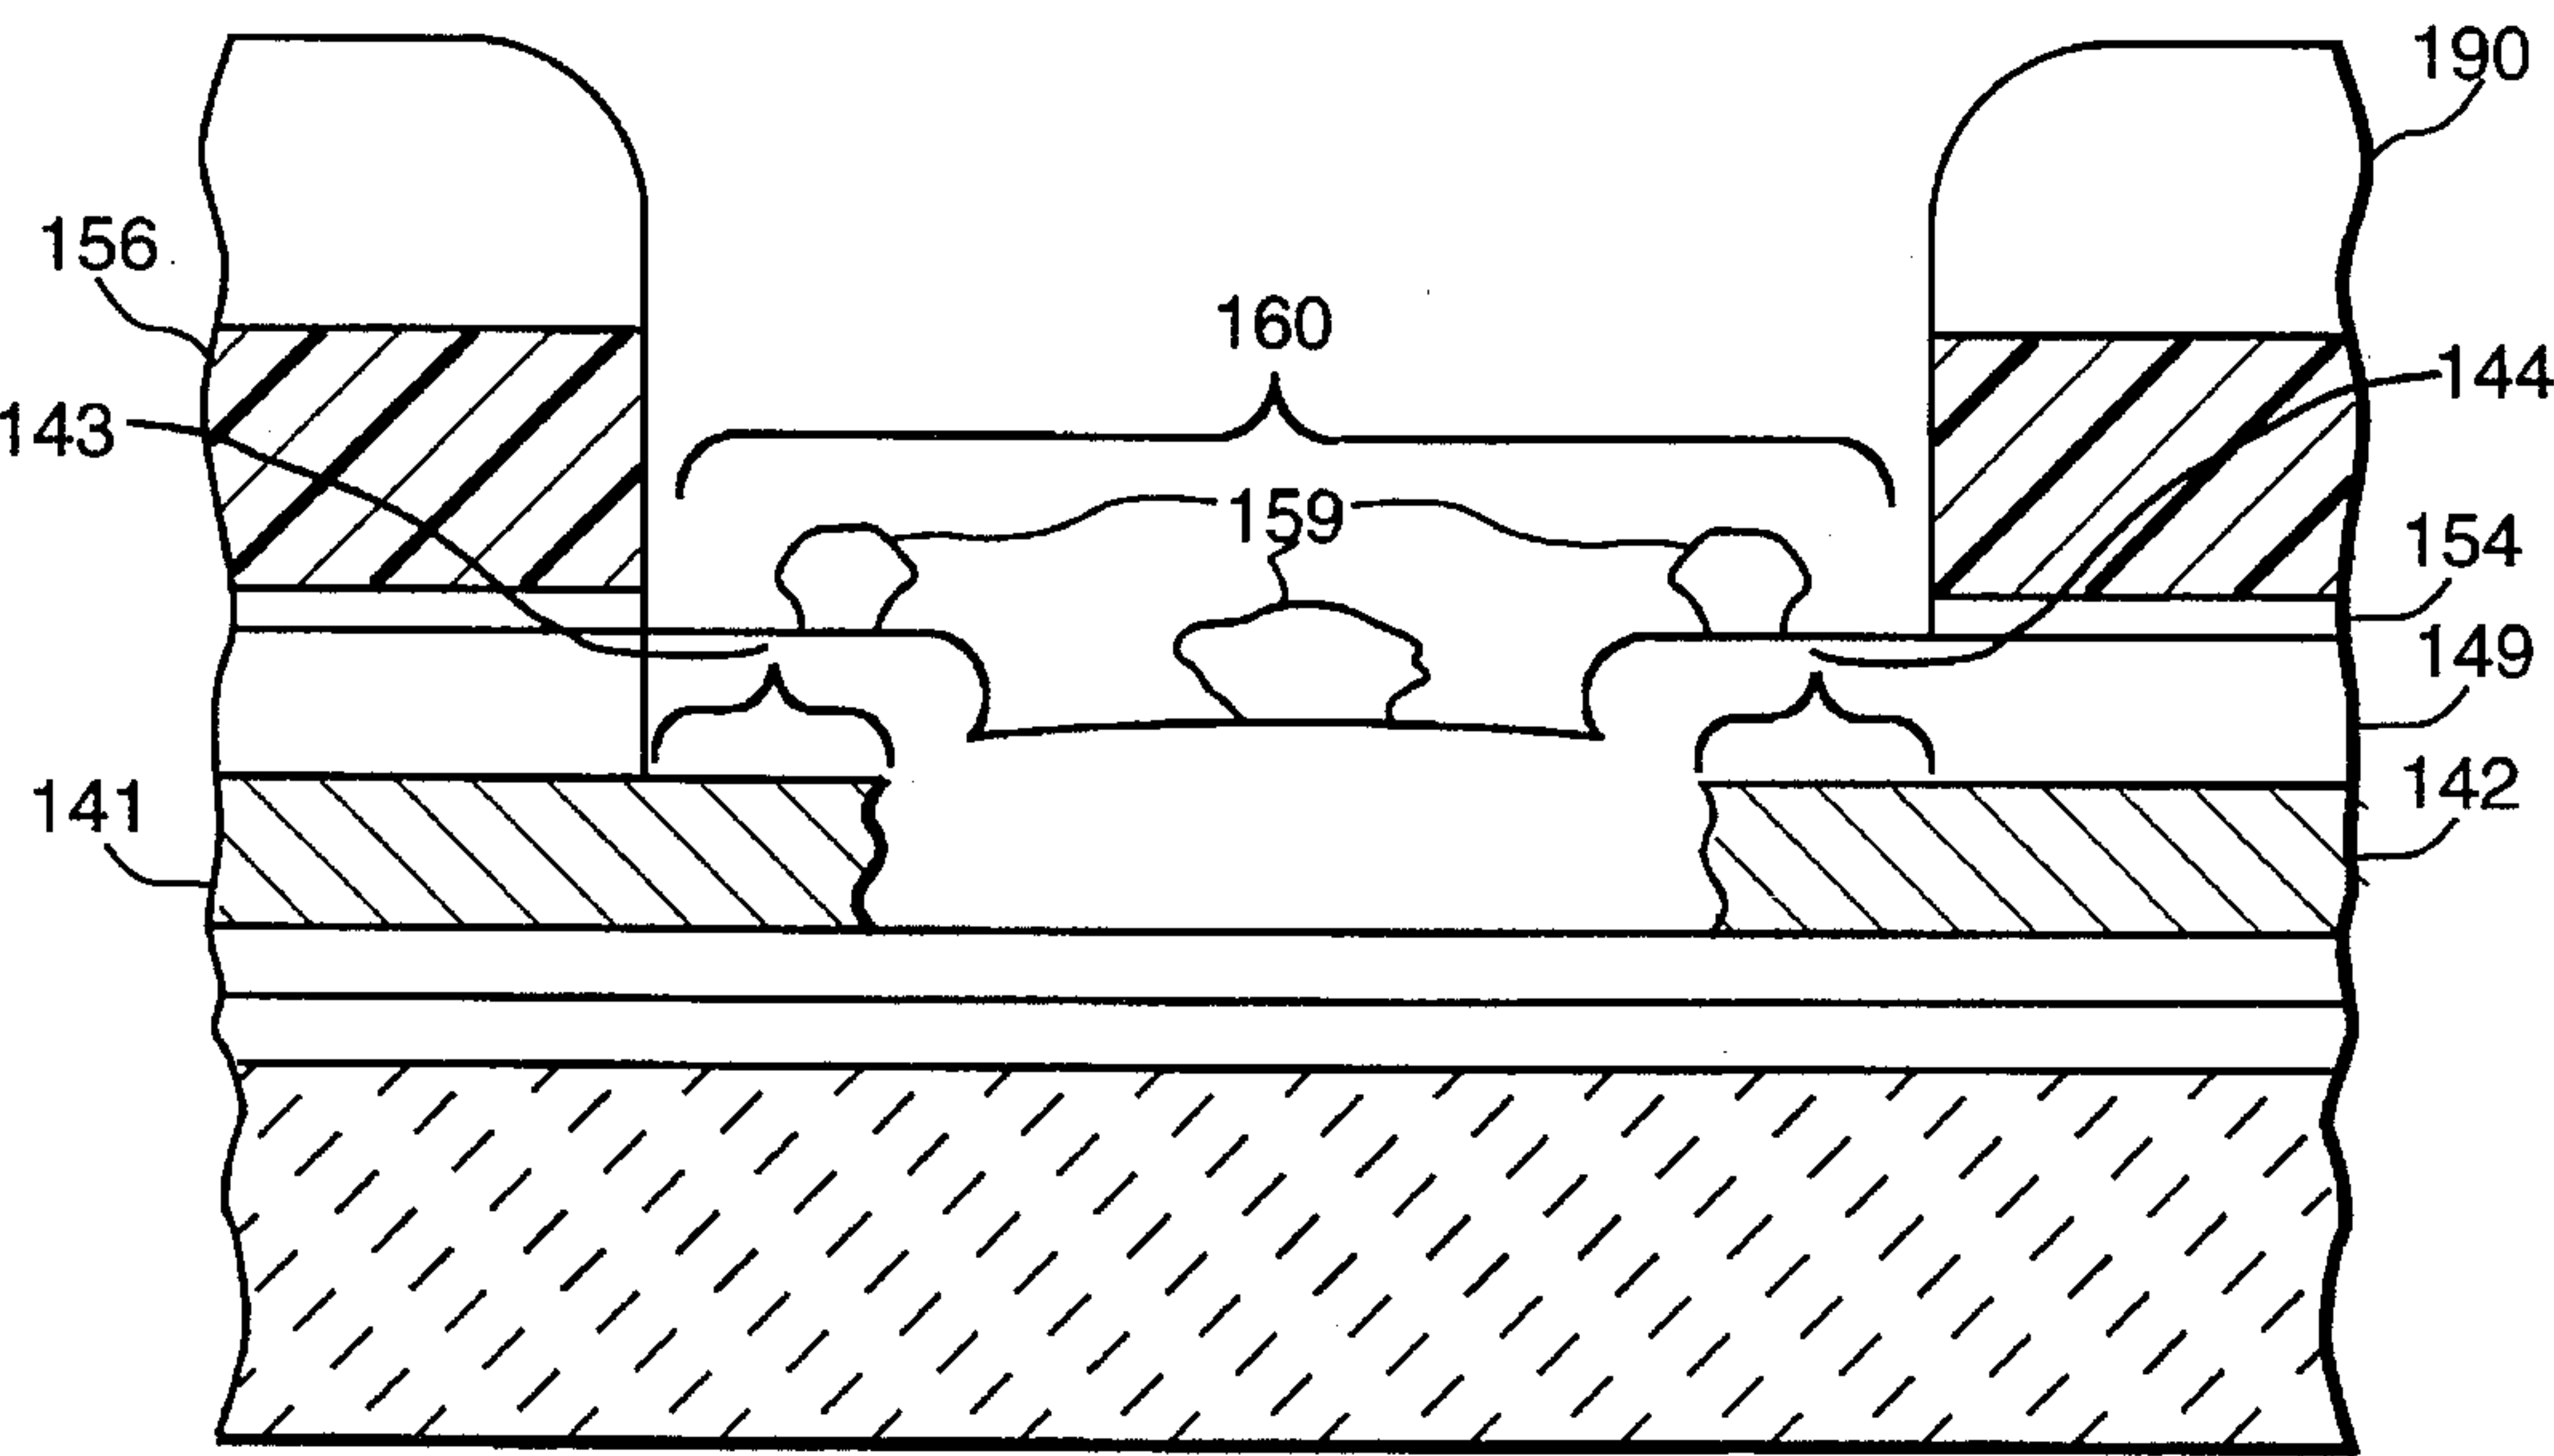
FIG. 2 is a cross-sectional view of an imager device in which ablation has been used to begin the formation of a repair area over the defect in the first conductive component in accordance with the present invention.

In accordance with the present invention, the open-circuit defect **145** in data line **140** is repaired with the use of a procedure that opens a repair area **160** (FIG. 2) around defect **145** that exposes address line **140** while maintaining the low noise characteristics of the address line. In particular, the process of exposing the conductive material comprising the component being repaired, e.g., address line **140**, is such that the conductive material is not contaminated. As used herein, "not contaminated," "uncontaminated" or the like refers to the conductive component to be repaired being fully exposed (that is, about 90% or more of the surface conductive component in repair area **145** is exposed with few, if any, residual materials from other components in the device are left on the surface of the conductive component in the repair area); and the condition of the conductive component (data line **140**) is substantially the same as it was when the data line was formed (that is, after deposition of the conductive material, patterning, and cleaning of the surface to complete the formation process of the conductive component during the fabrication process, which typically does not damage the conductive material but may result in some oxidation of the conductive material on the surface of the address line). The address line being in substantially the same condition further implies that the line is substantially geometrically the same shape as when formed, with the surface of the conductive material being relatively smooth without notches, depressions, or the like. One manifestation of the process of the present invention providing an uncontaminated address line **140** in the repair area is that, when repaired, the address line exhibits noise characteristics that

Repair area 160 (FIG. 2) is formed by removing portions of photoresist layer 190 and underlying portions of protective layer 150 to expose defect 145 and selected adjoining portions of data line 140. Typically laser ablation is used to remove the portions of photoresist layer 190, second protective layer 156, and first protective layer 154 from selected repair area 160. In particular, a xenon-chloride type excimer laser provides a finely-focused beam (e.g., in the range between about $1\text{ }\mu\text{m}^2$ to $20\text{ }\mu\text{m}^2$) that is very effective in ablating the above-mentioned non-conductive material with the ability to maintain precise boundaries around repair area 160. Laser ablation is not, however, as effective in removing FET passivation layer 154 as that layer comprises silicon oxide, which exhibits poor energy absorption in the visible and near ultraviolet (UV) wavelength range. It has been found that the poor energy absorption of the silicon oxide requires lengthy efforts at ablation to remove the material, and typically such an ablation efforts results in a contaminated surface of first conductive component 140 underlying the silicon oxide ablated. Thus, in accordance with this invention, laser ablation is stopped following removal of photoresist layer 190, the organic dielectric of second protective layer 156, and the silicon nitride of first protective layer 154 in repair region 160. Typically the ablation process results in some residual particles 159 remaining from portions of FET passivation layer 150 ablated away remaining in repair area 160, as illustrated in FIG. 2.

For example, in a typical imager device structure in which address line 140 comprises molybdenum having a thickness in the range between about $0.2\text{ }\mu\text{m}$ and $1\text{ }\mu\text{m}$ (and typically about $0.4\text{ }\mu\text{m}$), FET passivation layer 149 comprises silicon dioxide having a thickness of about $0.5\text{ }\mu\text{m}$, and first protective layer 154 comprises silicon nitride having a thickness of about $0.1\text{ }\mu\text{m}$, and second protective layer 156 comprises polyimide having a thickness of about $1.4\text{ }\mu\text{m}$, a Florod, Inc., brand Model LCM 308 excimer laser has been used at about 7% power (total power being about 350 microjoules) to ablate non-conductive material to form selected repair area 160 having dimensions of about $10\text{ }\mu\text{m}$ by $40\text{ }\mu\text{m}$ (on the surface of the array).

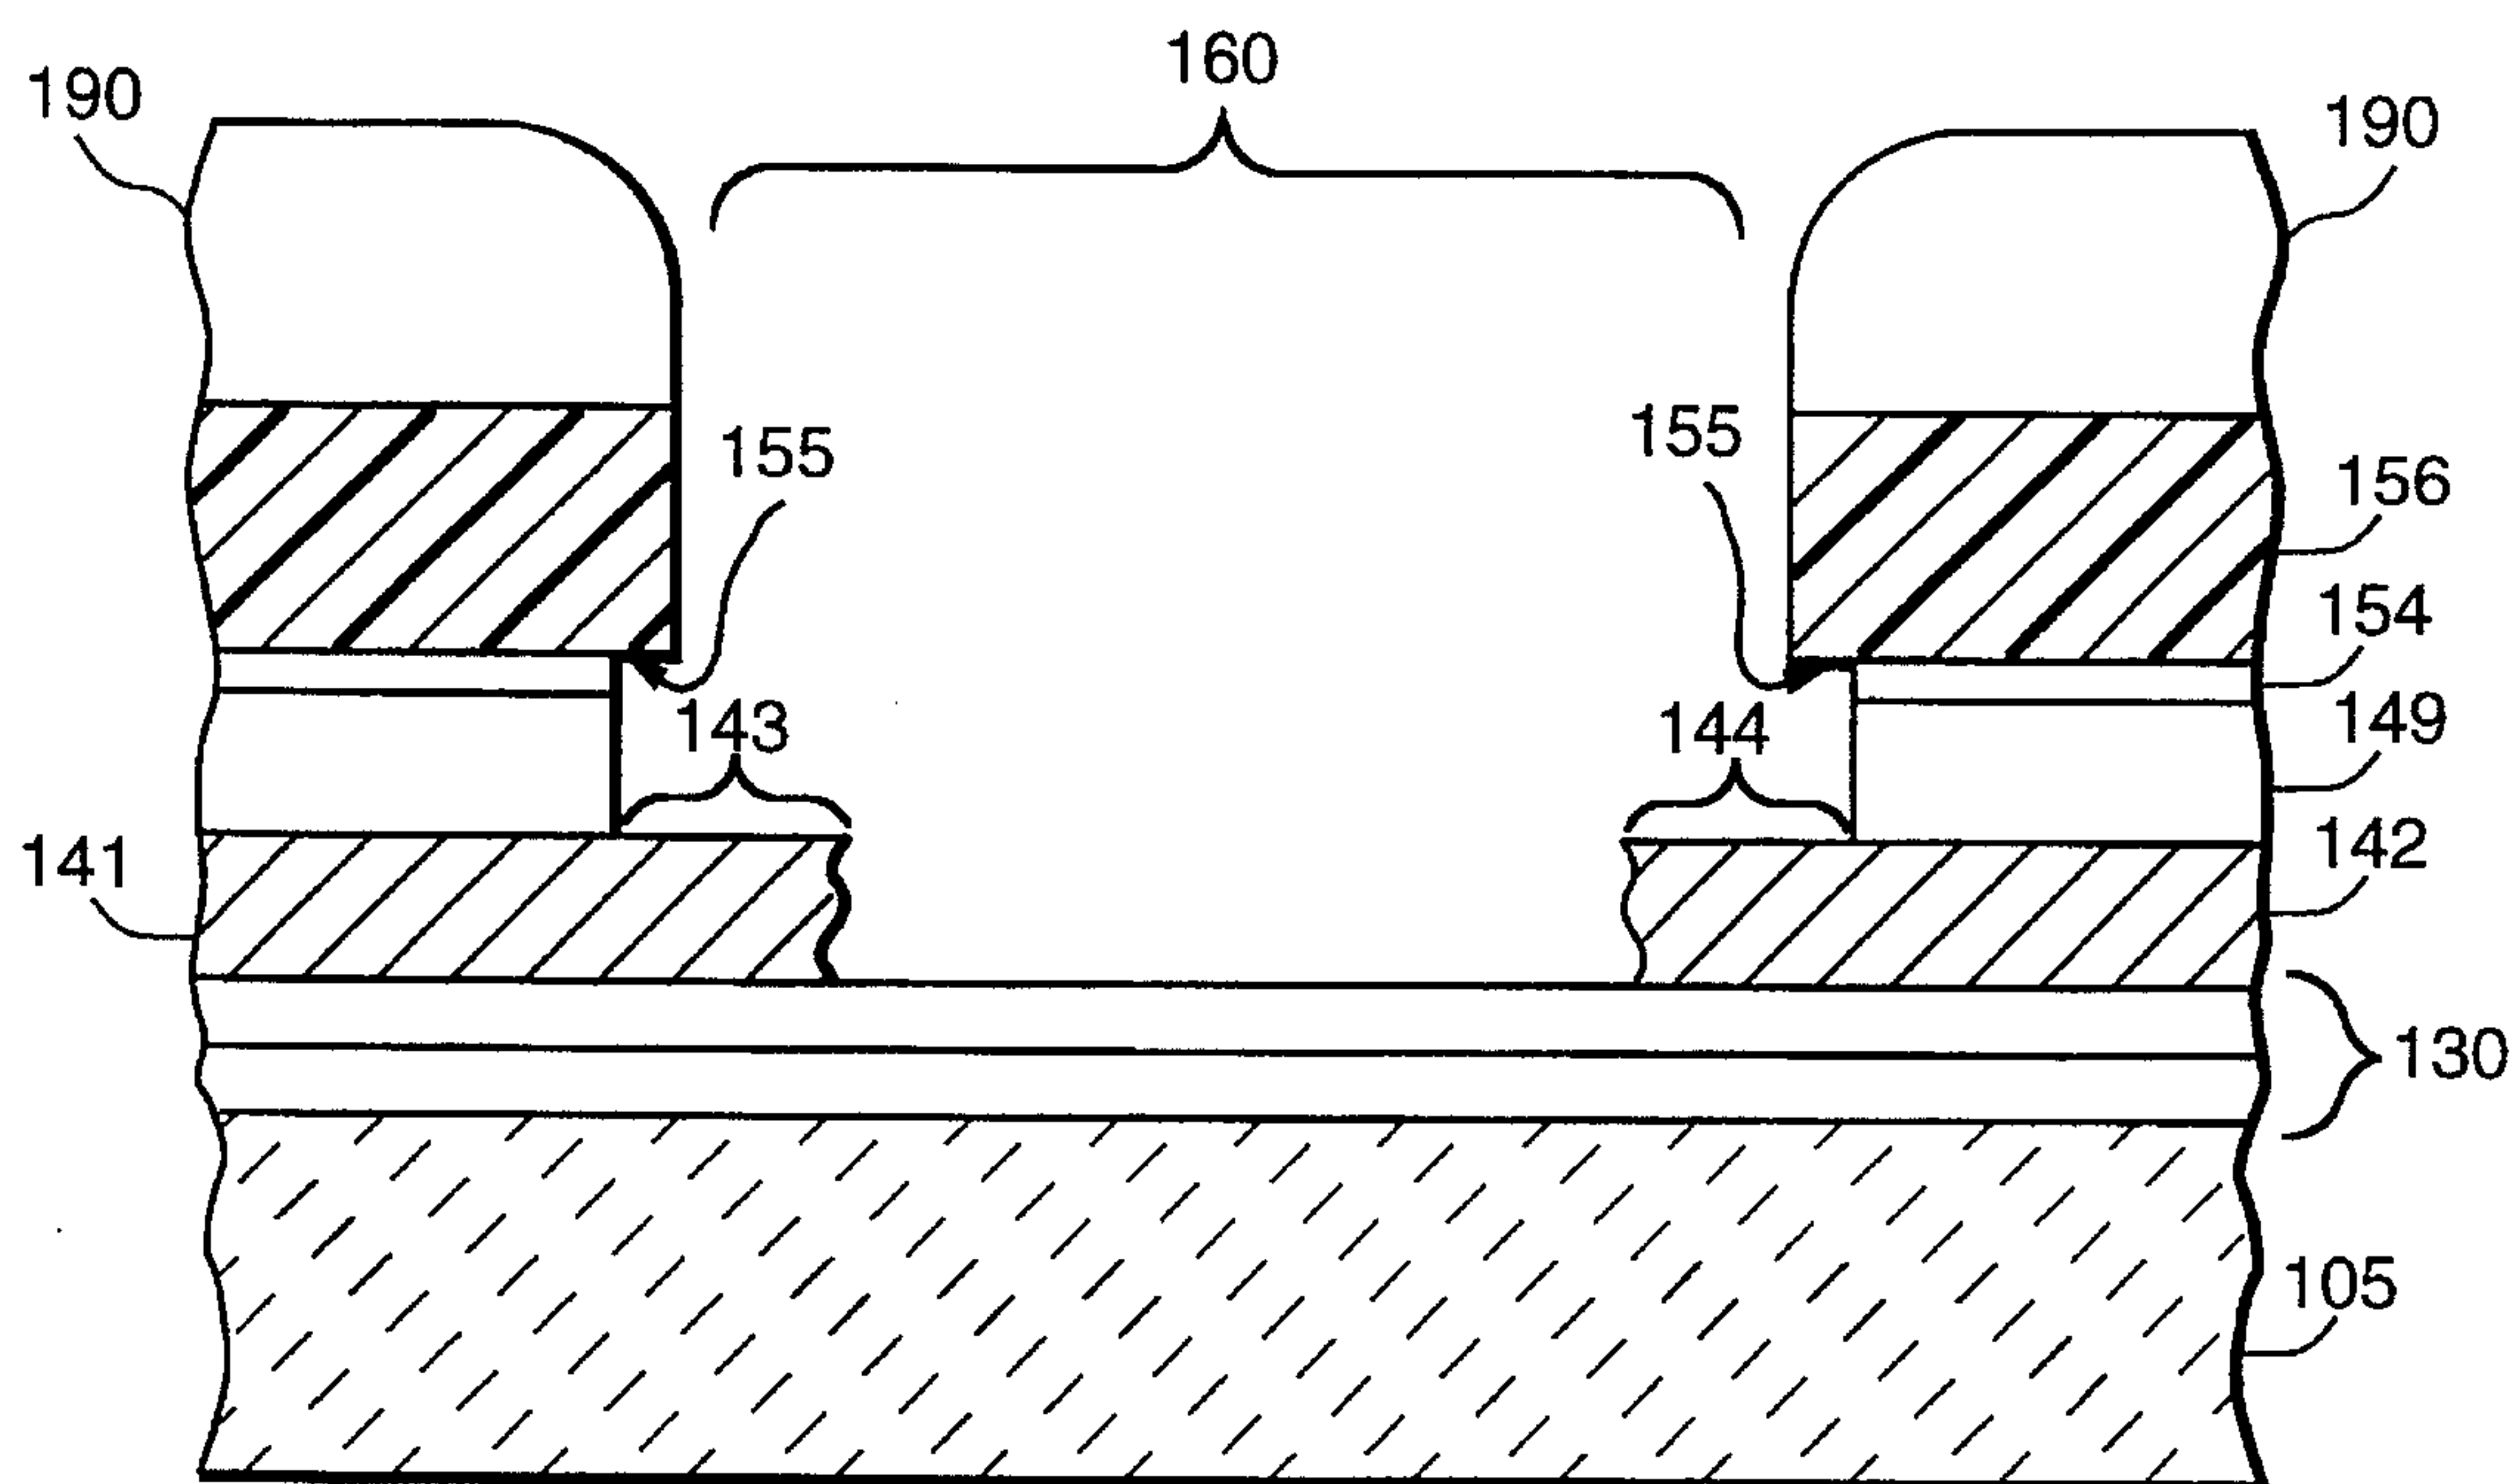
FIG. 3 is a cross-sectional view of an imager device in which the repair areas has been formed over the defect in the first conductive component following an etching step in accordance with the present invention.

In accordance with this invention, formation of repair area 160 is then completed by etching the residual dielectric material in repair area 160 so as to remove residual dielectric material in the repair area to expose defect 145 and adjoining portions of address line 140, as illustrated in FIG. 3, the etching step further providing that the exposed surfaces of

the address line 140 remain uncontaminated. The adjoining portions of data line 140 include a first segment 143 of first address line portion 141 and a second segment 144 of second address line portion 142 of address line 140, the adjoining portions collectively comprising areas on each portion of the data line adjoining by open circuit defect 145. Segments 143 and 144 are sufficiently large to allow the subsequently deposited conductive material to make satisfactory electrical contact to data line 140 and to form a stable structure. In a typical imager in which address line 140 has a width of about $7\text{ }\mu\text{m}$, segments 143 and 144 each have a length of about $10\text{ }\mu\text{m}$. Additionally, the sidewalls of photoresist layer 190 and the portion of barrier layer 150 where the non-conductive material has been ablated are typically also substantially smooth surfaces that are disposed substantially vertically between the lower surface of selected repair area 160 exposed by the ablation and the upper surface of barrier layer 150).

In one embodiment of the present invention, the etching step comprises wet etching the repair area with an etch ant selective to the dielectric material disposed in repair area 160. For example, a hydrofluoric acid-based etchant, such as buffered hydrofluoric acid (BHF) etchant or the like that does not attack the conductive material) is effective in the removal of residual particles 159 that comprise silicon nitride of first protective layer 152, and thus also lifting off any residual portions of the polyimide of second protective layer 156, and further effectively removes the silicon oxide comprising FET passivation layer 149. For this etching step, photoresist layer 190 and polyimide second protective layer 156 serve as a mask such that only the dielectric material in repair area 160 is exposed to the etchant. The selective nature of the etchant (e.g., BHF) results in removal of the inorganic (and lifting off of the organic) dielectric material remaining in repair area 160 following the ablation step without attacking the conductive material comprising address line 140; the etching results in exposing defect 145 and adjoining segments 143 and 144 of address line 140 without causing contamination to the surface of the address line conductive material. The wet etchant is further selected such that it does not significantly etch the silicon or n+ doped silicon of semiconductive layer 132. At the conclusion of the wet etching step, repair area 160 of array 100 appears as is illustrated in FIG. 3. As is seen in FIG. 3, residual particles 159 have been etched away, as has been the portions of FET passivation layer 149 exposed in the repair area under the opening in the mask formed by photoresist layer 190. Given the nature of the wet etch, a small undercut region 155 is formed under second protective layer 156 due to the etching along the sidewall of the silicon nitride of first protective layer 154 and the silicon oxide of FET passivation layer 149.

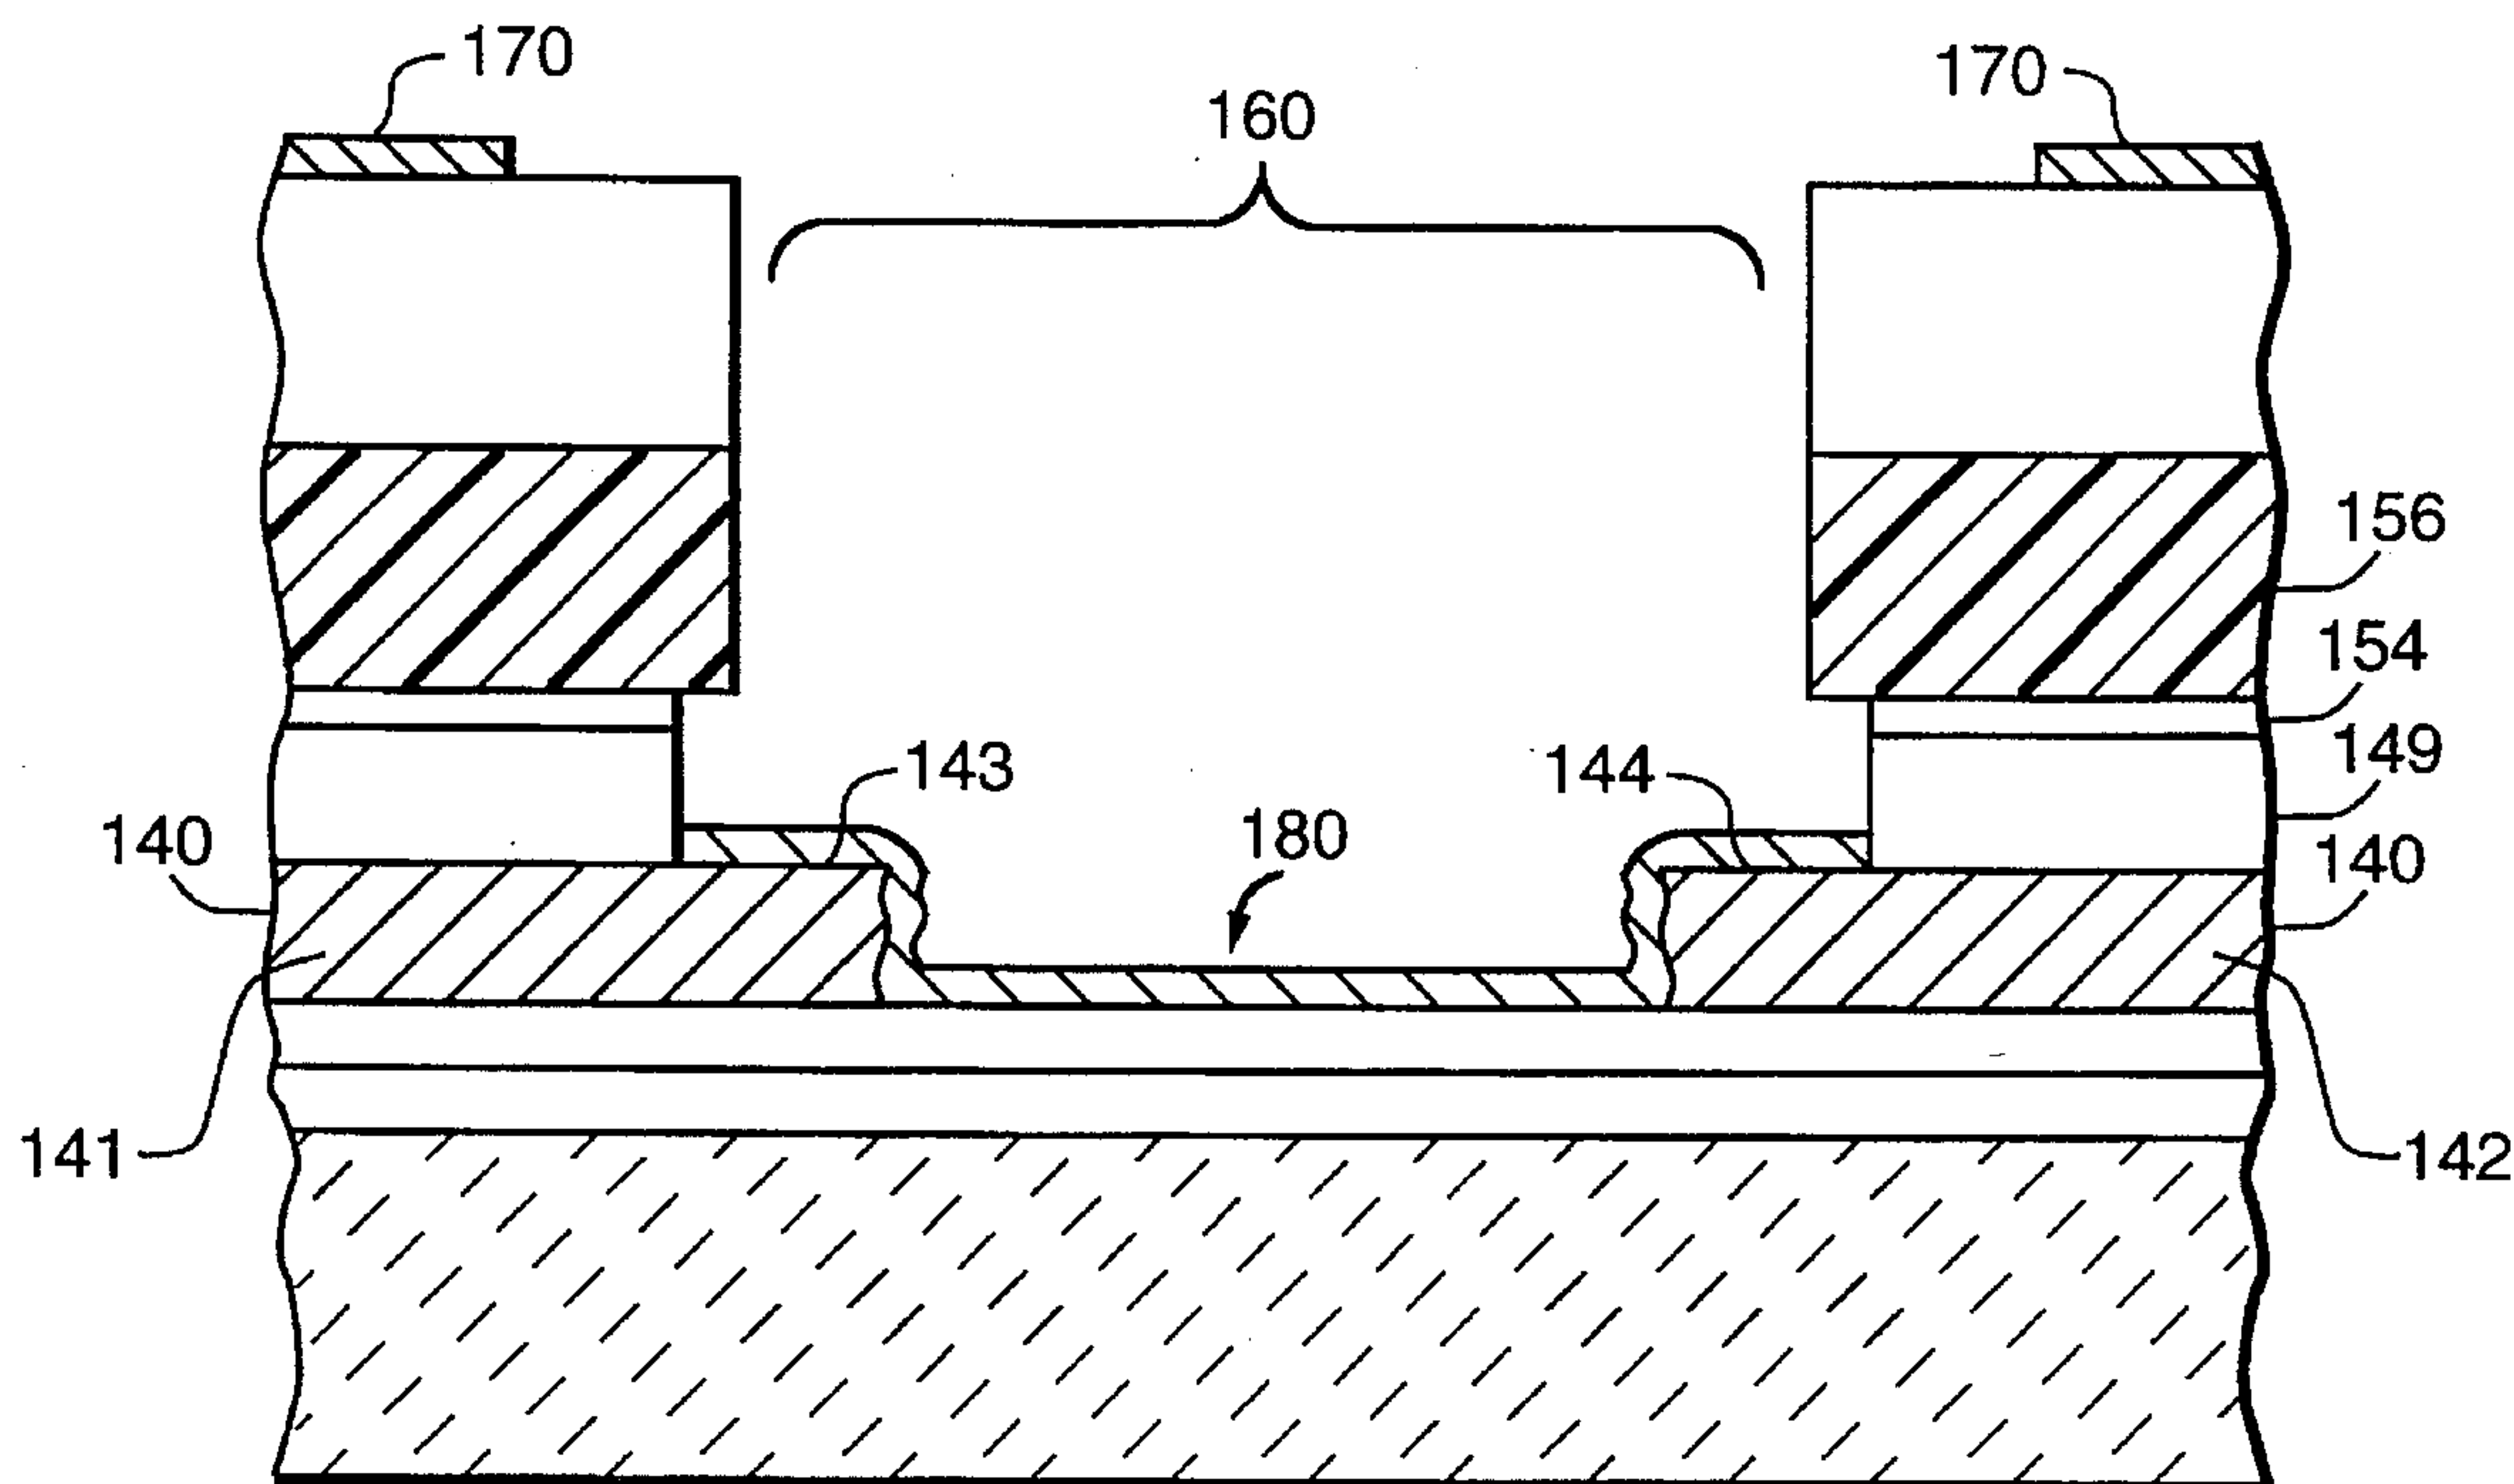
FIG. 4 is a cross-sectional view of an imager device after deposition of the repair shunt and second conductive component in accordance with the present invention.

Following the formation of repair area 160 such that uncontaminated portions of address line 140 are exposed around defect 145, as described further below, conductive material is deposited to form a second conductive component 170 (FIG. 4) on a succeeding level of the device. As used herein, "succeeding level of the device" refers to a conductive component that is formed in the fabrication process following the formation of address line 140, and thus is typically disposed on a different level of the sandwich of materials that are deposited to fabricate the components for the imager device. No restriction on the orientation of the device is to be implied by the terminology relating to levels of the components. As set out above, in the repair of a data line in an imager, the next conductive component to be deposited in the fabrication process is typically the common electrode of the photosensor array.

deposited. For example, common electrode **170** (FIG. 4) is formed in imager device **100** by depositing a conductive material (for imager devices, this material is deposited to form a substantially optically transparent layer) such as indium tin oxide, or the like, using, for example, a sputter process. Alternatively, conductive materials such as aluminum, chromium, or the like can be used to form the common electrode; if such non-optically transparent material is used, however, additional process steps are required to pattern the common electrode so that it does not prevent light from reaching large portions of the photodiode surface. Coincidentally with the deposition of common electrode **170**, a repair shunt **180** is formed in selected repair area **160** as the same conductive material that is used to form common electrode **170** is deposited over defect **145** and on segments **143** and **144** of data line **140**. As illustrated in FIG. 4, repair shunt **180** thus comprises the same conductive material as common electrode **170** and is disposed so as to electrically bridge defect **145** such that first portion **141** and second portion **142** of data line **140** are electrically coupled together. Similarly, the thickness of repair shunt **180** corresponds with the thickness of common electrode **170** as the two components are formed in the same deposition process. Alternatively, dependent on the component being repaired, the conductive material deposited to form the repair shunt may be the same as the conductive material of the underlying component in which the defect exists.

As illustrated in FIG. 4, repair shunt **180** extends over all surfaces of address line **140** that are exposed in repair area **160**, which coverage is desirable from the standpoint of structural integrity when using a conductive material such as indium tin oxide or the like. Alternatively, repair shunt **180** can be disposed in-between first portion **141** and second portion **142** of data line **140** in lieu of being disposed on the upper surfaces of segments **143** and **144**, so long as adequate electrical contact is made to bridge the open circuit between first and second data line portions **141**, **142**.

Following formation of repair shunt **180**, any conductive material coupling repair shunt **180** to common electrode **170** is removed so as to electrically isolate repair shunt **180** from common electrode **170**. Removal of such conductive material (as may be adhering to sidewalls of barrier layer **150** in selected repair area **160**) is typically accomplished with laser ablation, particularly with the use of an excimer laser as set out above. For example, portions of common electrode **170** extending around the edge of second protective layer **156** are removed to leave a gap between the common electrode and the repair area in the range between about 2 μm and 30 μm .
