[11] Patent Number: **5,690,469**

[54] **METHOD AND APPARATUS FOR REPLACING A VANE ASSEMBLY IN A TURBINE ENGINE**

[73] Assignee: **United Technologies Corporation**, Hartford, Conn.

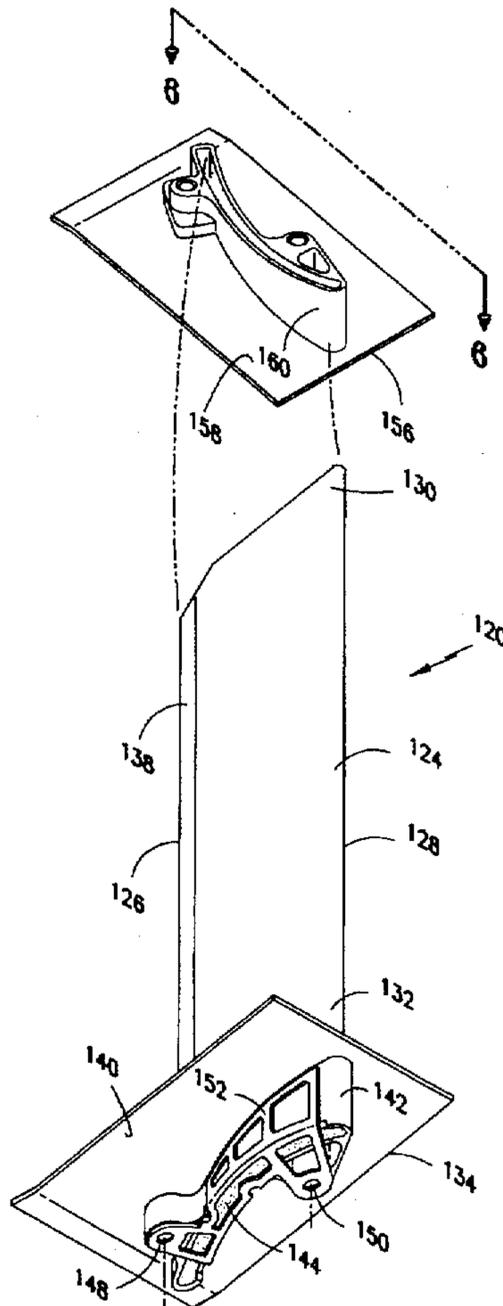
A repair kit for replacing an unserviceable vane assembly in a turbine engine includes a serviceable vane subassembly **120** having a serviceable airfoil **124** with a base **134** attached to the root end thereof and an opposing base **156** which is unattached to but slidably engagable with the serviceable airfoil. The opposing base is slipped over the tip end of the airfoil and slid toward the opposing base. The vane subassembly and opposing base are pivoted into position between inner and outer engine cases in place of an unserviceable vane assembly so that receptor sockets **148**, **150** in the attached base engage support pins **72** extending from the inner case. An adhesive **182** is applied to the tip end of the serviceable airfoil and the opposing base is translated into its installed position near the tip end of the airfoil. Upon curing of the adhesive, the opposing base becomes attached to the airfoil. The base is secured to the outer case by studs **196** and nuts **198**.

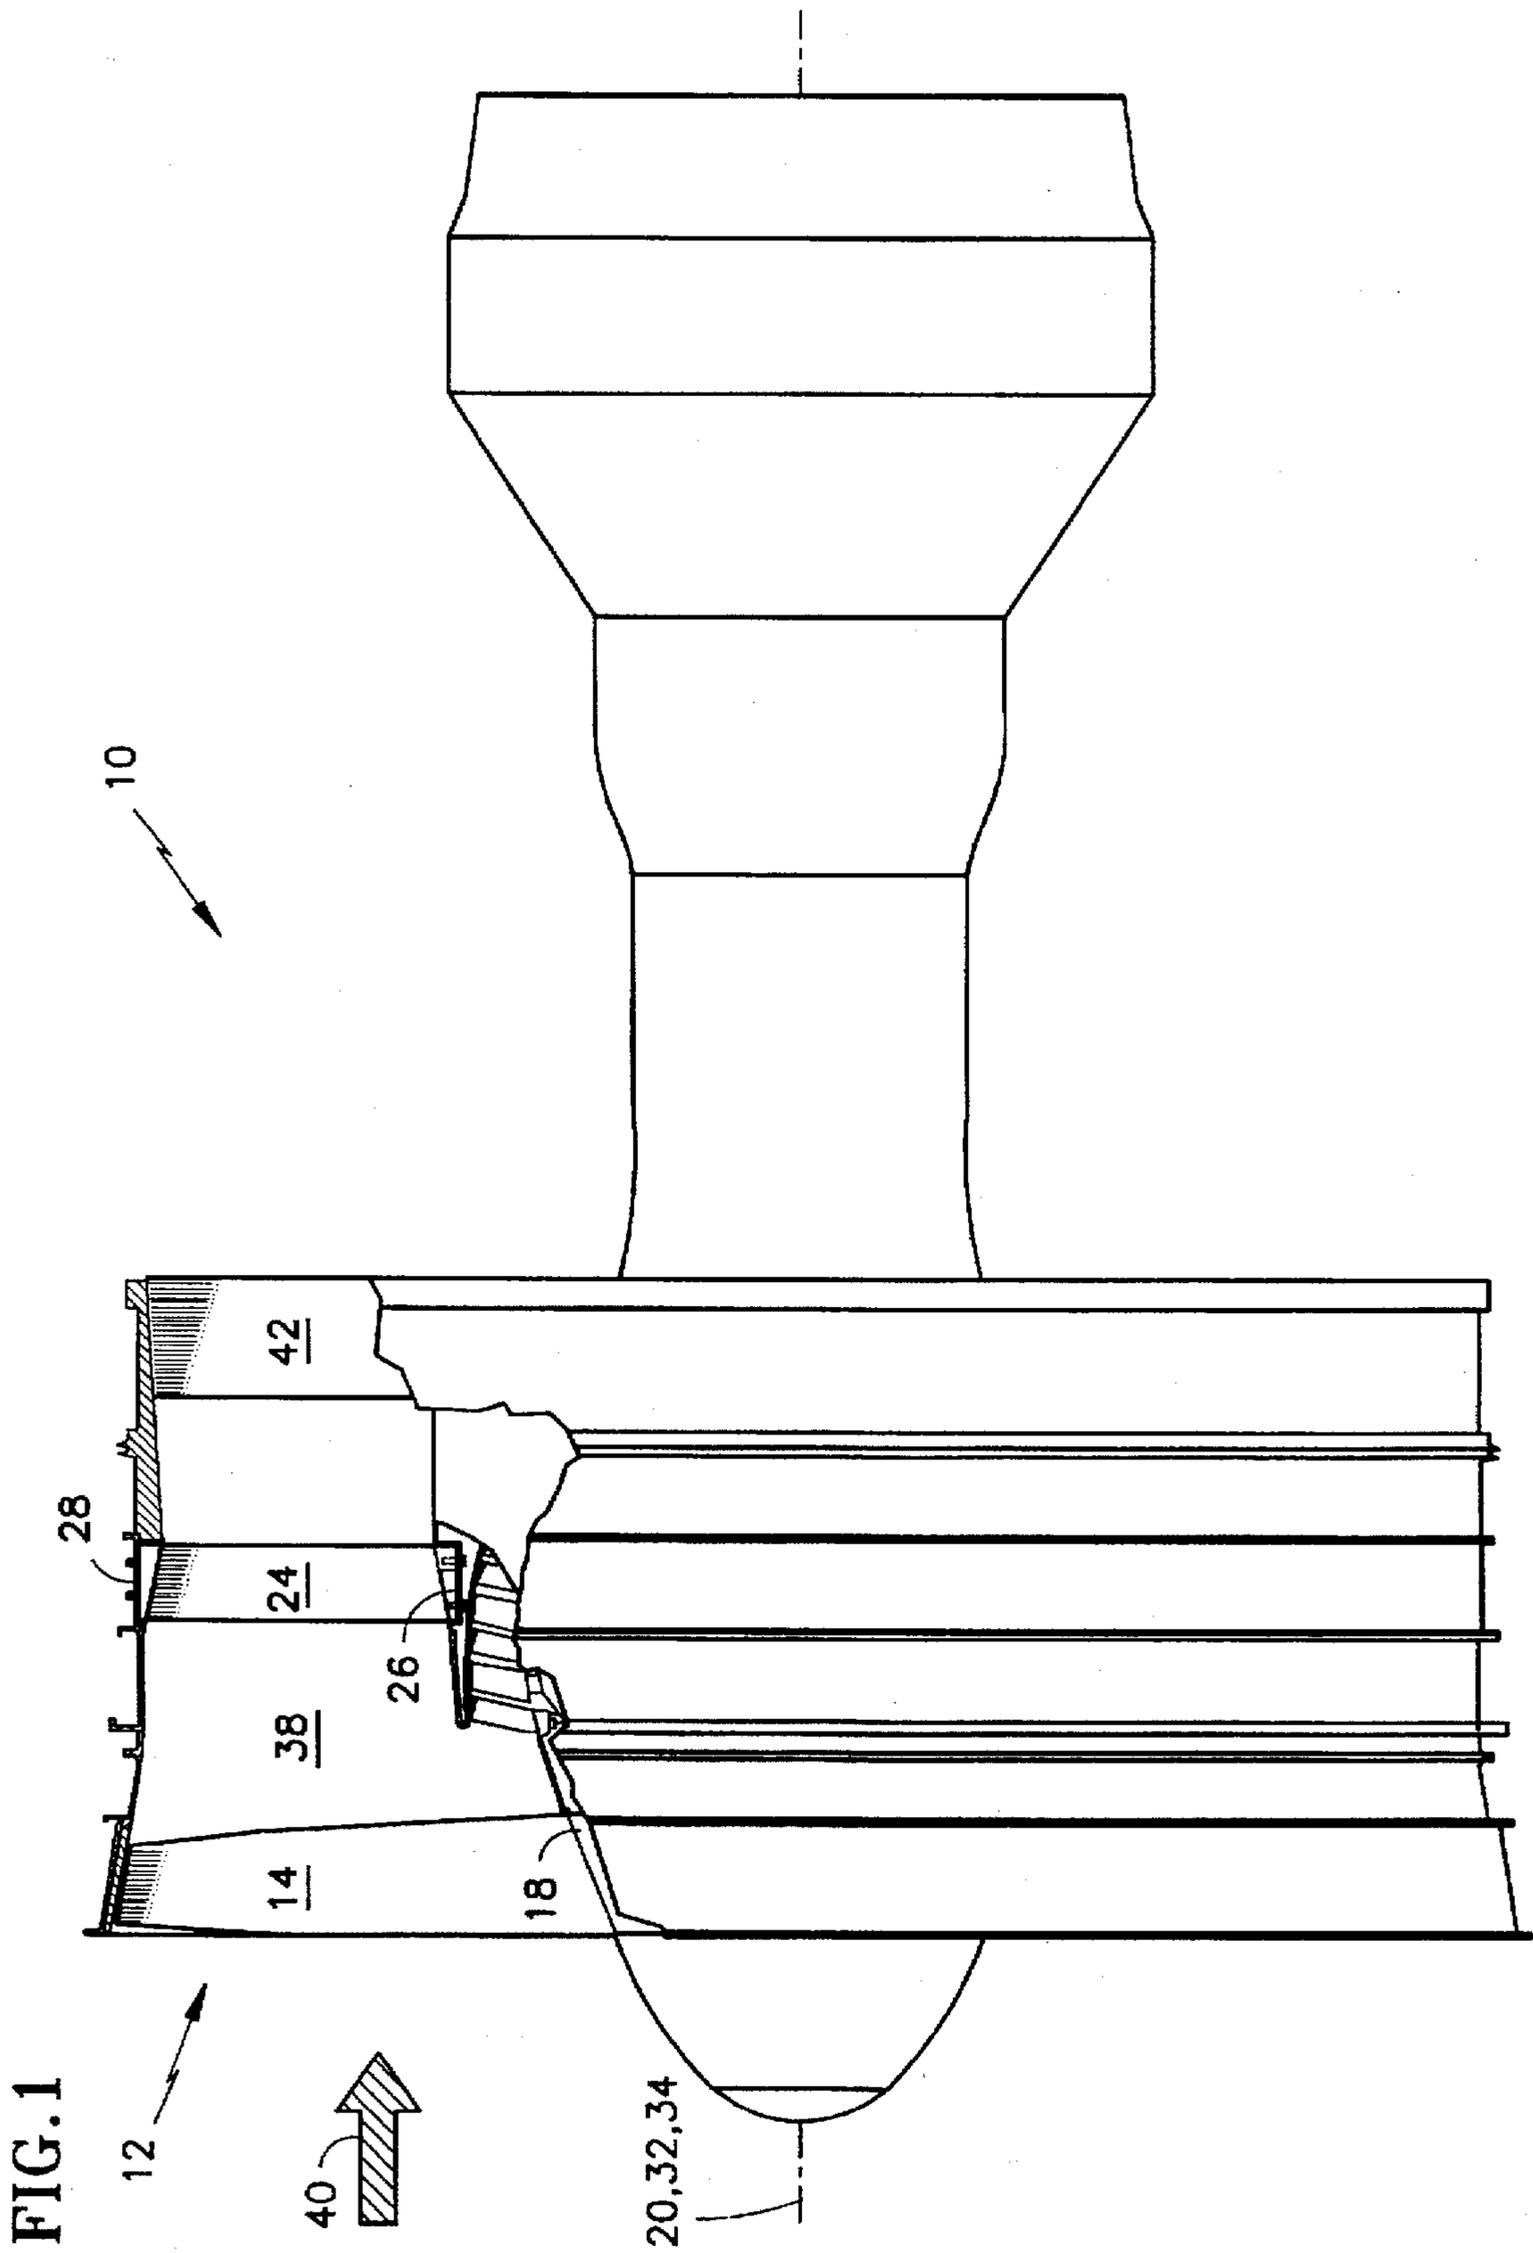
FIG. 1 is a schematic, partially sectioned side view of a turbine engine.

Referring to FIG. 1, a gas turbine engine 10 of the type used for aircraft propulsion includes a fan section 12 having an array of fan blades such as representative blade 14 extending radially outward from hub 18. The hub and blades are rotatable about an engine axis 20. The fan also includes an array of fan exit guide vane assemblies, such as representative guide vane assembly 24, which extends radially between inner and outer cases 26, 28 whose axes 32, 34 are common with the engine axis 20. A fan flowpath 38 extends through the fan section and a working medium fluid, such as air, flows through the flowpath in the direction generally indicated by directional arrow 40.

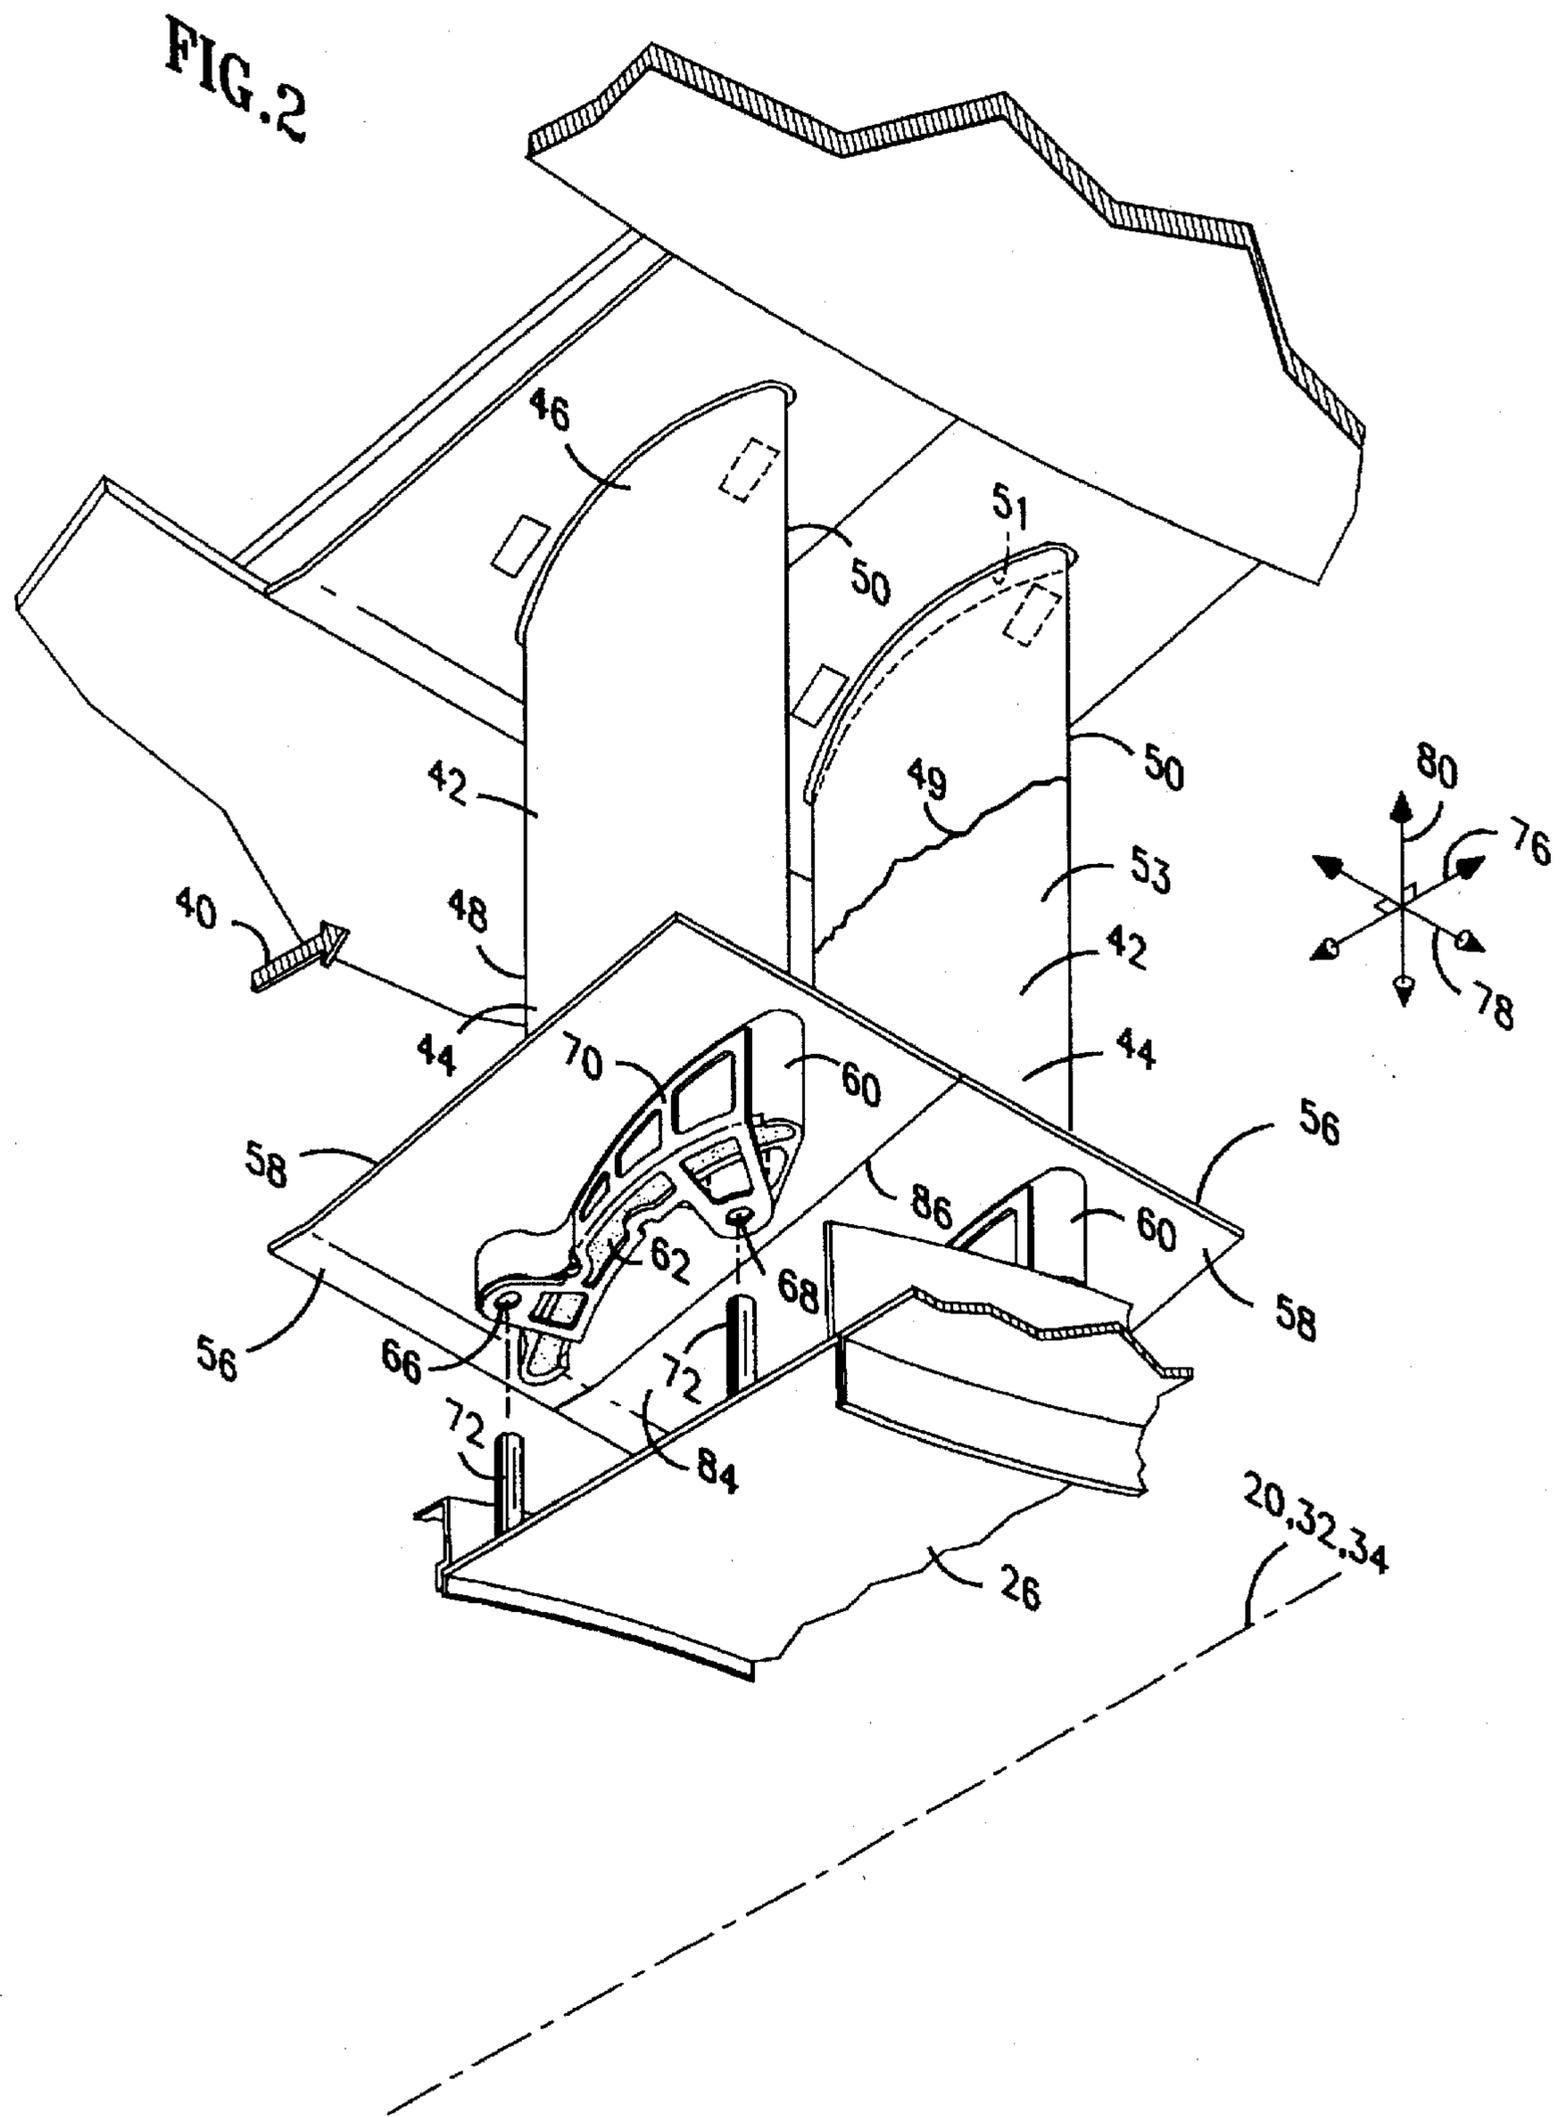
FIG. 2 is a partially exploded perspective view showing a portion of the fan section of a turbine engine including a fan exit guide vane assembly and the means by which the guide vane assembly is secured to an inner case.

Additional features of the vane assemblies are visible in FIGS. 2 and 3. Each vane assembly includes an airfoil 42 having an inner end 44 an outer end 46, a leading edge 48 and a trailing edge 50. Each vane assembly also includes a nonmetallic inner base 56 having a platform 58 and a sleeve 60 with a resilient polyurethane material 62 disposed therein. The inner end of the airfoil extends into the polyurethane material which damps airfoil vibrations and grips the inner end of the airfoil to attach the airfoil to the inner base. As discussed more fully in U.S. Pat. No. 5,411,370, the inner base also includes front and rear pin receptor sockets 66, 68 containing a polyurethane or silicone rubber material and a metallic shoe 70 which protects the base in the event of abnormal engine vibration. Each receptor socket corresponds to a support pin 72 extending radially outwardly from the inner case 26 (the view of FIG. 2 is slightly exploded so that the pins and receptor sockets are visible).

When fully assembled, each support pin engages its receptor socket to secure the inner base, and therefore the vane assembly, to the inner case, so that the base is radially spaced from the inner case to accommodate thermal expansion and contraction. The pinned connection secures the base to the inner case so that axial displacement (parallel to the engine axis as indicated by direction 76) and lateral displacement (tangent to the case as indicated by direction 78) are resisted while radial (direction 80) separation between the vane assembly and the case is unrestricted. Typically, a foam seal, not shown, is installed in the cavity 84 bounded by the inner case, the abutting platforms of neighboring inner bases and the sleeves associated with the neighboring inner bases. The foam seal minimizes leakage of air from the flowpath through seam 86 between abutting platforms.

According to the present invention, use of the above described repair kit substantially simplifies the replacement of an unserviceable vane assembly. As best appreciated by reference to FIGS. 2 and 3 an unserviceable vane assembly is removed from a vane array in a turbine engine by severing the airfoil from its leading edge **48** to its trailing edge **50** (for example along line **49**), removing the nuts **102** to disconnect the resulting outer stub **51** and outer base from the outer case, and sliding the inner stub **53** and inner base off the support pins.

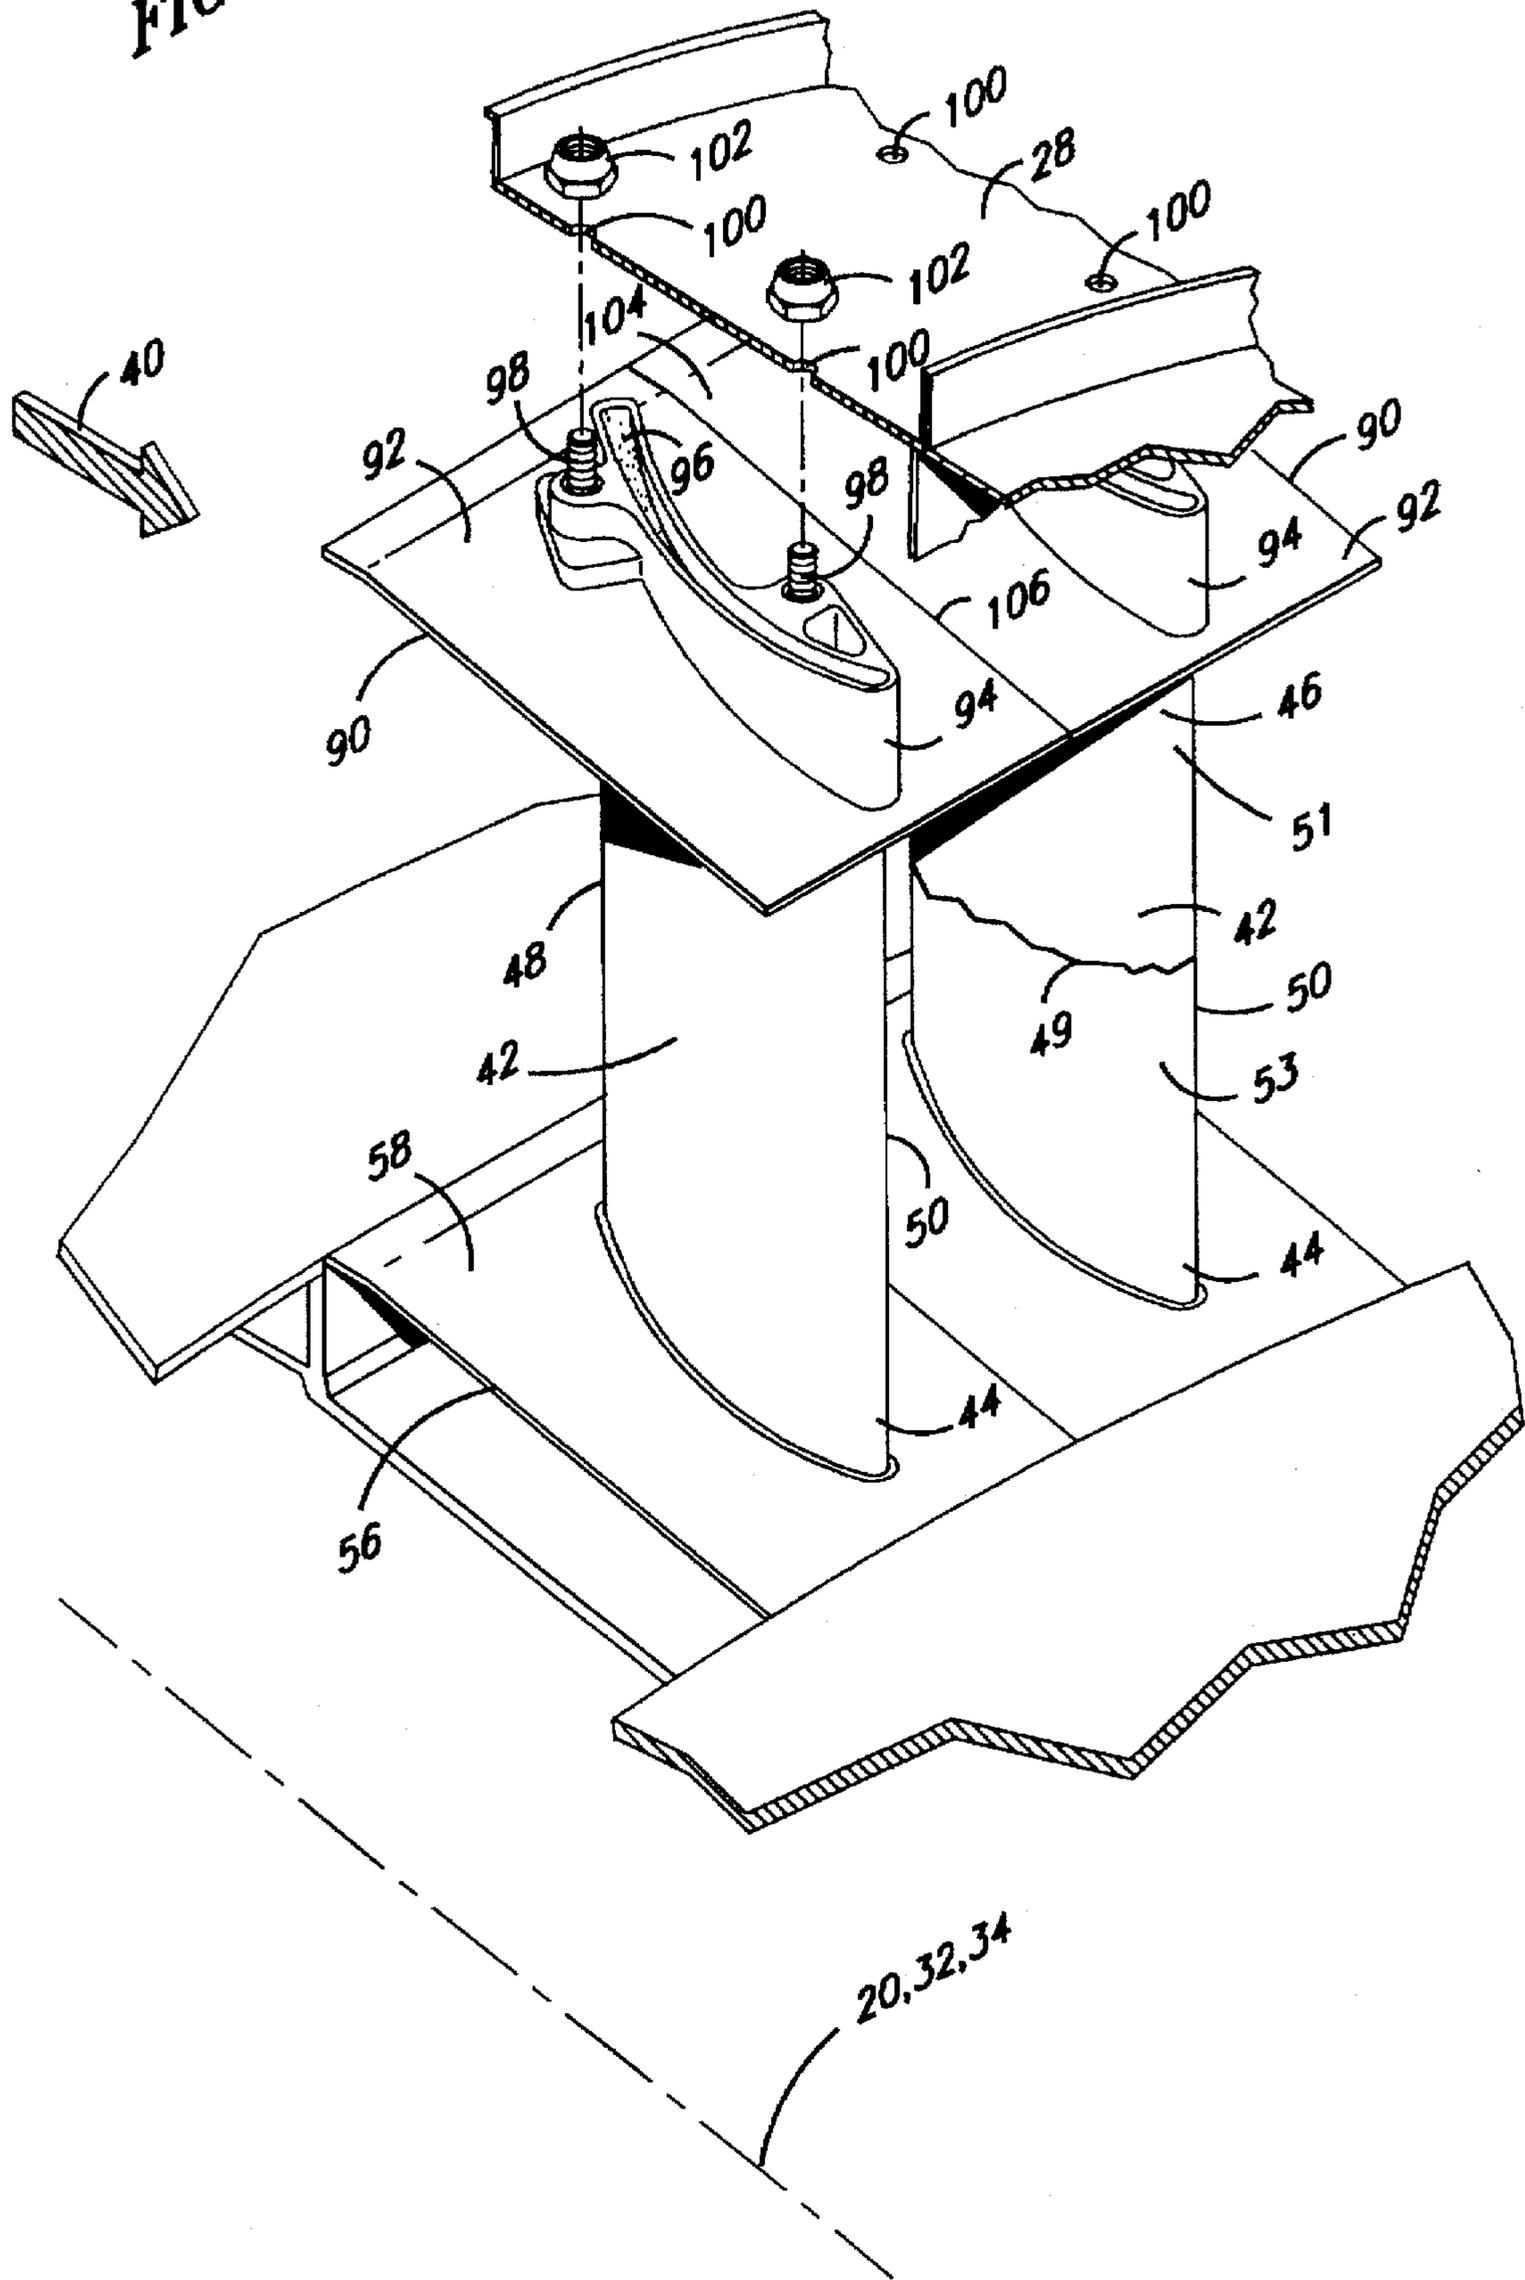
FIG. 3 is a partially exploded perspective view showing a portion of the fan section of a turbine engine including a fan exit guide vane assembly and the means by which the guide vane assembly is secured to an outer case.

The vane assembly also includes an outer base 90. The outer base has a platform 92 and a sleeve 94 with a polyurethane material 96 disposed therein. The outer end of the airfoil extends into the polyurethane material which damps airfoil vibrations and grips the outer end of the airfoil to attach the airfoil to the outer base. Stud 98 project radially outward from the outer base and extend through holes 100 in the outer case 28. (the view of FIG. 3 is slightly exploded so that the outer sleeve and studs are visible). Nuts 102 threaded onto the studs positively secure the outer base, and therefore the outer end of the vane assembly, to the outer case. A foam seal, not shown, is typically installed in the cavity 104 bounded by the outer case, the abutting platforms of neighboring outer bases and the sleeves associated with the neighboring outer bases. The foam seal minimizes leakage of air from the flowpath through seam 106 between abutting platforms.

The installation of the fan exit vane assemblies during factory construction of a new engine occurs with the inner case 26 resting on a support surface so that the case axis 32 is vertical. Each vane assembly 24 is slid radially onto a pair of support pins 72 so that the pins project into the receptor sockets 66 on the inner base 56. The outer case 28 is then positioned on the support surface so that the outer case circumscribes the vane assembly outer bases 90 and is coaxial with the inner case. Once the outer case is positioned, each vane assembly is slid radially outwardly along its pins until the outer sleeve 94 contacts the outer case 28. The studs 98 are inserted through both the outer platforms 92 and the case holes 100. Nuts 102 are threaded onto the studs to secure the outer base, and therefore the vane assembly, to the outer case. When necessary, disassembly is carried out by reversing the assembly procedure.

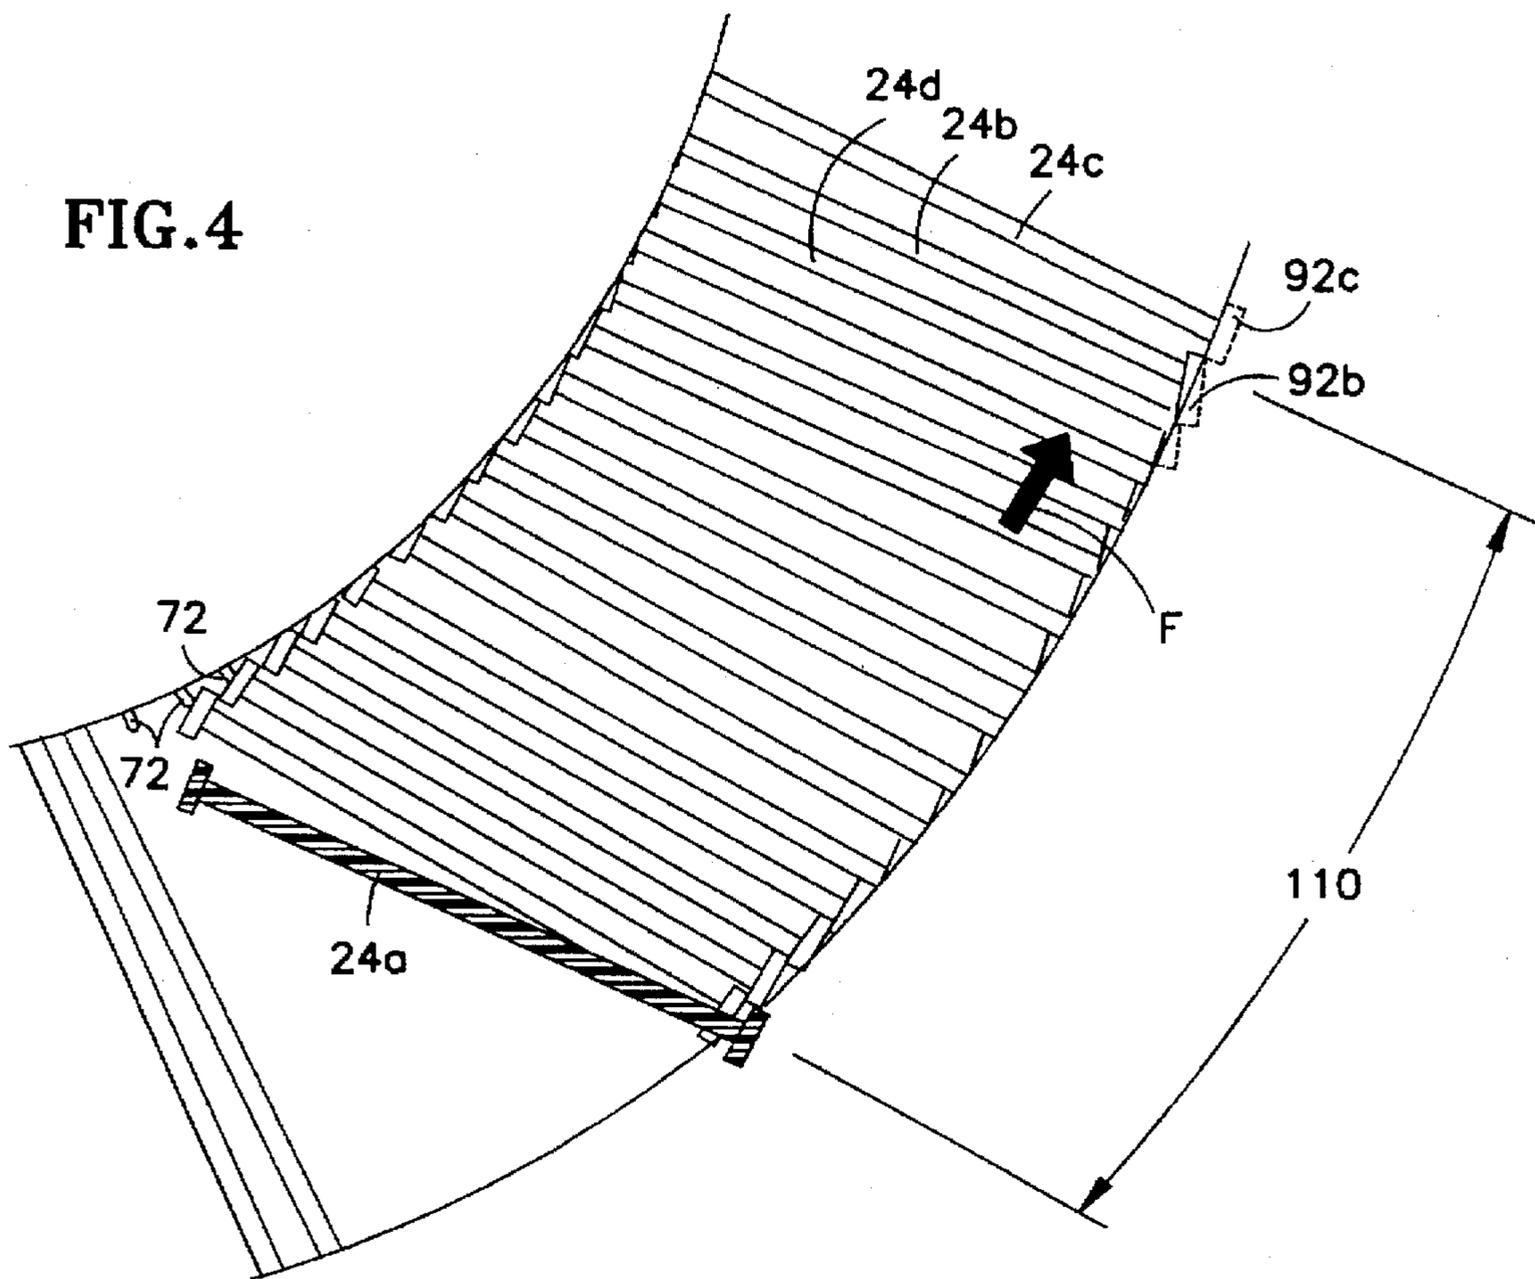
FIG. 4 is a schematic illustration of a portion of a fan exit guide vane array viewed parallel to the rotational axis of a turbine engine to demonstrate a prior art method of replacing an unserviceable vane assembly.

An alternate technique for removing and replacing a vane assembly is referred to as "shingling". Referring to FIG. 4, a sector 110 of neighboring vane assemblies, which are circumferentially adjacent to an unserviceable vane assem-

bly **24a**(or the opening left by a previously removed vane assembly), is identified. The outer end of the vane assembly **24b** most remote from the unserviceable vane assembly is disconnected from the circumscribing fan case **28**. The disconnected vane assembly is slid radially inwardly along its case support pins **72** so that its outer platform is radially displaced from the platforms of its neighbors **24c**, **24d**. A circumferentially directed force, such as force **F**, is applied to the outer end of the vane assembly. The resilient polyurethane material in the pin receptor sockets **66**, **68** (FIG. 2) deforms elastically in response to the force so that the vane assembly tilts away from the unserviceable vane assembly without becoming disengaged from the support pins. The outer end of the vane assembly is urged circumferentially until its outer platform **92b** overlaps or "shingles" the outer platform **92c** of its neighbor. Each vane assembly in the sector is similarly disconnected and shingled with its neighbor. By shingling a large enough sector of vane assemblies, sufficient circumferential clearance is accumulated that the unserviceable vane assembly **24a**, if not previously removed, can also be tilted circumferentially and disengaged from its support pins. The unserviceable vane assembly is then removed axially from the vane array and a serviceable vane assembly is installed by reversing the procedure just described. While this shingling procedure is simpler and less time consuming than disassembling the fan section, it is nevertheless labor intensive, requiring approximately six hours of effort by a qualified mechanic to replace a single vane assembly.

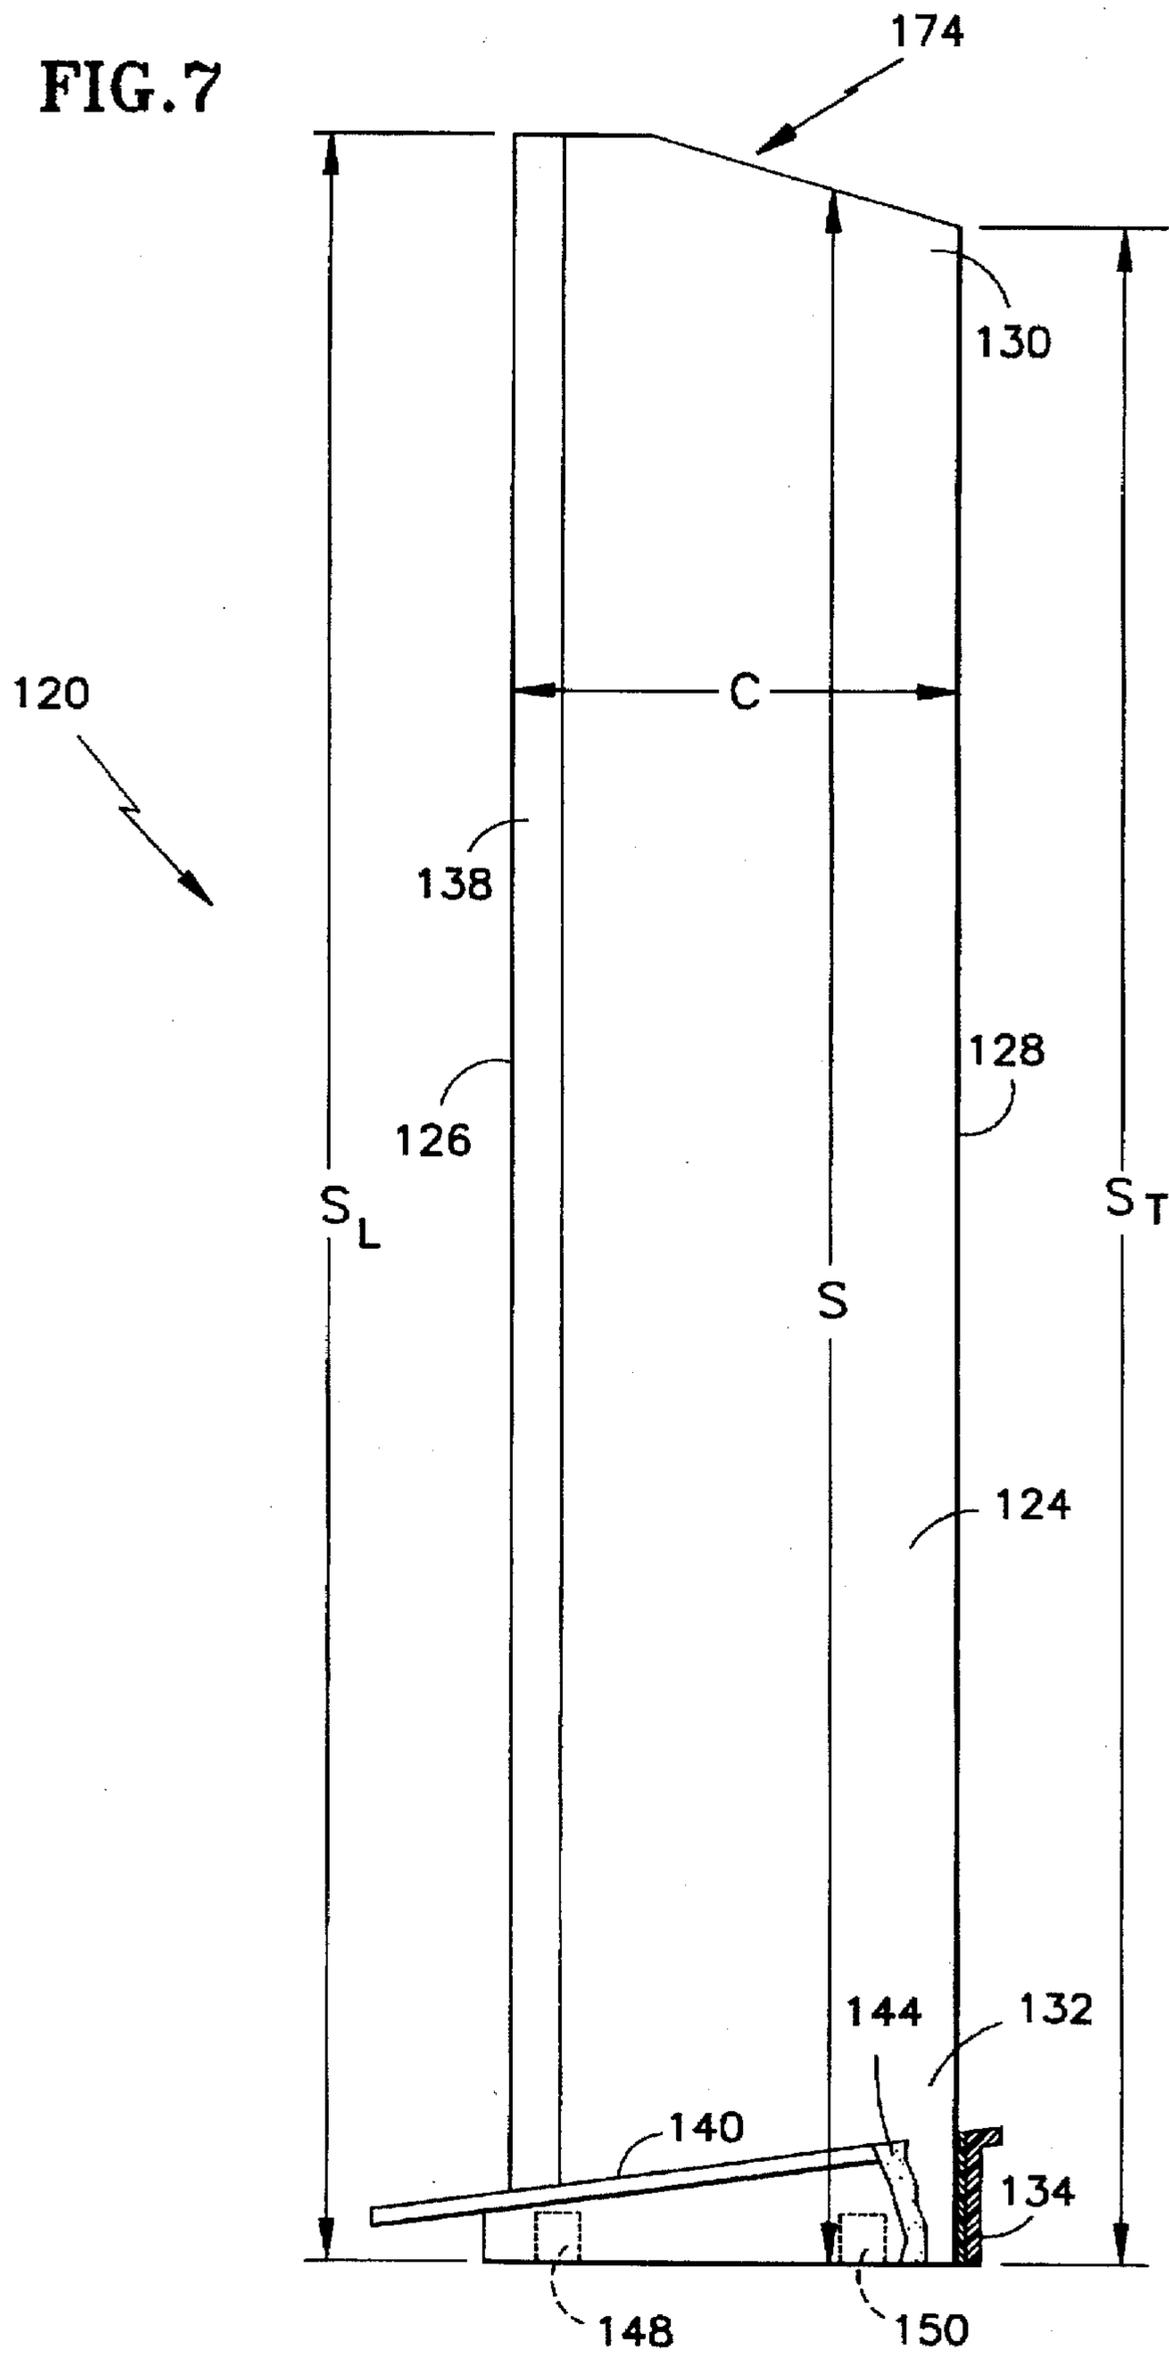
FIG. 8 is a side view of a serviceable vane subassembly and an opposing base of the present invention partially pivoted into position between an inner case and an outer case.

Referring now to FIGS. 8, 9, and 10, the method of replacing the unserviceable vane assembly includes sliding the opposing base **156** over the tip end **130** of the serviceable airfoil **124** and spanwisely toward the attached base so that the serviceable airfoil projects through and is embraced by the opposing base. The serviceable vane subassembly and opposing base are positioned, as best seen in FIG. 8, so that the attached base is in close proximity to the inner case **26** and the forward receptor socket **148** is partially engaged with its corresponding support pin **72**. The subassembly is pivoted about an essentially lateral axis **176** and is urged radially inwardly along the support pins until each support pin completely engages its receptor socket. The tapered region **174** at the tip end **130** of the serviceable airfoil, along with the reduced length of the airfoil in comparison to a prior art airfoil, prevent interference between the tip end and the outer case **28** as the vane subassembly is pivoted into position. A urethane adhesive **182** is applied to the serviceable airfoil near its tip end so that the opposing base can subsequently be bonded to the tip end of the serviceable airfoil. In the preferred embodiment, the adhesive is applied around the entire perimeter of the airfoil and, as seen best in FIG. 8, extends from the extremity of the tip end toward the root a distance  $d_1$  approximately equal to the depth  $d_2$  of the damping material **162** to ensure completeness of the bond between the base and the airfoil.

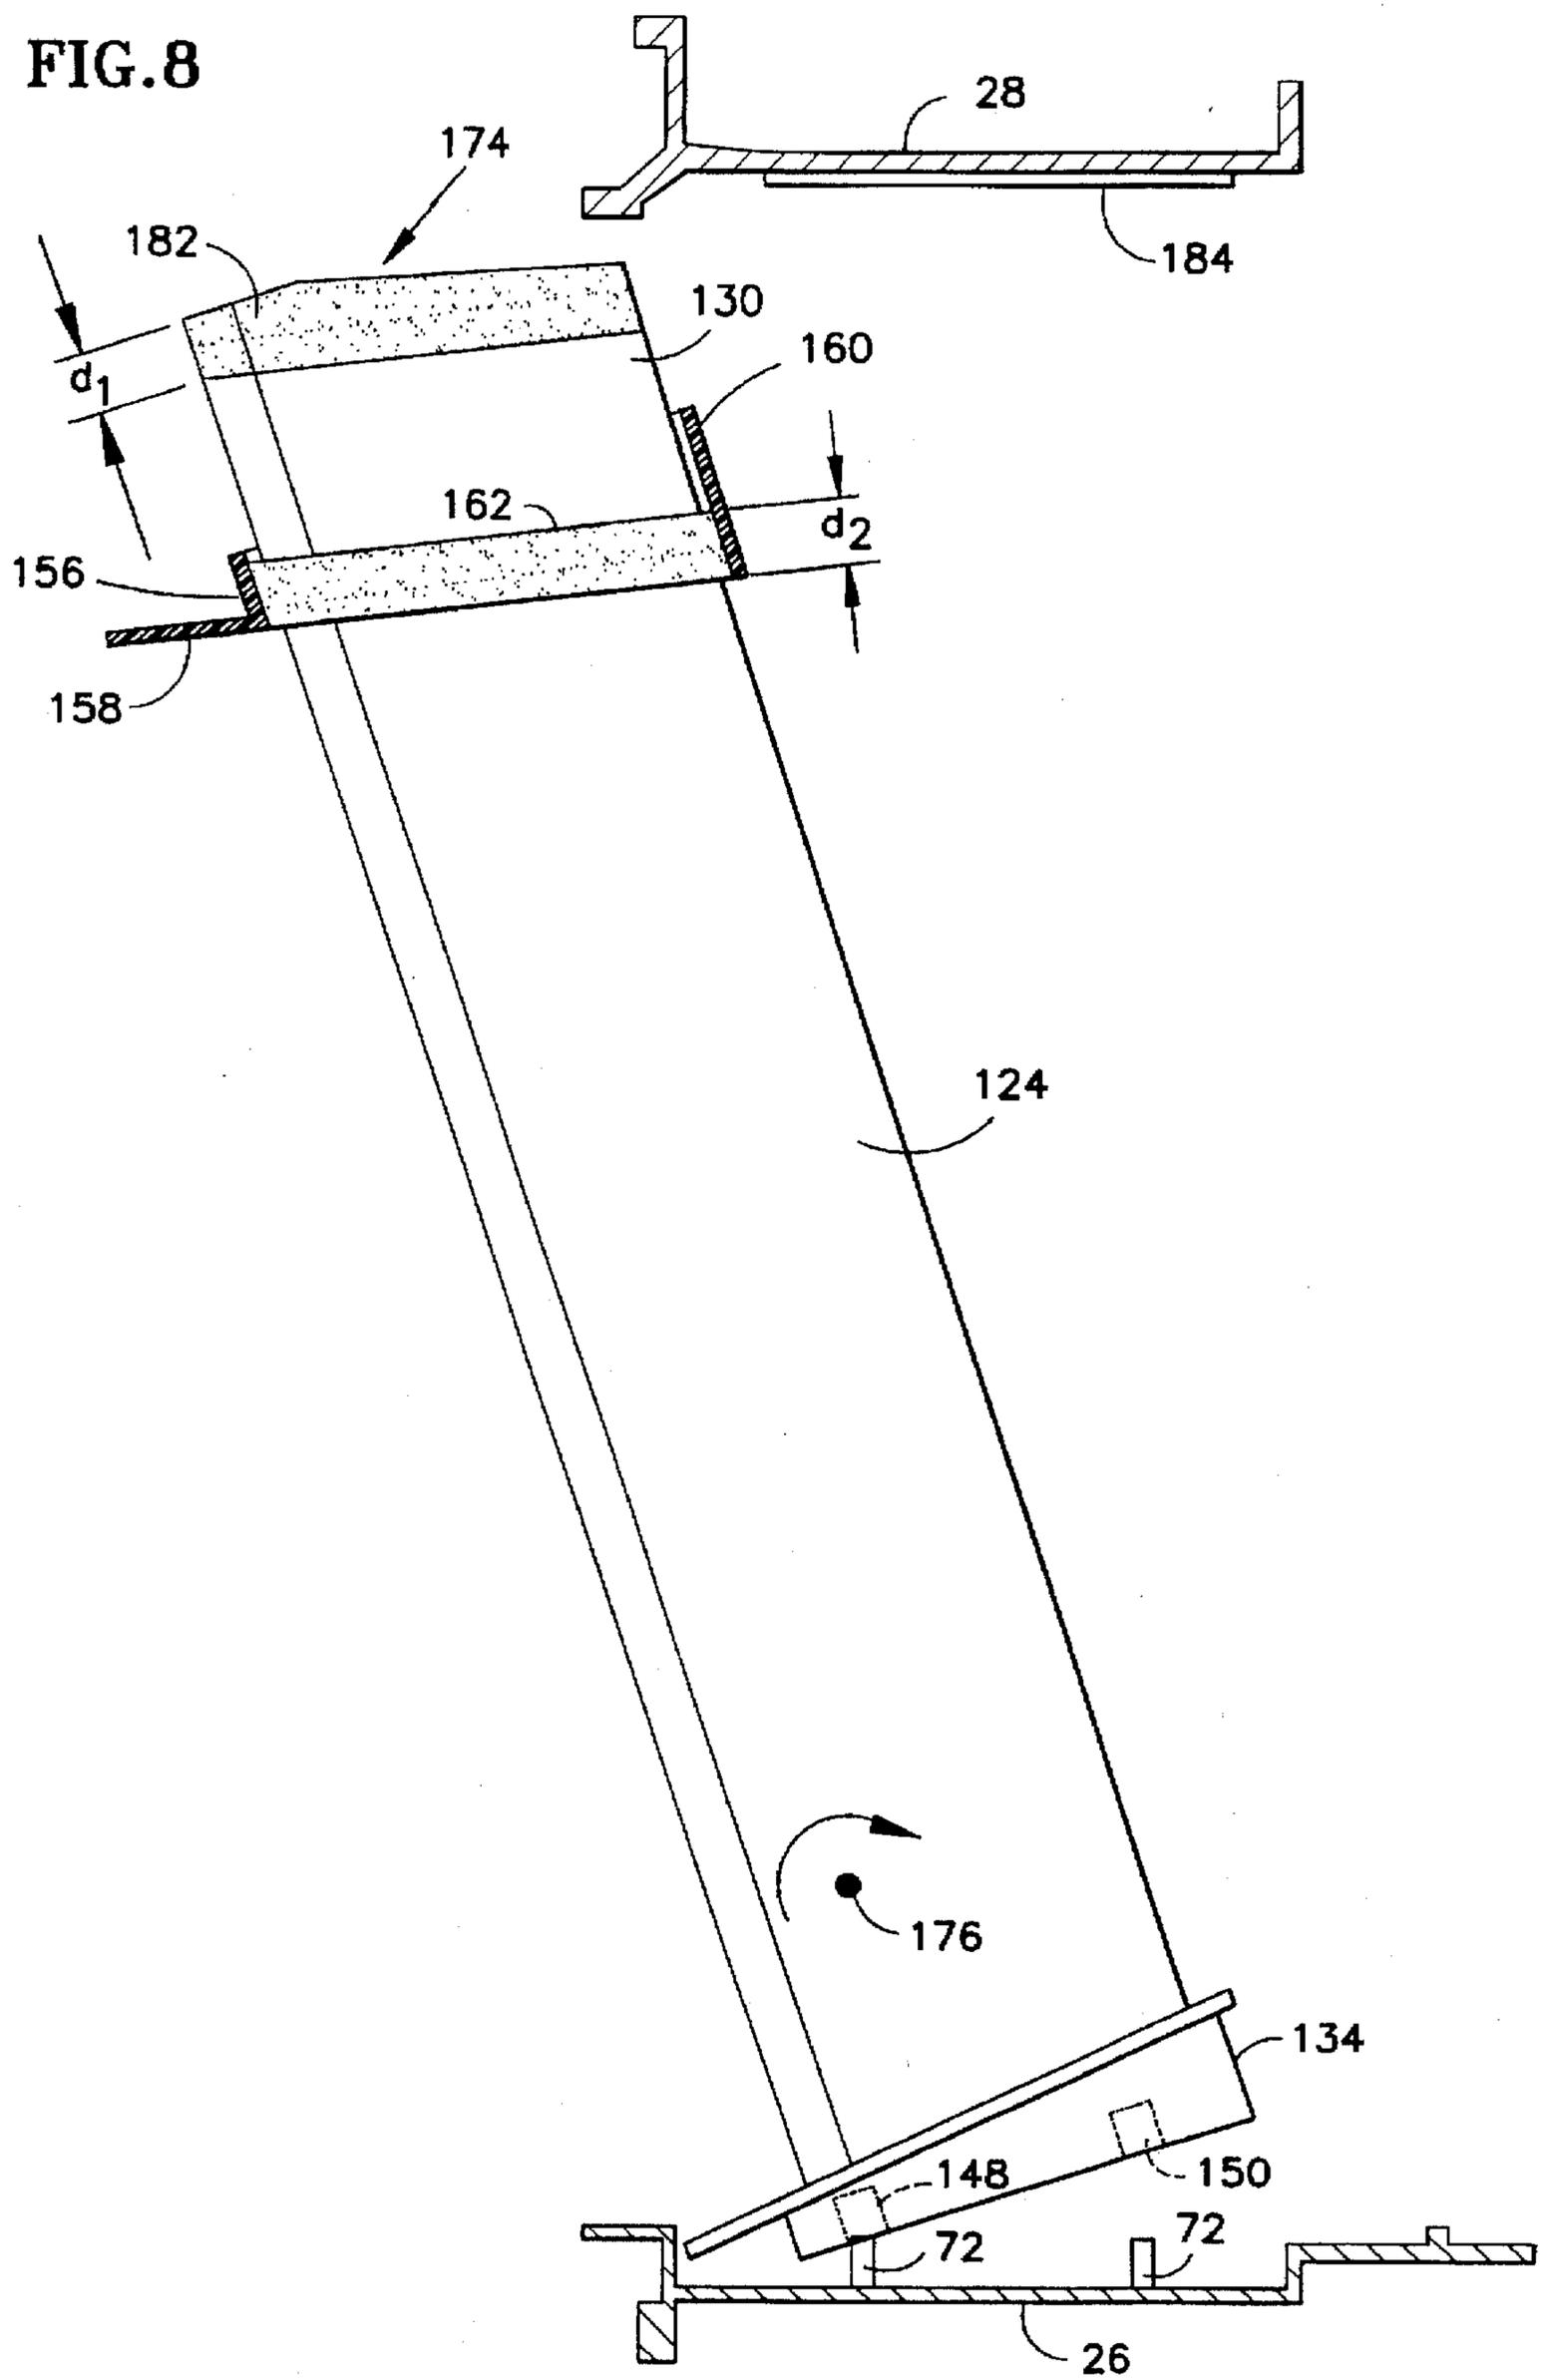
FIG. 9 is a side view of a serviceable vane subassembly and an opposing base of the present invention after having been installed between an inner case and an outer case.

Once the subassembly has been pivoted into position between the inner and outer cases, the opposing base is translated radially outward toward the tip end of the airfoil so that the adhesive **182**, which cures in approximately four hours at 21 degrees C. (70 degrees F.), bonds the airfoil to the damping material **162** (FIG. 6) and therefore attaches the base to the airfoil. In the preferred embodiment a mask **184** is applied to the outer case prior to translating the opposing base radially outward. The mask may be a polyester film masking tape or any other mask which adheres nonpermanently to the case. Any adhesive **182** which is squeezed out of the peripheral gap **170** (FIG. 6) during the radially outward translation of the outer base contacts the tape rather than the outer case. Thus, the mask guards against the formation of an adhesive bond between the opposing base or airfoil and the outer case, thereby ensuring that the airfoil and the opposing base can, if necessary, be subsequently disassembled from the outer case. A retainer, which in the preferred embodiment is a metallic peg **188**, is inserted into holes **190**, **192** in the airfoil and opposing base so that the peg protrudes slightly into the fan flowpath **38** (FIG. 10).

The retainer positions the opposing base relative to the airfoil and limits the displacement of the opposing base relative to the vane subassembly in the event that the adhesive bond between the airfoil and the opposing base fails. An additional quantity 194 of adhesive is applied to the juncture of the airfoil and the damping material to augment the bond and to hold the retaining peg in place. As seen best in FIG. 9, the opposing base is positively secured to the outer case by studs and nuts 196, 198 so that platform 158 is flush with the neighboring platforms (as seen in FIG. 2 for a prior art fan blade array).
