[11] Patent Number: **5,690,469**

[54] **METHOD AND APPARATUS FOR REPLACING A VANE ASSEMBLY IN A TURBINE ENGINE**

[73] Assignee: **United Technologies Corporation**, Hartford, Conn.

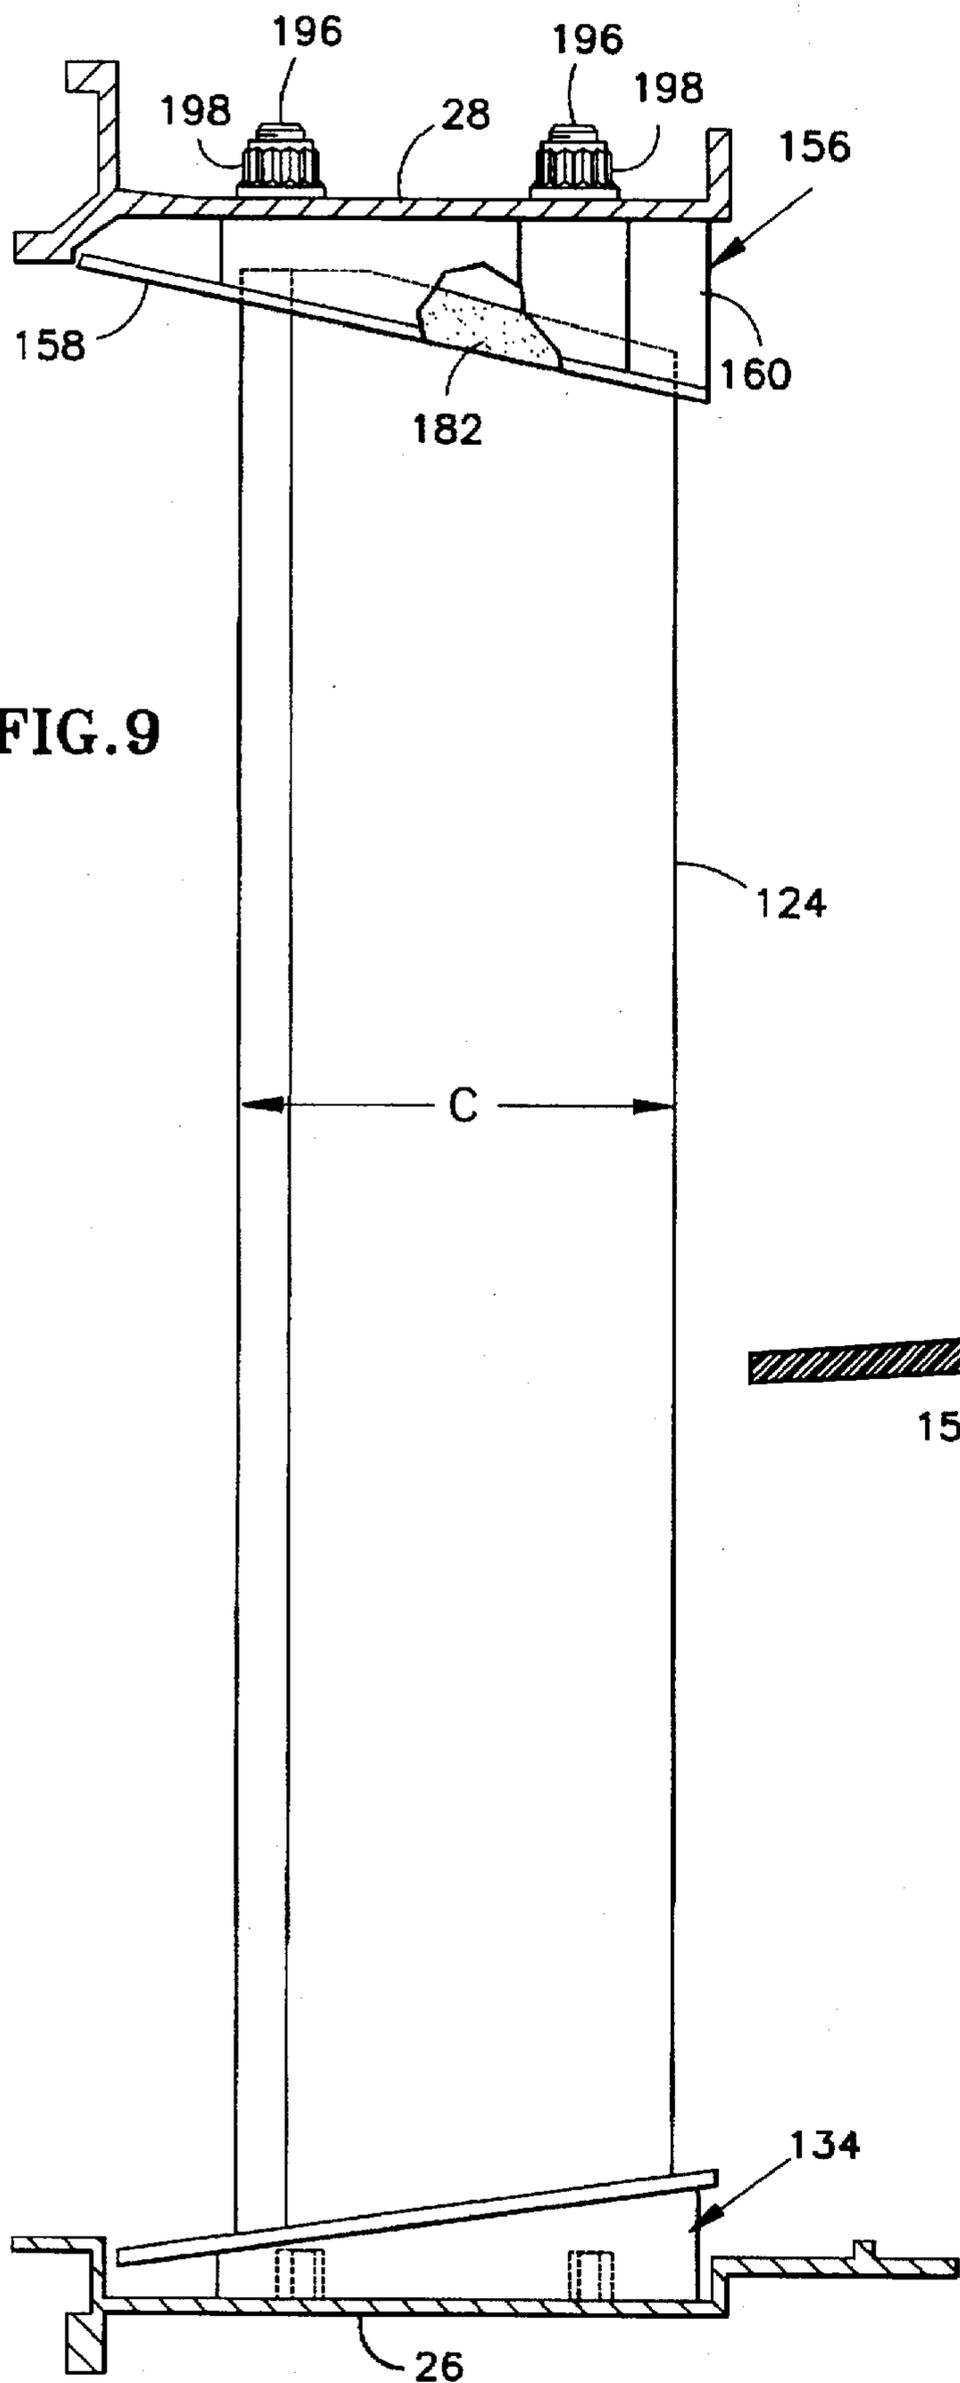
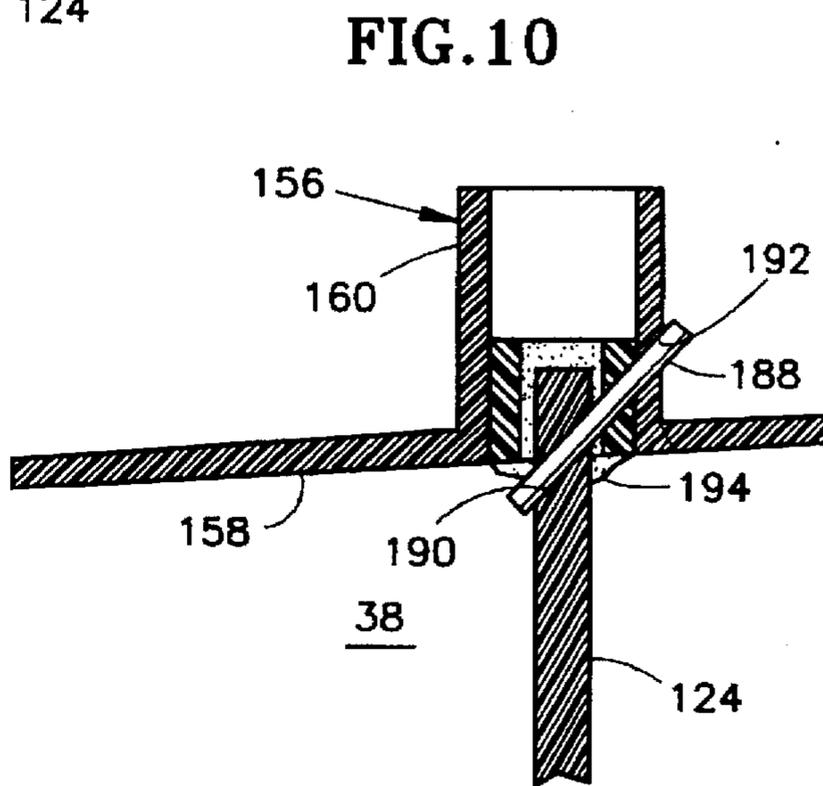
FIG. 10 is a view taken parallel to the engine axis showing a retaining pin projecting through a hole in the outer end of a serviceable airfoil and into an opposing base.

Once the subassembly has been pivoted into position between the inner and outer cases, the opposing base is translated radially outward toward the tip end of the airfoil so that the adhesive **182**, which cures in approximately four hours at 21 degrees C. (70 degrees F.), bonds the airfoil to the damping material **162** (FIG. 6) and therefore attaches the base to the airfoil. In the preferred embodiment a mask **184** is applied to the outer case prior to translating the opposing base radially outward. The mask may be a polyester film masking tape or any other mask which adheres nonpermanently to the case. Any adhesive **182** which is squeezed out of the peripheral gap **170** (FIG. 6) during the radially outward translation of the outer base contacts the tape rather than the outer case. Thus, the mask guards against the formation of an adhesive bond between the opposing base or airfoil and the outer case, thereby ensuring that the airfoil and the opposing base can, if necessary, be subsequently disassembled from the outer case. A retainer, which in the preferred embodiment is a metallic peg **188**, is inserted into holes **190**, **192** in the airfoil and opposing base so that the peg protrudes slightly into the fan flowpath **38** (FIG. 10).
