United States Patent [19]

[11] Patent Number: **5,690,469**

[54] **METHOD AND APPARATUS FOR REPLACING A VANE ASSEMBLY IN A TURBINE ENGINE**

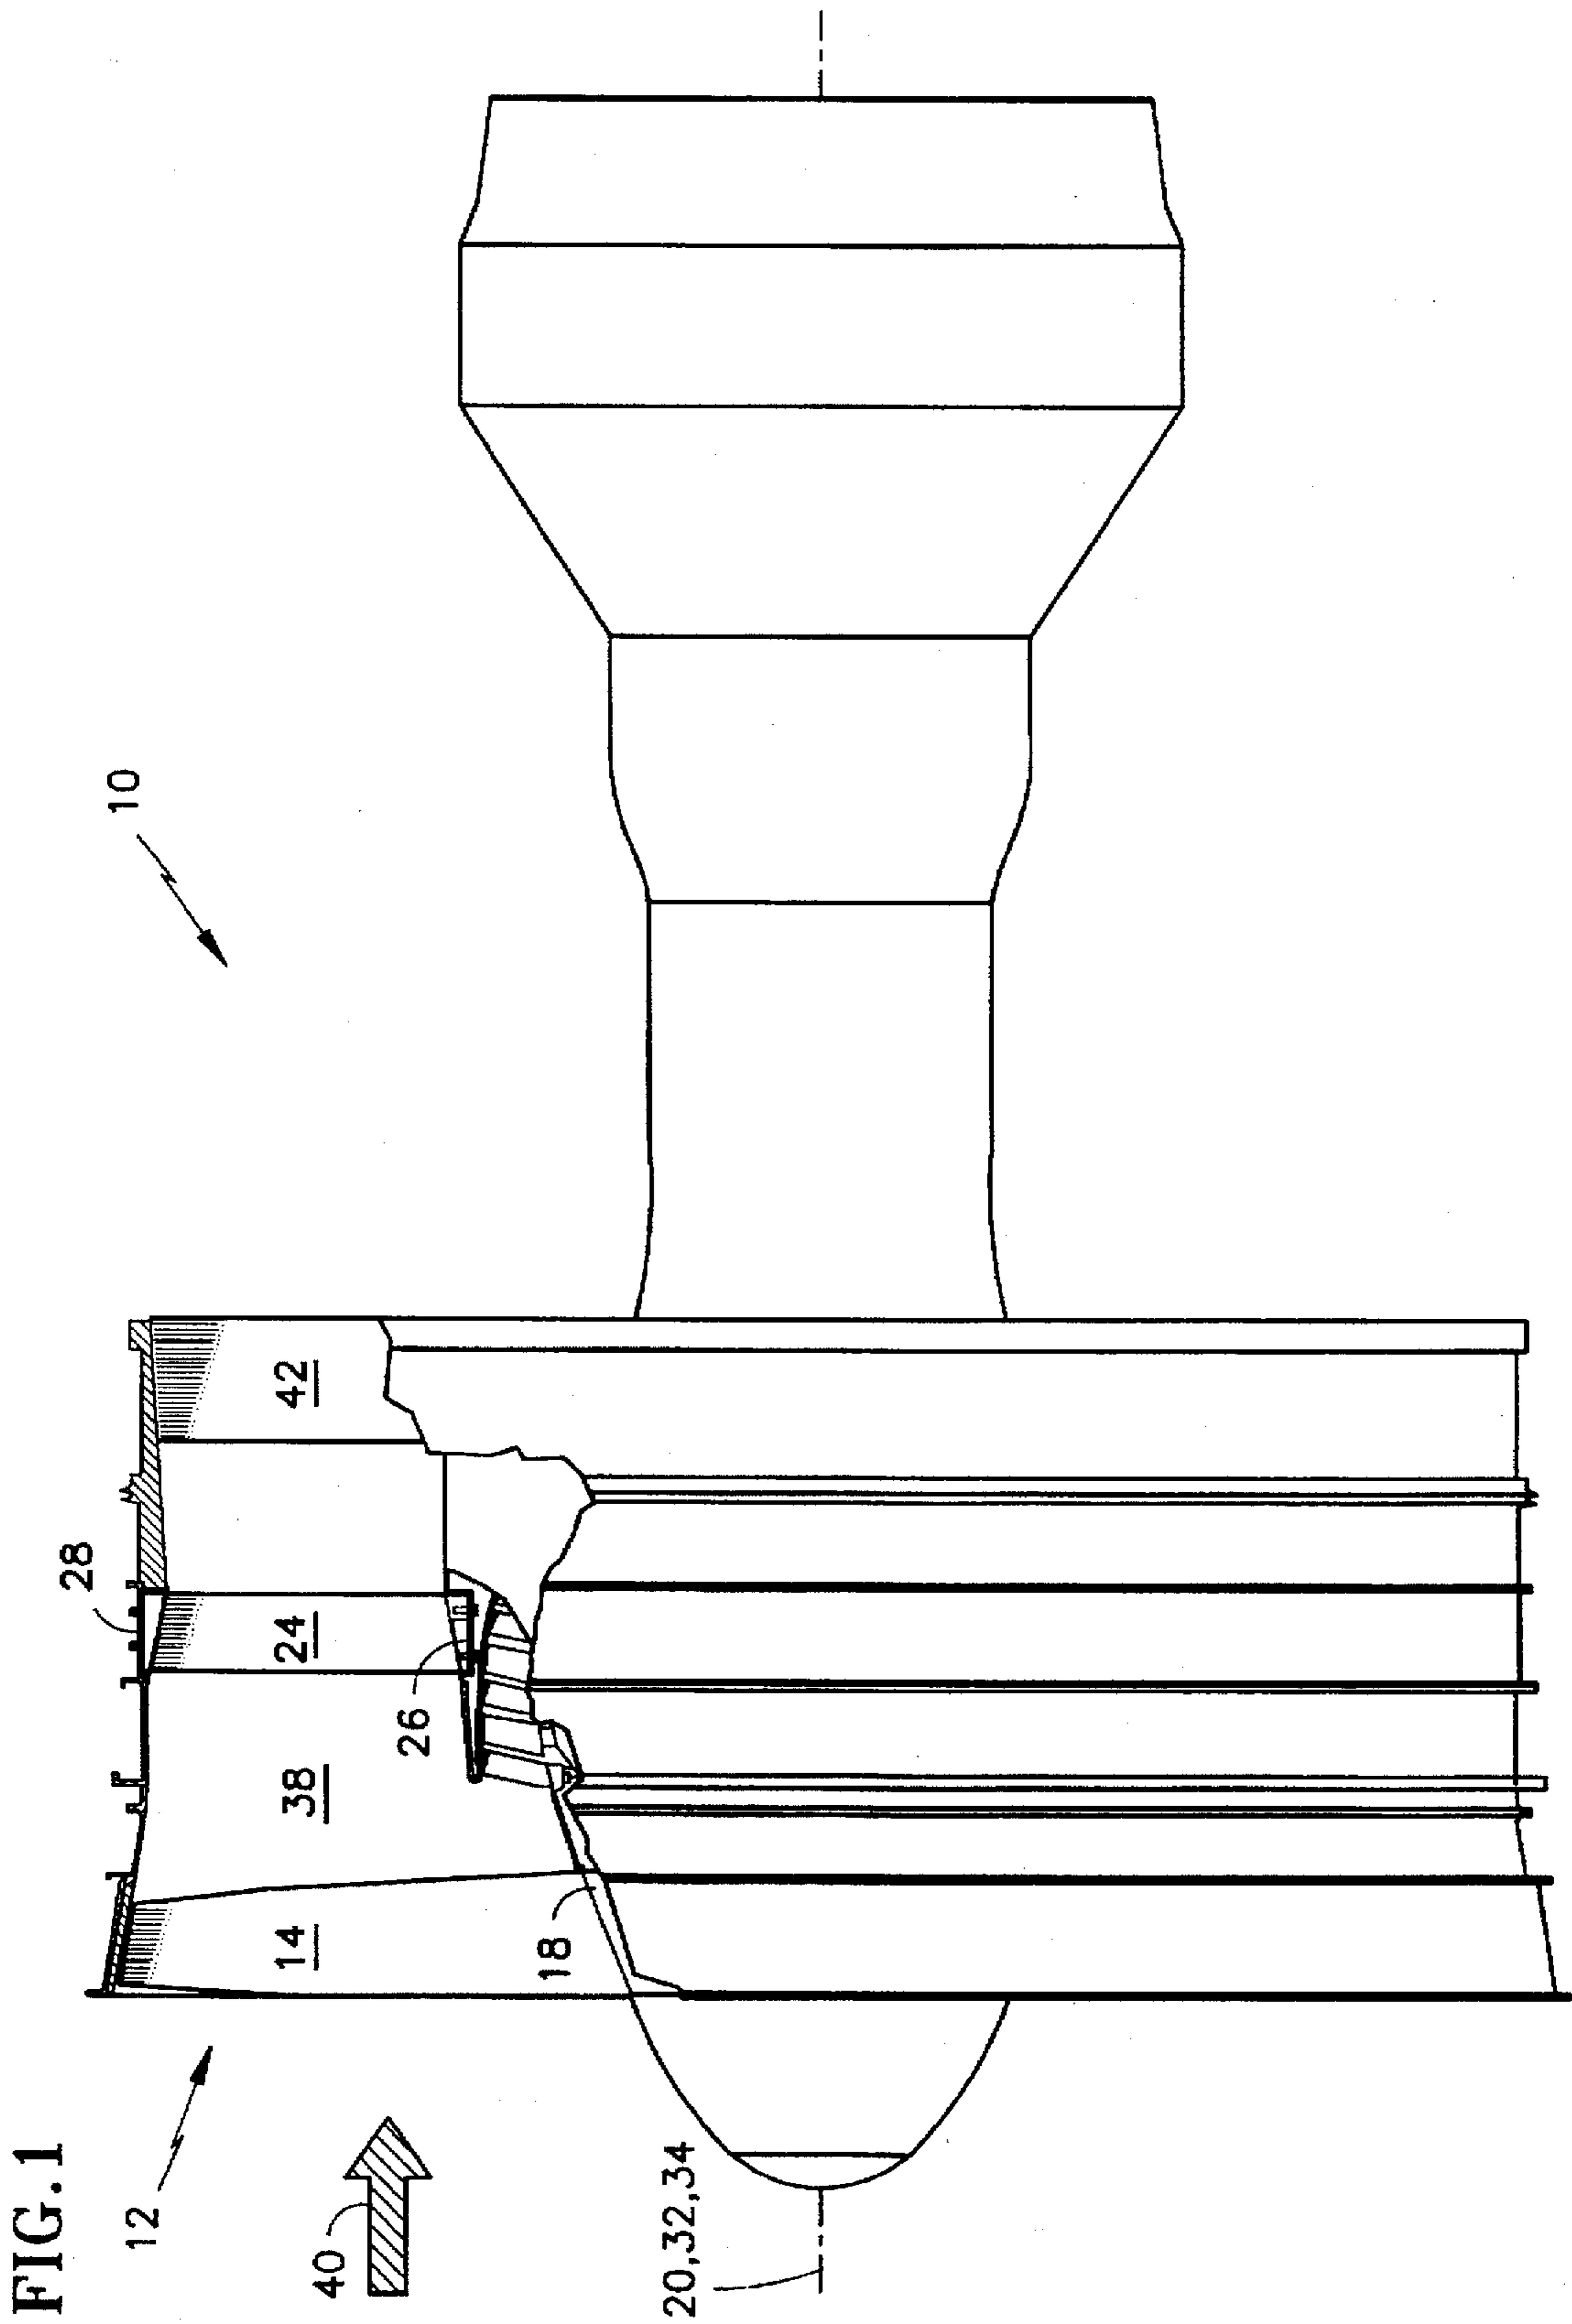
FIG. 1 is a schematic, partially sectioned side view of a turbine engine.

Referring to FIG. 1, a gas turbine engine 10 of the type used for aircraft propulsion includes a fan section 12 having an array of fan blades such as representative blade 14 extending radially outward from hub 18. The hub and blades are rotatable about an engine axis 20. The fan also includes an array of fan exit guide vane assemblies, such as representative guide vane assembly 24, which extends radially between inner and outer cases 26, 28 whose axes 32, 34 are common with the engine axis 20. A fan flowpath 38 extends through the fan section and a working medium fluid, such as air, flows through the flowpath in the direction generally indicated by directional arrow 40.

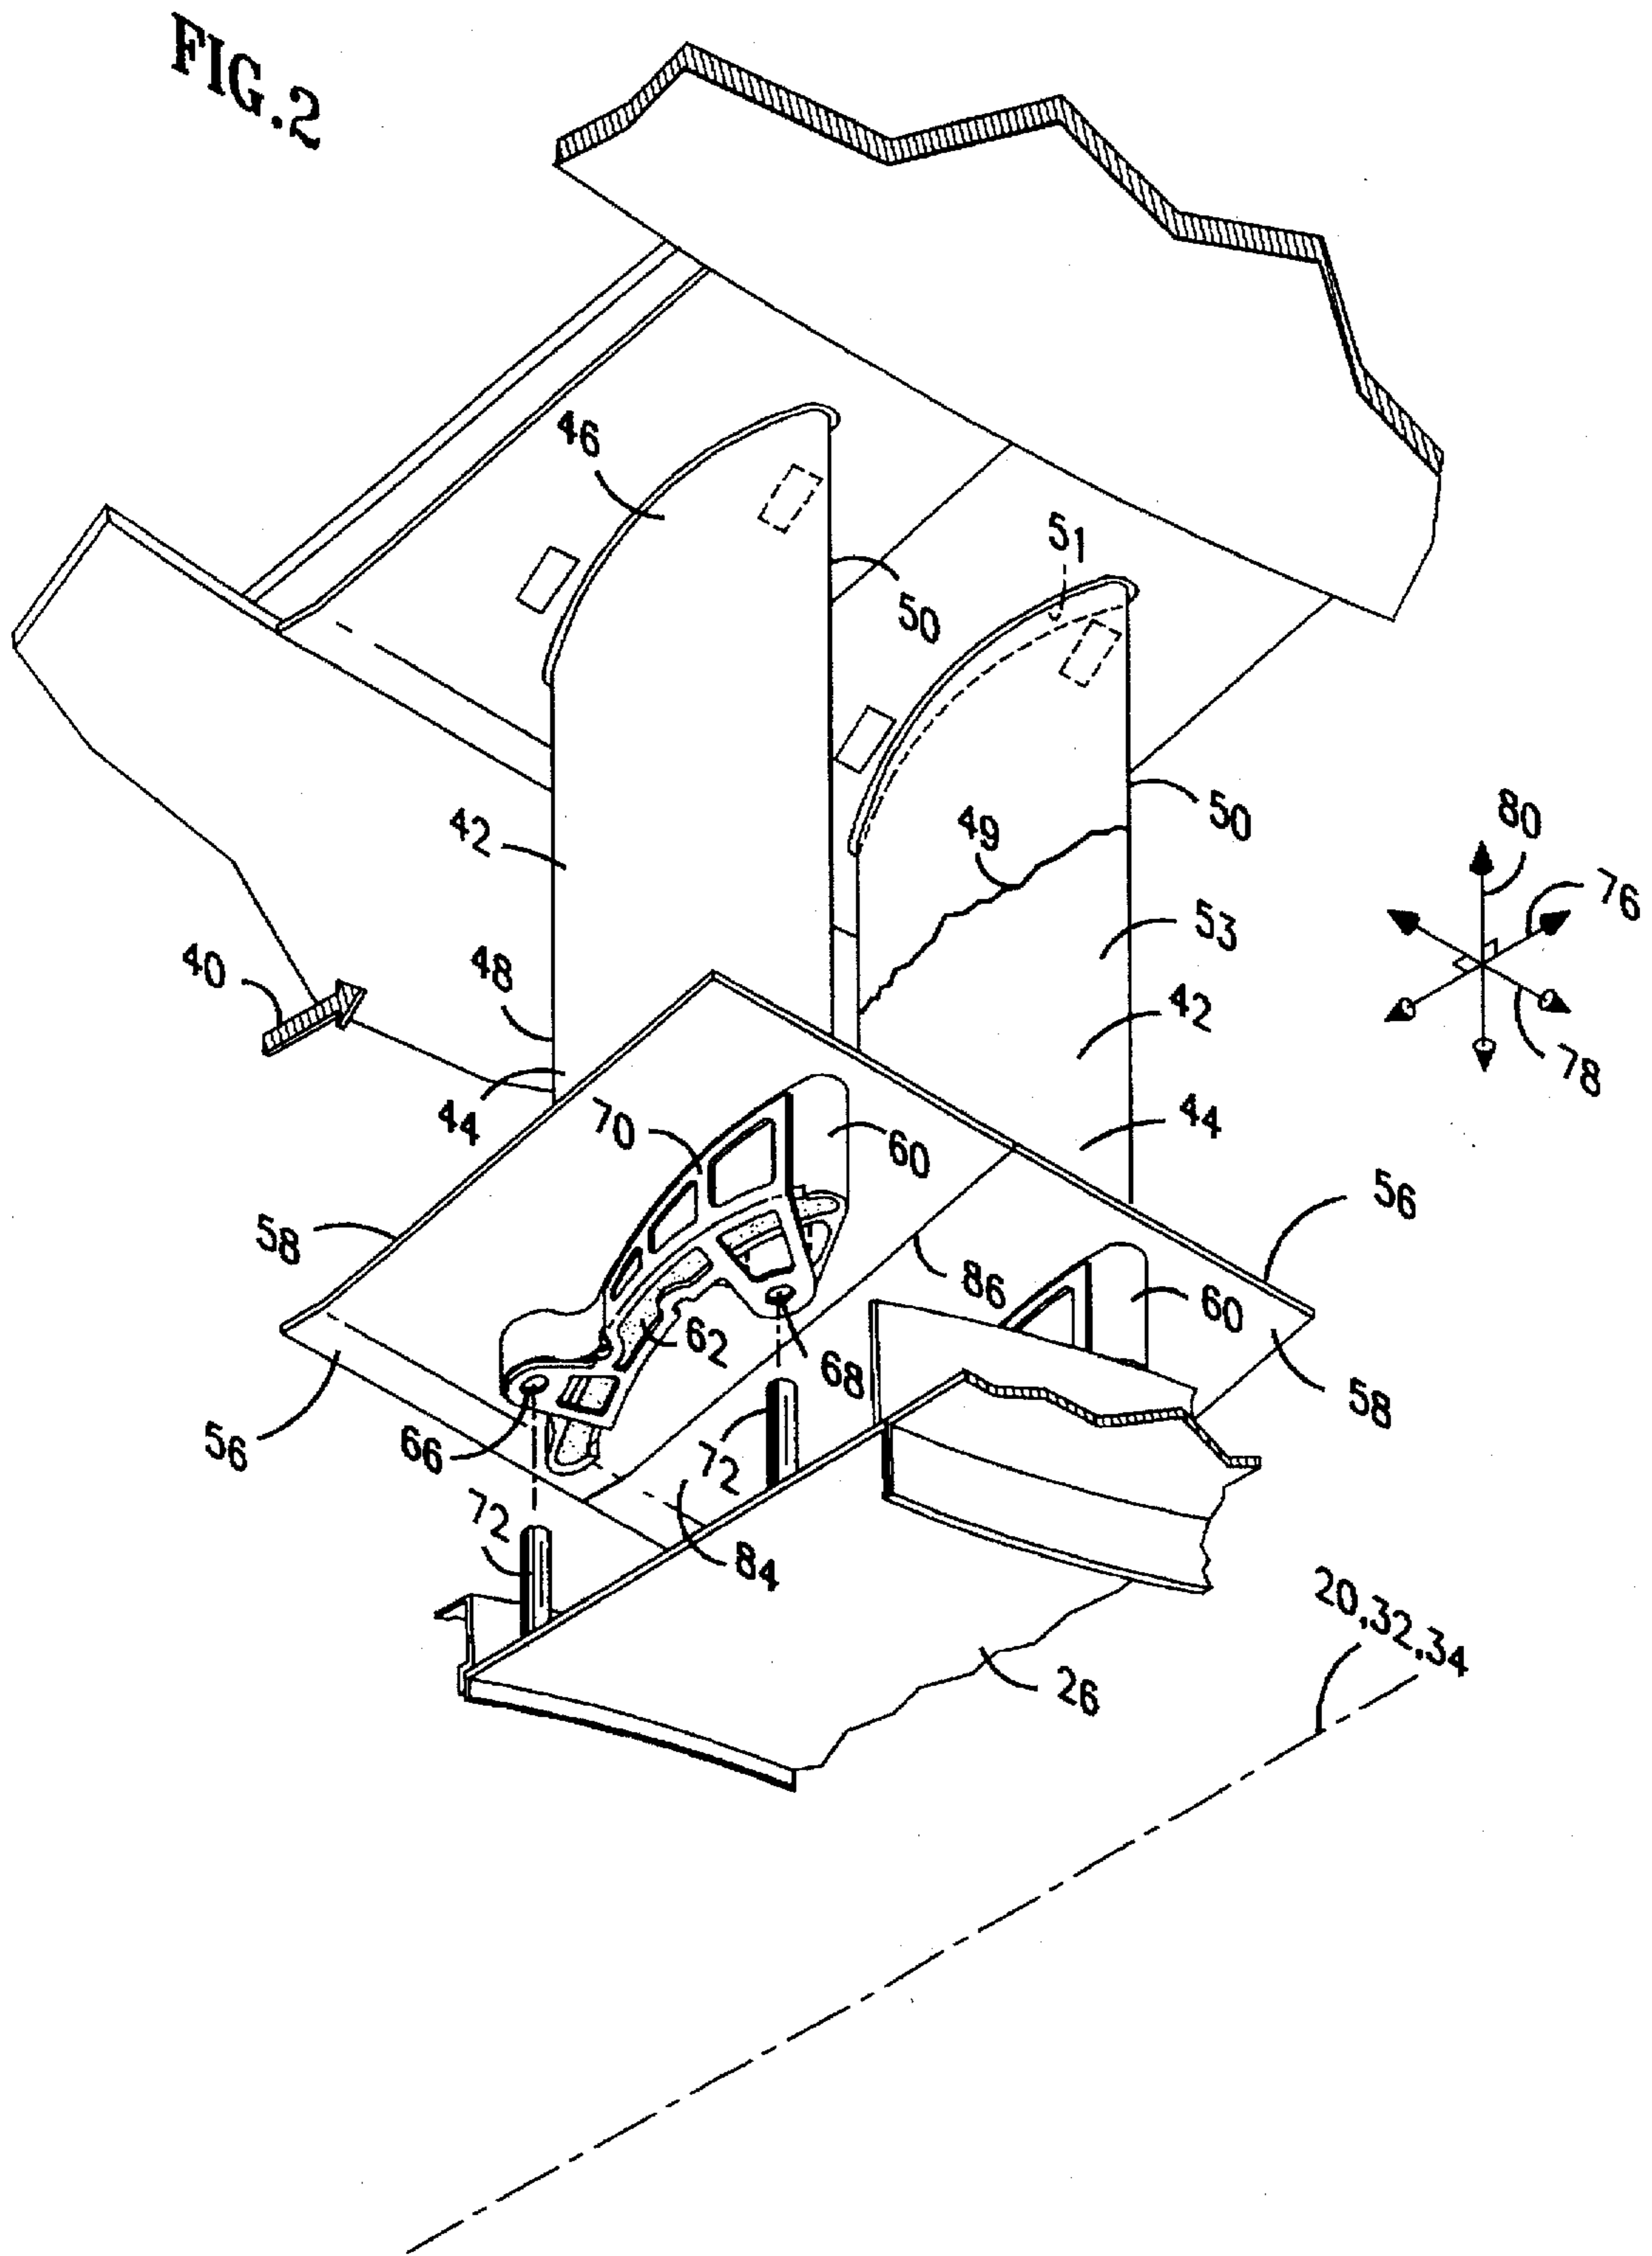
FIG. 3 is a partially exploded perspective view showing a portion of the fan section of a turbine engine including a fan exit guide vane assembly and the means by which the guide vane assembly is secured to an outer case.

Additional features of the vane assemblies are visible in FIGS. 2 and 3. Each vane assembly includes an airfoil 42 having an inner end 44 an outer end 46, a leading edge 48 and a trailing edge 50. Each vane assembly also includes a nonmetallic inner base 56 having a platform 58 and a sleeve 60 with a resilient polyurethane material 62 disposed therein. The inner end of the airfoil extends into the polyurethane material which damps airfoil vibrations and grips the inner end of the airfoil to attach the airfoil to the inner base. As discussed more fully in U.S. Pat. No. 5,411,370, the inner base also includes front and rear pin receptor sockets 66, 68 containing a polyurethane or silicone rubber material and a metallic shoe 70 which protects the base in the event of abnormal engine vibration. Each receptor socket corresponds to a support pin 72 extending radially outwardly from the inner case 26 (the view of FIG. 2 is slightly exploded so that the pins and receptor sockets are visible).

When fully assembled, each support pin engages its receptor socket to secure the inner base, and therefore the vane assembly, to the inner case, so that the base is radially spaced from the inner case to accommodate thermal expansion and contraction. The pinned connection secures the base to the inner case so that axial displacement (parallel to the engine axis as indicated by direction 76) and lateral displacement (tangent to the case as indicated by direction 78) are resisted while radial (direction 80) separation between the vane assembly and the case is unrestricted. Typically, a foam seal, not shown, is installed in the cavity 84 bounded by the inner case, the abutting platforms of neighboring inner bases and the sleeves associated with the neighboring inner bases. The foam seal minimizes leakage of air from the flowpath through seam 86 between abutting platforms.

The vane assembly also includes an outer base 90. The outer base has a platform 92 and a sleeve 94 with a polyurethane material 96 disposed therein. The outer end of the airfoil extends into the polyurethane material which damps airfoil vibrations and grips the outer end of the airfoil to attach the airfoil to the outer base. Stud 98 project radially outward from the outer base and extend through holes 100 in the outer case 28. (the view of FIG. 3 is slightly exploded so that the outer sleeve and studs are visible). Nuts 102 threaded onto the studs positively secure the outer base, and therefore the outer end of the vane assembly, to the outer case. A foam seal, not shown, is typically installed in the cavity 104 bounded by the outer case, the abutting platforms of neighboring outer bases and the sleeves associated with the neighboring outer bases. The foam seal minimizes leakage of air from the flowpath through seam 106 between abutting platforms.

According to the present invention, use of the above described repair kit substantially simplifies the replacement of an unserviceable vane assembly. As best appreciated by reference to FIGS. 2 and 3 an unserviceable vane assembly is removed from a vane array in a turbine engine by severing the airfoil from its leading edge **48** to its trailing edge **50** (for example along line **49**), removing the nuts **102** to disconnect the resulting outer stub **51** and outer base from the outer case, and sliding the inner stub **53** and inner base off the support pins.

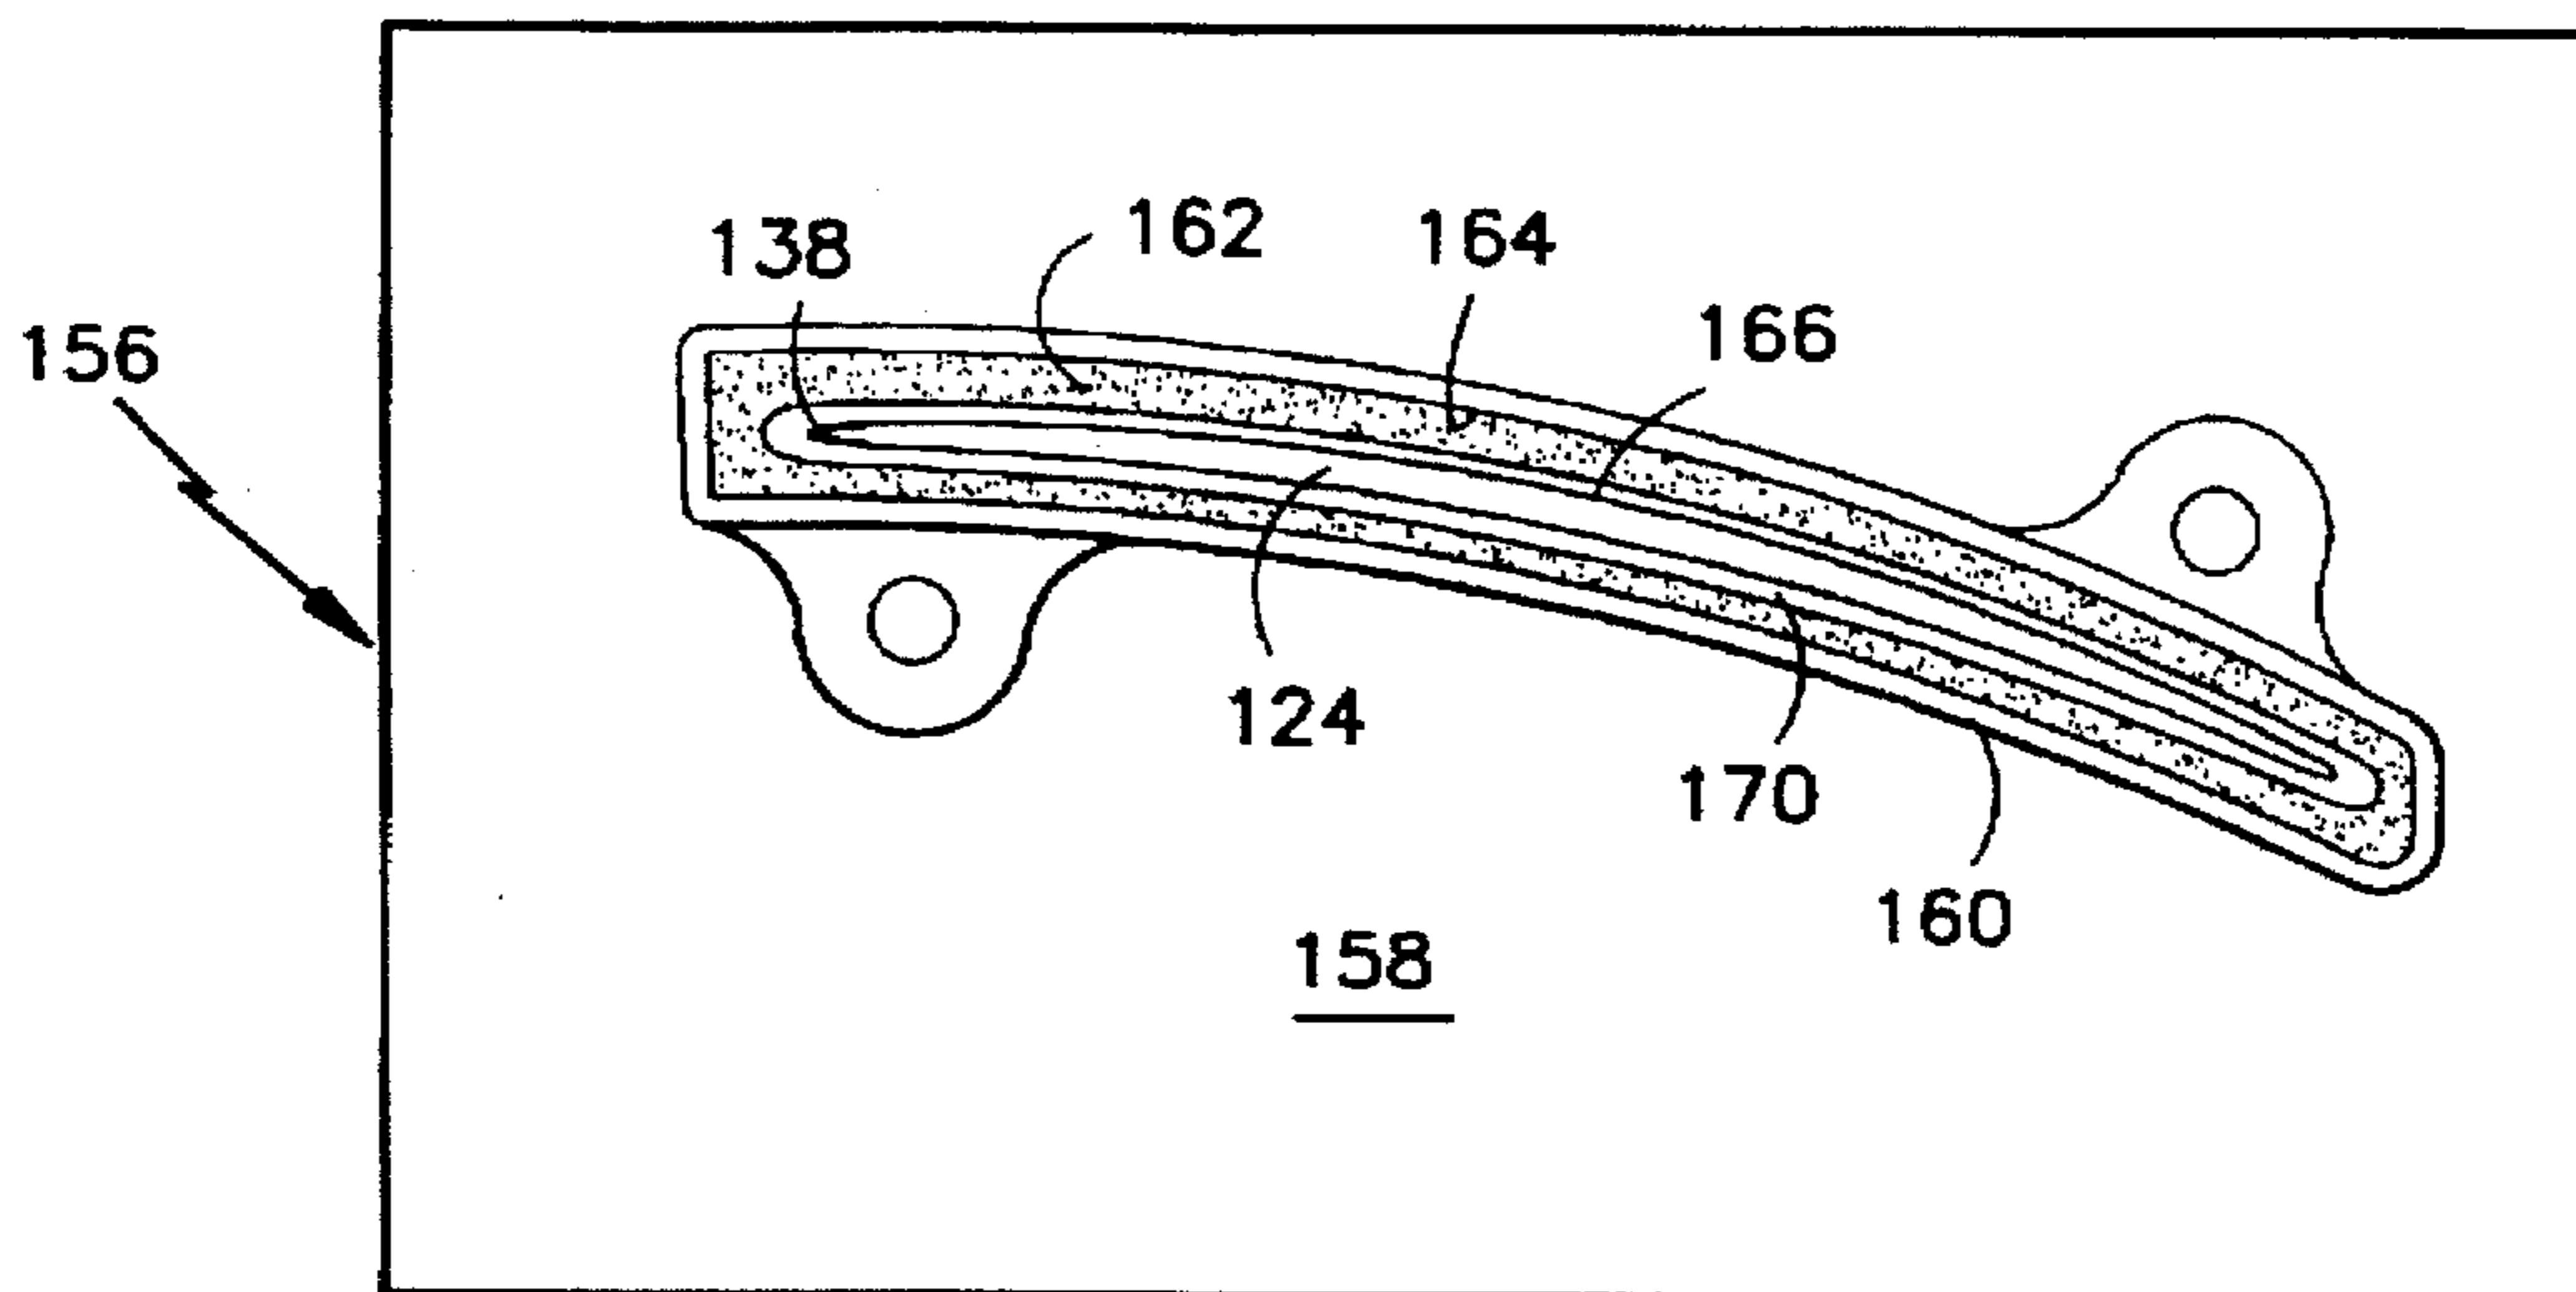
FIG. 6 is a plan view, taken essentially in the direction 6—6 of FIG. 5 showing further details of the opposing base.

Referring now to FIGS. 5, 6 and 7, a repair kit for substantially simplifying the replacement of an unserviceable fan exit guide vane assembly is illustrated. The repair kit includes a serviceable vane subassembly **120** comprising a serviceable airfoil **124** having a leading edge **126** a trailing edge **128**, a tip end **130**, a root end **132** and a nonmetallic base **134** attached to the root end. The airfoil is a resin impregnated carbon fiber compression molded airfoil having an erosion resistant coating and a stainless steel erosion guard **138** extending along the leading edge. The airfoil may, however, be made of aluminum or any other suitable material. The chord **C** (FIG. 7) of the airfoil extends generally from the leading edge to the trailing edge and the span **S** of the airfoil extends generally from the root to the tip. The attached base **134** has a platform **140** and a sleeve **142** with a resilient polyurethane vibration damping material **144** disposed therein. The root end of the serviceable airfoil extends into the polyurethane material which grips the root end to attach the serviceable airfoil to the base and to damp vibrations of the airfoil. The attached base also includes front and rear pin receptor sockets **148**, **150** containing a polyurethane or silicone rubber material and a metallic shoe **152** which protects the base in the event of abnormal engine vibration. The repair kit also includes an opposing base **156** comprising a platform **158** and a sleeve **160**. A polyurethane vibration damping material **162** (FIG. 6) is bonded to interior wall **164** of the sleeve leaving an opening **166** which is slightly larger than but generally of the same shape as the serviceable airfoil **124**. The opposing base **156** is unattached to the serviceable airfoil but, because opening **166** is larger than the airfoil, is slidingly engagable with the airfoil. That is, the opposing base can be slipped over the tip end of the airfoil and slid in the spanwise direction toward the attached base **134** so that the tip end of the airfoil projects through and is embraced by the sleeve. When so engaged, the damping material in the sleeve cooperates with the serviceable airfoil to define a peripheral gap **170** around the perimeter of the airfoil.

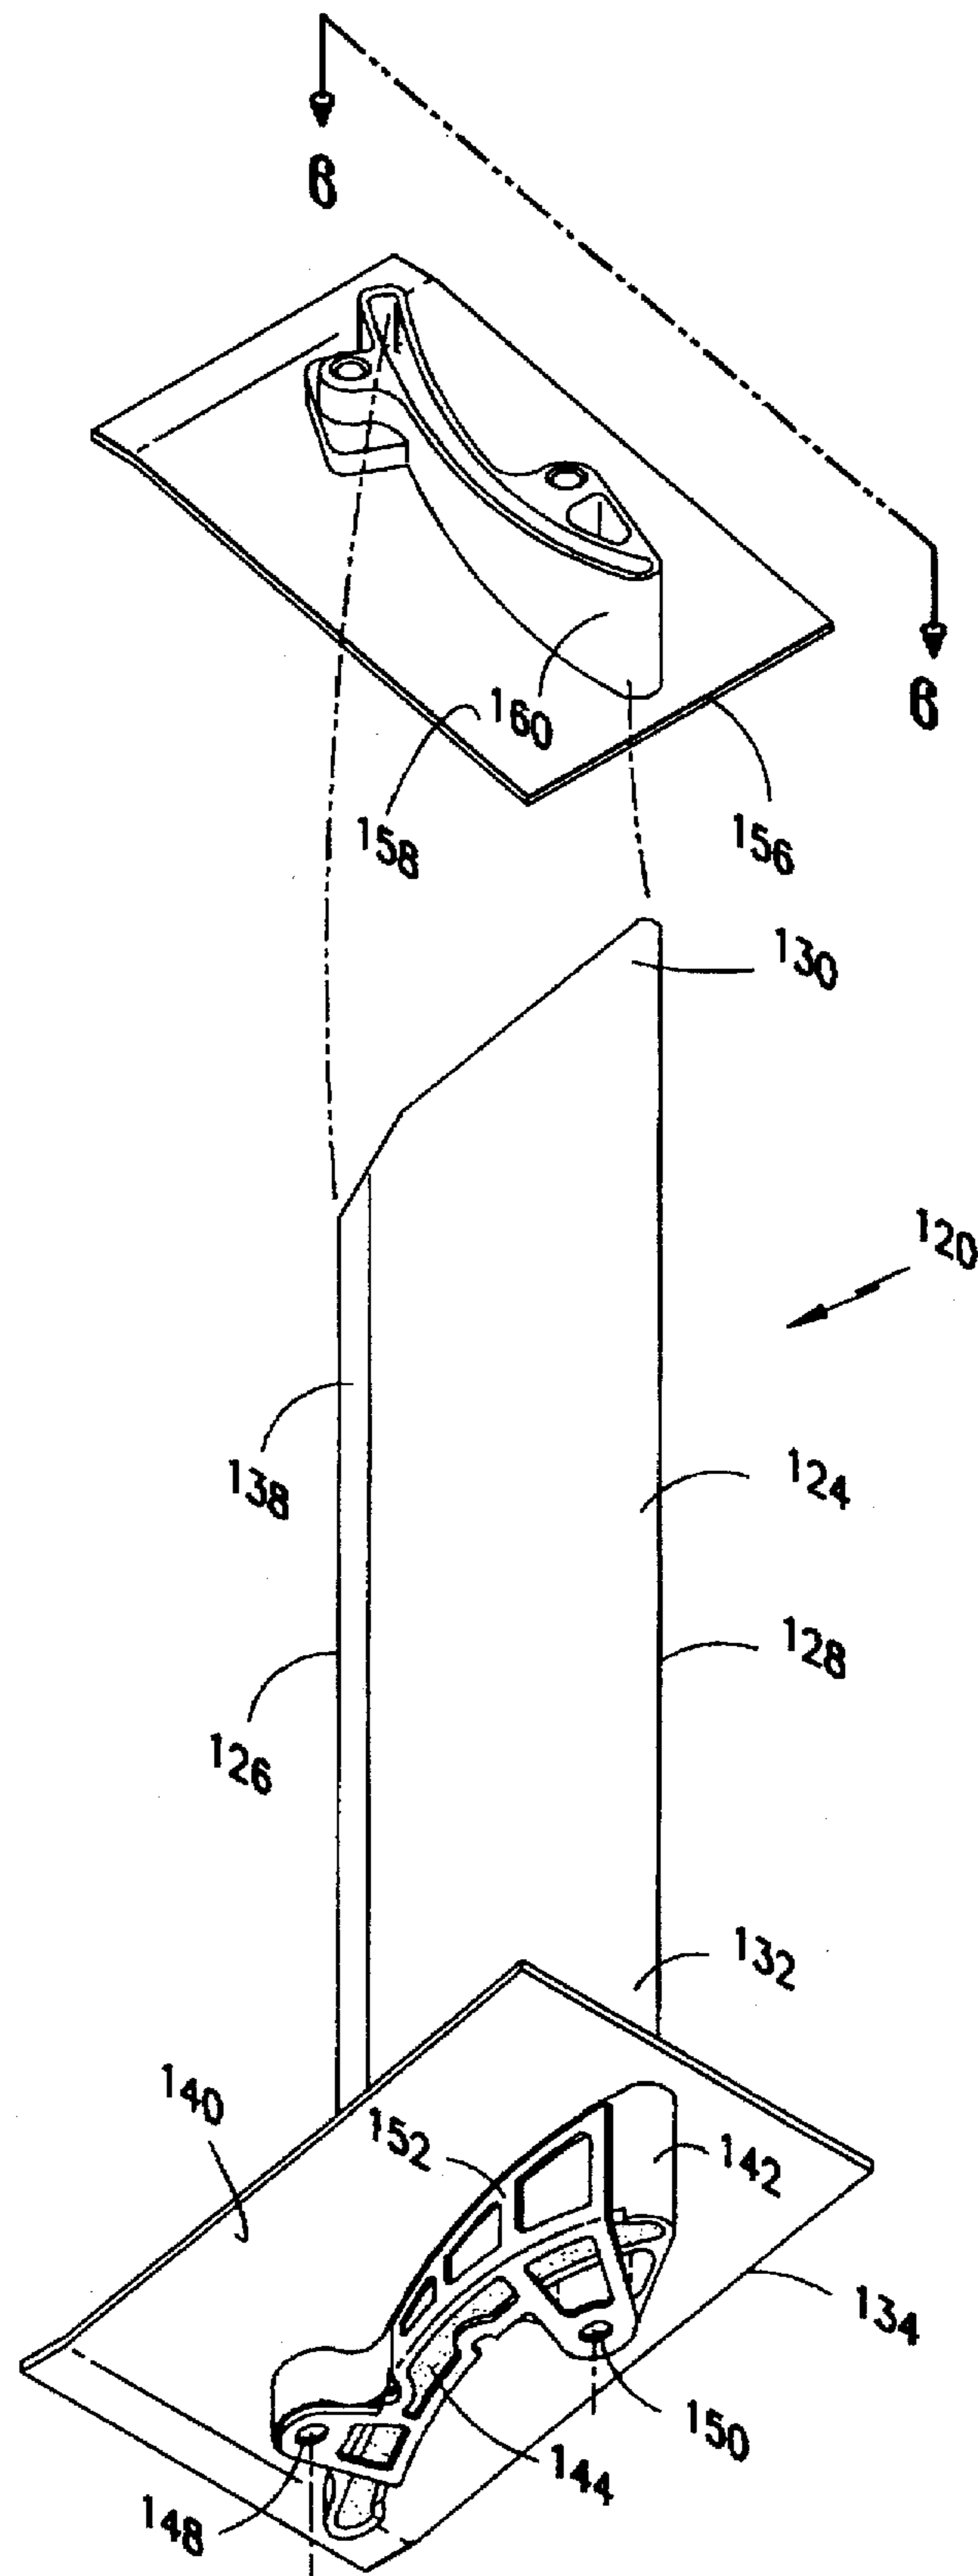
FIG. 7 is a side view of a serviceable vane subassembly of the present invention.

The tip of the serviceable airfoil, unlike that of the prior art airfoil, has a tapered region **174** from approximately 28% chord to 100% chord (i.e. to the trailing edge) so that the trailing edge span S_T is approximately 97% as great as the leading edge span S_L . In addition, the span of the leading edge of the serviceable airfoil is approximately 98% of the leading edge span of an unserviceable airfoil. As explained more fully below, the taper and reduced span of the serviceable airfoil facilitate the installation of the serviceable vane subassembly into the vane array.

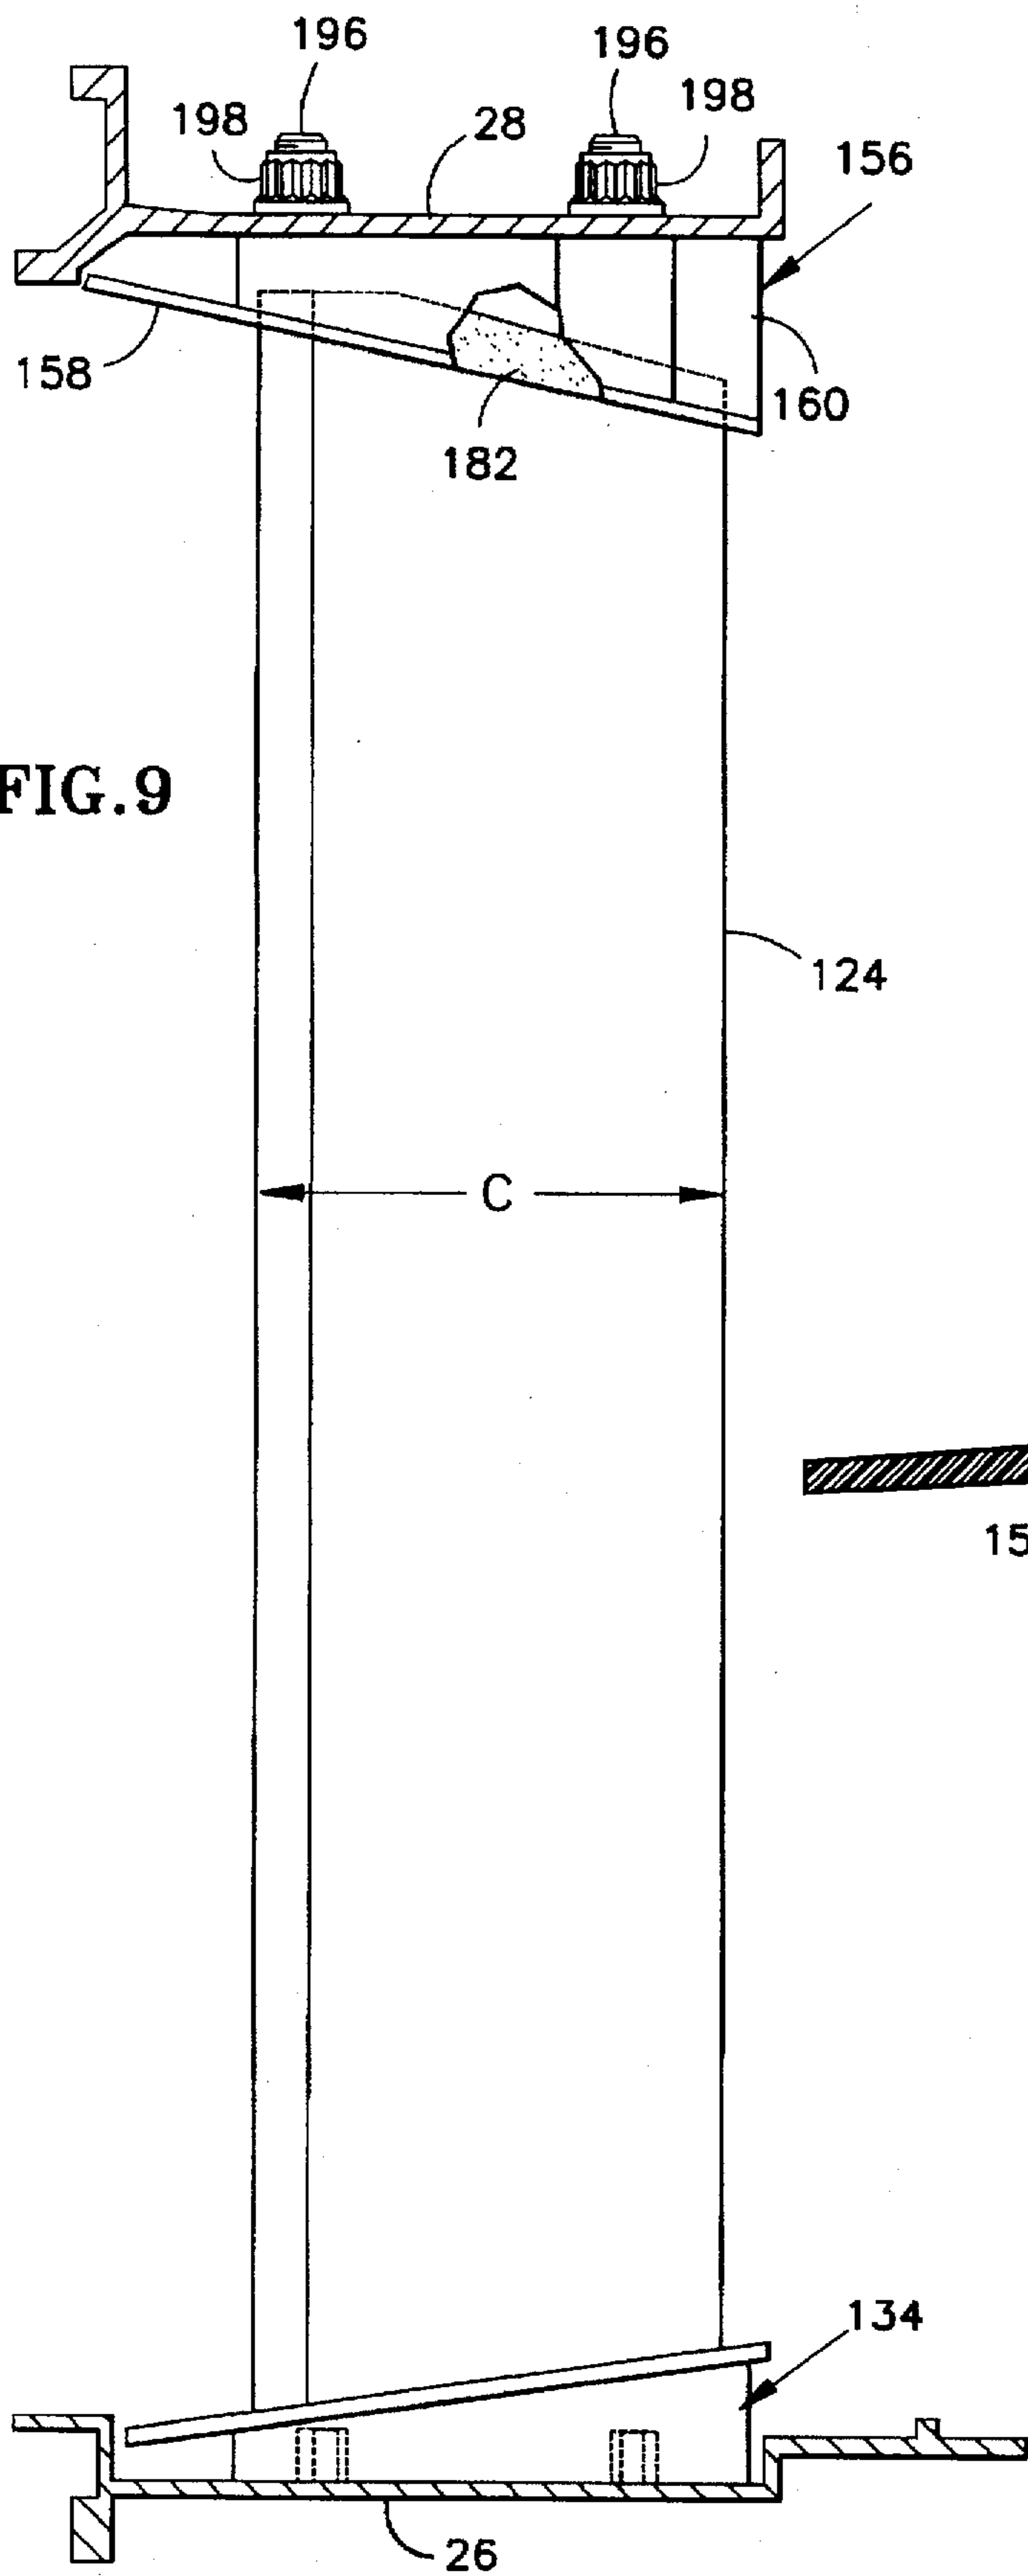
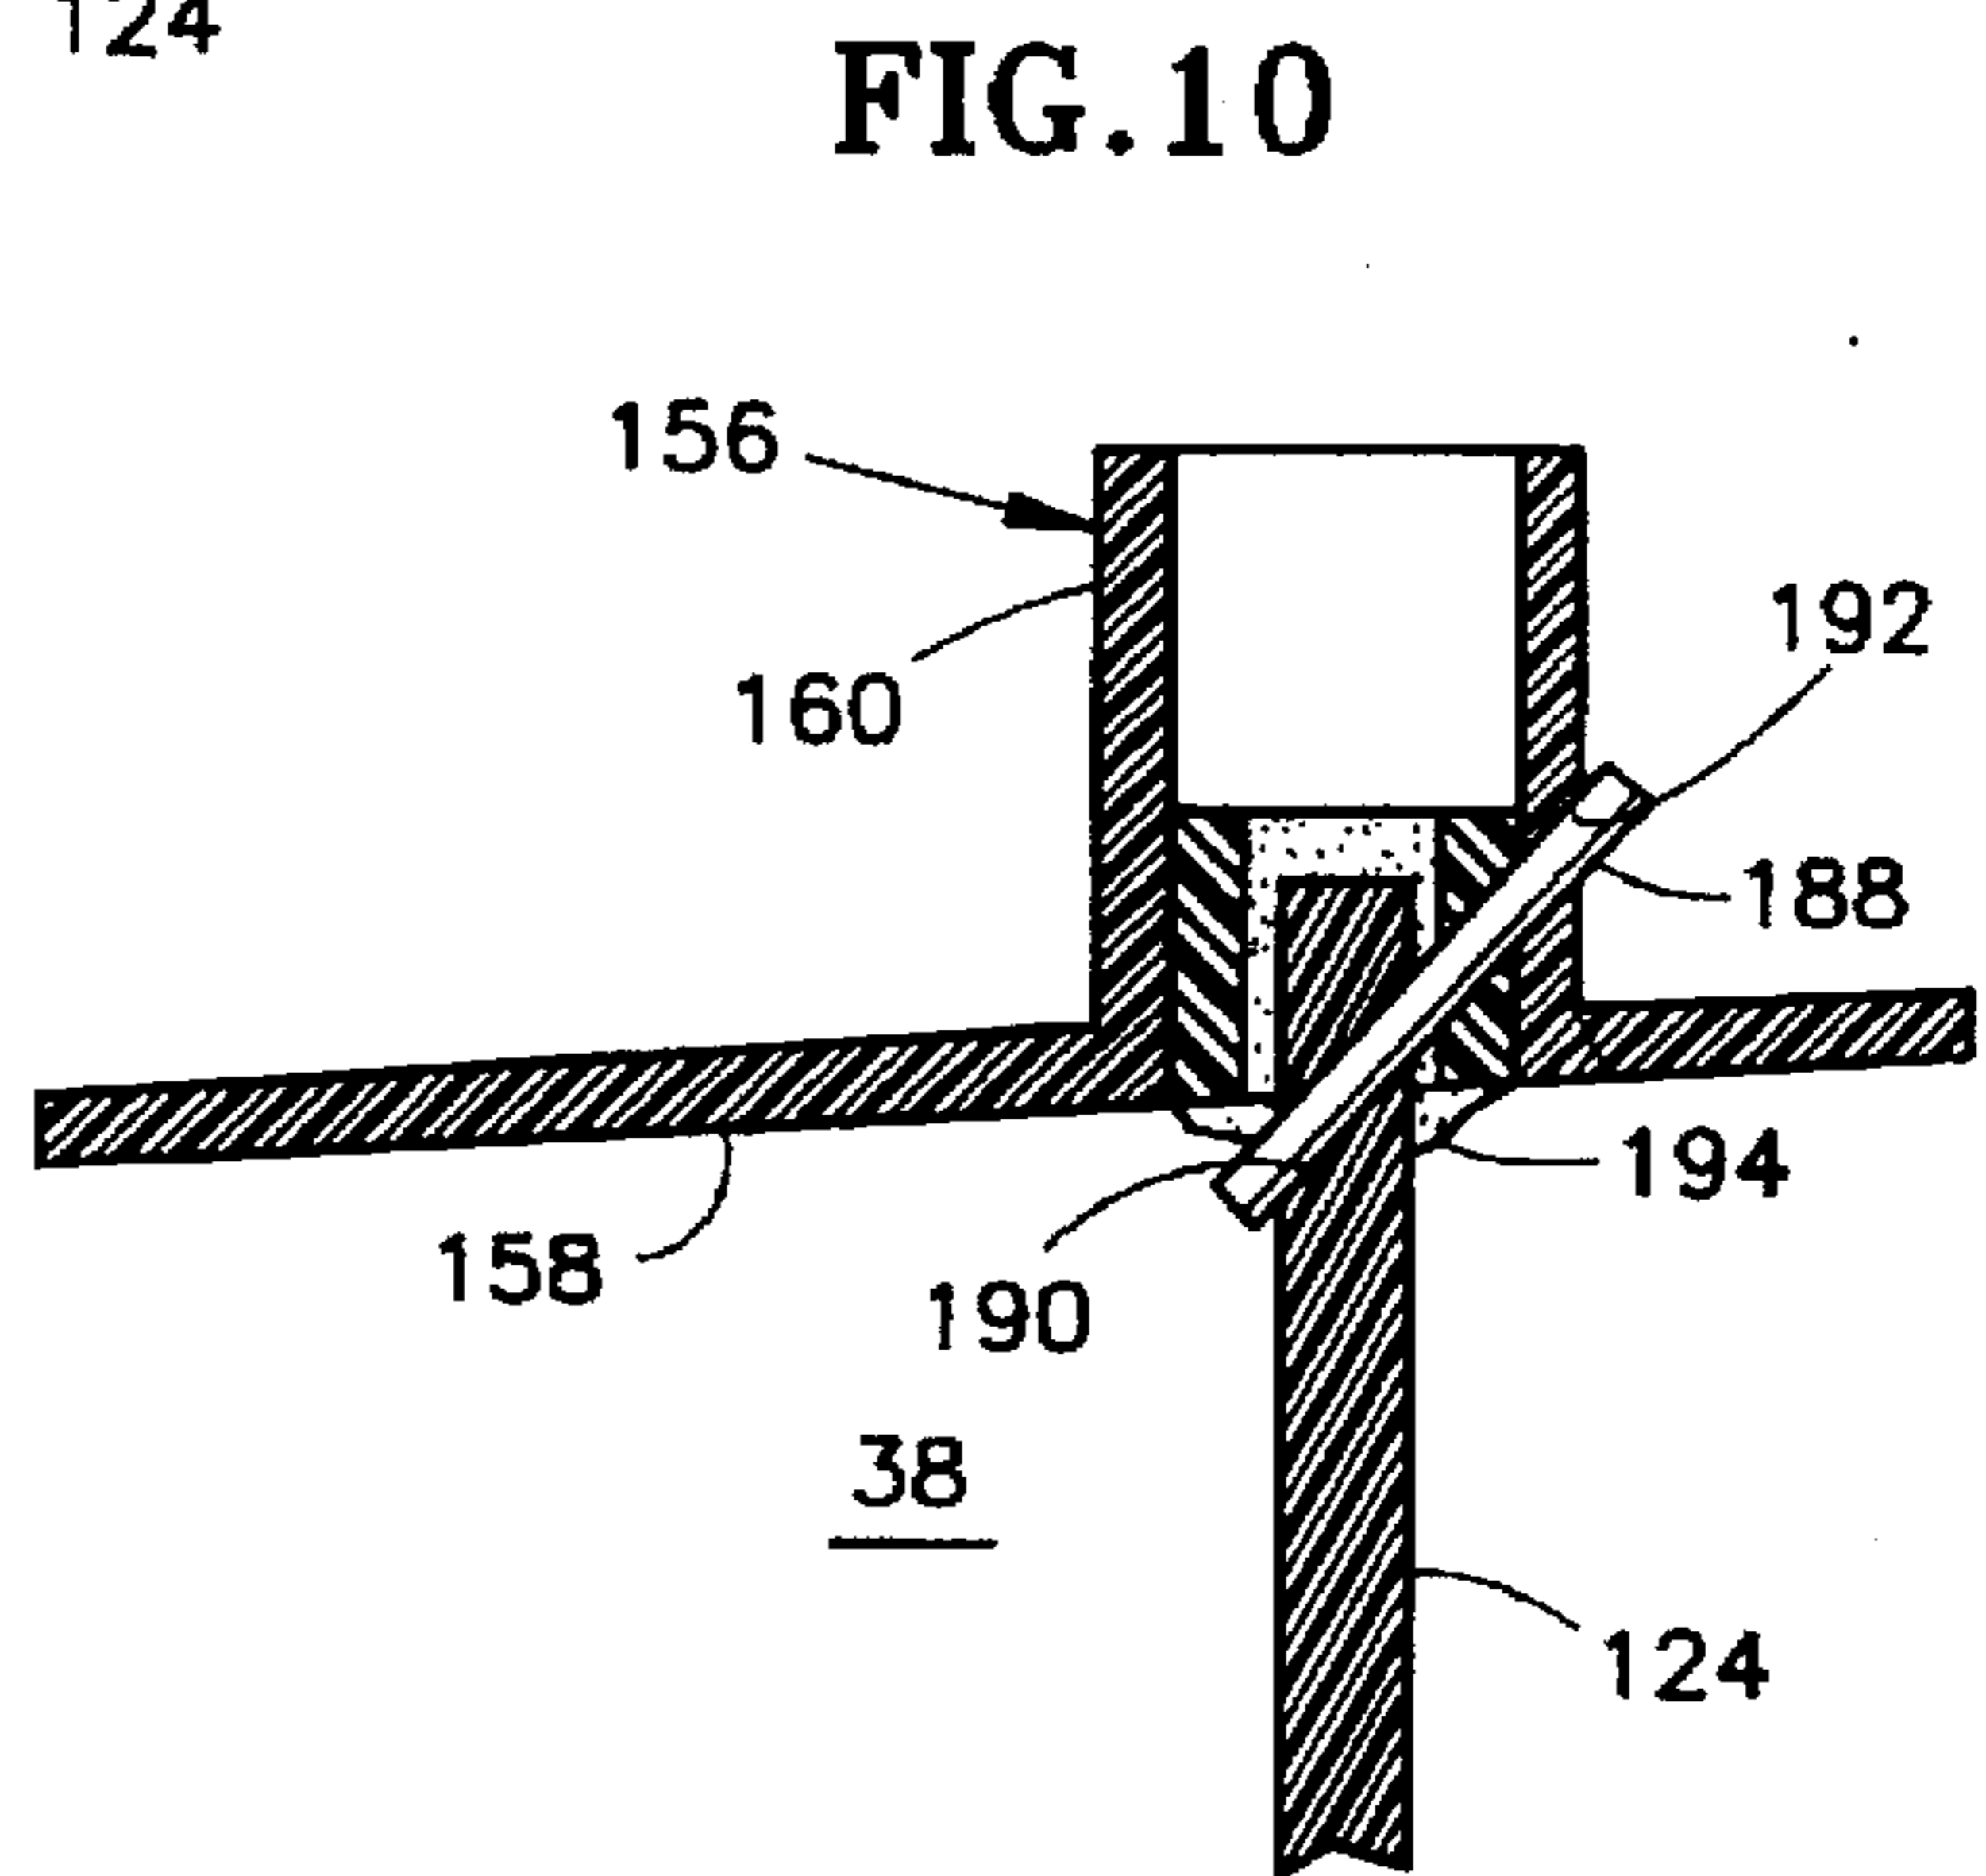
FIG. 10 is a view taken parallel to the engine axis showing a retaining pin projecting through a hole in the outer end of a serviceable airfoil and into an opposing base.

Once the subassembly has been pivoted into position between the inner and outer cases, the opposing base is translated radially outward toward the tip end of the airfoil so that the adhesive **182**, which cures in approximately four hours at 21 degrees C. (70 degrees F.), bonds the airfoil to the damping material **162** (FIG. 6) and therefore attaches the base to the airfoil. In the preferred embodiment a mask **184** is applied to the outer case prior to translating the opposing base radially outward. The mask may be a polyester film masking tape or any other mask which adheres nonpermanently to the case. Any adhesive **182** which is squeezed out of the peripheral gap **170** (FIG. 6) during the radially outward translation of the outer base contacts the tape rather than the outer case. Thus, the mask guards against the formation of an adhesive bond between the opposing base or airfoil and the outer case, thereby ensuring that the airfoil and the opposing base can, if necessary, be subsequently disassembled from the outer case. A retainer, which in the preferred embodiment is a metallic peg **188**, is inserted into holes **190**, **192** in the airfoil and opposing base so that the peg protrudes slightly into the fan flowpath **38** (FIG. 10).
