FAILED MEMORY CELL REPAIR CIRCUIT OF SEMICONDUCTOR MEMORY

BACKGROUND OF THE INVENTION

1. Field of the Invention

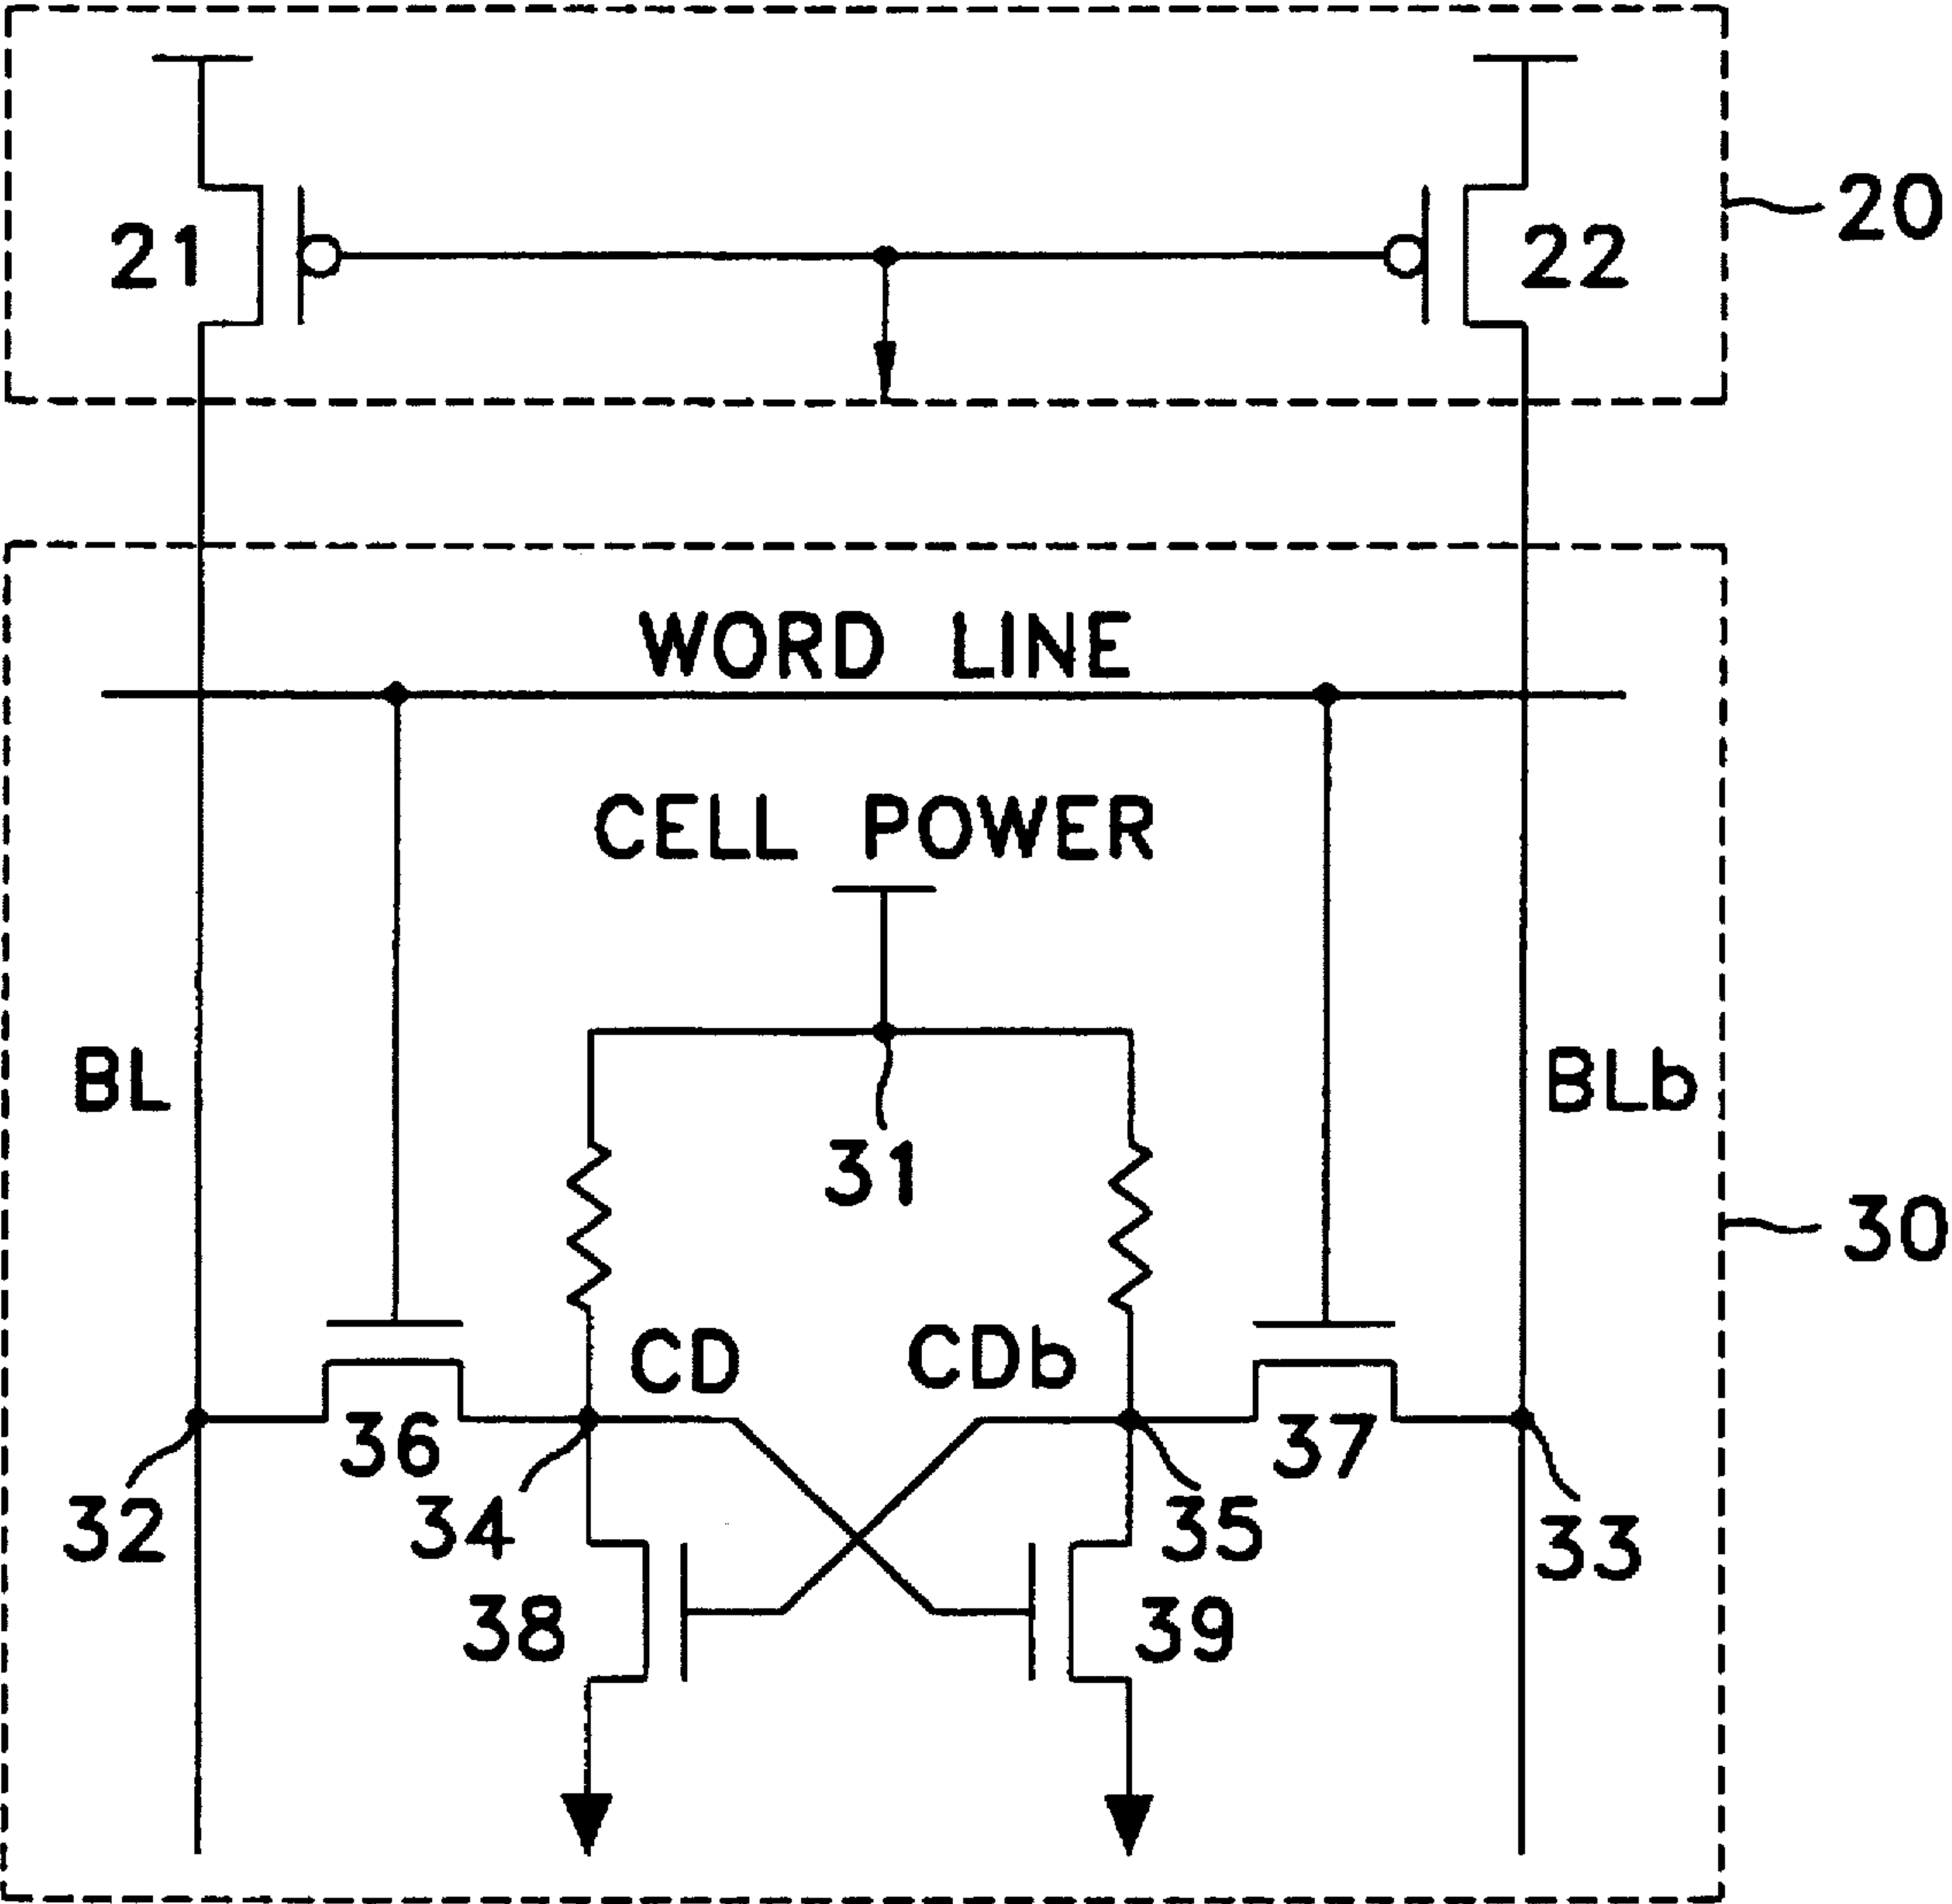
(PRIOR ART)
FIG. 1

Second, the case where the standby current failure occurs within the memory cell array will be explained with reference to FIG. 1. FIG. 1 is a circuit diagram illustrating a memory cell structure in a typical static random access memory. In a memory cell 30, nodes connected to current sources which may generate the standby current failure are bit line pair BL and BLb (nodes 32 and 33, respectively) and a cell power node 31. Since the node 31 receiving the cell power is connected to a high resistance load or a current limit means, an extremely limited data maintaining current is supplied to cell nodes CD and CDb (34 and 35 appearing at the drain terminals of access transistors 36 and 37, respectively.) Moreover, the current sources connected to the bit line pair BL and BLb nodes 32 and 33 are supplied to the bit lines by the precharge circuit 20 for maintaining the bit lines at a given voltage in a standby state. Where the current source flowing to the bit lines causes the standby current failure, a circuit diagram for repairing the standby current failure is shown in FIG. 2, which is disclosed in U.S. Pat. No. 4,587,639.

FIG. 1 is a circuit diagram illustrating a structure of a memory cell in a typical static random access memory;

However, while the circuit of FIG. 2 prohibits the operation of the bit line precharge circuit 20 in the failed column, there remains a problem in that a standby current failure occurring at an individual cell power node (31 of FIG. 1) can continue to draw current. Therefore, in order to solve this problem, another prior art standby current cell repair circuit 60 is shown in FIG. 3, and disclosed in U.S. Pat. No. 4,639,895. Referring now to FIG. 3, another standby current failed cell repair circuit 60 includes a series of transmission transistors, each of which transmits a supply voltage in response to a common control signal Pb of a logic "low" state, and a series of fuses, e.g. fuse F21, each connected in series between a respective one of the transmission transistors and a corresponding one of the cell power lines. Each transmission transistor provides supply power to the corresponding row of memory cells as long as the corresponding fuse remains in met. Repair circuit 60 thus separates cell power lines within the memory cell array by individual rows, or by a specific number of rows, and connects the cell power lines together along each such row. When cell power supplied to a standby current failed memory cell (or the row having the cell) is cut off, the cell(s) no longer draw current at the cell power node. For example, when the row 21 is determined to have a standby current failure, the supply of cell power connected to the memory cells along the row is stopped by blowing open the corresponding fuse F21.

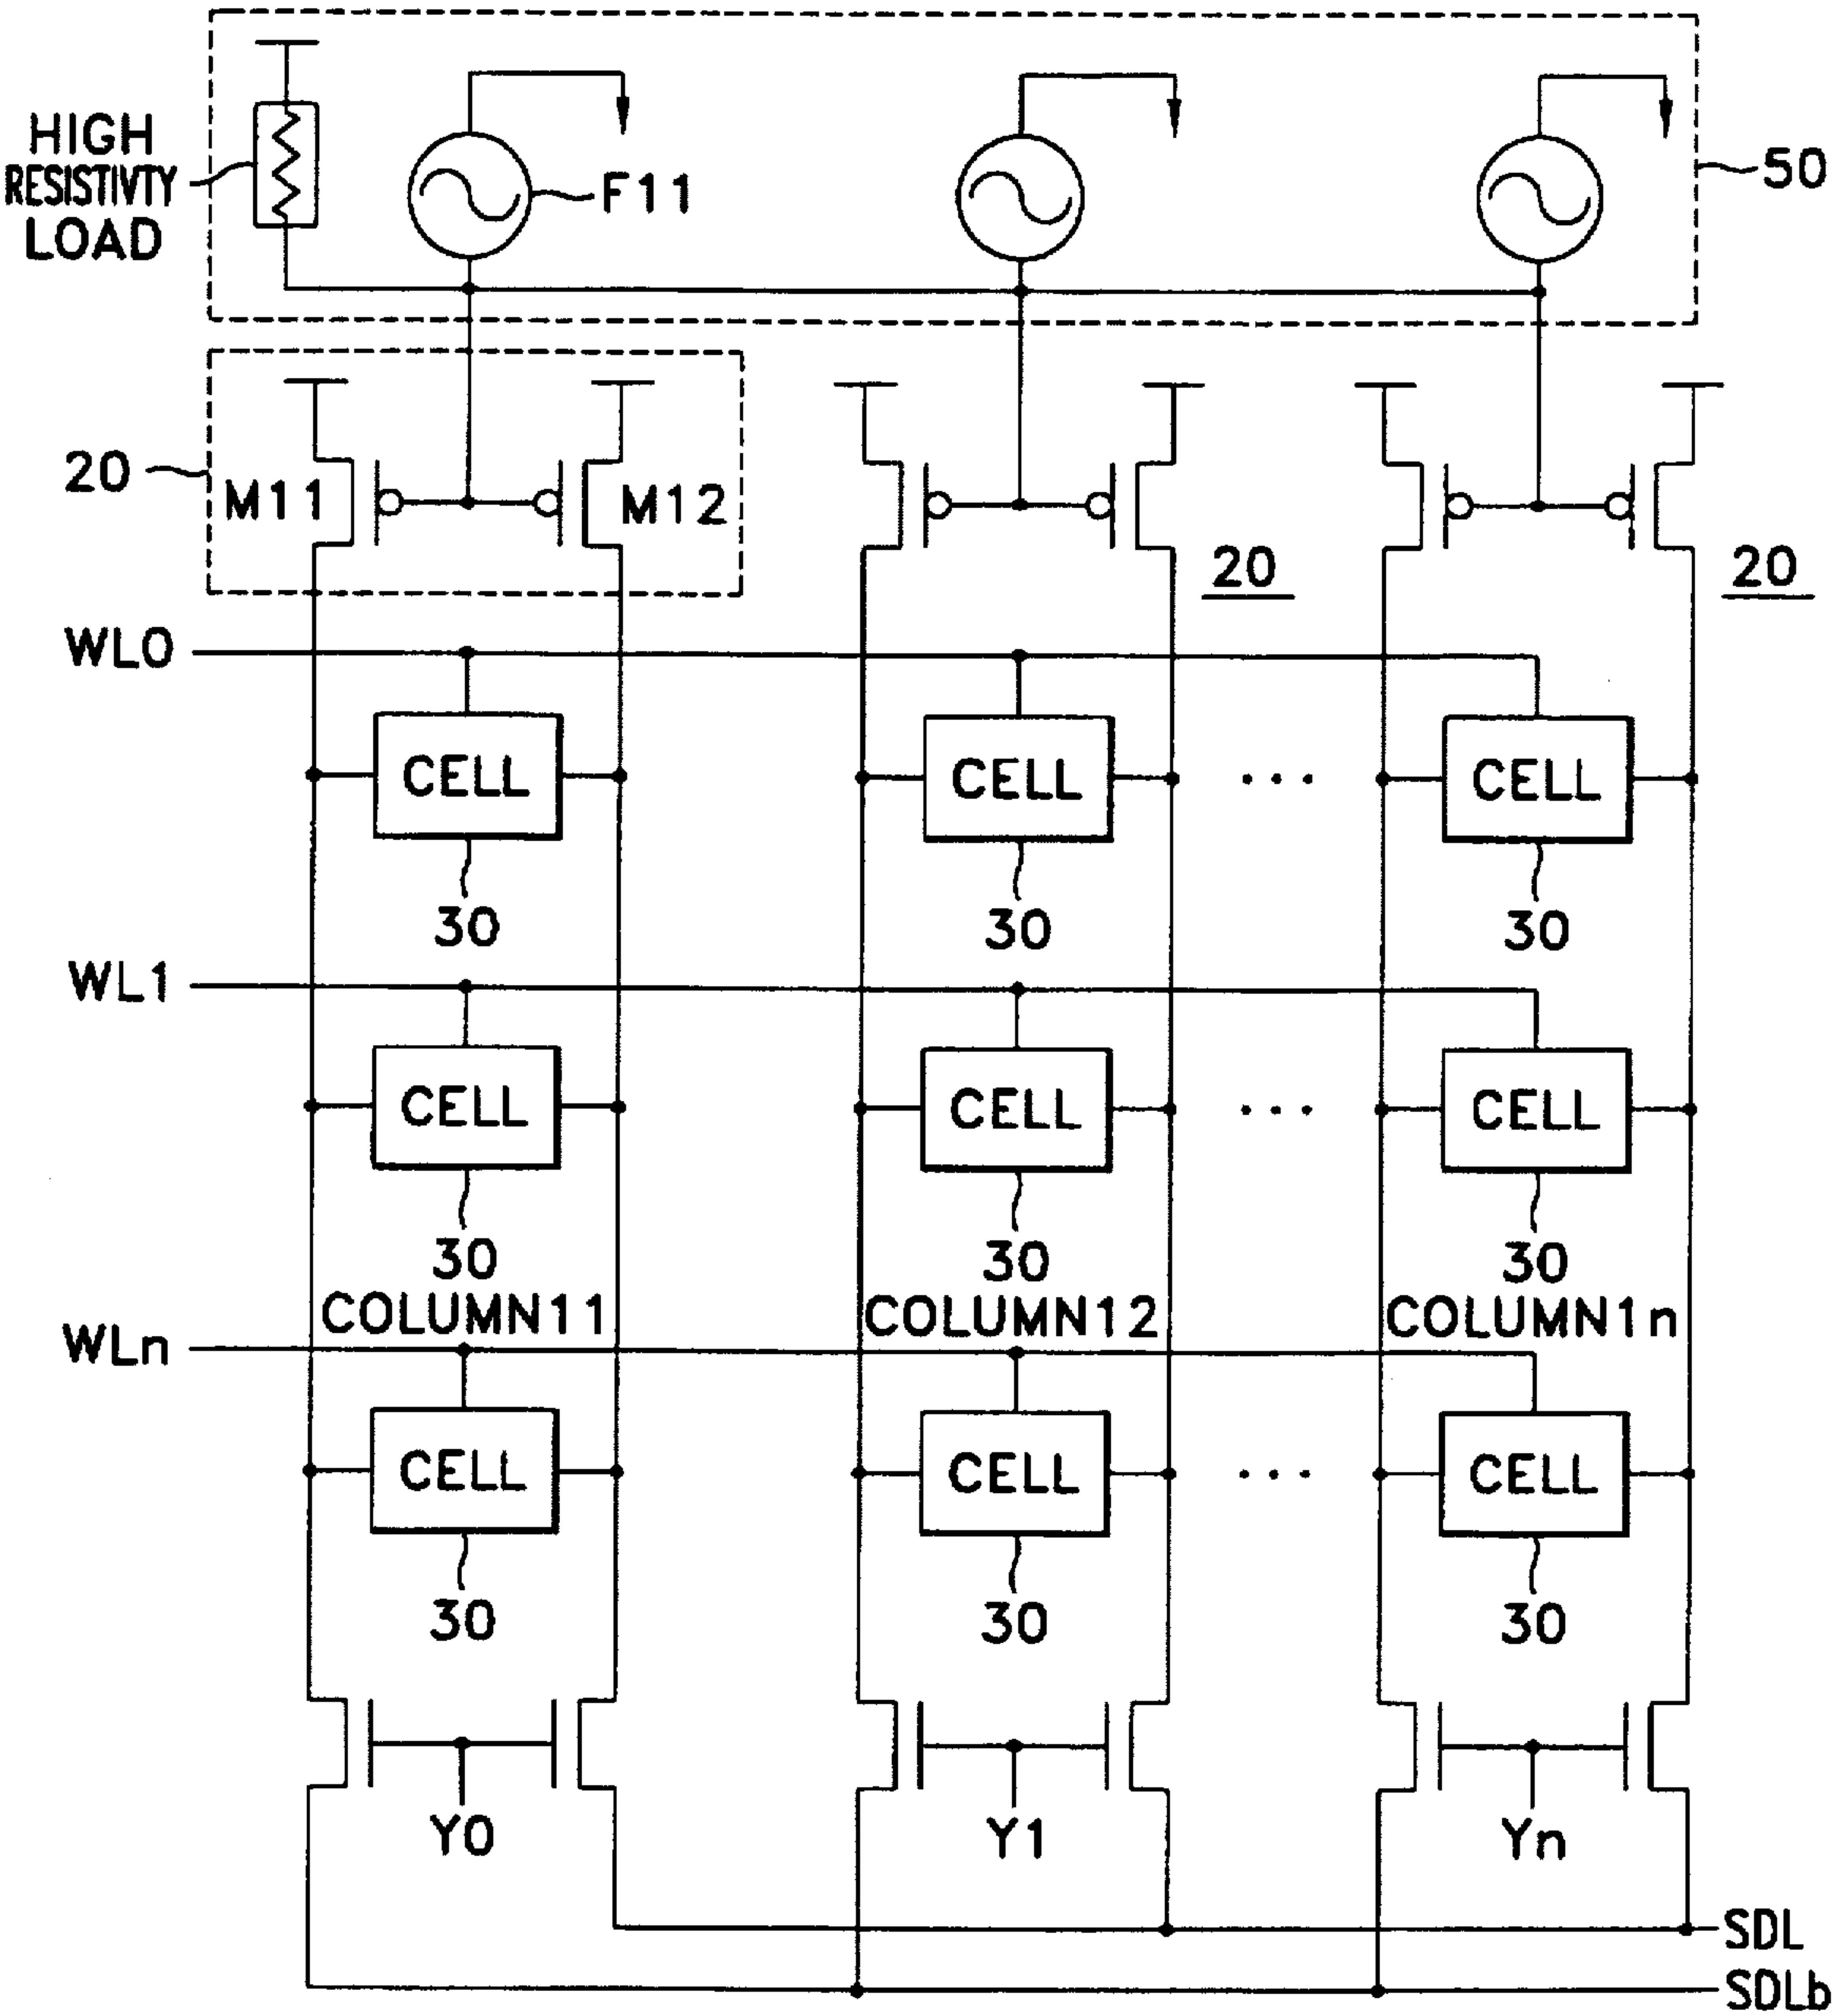
(PRIOR ART)
FIG. 2

FIG. 2 is a circuit diagram illustrating a standby current failure memory cell repair circuit, which is useful where the current sources connected to the bit lines (i.e., the bit line precharge circuit 20) causes the standby current failure. A repair circuit 50 includes a series of fuses, e.g. FI 1, each connected between one terminal of a high resistivity load and a ground potential. Each fuse is connected to a corre-

sponding column in the precharge circuit 20. The repair circuit 50 selectively disables the current sources supplying current to memory cells 30. Specifically, the repair circuit disables the current sources, e.g. M11, M12 that supply current to the column of the array in which a standby current failure occurs. Shutting off the precharge current source prevents abnormal standby current from flowing through the failed column. Of course, the failed column can be replaced by an available redundant column. The circuit in FIG. 2 is different from the typical failed cell repair circuit in that the bit line precharge circuit 20 positioned in the failed column is turned off by the circuit 50.

To illustrate, if the column 11 is determined to have a standby current failure, the fuse F11 connected to the gates of transistors M11 and M12 within the precharge circuit 20 of the column 11 is blown open. This results in a logic "high" level applied to the gates of the bit line precharge circuit 20 corresponding to the failed column, so transistors M11 and M12 are turned off. Accordingly, the current supply to the bit lines of column 11 is stopped.

FIG. 2 is a circuit diagram illustrating a standby current failed cell repair circuit in a conventional memory device;

The circuits of FIGS. 2 and 3, however, do not entirely resolve the standby current failure problem. The repairing operation of FIG. 2 is executed by columns, and addresses only excessive bit line precharge current. The repairing operation of FIG. 3, on the other hand, is executed by row and remedies only excessive cell power node current. Neither approach ensures that all standby current failures are resolved. Moreover, if repairing operations are simultaneously executed in both row and column directions, double repairing operations are required and double fuses and repairing circuits must be provided in the memory device. Such a design of a memory device results in unduly complicated structure and the product yield therefore may be accordingly reduced.

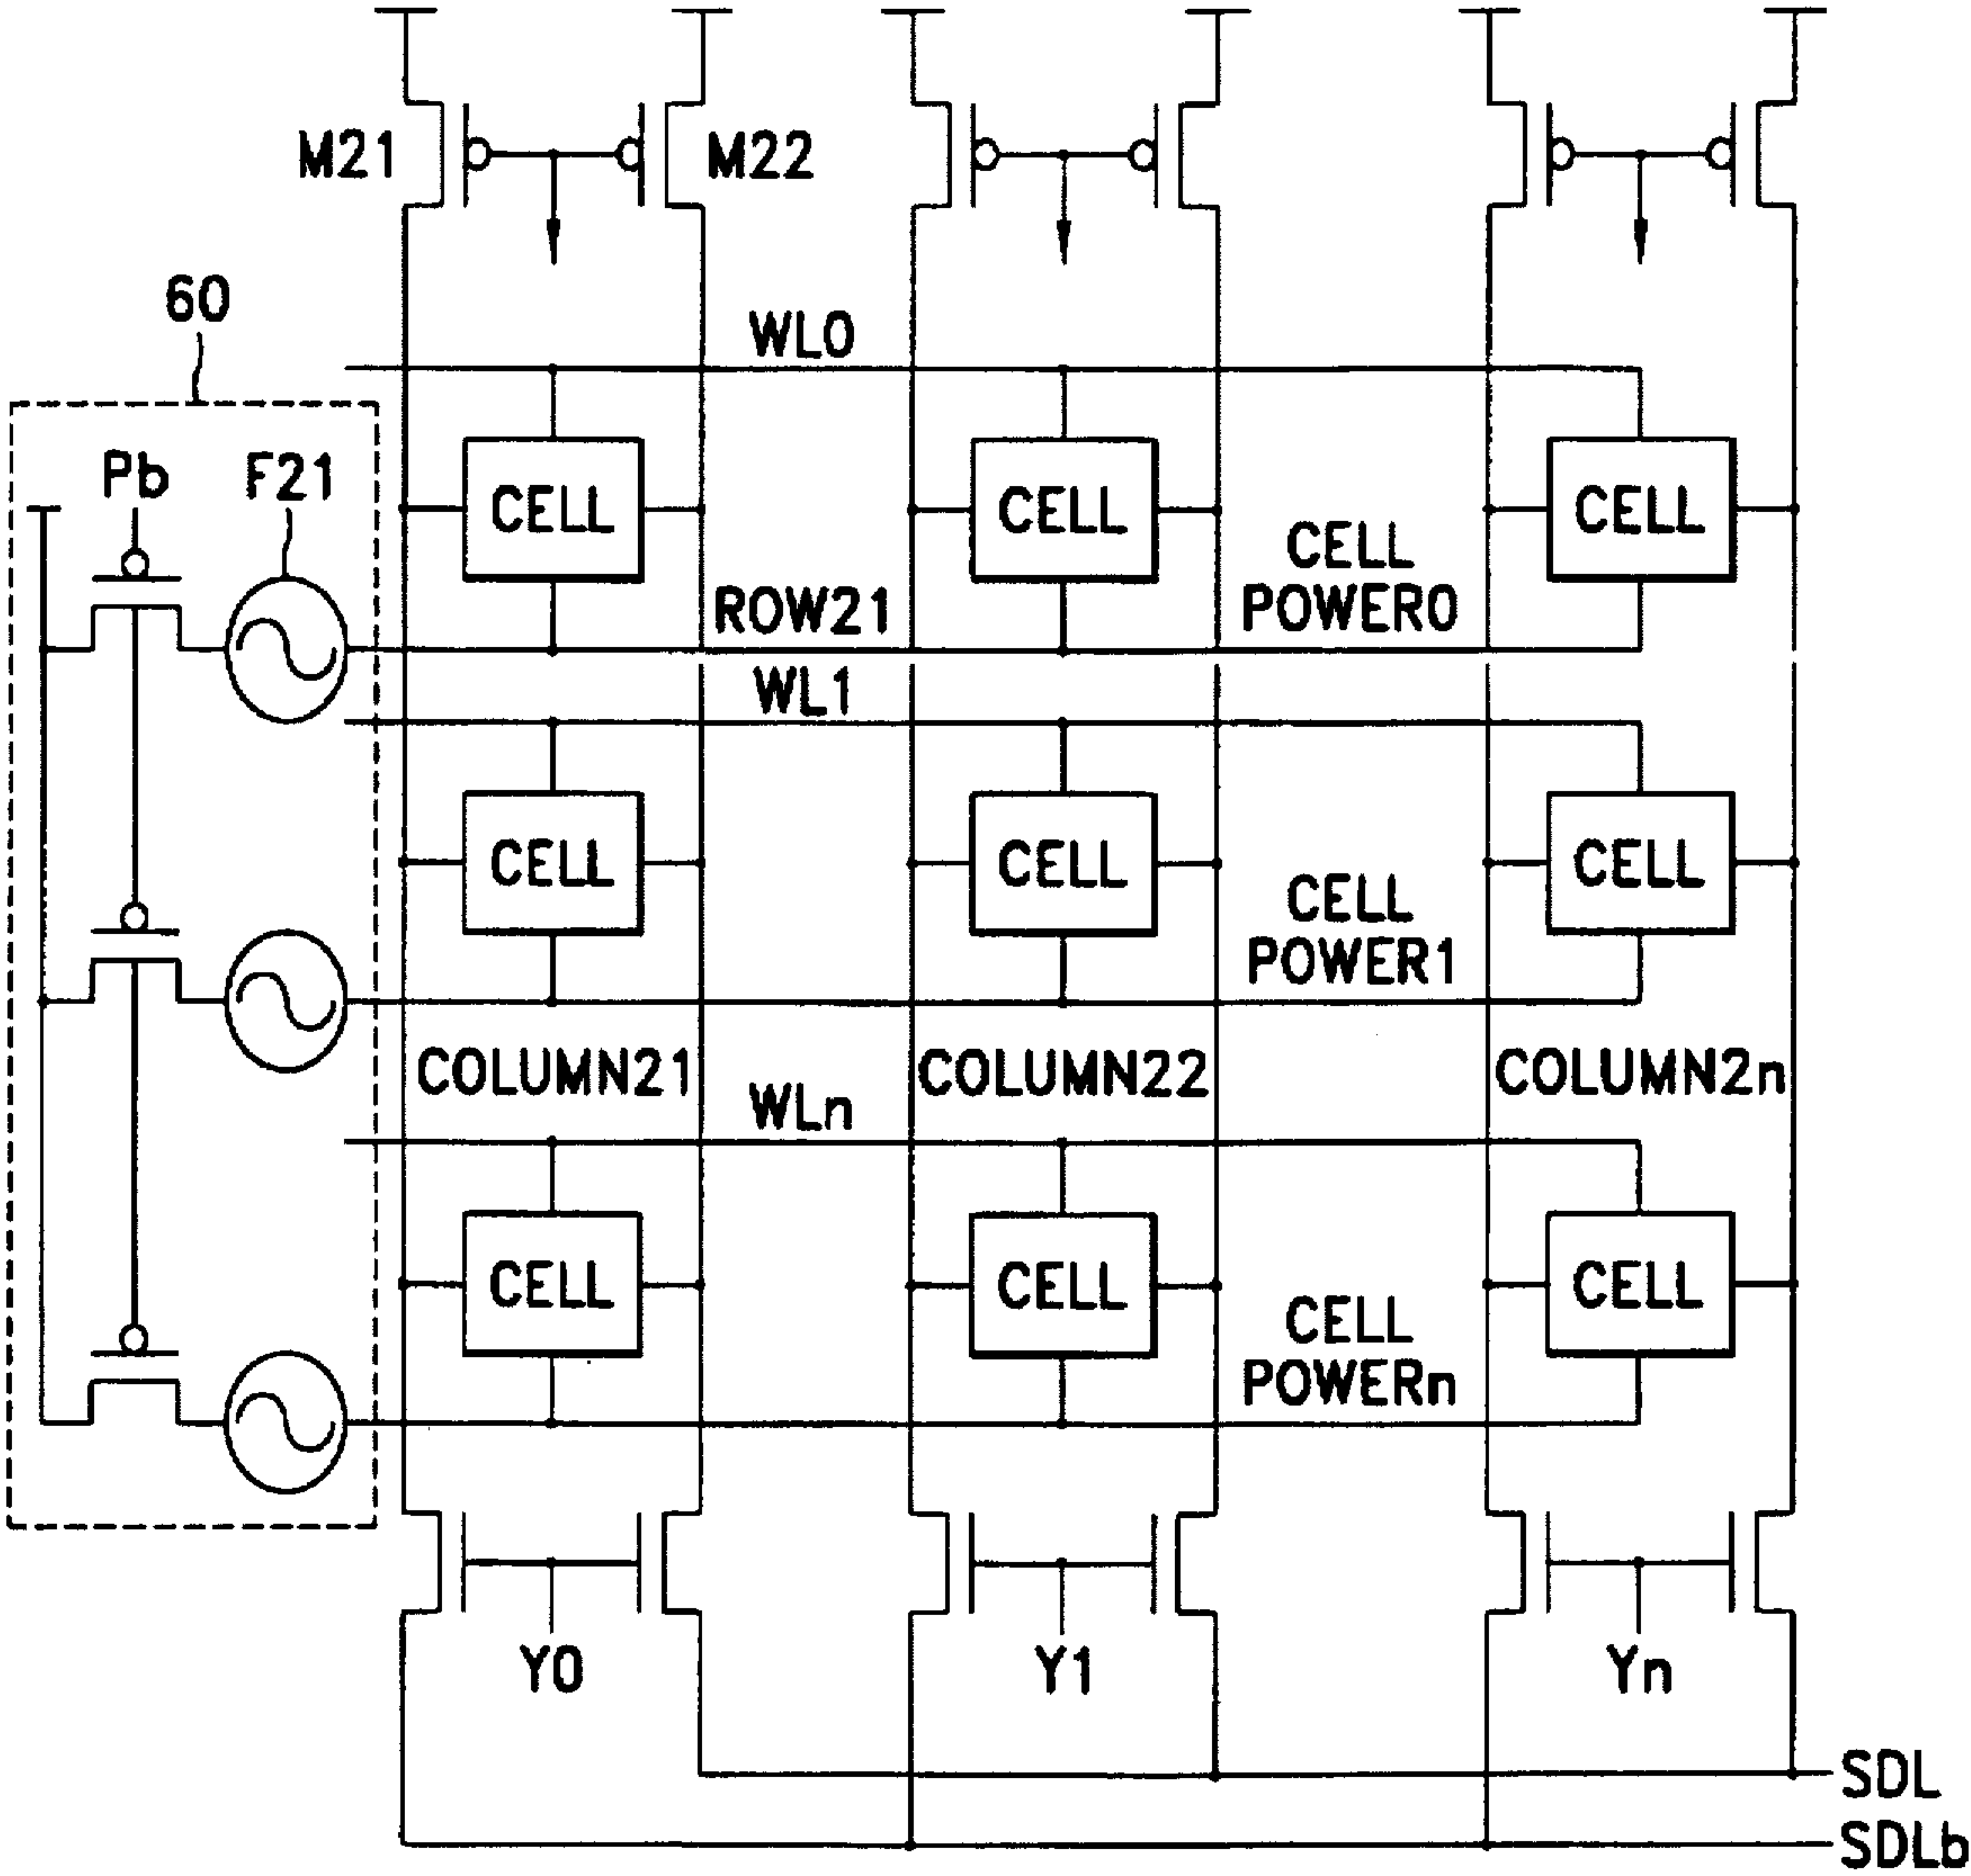
(PRIOR ART)
FIG. 3

FIG. 3 is a circuit diagram illustrating a standby current failed cell repair circuit in another conventional memory device;

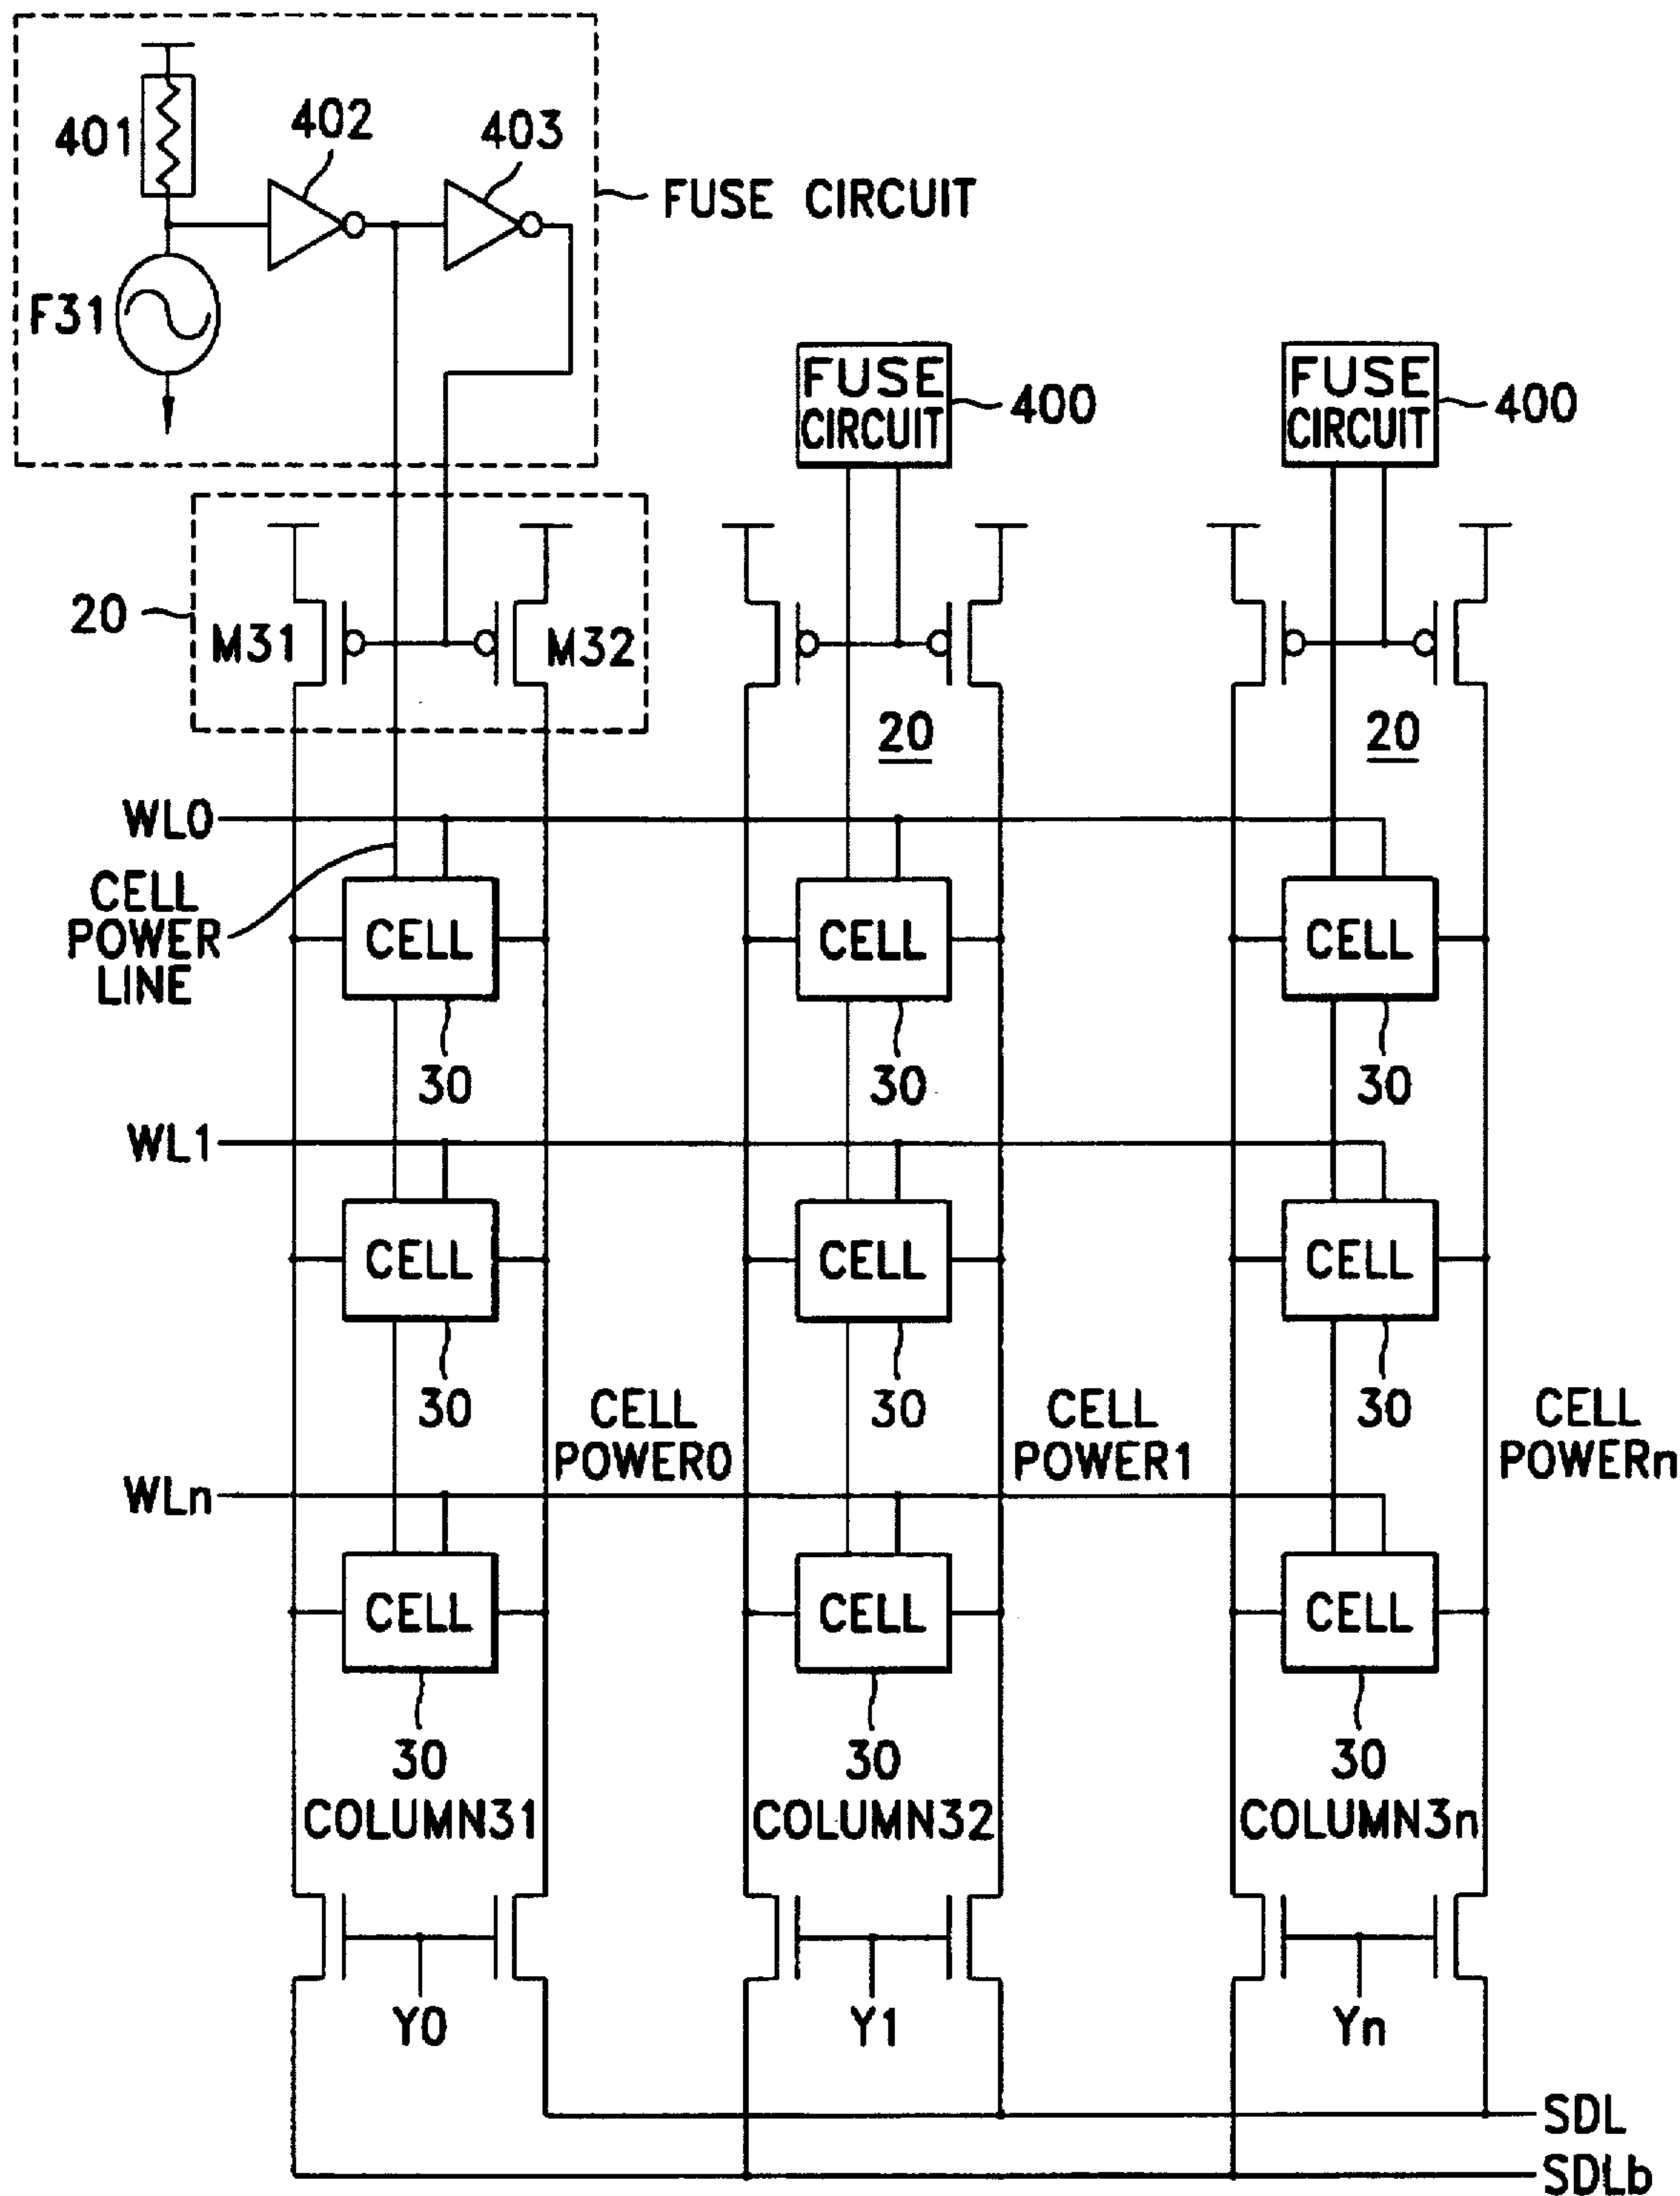
FIG. 4 is a circuit diagram illustrating a standby current failed cell repair circuit according to one embodiment of the present invention; and

Referring first to FIG. 4, the cell power supplied to each memory cell 30 in a column of the memory array is connected to a fuse circuit 400 through a common cell power line. (The cell power node internal connection is shown in FIG. 1.) The fuse circuit 400 implements a current cutoff device as follows. The fuse circuit 400 includes a resistor 401 and a fuse F31 connected in series between a cell power

supply source and a ground potential. A first inverter 402 has an input terminal connected to the common node intermediate the resistor 402 and the fuse F31. In operation, while the fuse is in tact, the common node is pulled down to ground, and the inverter 402 outputs a high signal providing cell power to the cell power line. If and when a standby current failure is detected, the fuse F31 is blown open, and the common node is pulled high, so that the inverter 402 outputs a logic low or ground potential to the cell power nodes, ie. the cell resistor load terminals. A second inverter 403 has an input connected to the output terminal of the first inverter 402. The second inverter output terminal is connected to the column precharge circuit 20, ie. to the gates of transistors M31 and M32, so as to turn off the transistors when inverter 402 goes low. Thus the fuse circuit rams cuts off the cell power line current, and cuts off the precharge circuit as well, of a column in which a standby current failure has been detected. Similar fuse circuits 400 are provided for each column of the array as indicated in FIG. 4.

Consequently, the column of the array in which the standby current failure occurs is electrically isolated from the current source and hence no longer exhibits excessive standby current drain. The isolated column is replaced by a redundant column. The particulars of such replacement are known to those skilled in the art, and hence are omitted here.

FIG. 4 is a circuit diagram illustrating a standby current failed cell repair circuit according to one embodiment of the present invention, and FIG. 5 is a circuit diagram illustrating a standby current failed cell repair circuit according to another embodiment of the present invention.

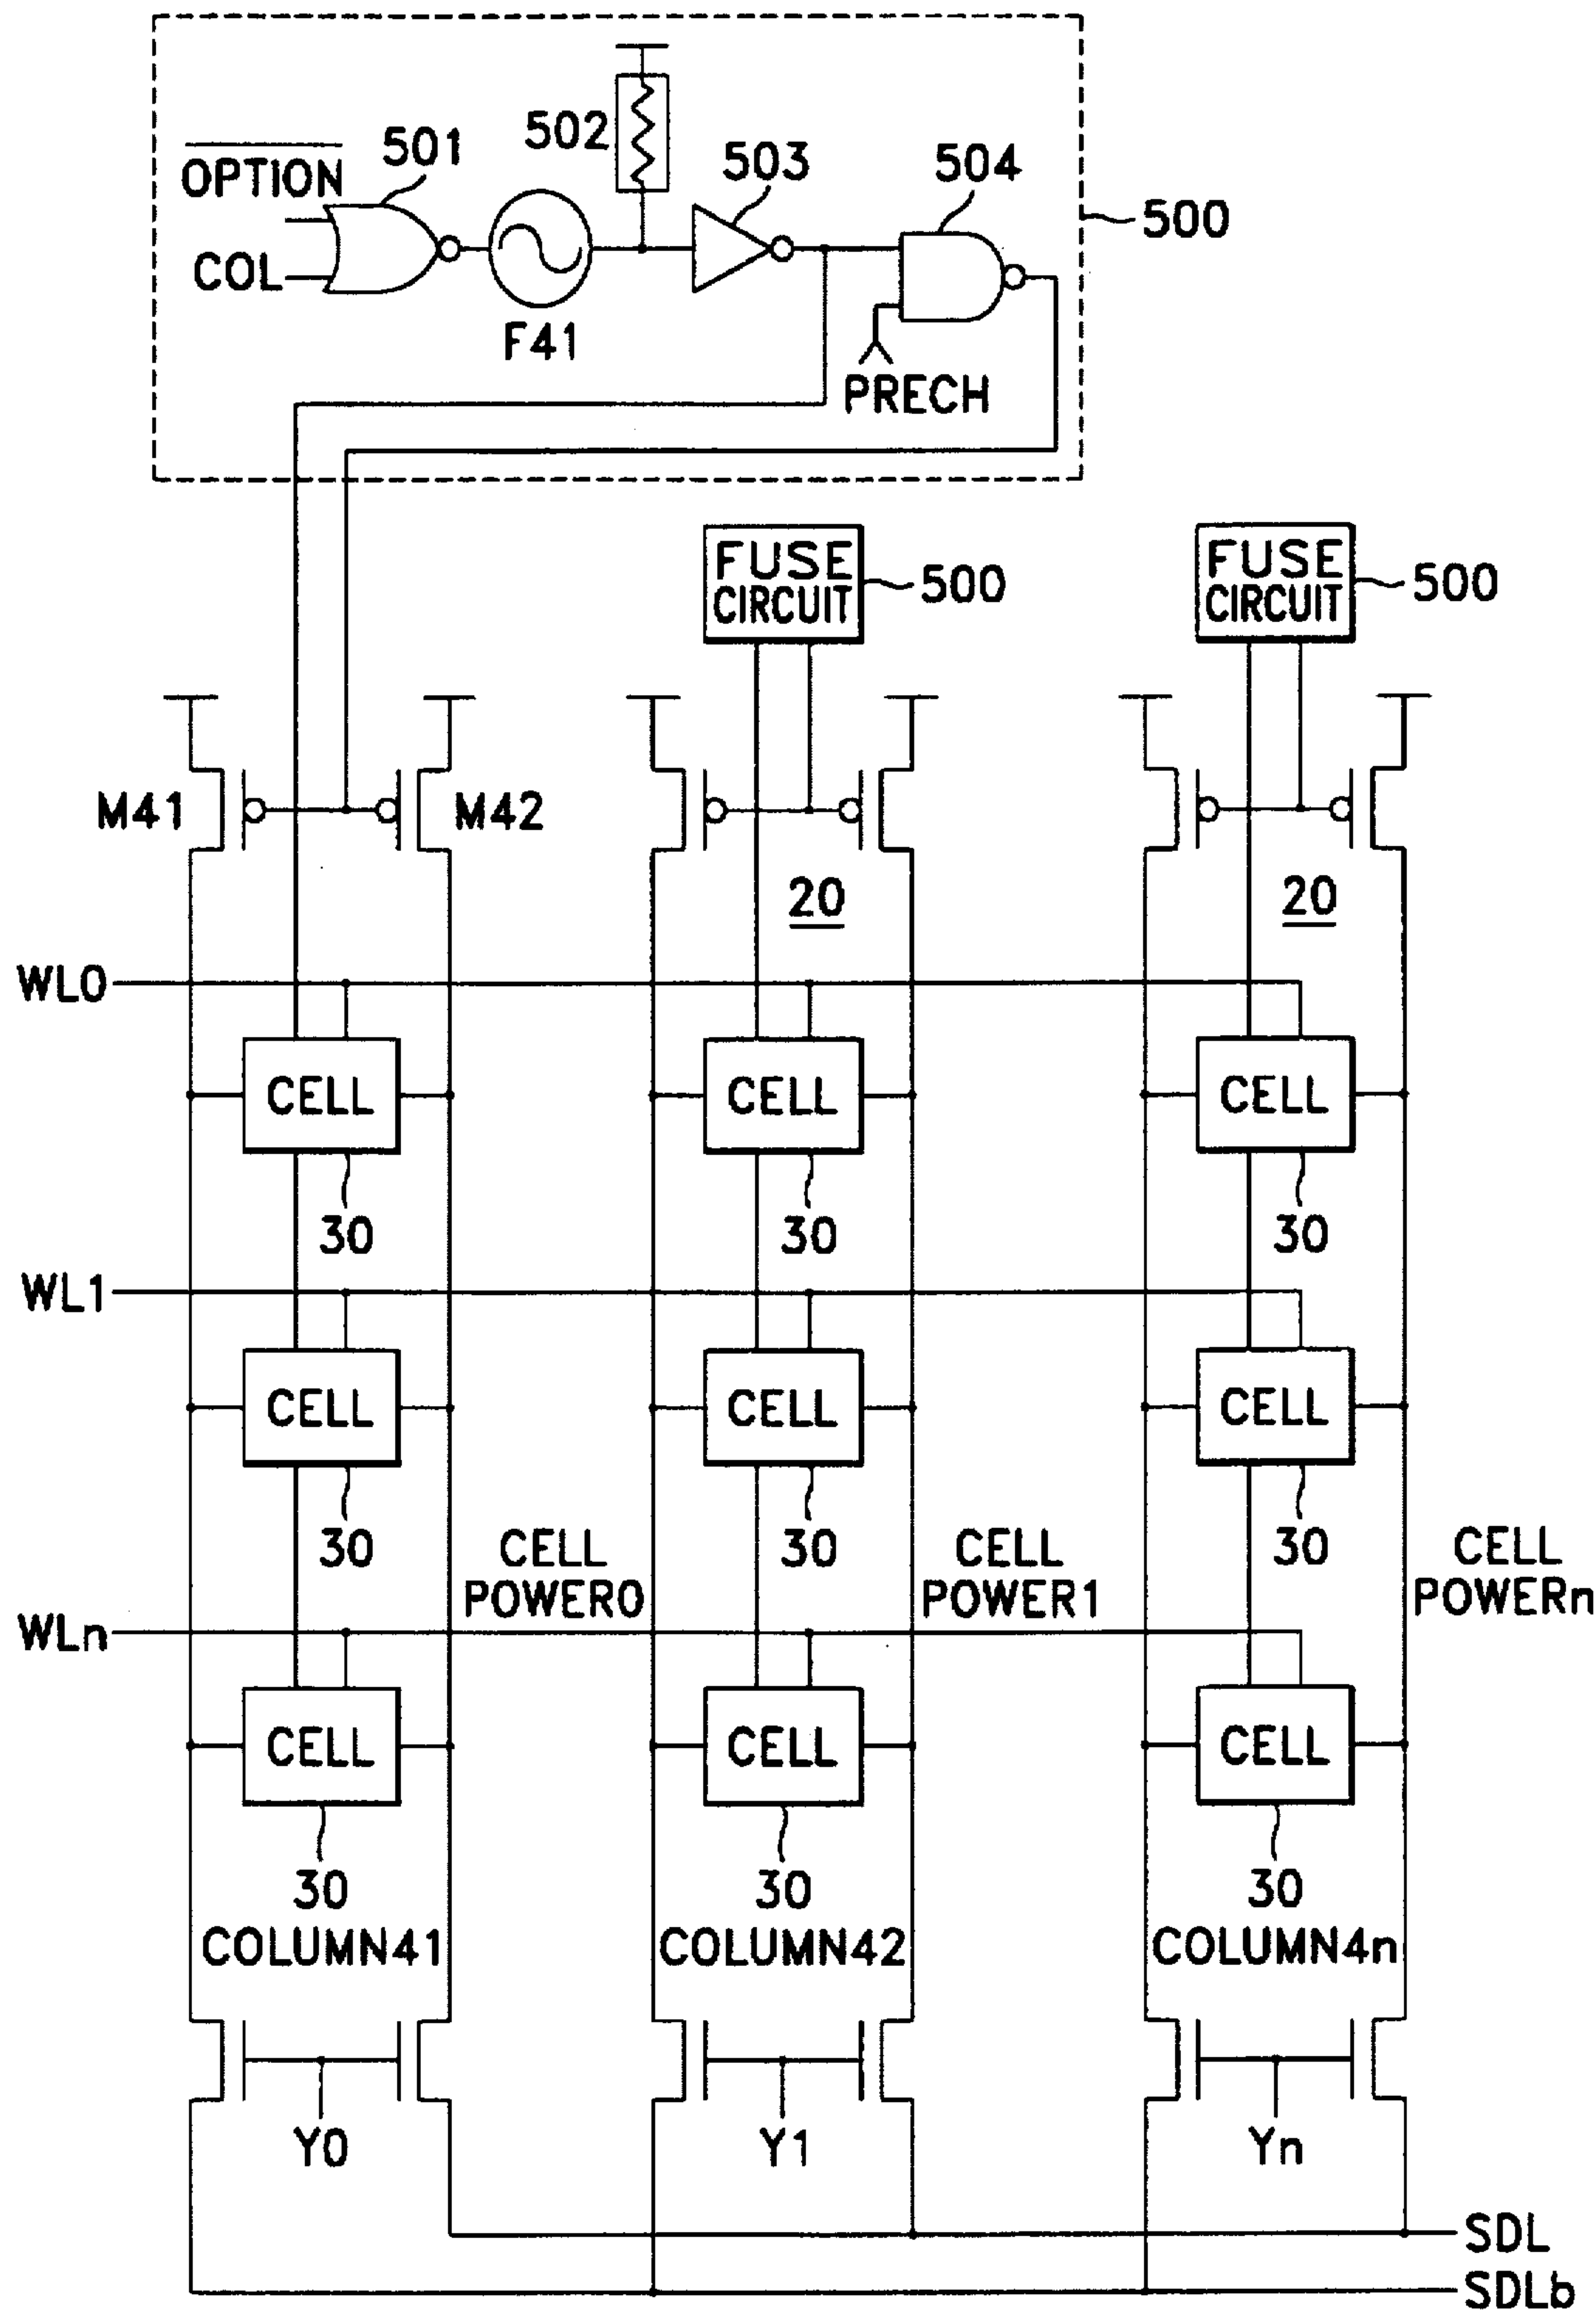
FIG. 5 is a circuit diagram illustrating a standby current failed cell repair circuit according to another embodiment of the present invention.

Referring next to FIG. 5, an alternative fuse circuit 500 includes a resistor 502 and a fuse F41 connected to each other at a common node. The resistor is arranged to pull up the common node to a cell power supply node. A NOR logic gate 501 has an output terminal connected to the fuse F41, one input terminal connected to an external selection signal COL, and the other terminal connected to a first internal selection signal/OPTION. Thus, when either selection signal goes high, the NOR output goes low, pulling the common node down substantially to ground, provided the fuse is in tact (conductive). An inverter 503 has an input terminal connected to the common node between the resistor 502 and the fuse F41, and has its output connected to the corresponding column cell power line. When the fuse F41 is open, the common node goes high, and the output of inverter 503 goes low, thus providing substantially a ground potential to the resistor load terminals—i.e. the cell power nodes—by the blowing of the fuse F41, in the case where the memory cells are identified as standby current failed cells.; and a NAND gate 504 having one input terminal connected to an output terminal of the inverter 503 and the other input terminal connected to an internal selection signal, for providing the cell power to the gate terminals of the precharge transistor pair M41 and M42, in the case where the inverter 503 outputs the ground potential and for providing a given voltage to the gate terminals of the precharge transistor pair M41 and M42 in response to the second internal selection signal, in the case where the inverter 503 outputs the cell power.

In FIG. 5, the column is electrically cut from the current source by the external selection signal as well as the fuse device. Further, an arbitrary column is electrically connected to the current source by the internal selection signal COL regardless of the external selection signal state. The external selection signal is a mode selection signal for implementing a specific test. The internal selection signal COL can use a column address decoding signal. In other words, when the

external selection signal and the internal selection signal COL are at ground potential levels, all of the columns are then electrically cut from the current source. Then, the cell power is applied to the signal COL of a selected column and only the selected column is connected to the current source. In this way, the column select circuitry (not shown) can be used to survey the device to locate a column that exhibits excessive standby current—ie. a failed column—simply by stepping through all of the array column addresses so that the COL internal selection signals are asserted one at a time. As discussed in the above, the present invention is advantageous in that a standby current failure attributable to a cell power node is avoided, and operation of the failed cell is terminated as to the bit line current source as well.
