Nagaraj et al.

[45] **Date of Patent:** Mar. 3, 1998

METHOD FOR REPAIRING A THERMAL BARRIER COATING

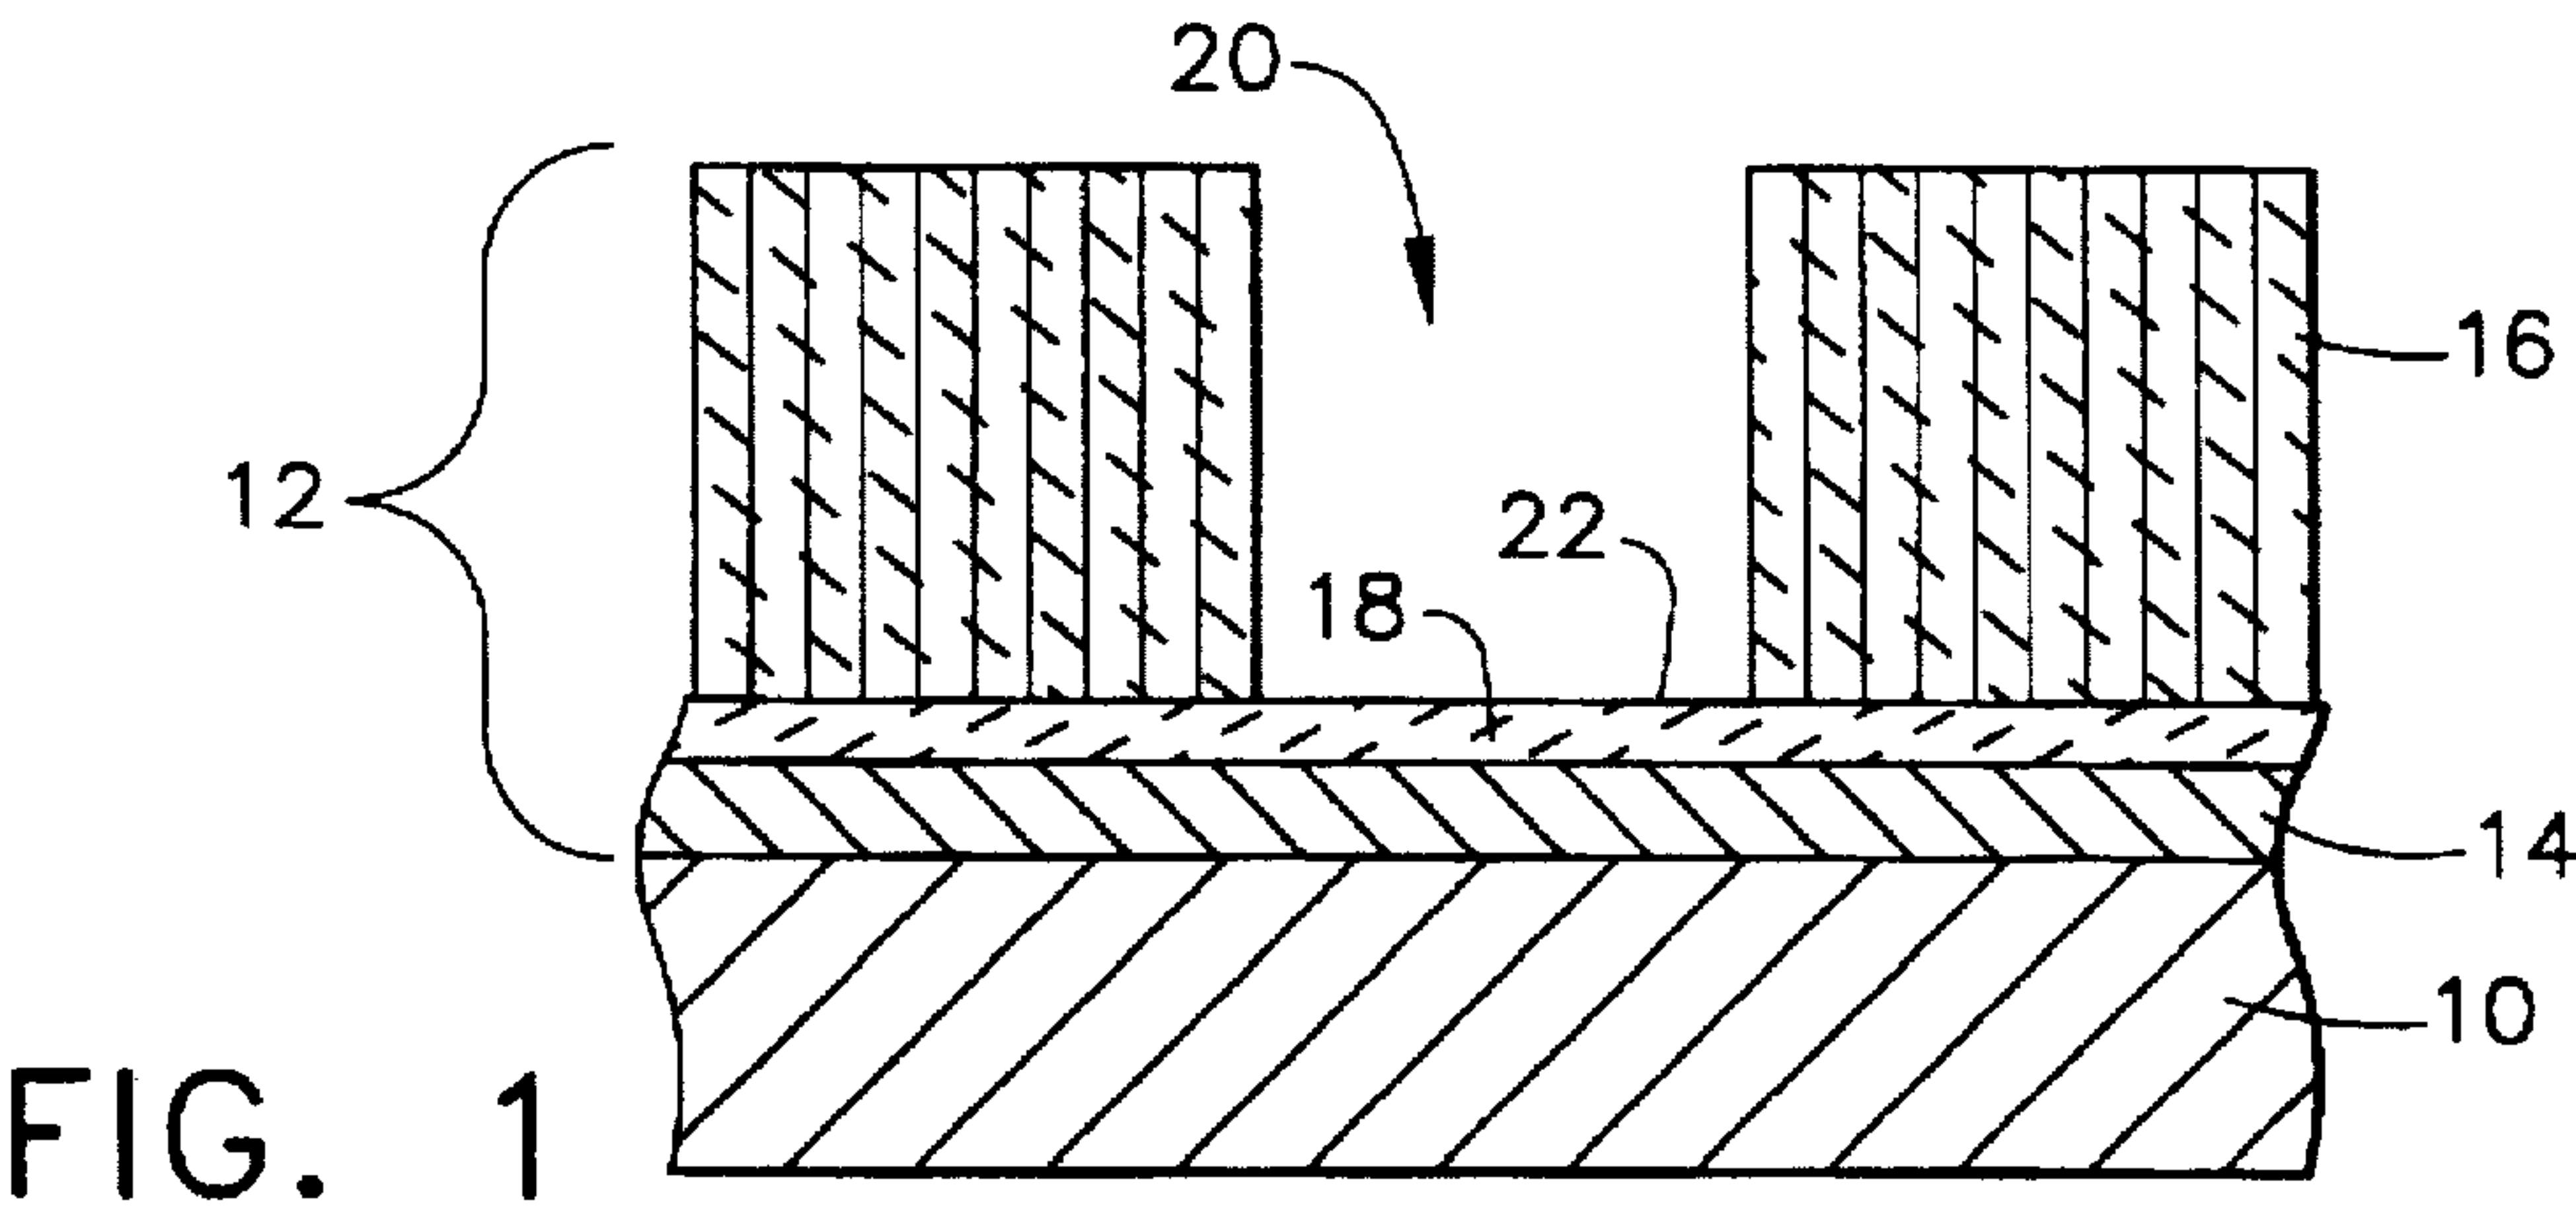
FIG. 1 shows a cross-sectional representation of a component that has suffered localized spallation; and

As represented in FIG. 1, the method of this invention is particularly suited for the repair of a thermal barrier coating system 12 composed of a metallic bond layer 14 formed on the surface of the article 10, and a columnar ceramic layer 16 overlaying the bond layer 14. As is the situation with high

As a component of a gas turbine engine, surfaces of the article 10 are subjected to hot combustion gases during operation of the engine, and are therefore subjected to severe attack by oxidation, corrosion and erosion. Accordingly, the article 10 must remain protected from the hostile environment of the turbine section by the thermal barrier coating system 12, and loss of the ceramic layer 16 will lead to premature and often rapid deterioration of the article 10. Localized spallation 20 of the ceramic layer 16 is represented in FIG. 1, with the repair process of this invention being represented in FIGS. 2 and 3.

temperature components of a gas turbine engine, the article 10 may be formed of a nickel-base or cobalt-base superalloy. The bond layer 14 is preferably formed of a metallic oxidation-resistant material, so as to protect the underlying article 10 from oxidation and enable the ceramic layer 16 to more tenaciously adhere to the article 10. A preferred bond layer 14 is formed by a nickel-base alloy powder, such as NiCrAlY, or an intermetallic nickel or platinum aluminide, which has been deposited on the surface of the article 10 to a thickness of about 20 to about 125 micrometers. Preferred methods for depositing bond layers of the type described above include vapor deposition techniques for aluminide coatings and low pressure plasma spray (LPPS) techniques for a NiCrAlY bond coat, though it is foreseeable that other deposition methods such as air plasma spray (APS) or physical vapor deposition (PVD) techniques could be used. Following deposition of the bond layer 14, an oxide layer 18 such as alumina may be formed on the surface of the bond layer 14 at an elevated temperature. The oxide layer 18 provides a surface to which the columnar ceramic layer 16 can tenaciously adhere, thereby promoting the resistance of the coating system 12 to thermal shock.

To attain the desired strain-tolerant columnar grain structure represented in the Figures, the ceramic layer 16 is preferably deposited by physical vapor deposition using techniques known in the art. A preferred material for the ceramic layer 16 is an yttria-stabilized zirconia (YSZ), a preferred composition being about 6 to about 8 weight percent yttria, though other ceramic materials could be used, such as yttria, nonstabilized zirconia, or zirconia stabilized by ceria (CeO_2) or scandia (Sc_2O_3). The ceramic layer 16 is deposited to a thickness that is sufficient to provide the required thermal protection for the article 10, generally on the order of about 75 to about 300 micrometers.

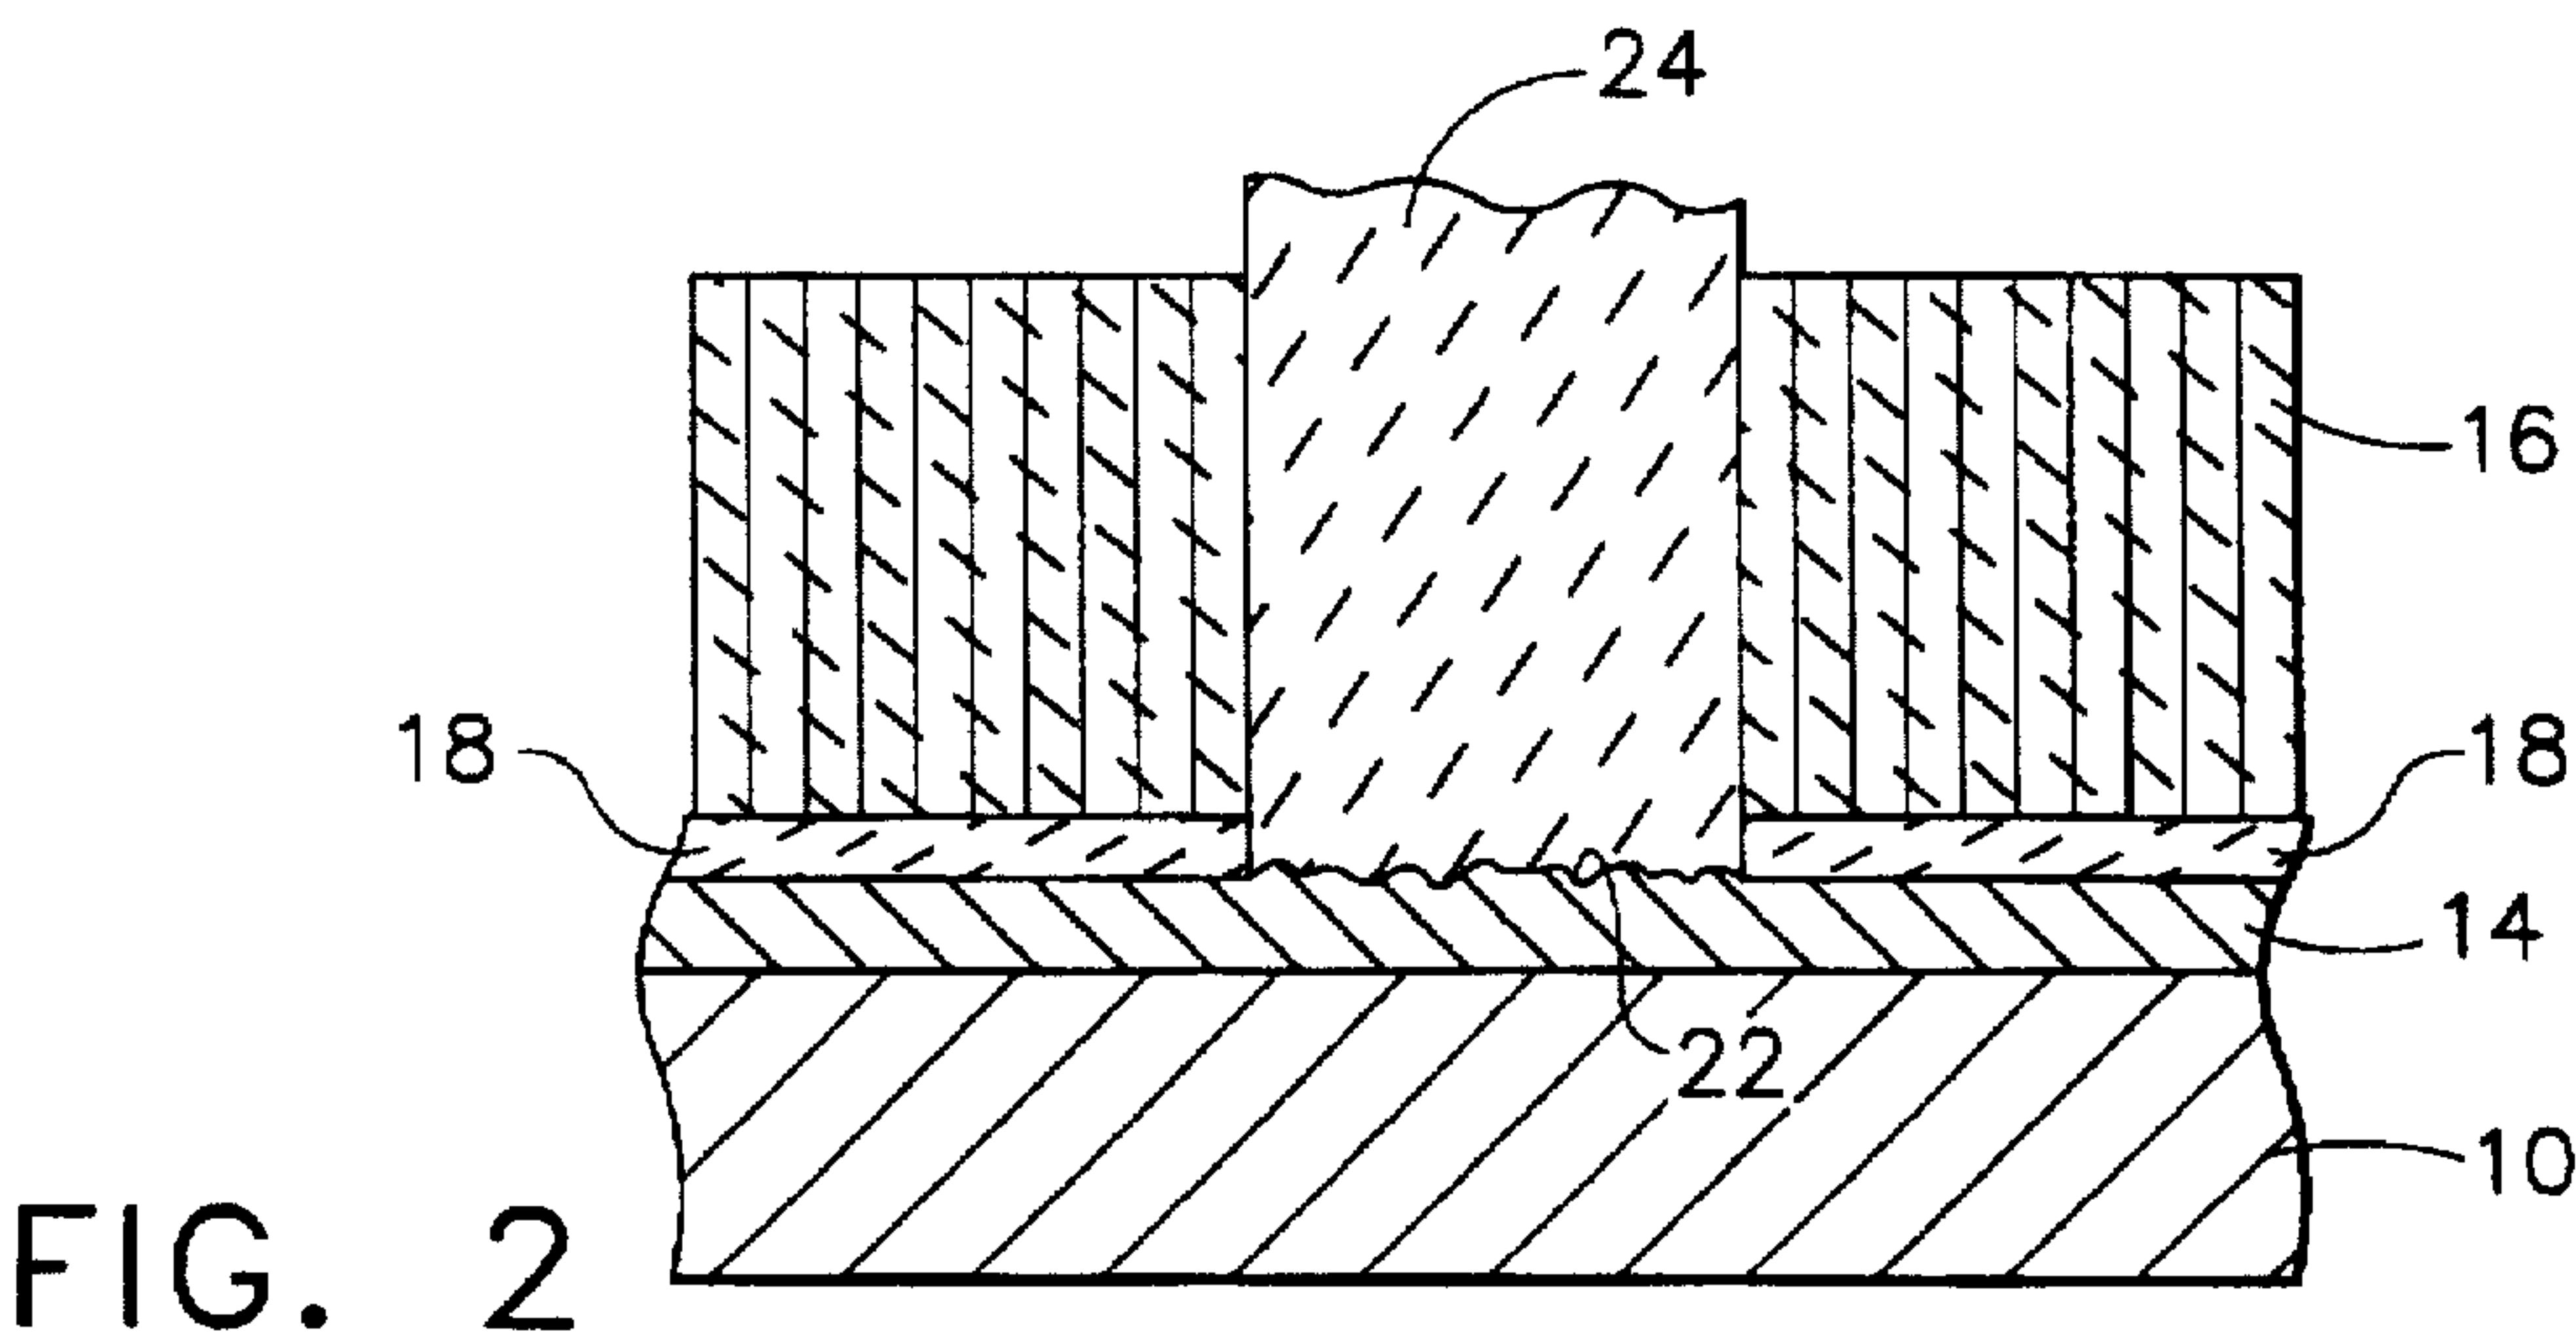
FIGS. 2 and 3 are cross-sectional representations of repair steps entailed in a preferred embodiment of this invention.

Once free of contaminants, the bond layer 14 is then treated such that its surface 22 becomes textured, as represented by FIG. 2. Preferred treating methods include grit blasting, micromachining, photolithography, laser etching and water jet techniques. Preferred grit blasting media include alumina, though other materials could be used. Suitable micromachining techniques include the use of

Finally, as represented in FIG. 2, a ceramic material is then deposited on the textured surface 22 of the bond layer 14 so as to form a ceramic repair layer 24 that completely covers the bond layer 14. A preferred deposition method is a plasma spray technique process, though physical vapor deposition techniques can be used to deposit the ceramic material such that the repair layer 24 has a columnar grain structure. With either technique, the ceramic layer 16 is masked to prevent deposition of the repair material on the ceramic layer 16. According to this invention, the preferred repair method is to form the repair layer 24 by plasma spray, the random ceramic grain structure of which is represented in FIGS. 2 and 3. Generally, masking of the surrounding surface of the ceramic layer 16 is less complicated if a plasma spray deposition technique is used. For example, if any holes are intentionally present in the article 10, such as cooling holes often present in airfoils to reduce their operating temperature, fibers can be placed in the holes or a gas can be flowed through the holes in order to prevent closure by the deposited ceramic. Furthermore, physical vapor deposition techniques generally result in the entire article 10 being heated to a high temperature, whereas plasma spray techniques directly heat only the localized region being repaired on the article 10.

Due to process control limitations, the ceramic material will typically be deposited until the surface of the repair layer 24 projects above the surrounding surface of the ceramic layer 16, as shown in FIG. 2. Afterwards, the surface of the repair layer 24 is polished or otherwise abraded until the repair layer 24 is substantially level with the ceramic layer 16, and the repair layer 24 merges with the ceramic layer 16 as portrayed in FIG. 3.

The treatment selected should sufficiently texture the surface 22 of the bond layer 14 to yield macro surface features, resulting in an average surface roughness R_a of at least about 300 micrometers. With laser techniques, such macro surface features can be in the form of a groove pattern that is selectively developed on the surface 22 of the bond layer 14. Laser techniques, and to a lesser extent grit blasting and water jet techniques, are also capable of producing a desirable combination of macro and micro surface features, as discussed below.
