# United States Patent [19]

[11] Patent Number: **5,723,078**

[54] **METHOD FOR REPAIRING A THERMAL BARRIER COATING**

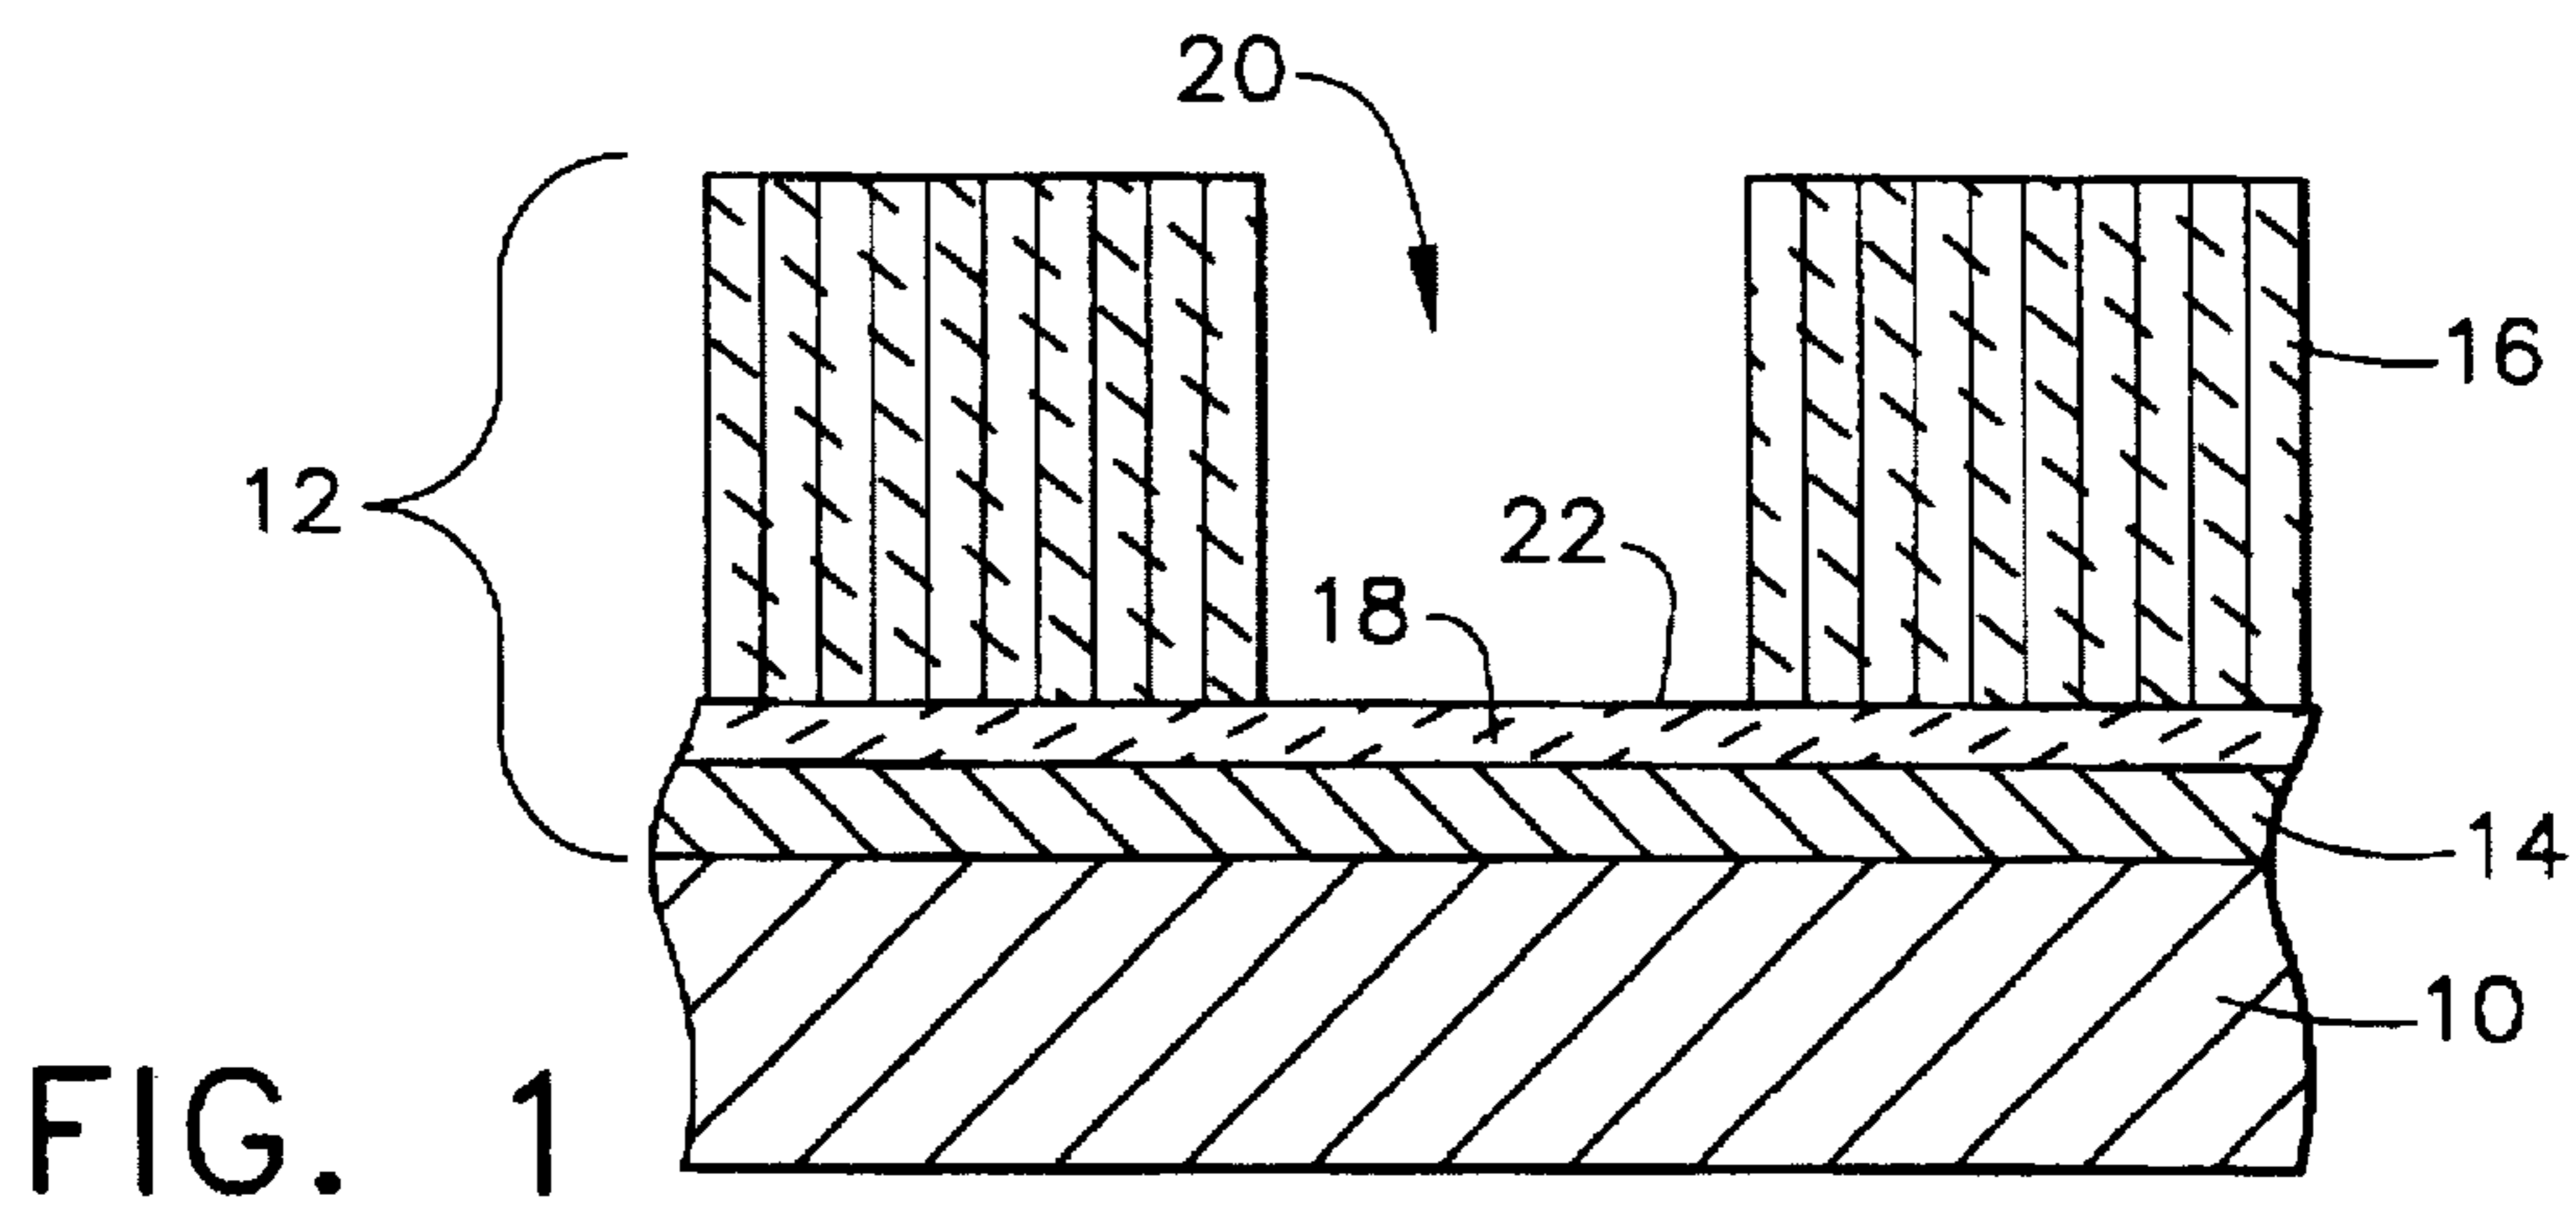
FIG. 1 shows a cross-sectional representation of a component that has suffered localized spallation; and

As represented in FIG. 1, the method of this invention is particularly suited for the repair of a thermal barrier coating system 12 composed of a metallic bond layer 14 formed on the surface of the article 10, and a columnar ceramic layer 16 overlaying the bond layer 14. As is the situation with high

As a component of a gas turbine engine, surfaces of the article 10 are subjected to hot combustion gases during operation of the engine, and are therefore subjected to severe attack by oxidation, corrosion and erosion. Accordingly, the article 10 must remain protected from the hostile environment of the turbine section by the thermal barrier coating system 12, and loss of the ceramic layer 16 will lead to premature and often rapid deterioration of the article 10. Localized spallation 20 of the ceramic layer 16 is represented in FIG. 1, with the repair process of this invention being represented in FIGS. 2 and 3.

The repair method of this invention begins with cleaning the bond layer 14 exposed by the localized spallation 20 so as to remove oxides and any residual fragments of the ceramic and oxide layers 16 and 18. While various techniques can be used, a preferred method is to grit blast the exposed surface of the bond layer 14, such as by a technique known as pencil grit blasting. This step is selectively performed to ensure that the remaining ceramic layer 16 is not subjected to the procedure. It may be desirable to mask the surrounding ceramic layer 16 with, for example, tape masking, during the grit blasting operation. In addition to providing a level of protection to the ceramic layer 16, tape masking would also serve as a proof test for the integrity of the ceramic layer 16 immediately surrounding the spallation 20.

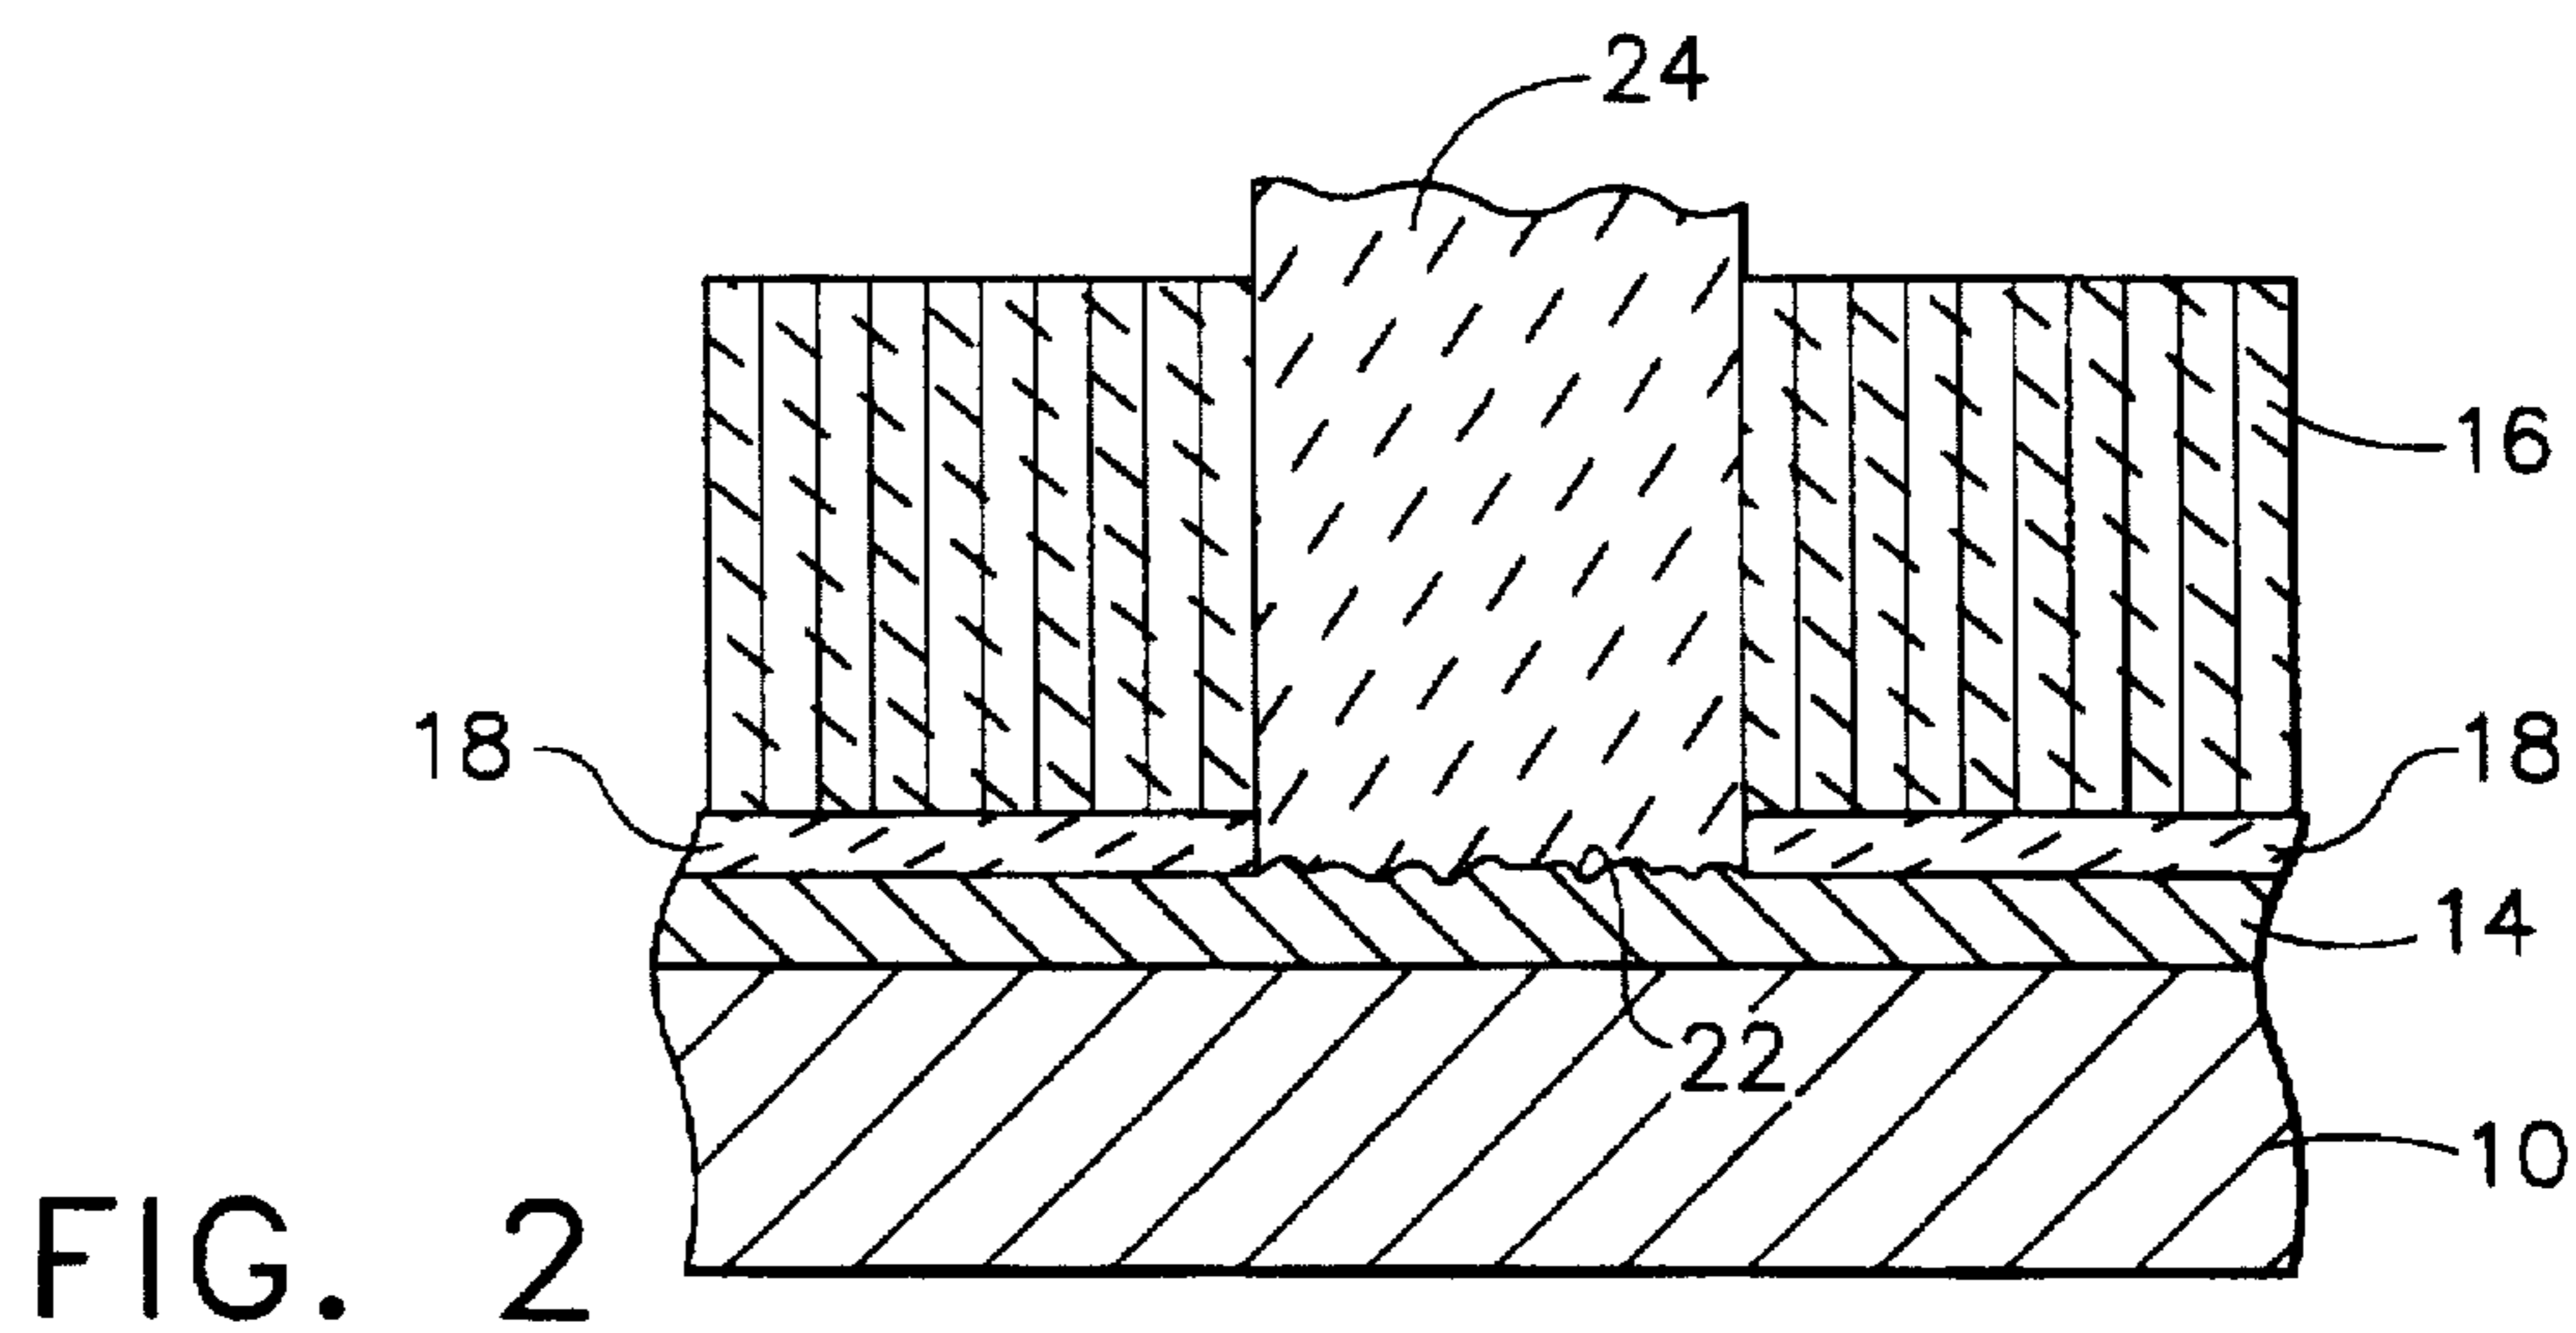
FIGS. 2 and 3 are cross-sectional representations of repair steps entailed in a preferred embodiment of this invention.

Once free of contaminants, the bond layer 14 is then treated such that its surface 22 becomes textured, as represented by FIG. 2. Preferred treating methods include grit blasting, micromachining, photolithography, laser etching and water jet techniques. Preferred grit blasting media include alumina, though other materials could be used. Suitable micromachining techniques include the use of

Finally, as represented in FIG. 2, a ceramic material is then deposited on the textured surface 22 of the bond layer 14 so as to form a ceramic repair layer 24 that completely covers the bond layer 14. A preferred deposition method is a plasma spray technique process, though physical vapor deposition techniques can be used to deposit the ceramic material such that the repair layer 24 has a columnar grain structure. With either technique, the ceramic layer 16 is masked to prevent deposition of the repair material on the ceramic layer 16. According to this invention, the preferred repair method is to form the repair layer 24 by plasma spray, the random ceramic grain structure of which is represented in FIGS. 2 and 3. Generally, masking of the surrounding surface of the ceramic layer 16 is less complicated if a plasma spray deposition technique is used. For example, if any holes are intentionally present in the article 10, such as cooling holes often present in airfoils to reduce their operating temperature, fibers can be placed in the holes or a gas can be flowed through the holes in order to prevent closure by the deposited ceramic. Furthermore, physical vapor deposition techniques generally result in the entire article 10 being heated to a high temperature, whereas plasma spray techniques directly heat only the localized region being repaired on the article 10.

Due to process control limitations, the ceramic material will typically be deposited until the surface of the repair layer 24 projects above the surrounding surface of the ceramic layer 16, as shown in FIG. 2. Afterwards, the surface of the repair layer 24 is polished or otherwise abraded until the repair layer 24 is substantially level with the ceramic layer 16, and the repair layer 24 merges with the ceramic layer 16 as portrayed in FIG. 3.

The treatment selected should sufficiently texture the surface 22 of the bond layer 14 to yield macro surface features, resulting in an average surface roughness  $R_a$  of at least about 300 micrometers. With laser techniques, such macro surface features can be in the form of a groove pattern that is selectively developed on the surface 22 of the bond layer 14. Laser techniques, and to a lesser extent grit blasting and water jet techniques, are also capable of producing a desirable combination of macro and micro surface features, as discussed below.
