United States Patent [19]

5,735,551

[54]	PIPE REPAIR APPARATUS AND METHOD		
[75]	Inventors:	Gerald E. Whitman, Morris; Matthew D. Krouse, Naperville; Kenneth R. Sturtecky, Geneseo; Thomas J. Behringer, Bartlett, all of Ill.	
[73]	Assignee:	Commonwealth Edison Company. Chicago, Ill.	
[21]	Appl. No.:	697,312	
[22]	Filed:	Aug. 22, 1996	
		F16L 55/178 285/15; 285/179; 285/191; 285/906; 29/463	
[58]	Field of S	earch	
_

PIPE REPAIR APPARATUS AND METHOD

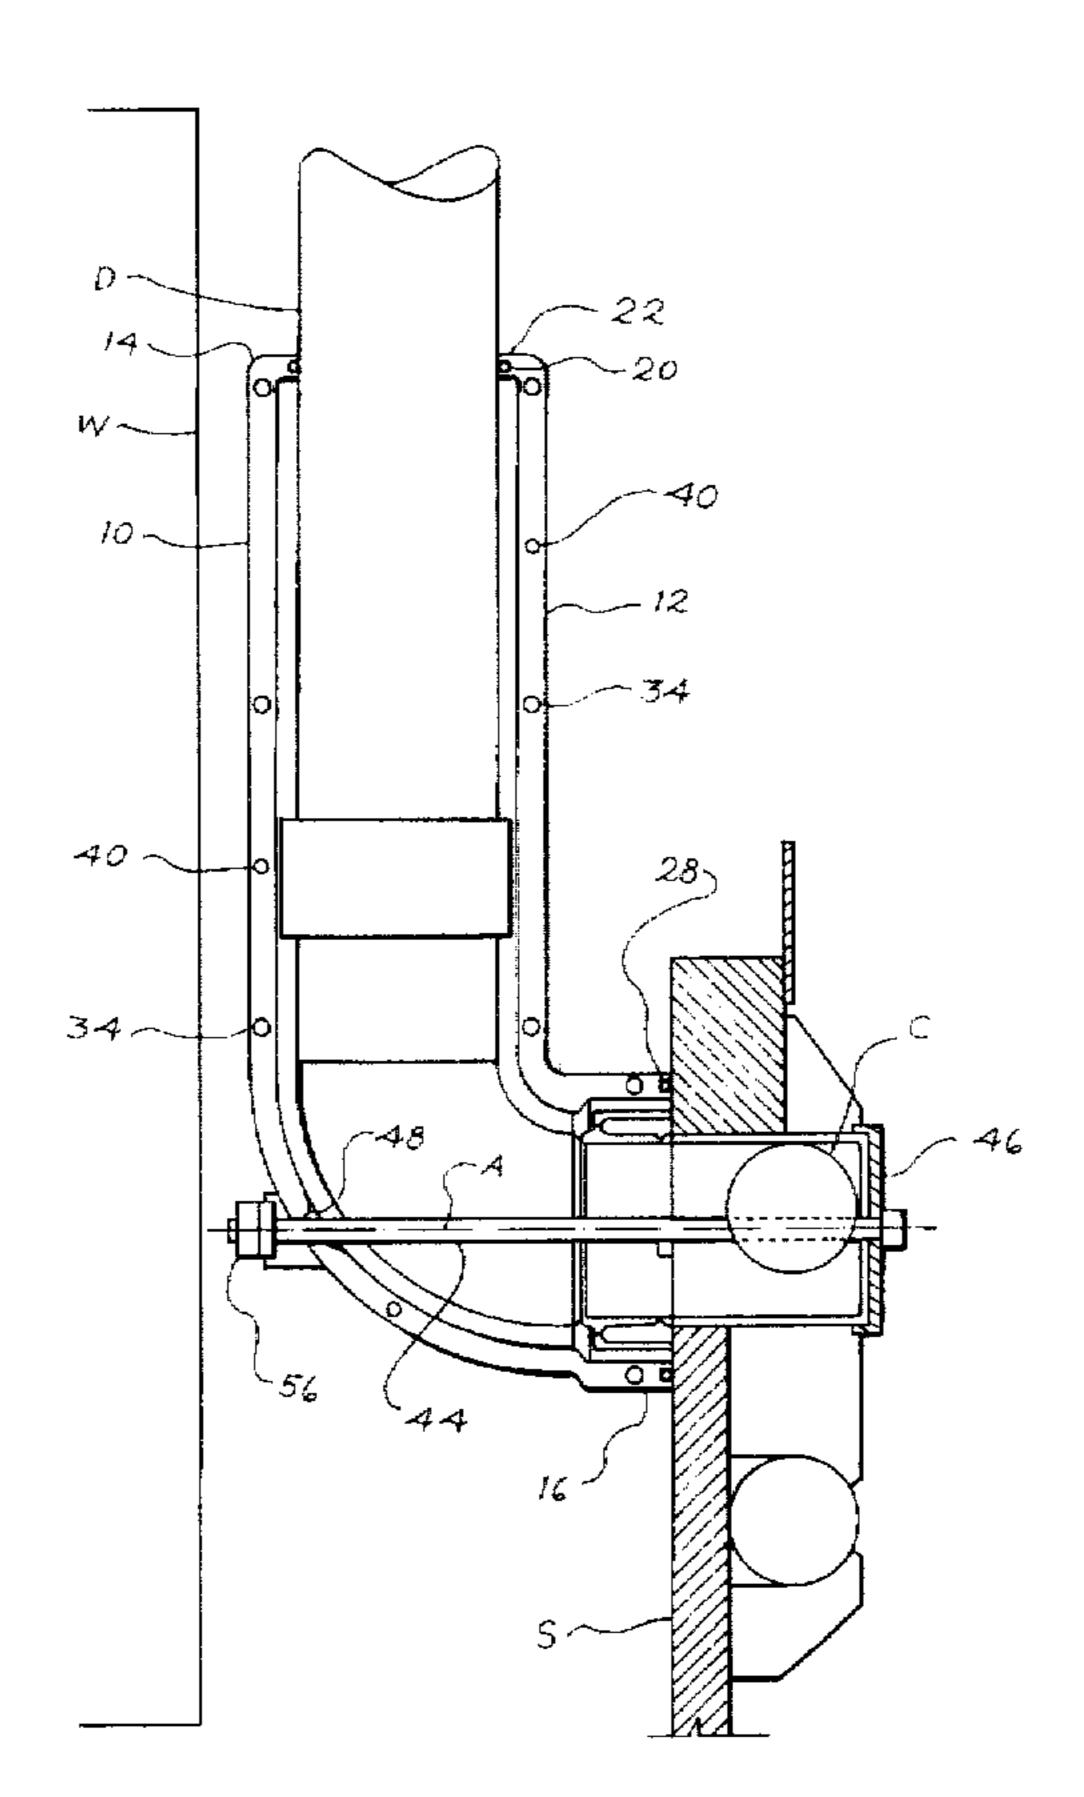
FIG. 1 is an elevational assembly drawing showing a 65 preferred embodiment of the pipe repair of this invention mounted in place to a shroud of a nuclear reactor.

FIG. 1 shows selected portions of a boiling water nuclear reactor, including a core shroud S and a core spray sparger C. Core spray water is delivered to the core spray sparger by a vertically oriented pipe, known in the art as a core spray downcomer D. All of these elements are contained within the inside wall W of the reactor pressure vessel (RPV). The core spray downcomer D functions as a core spray supply pipe in the core spray system of the nuclear reactor. The downcomer D includes an elbow adjacent to the shroud S, and a number of welds are conventionally used to fabricate this portion of the downcomer. The elements of FIG. 1 discussed above are conventional, and have been described to define the environment in which the presently preferred embodiment of this invention is used.

FIG. 1 shows a pipe repair 10 mounted on the downcomer D. The pipe repair 10 includes two housings 12, which are mirror images of one another. In FIG. 1, one of the housings 12 is shown, and the other has been deleted for clarity of illustration.

As shown in FIG. 1, the housings 12 are held together by eight threaded fasteners such as bolts 34. The housings 12 are threaded to receive these bolts 34, such that the bolts 34 are captured in one of the housings 12, and then threaded into the other. In this way, loose hardware is eliminated to facilitate reliable remote assembly. As shown in FIGS. 13 and 14, the heads of the bolts 34 are surrounded by bolt head keepers that include tubular walls 36 that can be crimped around the bolt head to prevent loosening of the bolt. The tubular walls 36 are integrally formed with rectangular baseplates 38 that are shaped to engage complementary recesses in the housings 12 to prevent rotation of the baseplate 38 and therefore the wall 36.

The pipe repair 10 is structurally secured in place to the shroud S by a retainer which in this embodiment takes the form of a threaded rod 44 (FIG. 1). This rod reacts at one end against a cap 46 mounted on the inside of the shroud S, and at the other end on the pipe repair 10. The rod 44 clamps the 65 second end 16 and the seal 28 firmly against the outer surface of the shroud S, to prevent leakage therebetween. As

best shown in FIG. 1, the rod 44 extends along a longitudinal axis A defined by the lowermost portion of the downcomer D, through an opening formed in the downcomer D, and then through an aperture 48 in the pipe repair 10.

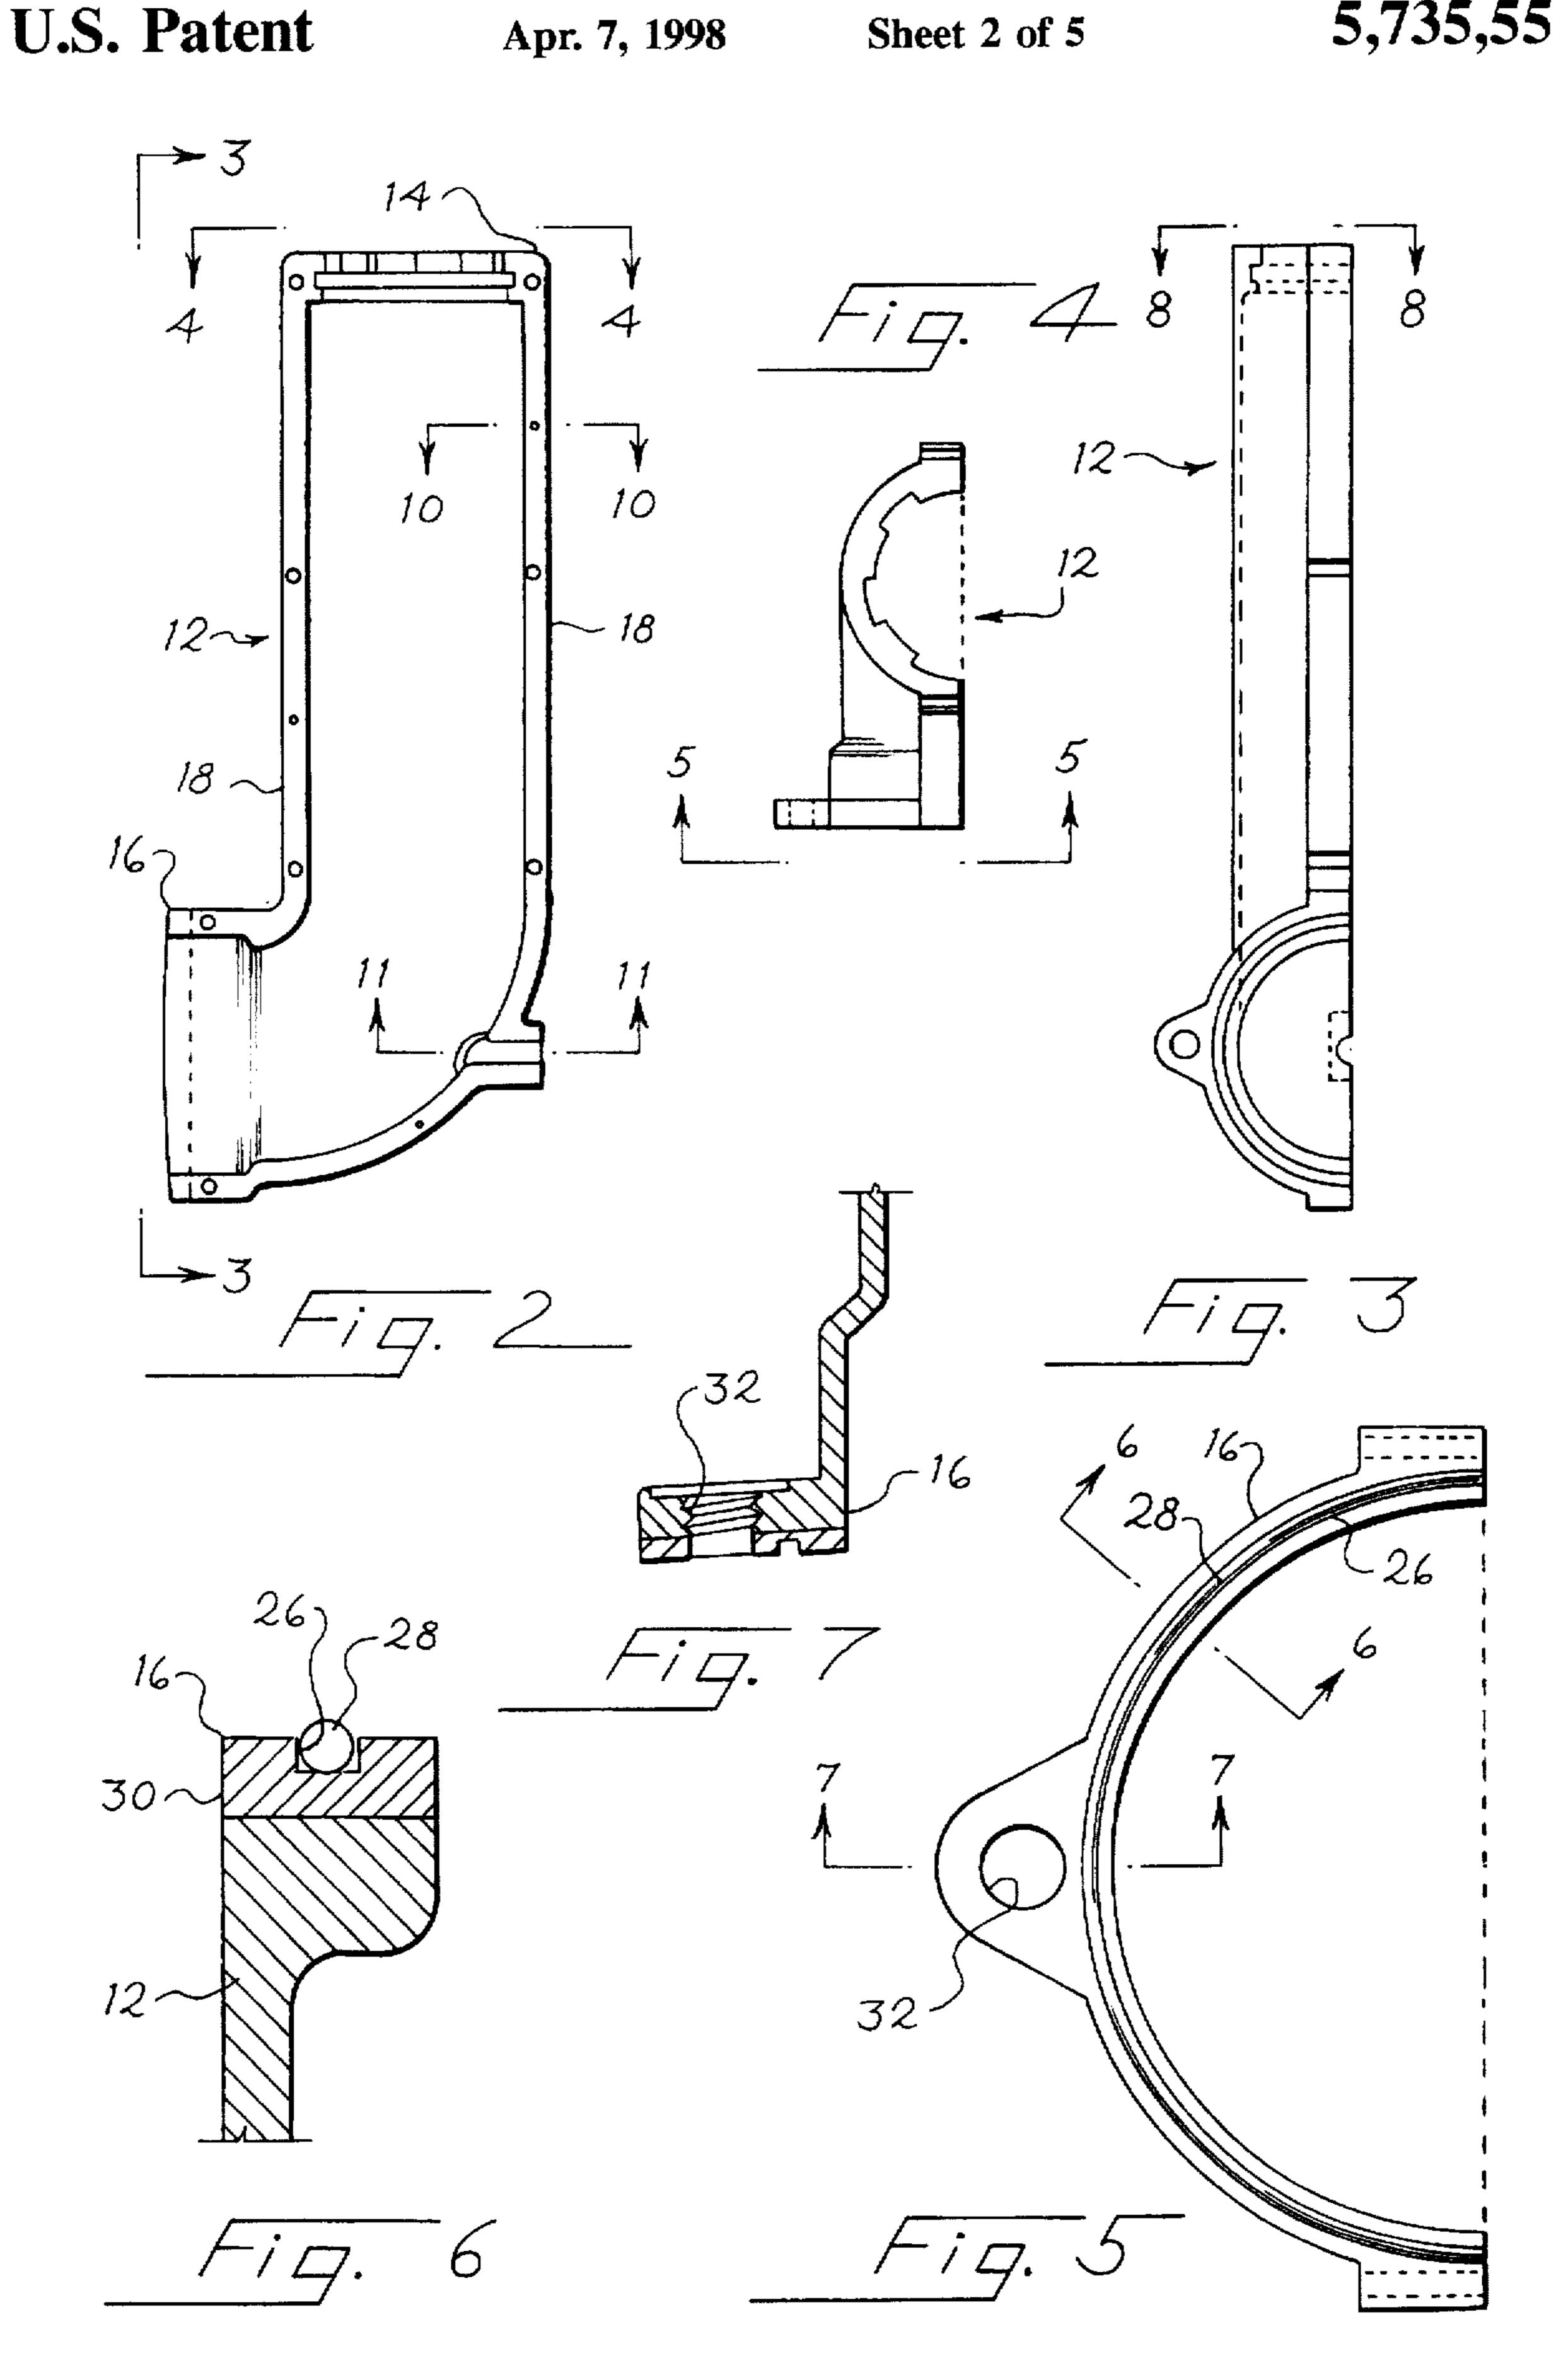
FIG. 5 is a view of the lower face of the housing of FIG. 2 taken along line 5—5 of FIG. 4.

FIG. 6 is a cross-sectional view taken along line 6—6 of FIG. 5.

FIG. 7 is a cross-sectional view taken along line 7—7 of FIG. 5.

FIGS. 5-7 provide details of construction regarding the second end 16. As shown in FIGS. 5 and 6, the second end defines a circular groove 26 that receives a seal 28. This seal 28 is positioned to create a seal against the outer surface of the shroud S, as shown in FIG. 1. As shown in FIG. 1, the outer surface of the shroud S forms a wall that extends outwardly from the downcomer D immediately adjacent to the second end 16 of the pipe repair 10. As shown in FIG. 6, the second end 16 is preferably provided with a region that is built up of a material such as ER-209 weld material that can be machined after solution annealing, without becoming unduly susceptible to cracks and corrosion. As shown in FIG. 7, the second end 16 of each housing 12 defines a threaded opening 32 that receives a threaded pin as described below to locate and align the housing 12 on the shroud S, and prevents lateral and torsional movement. The shroud S includes a mating recess (not shown) designed to receive the end of the threaded pin.

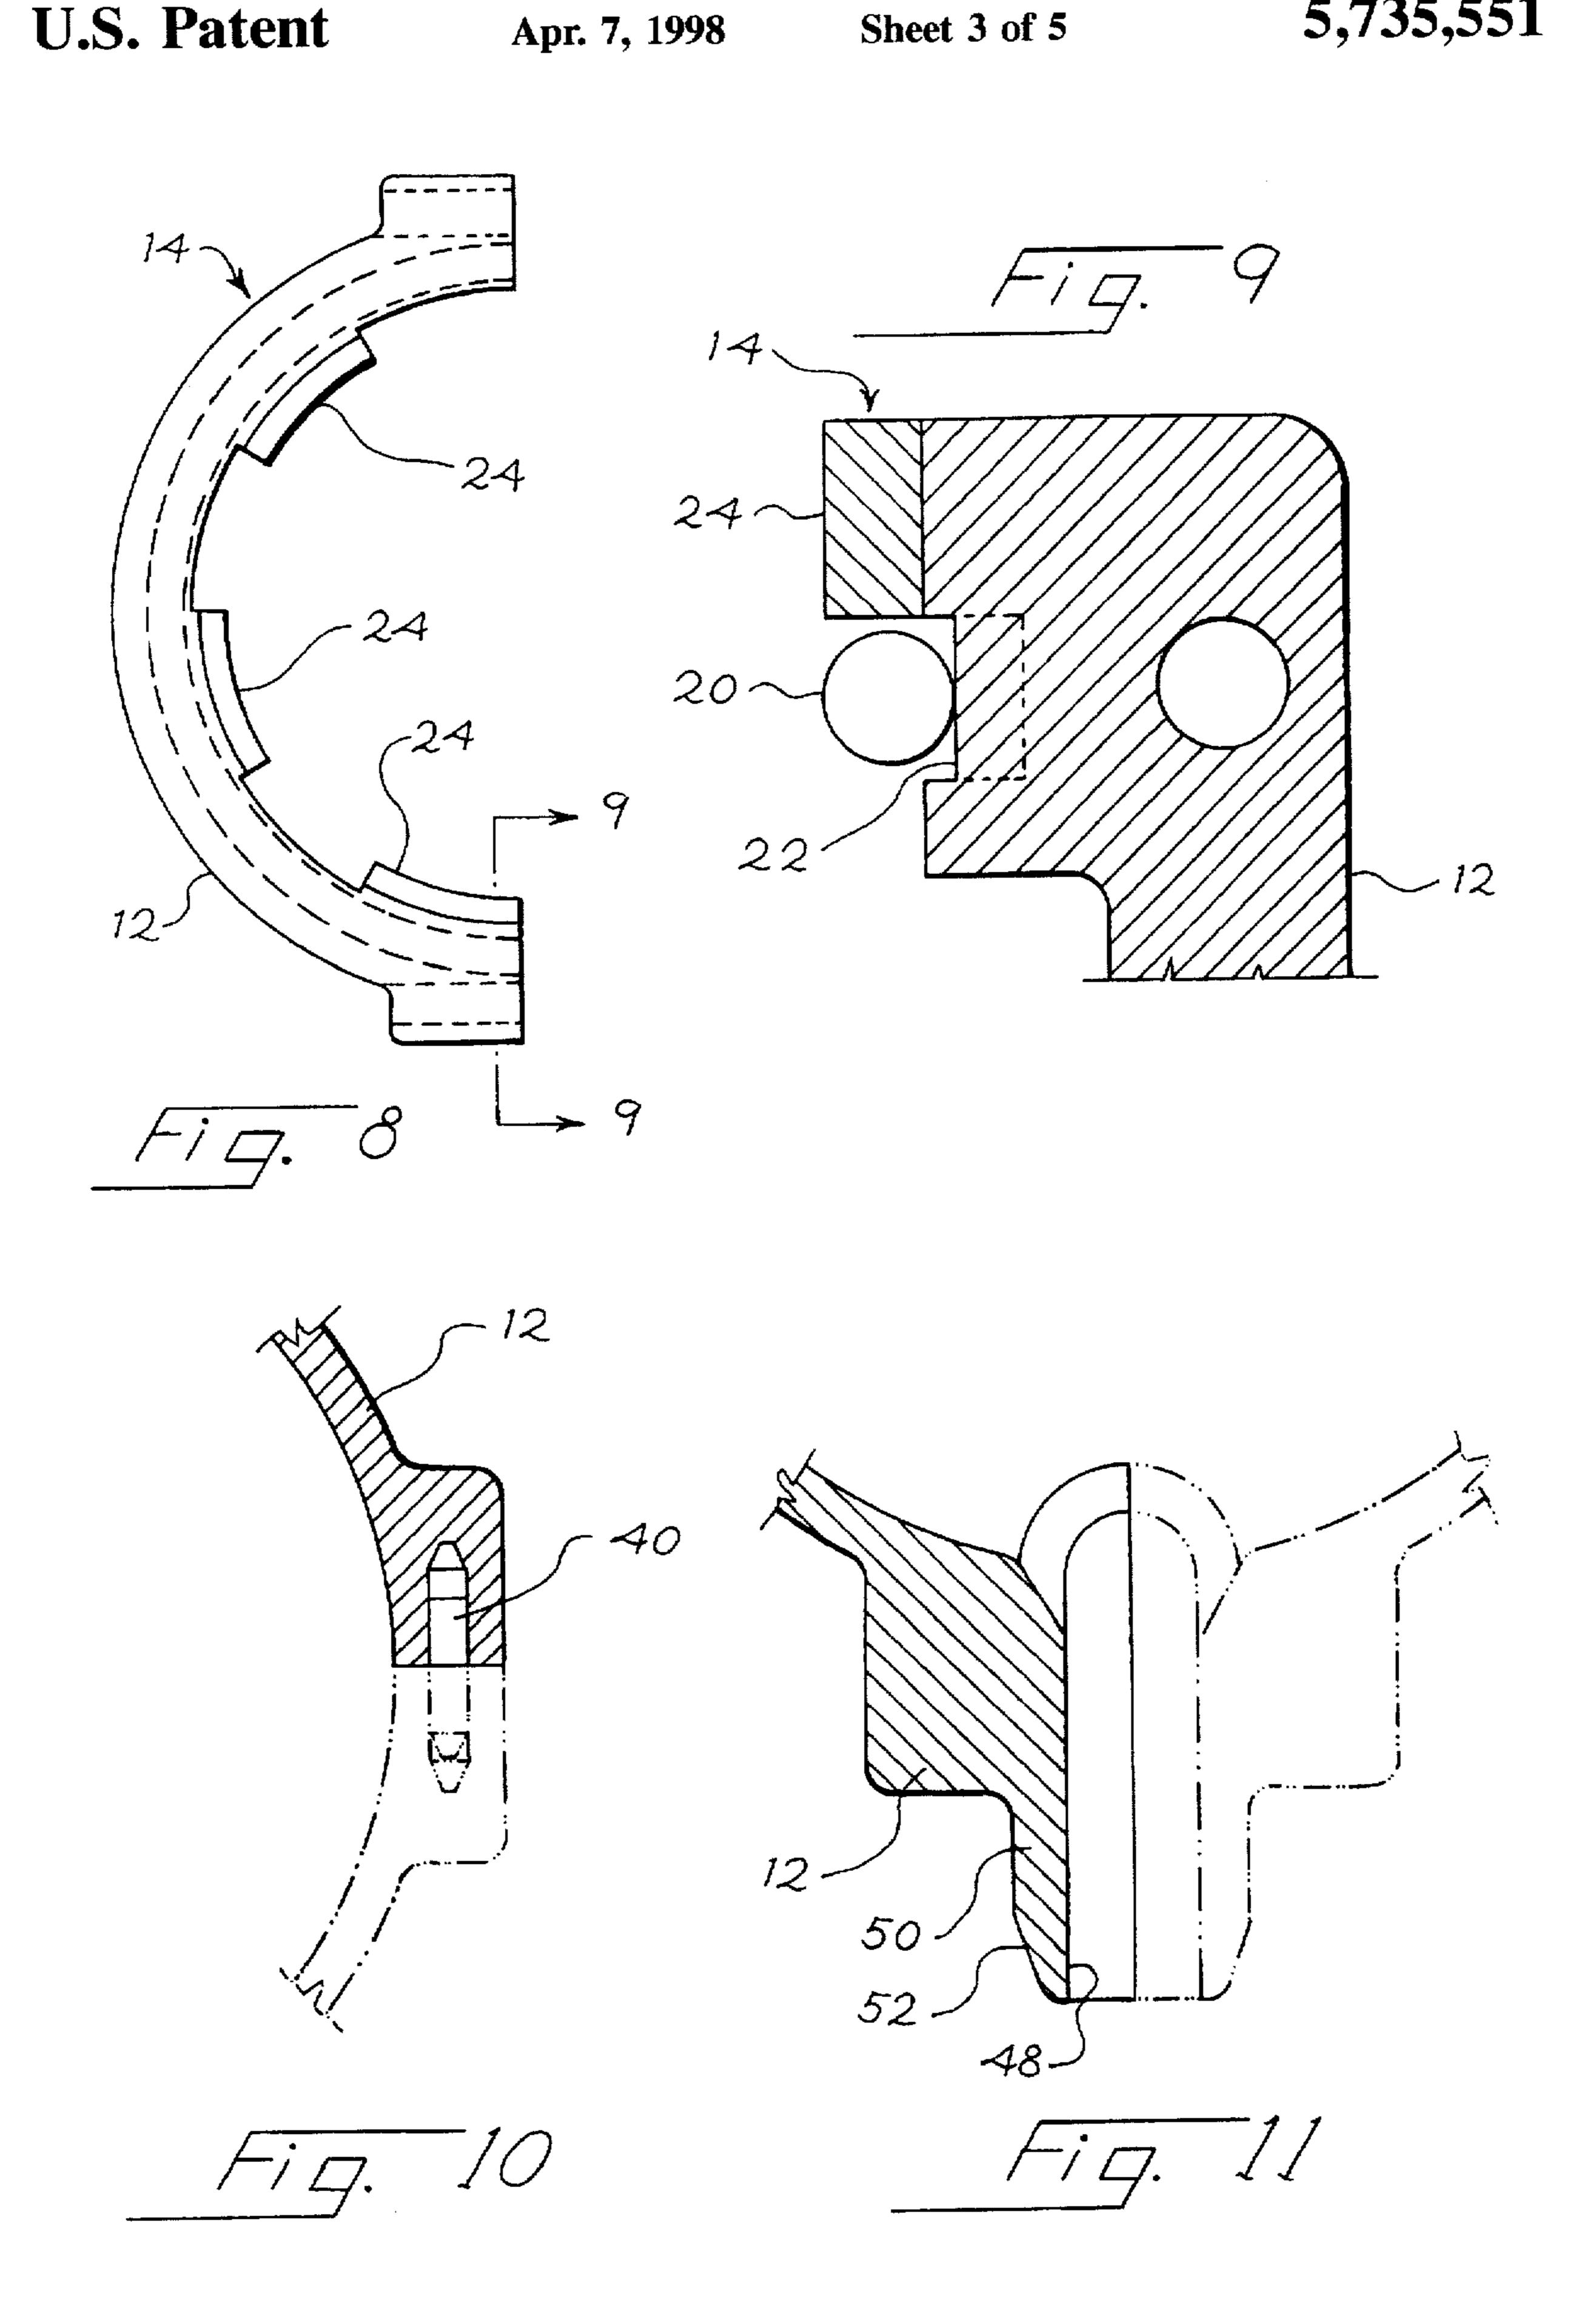
FIG. 8 is a view of the upper face of the housing of FIG. 3, taken along line 8—8 of FIG. 3.

FIG. 9 is a cross-sectional view taken along line 9—9 of FIG. 8.

FIG. 10 is a cross-sectional view taken along line 10—10 of FIG. 2.

FIG. 11 is a fragmentary sectional view taken along line 11—11 of FIG. 2.

FIGS. 8 and 9 provide details of construction regarding the first end 14. As shown in FIGS. 8 and 9, the first end 14 defines radially inwardly directed protrusions 24 that are shaped to engage the outer surface of the downcomer D. As shown in FIG. 9, these protrusions 24 are preferably provided with a region that is built up of a material such as ER-209 weld material that can be machined after solution annealing, without becoming unduly susceptible to cracks and corrosion. The protrusions 24 allow the housings 12 to grip an irregular (out-of-round) downcomer D without 20 crushing it.

The housings 12 also include three alignment pins 40 as shown in FIG. 10, which facilitate alignment at the time of assembly. One of the alignment pins 40 is shown in greater detail in FIG. 16. Each alignment pin 40 is press fit into one of the housings 12 and then releasably fit into the other.

FIG. 11 shows a cross-sectional view that illustrates the housing 12 in the region of the aperture 48. Note that the housing 12 includes a protrusion 50 adjacent the aperture 48, and this protrusion 50 includes surfaces 52 that engage wedging surfaces 54 of a wedge block 56 (FIG. 12). A preferred embodiment of the cap 46 is shown in FIGS. 17 and 18. This cap 46 includes a seal 45 similar to the seals 20, 28 described above.

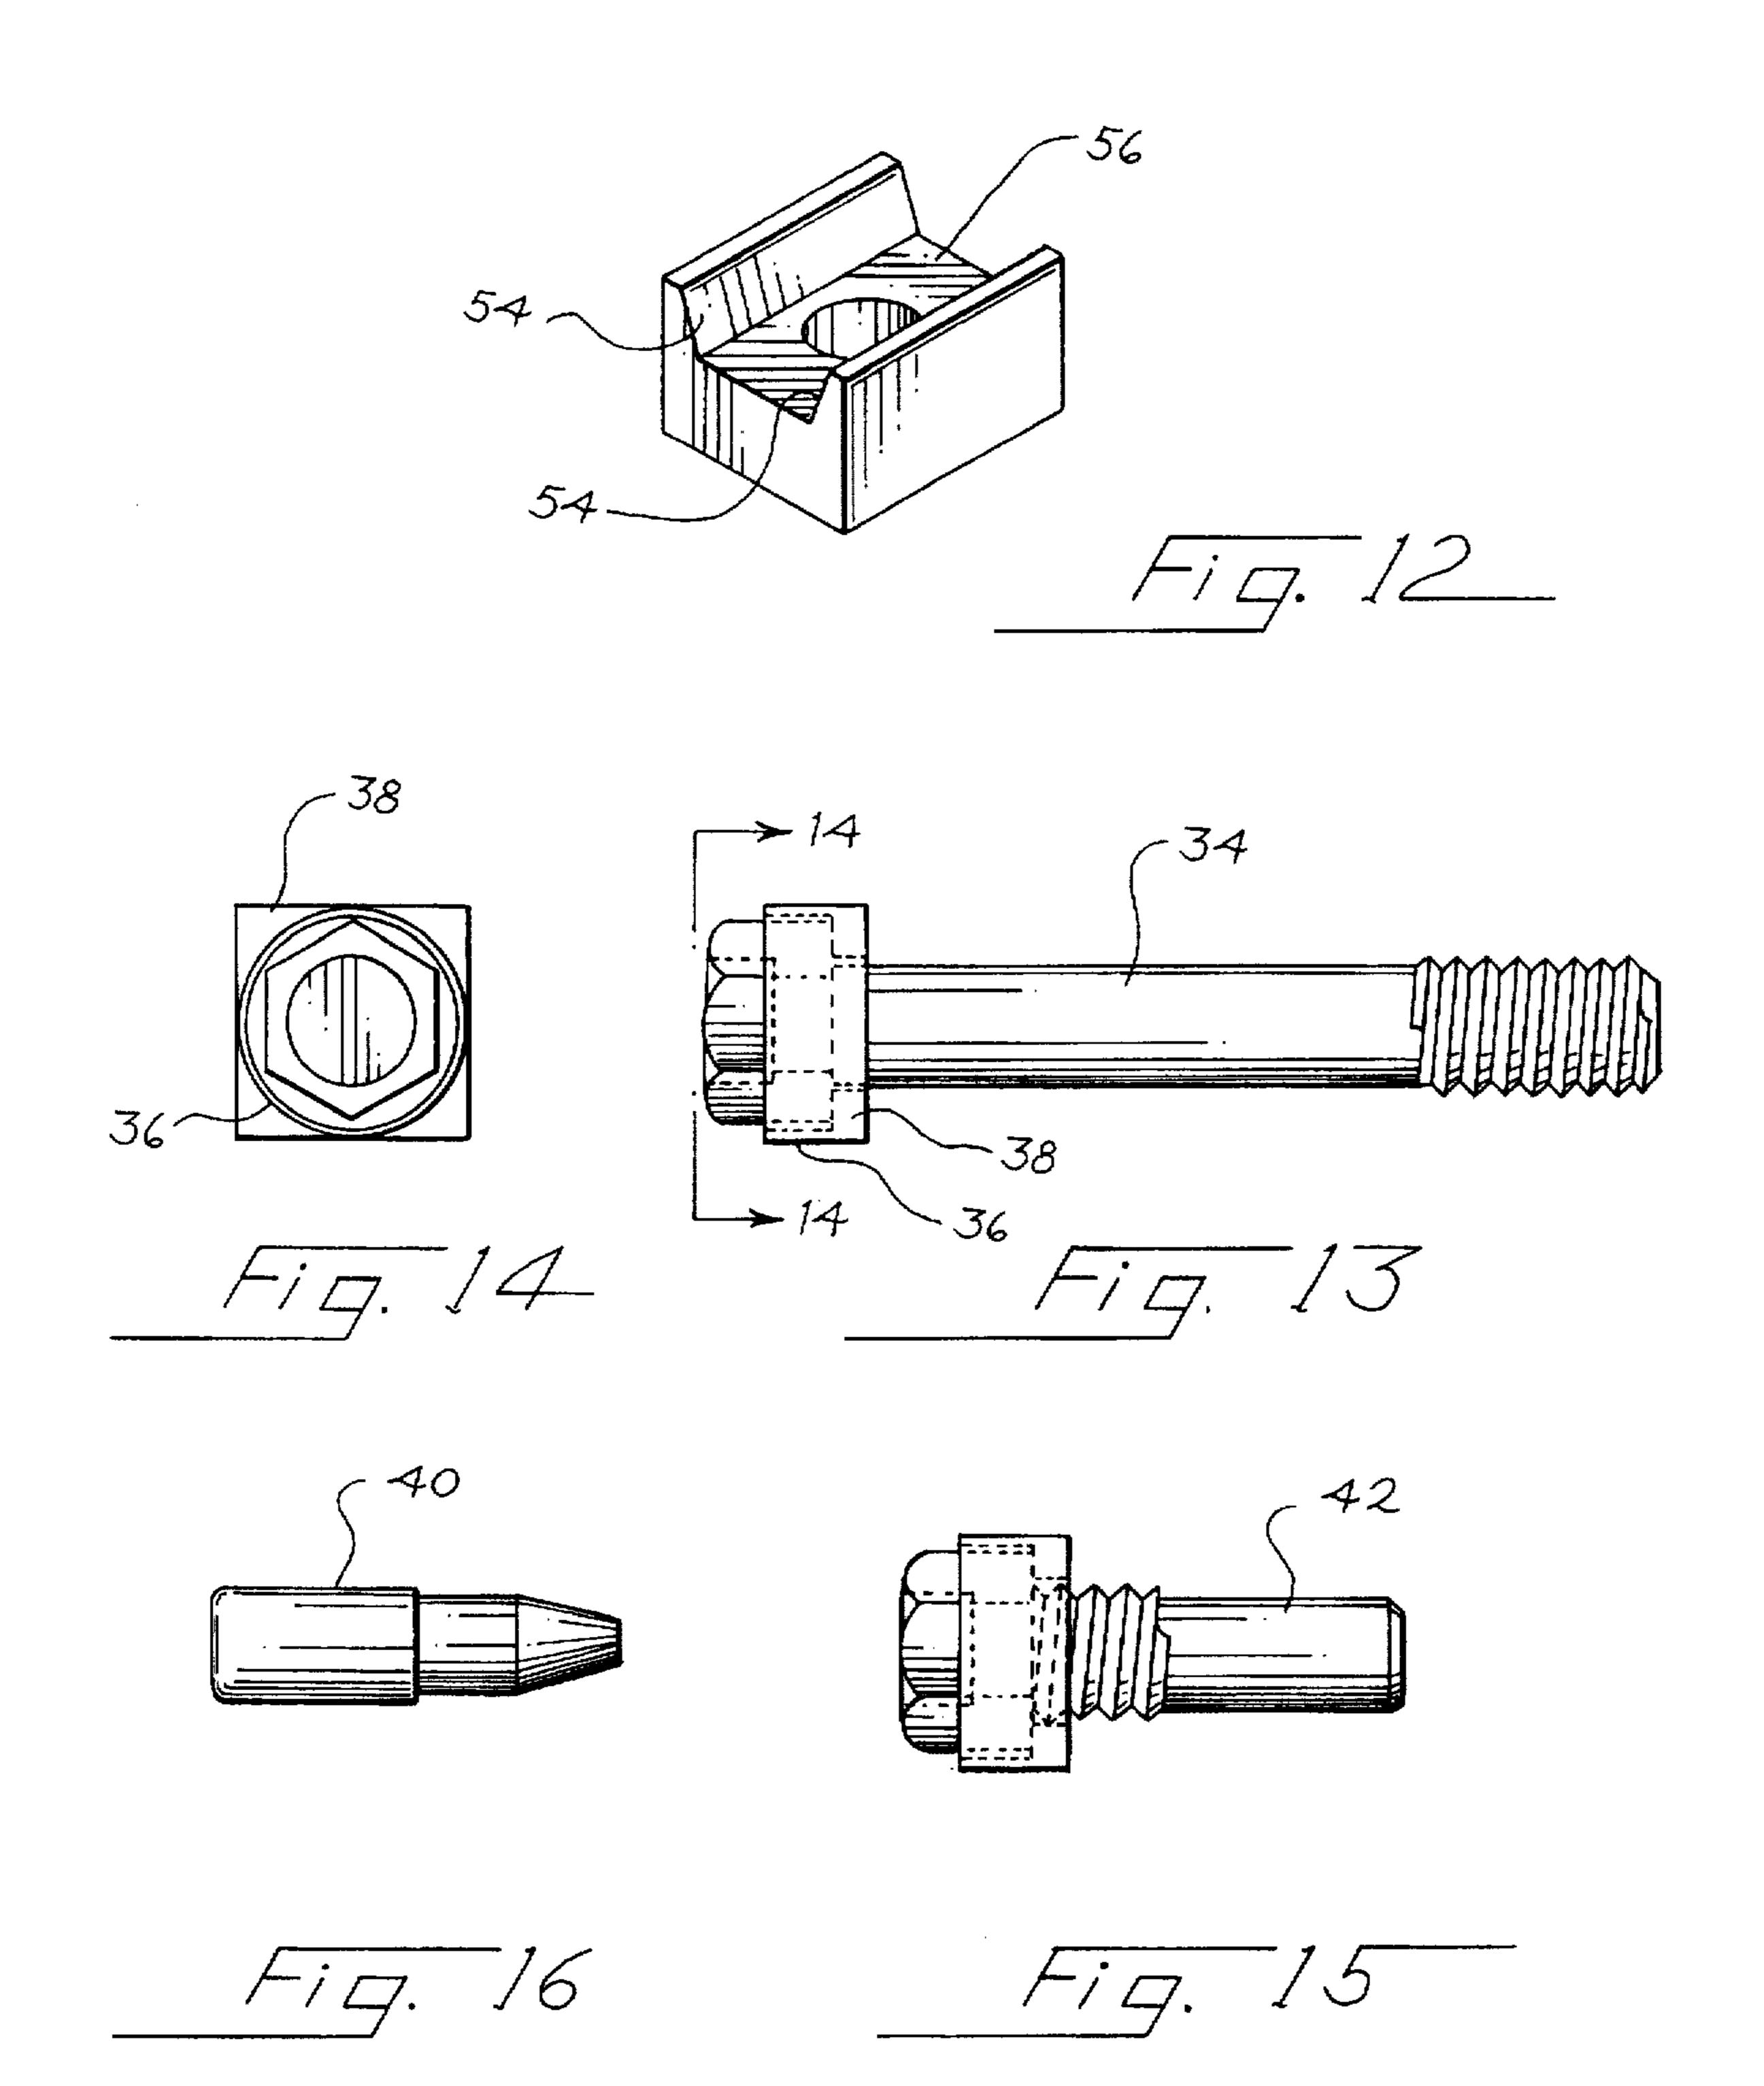
FIG. 12 is a perspective of a wedge block included in the embodiment of FIG. 1.

FIG. 13 is a plan view of a threaded fastener included in the embodiment of FIG. 1.

FIG. 14 is an end view taken along line 14—14 of FIG. 13, showing a retainer device.

FIG. 15 is a side view of a threaded pin included in the embodiment of FIG. 1.

FIG. 16 is a side view of an alignment pin included in the embodiment of FIG. 1.

FIG. 17 is a plan view of a cap included in the embodiment of FIG. 1.

FIG. 18 is a cross-sectional view taken along line 18—18 of FIG. 17.

The openings 32 receive threaded pins 42, shaped as shown in FIG. 15.

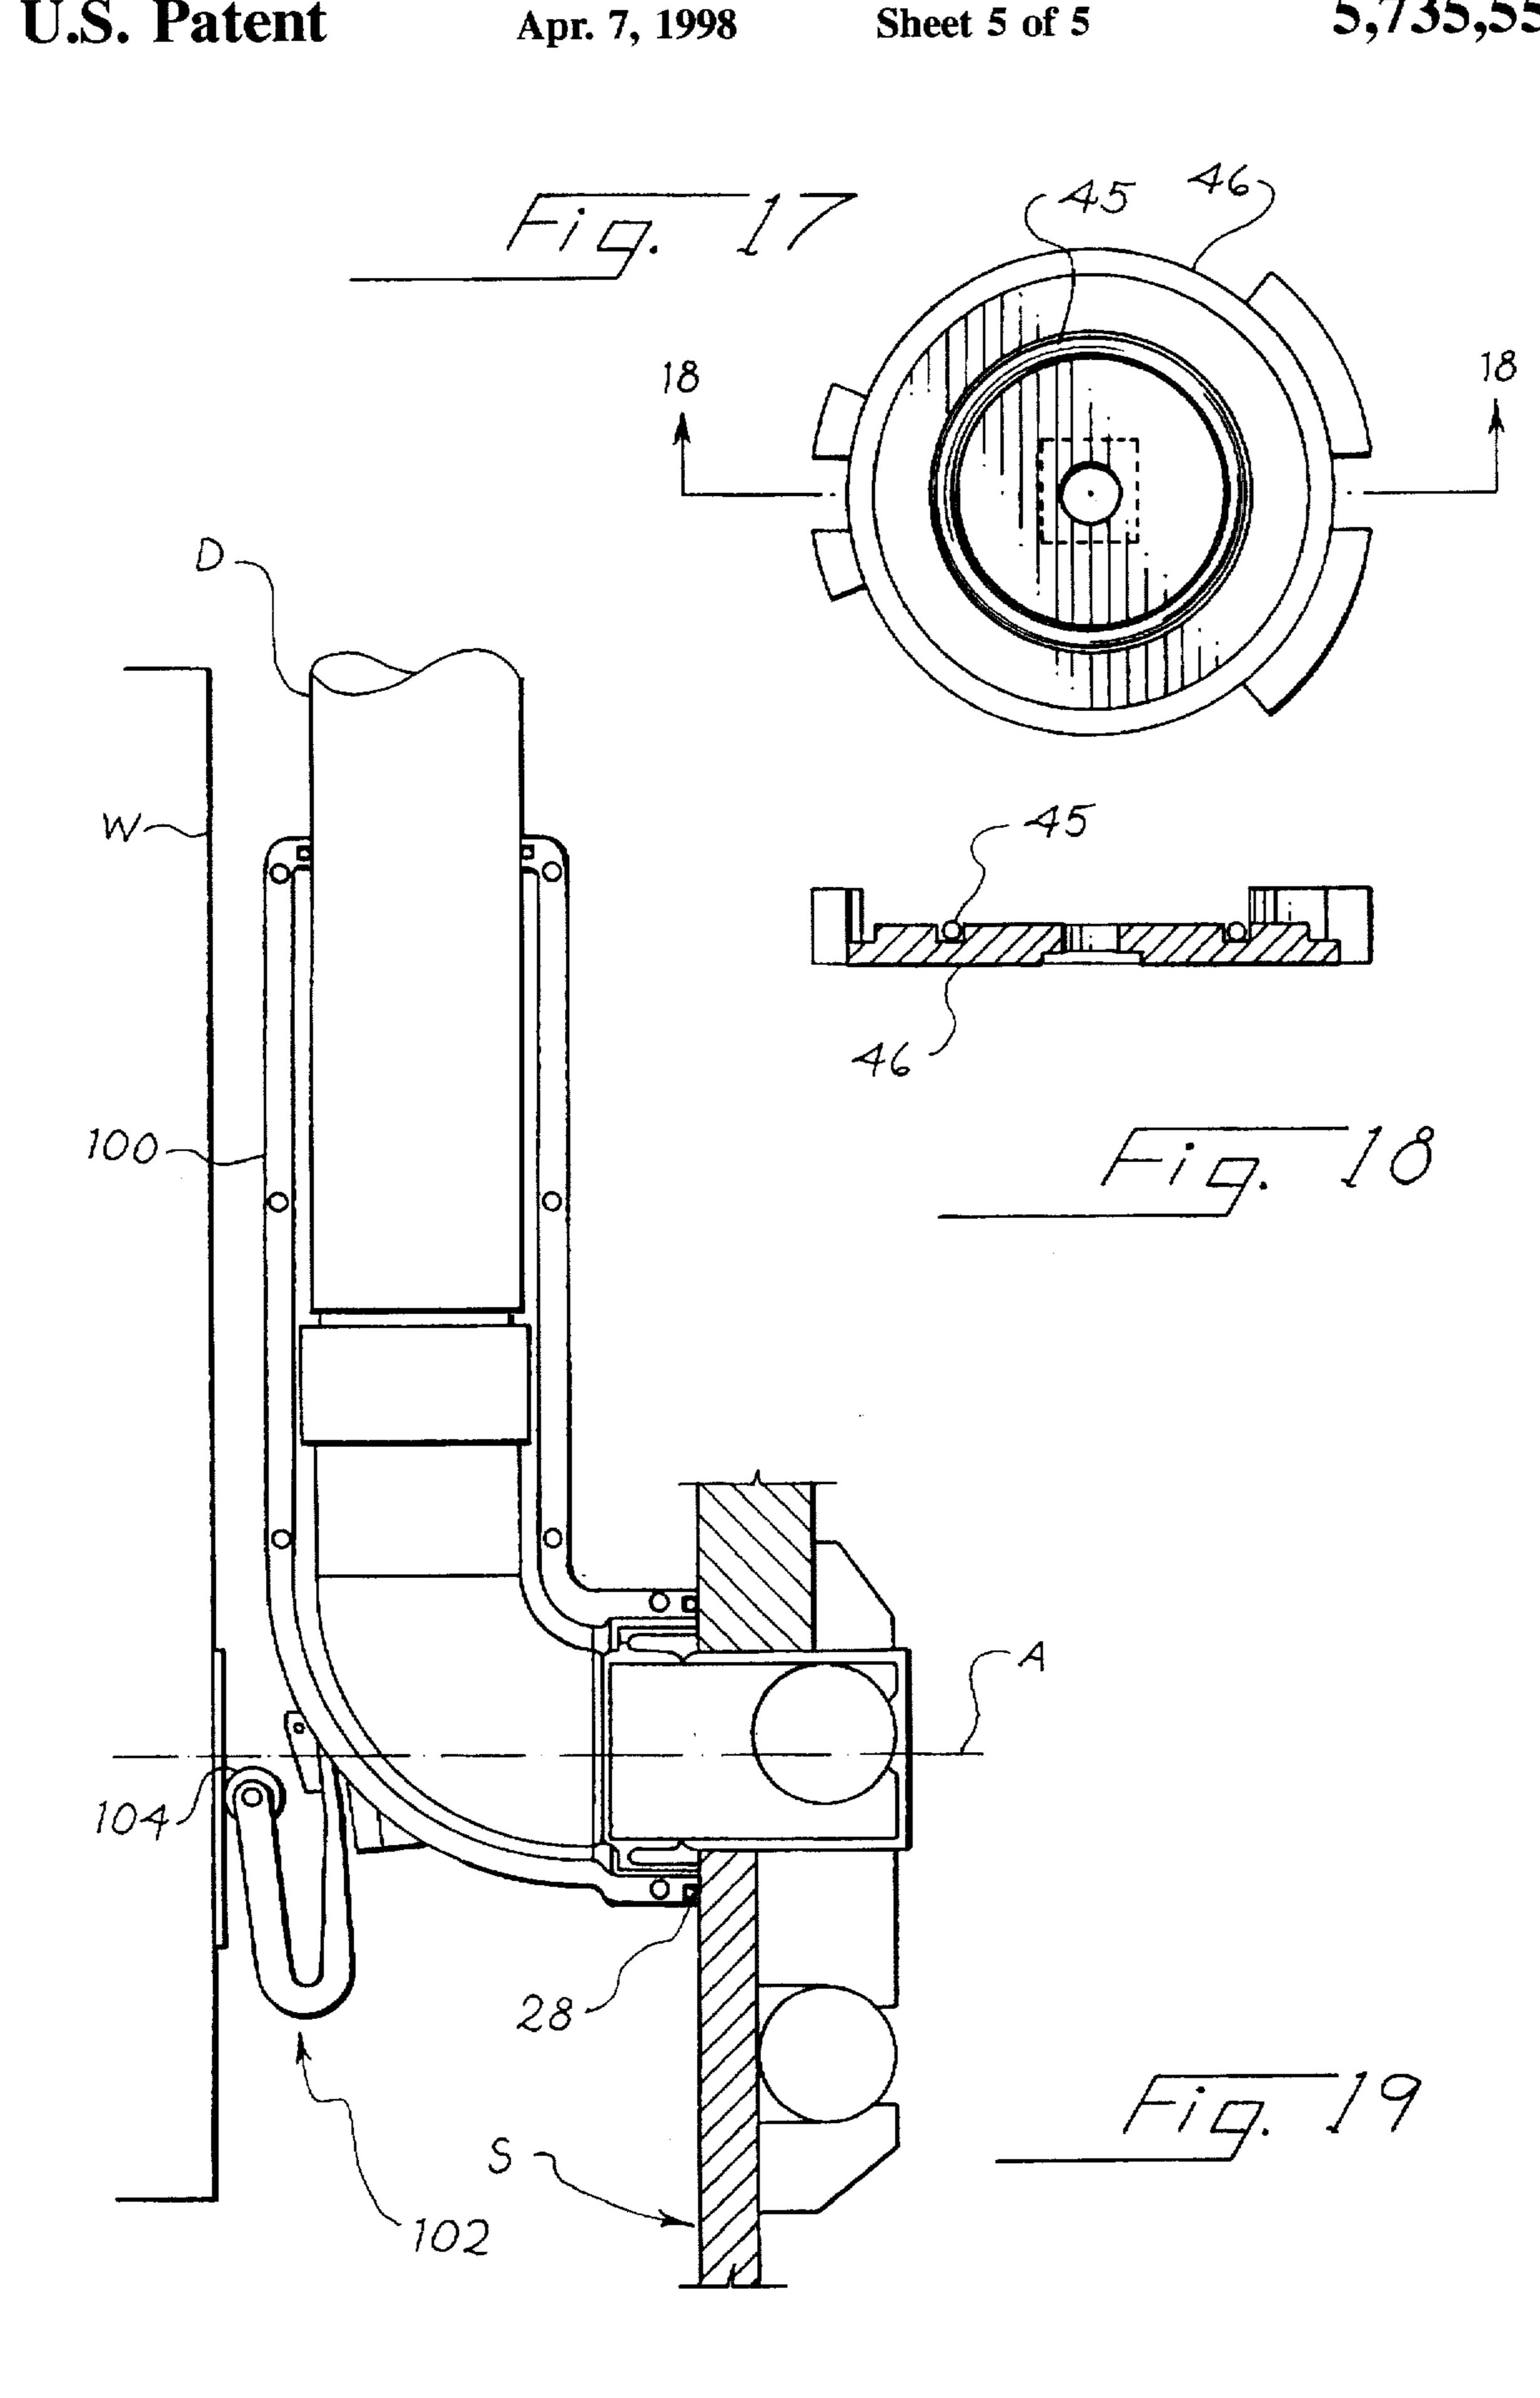
FIG. 19 is an assembly drawing of a second preferred embodiment of the pipe repair of this invention.

FIG. 19 shows an assembly drawing of a second embodiment 100 of the pipe repair of this invention. The pipe repair 100 is substantially identical to the pipe repair 10 described above, except that the threaded rod 44 is deleted. In this case, the pipe repair 100 is retained in place against the shroud S by a spring fixture 102. The spring fixture 102 includes a roller 104 that reacts against the wall W of the nuclear reactor vessel. The spring fixture 102 is secured at one end to the pipe repair 100 in alignment with the axis A, and acts to clamp the seal 28 firmly against the shroud S.
