[54] **POST-FABRICATION REPAIR THIN FILM IMAGER STRUCTURE**
[75] **Inventor:** **Roger Stephen Salisbury, Schenectady, N.Y.**
[73] **Assignee:** **General Electric Company, Schenectady, N.Y.**

POST-FABRICATION REPAIR THIN FILM IMAGER STRUCTURE

FIGS. 1(A)–1(D) are cross-sectional views illustrating steps in the repair of a defect in an imager device in accordance with this invention.

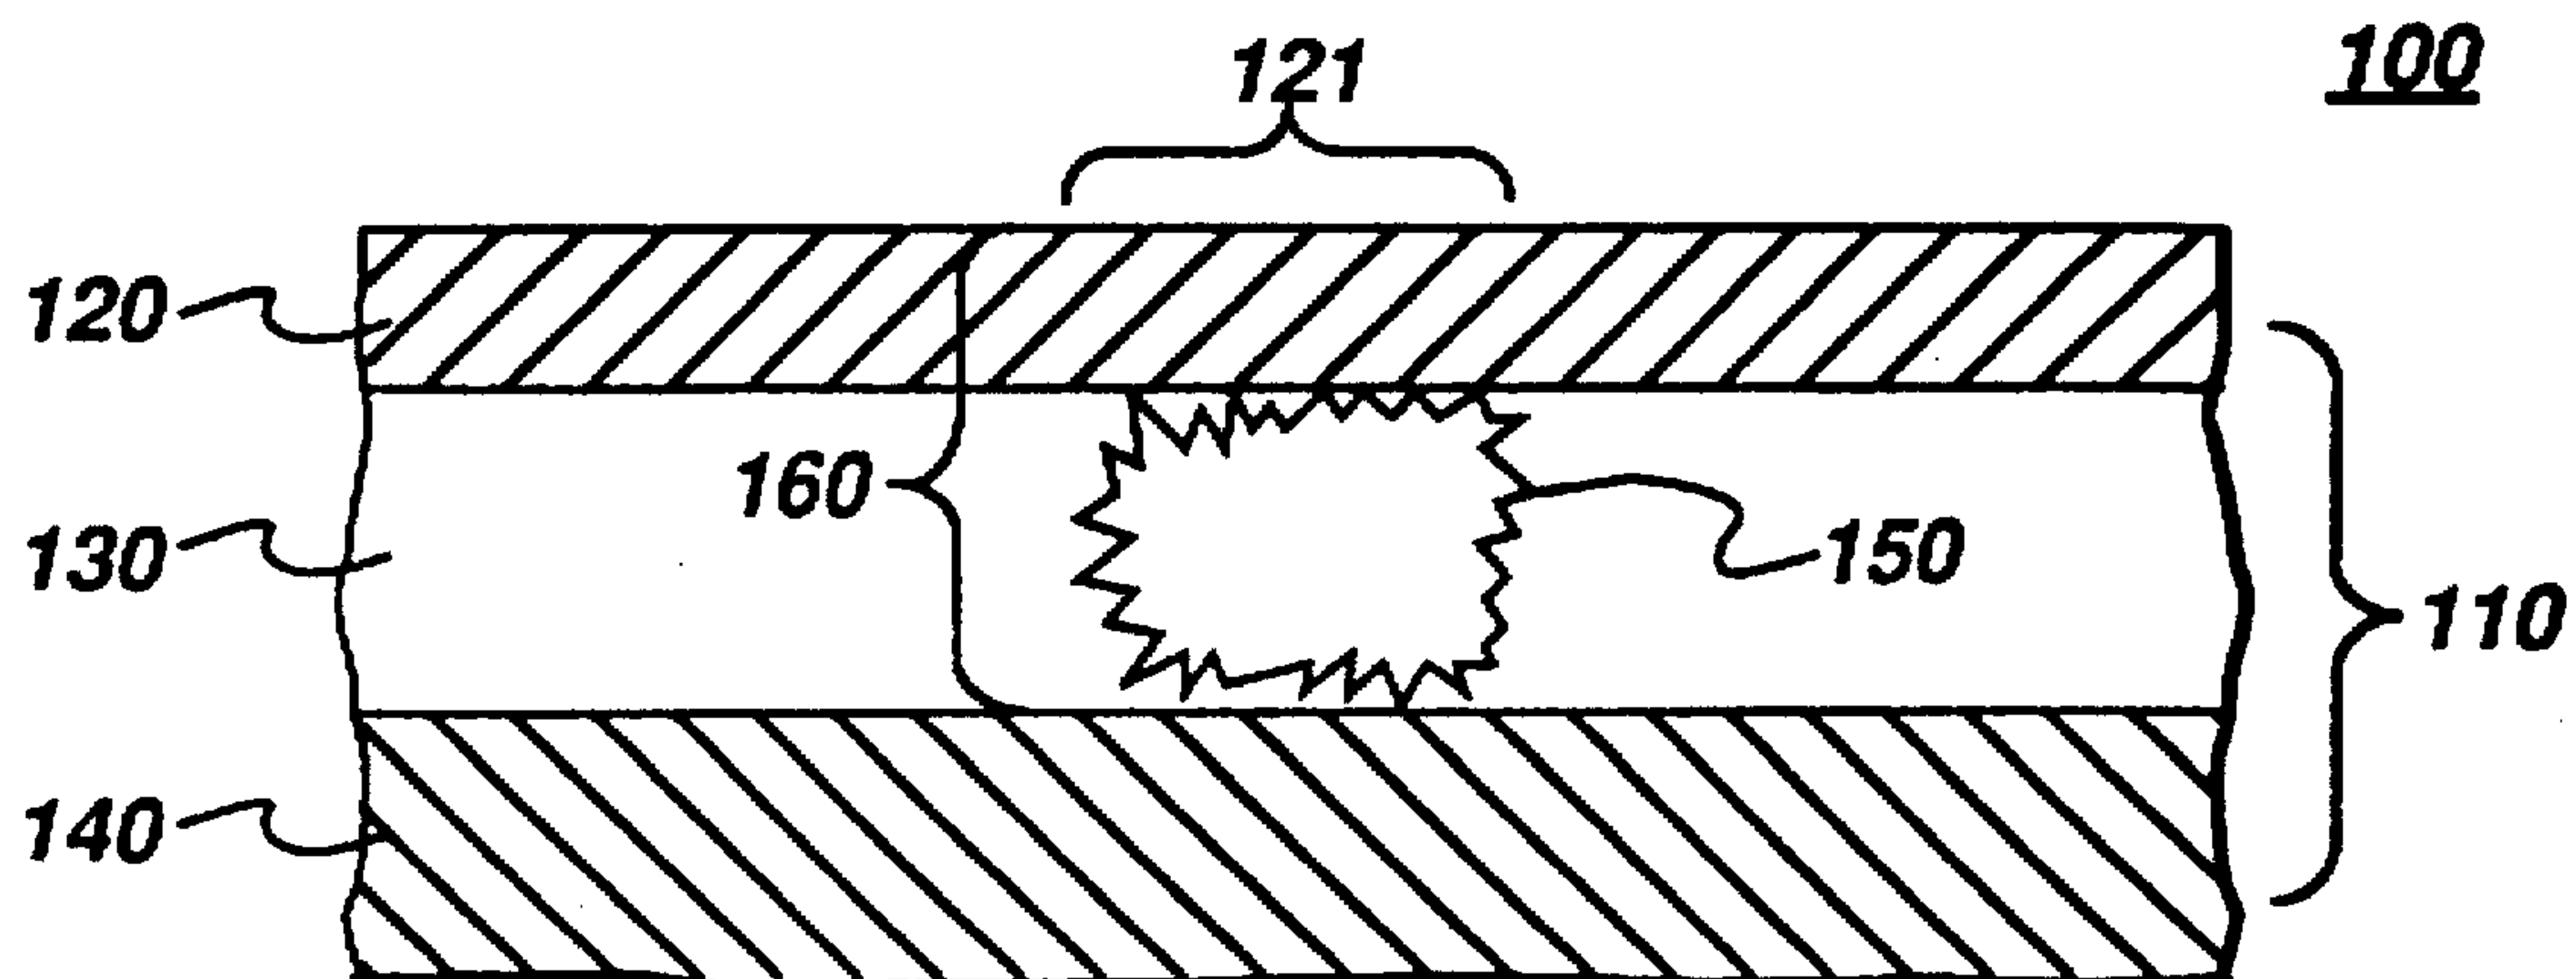
fig. 1A

FIG. 1(A) illustrates imager device 100 at a stage in the fabrication process following deposition of the common electrode and prior to the mating of the scintillator to imaging array 110. At this point in the fabrication process final checks are made of imaging array 110 to locate electrical defects; arrays that are not repairable to maintain a satisfactory performance must be rejected. Electrical defects include electrical short circuits between underlying components in the array, such as between address lines, between address lines and switching transistors, or between the common electrode and underlying components. Open circuit conditions can also occur which require repair and removal of portions of the earlier-deposited components in

A defect 150 is shown in FIG. 1(A) that comprises a piece of conductive material debris that presents a short circuit between common electrode 120 and underlying component 140. The illustration of defect 150 is made by way of example and not limitation, and defect 150 is representative of any short circuit condition; further, if defect 150 (or any other type of defect requiring repair) is disposed between other underlying components, the same repair procedures are used to remove the portion of common electrode 120 overlying the defect and produce a low leakage repaired structure.

In array 110, an upper conductive layer 120 (also referred to as common electrode 120) is disposed over a dielectric material layer 130 that is in turn disposed to electrically insulate upper conductive layer 120 from an underlying component 140. Common electrode 120 provides a common contact to a plurality of photodiodes (not shown) or the like and thus is disposed over substantially the entire imaging array, overlying substantially every component in the imaging array. Common electrode comprises an electrically conductive material that is also light transmissive so as to allow optical photons to pass from the scintillator to the photosensors; typically the material is a transparent conducting oxide such as indium-tin oxide, gallium-tin oxide, tin oxide, or the like. Indium tin oxide and tin oxide, for example, can be deposited in a plasma sputtering process to a thickness in the range between 600 angstroms and 1400 angstroms to form common electrode 120.

Dielectric layer 130 typically comprises an organic dielectric such as polyimide or the like that is deposited in a spin process to a thickness in the range between 1 μm and 2 μm . Alternatively, dielectric layer 130 comprises an inorganic dielectric material such as silicon nitride or silicon oxide. Dielectric layer 130 extends across array 110 to form a region in which common electrode 120 is electrically insulated from underlying components in the array except at contact points on the photodiode, at which points dielectric layer material is removed so that the conductive material of common electrode 120 is disposed in electrical contact with a surface of the photodiode.

By way of example and not limitation, underlying component 140 illustrates a conductive material in the array, such as address line, a transistor electrode, or the like. As used herein, "underlying" refers to a component that is formed in the fabrication process prior to the deposition of the common electrode 120, and thus is disposed on a different level of the sandwich of materials that are deposited to fabricate the components for the imager device. No restriction on the orientation of the device is to be implied by the terminology relating to levels of the components. Underlying component 140 typically comprises a conductive material such as aluminum, gold, titanium, molybdenum or the like, or a heavily doped semiconductive material (such as n-type doped amorphous silicon). Alternatively, component 140 may comprise a layer of semiconductive material, such as the amorphous silicon comprising the photodiode body.

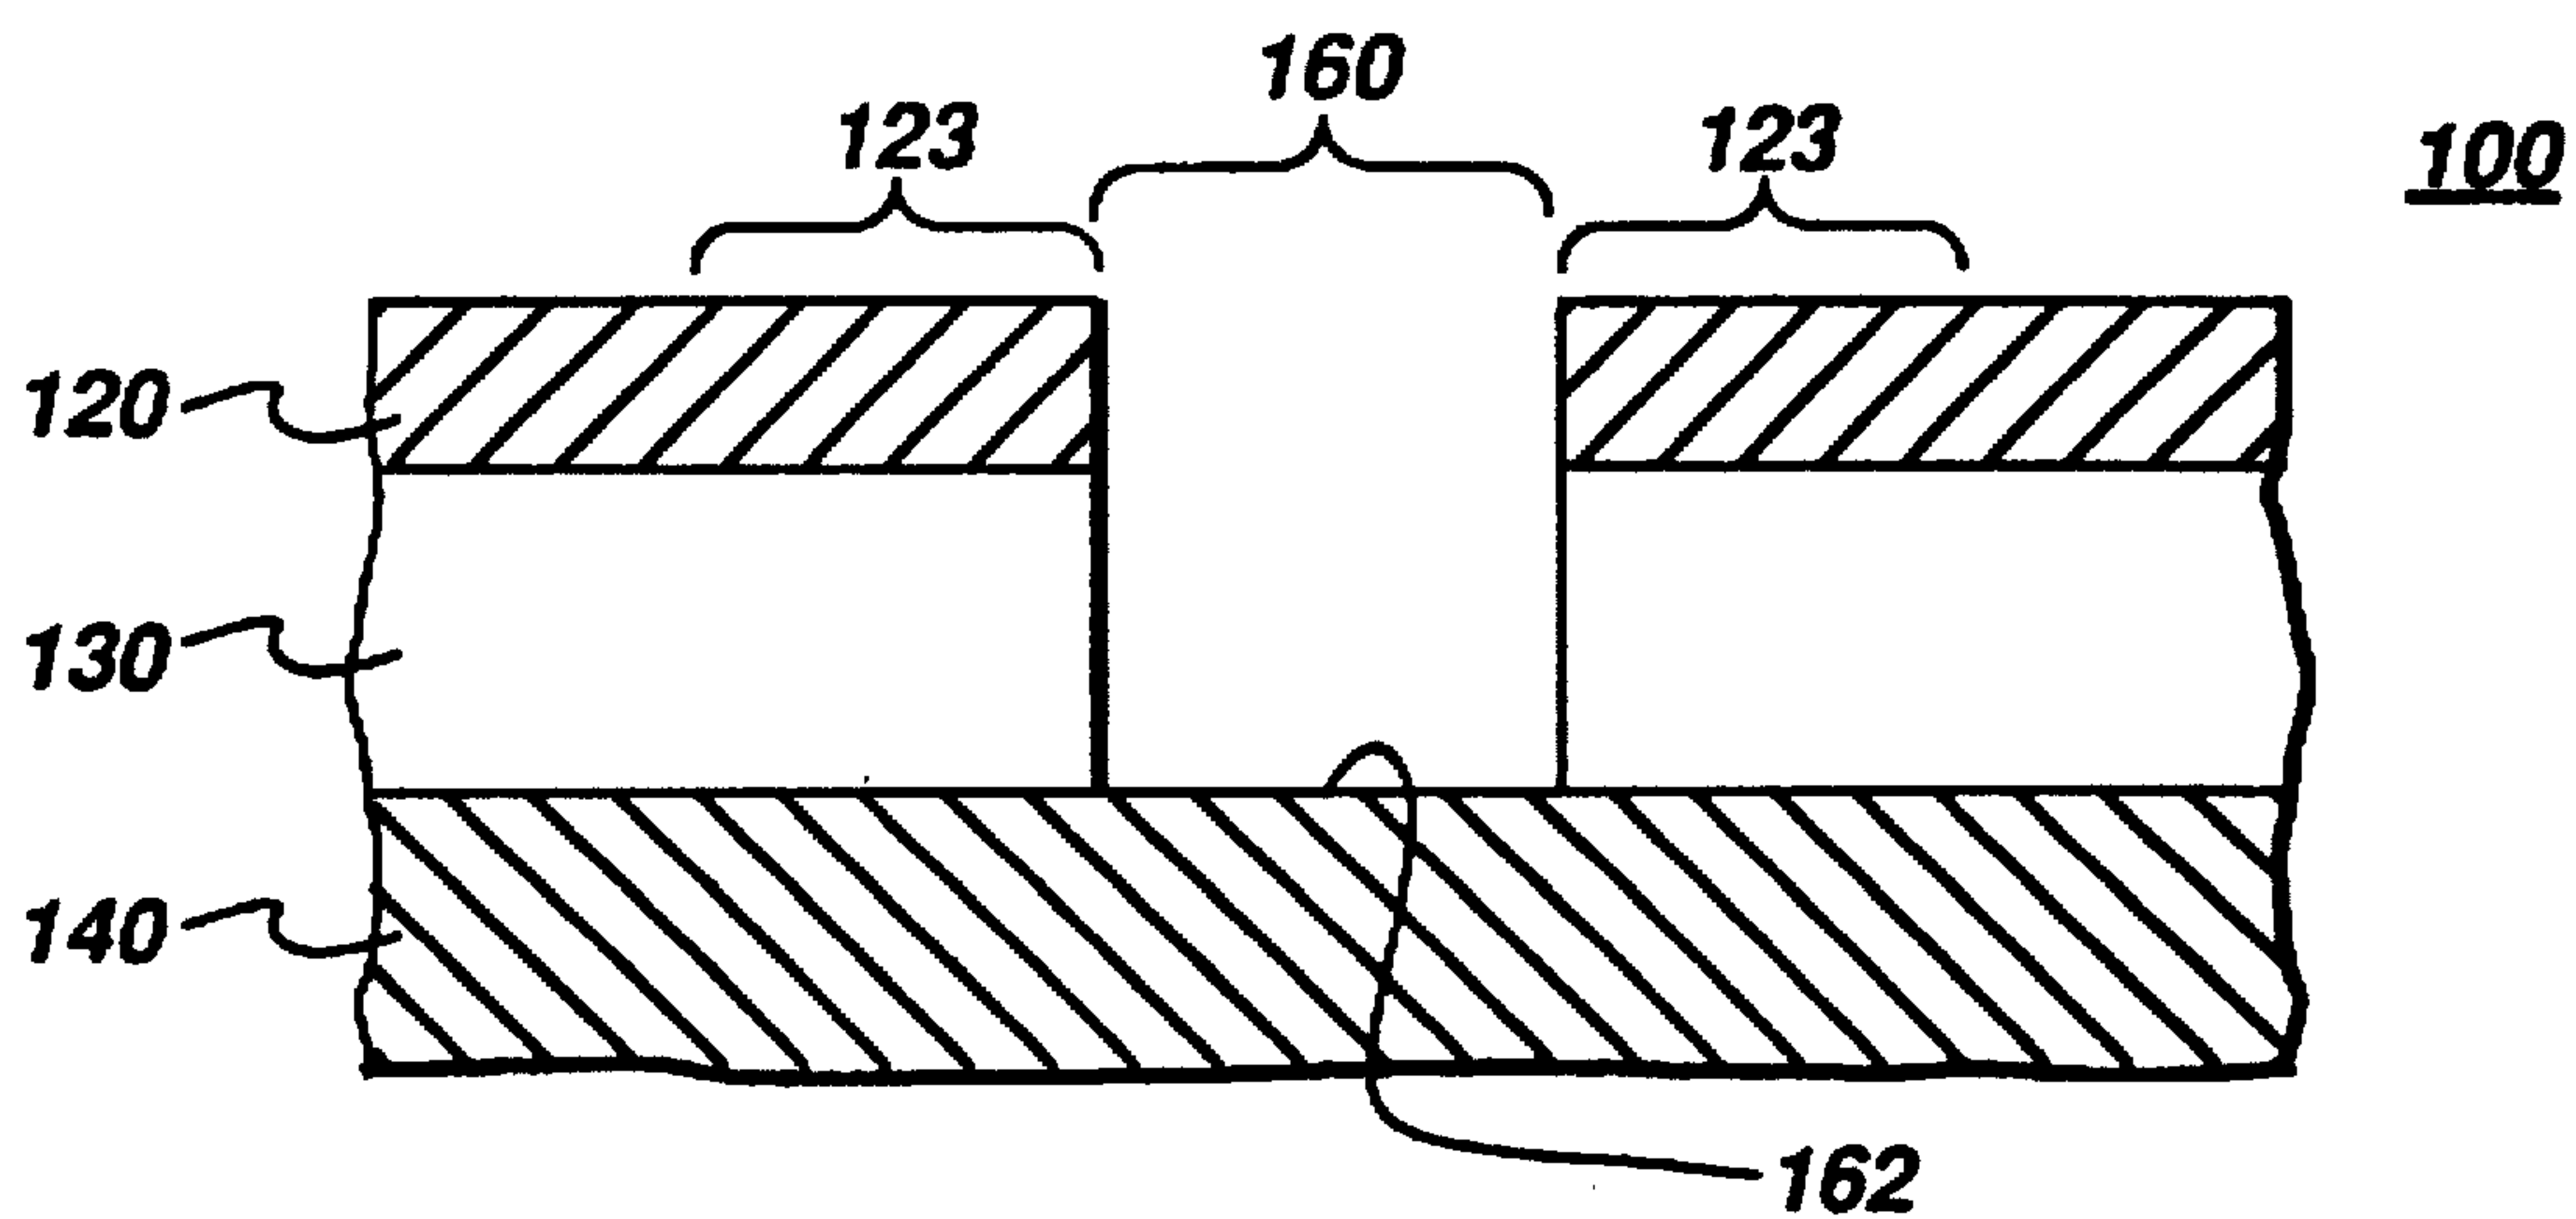
fig. 1B

In accordance with the present invention, the short-circuit defect in imager array 110 is repaired by removing a first portion 121 of common electrode at a repair site (or defect region) 160 on imager array 110. Typically laser ablation is used to remove common electrode first portion 121. In particular, an excimer laser operated at low power provides a finely-focused beam that is very effective in ablating the conductive material of common electrode 120 without simultaneously ablating other components in the array or causing such a rapid vaporization of the transparent conducting oxide that results in conductive residue being driven into underlying dielectric layer 130. The low power used to remove common electrode first portion 121 is typically in the range between about 50 microJoules (μJ) and 60 μJ , which is about 15% of full power in a LCM 308 model excimer laser. Operation of the laser at lower power may necessitate several passes over repair site 160 to completely remove the conductive material of common electrode 120 in the repair area.

After removal of common electrode first portion 121, defect 150 and surrounding portions of dielectric layer 130 are then removed. Laser ablation is typically used to effect this removal, such as with an excimer laser operated at higher power than that used for removal of the common electrode material (e.g., at power levels in the range between 250 μJ and 350 μJ). Laser ablation typically allows fine resolution in removing material from the array (that is, the beam can be focused to an area of about 3 microns square so that the defect can be excised with minimal removal of material surrounding the defect region). Laser ablation also typically results in relatively smooth vertical sidewalls in repair site 160. At the conclusion of this first laser ablation step, the repair region of imager array 110 appears as illustrated in FIG. 1 (B). For the defect illustrated in the Figures, removal of the defect results in repair site 160 having a bottom surface 162 comprising the conductive material of underlying component 140.

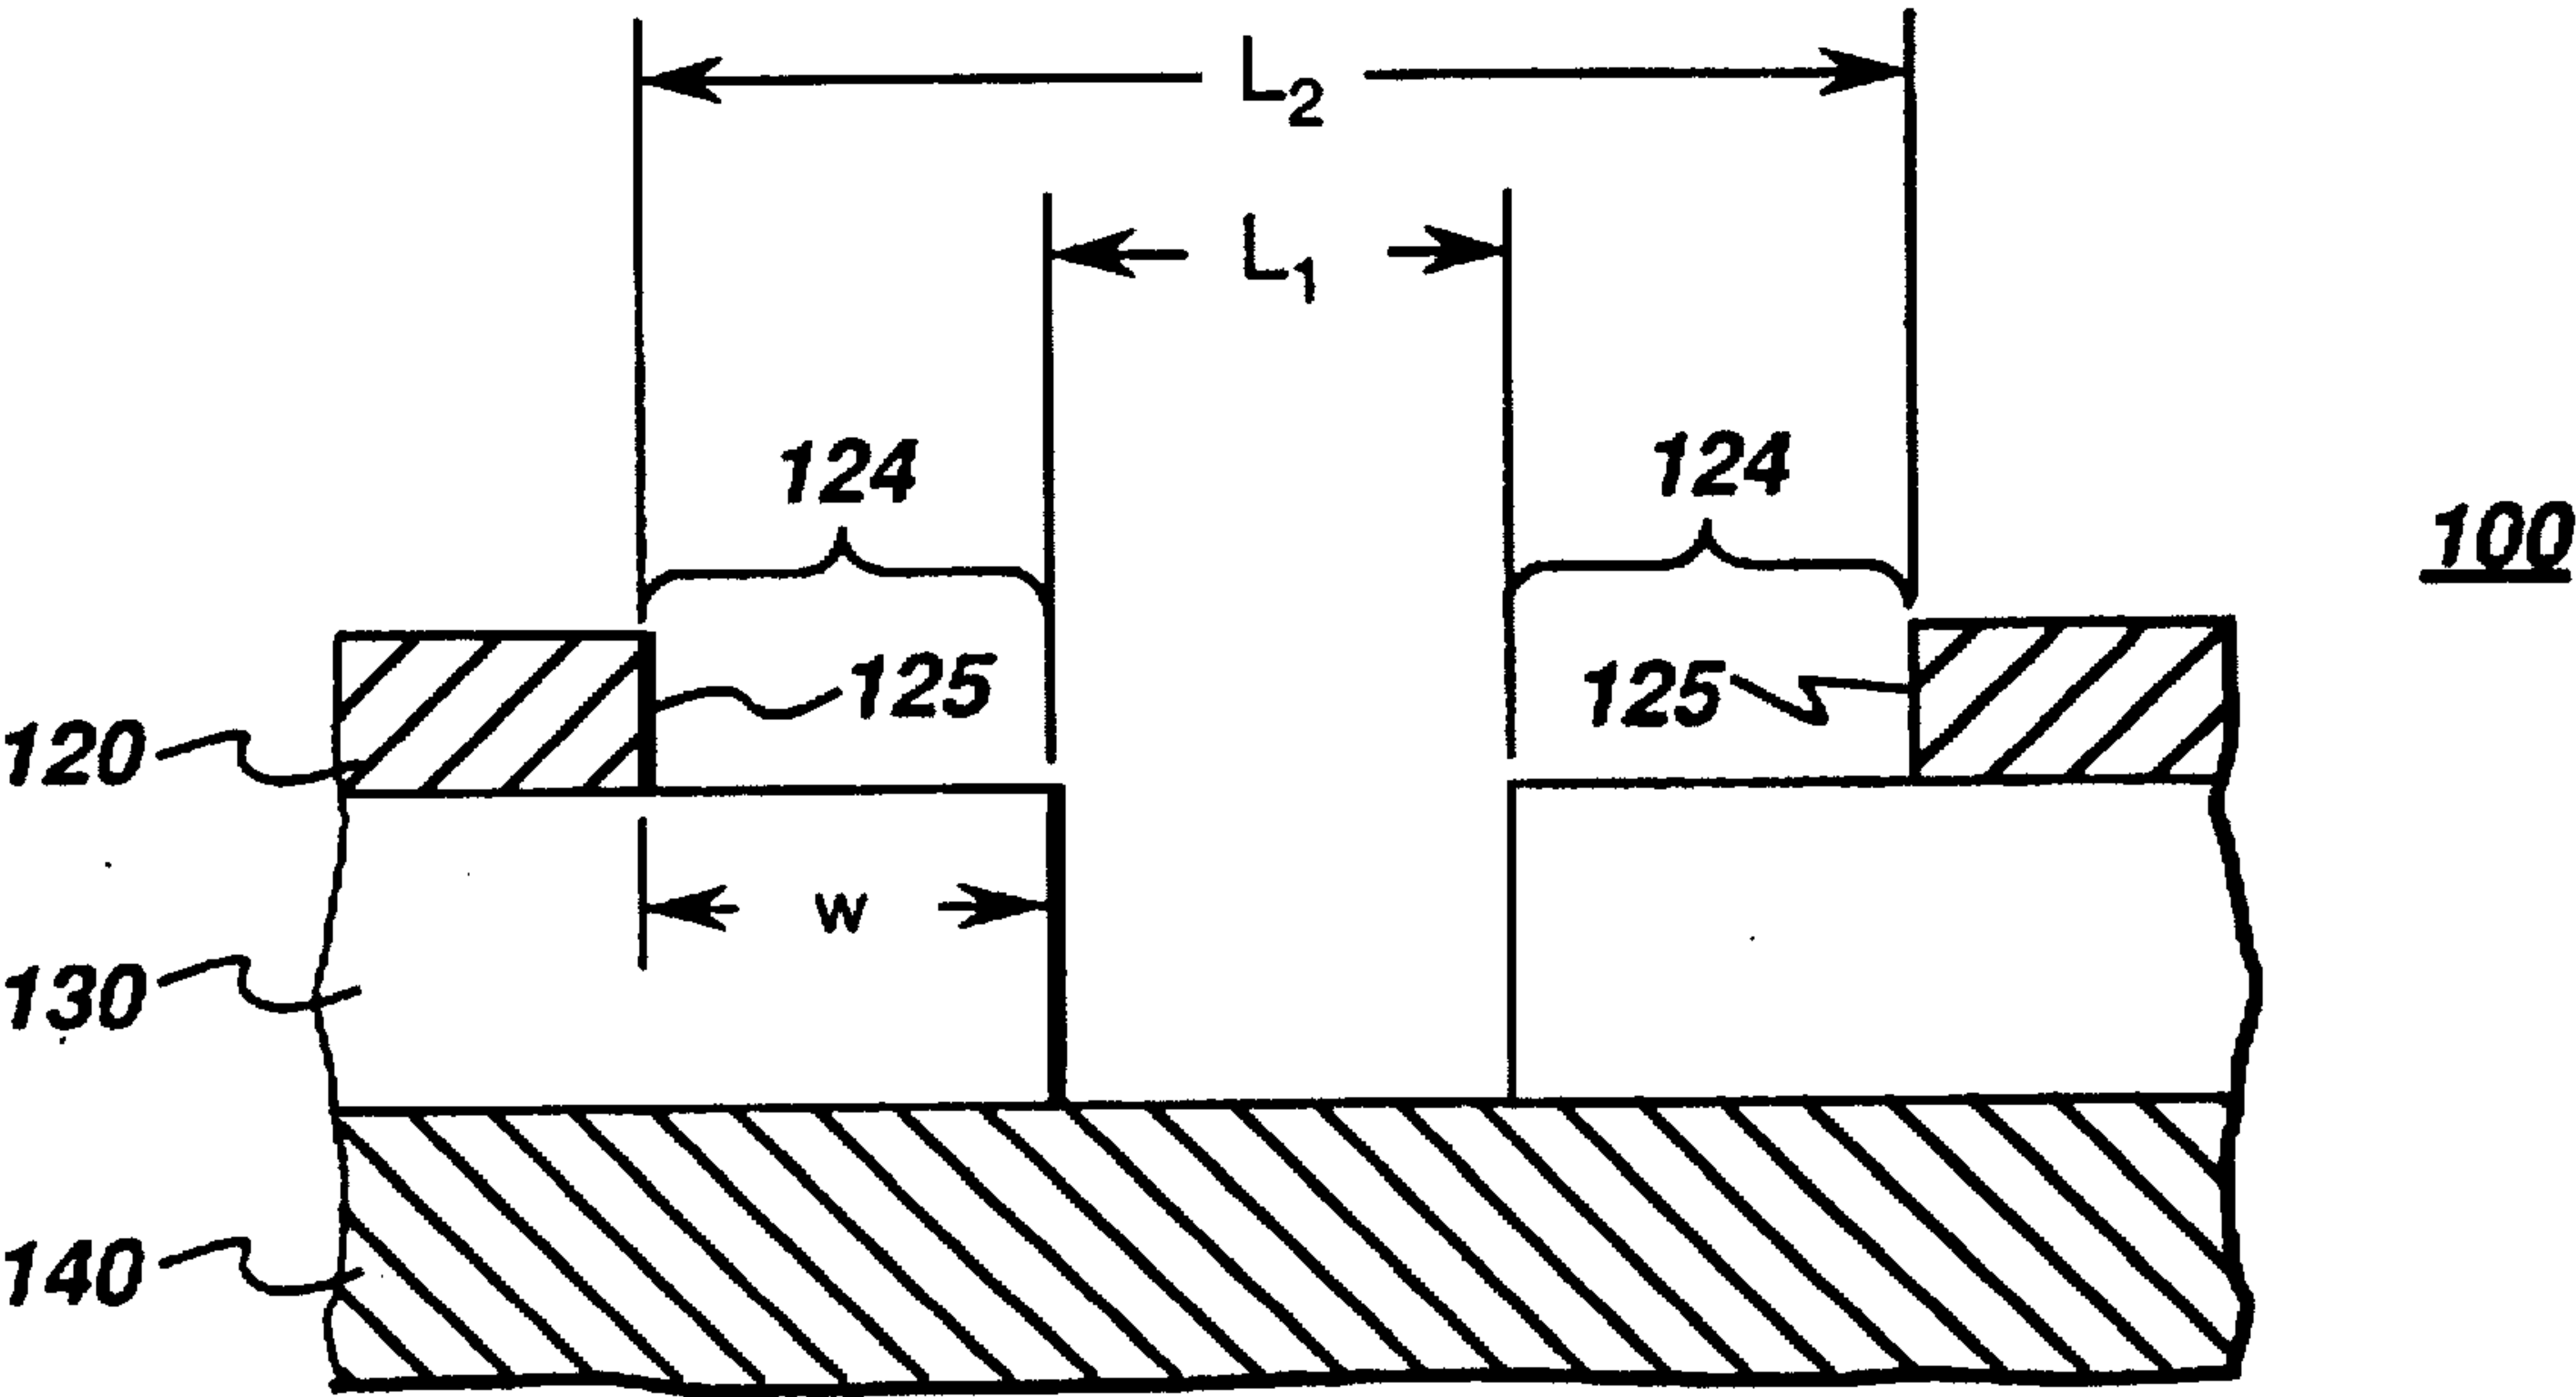
fig. 1C

Next, in accordance with this invention, a second portion 123 of common electrode 120 is removed to form an intermediate step level 124 (FIG. 1 (C)) around the periphery of repair site 160. The surface of intermediate level step 124 comprises the dielectric material of dielectric layer 130, that is, the conductive material of common electrode 120 is removed to expose the dielectric material. The lateral dimension L_1 of bottom surface 162 is less than the lateral dimension L_2 of the intermediate step level such that the width W of step 124 is greater than 1 μm , and typically is in the range between about 1 μm and 3 μm . Laser ablation, using the low power levels noted above, is used to remove common electrode second portion 123 to optimize the ablation while reducing the conductive material driven into underlying dielectric layer 130. The setback of common

electrode sidewalls 125 from dielectric layer sidewalls 164 in repair site 160 serves to reduce possible paths for electrical leakage between common electrode 120 and underlying component 140. For many imager arrays (such as those used in medical imaging), it is desirable that leakage be less than 100 pA in order to minimize array noise. Data from repaired wafers indicate that for repairs conducted in the conventional manner, that is, without the set-back of the common electrode material around the repair site, only about one-half of the wafers exhibit leakage of 100 pA or less; for wafers repaired in accordance with this invention, about 95% of the wafers exhibit leakage of 100 pA or less. This reduction of leakage is critical in high resolution x-ray imagers used in medical applications, and can constitute the difference between acceptance or rejection of a repaired imaging array 110 for use in a radiation imaging device.

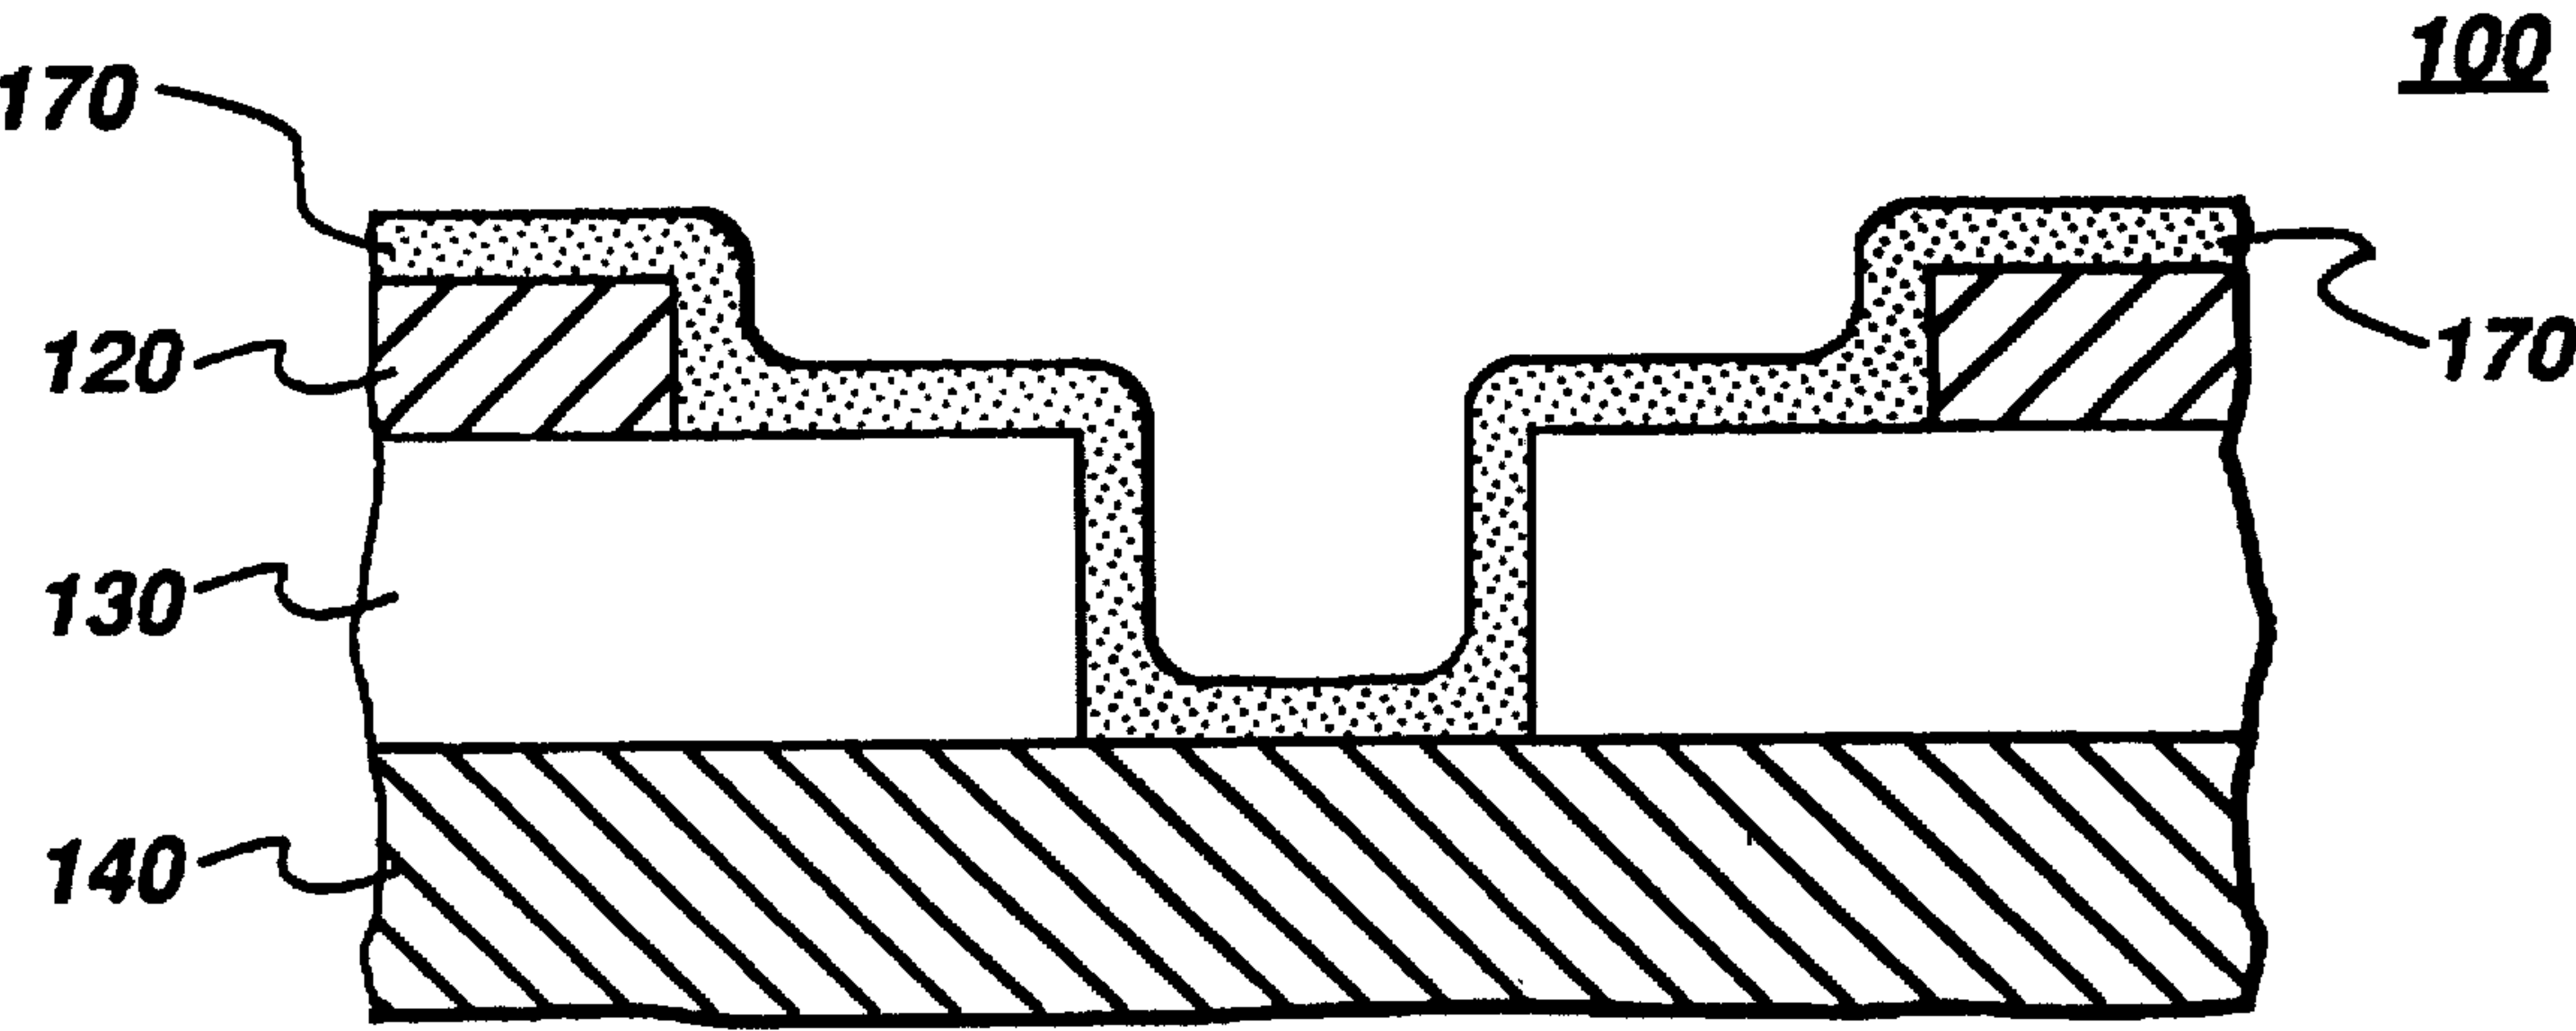
fig. 1D

Following formation of intermediate level step 124, a passivation layer 170 is formed over the repaired area to enhance the long term low-leakage characteristics of repair site 160. Passivation layer 170 comprises a dielectric material such as, silicon nitride, silicon oxide, or the like, which is deposited in a plasma enhanced vapor deposition process to a thickness of about 1500 angstroms.
