US005736758A

[11] Patent Number: **5,736,758**
[45] Date of Patent: **Apr. 7, 1998**

[54] **POST-FABRICATION REPAIR THIN FILM IMAGER STRUCTURE**

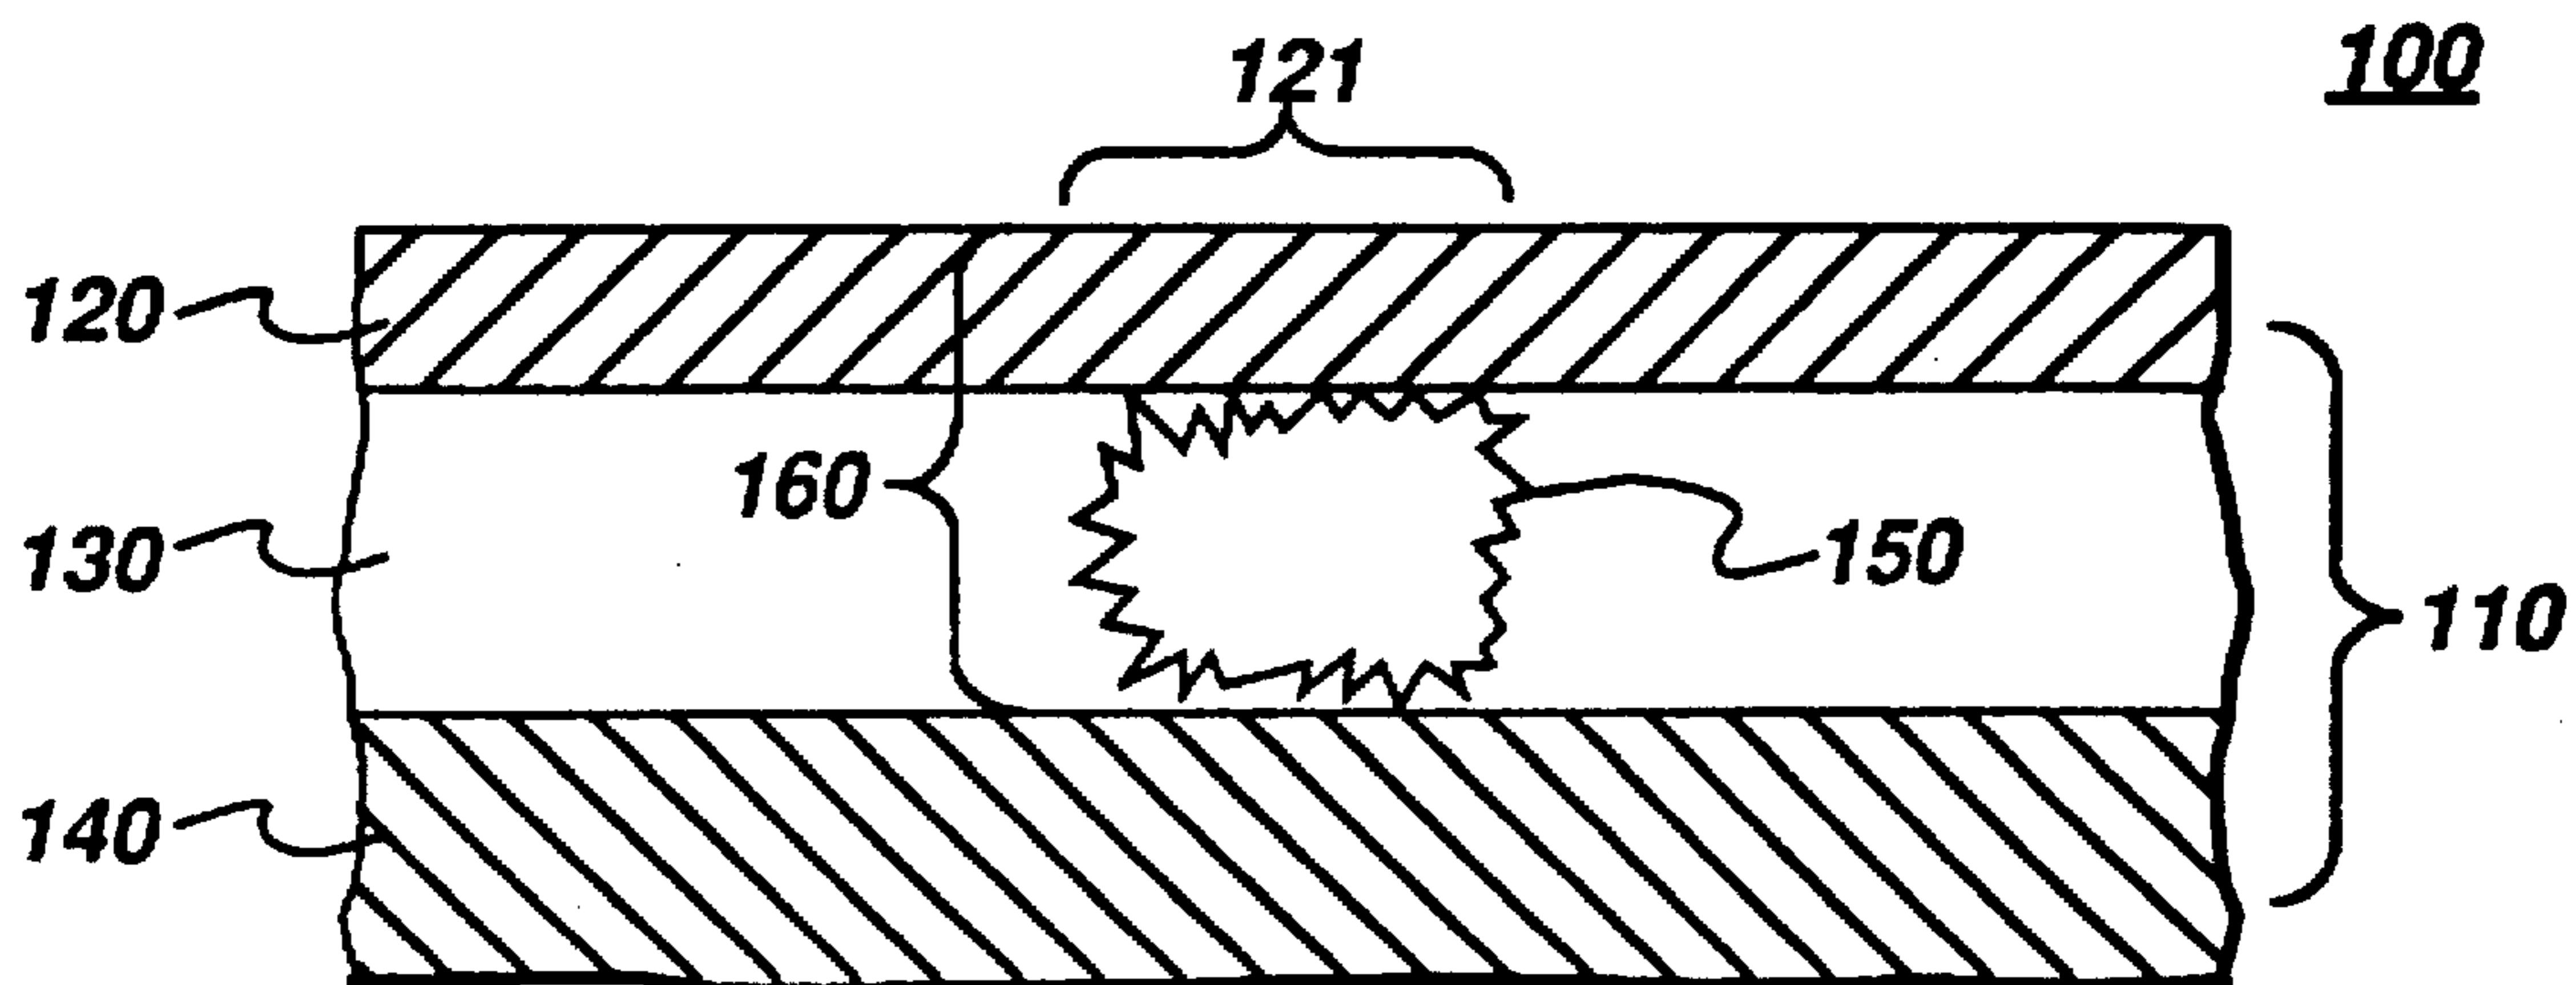
fig. 1A

FIG. 1(A) illustrates imager device 100 at a stage in the fabrication process following deposition of the common electrode and prior to the mating of the scintillator to imaging array 110. At this point in the fabrication process final checks are made of imaging array 110 to locate electrical defects; arrays that are not repairable to maintain a satisfactory performance must be rejected. Electrical defects include electrical short circuits between underlying components in the array, such as between address lines, between address lines and switching transistors, or between the common electrode and underlying components. Open circuit conditions can also occur which require repair and removal of portions of the earlier-deposited components in

A defect 150 is shown in FIG. 1(A) that comprises a piece of conductive material debris that presents a short circuit between common electrode 120 and underlying component 140. The illustration of defect 150 is made by way of example and not limitation, and defect 150 is representative of any short circuit condition; further, if defect 150 (or any other type of defect requiring repair) is disposed between other underlying components, the same repair procedures are used to remove the portion of common electrode 120 overlying the defect and produce a low leakage repaired structure.

In array 110, an upper conductive layer 120 (also referred to as common electrode 120) is disposed over a dielectric material layer 130 that is in turn disposed to electrically insulate upper conductive layer 120 from an underlying component 140. Common electrode 120 provides a common contact to a plurality of photodiodes (not shown) or the like and thus is disposed over substantially the entire imaging array, overlying substantially every component in the imaging array. Common electrode comprises an electrically conductive material that is also light transmissive so as to allow optical photons to pass from the scintillator to the photosensors; typically the material is a transparent conducting oxide such as indium-tin oxide, gallium-tin oxide, tin oxide, or the like. Indium tin oxide and tin oxide, for example, can be deposited in a plasma sputtering process to a thickness in the range between 600 angstroms and 1400 angstroms to form common electrode 120.

Dielectric layer 130 typically comprises an organic dielectric such as polyimide or the like that is deposited in a spin process to a thickness in the range between 1 μm and 2 μm . Alternatively, dielectric layer 130 comprises an inorganic dielectric material such as silicon nitride or silicon oxide. Dielectric layer 130 extends across array 110 to form a region in which common electrode 120 is electrically insulated from underlying components in the array except at contact points on the photodiode, at which points dielectric layer material is removed so that the conductive material of common electrode 120 is disposed in electrical contact with a surface of the photodiode.

By way of example and not limitation, underlying component 140 illustrates a conductive material in the array, such as address line, a transistor electrode, or the like. As used herein, "underlying" refers to a component that is formed in the fabrication process prior to the deposition of the common electrode 120, and thus is disposed on a different level of the sandwich of materials that are deposited to fabricate the components for the imager device. No restriction on the orientation of the device is to be implied by the terminology relating to levels of the components. Underlying component 140 typically comprises a conductive material such as aluminum, gold, titanium, molybdenum or the like, or a heavily doped semiconductive material (such as n+type doped amorphous silicon). Alternatively, component 140 may comprise a layer of semiconductive material, such as the amorphous silicon comprising the photodiode body.

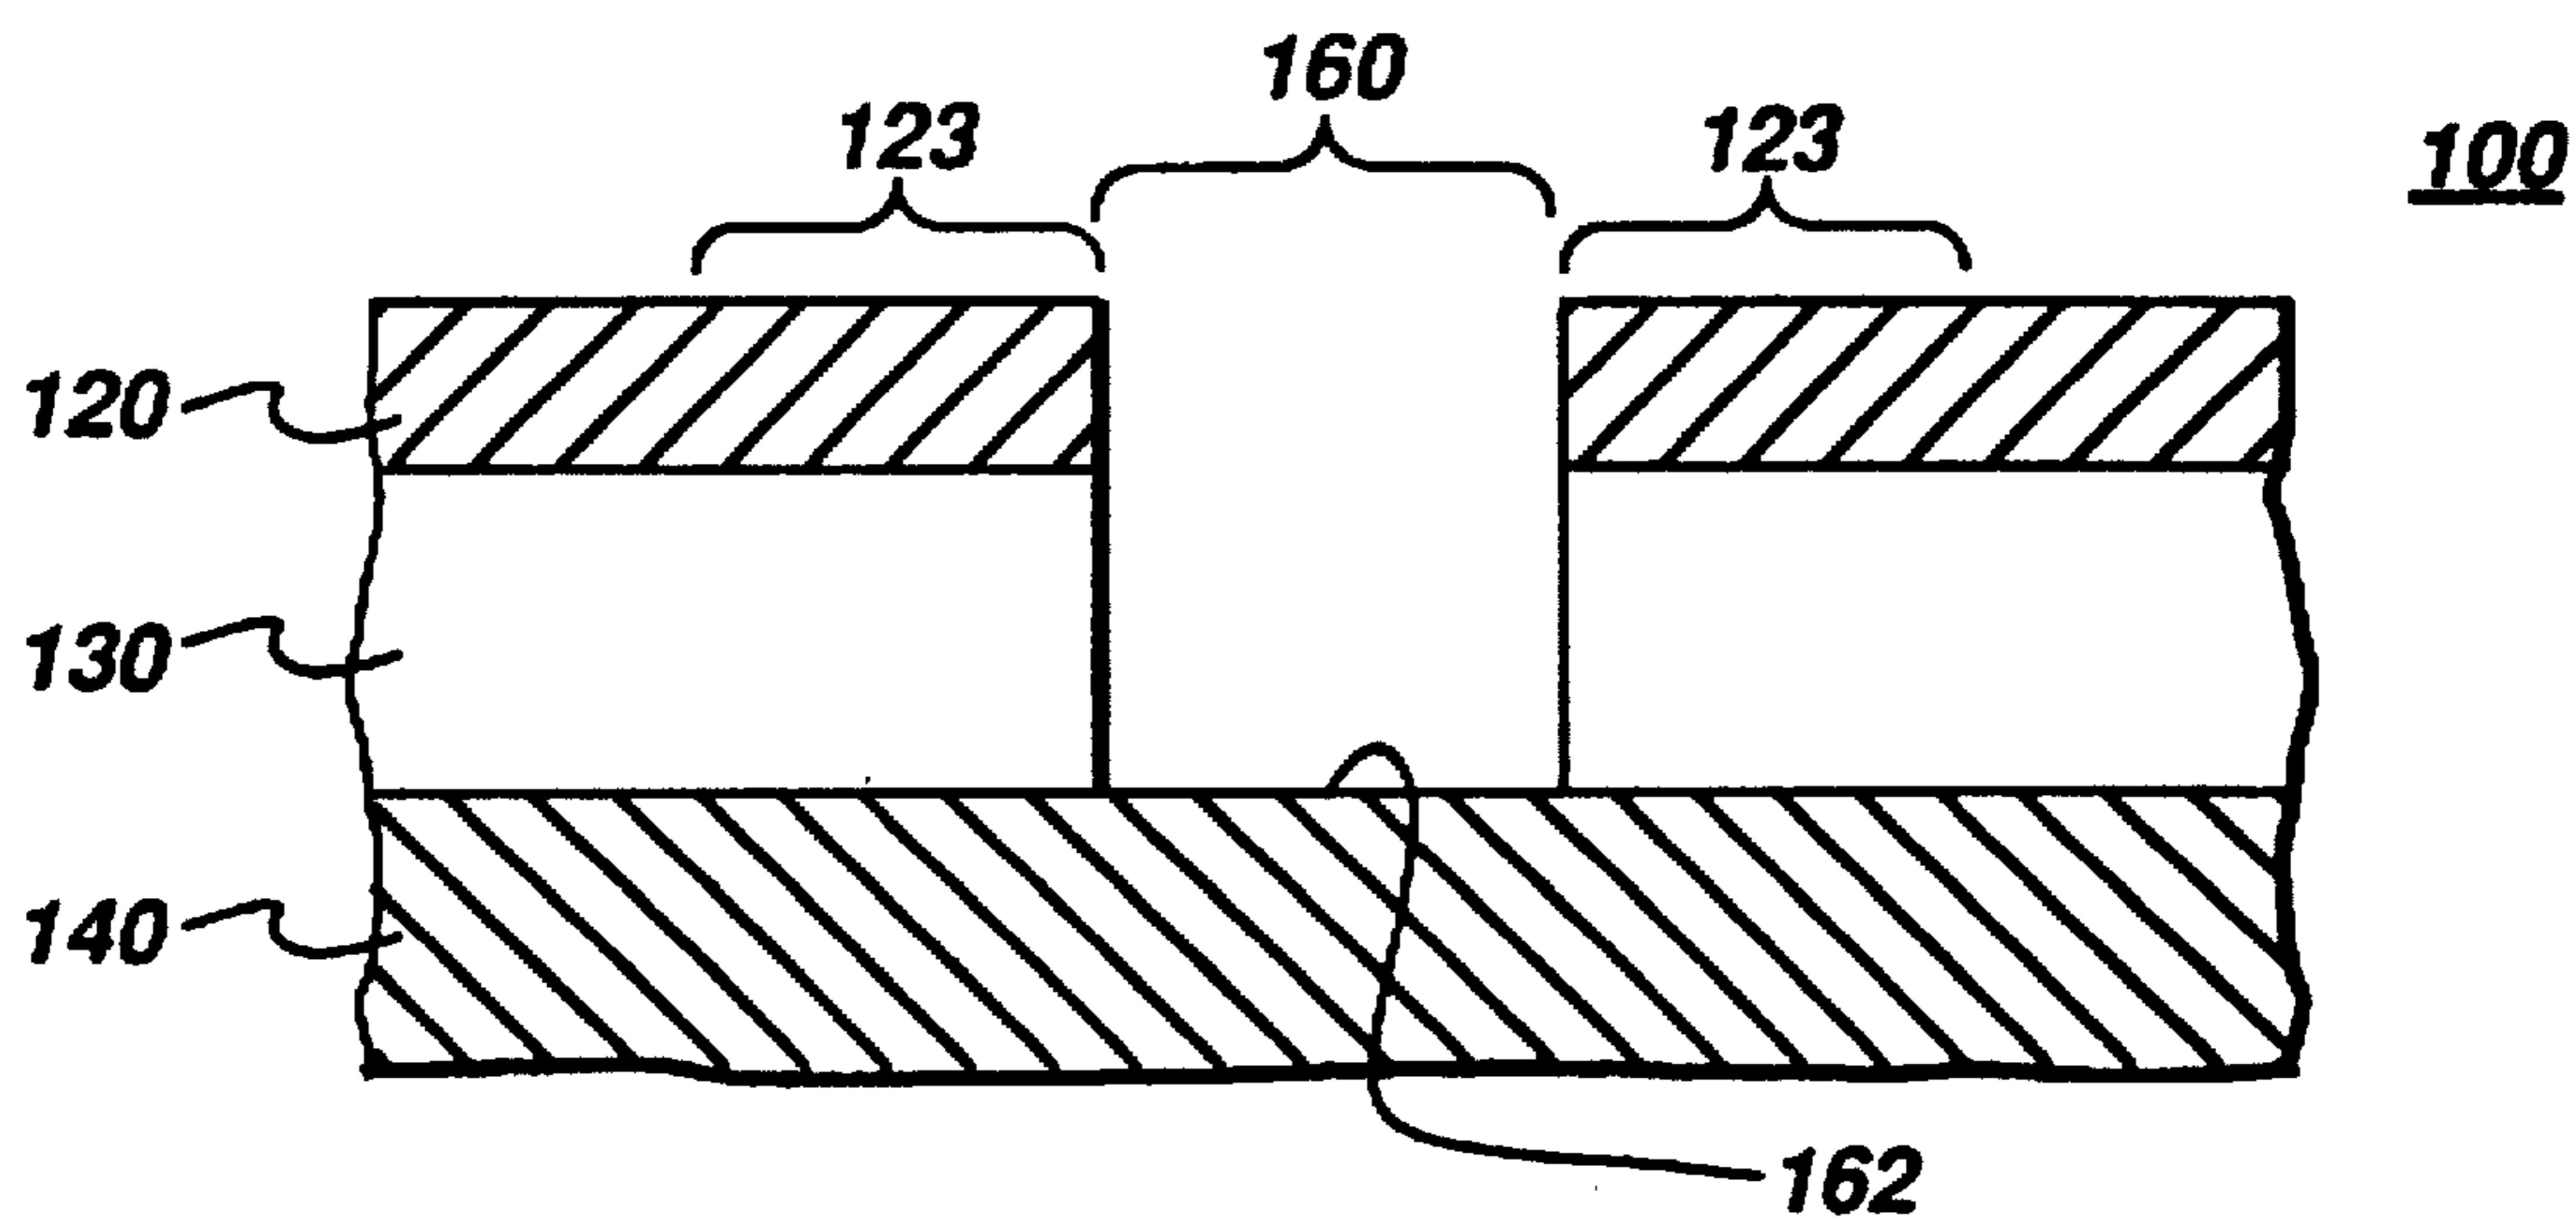
fig. 1B

In accordance with the present invention, the short-circuit defect in imager array 110 is repaired by removing a first portion 121 of common electrode at a repair site (or defect region) 160 on imager array 110. Typically laser ablation is used to remove common electrode first portion 121. In particular, an excimer laser operated at low power provides a finely-focused beam that is very effective in ablating the conductive material of common electrode 120 without simultaneously ablating other components in the array or causing such a rapid vaporization of the transparent conducting oxide that results in conductive residue being driven into underlying dielectric layer 130. The low power used to remove common electrode first portion 121 is typically in the range between about 50 microJoules (μJ) and 60 μJ , which is about 15% of full power in a LCM 308 model excimer laser. Operation of the laser at lower power may necessitate several passes over repair site 160 to completely remove the conductive material of common electrode 120 in the repair area.

After removal of common electrode first portion 121, defect 150 and surrounding portions of dielectric layer 130 are then removed. Laser ablation is typically used to effect this removal, such as with an excimer laser operated at higher power than that used for removal of the common electrode material (e.g., at power levels in the range between 250 μJ and 350 μJ). Laser ablation typically allows fine resolution in removing material from the array (that is, the beam can be focused to an area of about 3 microns square so that the defect can be excised with minimal removal of material surrounding the defect region). Laser ablation also typically results in relatively smooth vertical sidewalls in repair site 160. At the conclusion of this first laser ablation step, the repair region of imager array 110 appears as illustrated in FIG. 1 (B). For the defect illustrated in the Figures, removal of the defect results in repair site 160 having a bottom surface 162 comprising the conductive material of underlying component 140.

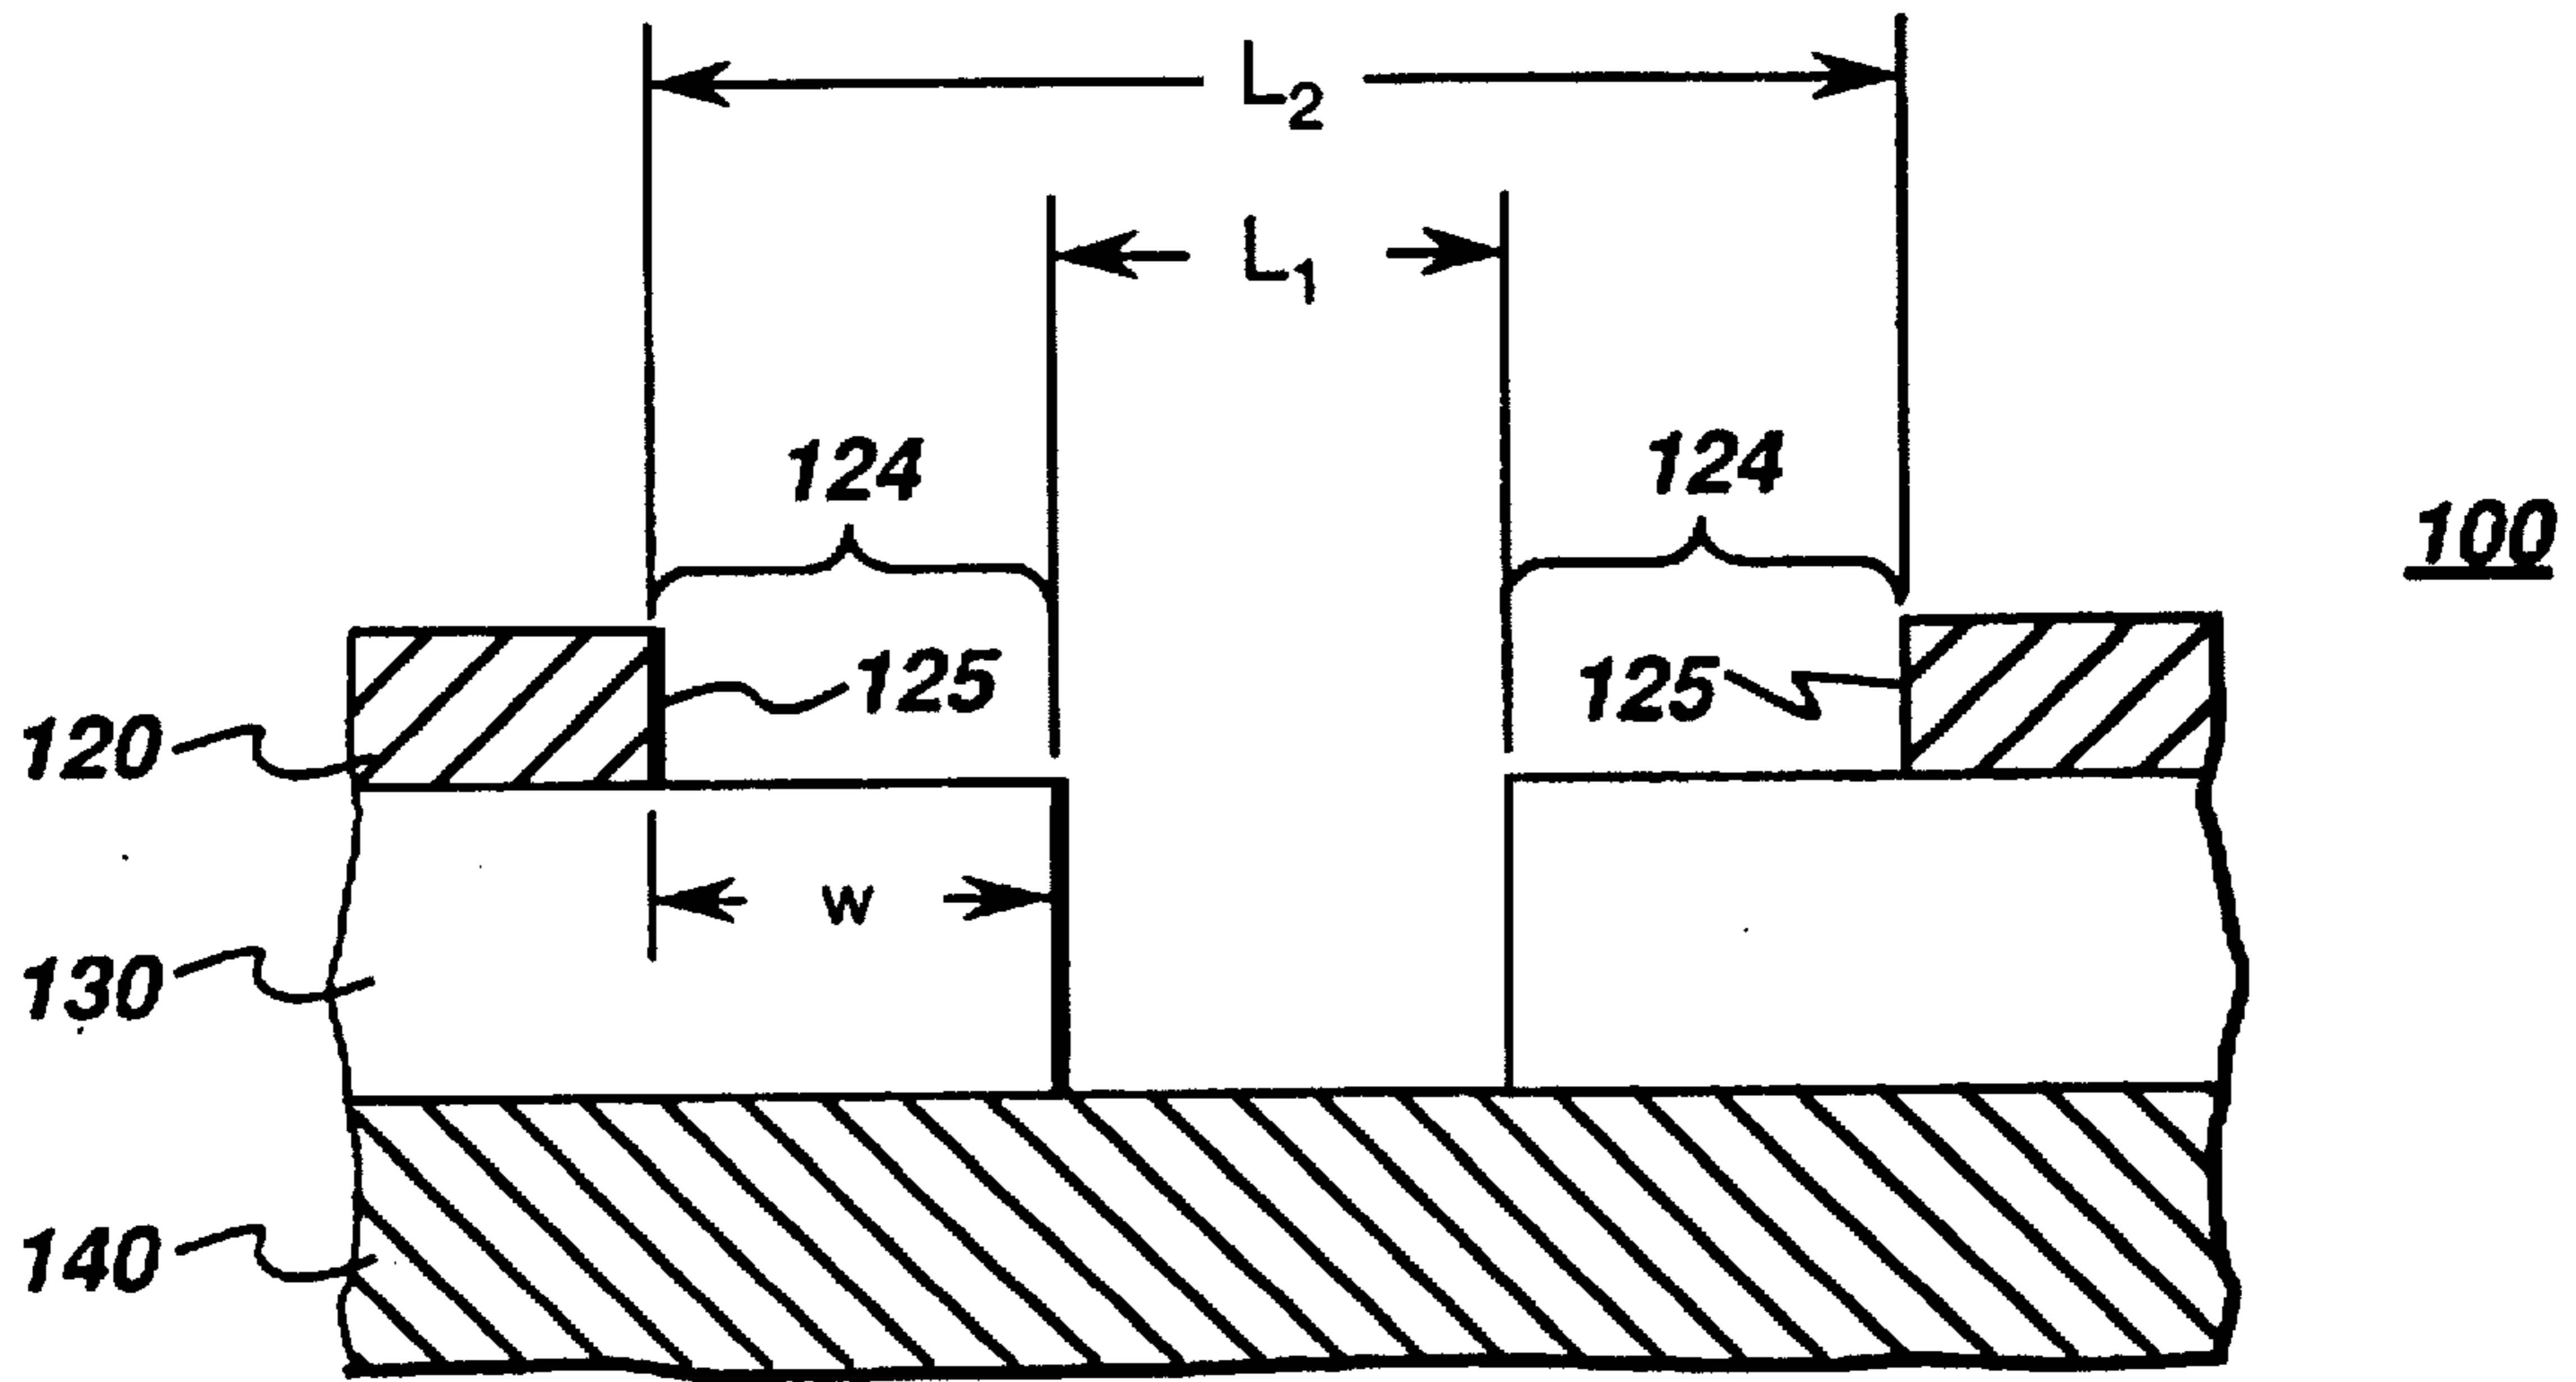
fig. 1C

Next, in accordance with this invention, a second portion 123 of common electrode 120 is removed to form an intermediate step level 124 (FIG. 1 (C)) around the periphery of repair site 160. The surface of intermediate level step 124 comprises the dielectric material of dielectric layer 130, that is, the conductive material of common electrode 120 is removed to expose the dielectric material. The lateral dimension L_1 of bottom surface 162 is less than the lateral dimension L_2 of the intermediate step level such that the width W of step 124 is greater than 1 μm , and typically is in the range between about 1 μm and 3 μm . Laser ablation, using the low power levels noted above, is used to remove common electrode second portion 123 to optimize the ablation while reducing the conductive material driven into underlying dielectric layer 130. The setback of common

electrode sidewalls 125 from dielectric layer sidewalls 164 in repair site 160 serves to reduce possible paths for electrical leakage between common electrode 120 and underlying component 140. For many imager arrays (such as those used in medical imaging), it is desirable that leakage be less than 100 pA in order to minimize array noise. Data from repaired wafers indicate that for repairs conducted in the conventional manner, that is, without the set-back of the common electrode material around the repair site, only about one-half of the wafers exhibit leakage of 100 pA or less; for wafers repaired in accordance with this invention, about 95% of the wafers exhibit leakage of 100 pA or less. This reduction of leakage is critical in high resolution x-ray imagers used in medical applications, and can constitute the difference between acceptance or rejection of a repaired imaging array 110 for use in a radiation imaging device.

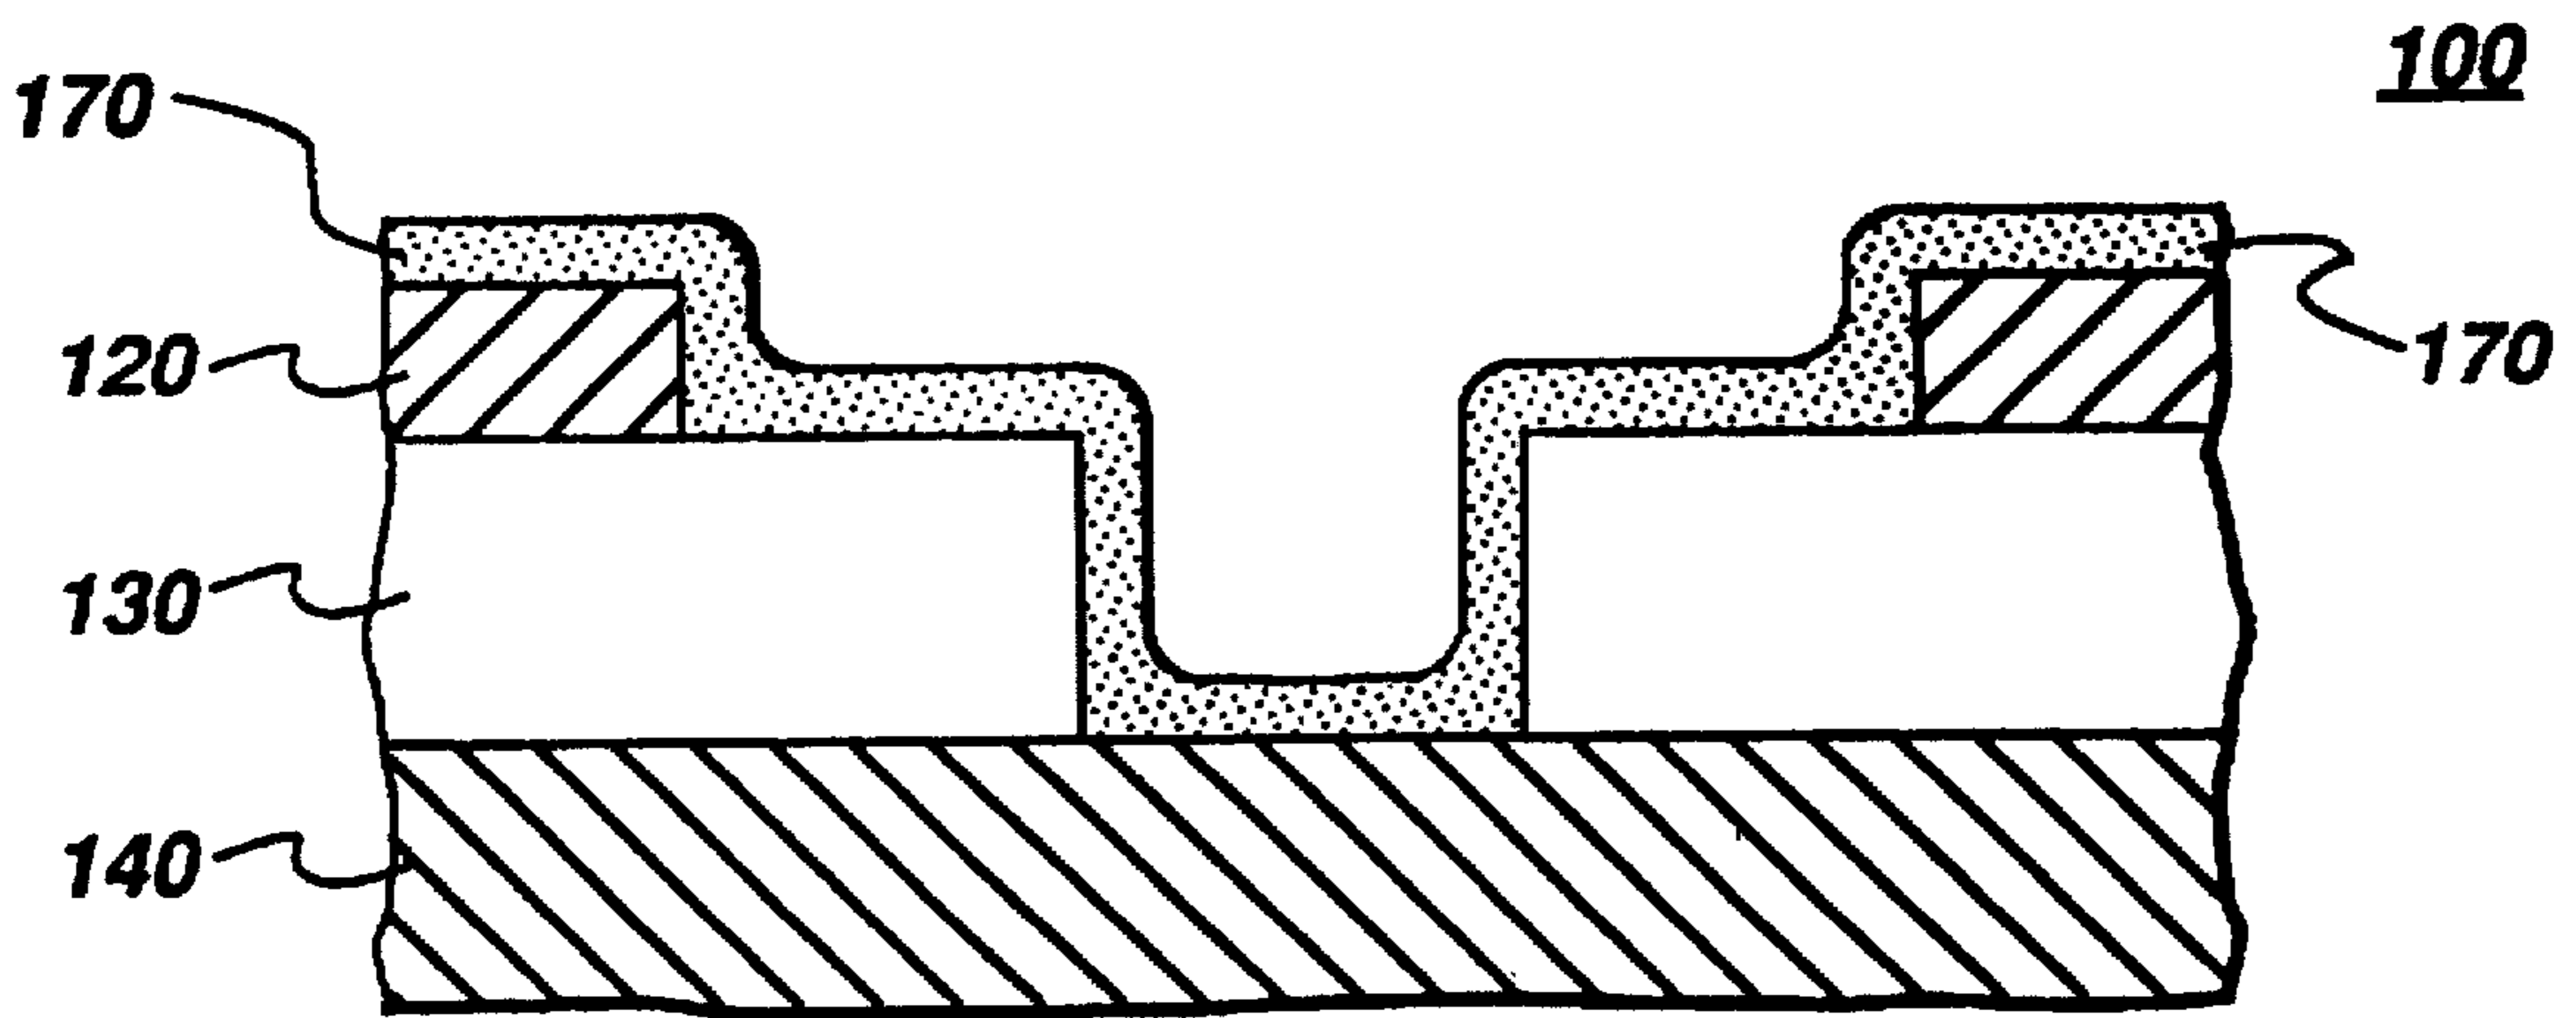
fig. 1D

Following formation of intermediate level step 124, a passivation layer 170 is formed over the repaired area to enhance the long term low-leakage characteristics of repair site 160. Passivation layer 170 comprises a dielectric material such as, silicon nitride, silicon oxide, or the like, which is deposited in a plasma enhanced vapor deposition process to a thickness of about 1500 angstroms.
