# United States Patent [19]

[11] Patent Number: **5,741,378**

[54] **METHOD OF REJUVENATING COBALT-BASE SUPERALLOY ARTICLES**

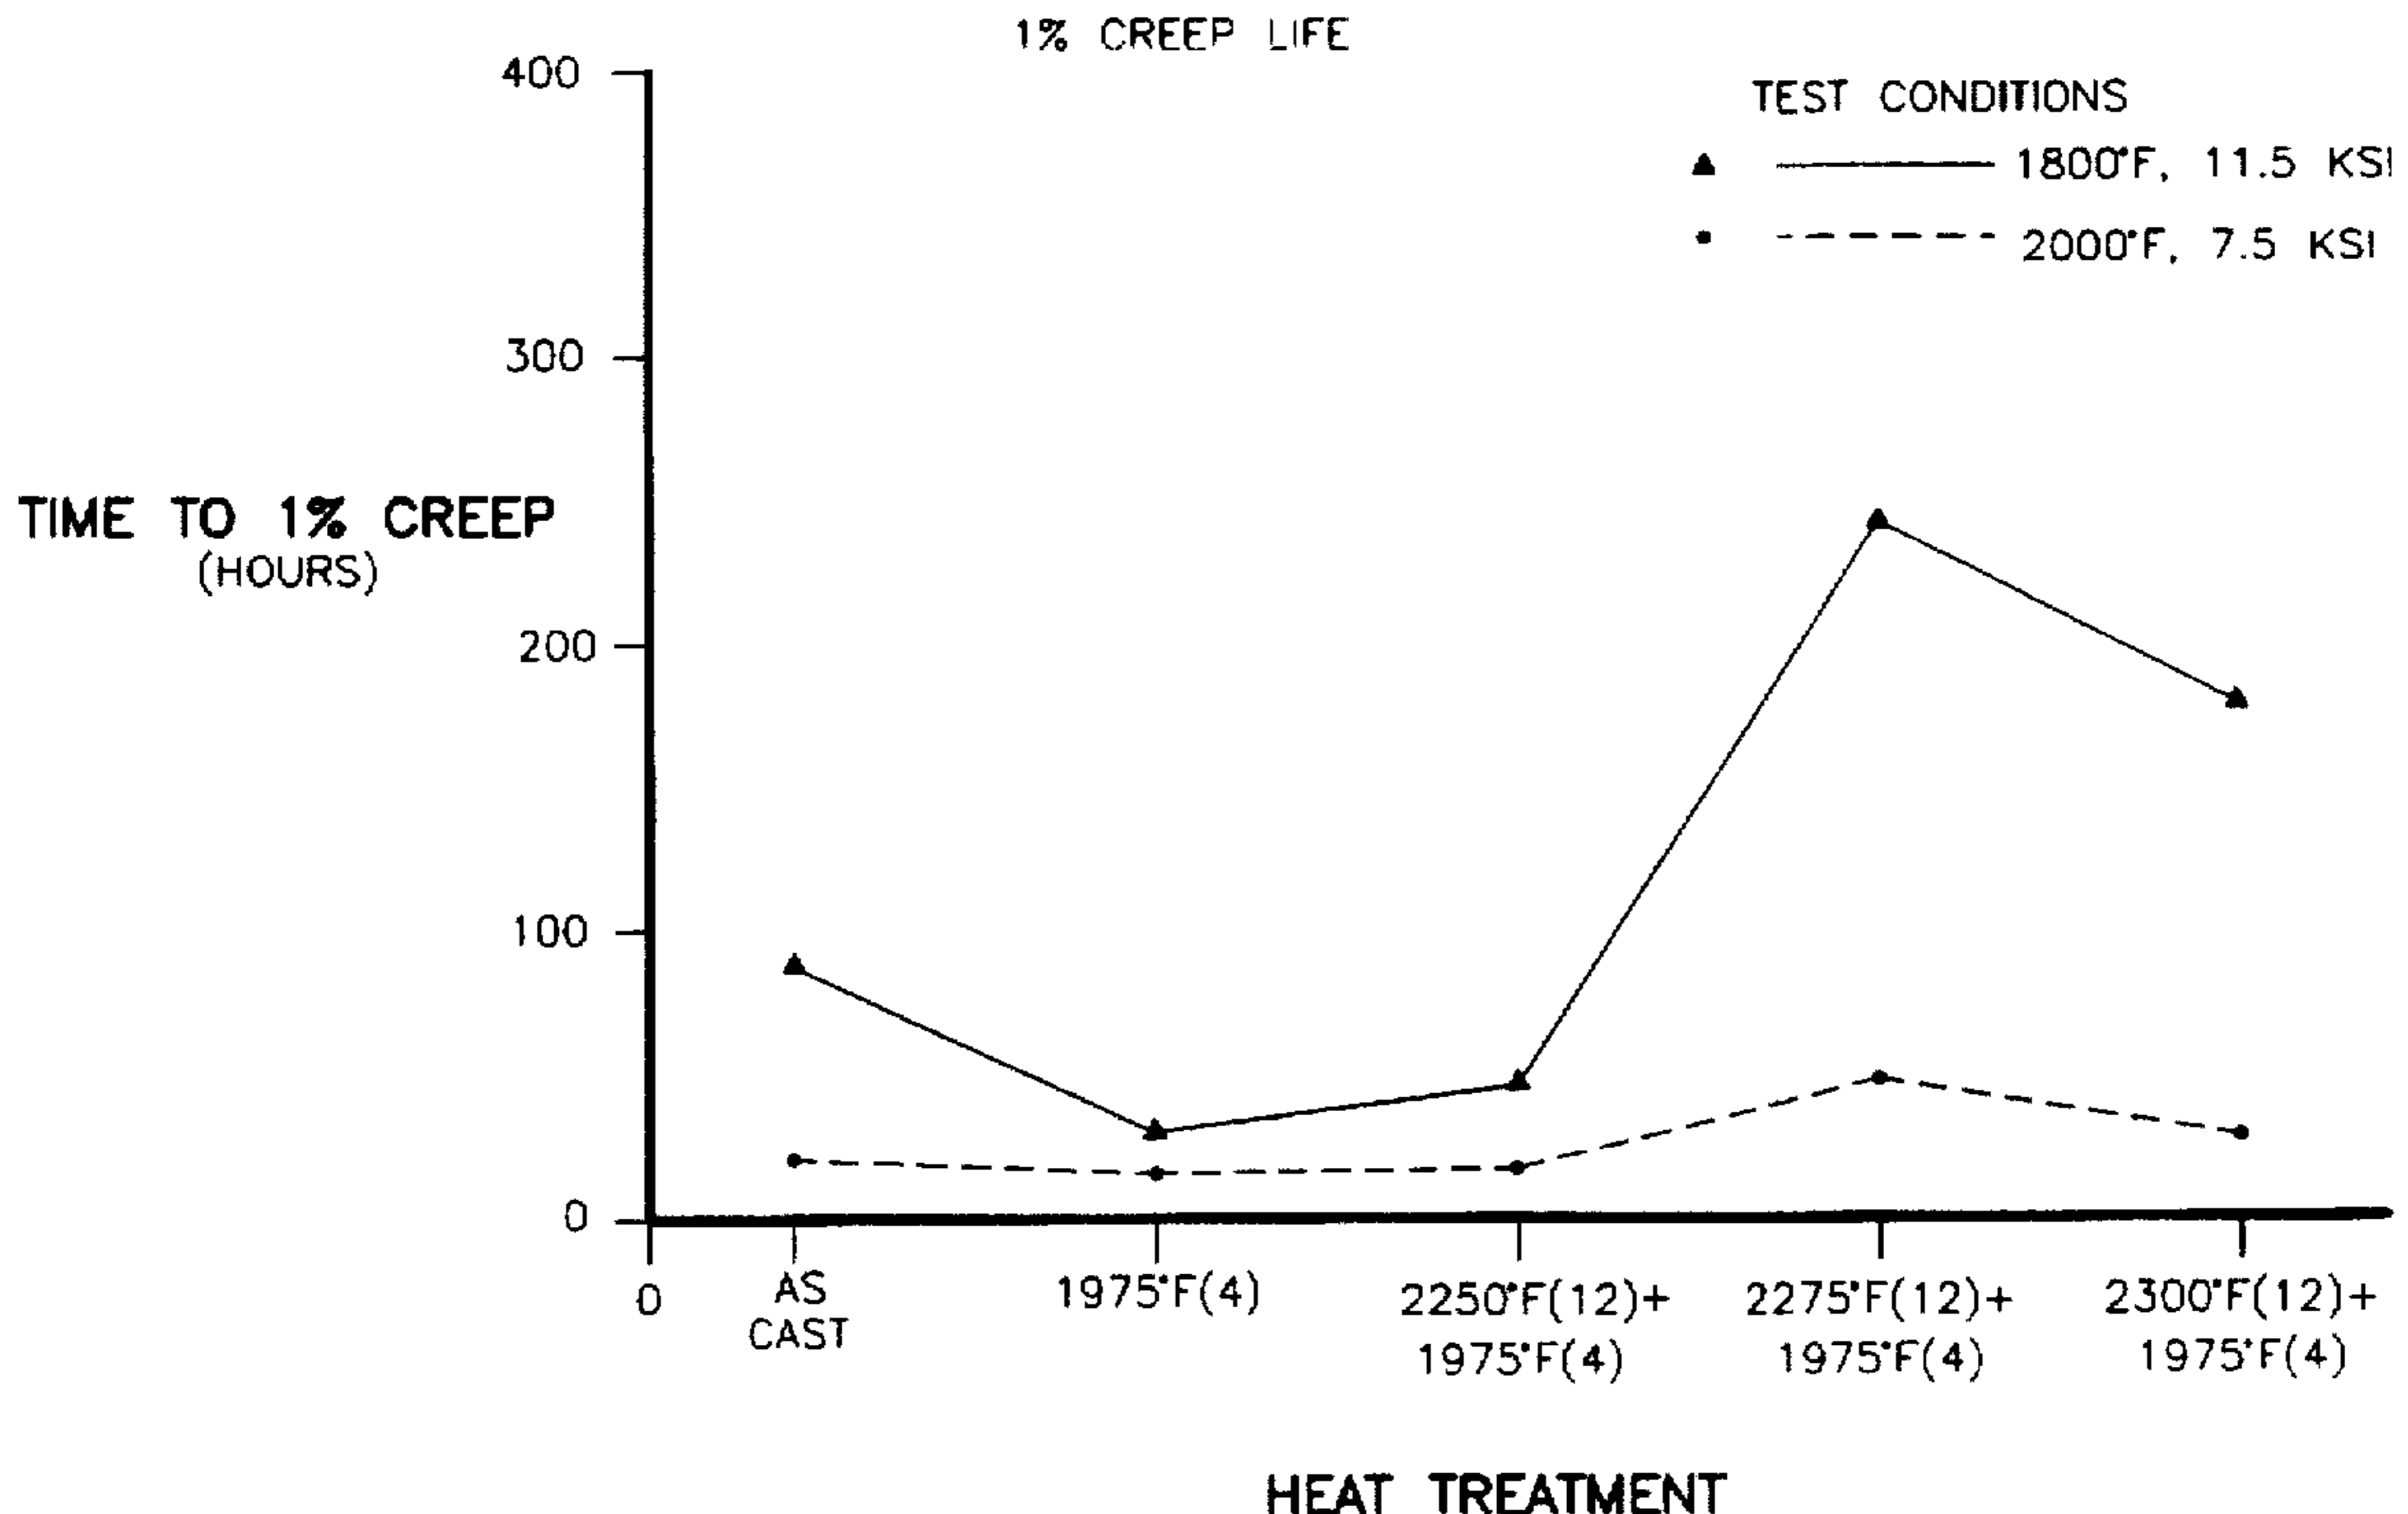
FIG. 1 is a graph showing the 1% creep life for MAR-M 509 for various processing conditions.

The 1% creep life was determined at 1800° F. and 11.5 ksi, and at 2000° F. and 7.5 ksi. The results as shown in FIG. 1 show that the 1% creep life peaked in the samples prepared at 2275° F. in both cases, with an improvement at the lower test temperature of about 700%, and at the higher test temperature of about 200%, compared to the baseline condition of four hours at 1975° F. on as-cast material.

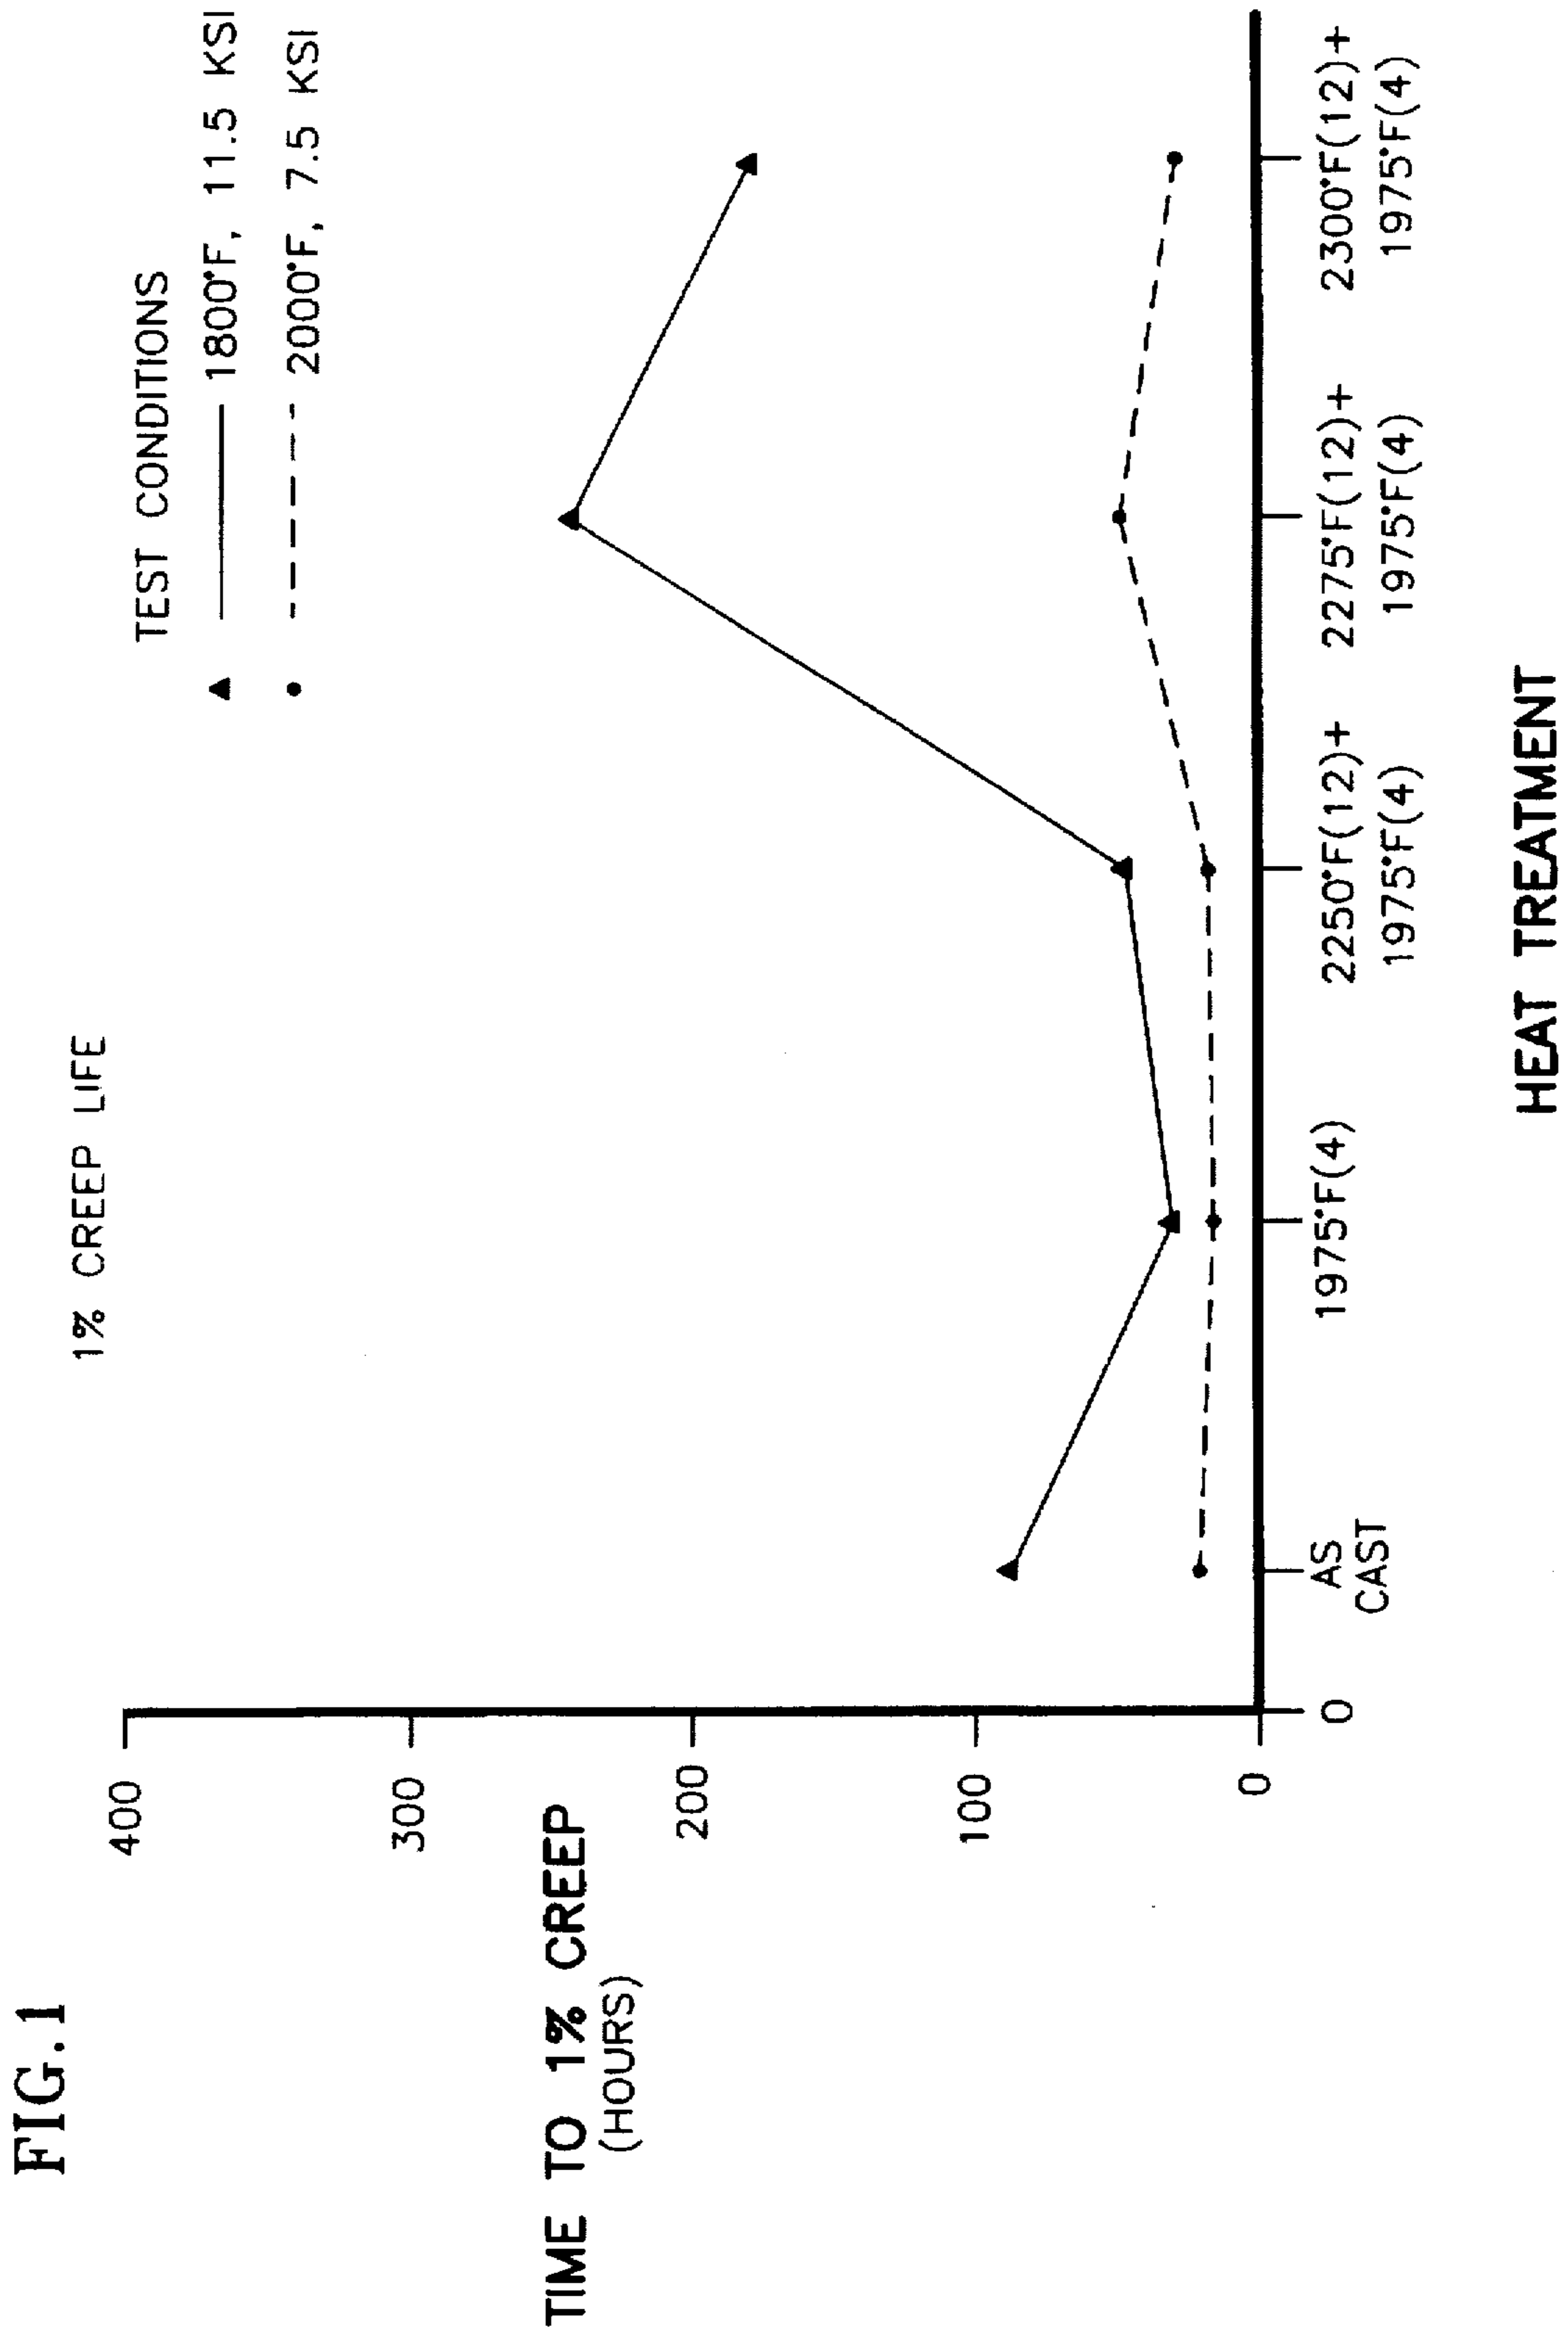
RUPTURE ELONGATION

TEST CONDITIONS  
▲ — 1800°F, 11.5 KSI  
● - - - 2000°F, 7.5 KSI

FIG. 2 is a graph showing the rupture elongation for MAR-M 509 for various processing conditions.

The rupture elongation for similarly prepared samples at the same test temperatures, as shown in FIG. 2 showed that this property remained at approximately the same level in the samples prepared using the invention processing as that of the baseline sample. A thermal cycle of eight hours at 2265° F. followed by a coating diffusion cycle of 1975° F. for four hours resulted in an improvement in the impact resistance of about 68% compared to the baseline sample.

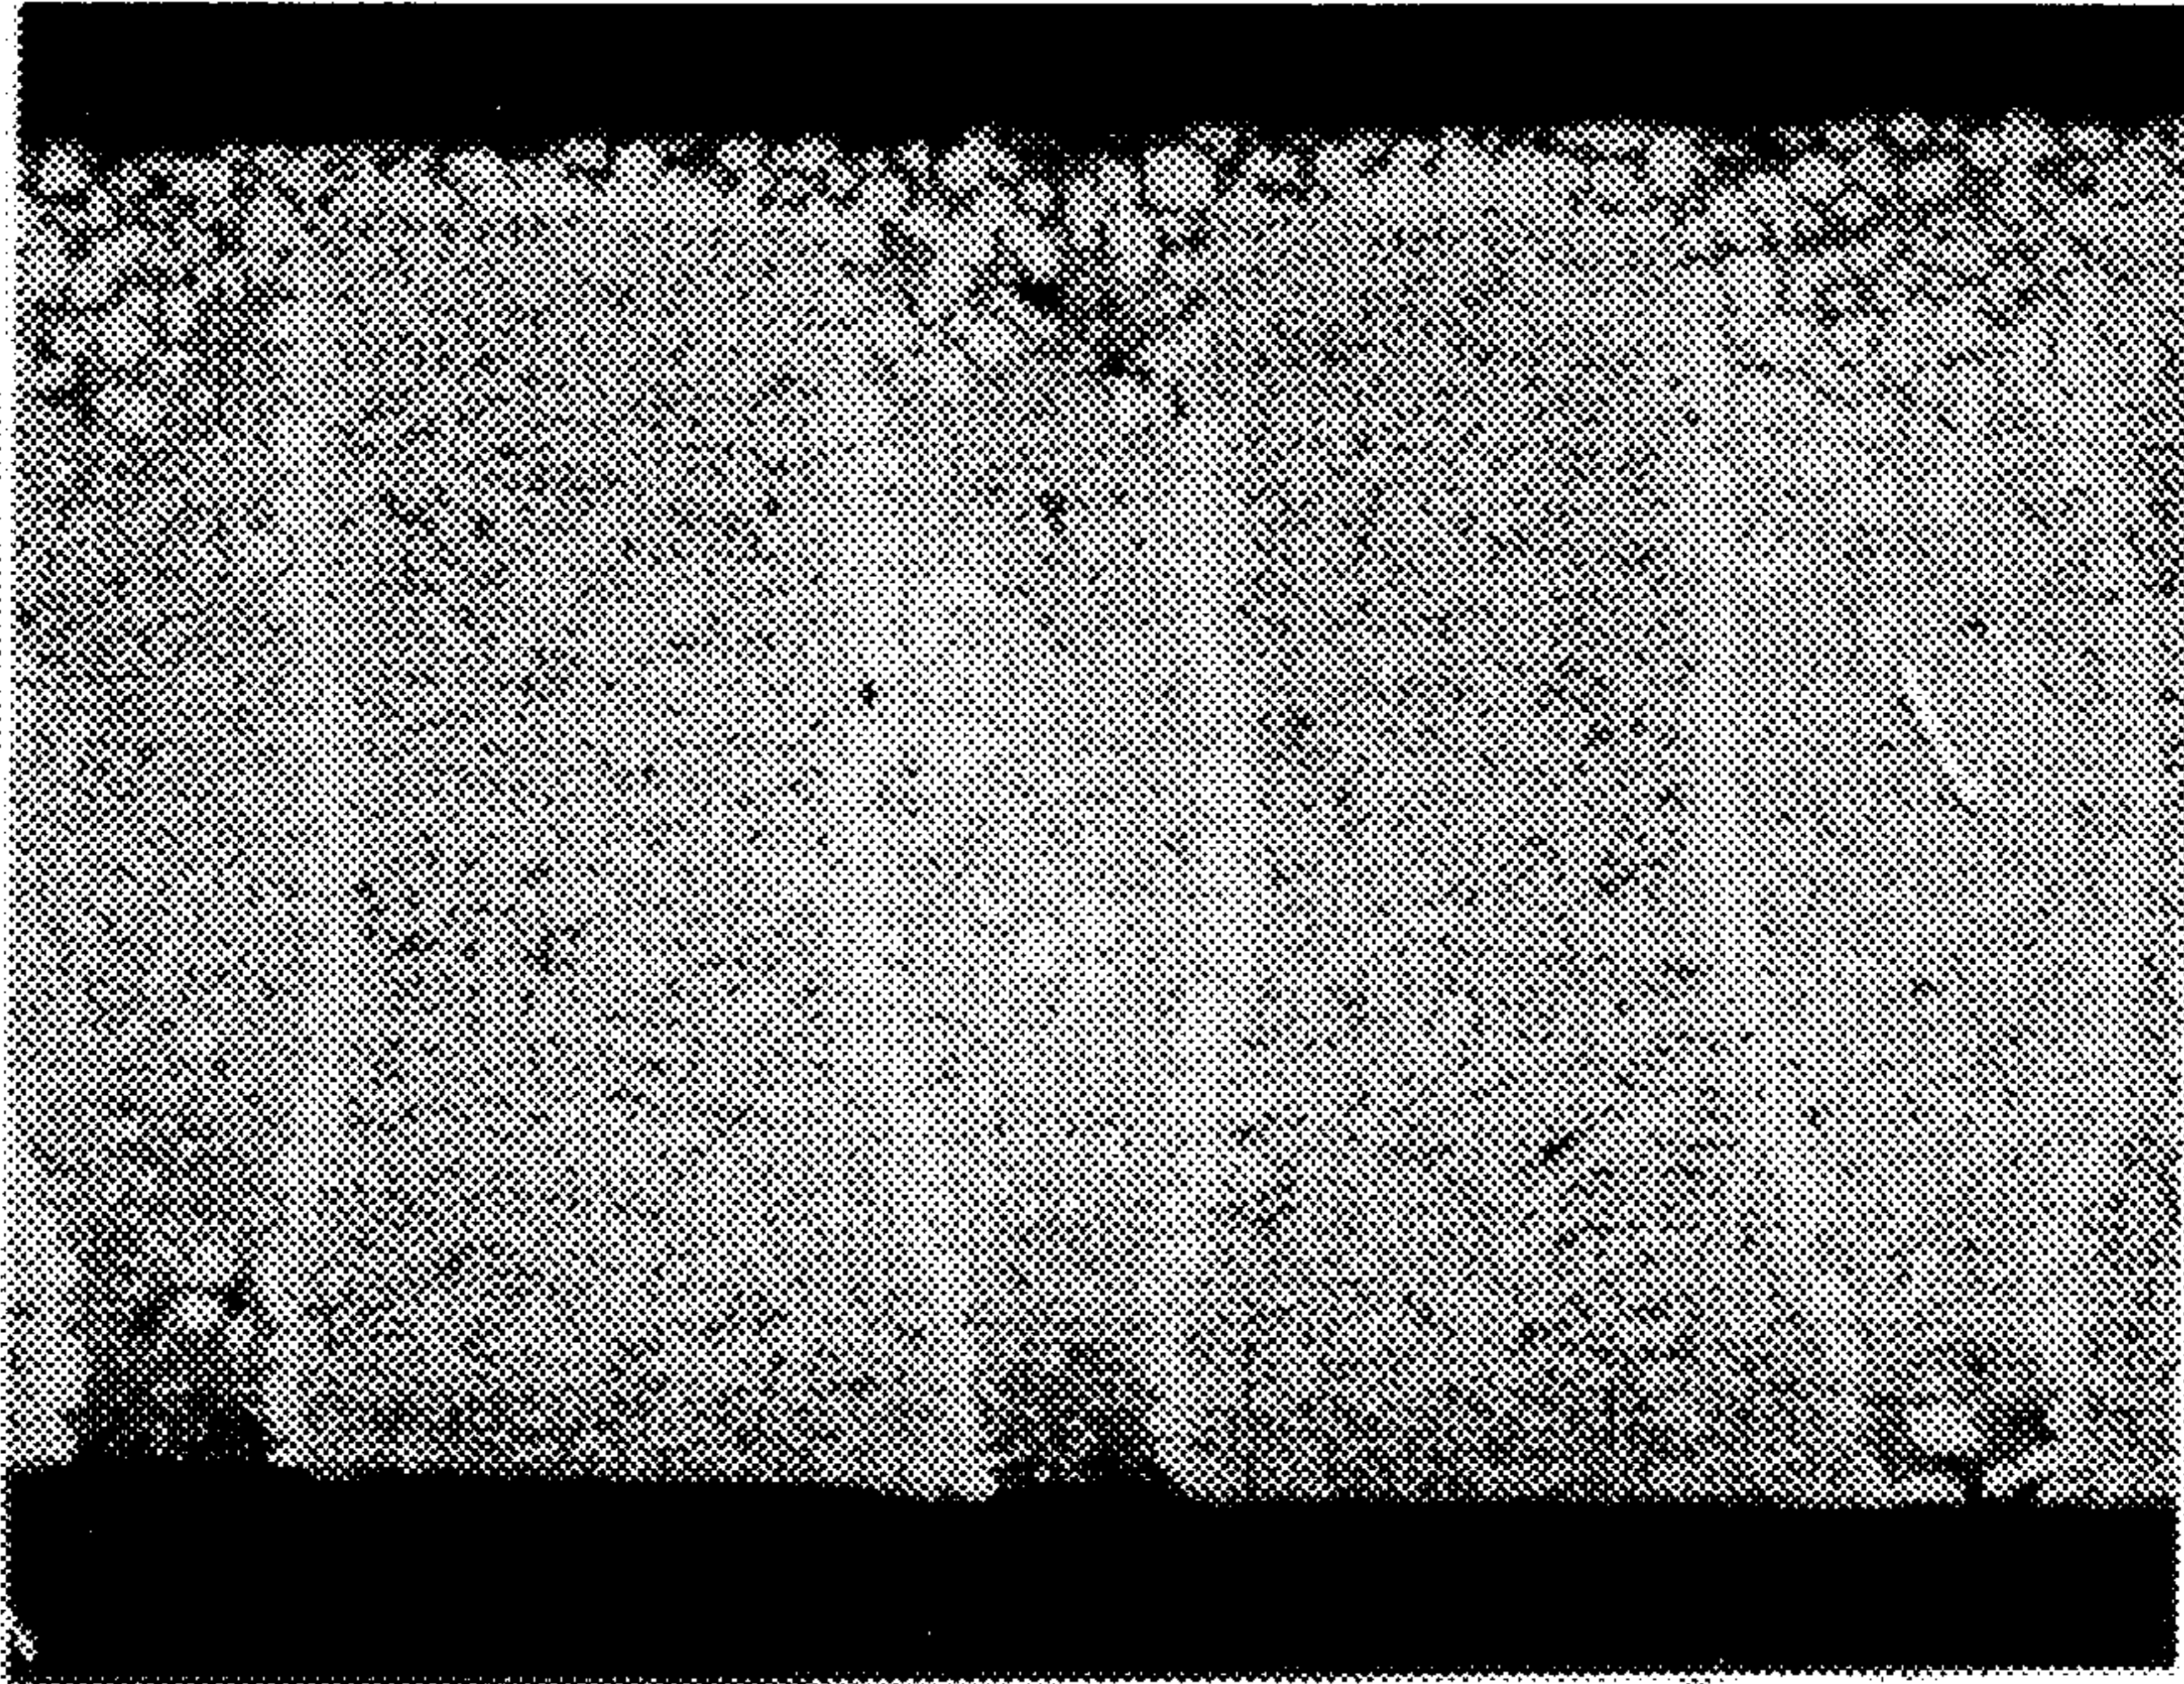
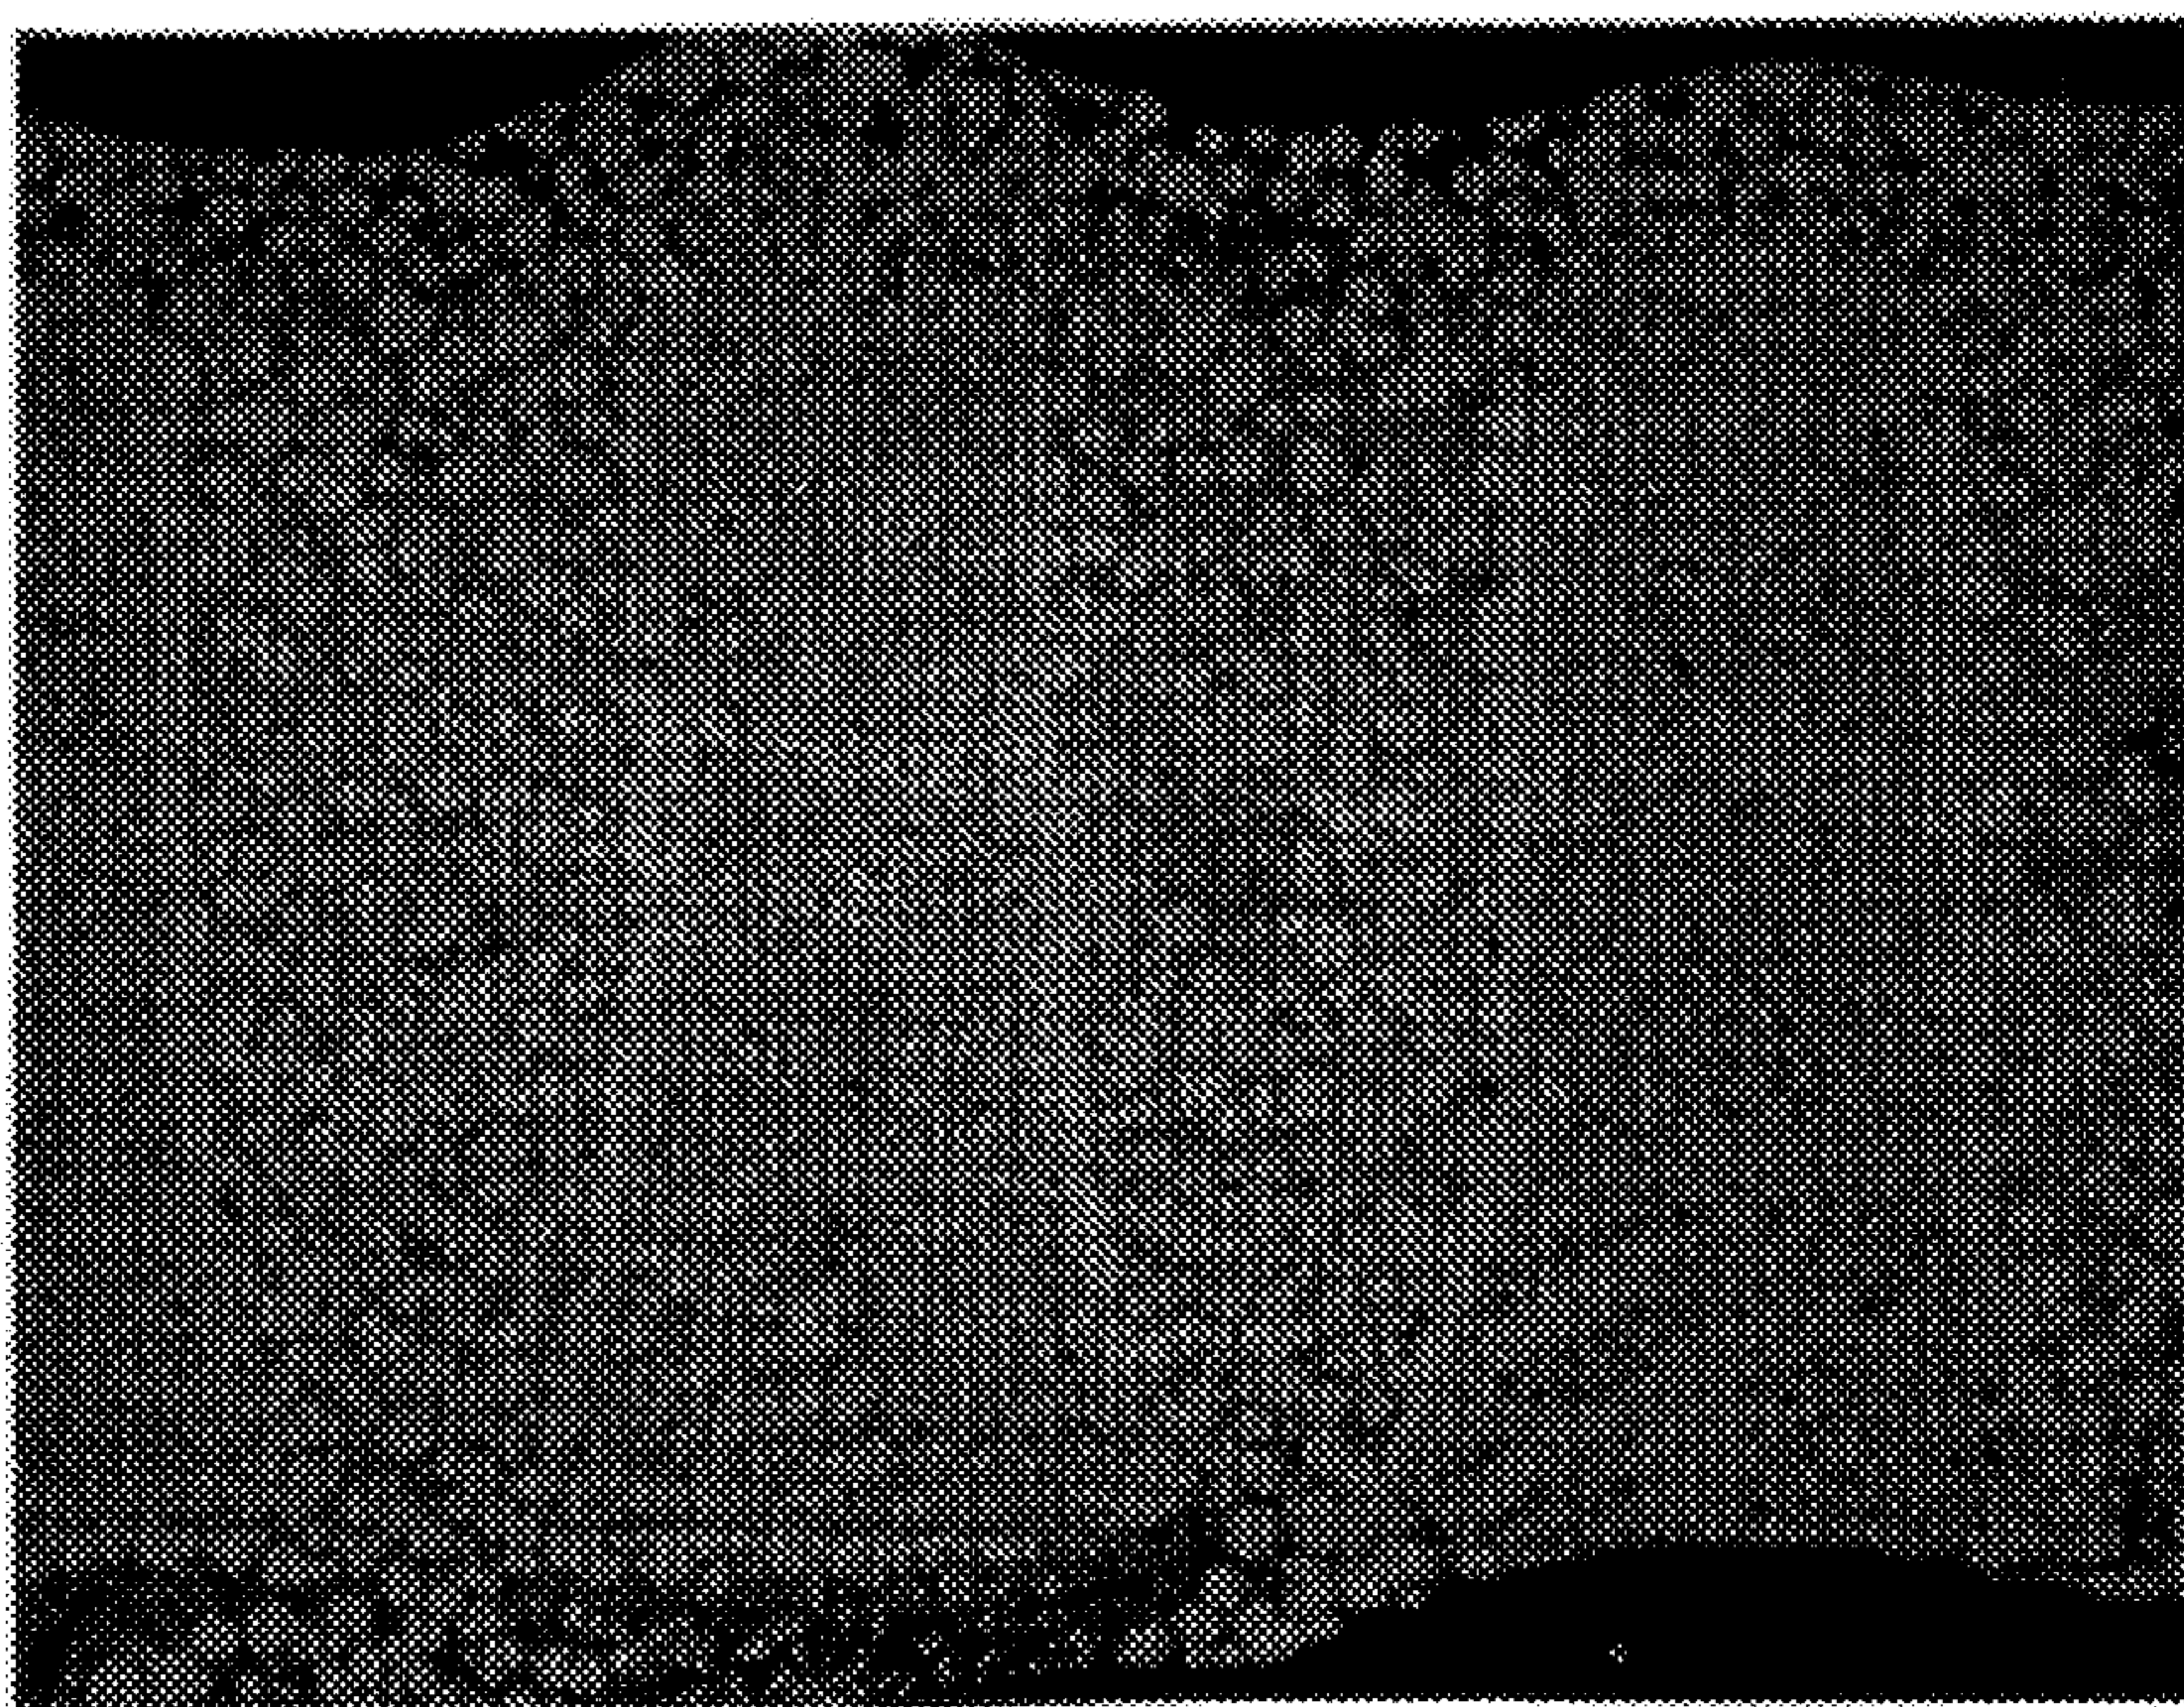
FIG. 4 is a 20X photomicrograph of the repaired cooling holes in a MAR-M 509 turbine vane with the repair powder packed into the holes prior to melting and isothermal diffusion.

In comparison, the microstructure of the filler material where the powder was packed into the cooling holes is shown in FIG. 4. Here the MAR-M 509 particles are uniformly distributed throughout the length of the holes, with the AMS 4783 matrix uniformly distributed between the particles.

This procedure successfully filled the gap, with the repair powder remaining in the gap, rather than running out when the low melting point powder melted. The microstructure is similar to that shown in FIG. 4.
