[54]	NONDESTRUCTIVE INSPECTION METHOD OF POLYMER INSULATOR AND APPARATUS FOR PERFORMING THE SAME						
[75]	Inventors:	Yasushi Okawa, Kasugai; Itsushi Nakamura, Nagoya; Tomio Suzuki, Yokkaichi; Masahiro Hori, Nagoya, all of Japan					
[73]	Assignee:	NGK Insulators, Ltd., Japan					
[21]	Appl. No.:	824,954					
[22]	Filed:	Mar. 27, 1997					
[30]	Forei	gn Application Priority Data					
	28, 1996 7. 8, 1996						
		G01N 29/14					
[52]	U.S. Cl						
[58]		earch					
[56]		References Cited

NONDESTRUCTIVE INSPECTION METHOD OF POLYMER INSULATOR AND APPARATUS FOR PERFORMING THE SAME

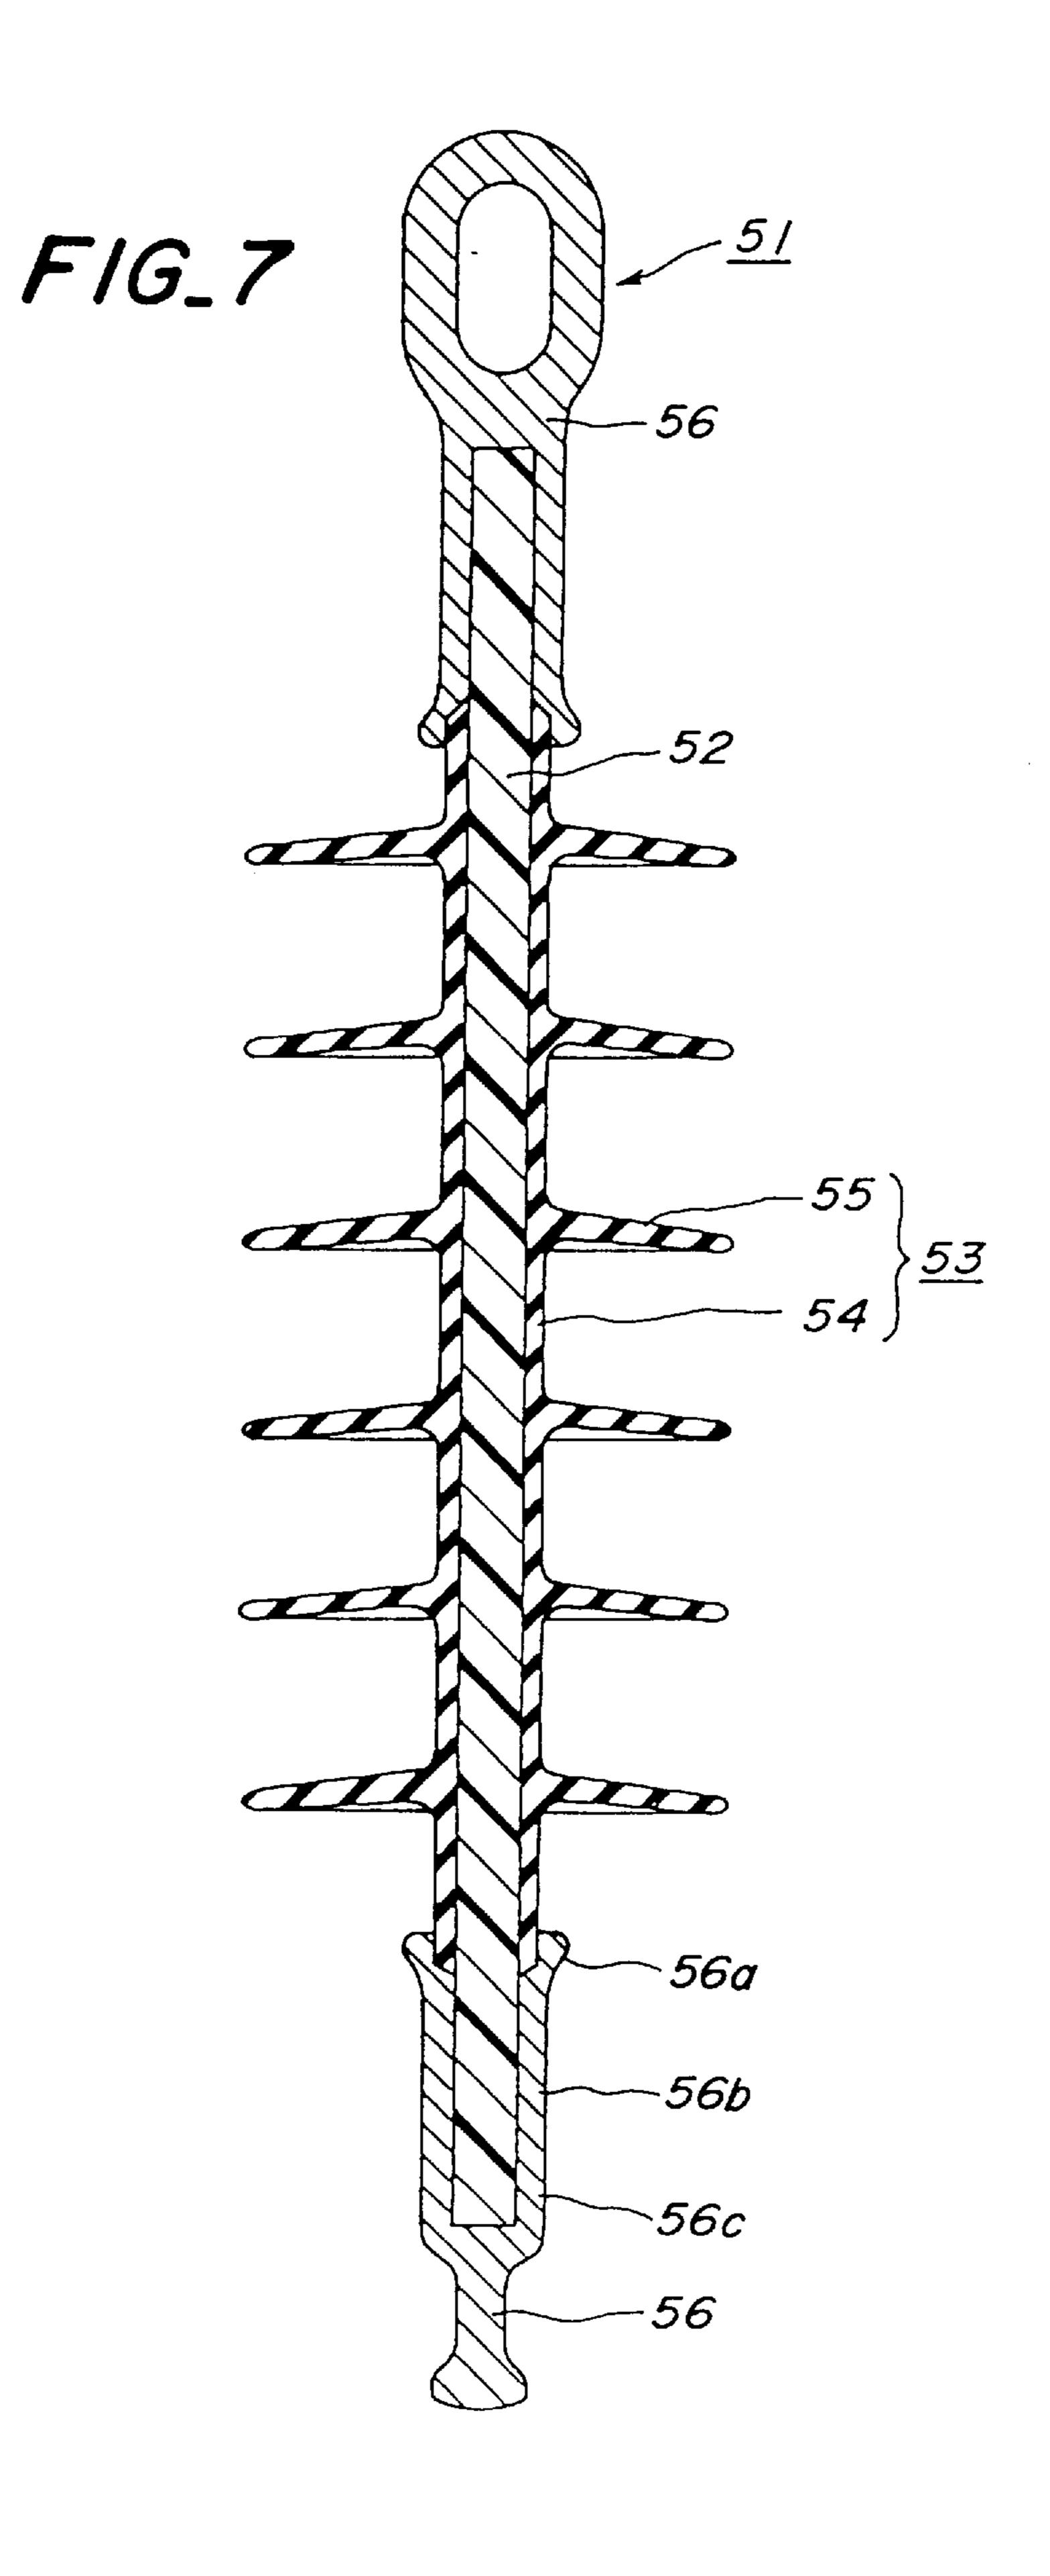
A polymer insulator having an FRP core, an outer cover portion arranged around the FRP core, and at least one metal member secured to at least one end of the FRP core is generally known. FIG. 7 is a cross sectional view showing one embodiment of the polymer insulator to which the present invention can be applied. In the embodiment shown in FIG. 7, a polymer insulator 51 comprises an FRP core 52 and an outer cover portion 53. The outer cover portion 53 comprises a sheath portion 54 arranged on an overall outer surface of the FRP core 52 and a plurality of shed portions 55 projected from the sheath portion 54. Moreover, metal members 56 are secured to both end portions of the FRP core 52.

FIG. 7 is a schematic view depicting one embodiment of a polymer insulator to which the present invention is applied.

One embodiment of a polymer insulator to be inspected is the same as the known polymer insulator as shown in FIG. 7. In FIG. 7, the polymer insulator uses a solid FRP core, but 60 it is possible to apply the nondestructive inspection method according to the invention to a polymer hollow insulator which uses a cylindrical FRP core if the metal members are secured to the both end portions of the cylindrical FRP core as mentioned above.

Moreover, in an extreme case such that a surface roughness on an inner surface of the metal member is rough and a pressure applying method is bad, the FRP core 52 itself is sometimes fractured within the metal member 56. If such a fractured position of the FRP core 52 is at an inlet portion 56a of the metal member 56, it is possible to detect and 65 eliminate such a fractured polymer insulator substantially completely by the examination method mentioned above, 2

since a tensile strength is decreased due to a decrease of a securing area. However, if such a fractured position is at an intermediate portion 56b or at a bottom portion 56c of the metal member 56, a tensile strength is increased as compared with the case mentioned above, since a remaining securing method is increased gradually from the intermediate portion 56b to the bottom portion 56c as compared with the inlet portion 56a. A polymer insulator being fractured at the intermediate portion 56b and the bottom portion 56c can nevertheless sometimes pass the examination method mentioned above. Since such a fracture can not also be detected from an appearance of the polymer insulator 51 unless the polymer insulator 51 is dismembered, it is necessary to perform a nondestructive inspection method.
