[11] Patent Number: **5,860,689**

[54] **METHOD FOR PROTECTING A WINDSHIELD FROM CRACKS**

[73] Assignee: **Edgeguard, Inc.**, Grand Junction, Colo.

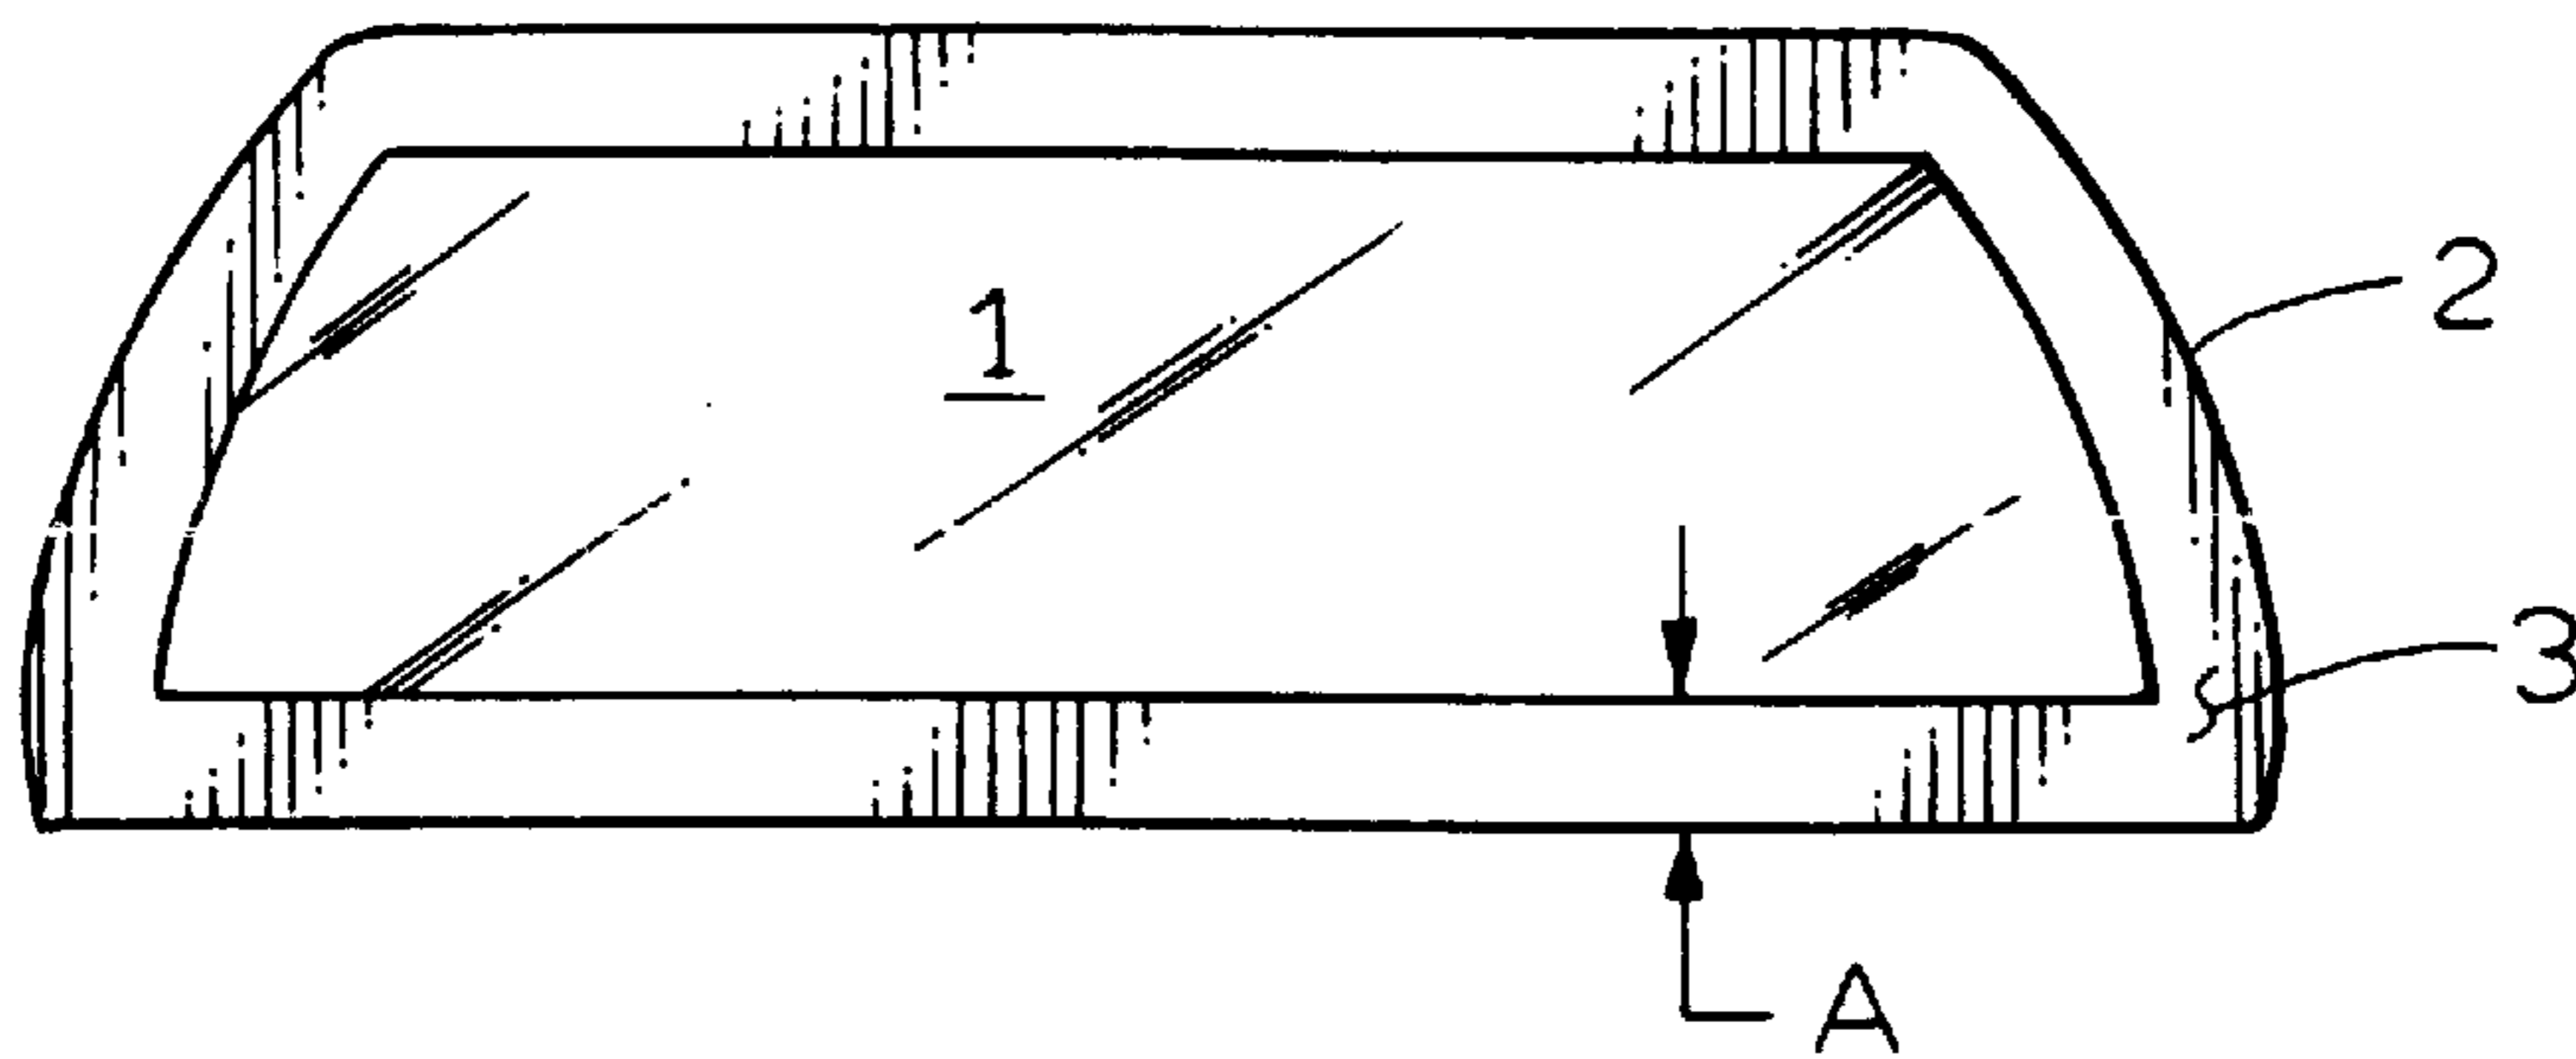
FIG. 1 shows a front view of a windshield having the inventive film applied in an exemplary OEM application.

Referring to FIG. 1, in the present invention, an automobile windshield 1 having a molding 2 around its periphery is the subject of the invention. A clear plastic film 3 is placed around the periphery inside the molding. The film 3 should have the selected dimension A. It should be adhered permanently to the windshield by an adhesive layer. Alternatively the film can be adhered in a manner which allows periodic replacement, for example if the film becomes damaged or worn or loses its clarity.

A preferred method of providing the peripheral protection for OEM applications is to prepare a one piece four sided clear plastic frame of the selected dimensions. It would be shaped to fit along the inside of the molding although it could extend under the molding to the glass edge. Most windshields are curved at the sides, some are curved at the top or bottom. Therefore, the four sided plastic frame is configured to match the periphery of the windshield against the molding and extending inward into the viewing area the selected distance. The frame therefore should match the curves to give a uniform distance from the molding. This is seen in FIG. 1. However uniformity is not essential as noted below. If the film frame extends under the molding, then curved matching against the molding is irrelevant.

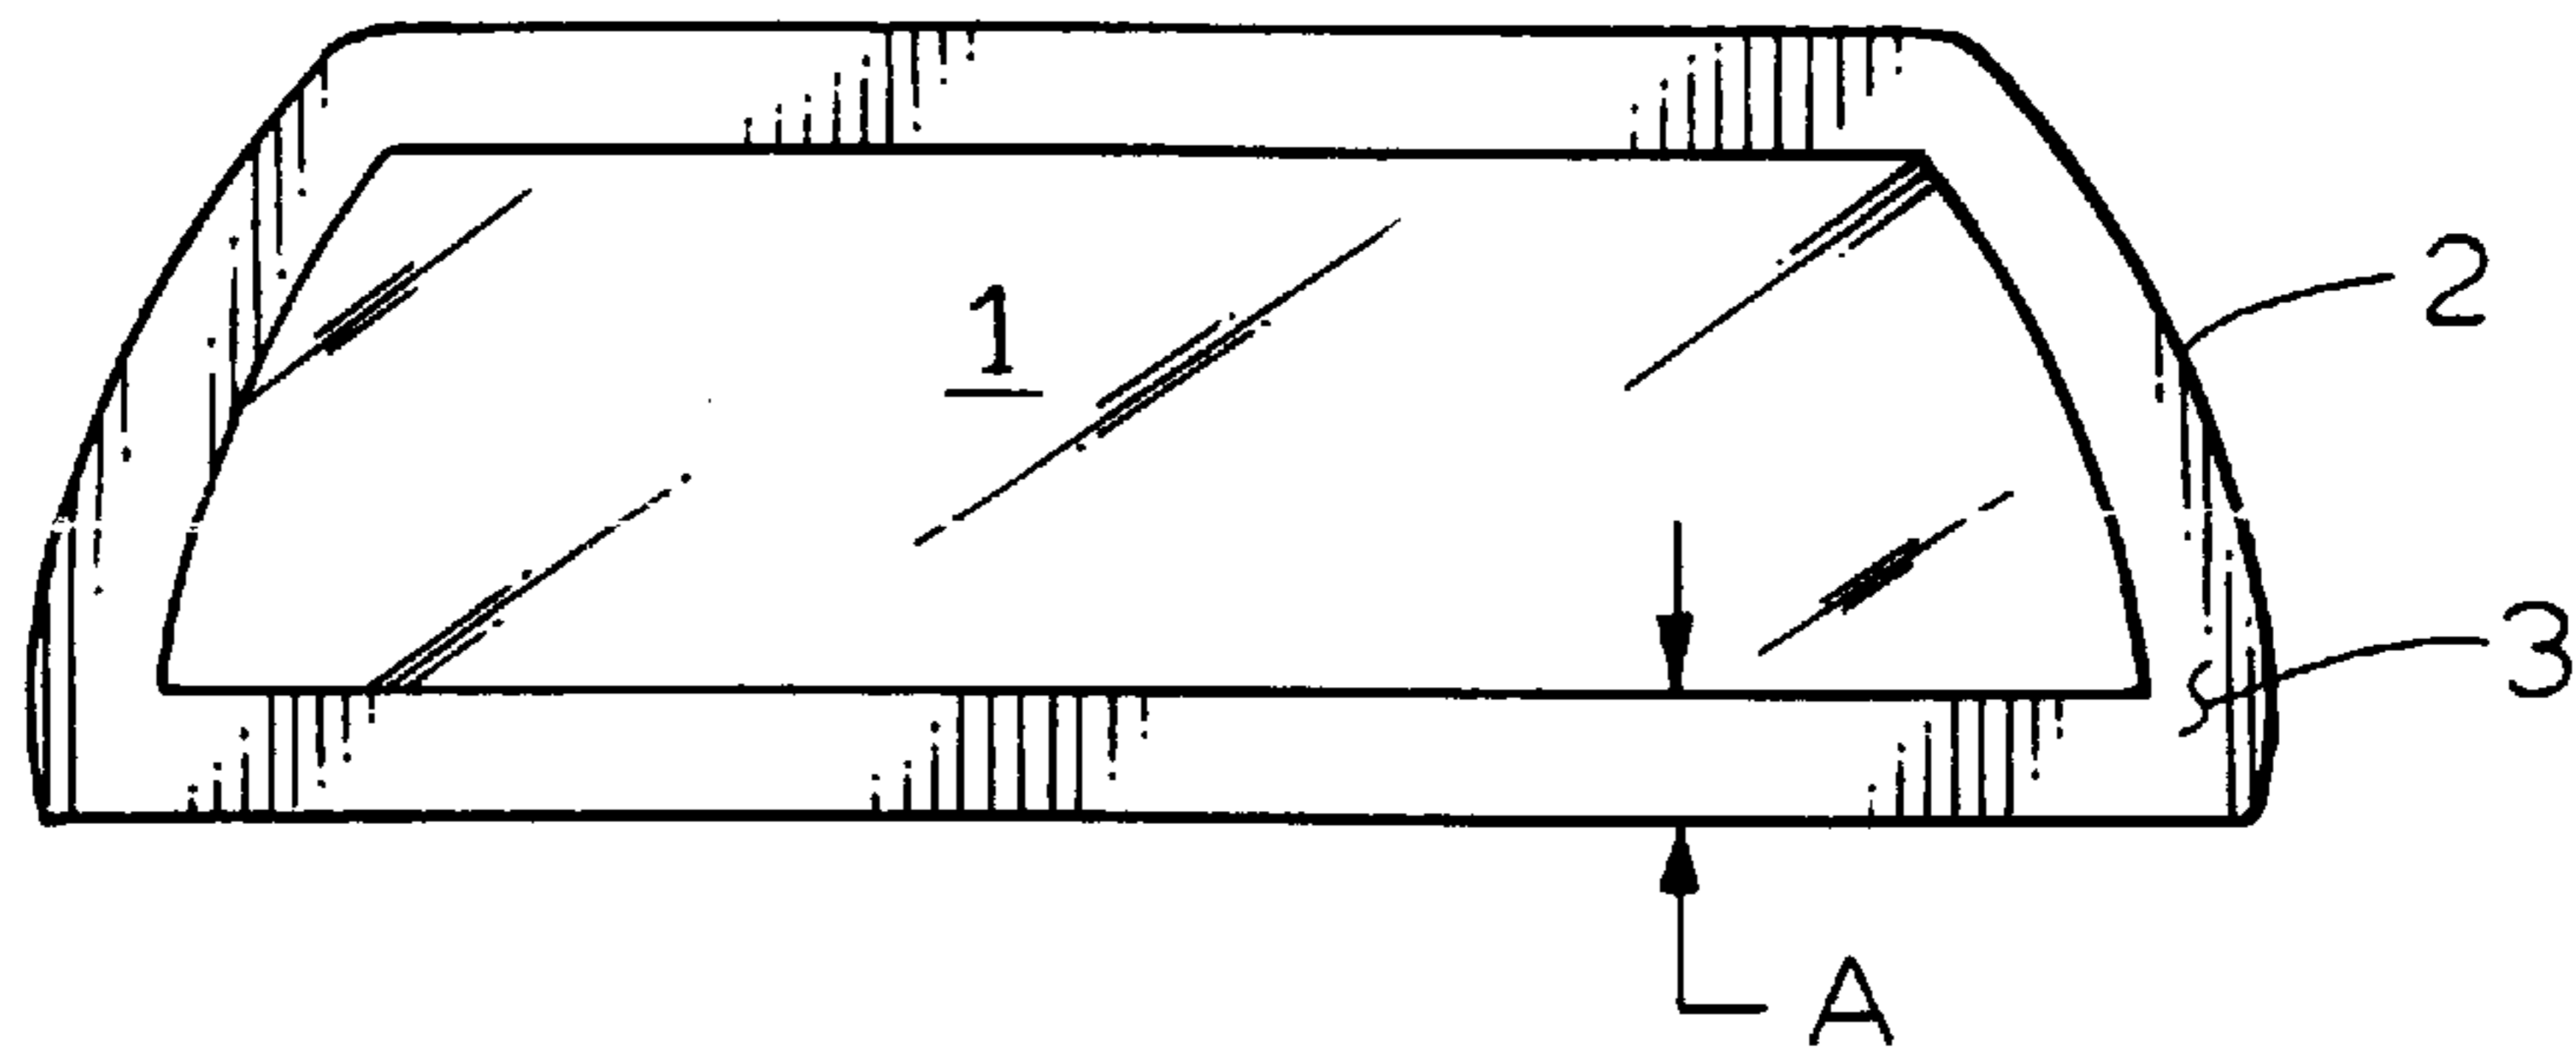
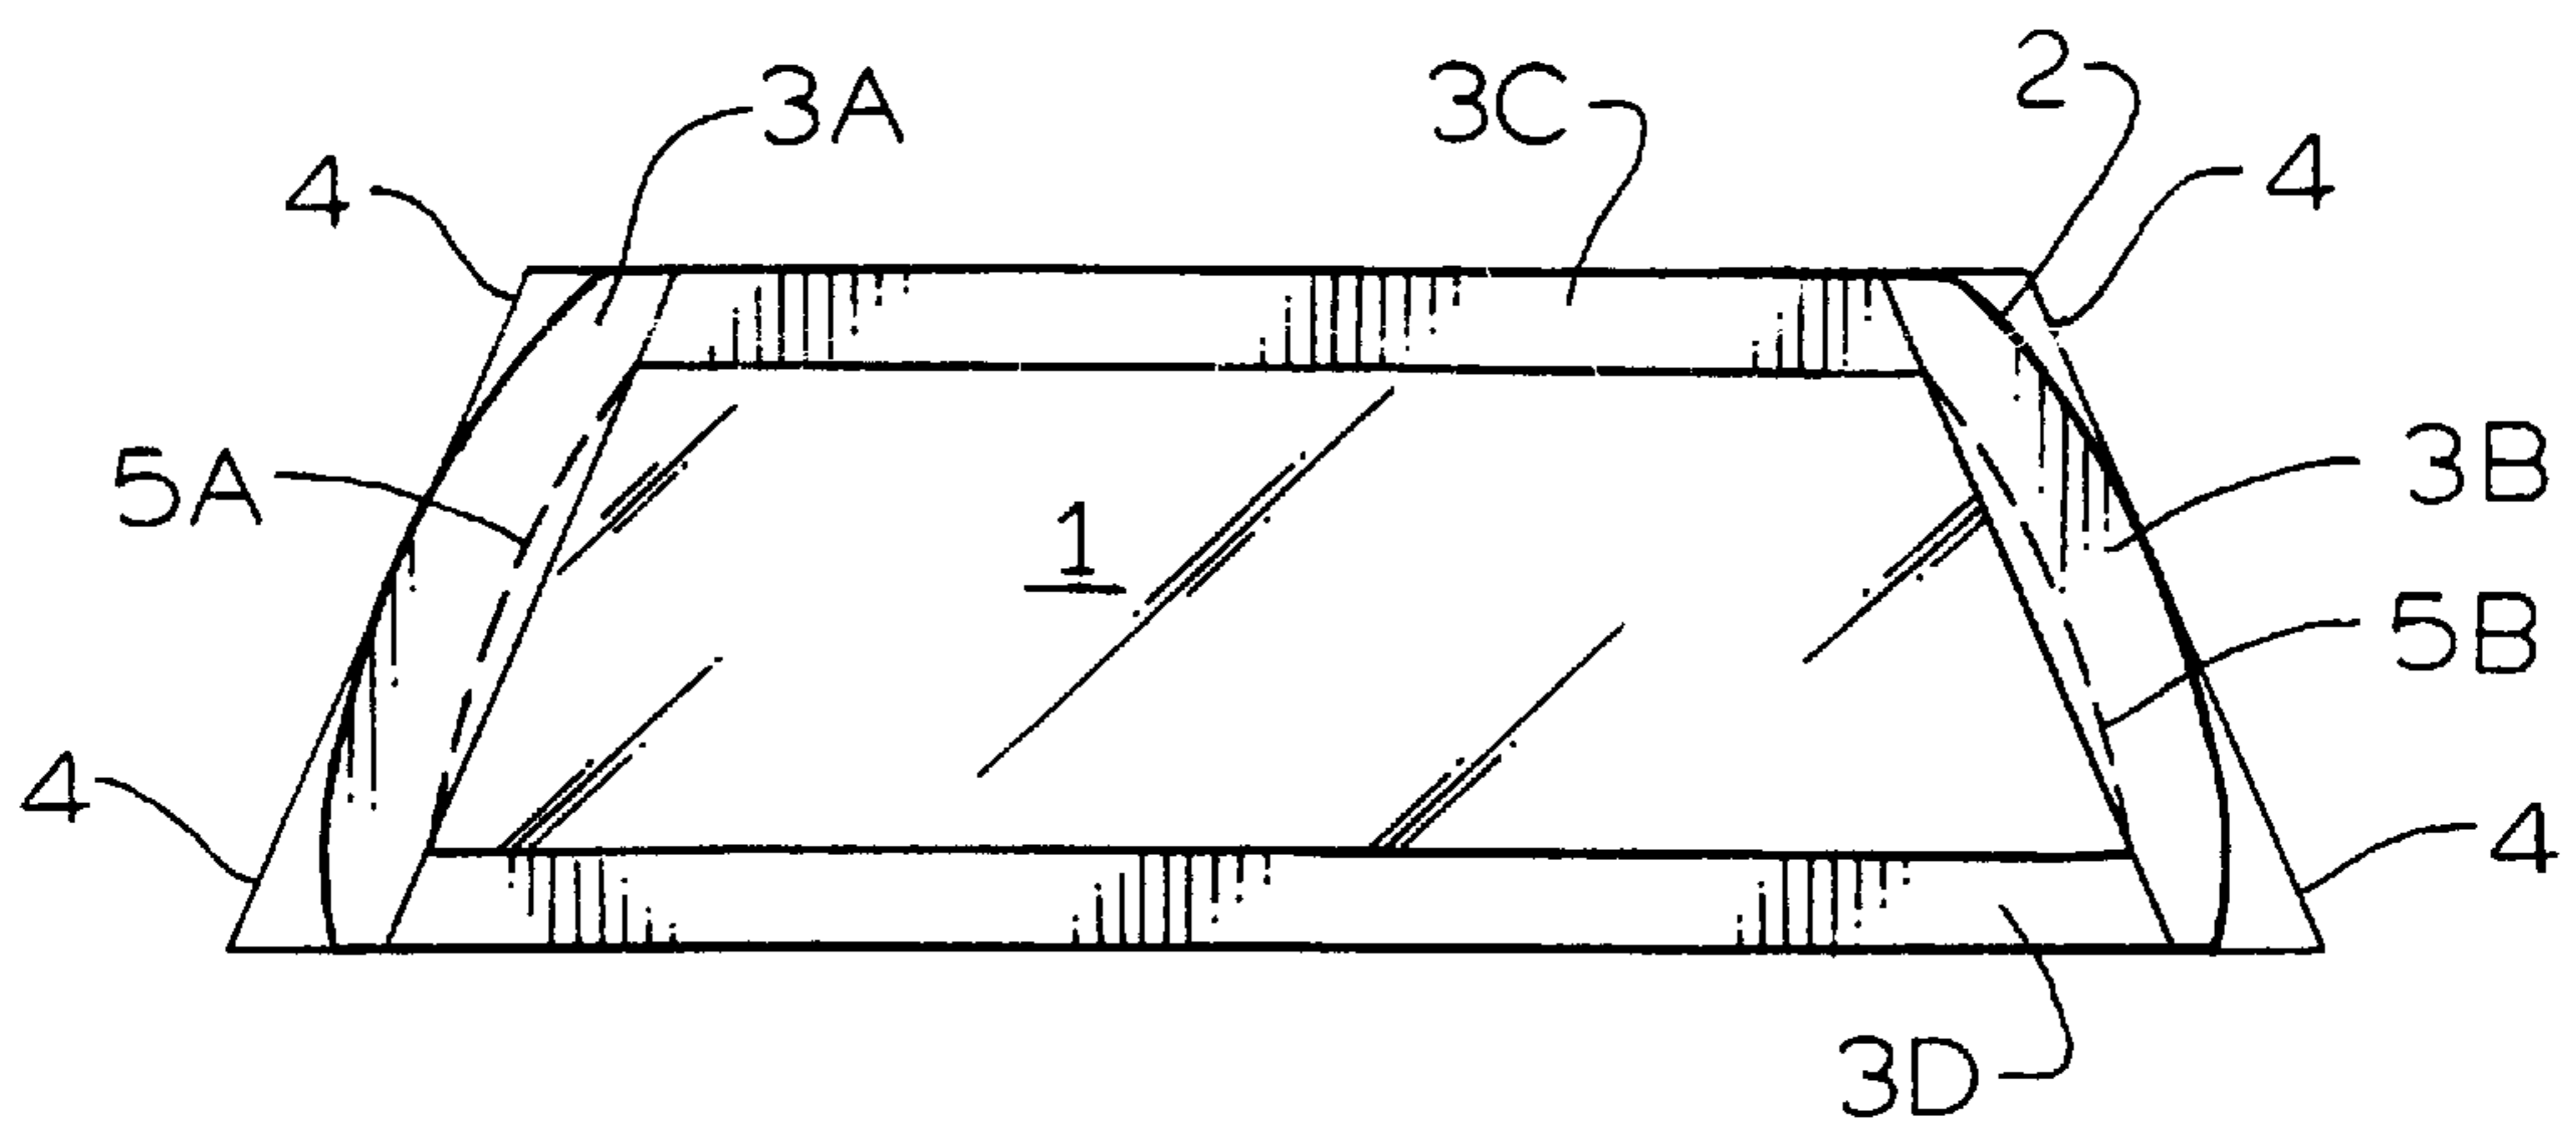
FIG. 2 shows a front view of a windshield having the inventive film applied in an exemplary aftermarket application.

A preferred method of providing the peripheral protection for aftermarket applications uses a roll of film from which desired lengths are cut off. Then the pieces are laid onto the windshield, marked and cut to the desired configuration. FIG. 2 shows this means and method. The windshield 1 has a molding 2 surrounding it. The plastic frame is formed of four separate pieces, 3A, 3B, 3C and 3D on the left side, right side, top and bottom respectively. Since the individual frame pieces are cut from a roll or a strip of selected width the corners 4 are to be trimmed off, the ends cut to fit and the inside edges such as pieces 3A and 3B are preferably trimmed to a curvature to match the molding curvature as seen at 5A and 5B. Templates of paper or cardboard may be made first. Then the film element or elements are prepared with an adhesive and placed on the windshield. The film could also be supplied in wide sheets from which strips are cut having the requisite width and shape.
