United States Patent [19]
Salisbury

[54] **PROCESS FOR REPAIRING DATA TRANSMISSION LINES OF IMAGERS**

[73] Assignee: **General Electric Company**, Schenectady, N.Y.

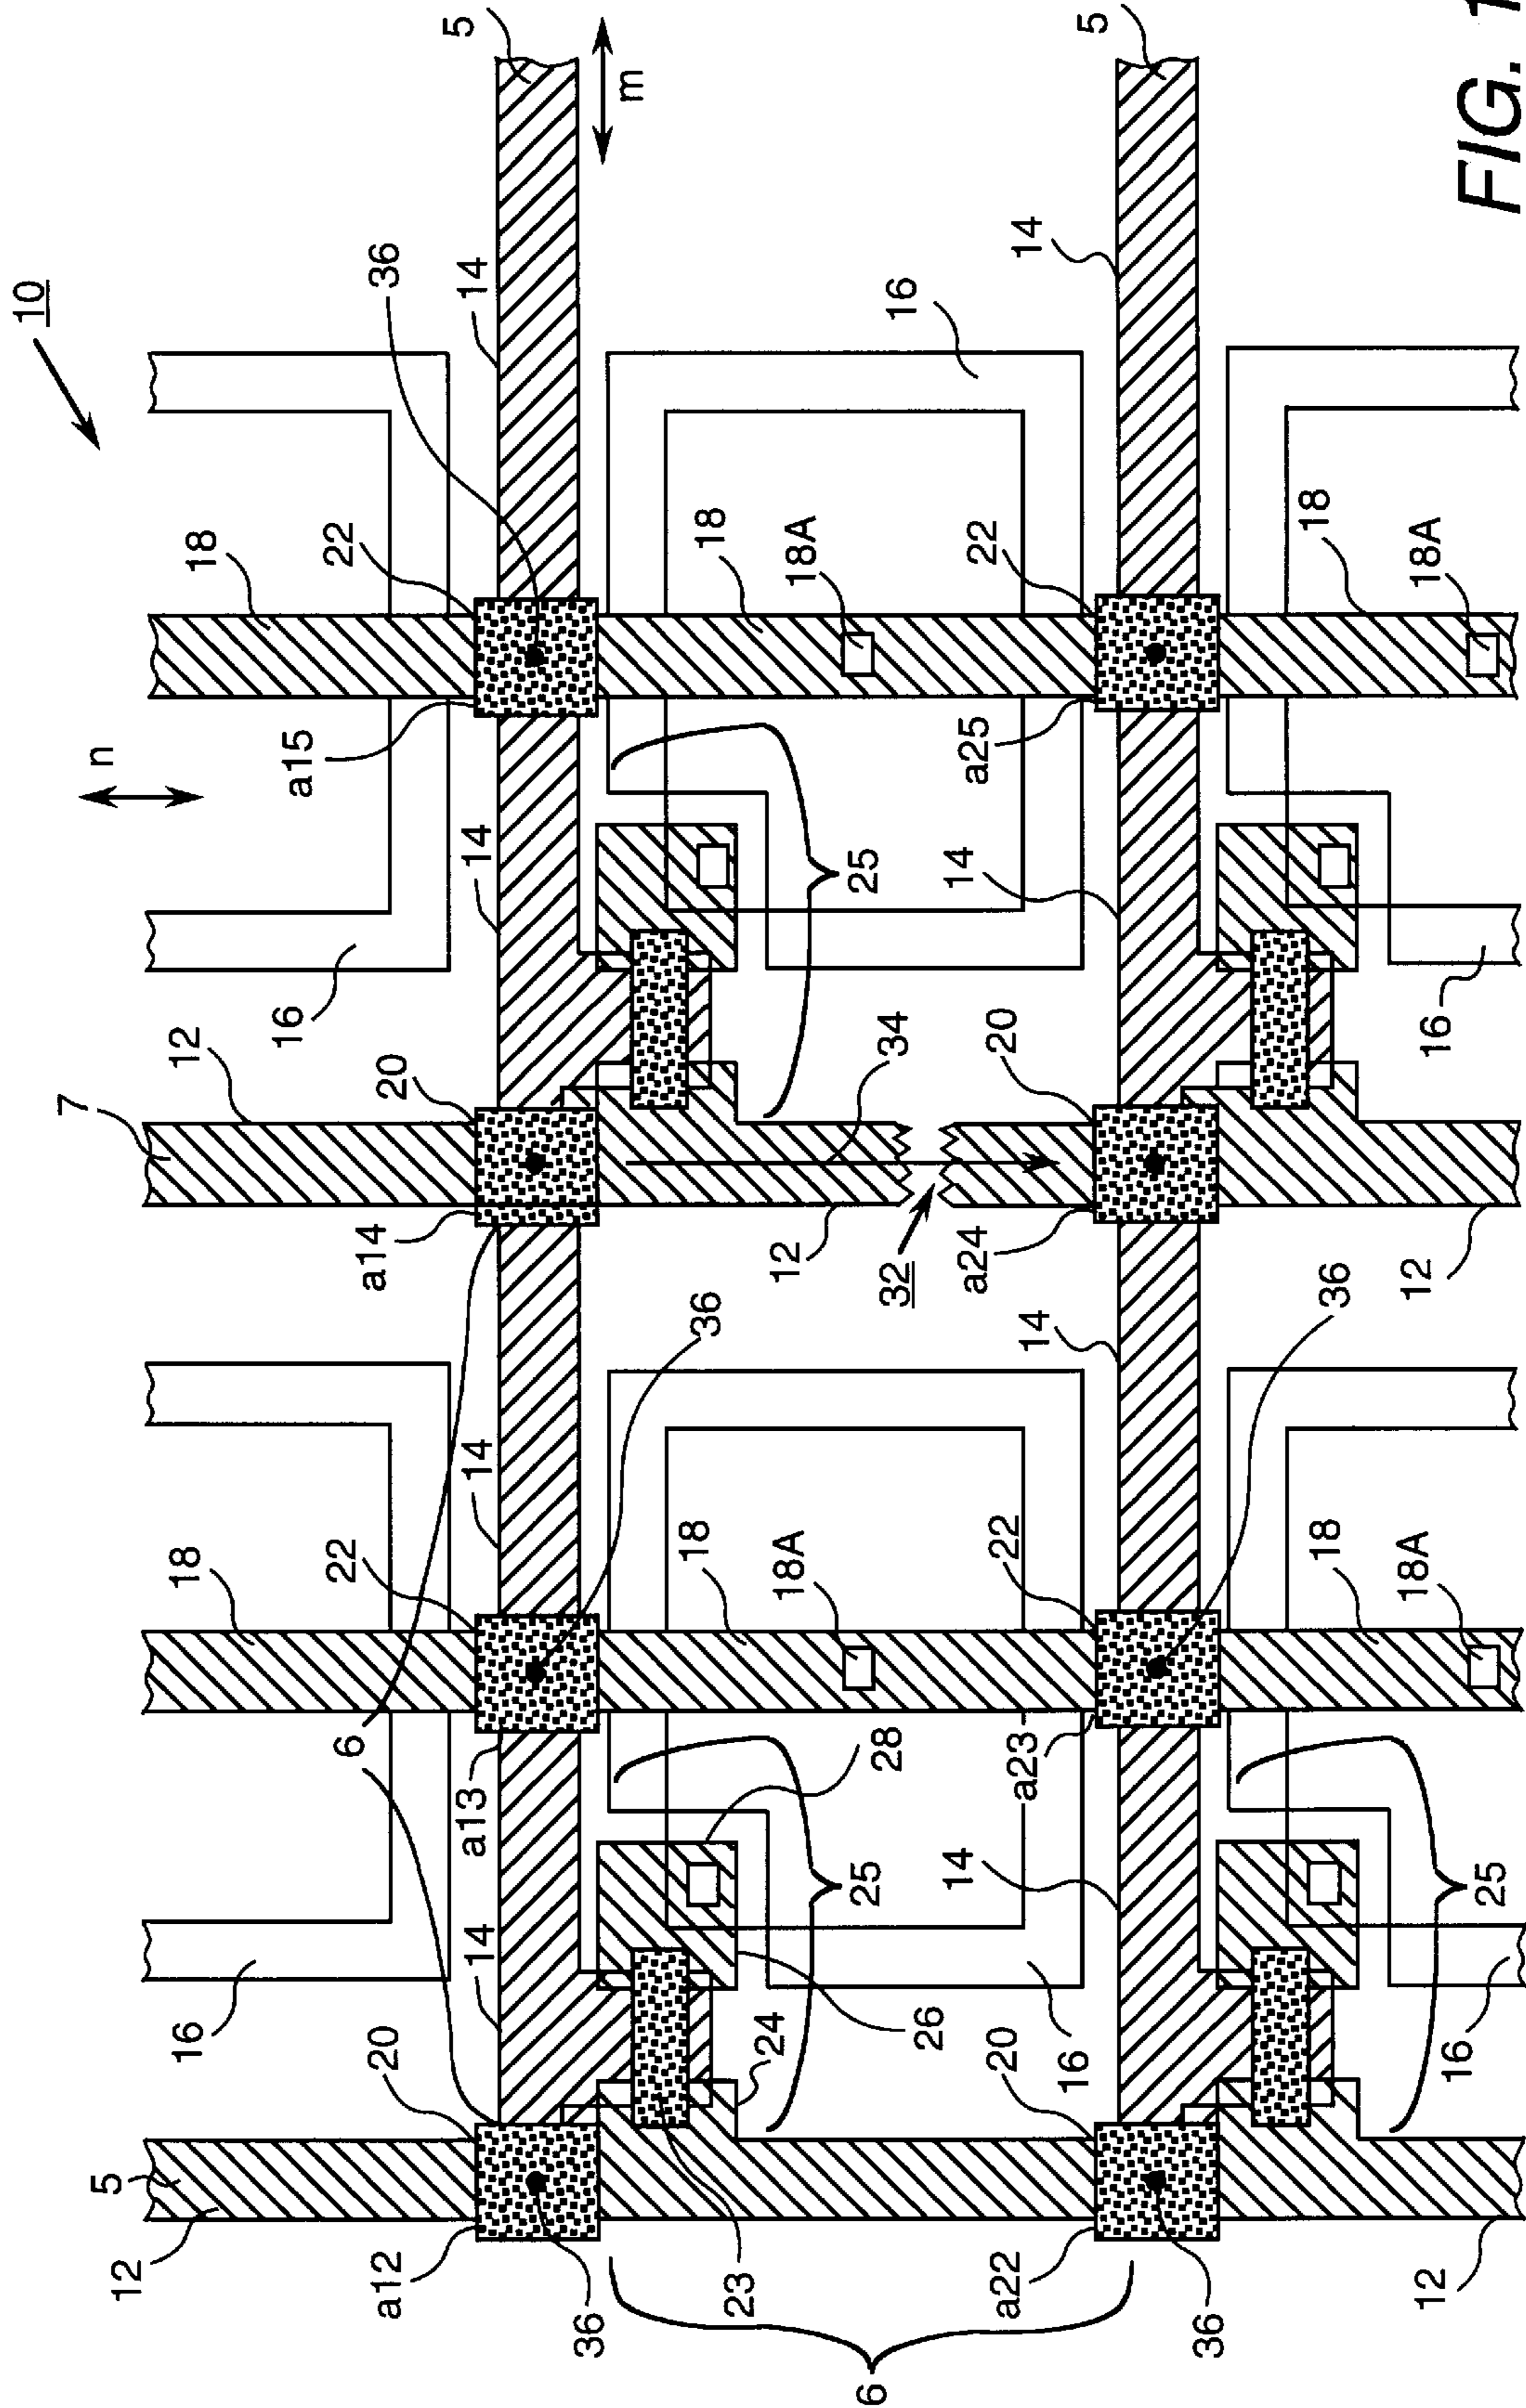
FIG. 2 depicts a repair shunt arrangement coupled to the data line with an electrical defect in accordance with the present invention.

In one embodiment of the present invention, a plurality of weld pads **36** are provided, typically at each scan-data line crossover **20** and at each scan-common electrode crossover **22**, as is illustrated in FIG. **2**. These weld pads **36** are formed

Once electrical defect **32** in defective data line **7** is identified, the process of repairing data line **7** includes the steps of forming a repair shunt **110** (schematically represented by the dark line over portions of preexisting conductive lines **14** and **18** in FIG. **2**) and fusing the repair shunt to defective data line **7** so as to electrically bypass defect **32**. As used herein, "fusing" and the like is used to refer to forming an electrical connection between two lines, typically by application of heat to melt the conductive material of the two lines to be connected and to remove dielectric material between the two lines to enable the making of the electrical connection. One example is the application, that is, directing the beam of a laser, such as an excimer laser, in the region to be fused so as to weld the two conductive lines together and ablate intervening dielectric material.

Formation of repair shunt **110** includes the steps of forming a first pixel scan line segment **120**, a common electrode segment **130**, and a second pixel line segment **140** (these segments are also referred to collectively as the "repair segments"). First pixel scan line segment **120** comprises a portion of a first scan line **70** that is coupled to the FET **102** coupled to repair area pixel **100**; common electrode segment **130** comprises a portion of a repair common electrode line **80** that overlies repair area pixel **100**; and second scan line segment **140** comprises a portion of a second scan line **75** disposed on the opposite side of repair pixel **100** from first scan line **120** (that is, the scan line for the next row of pixels below (as illustrated in FIG. **2**) the scan line coupled to repair area pixel **100**).

Common electrode segment **130** is formed by severing repair common electrode line **80** at sever points **74** and **75**. Sever point **74** is disposed on repair common electrode line **80** between first scan common electrode crossover element **93** and the edge of the array (that is, the end of the common electrode line **80** coupled to bias source at the edge of the array in the upper direction as illustrated in FIG. 2). Sever point **75** is disposed on repair common electrode line **80** between second scan common electrode crossover element **97** and the opposite edge of the array (that is, the end of the common electrode line **80** coupled to bias source at the edge of the array in the lower direction as illustrated in FIG. 2).

The three repair segments, that is first scan line segment **120**, common electrode segment **130**, and second scan line segment **140**, are then fused together to make repair shunt **110** electrically conductive. First scan line segment is welded to common electrode segment **130** at first scan-common electrode line crossover element **93**, and common electrode element **130** is welded to second scan line segment **140** at second scan-common electrode crossover element **97**. In embodiments of the invention comprising respective weld pads **36**, the welding of the address lines together at the crossover points is typically accomplished by applying the laser to the crossover element in the vicinity of the weld pad to effect the electrical fusing of the two conductive lines.

Repair shunt **110** is then fused to repair data line **7** to provide the electrical bypass of defect **32** in repair data line **7**. In one embodiment of the present invention, electrical connection between repair shunt **110** and repair data line **7** is made via respective weld connections at first scan-data crossover element **92** and at second scan-data line crossover element **96** by fusing the two conductive lines together at the respective crossover elements (that is, forming the respective weld connections). As noted above, in embodiments of the invention comprising weld pads **36**, such electrical fusing (or welding) the lines is done in the vicinity of the respective weld pads **36** situated at the crossover elements.
