[11] Patent Number: **5,976,978**

[54] **PROCESS FOR REPAIRING DATA TRANSMISSION LINES OF IMAGERS**

[73] Assignee: **General Electric Company**, Schenectady, N.Y.

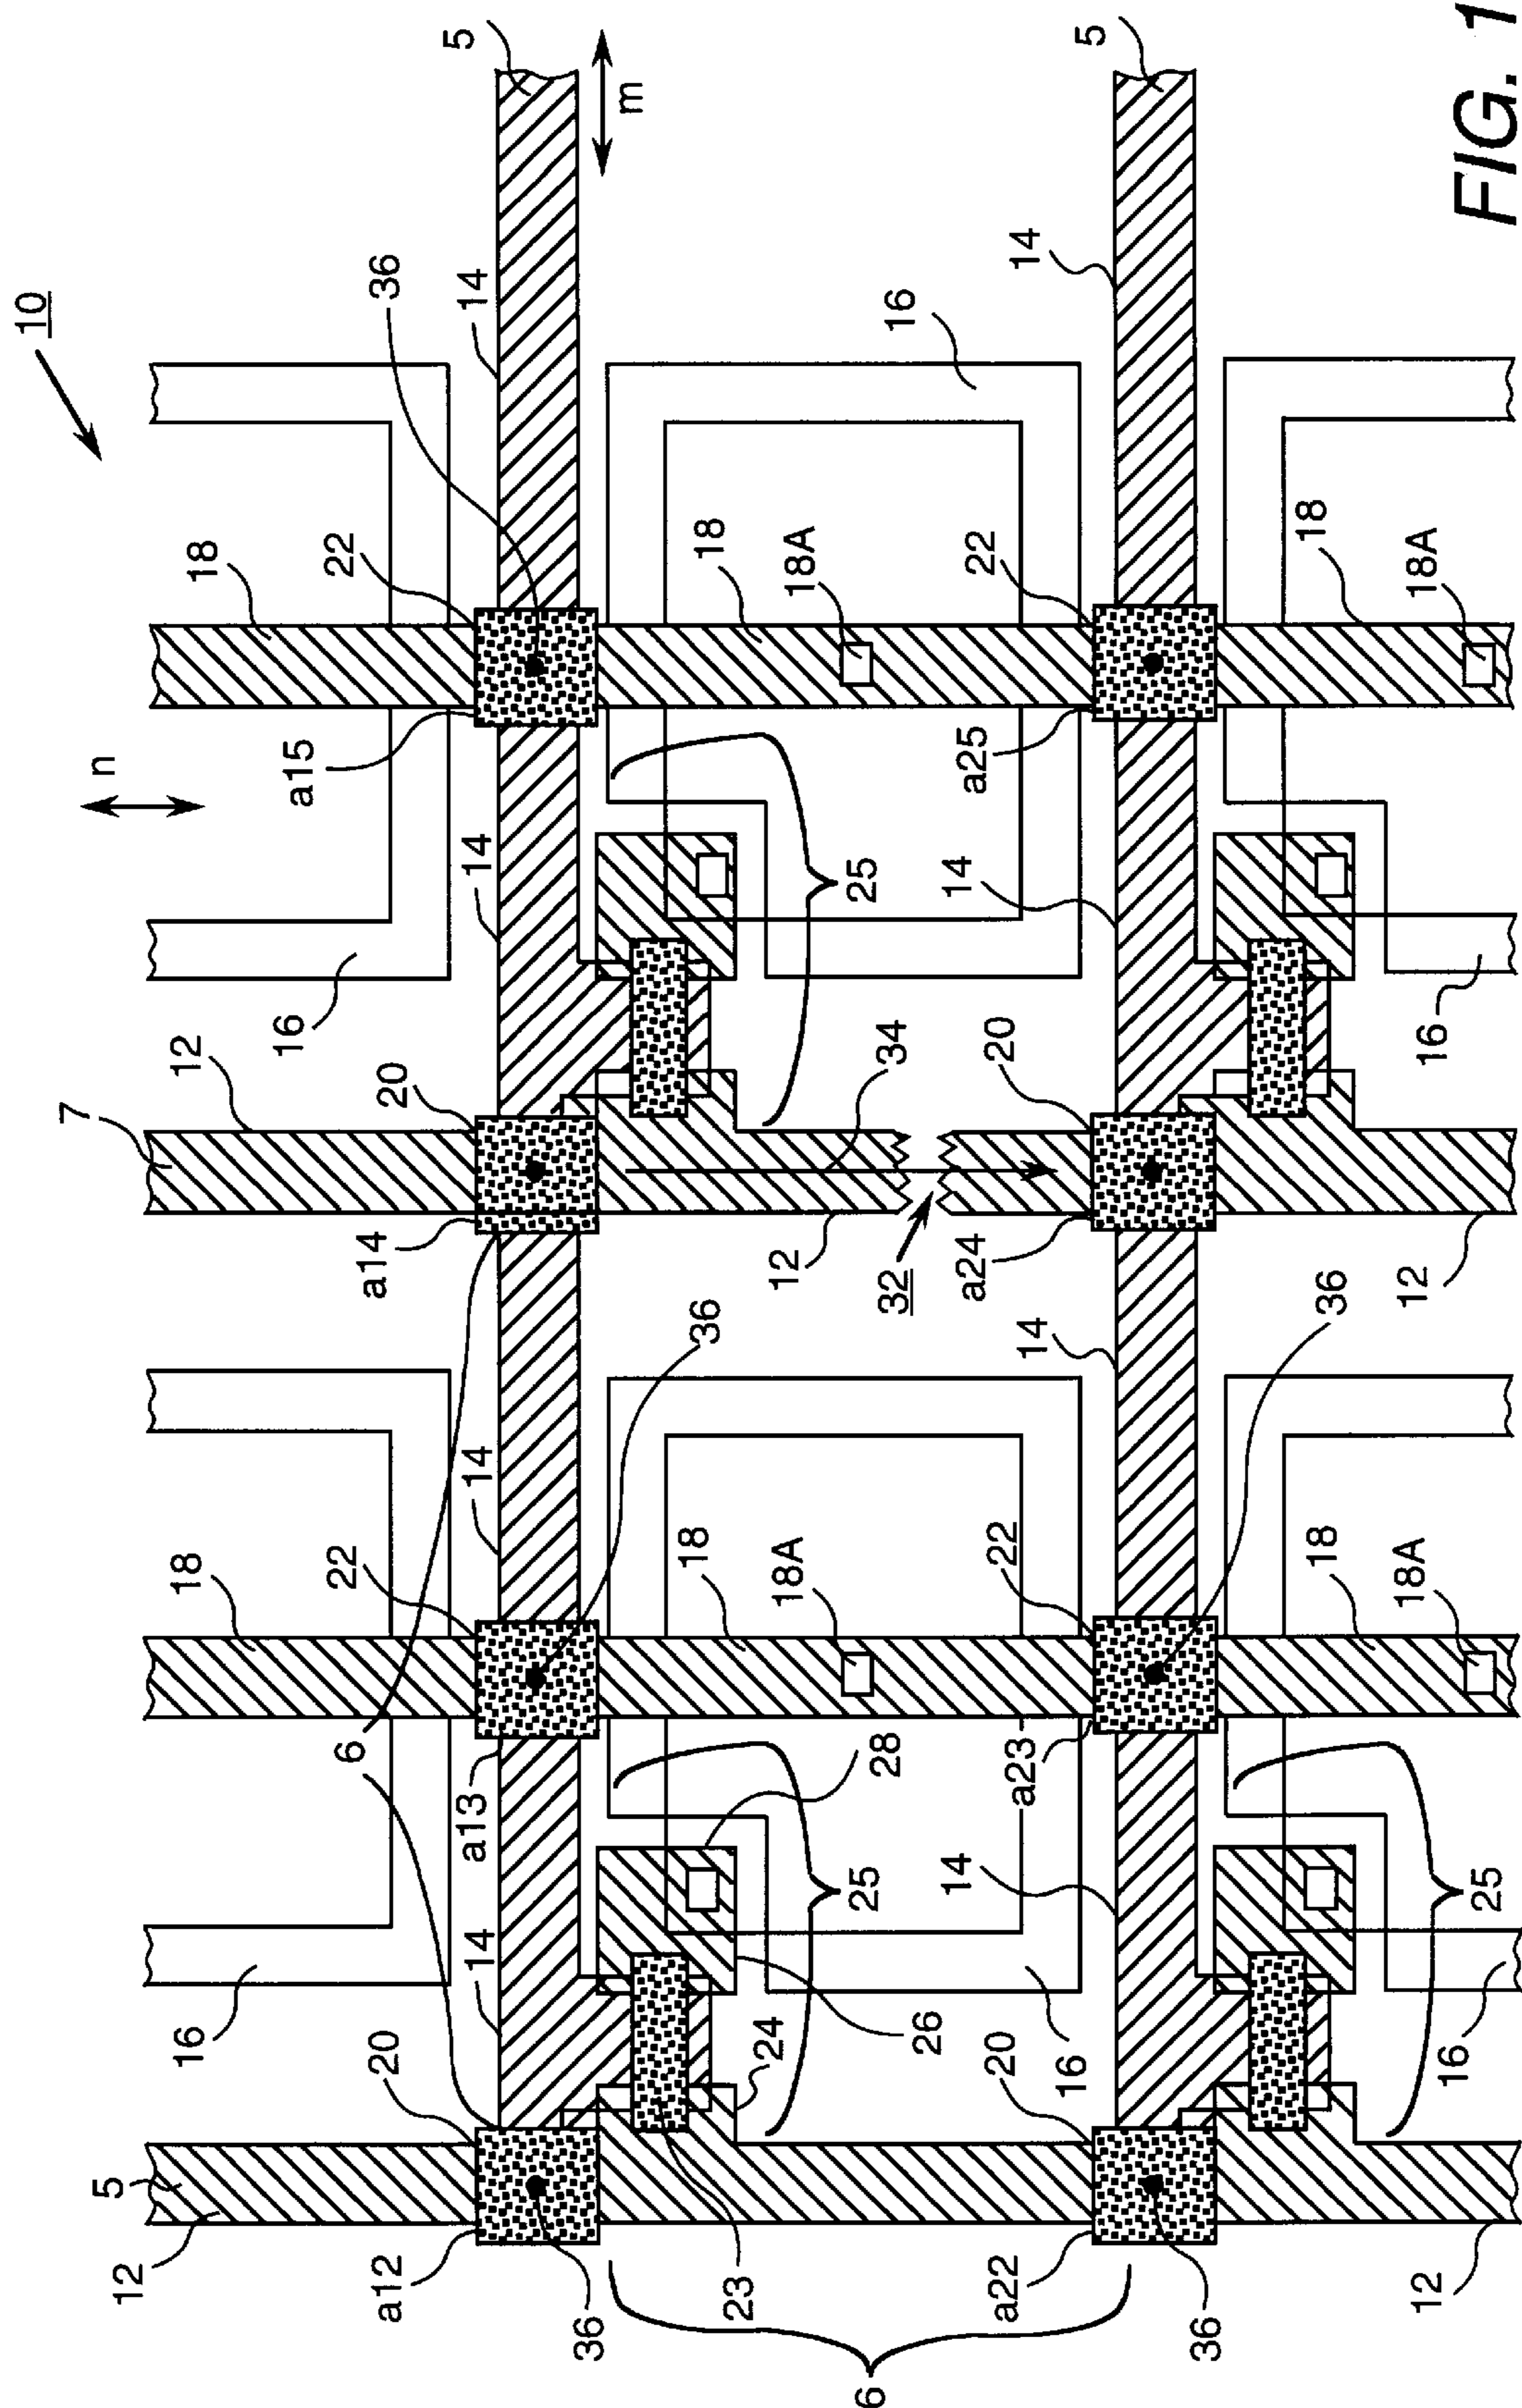
FIG. 1 is a schematic illustrating a portion of an imager comprising a pixel array having an electrical defect in a data line of the array.

A solid state radiation imager **10**, such as may be used for X-ray imaging, is illustrated in part in FIG. 1. Imager **10** comprises an array of pixels **6** disposed in rows and columns that comprise a photosensor array used to generate electrical signals corresponding to radiation incident on the imager (in an x-ray imager, a scintillator material (not shown) absorbs the incident x-rays and in turn generates optical photons that are detected by the photosensor array). Each pixel typically comprises a photosensor **16** (typically a photodiode) and an associated switching transistor **25**, and is coupled to two

respective address lines **5**. Address lines **5** are disposed in an array of rows and columns; as illustrated in FIG. **1**, one set of address comprises data lines **12** (coupled to the diode for readout of charge accumulated on the diode) and another set of address lines comprises scan lines **14** (coupled to the respective pixel switching transistor **25** to cause the transistor to be in a conductive or non-conductive state). Photodiodes **16** are further coupled to diode common transmission lines **18** via a conductive pad **18A**. The location in the array of particular pixels **6**, and the pixel's associated photodiode and address lines, can be defined with coordinates to specify the location of a row and a column of scan, data, diode common transmission lines of the imager **10**.

In a common embodiment, data transmission lines **12** typically comprise molybdenum; scan data transmission lines **14** typically comprise chromium, molybdenum, or a combination thereof; and diode common transmission lines **18** comprise molybdenum or alternatively indium tin oxide. Scan lines **14** are arranged so as to form and interconnect the m rows (depicted as disposed horizontally in the figures) of imager **10**, and the n columns (depicted as oriented vertically in the figures) are formed by respective data transmission lines **12** as shown in FIG. **1**. For such an arrangement, the respective positions in the array where scan lines **14** underlie data transmission lines **12** (the scan lines and data lines normally being electrically isolated from one another by intervening layers of a dielectric material) define respective scan-data crossover elements **20**. Further, the positions in the array where scan lines **14** underlie diode common electrode lines **18** (the scan and common electrode lines being normally electrically isolated from the other by an intervening layer of dielectric material) define respective scan-common electrode crossover elements **22**. The scan-data line crossover elements **20** and scan-common crossover elements **22** are located at the elements of the matrix of the imager **10**, such as a_{12} , a_{13} . . . a_{25} shown in FIG. **1**.

At times fabrication processes (e.g., masking and etching) result in electrical defects in data lines; as used herein, "electrical defect" and the like refer to open circuit conditions or alternatively very high resistance connections that make the data line unserviceable because of the high level of noise in the line introduced by transmissions over the defect. One example of such an electrical defect **32** is illustrated in FIG. **1**, in which defect **32** is represented as an open circuit condition in defective data address line **7**. Defect **32** is a break in the data transmission line that interconnects the matrix locations a_{14} and a_{24} so as to break the electrical path **34** therebetween.

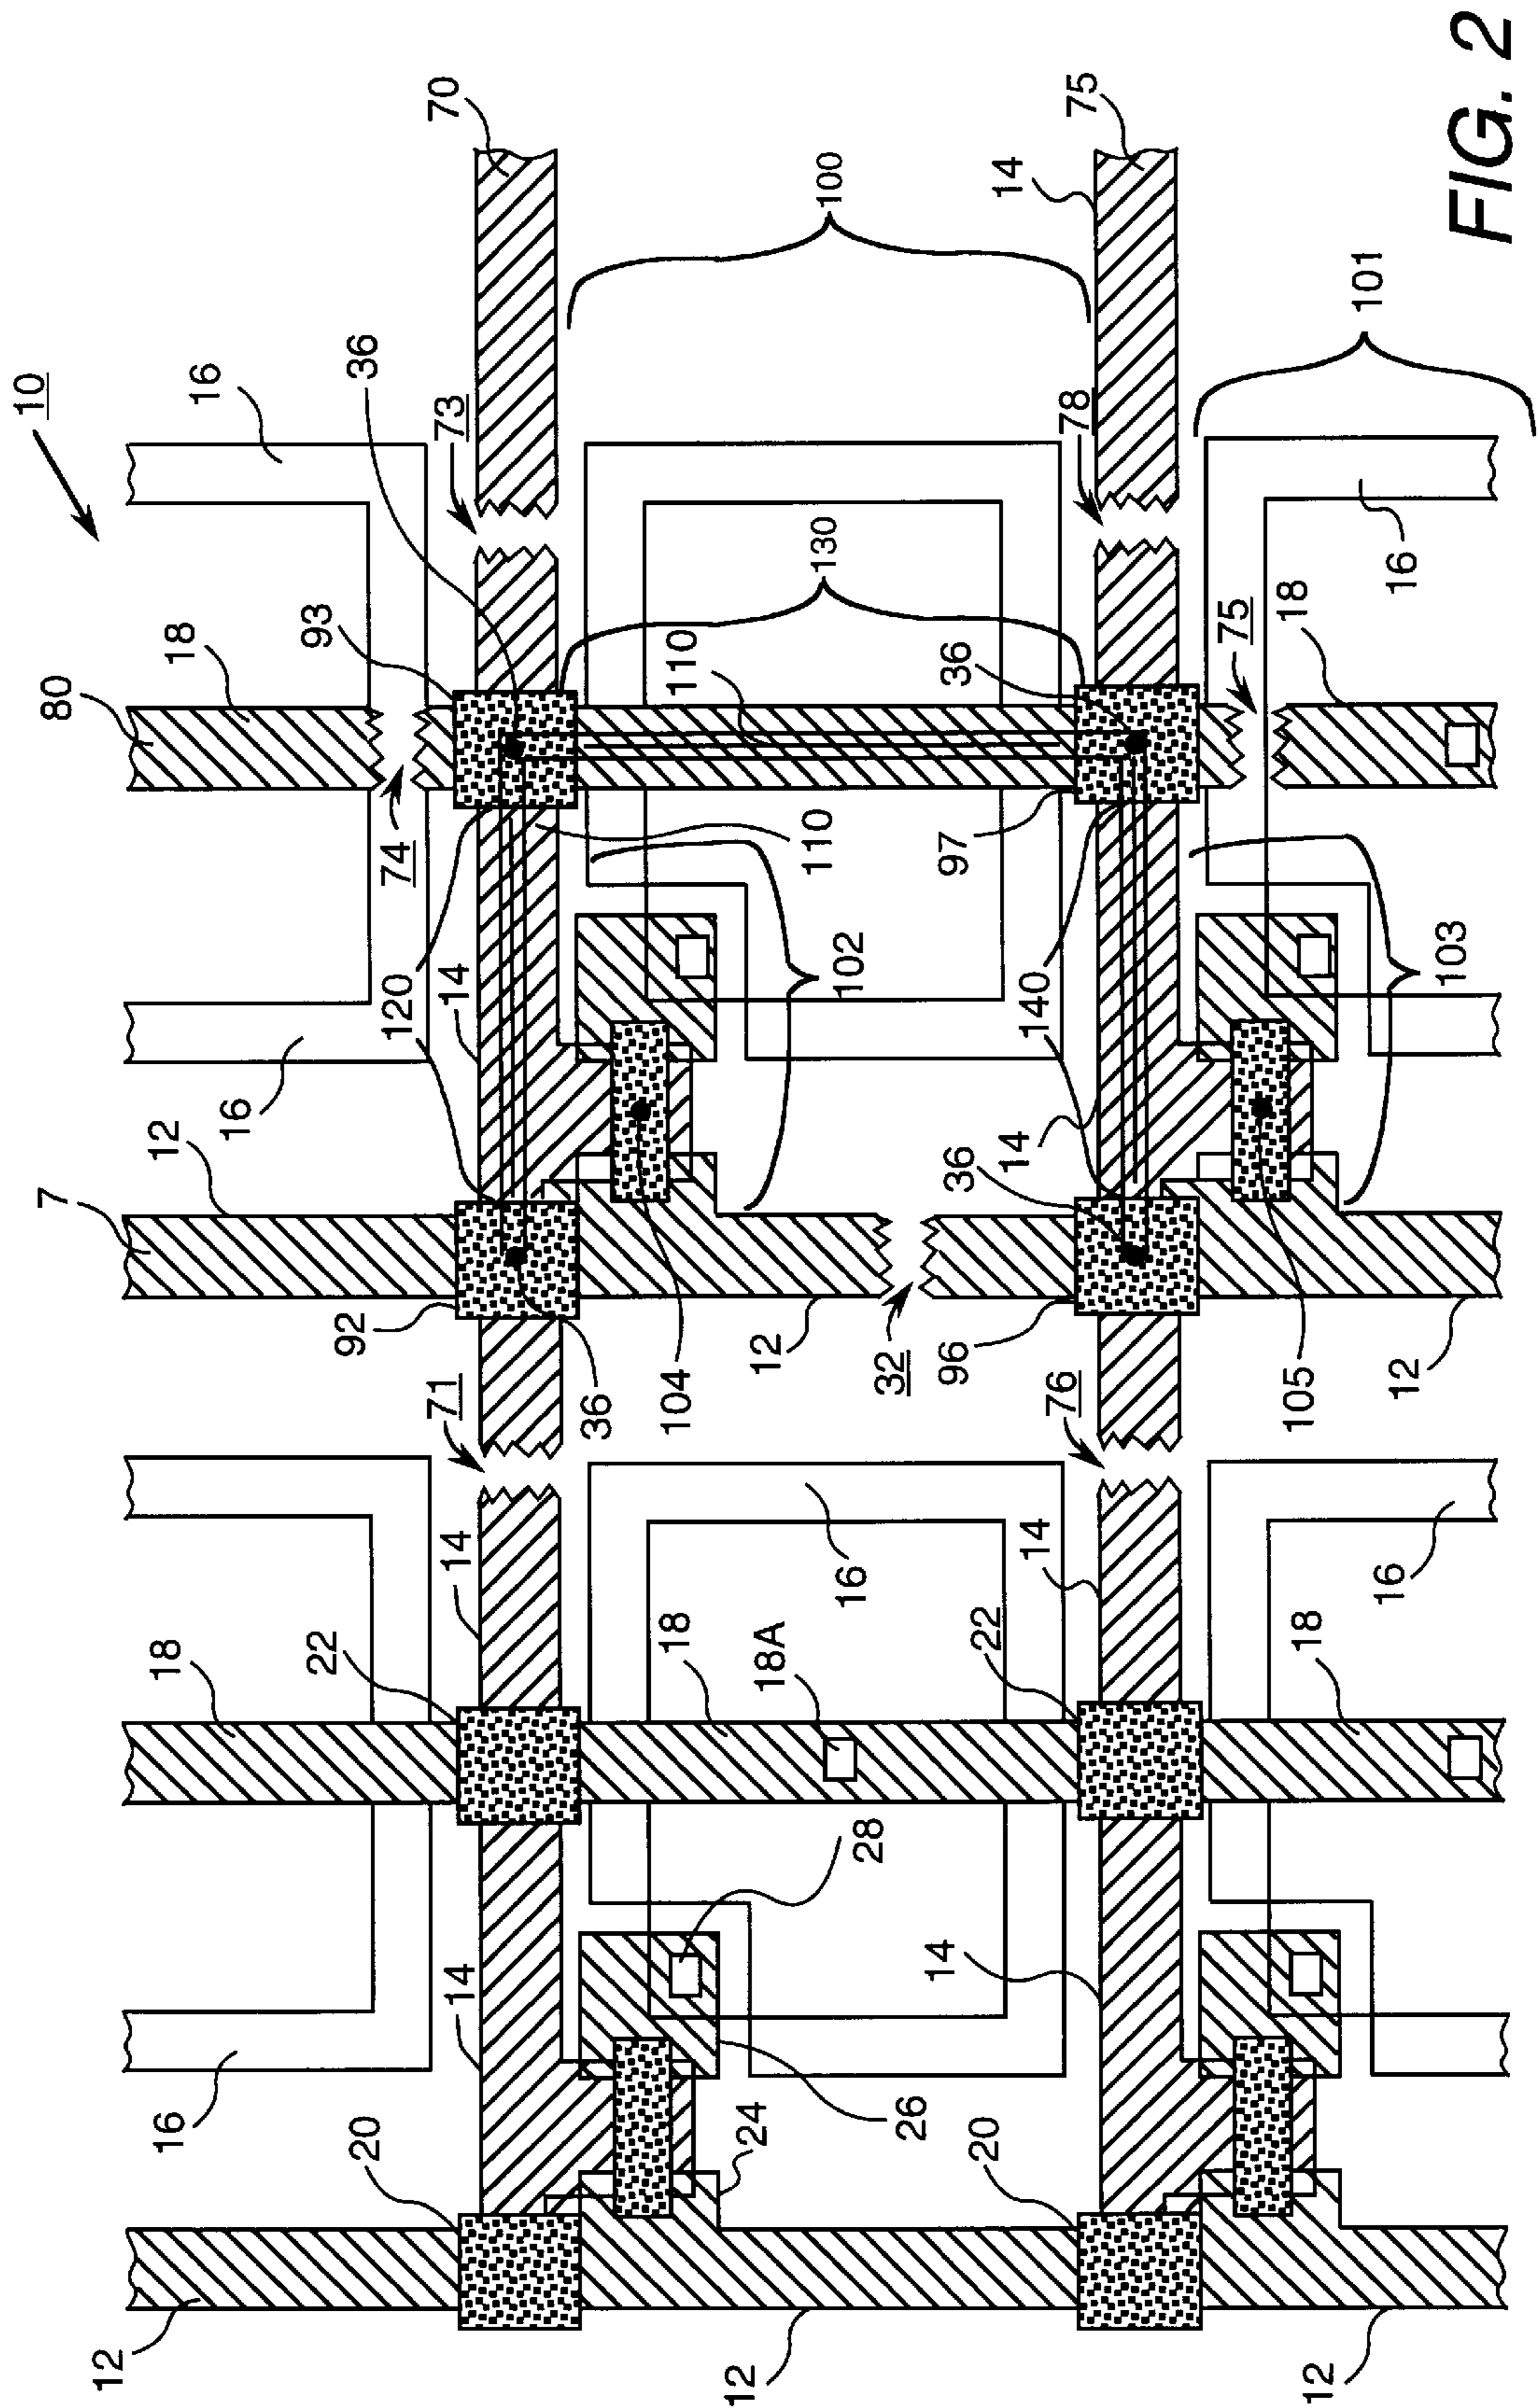
FIG. 2 depicts a repair shunt arrangement coupled to the data line with an electrical defect in accordance with the present invention.

In one embodiment of the present invention, a plurality of weld pads **36** are provided, typically at each scan-data line crossover **20** and at each scan-common electrode crossover **22**, as is illustrated in FIG. **2**. These weld pads **36** are formed

Once electrical defect **32** in defective data line **7** is identified, the process of repairing data line **7** includes the steps of forming a repair shunt **110** (schematically represented by the dark line over portions of preexisting conductive lines **14** and **18** in FIG. **2**) and fusing the repair shunt to defective data line **7** so as to electrically bypass defect **32**. As used herein, "fusing" and the like is used to refer to forming an electrical connection between two lines, typically by application of heat to melt the conductive material of the two lines to be connected and to remove dielectric material between the two lines to enable the making of the electrical connection. One example is the application, that is, directing the beam of a laser, such as an excimer laser, in the region to be fused so as to weld the two conductive lines together and ablate intervening dielectric material.

Formation of repair shunt **110** includes the steps of forming a first pixel scan line segment **120**, a common electrode segment **130**, and a second pixel line segment **140** (these segments are also referred to collectively as the "repair segments"). First pixel scan line segment **120** comprises a portion of a first scan line **70** that is coupled to the FET **102** coupled to repair area pixel **100**; common electrode segment **130** comprises a portion of a repair common electrode line **80** that overlies repair area pixel **100**; and second scan line segment **140** comprises a portion of a second scan line **75** disposed on the opposite side of repair pixel **100** from first scan line **120** (that is, the scan line for the next row of pixels below (as illustrated in FIG. **2**) the scan line coupled to repair area pixel **100**).

Similarly, second scan line segment **130** is formed by electrically isolating segment **140** by severing second scan line **75** at second scan line sever locations **76** and **78**. Second scan line sever location **76** is disposed on second scan line **75** a second scan-common electrode crossover element **97** and the edge of the array (that is, opposite end of second scan line **75** that is coupled to readout electronics on the right side of the array as illustrated in FIG. 2); second scan line sever location **78** is disposed on second scan line **75** between a second scan-common electrode crossover element **97** and the edge of the array (that is, opposite end of second scan line **75** that is coupled to readout electronics on the right side of the array as illustrated in FIG. 2).

Common electrode segment **130** is formed by severing repair common electrode line **80** at sever points **74** and **75**. Sever point **74** is disposed on repair common electrode line **80** between first scan common electrode crossover element **93** and the edge of the array (that is, the end of the common electrode line **80** coupled to bias source at the edge of the array in the upper direction as illustrated in FIG. 2). Sever point **75** is disposed on repair common electrode line **80** between second scan common electrode crossover element **97** and the opposite edge of the array (that is, the end of the common electrode line **80** coupled to bias source at the edge of the array in the lower direction as illustrated in FIG. 2).
