**United States Patent** [19]  
**Salisbury**

[11] **Patent Number:** **5,976,978**  
[45] **Date of Patent:** **Nov. 2, 1999**

[54] **PROCESS FOR REPAIRING DATA TRANSMISSION LINES OF IMAGERS**

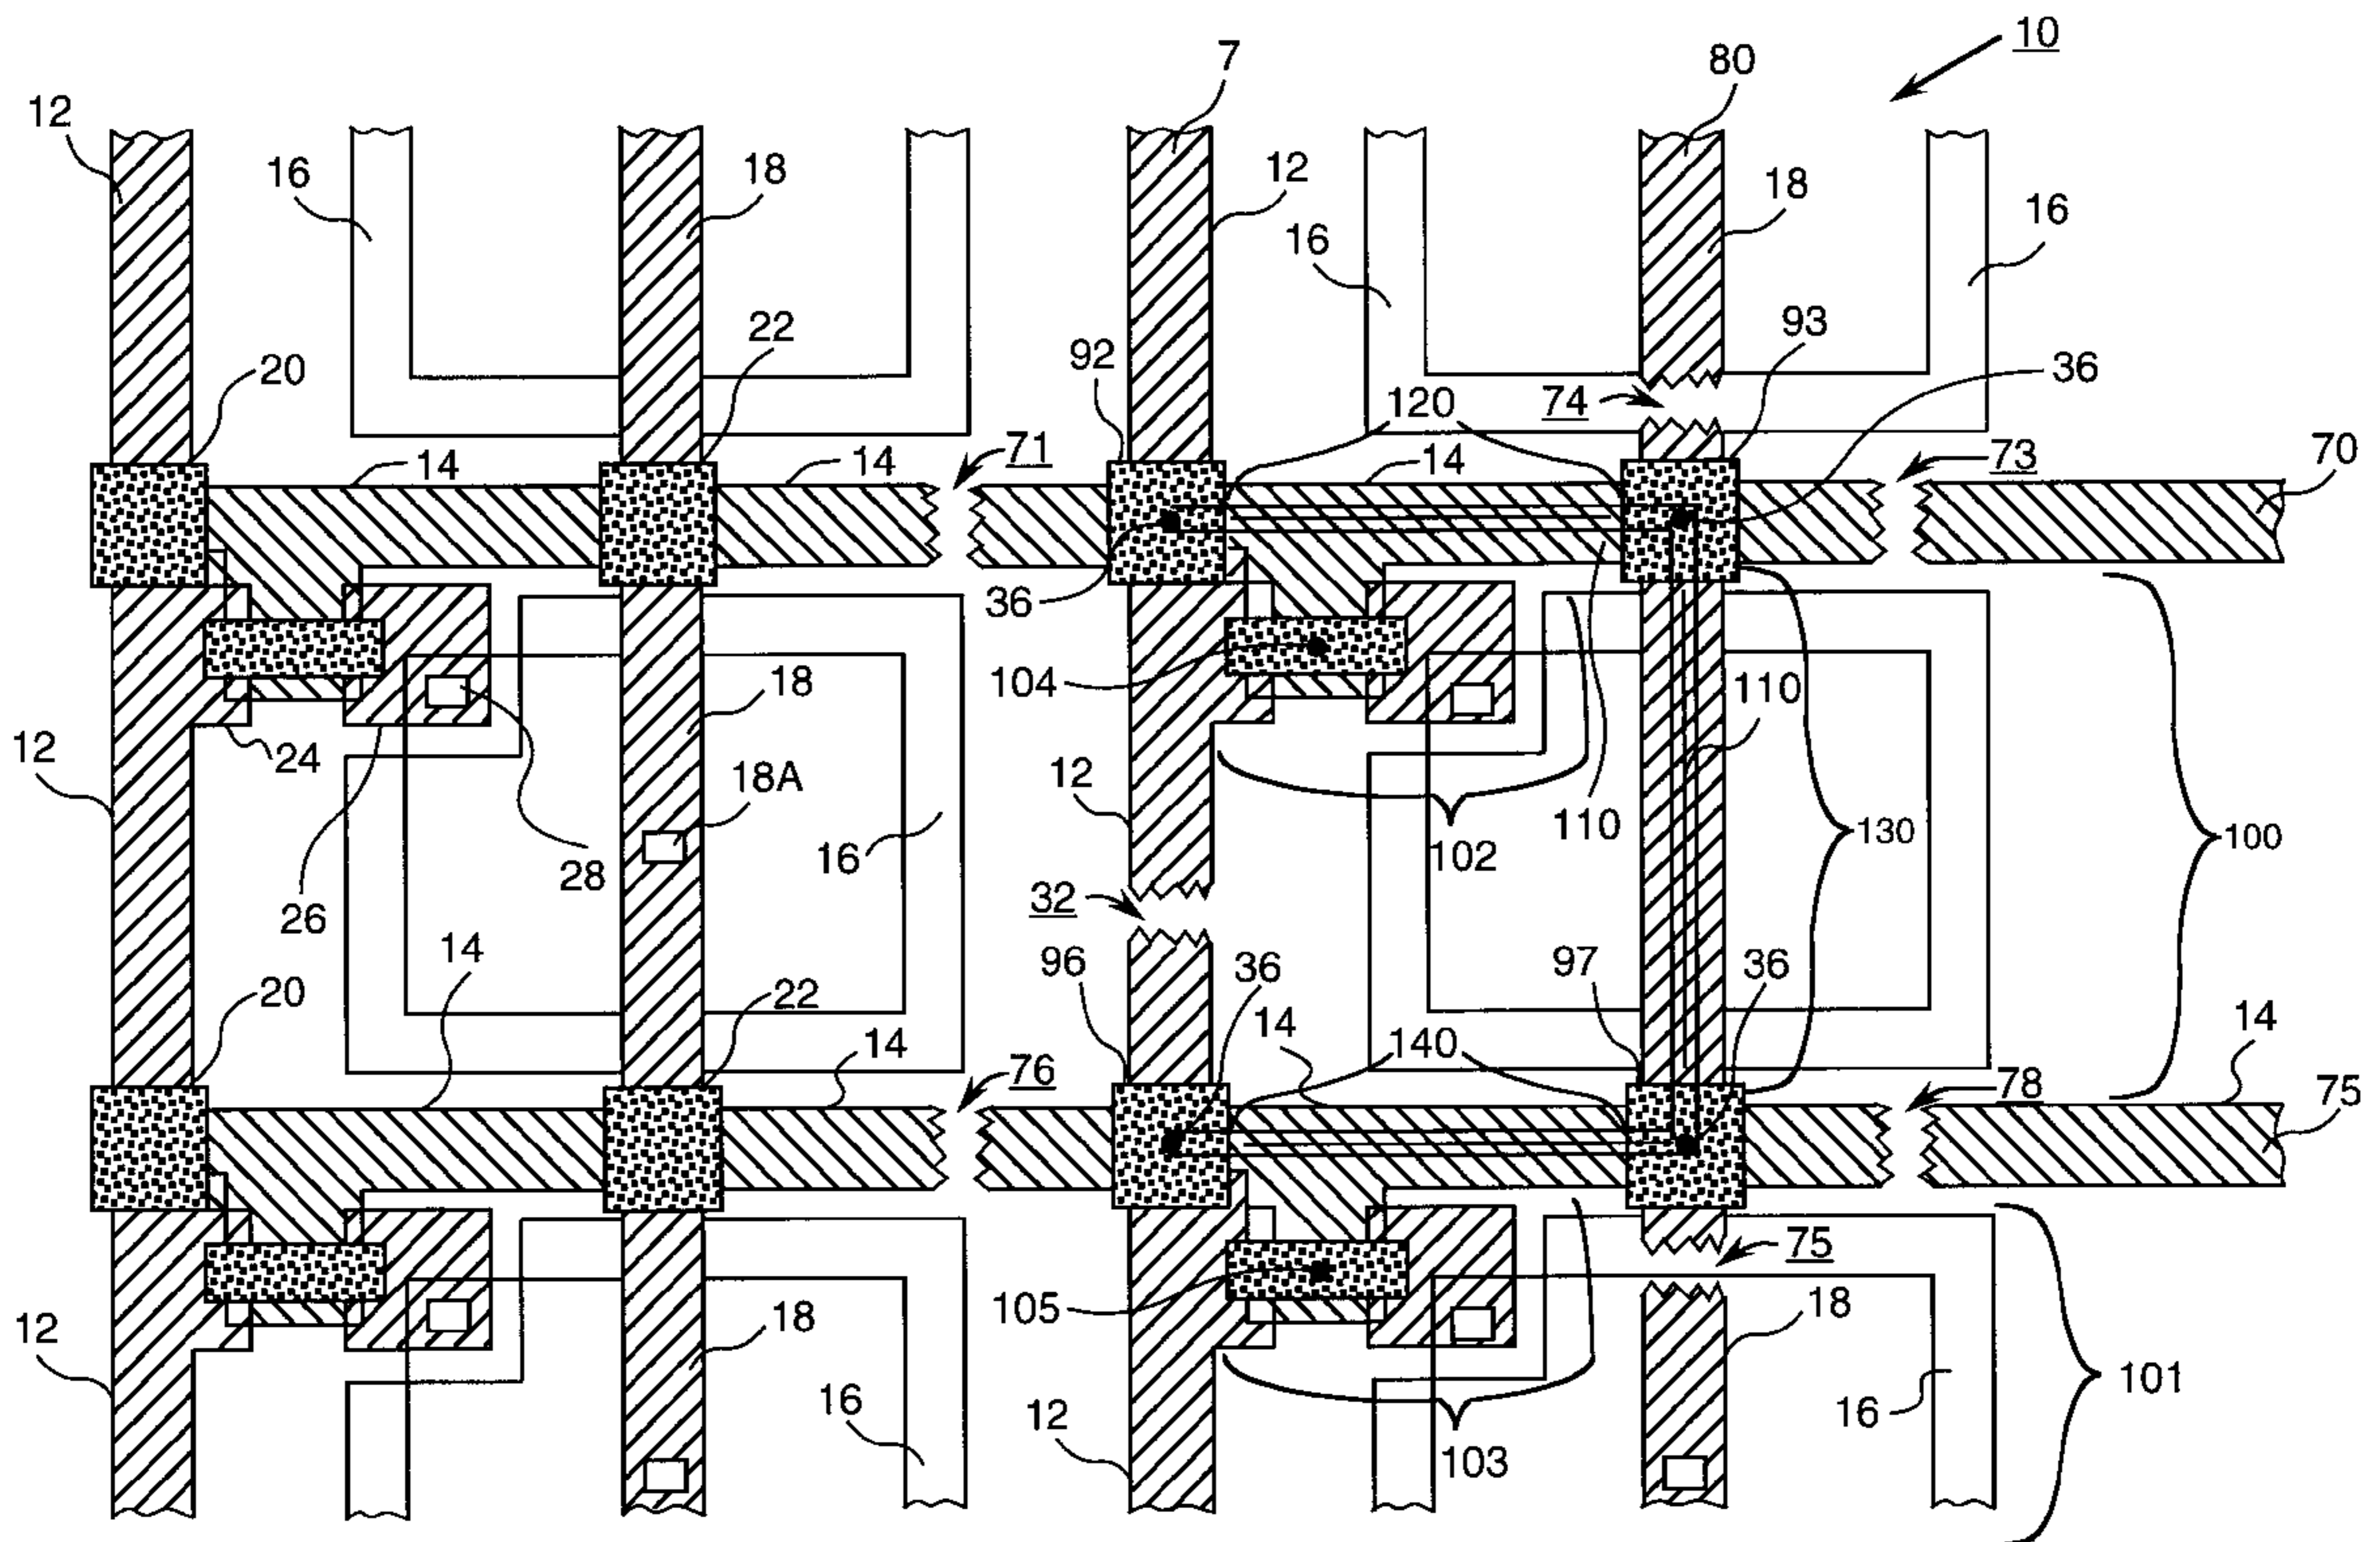
FIG. 1 is a schematic illustrating a portion of an imager comprising a pixel array having an electrical defect in a data line of the array.

respective address lines **5**. Address lines **5** are disposed in an array of rows and columns; as illustrated in FIG. **1**, one set of address comprises data lines **12** (coupled to the diode for readout of charge accumulated on the diode) and another set of address lines comprises scan lines **14** (coupled to the respective pixel switching transistor **25** to cause the transistor to be in a conductive or non-conductive state). Photodiodes **16** are further coupled to diode common transmission lines **18** via a conductive pad **18A**. The location in the array of particular pixels **6**, and the pixel's associated photodiode and address lines, can be defined with coordinates to specify the location of a row and a column of scan, data, diode common transmission lines of the imager **10**.

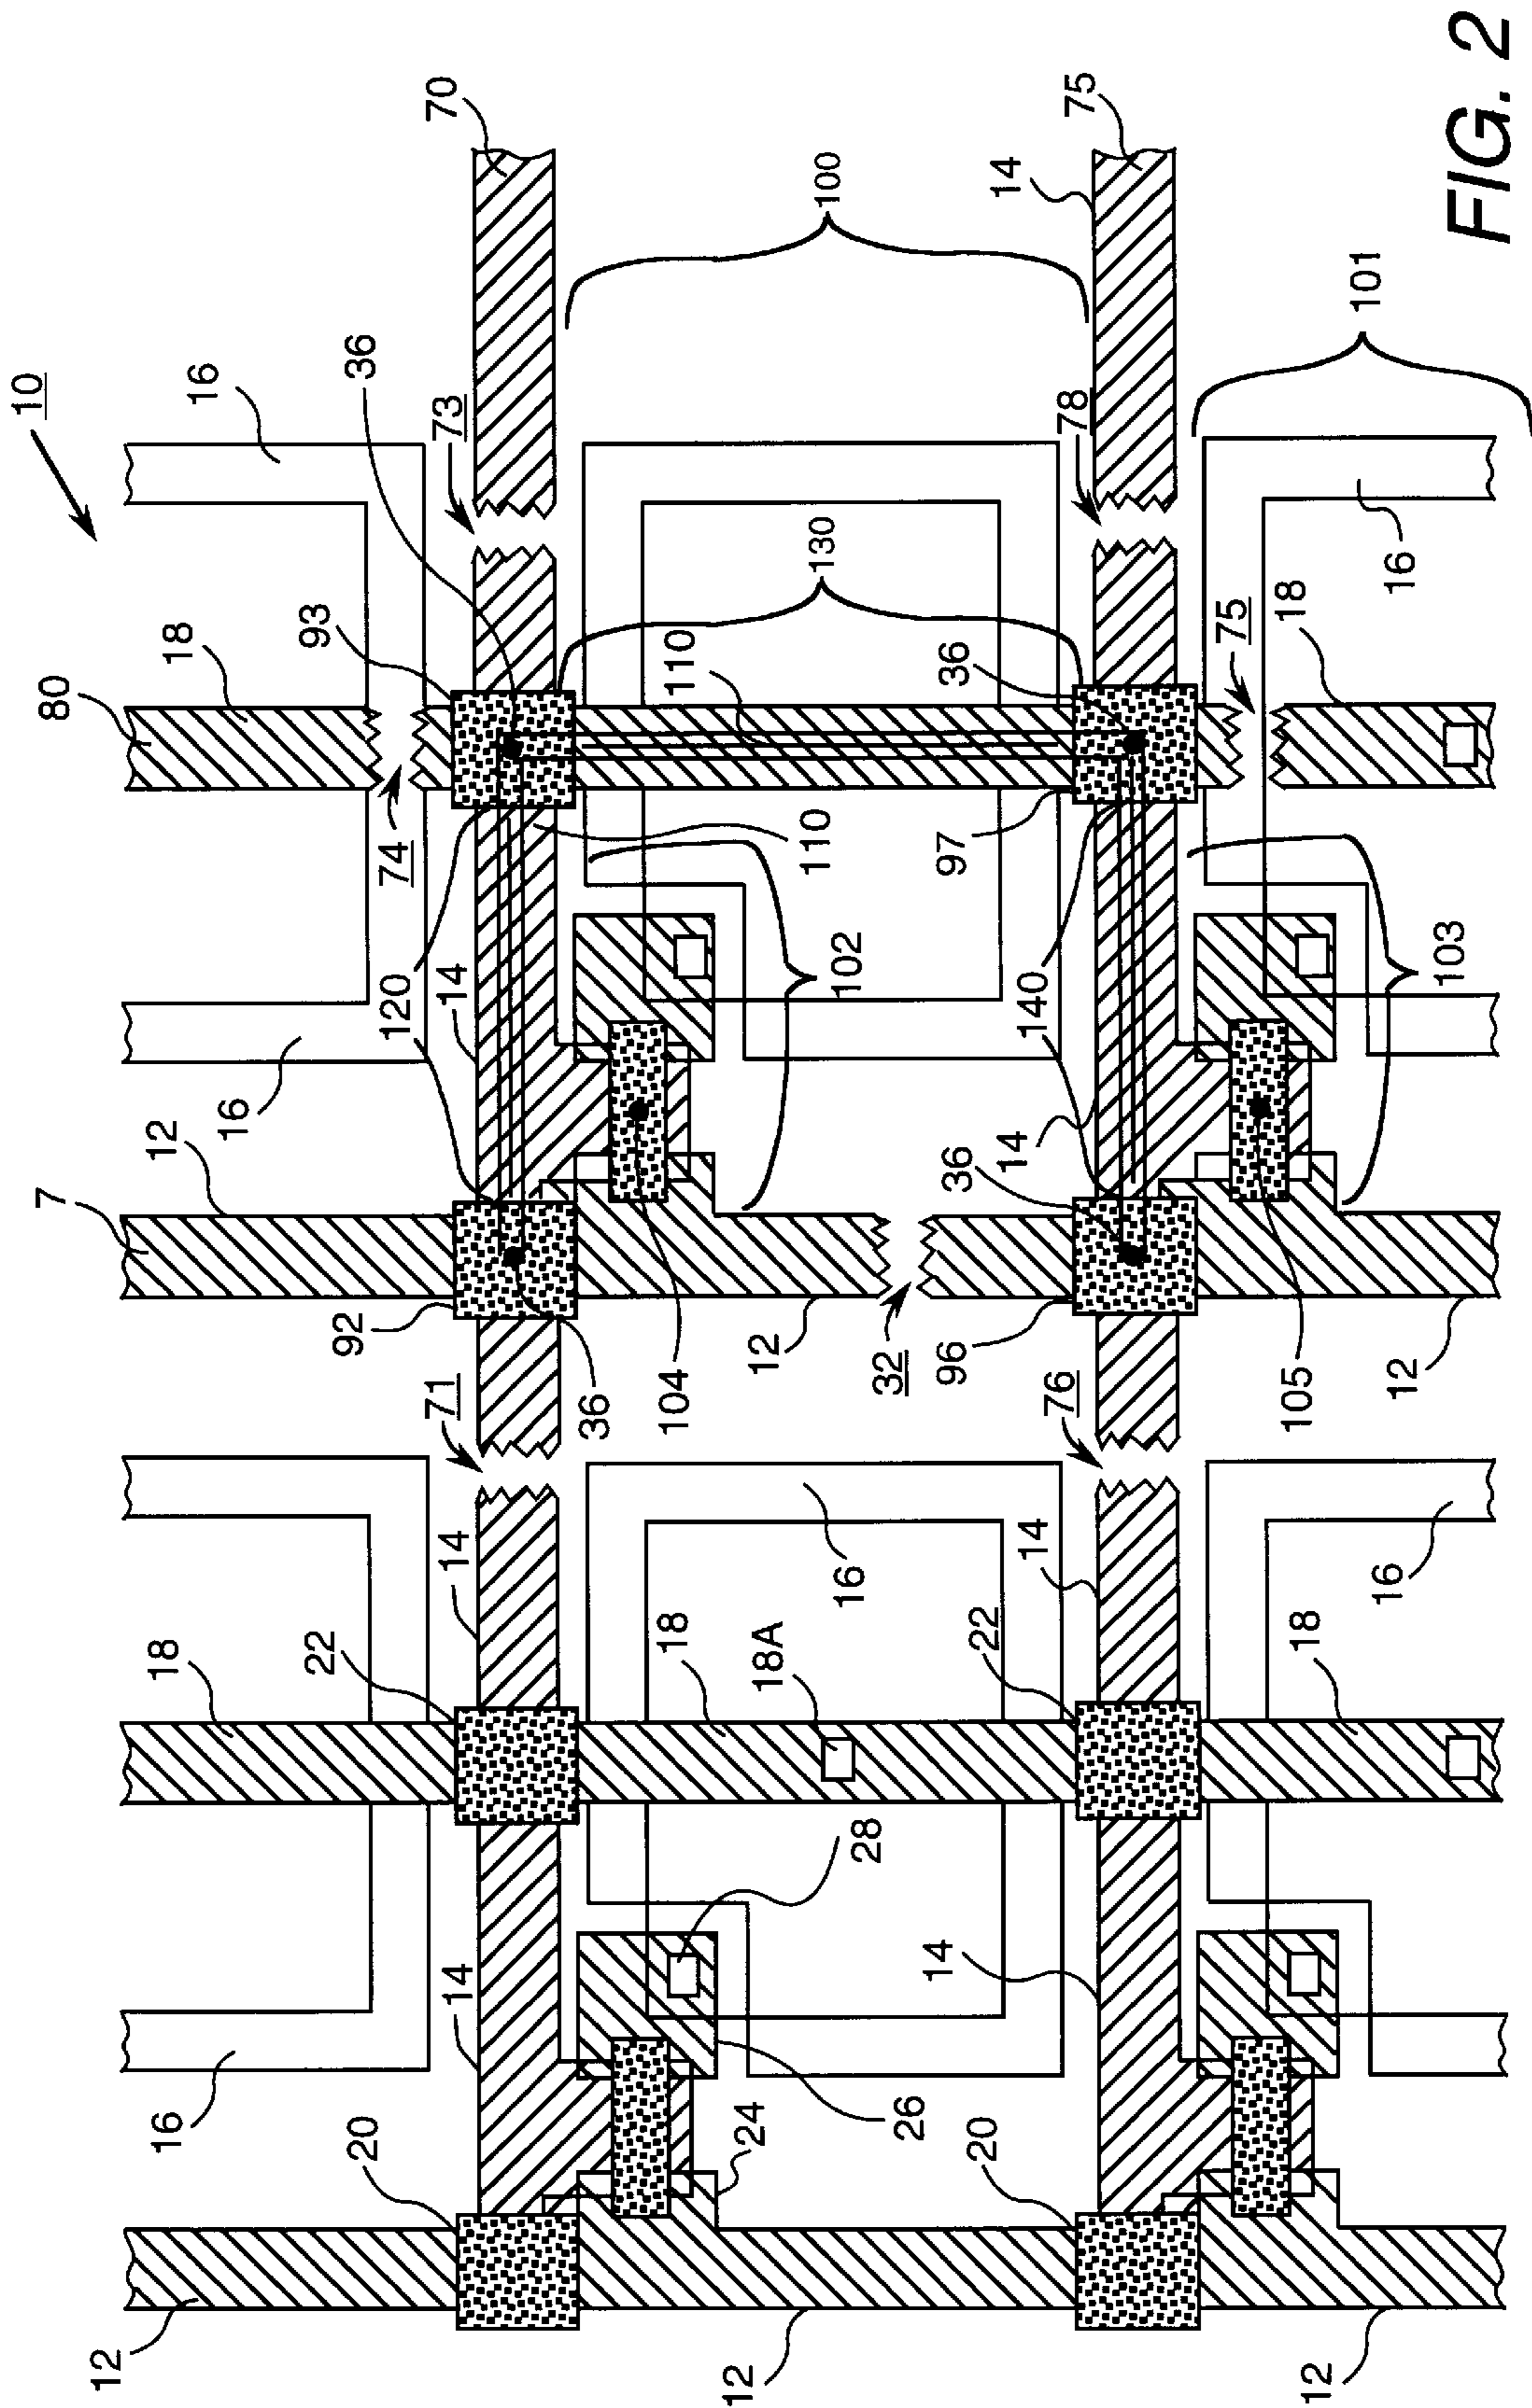
FIG. 2 depicts a repair shunt arrangement coupled to the data line with an electrical defect in accordance with the present invention.

In one embodiment of the present invention, a plurality of weld pads **36** are provided, typically at each scan-data line crossover **20** and at each scan-common electrode crossover **22**, as is illustrated in FIG. **2**. These weld pads **36** are formed

Once electrical defect **32** in defective data line **7** is identified, the process of repairing data line **7** includes the steps of forming a repair shunt **110** (schematically represented by the dark line over portions of preexisting conductive lines **14** and **18** in FIG. **2**) and fusing the repair shunt to defective data line **7** so as to electrically bypass defect **32**. As used herein, "fusing" and the like is used to refer to forming an electrical connection between two lines, typically by application of heat to melt the conductive material of the two lines to be connected and to remove dielectric material between the two lines to enable the making of the electrical connection. One example is the application, that is, directing the beam of a laser, such as an excimer laser, in the region to be fused so as to weld the two conductive lines together and ablate intervening dielectric material.

Formation of repair shunt **110** includes the steps of forming a first pixel scan line segment **120**, a common electrode segment **130**, and a second pixel line segment **140** (these segments are also referred to collectively as the "repair segments"). First pixel scan line segment **120** comprises a portion of a first scan line **70** that is coupled to the FET **102** coupled to repair area pixel **100**; common electrode segment **130** comprises a portion of a repair common electrode line **80** that overlies repair area pixel **100**; and second scan line segment **140** comprises a portion of a second scan line **75** disposed on the opposite side of repair pixel **100** from first scan line **120** (that is, the scan line for the next row of pixels below (as illustrated in FIG. **2**) the scan line coupled to repair area pixel **100**).

Similarly, second scan line segment **130** is formed by electrically isolating segment **140** by severing second scan line **75** at second scan line sever locations **76** and **78**. Second scan line sever location **76** is disposed on second scan line **75** a second scan-common electrode crossover element **97** and the edge of the array (that is, opposite end of second scan line **75** that is coupled to readout electronics on the right side of the array as illustrated in FIG. 2); second scan line sever location **78** is disposed on second scan line **75** between a second scan-common electrode crossover element **97** and the edge of the array (that is, opposite end of second scan line **75** that is coupled to readout electronics on the right side of the array as illustrated in FIG. 2).

Common electrode segment **130** is formed by severing repair common electrode line **80** at sever points **74** and **75**. Sever point **74** is disposed on repair common electrode line **80** between first scan common electrode crossover element **93** and the edge of the array (that is, the end of the common electrode line **80** coupled to bias source at the edge of the array in the upper direction as illustrated in FIG. 2). Sever point **75** is disposed on repair common electrode line **80** between second scan common electrode crossover element **97** and the opposite edge of the array (that is, the end of the common electrode line **80** coupled to bias source at the edge of the array in the lower direction as illustrated in FIG. 2).
