United States Patent [19][11] **Patent Number:** **6,002,790****Horvath et al.**[45] **Date of Patent:** **Dec. 14, 1999**[54] **METHOD FOR DETECTING AND MEASURING VOIDS IN CONDUCTOR INSULATION SYSTEMS**[75] Inventors: **David A. Horvath**, Ann Arbor; **Steven M. Avila**, Novi, both of Mich.[73] Assignee: **Advent Engineering Services, Inc.**, Ann Arbor, Mich.[21] Appl. No.: **08/762,536**[22] Filed: **Dec. 9, 1996**[51] **Int. Cl.**⁶ **G06K 9/00**[52] **U.S. Cl.** **382/141; 348/92**[58] **Field of Search** 382/141, 144, 382/145, 149; 348/86, 92, 125, 128; 250/339[56] **References Cited**

METHOD FOR DETECTING AND MEASURING VOIDS IN CONDUCTOR INSULATION SYSTEMS

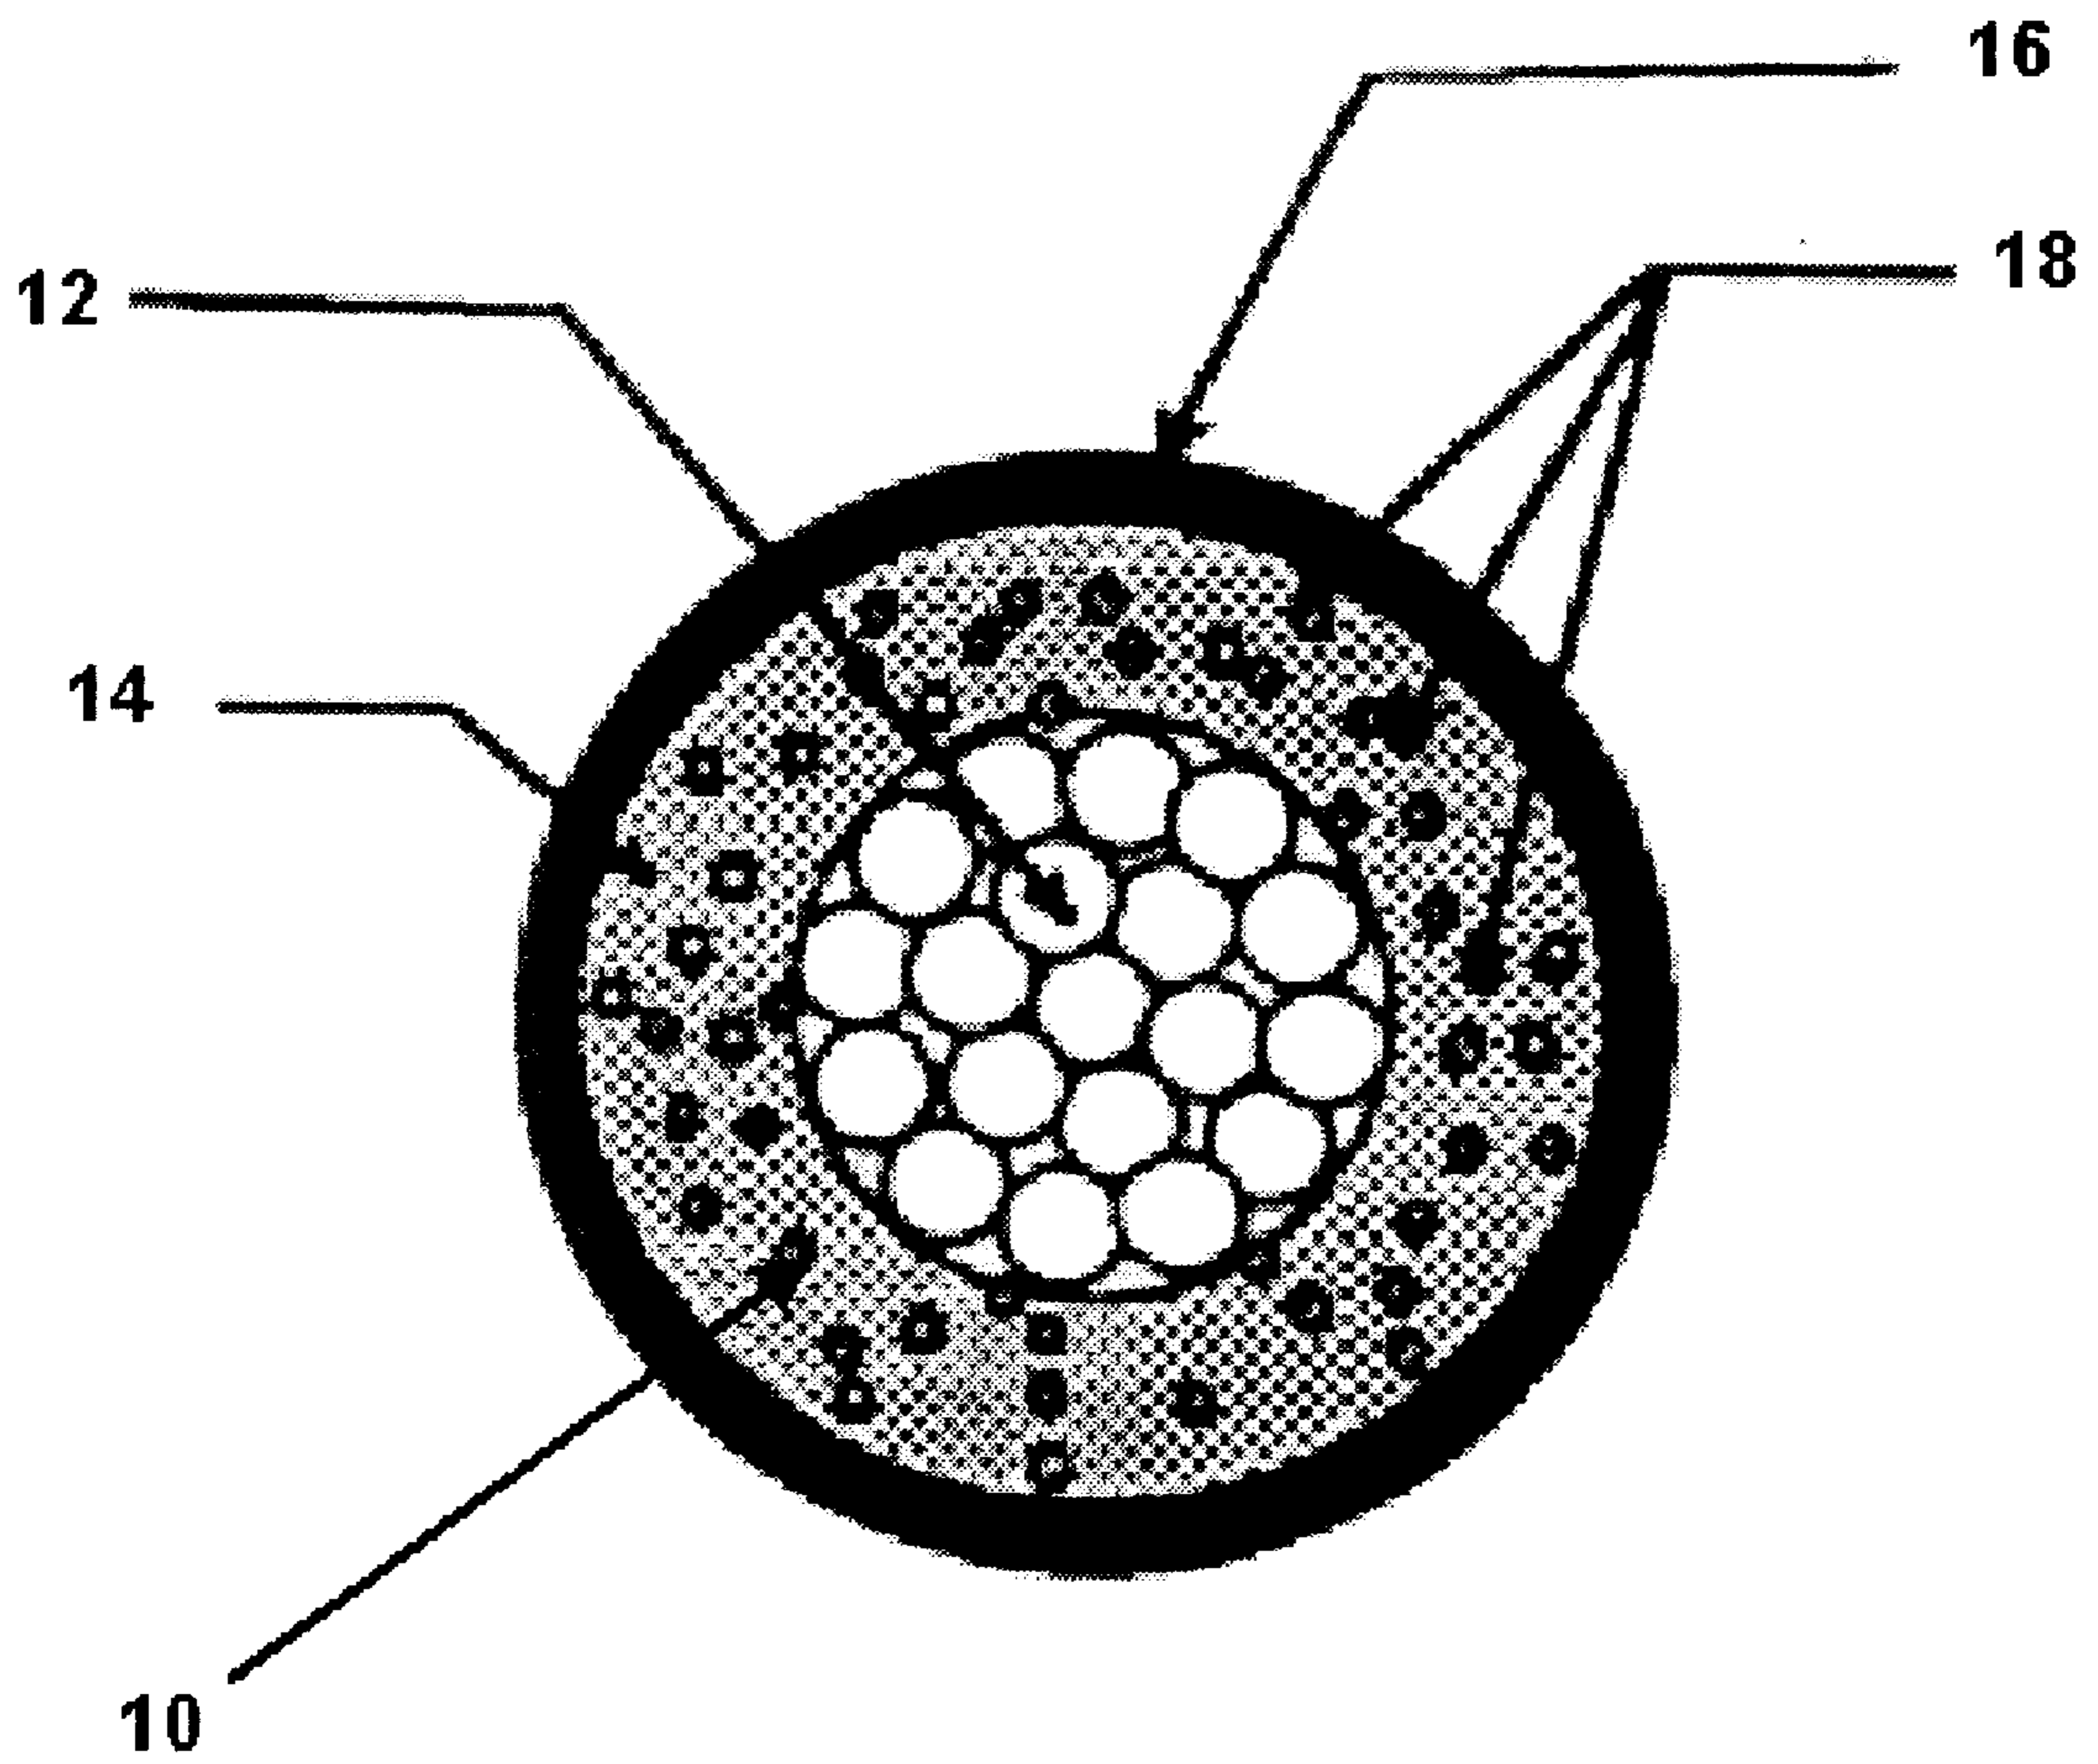
Figure 1

FIG. 1 is a lateral cross-sectional view of a conventional conductor insulation system showing voids present in the insulation material thereof.

Turning now to the drawings, FIG. 1 illustrates a conductor insulation system 10 having one or more conductors 12 surrounded by a suitable conductor insulation material

14. To protect the conductor insulation material 14 from the environment, a cable jacket 16 of suitably durable and insulative material is disposed therearound.

As shown in FIG. 1, the conductor insulation material 14 includes a number of voids 18 therein. As discussed above, electrical discharges may occur in the voids 18, which may ultimately result in cable malfunction or failure. Further, the voids 18 may cause electrical trees to appear and grow in the insulation material 14, which can also lead to the rapid breakdown of the conductor insulation system 10.

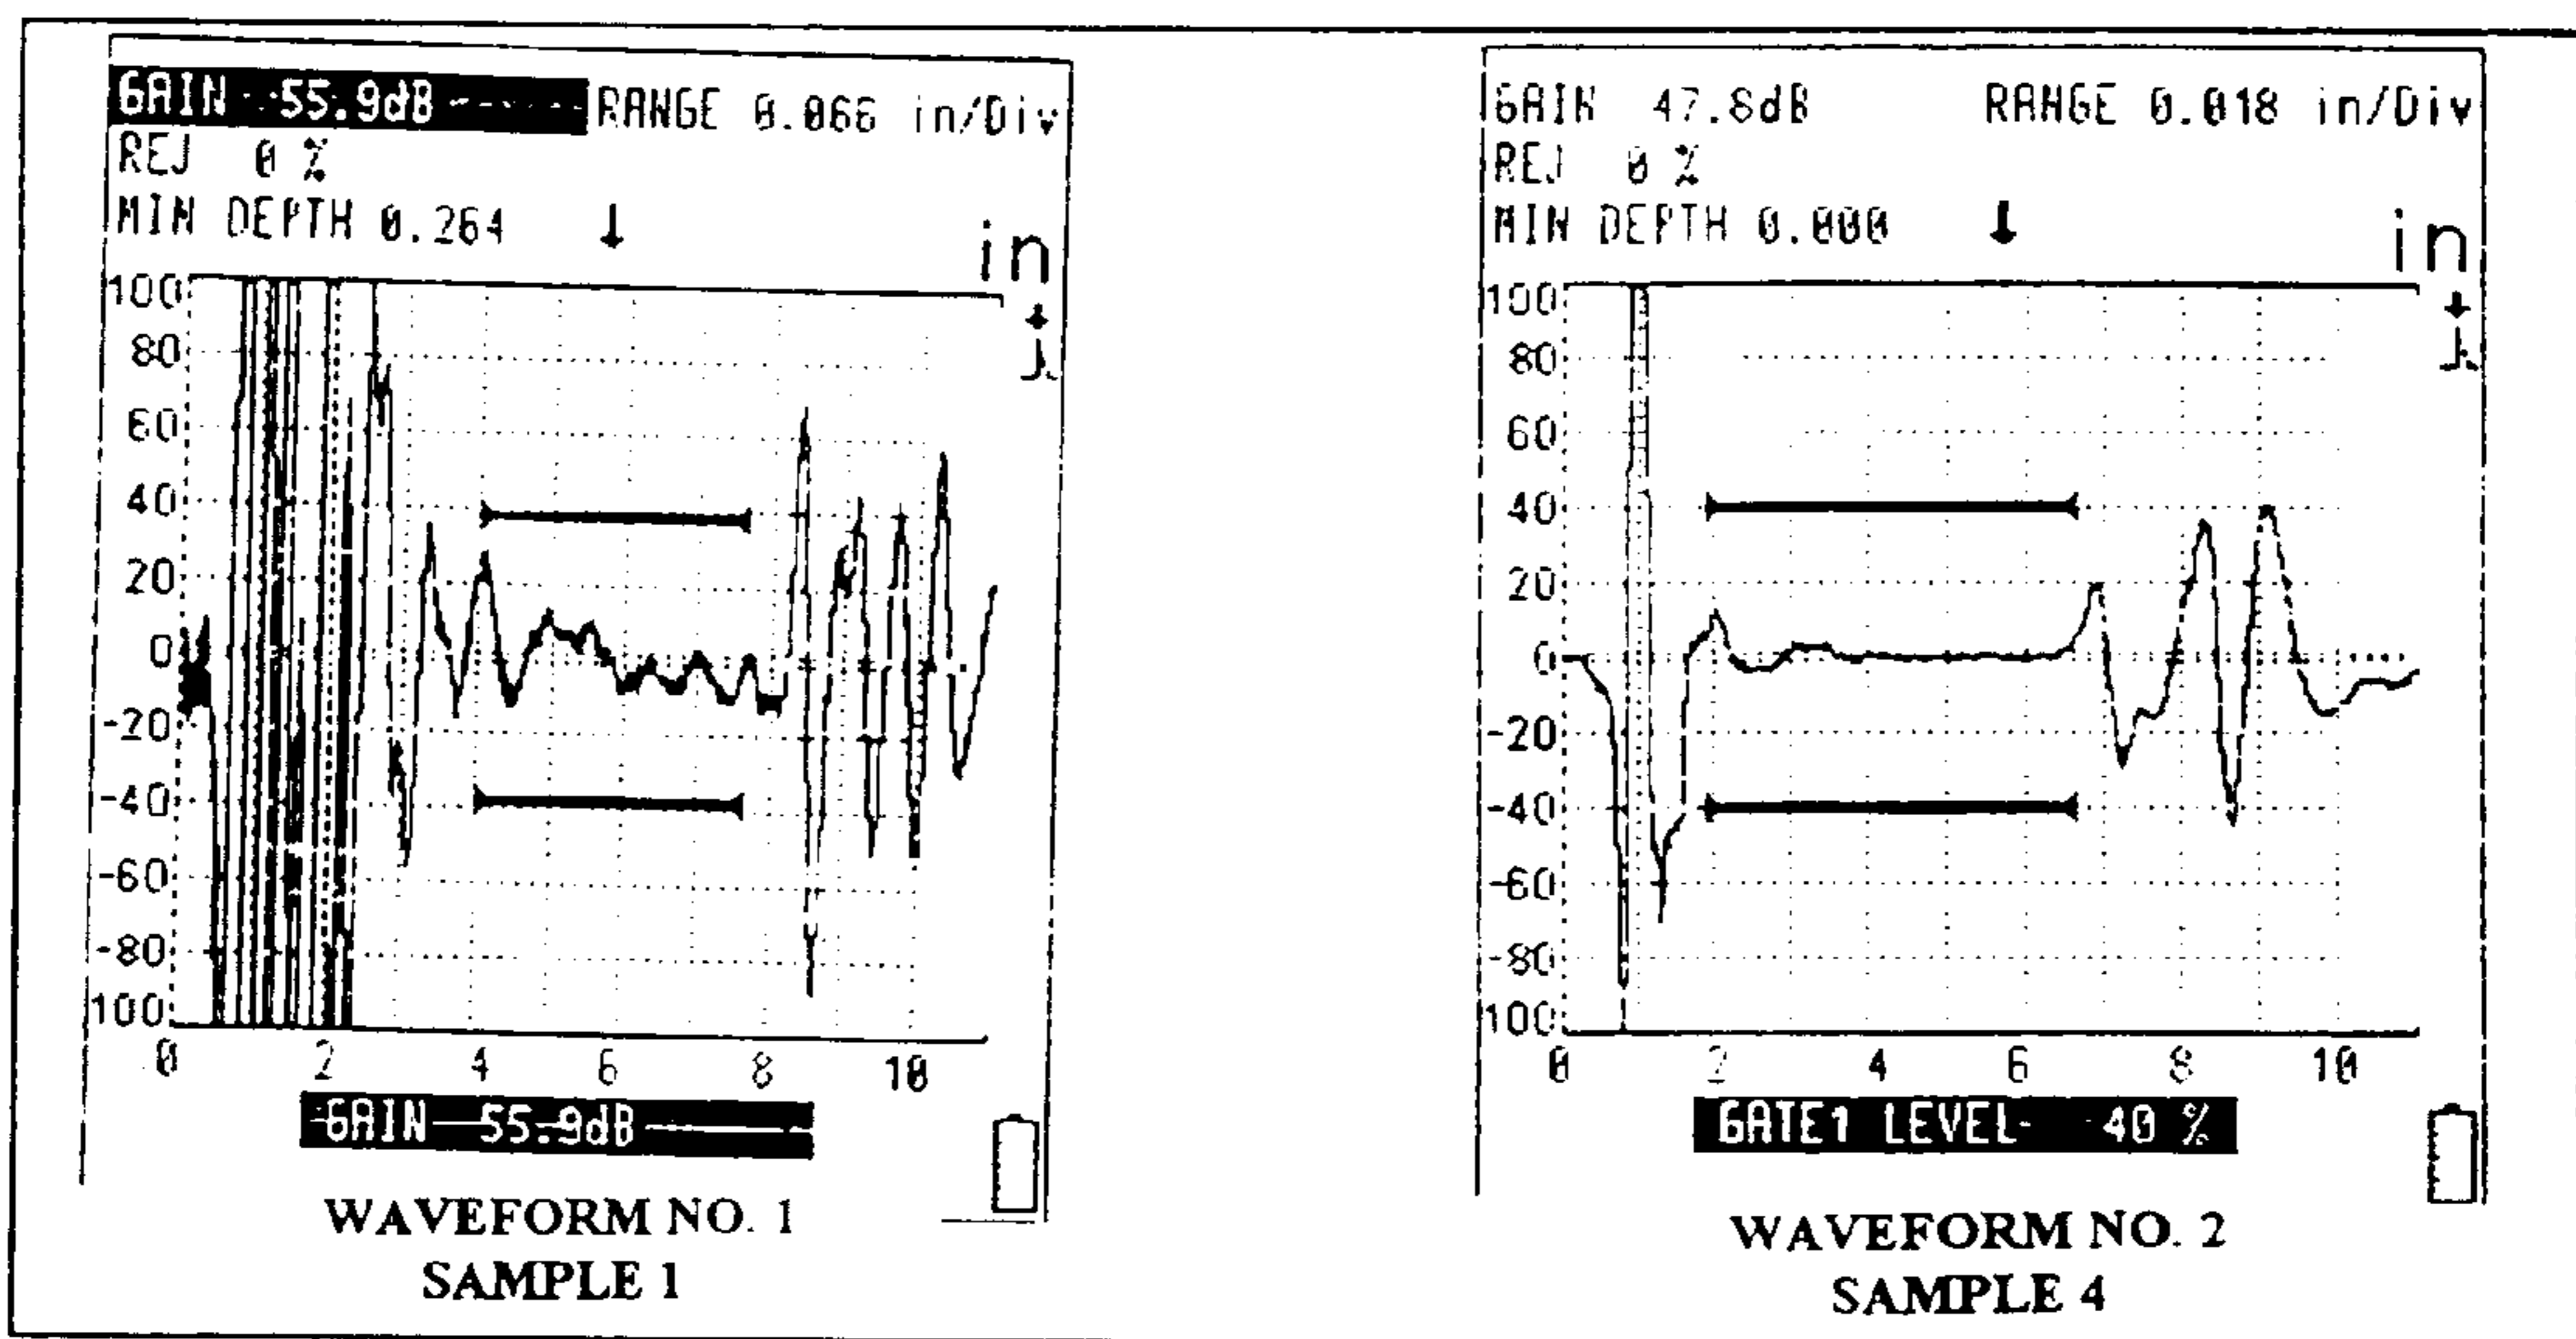
Figure 3A

FIG. 3 is a graphic representation of the results of Ultrasound Test 1.

As shown in FIG. 3, the y-direction corresponds to the acoustic amplitude and the x-direction corresponds to the time (μ sec). Samples 1, 2, and 3 fall into a category represented by FIG. 3, Waveform #1, which is an oscilloscope display made with a 2.25 MHz transducer.

The first large interface echo on the left, identified as Reflection No. 1 (between approximately 0.2 and 2.25 μ s), is the sound reflection from the secondary echo received at surface entry (outside diameter) of the cable jacket. The next large signal, identified as Reflection No. 2 (between approximately 8 and 10 μ s), is the sound reflection from the secondary echo received at the metal interface between the conductor and conductor insulation.

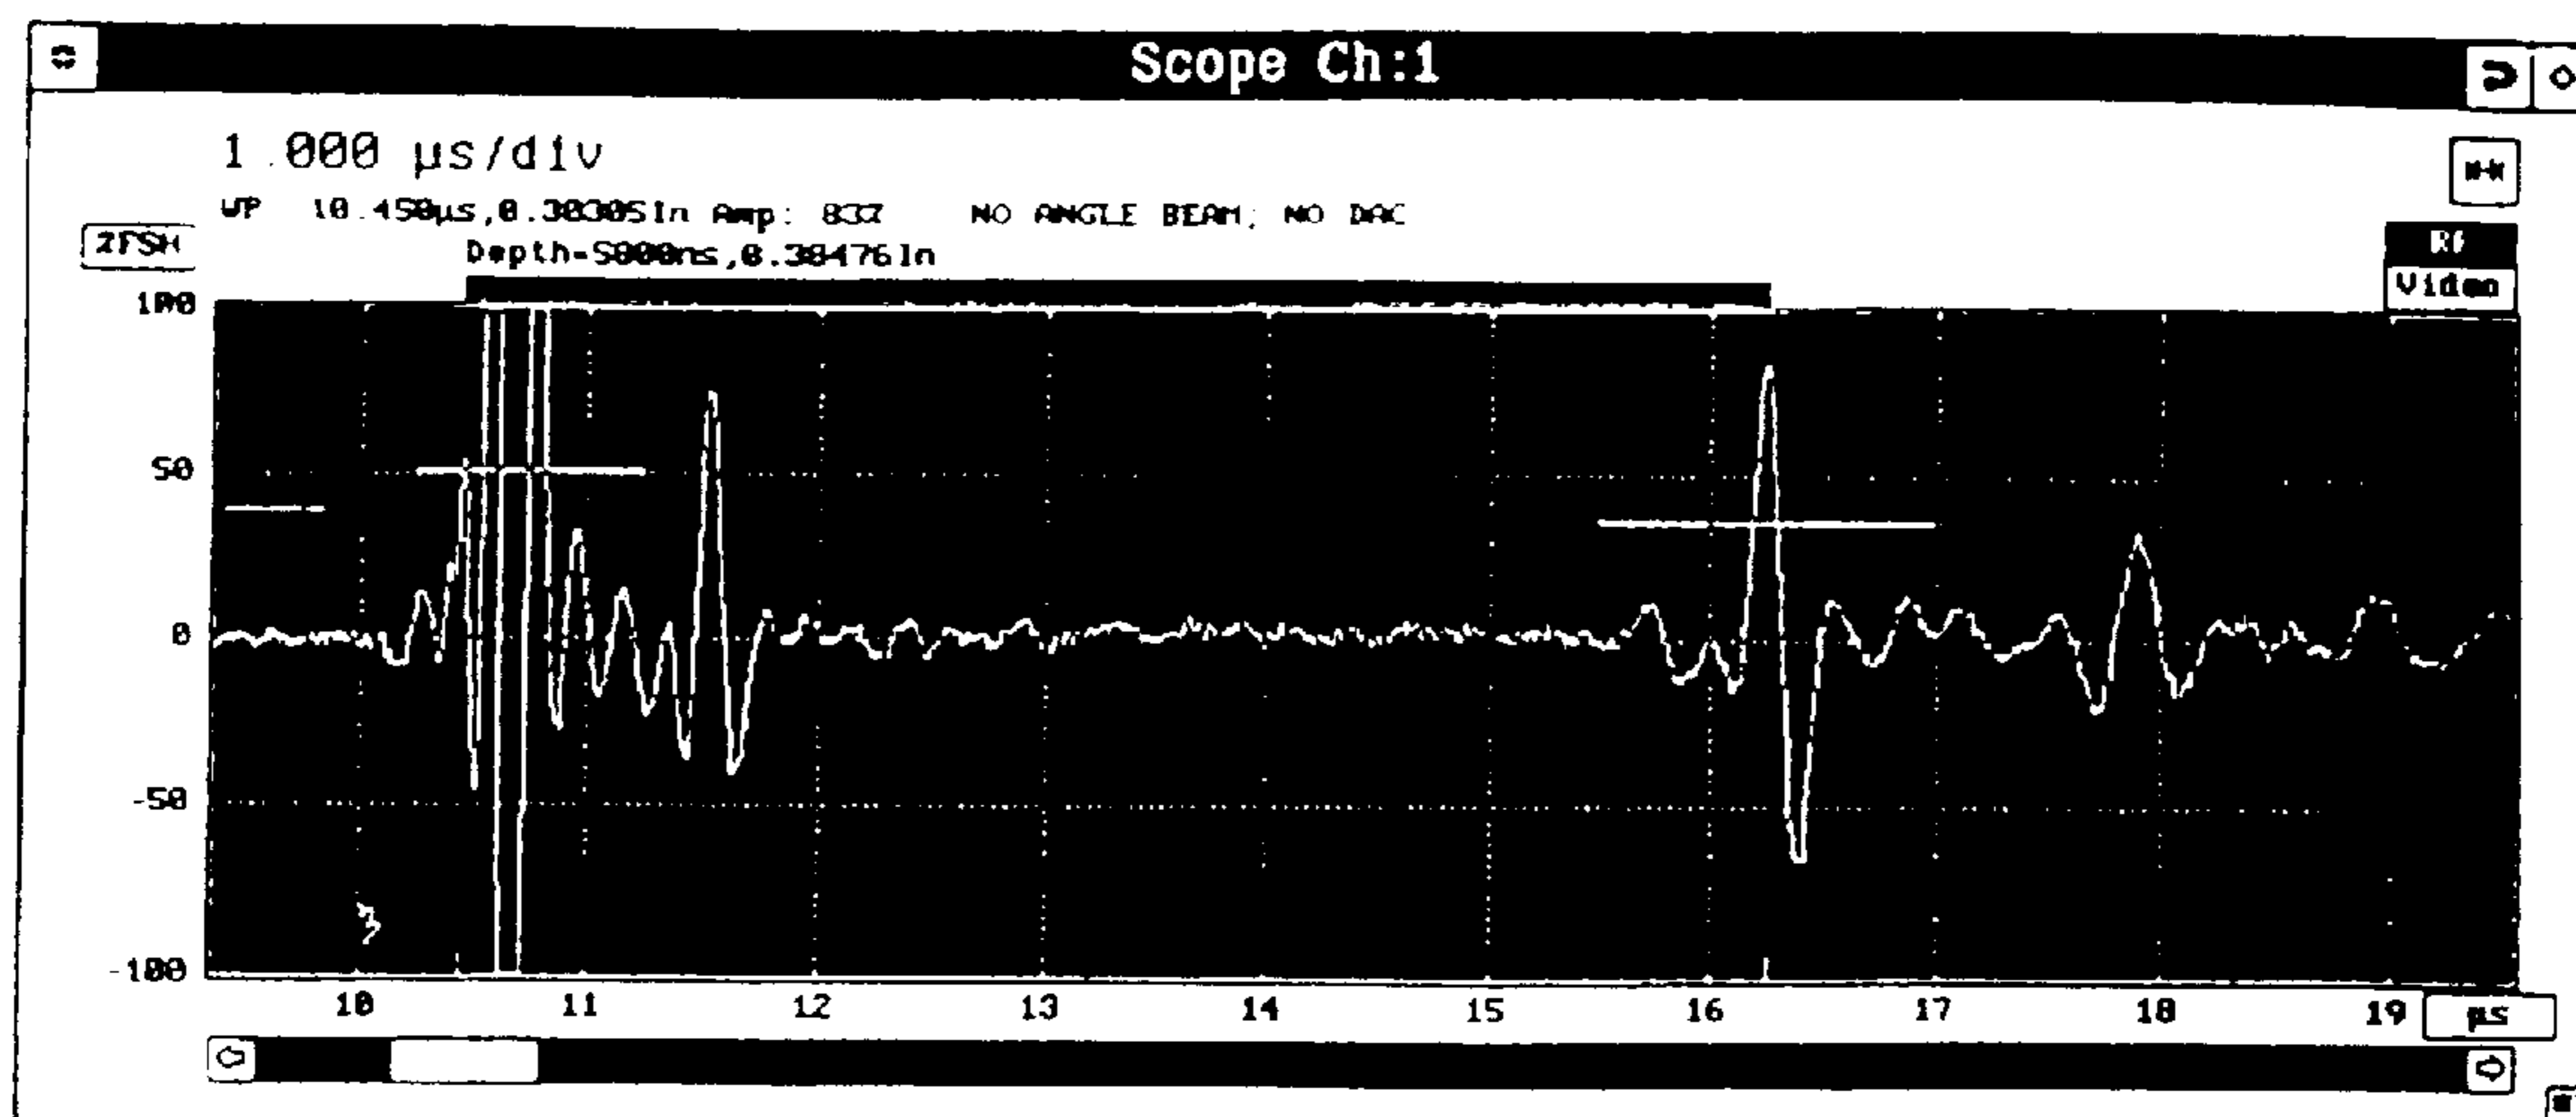
Figure 4

FIG. 4 is a graphic representation of the results of Ultrasound Test 2.

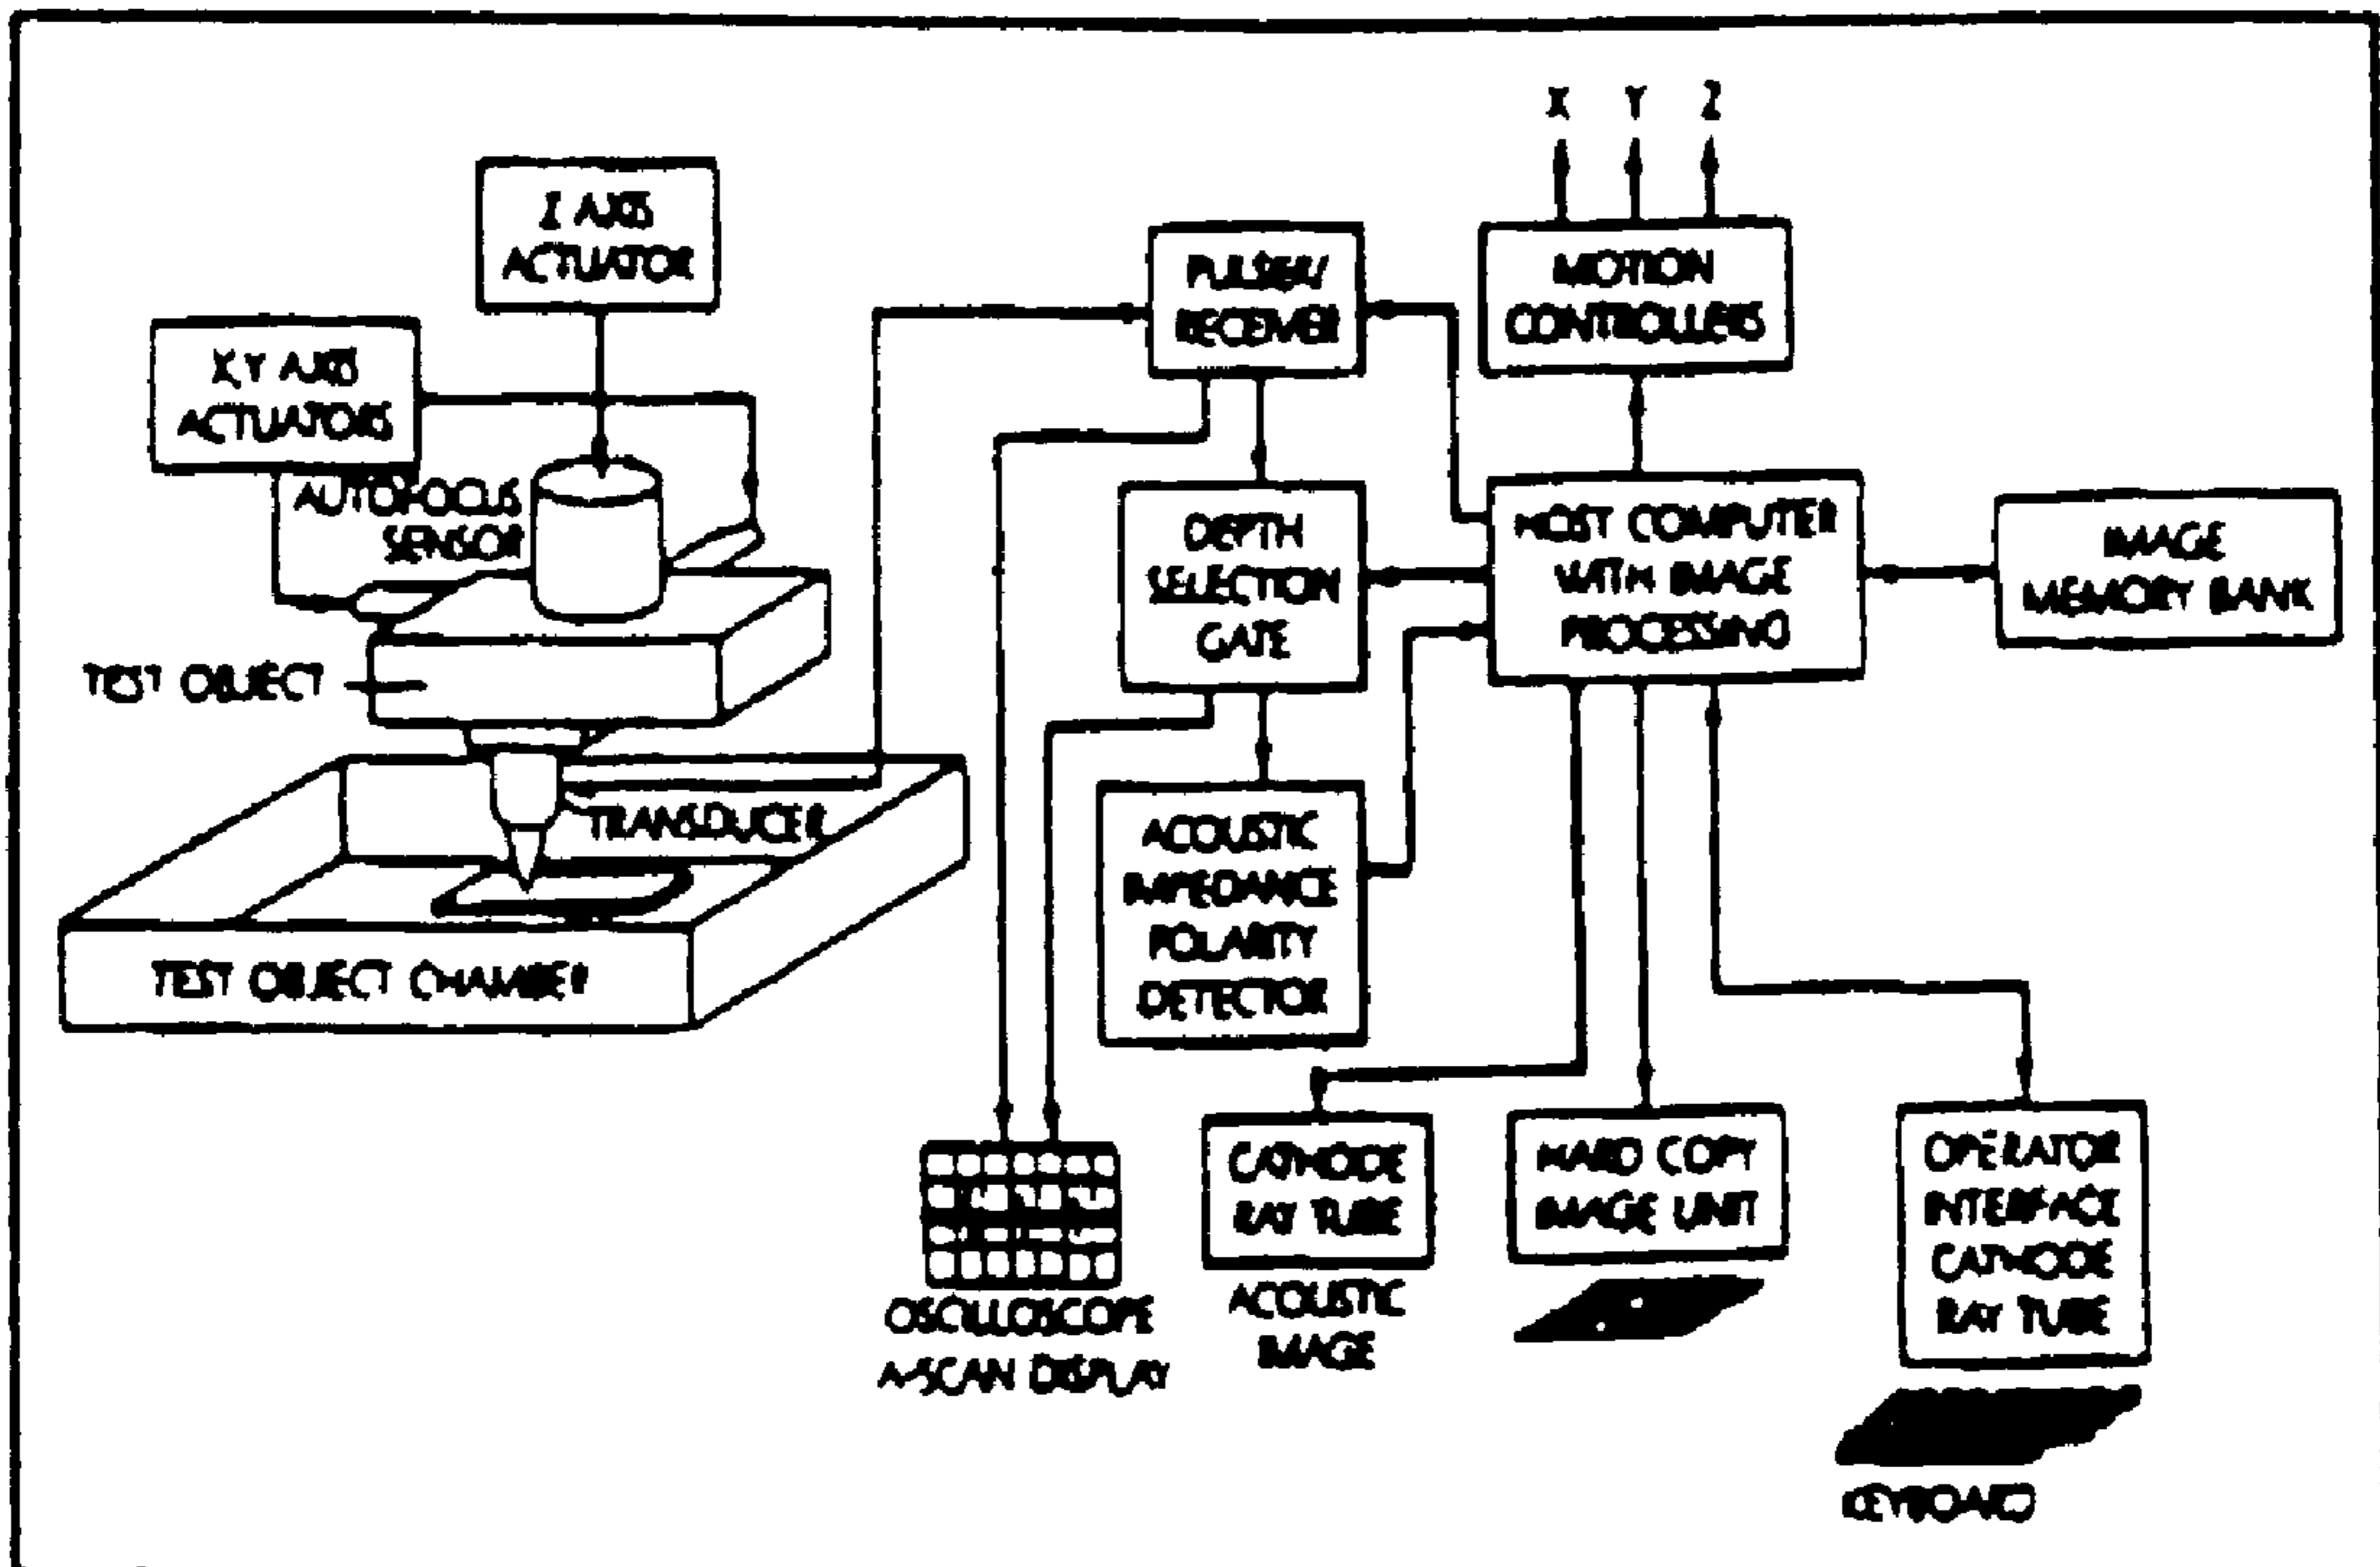
Figure 5

FIG. 5 is a schematic representation of a C-SAM operating system and its attendant components.

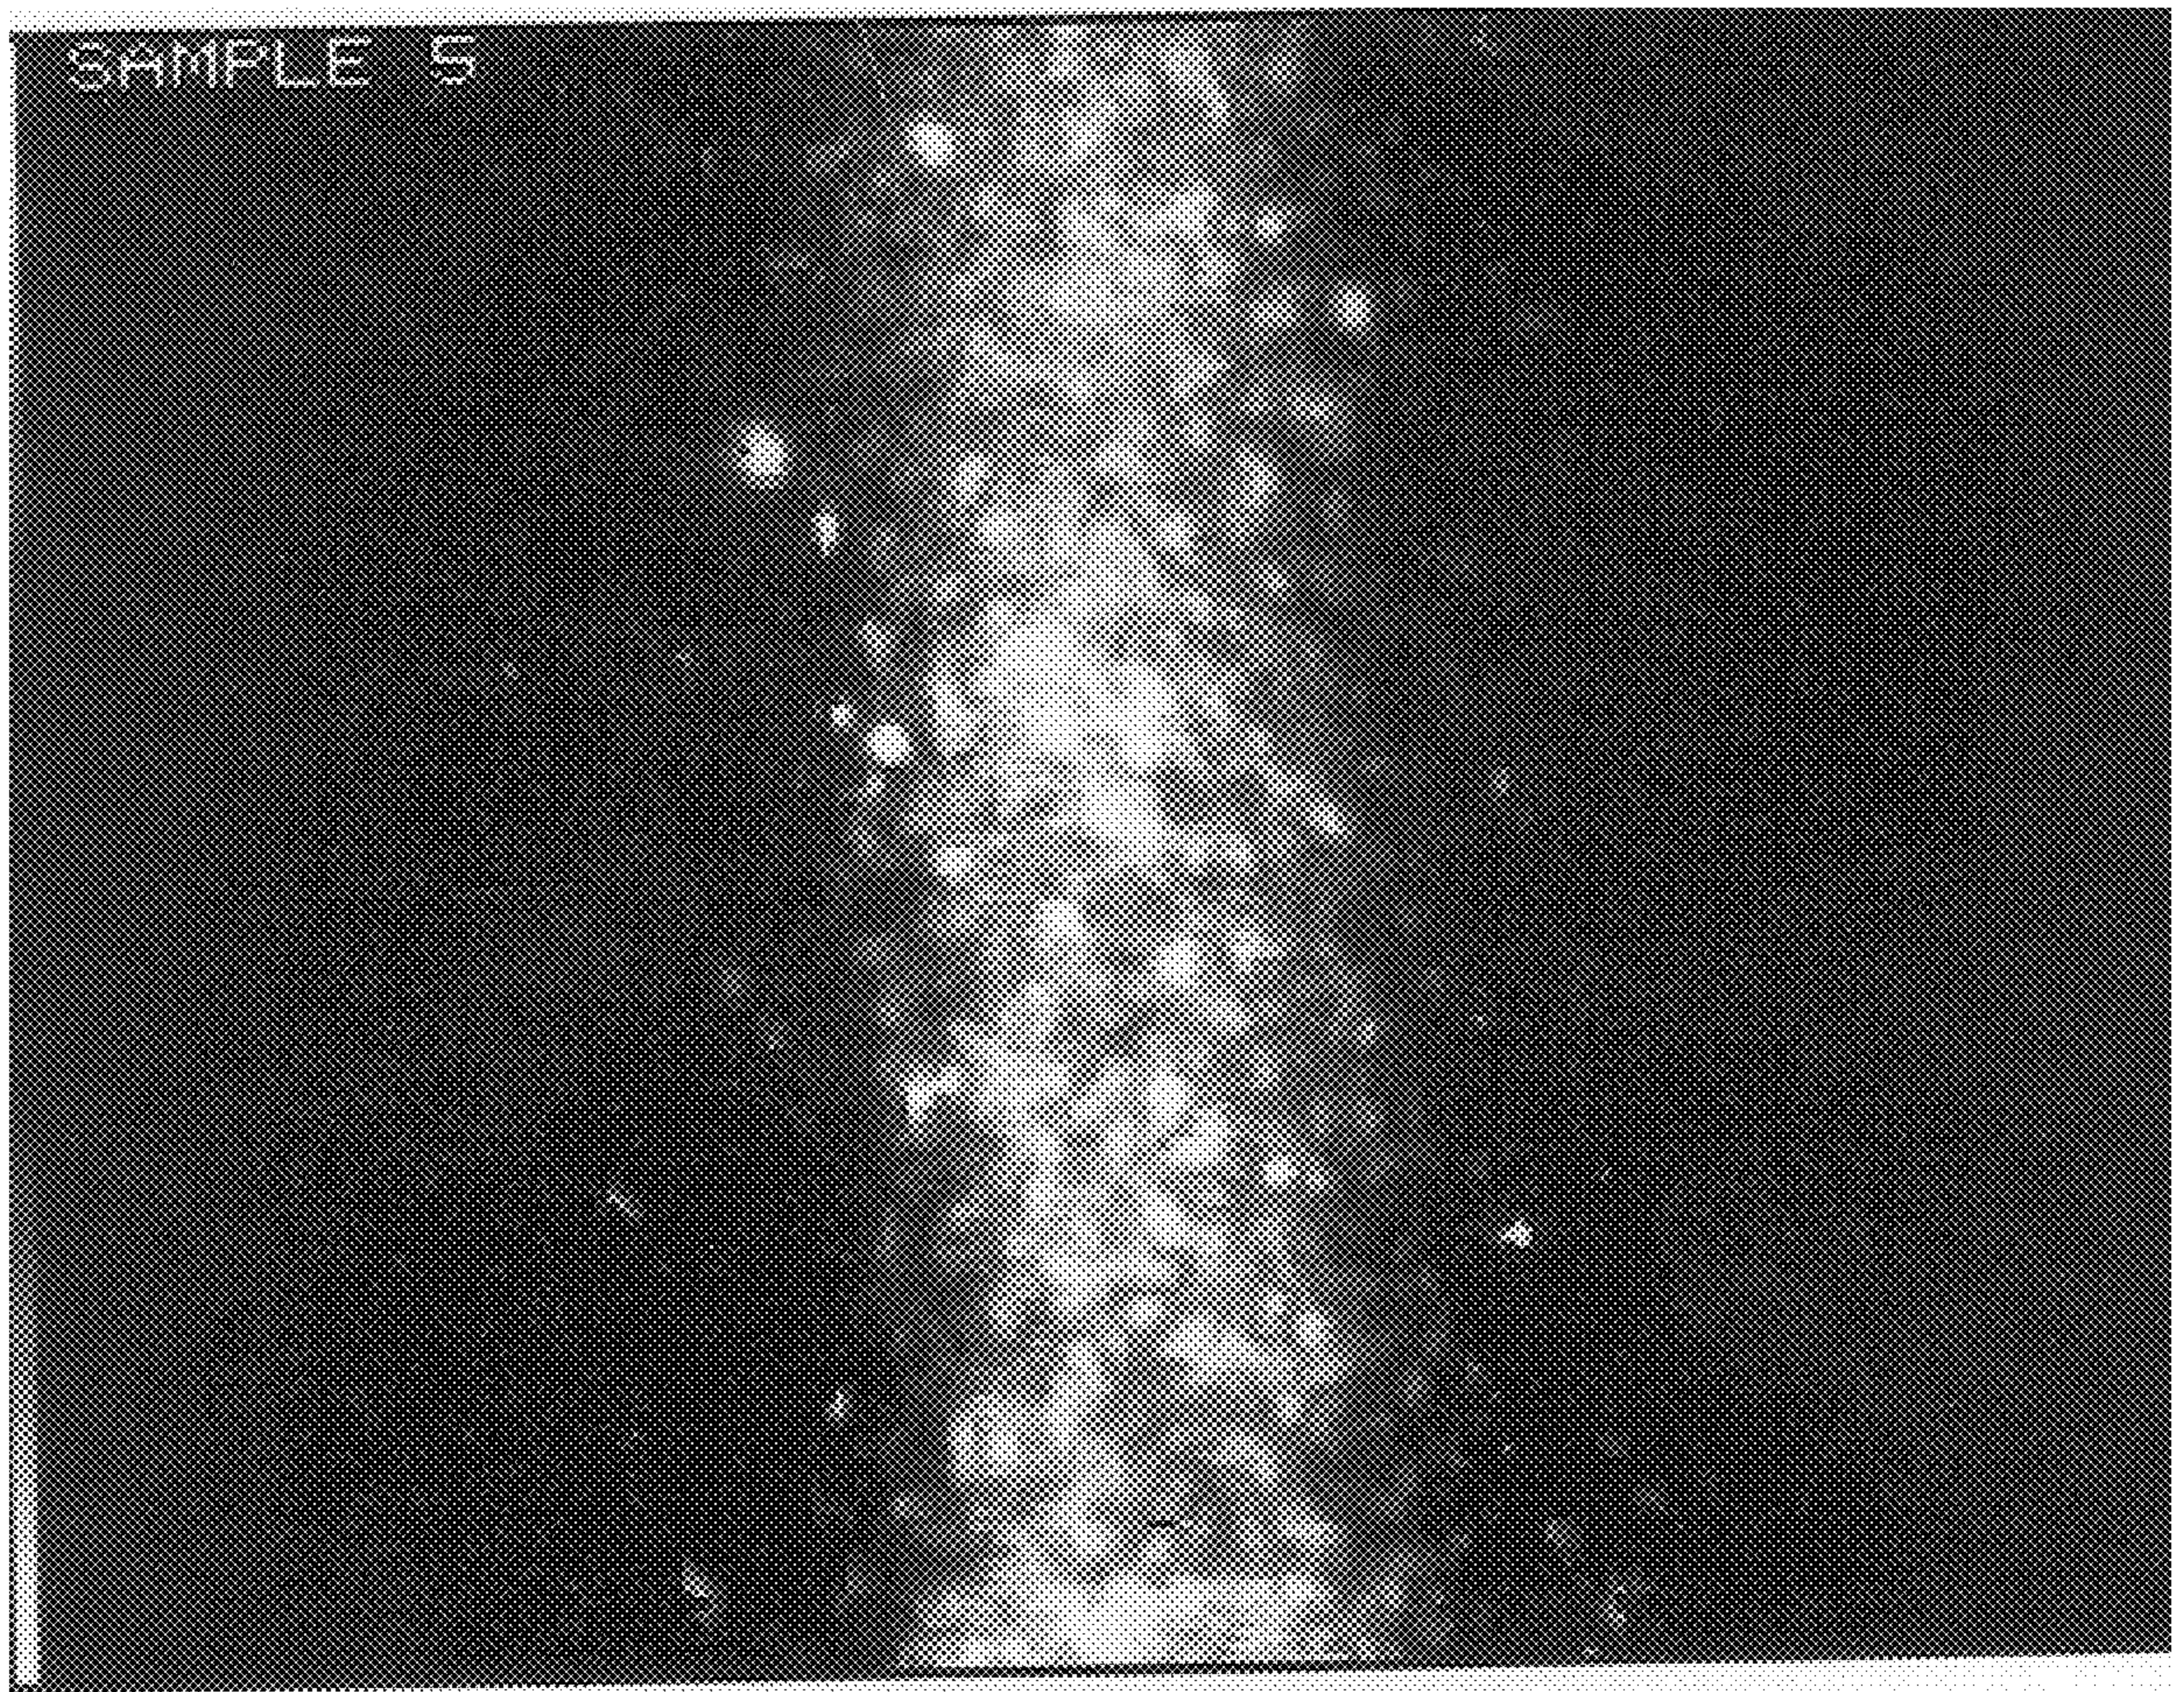
FIG. 6 is an acoustic image of Sample 5 at 15 MHz.

The bright spherical-shaped spots of FIGS. 6, 7 and 8 are classified as voids because they correspond to high amplitude reflections from the interface of a high-acoustic impedance material from inside the void or impurity pocket, such as a gaseous cavity, air bubble, or other void type. Differences in acoustic impedance between air or gas and a solid material cause most of the ultrasonic energy to be reflected at the surface boundary of a gaseous cavity, air bubble, or void.

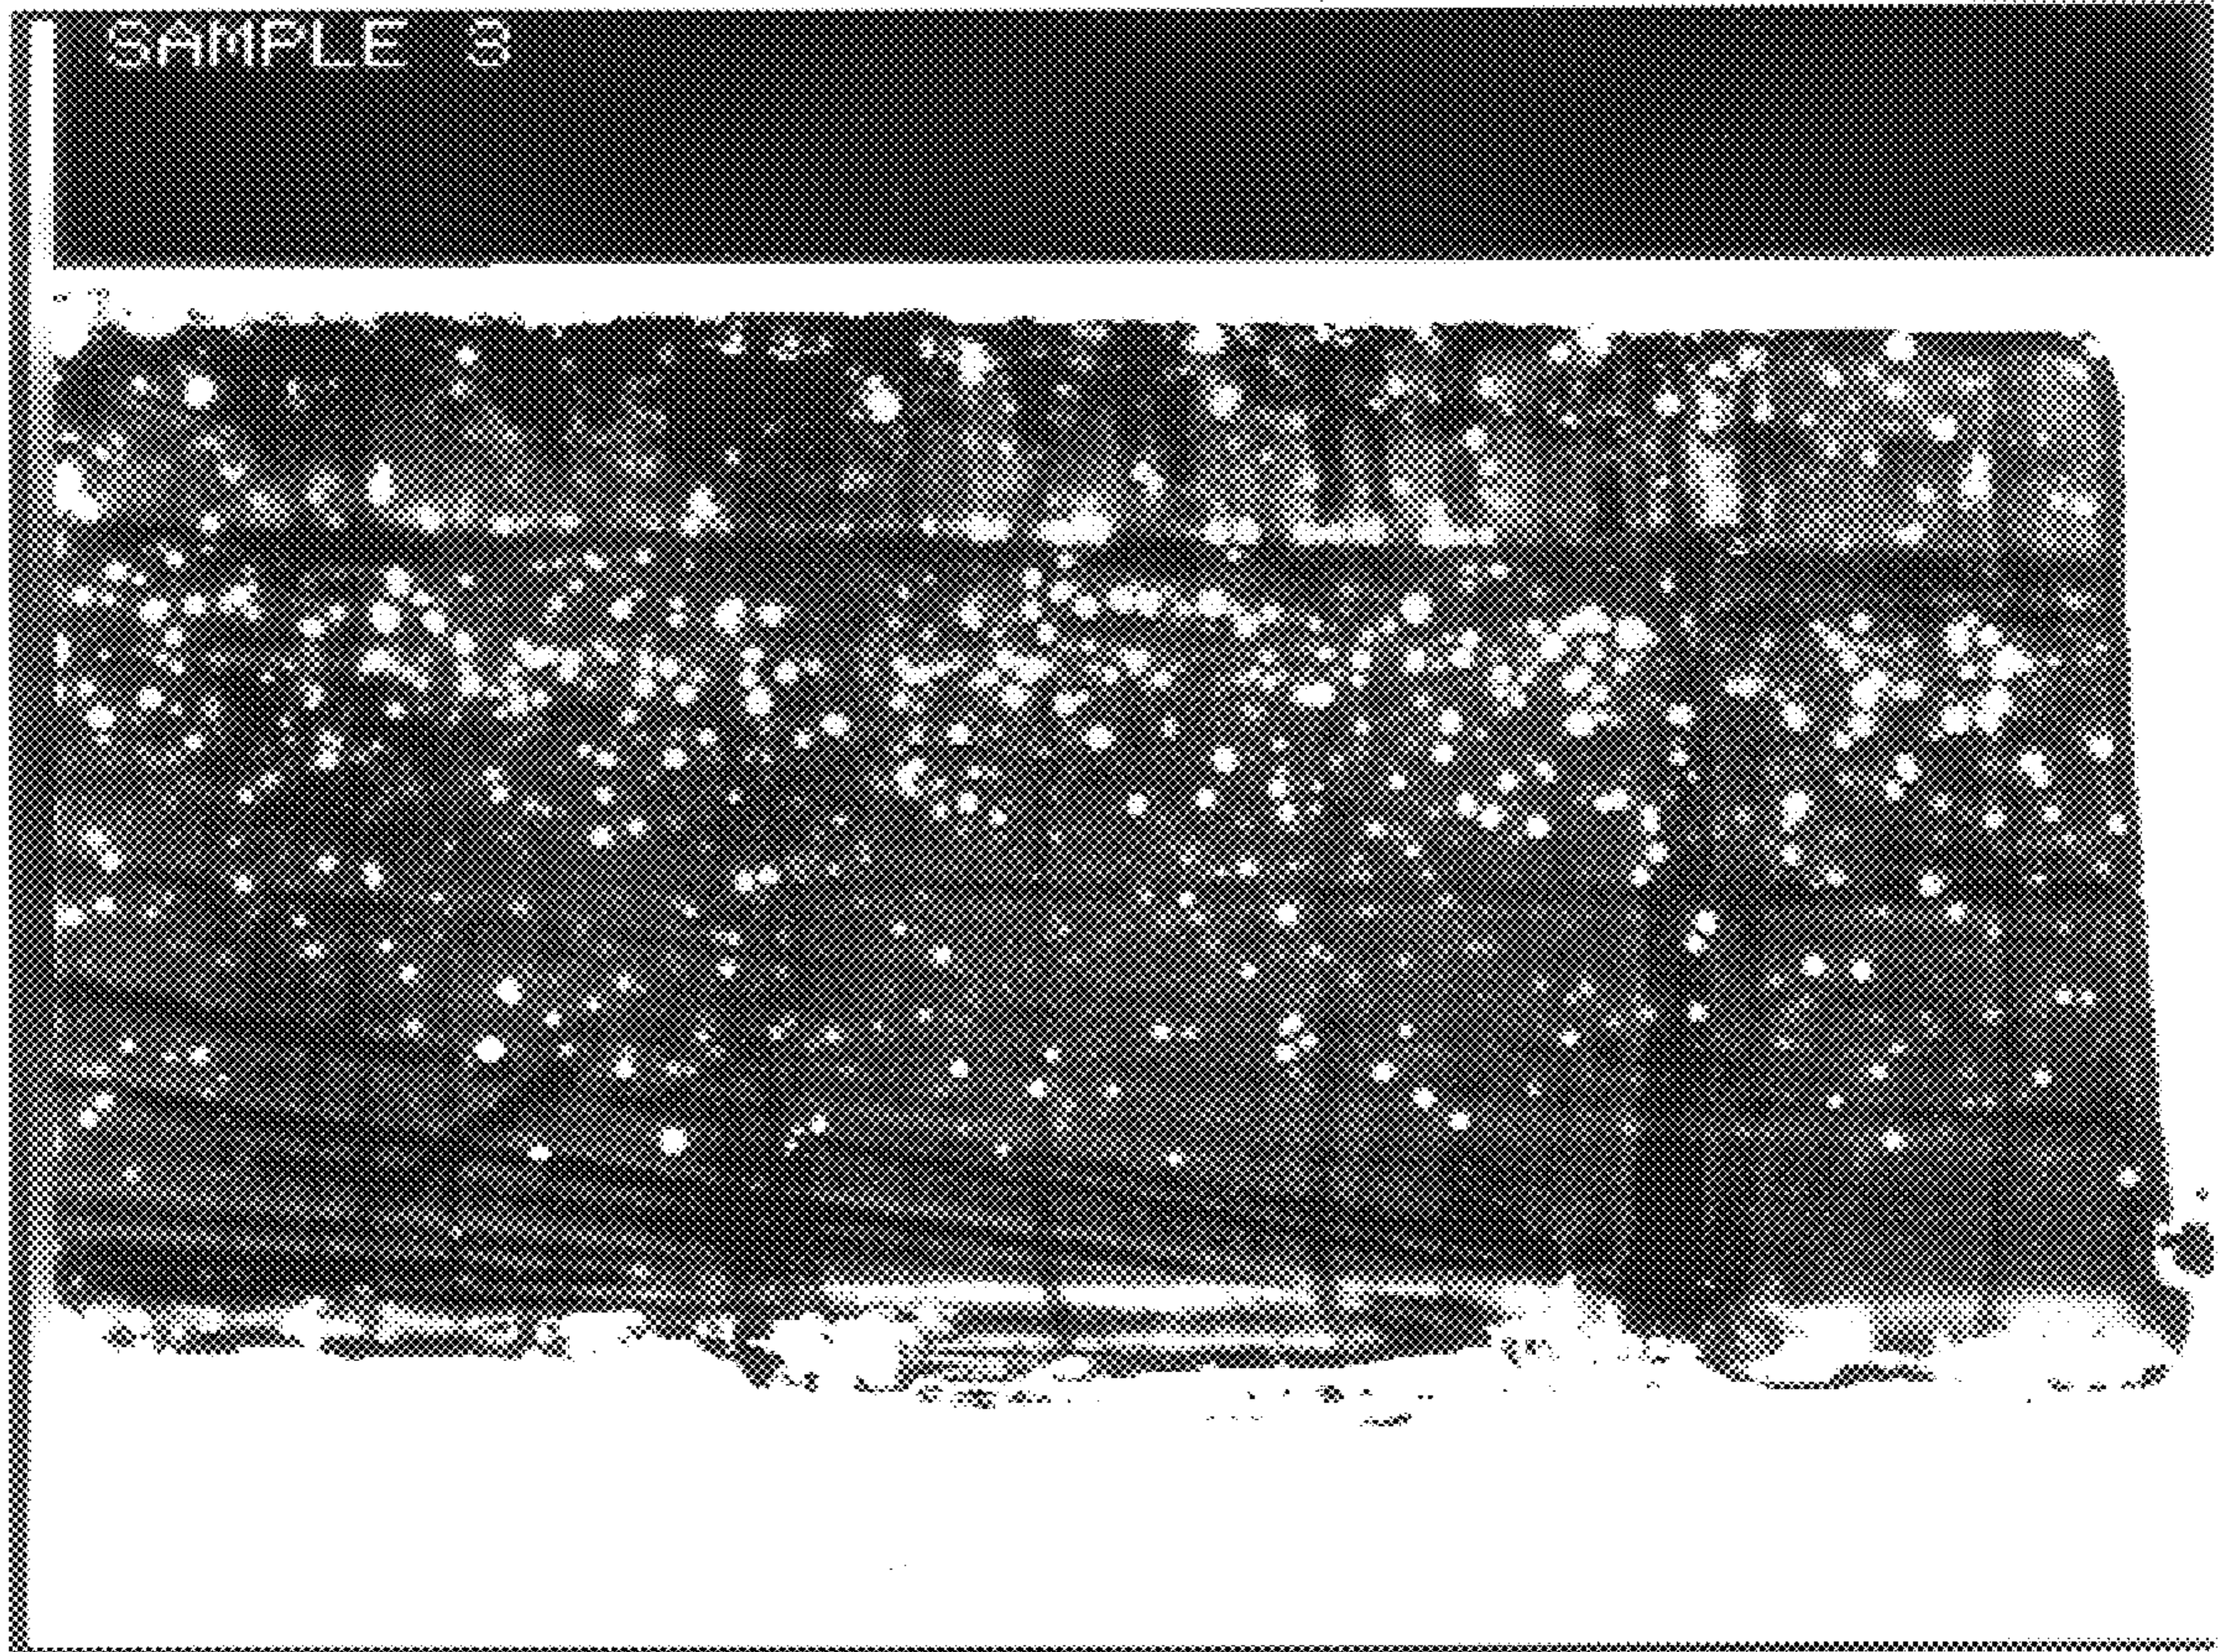
FIG. 7 is an acoustic image of Sample 3.
