United States Patent [19][11] **Patent Number:** **6,002,790****Horvath et al.**[45] **Date of Patent:** **Dec. 14, 1999**[54] **METHOD FOR DETECTING AND MEASURING VOIDS IN CONDUCTOR INSULATION SYSTEMS**[75] Inventors: **David A. Horvath**, Ann Arbor; **Steven M. Avila**, Novi, both of Mich.[73] Assignee: **Advent Engineering Services, Inc.**, Ann Arbor, Mich.[21] Appl. No.: **08/762,536**[22] Filed: **Dec. 9, 1996**[51] **Int. Cl.**⁶ **G06K 9/00**[52] **U.S. Cl.** **382/141; 348/92**[58] **Field of Search** 382/141, 144, 382/145, 149; 348/86, 92, 125, 128; 250/339[56] **References Cited**

METHOD FOR DETECTING AND MEASURING VOIDS IN CONDUCTOR INSULATION SYSTEMS

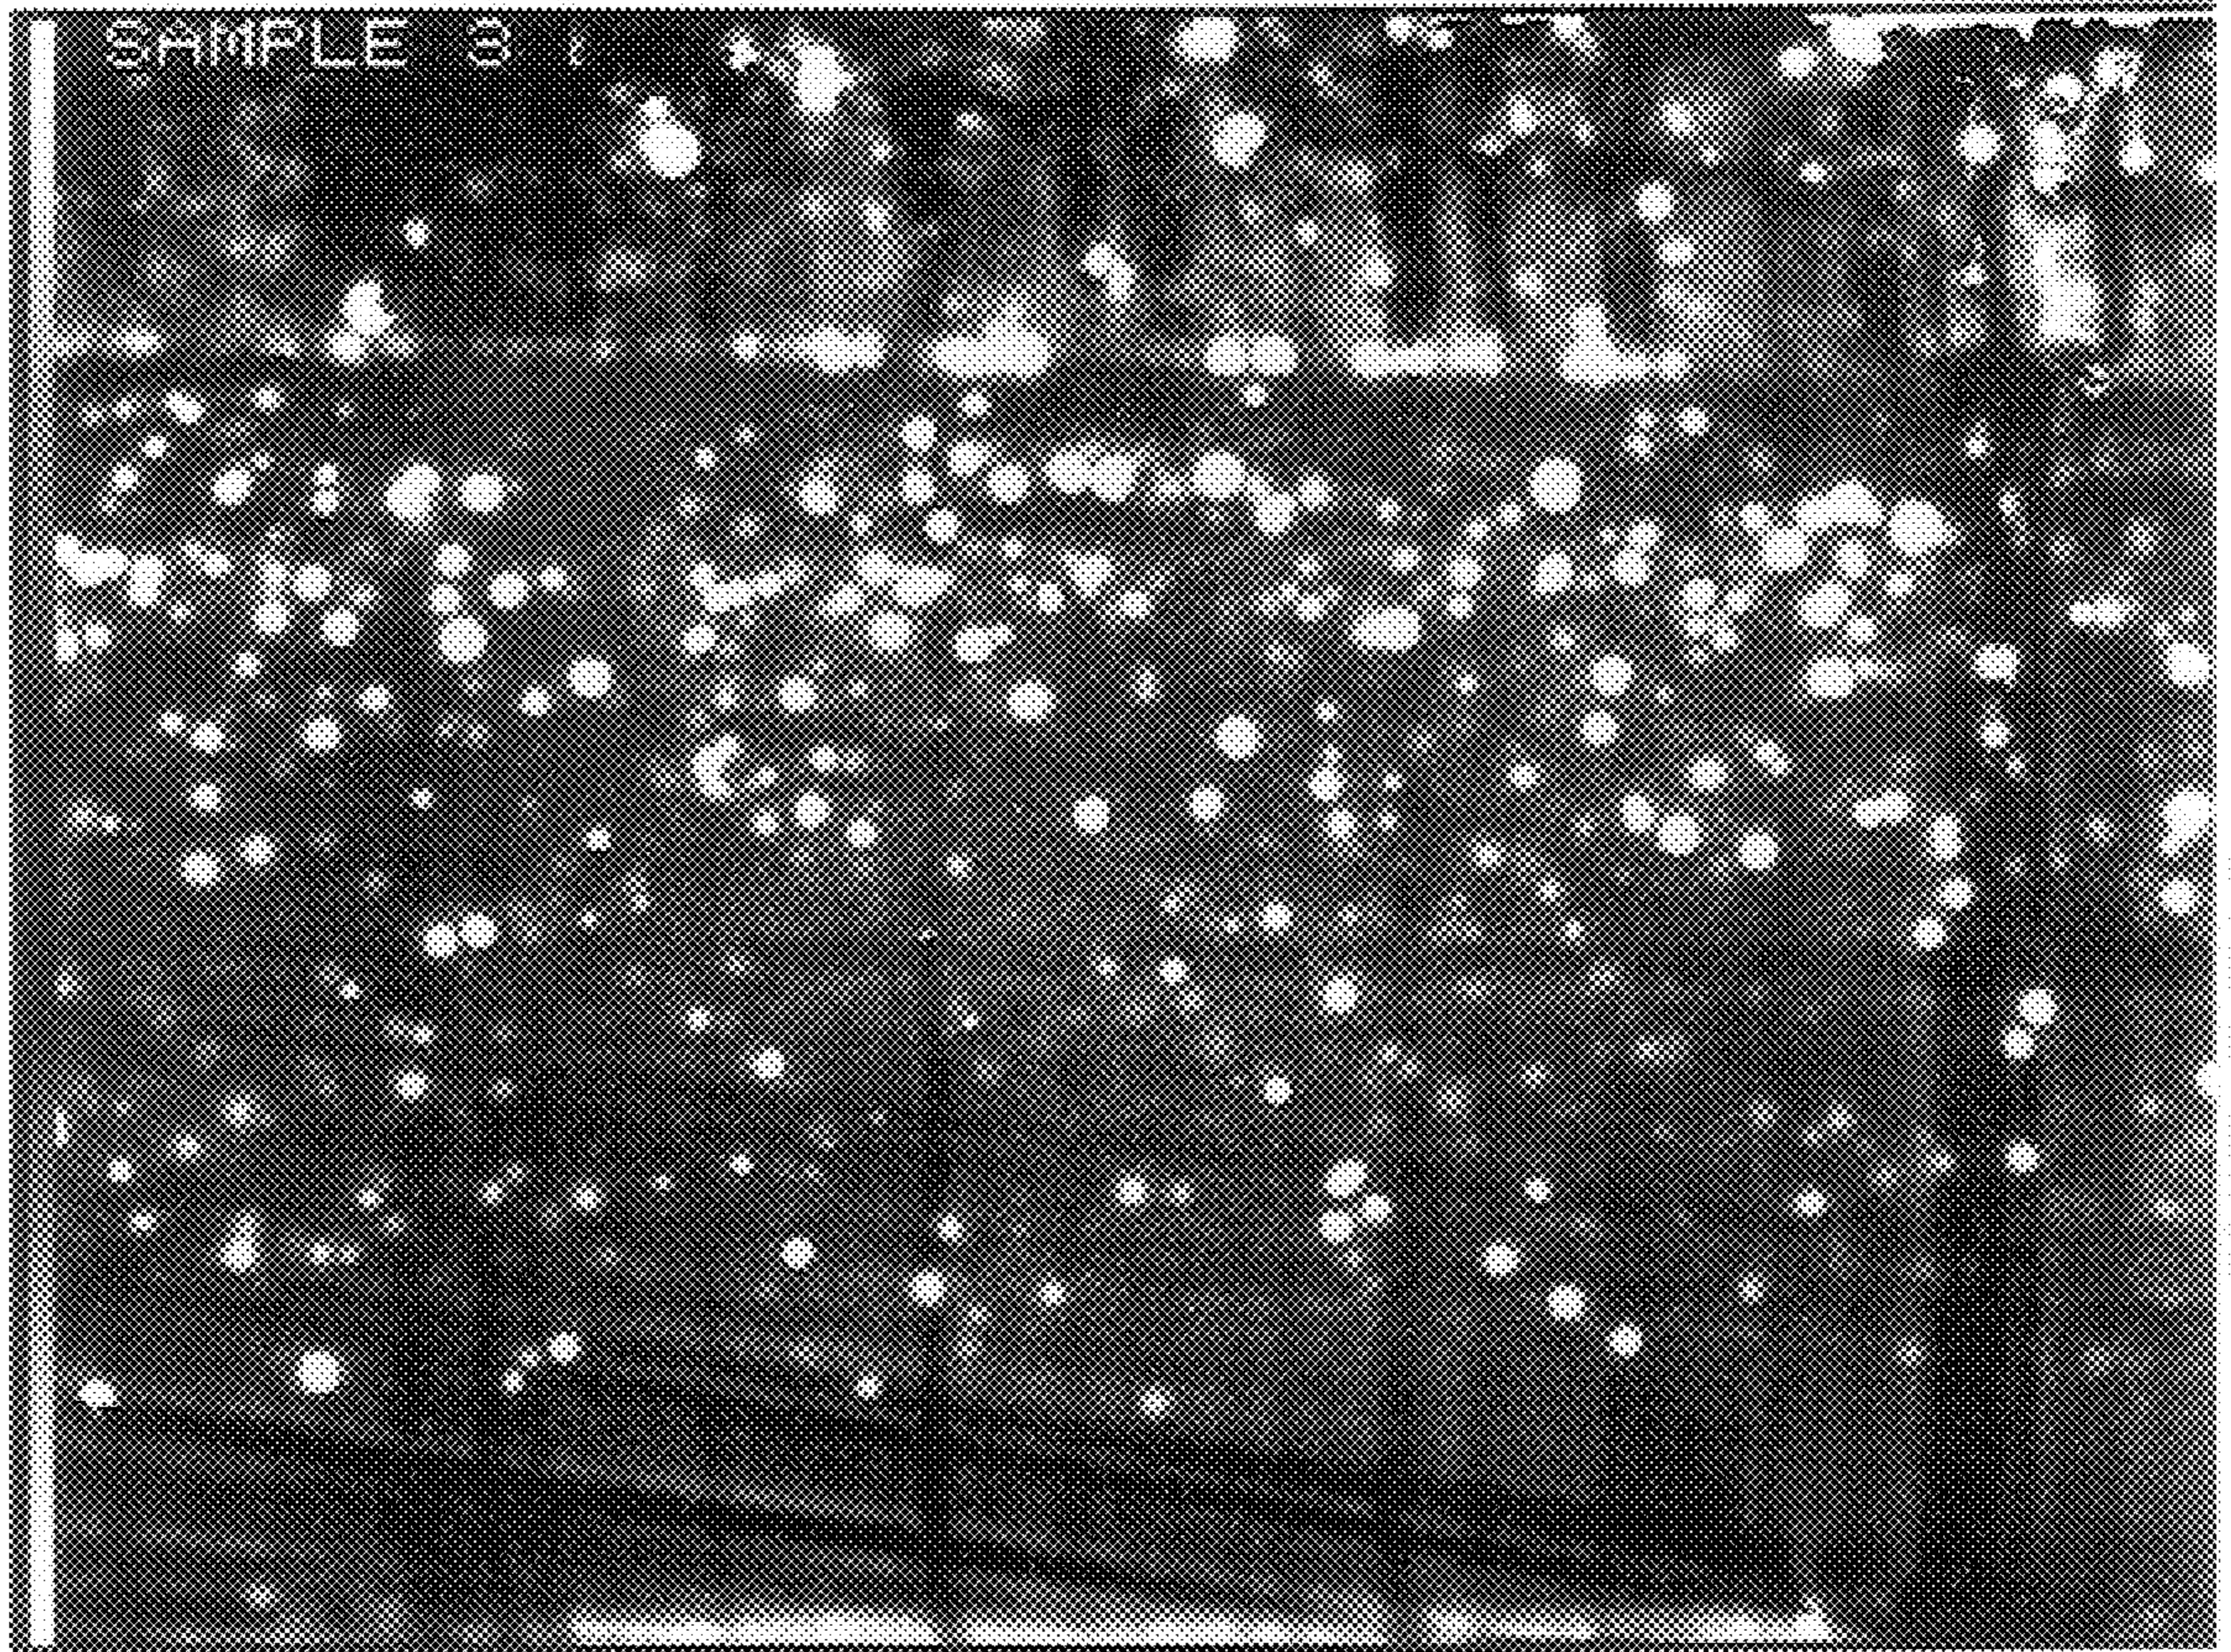
FIG. 8 is a magnified version of FIG. 7.

The bright spherical-shaped spots of FIGS. 6, 7 and 8 are classified as voids because they correspond to high amplitude reflections from the interface of a high-acoustic impedance material from inside the void or impurity pocket, such as a gaseous cavity, air bubble, or other void type. Differences in acoustic impedance between air or gas and a solid material cause most of the ultrasonic energy to be reflected at the surface boundary of a gaseous cavity, air bubble, or void.

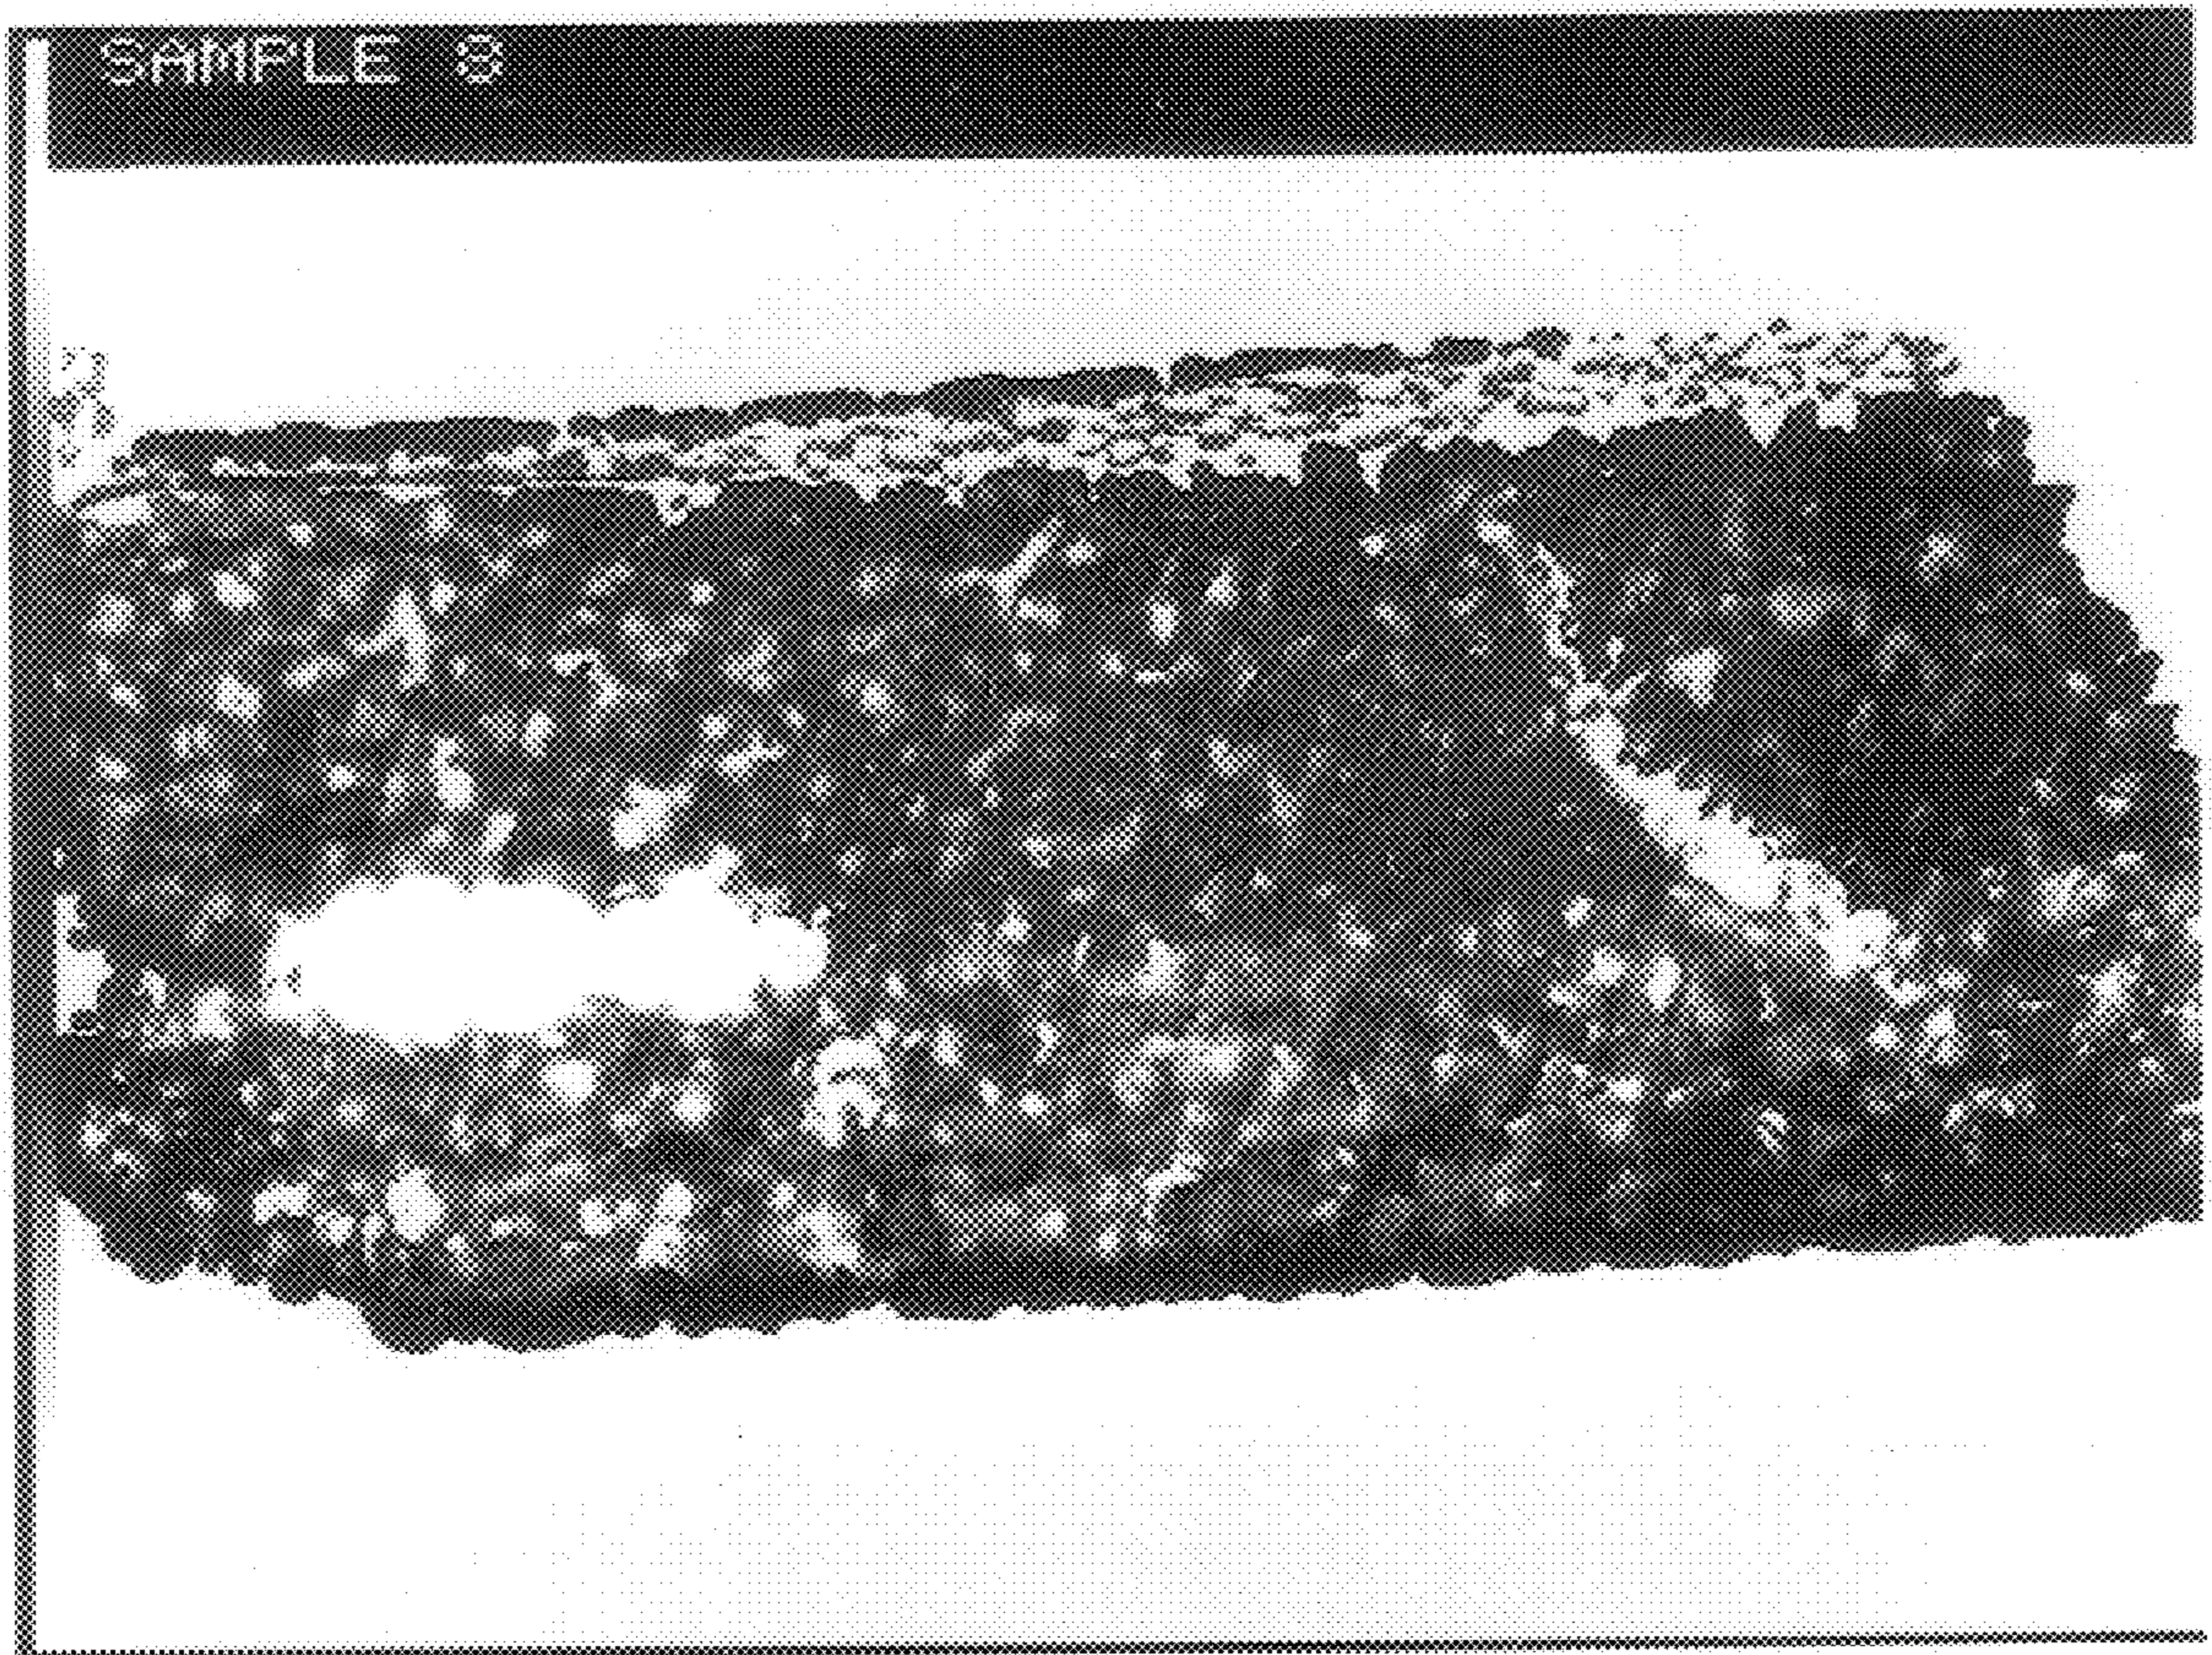
FIG. 9 is an acoustic image of Sample 8 at 50 MHz.

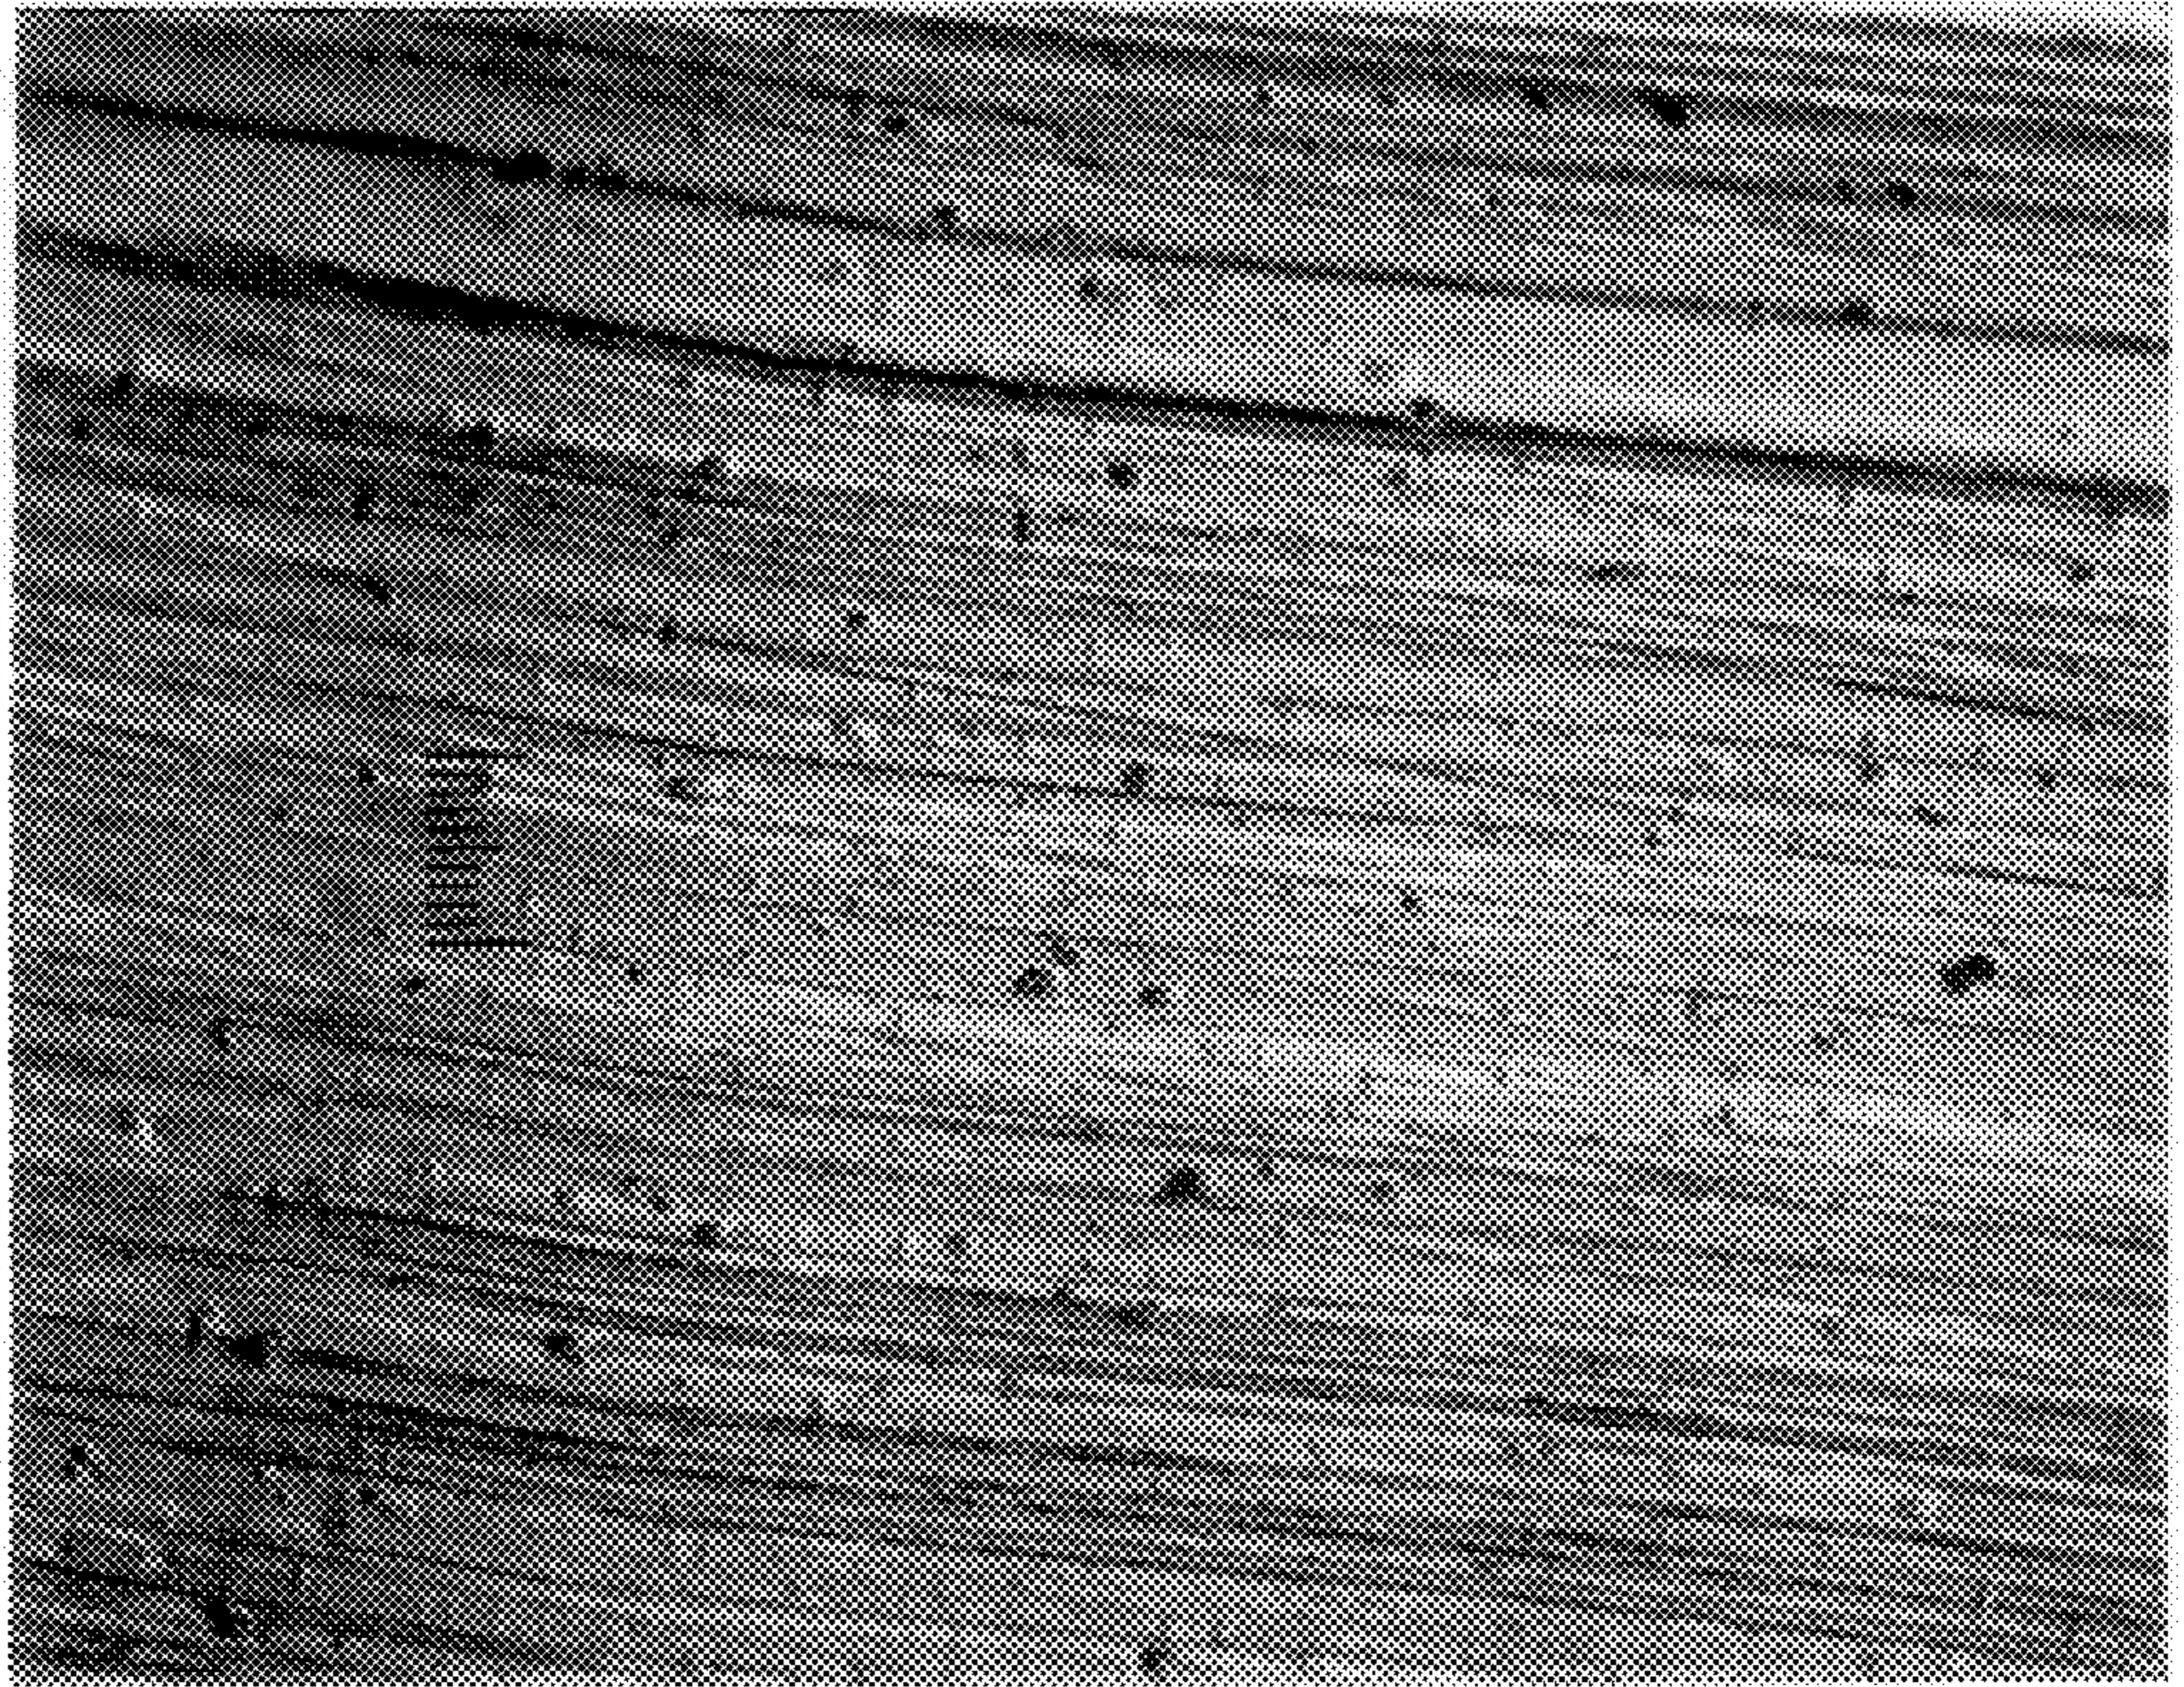
FIG. 10 is an optical image of Sample 1 at 200 \times .

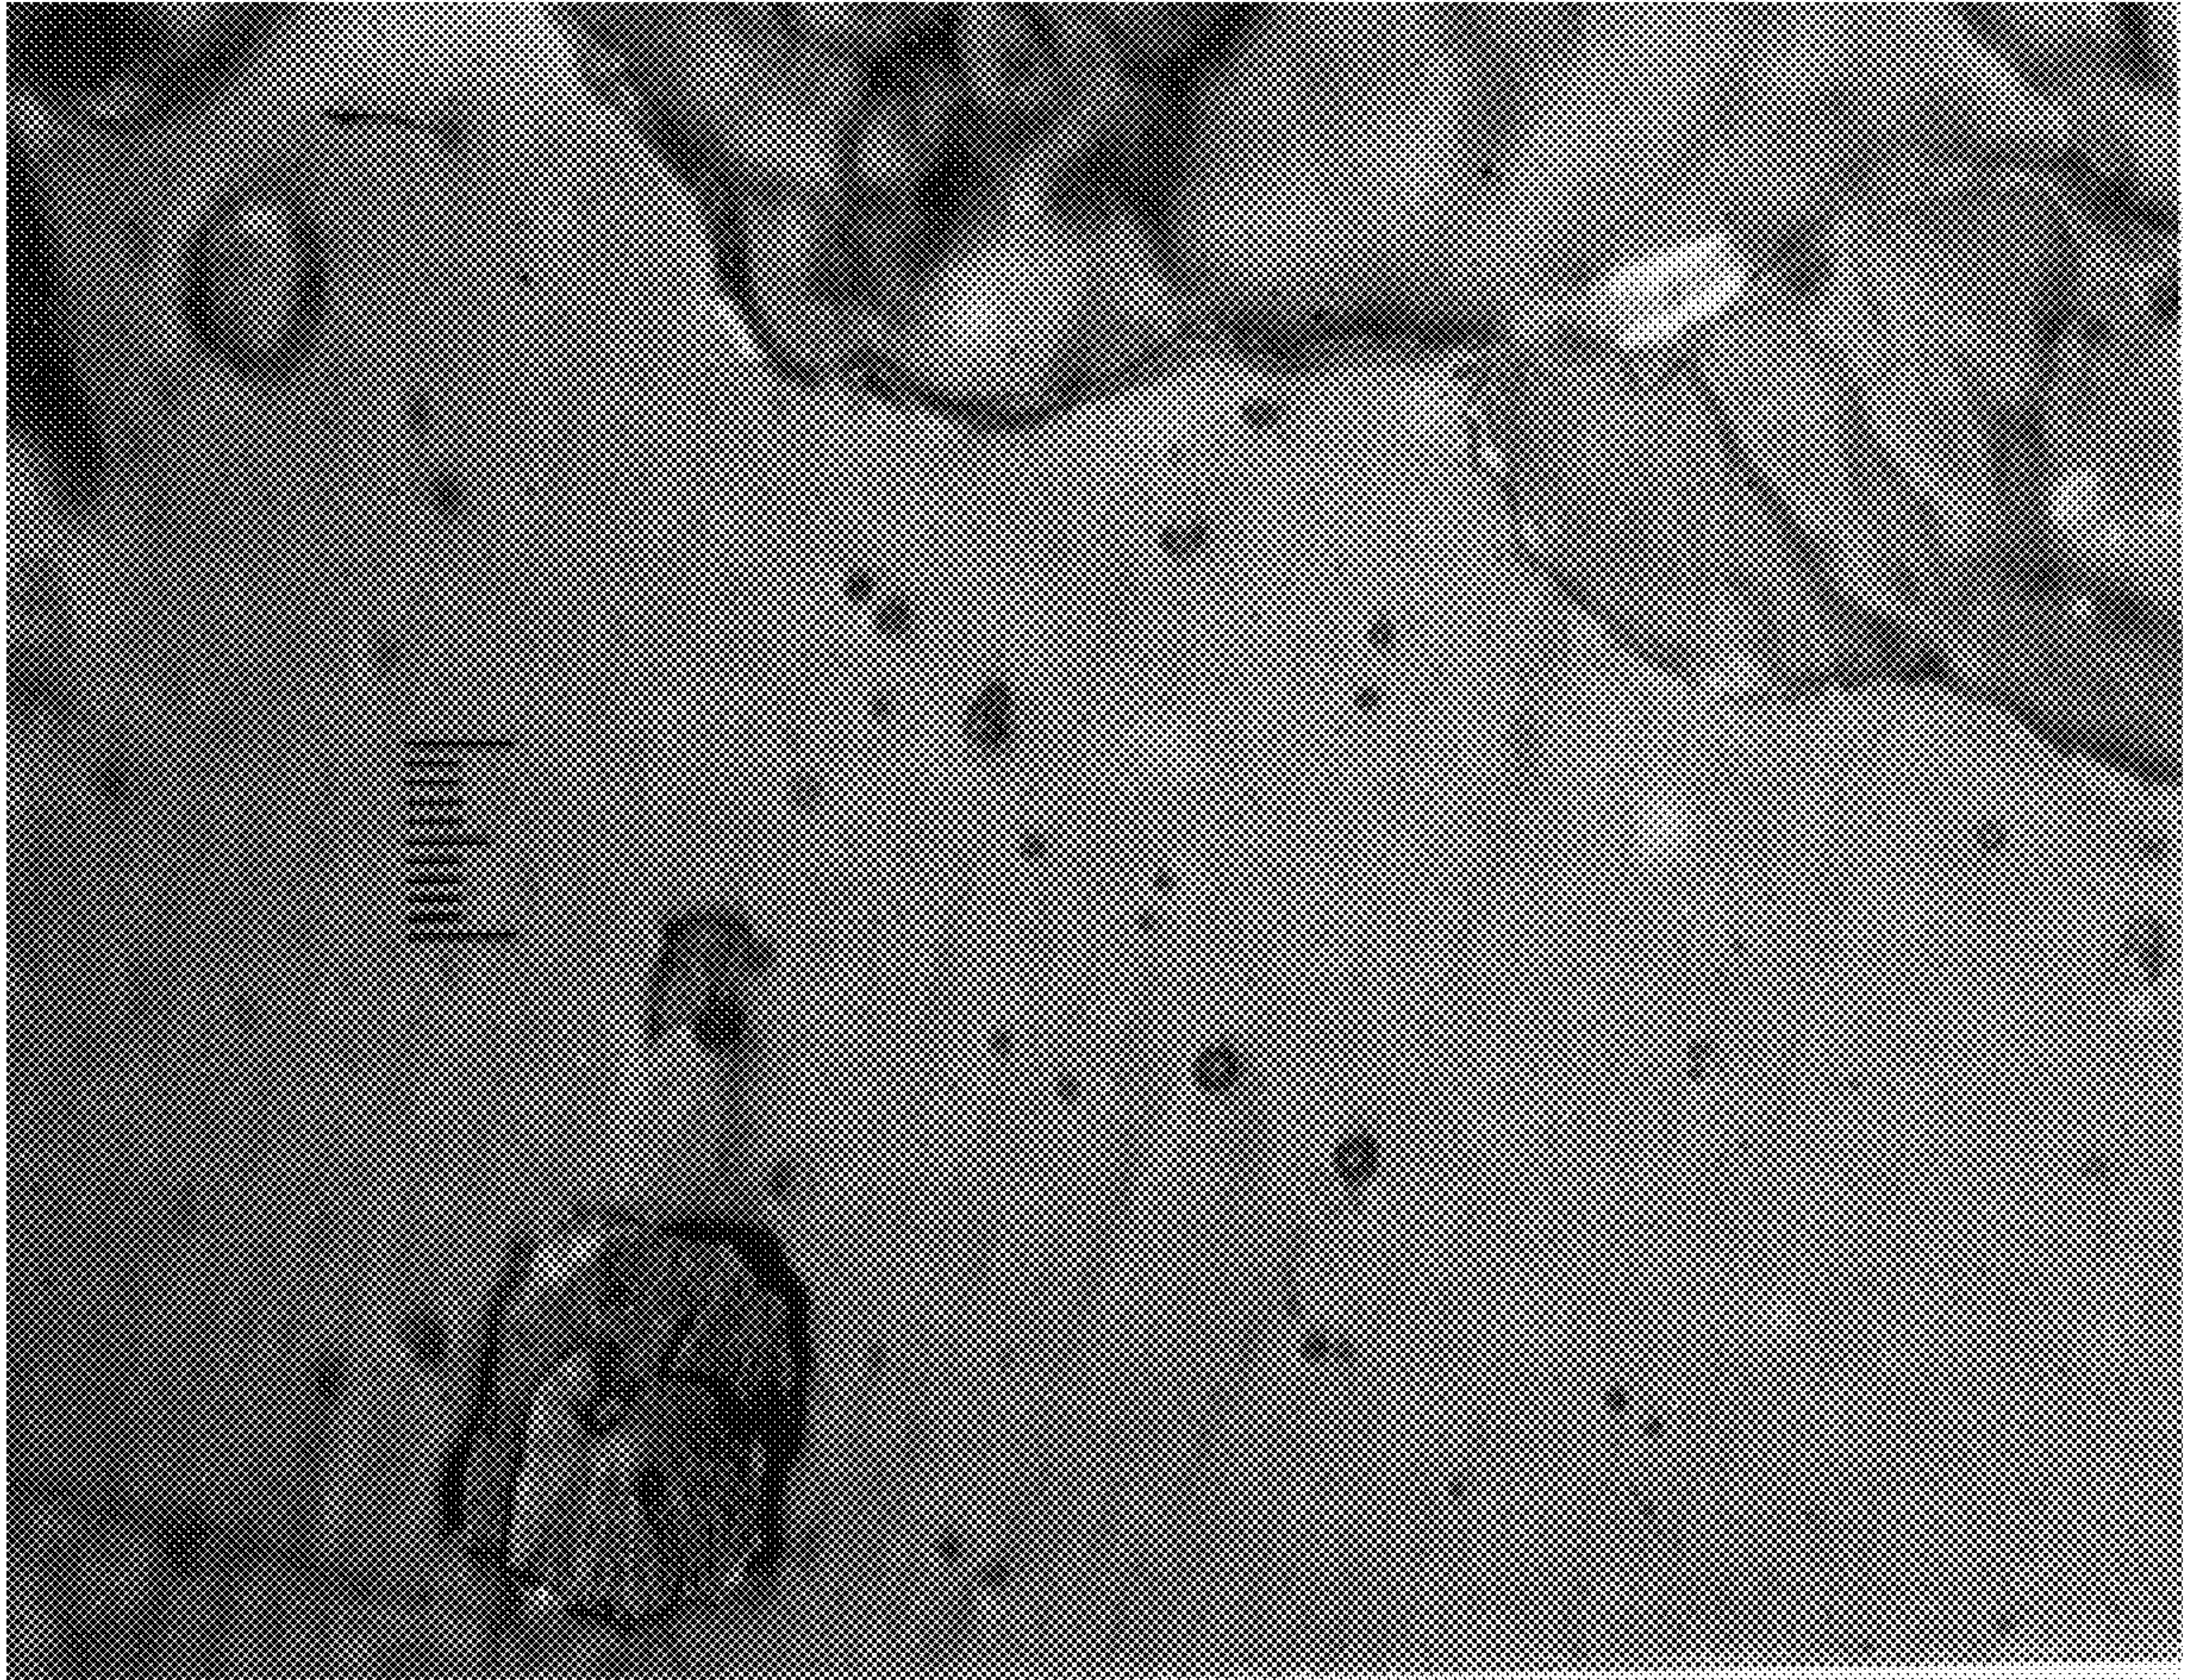
FIG. 11 is an optical image of Sample 3 at 500 \times .

There are an estimated 30 voids, identified over a 0.03 cm^3 volume. Correspondingly, this equates to a density of about 1000 voids/ cm^3 . FIG. 11 illustrates a freeze fracture surface of a lateral cross-sectional cut. The scale shown (at the left edge) is one centimeter. It is estimated that the smallest void is about 2 microns and the largest is about 4 microns.

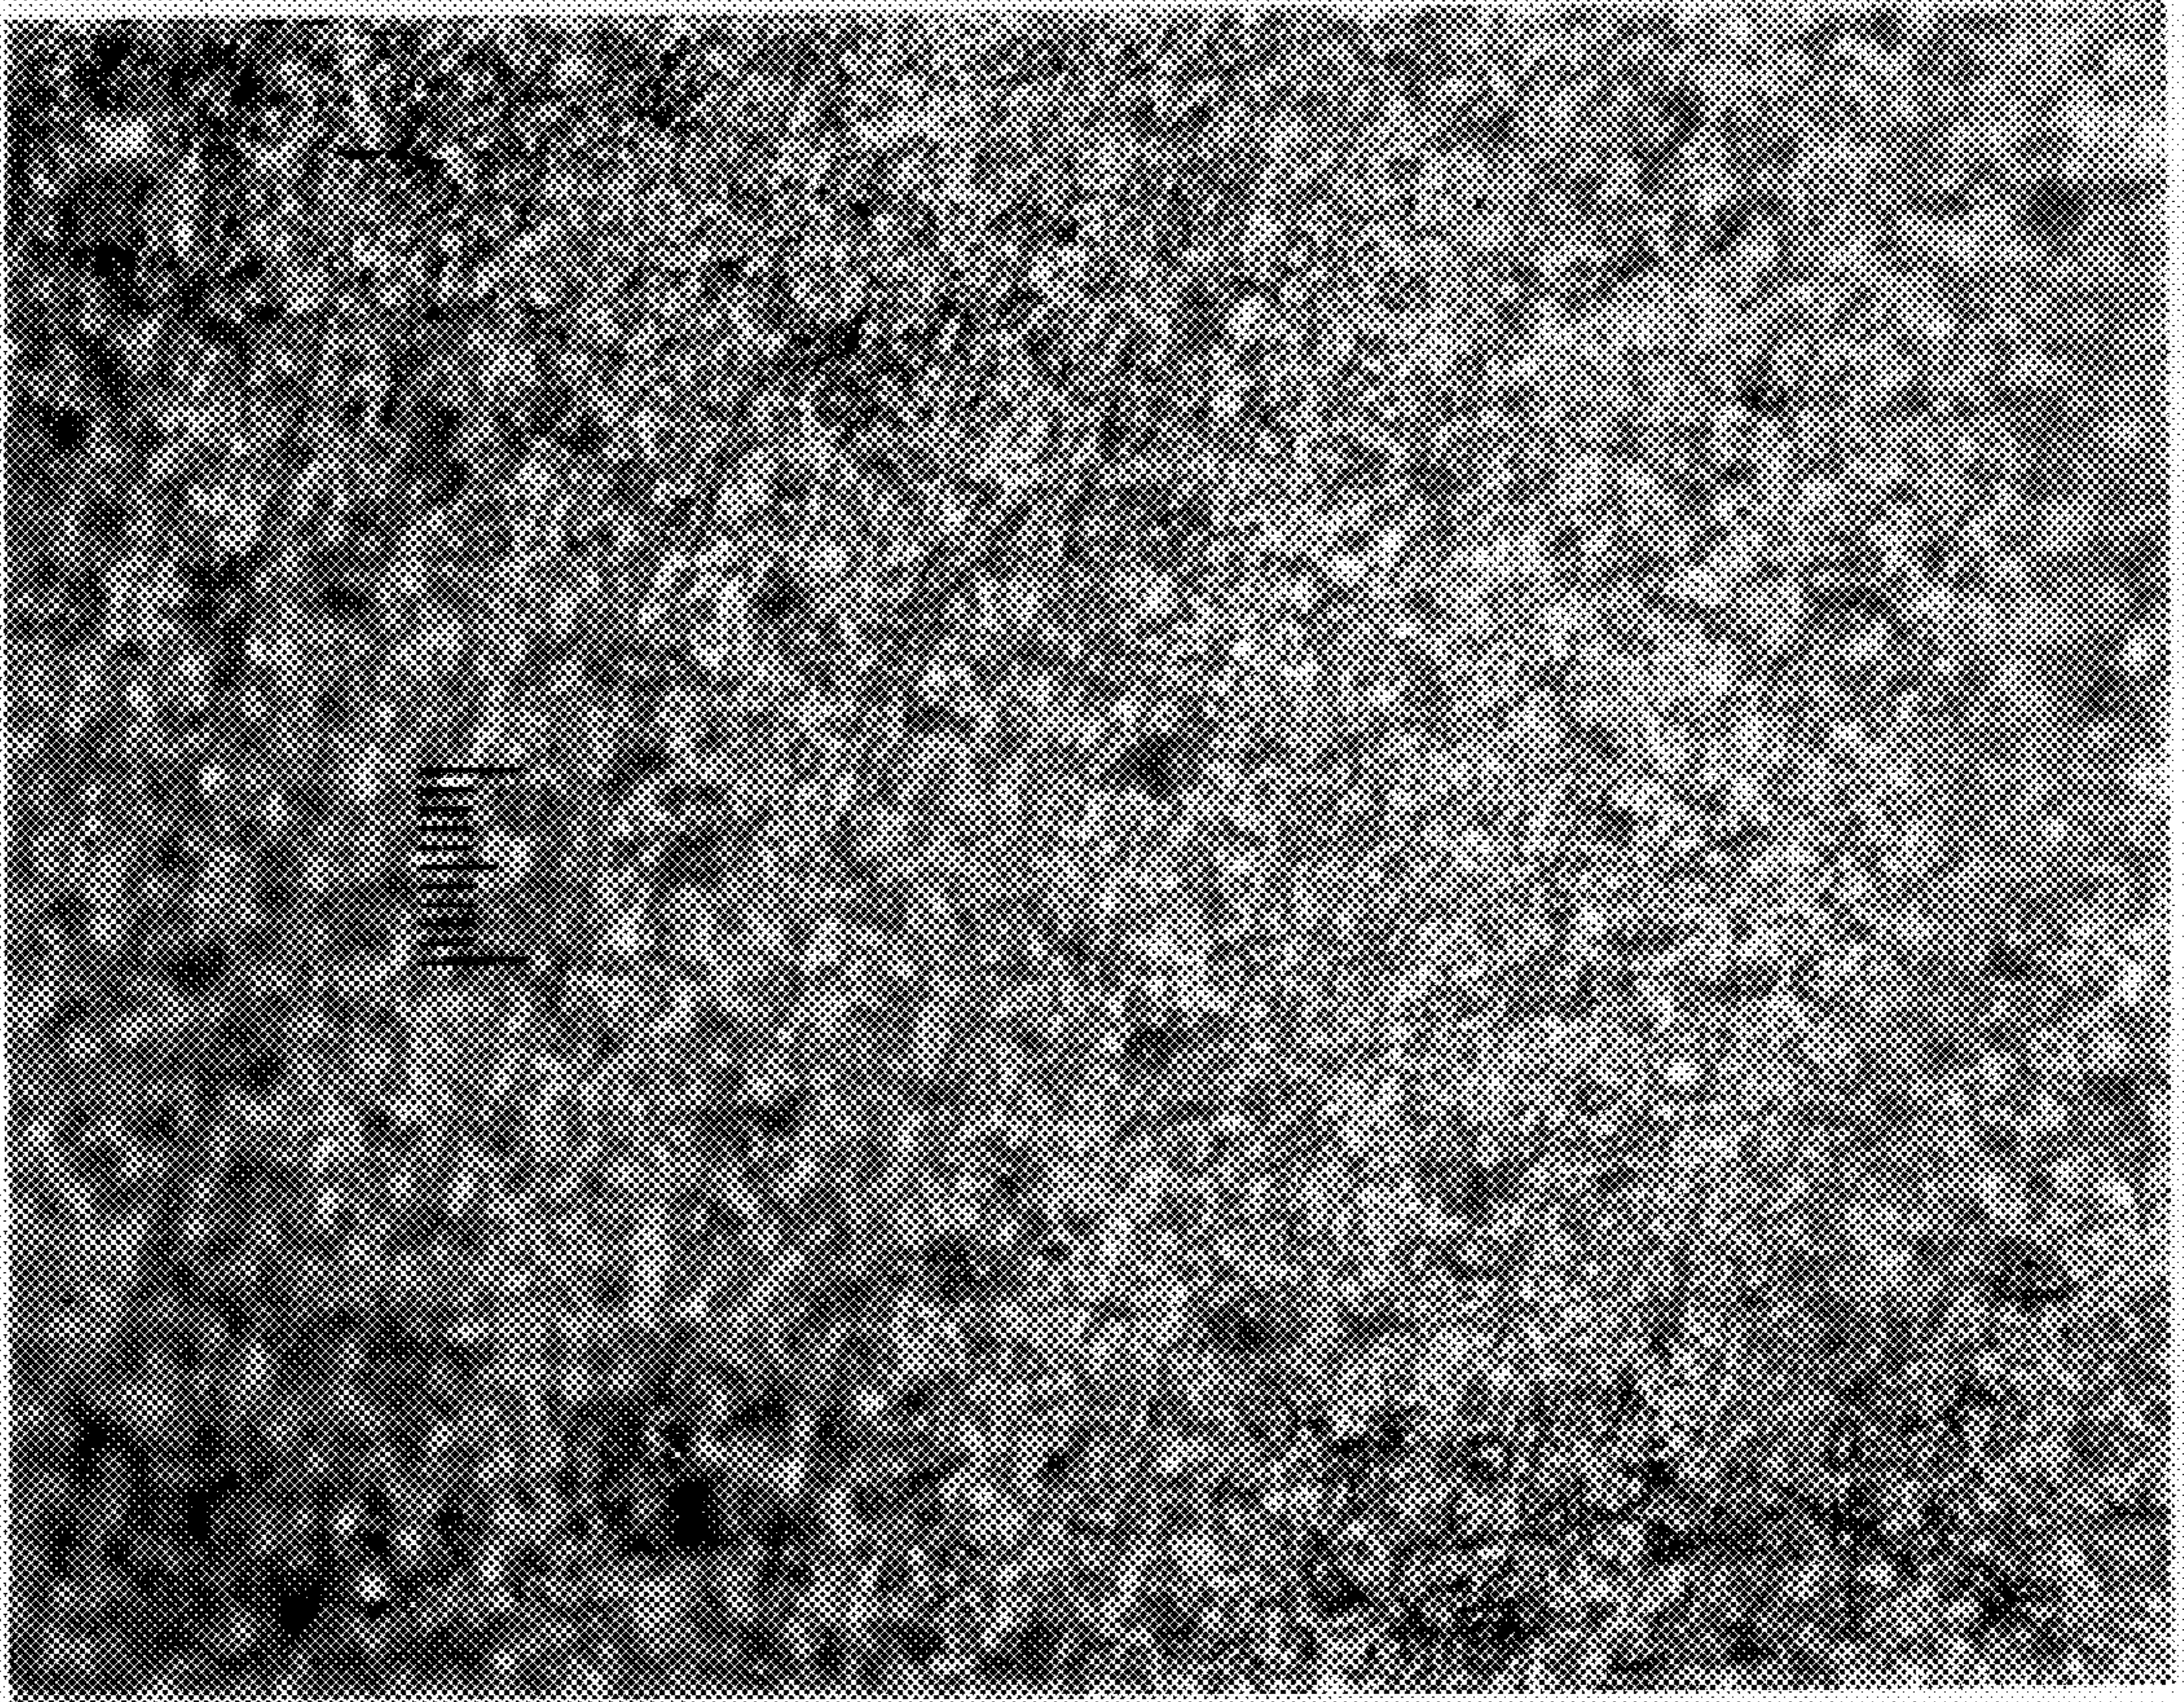
FIG. 12 is an optical image of Sample 8 at 200 \times .

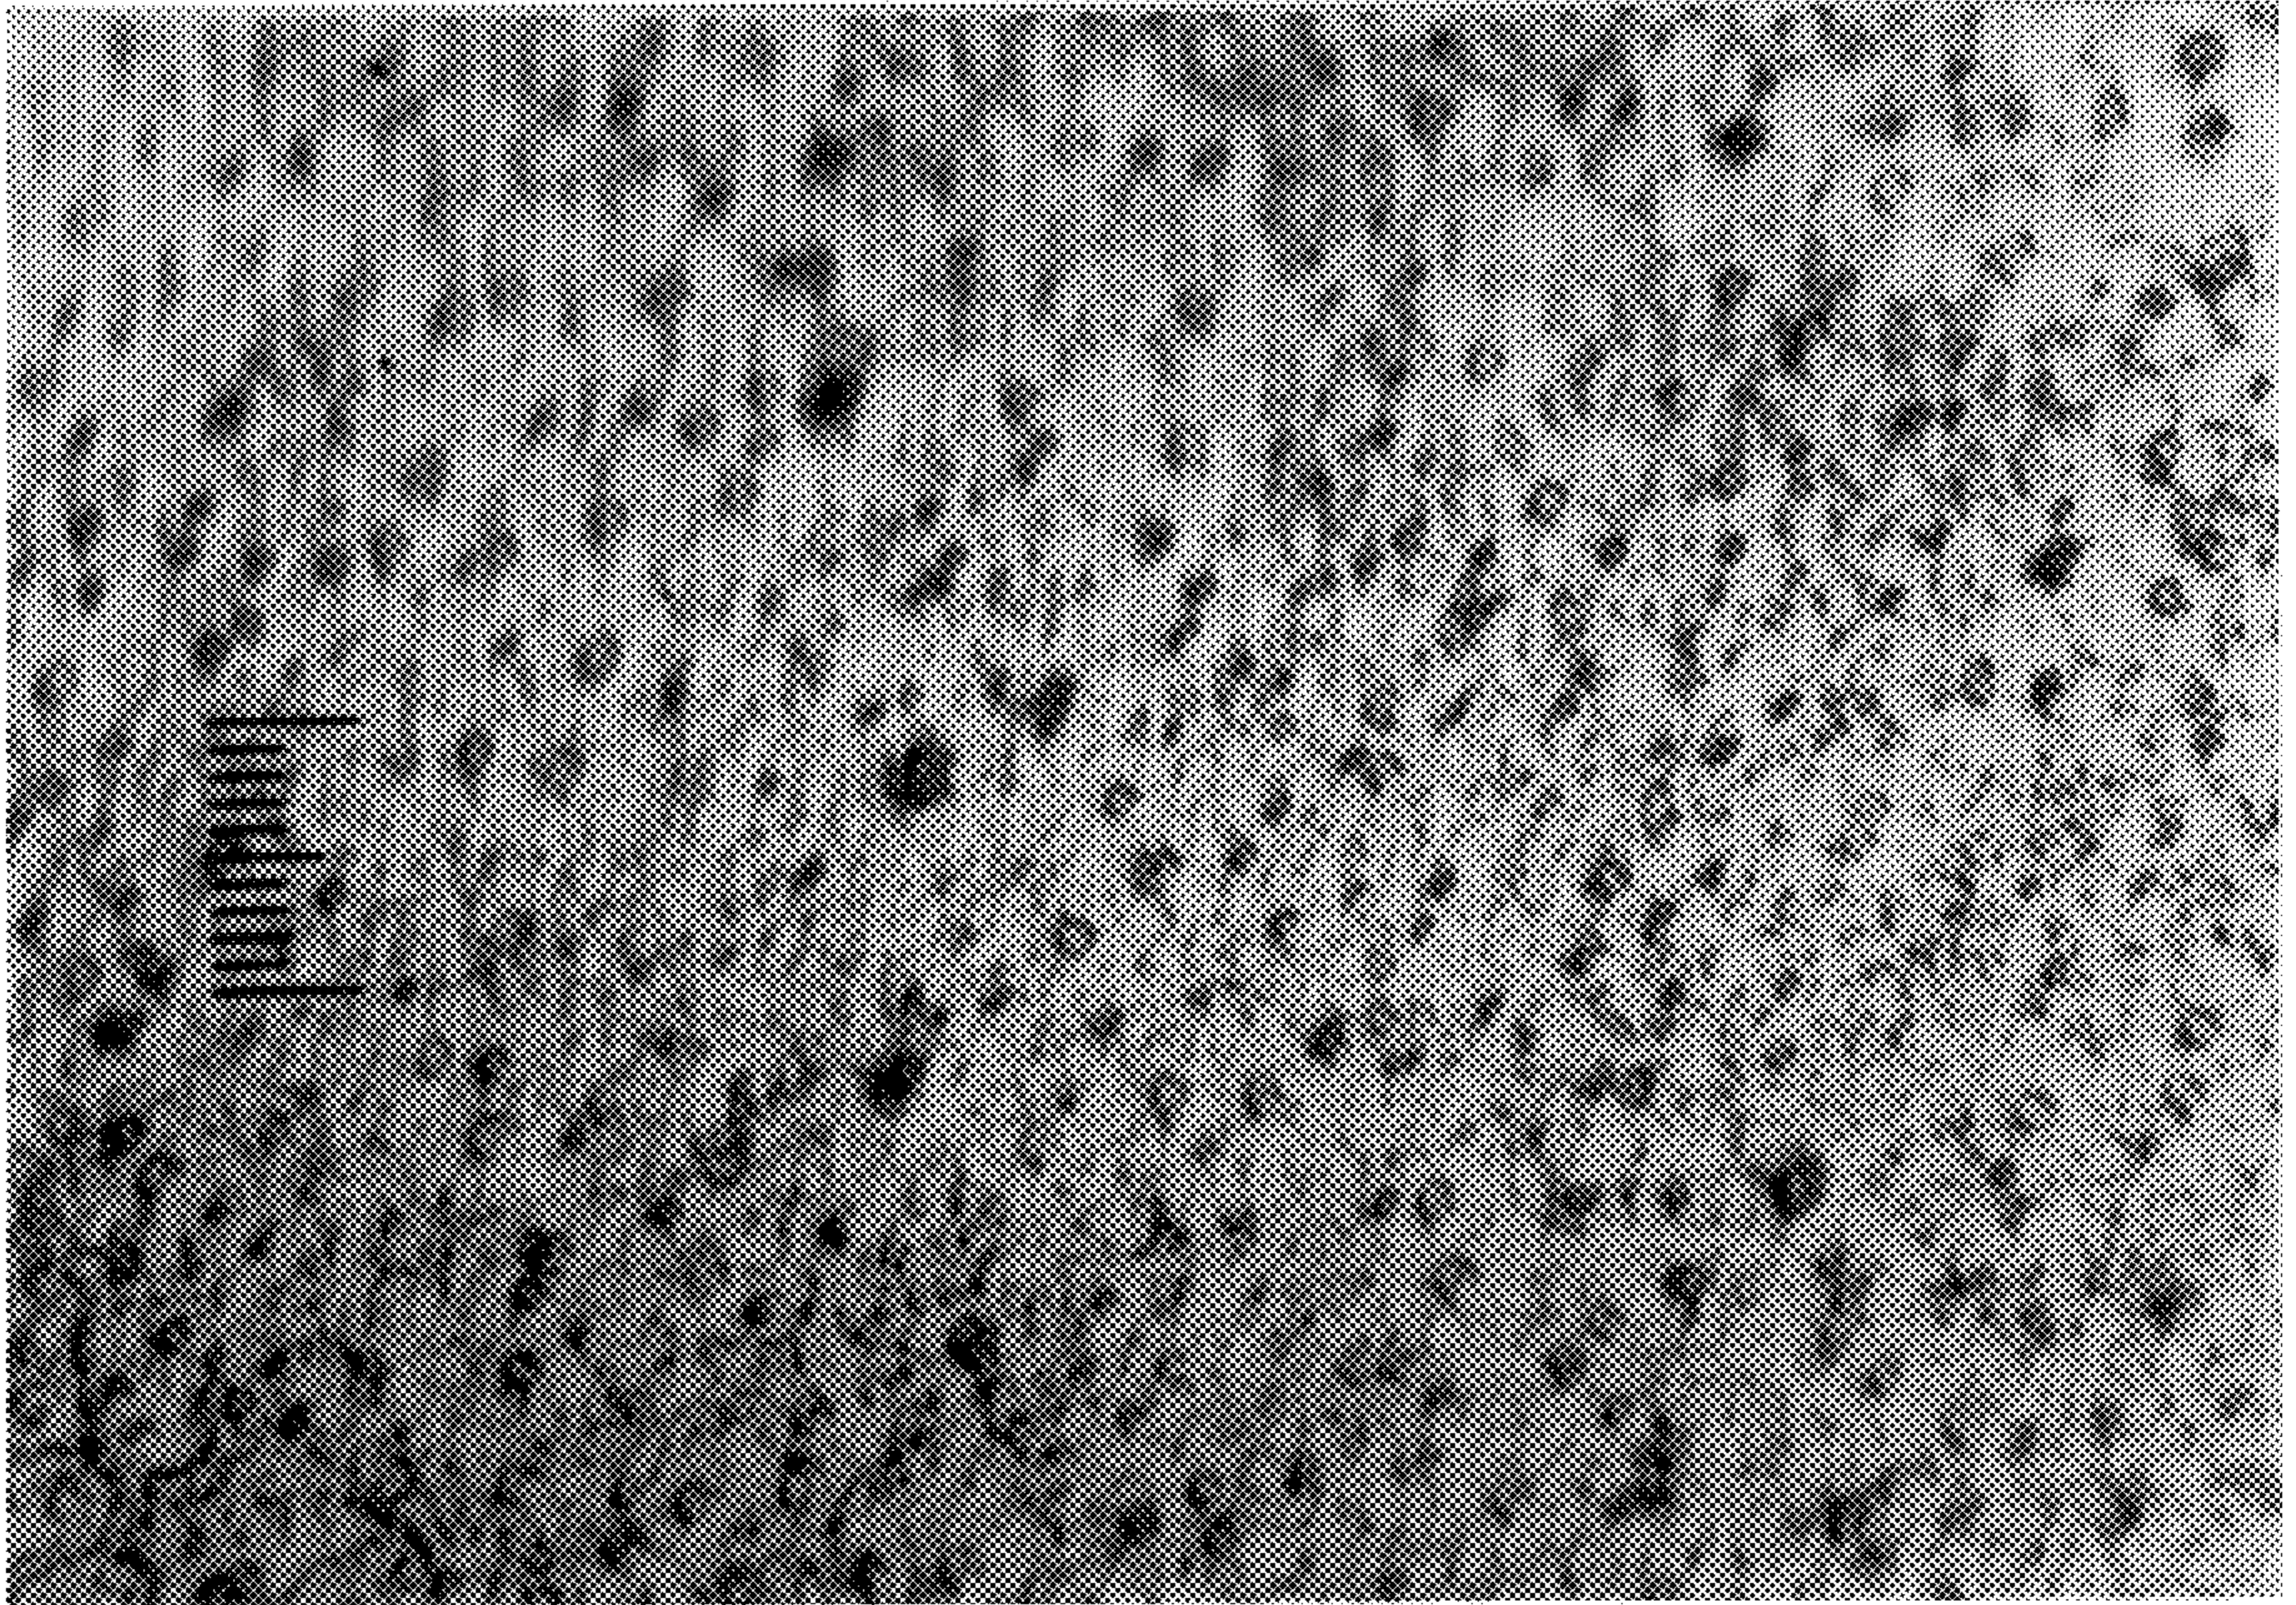
FIG. 13 is an optical image of Sample 1 at 500 \times .

There are an estimated 50 spherical voids, identified over a 0.1 cm^3 volume, which equates to a density of approximately 500 voids/ cm^3 . FIG. 13 depicts a freeze fracture-surface of a lateral cross-sectional cut. With a scale of 1½ cm, it is estimated that the smallest void is about 4 microns and the largest is about 8 microns.
