United States Patent [19][11] **Patent Number:** **6,002,790****Horvath et al.**[45] **Date of Patent:** **Dec. 14, 1999**[54] **METHOD FOR DETECTING AND MEASURING VOIDS IN CONDUCTOR INSULATION SYSTEMS**[75] Inventors: **David A. Horvath**, Ann Arbor; **Steven M. Avila**, Novi, both of Mich.[73] Assignee: **Advent Engineering Services, Inc.**, Ann Arbor, Mich.[21] Appl. No.: **08/762,536**[22] Filed: **Dec. 9, 1996**[51] **Int. Cl.**⁶ **G06K 9/00**[52] **U.S. Cl.** **382/141; 348/92**[58] **Field of Search** 382/141, 144, 382/145, 149; 348/86, 92, 125, 128; 250/339[56] **References Cited**

METHOD FOR DETECTING AND MEASURING VOIDS IN CONDUCTOR INSULATION SYSTEMS

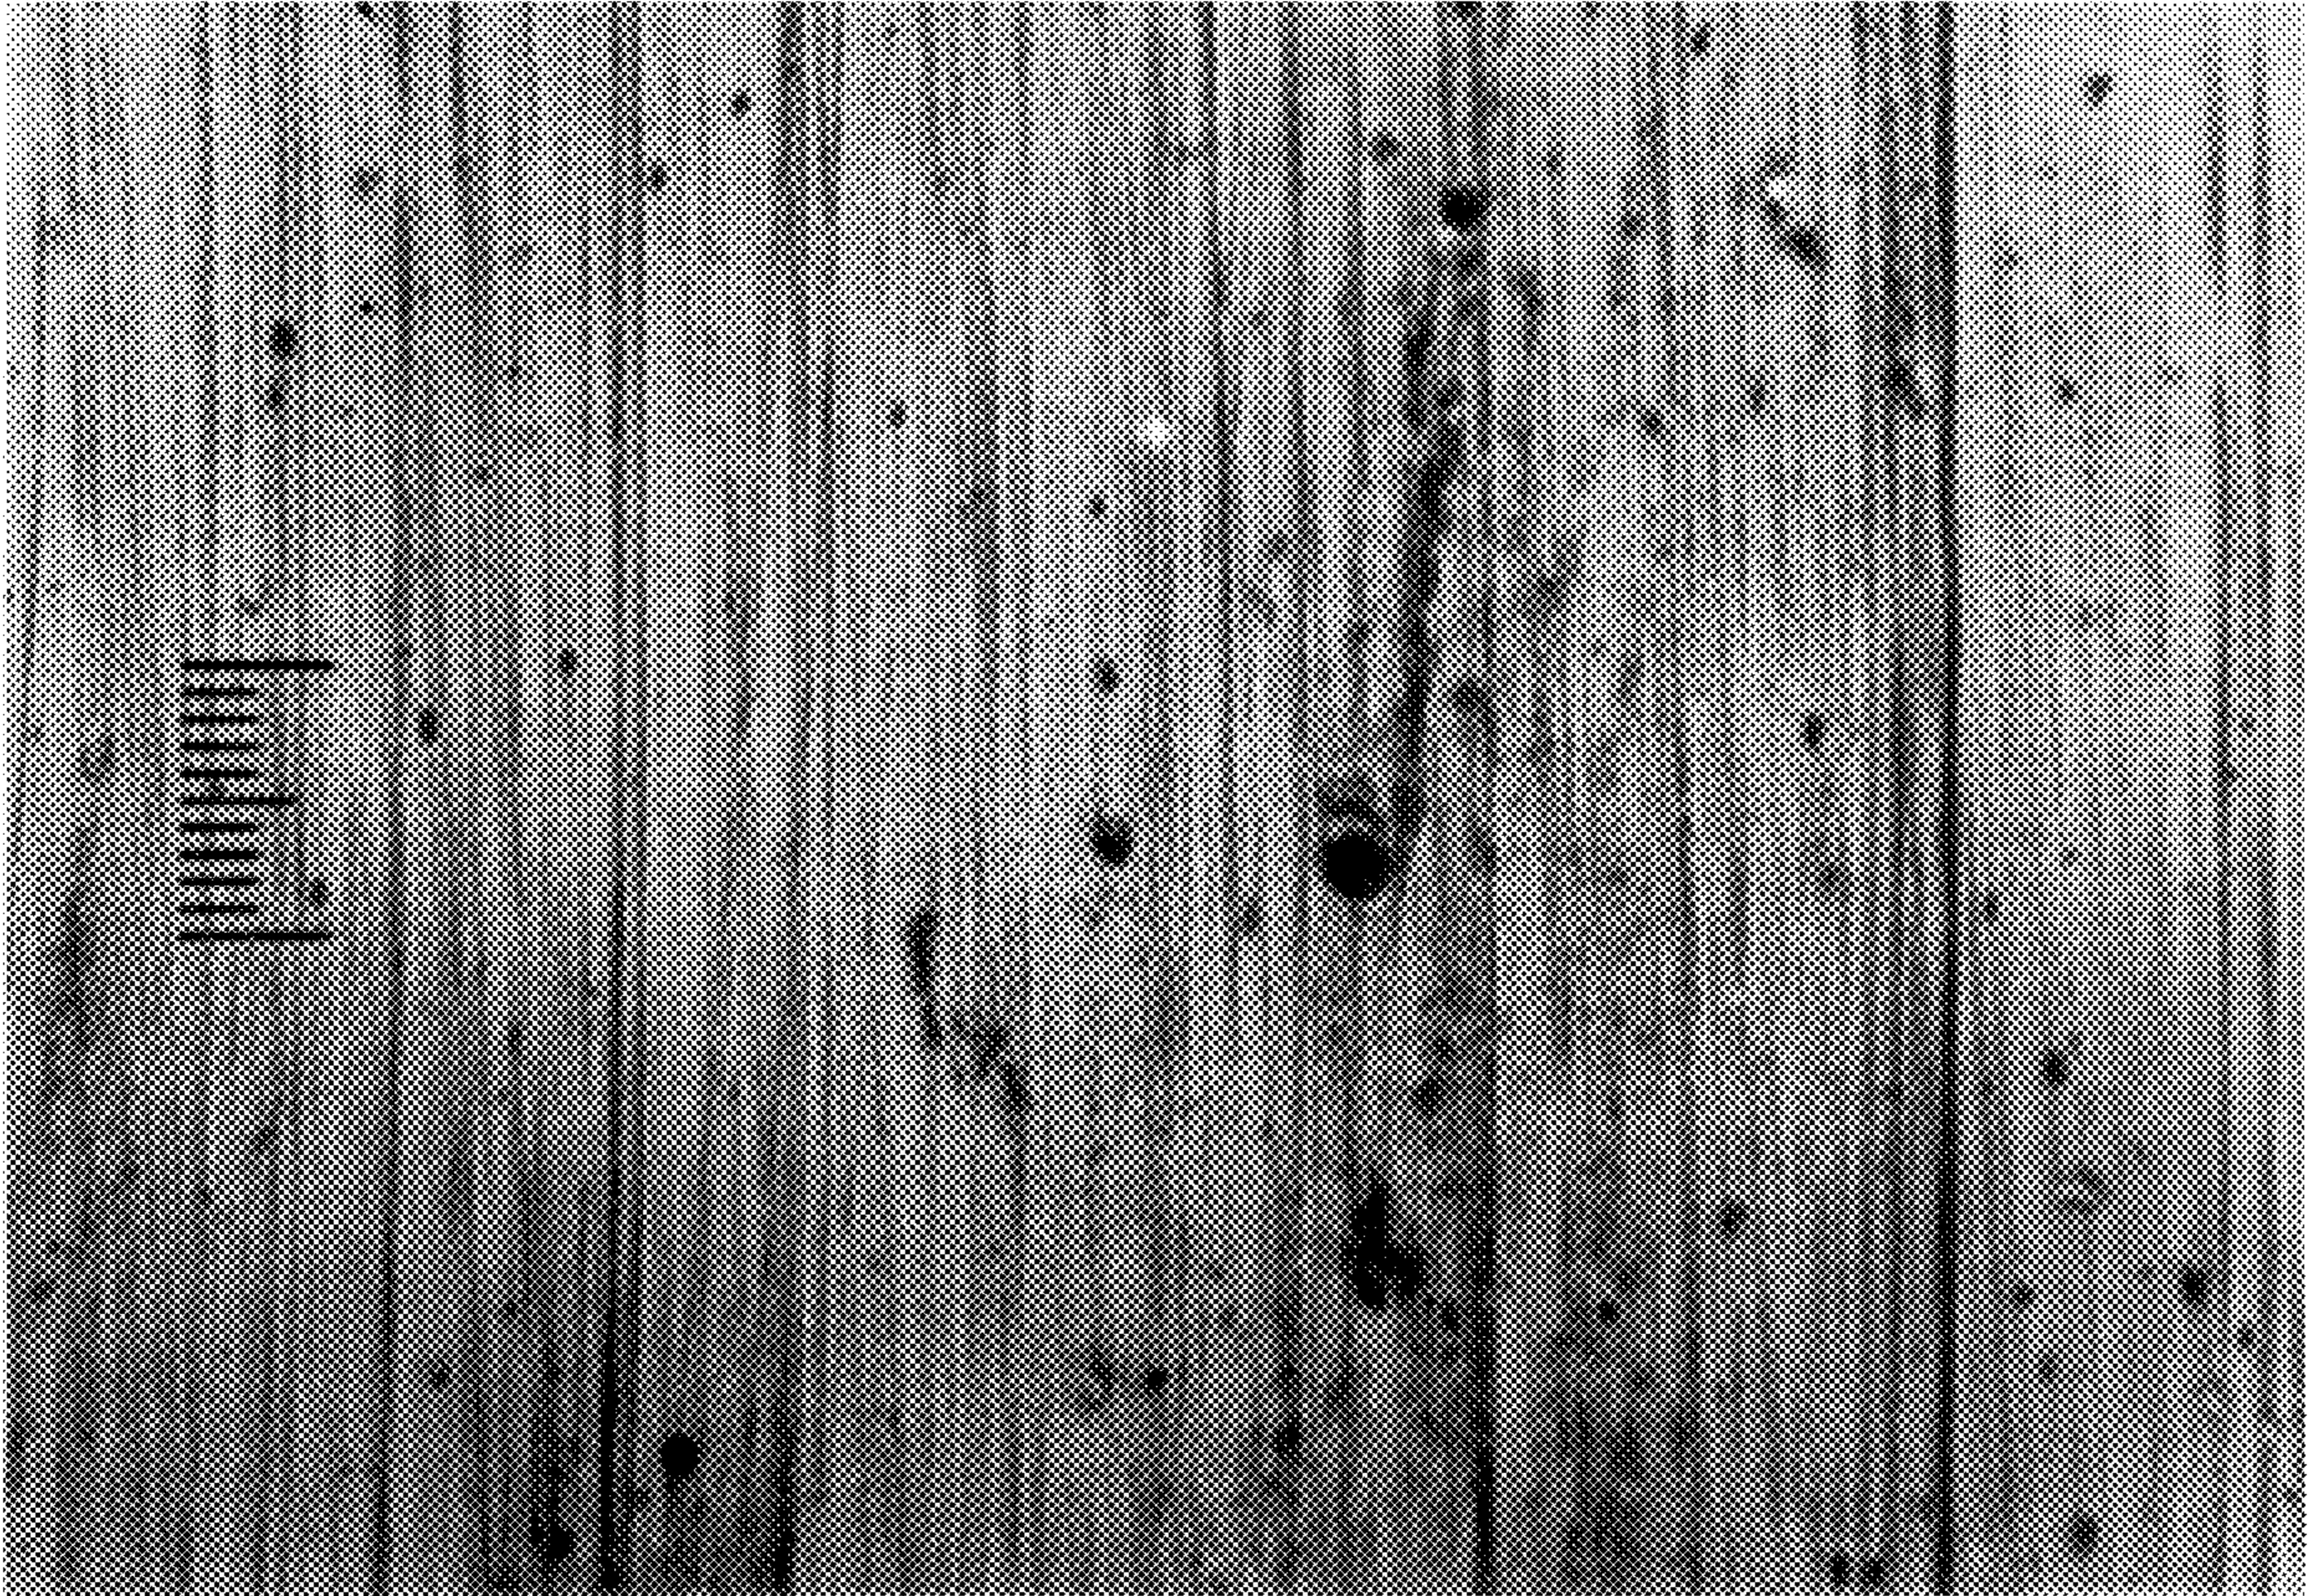
FIG. 14 is an optical image of Sample 3 at 200 \times .

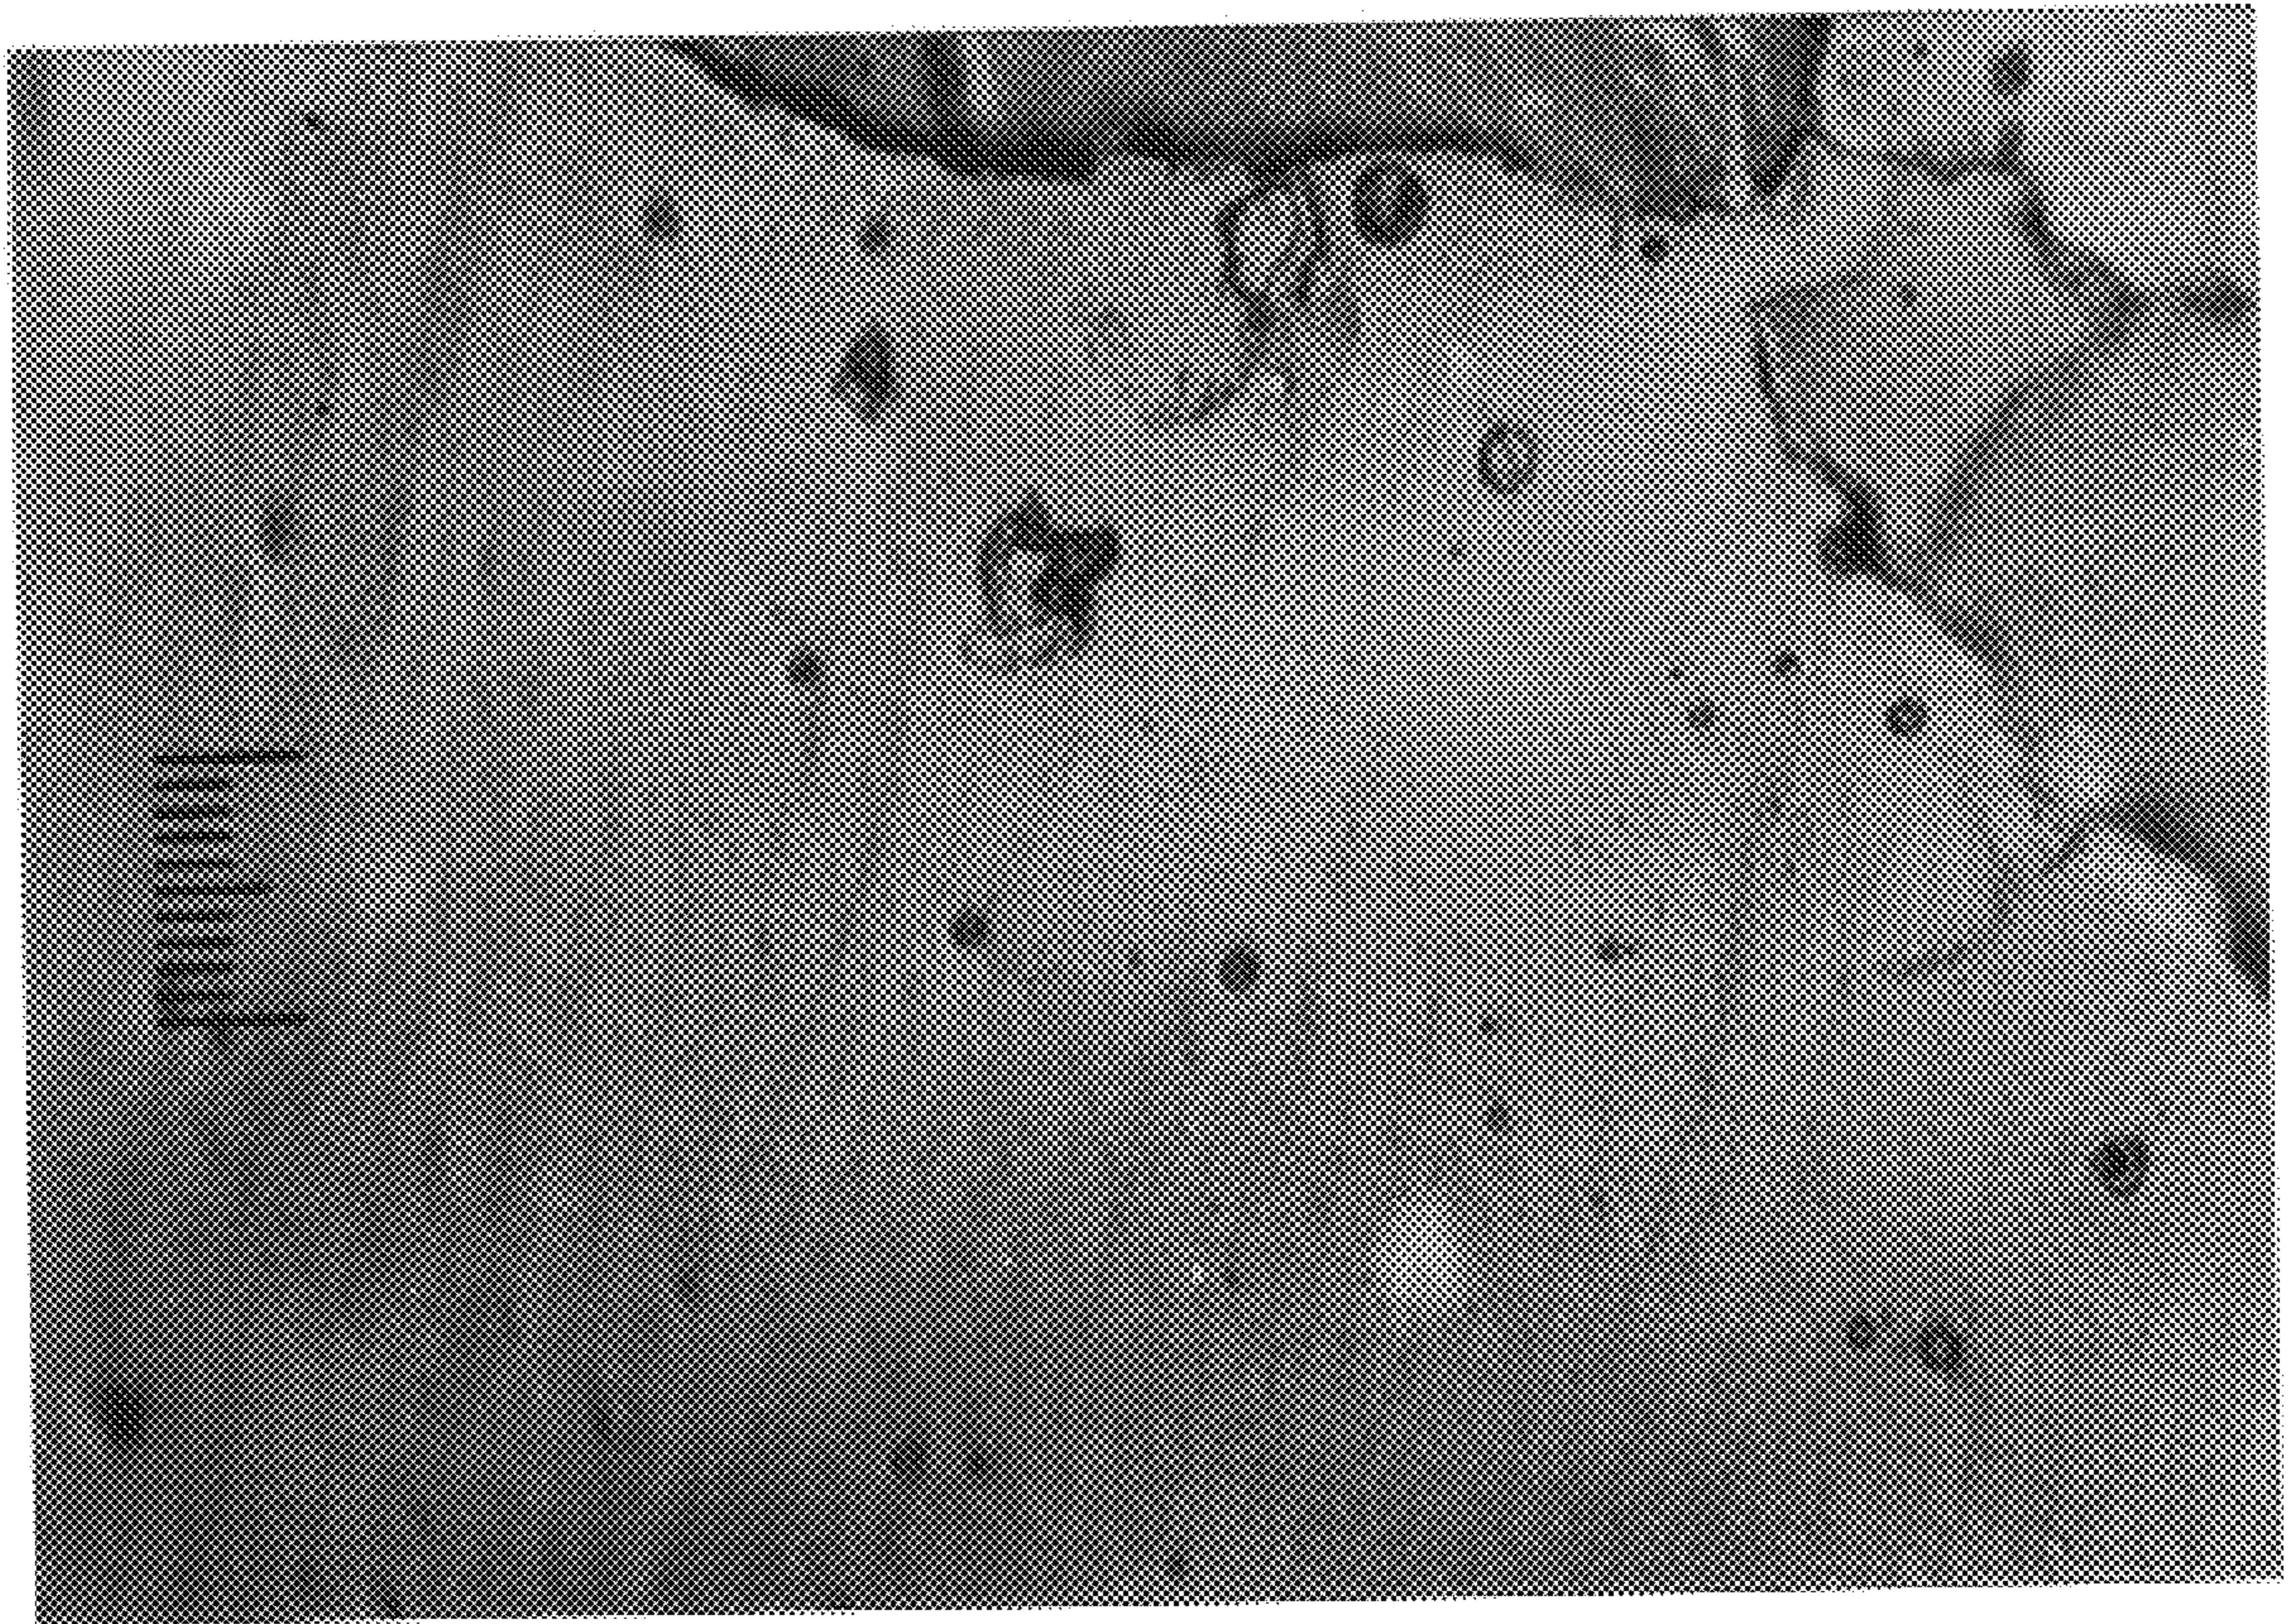
FIG. 15 is an optical image of Sample 3 at 500 \times .

There are an estimated 25 voids, identified over a 0.1 cm^3 volume, which equates to a density of approximately 250 voids/ cm^3 . FIG. 15 represents a freeze fracture surface of a lateral cross-sectional cut. With the scale of 1½ cm, it is estimated that the smallest void is about 2 microns and the largest is about 8 microns.

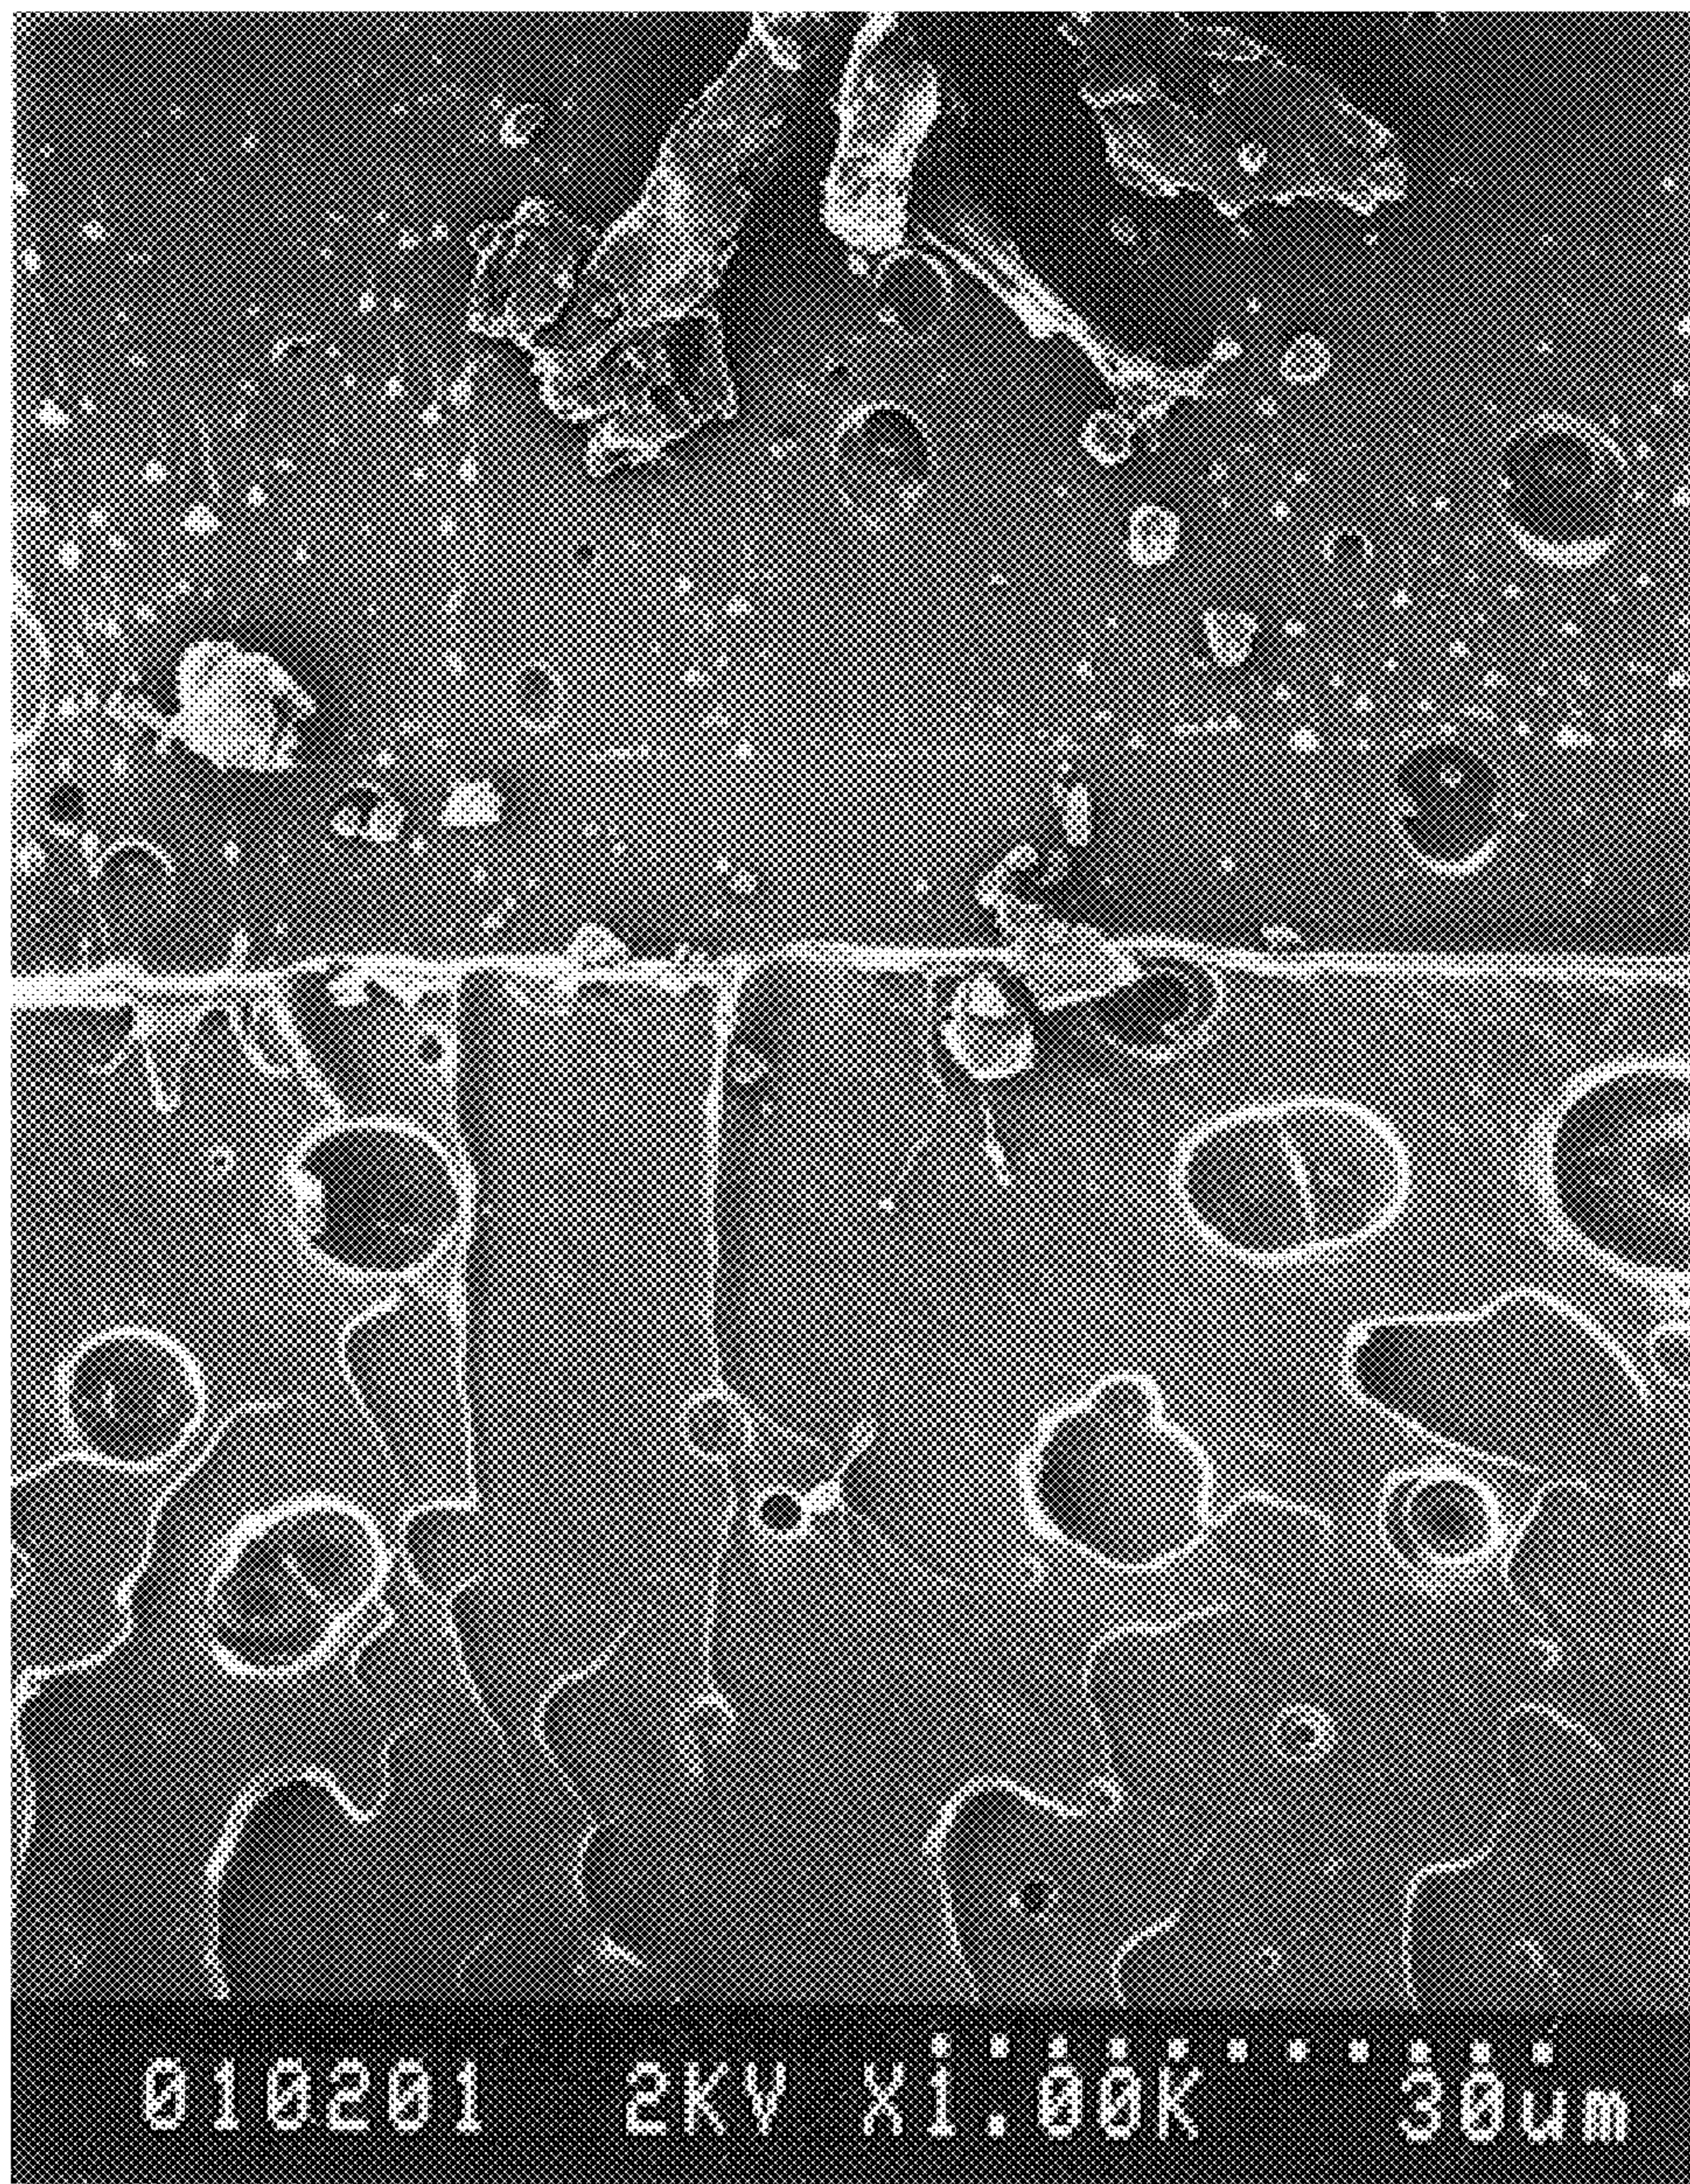
FIG. 16 is a scanning electron microscopic image of Sample 1 at 1000 \times .

An estimated 33 spherical voids are identified over a $0.05\ \text{cm}^3$ volume, which corresponds to a density of about 660 voids/ cm^3 . FIG. 16 represents a longitudinal cross-sectional cut. The top portion is smoother since it is cut with a razor blade. The bottom portion is a freeze-fracture. The scale at the lower right of the micrograph is $30\ \mu\text{m}$. The smallest void identified is about 0.5 micron, while the largest void is estimated to be 12 microns.

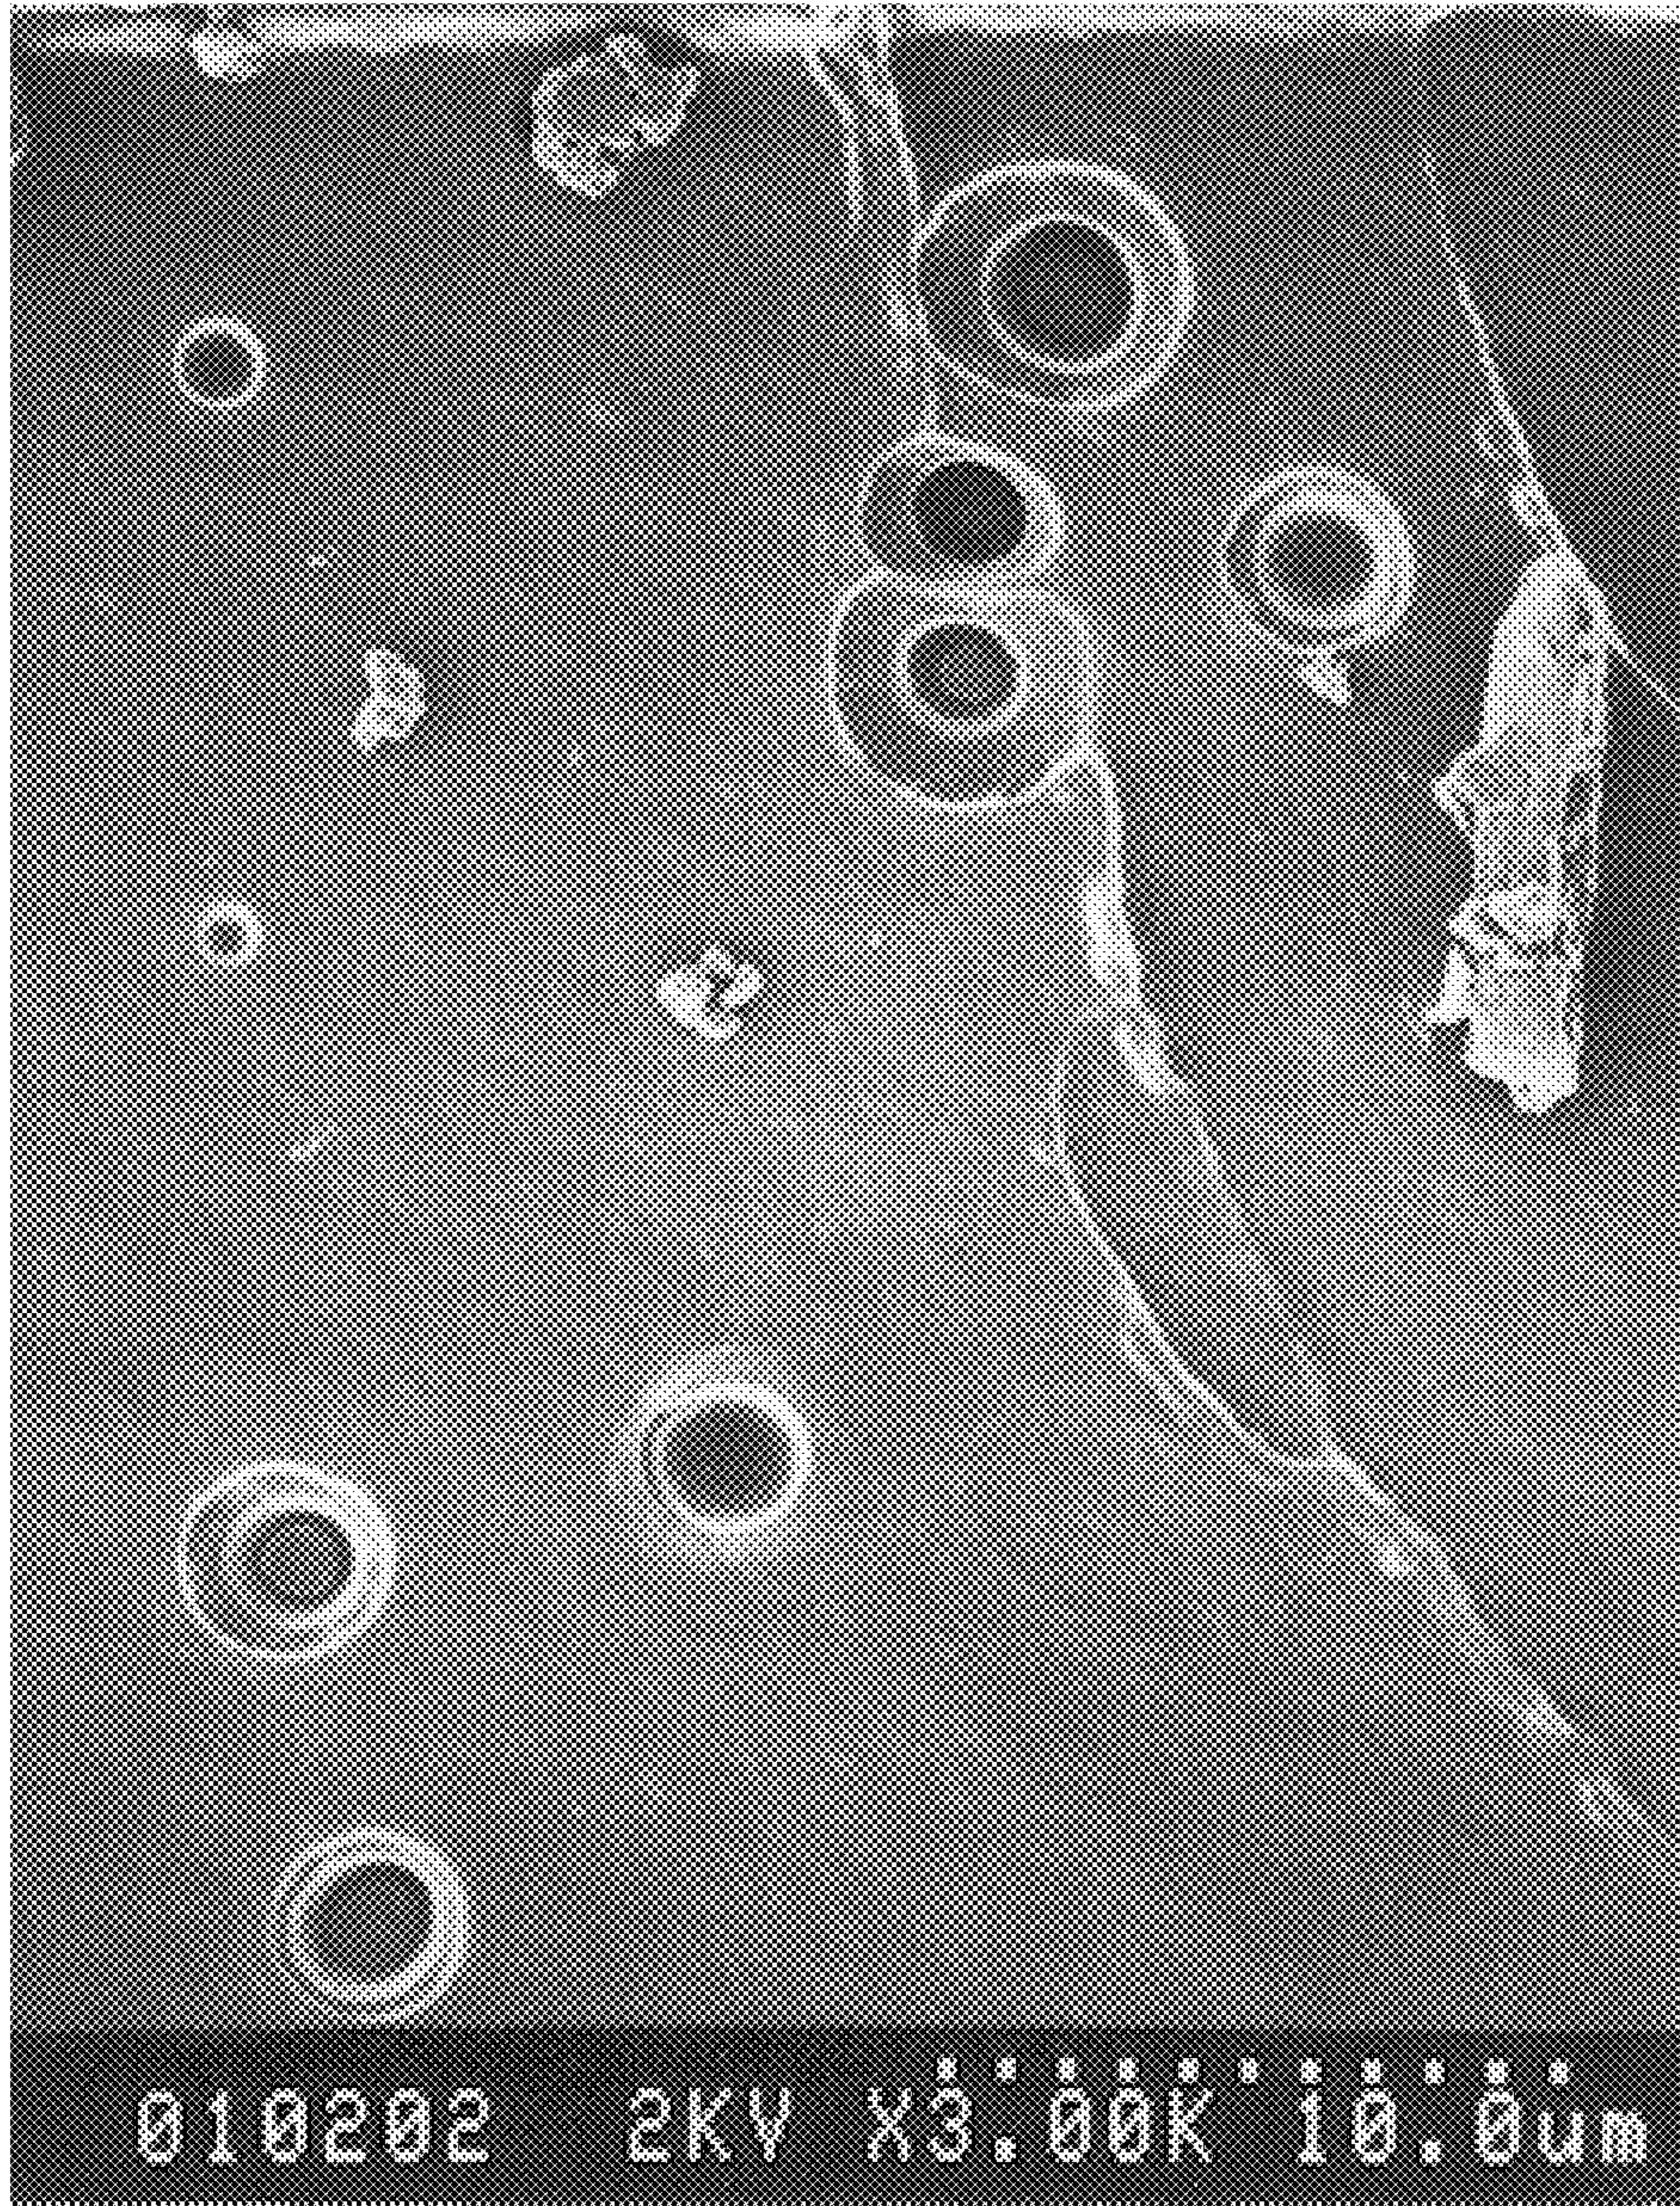
FIG. 17 is a scanning electron microscopic image of Sample 1 at 3000 \times .

An estimated 9 spherical voids are identified over a $0.03\ \text{cm}^3$ volume, which corresponds to a density of about 300 voids/ cm^3 . FIG. 17 depicts a freeze-fracture surface of a longitudinal cross-sectional cut. The circular anomalies inside the voids were examined with a high (i.e., $15000\times$) magnification. Nothing internally was revealed in the void. With a scale of $10\ \mu\text{m}$, the smallest void identified is about 2 microns; the largest void is estimated to be 4.5 microns.

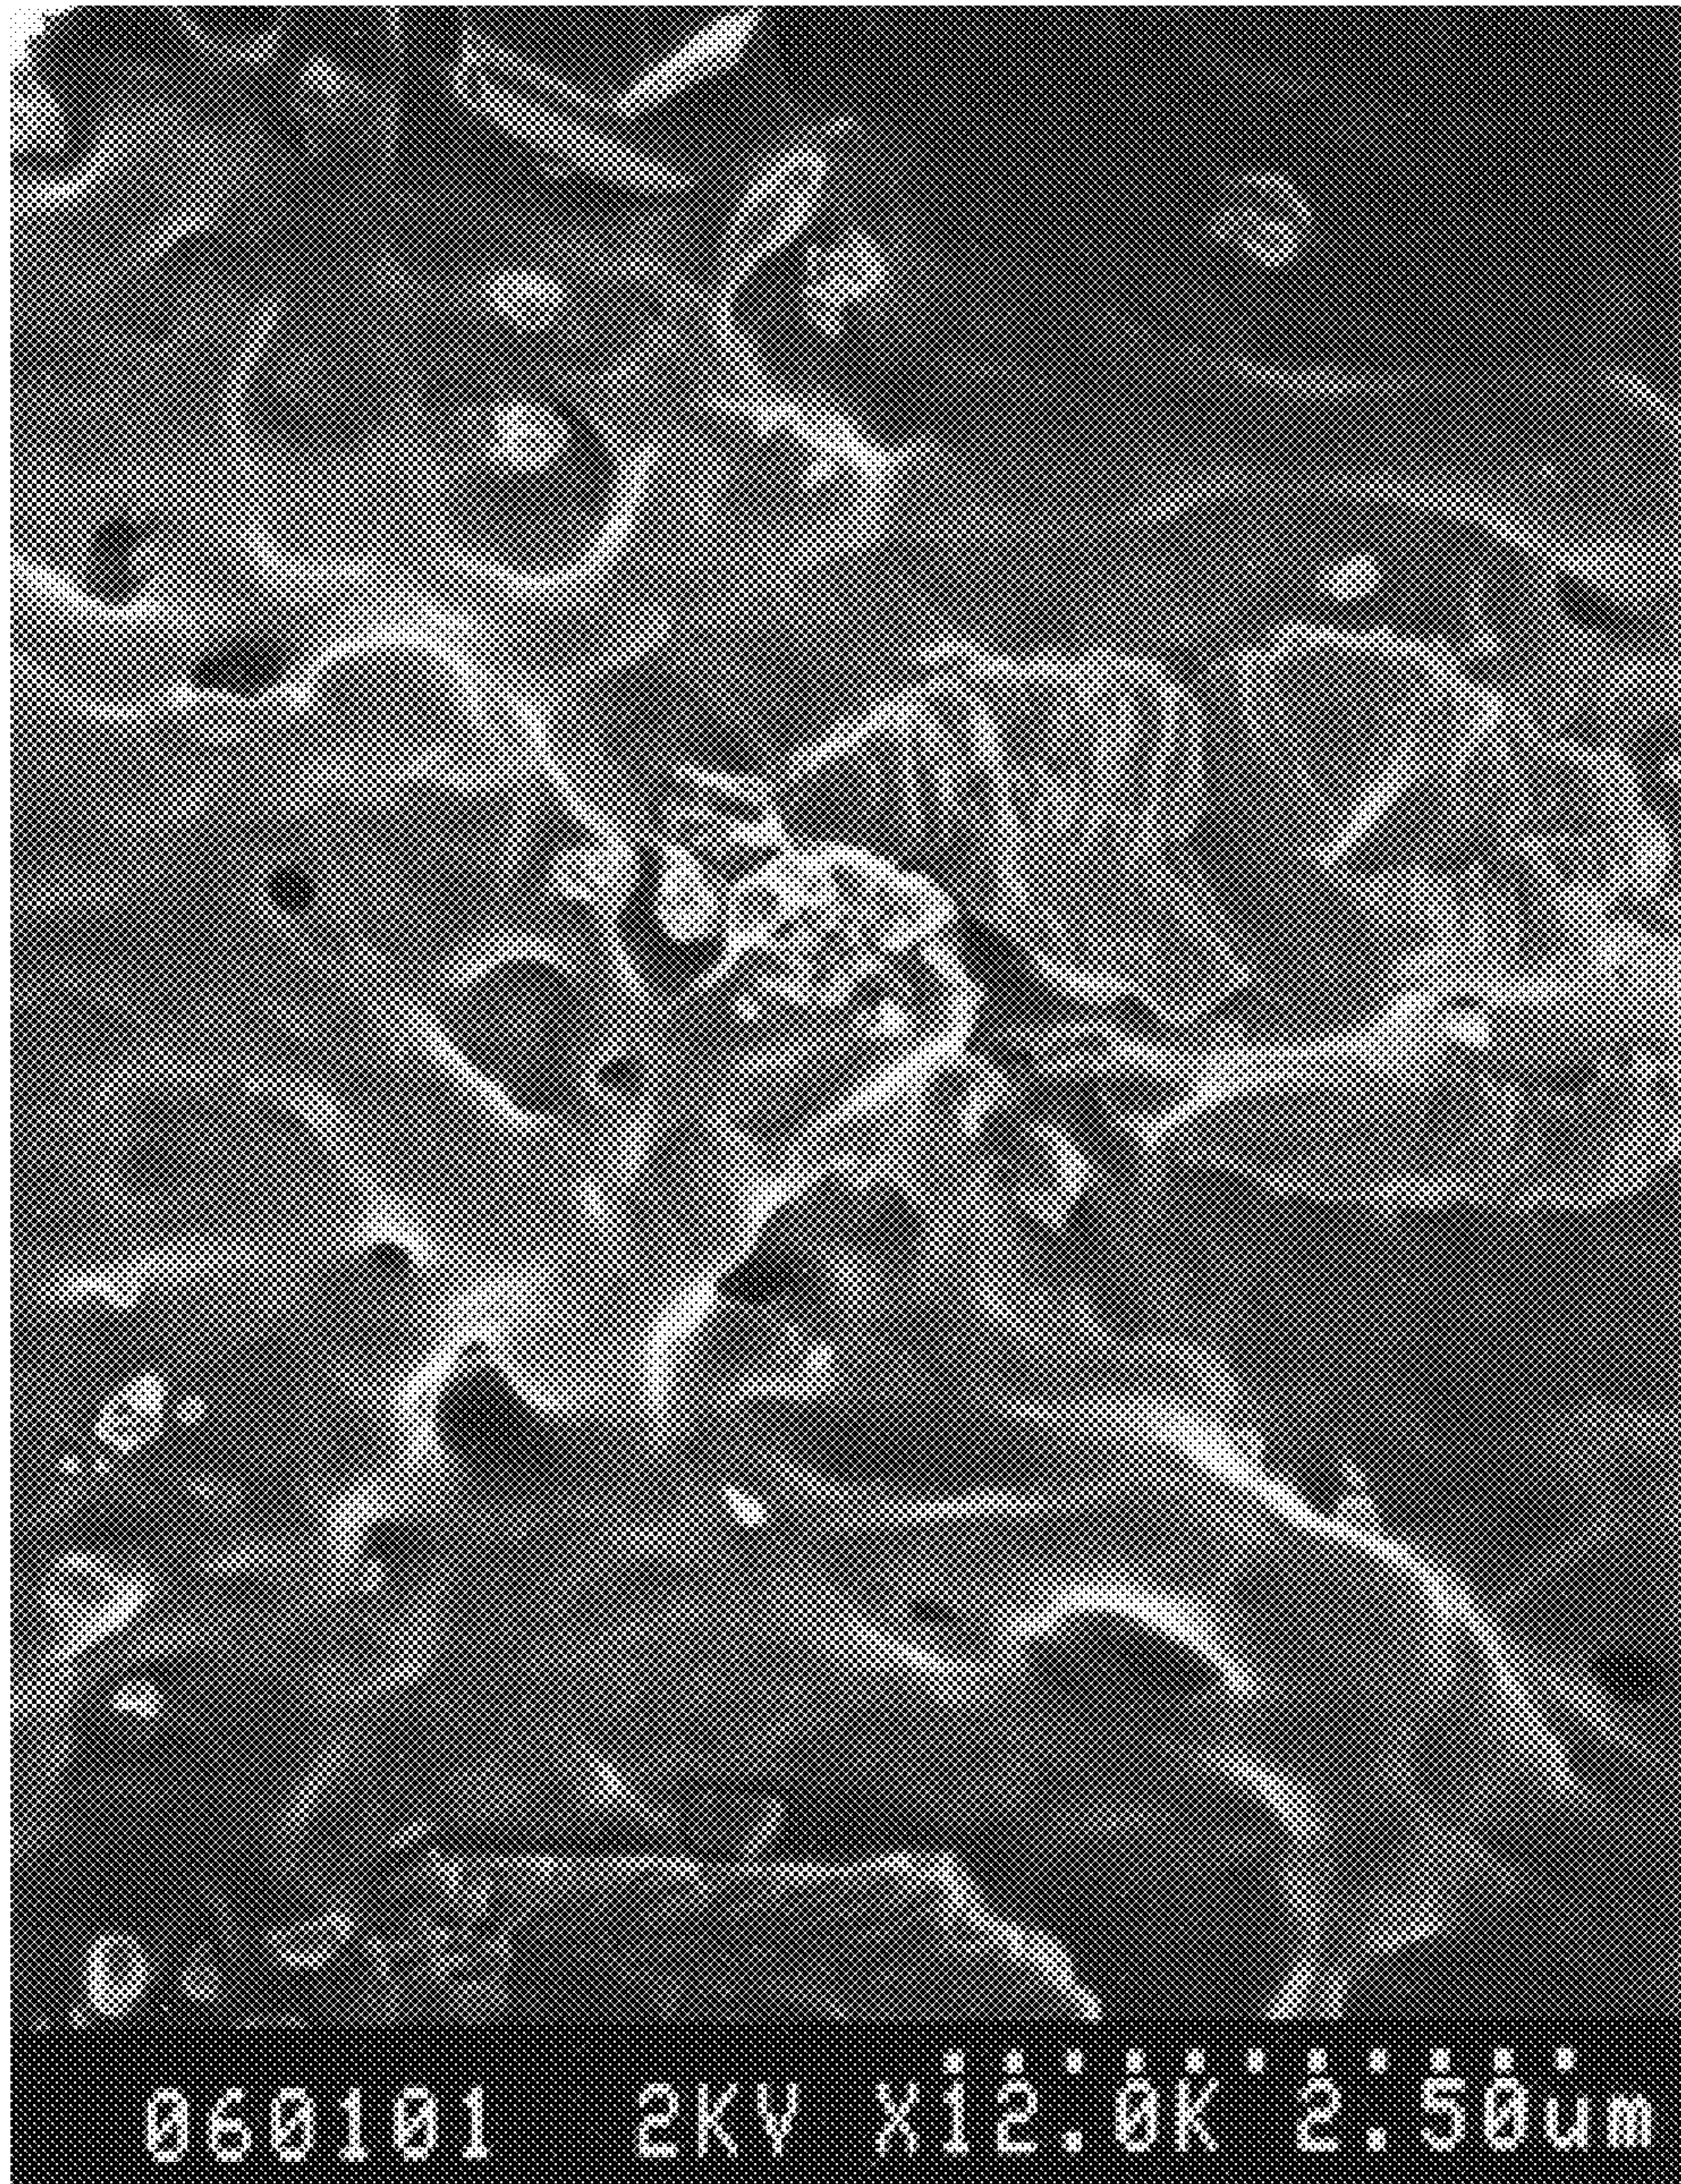
FIG. 18 is a scanning electron microscopic image of Sample 6 at 12000 \times .

An estimated 12 spherical voids are identified over a $0.004\ \text{cm}^3$ volume, which relates to a density of approximately 3000 voids/ cm^3 . FIG. 18 illustrates a freeze-fracture surface of a lateral cross-sectional cut. The smallest void identified with a scale of $2.5\ \mu\text{m}$ is about 0.3 micron. The largest void is estimated to be 0.5 micron.

areas of Sample 1. FIG. 18 shows entire spherical-shaped cavities grouped in a pattern in Sample 6. FIGS. 19 and 20 show much smaller cavities in a grouped pattern in Sample 8. The fact that void size is smaller in the new cable insulator supports the theory that void size increases with age. However, other possible causes of smaller void sizes include improved manufacturing processes and addition of fillers in the insulation material.
